The Present Status of the Bevatron Power Supply

THE PRESENT STATUS OF THE BEVATRON
POWER SUPPLY

UCRL-8345 Rev.
Particle Accelerators
and High-Voltage Machines

November 1, 1958

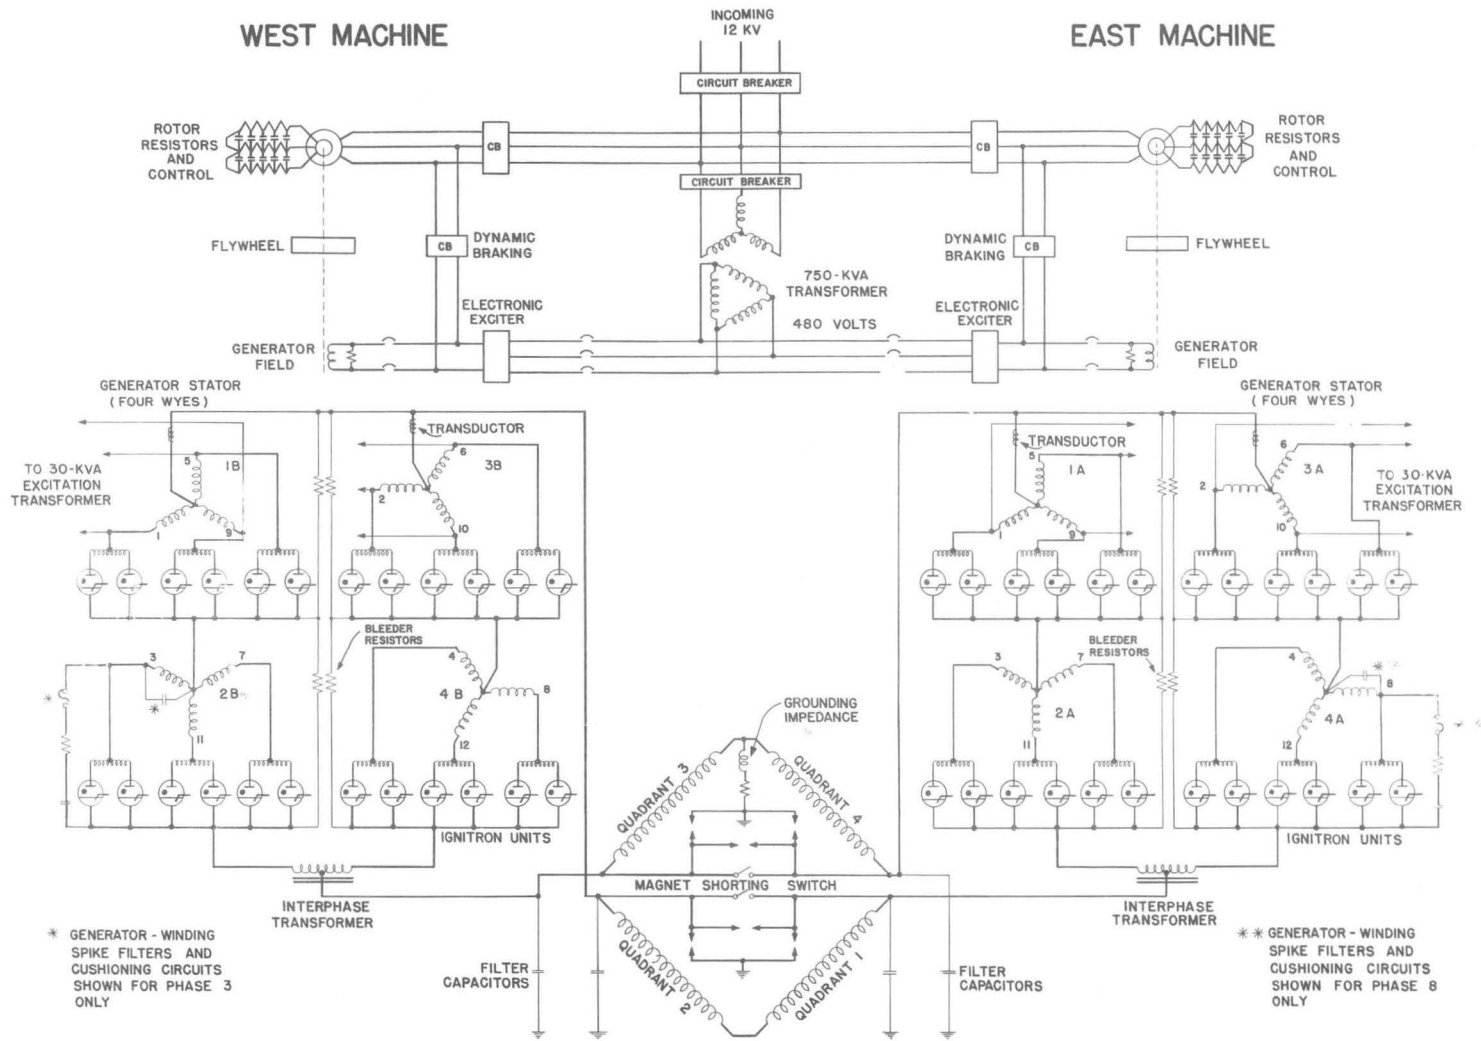
MUB-257

The primaries of the peaking transformers are cross-connected between parallel branches (Fig. 1b). The peaking transformers for 1A are fed from 3A, etc. This was done to try to equalize the currents through the two parallel branches of the machine. It is surmised that with this cross-connection, commutation notching will advance the peakers of the light current branch and thereby provide a feedback effect to balance the branch currents.

Certain ignitron control circuits require generator frequency power. This power is provided by four 30-kva, 3-phase transformers connected to the generator bus, two on each generator. These transformers are equipped with motor-driven tap changers for voltage control. The voltage regulator maintains 270 volts on the secondary by adjusting the generator-terminal voltage. Fused disconnects provide primary protection. There is a 30° phase difference between the two transformers on each generator (Fig. 1b).

Fig. 1b. Bevatron power supply and magnet: simplified diagram.

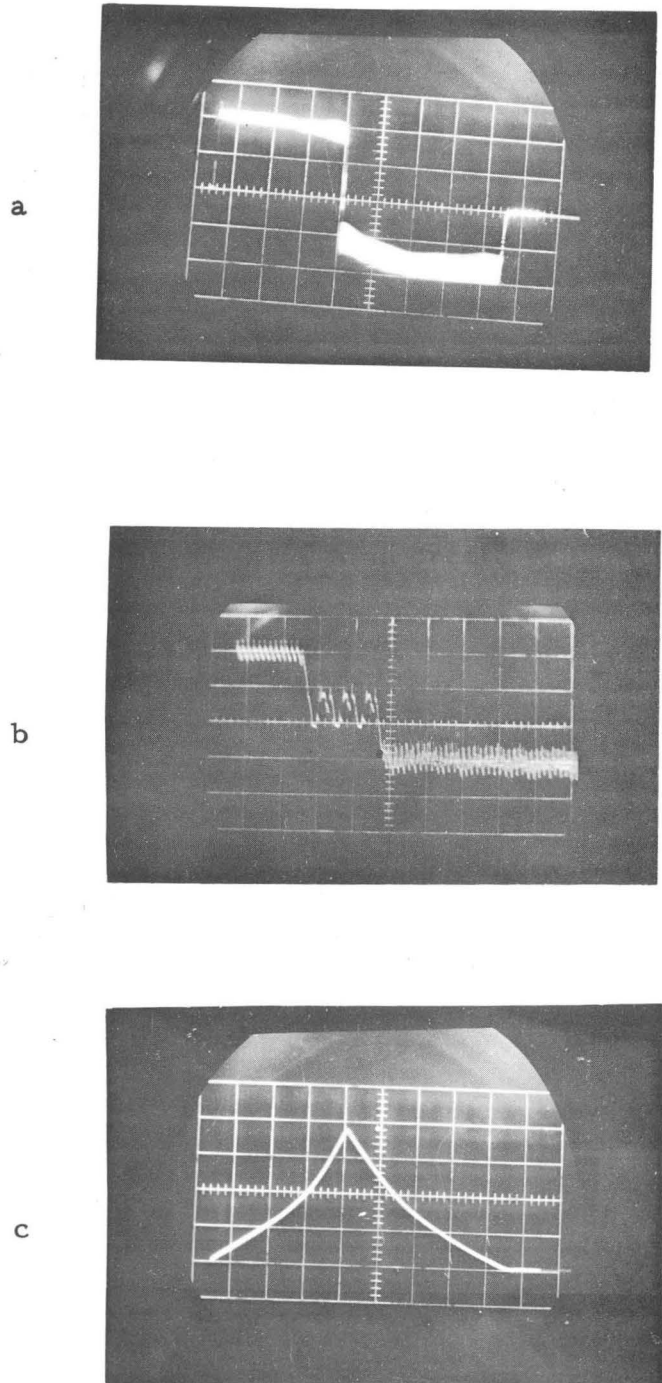
Fig. 9. Single pulse of Bevatron magnet, showing voltage and current wave shapes: (a) magnet voltage during rectification and inversion; (b) magnet voltage at change-over; (c) magnet current--8400 amp crest.

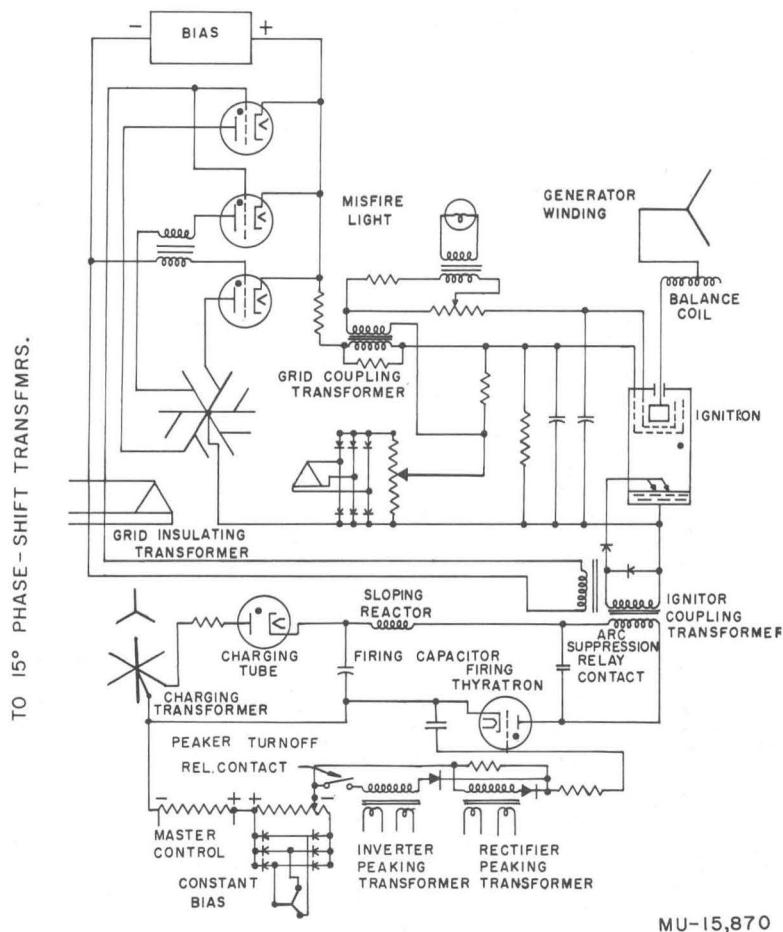
The IPJ-7 ignitron has two grids, an inner and an outer grid (Fig. 10). The outer grid must conduct reliably with sufficient current to insure that the tube does not extinguish, particularly at light anode currents. Likewise, the inner grid must be positive and conduct for more than 60 degrees to insure that two ignitrons in series will be picked up.

The voltage applied to the outer grid is obtained from the respective generator. This voltage is distorted by commutating notches (Fig. 13). The nominal sine wave form is hardly recognizable during inversion. To improve the voltage for firing the grids, banks of transformers (Fig. 10) were interposed between generators and ignitron grid circuits to introduce a 15° phase shift. Later a bank of transformers giving a 25% boost (from 60 to 75 volts rms at the grids) was installed between the grid transformers and the 15°-phase-shift transformer bank.

Fig. 10. Bevatron ignitron converter-excitation circuits.

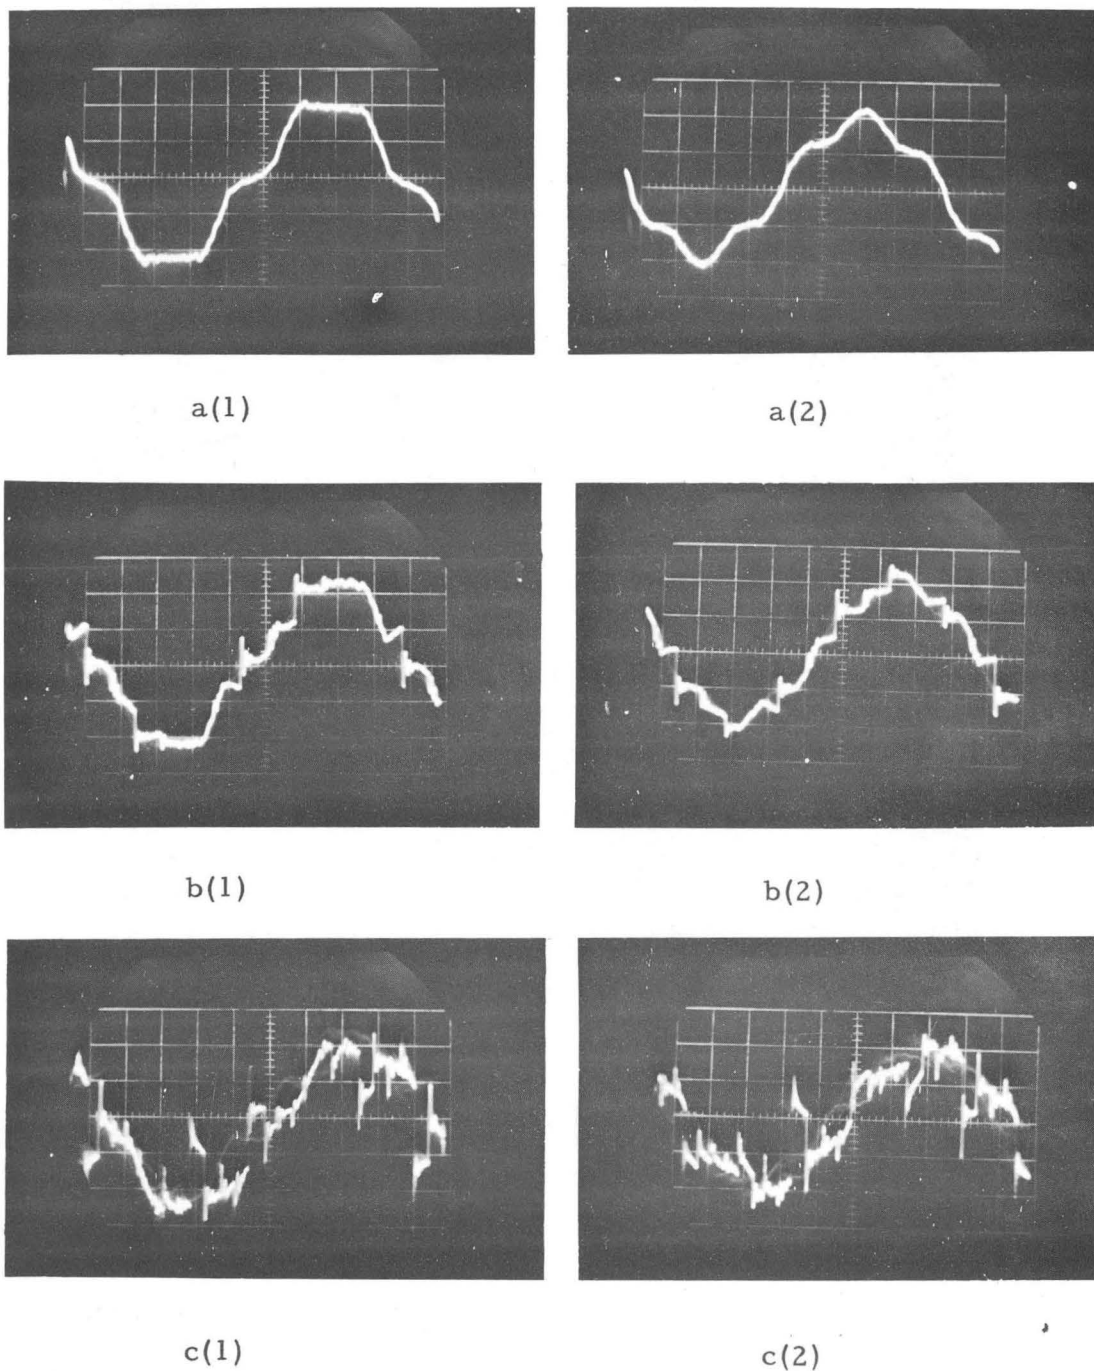
Fig. 13. Generator voltages: (a) no load--(1) phase to neutral, (2) phase to phase; (b) rectification--(1) phase to neutral, (2) phase to phase; (c) inversion--(1) phase to neutral, (2) phase to phase.

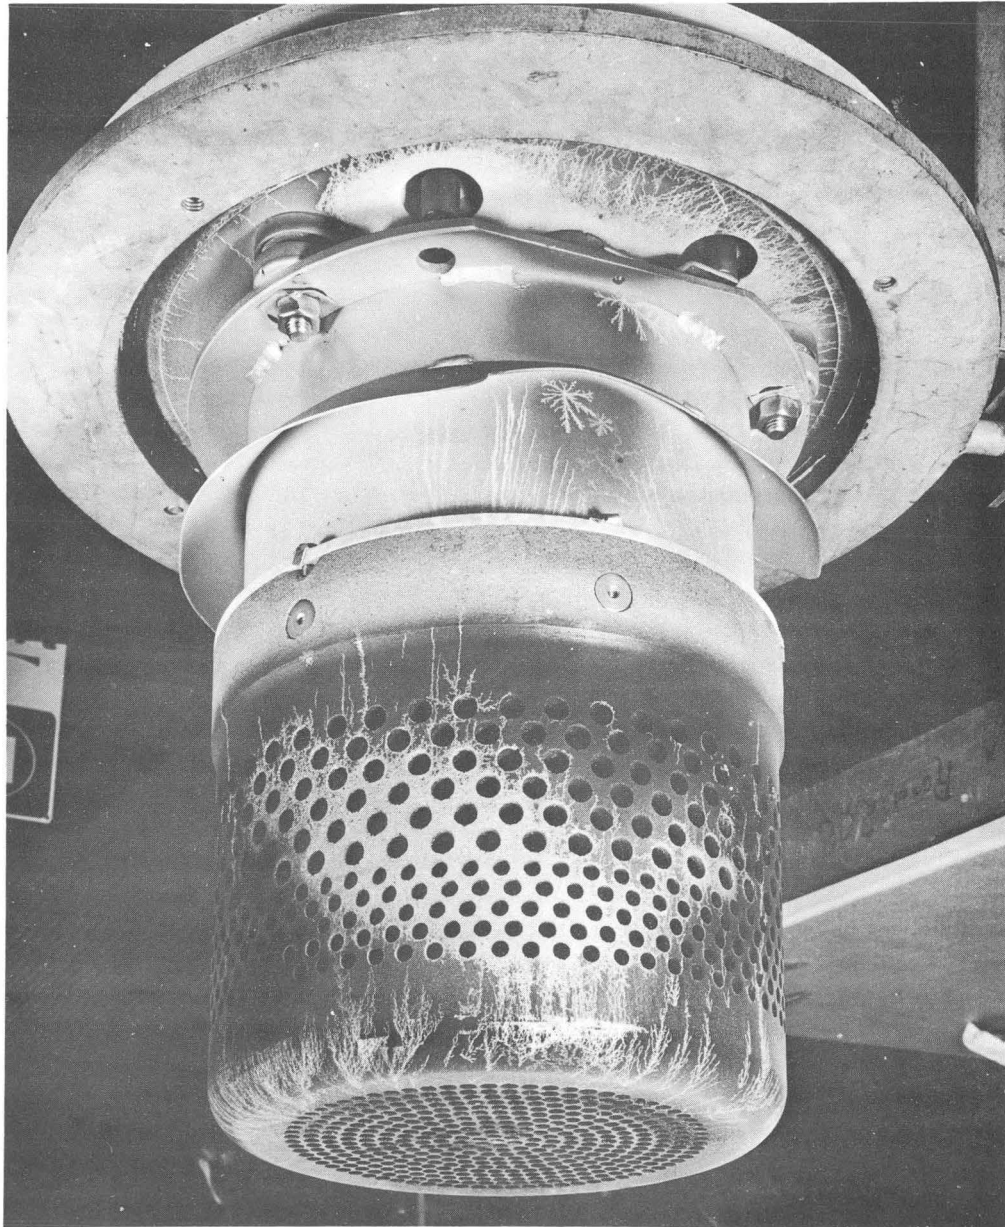
ZN-2002

Fig. 15a. Interior parts of ignitron: outer graphite grid.

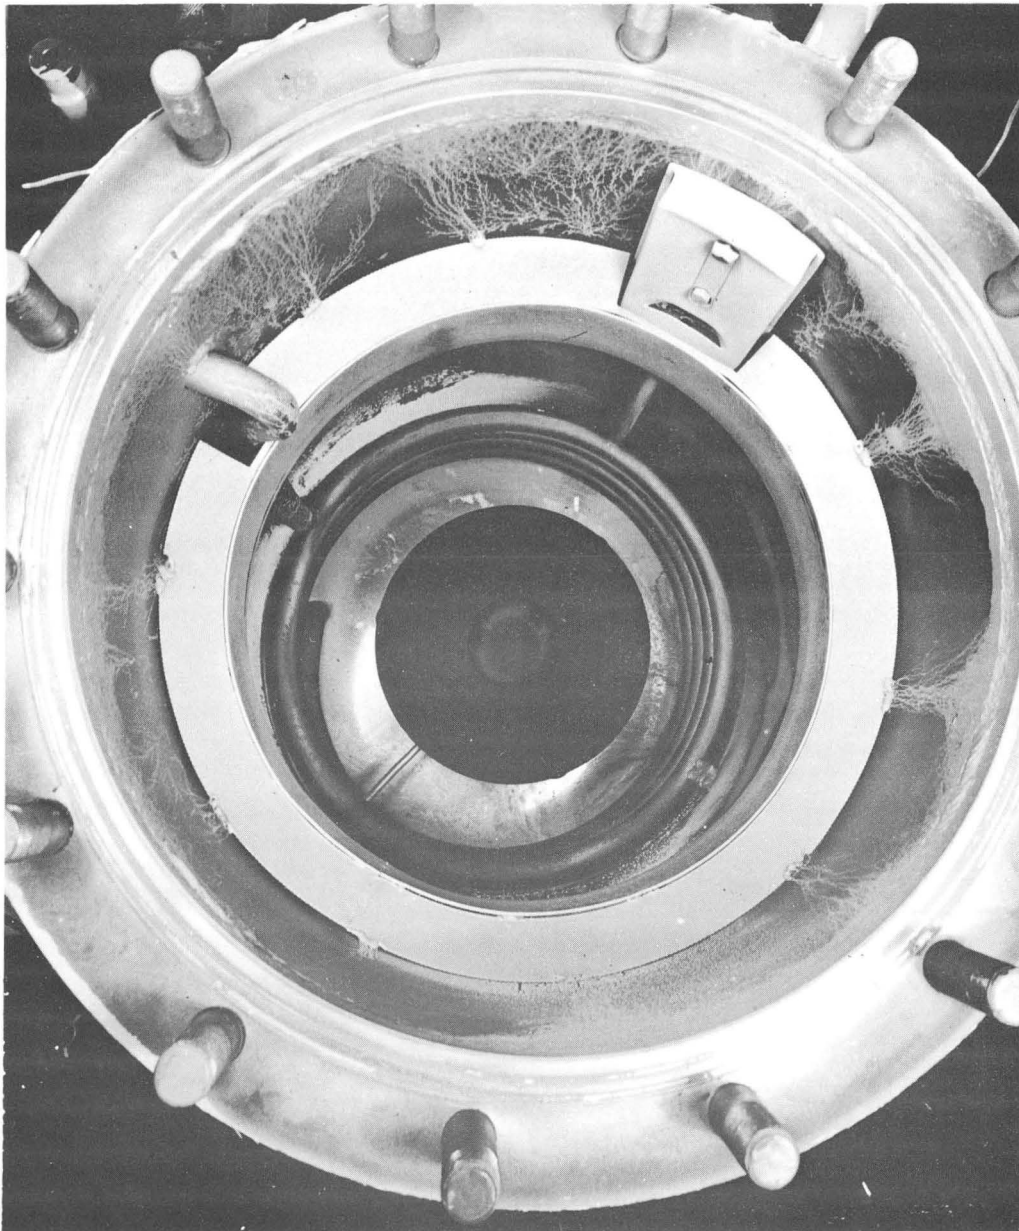
ZN-2003

Fig. 15b. Interior parts of ignitron: ignitron tank, showing cooling coils and blast bubble at center and vacuum connection at upper right.

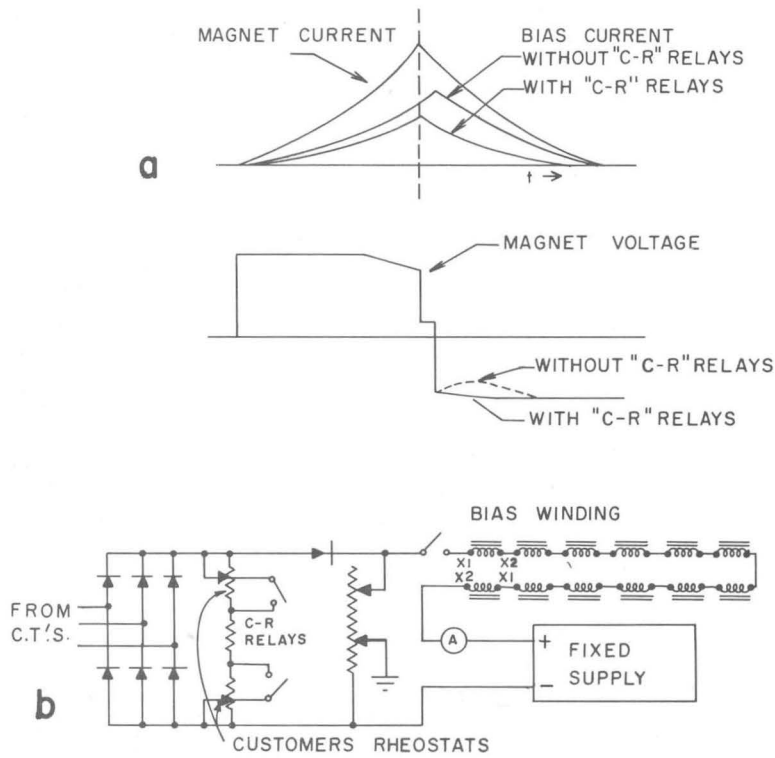
MU-15,869

Figure 17 shows the effect the "C-R" relays have on the signal current and the resultant effect on the converter dc counter voltage.

Fig. 17. Customer's rheostat: (a) effects of c-r relays on current and voltage; (b) schematic of c-r rheostat and relays circuit.

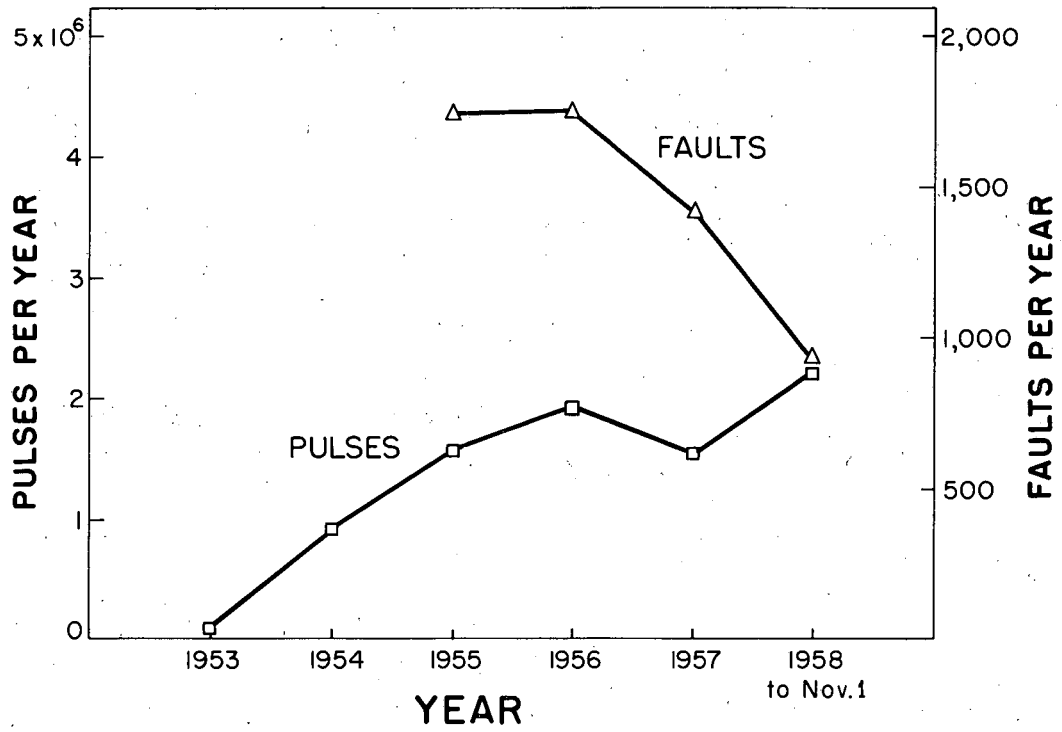
MU-16397

Most of the power-supply electrical apparatus is interconnected in such a manner that failure of but one small component can stop magnet pulsing. The power supply has already been pulsed eight million times. The next eight million pulses should occur within a much shorter period (Fig. 19). To accomplish this will require increased maintenance. For some apparatus, such as the high-voltage rectifiers, good preventive maintenance checks have yet to be found.

Figure 19 indicates the increasing number of pulses per year produced by the Bevatron. This increase reflects both the longer operating hours and the improvements in the over-all accelerator. From the standpoint of the power supply the most frequent and elusive trouble, the inversion arc-through, has been greatly reduced. This is indicated by the number of pulses per fault, which has increased from about 1000 to 7000 during the past year. There now remains the task of making these standard power-supply components withstand up to five million pulses per year.

Fig. 19. Bevatron pulses and faults by year.
