Post-breach Monitoring of a Natural Beaver Dam on French Creek

Final Draft: Post-breach Monitoring of a Natural Beaver Dam on French Creek

Kendyl Bree and Eleanor Beshlian

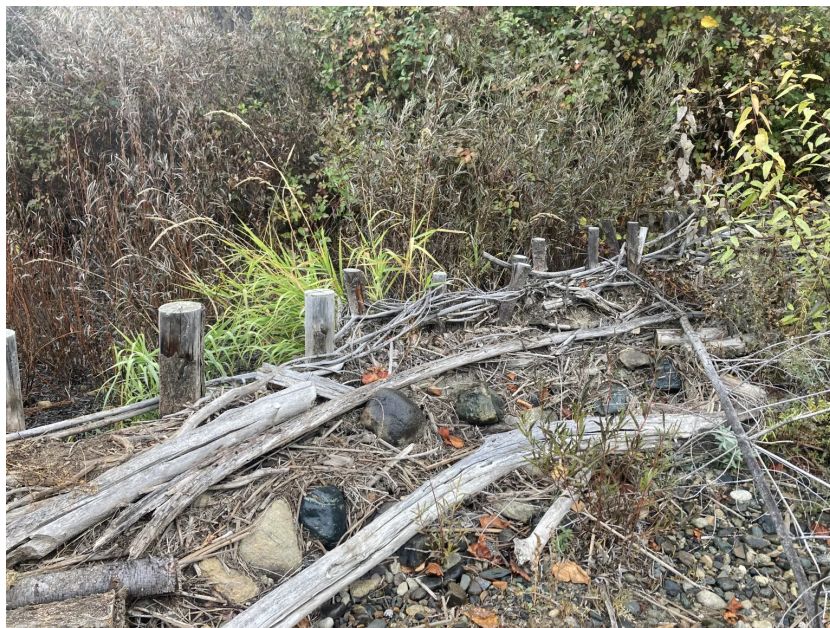
In 2021, high flows led to a breach in the natural beaver dam at the French Creek site (C. Gilmore, Scott River Watershed Council, personal communication, October 2023). The beavers are now rebuilding the damaged dam, though water still flows through the breach (Figure 1). We performed this research the week before the Scott River Watershed Council planned to repair the breach with the installation of vertical posts, which they hope the beavers will build upon and maintain (example pictured in Figure 2). This positions our project to provide unique insights regarding the response of the stream to the breach. Our research addresses how the channel form, groundwater levels, and sediment coarseness were impacted by the 2021 natural beaver dam breach. We hope it may serve as a baseline to inform how the later installment of vertical posts affects the system, to further show the positive impacts of BDAs on French Creek, and the entire watershed.

Figure 1. Looking upstream at the breach in the natural beaver dam on French Creek. 11/5/23, Etna, CA.

In light of the French Creek's role as a spawning ground for coho salmon, particular care should be taken in reinforcing the beaver dam so future fluxes of fine sediment such as the one we observed directly downstream of the breach may be averted.

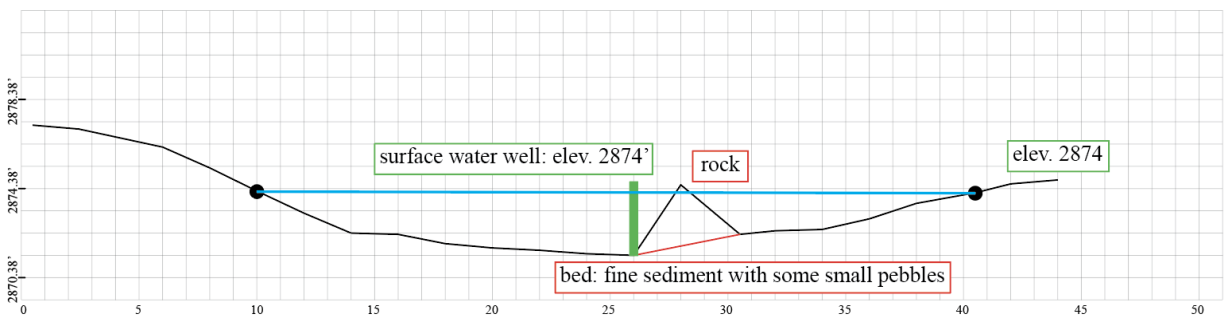
Figure 6. Cross-section 1.

The cross-sections consistently demonstrated a relatively shallow, broad channel (Figures 6, 7, 8, 9). Cross Section 3 (below the breach) featured the smallest below-water area at 19.8 ft². (Figure 8, Table 3). The shallower channel below the dam may be an indication of the impact of the fine sediment released in the breach, and also is in line with our findings on the velocity.

Survey Data Site 1: Above Breached Dam, in line with Surface Water Well

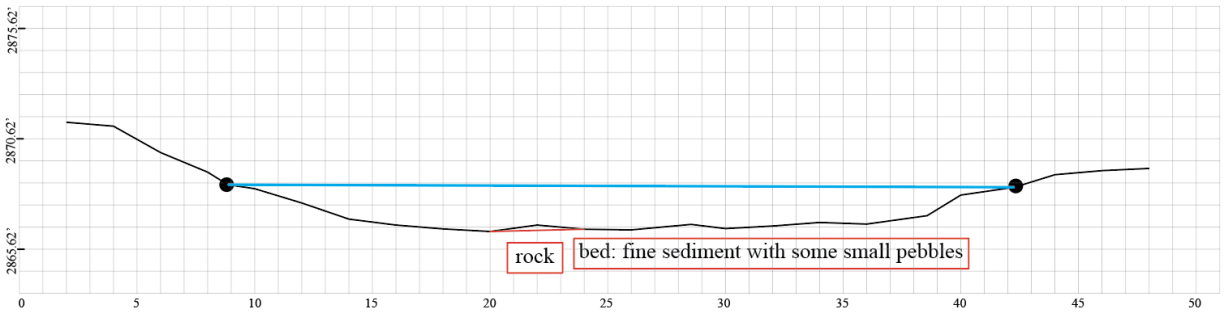
Figure 7. Cross-section 2.

Survey Data Site 2: Above Breached Dam (measures 5' from Site 1, 64'9" from Cross Section 1)

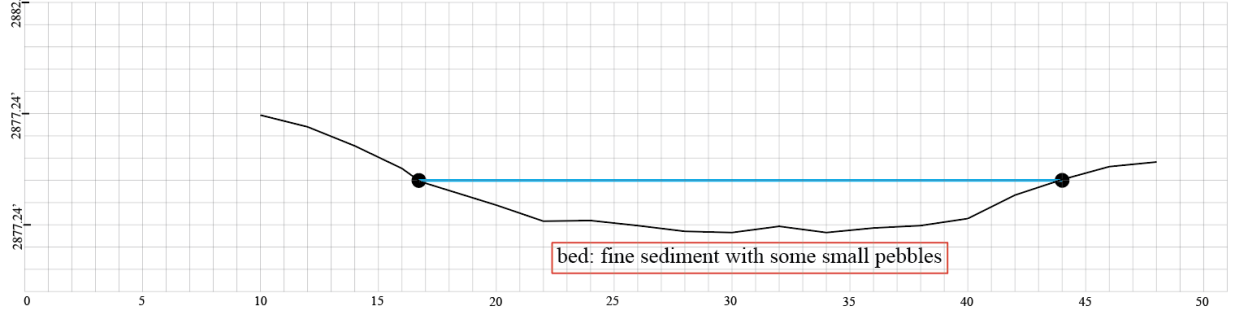
Figure 9. Cross-section 4.

Survey Data Site 4: Above Groundwater Well (height of 4.92', BS point measures 5.12', 31'9" from well)
