U.S.—Japan Seminar on Seismic Disaster Mitigation in Urban Area by Geotechnical Engineering June 26-27, 2002 Anchorage, Alaska

#### An Overview of the Great Alaska Earthquake of 1964

by S. J. Brandenberg<sup>1</sup>, & I. M. Idriss<sup>2</sup>

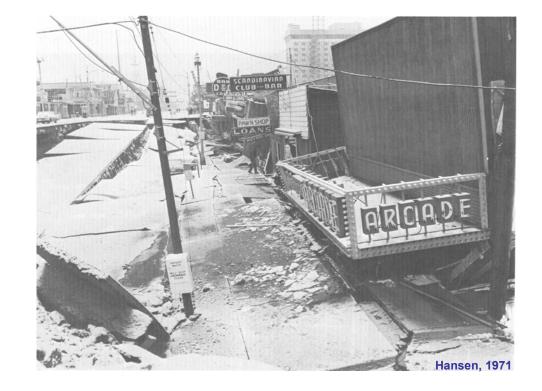
A number of landslides occurred in the Anchorage area. The government hill slide north of ship creek impacted an elementary school. The L Street and the Fourth Avenue Slides occurred in downtown Anchorage. The Turnagain Heights slide, southwest of downtown, involved the largest ground movements of the slides in the Anchorage area. Slide 5 shows the locations and areal extent of the landslides caused by the 1964 earthquake in and around Anchorage. Slide 6 is a photo at the head of the Fourth Avenue Slide.

### Plan View of Landslides in Anchorage Area Caused by 1964 Earthquake

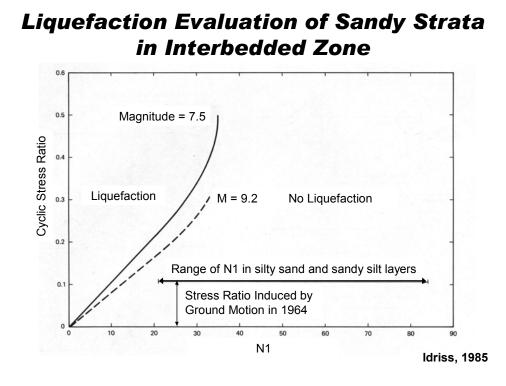
The Bootlegger Cove Clay layers in the interbedded zone are stiff to very stiff with OCR ranging from 3 to 4. Fluctuations of lake level during glaciation and subsequent drainage of the lake probably exposed the sediments to subaerial conditions, resulting in increased strength. Slide 14 shows the OCR of the Bootlegger Cove clay vs. depth below the interbedded layers. The Bootlegger Cove Clay below the interbedded zone is uniform with OCR ranging from 1.2 to 1.5. The SHANSEP (Stress History and Normalized Soil Engineering Properties) was used to evaluate the in-situ undrained shear strength of the clay. Slide 15 shows the peak undrained shear strength from direct simple shear tests performed on samples of the Bootlegger Cove clay. The normalized strength was related to the OCR by  $\frac{S_u}{\sigma^2} = 0.19 \cdot (OCR)^{0.78}$ . Slide 16 shows results of cyclic direct simple shear tests. The soil was loaded cyclically until a predetermined excess pore pressure was obtained, then it was monotonically sheared undrained shear strength. The residual strength of the clay was estimated to be about 30% of the peak undrained shear strength from results of miniature vane tests, CPT tests and direct shear tests (Idriss 1985).

**Bootlegger Cove Clay: OCR vs Depth**

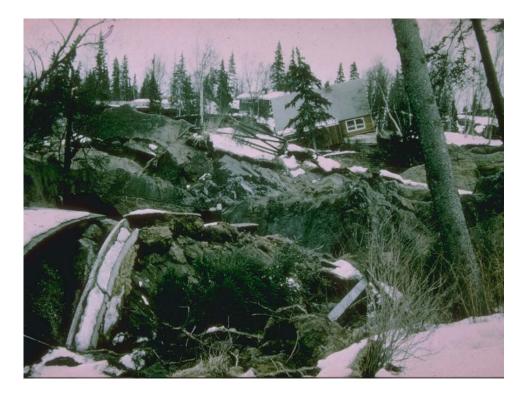
*Turnagain Heights Slide - Soil Profile Through East End of Slide Area*
