**PROCEEDINGS OF U.S.-JAPAN SEMINAR
ON SEISMIC DISASTER MITIGATION
IN URBAN AREA
BY GEOTECHNICAL ENGINEERING**

**U.S.—Japan Seminar on Seismic Disaster Mitigation
in Urban Area by Geotechnical Engineering**

An Overview of the Great Alaska Earthquake of 1964

by S. J. Brandenberg¹, & I. M. Idriss²

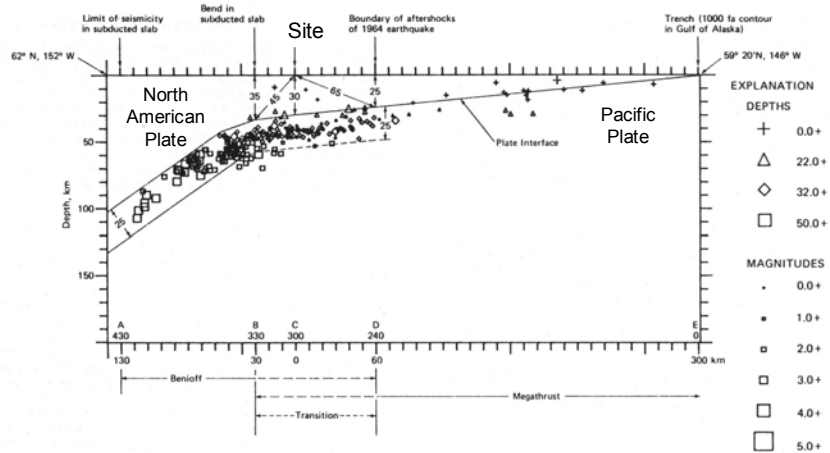
The boundary between the plates where the underthrusting occurs is a northwestward dipping subduction zone. The 1964 Alaska earthquake was a megathrust earthquake, characterized by interplate faulting on the plate interface. The length of the zone that ruptured is about 750 km (Sykes and Quittmeyer, 1981) and the width that ruptured is estimated from 200 km (Sykes and Quittmeyer, 1981) to 360 km (Davies and House, 1979). Slide 4 shows a cross

Cross-Section of Subduction Zone Relative to Anchorage

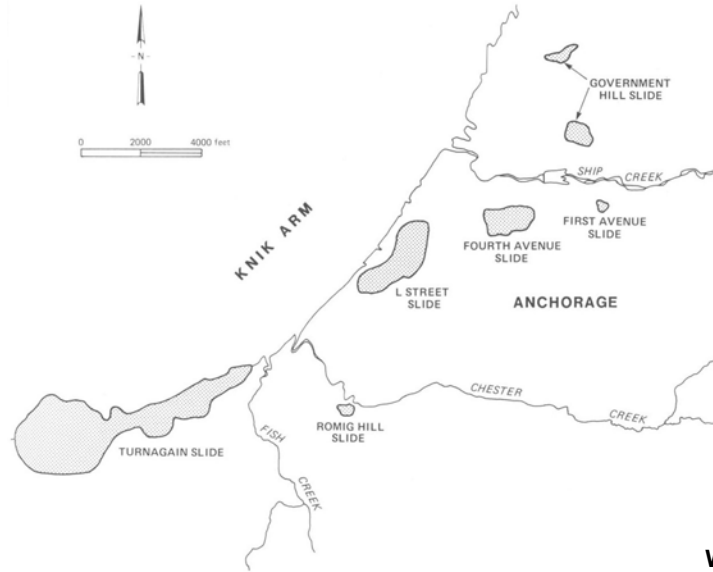
A number of landslides occurred in the Anchorage area. The government hill slide north of ship creek impacted an elementary school. The L Street and the Fourth Avenue Slides occurred in downtown Anchorage. The Turnagain Heights slide, southwest of downtown, involved the largest ground movements of the slides in the Anchorage area. Slide 5 shows the locations and areal extent of the landslides caused by the 1964 earthquake in and around Anchorage. Slide 6 is a photo at the head of the Fourth Avenue Slide.

Plan View of Landslides in Anchorage Area Caused by 1964 Earthquake

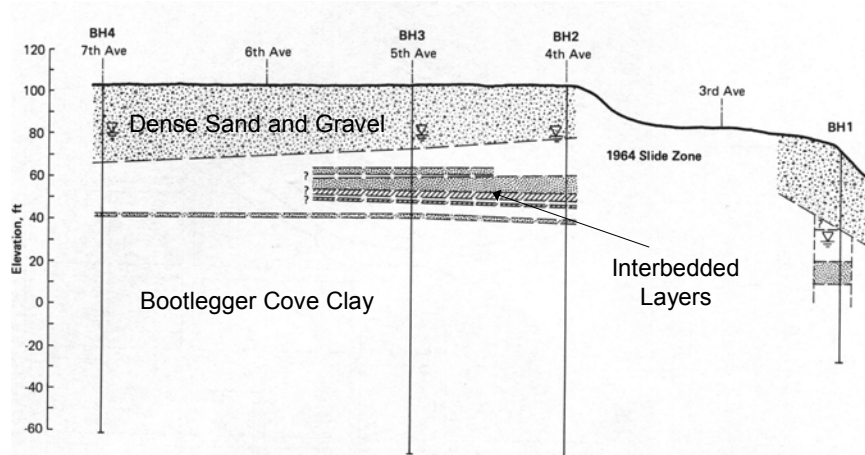
Slide 11

Soil Conditions from 1982 Subsurface Investigation

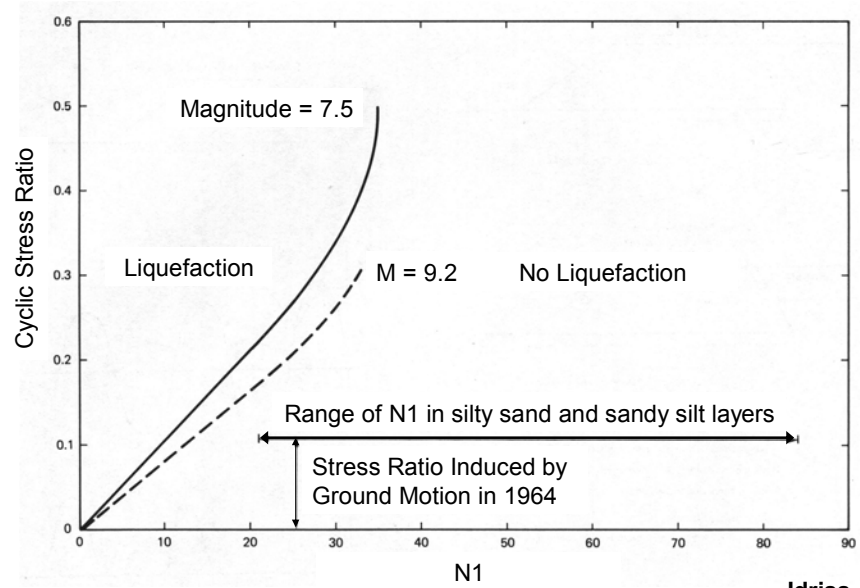
Slide 13

minimum factor of safety against liquefaction was 1.6, which indicates that liquefaction of these soils was unlikely during the 1964 earthquake (Idriss 1985).

Liquefaction Evaluation of Sandy Strata in Interbedded Zone

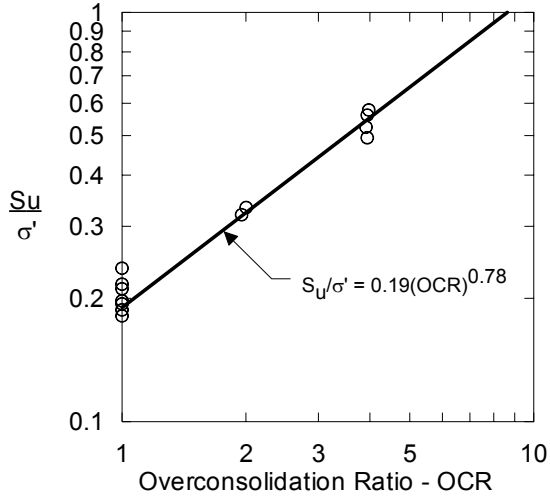
The Bootlegger Cove Clay layers in the interbedded zone are stiff to very stiff with OCR ranging from 3 to 4. Fluctuations of lake level during glaciation and subsequent drainage of the lake probably exposed the sediments to subaerial conditions, resulting in increased strength. Slide 14 shows the OCR of the Bootlegger Cove clay vs. depth below the interbedded layers. The Bootlegger Cove Clay below the interbedded zone is uniform with OCR ranging from 1.2 to 1.5. The SHANSEP (Stress History and Normalized Soil Engineering Properties) was used to evaluate the in-situ undrained shear strength of the clay. Slide 15 shows the peak undrained shear strength from direct simple shear tests performed on samples of the Bootlegger Cove clay. The normalized strength was related to the OCR by $\frac{S_u}{\sigma'_v} = 0.19 \cdot (OCR)^{0.78}$. Slide 16 shows results of cyclic direct simple shear tests. The soil was loaded cyclically until a predetermined excess pore pressure was obtained, then it was monotonically sheared undrained to failure. At $r_u = 0.9$, the strength of the clay was found to be 70% to 75% of the peak undrained shear strength. The residual strength of the clay was estimated to be about 30% of the peak undrained shear strength from results of miniature vane tests, CPT tests and direct shear tests (Idriss 1985).

Bootlegger Cove Clay: DSS Test Results

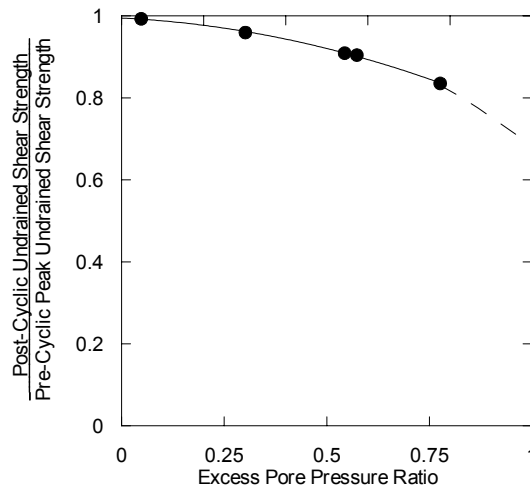
Slide 16

Bootlegger Cove Clay: Cyclic DSS Test Results

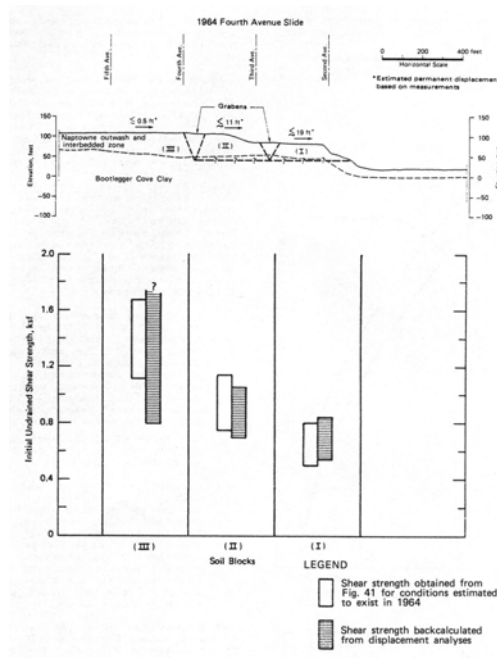
A Newmark sliding block analysis was performed to determine whether the movements measured at the Fourth Avenue slide could be attributed to undrained failure of the Bootlegger Cove clay. Slide 17 shows the undrained shear strength vs. ground displacement that was used in the analysis. For ground displacements less than ½ ft, the peak undrained shear strength was used, and was decreased with each cycle to account for the influence of excess pore pressure. When ground displacements exceeded ½ ft, the residual strength was used. The peak undrained shear strength was varied until displacement from the analysis matched the measured displacement for each soil mass. Slide 18 shows the undrained shear strength from displacement analysis compared with the undrained shear strength estimated to have existed in 1964. There is good agreement between the undrained shear strengths, indicating that the Fourth Avenue slide was caused by undrained failure of the Bootlegger Cove clay (Idriss 1985).

Results of Newmark Sliding Block Analysis

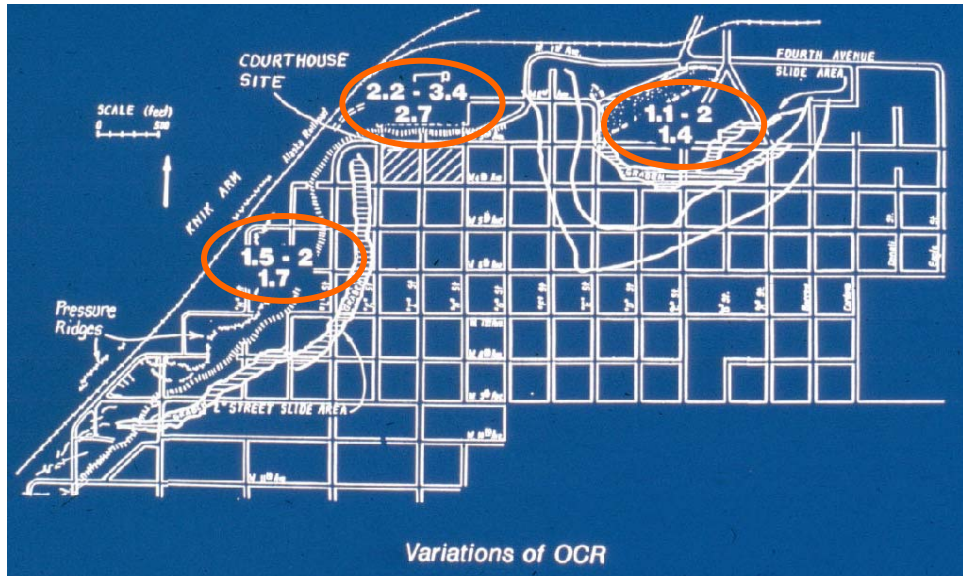
Slide 19

The Fourth Avenue Slide and the L Street Slide both involved significant soil movement, and were separated by a zone of no appreciable movement in 1964. The bluff area at the northwest corner of downtown near the courthouse did not slide during the 1964 earthquake. The OCR of the Bootlegger Cove Clay in this region ranged from 2.2 to 3.4 with an average of 2.7. In contrast, the average OCR at the Fourth Avenue slide was 1.4, and at the L Street slide was 1.7 (Idriss 1985, Moriwaki et al 1989, Woodward-Clyde Project files for the courthouse study). The variation of OCR at the three locations is shown in Slide 19. The higher undrained shear at the courthouse site (relative to the Fourth Avenue slide and L Street slide areas) was sufficient to prevent sliding in 1964.

Bootlegger Cove Clay: Variation of OCR with Location in Anchorage
