Saeltzer Dam Removal on Clear Creek 11 years later: An assessment of upstream channel changes since the dam's removal

Saeltzer Dam Removal on Clear Creek

11 years later: An assessment of upstream channel changes since the dam's removal

December 14, 2011

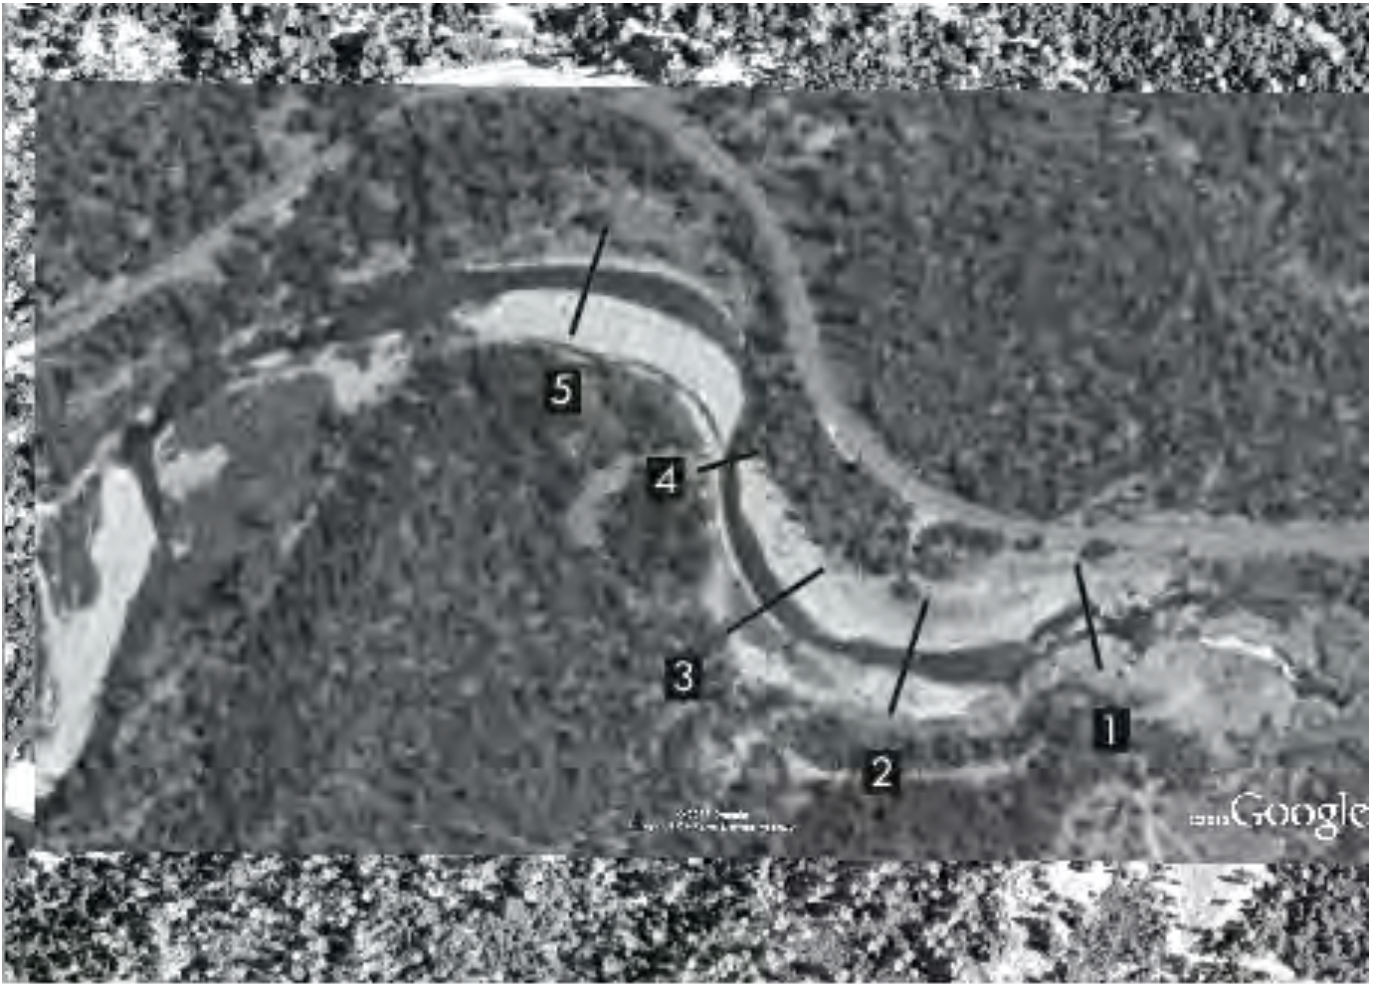
Figure 2.
Five cross sections conducted in 2003 by Ferry and Miller (cited in Miller and Vizcaino 2004).

- the channel suggests that any recent erosion has been minimal. A better determination of upper bank stability can be made if cross section 3 is resurveyed in the future (Figure 2).

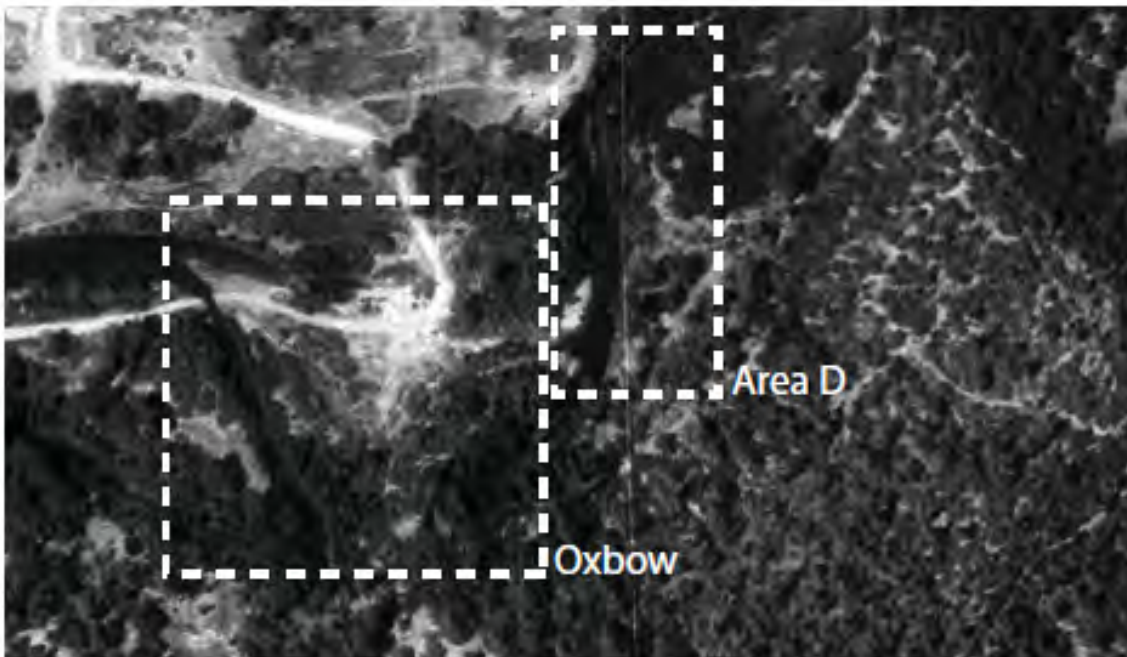
Figure 13a.
1998 Aerial photograph of area D and the Oxbow.

- D. In the third bend, approximately 2300 feet (700 m) upstream of the dam site in area D, the channel moved approximately 160 feet (50 m) east. This may be related to a meander cutoff that occurred just upstream during this time period (Figures 13a, 13b, 13c).¹⁶ Meander cutoffs result in a steeper channel grade, and an associated increase in water velocity and sediment transport (Knighton 1998). This increase in velocity likely caused the major eastward shift of area D between 1998 and 2004.

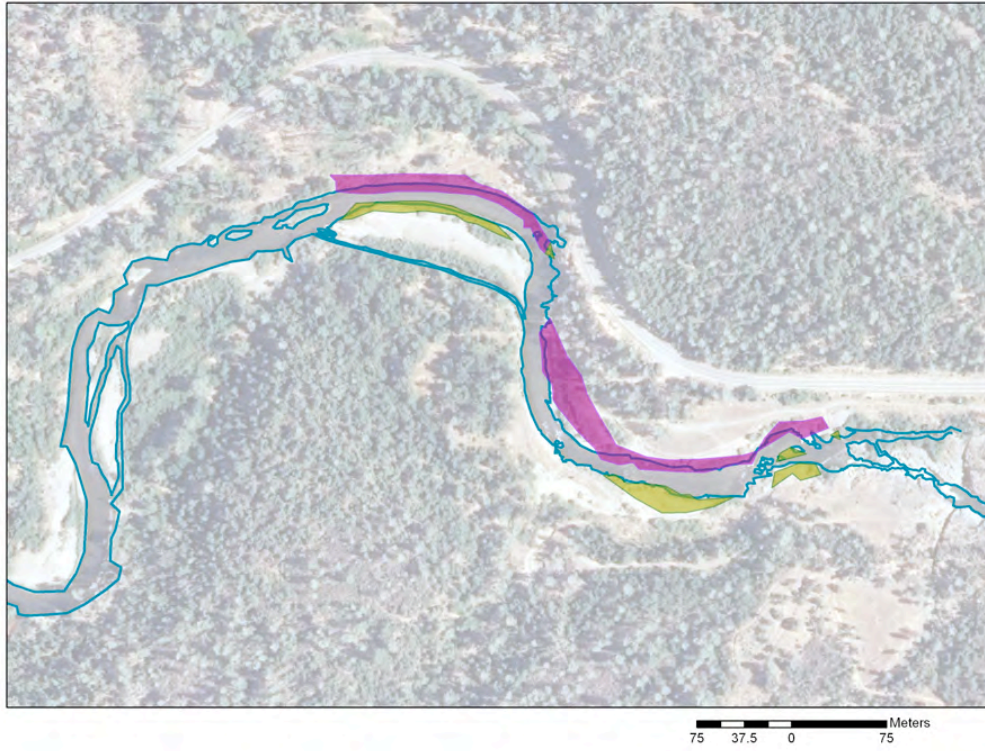
We then transposed these interpreted areas of 2003/04 erosion and deposition onto the 2011 channel²¹ (Figure A4). This analysis demonstrates the relationship between 2003 areas of erosion and stream channel change noted in 2011, specifically in areas A and C.

Figure A4.
Interpreted 2003/04 erosion and deposition compared with the 2011 channel form.

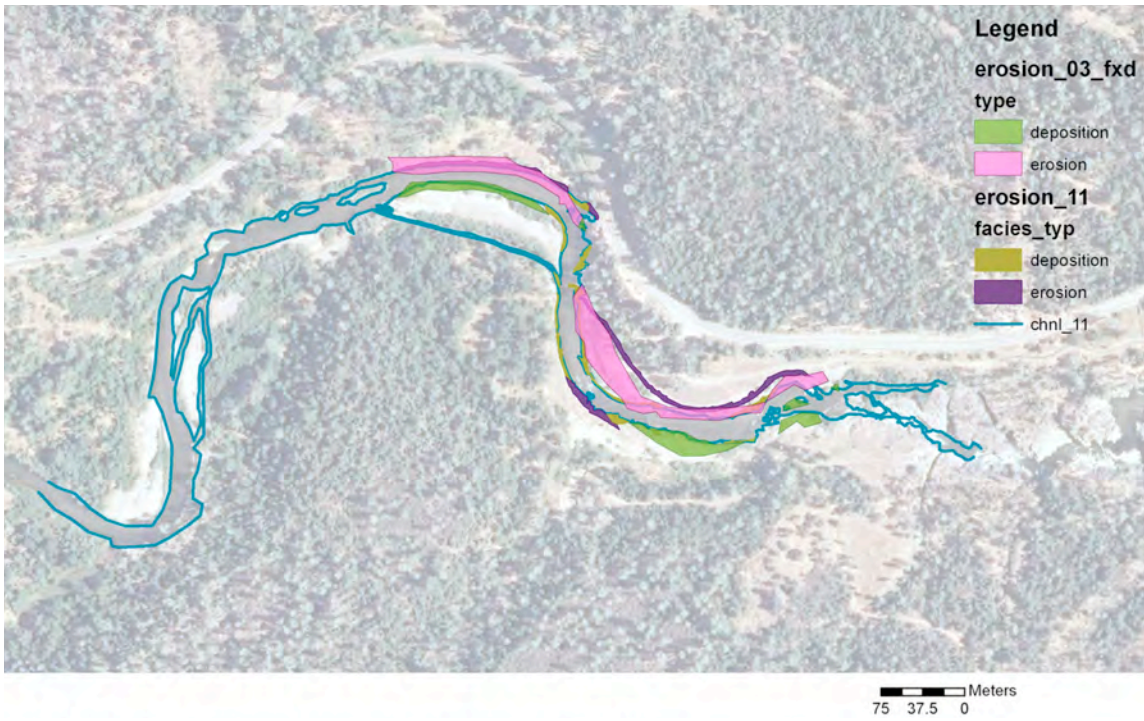
Finally, by layering the interpreted 2003 areas and the observed 2011 areas of erosion and deposition, we observed incremental patterns of erosion and deposition since 2003/04, also in areas A and C (Figure A5). Results and discussion of this analysis can be found in those respective sections of the primary document.

Figure A5 (7c).
Compared areas of erosion and deposition, between 2003/04 and 2011, on the 2011 channel.

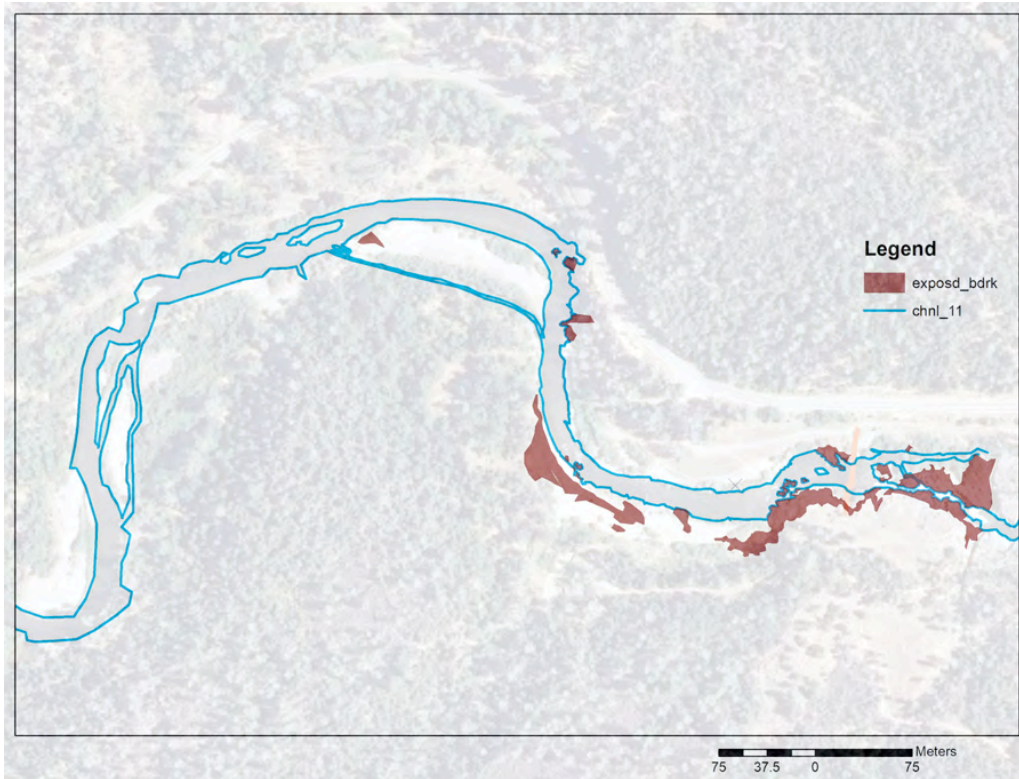
Figure B2.
2011 Exposed bedrock.

Small cobble with mixed gravel was the dominant type, primarily observed in those areas where channel change occurred between 1998 and 2011 (Figure 12c). Exposed bedrock was also significant (Figure B2), as we believe its presence aids in stabilization since 2004. Our 2011 observations of areas of erosion and deposition further support this conclusion (Figure 7b).
