BEVATRON OPERATION AND DEVELOPMENT. XIII

February, March, April 1957

Walter Hartsough and William Salsig

MAGNET-COIL SHROUD: FAILURE AND REPAIR

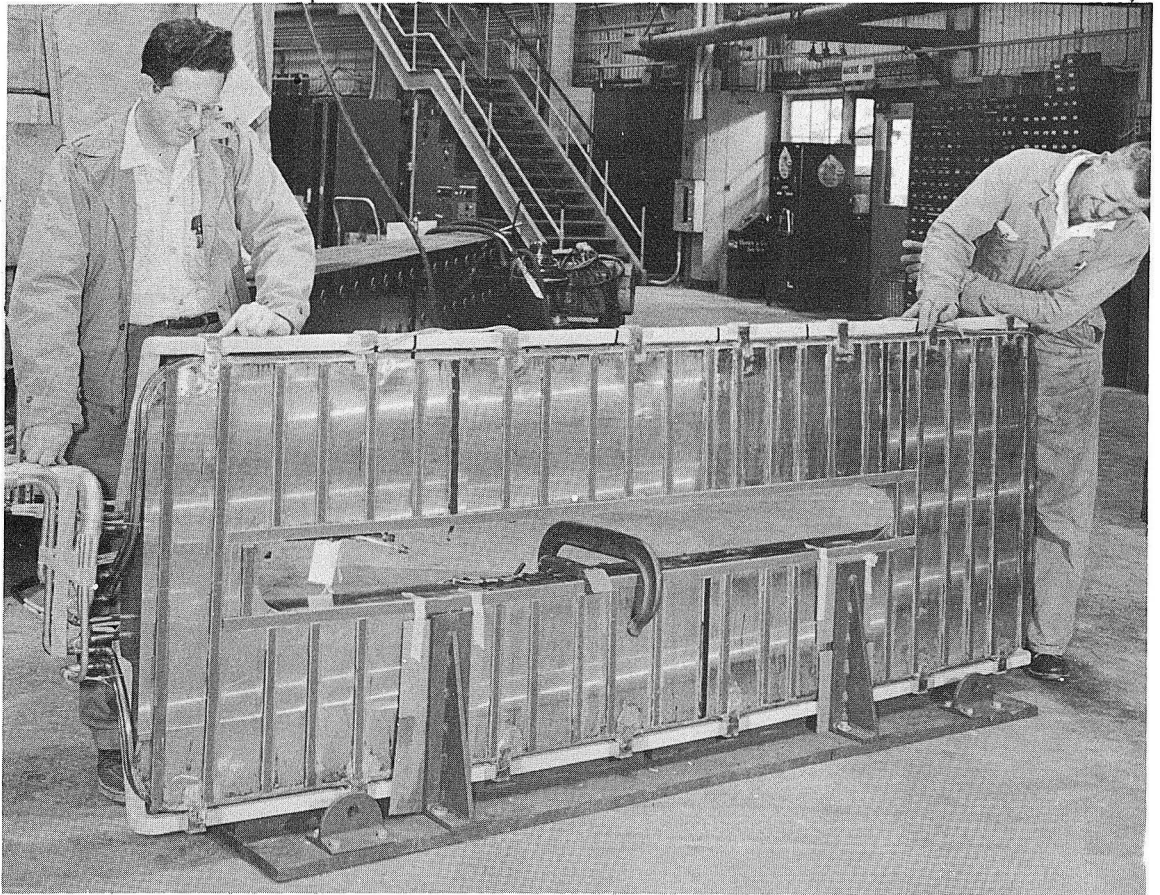
ZN-1907

Figures 10 and 11 show the four-sector stanchion complete with eddy-current correction coil, air-cooling manifolds, and insulating spacer strips, ready for installation. Figure 12 shows the stanchion as installed. The air-cooling manifold connections inside the vacuum tank are depicted in Figs. 12 and 13; the external distribution and monitoring manifold for the air cooling of both three- and four-sector stanchions is shown in Fig. 14.

Fig. 10. Four-sector stanchion with air-cooling manifold and magnetic field correction coil. Inner surface.

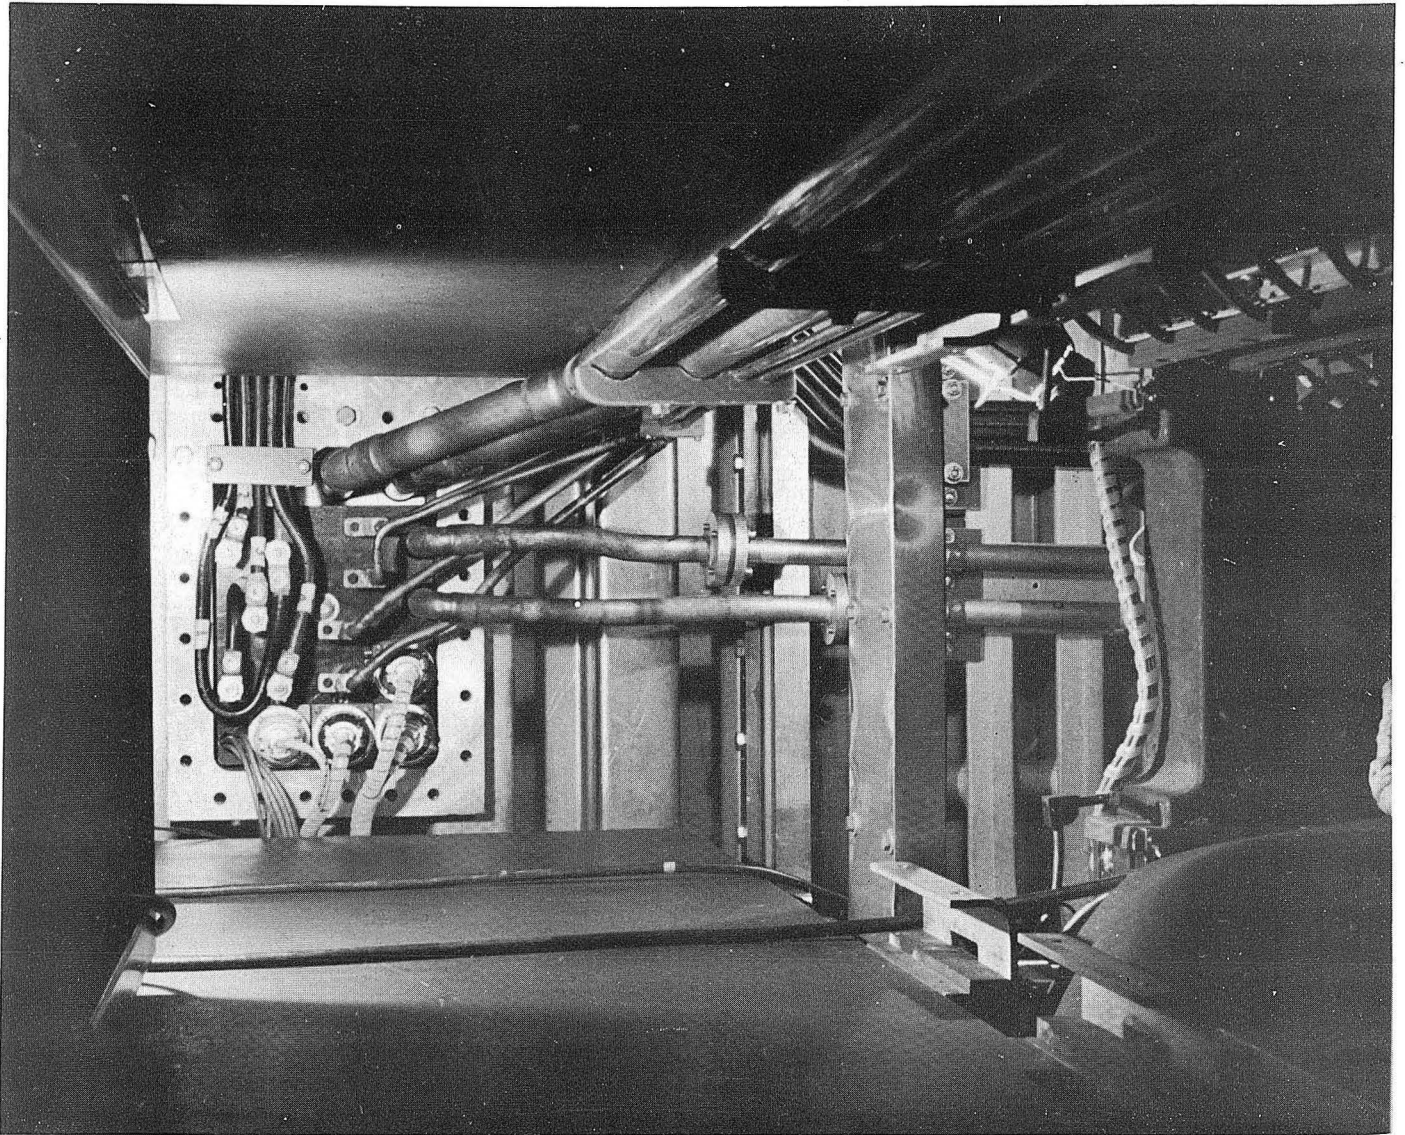
ZN-1909

Fig. 12. Four-sector stanchion installed at the exit end of quadrant III. The one-sector stanchion for the northwest experimental area (K-meson beams) can be seen toward the left side of the photograph.

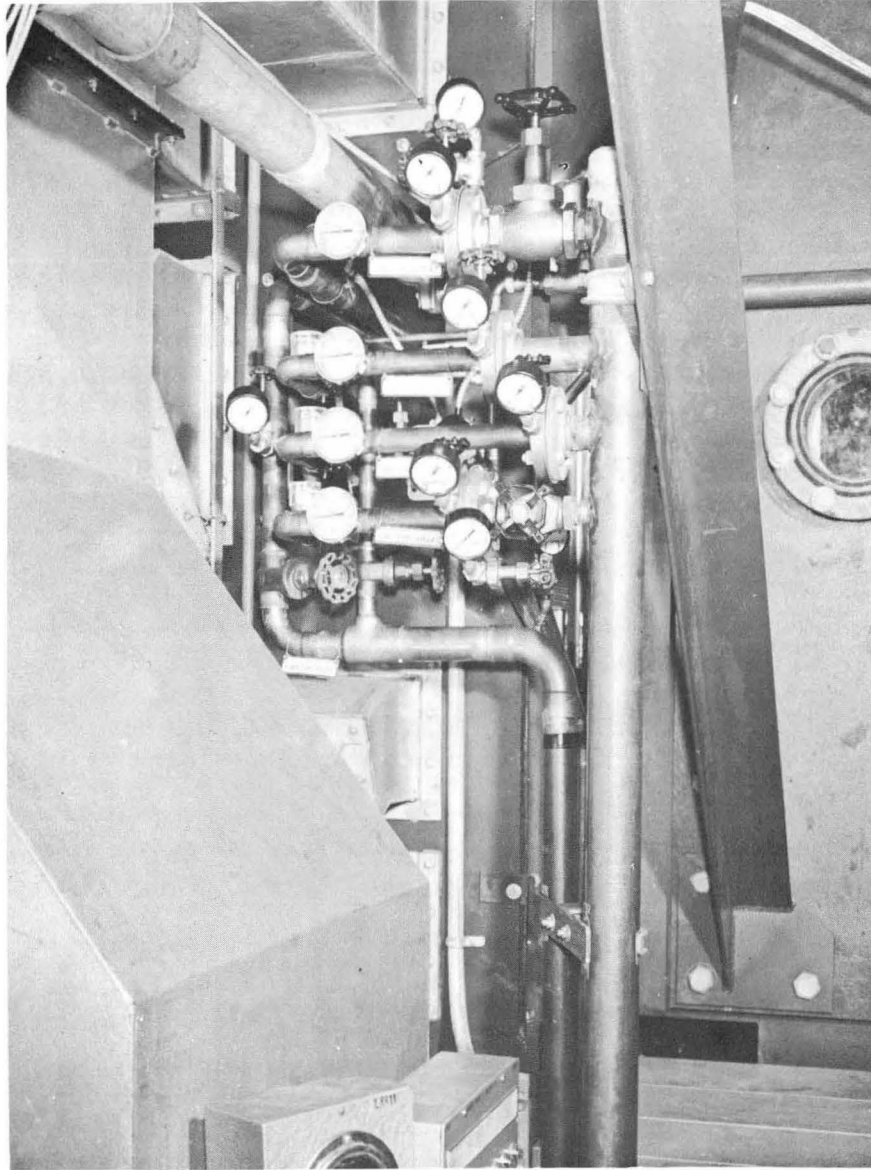
ZN-1910

Fig. 13. Stanchion air-cooling and monitoring lines at the vacuum side of the vacuum feed-through plate.

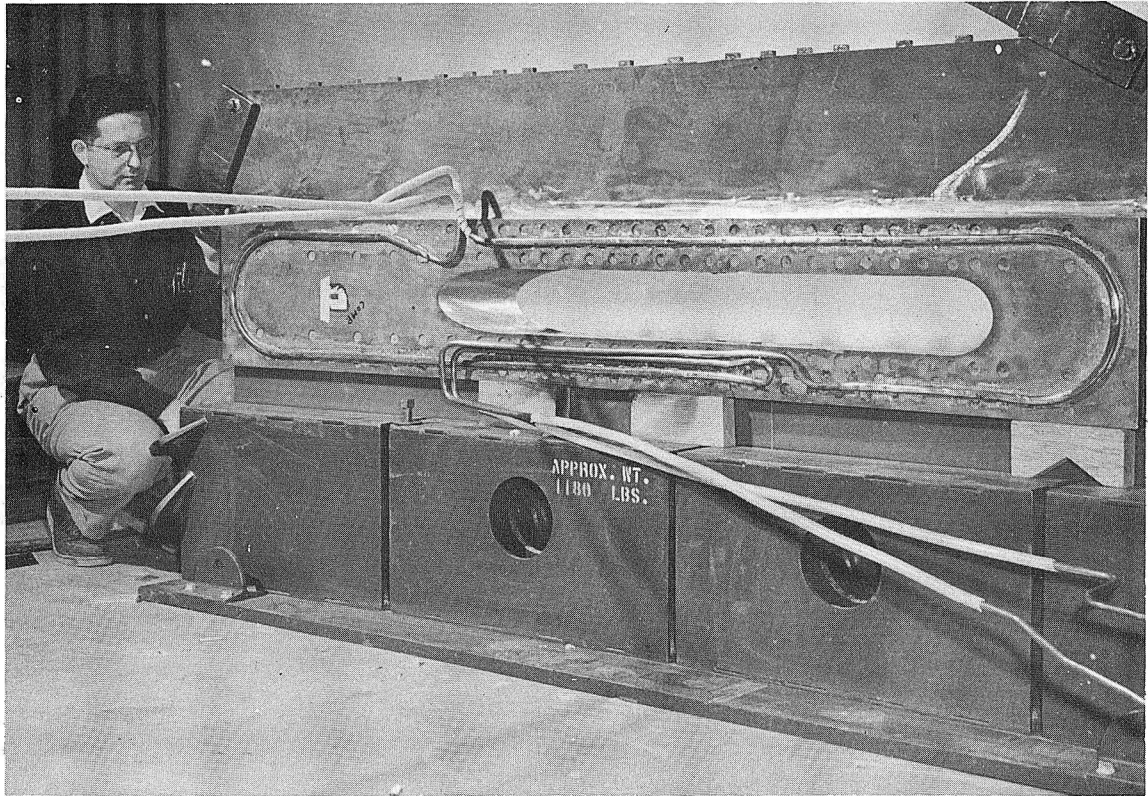
ZN-1912

Figures 15 and 16 depict the three-sector stanchion, complete with cooling manifold and spacer insulation, ready for installation. Figure 17 shows the stanchion installed.

Fig. 15. Three-sector stanchion ready for installation. Outer surface.
