Addressing channel incision through floodplain reconnection: Revisiting the Lower Tassajara Creek project

PRELIMINARY REPORT

LA227 Restoration of Rivers and Streams

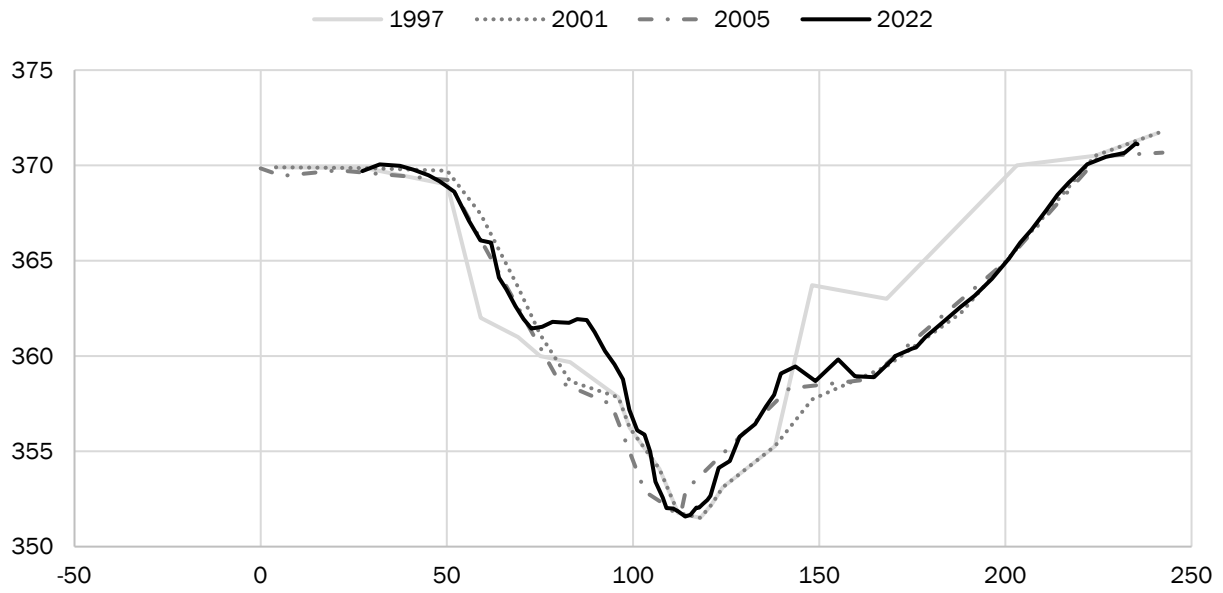
(b) XS B: upper reach, south of Gleason Dr (looking downstream)

Both the LiDAR comparison and the cross-section overlays revealed apparent depositional landforms that appeared between 2006 and 2021. These areas are concentrated in the upper reach from Gleason Dr to Central Pkwy, including at cross sections B and D, and are consistent between the two analyses. Zones of increased elevation tend to extend in the longitudinal direction, including downstream of existing landforms (e.g., the depositions below the promontory) and vegetation (e.g., at the coyote brush on the floodplain near cross section D) or among dense willows (as observed on the right bank at cross section B). The longitudinal forms on the floodplain near cross section D are among the most visually striking; they are made up largely of sand with a consistently fine texture (Figure 28). I excavated a hole at cross section B and observed coarser sand at depths of 2 feet below the surface, with finer sand at the surface (Figure 27).

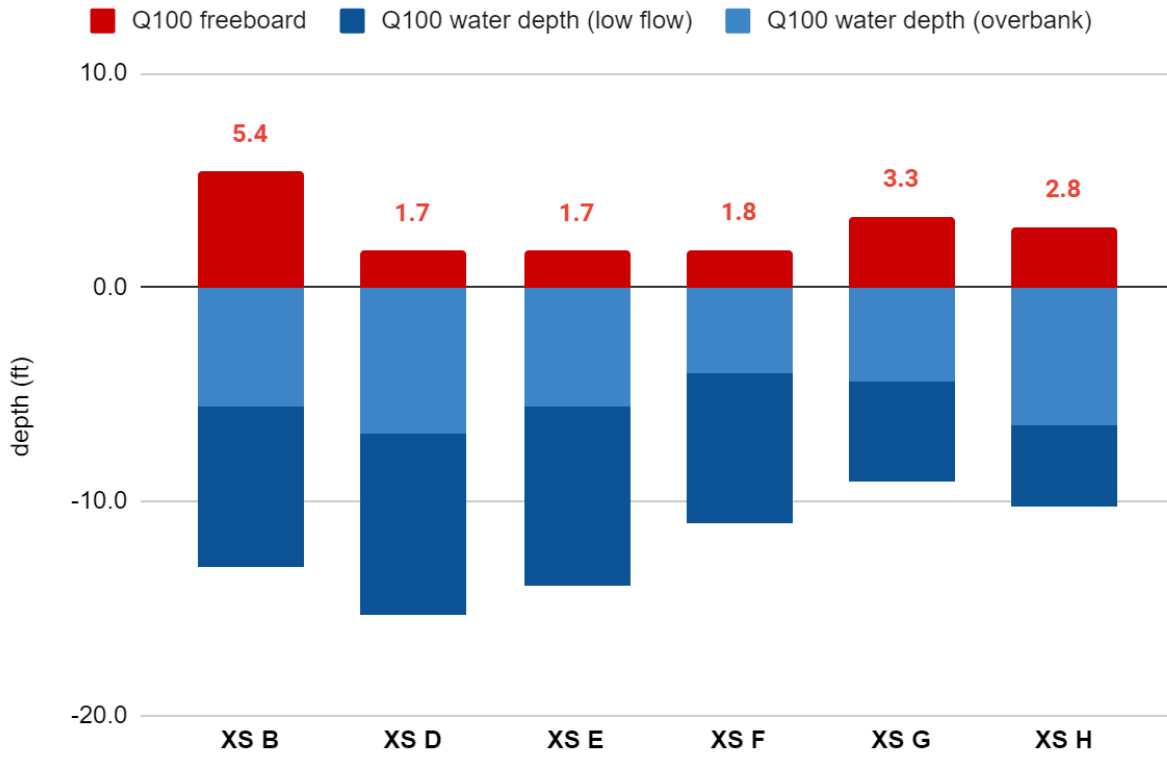
Figure 23. 100-year freeboard estimates by cross section

100-year freeboard estimates range from 1.7 to 5.4 feet (Table 5; Figure 23). These are conservative freeboard estimates because the very high design roughness of $n=0.12$ is applied to the overbank floodplain, and the higher 100-year flow estimate from Alameda County (5,200 cfs) is used. As expected, the freeboard for the flood control channel is lowest at cross section E, where the channel width was constrained by the presence of an old growth oak tree on the upper left bank. In-channel velocities at this location are the greatest, exceeding 10 ft/s in the 5-year flood.

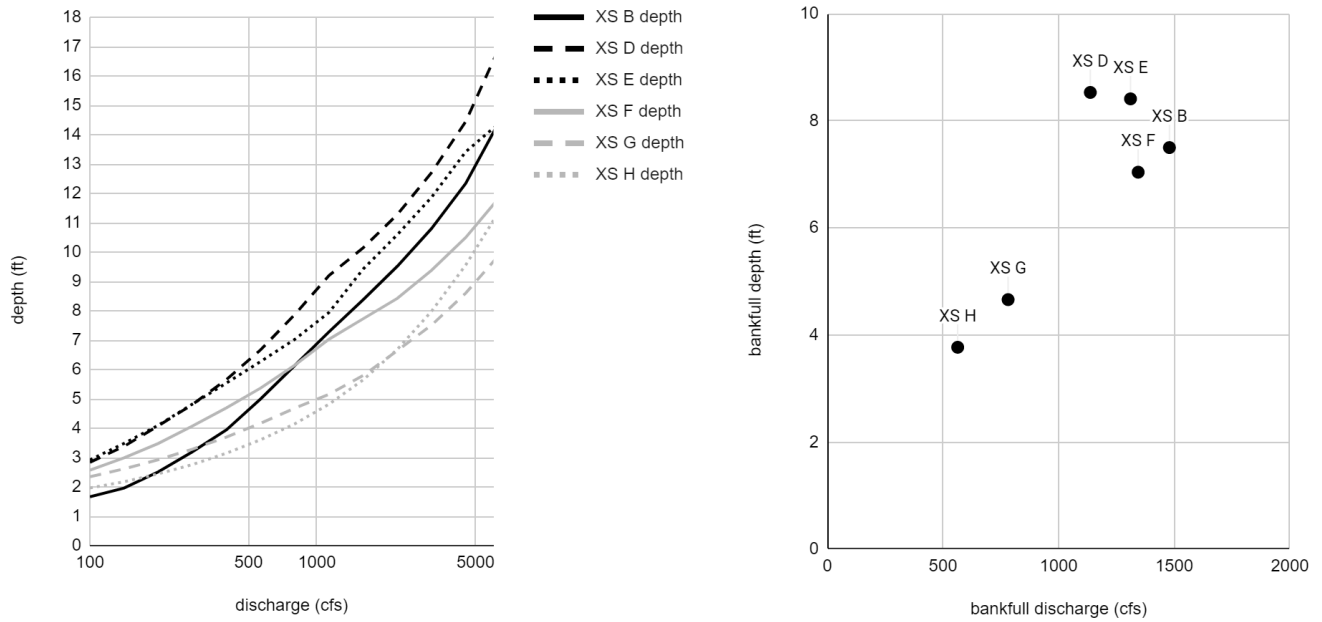
Figure 24. Depth-discharge rating curves and bankfull estimates by cross section

Using rating curves of depth versus discharge output from HEC-RAS (Figure 24), bankfull discharge was derived for each cross section (Table 6). Approximate recurrence intervals were then determined based on power function interpolation of the published Tassajara Creek 2-year, 5-year, and 100-year flows, because the creek does not have a long term gauge (Figure 25). Bankfull discharge ranges from as low as 563.5 cfs in cross section H, a 1.4-year flow, to as high as 1727.6 cfs in cross section B, an 8.7-year flow (Table 6). Bankfull discharge is less than the BKF design 2-year flow for the two lowest cross sections (cross sections G and H) and exceeds the design 5-year flow for all the other cross sections.

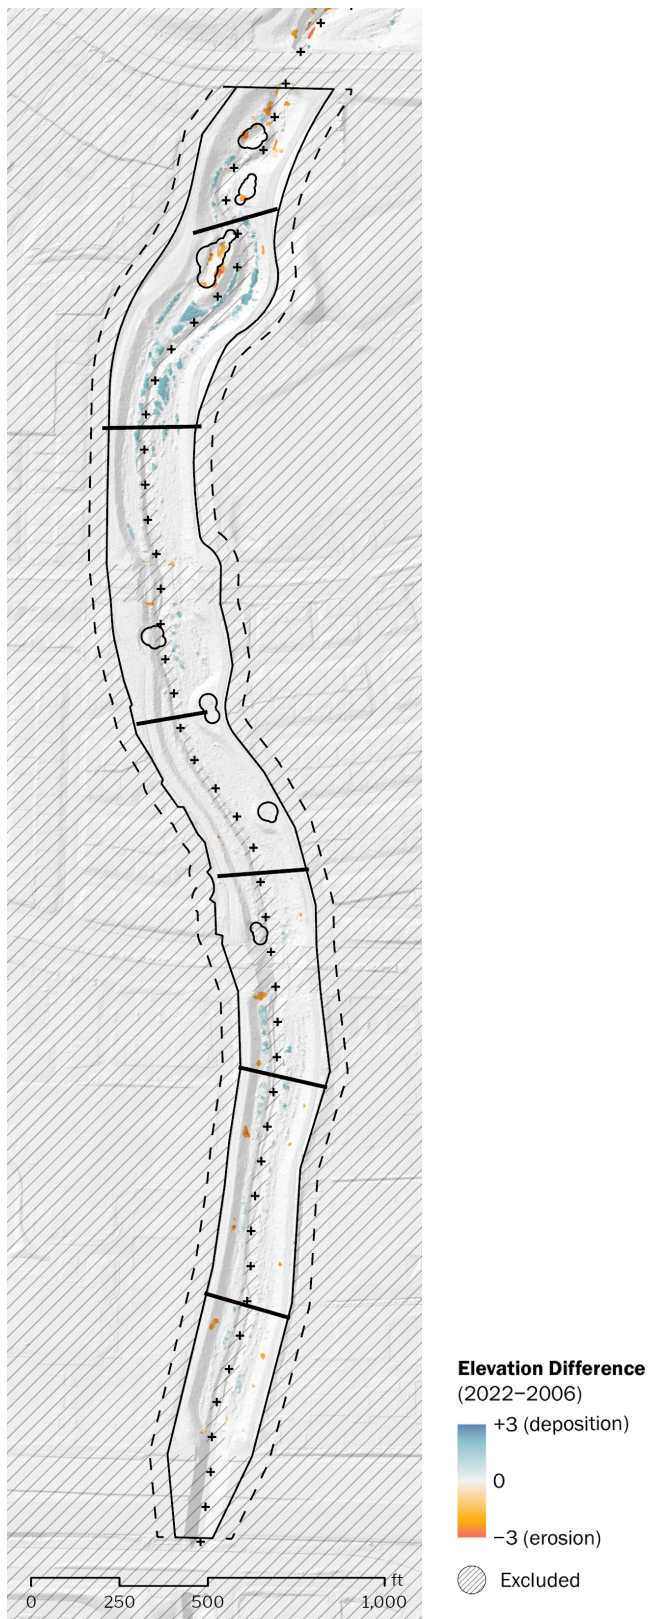
Figure 26. LiDAR differencing result

Differencing of the 2006 and 2021 LiDAR floodplain data, illustrated in Figure 26, suggests substantial changes in the upper reach that align with observations from the cross-section overlays. Overbank aggradation is apparent on either side of the low flow channel between the Gleason Dr culvert and the Central Pkwy crossing, as well as on the downstream end of the promontory between cross sections B and D. The difference in elevation is as high as 4 ft on cross section B, 3 ft at the promontory, and 2.5 ft on cross section D. Negative elevation changes (soil loss) are detected at the known scour pools on the distal side of the promontory, and at a location on the side of the promontory where a buckeye tree uprooted and slid. Some of the detected changes, such as the apparent decrease in elevation at the scour pools, may be due to the increased resolution of the second LiDAR survey relative to the first. However, for others, such as the erosion near the buckeye, evidence in the field is consistent with the LiDAR results.
