The Urban Gauntlet for Steelhead Trout: A Reconnaissance Study of Habitat in UpperBollinger and Little Pine Creeks, Contra Costa County

Ali Parmer, Derek Morimoto, Rebecca Kaliff

December 15, 2020

UC Berkeley, Landscape Architecture 227: River Restoration

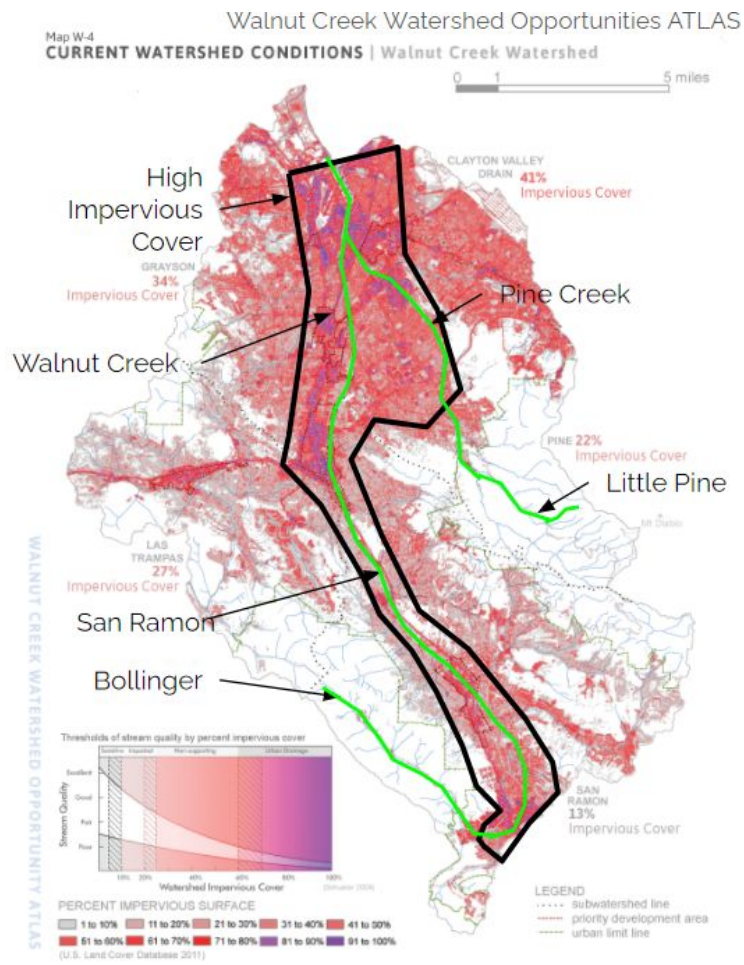
high impervious cover, and the black outline is meant to highlight highly urbanized areas as well as which reaches are within dense urban areas or are more rural. Walnut Creek, Pine Creek, and San Ramon creek were all within urban drainages whereas Little Pine Creek and Bollinger Creek are more rural.

**Figure 4:** Urban Gauntlet boundary analysis using percent impervious cover.

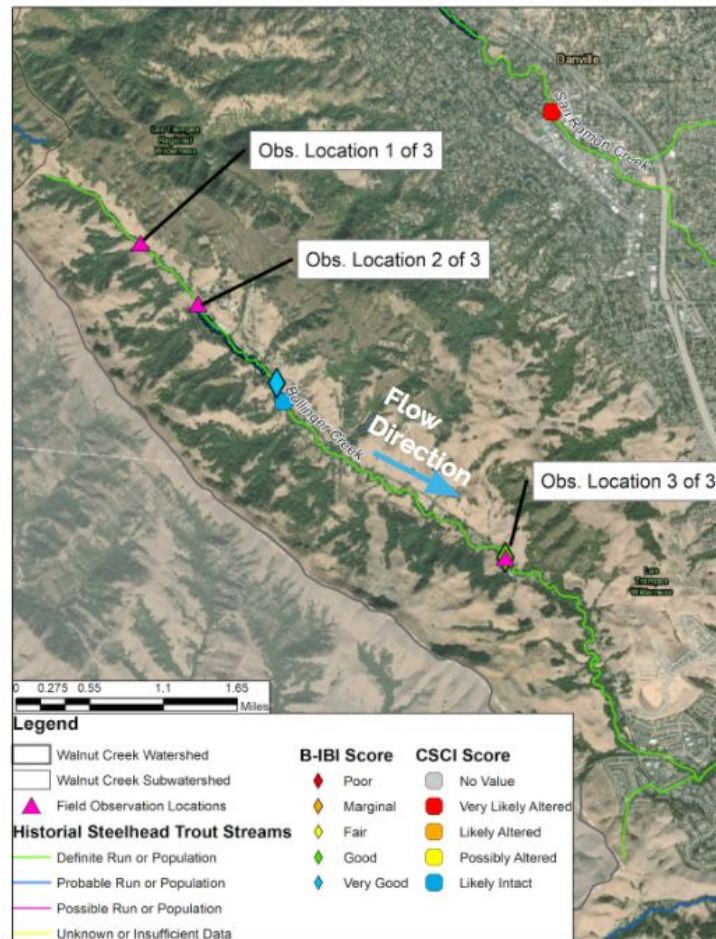
**Figure 10:** Bollinger Canyon Creek and three observation locations.

side-slopes. The channel appeared incised for approximately 100 ft, but downstream it became wider with overhanging banks for cover and space for step pools as the creek meandered around mature trees. Grain size decreased moving downstream of the culvert and spawning gravels were observed. Canopy cover remained at 90% along the channel.

Spawning habitat potential decreased downstream of Bollinger Canyon Creek, consistent with past B-IBI and CSCI Scores. The uppermost observed reach of Bollinger Canyon Creek had the greatest canopy cover, presence of large woody debris, overhanging banks, and gravel; all preferred steelhead spawning habitat attributes (CalFish 2020). Downstream at our second stop along the creek, there was also dense canopy cover (80%), large woody debris, and a mixture of boulders and gravel. Although steelhead trout would not spawn in areas with boulders, they could use those reaches as resting areas as the boulders created space for step pools. This reach had bank erosion at one location adjacent to a parking lot, likely caused by runoff from the impervious surface. The furthest downstream location observed along Bollinger Creek had the lowest amount of canopy cover (60%) and boulder-sized riprap throughout the channel. Thus,

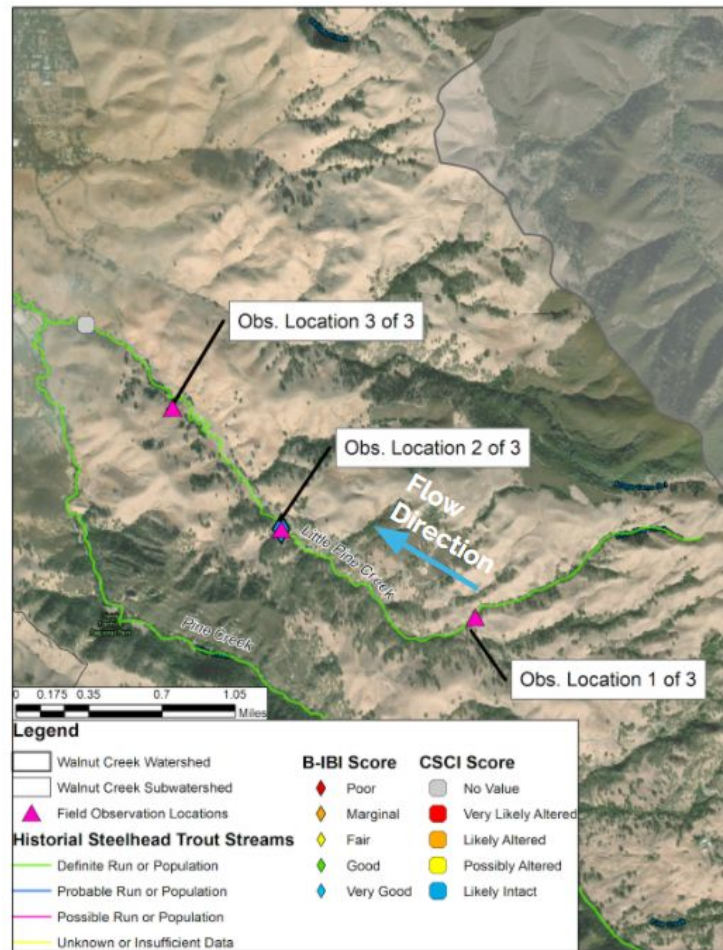
**Figure 14:** Little Pine Creek and three observation locations.

The creek was a v-shaped channel with steep side-slopes primarily composed of bedrock. A reinforced concrete pipe culvert crossed under the road before traveling down a steep hillside (Figures 15a, 15b). The bottom width and top width measured 3 ft and 30 ft respectively and the steep side-slopes carried the channel depth to approximately 30 ft. There was little observed habitat cover, no spawning gravels, and minimal canopy cover of about 10%.

Little Pine Creek had different habitat characteristics than Bollinger Canyon Creek. At the most upstream observed reach, the bedrock v-shaped channel had no gravel and minimal canopy cover, suggesting inadequate spawning habitat conditions. Conversely, the second observation location downstream had 70% canopy cover and had a gravel-dominated bed. These improved habitat conditions were consistent with the “very good” B-IBI score. Although these conditions aligned with steelhead trout habitat preferences, there were two small drop structures observed, which could hinder them from reaching further upstream. The third reach along Little Pine Creek reverted to similar conditions as the uppermost reach, which 10% canopy cover but had primarily fine-grained bed material. Thus, this location was not an optimal spawning habitat, but could serve as a passageway to swim to the better habitat upstream. Lower in the Pine Creek subwatershed, satellite images revealed Pine Creek as a rectangular concrete channel, in addition to the myriad of drop structures, thus would not be an optimal spawning habitat for steelhead trout. Therefore, efforts would need to be made to allow steelhead trout to reach the second observation location along Little Pine Creek.

3. Invite fish passage experts in the field to assess whether steelhead trout can safely migrate up tributaries across drop structures on Little Pine and through observed culverts and long stretches without canopy cover. If not, ask the experts for recommendations on how to modify structures to permit fish passage.
