Geotechnical reconnaissance findings of the October 30 2020, Mw7.0 Samos Island (Aegean Sea) earthquake

Bulletin of Earthquake Engineering, 20(14)

Abstract

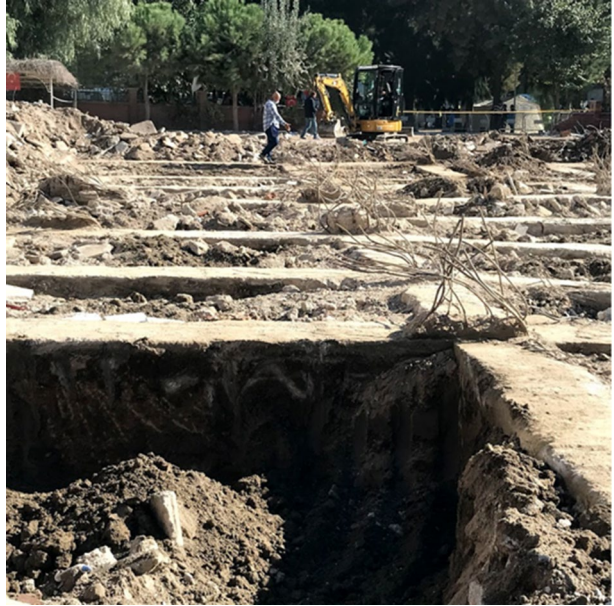
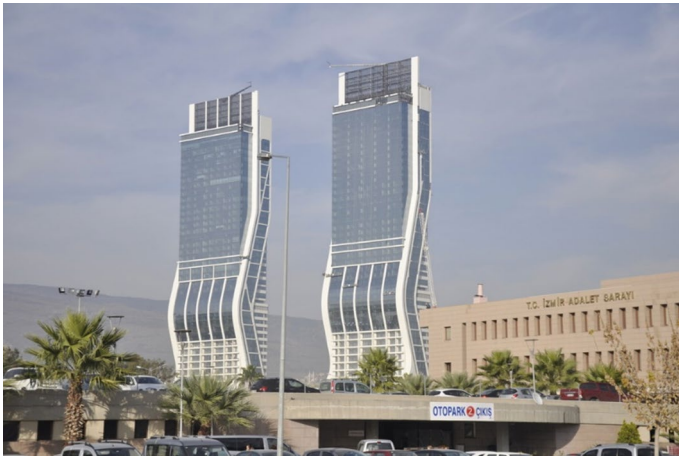
Fig. 2 Two-way combined footing system (grid spread footing foundation) of one of the heavily damaged buildings in Bayrakli, whose collapse is not foundation induced

Fig. 3 200 m high Twin Folkart Towers in Bayrakli supported on a piled raft system. No earthquake-induced damage was identified or reported for such foundation systems

two-way combined footings or individual footings with strip beams. Mat foundations are not very common for these low to mid-rise buildings belonging to pre-1995 period, despite the soft nature of underlying foundation soils. Figure 2 illustrates the foundation system of one of the fully collapsed buildings in Bayrakli whose collapse is not foundation induced. The recent development of high-rise buildings (Fig. 3) has, however, introduced the increasingly common use of piled raft systems. Barrette (rectangular pile) elements have been used in the foundation of these high-rise buildings. Additionally, in recent residential developments in Mavisehir, ground improvement applications in the form of jet grouting

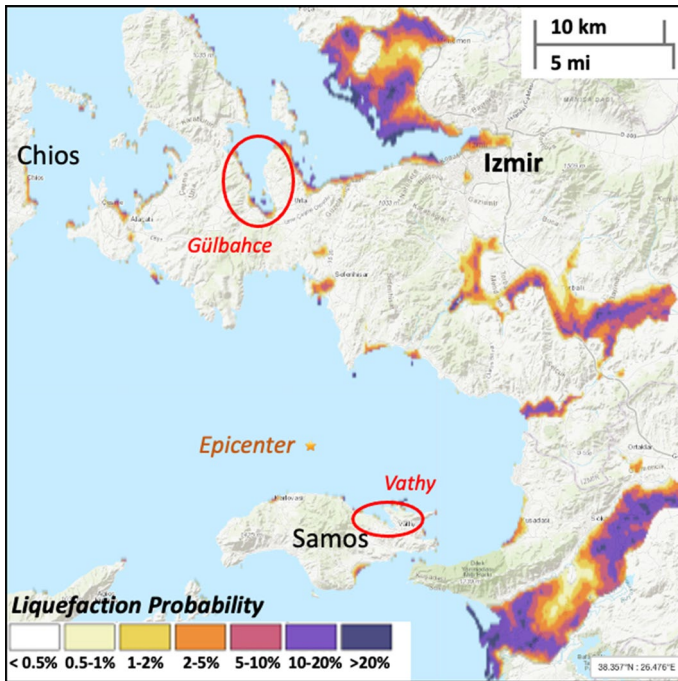
Fig. 5 USGS liquefaction susceptibility map released after the event showing liquefaction probability in the region surrounding the epicenter (not necessarily associated with the source at hand). The red ellipses indicate the only locations where evidence of liquefaction manifestation was identified

the port of the island of Chios located 100 km to the north-west of Samos; see Fig. 5) and its nearshore alluvial deposits in particular, despite the fact that the accompanying effects were not destructive.

Starting with the Anatolian side, as presented in Fig. 5, potentially liquefiable sites and shores were visited, and the lack of surface manifestation of soil liquefaction triggering was documented as no sand boils or displacements were identified. However, a number of surface manifestations were documented in Gulbahce-Izmir and Samos Island indicating the triggering of soil liquefaction, which will be discussed next (Fig. 6).

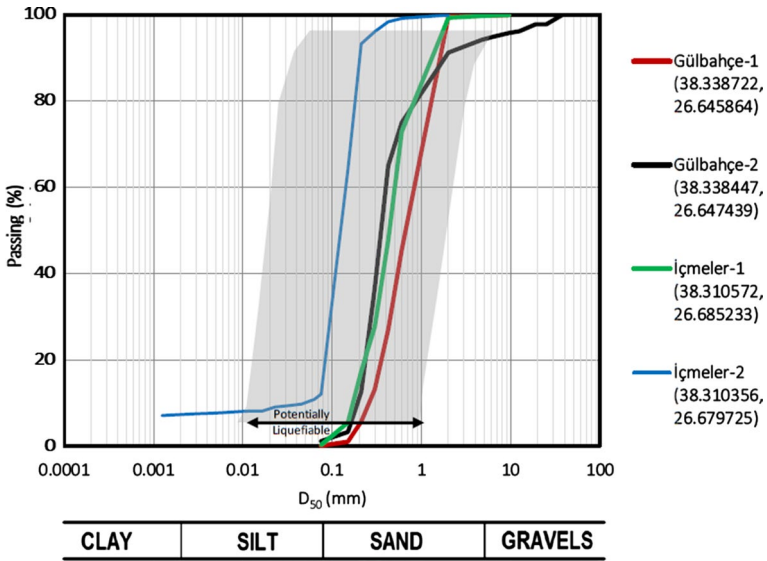
Consistent with the USGS susceptibility predictions, 45–50 km away from the rupture, along the shores of the Icmeler and Gulbahce districts, sand boils were observed, as shown in Fig. 7a through d. These sites were close to the Gulbahce fault zone, and documented artesian pressures along with hot water springs which are known to be present at these sites, which are also believed to have contributed to the observed soil ejecta formation. Figure 8 illustrates the results of grain size distribution analyses performed on soil samples retrieved from the sand ejecta. As can be seen, all samples were uniform and within the bounds typically delineated as liquefiable uniform soils.

Fig. 8 Grain size distribution curves of sand ejecta obtained from Gülbahçe, along with the bounds of typically liquefiable non-uniform soils

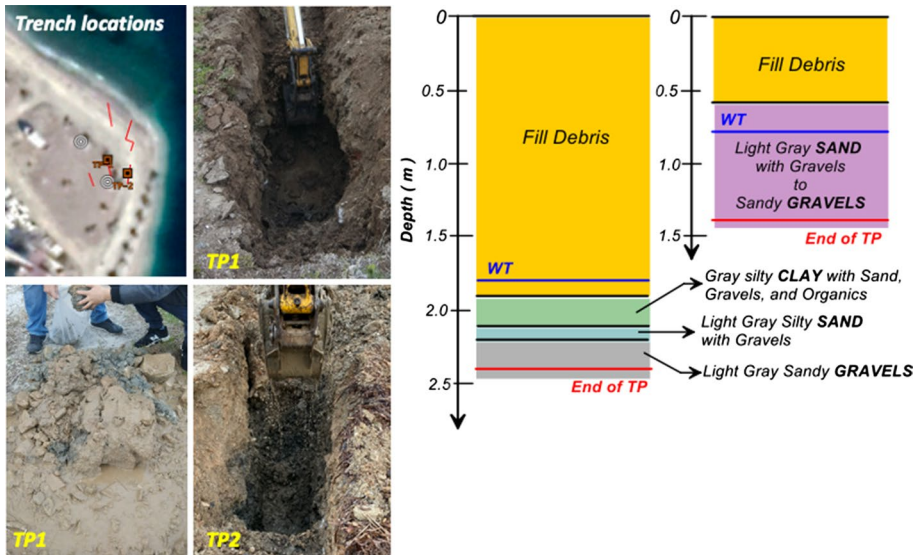
Fig. 11 Trenching at the Malagari liquefaction site and rough stratigraphy resulting from it

their broader extent were still easily visible and distinguishable. In the same area, ground cracks compatible with a lateral spreading mode of failure were observed and are emphasized in the inset of Fig. 10. The combination of the aforementioned with a free face to water, like in Malagari, eases the process, but lateral spreading has been manifested also in case histories with no free face (e.g. Balboa Boulevard failure during the 1994 Northridge earthquake—e.g. Stewart et al. 1996, Pretell et al. 2020). Trenching and soil sampling at two locations at the Malagari site were performed, which yielded two rough cross-sections and three grain size distributions for samples at three distinct depth intervals at the site illustrated in Figs. 11 and 12 respectively. The fines portion in all three samples was found to be non-plastic.

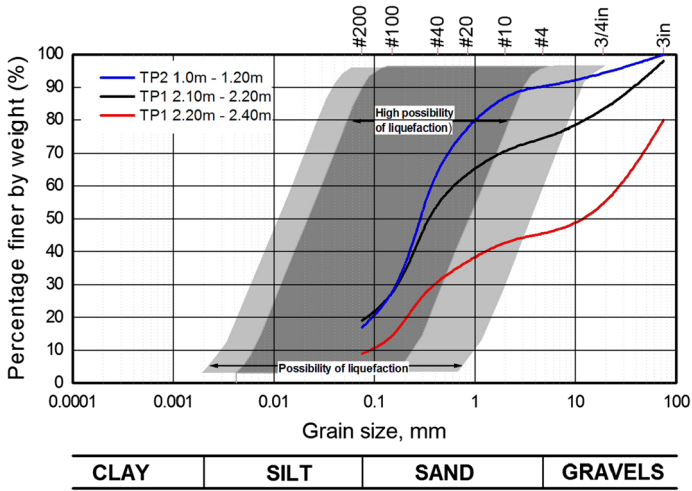
Fig. 12 Grain size distributions of three samples retrieved from different depths at the two trenching locations at the Malagari liquefaction site, along with the bounds of typically liquefiable non-uniform soils. The fines were found to be non-plastic (NP). (Geographic coordinates are provided in Fig. 10)

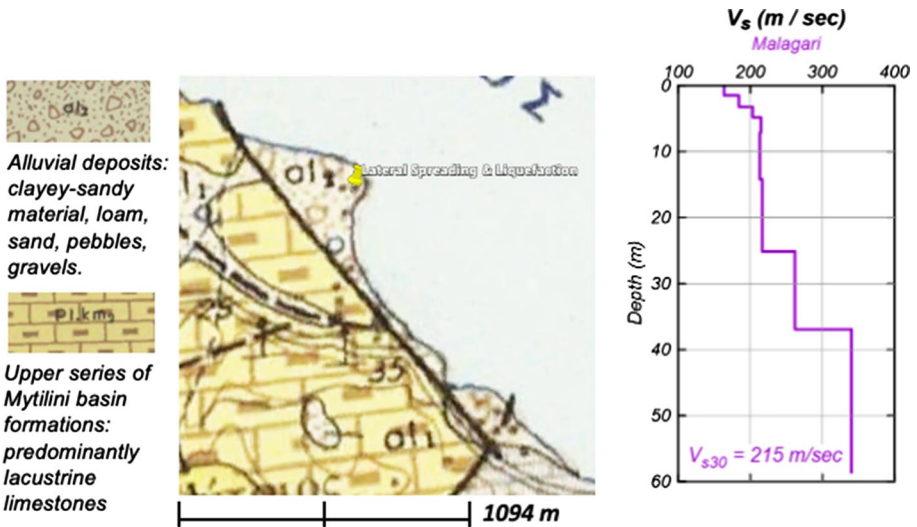
Shear wave velocity measurements performed after the earthquake using geophysical methods such as MASW (Professor Panagiotis Pelekis—20th December 2020) in the Malagari area that was affected by liquefaction yielded a time-averaged shear-wave velocity in the upper 30 m of the site $V_{s30}=215$ m/sec. The distribution of shear wave velocity V_s with depth is shown in Fig. 13. There are no borehole SPT or CPT data available at this site and the only relevant information is that from the Port of Malagari (West side of Vathy gulf) and borehole BH5 (Fig. 33). The geologic map of Samos (Fig. 13, but also Fig. 32) indicates that the Malagari site has alluvial deposits featuring plain deposits of clayey-sandy material, loam, sand, pebbles and gravels, which are potentially liquefiable when saturated. This particular site, where liquefaction was undoubtedly manifested, can be studied as a case history of either True Negative or True Positive liquefaction manifestation after more data are obtained and processed.

Fig. 13 Geologic map of Malagari indicating alluvial deposits and shear wave velocity profile at Malagari down to a depth of 60 m. (Geographic coordinates are provided in Fig. 10)

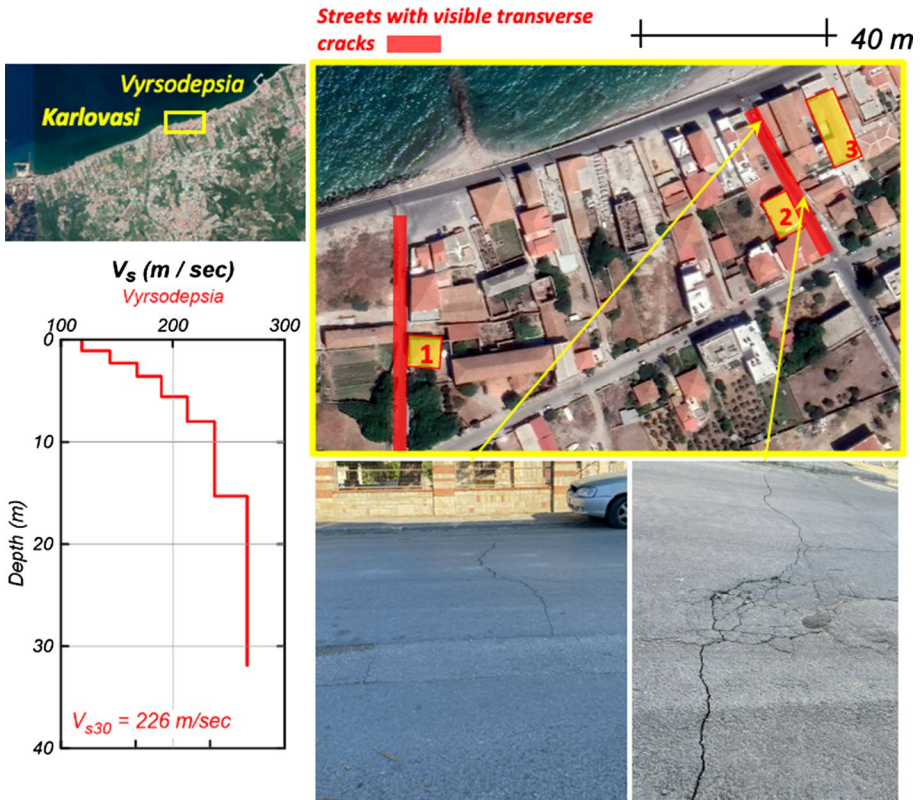
Lateral spreading effects were also evident through structural damage at other nearshore locations in the northern part of the island. Specifically, Figs. 14 and 15 illustrate three buildings and their location close to the north shore of the island, in the neighborhood Vyrsodepsia in Karlovasi. No surface manifestation of liquefaction was identified nearby, but the ground cracking crossing the street pavement and running through the buildings (the two in Fig. 16 are about 70 m inland and the one in Fig. 17 is about 20 m inland), in combination with the level/mildly sloping ground, the shallow water table, and the free face to the sea are all compatible with the hypothesis of lateral spreading.

Fig. 14 Plan view of Karlovasi and the Vyrsodepsia neighborhood with buildings likely affected by lateral spreading towards the seafront alongside with shear wave velocity profile of the area down to a depth of 30 m (aerial close up at 1382 ft, 37o47'57.94" N, 26o42'23.27" E). The enumerated buildings are individually shown in Figs. 16 and 17

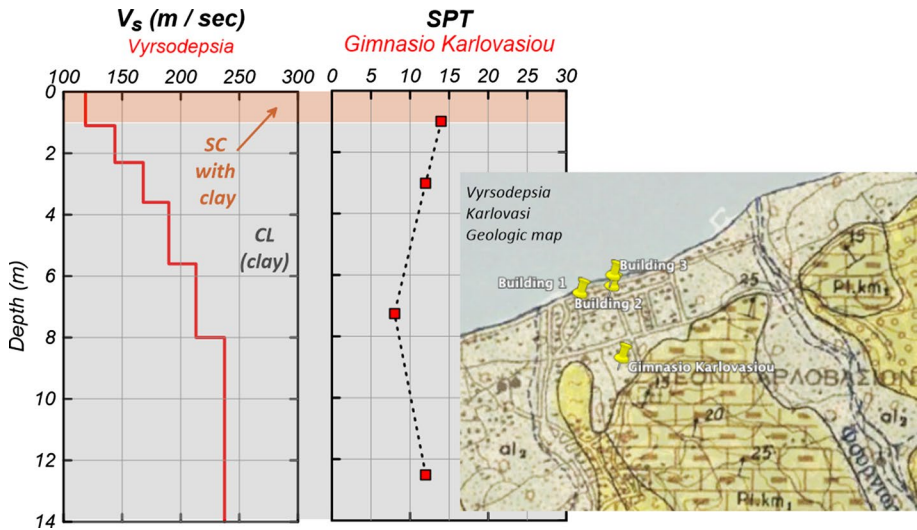
Fig. 15 Shear wave velocity profile down to a depth of 14 m alongside with SPT blow count information from the nearest borehole at the High School of Karlovasi (Gymnasium). Locations are shown in inserted geologic map

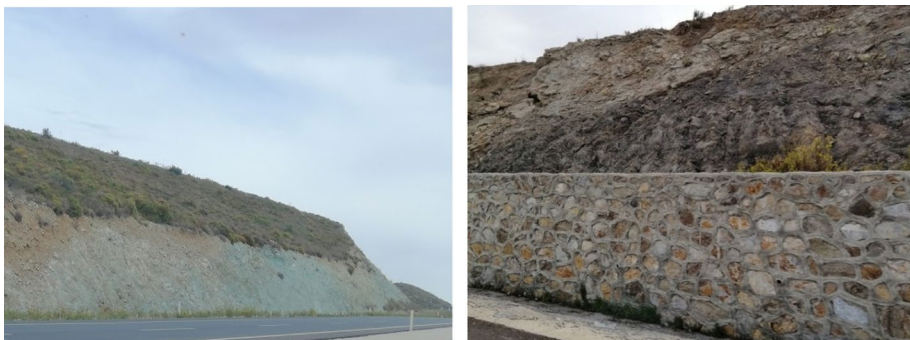
not presented herein. Furthermore, the highways were investigated and no proof of any seismically induced damage both on the highways or on the shoulder slopes was found, as shown in Fig. 19.

Fig. 19 Selected indicative views of highway cuts with no signs of slope instability ($38^{\circ}17'31.6''$ N $26^{\circ}40'14.6''$ E)

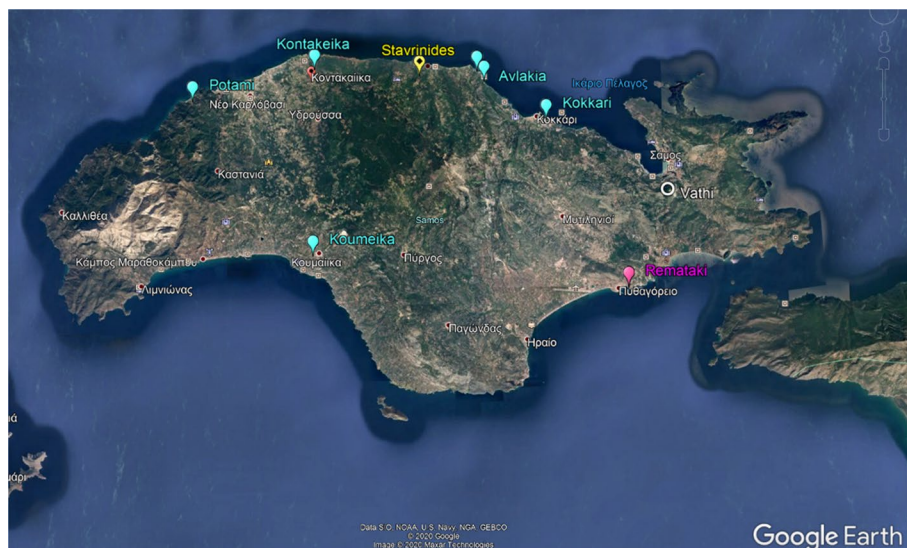
A series of minor-to-moderate slope failures and rockfalls were identified during the earthquake reconnaissance, mainly in the northern part of the island of Samos. The areas with nearby slope failures which are marked in a Google Earth map (Fig. 20) were located mainly by the reconnaissance team of HAEE/ETAM. The exact coordinates of these failures are also listed in Table 1, while some additional cases reported in Lekkas et al. (2020) and HSMGE (2020) are also shown. A brief description and representative photos are given below for some of these cases.

Fig. 20 Geographical distribution of slope-type failures located by the HAEE/ETAM reconnaissance team during the visit on 7th November, 2020 (cyan pins). Additional sites with light slope failures recorded by Lekkas et al. (2020) (magenta pin) and HSGME (2020) (yellow pin) are also shown

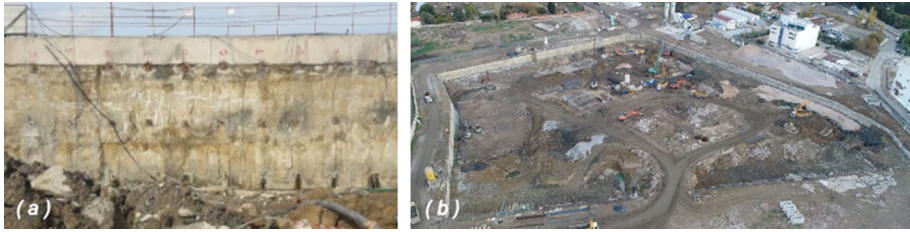
The new downtown district (Bayrakli-Bornova) of Izmir (Turkey) is founded on the sedimentary basin, where the heavily affected region from the earthquake is situated. Numerous high-rise buildings are constructed on these soft soil conditions. Many of them have multi-story basements, thus deep excavation systems had to be designed reaching depths of 20 m. Due to the shallow ground water level and the proximity to the shoreline, typical shoring systems contain mostly diaphragm walls laterally supported by pre-stressed anchors. In the sedimentary district, two well-monitored deep excavation systems, which were under construction in the three months leading up to the earthquake, were shaken (Fig. 25). Both of these systems reached a depth of about 9 m while their satisfactory performance was recorded by

Fig. 25 **a** Pre-earthquake view of shored deep excavation located in the “new downtown” district in Bayrakli-Bornova ($37^{\circ}53'50.4''$ N $27^{\circ}22'06.2''$ E), and **b** Plan view of the site under discussion

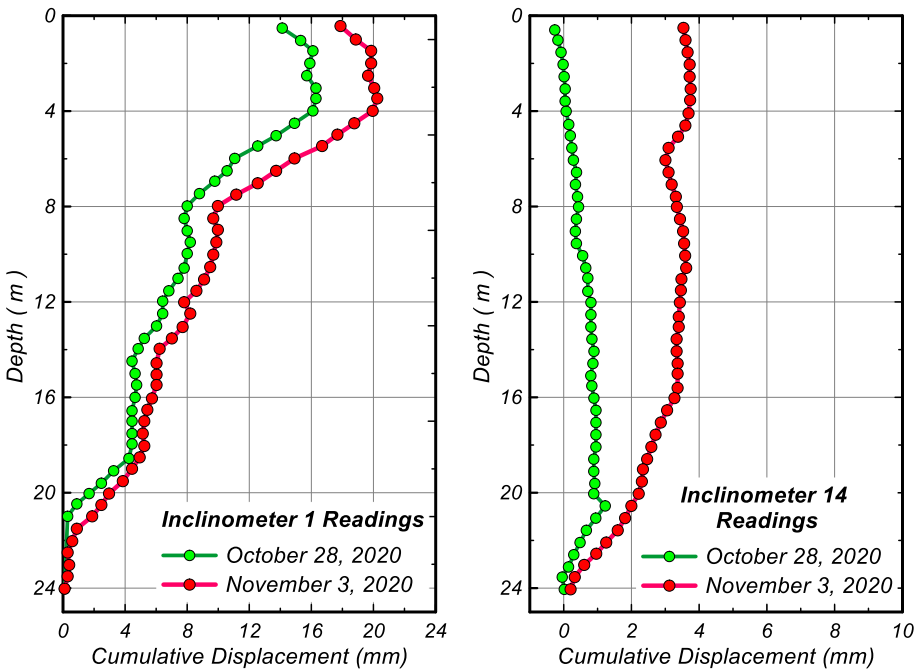
the installed monitoring system (Fig. 26). No failure or relaxation of pre-stressing loads on anchors was measured/observed. These observations are also supported by inclinometer measurements taken before and after the earthquake. The measurements suggest that the lateral displacements (illustrated in Fig. 26) accumulated during the earthquake were less than 2 mm. No relevant data are available from Samos (or any of the nearby islands) in Greece, since there are no similarly deep excavations constructed.

Fig. 26 Inclinometer data covering the period of earthquake shaking, at a 9 m-deep excavation in Izmir, Turkey, supported by diaphragm walls

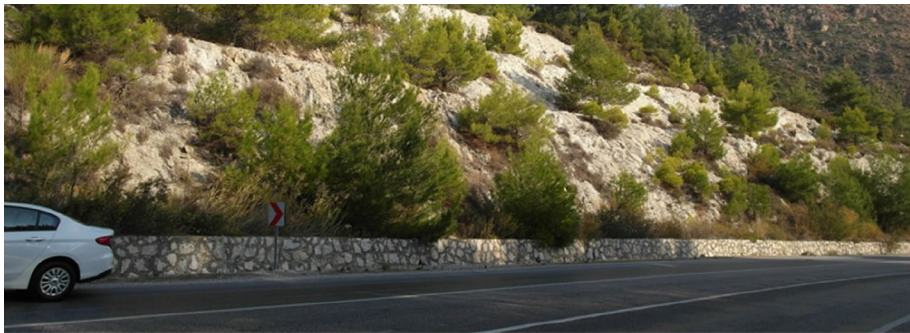
Fig. 28 Short, stoned retaining walls on the toe of the highway cuts between Menderes and Gumuldur in the south of İzmir city center

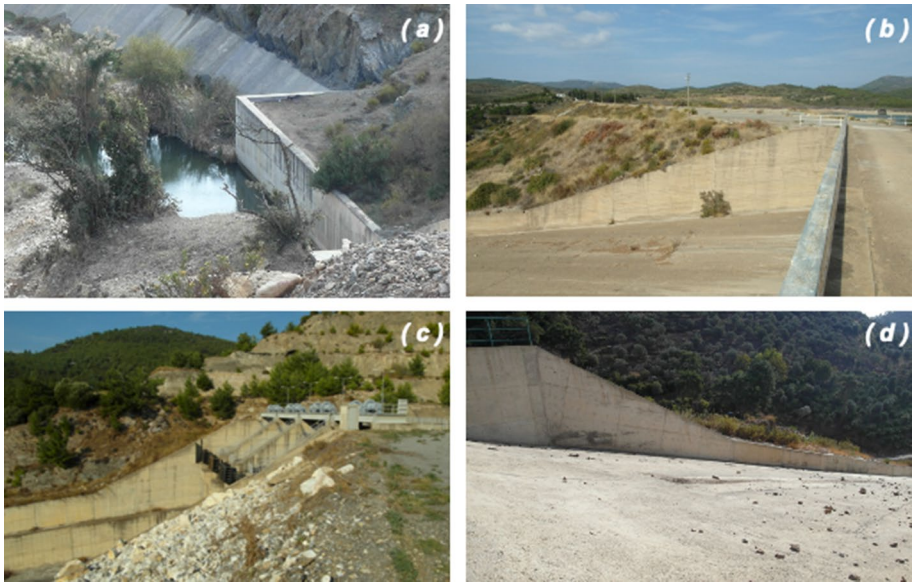
Fig. 29 a Wall on the end of spillway chute of Kavakdere Dam, and side walls of spillways of b Urkmez Dam, c Tahtalı Dam, and d Gumuldur Dam

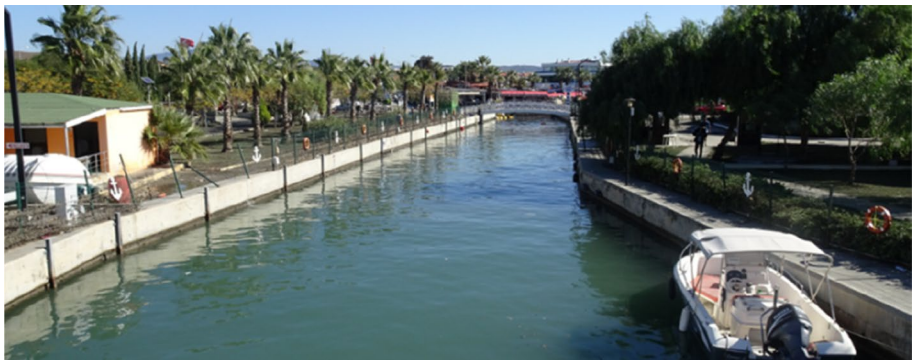
Fig. 30 Sidewalls of the river canal in the Sığacık Marina where no displacements were observed (Photo: Courtesy of Gurel Özdemir). (38°11'33.86"N 26°47'4.07"E 14:16 / 31.10.2020)

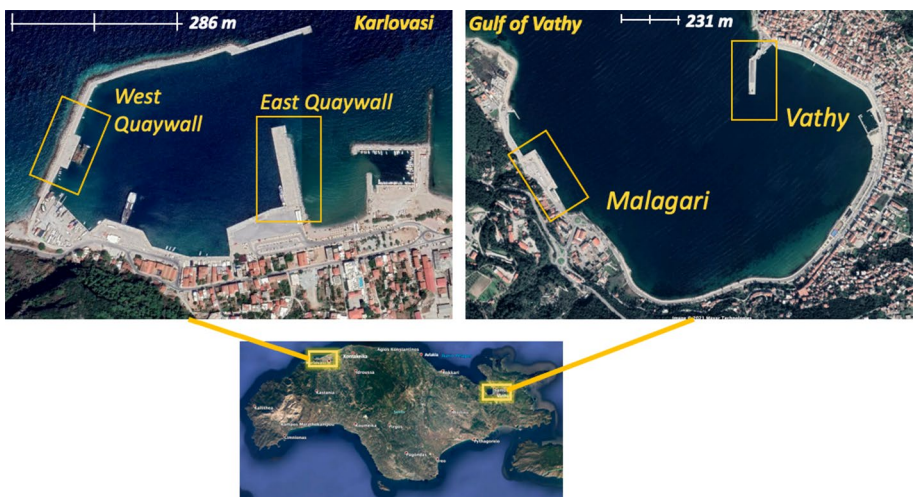
The ports of Vathy and Karlovasi (Fig. 31) are the two main gates of ferry connection between Samos and the mainland, as well as the rest of the islands in NE Aegean

Sea and the Dodecanese islands. Both ports are situated at the northern part of Samos and suffered damage due to the earthquake. There is also a smaller port, Kokkari, which is located in-between the Vathy and Karlovasi ports. That port was also affected by the earthquake; however, the economic impact of the damage was less important relative to that of the other two ports. At the southern part of the island, there are some other ports, at Pythagorio, Iraion, and Marathokampos bay, that were less affected by the earthquake (HAEE/ETAM 2020).

Fig. 31 Satellite images providing an overview of ports of interest in Samos where significant earthquake damage was observed. Annotations indicate the names assigned for ease of reporting herein

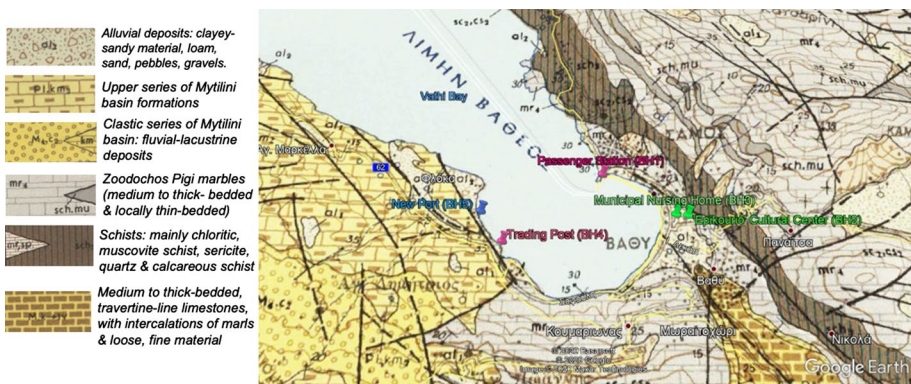
Fig. 32 Detail of the geological map of Samos, according to the Hellenic Survey of Geology and Mineral Exploration (HSGME 2020). A number of boreholes are shown, carried out on the same geological formation (al2)

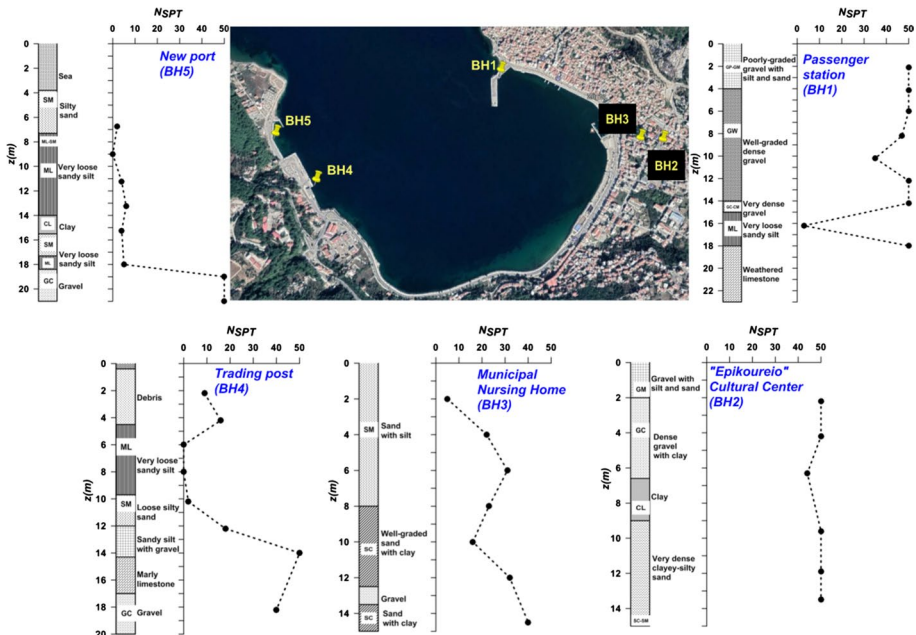
pattern that can be observed as one moves alongshore, from east (BH 1) to west (BH 4 and BH 5): if continuous, the layer of sandy silt or silty sand (ML-SM) emerges at shallower depths and also gets thicker (Fig. 33). However, given the distance between Vathy and Malagari as well as the relative depth and thickness of the ML-SM layer in each location, it is also possible that this is not the same layer across the sites. The associated SPT blow counts are extremely low (essentially zero), which indicates very low strength and high compliance. As the associated materials are non-plastic and saturated, this provides evidence of susceptibility to liquefaction.

Fig. 33 Four geotechnical borehole logs (BH1, BH2, BH3, BH4) alongshore from the eastern (old) port to the western (new) port at Vathy (courtesy of G. Milionis—modified by Em. Rovithis). One offshore borehole (BH5) at the NW edge of the new port (kindly provided by the Ministry for the Environment, Physical Planning and Public Works of Greece – modified by Em. Rovithis)

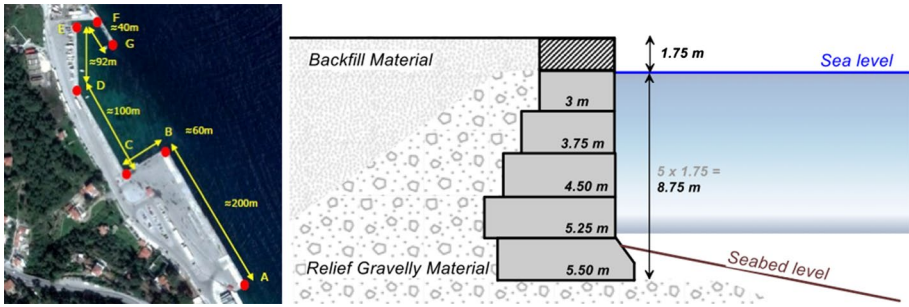
The western (new) port of Vathy, Malagari, is the commercial port where passenger and car ferries are mainly serviced, as well as smaller ships. The total length of the coastal quay wall is about 500 m along the NW–SE direction. Some basic geological features and relevant geotechnical data have already been presented in Fig. 32. Based on these data, a remediation study and the quay wall and the port infrastructure was put together on December 2017 (Triton, 2017). Figure 35 shows the quay walls, as part of the recent rehabilitation project (Triton, 2017). According to Triton (2017), the jetty of Malagari is a gravity structure made of overlapping layers of artificial boulders (5 in each column). On the crown there is an in-situ cast superstructure. The quay wall is founded on a rockfill prism, whose external side along the seaside is protected by natural boulders. A representative sketch of a typical cross-section of the quay wall is depicted in Fig. 35 (Triton, 2017). The technical issues encountered before the earthquake mainly relate to scouring of the quay walls which can be attributed to leakage of the relief prism and upstream backfill material, leading to substantial subsidence behind the quay walls, opening of cracks parallel and transversely to the sea front, and a mild rotation of some quay wall columns towards the sea. The remedial measures outlined in the 2017 report were probably in progress (yet, not completed) when the earthquake struck.

Fig. 35 Satellite view over infrastructure of the western Vathy port (Malagari) (Triton 2017) and typical cross-section of the quay wall of the new (Malagari) port of Vathy corresponding to section A–B (out-of-scale drawing, modified after Triton 2017)

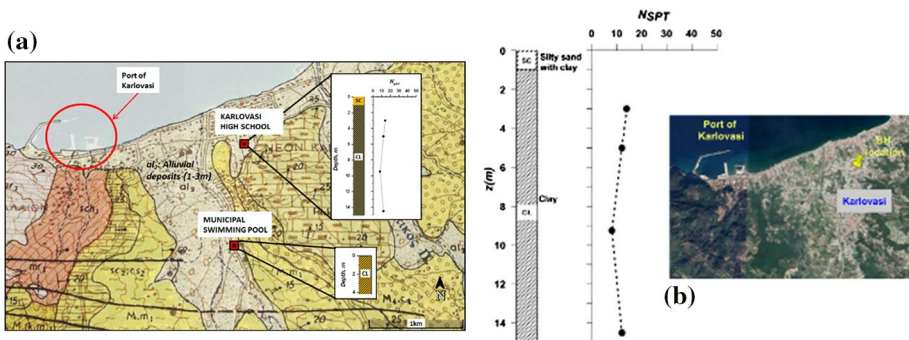
from a borehole close to the high school of Karlovasi indicate that the soil consists of grey to grey-brownish medium stiff to stiff sandy clay of medium plasticity (excluding the top 1 m that consists of silty sand with a few gravels). The distance to the closest part of Karlovasi port (east quay wall) is about 2 km; therefore, it is difficult to extrapolate as to the subsoil in the port. However, based on the soil layering at Vathy, there is a possibility that the surficial layer of silty sand gets thicker near the seashore. This however, albeit generally true, cannot be reliably deduced without geotechnical data.

Fig. 37 **a** Part of the detailed geological map of Samos Island, published by the Hellenic Survey of Geology and Mineral Exploration (HSGME 2020) with the location of two (2) geotechnical boreholes on the same geological formation (a12). **b** Borehole log next to the High School of Karlovasi (Gymnasium), at a distance of about 2 km from the east quay wall of the port and 550 m from the seafront
