Preliminary Environmental Investigations at the Lawrence Berkeley Laboratory

I. Javandel

November 1990

LBL-29898

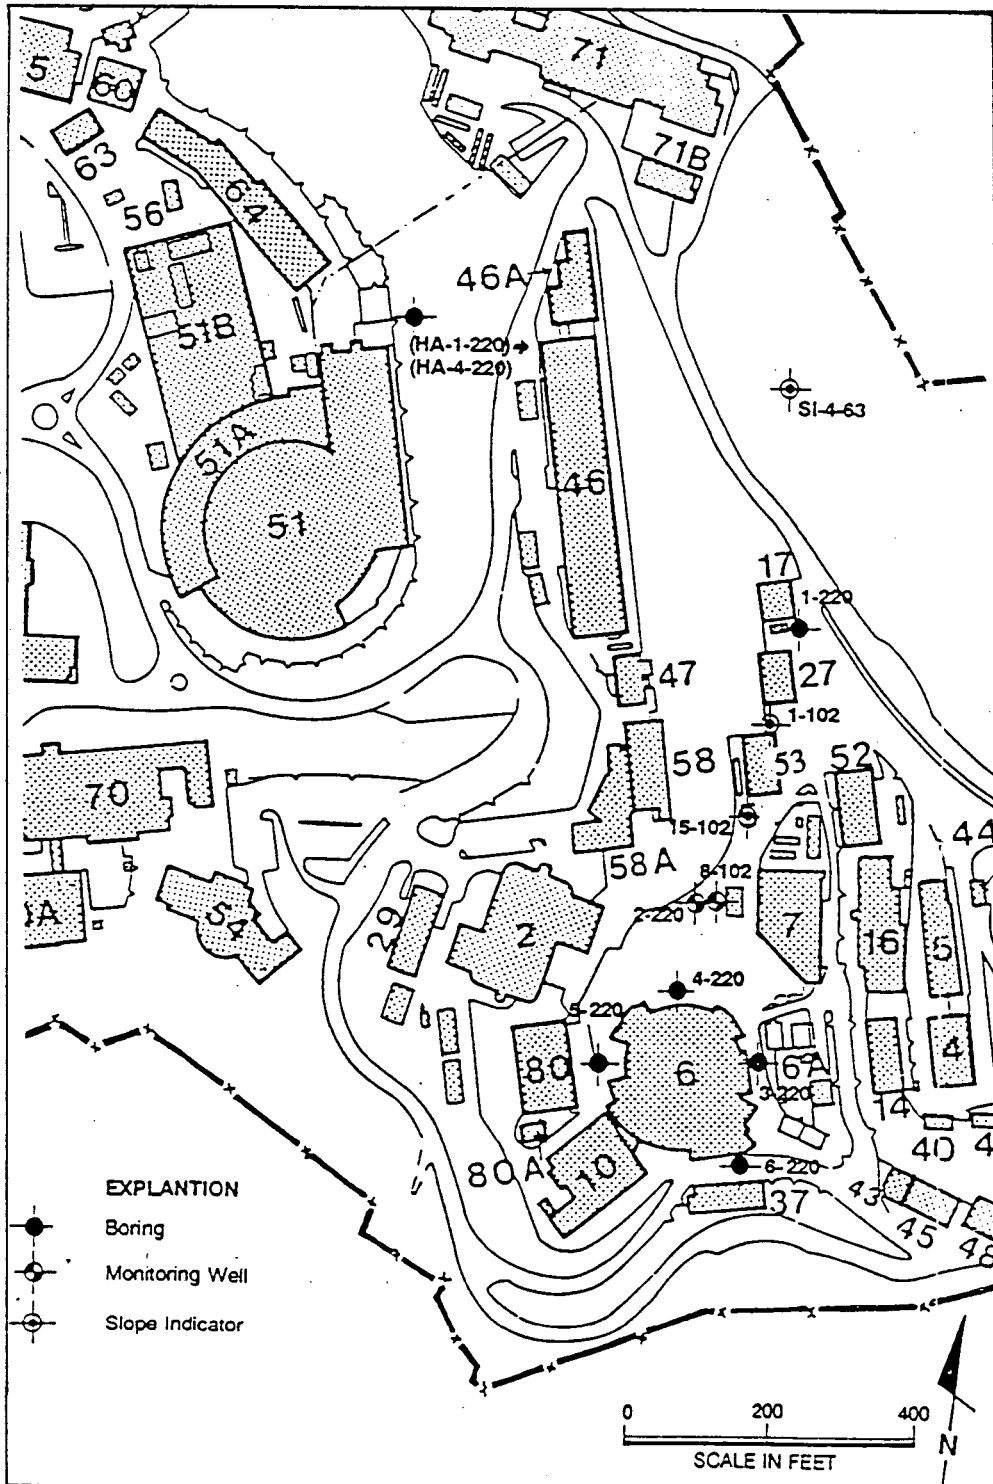
Following the outcome of the above Survey, in September 1988 LBL hired Harding Lawson associate (HLA) to perform a fast track sampling effort at the LBL site (Harding Lawson, 1988). HLA collected water samples from three slope indicators. One of these, situated on the hill east of Building 46, has no LBL facility upstream from it. Chemical analysis of the sample from this slope indicator did not show any contamination. The other two slope indicators were located north and south of Building 53. The water sample from the slope indicator north of Building 53 showed a very low level of chloroform, TCE and PCE, all of them below their respective Safe Drinking Water Act (SDWA) maximum contaminant level (MCL). The sample collected from the slope indicator south of Building 53, however, showed a relatively high concentration of TCE and PCE, far above the MCL. Figure 1 shows the location of these slope indicators, and the results of chemical analysis are given in Table 1.

Figure 1. Location of monitoring wells, slope indicators, and soil samples used in 1988 HLA studies.

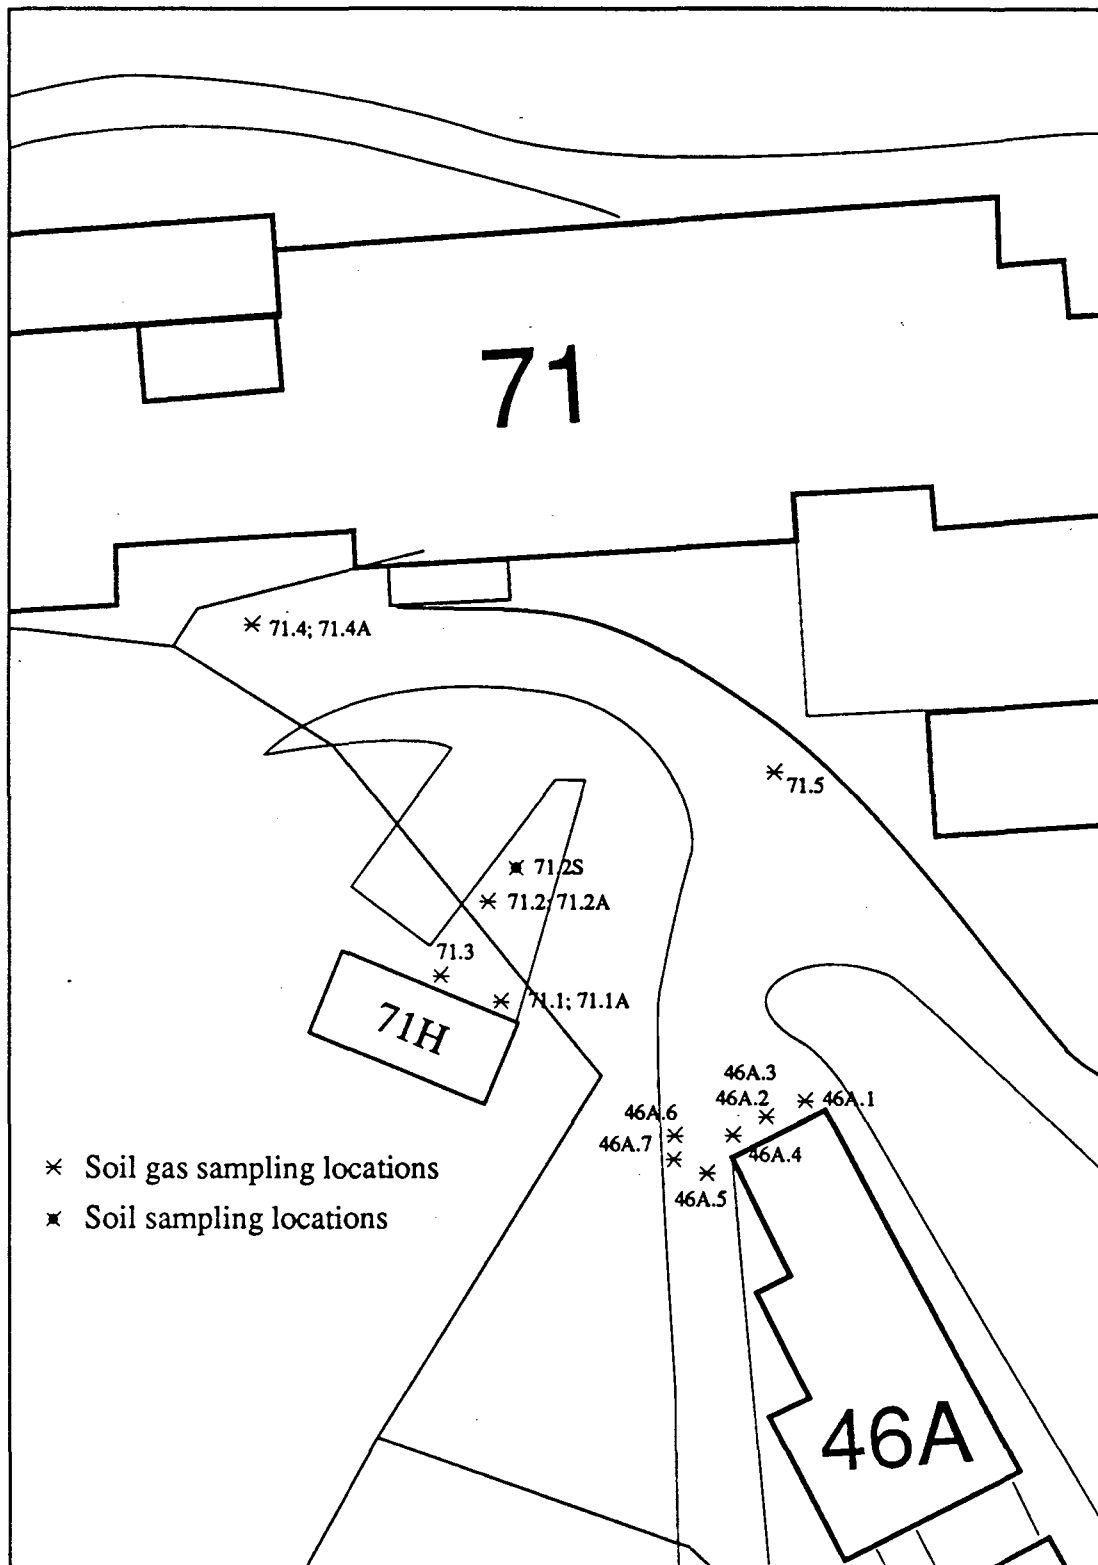
We then moved to the south boundary of Building 71. Extensive distribution of utilities underground limited locations where we could collect soil gas for analysis. Therefore, only two locations were selected. One at the point 71.4 and the other at 71.5 (Figure 10). A soil gas sample collected at 5 ft depth at point 71.4 showed a relatively high concentrations of Freon 113, (887 $\mu\text{g/L}$) and cis-1,2-DCE (193 $\mu\text{g/L}$). Some TCE (11.5 $\mu\text{g/L}$) and PCE (5.57 $\mu\text{g/L}$) were also detected in this sample. Note that except for Freon 113 which was stored in a large tank located very close to this sampling location, the other three compounds detected here are exactly the same that we have seen in the Hydraulers No. 51.01.03 and 51.01.04, which extend under Building 46A. We then tried to get a sample from 10 ft depth. Hitting hard rock, we had to stop penetration and obtained a sample at 7.5 ft depth instead. This sample also showed some Freon 113 and DCE but in much smaller concentrations, indicating that the source was perhaps very close to the upper sampling point where we obtained the soil gas. Analysis of the soil gas sample from 5 ft depth at the point 71.5 did not show any detectable concentration of compounds tested for.

Another area that was under suspicion was near Building 46A. That is the site of a former motor pool operation which used an underground gasoline storage tank. Therefore, we examined three locations on the north side of B46A as shown in Figure 10. Samples were collected from depths between 5 to 20 ft. The shallow samples did

Figure 10. Soil gas and soil sampling locations in the vicinity of Bldgs. 46A and 71.

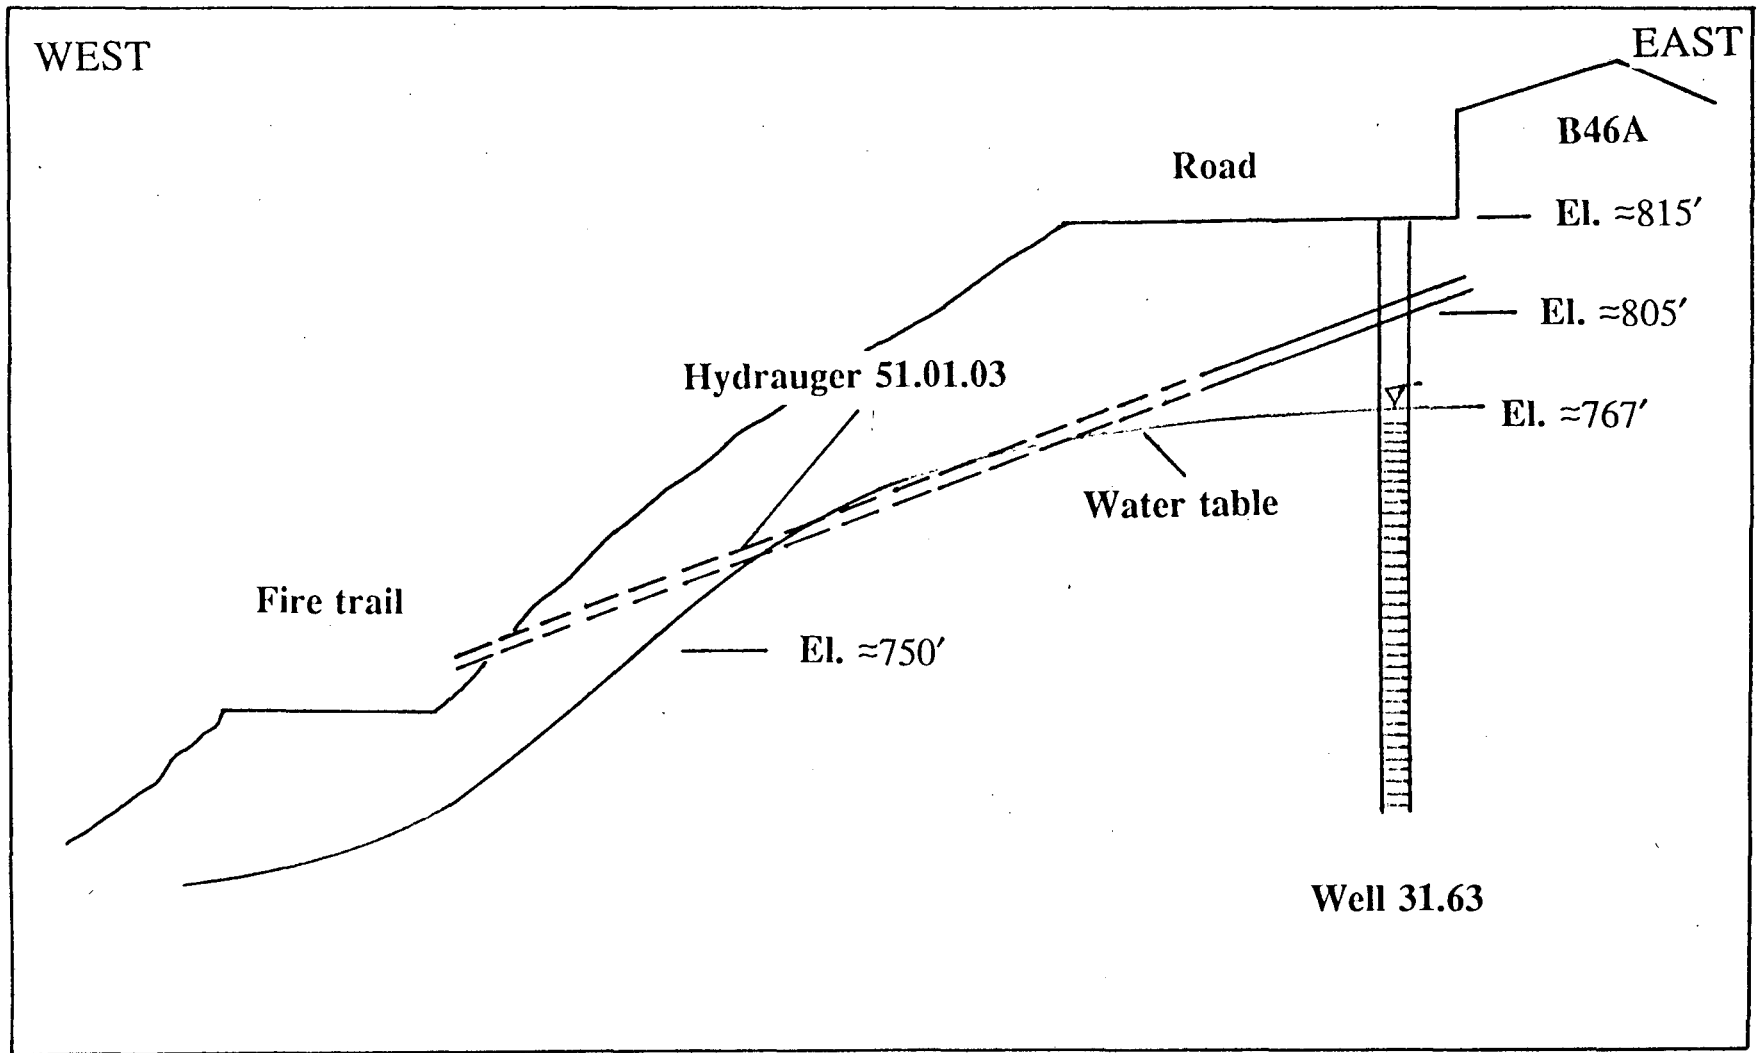
One more issue needs to be resolved. If hydraugers extending below Building 46A carry PCE, TCE, and DCE, what is the reason for not detecting those chemicals in the water samples collected from Well 31.63 that is drawing groundwater close to Building 46A? Figure 13 shows an east-west cross section passing under B46A. Approximate position of water table during summer of 1990 and both Hydrauger No. 51.01.03 and Well 31-63 are shown in this figure. Most of the indicated elevations are approximate. However, they are accurate enough to justify the following argument.

It is apparent from this figure that the water entering the hydrauger is coming from a part of the aquifer which is close to the west side of the road. This is approximately the same section of the aquifer which receives contaminants from the sanitary sewer coming from Building 71. The piezometric map of groundwater in this area that is presented in Figure 14 seems to support the above scenario too.

Figure 13. A west-east cross section beneath Building 46A.

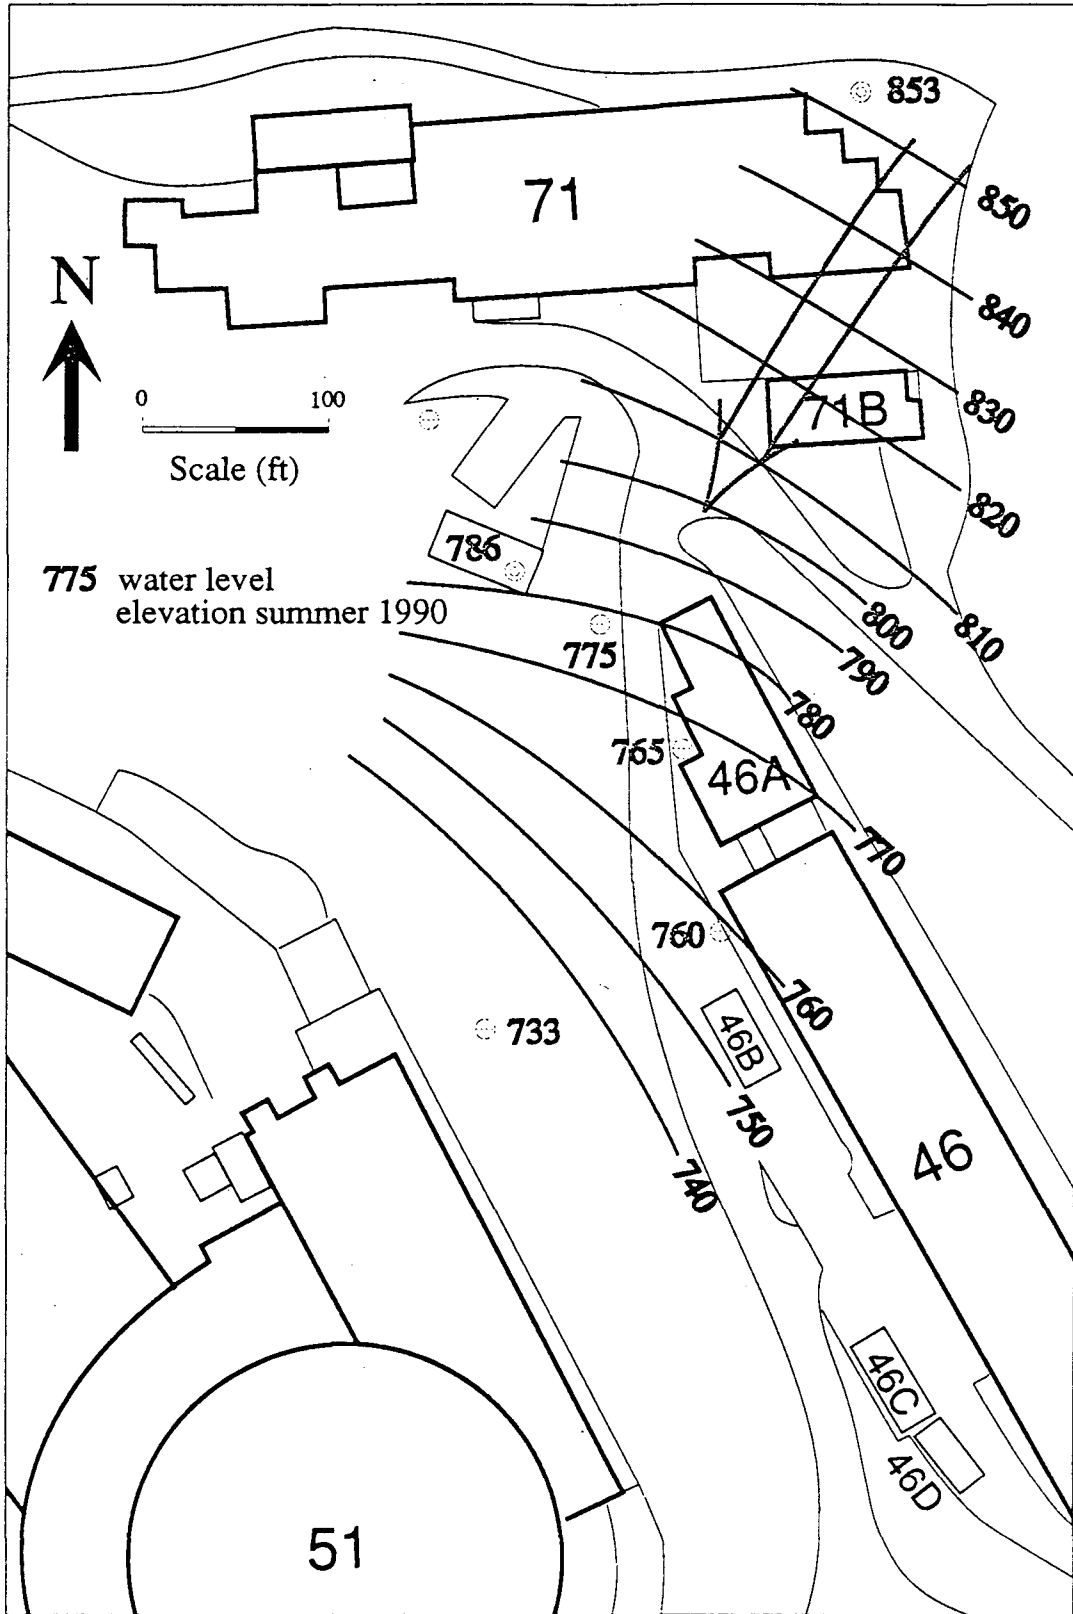
Figure 14. Piezometric map of groundwater in the vicinity of Bldgs. 46, 51 and 71, during the summer of 1990.

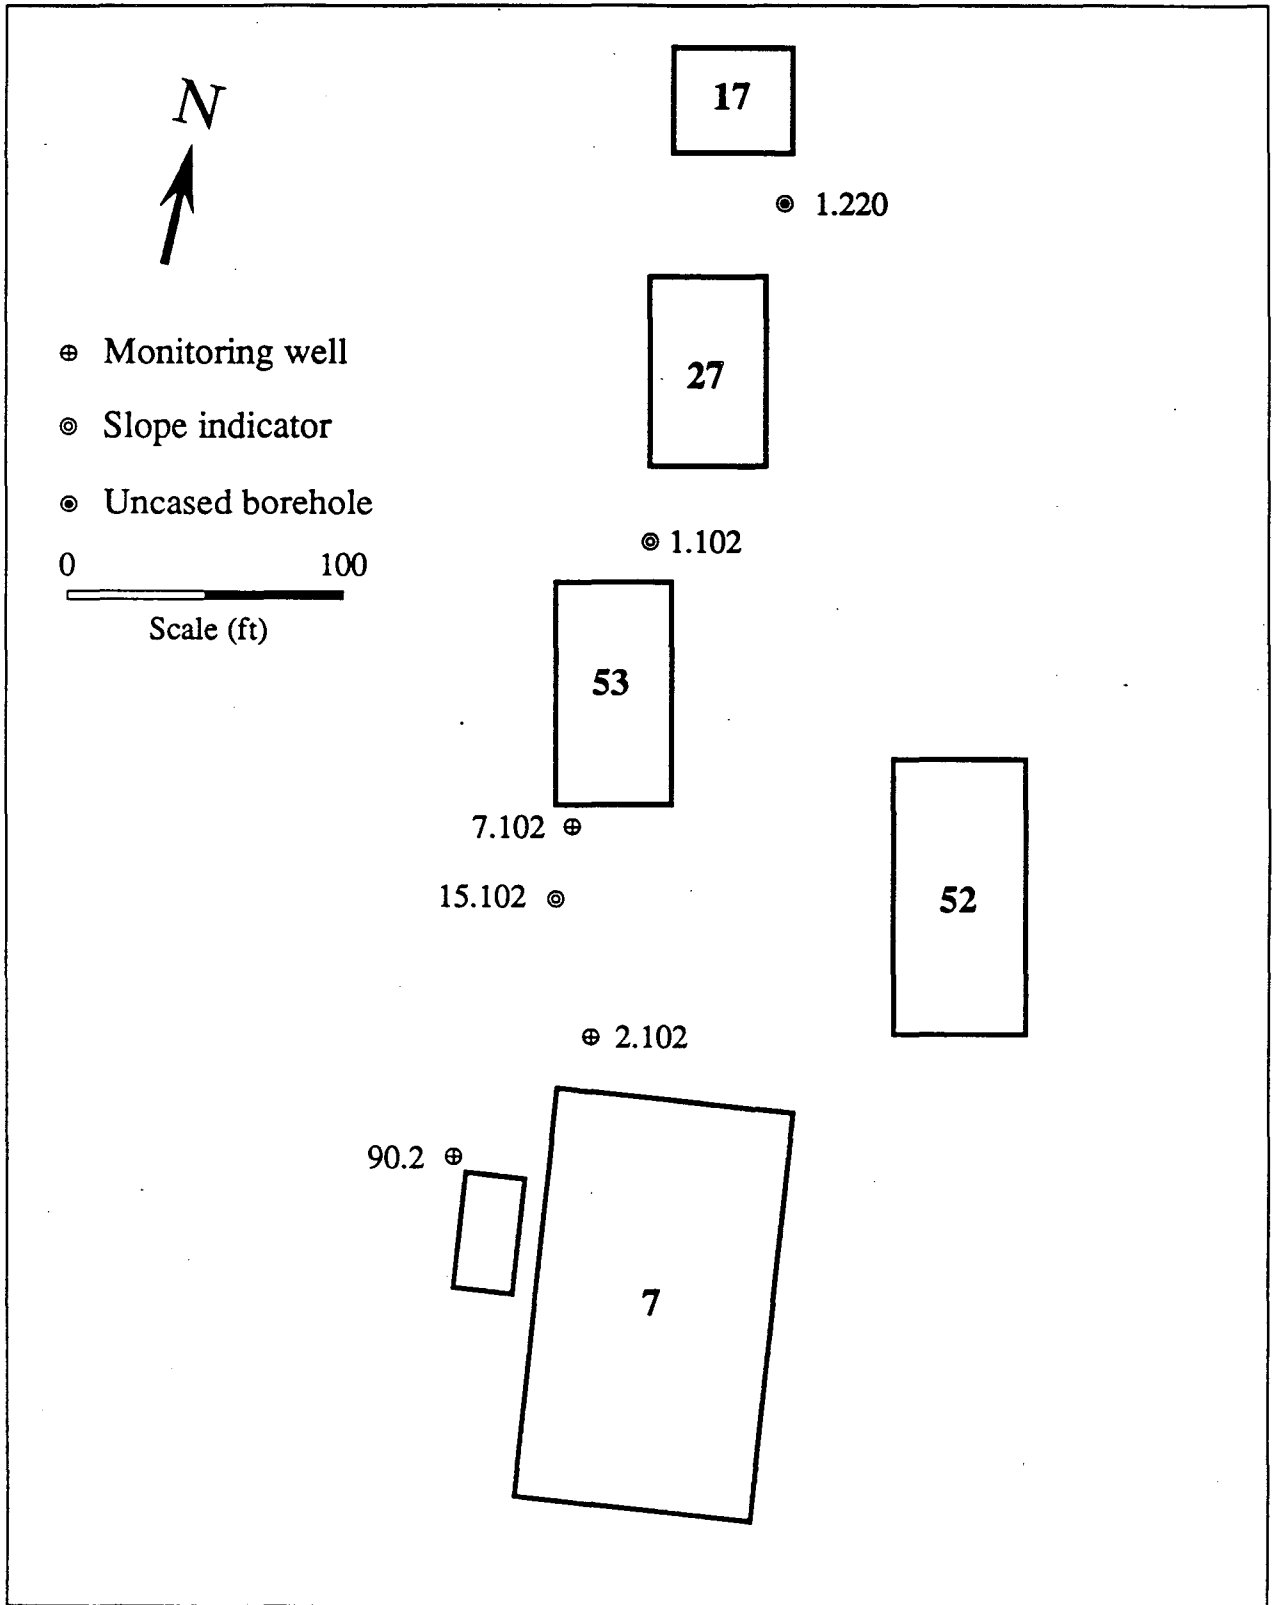
Figure 20 shows the location of monitoring wells and slope indicators in the vicinity of Buildings 6, 7 and 53. During the last year of study (1989-1990), Well 1.220 was dry and slope indicator 1.102 was partially filled with dirt; therefore, neither could be used. Unfortunately, construction activities for the Advanced Light Source Building has damaged the two other monitoring wells 2-220 and 8-102 shown in Figure 1. However, we identified another Well 7.102 south of Building 53. Another monitoring Well 2.102 was also added to this study. The following is a discussion of the activities carried out in this area and the results of study to date.

Figure 20. Locations of monitoring wells and slope indicators in the vicinity of Bldgs. 6, 7 and 53.

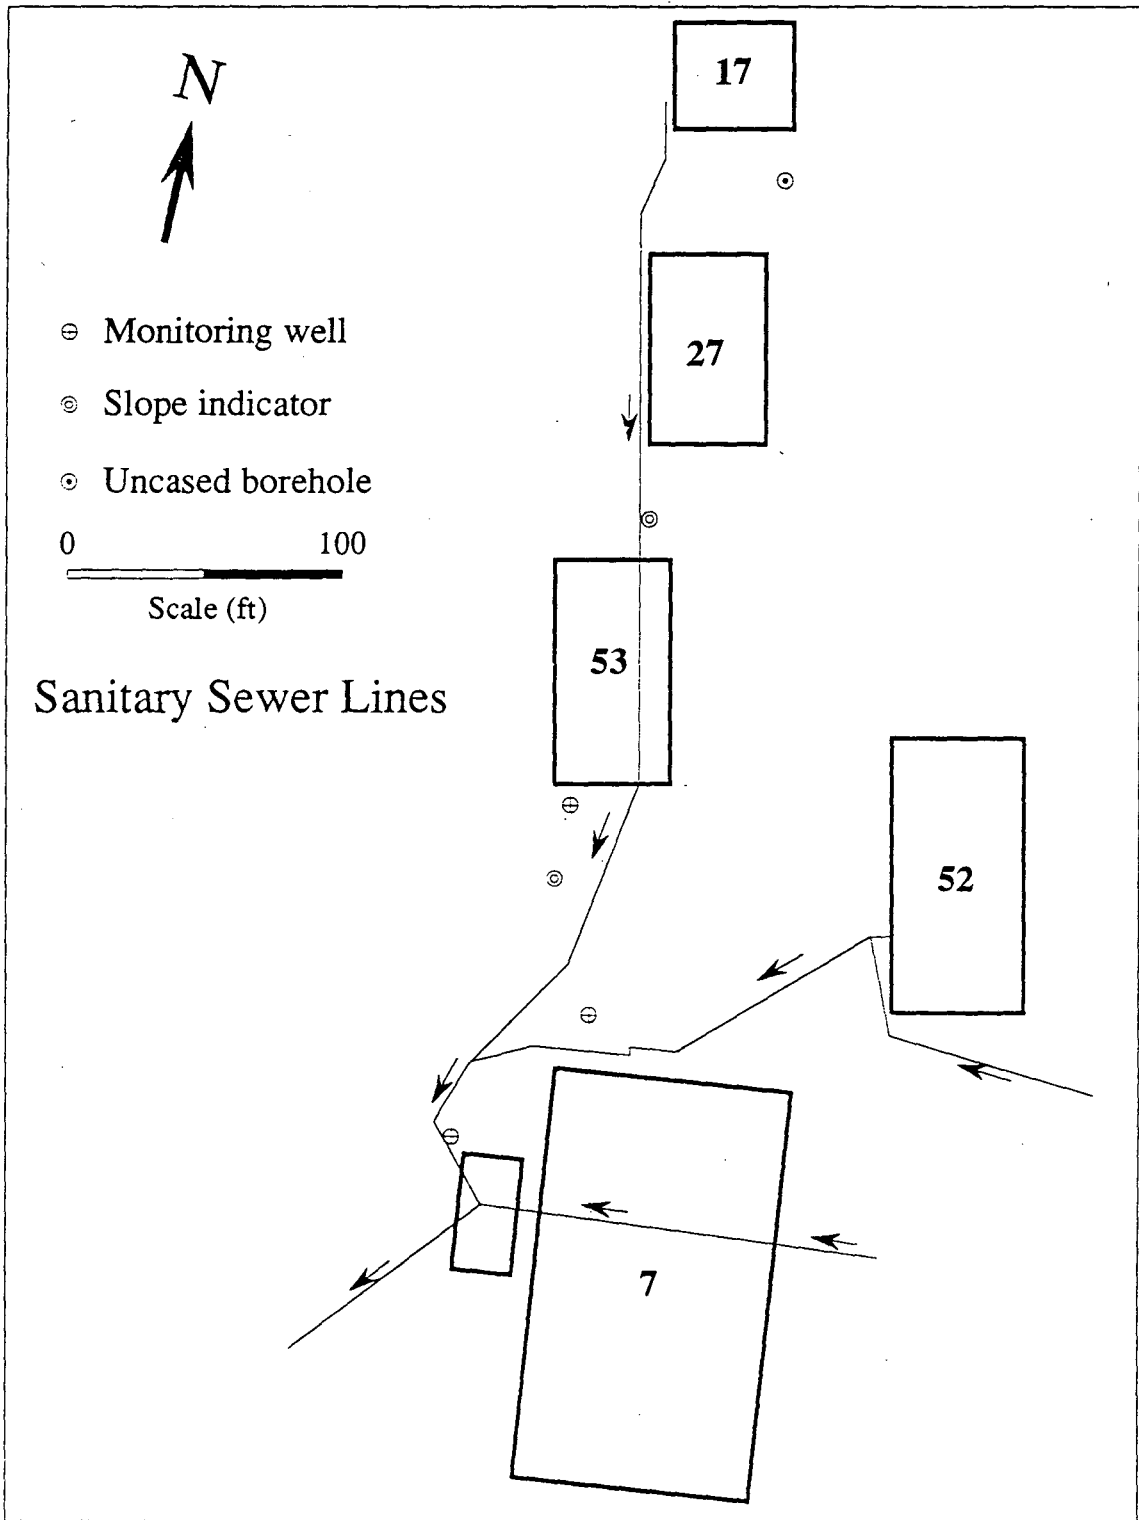
Figure 23. Sanitary sewer lines in the vicinity of Bldgs. 7, 52 and 53.

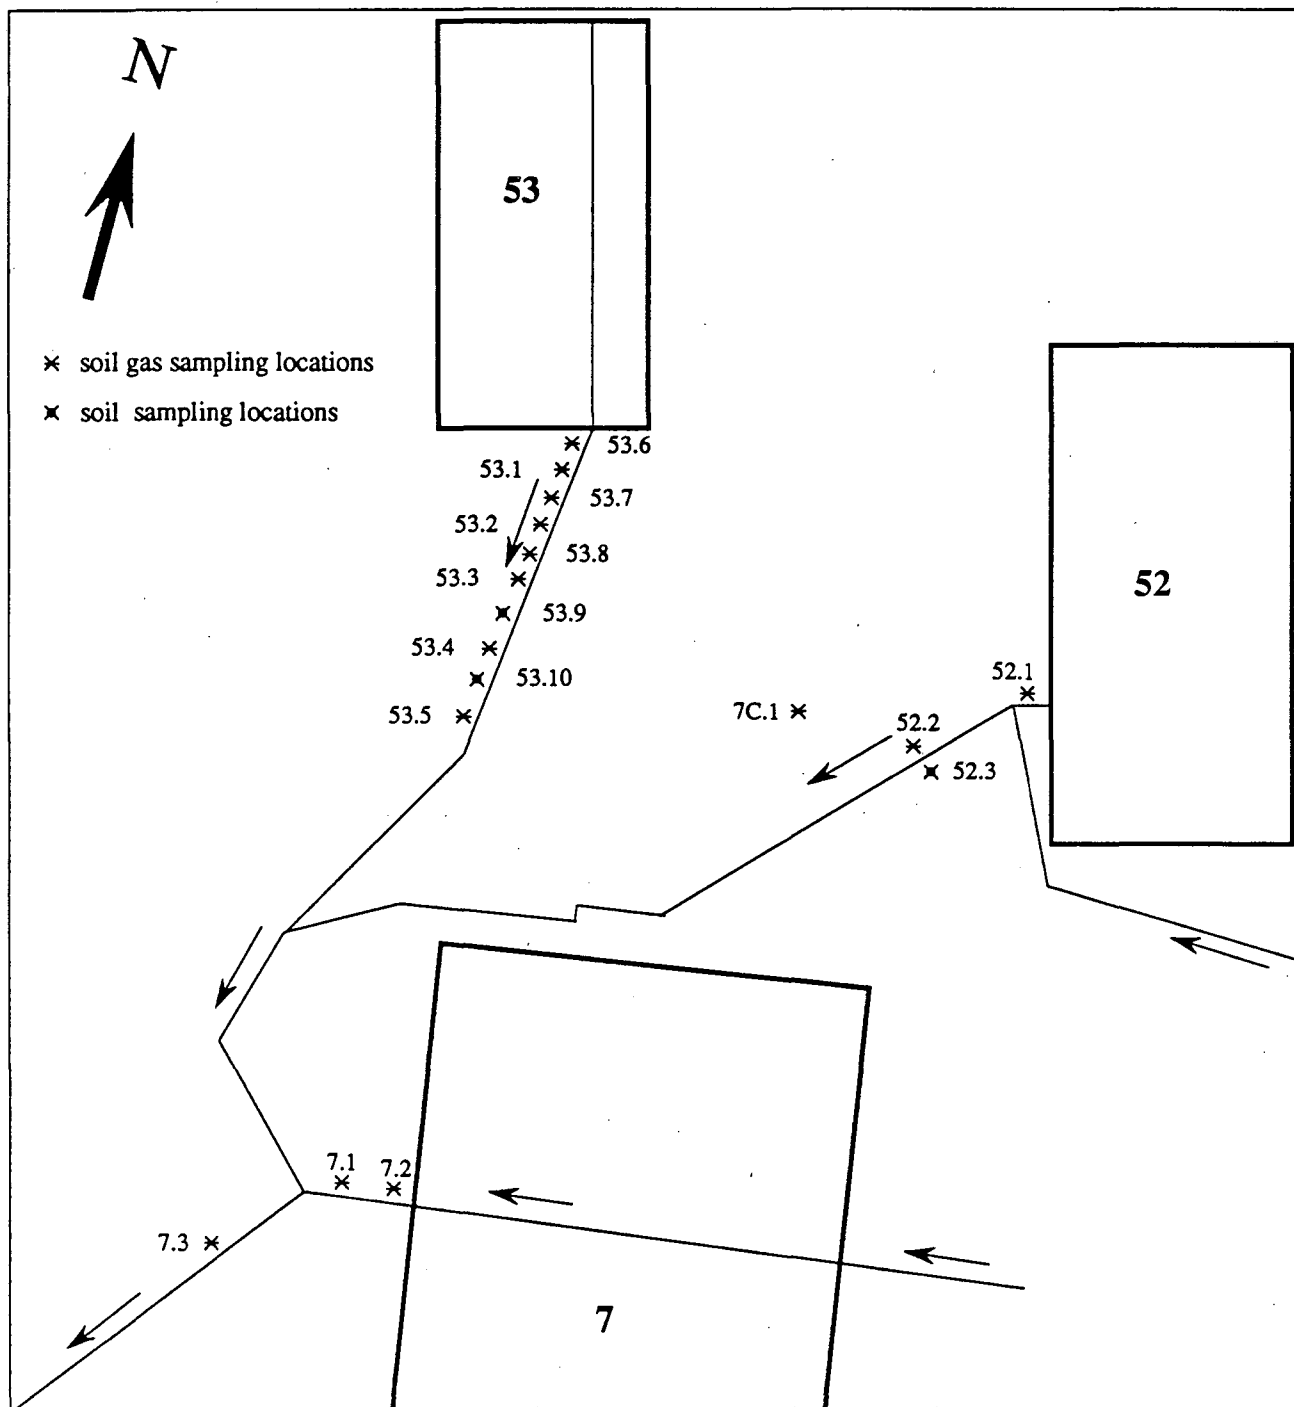
Figure 24. Locations of round two soil and soil gas survey in the vicinity of Bldgs. 7, 52 and 53.

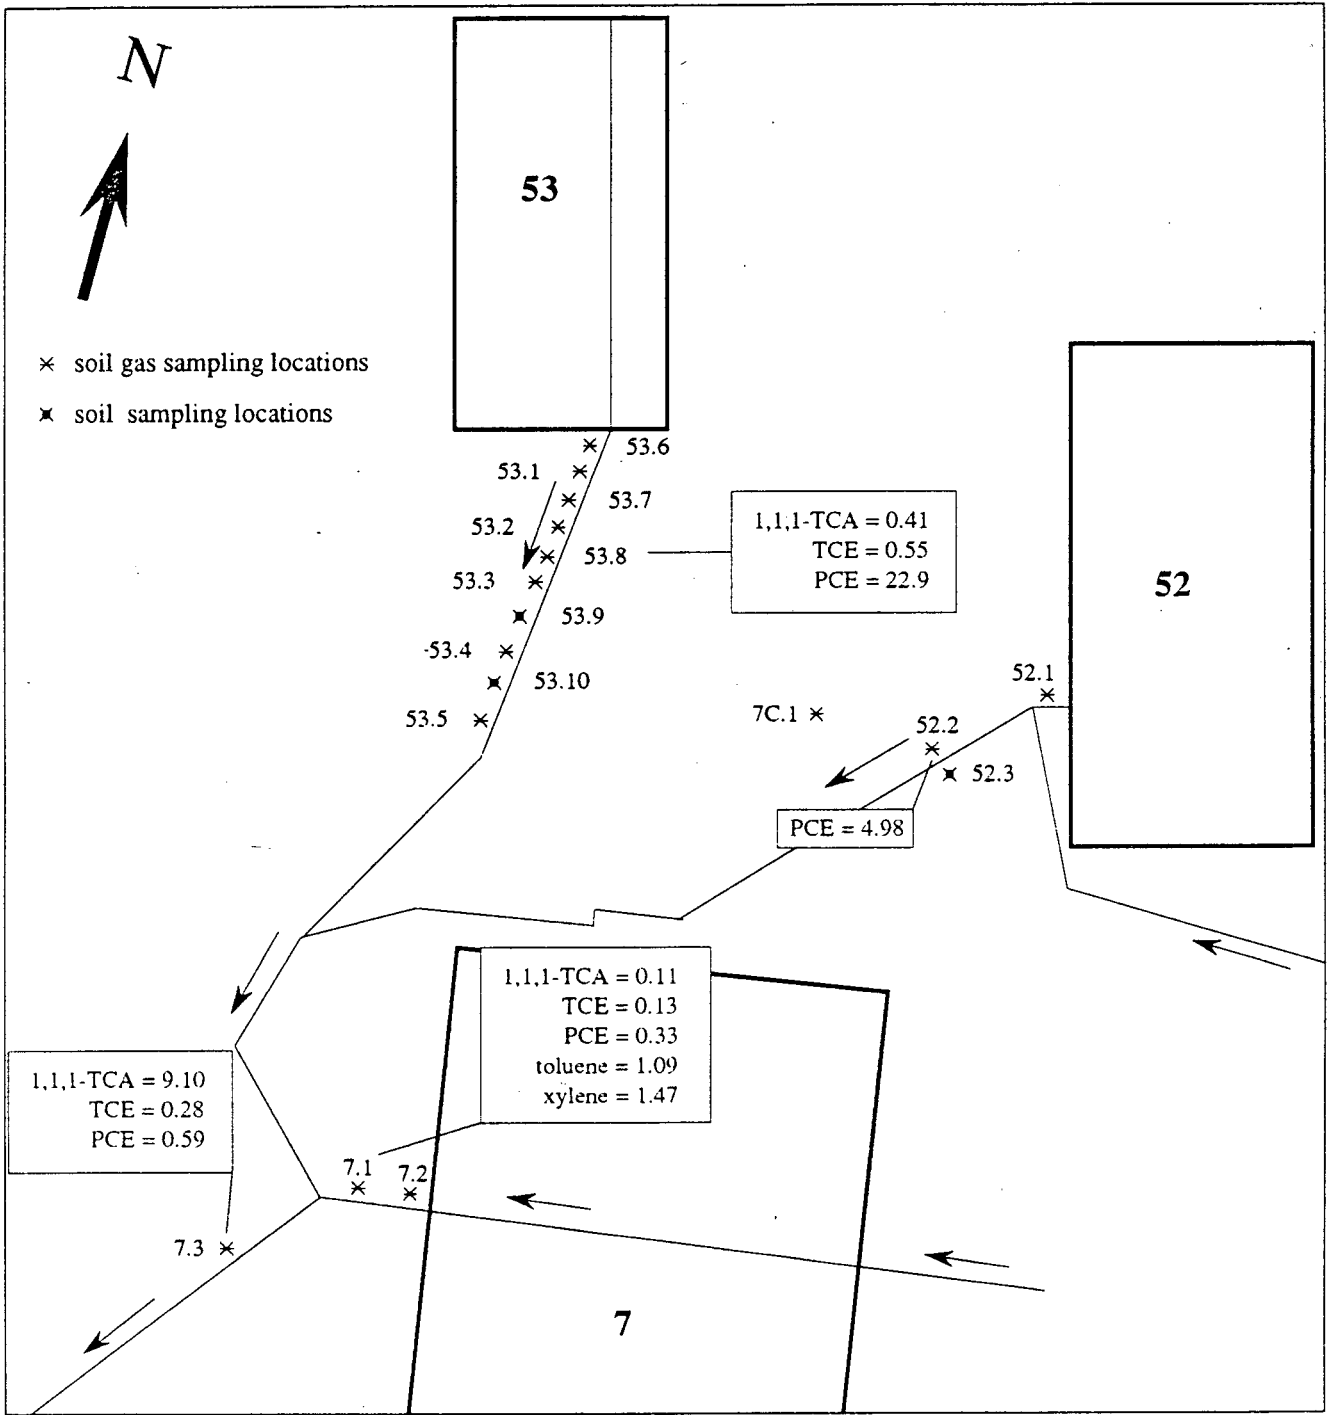
Figure 25. Results of round two soil and soil gas survey in the vicinity of Bldgs. 7, 52 and 53.

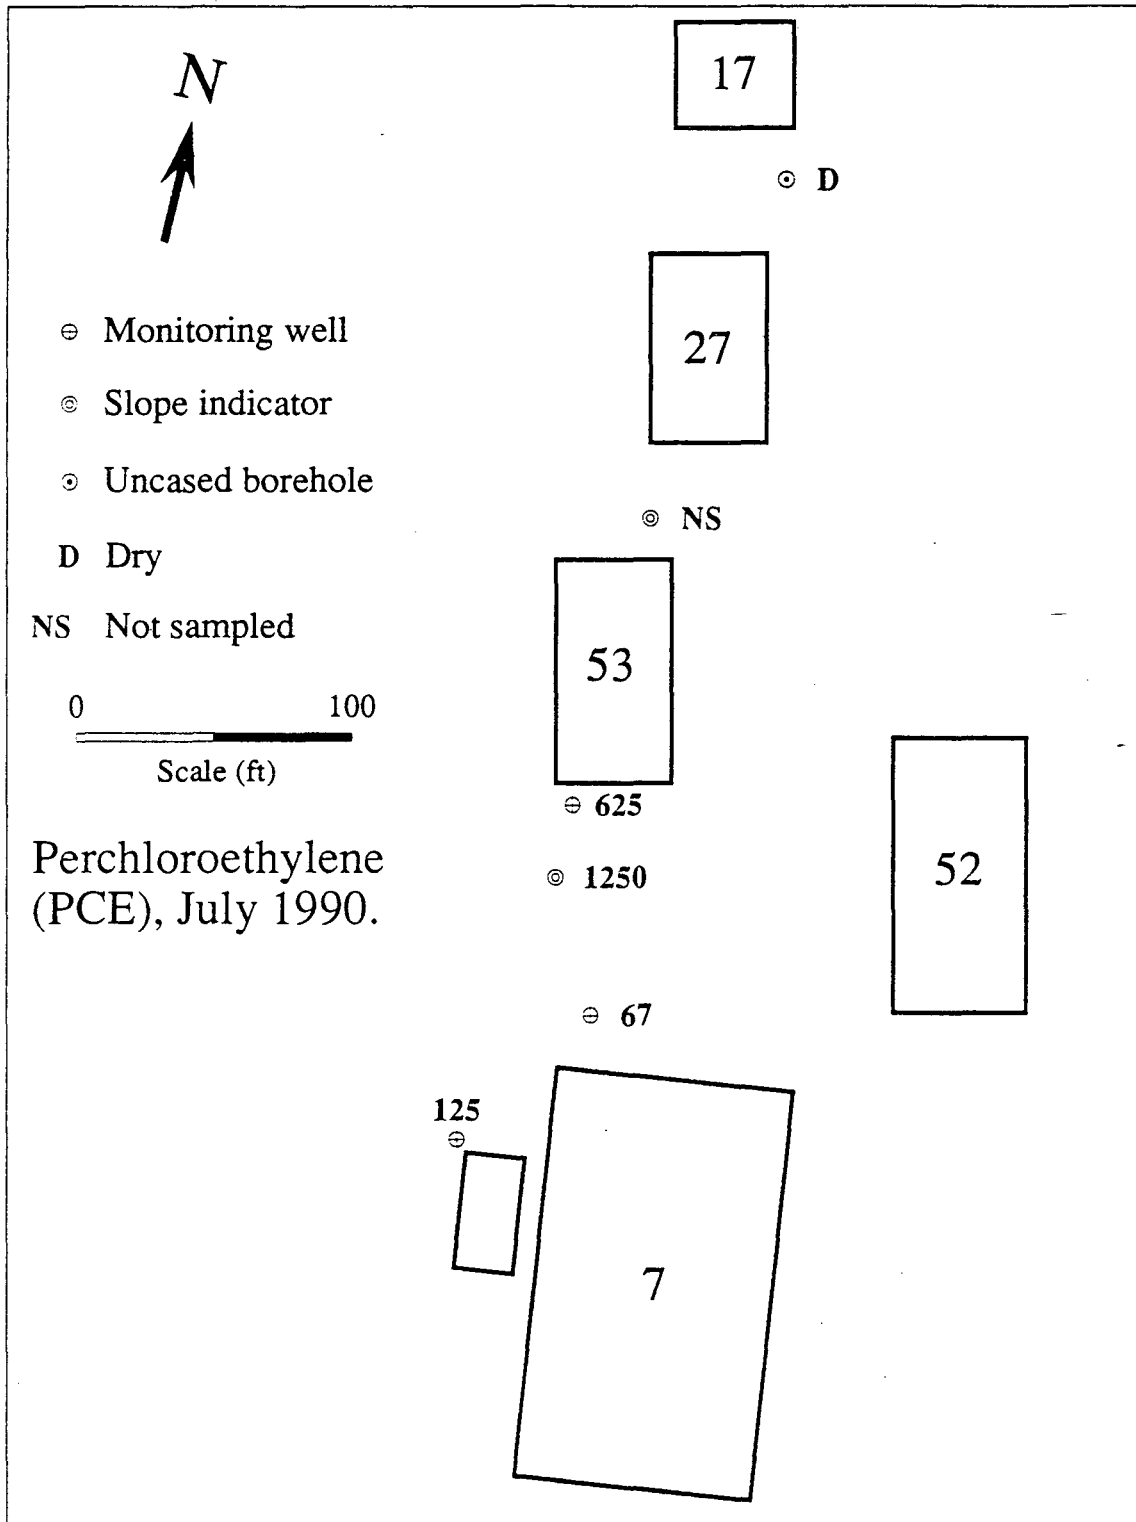
Water samples collected from monitoring Well 7.102 and slope indicator 15.102 show relatively high concentrations of PCE, in the order of several hundred ppb. Concentration of TCE and DCE are much less, but still significant. In addition, they show relatively high concentration of ethane compounds. Figure 26 through 29 show distribution of PCE, TCE, 1,1-DCE and total ethylene and ethane compounds in the water samples taken during July 1990 from monitoring wells and slope indicators in this area. A new well was drilled at the northwest corner of Building 7, called 90.2. This

Figure 26. Perchloroethylene (PCE) concentration in ppb, measured in water samples from wells and slope indicators in July 1990.

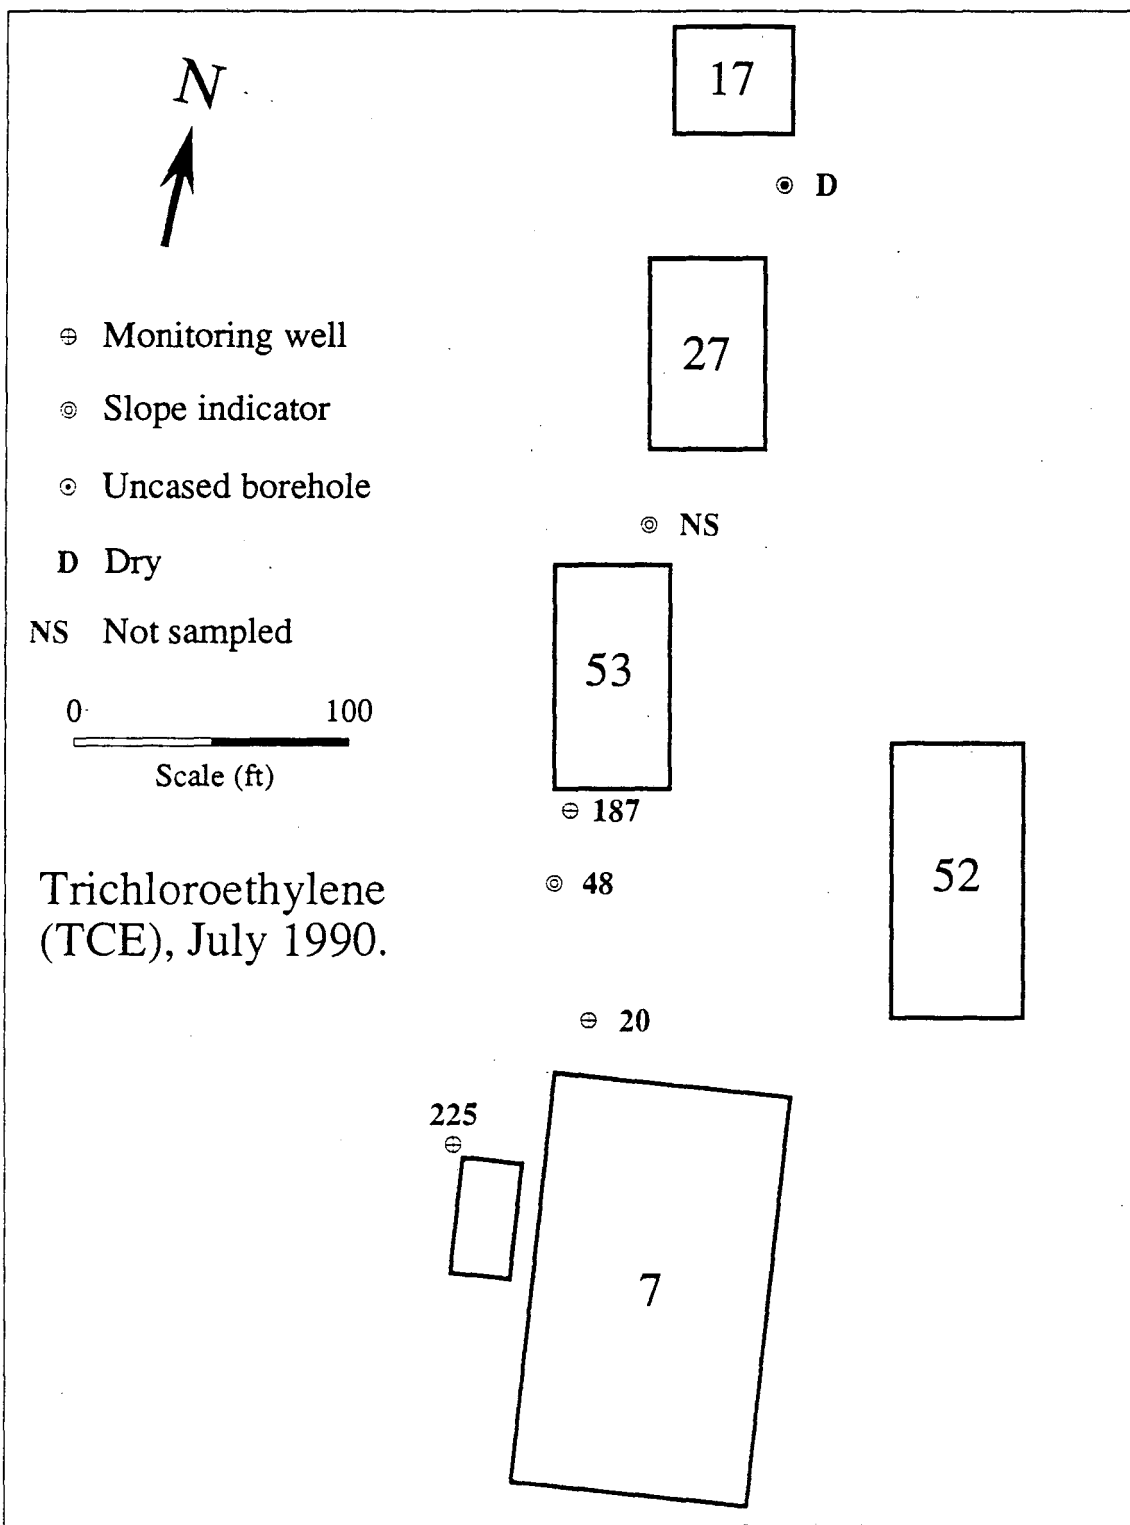
Figure 27. Trichloroethylene (TCE) concentration in ppb, measured in water samples from wells and slope indicators in July 1990.

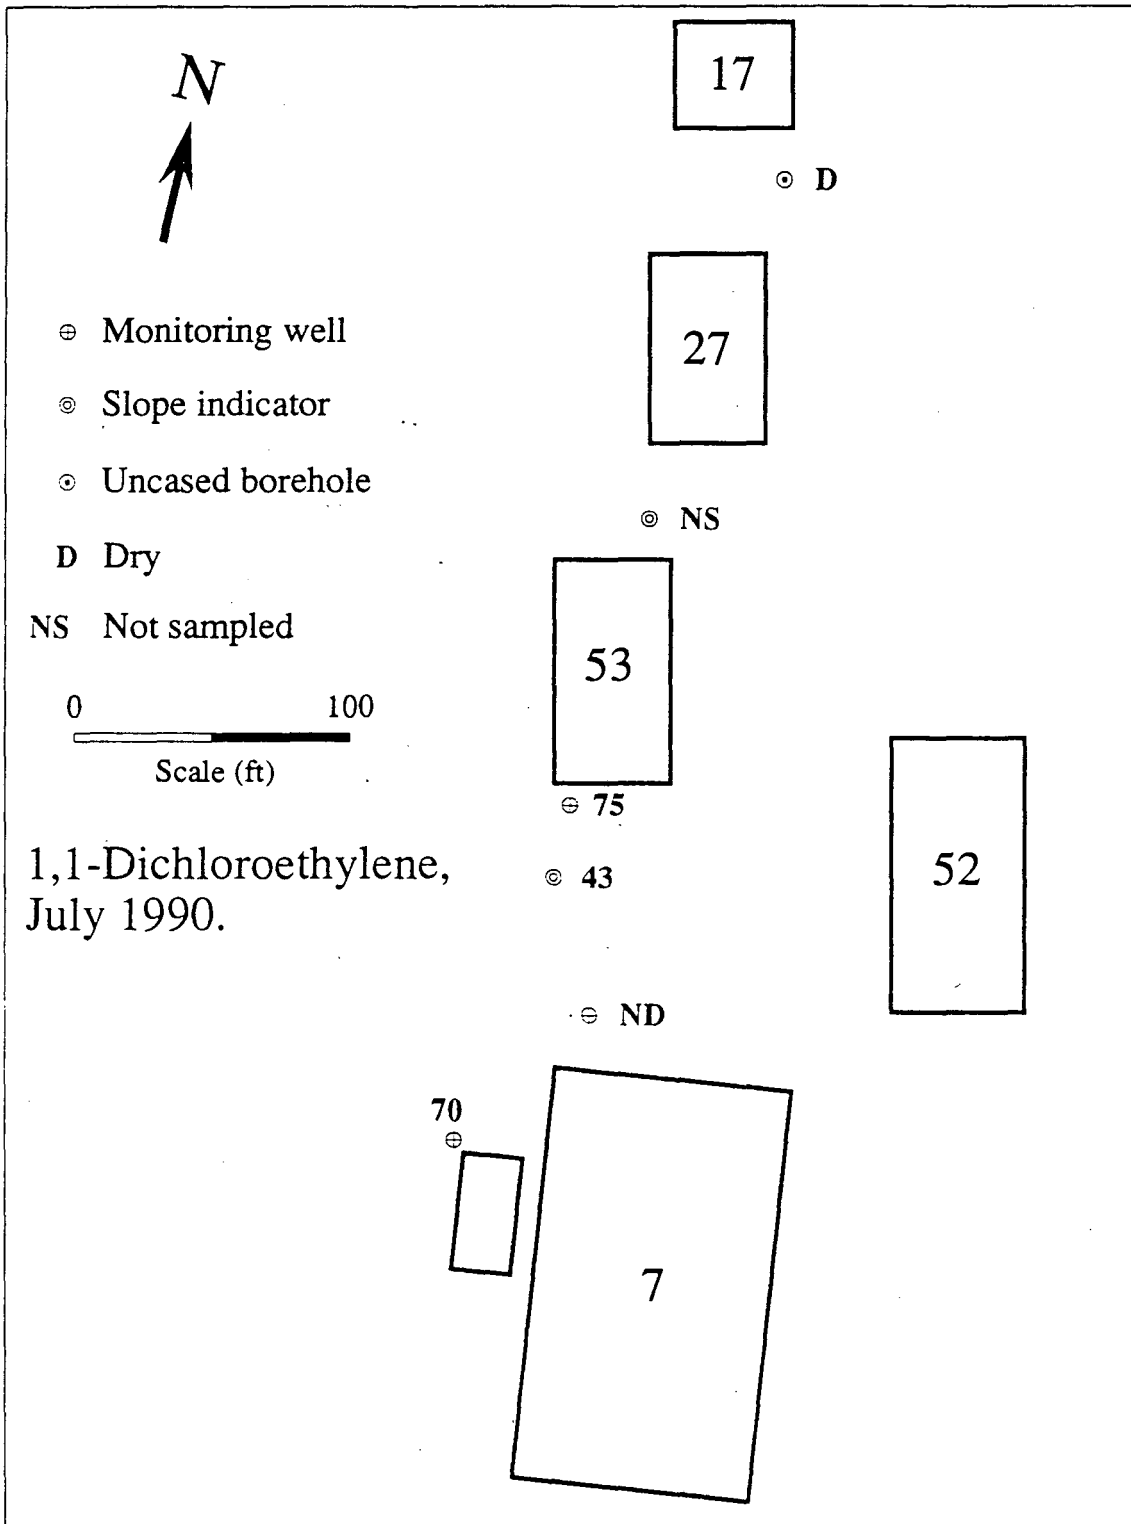
Figure 28. 1,1-Dichloroethylene concentration in ppb, measured in water samples from wells and slope indicators in July 1990.

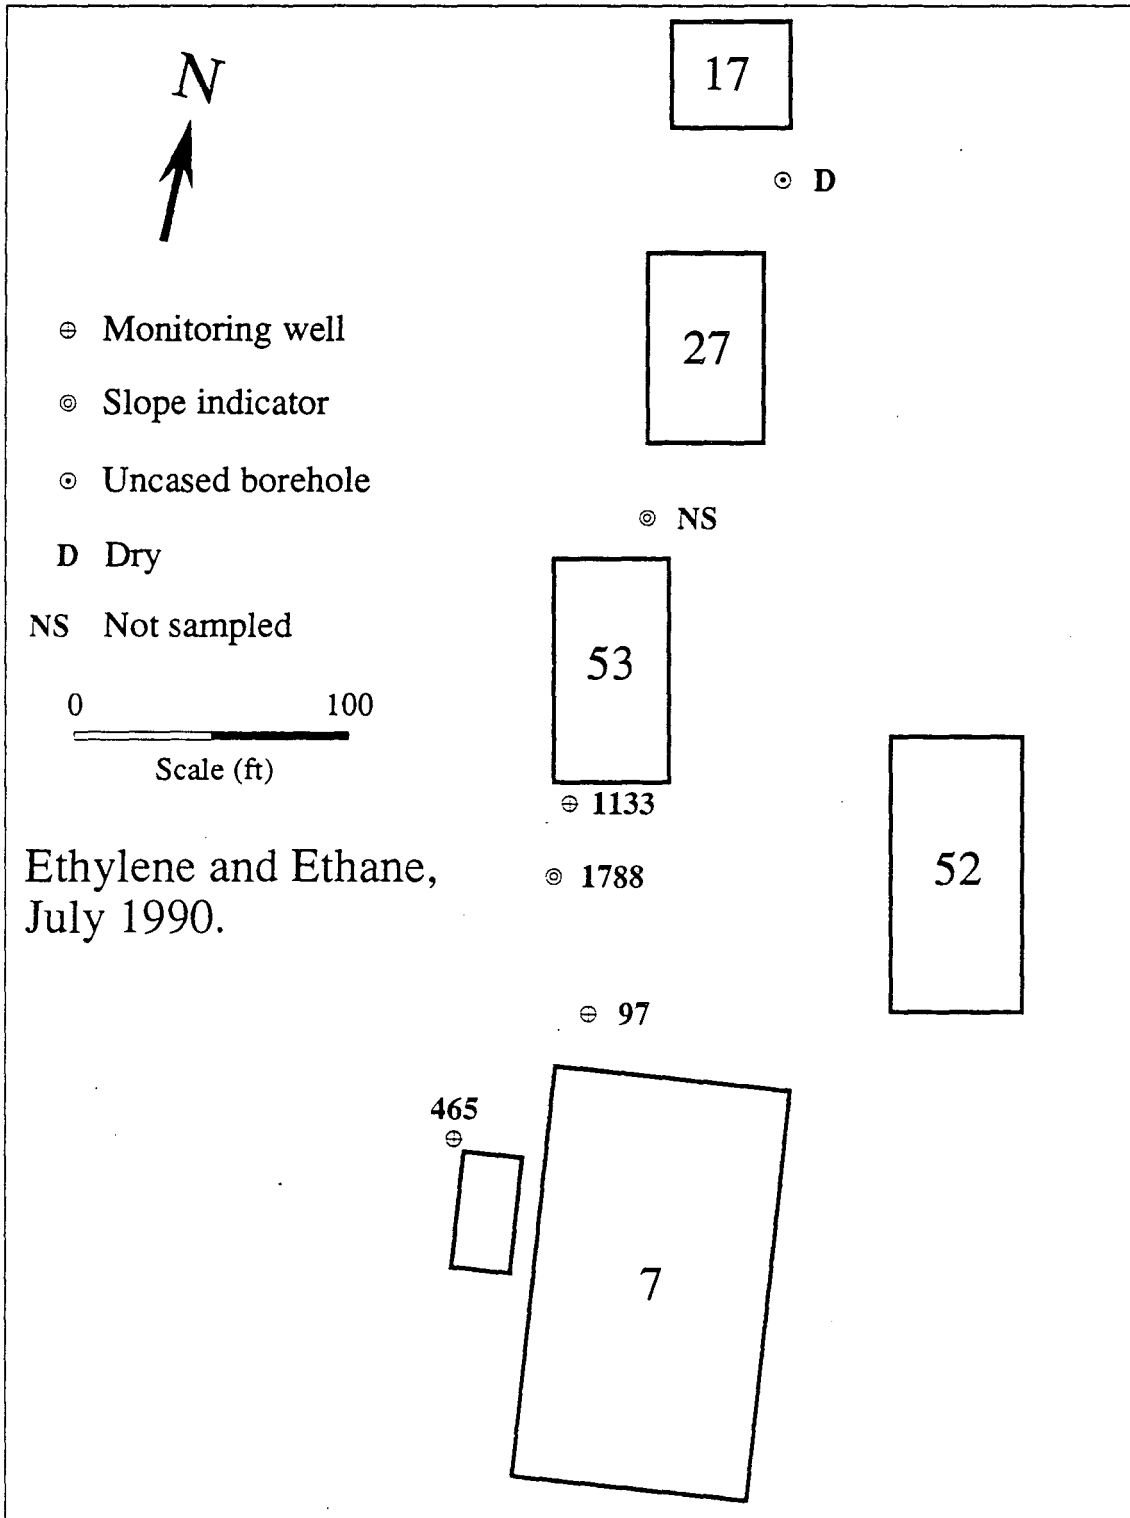
Figure 29. Total ethylene and ethanes concentrations in ppb, measured in water samples from wells and slope indicators in July 1990.
