Preliminary Environmental Investigations at the Lawrence Berkeley Laboratory

I. Javandel

November 1990

LBL-29898

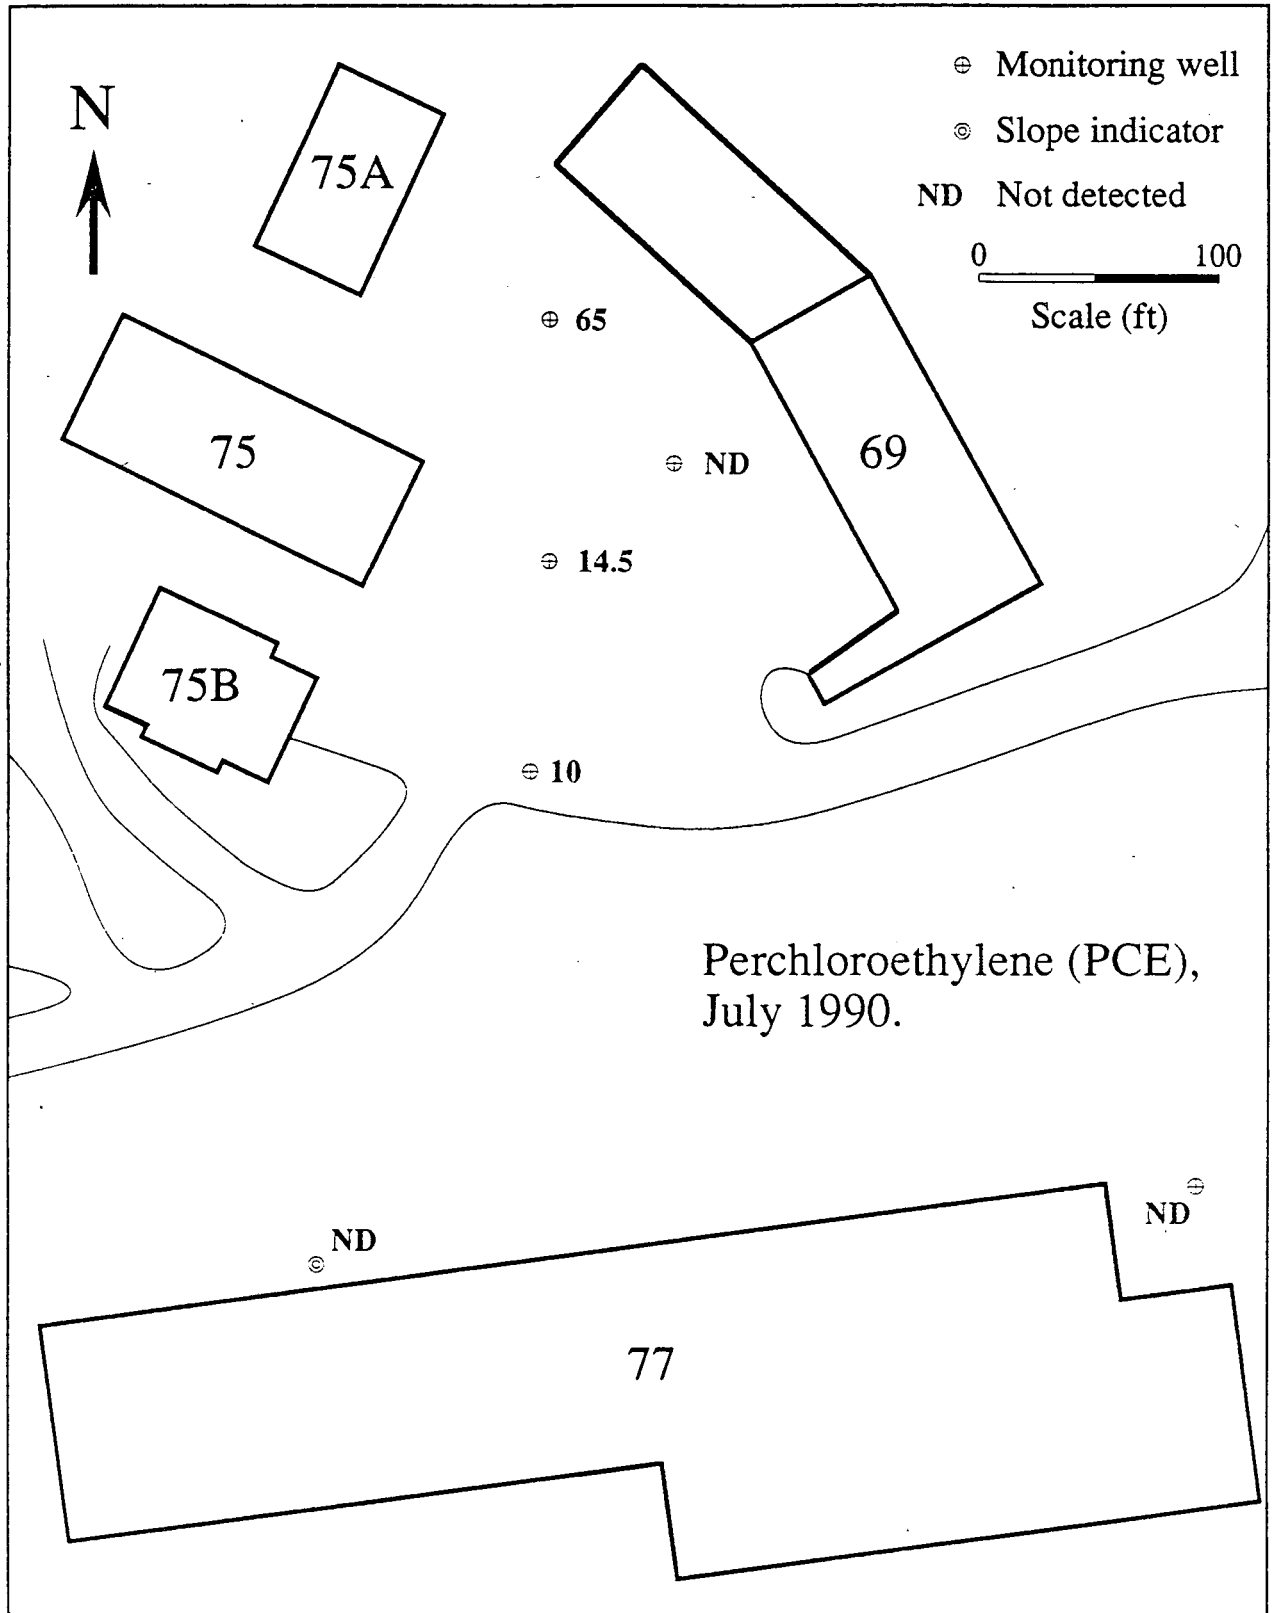
Figure 31. Perchloroethylene (PCE) concentration in ppb, measured in water samples from wells and slope indicators in July 1990.

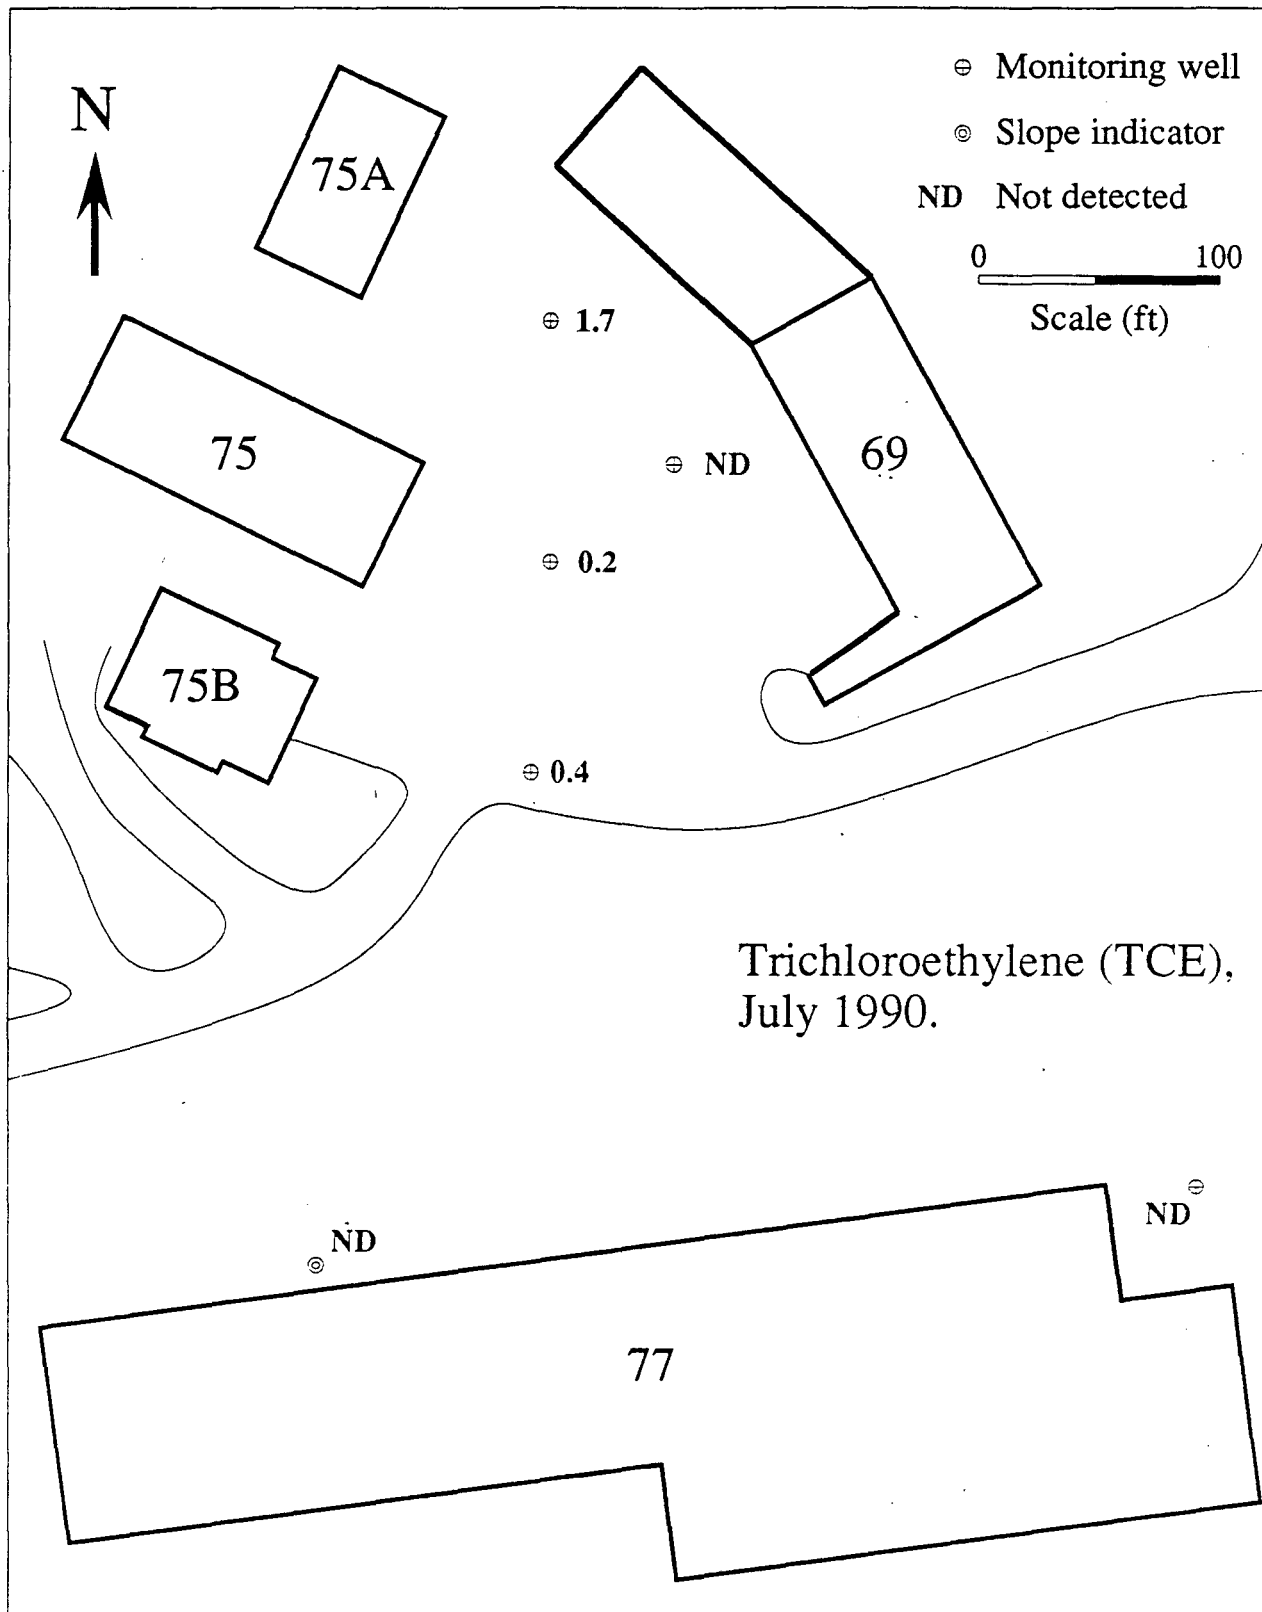
Figure 32. Trichloroethylene (TCE) concentration in ppb, measured in water samples from wells and slope indicators in July 1990.

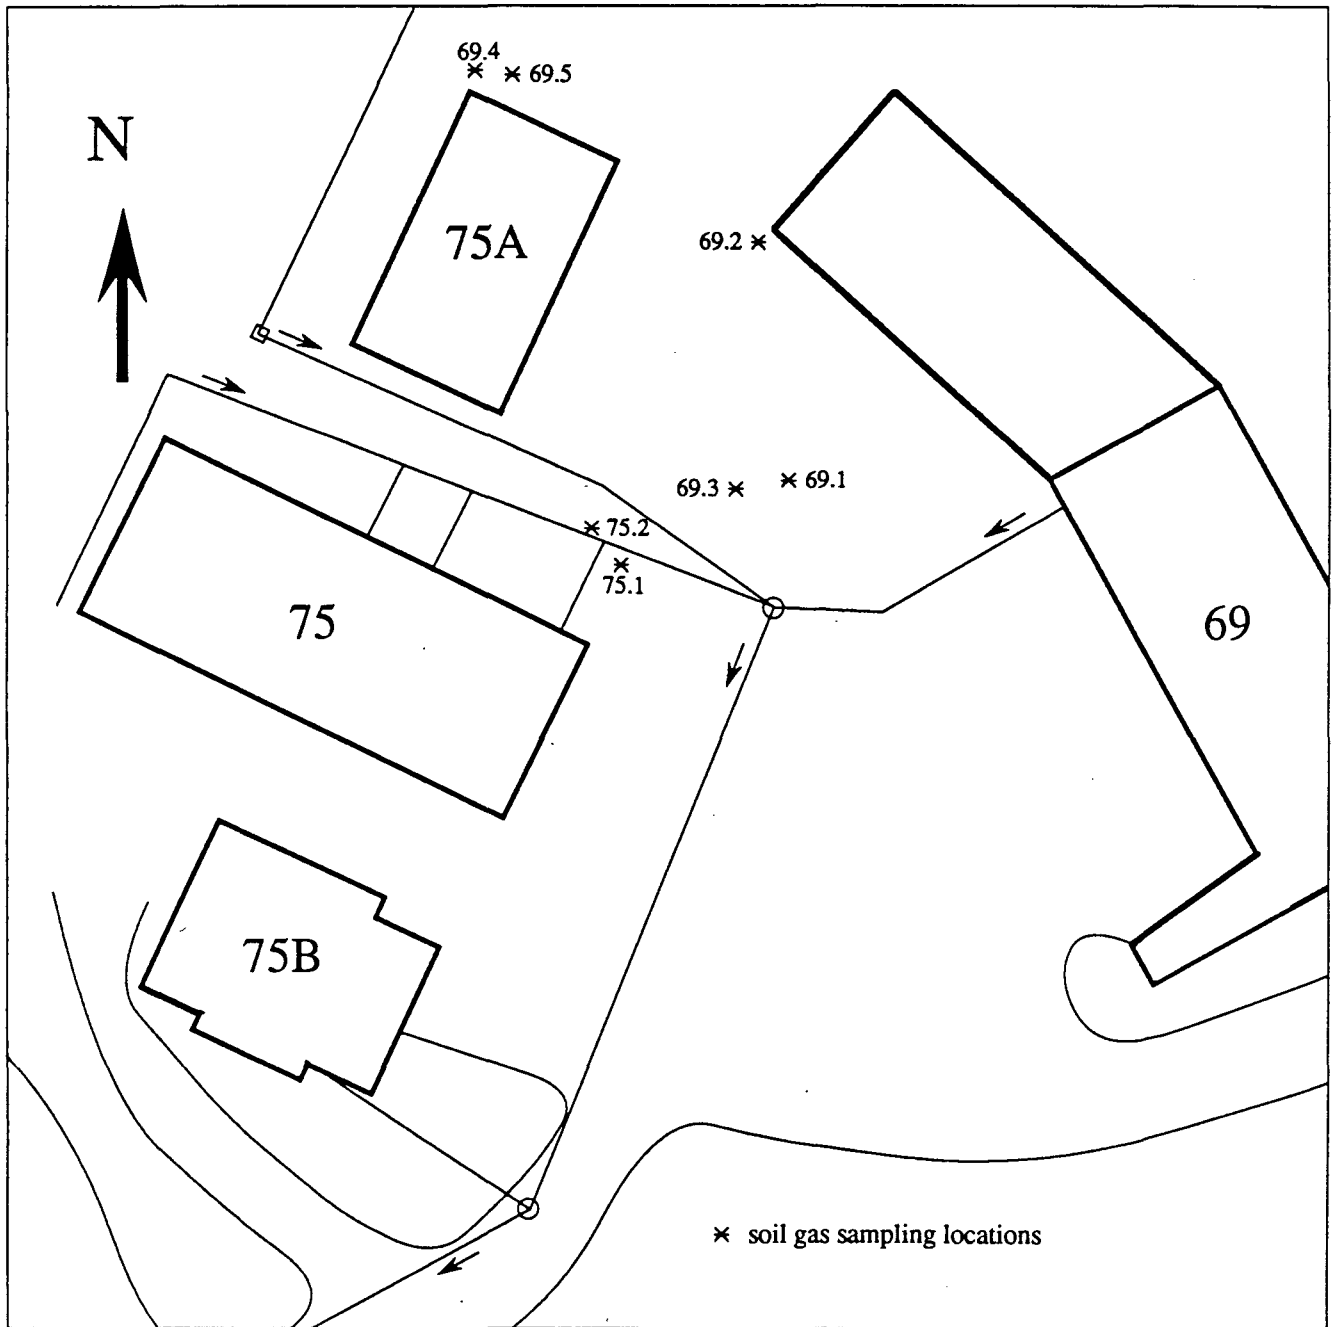
Figure 35 shows the sanitary sewer lines in this area. Since the general direction of groundwater in this area is from north to south (see Figure 36), contamination observed in Well 9.130 can not be explained by leakage from these lines. During September 1990 we conducted the first round of soil gas surveys in this area. Figure 37 shows the locations where soil gas samples were collected and tested. Points 69.1 and 69.3 were chosen at two sides of the contaminated Well 9.130. Points 69.2, 69.4 and 69.5 were randomly selected because this area was used as a salvage yard in the past and some spills could have occurred. Two other points, namely 75.1 and 75.2 were selected to be very close to the sanitary line out of Building 75. All of the above soil samples were collected from a depth of 5 ft.

Results of this soil gas survey are also shown in Table 5. No significant amount of TCE or PCE were detected in these soil gas samples. Figure 38 shows total hydrocarbons detected in these samples.

Figure 37. Soil gas sampling locations in the vicinity of Bldgs. 69, 75 and 75A.
