Stability investigation and stabilization of a heavily fractured and loosened rock slope during construction of a strategic hydropower station in China

This paper presents a case history of the 205 m high intake slope at the Huangjinping (HJP) hydropower station on the Dadu River. Deformation and cracks developed on the cut slope during excavation, and the deformation extended onto the natural slope above the cut, giving rise to serious safety concerns. Research was conducted to study the engineering geological conditions and the deformation characteristics of the slope during excavation. In situ monitoring data and possible causes of cracking were analyzed. The results show that the zone of loosened rock mass extended much deeper into the rock mass than it did at other sites in the region because of the tectonic history of the site and cutting. The empirically designed cable anchors with lengths of 40 m or 45 m were insufficient to stabilize the slope, while the remedial cable anchors as long as 100 m successfully stabilized the slope. The analytic method and procedure used in this paper could be useful to similar projects.

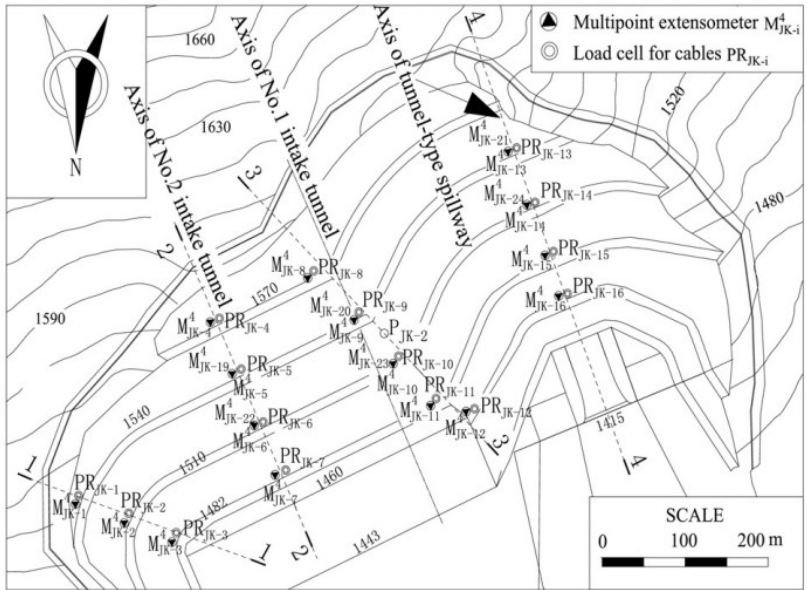
In order to monitor the rock mass deformation, from January 2011 to October 2011, sixteen multipoint extensometers (M_{JK-1}^4 - M_{JK-16}^4) were installed in four sections (in Fig. 8). However, some multipoint extensometers were destroyed by follow-up construction; these were replaced with new multipoint extensometers installed in the same positions. Meanwhile, as illustrated in Fig. 8, load cells for the cables were installed in four sections on the cut slope. Inclinator casings for detecting potential slip planes were installed in the boreholes. After the large deformation, twelve inclinometers were installed to monitor the further deformation and potential slid surface.

Fig. 8. Monitoring instruments on the cut slope. Note: M_{JK-1}^4 to M_{JK-16}^4 were destroyed by follow-up construction, and M_{JK-1}^4 - M_{JK-16}^4 were installed at the same position to replace them.

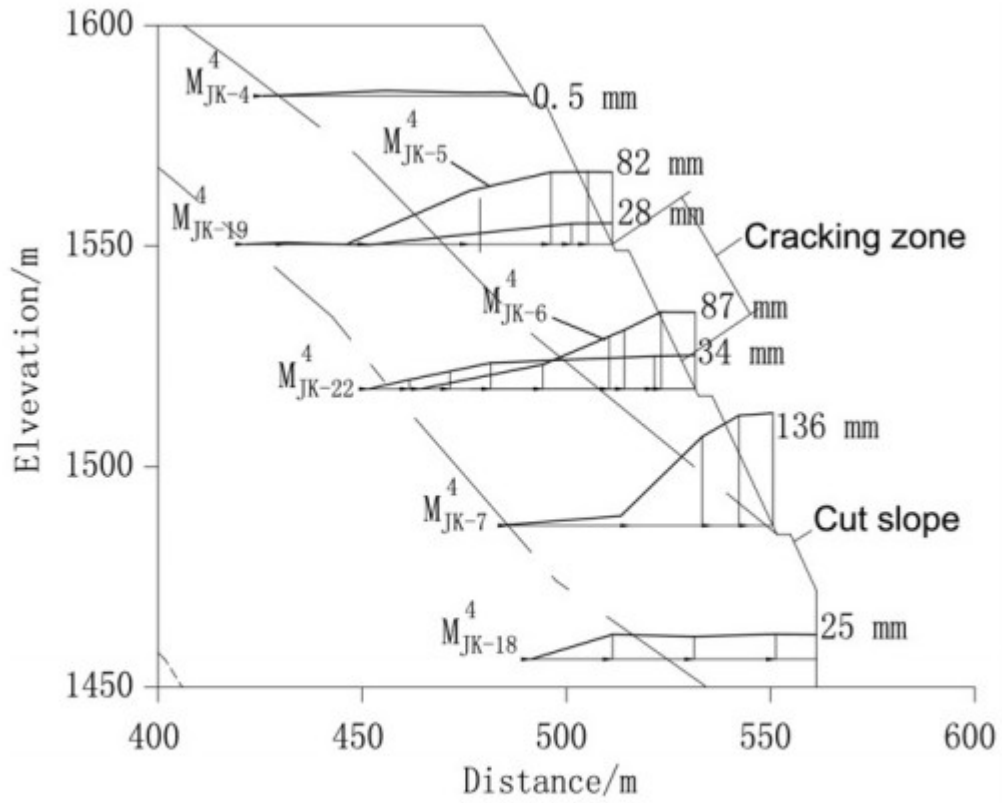
Fig. 11. Deformation-horizontal depth curves of section 2-2. Note: Displacement unit is mm; M_{JK-4}^4 is unavailable.

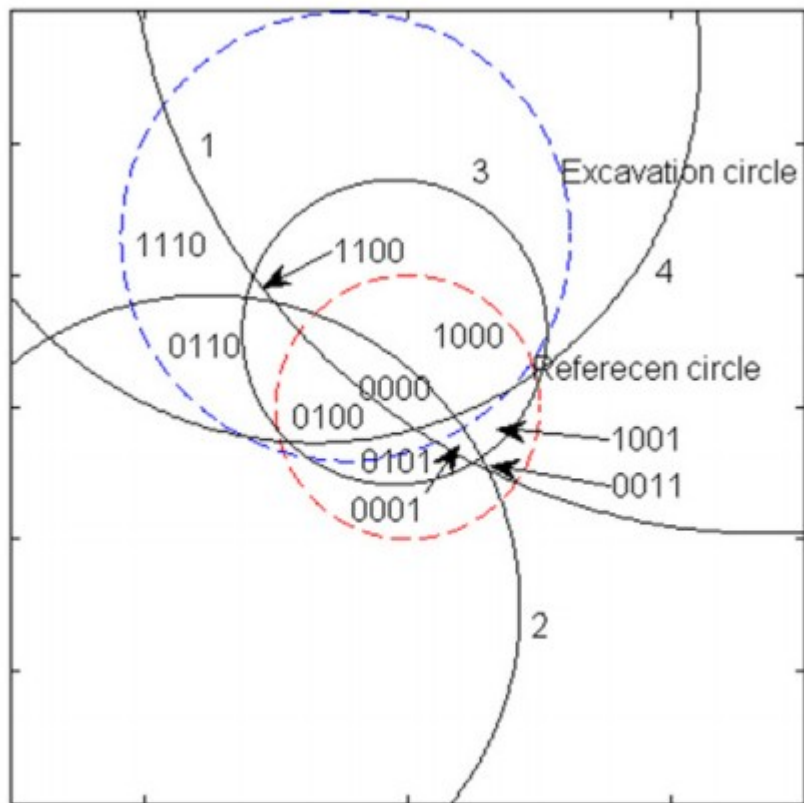
Field investigations showed a diabase vein ($\beta\mu 6$) and three sets of discontinuities (L1, L2, and L3) in the cut slope cracks area. The mean orientations of those discontinuities are listed in Table 2. Block theory analysis of the joint data identified two removed infinite blocks: block 0000 and block 1100, as shown in Fig. 13. Worse still, the reinforced concrete lattice was not used in this area, because the rock mass in the zone had more widely spaced joints. Therefore, the cracking was most likely caused by the moving of the key blocks, i.e., the deformation was localized in the zone without lattice support.

Fig. 13. Identification of removable blocks for cut slope cracking area using stereographic projection. Note: block 0000 and block 1100 are removable infinite blocks.

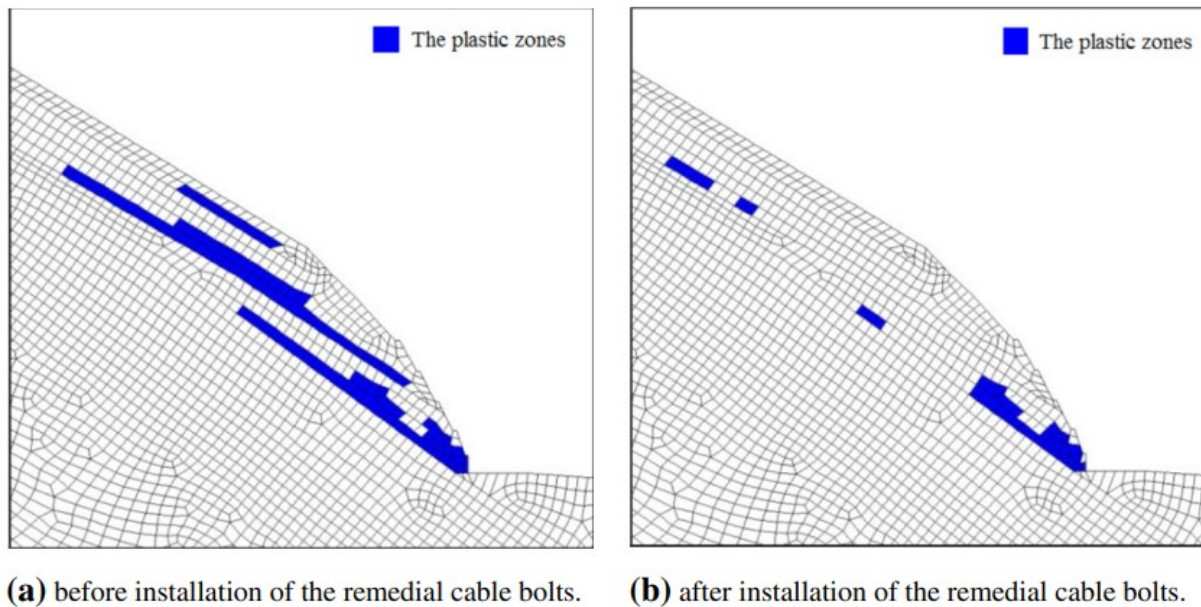
Fig. 19. Comparison of the extent of the plastic zones in section 2-2.

As shown in Fig. 18, during stage 6 (from point E to F), the plastic zone was sharply reduced as a result of the installation of the remedial cable anchors. In addition, Fig. 19 shows a comparison of the plastic zones in section 2-2 before and after the installation of the remedial cable anchors. These results also show that the extent of the plastic zone was dramatically reduced after the installation of the remedial reinforcements. The conventionally computed static factors of safety are 1.20 and 1.09 under normal and seismic conditions, respectively. These factors of safety meet the design code requirements, in this case the 2007 Professional Standards of People's Republic of China.

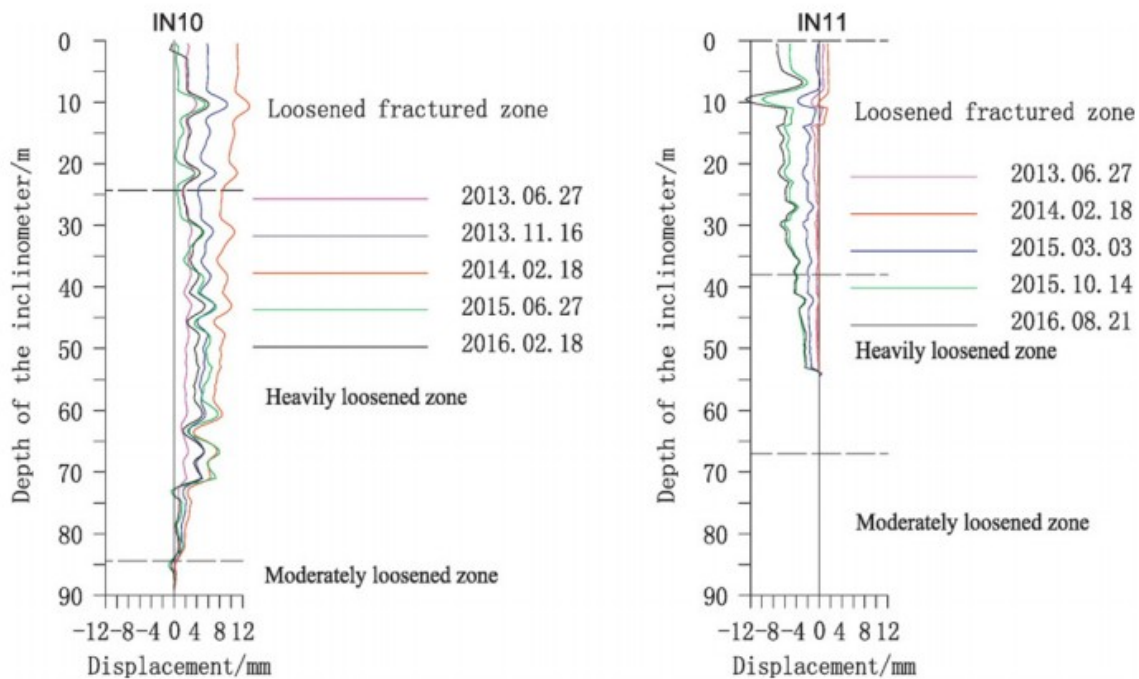
Fig. 20. Results from inclinometers IN10 and IN11.
