The Present Status of the Bevatron Power Supply

UCRL 8345 REV.

THE PRESENT STATUS OF THE BEVATRON POWER SUPPLY J. Gordon Harding, Harold W. Vogel, and Thomas W. Sibary

This report brings up to date the description of the Bevatron power supply. Changes made since the original installation are described, and problems still encountered are treated.

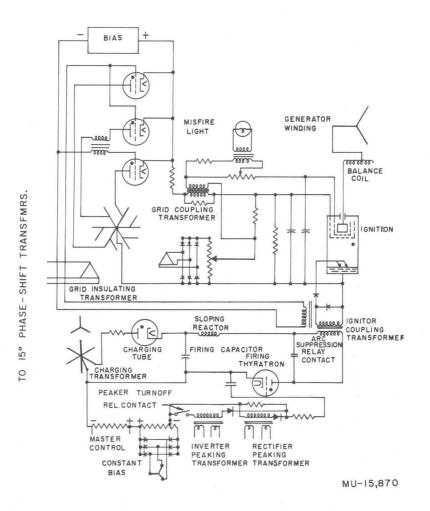
To obtain accurate timing of the ignitor pulses to the converters the ignitor firing circuits are controlled by thyratrons (Fig. 10). The thyratrons used to switch the circuits are triggered by peaking transformers which are excited at generator frequency. Paralleled ignitrons have their firing tubes (thyratrons) triggered by the same peaking transformers so that any jitter at the beginning of the ignitor pulse is several times smaller than normal ignitron-firing jitter.

The IPJ-7 ignitron has two grids, an inner and an outer grid (Fig. 10). The outer grid must conduct reliably with sufficient current to insure that the tube does not extinguish, particularly at light anode currents. Likewise, the inner grid must be positive and conduct for more than 60 degrees to insure that two ignitrons in series will be picked up.

The voltage applied to the outer grid is obtained from the respective generator. This voltage is distorted by commutating notches (Fig. 13). The nominal sine wave form is hardly recognizable during inversion. To improve the voltage for firing the grids, banks of transformers (Fig. 10) were interposed between generators and ignitron grid circuits to introduce a 15° phase shift. Later a bank of transformers giving a 25% boost (from 60 to 75 volts rms at the grids) was installed between the grid transformers and the 15°-phase-shift transformer bank.

Fig. 10. Bevatron ignitron converter-excitation circuits.

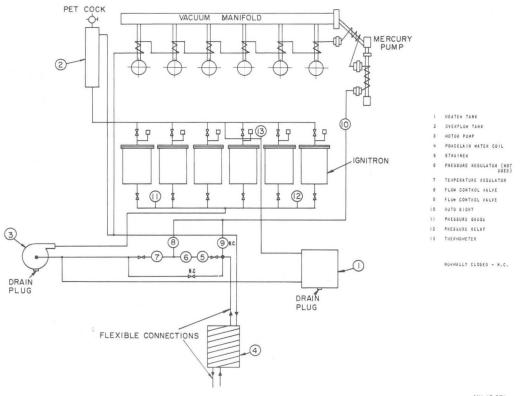
The cooling system is shown in Fig. 16.

Fig. 16. Ignitron-stand cooling system.

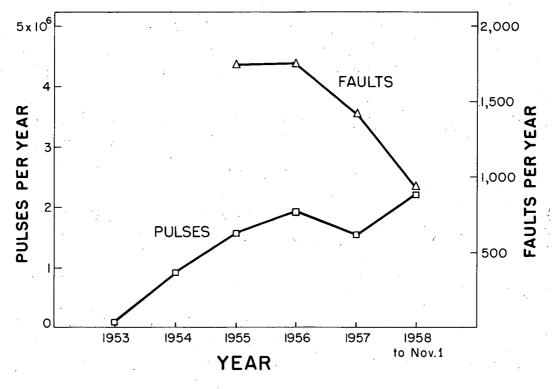
Most of the power-supply electrical apparatus is interconnected in such a manner that failure of but one small component can stop magnet pulsing. The power supply has already been pulsed eight million times. The next eight million pulses should occur within a much shorter period (Fig. 19). To accomplish this will require increased maintenance. For some apparatus, such as the high-voltage rectifiers, good preventive maintenance checks have yet to be found.

Figure 19 indicates the increasing number of pulses per year produced by the Bevatron. This increase reflects both the longer operating hours and the improvements in the over-all accelerator. From the standpoint of the power supply the most frequent and elusive trouble, the inversion arc-through, has been greatly reduced. This is indicated by the number of pulses per fault, which has increased from about 1000 to 7000 during the past year. There now remains the task of making these standard power-supply components withstand up to five million pulses per year.

Fig. 19. Bevatron pulses and faults by year.
