High Energy Wide Area Blunt Impact Damage to Internal Structural Components of Composite Aircraft Fuselage Structures

A dissertation submitted in partial satisfaction of the  
requirements for the degree Doctor of Philosophy

Structural Engineering

Moonhee Nam

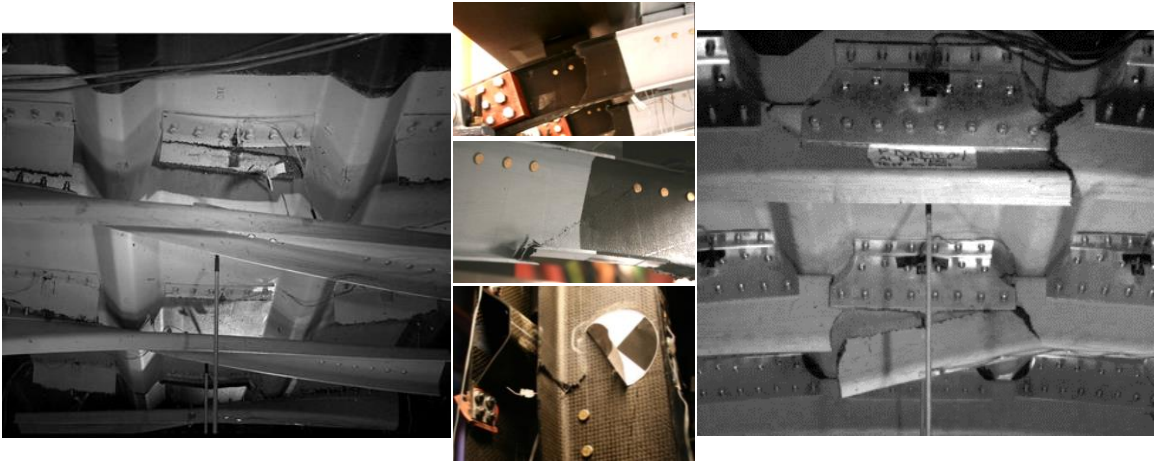
**Figure 1.4: Severe internal damage by HEWABI (shear tie and C-frame fracture) [8].**

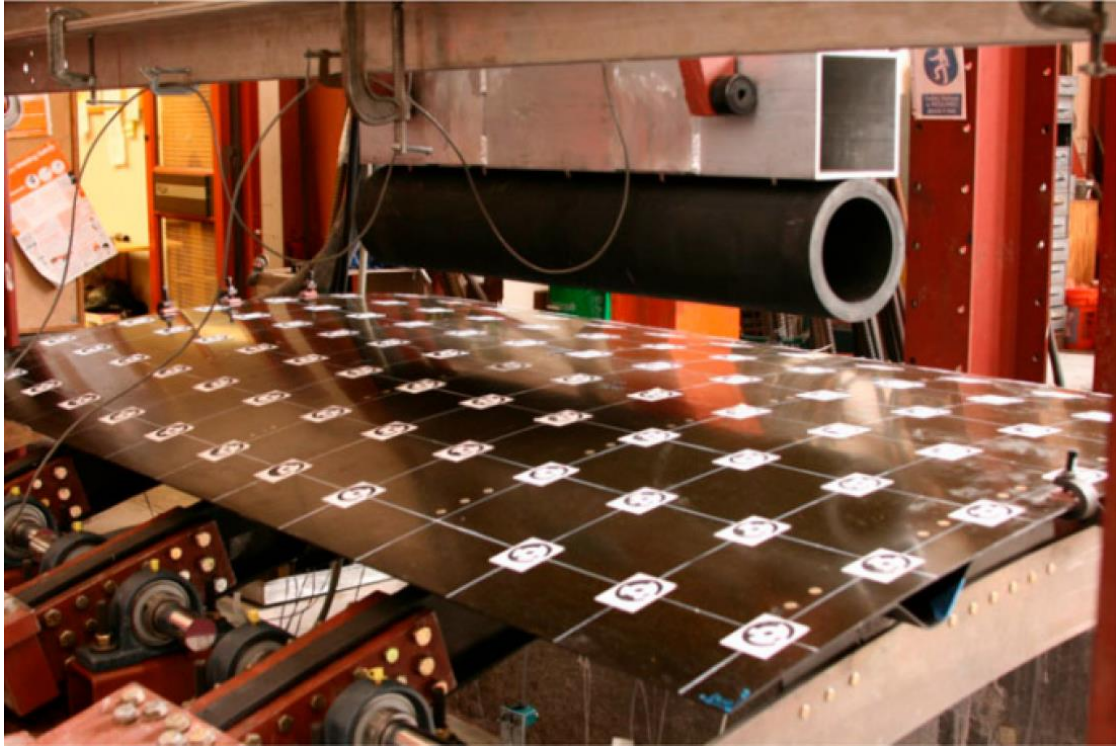
**Figure 1.5: External skin after sustaining internal damage at levels shown in Figure 1.4 [11].**

Although severe and wide-spread internal damage modes were generated by HEWABI in the structural-level frame panel tests. There were no clear, externally visible indications of damage being present, despite the degree of major internal damage as shown in Figure 2.4 to Figure 2.6.

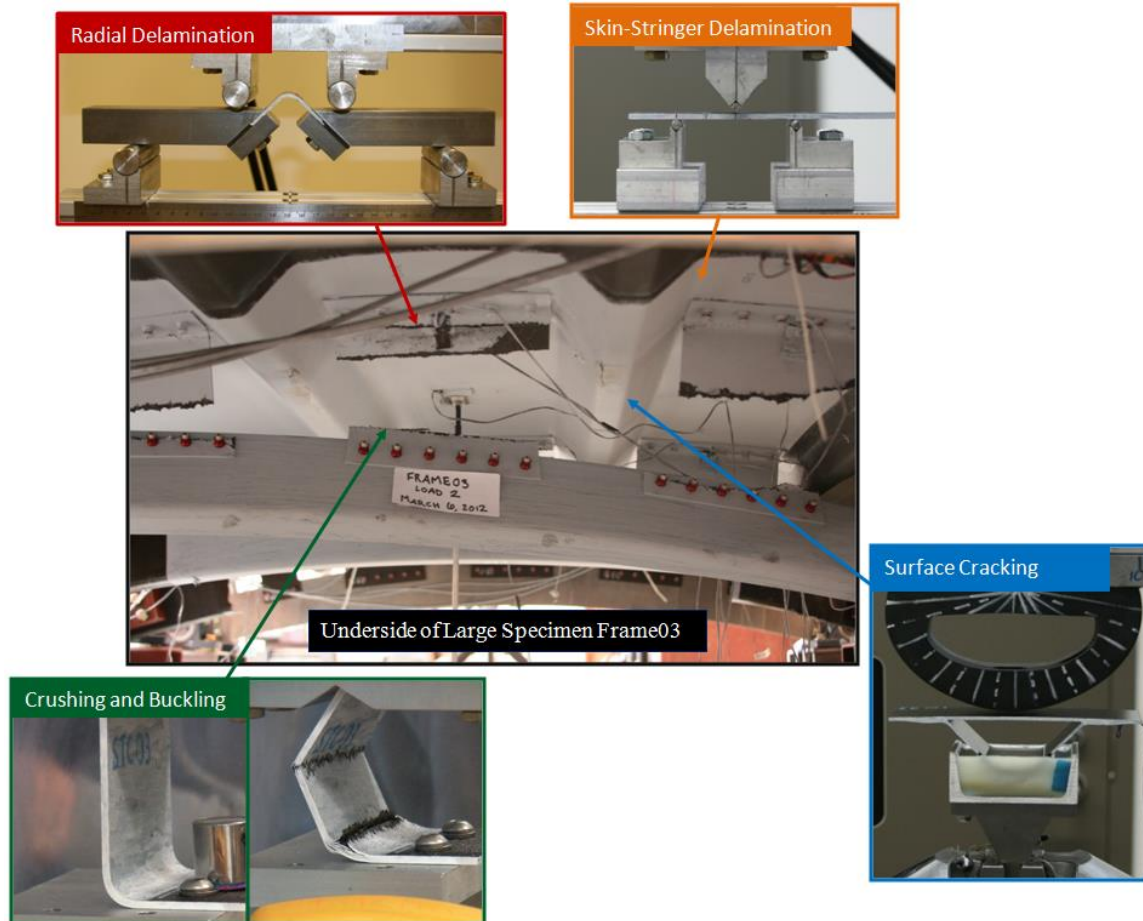
**Figure 1.10: Analysis of the key failure modes in the fuselage panel through element-level experiments [11].**

From the Phase 2 structural-level Frame03 experiment, key damage modes were identified. These are: delamination and crushing of the shear tie corner, skin-stringer

disbond, and skin cracking as shown in Figure 1.10. Each failure mode altered the local stiffness of the panel and re-directed the load path in the large-scale specimens.

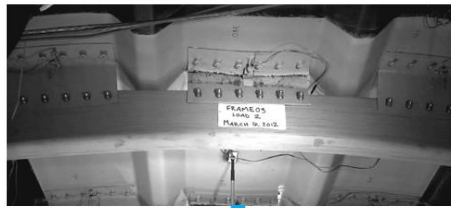
Figure 2.5 shows the internal damage sequence of the Frame03 panel during dynamic impact applied on the skin side at the location loading directly onto three shear ties. The damage initiated at the impacted shear tie curved corners, more specifically, delamination and fiber crushing damage. These failure modes are generated due to the local bending and shear stresses created by the direct compression from the bumper. With more loading, the three impact-loaded shear ties were completely fractured as shown in Figure 2.5. The following failure events were contact between the C-frame and stringers, as well as twisting of the C-frame due to of the stabilizing component (the now fractured

Compression Failure of the Loaded Shear Ties

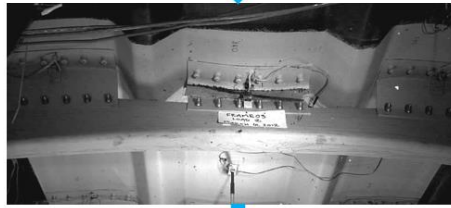
Rotation of C-Frame

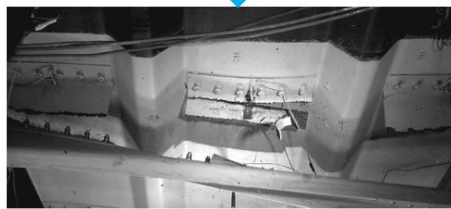
shear tie). Unlike in the quasi-static experiments, contact between C-frame and stringer did not prevent further C-frame twisting, thereby leading to wide-spread shear tie and C-frame failures away from the direct impact zone. The C-frame developed fracture near the boundary supports as shown in Figure 2.5.

C-Frame Failure near Boundary Supports in Bending and Twisting state

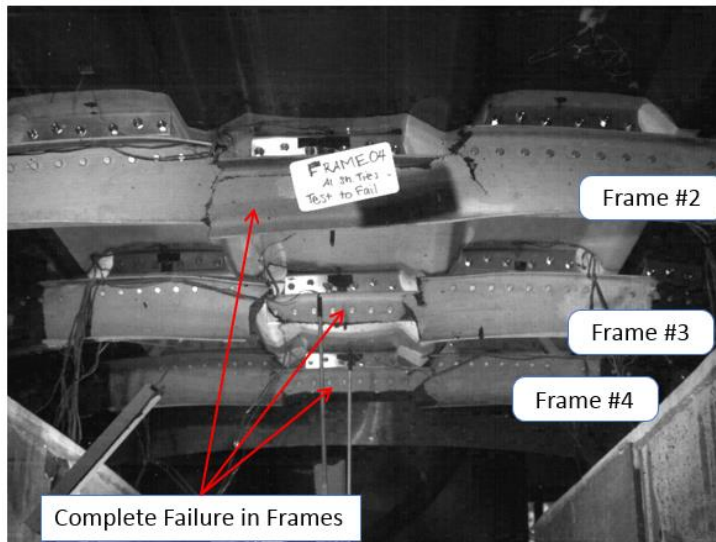
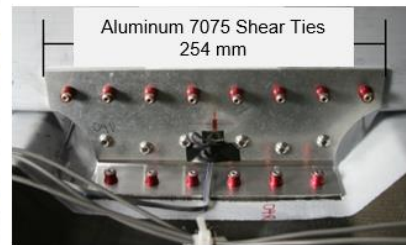
In the Frame03 test, initial failure occurred at the shear tie corners with delamination and crushing failure modes. Based in interaction with industry engineers, the composite shear ties were replaced with strong shear ties (aluminum 7075) in the Frame04-2 panel to investigate how shear tie strength affects resulting failure modes (see Figure 2.6). The strong shear ties did not fail (unlike the composite shear ties), leading to local direct shear fracture of all three C-frames at the impact location as shown in Figure 2.6.

**Figure 2.6: Direct shear failure of C-frames in Frame04-2 panel loaded onto strong shear ties [8, 11].**

When investigating Frame04-2 (strong shear ties) failure mechanism, Frame04-2's strong shear ties were not the first component to fail and were able to carry the impact load with minimal deformation of the shear ties. These directly transfer load to the C-frames, thereby resulting in localized shear fracture of the C-frames. Therefore, the shear ties played a key role in damage initiation and evolution affecting subsequent failure modes.

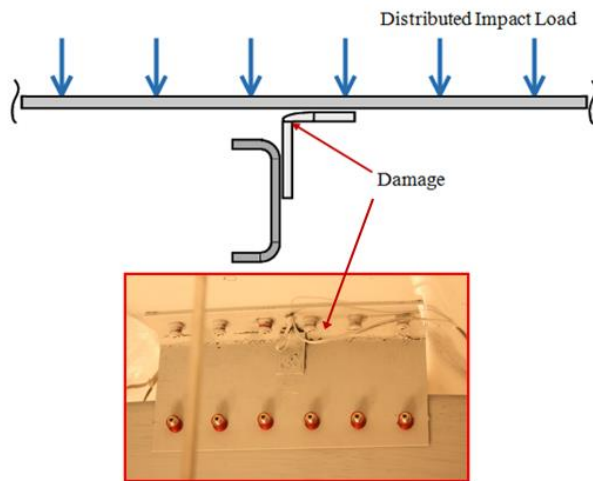
The shear tie coupon experiments and FE modeling methods are described briefly in this section. In the blunt impact testing early shear tie damage influenced the subsequent structural behavior, especially as the fractured shear tie could no longer stabilize the C-frame against rotation. In the large-scale Frame01 and Frame03 tests, the damage initiated at the shear tie curved corner, as shown in Figure 2.7. The successive shear tie element experiment was conducted to excite key damage modes at the shear tie curved corner: delamination, fiber crushing as well as buckling/fracturing due to compression loading.

Impacted Shear Ties – Delamination/Crush Observed in Large-Scale Tests

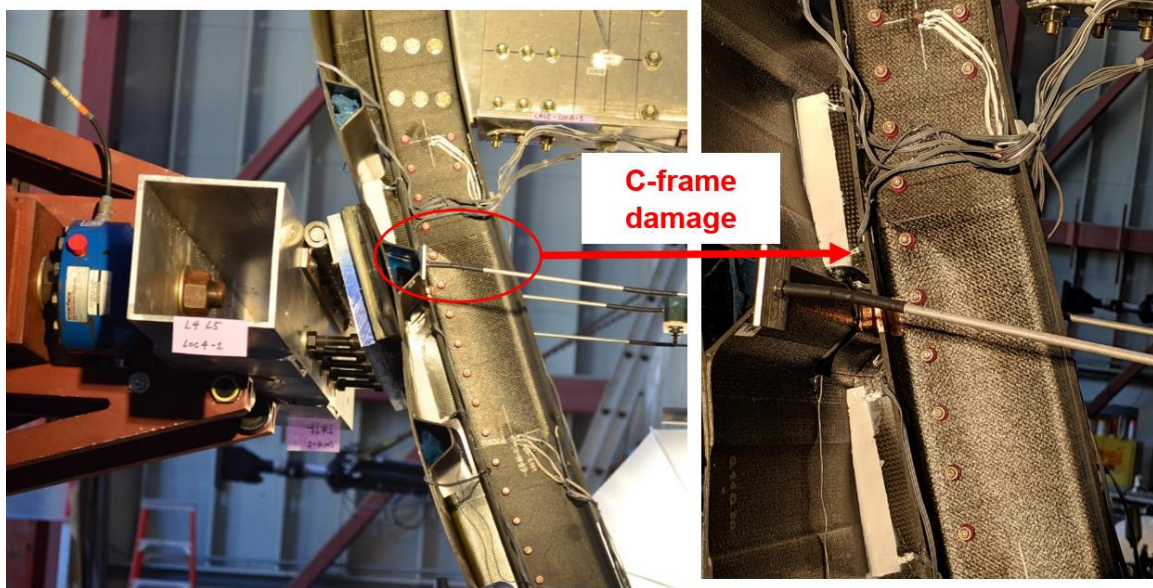
After the shear tie web fracture, the C-frame fracture was followed with abrupt cracking starting at a Hi-Lok bolt on the web of the loading location (Loc4) and at the floor joint through the lower bolt line shown in Figure 3.64. Through the video examination, when the shear tie web was fractured, the stringer (at Loc4) started to contact and push the C-frame outer flange causing the C-frame local web twisting and buckling (initiated at Hi-Lok bolts) as shown in Figure 3.65. Then, abrupt C-frame cracking occurred starting at the Hi-Lok bolt on the C-frame web of Loc4 by stress concentration under combined shear and bolt pulling as well as through the lower bolt line of the floor joint under shear in the shear dominated boundaries as shown in Figure 3.64 and Figure 3.65.

Loc4 stringer pushing the outer flange of C-frame

**Web local twisting and buckling**  
under combined bolt pulling and  
shear modes due to stringer push

**Figure 3.65: C-frame damage initiation at the Hi-Lok fastener on the web at Loc4 right after shear tie web fracture in Loc4-1\_L4L5.**

Through the video and strain examination, it turned out that the C-frame was fractured by the stringer contact showing combined shear and bolt pulling (by local twisting) failure modes.

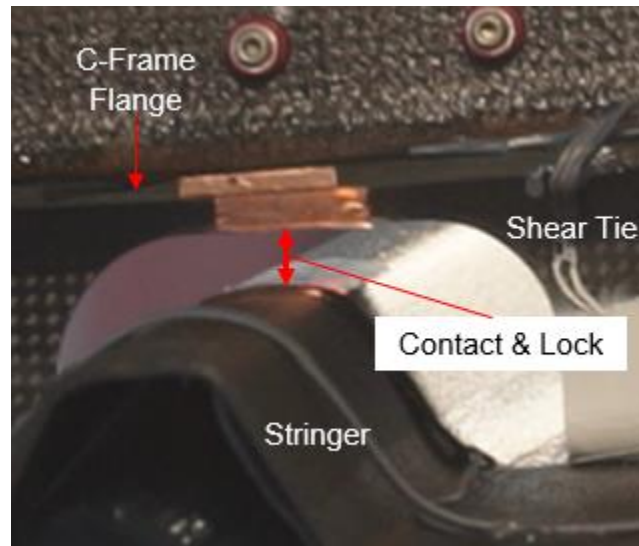
The damage initiated at the loading location (Loc4) in the shear tie radius region showing delamination and fiber crushing mode. As load increased, the crack grew gradually along the shear tie radius from Loc4 upward and downward. Shear tie web-stringer hat contact occurred (see Figure 3.72) which led to cutting of the stringer hat due to the shear tie web penetration. The penetration of the shear tie into the stringer hat caused locking of the shear tie and connected C-frame, thereby preventing rotation and lateral movement. With further loading, the extensive shear tie web diagonal cracks occurred abruptly between the loading location and the floor joint. Lastly, the abrupt C-

frame fracture was followed due to the stringer contact at Loc4 with cracks beginning at a Hi-Lok bolt on the web as well as along the lower bolt line of the floor joint in the shear dominated zone between the loading point and the upper floor beam boundary (through stiffest load path).

**Figure 3.72: Stringer-shear tie contact, shear tie penetration, and locking C-frame.**

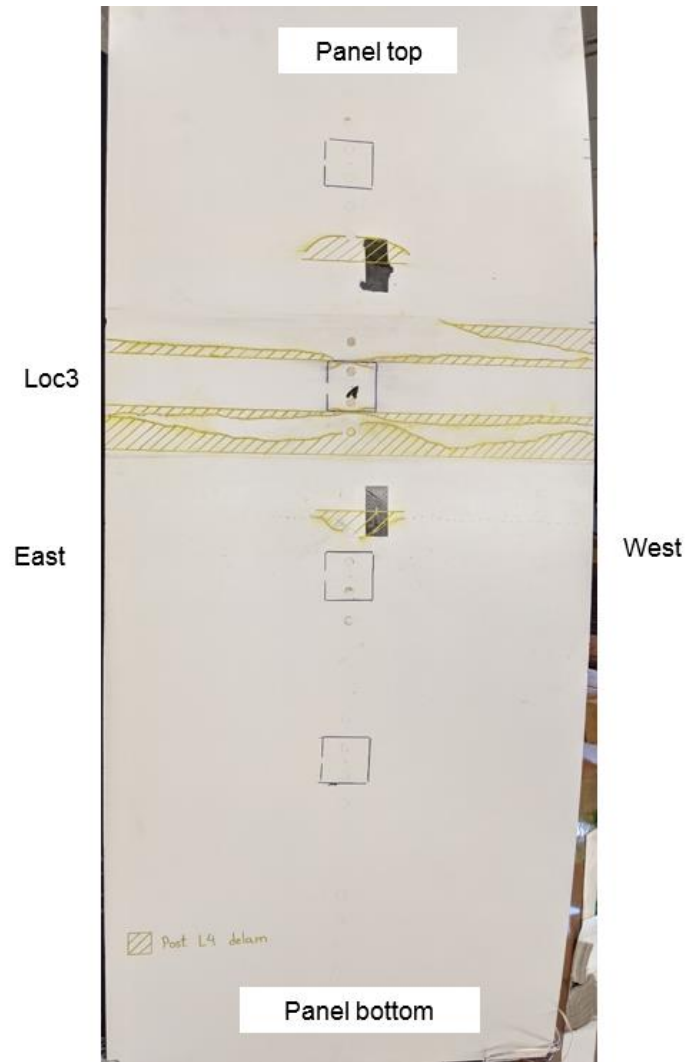
**Figure 3.80: A-scan results after Loc3-2 test.**

From ultrasonic A-scan results (Figure 3.80), the skin-stringer disbond initiated both at the panel's center and at the side ends (stringer free edges), and it may likely not occur in case of a wide panel along stringer direction with multiple shear ties and C-frames. Moreover, this disbond did not occur in Loc3-1 test. It accompanied the crack at stringer heel in the very early stage of the loading influencing the structural response. Due to this, the event of shear tie-stringer contact occurred earlier with less shear tie damage in Loc3-2 test by comparison with the Loc3-1 test results.

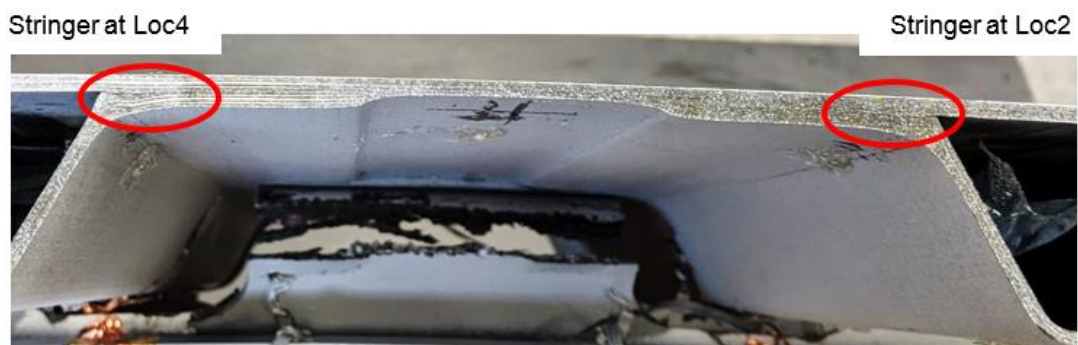
Most of all, from the early stage of the Loc3-2 test, complex delamination failure occurred between the stringer flange (at lower Loc2 as well as upper Loc4) and skin in the co-cured outer panel as shown in Figure 3.80 and Figure 3.81.

**Figure 3.81: Visible skin-stringer disbond after Loc3-2 test.**

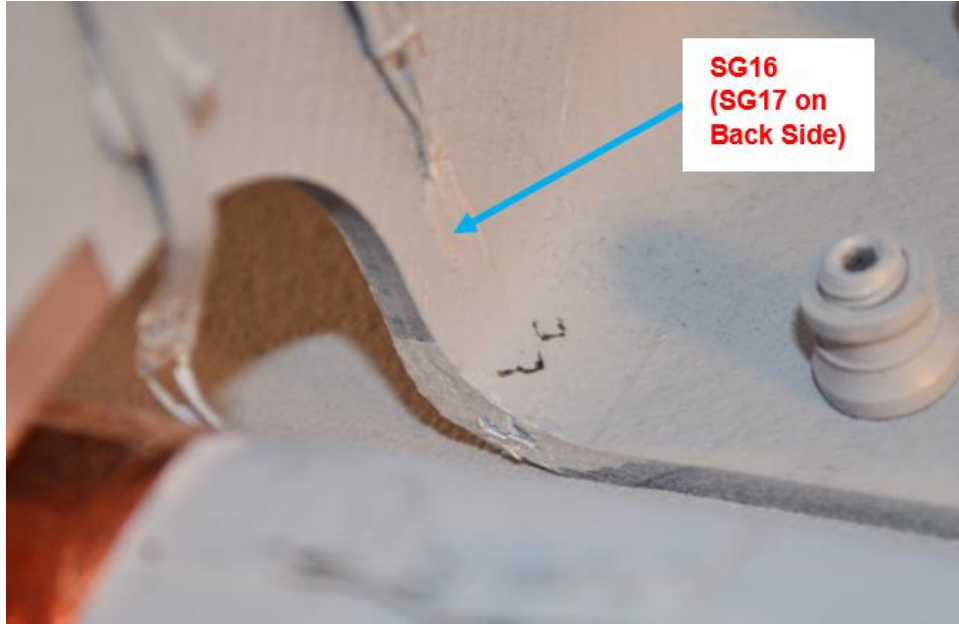
After Loc3-1\_L1, there was some paint chipping as shown in Figure 3.83, but it was hard to detect the obvious signs of shear tie delamination through visual inspection.

**Figure 3.83: Paint chipping observed on Loc3 shear tie radius after Loc3-1\_L1.**

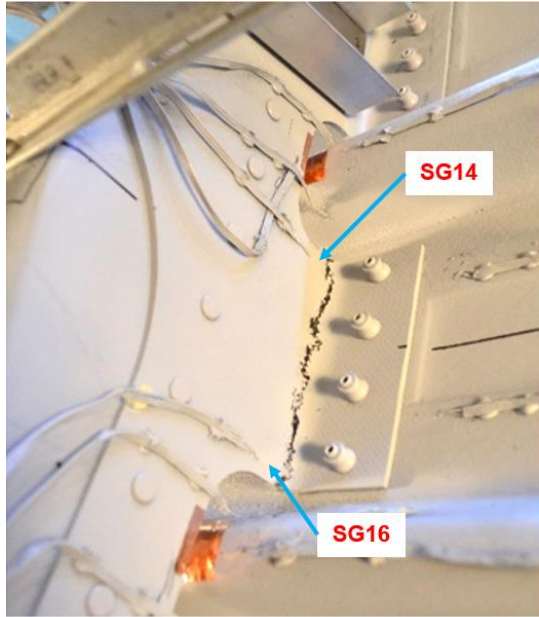
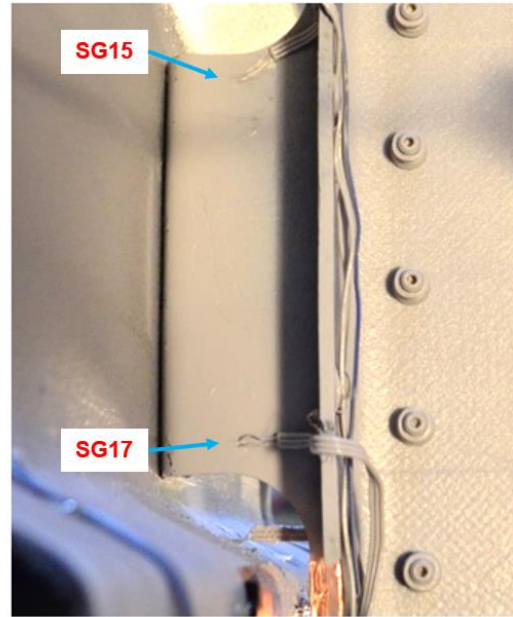
**Figure 3.85: Shear tie crack observed in Loc3-1\_L2.**

The first load drop occurred in Loc3-1\_L2, because of a shear tie crack on entire radius region abruptly as shown in Figure 3.85. This is due to fiber crushing by the direct compressive loading to the shear tie, and the development of radius crushing involves delamination (it is found the previous large-scale and small-scale tests [8,11]). This crack did not penetrate through the entire thickness, as shown in the west side picture of Figure 3.85.

Shear tie crack as seen from East side

No crack as seen from West side

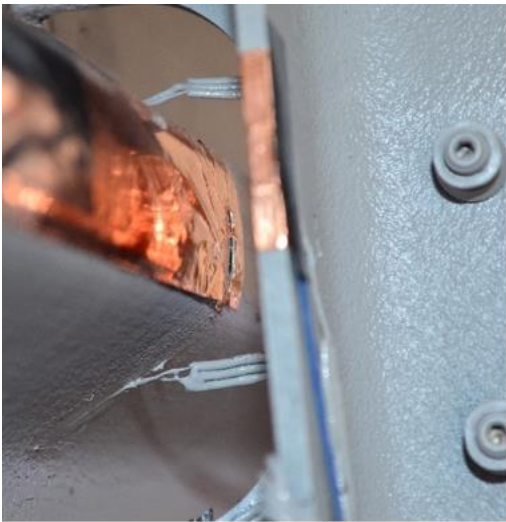
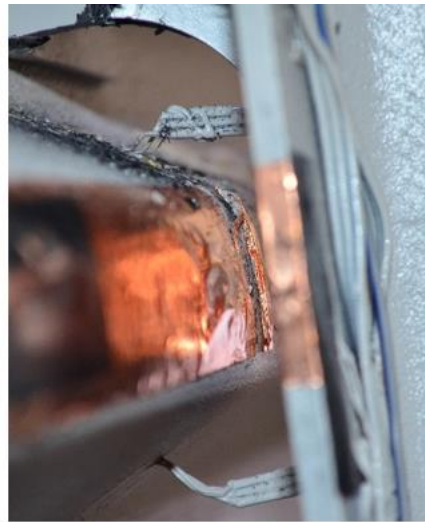
**Figure 3.88: Stringer hat damage after Loc3-1\_L3.**

**Stringer 2**

**Stringer 3**

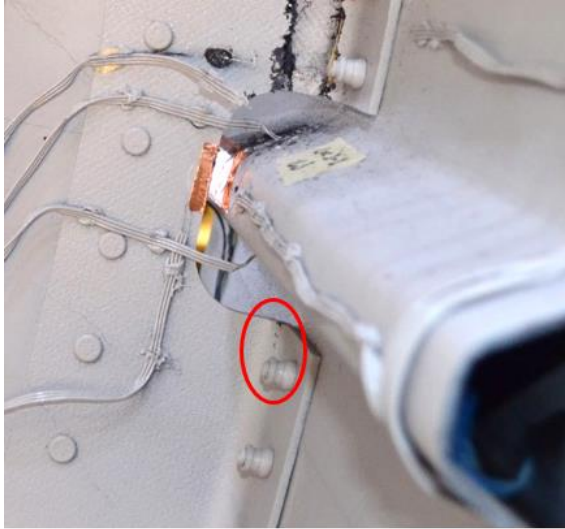
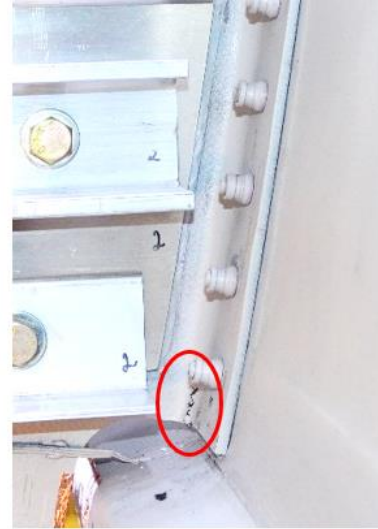
**Figure 3.89: Shear tie radius damage at lower Loc1 and upper Loc5 after Loc3-1\_L3.**

During Loc3-1\_L3 testing, the second crack occurred on the shear tie web below the outer flange of C-frame (Figure 3.87). It was due to shear tie web buckling by the eccentric (effect of the eccentric shear center of open C section) compressive loading. By this damage, stringers 2 and 3 (at Loc2 and Loc4, respectively) contacted shear tie, as indicated by the contact sensors. As load increased further, stringer hat was cut by shear tie web penetration (Figure 3.88). As stringer hat damage progressed, the damage initiated in lower Loc1 and upper Loc5 shear tie radius (Figure 3.89).

Upper Loc5

Lower Loc1

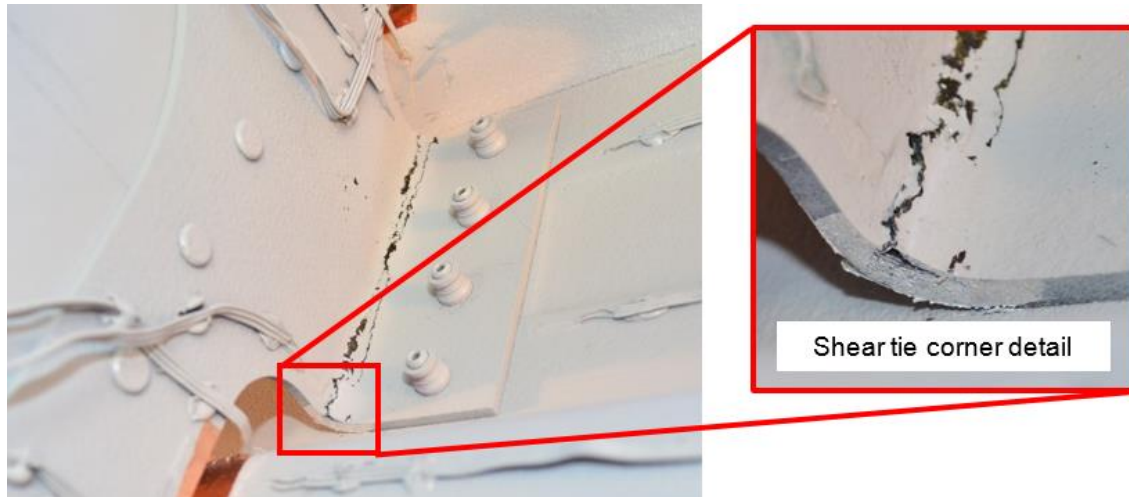
During Loc3-2\_Pre-test, due to a shake table controller mishap, the load level achieved was somewhat equivalent to Loc3-1\_L2. This resulted in shear tie crack along radius region as shown in Figure 3.91. In close-up view of Figure 3.91, delamination was captured in shear tie radius region as shown.

**Figure 3.91: Loc3-2\_Preload damage – radius delamination detected.**

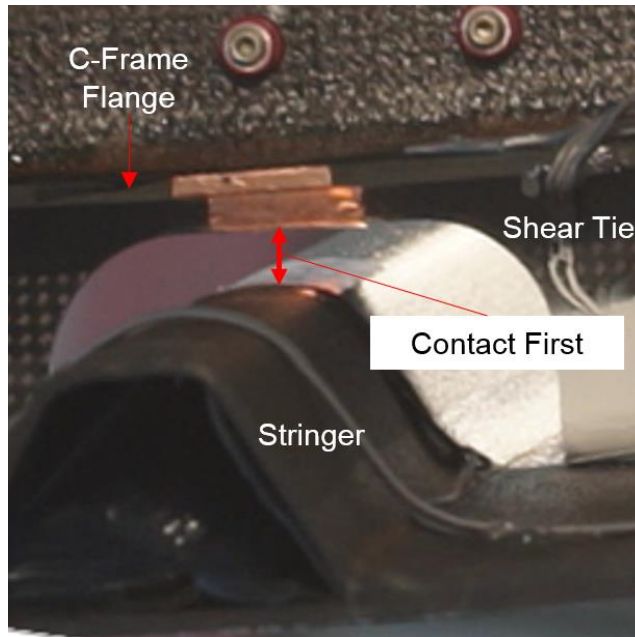
The loading locations explored were quite stiff due to the floor structure interaction. Shear dominated failure with significant internal damage in the shear tie, stringer, and C-frame developed. However, the damage extent is more localized in comparison with the 1<sup>st</sup> generation Frame03 (dynamic) test's broad damage extent in which large rotation of the C-frame resulted in damage near the far-away boundary conditions fixtures [8, 11]. In the 2<sup>nd</sup> generation test panels, the C-frame was stiffened with continuous and thicker shear ties (2.5 mm thickness in the 1<sup>st</sup> generation vs. 3.5 mm thickness in the 2<sup>nd</sup> generation). Thus, the C-frame's lateral movement and rotation was minimized. In comparison with the 1<sup>st</sup> generation Frame01 and Frame02 (quasi-static) tests, the same C-frame failure mechanism was observed without large rotation of C-frame in these 2<sup>nd</sup> generation tests. That is because severe damage to the shear tie led to contact between the stringer and C-frame and ultimately resulting in C-frame failure. However, as shown in Figure 3.102, in the 2<sup>nd</sup> generation specimen, the geometry of component assembly at the mouse hole led to delay of stringer-C-frame contact as shear tie contacted the stringer first and failure progressed for a while by the geometry interaction.

**Figure 3.102: Geometry interaction at mouse hole.**

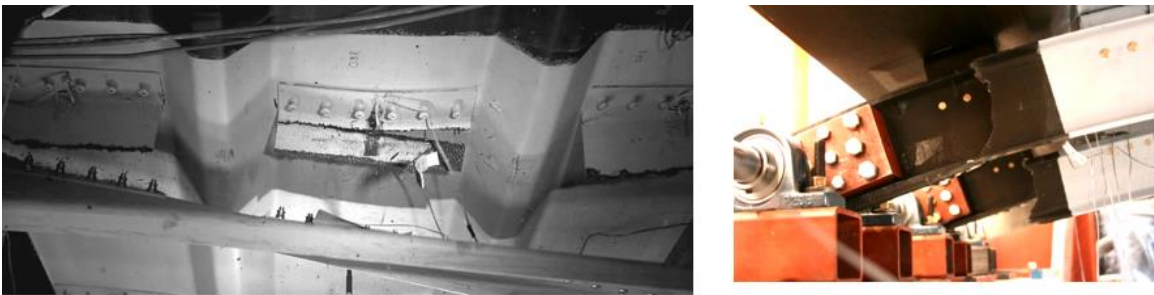
As shown in Figure 4.2, C-frames were fractured near boundary fixtures showing large rotation in combined bending and twisting state by open C-section shear center offset effect, after losing shear ties in the Fram03 test [8, 11]. This section is for completing Frame03 FE simulation by updating frame element FE modeling definition validated through element-level tests. Previous FE simulations included detailed study of the shear tie progressive failure and how it affected global response of these HEWABI test specimens [11], but did not include the final failure mode: frame failure.

**Figure 4.2: Combined bending-twisting failure in C-frames [8,11].**

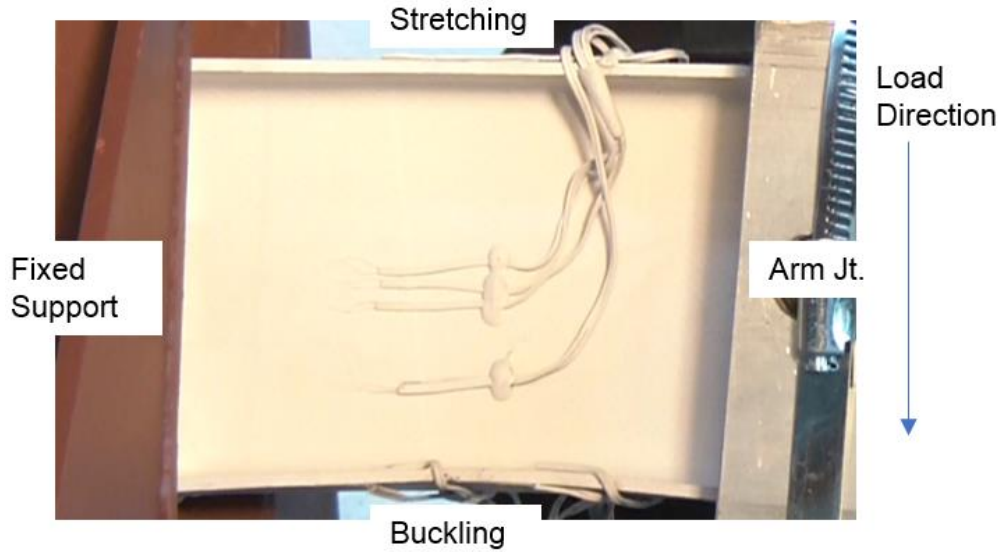
C-frame tests were conducted with quasi-static loading. As load increased, buckling of the compression flange, and stretching of the tension flange were observed as shown in Figure 4.8.

**Figure 4.8: Loaded specimen view; bottom flange buckling prior to failure.**

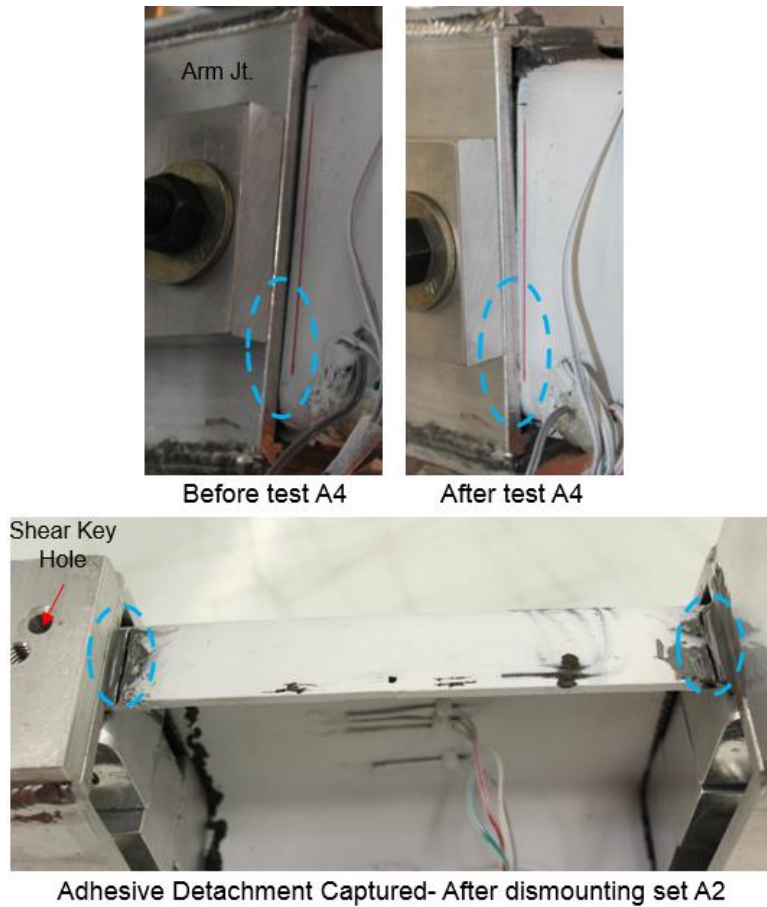
During tests, from the early stage to the end of each test, some amount of slip occurred at the contact surfaces between specimen and aluminum rectangular tube at both wedge grip joints (see Figure 4.10). It was the key challenge to overcome in the interpretation of test data. Although C-clamp and shear keys were applied at these joints, slip could not be completely stopped. It affected test results significantly and made hard to compare test results with FEA results.

**Figure 4.10: Challenges to controlling slip and adhesive detachment at joints.**

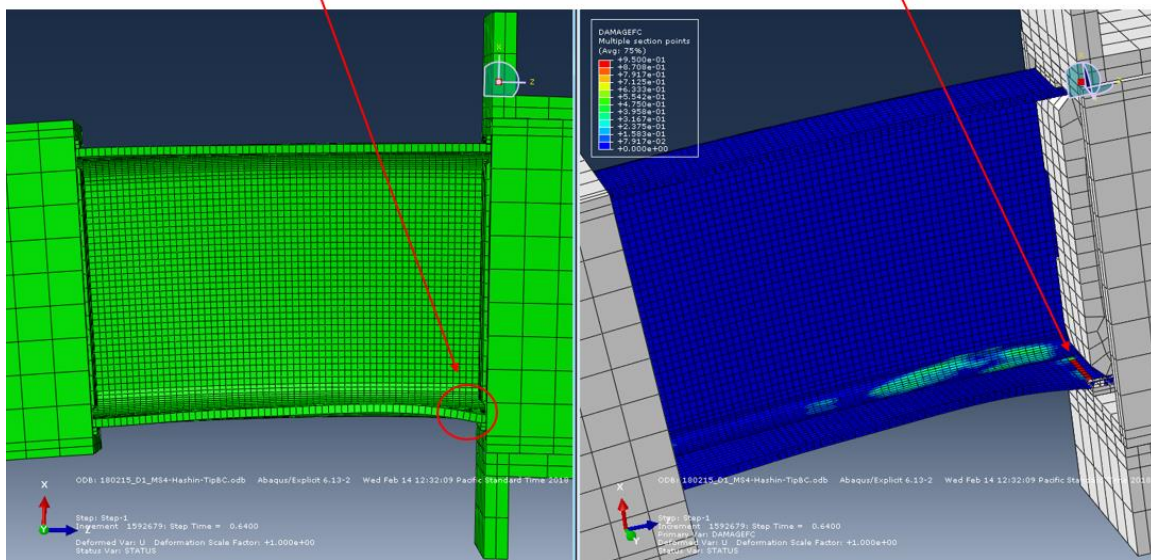
**Figure 4.18: Failure prediction in combined bending-twisting case.**

The FE model predicted the fiber failure and corresponding failure locations right after the maximum reaction force in FE simulation. In the bending case, as shown in Figure 4.17, the FE model predicted the fiber tension failure in the tension flange at the fixed support which is different from the results in bending tests. On the other hand, in the combined bending-twisting case, as shown in Figure 4.18, the FE model predicted the

- Almost all plies (10 layers out of 14) are fully damaged in the compression flange at arm joint.
- No element deletion but sudden bulge at the location

Fiber compression damage in 1 and 2 direction (Damage index: 0.95); No element deletion because not all plies are fully damaged. The model predicts the failure location in the test.

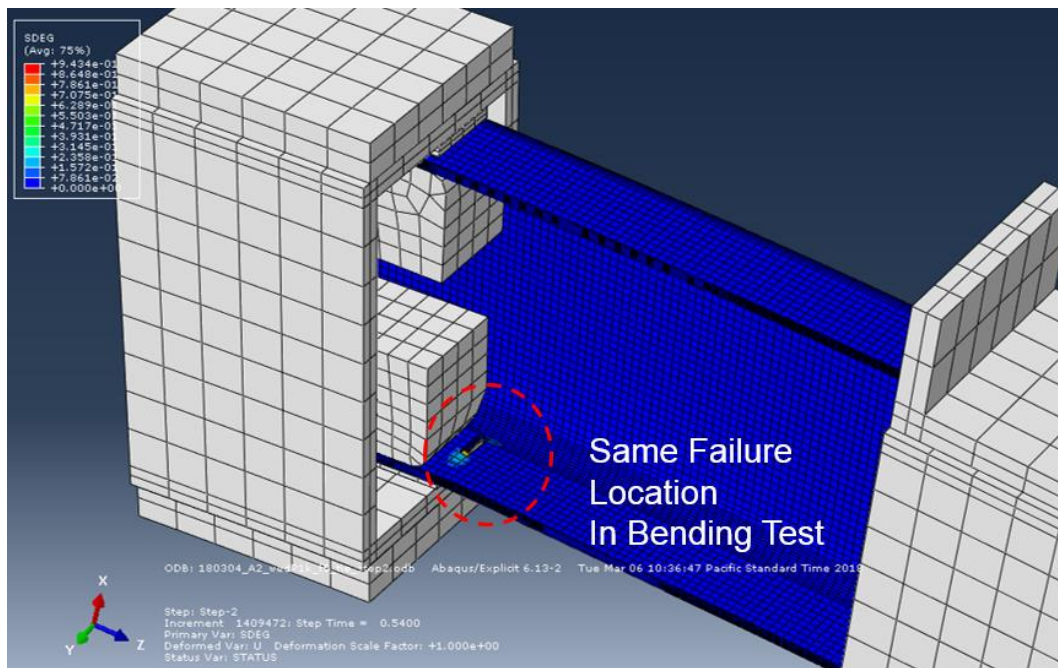
**Figure 4.19: Effect of boundary condition including slip phenomenon.**

contact formulation with friction coefficient of 0.5 was applied at the interface between the adhesive and the metal surface in the fixtures. To prove effect of the boundary condition by including slip phenomenon observed in tests, hypothetical wedge pressure and friction coefficient were applied at connection joints in bending failure FE simulation. As shown in Figure 4.19, the FE model predicted the correct failure location.

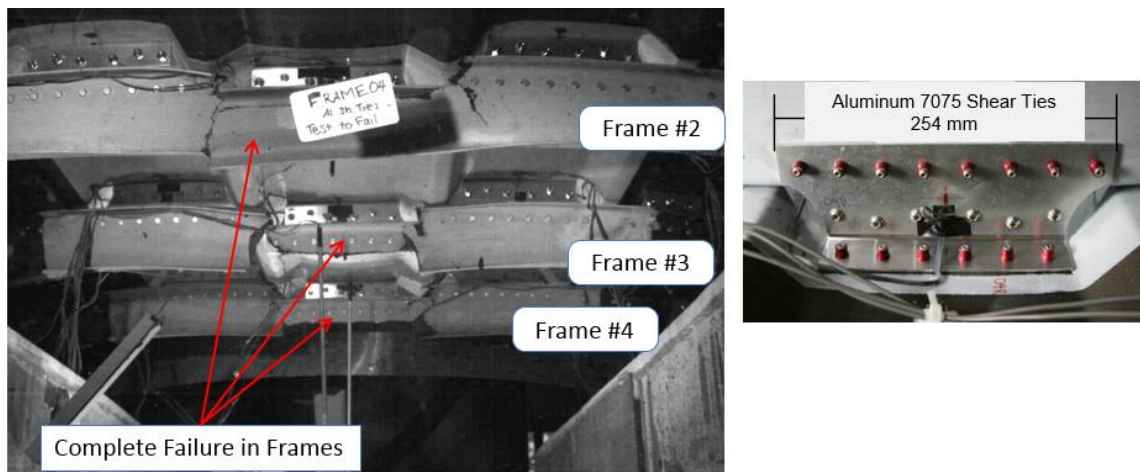
**Figure 4.20: Direct shear failure in C-frames [8,11].**

As shown in Figure 4.20, abrupt fracture in C-frame by the direct shear from the strong shear tie was observed in the previously conducted 1st generation Fram04-2 test [8, 11].

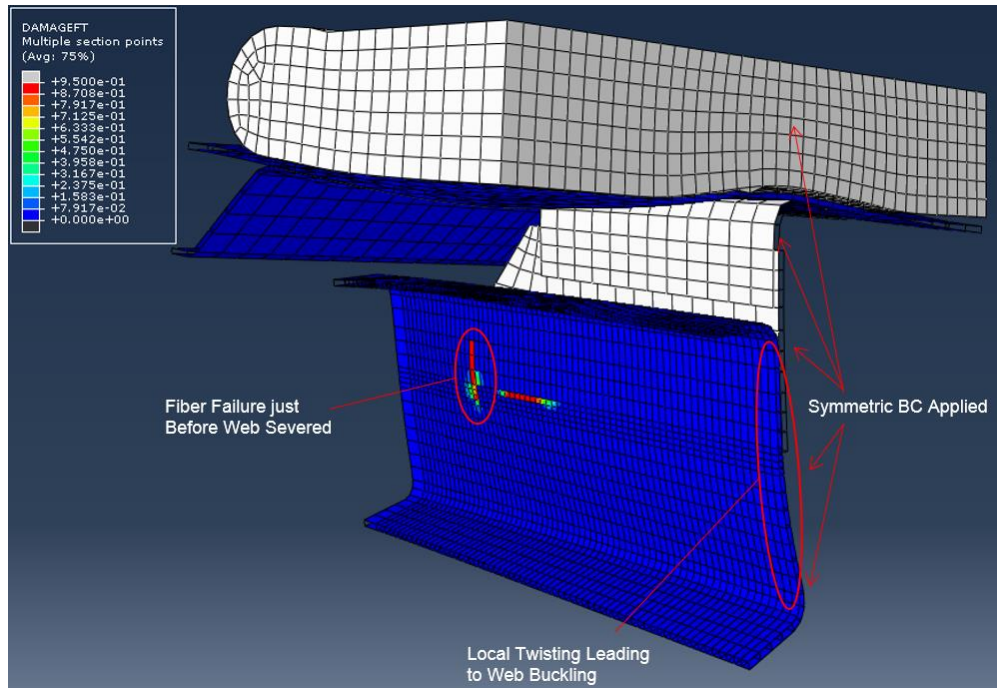
**Figure 4.25: Center C-frame behavior and fiber failure just before fracture.**

The load-displacement curve comparison between the experimental data and FEA result is shown in Figure 4.24. The two curves show good agreement in the initial elastic behavior, but the FEA result shows the earlier abrupt C-frame fracture with web severing along the shear tie vertical edge as shown in Figure 4.25 and Figure 4.26. Although the failure mode was different, key phenomena were captured in FEA related to the development of failure at the bolted connections observed in the test. More specifically, in Figure 4.26, the reduced strength outer plies for the effective fastener modeling are totally damaged along the horizontal shear tie edge (bolted connection line). In Figure 4.25 and Figure 4.26, the C-frame shows web local twisting (leading to buckling) along the shear tie horizontal bolted connection line by eccentric compressive load (open C-section shear center effect) from shear tie.

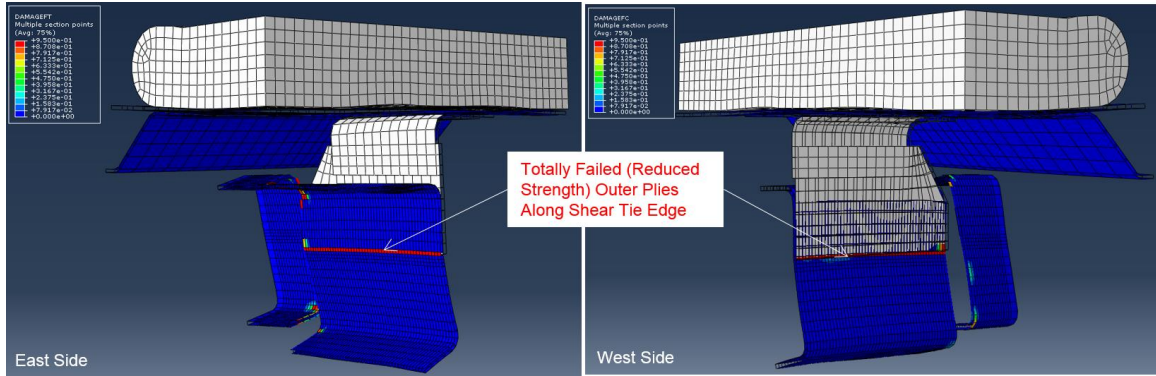
**Figure 4.26: Severed center C-frame and totally failed reduced strength plies.**

In conclusion, the FE model is able to catch the initial crack location close to the location observed in the test. However, in FEA, the C-frame fails 22% earlier showing lower strength than the test. It is suspected that inadequate material properties were applied in FE model. Especially in-plane shear strength response is difficult, as well as the in-plane fracture energy parameters were estimated using other existing similar materials. Also, in FEA, the C-frame shows different failure mode from the test. The symmetric FE model represents the identical C-frame boundary condition at both ends, but in actuality, a slightly different boundary condition was applied at each end of C-frame in the test (mainly, one side was free to allow frame elongation, whereas the other side was fully pinned, like classical simply-supported beam). It is suspected that this aspect is influencing the variance between the FE model and test data, and would require further investigation with a full model (no symmetry). C-frame failure progression in the Frame04-2 test is: that (i) a crack was initiated at upper radius corner of C-frame near the shear tie vertical edge corner, and (ii) the crack grew through the first bolt and along the horizontal bolt line with local web twisting by the eccentric compressive load from the

way the shear tie connects directly to the web offset from the shear center. These phenomena influence the development of failure at the bolted connections. To better understand and be able to simulate this phenomenon, a detailed experimental and numerical investigation at smaller scale is required, exploring combined compression and local twisting (bending) load transfer through bolted connections. This idea is conceptually shown in Figure 4.27.

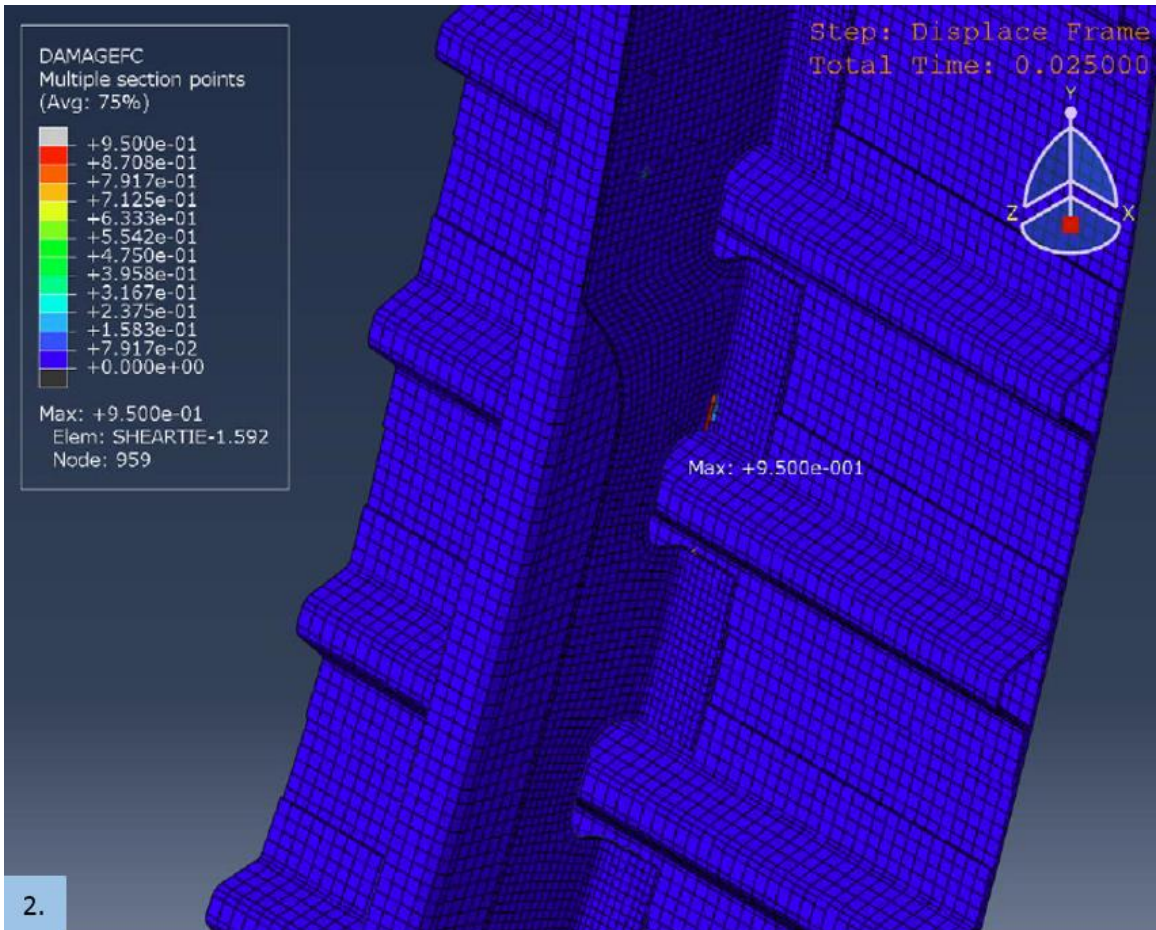
**Figure 5.8: Shear tie radius damage initiation.**

After the initiation of shear tie radius delamination (per above-described calculation), as shown in Figure 5.8, shear tie radius fiber damage initiation from the upper side of Loc4 mouse hole is predicted. Shear tie-stringer contact and stringer hat fiber damage initiation then follow (see Figure 5.9 and Figure 5.10, respectively).

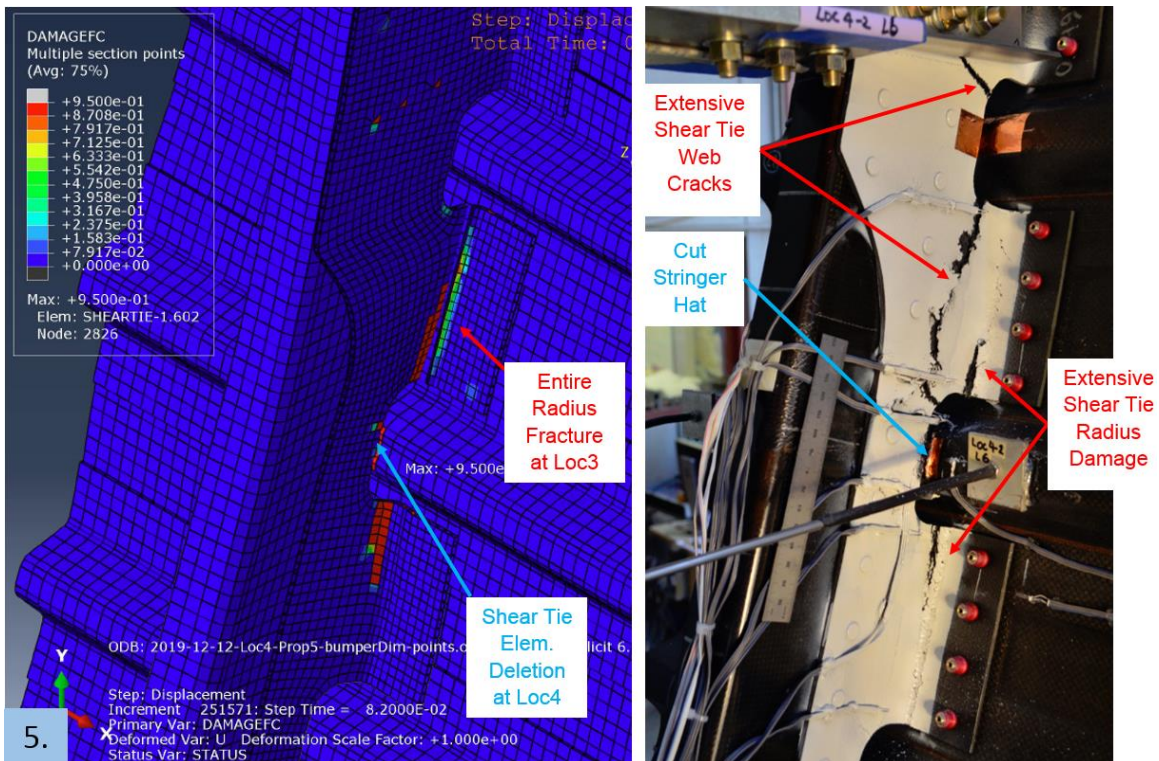
**Figure 5.11: Entire radius fractured at Loc3 in FE simulation.**

The major discrepancy between FE prediction and test results is shear tie failure mode and location. As shown in Figure 5.11 and Figure 5.12, the subsequent key event in FE simulation is abrupt entire shear tie radius fracture at Loc3, which did not occur in the tests. In the tests, the radius crack grew gradually showing radius crushing and delamination mode until abrupt significant web fracture occurred with a large diagonal crack. In addition, shear tie web element deletion is predicted at Loc4. This did not occur in the tests. Furthermore, in the tests, the stringer hat was cut by the shear tie web at

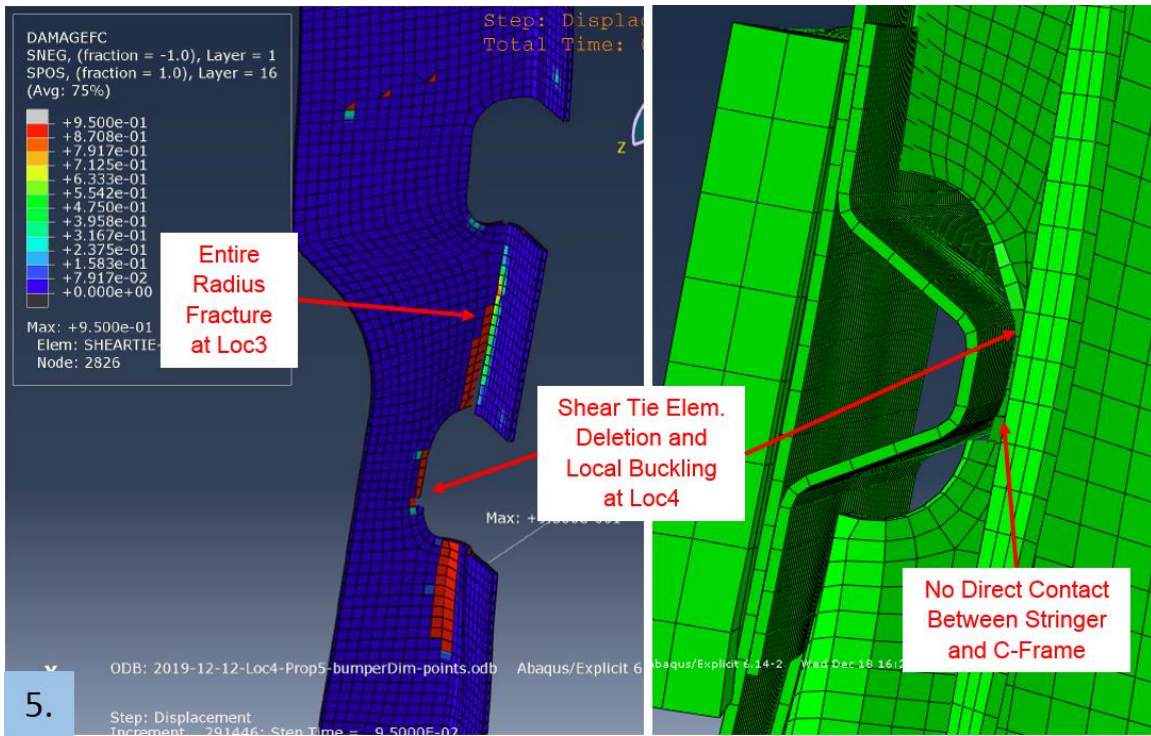
**Figure 5.12: Shear tie fracture and component interaction.**

Loc4. However, in FE simulation, there is not any element deletion from stringer hat contact until the end of the simulation. The shear tie web element deletion and its local deformation mode at Loc4 by crushing makes no direct contact between stringer and C-frame as shown in Figure 5.12.

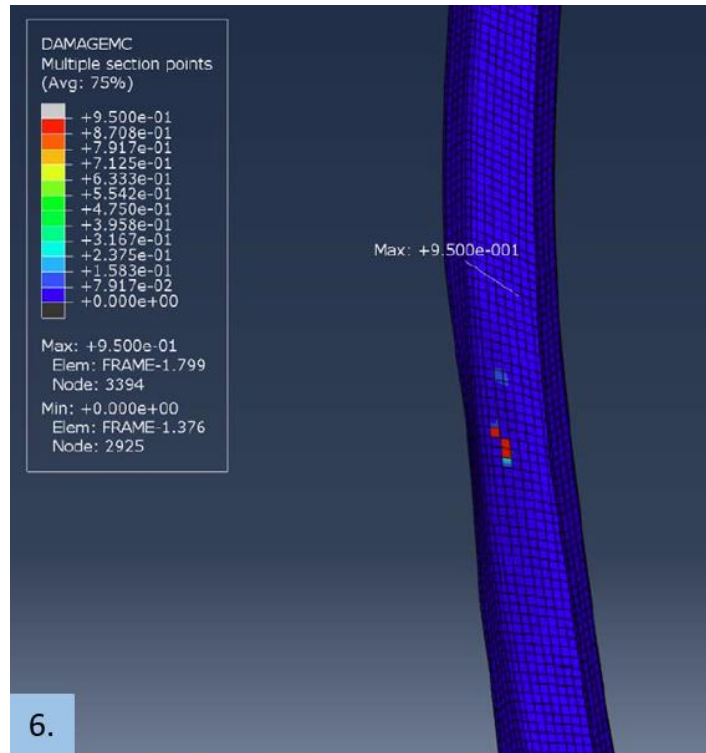
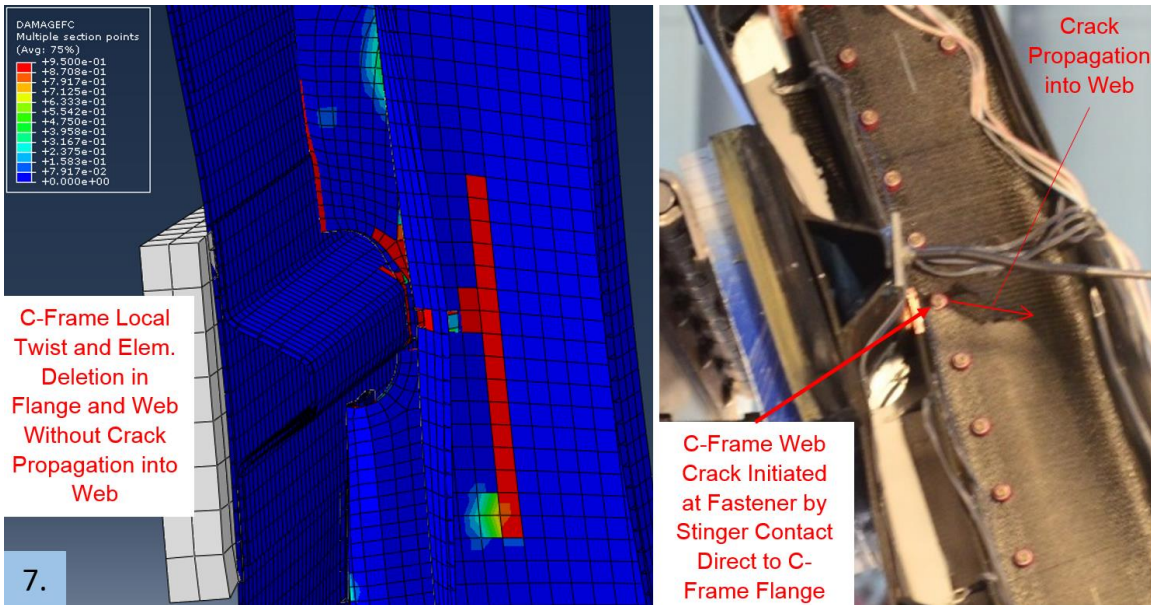
**Figure 5.13: C-frame damage initiation (numbered 6) and crack (numbered 7) at Loc4.**

As shown in Figure 5.13, the C-frame failure location agrees with test result, but the contact and interaction with the stringer, as well as concentrated stress at the fastener, observed in the experiment (see test photo in Figure 5.13), was not addressed and should be included in future improvements.

In the FE prediction, the C-frame failure location agrees with test results, but the contact and interaction with the stringer, as well as concentrated stress at the fastener needs to be more accurately accounted for. In CODAMEIN research [17, 18], shear ties to frames interactions were modeled using connector elements. For the representation of the fasteners, translational stiffness as well as axial and shear strengths were defined. This approach is recommended first. As mentioned in Chapter 4, the smaller scale study is recommended as well for the failure at fastener by concentrated stress under combined local bending and compression load state.
