Towards a Stable Future: A Design Proposal for Cerrito Creek in Blake Garden, Kensington, California

UC Berkeley Dept. Landscape Architecture  
& Environmental Planning

LA 227/Spring 2010

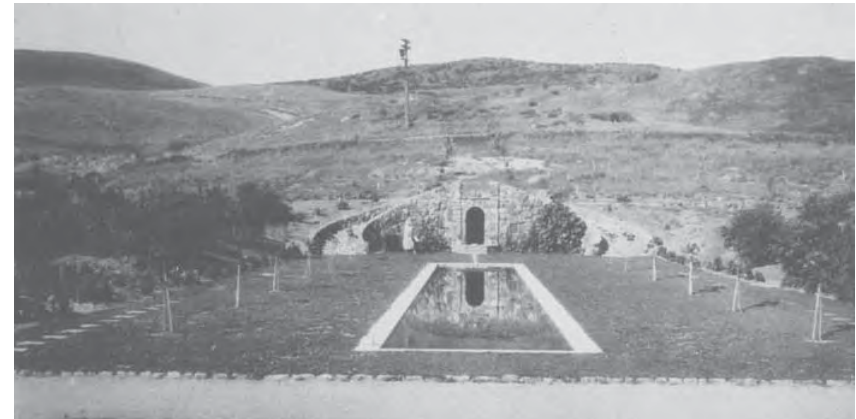
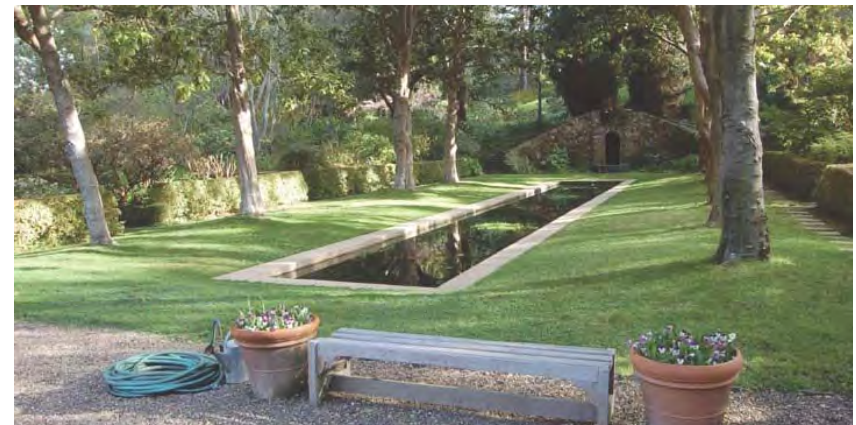
Fig. 1: Grotto at Blake Garden

Grotto 2008

Grotto 1924

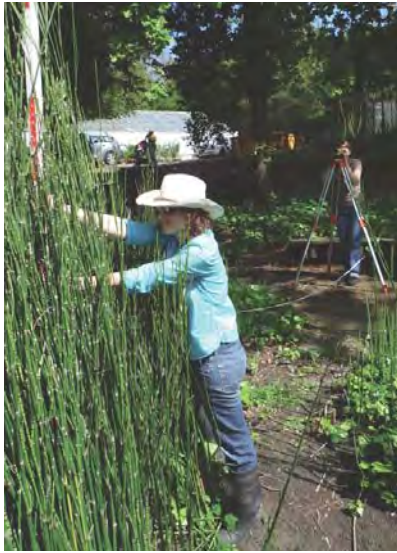
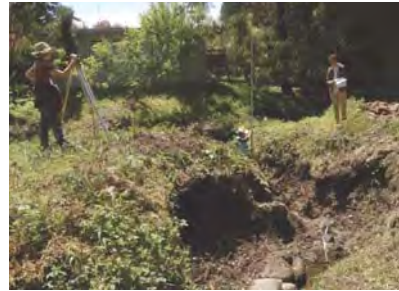
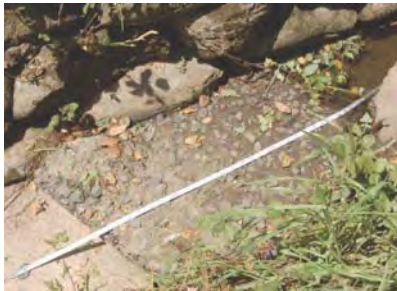
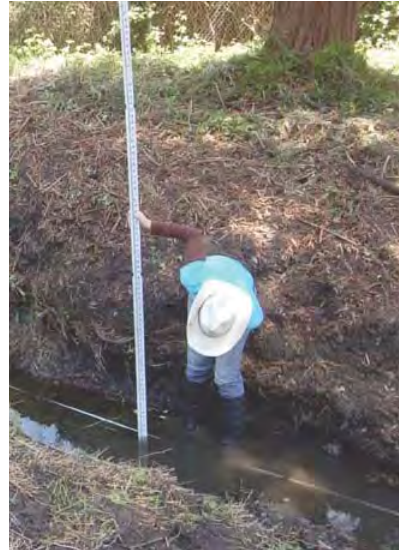
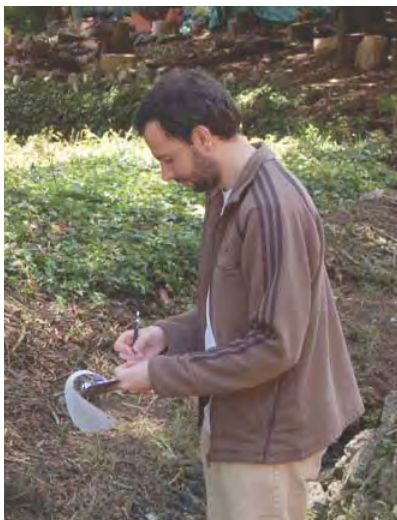
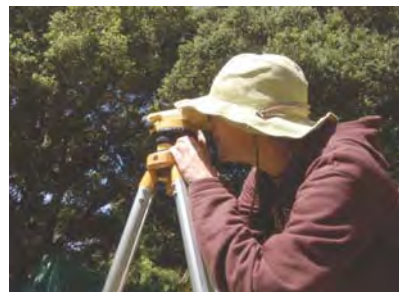
Fig 5: Surveying

Our team conducted surveys in late April of 2010, including over 400 feet of the longitudinal section of the North Branch, 75 feet along the South Branch, and eighteen cross sections, using compass readings and triangulation for spatial reference (Fig 5). In November of 2010, we re-marked our previous surveyed sections with permanent survey markers so that the survey may be reproduced in the future, and potential restoration activities monitored.

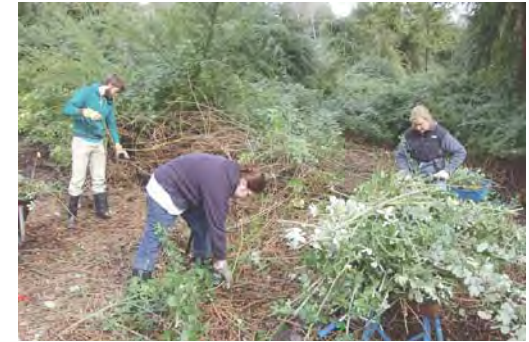
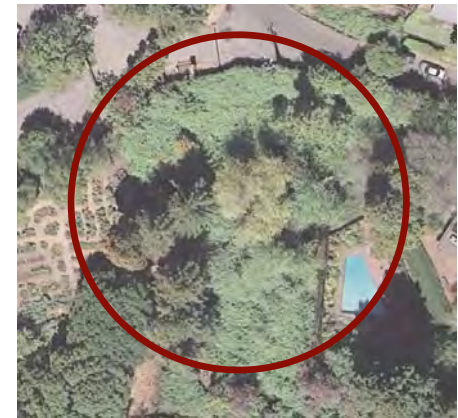
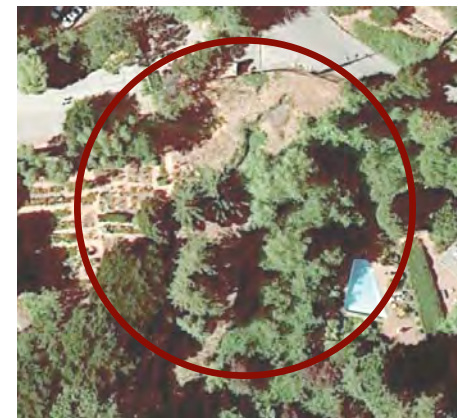
Between 2007 and 2009, garden staff and volunteers removed blackberries that grew along the creek. This is an undesired invasive species that completely covered the channel (Fig 9). Staff continues to maintain low levels of vegetation by regularly cutting back new growth, but left blackberry roots within four feet of the channel intact to maintain bank stability. Twitchell’s goals include making the creek more visible, conducting stream restoration, and integrating the creek into the designed garden.

2007

2010

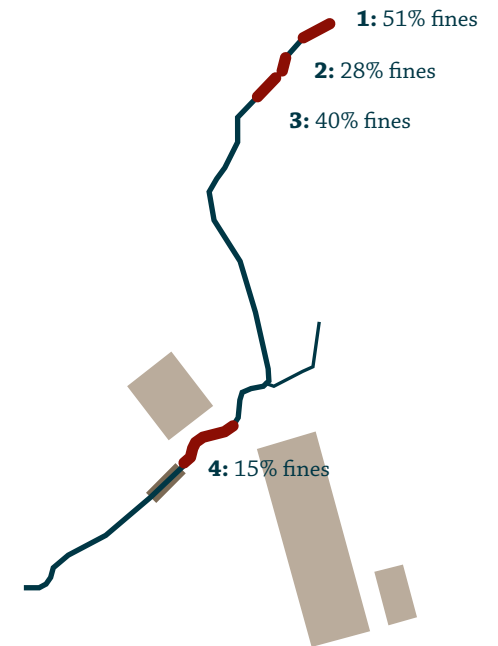
Fig 11: Pebble Counts

The results of the four pebble counts showed fine sediment deposition at the top of the site with steadily decreasing fines and increasing size classes moving downstream. (Fig. 10) Specifically the pool at the out fall of the upstream culvert (count 1) contained 51% fines with 98% of the samples less than 16 mm in width, this indicates that the stormdrain is carrying almost exclusively fine sediment. The percent fines decreased moving downstream. The first scour pool below the largest headcut (count 2) revealed 40% fines and 70% <16 mm wide, while the second pool (count 3) contained 28% fines and 64% <16 mm. The riffle above the grade control culvert only contained 15% fines and 37% <16 cm, and is instead comprised 50% gravel and 20% cobble.

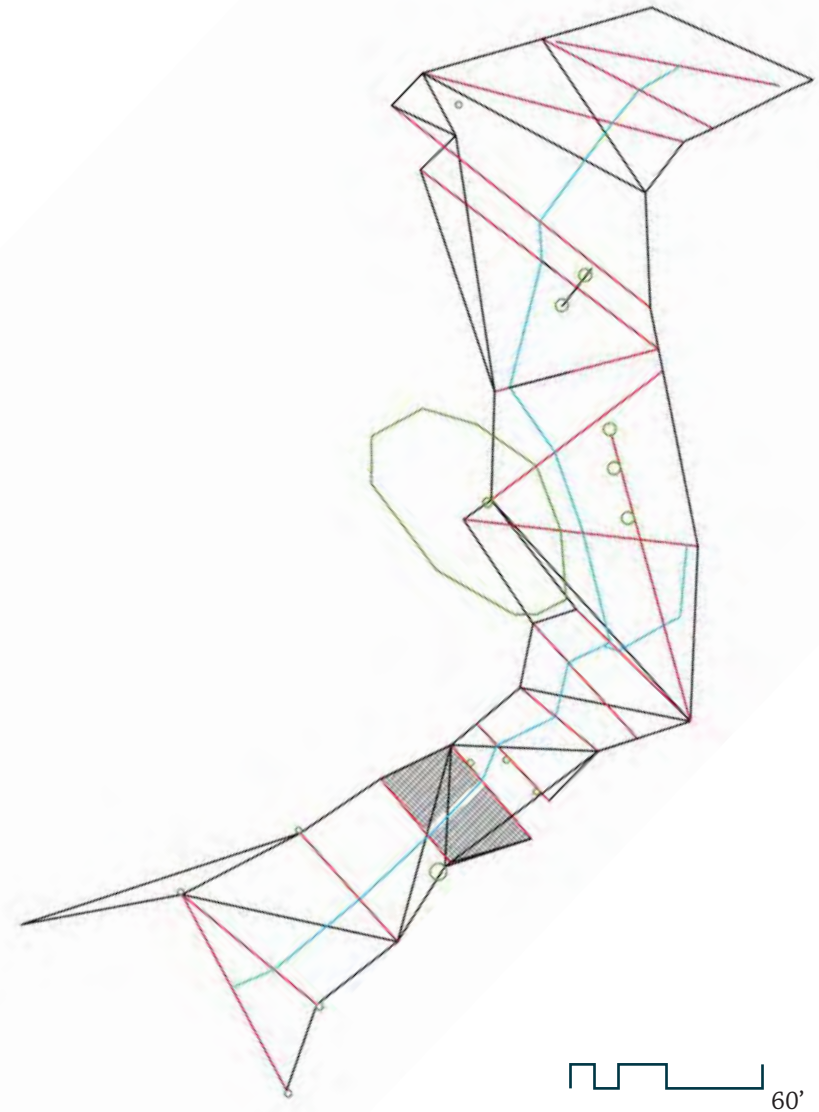
Fig 14: long profile / april 2010

*Long Profile:* Our survey found that the average slope of the South Branch is 5.7% , and the average slope of the North Branch is 7.1%. The total surveyed reaches have an average slope of 6.7%. (Fig 15)

The channel slope from the upstream culvert where the North Branch enters Blake Garden to the downstream end of our long profile has six different reaches with distinct channel processes and slopes (Fig 15). Reach 1 begins at the culvert

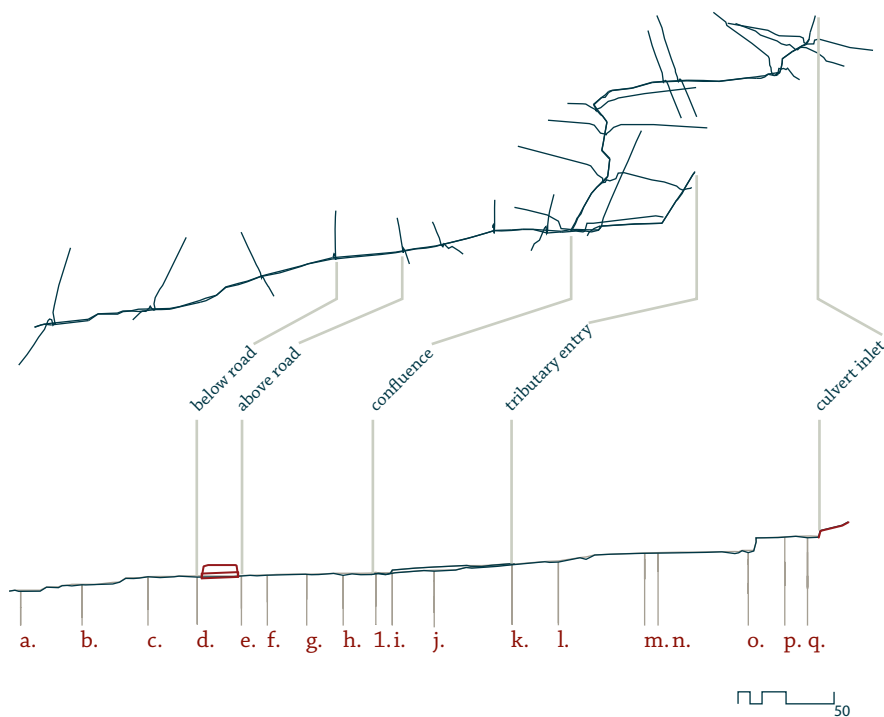
Fig 16: cross sections comparisson **o** and **q**

at cross section Q and stretches to cross section O and has an average slope of 20%. Here water enters into a pool from the culvert and then heads down a drop of 8 ft to a second pool (Fig 16). This section is actively incising and threatens to cut back to the culvert outlet just below the road. Reach 2 extends from sections O to M, has a slope of 0.08%, and appears stable (Fig 17). Reach 3, between L to I (confluence) has a slope of 6%. Here the creek is deeply incised from past down-cutting and the banks are much less stable. Further downstream, there is increased undercutting and bank failure. The stream bed appears relatively stable, perhaps because of the more resistant bed material, and side-cutting is the dominant process here (FIGURE 21). We delimit Reach 4 of the long profile from the confluence to the culvert crossing (sections H to E). Here the culvert is acting as a grade control structure, and the average slope is predictably low at 0.08% (image). Reach 5, from the bottom of the culvert to immediately downstream from section C, is stable and still maintains the lateral connectivity to a floodplain, in high flows, with an average slope of 1.6%. Reach 6, from there to the downstream end of our long profile (sections B and A), is much steeper (11.1%). There are active head cuts moving upstream toward the culvert.

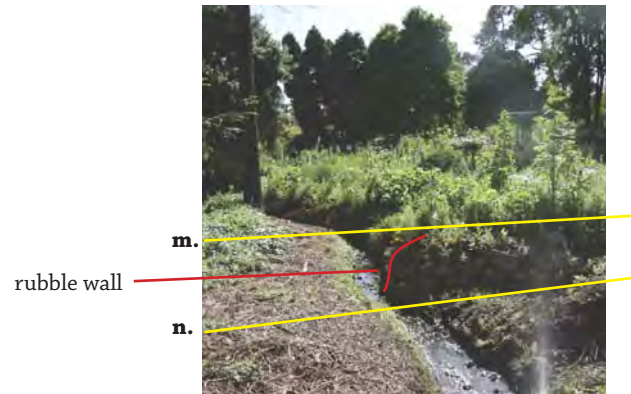
Fig 18: cross sections **j**, **h**, and **1**.

There are two segments within our site that show significant bank erosion. The first is reach 3, between sections I and K; despite past efforts, this segment has steepened banks with heights ranging from four to seven feet. There is evidence of recent bank failure and significant undercutting (up to 2.5ft in some places) (Fig 18). The second segment is reach 6, at the downstream end of our site, between sections A and C, here again there is active undercutting and steepened banks that follow the active head-cuts within the channel.

**Cross Sections:** We surveyed a total of eighteen cross sections illustrating the changing channel morphology (Fig 14). Cross sections N and M depict a stable channel (Fig 17); section N has a channel and small floodplain. Section M is beginning to experience incision and shows a rubble wall on one side constricting the channel (Fig 17). Cross section O demonstrates the most dramatic pool and scouring along the stream banks, below the largest head cut in our survey area (Fig 16). Cross sections J and H demonstrate incision on the North Branch compared to the stable channel on the South Branch (Cross-section 1). The most dramatic undercutting and bank failure occurs at cross section H where both sides of the channel are undercut, one at .75ft and the other at 1.6ft (Fig 18).

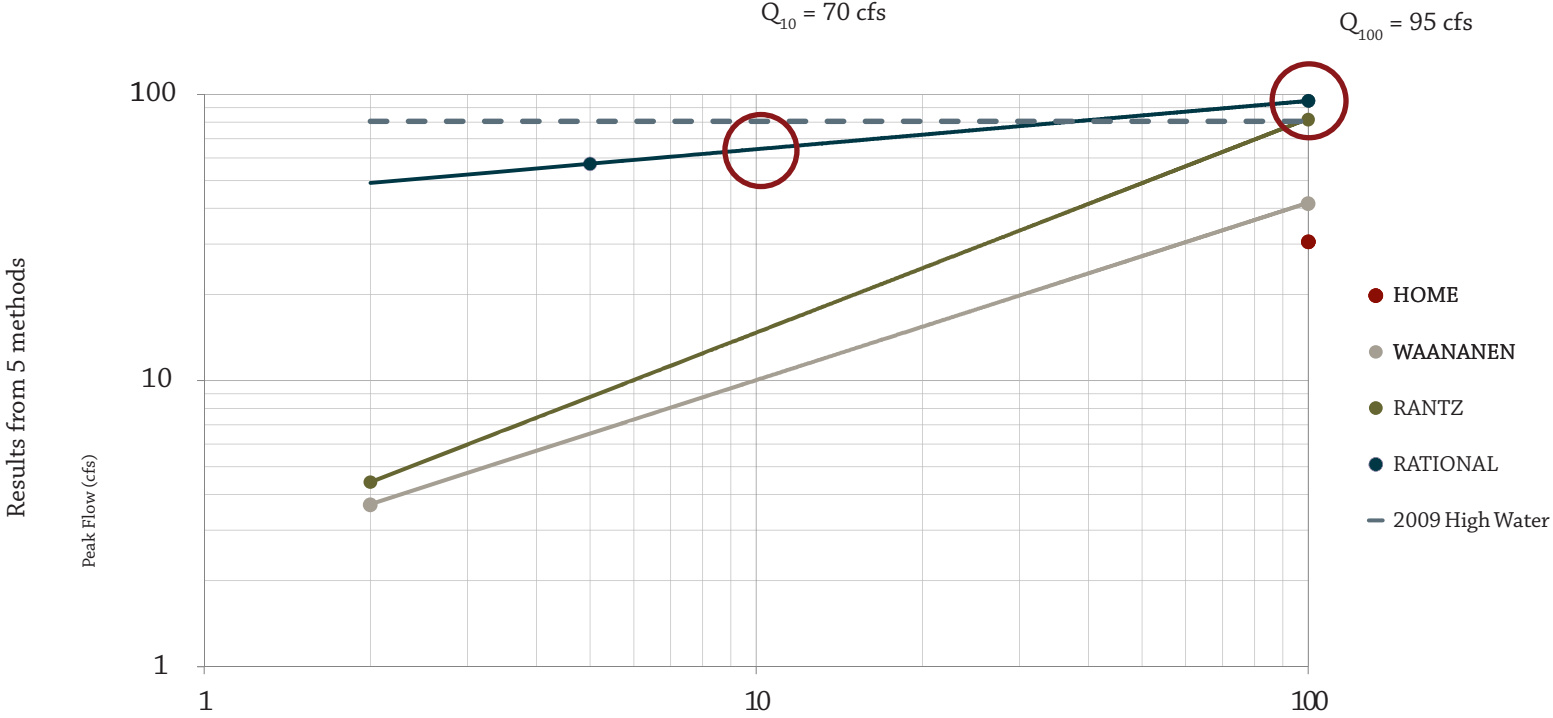
Fig 21: watershed analysis

the South Branch. In our more recent field visits, we observed that almost all the stormwater in the watershed converges into the stormdrain system that culminates at the culvert located at the upstream end of the North Branch. As such, we will consider that all the peak flow will have to be conveyed through the North Branch in our design proposal. The watershed has an average slope of 12%. The Alameda County Hydrology and Hydraulics Manual (Alameda, 2003) defines a runoff coefficient (C) of 0.6, for a Type D soil with approximately 50% impervious surfaces (equivalent to a 1/8 acre residential plot configuration) which corresponds with the conditions of our site (Fig 23). Given the soil type D (CoE) and our estimated impervious surfaces at 47.7%, C=0.6 was selected for further calculations (Fig 21).

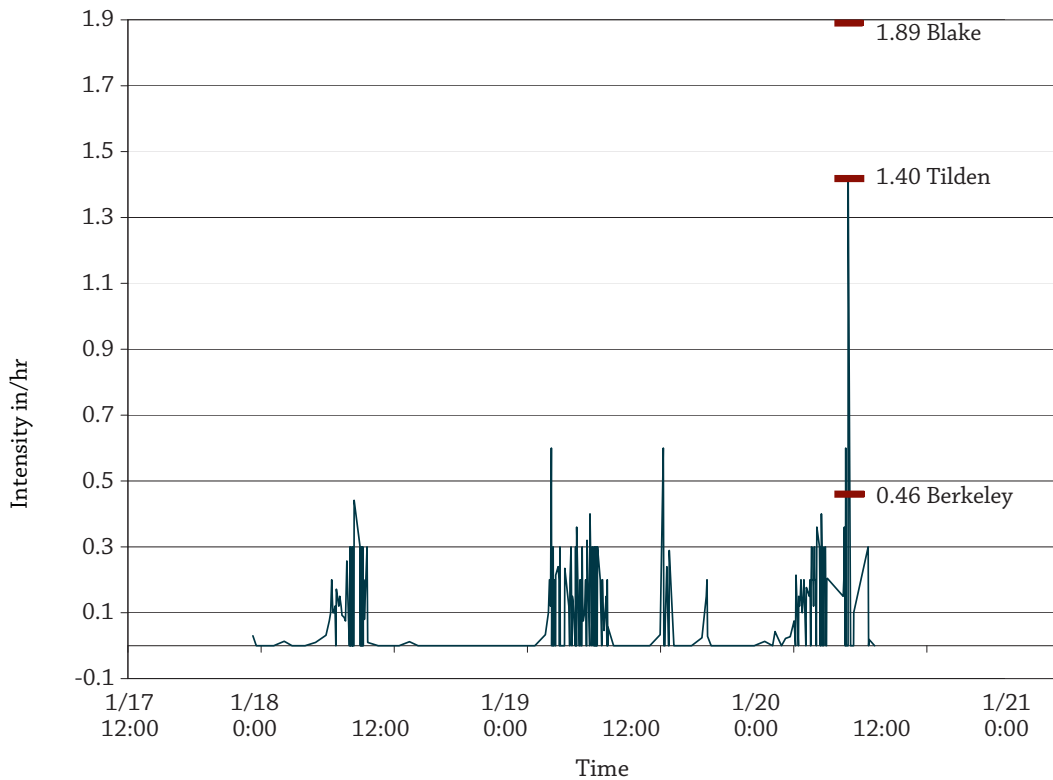
Fig 22: Jan 20, 2010 storm comparison

On January 20th, 2010, a short, but very intense, precipitation event was registered in the Blake Garden watershed. The gage at Blake Garden collected 1.89 inches of rain in an hour. This seems to have been a very spatially concentrated event. This is demonstrated by the high intensity of 1.40 in/hr logged at the nearby Tilden gauging station, while the UC Berkeley gauging station only registered 0.46 in/hr for the same storm event. (Fig 22)

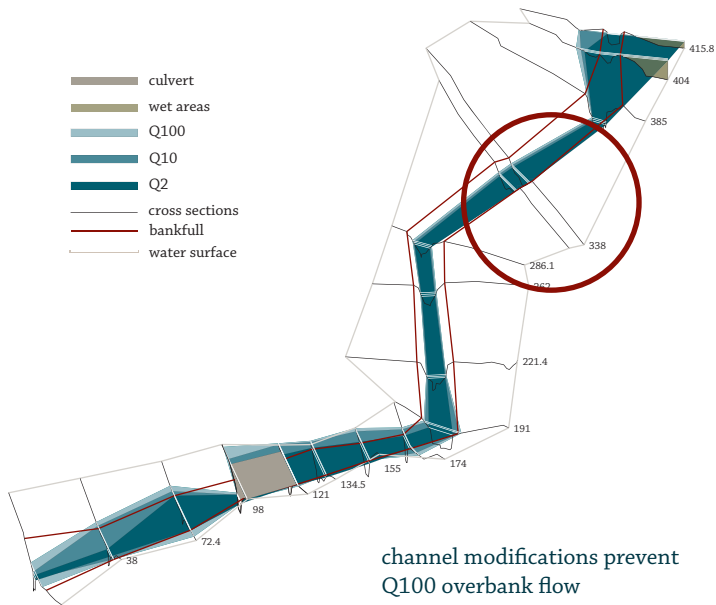
Fig 25: HEC-RAS model of flow with channel modifications

*HEC-RAS:* Our hydrologic calculations and field survey allowed us to model flows in the creek using HEC-RAS. With the help of Raymond Wong, we used the peak flows estimated with the Rational method, for the 2, 5 and 100-year return interval as inputs, noting predicted bank overtopping. The choice of the Rational method’s results and these return periods is based on the comparison between the results of the several methods, produced on the previous semester in LA222, and identifying the Rational as the most consistent. It is also the method recommended the Contra Costa County Flood Control and Water Conservation District (CCCFCO). We tested the model for consistency against our field observations of high flows and bank overtopping during rain events. We then used HEC-RAS to model these flows through the channel using a modified, typical cross-section to see how it would respond to channel interventions (Fig 24-25).
