Post project evaluation of Miller Creek (Marin, CA) restoration : vegetation survival

Post Project Evaluation of Miller Creek (Marin, CA) Restoration: Vegetation Survival

LA222 Hydrology for Planners
Spring 2004
Prof. Matt Kondolf

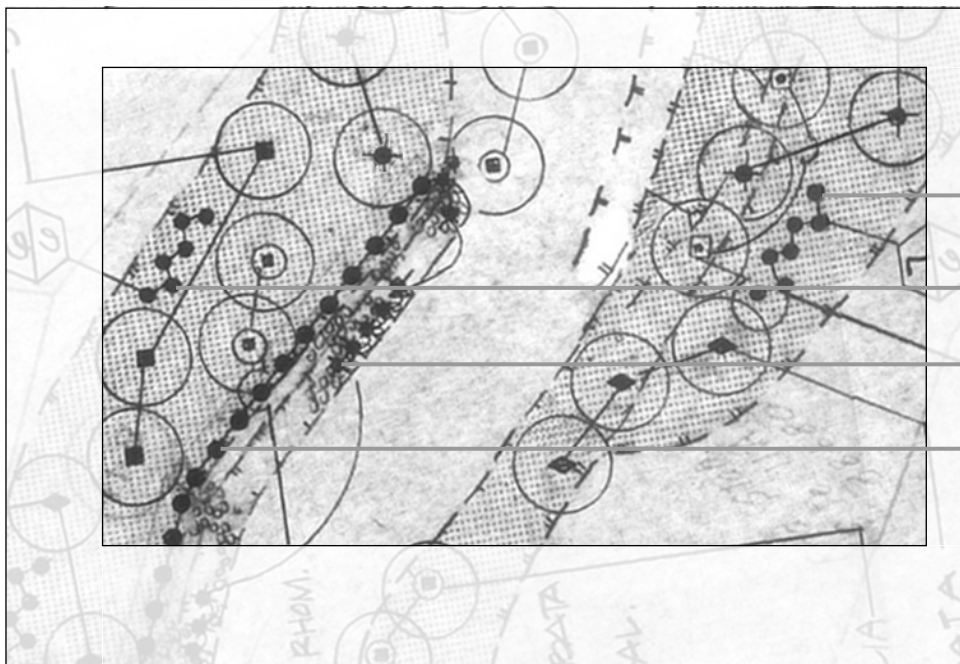
Figure 8. Planting Plan Plot 2

Plot 2 is our middle plot. It corresponds to station 38 in the original restoration project plans and in Pope-Daum and Yin’s report. Figures 8 and 9 show the original planting plan and vegetation survey for this plot. As in the first plot, the left bank is more open and grassy, with occasional shrubs, while the right bank has more trees and shrubs (Figure 4). Deer have grazed on the plants in this section, especially on the oaks. Heavy sand deposits cover the grasses and forbs on both banks.

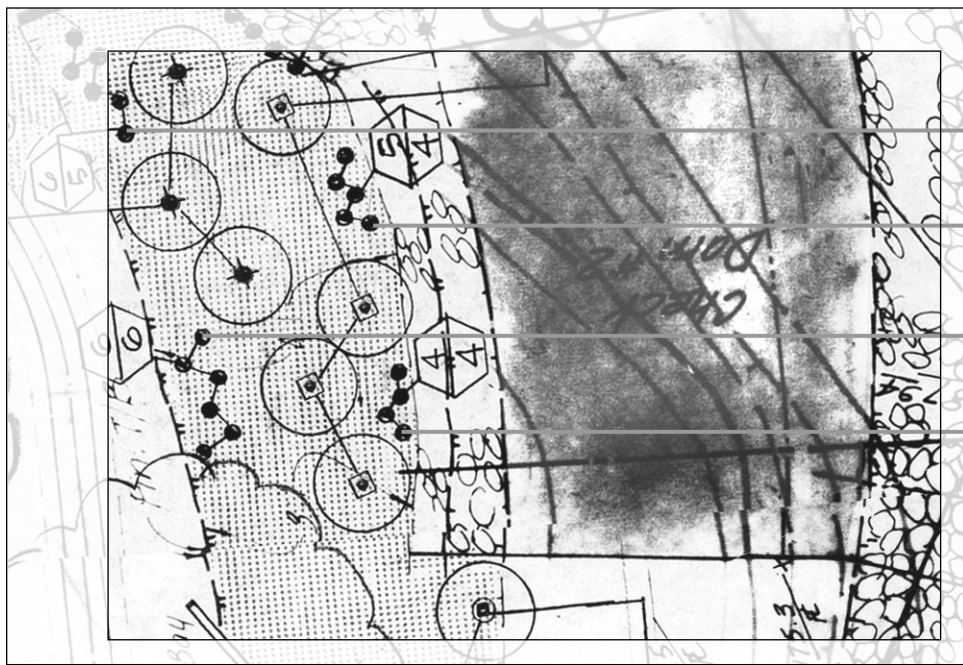
Figure 10. Planting Plan Plot 3

Plot 3 is our downstream plot. It corresponds to station 18 in the original restoration project plans. Figures 10 and 11 show the original planting plan and vegetation survey for this plot. Compared to the other two plots and the designers' anticipated success rates, the restoration planting in this plot was effective (Figure 5). Unfortunately, the planting plans only show the left bank (Figure 10). On the plan, the right bank was planned to be ripped and seeded with grasses. Currently, the right bank supports a fair number of seedlings and young trees, including live oak, valley oak, buckeye, and ash. Newer wire cages suggest that the valley oak (all 18 in tall) were recently planted. The creek bed is lined on both sides by large, dense willows. In contrast to the two upstream sites, the creek is narrower and more shaded in this reach. The planned check dam (riprap) is visible at the bend in the creek created by the gravel bar and willows. Our analysis only considers the left bank, as the right bank was not designed or planted until recently.

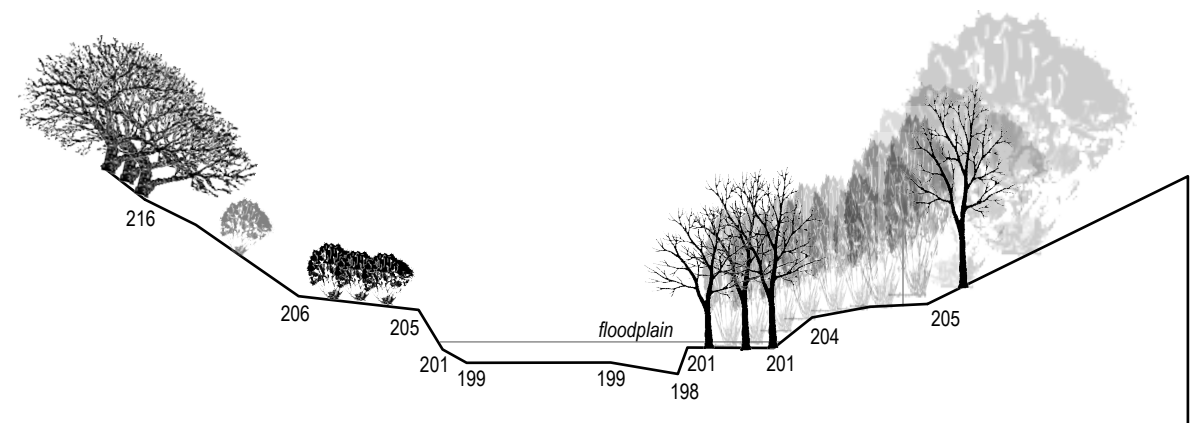
Figure 18. Schematic Cross-Section Plot 1

Figures 18 to 20 show the three schematic cross sections in relation to their plots. The sections for plots 1 and 2 are from Pope-Daum and Yin's study (2003). The section for plot 3 is drawn from the original grading plan (Guzzardo 1989c). None are entirely precise because the channel is always changing, but they are sufficient for our purposes. Table 3 and Figure 21 show the results of our elevation analysis. Table 3 includes only those trees planted, and whether or not they survived. There did not seem to be any strong correlation with elevation, except that trees seemed to either survive or die at a particular location. For almost all of the elevations, the survival rate of a species was either 0 or 100 percent. Figure 21 shows tree survival with elevation and height above the thalweg. It shows all individuals to give a sense of where certain species grow, both within plots and between plots. The planting schemes for the three plots look similar, in terms of trees and their height above the thalweg. Alders were planted lower in the floodplain, while oaks were planted higher. However, while almost all of the trees in the third plot survived, many of those in the upper two plots, even those planted low in the floodplain, did not. This could be due to a lower water table in the upstream section of the creek, or another unknown factor. Trees tended to survive or die in clumps, which indicates that local factors play a large role in survival. In order to determine the height of the water table, more studies would need to be done. Downstream of the study plots, the stream is perennial, while upstream areas have intermittent flow, suggesting that the summer water table might be higher downstream. Piezometers installed at different locations, and monitored throughout the dry season, would show if this is the case.

Figures 18 to 20 show the three plots and schematic cross-sections. For each site, we mapped an “active floodplain” area based on topography and observed high water marks. We suspect that these high water marks were left from a recent storm (February 25, 2004). Weather data show 3.51 inches of rain fell that day in nearby San Rafael (Accuweather.com 2004). Data did not show the event's duration, but we remembered the storm lasted for less than
