Hail Ice Damage of Stringer-Stiffened Curved Composite Panels

A Thesis submitted in partial satisfaction of the requirements

Structural Engineering

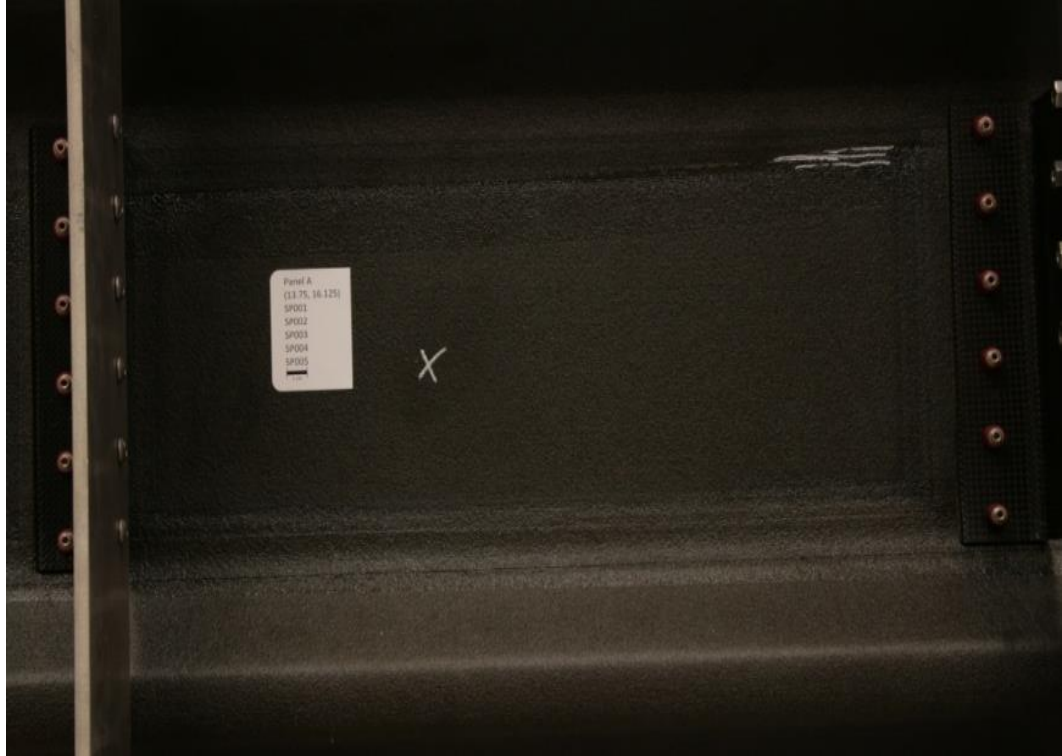
Figure 49. Type I: Back of SP001 (N/A), SP002 (307.2 J), SP003 (430.7 J), SP004 (460.3 J), and SP005 (546.8 J).

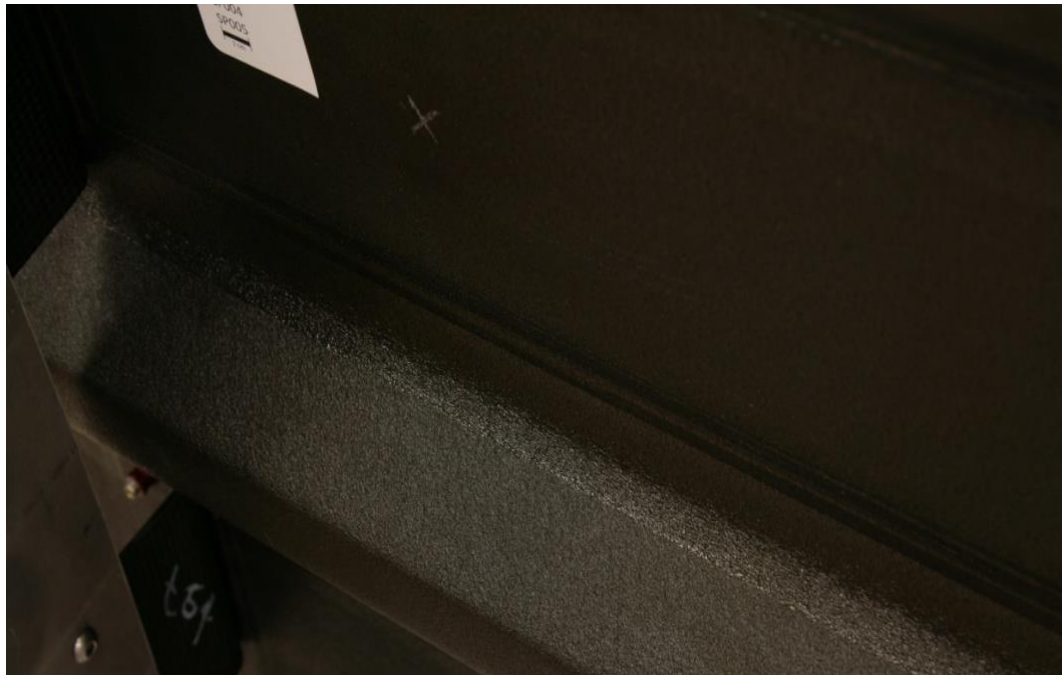
Figure 50. Type I: Bottom of back of SP001 (N/A), SP002 (307.2 J), SP003 (430.7 J), SP004 (460.3 J), and SP005 (546.8 J).

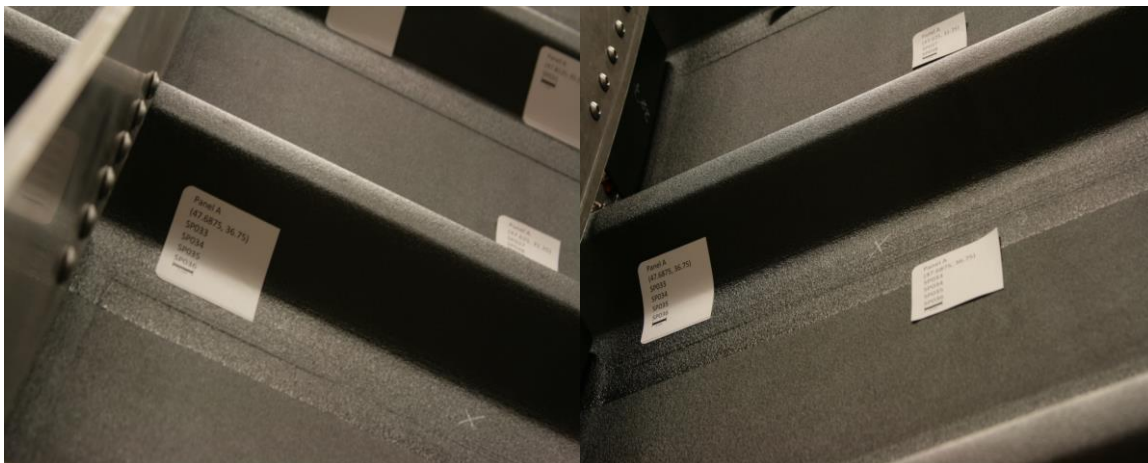
Figure 88. Type IIb: Back of SP033 (163.4 J), SP034 (181.2 J), SP035 (226.4 J), and SP036 (275.9 J).
