REPORT DATE OF PUBLICATION: July 2021
Research Report: UCPRC-RR-2020-01

Concrete Overlay on Asphalt Pilot Project at Woodland SR 113: Construction

Partnered Pavement Research Center (PPRC) Project Number 3.39 (DRISI Task 3201):
Implementation and Field Performance Evaluation of Concrete Overlay on Asphalt

University of California
Pavement Research Center
UC Davis, UC Berkeley

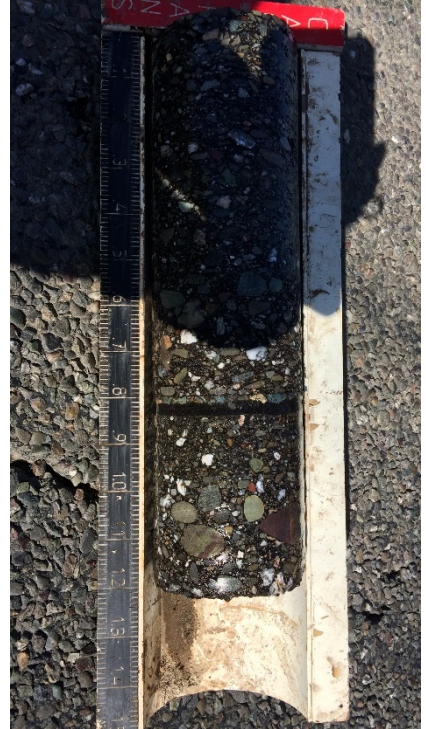
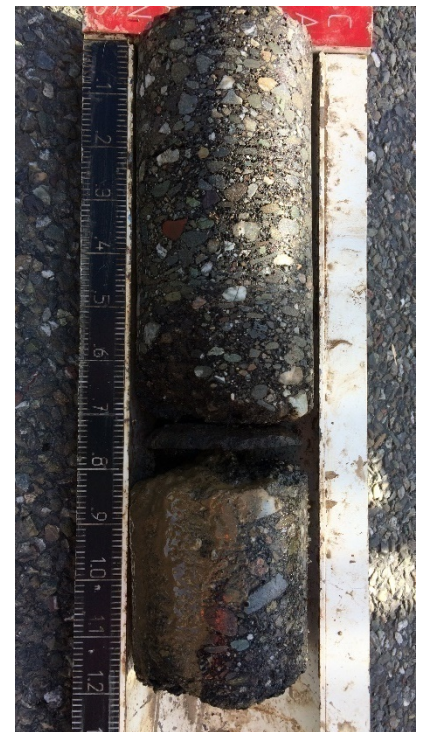
Figure 2.5: Cores extracted from between the wheelpaths: Segment A.

All the cores were extracted from spots in or between the wheelpaths. None were extracted at cracked locations or shoulders. The Segment A cores did show frequent delamination and some moisture damage (Figure 2.5) to the asphalt, but the Segment B cores showed the asphalt to be in good condition (Figure 2.6). A second set of cores was extracted from both segments on top of asphalt cracks. These cores showed that cracking had affected the full depth of the asphalt layer and that moisture had produced considerable damage in the lower asphalt lifts (Figure 2.7).

Based on these findings—the asphalt delamination risk that was seen in the Segment A cores (Figure 2.5) and the somewhat better condition of the asphalt in the top lift than in the lower lifts—a recommendation was made that the project include either a minor amount of grinding or no grinding. Ultimately, this recommendation was overridden by another recommendation included in a flooding-risk evaluation that warned against elevating the road surface.

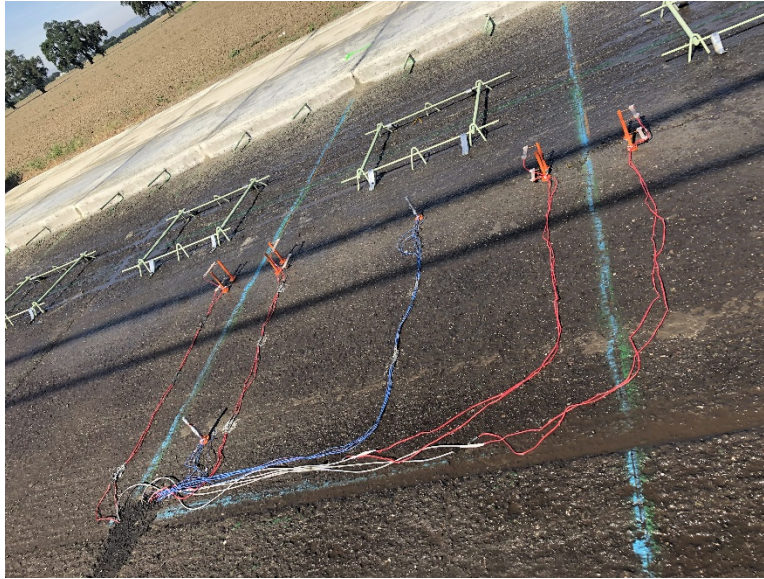
Figure 3.12: Instrumented point A32, right before concrete overlay placement.

All sensors fixed to rods or chairs, zip ties tips and sensor labels cut, cables fixed with epoxy to the asphalt base.

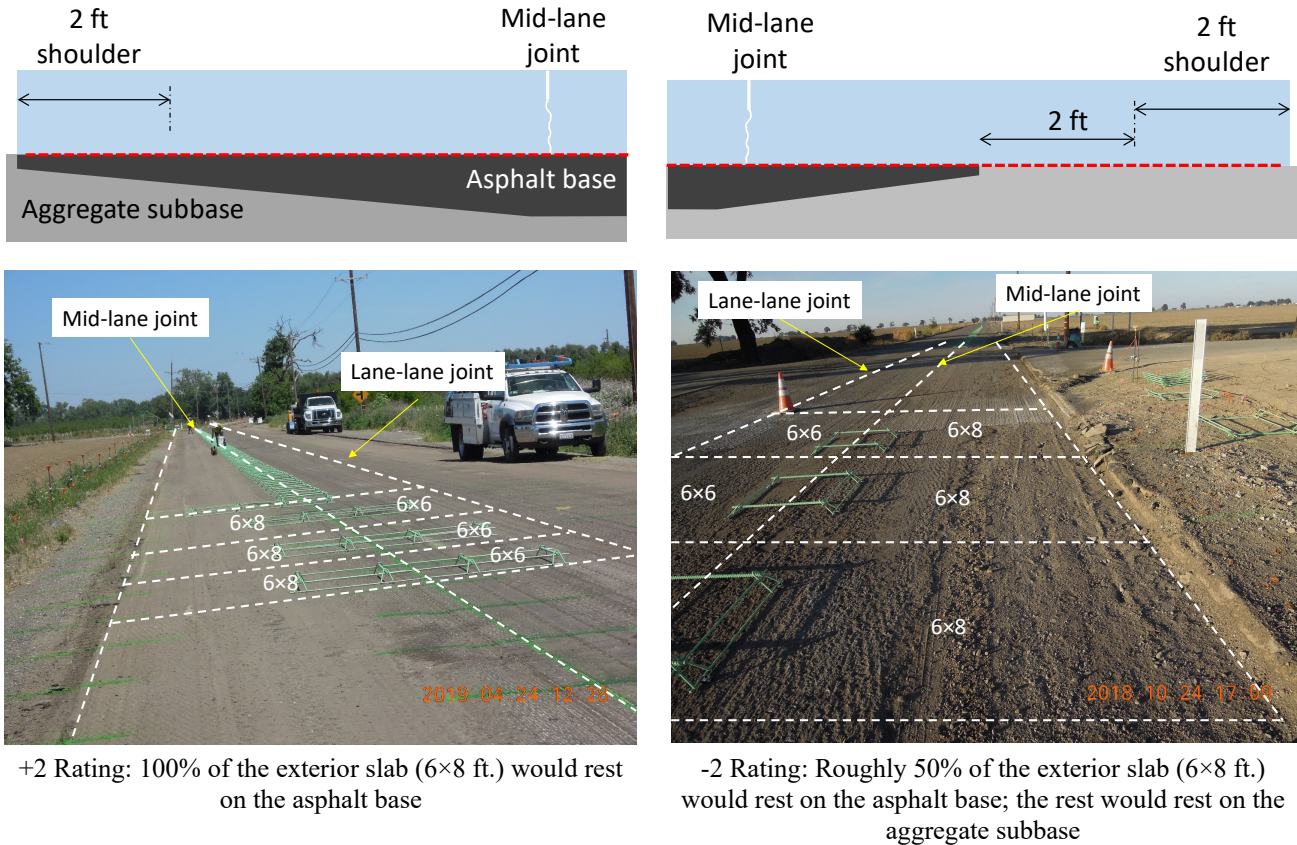
Figure 4.6: Criteria for rating asphalt condition at the shoulder edge of the roadway.

A visual survey was conducted to quantify the condition of the milled asphalt base at the shoulder edge of the roadway. In this survey, a rating between -2 and +2 was assigned to each 100 ft. long roadway segment. A -2 rating refers to a scenario where an insufficient asphalt base width ends about 2 ft. inside the lane-shoulder line while a +2 rating refers to a scenario where the asphalt base extends 2 ft. into the shoulder, as shown in Figure 4.6. A +2 rating was also assigned to segments where the shoulder had been paved with asphalt (Figure 4.5) after milling. The results of the visual survey are shown in Figure 4.7.

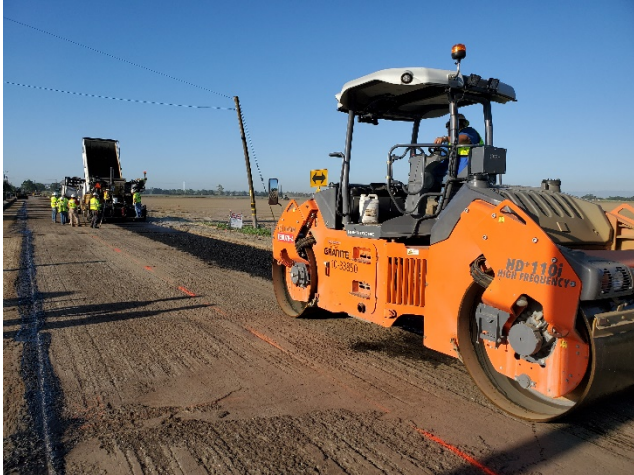
Patching areas with insufficient or missing asphalt base at the shoulder edge of the roadway

Pre-paving work included patching the areas with insufficient or missing asphalt base at the shoulder edge of the roadway and applying a tack coat on the milled old HMA (Figure 4.8). During the placement and compaction of the RHMA-G overlay, the air temperature was approximately 80 to 90°F, the sky was clear (Figure 4.9), and the wind speed was low (< 7 mph). The asphalt temperature during the rolling wheel compaction varied between 300°F, at the beginning of the breakdown compaction, to 200°F, at the end of the compaction process, meeting the specifications in Section 39. After the RHMA-G construction, a set of nine cores was extracted. The average air void content of the cores was 7.5% based on the saturated surface-dry method (AASHTO T 166), with individual values varying from 4% to 10%. This variation percentage is relatively high, but it is similar to the variation observed in the same asphalt mix type in overlays with similar thicknesses. The upper limit of the variation range was slightly above the 9% maximum prescribed in Section 39. The larger the air void content of the asphalt mix, the lower the stiffness and the greater the moisture susceptibility will be. The RHMA-G thickness varied from 1.2 to 1.8 in., with an average value of 1.5 in.

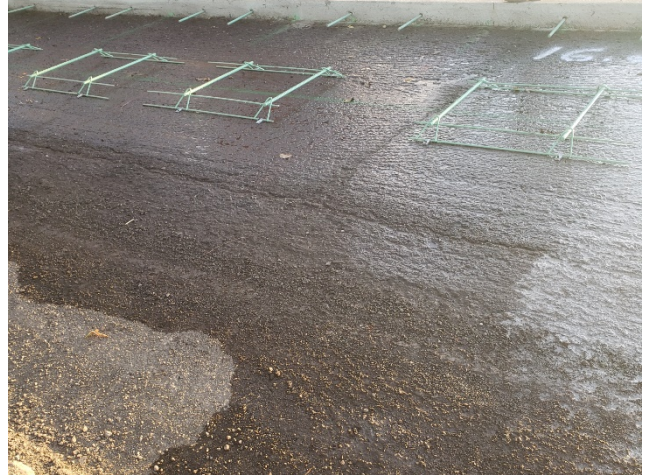
Figure 4.12: Dirt on the asphalt surface before concrete paving.

Preparing the asphalt surface for construction of the overlay included these steps: patching the asphalt where the milled asphalt base had been removed or was insufficient (Figure 4.5), placing the tie bar baskets, and moisture conditioning the asphalt surface. Despite a prescription in the project special provisions calling for a thorough asphalt surface cleaning before placement of the concrete overlay, this task was not performed. Instead, an asphalt surface cleaning operation was only performed after the milling was completed. Further, this cleaning operation did not include an air pressure cleaning that would normally ensure the removal of dust, grit, and foreign material. Similarly, the newly placed RHMA-G was not cleaned to eliminate surface contamination before placement of the concrete overlay. As a result, the asphalt surface was not as clean as is desired for COA construction (Figure 4.12), and this may have had a negative effect on the concrete-asphalt bonding.

Note: Dirt on the asphalt surface has a negative impact on concrete-asphalt bonding.

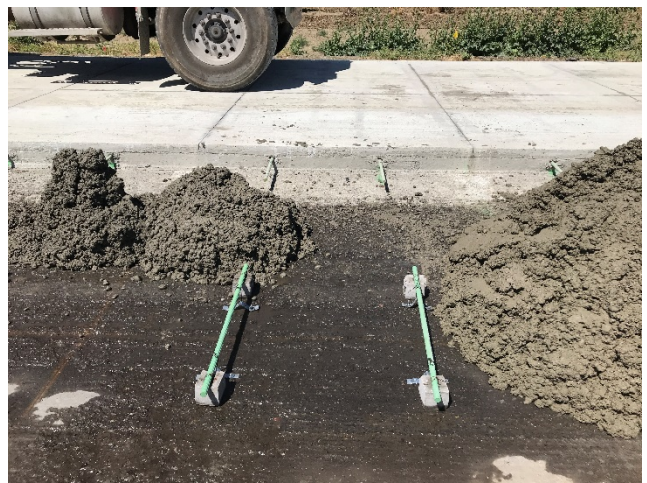
Tie bar baskets were used for the midlane longitudinal joint, as shown in Figure 4.13, except for a small portion in the northbound lane around PM 12.655, where a noncompliant handmade system was used. The tie bars of the longitudinal joint between lanes were inserted manually into the plastic concrete, as shown in Figure 4.14. This technique, which is not one of the options prescribed in Caltrans Standard Specifications, Section 40 yields little control of the tie bar position and allows air pockets to form in the concrete around the manually inserted tie bar.

Handmade system used on a small portion of the project, northbound lane around PM 12.655

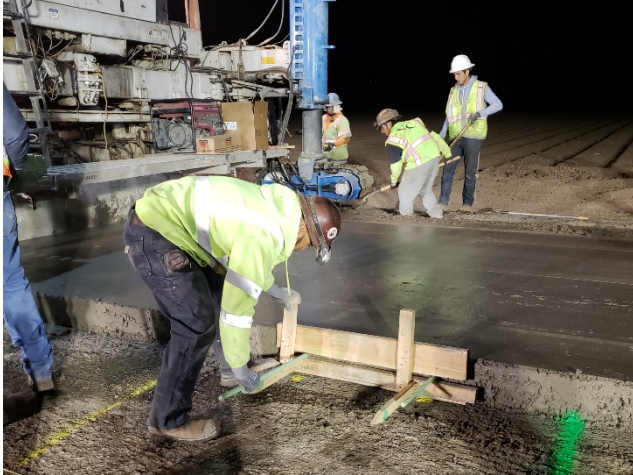
Manual insertion of tie bars in the plastic concrete

Note: Manual insertion of the tie bars in the plastic concrete is not one of the options prescribed in Caltrans Standard Specifications, Section 40.

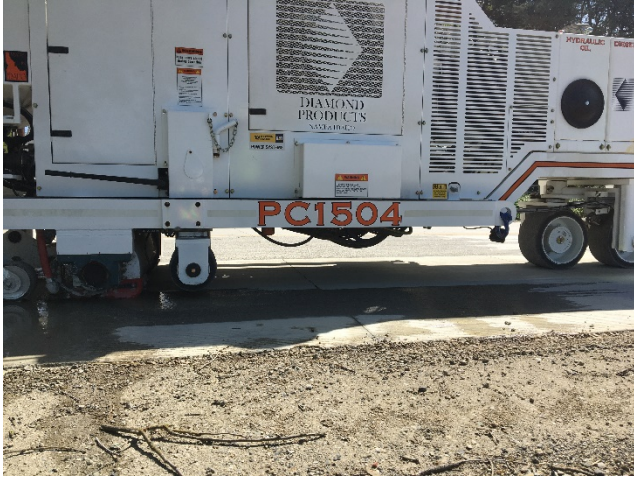
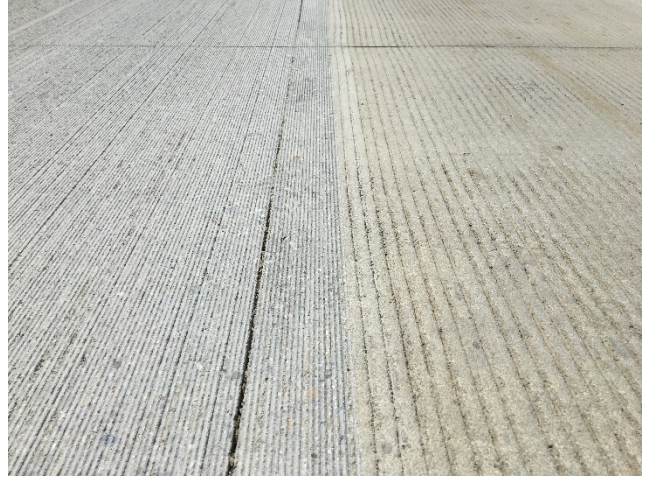
Figure 4.32: Diamond grinding.

Area on the left side of the photo has been ground; area on the right has not been ground yet (and retains its tined texture)

To try to meet Caltrans smoothness specifications, the complete project was subjected to grinding (blanket grinding). The appearance of the post-grinding surface can be seen in Figure 4.32. Grinding operations took place in April 2019 on Segment B and in the second half of May 2019 on Segment A. Overall, the grinding resulted in a 40% MRI improvement, although the improvement for individual 0.1 mi. segments varied from 19% to 53% (Figure 4.33).

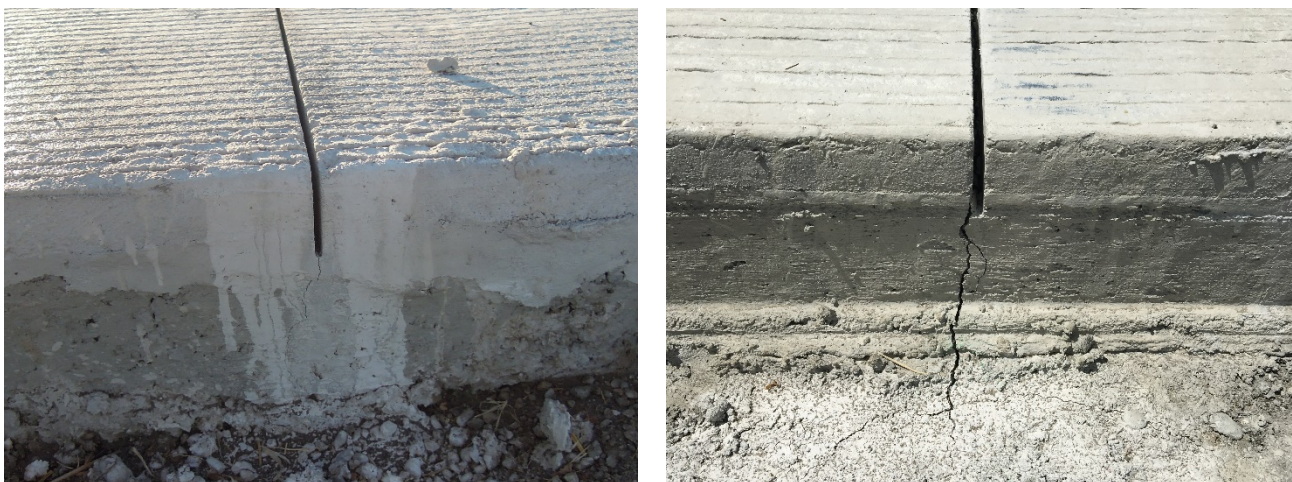
Figure 4.34: Deployed transverse joints.

Deployment of the transverse joints was evaluated visually, by examining the edges of the concrete overlay (Figure 4.34). The joint deployment evaluation started the day after the concrete overlay construction and continued every day until the edges of the overlay were no longer visible. (Note: a granular backfill was built outside the concrete shoulder before the road was opened to traffic; this backfill covered the edge of the concrete overlay, making the edge of the transverse joints invisible.)

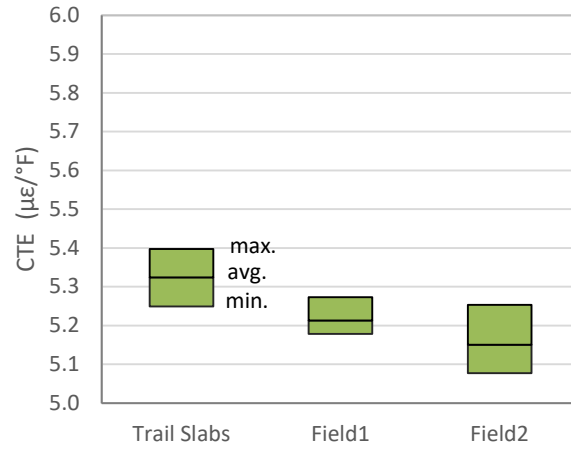
Figure 5.4: Concrete CTE (at age 42 days).

The concrete's CTE was around $5.2 \mu\epsilon/^\circ\text{F}$ (Figure 5.4). This CTE value is within the typical range that can be expected for pavement concrete in California. A petrographic analysis of the concrete's coarse aggregate was unavailable.

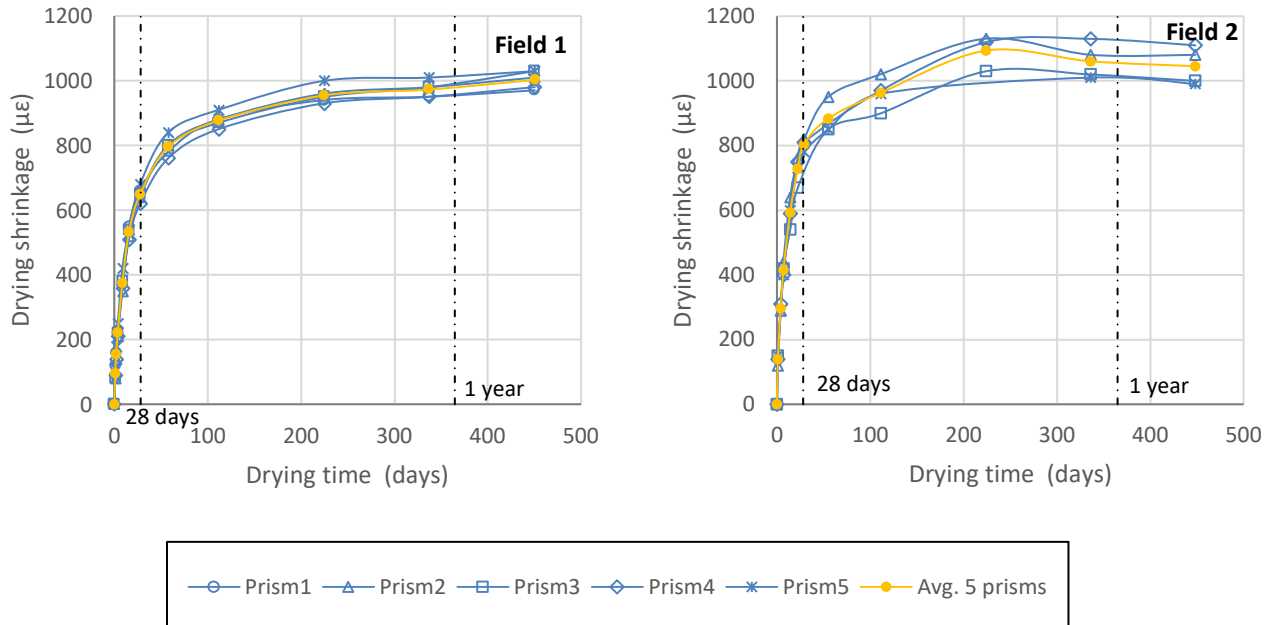
Figure 5.5: Concrete drying shrinkage.

The drying shrinkage results are shown in Figure 5.5. The measured drying shrinkage was relatively high, particularly compared to the limit of 500 $\mu\epsilon$ after 28 days drying that is prescribed by Caltrans Standard Specifications, Section 90. Field1 prisms reached 650 $\mu\epsilon$ shrinkage after 28 days while the Field2 prisms reached 800 $\mu\epsilon$ at that same age. Nonetheless, these values cannot be directly compared to the Section 90 500 $\mu\epsilon$ limit for two reasons. First, the moisture-curing period prescribed in Section 90 lasts until the specimens are seven days old, which is longer than the moisture-curing applied to the specimens in this research project. And second, the Section 90 limit refers to laboratory specimens, but the specimens used in this project were sampled and prepared in the field. According to ASTM C157-17 (note 2), field specimens “can show up to twice as much drying shrinkage as laboratory cast specimens from the same materials and proportions.”
