**REPORT NO.
UCB/SEMM-97/04**

**CYCLIC TESTING OF
FOUR FULL-SCALE STEEL
BEAM-COLUMN CONNECTIONS
WITH "DOGBONES"**

Report to DASSE Design, Inc.

FEBRUARY 1997

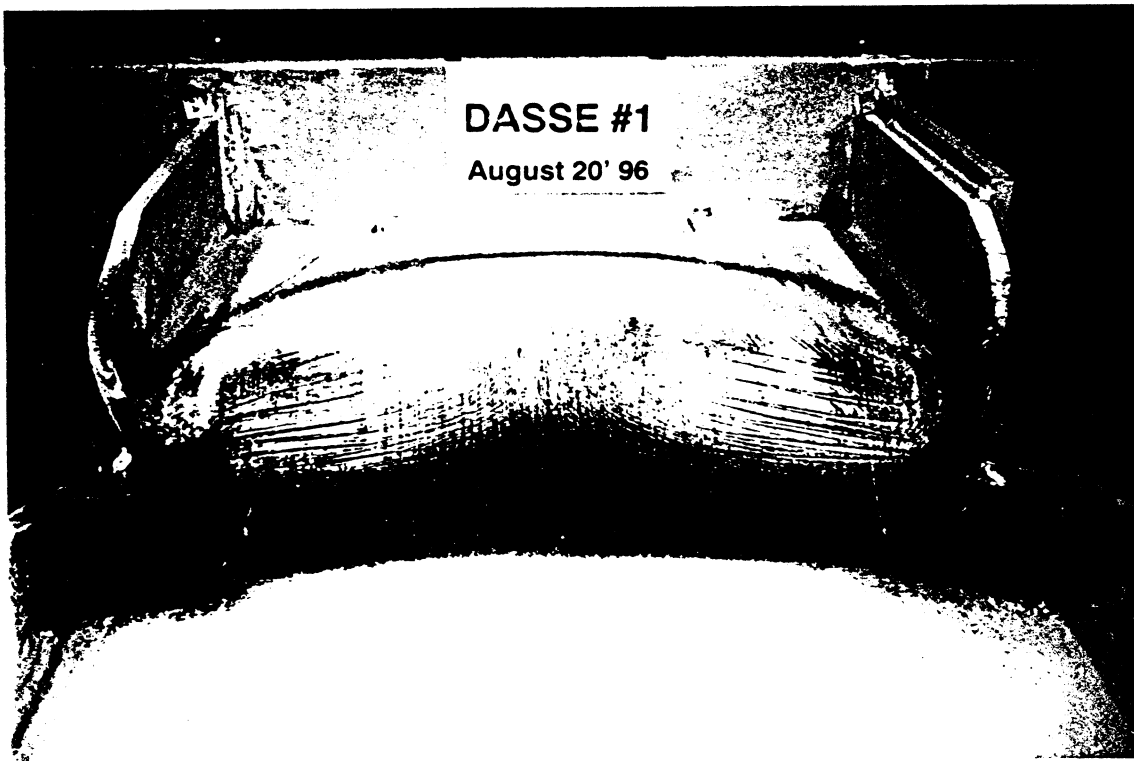
FIGURE 34: SPECIMEN1 -- BEAM AFTER THE TEST
