Post-Project Performance Assessment of a Multi-Phase Urban Stream Restoration Project on Lower Codornices Creek

LA227 - Restoration of Rivers and Streams

UC Berkeley - Fall 2011

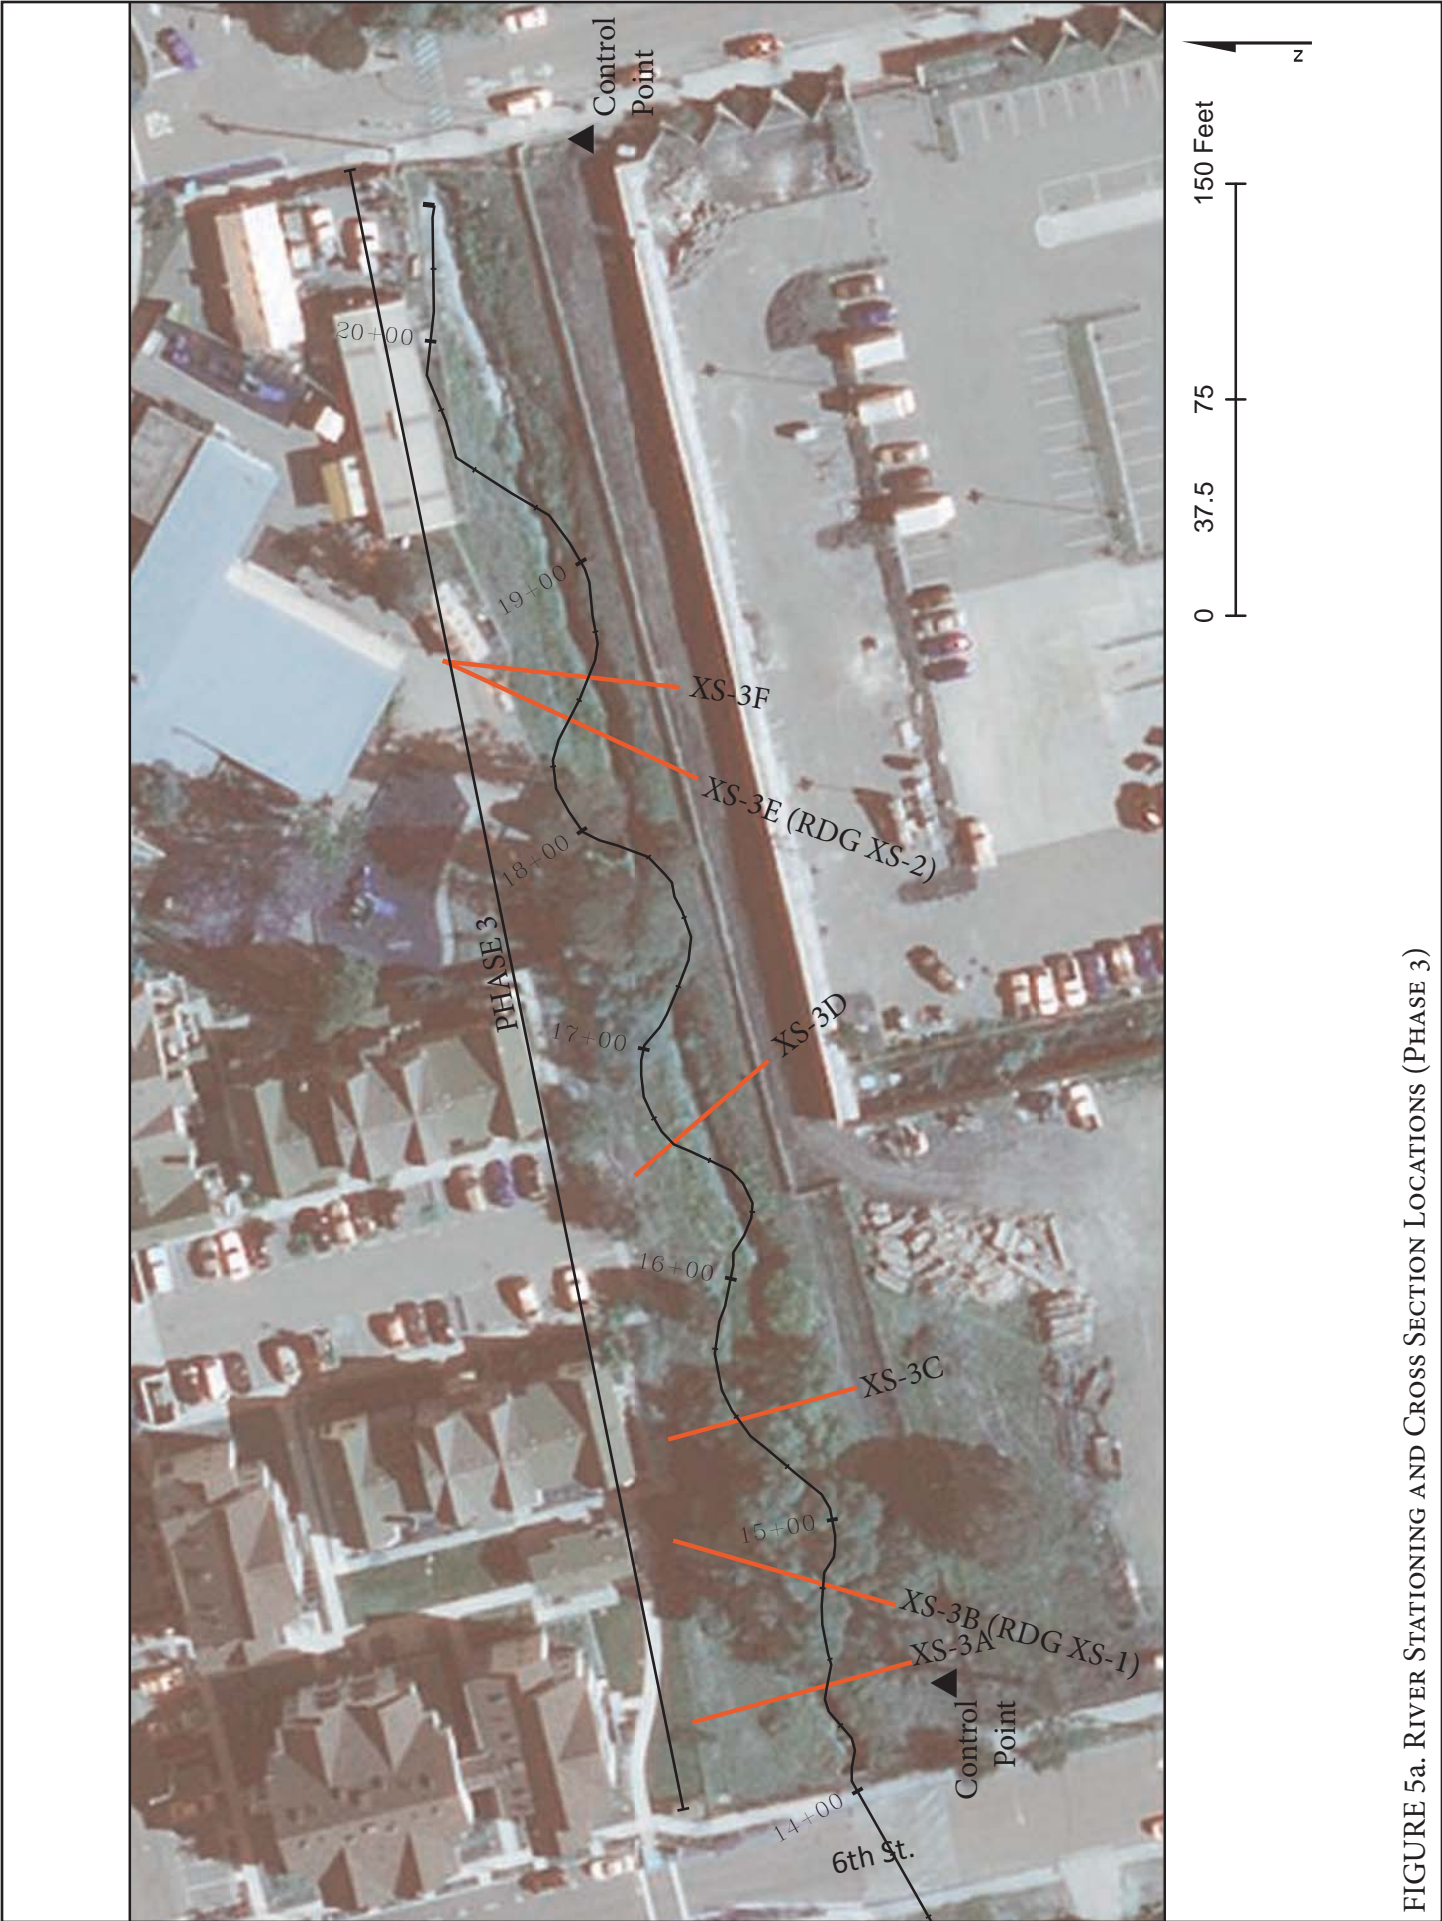
FIGURE 5a. RIVER STATIONING AND CROSS SECTION LOCATIONS (PHASE 3)

We collected topographic data in Phase 3 utilizing a RTK GPS survey of the longitudinal profile and six cross-sections (Figure 5a). Four of these cross sections (3A, 3C, 3D, and 3F) were also completed by our research team in conjunction with the LA 227 class field trip to the site on October 8th. We established rebar monuments at the cross-section endpoints during the October 8th field trip, capping each with plastic survey markers. On October 29th, our second and final day of field work, we resurveyed the cross-sections using an auto-level, rod, and tape, in order to compare the results to the RTK GPS results. We surveyed six additional cross sections on October 29th in Phases 1 and 2 using an auto-level, rod and tape (Figure 5b). We were unable to locate all the monuments associated with the Phase 1 and 2 Monitoring Report (FRE, 2010), so we estimated the locations based on the figures from the report. Upon receiving locations of two Phase 3 cross-sections surveyed by RDG on September 14, 2011, we returned to the site on November 19th to resurvey these locations (XS 3B, 3E). It should be noted that additional flows (all less than 136 cfs) occurred between the October 5th discharge and this survey date. Therefore, these two cross-sections do not isolate effects of the October 5th discharge, but are the only reference cross-sections we were able to reoccupy.
