Post-Project Appraisal of Baxter Creek at Booker T. Anderson Park  
Shopping Carts: The New Boulders

December 2005

By:  
Colleen Bronner  
Maggie McKeon  
Janel Weston

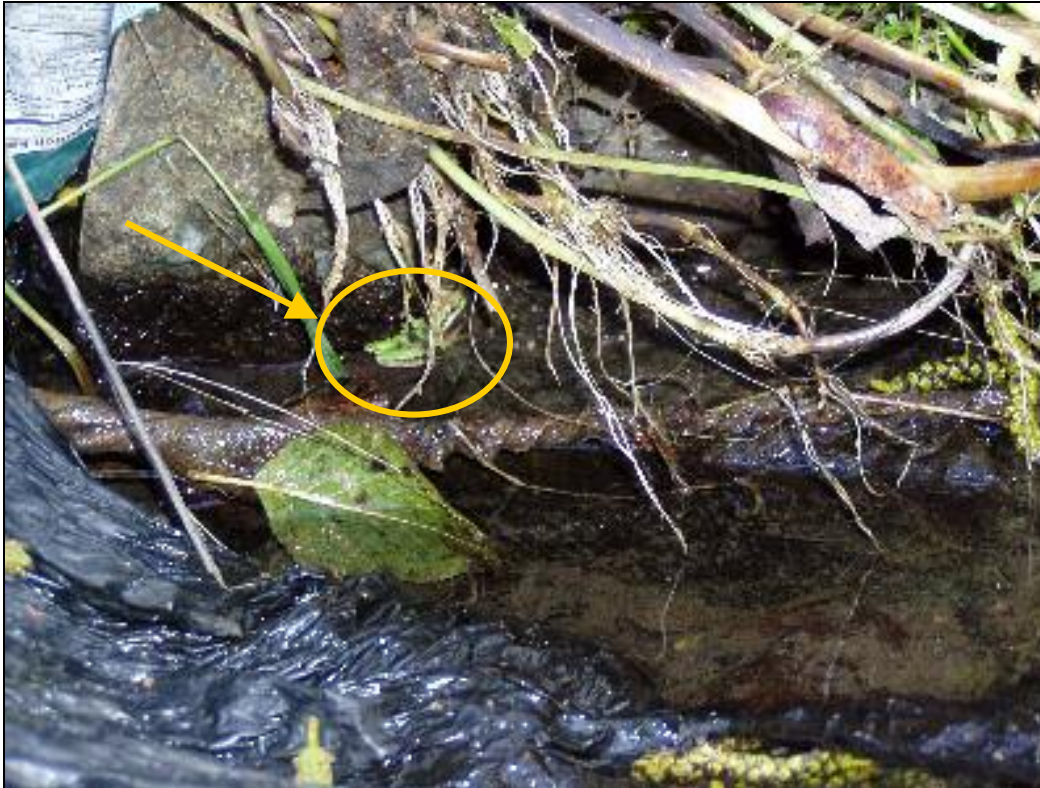
The only insects we saw at all three sites were ants and small, green hopping insects. We did not see any other water insects throughout this reach of Baxter Creek. We saw one frog (Figure 21) while surveying a cross-section of the creek and neighborhood children reported catching frogs in the creek. The large amount of trash and the oily residue on parts of the water surface could be contributing to the small amount of insects and other wildlife living in the water.

*Figure 21: Frog in Booker T. Anderson Jr. Park Reach*
