Evolution of a Compound Channel: Tassajara Creek, Dublin, California

Term Project  
LAEP 227: Restoration of Rivers and Streams

Final Draft  
December 17, 2007

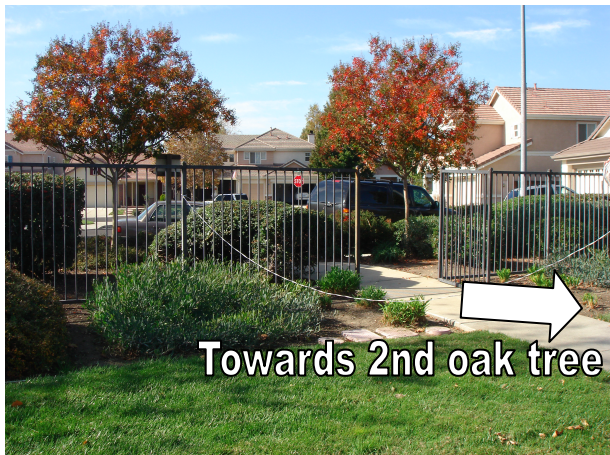
**Figure 7.RB: Right bank tie off point**

On the right bank, we tied off the survey rope to the second fencepost downstream from the gate to Owl Court (Figure 7.RB). On the left bank, we tied off the survey rope to the second large oak tree (Figure 7.LB).

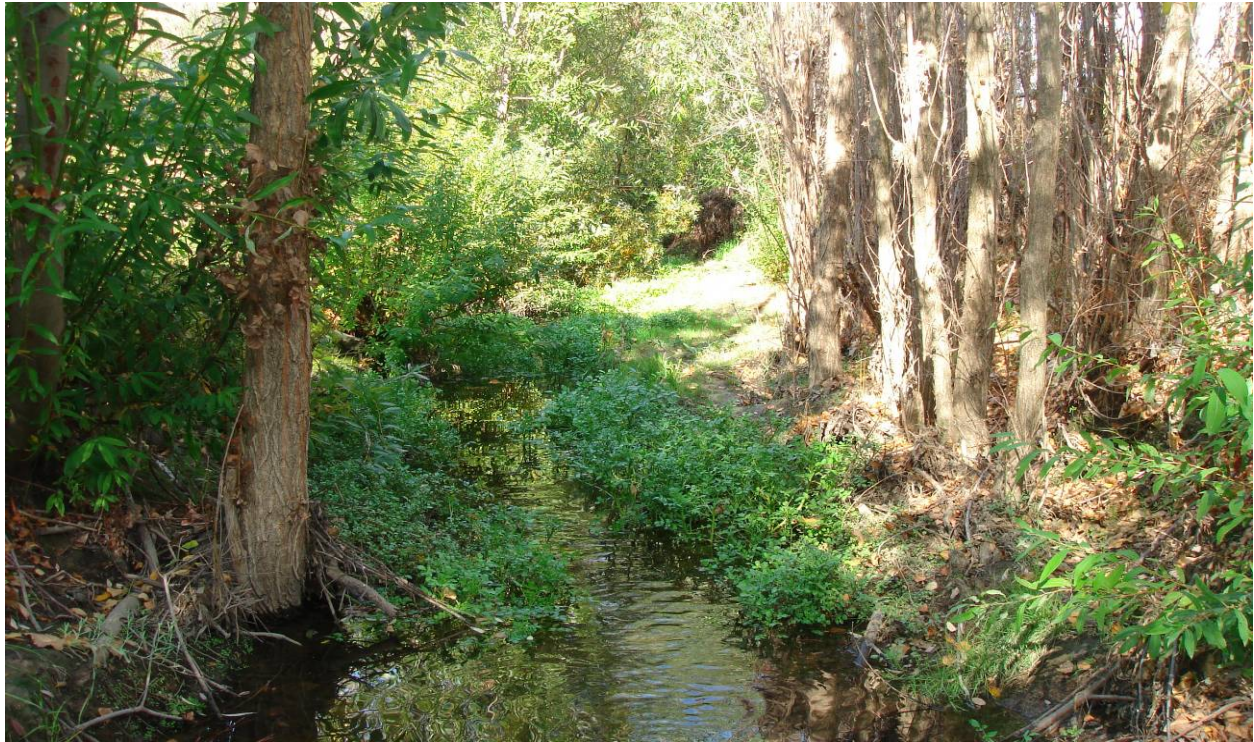
**Figure 8.1: EE' Looking upstream from thalweg (2007)**

sections upstream and downstream by Oden and DeHollan in 2004 were compared to photos we took at each cross-section. At cross-section E-E', the vegetation appears to have thinned since 2004 (Figure 8). The vegetation at E-E' still is growing well and will naturally vary from year to year, so we do not consider the reduced vegetation indicating a problem with habitat. At cross-section F-F', the amount of vegetation appears to be the same (Figure 10). The vegetation at cross-section G-G' has significantly increased since 2004 (Figure 12). At G-G', the vegetation was growing thickly enough to impede our resurvey. We observe from a photograph time series taken around Gleason Ave (Figure 14) that the vegetation has significantly increased over time. We conclude that the project has successfully increased riparian vegetation and habitat by comparing pre restoration riparian vegetation (Figure 14.1) with current vegetation (Figure 14.4). We interpret our photograph comparison to prove that the riparian vegetation is flourishing. We observed wildlife in the vegetation in numerous locations and macroinvertebrates, including spiders and shellfish, were found extensively along the reach resurveyed. We found make-shift chairs next to the project reach and people were observed regularly using the path adjacent to the creek.

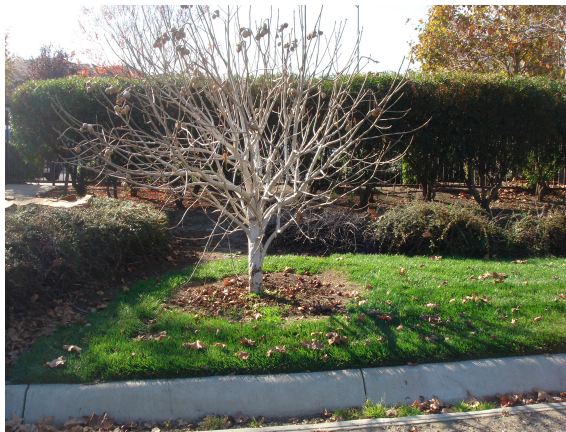
**Figure 9.RB: Right bank tie off point**

On the right bank, we tied off the survey tape to the buckeye tree upstream from the gate to Peakcock Court (Figure 9.RB). On the left bank, we tied off the survey rope to a small tree (Figure 9.LB).

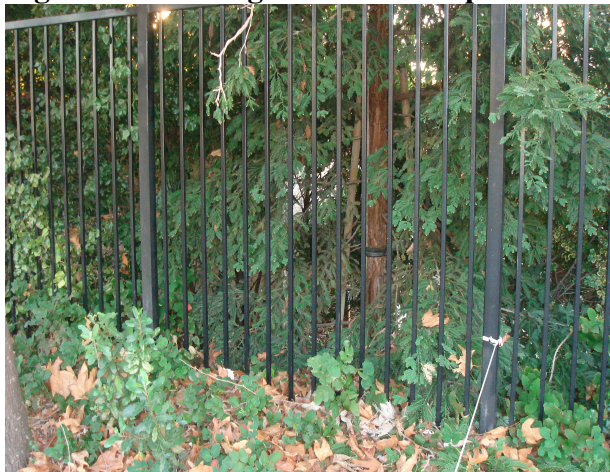
**Figure 11.RB: Right bank tie off point**

On the right bank, we tied off the survey tape to a fencepost upstream from the shed in the Extended Stay America (Figure 11.RB). On the left bank, we tied off the survey tape to a pink flagged fencepost (Figure 11.LB).
