Development of Characterization Technology for Fault Zone Hydrology

ICEM2010-40121

DEVELOPMENT OF CHARACTERIZATION TECHNOLOGY FOR FAULT ZONE HYDROLOGY

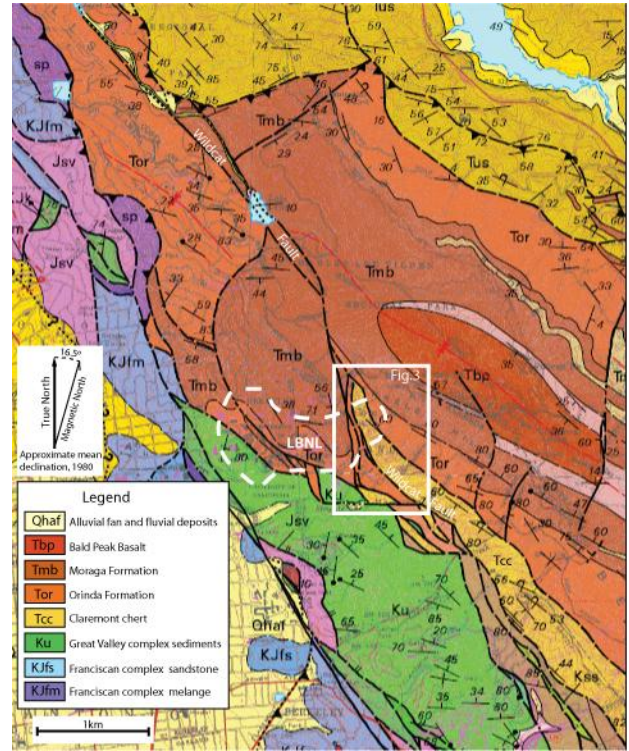
Figure 2 Geologic map of the area around the LBNL site, modified after Graymer[6]. The location of LBNL and the area shown in Figure 3 are indicated by broken and solid white lines, respectively.

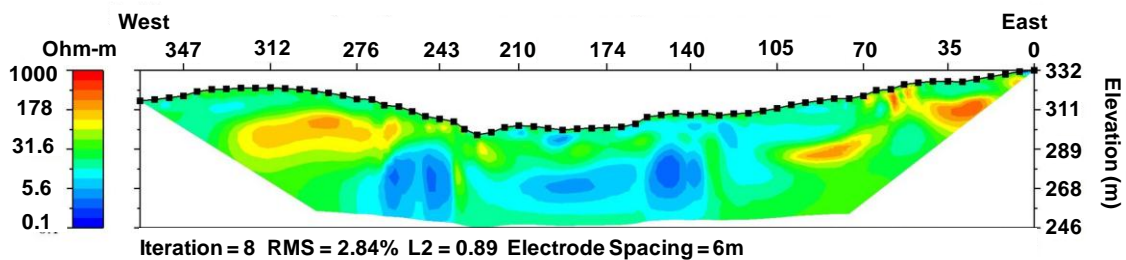
Figure 5 Inversion result of the resistivity survey along ER4 shown in Figure 3 Discontinuities are suspected at near 140m and 240m from the East.

Although it was possible to infer the existence of multiple discontinuities from the results of seismic reflection analysis and resistivity profiling, the geophysical results were largely inconclusive in locating the fault. This is because the geology of the Berkeley Hills is very complex, as discussed above. The Claremont chert formation is extensively folded, fractured and faulted, with no clear reflective horizons. (Because of the steep terrain, there are many landslides.) However, the most recent electrical resistivity survey, using the dipole-dipole technique along the ER4 line shown in Figure 3, revealed two discontinuities rather clearly. Figure 5 shows the inverted resistivity map. As can be seen from the figure, discontinuities can be seen at ~140 m and 240 m from the east end of the profile. It is assumed that the discontinuity at 140 m is the Wildcat Fault. The other discontinuity could be the East Canyon Fault, whose existence has been disputed in the past.

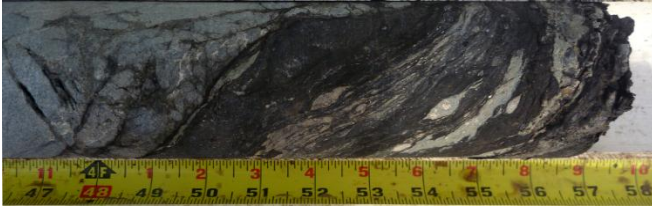
Figure 6 The core of foliated cataclasite at 92m depth in WF-2 consisting of highly sheared, anastomosed, stretched fragments of light yellow soft to hard siltstone and light gray sandstone embedded in a matrix of sheared black shale.

Several shear zones and fault gouges were observed in all three boreholes, in addition to several hundred fractures. Figure 6 shows one of the shear zones observed in the core at 92 m from WF-2: a foliated cataclasite consisting of highly sheared, anastomosed, stretched fragments of siltstone and sandstone embedded in a matrix of sheared black shale. Whether any one of the zones is the main Wildcat fault or, if not, how they are related to the Wildcat Fault, is not clear. There still is a distinct possibility that the main fault lies between WF-1 and WF-2. At this writing, a fourth borehole, WF-4, is being considered. One plan is to drill in an inclined fashion from the west to the east, parallel to the line that connects WF-2 and WF-1 with some offset either to the north or south, which would encounter the main fault plane at an angle, if it indeed exists.

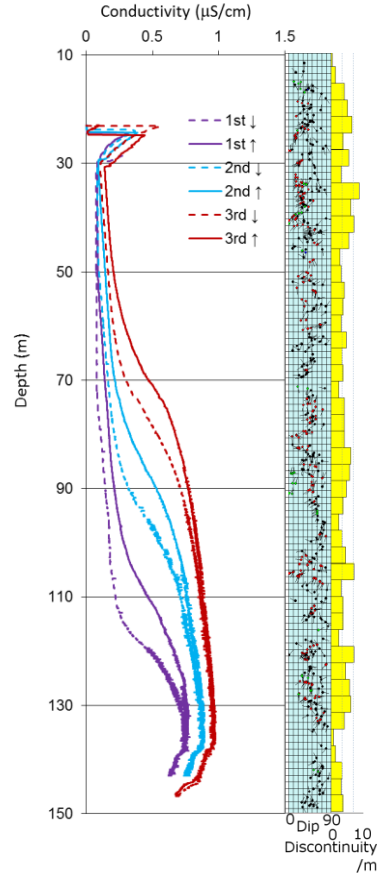
Figure 7 FFEC log results plotted against the tadpole plot of discontinuity and discontinuity counts based on televiewer analysis in WF-2.

Borehole geophysical logs were conducted in all three boreholes including caliper, gamma, resistivity, acoustic televiewer, and sonic log. In addition, flowing fluid conductivity logs (FFEC) were conducted in each hole. FFEC logs can pinpoint inflow zones caused by the electric conductivity contrast artificially created between the formation fluid and that of the borehole under a pumping condition [7]. Figure 6 shows the FFEC results from WF-2 plotted against the tadpole and frequency plot of discontinuities, which include fractures and beddings. As can be seen from the figure, only one inflow point at 136 m was detected by the FFEC log, whereas 309 fractures and 152 beddings were counted by the televiewer log. This result shows that the fracture density is not a good indicator for flow. In fact, the inflow point is at a depth where fracture density is at its lowest. Similar results were obtained in the other two boreholes.

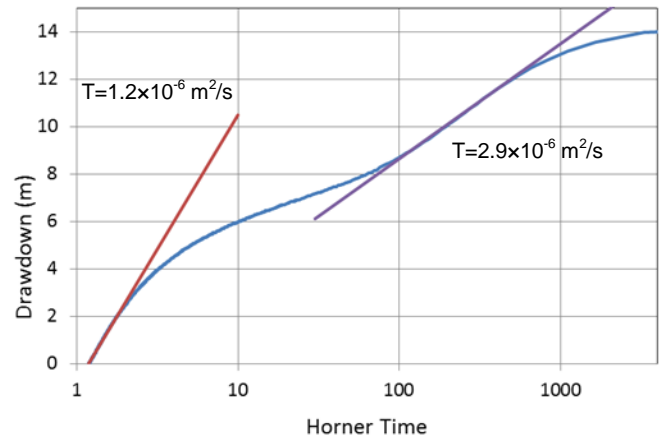
Figure 8 Horner plot of the recovery data of a pumping test in WF-2 with a packer at 76m. Note the double humps in the recovery data that may be indicative of a fault.

Figure 8 shows the Horner plot for the recovery data after WF-2 was pumped for ~10 hours below the packer at 7 m depth, i.e., water was pumped from the interval between 76 m and 150 m. As can be seen from the figure, there are two inflection points, which can be interpreted in multiple ways. The most likely interpretation is that the transmissivity of the rock near the borehole, roughly 3×10^{-6} m²/s, precedes a higher transmissivity zone beyond it, possibly the fault damage zone, and finally seeing the effect of a no-flow boundary caused by the core of the fault. This interpretation is based on the final asymptotic straight line having a slope roughly twice that of the first line, as shown in Figure 8.

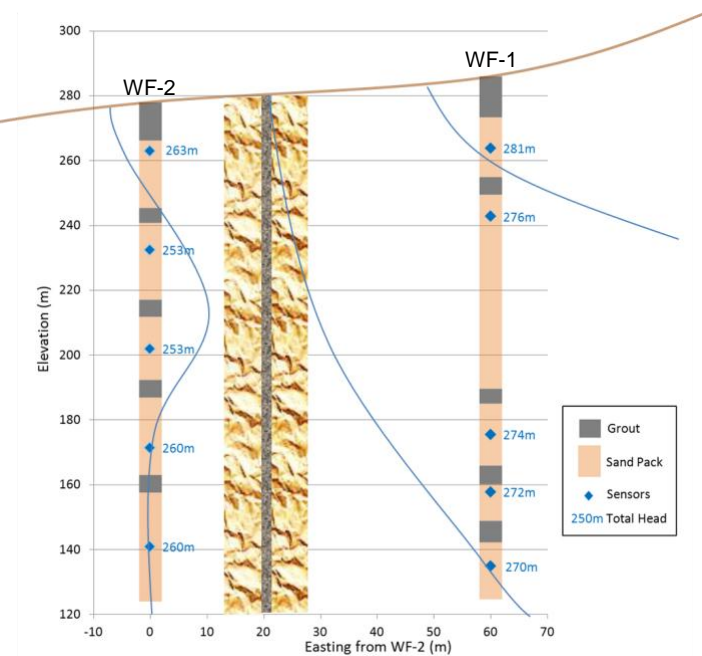
Figure 9 Plot showing the location of the sensors and completion intervals. Also shown are the hydraulic head contours. In the middle is the suspected Wildcat Fault.

Figure 9 shows the monitoring intervals and the location of sensors in WF-1 and WF-2. Also shown are the total head values and the contours. The heads in WF-1 decrease with depth, indicating a downward flow, whereas in WF-2, the head is the lowest in the mid depth of the hole. These non-monotonic heads indicate the complex nature of the hydrology near the fault. WF-3 is not yet completed at this writing.
