Development of Fan Diagnostic Methods and Protocols for Short Term Monitoring

TECHNICAL REPORT

October 2003
500-03-097-A14

Prepared By:
Buildings Technologies Department
Lawrence Berkeley National Laboratory

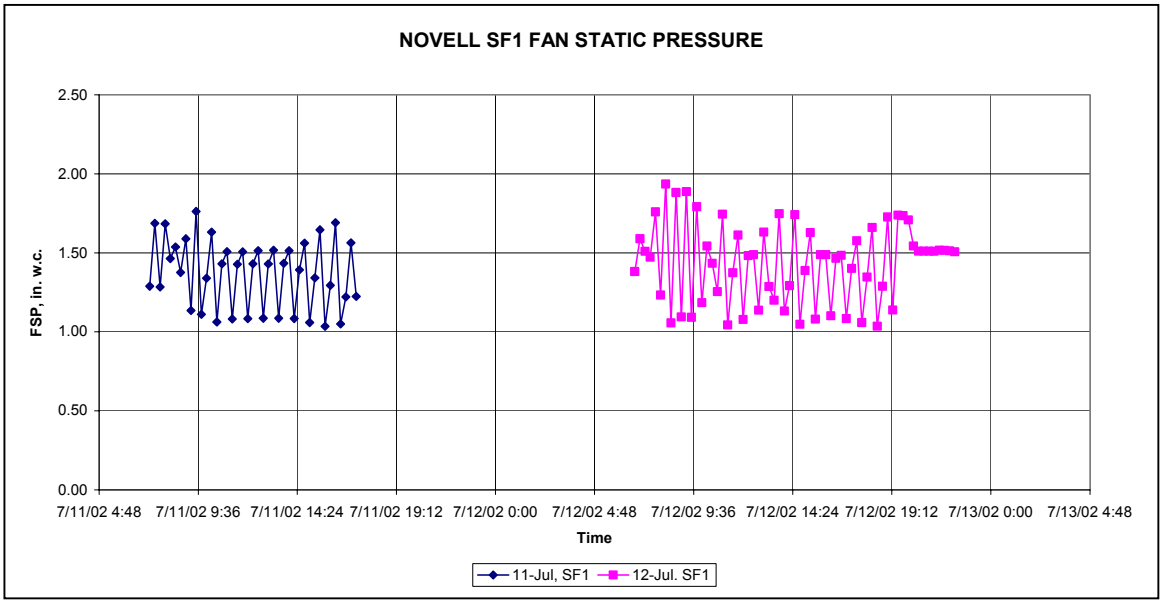
Figure I-1: SF1 static pressure oscillations

Although one fan always operates at night, inspection of the data revealed what appears to be a daily occupancy schedule of 5:30 AM to 8:30 PM. At these times the lag fan is enabled or disabled, respectively. Analysis of the data (secondary chilled water flows) suggests that the chiller is locked out at 60-63°F outside air temperature (OAT). Calibration of the fan drives made with a handheld tachometer revealed an error in the speed data reported in the base data set; this error was corrected for our analysis. Likewise, handheld comparisons for mixed air temperature (MAT) and OAT revealed an offset in OAT of about +5°F (i.e., sensor reading low).

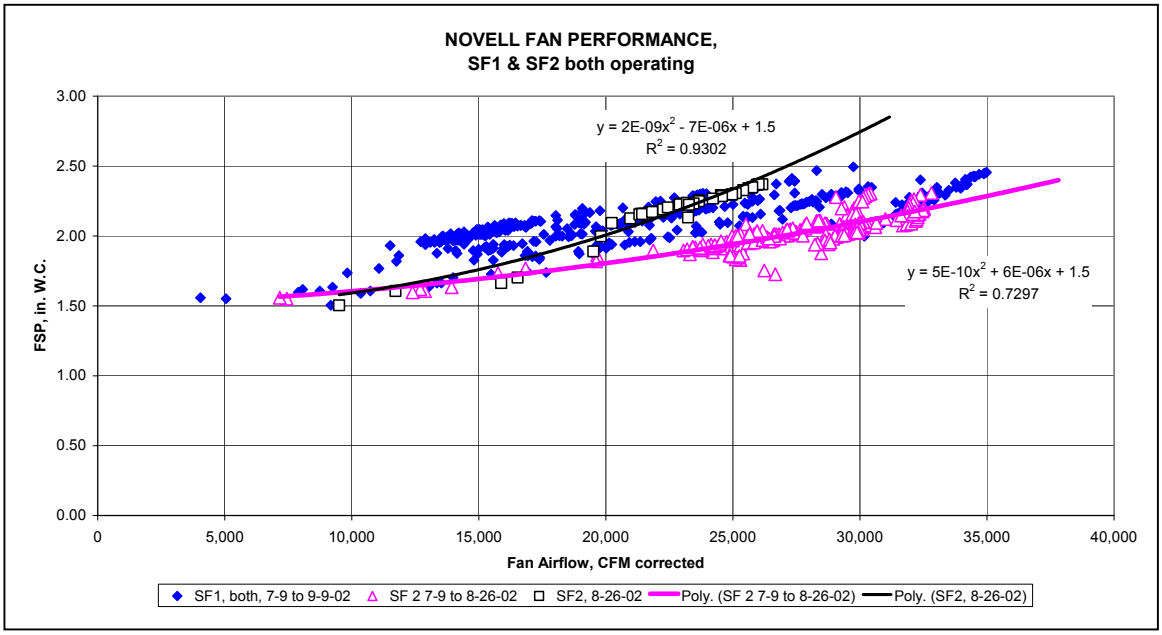
Figure I-2: Novell Maximum operating point analysis

Using a modification of the original protocol, we determined the maximum operating point by first plotting FSP versus airflow for high load conditions. Regressions on this data produces a *system* operating curve (i.e., the states that the fan assumes to meet system demands) which can be used to extrapolated to higher load conditions. Similar charts are made for speed and power vs. airflow. Once these curves are obtained they can be used to extrapolate to the maximum operating point for the monitoring period. As noted in the body of this report, these regressions can also be used to extrapolate to the design speed to find the equivalent operating point to compare to the design intent. (See Apply Tools section for further discussion.) For these charts the airflow was corrected by -17% per the tracer gas calibration results (see Appendix IV). The data set used for this analysis was derived from the complete set for July through September 2002. The data was filtered to select only those records where both fans were operating on warm days (since these are representative of peak operating conditions) and to remove obvious transient and oscillating conditions (e.g., when a fan was cycled off or on). As shown by the fan operating curves in Figure I-2, SF2 operates at a somewhat greater volume than SF1. Sometimes this behavior is switched, the fans rarely seem to operate at the same volume despite running at the same speed. This behavior may be a result of operation in an unstable region of the fan curves due to oversizing and/or greater than expected system resistance. Plug fans have a fan (flow vs. FSP curve) characteristic similar to forward curve fans where the FSP curve flattens in the "do not select" region.

Note also that the performance over the measured range is not consistent for all periods of operation. Figure I-2 shows two distinct system curves for two different periods for SF2. It is unclear as to why, when two fans are operating in parallel that the system resistance seems to vary for an individual fan. For the lower system curve (triangle data points) for SF2 the maximum operating condition for the monitoring period was 33,000 cfm at 2.3 in. w.c. FSP. Extrapolation to the equivalent design point could not be done for this system due to limited speed data in the BMS dataset (partly due to the fact that the fans operate over a narrow speed range because a staging strategy is used to control static pressure).

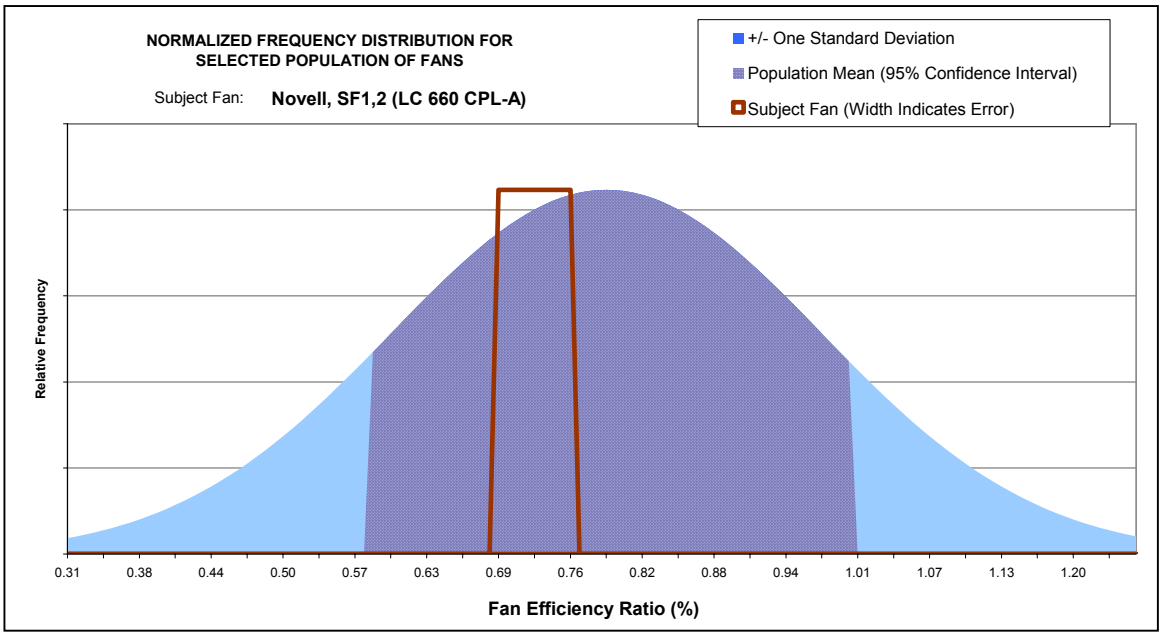
Figure I-3: Novell Benchmarking example, fan efficiency ratio (FA_BM_tool)

Table I-1 shows the results of the comparison of the maximum operating point to the original design point of 79,860 cfm and 4.0 in. w.c. This table indicates that as measured, the fan operates at an efficiency of 42%. Using the catalogue data for these fans it was found that when both fans are running they operate mostly in the "do not select" region of the fan curves. However, the catalogue efficiency does not decrease significantly due to this design operating point difference. Assuming there are no gross errors in measurements, this suggests that there may be other problems with the fans that are causing a drop in efficiency, such as system effect. (See Discussion section in body of report.)

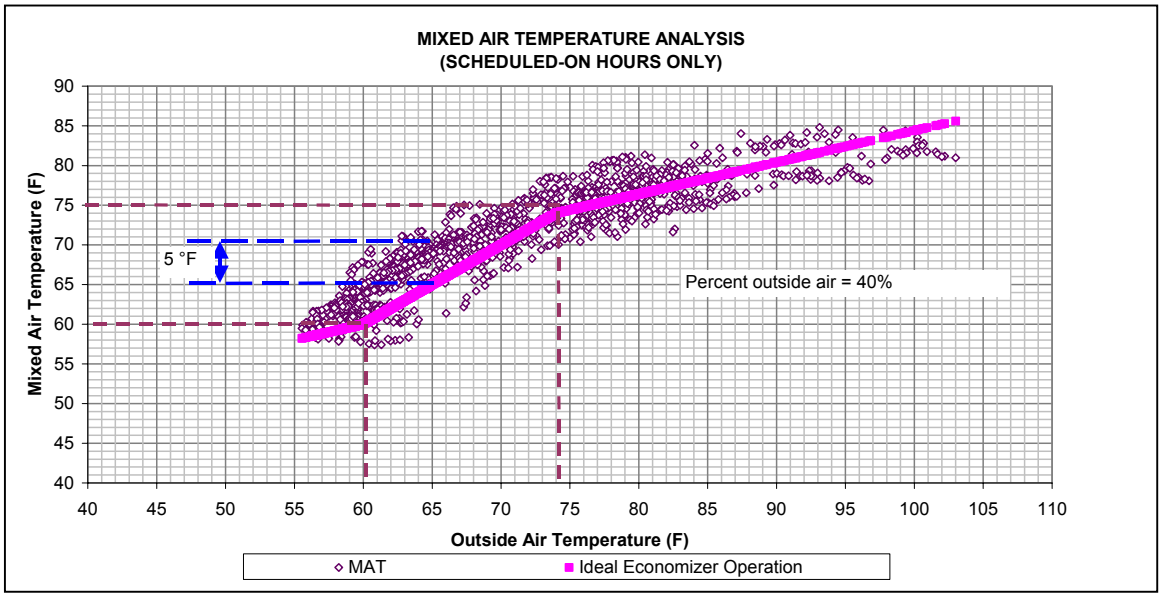
Figure I-4: Novell economizer performance (STA_tool)

Selected results from the SA_Tool are shown in Figures I-4 and I-5. Figure I-4 shows economizer performance. Note that when the economizer is open the mixed air temperature (MAT) is about 5°F greater than OAT as shown in Figure I-4. This is consistent with a single point calibration made at the site. It appears that the OAT sensor is out of calibration. This also explains why there is no apparent difference in the trend below 60°F since the economizer will end up being fully open because the actual OAT is greater than that read by the control system while it tries to modulate to control to 60°F SAT. Also, note that the 40% outside air fraction shown will also be in error; when the chart is corrected for the 5°F offset (not shown) in OAT, a value of 30% is obtained. This indicates the importance of accurately calibrated sensors and highlights how installed short-term data loggers may yield more reliable results.

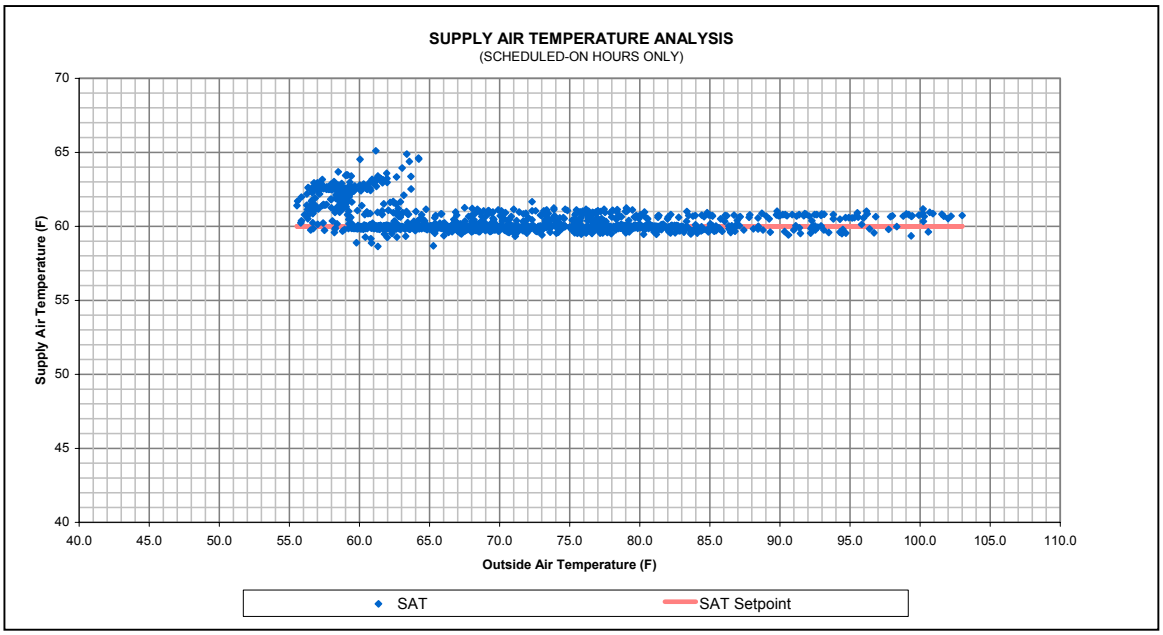
Figure I-5: Novell SAT temperature performance (STA_tool)

Figure I-5 shows the SAT versus OAT, which confirms a constant setting of 60°F without reset. The large scatter below about 63°F results from the economizer operation when the chiller is locked out as explained previously.

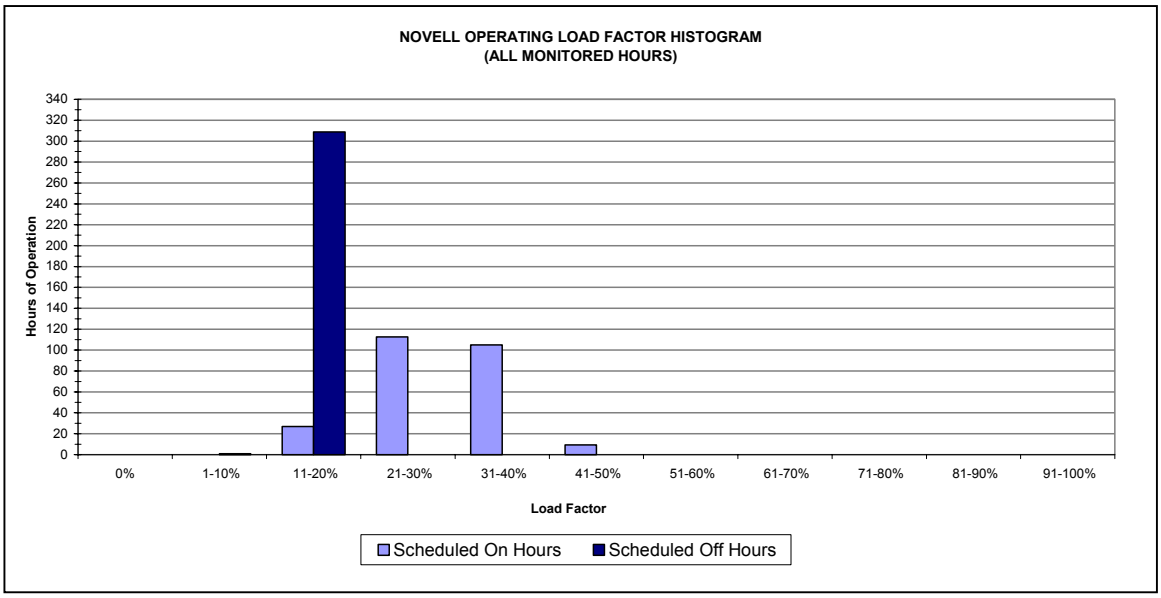
Figure I-6: Novell load factor histogram for both SF1 + SF2 (FPA_tool)

Figure I-6 clearly shows the large number of hours where fans are operating at low load factors (but not necessarily low efficiencies; see above). This is true even for the occupied part of weekdays. However, this is primarily due the fact that only one fan is operated for much of the time as shown by comparing Figure I-6 with Figure I-7. This causes the chart to indicate a substantial number of hours at low load factors due to operating at low loads at night. However, the distribution is broader and more even than for two fans yielding a better representation of the performance. Table I-2 shows that off-hours operation accounts for about 33% of the estimated total annual fan consumption. Figure I-8 shows the load factor versus OAT which shows only a slight sensitivity to OAT, indicating an internally load dominated building. Figure I-9 shows the daily profile for load factor and again indicates the low load factor for occupied hours and the pervasive off-hours power use at low load factor, which would be expected when night time loads are serviced.

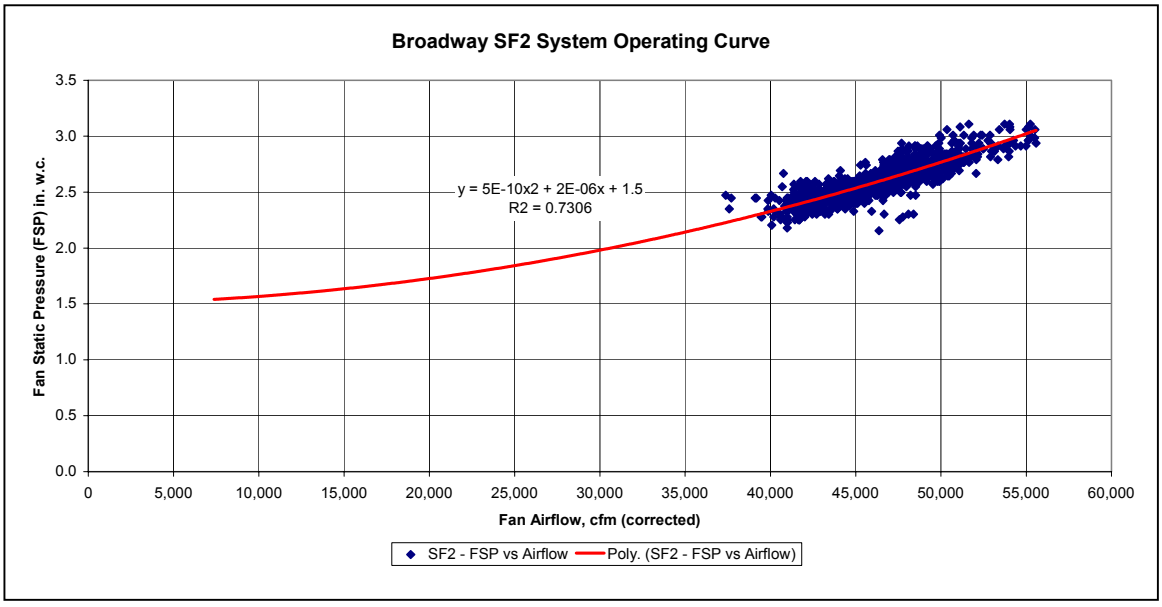
Figure II-1: Broadway system operating curve for SF2

We tried two methods to determine the max operating point: (1) we increased the SAT to simulate the design maximum operating condition, and (2) we used the corrected logged airflow and FSP to develop the system operating curve as described in Objective #3 of the Outcomes section of the body of this report. Method 1 proved to be too cumbersome and was abandoned in favor of the system curve method described in the body of the this report. Figures II-1 and II-2 show results from this analysis. From these regressions the maximum operating point for the monitoring period was determined to be 55,000 cfm; other associated data are shown in Table II-1.

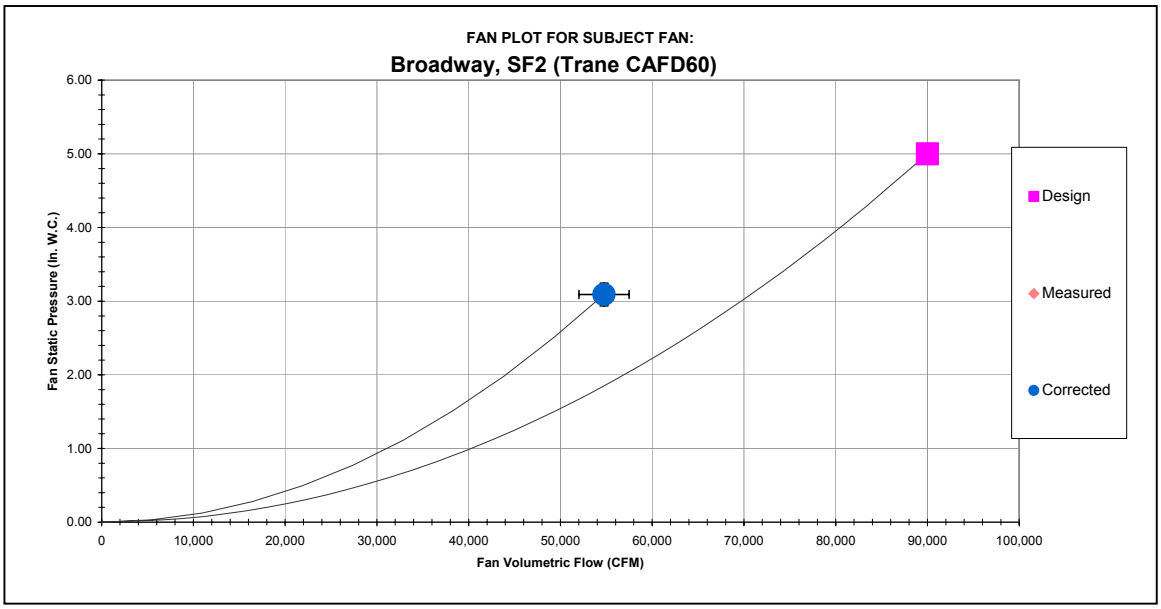
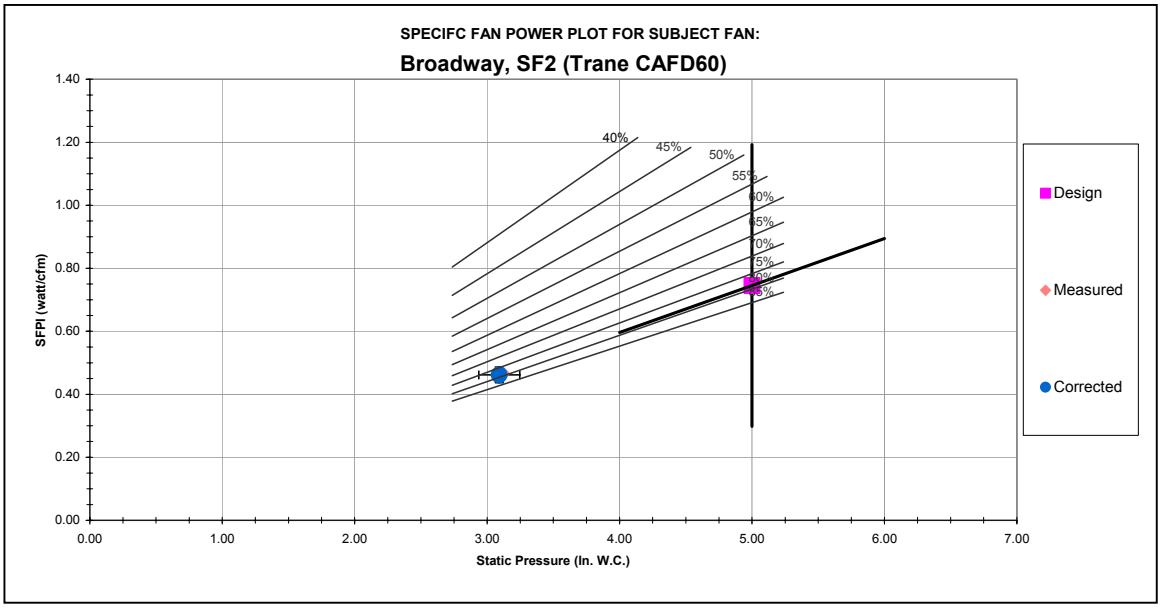
Figures II-3 and II-4 indicate that the system resistance is somewhat greater than design but the output (airflow and FSP) is significantly less than design (when compared at design speed). However, these results are contradictory because we would expect this reduced output to be accompanied by a reduction in fan efficiency; fan efficiency is still 79% based on our measurements. Although system effect factors may be less of an impact than in the other systems studied, the outlet configuration was still not ideal so we would expect some impact on output and fan efficiency. Extensive review of the data and calibration procedures provided no explanation of this contradictory result. However, we suspect that the power readings might be faulty for some reason (e.g., wrong conversion factors for CTs etc.) but there was no opportunity to investigate this further.

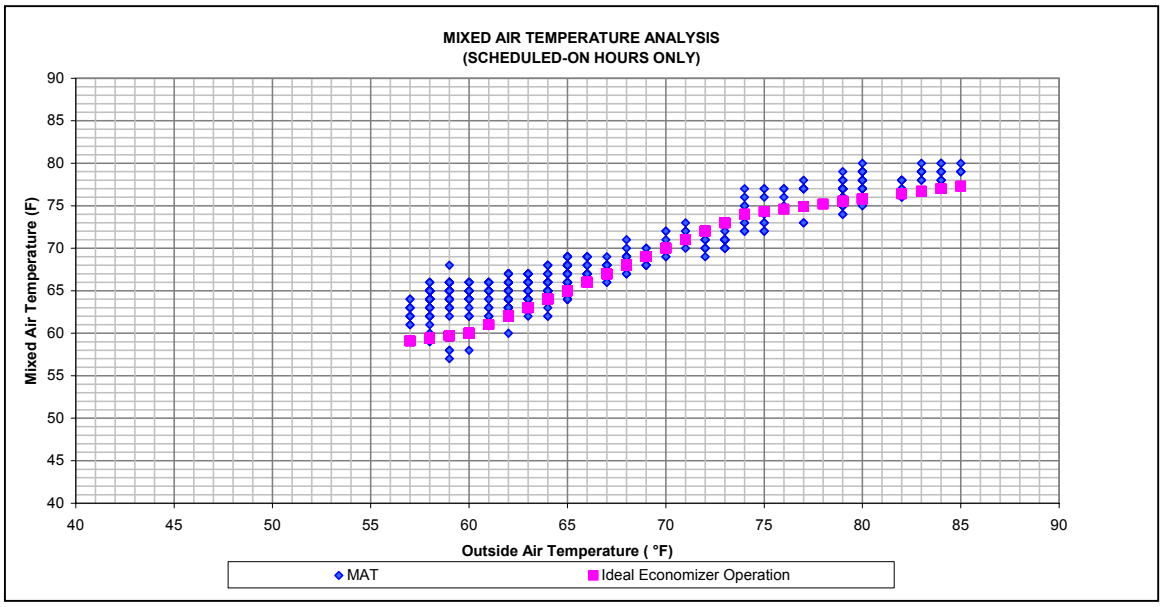
Figure II-5: Broadway economizer performance (STA_tool)

Selected results from the SA_Tool are shown in Figures II-5 and II-6. In Figure II-5, which shows economizer performance, the data points for mixed air temperature (MAT) generally track the ideal economizer operation line and this represents normal economizer operation; however, there is a tendency for high MAT when the OAT is below about 68°F. This operation indicates there might be leakage by the mixed air damper that allows warmer return air to continue to mix with the outside air thus producing mixed air temperatures that are too warm and thus potentially adding to the cooling load during partial mechanical cooling periods. It was observed that the main damper sections are misaligned during actuation and OSA dampers seemed to hunt when near the changeover point while controlling SAT to the (reset) value of 63°F. Mixed air dampers also were not moving in unison with the OSA dampers. Other researchers from Lawrence Berkeley National Laboratory reported that this is due to delay problems with the BMS control algorithms due to the heavy demands of data trending.

Figure II-5 shows that the economizer operates at an estimated 40% outside air fraction. This is a relatively high value especially for a climate like the Bay Area where during much of the operating hours the economizer is open 100% [1], which offsets the need to operate at high load conditions at high outside air fractions. Readjusting the economizer minimum position could save energy.

It is recommended to calibrate the sensors and to verify proper operation of the mixed air damper during the economizer cycle, and to reduce trending requirements.

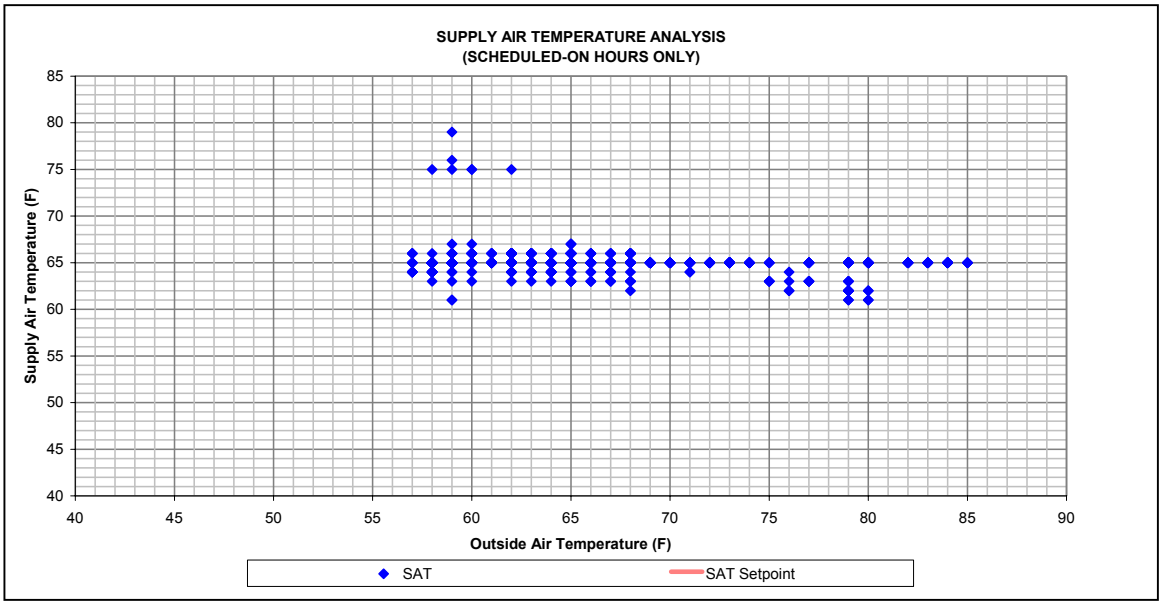
Figure II-6: Broadway SAT temperature performance (STA_tool)

Figure II-6 shows the SAT versus OAT, which indicates an average operating temperature that varies around 65°F. Recall that the data used for these charts has been truncated to two significant figures so the true variation is masked. Therefore, it is not clear if the reset is working properly or not. However, the fact that the SAT rises to about 65°F suggests that the system is using more airflow than required to meet load under some conditions. Supply air reset strategies normally result in increased overall energy use because fan energy is less efficient than chiller energy.

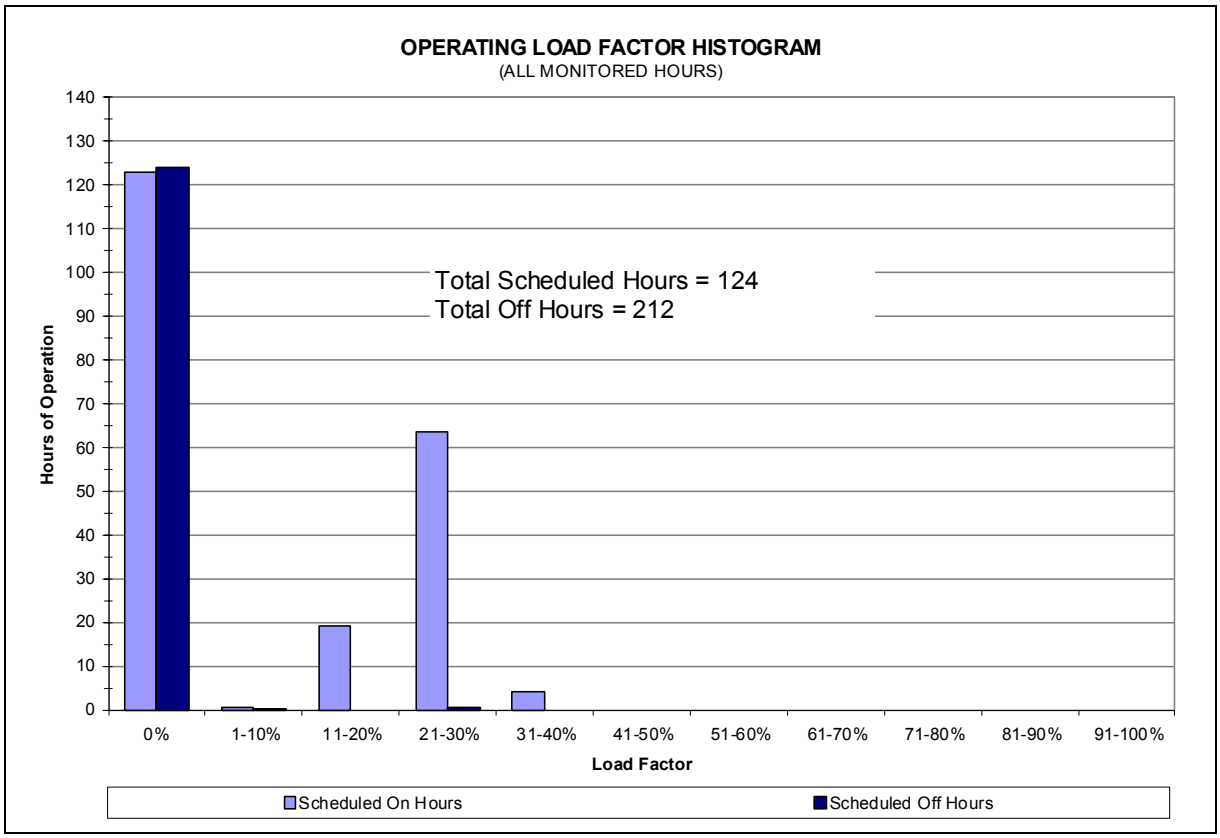
Figure II-7: Broadway load factor histogram for SF2 (FPA_tool)

Figure II-7 clearly shows the large number of hours where SF2 is operating at low load factors although turndown occurs over an expected range. These results could be skewed by a suspected error in the power readings.

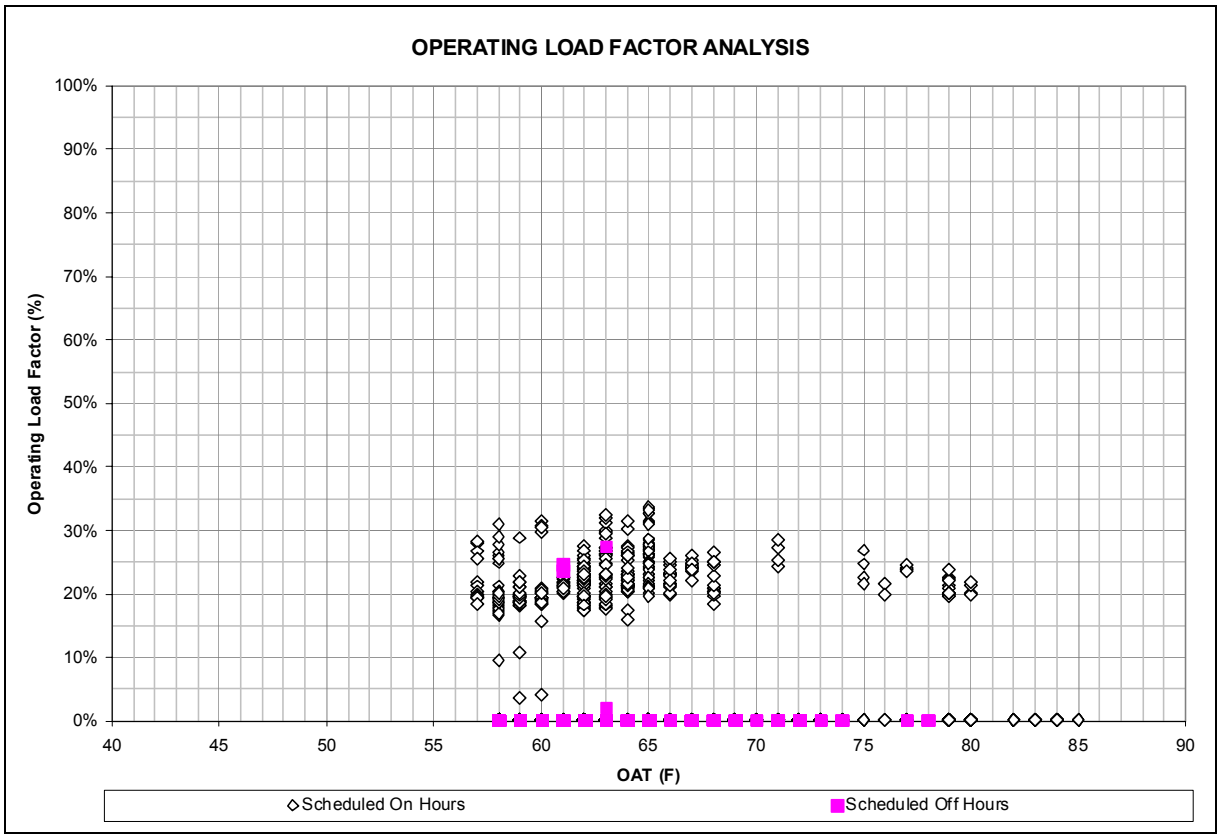
Figure II-8: Broadway SF2 load factor vs OAT (FPA_tool)

Figure II-8 shows the load factor versus OAT where there appears to be little sensitivity to OAT, indicating an internally load dominated building.

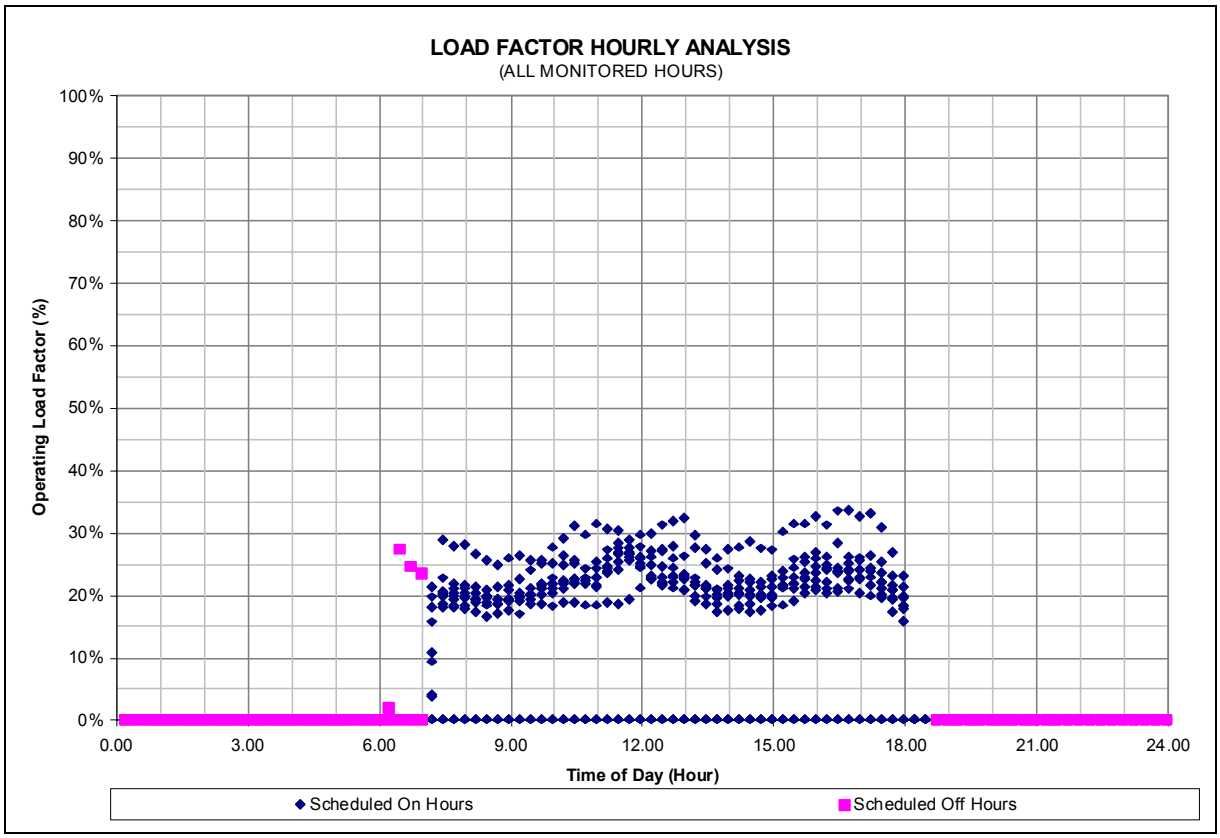
Figure II-9: Broadway daily load factor profile (FPA_tool)

Figure II-9 shows the daily profile for load factor and again indicates the low load factor for occupied hours.

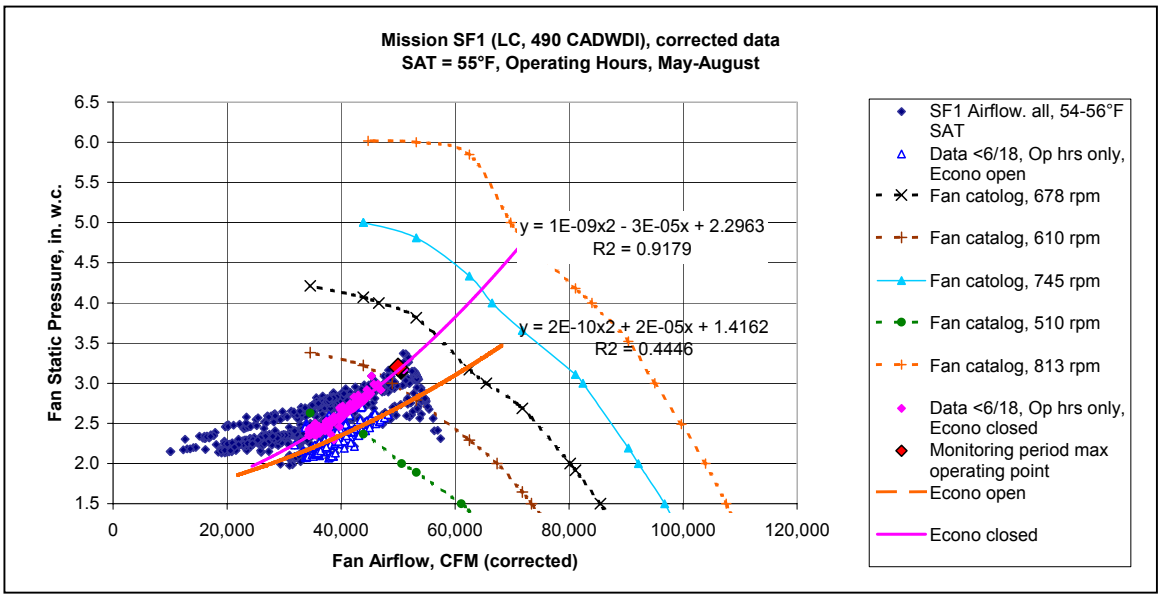
Figure III-1: Mission measured system operating trends and catalog fan curves for SF1

Using the procedure described in Objective #3 of the outcomes section of the body of this report, the maximum operating point for the monitoring period was determined to be 50,000 cfm from Figure III-1. Other parameters associated with this point are shown in Table III-2. Figures III-2 and III-3 show other charts used for determining the monitoring period maximum operating point.

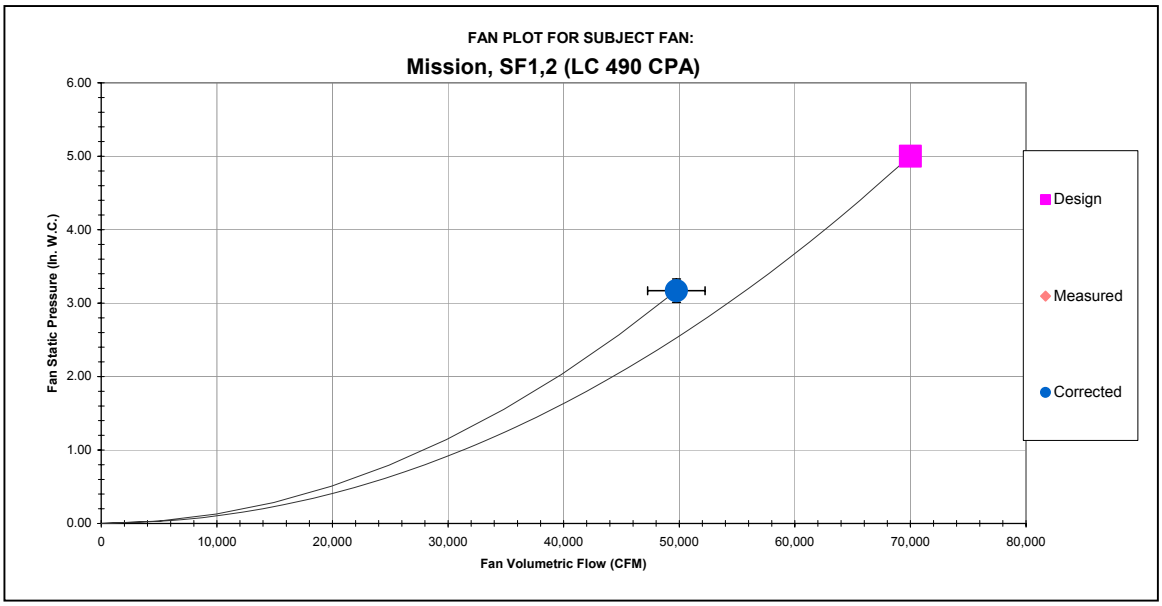
Figure III-4: Mission fan operating point comparison

Figure III-4 shows a comparison between design and maximum operating conditions and that there is little difference in system resistance between the design and actual operation, but airflow demand is about 25% less.

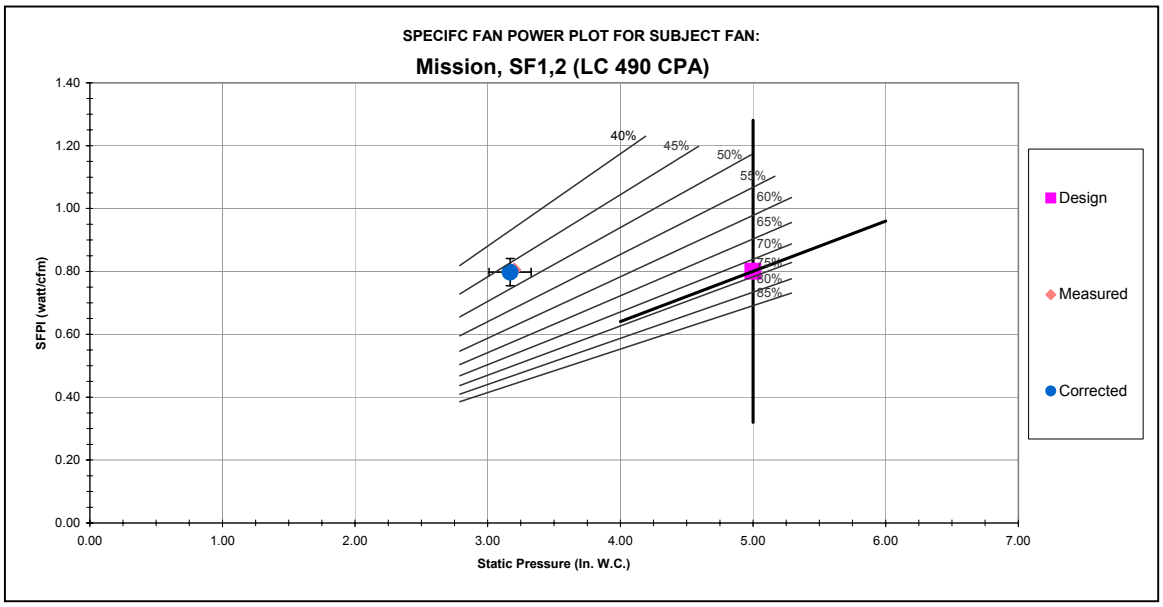
Figure III-5: Mission specific fan power comparison

The maximum operating point can be compared in another way as illustrated in Figure III-5. This figure shows the performance as a function of static pressure and the specific fan power (SFPI). As described in Webster [Webster 1999], four quadrants are defined by the heavy lines shown in the figure. When the operating point falls in the upper left quadrant as shown, energy can be saved by determining the cause of low efficiency and correcting it, if economically feasible. It is obvious from this and other analyses below that these fans are operating significantly below their design efficiency, about 64% of rated efficiency. Analysis of fan fan performance under VAV control (see Figure 1 and associated discussion in body of report) shows that, theoretically, the fan efficiency difference between these two operating conditions should be small, which suggests that there may be a problem with the fan that if corrected may yield savings in fan energy.

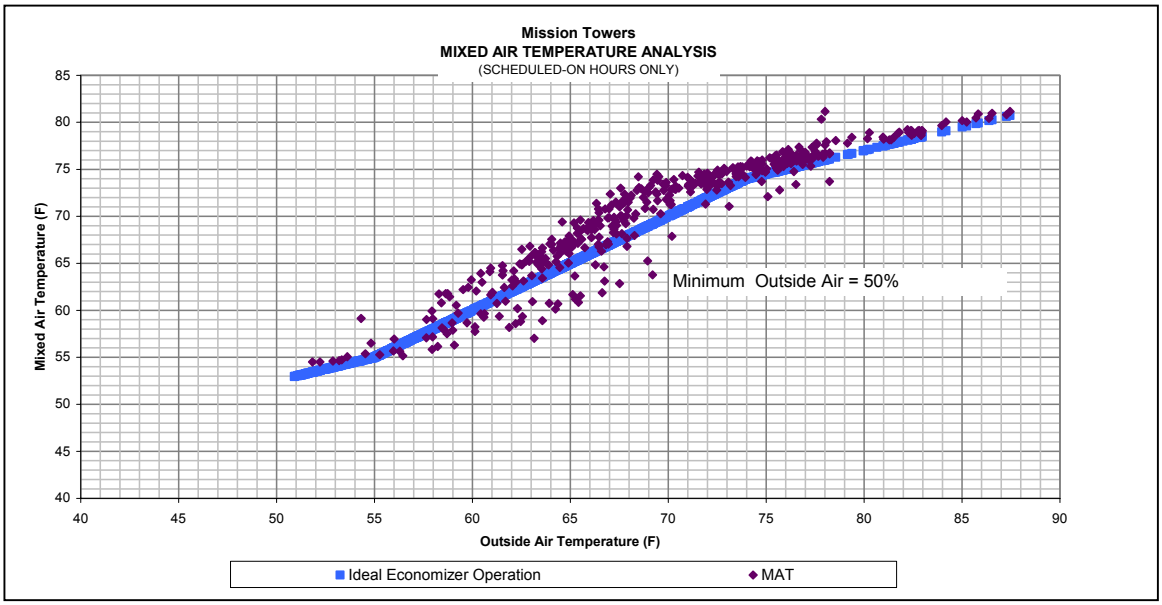
Figure III-7: Mission economizer performance with OAT corrected by –5°F.

Figure III-7 also indicates that MAT increases relative to OAT as OAT increases. This could be caused by leakage through the return air damper, which might be influenced by how the relief fans are operating at higher loads.

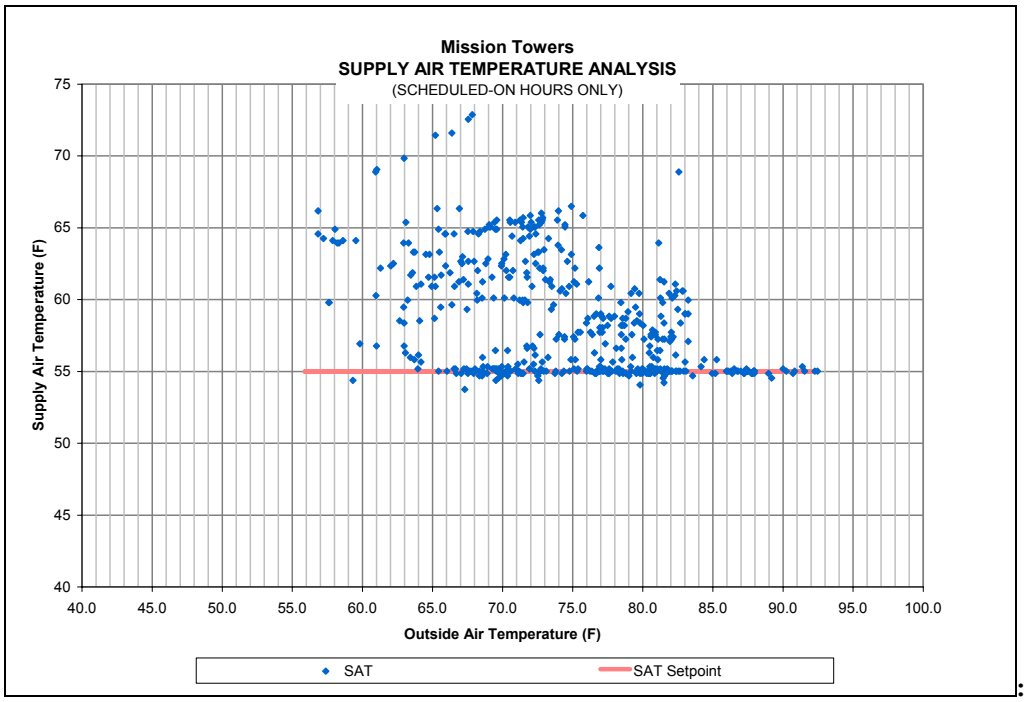
Figure III-8: Mission SAT temperature performance (STA_tool)

Figure III-8 shows a significant amount of scatter for the SAT; it is too scattered to be the result of a reset schedule. A more detail inspection of the data suggested that the SAT set point (either by reset or minimum setting) is different on weekends than weekdays, which would add scatter to the data. It is also possible that there is a problem with SAT controls and/or that the chiller is being cycled off for some reason allowing the SAT drift upward. Further analysis of this issue is seems warranted.

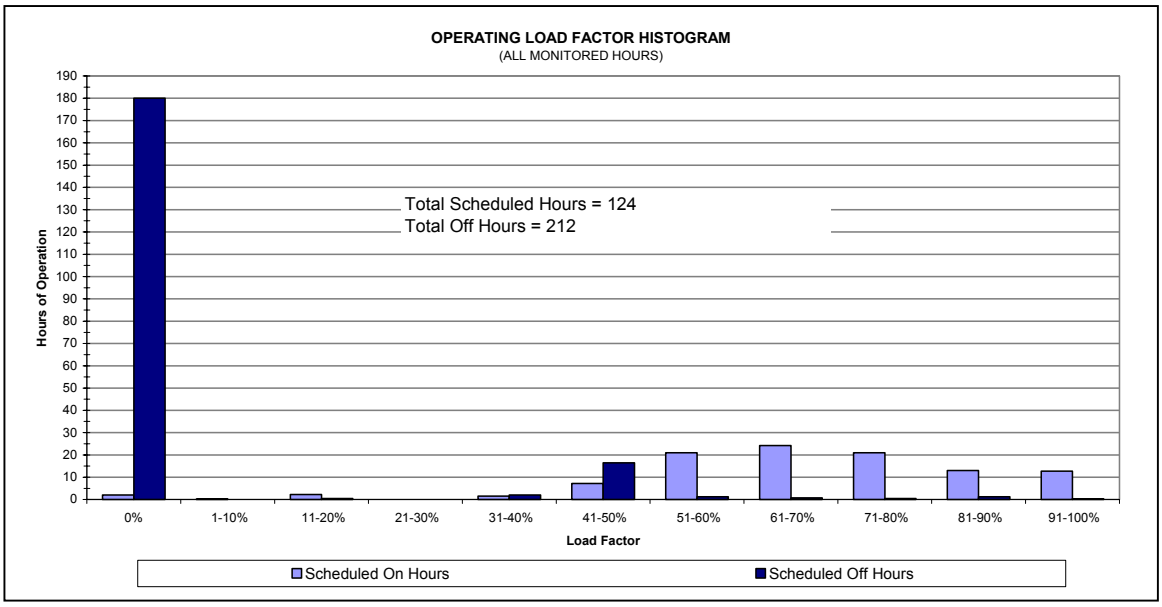
Figure III-9: Mission load factor histogram for both SF1 and SF2 (FPA_tool)

The fans for the Mission system operate together on a nominal schedule of 8:00 AM to 6:00 PM during the weekdays, 7:30 AM to 12 noon on Saturday, off on Sunday so the combined power for SF1 and SF2 was used in the power analysis tool. Figure III-9 shows a histogram of fan power usage. This chart indicates a uniform profile at relatively high load factors, which is typical for VAV systems in summer. This corroborates that the system turns down in response to load in a normal manner. Note, however, that the system operated some time during non-scheduled hours, most likely due to occupant override.

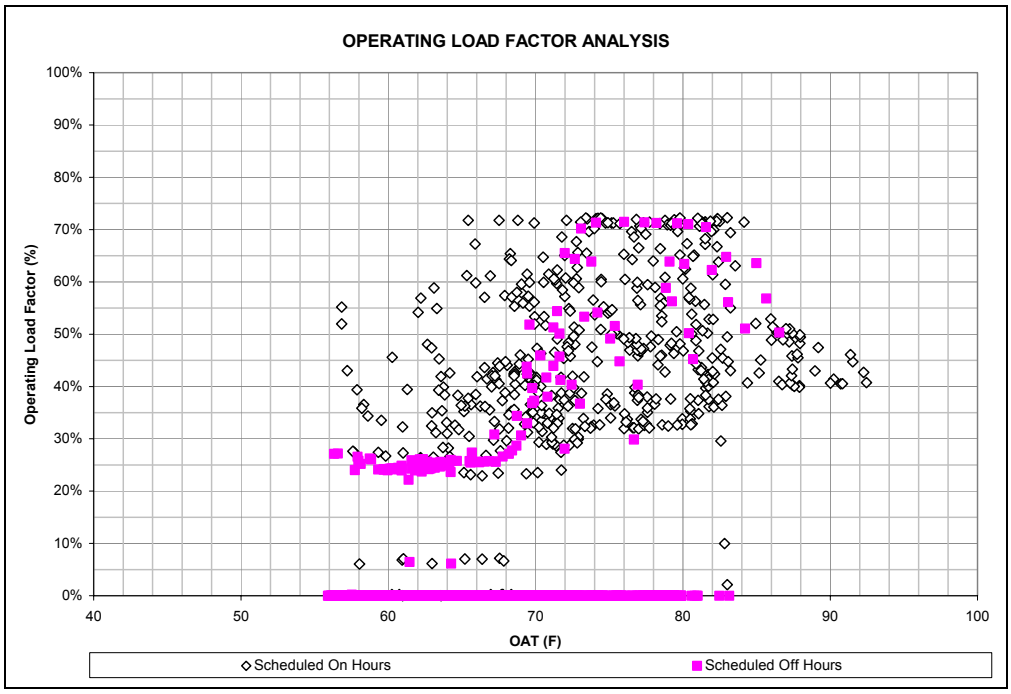
Figure III-11: Fan Power Analysis Tool: Load factor vs OAT

Figure III-11 shows the load factor as a function of OAT. There is virtually no directionality to the data indicating that the loads are predominately internally generated.

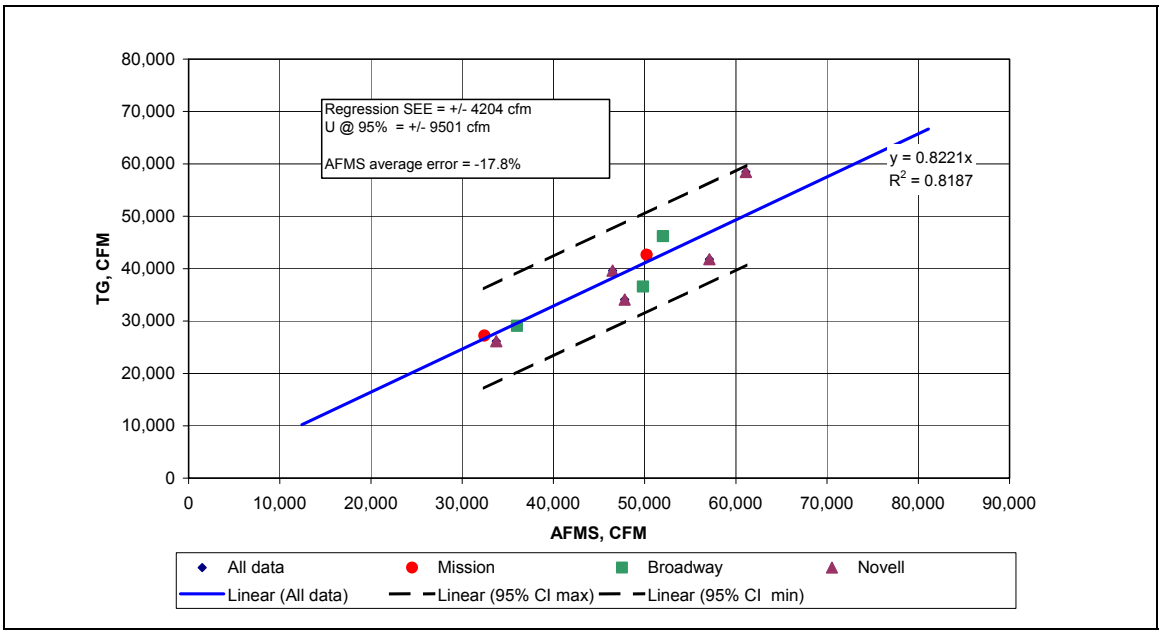
Figure IV-1: Airflow measurement results summary

Results from these tests are summarized in Figure IV-1. Since all fans measured were manufactured by Loren Cook and had similar inlet designs, it is likely that the results would be similar for each site. This is indicated in the results summarized in Figure IV-1. A linear curve fit of the data is shown and has an R^2 of 0.82. Using this fit as the correction to the AFMS readings results in an average error of –17.8%. We used the standard error of the regression to represent the uncertainty (at 95% confidence) in these measurements; Figure IV-1 shows that the uncertainly varies over the range of 15-35% over the range of measurements made. All AFMS data for each site were corrected using the linear equation shown in Figure IV-1.
