North Campus Open Space Restoration Project As-Built Grading and Hydrology Report

**North Campus Open Space Restoration Project
As-Built Grading and Hydrology Report**

July 2018

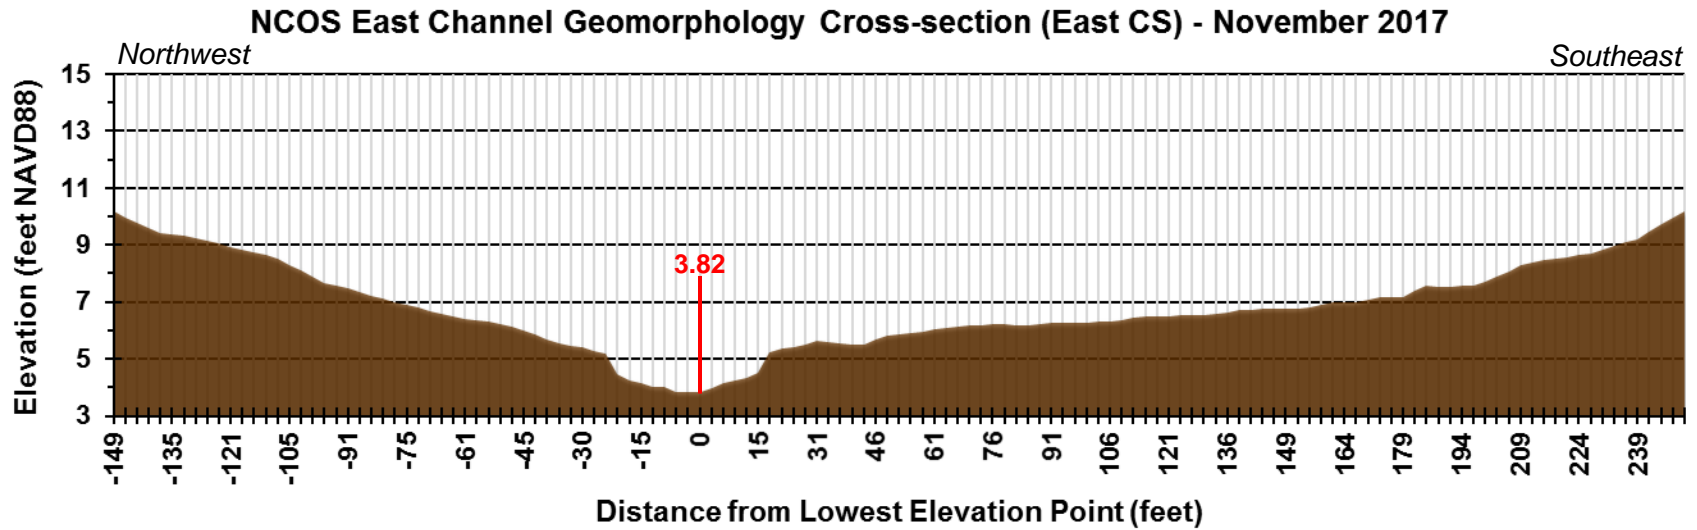
Figure 5. Profiles of as-built elevation cross-section transects in the East Channel (East CS) and the upper portion of the Main Channel (Main CS) of NCOS. The lowest elevation recorded is indicated in red. See Figure 4 for a map of the transects.

Baseline, as-built channel geomorphology cross-section and thalweg transects were established and measured with a high accuracy (within 5 cm) RTK GPS unit in November, 2017, one month after the completion of grading. These include seven cross-section transects between the 10-foot elevation contour lines on opposite sides of the Main and East channels, across Phelps creek (downstream of the bridge) and the downstream side of Venoco Bridge, and seven additional transects across the width of the sub-tidal channel (Figure 4). Profile charts of four of the transects are provided in Figures 5 and 6. The seven sub-tidal transects and the longer Main and East channel cross-sections are used together for an overall baseline thalweg elevation measurement (Table 1). The sub-tidal elevations of these transects demonstrate that the channel bathymetry was constructed as per plan specifications. The baseline cross-section and thalweg transects will be re-surveyed in 2019 and 2021.

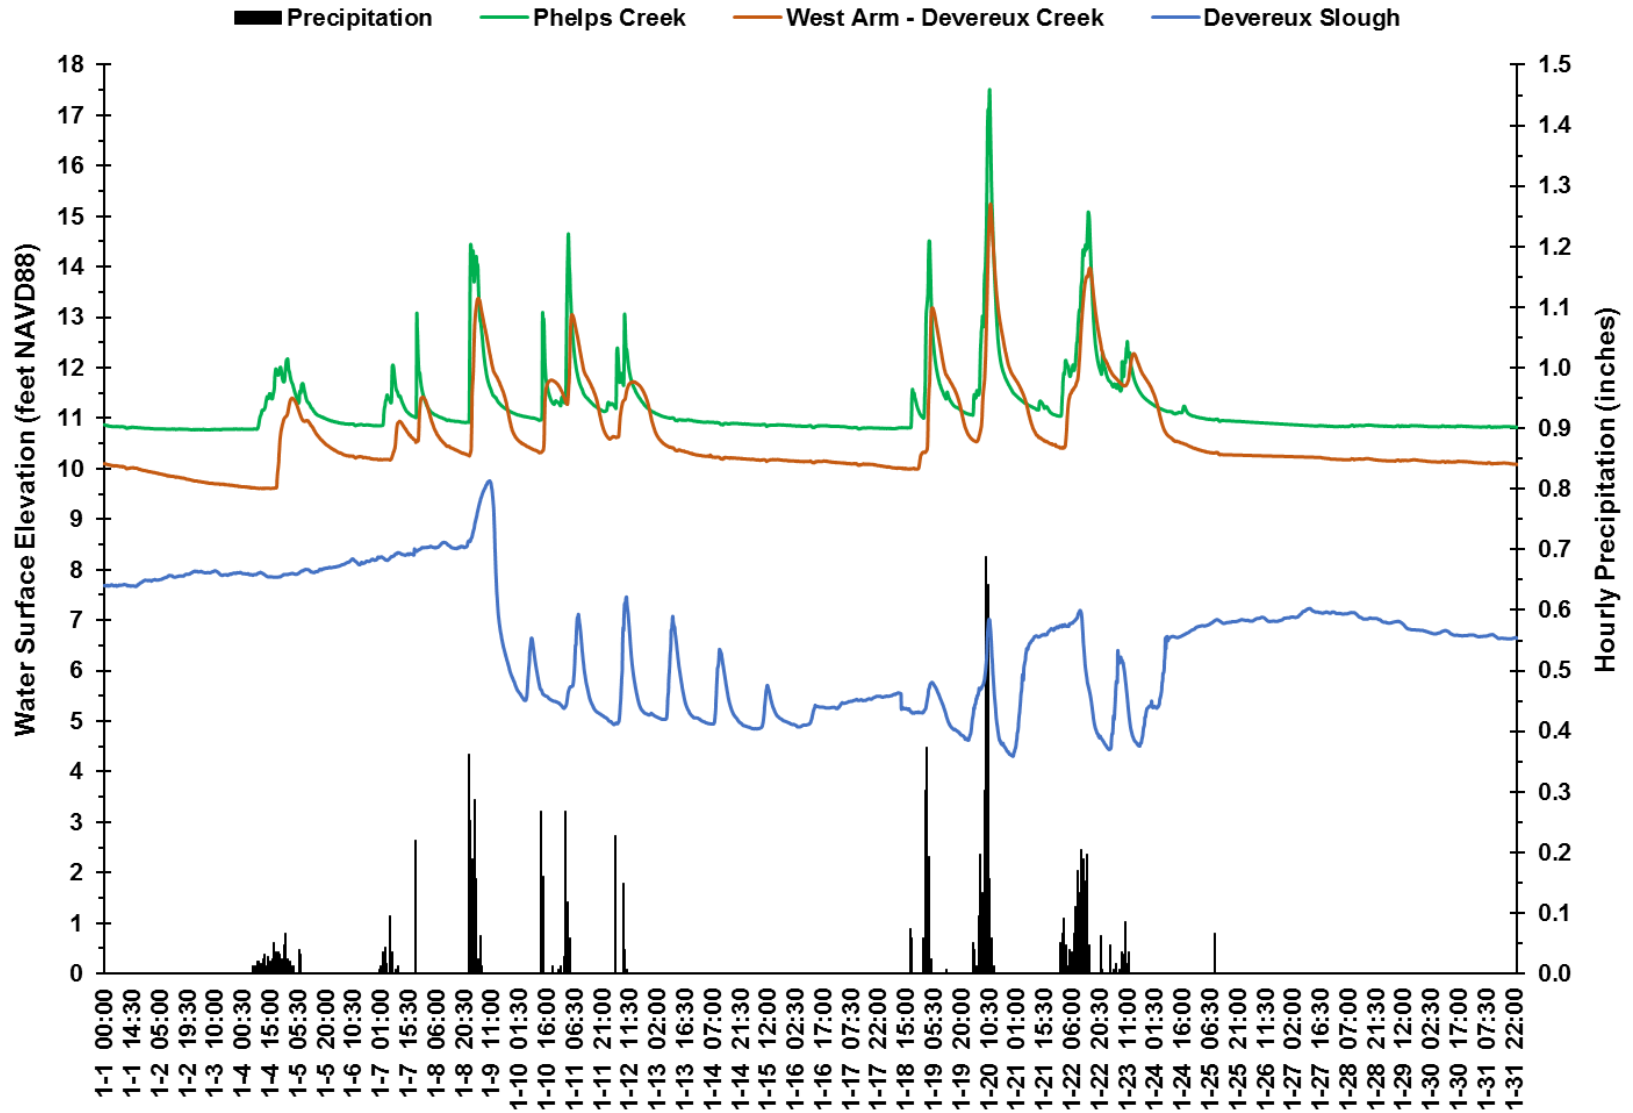
Precipitation and Water Elevations in NCOS Tributaries and Devereux Slough - January 2017

Figure 7. Pre-grading NCOS water surface elevations and precipitation, January 2017.

Prior to the NCOS restoration project, half of the wetland's potential water-holding capacity was supplanted by soil deposited to create the golf course. This caused water levels to rise rapidly to flood levels at the interface between the incoming creeks and the former wetland. Before the restoration of NCOS began, water levels recorded in Phelps and Devereux Creeks would rise by at least 3 feet immediately following rainfall amounts above 0.3 inches per hour, as was recorded in January 2017 (Figure 7). In March 2018, five months after the completion of the grading of the restoration project, the amount of water level rise has decreased by a foot or more in both creeks following similar rain events (Figure 8). See Figure 9 for a map showing the location of the water level loggers.

In the winter of 2016-17, it took 6 inches of rain to cause Devereux Slough to breach the sand bar (on 1/9/17) and connect the system to the ocean. Following the completion of the grading in October 2017, the slough did not breach until rainfall totals reached 7.8 inches on 3/22/18, reflecting an increased water holding capacity of the system. This increased capacity is also reflected in the hypsometric curve in Figure 10. The sand bar at the mouth of the slough usually holds the water in the system up to about 9.5 feet elevation. The blue line in Figure 9 shows the capacity of the system before the project, when the mouth would breach after holding about 200 acre feet of water. The orange line shows the post-project capacity of the system, indicating it will hold closer to 350 acre feet before it breaches. The conclusion is that the hydrology of the as-built, restored system at NCOS closely follows the modeled predictions, and provides increased wetland capacity, habitat diversity and flood protection.

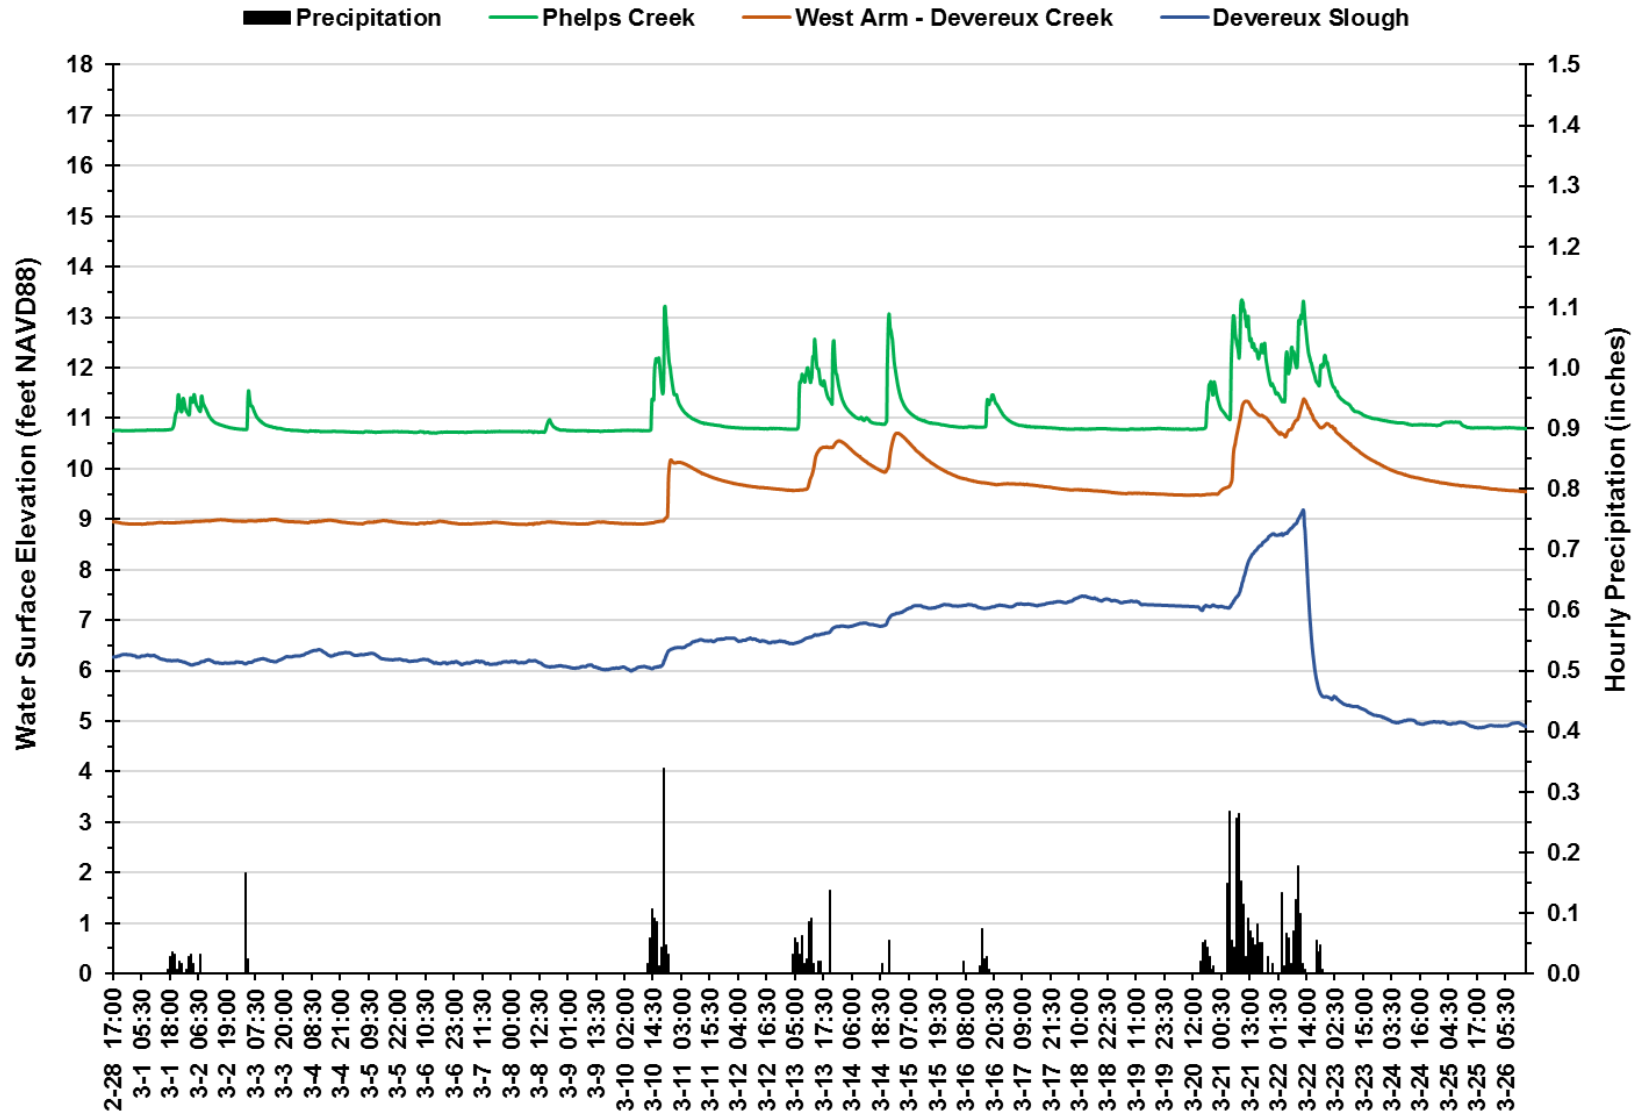
Precipitation and Water Elevations in NCOS Tributaries and Devereux Slough - March 2018

Figure 8. Post-grading NCOS water surface elevations and precipitation, March 2018.

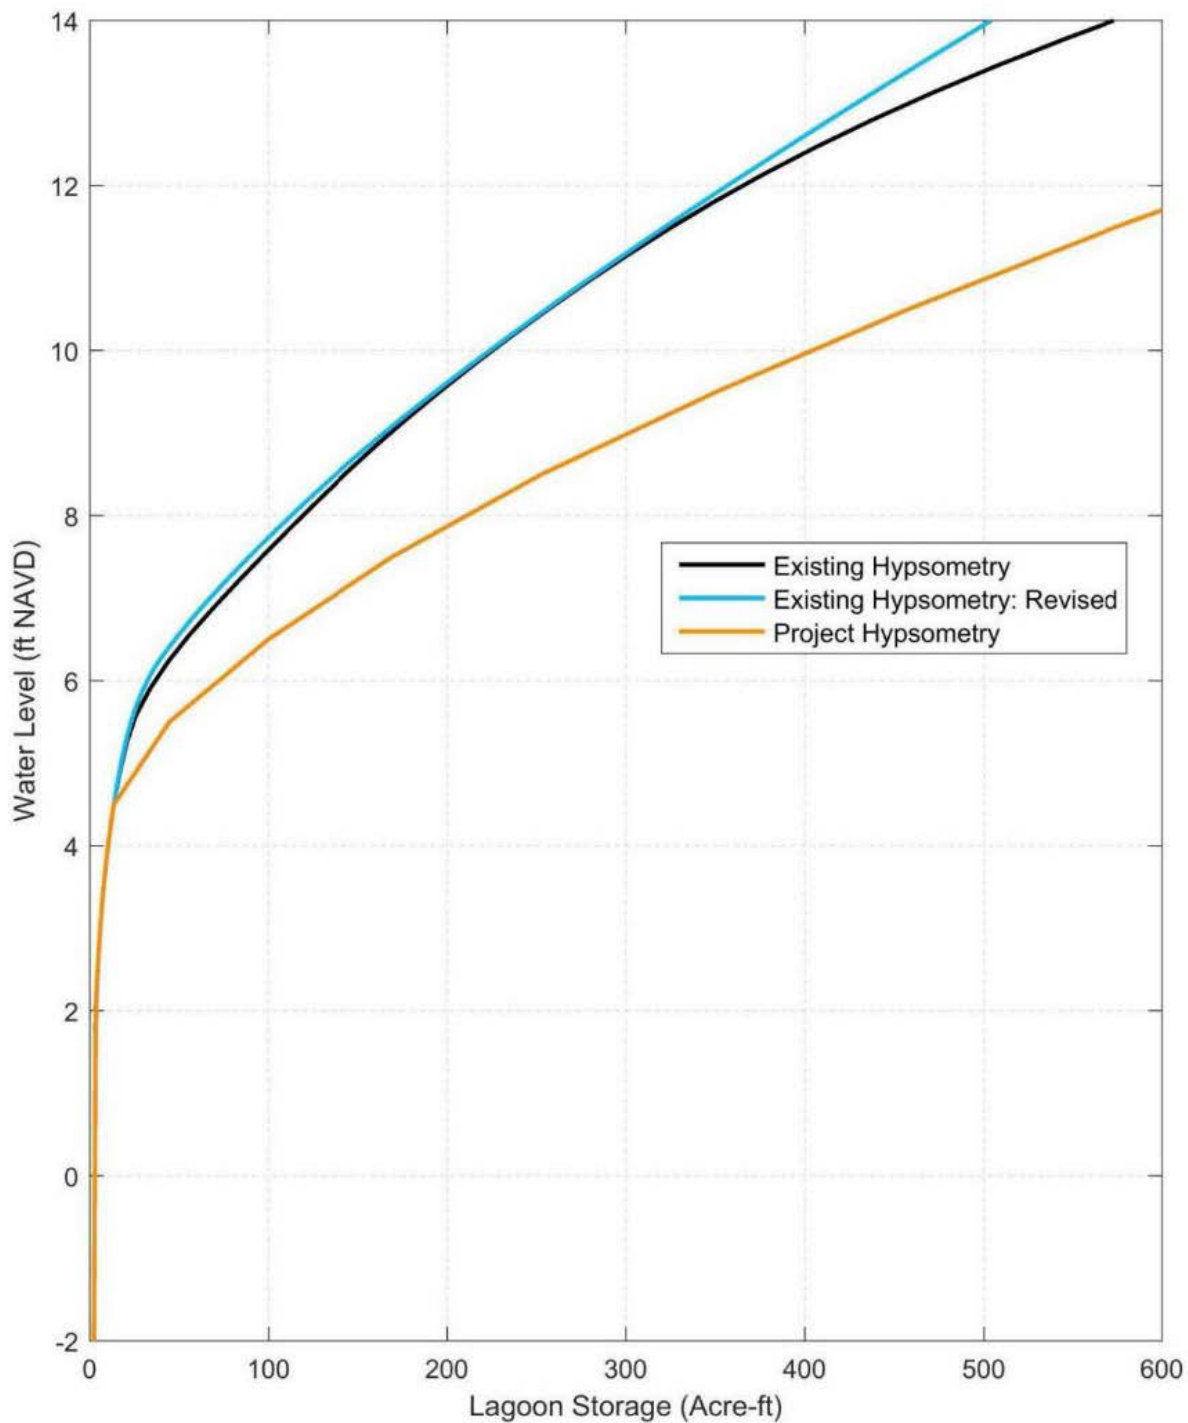
Figure 10. Comparison of pre- and post-grading water stage-storage curves for Devereux Slough (Lagoon). Notice the lower post-project water levels at equivalent water storage levels (orange line). Pre-grading hypsometry is from Rich (2013). Revised pre-grading hypsometry is based on an ESA and Stantec survey. Post-grading hypsometry is based on the ESA grading plan for NCOS.

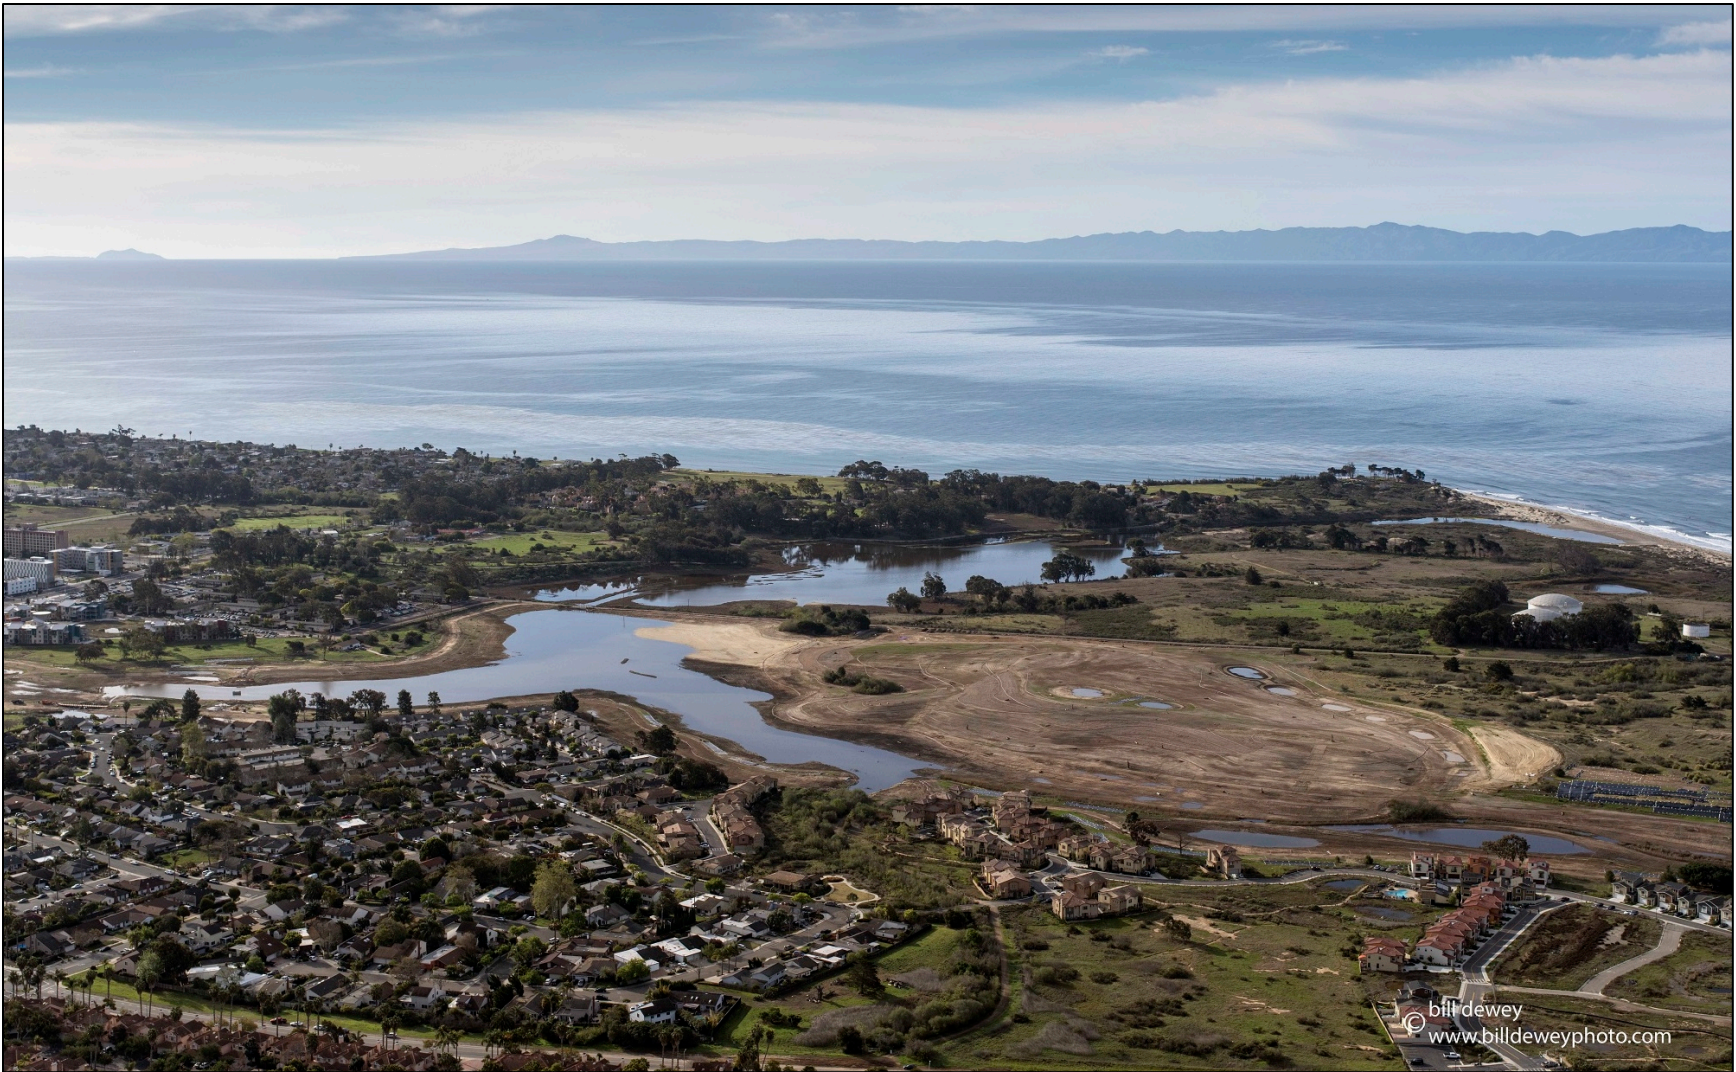
Aerial image of the North Campus Open Space project site after the completion of the grading phase, taken by Bill Dewey on March 18, 2018.

Oblique aerial photos of the NCOS project site have been periodically captured by Bill Dewey. One pre- and one post-grading aerial photo are provided on the following two pages. Quarterly landscape photo monitoring of the NCOS restoration project began in December 2016, with the first complete set of baseline, pre-grading photos taken on April 10-11, 2017. On the following pages, a subset of key photos from this baseline set are compared with photos taken after the completion of grading (April 2018). The photos are preceded by a map of the photo monitoring point locations, with the key subset photo point locations highlighted for reference (Figure 11).
