Novel Quantitative Composite Delamination Injection Repair Procedure and Characterization for Strength Restoration

A Dissertation submitted in partial satisfaction of the requirements  
for the degree Doctor of Philosophy

Materials Science and Engineering

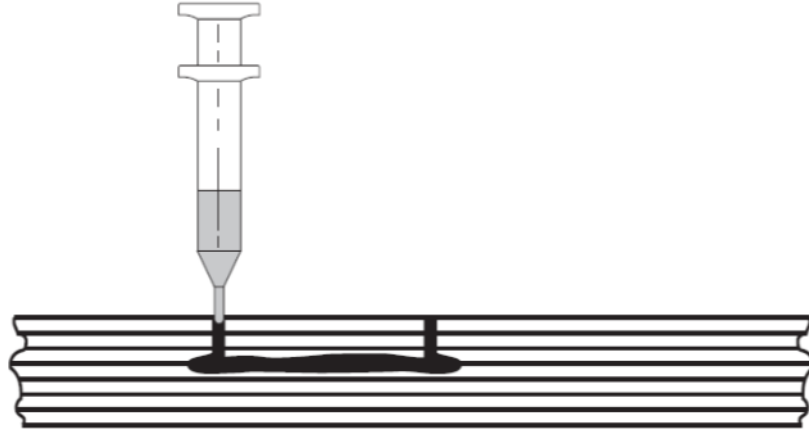
The injection repair process includes drilling holes to the depth reported by non-destructive inspection procedures (typically ultrasonic testing) and injecting and infiltrating the delaminated composite material with low viscosity epoxy repair resin that is assumed to “bond” the laminate plies back together and filling the delaminated void (see Figure 1.2). After injection and cure of the repair resin, the area is inspected to determine area filled and the process is repeated until the delamination is considered filled or repaired by the aircraft program.

**Figure 1.2. Example of injection repair of a delamination**

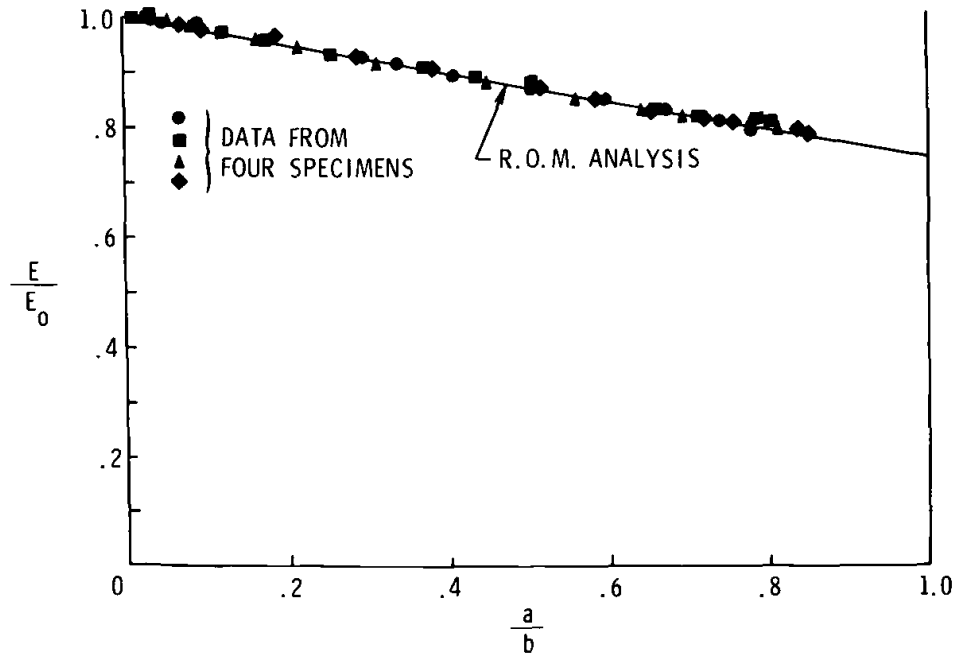
Another major concern about delamination in composite laminates is the ability for the delamination to grow rapidly and eventually cause a premature failure of the composite laminate. O'Brien [2] also published a correlation of delamination size to laminate stiffness as shown in Figure 2.3. It was found that an increase in delamination will reduce the stiffness under static

**Figure 2.3. Stiffness as a function of delamination size [2]**

and fatigue loading. This stiffness loss could cause premature failure of the laminate due to the inability to carry designed loads. This presents an issue with usage of highly loaded composites, such as implementation in aircraft flight control surfaces. Therefore characterization and understanding of delaminations has been broadly researched.

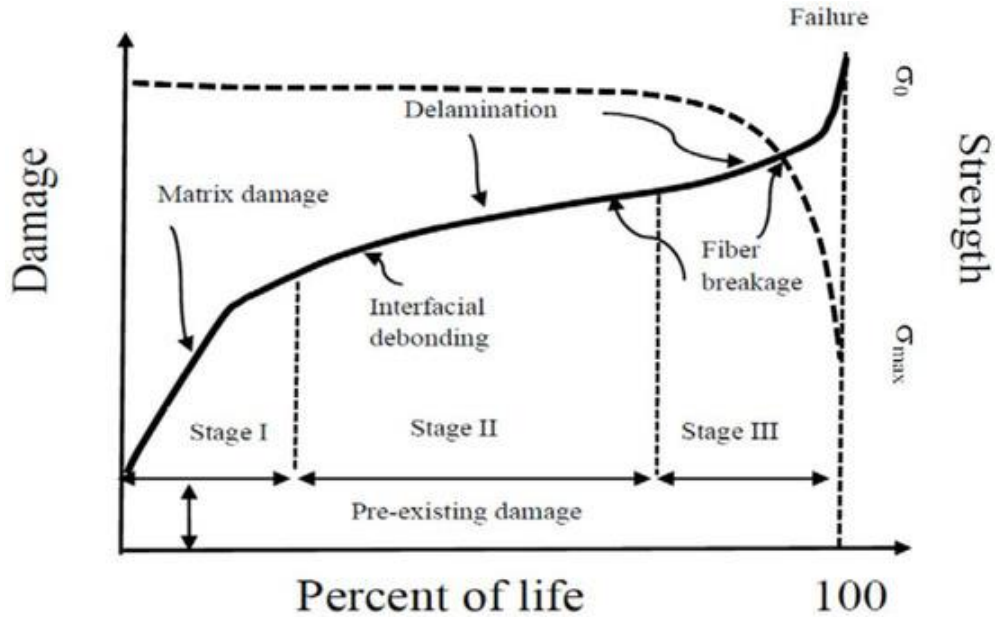
Figure 2.5. The schematic of damage development and the corresponding strength evolution under constant amplitude (CA) loadings [15]

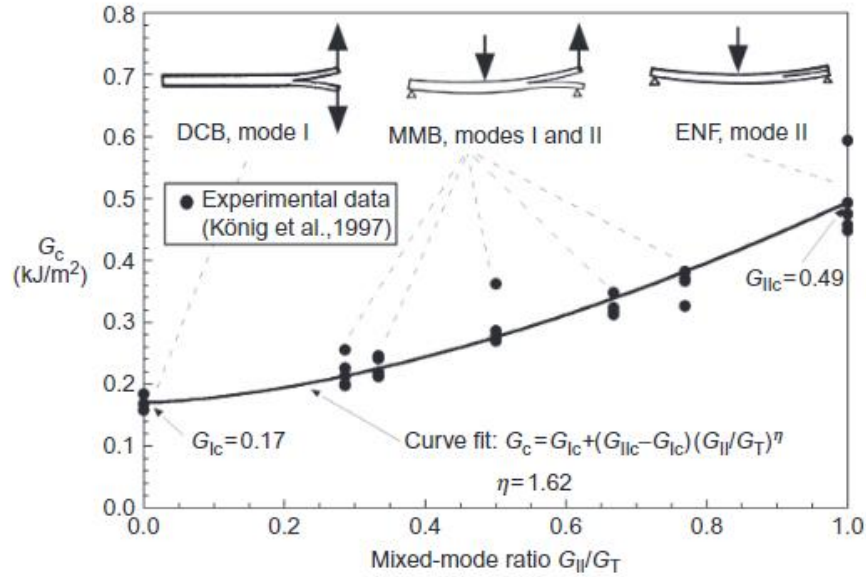
Furthermore, researchers have experimentally determined that  $G_c$  values correlate to the fracture mode in brittle PMCs as shown in Figure 2.10 [28].

**Figure 2.10. Critical strain energy release rate as a function of mixed-mode ratio for T900/914C PMC [28]**

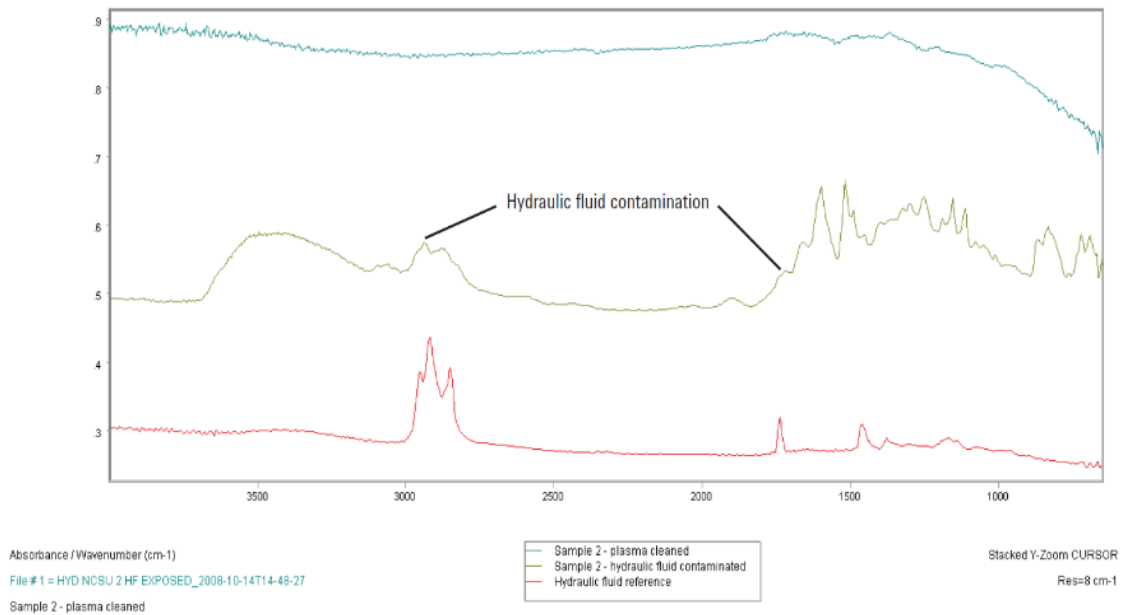
**Figure 2.21. DRIFTS spectra of a cleaned and hydraulic fluid contaminated PMC [68]**

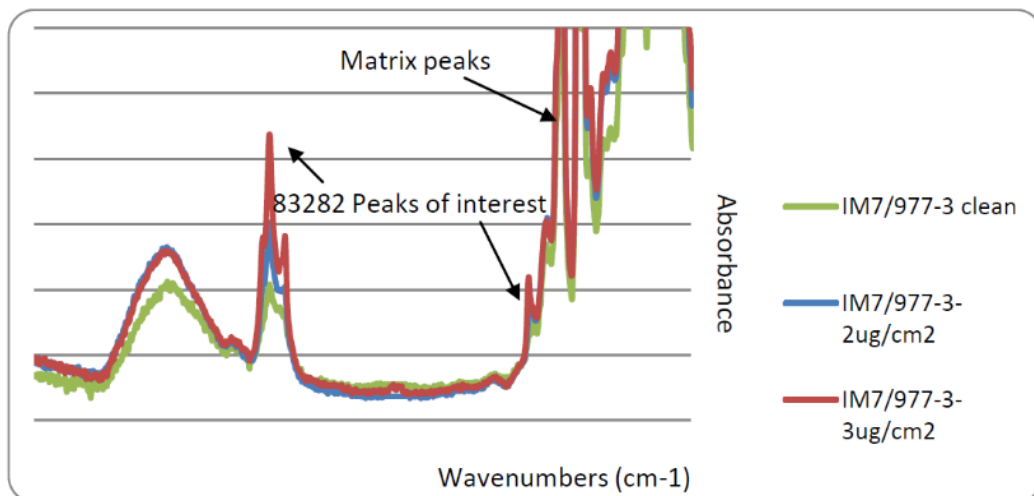
**Figure 2.22. FTIR-ATR spectra of a cleaned and hydraulic fluid contaminated PMC [62]**

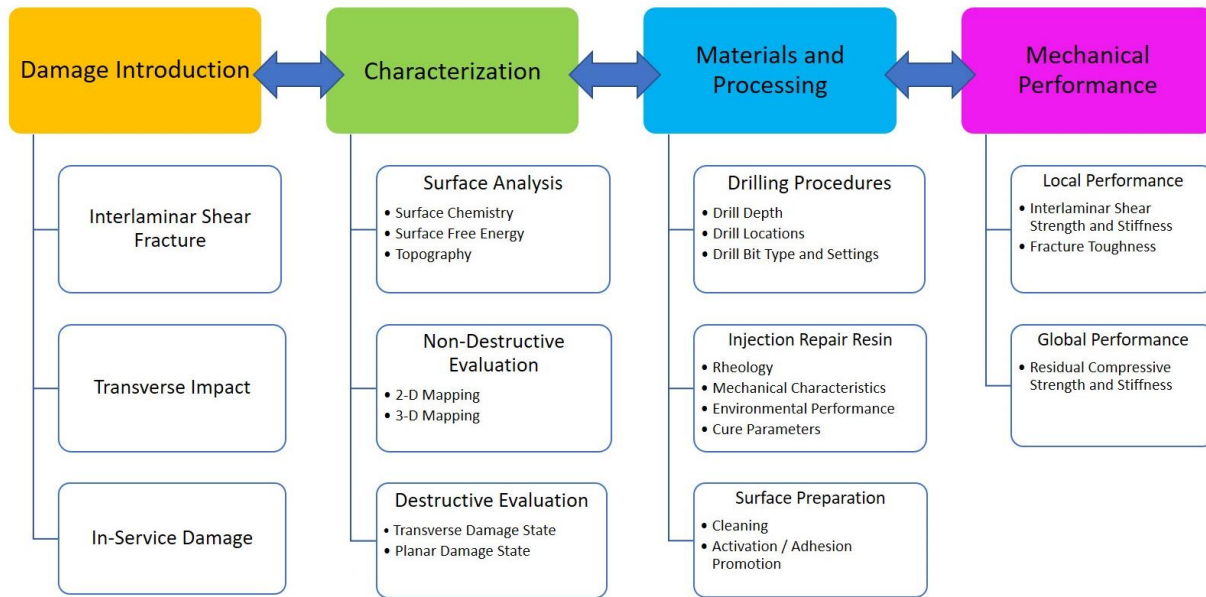
In order to successfully create an new injection repair procedure that could be used for repair of aerospace components, some primary key technical objectives need to be addressed by this study. In Figure 2.26 are the key technical challenges that must be addressed by scientific and engineering investigation to ensure the novel repair procedure is successful and encompassing to ensure strength restoration is achieved.

**Figure 2.26. Delamination injection repair key technical challenge roadmap**

The key technical challenges are segmented into four different topic areas: 1. Damage Introduction, 2. Characterization, 3. Materials and Processing, and 4. Mechanical Performance. These key technical challenges have arrows at the headers to show that the challenges must not only be addressed, but a feedback loop must be considered to ensure a robust solution is found.

This study aims to complete testing and analysis to address all of the key engineering challenges shown in Figure 2.26. Although this study will address the different methods of damage introduction, damage characterization, and materials and process development, the objective of will ultimately provide a quantitative solution for restoring mode II fracture toughness by injection repair of interlaminar shear induced fractures. In addition, initial follow on work addressing drilling procedure development and global mechanical test assessment of complex impact induced delaminations will be addressed.

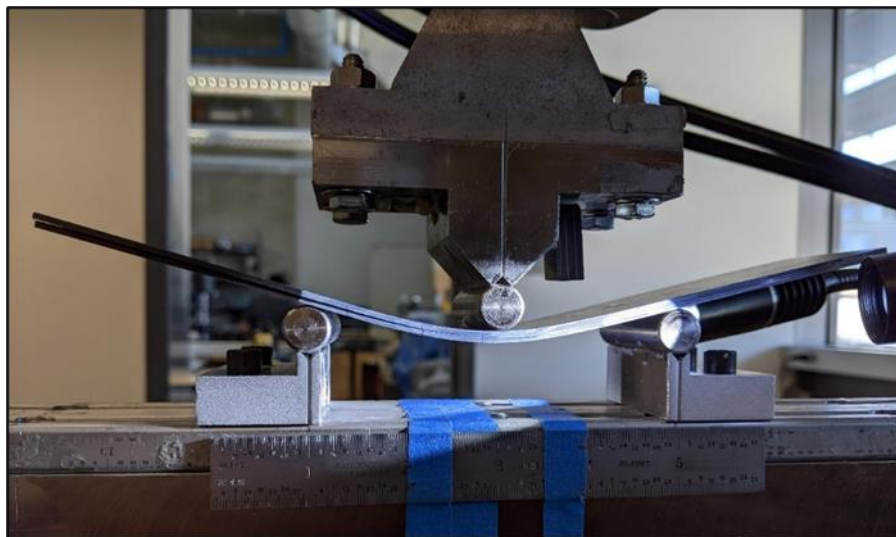
**Figure 3.3. Laboratory ENF test fixture set-up and specimen during testing**

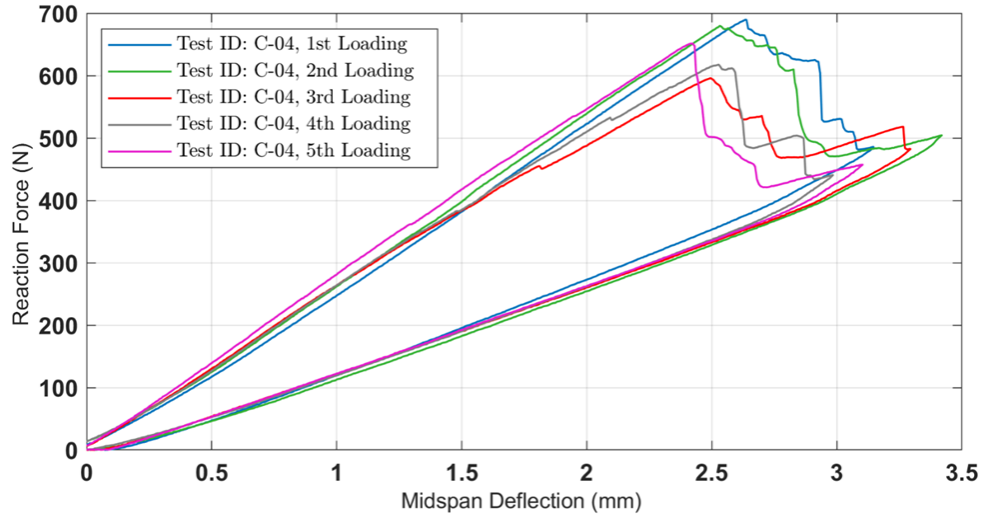
For the crack propagation, the specimens were loaded until a crack was observed through a drop in load and in some cases an audible crack. The specimens were flipped over, shifted left (in Figure 3.2, keeping  $a_0$  at 30 mm) and loaded again to extend the cracks further than 50.8 mm. Shown in Figure 3.4 are the load versus displacement plots for loading the same ENF coupon five times. Similar loading profiles were observed for loading of the same coupon.

**Figure 3.4. Load v. displacement plot of multiple loading of same modified ENF coupon**

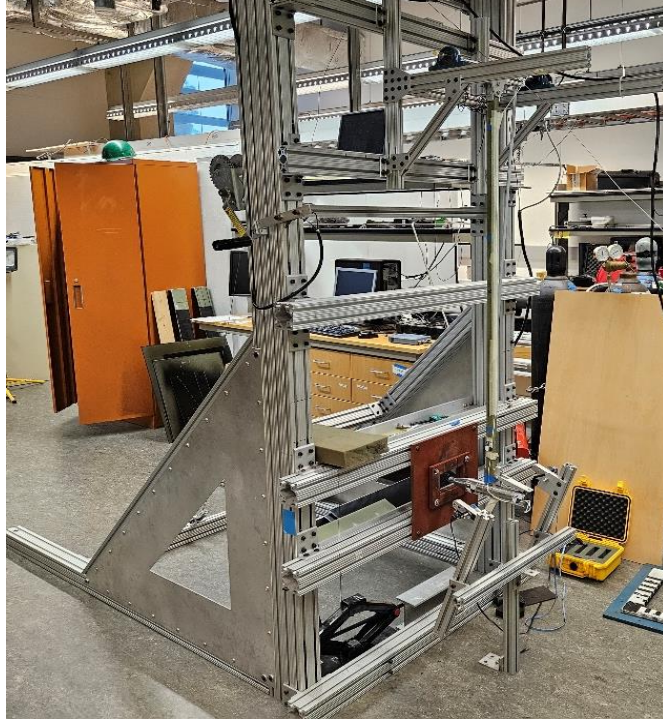
The specimen size was determined according to the ASTM D7136 [11] test method. The specimens had nominal dimensions of 100 mm by 150 mm with the 0° direction aligned with the long side of the specimens. These specimens were cut from the panels using a wet diamond blade tile saw. The specimens were impacted in the manner defined by ASTM D7136, via a low velocity drop weight (pendulum impact) as shown in Figure 3.6. Coupons were impacted at 10J, 15J, 20J, and 40J to determine size of resultant delamination.

**Figure 3.6. Pendulum impactor set-up**

The impactor tip had a force-measuring instrumented hemispherical hardened steel tip with a 25.4 mm diameter. The pendulum impactor had an arm length of 1,402 mm, and a total mass of 4.8 kg and was set up with a laser photogate to measure actual incoming head velocity just prior to the impact event as well as rebounding velocity. NDI of damaged specimens was performed using ultrasonic pulse echo test methods to map the delamination location boundary using gel-coupled A-scan, as marked in Figure 3.7. The delamination size is defined as the length of the longest axis measured from the A-scan mapped damage (see Figure 3.7).

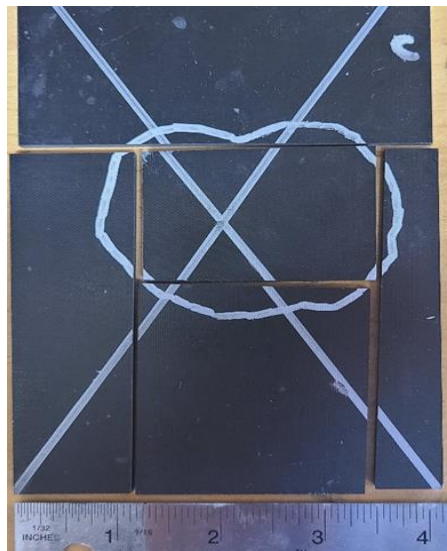
Once specimens were impacted and characterized using NDI, they were sectioned using a lapidary trim saw equipped with a diamond coated blade into 5 sections as shown in Figure 3.8. Middle sections where impact occurred were identified as delaminated and were filleted open using a scalpel for analysis. Side sections were kept intact and utilized for inspection of the delamination through thickness profile.

**Figure 3.8. 20J impact specimen sectioned for microscopic observation**

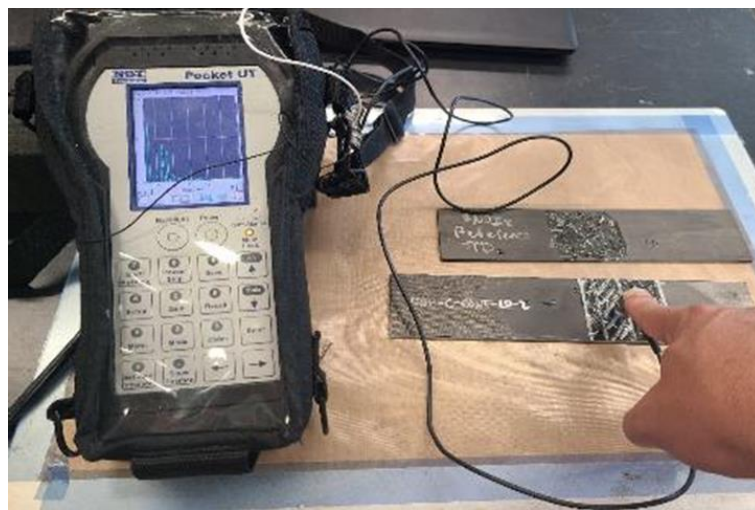
Coupons were inspected for delaminations and repair resin bondline integrity using pulse-echo ultrasonic testing. Single-sided ultrasonic scanning, via A-scan presentation, was performed by hand using a Mistras PocketUT system equipped with a 3.5 MHz, 6.4mm diameter delay line and transducer (see Figure 3.10). All scanning was coupled with glycerin gel. A standard was used with known defects of which 50% screen height attenuation within the A-scan were considered areas of delamination. The A-scan waveform for inspecting the coupons can be found in Figure 3.11. The area in between the front surface and back surface signal would increase in amplitude if there was a defect present.

**Figure 3.10. Pulse-echo ultrasonic A-scan hand inspection test set-up**

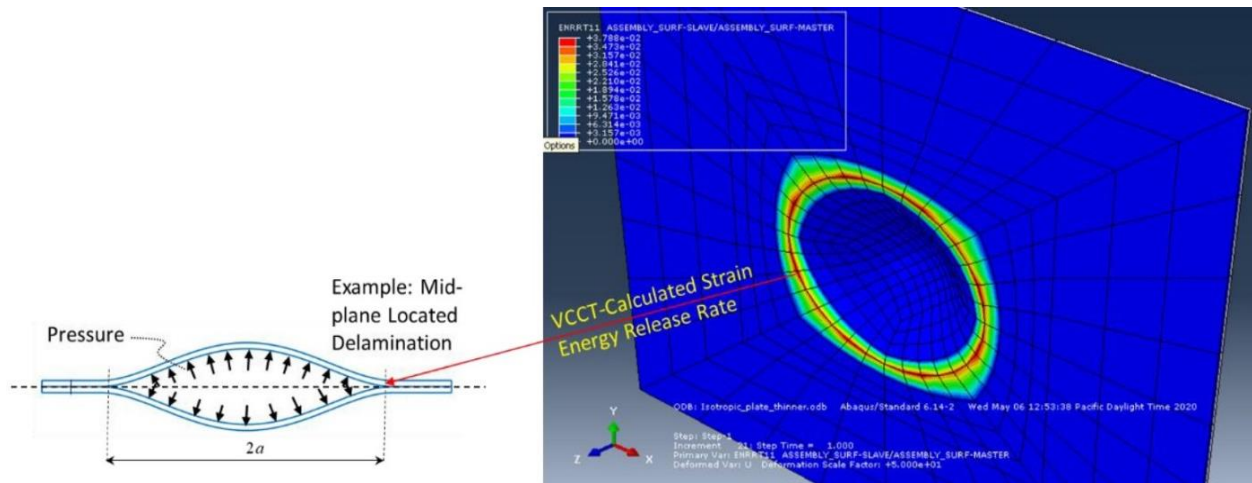
**Figure 3.21. Finite element analysis virtual crack closure technique model for circular-shaped delamination growth**

The goal of the FEA model is to determine the pressure at which the crack tip propagates using the mixed mode fracture growth criterion. Delamination internal pressure (blister pressure) schematic is shown in Figure 3.21, along with an example result from the VCCT FEA model.

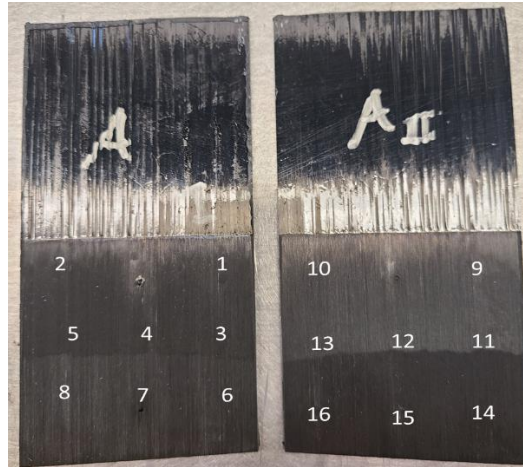
**Figure 3.28. FTIR analysis locations on ENF process development coupon**

A Thermo-Fisher Nicolet Fourier Transform Infrared spectrometer equipped with an Attenuated Total Reflectance (ATR) accessory was used to inspect the internal surfaces of the simulated delaminations. Coupons were cut at the end of the delamination, opened, and analyzed with a diamond ATR crystal which was pressed on the laminate surface using a 15 N probe clutch. A background spectrum was collected every 10 minutes and 32 scans were collected per sample location. 16 sample locations were collected per coupon as shown in Figure 3.28. A control sample was collected on a known contaminated panel for reference when analyzing FTIR data.

through Figure 4.40 are the results of 16 areas (see Figure 3.28 for locations) that were inspected with FTIR on each coupon after cleaning a contaminated ENF process development coupon. The coupons were treated with an atmospheric plasma for 20 minutes each (10 minutes on each injection hole).

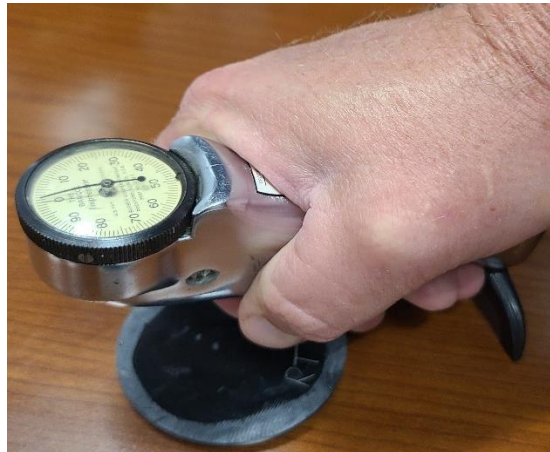
**Figure 3.32. Barcol hardness impressor diagram (Left) and impressor in use (Right)**

In addition to visual inspection for porosity, the samples were also tested using a Barcol Hardness tester in accordance with ASTM D2583 [83]. Barcol Hardness is a process verification test that is completed on thermoplastic materials to determine the polymer degree of cure. Higher Barcol hardness readings are typically correlated to higher epoxy degree of cure. Ten Barcol hardness readings were taken per a cure parameter testing sample when surface was not too porous for measurements. Figure 3.32 shows a schematic of the Barcol hardness tester and a picture of the test being completed.

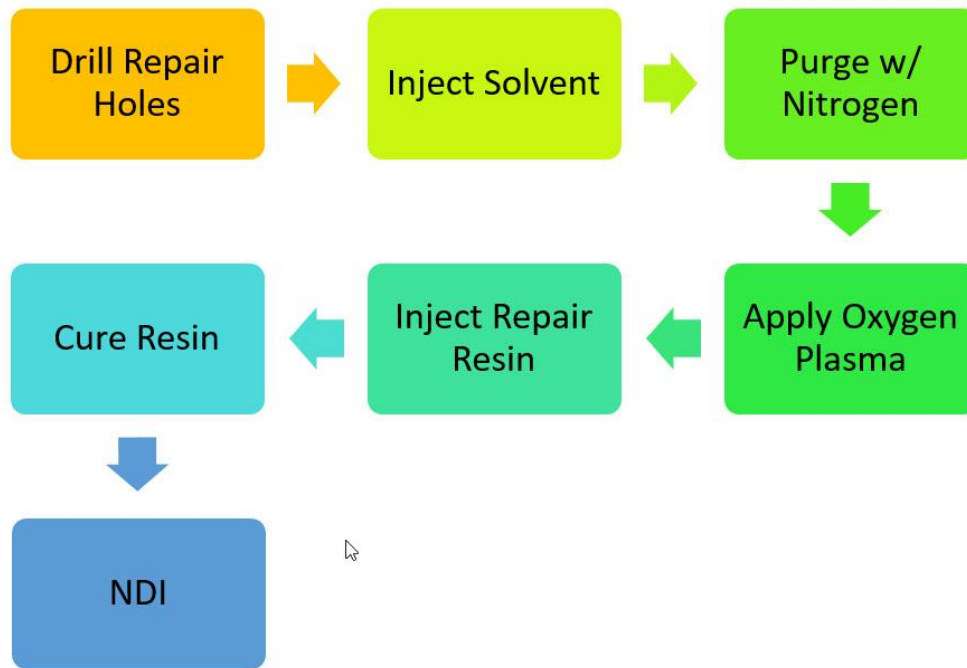
The novel process performed to repair the simulated delaminations in this study was seven steps. These steps are outlined in the repair flow chart in Figure 3.34.

**Figure 3.34. Novel injection repair process flowchart**

**Step 1: Drill Repair Holes:** A minimum of two #44 drill bit (2.18 mm diameter) holes will be drilled within the delamination to the depth identified by non-destructive inspection of the defect. If defect depth information is not available, drilling to a depth within two plies of the backside surface was used.

**Step 5: Inject Repair Resin:** The diluted EA9396 injection repair resin was placed into a 20 mL syringe equipped with a 14-gauge needle (2.1 mm outer diameter). A minimum of 5 mL of injection resin was placed into each entry hole until the resin would come out the opposite hole. This process was repeated one more time for each hole.

**Step 7: NDI:** Post repair processing, the ENF coupons were inspected for bondline integrity using pulse-echo ultrasonic testing. Single-sided ultrasonic A-scanning was performed by hand using a Mistras PocketUT system equipped with a 3.5 MHz, 6.4mm diameter delay line and transducer

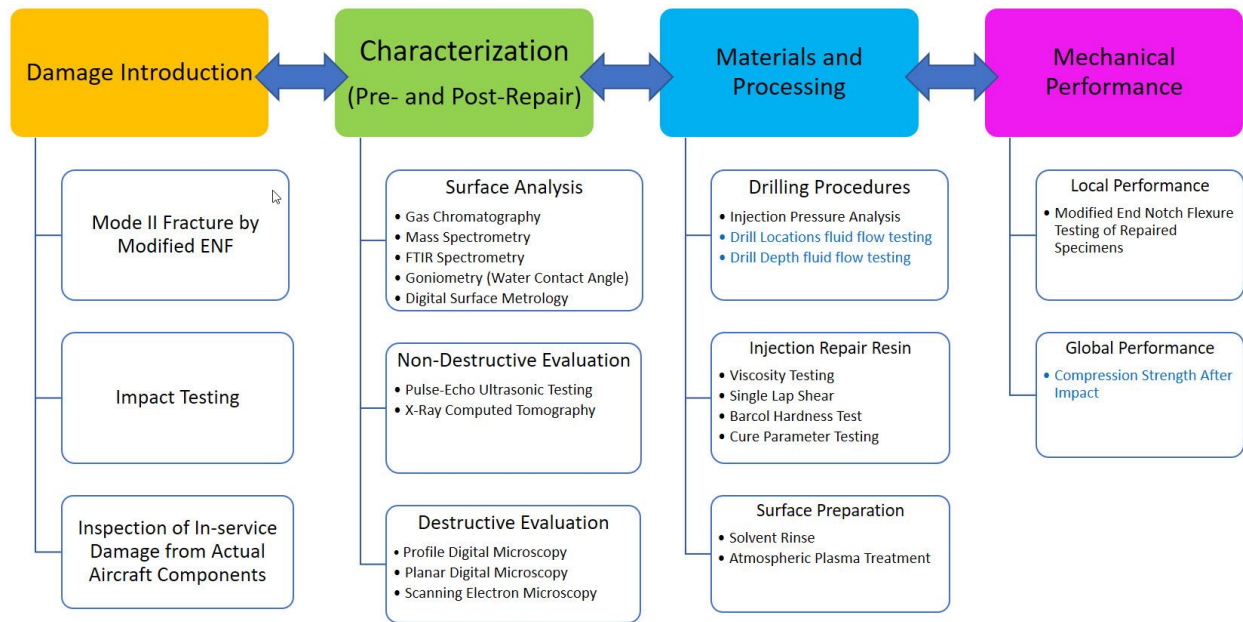
In order to address the key engineering challenges discussed in section 2.5, experimental and analytical testing was completed. Each key engineering challenge required multiple types of experimental tests or analysis to determine a viable solution, these experiments are outlined in Figure 4.1.

**Figure 4.1. Experimentation roadmap of results completed in this study**

The key experimental contributions of this study are in each bubble attached below the key engineering challenge. The results of each set of experiments were considered a step toward the goal of creating a novel strength restoring injection repair procedure. Experiments names with blue text are currently being investigated, however preliminary work has been conducted and is discussed in Chapter 6. This Chapter will address and go into depth the results completed for all experiments colored with black text in Figure 4.1.

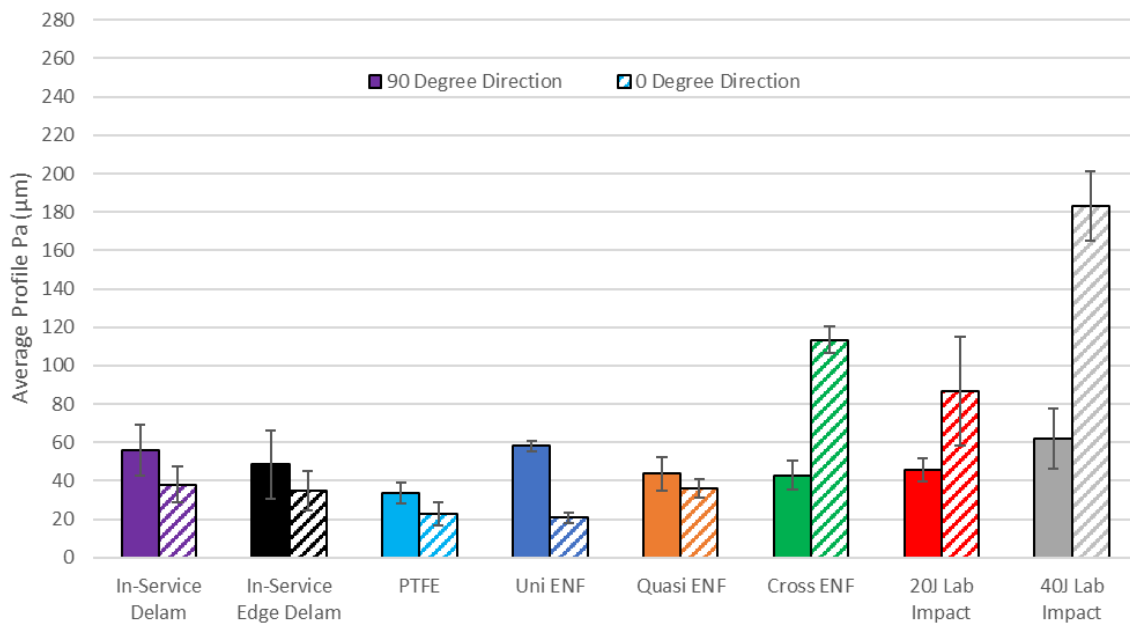
“Z(x)” is the profile height function and “L” is the evaluation length. The sampling lengths used for profilometry was equivalent to “ $\lambda_c$ ”. Sampling lengths used for roughness analysis was 0.8 mm. Results of the metrological analysis of the arithmetic average surface profile and root mean square profiles taken along the 0° and 90° direction are shown in Figure 4.21 and Figure 4.22, respectively.

**Figure 4.21. Arithmetic average profilometry ( $P_a$ ) values of delamination surfaces**

The arithmetic average and root mean square profile measurements exhibited similar data trends for all delamination coupons, however the RMS measurements results consistently had larger profile measurements for all coupon configurations. The unidirectional ENF coupon exhibited approximately 300% larger profile changes in the 90° direction when compared to the 0° direction measurements. The 0° direction was aligned completely with the coupon fiber direction; therefore the 0° direction measurements did not cross perpendicular over the fibers on the fracture surface and thus a smoother surface topography resulted. The quasi-isotropic coupon exhibited a more consistent profilometry between the 0° and 90° measurements, where the 90° direction arithmetic average profile ( $P_a$ ) was 16% larger than the 0° measurement and root mean square profile ( $P_q$ ) was 13% larger in the 90° direction compared to the 0° direction. The cross-ply ENF coupon surface profile had a much larger change in measured primary profile ( $P_a$  and  $P_q$ ) due to the 0° direction measurements being 250% larger than the 90° profile measurements. This

large change in profile is attributed to the observed multi-ply transverse fracture that occurred at the mid-plane of the coupon, creating a large step-like feature within the delamination coupon. This was previously observed in both profilometry and the areal damage characterization. The delamination created by the PTFE insert also exhibits a surface profile where the 90° direction measurements are on average 33% larger than the 0° measurements. This is a byproduct of the woven cloth used within the PTFE insert, leaving a surface pattern after curing.

The previously in-service enclosed delamination exhibited primary profile measurements that were larger in the 0° measurement direction when compared to the 90° direction by 47% and 51% for Pa and Pq, respectively. The edge delamination also exhibited a change due to the Pa and Pq measurement direction, approximately a 30% decrease in primary profile measurements when comparing 90° measurements to 0° measurements. The consistency of the damage profile for in-service delamination is comparable to the PTFE delaminations when comparing the change in profilometry with respect to measurement direction. The only coupon to have a more consistent fracture surface profile with respect to the measurement direction was the quasi-isotropic ENF coupon. The in-service delamination profile depths are more comparable to the quasi-isotropic ENF fracture coupon where the average difference in Pa measurement was 5.18µm. The PTFE fracture surface had an average difference in Pa of 9.85µm.

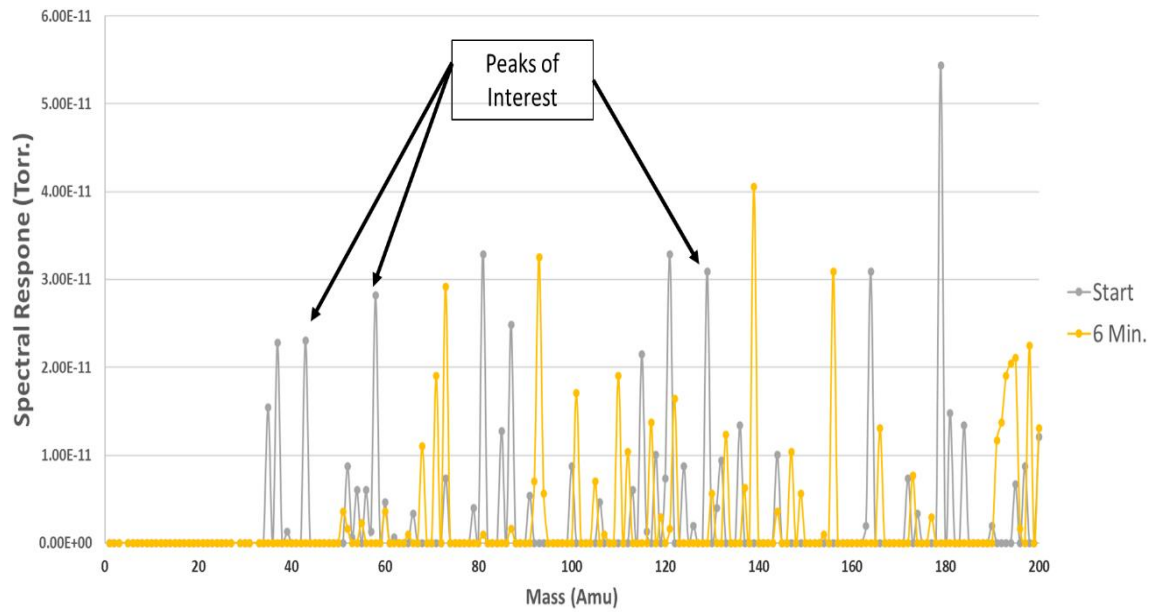
**Figure 4.30. Mass spectra of hydraulic fluid before and during plasma cleaning**

For the hydraulic fluid contamination removal observed in Figure 4.30, please note the average response was two orders of magnitude less than the lubricating oil sample. Although a weaker response was recorded which in turn created more scatter in molecular response, the peaks of interest found at 43, 44, 57, and 58 amu showed a major reduction in response when comparing  $t = 0$  min. (shown in grey) and  $t = 6$  min. (shown in yellow).

In addition, the spectral responses at 156 amu for lubricating oil and 129 amu for hydraulic fluid were two orders of magnitude weaker in mass spectra response for each respective material at both time intervals. This is likely due to the electron ionization method used in the QGA and that the constituents at 156 and 129 amu were also considered secondary confirmation peaks. Therefore the targeted molecular species at 43, 44, 57, and 58 were found to reduce during plasma exposure for both lubricating oil and hydraulic fluid would then be used for real-time process

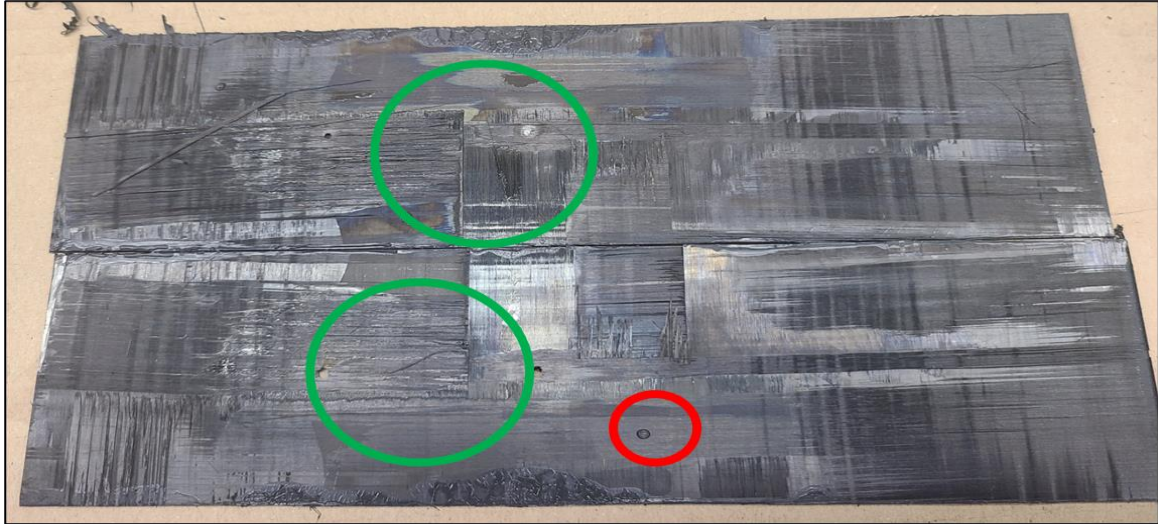
**Figure 4.34. WCA readings after atmospheric plasma treatment of hydraulic fluid contaminated modified ENF coupon**

In addition to real-time spectrometry, the enclosed delamination coupon was opened immediately after plasma cleaning and analyzed using WCA. Ten readings were taken for each of the lubricating oil and hydraulic fluid contamination removal coupons. Readings were taken in areas between the drill holes and within 12 mm forward and aft of the drill location. Shown in Figure 4.33 and Figure 4.34 are examples of the location of the WCA readings.

The resulting WCA data for the lubricating oil contaminated and cleaned coupon was  $<5^\circ$  for all sites analyzed. The detectable limit of the Surface Analyst unit is  $5^\circ$ , therefore the cleaning of lubricating oil was considered successful. Also shown in Figure 4.33 is a close-up of a reading taken under the fractured fibers within the coupon. This reading was also  $<5^\circ$ , exhibiting that the solvent-plasma cleaning process was infiltrating below the immediate surface of the coupon. Although, the hydraulic fluid contaminated coupon had  $<5^\circ$  readings in all areas in between the two drill holes, there was a single reading aft of the drill holes where an average  $72^\circ$  WCA resulted. This area was found to still be contaminated (see Figure 4.34, circled in red) and further cleaning would be required to ensure removal of contaminants.

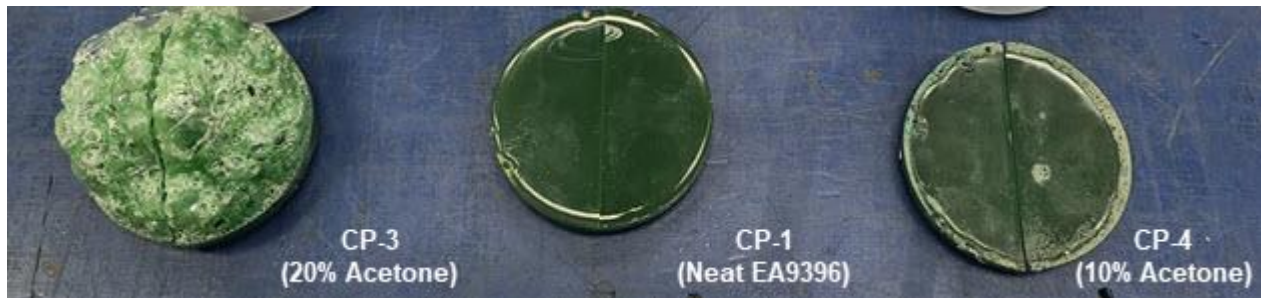
**Figure 4.47. Cure parameter testing of diluted EA9396 resin puck coupons**

Cure parameter testing using resin pucks was completed to determine if diluted EA9396 would cure with induced porosity due to the solvent diluents being introduced into the repair resin. Experimental set-up of cure parameter testing coupon is described in section 3.3.4 and list of test samples are shown in Table 3.7. Example of the cure parameter resin pucks after cure can be seen in Figure 4.47.

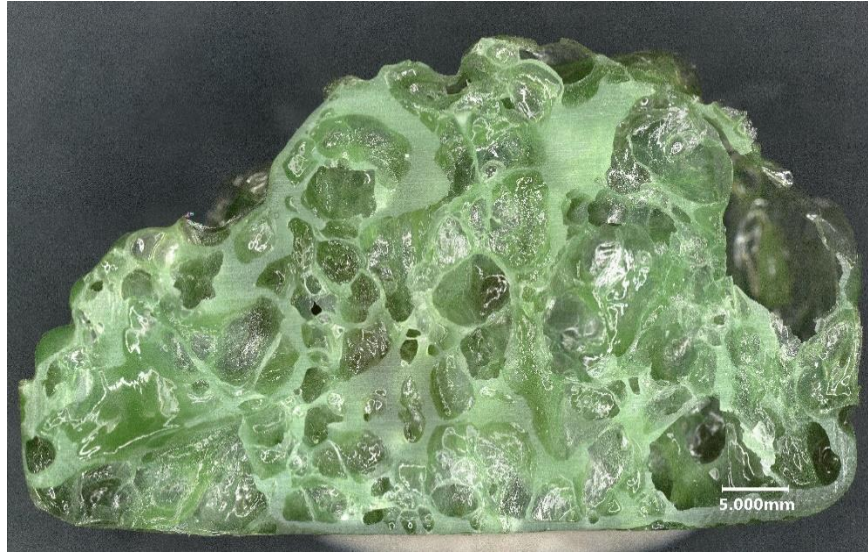
**Figure 4.49. CP-2 (30% acetone diluted EA9396) cure parameter coupon section**

Figure 4.48 through Figure 4.52 show the macroscopic cross-section of each cure parameter coupon and a 100x zoom photomicrograph where micro-porosity was present. Cure parameter coupon CP-1 (undiluted EA9396 resin) was cured using the manufacturer recommended cure cycle of 1 hour at 66°C with no room temperature hold. CP-1 showed little to no visual indications of porosity in the macroscopic inspection (see Figure 4.48), however micro-porosity was observed in the 100x magnification microscopic photographs.

A 1 hour cure cycle at 88°C after a 16 hour room temperature hold was completed on samples CP-2 through CP-4. The 1 hour at 88°C is a repair cure cycle developed for use of the EA9396 epoxy resin on 220°F service temperature aircraft [82] and the 16 hour room temperature hold was utilized to allow the acetone to vaporize out of the diluted mixture prior and for the EA9396 to gel. Samples CP-2 (30% acetone dilution) and CP-3 (20% acetone dilution) were cured at 88°C for 1 hour after a 16 hour room temperature hold, show major porosity in the cured coupon (see Figure 4.49 and Figure 4.50), therefore no microscopic visual inspection was completed. Sample CP-4 (10% acetone dilution) was cured at 88°C for 1 hour after a 16 hour room temperature hold, exhibited porosity on the surface of the coupon around the edges and micro-porosity was observed in the photomicrograph of the coupon cross-section. The porosity in all coupons was not observed after the 16-hour room temperature hold, but appeared after the elevated temperature

cure at 88°C was completed even if the coupon appeared gelled. It was determined that the cure temperature at 88°C was above the boiling point of acetone at 56°C. Therefore it was determined that a longer solvent room temperature off-gas period was required to prevent the solvent from boiling and creating porosity in the repair resin.

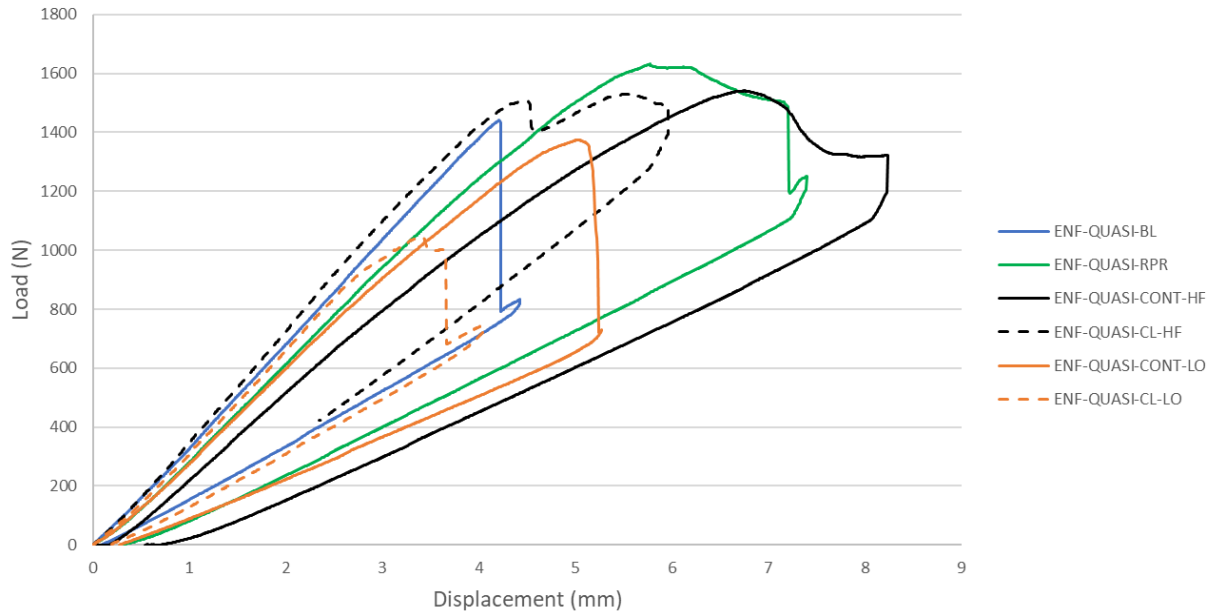
**Figure 4.63. Load vs. displacement curve of quasi-isotropic modified ENF coupons**

The quasi-isotropic modified ENF testing did not exhibit as much discrepancy in stiffness between samples sets. The ENF-QUASI-RPR, ENF-QUASI-CL-HF, and ENF QUASI-CL-LO coupon sample sets that were representative of non-contaminated or contaminated and cleaned delaminations, have similar stiffness to the baseline laminate. However the contaminated samples sets (ENF-QUASI-CONT-LO and ENF-QUASI-CONT-HF) did not have a considerable reduction in coupon stiffness as seen in the unidirectional coupon testing. The non-contaminated or cleaned coupons had stiffness ranging between 325-375 N/mm, whereas the contaminated coupons had stiffness between 283-308 N/mm. The reduction in contaminated coupon stiffness was approximately 12% compared to baseline laminate properties.

In order to test the effect of the novel injection repair process on laminates that are more representative of lay-ups found on aircraft, quasi-isotropic modified ENF testing was completed. Figure 4.63 shows an example of the load versus displacement curves for the each of quasi-isotropic modified ENF sample sets.

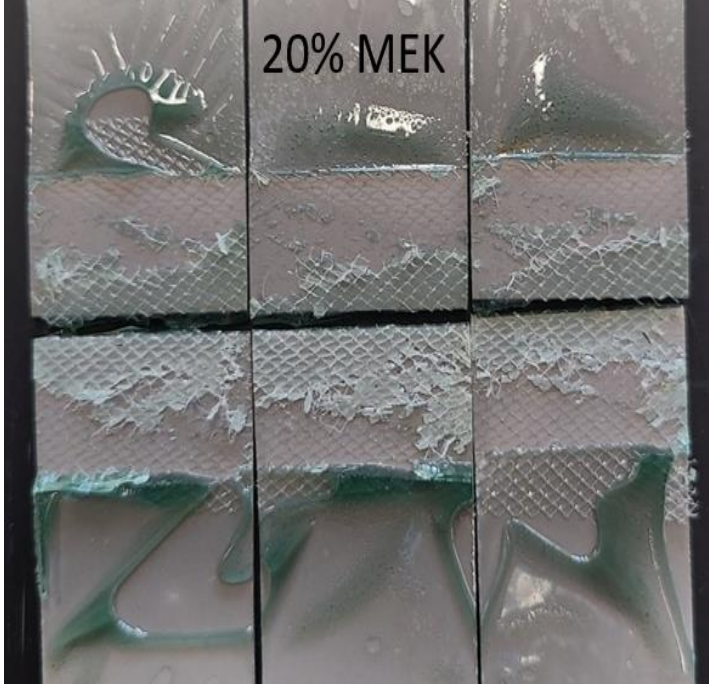
Figure B.5. LS-MEK-20 coupon failure surfaces

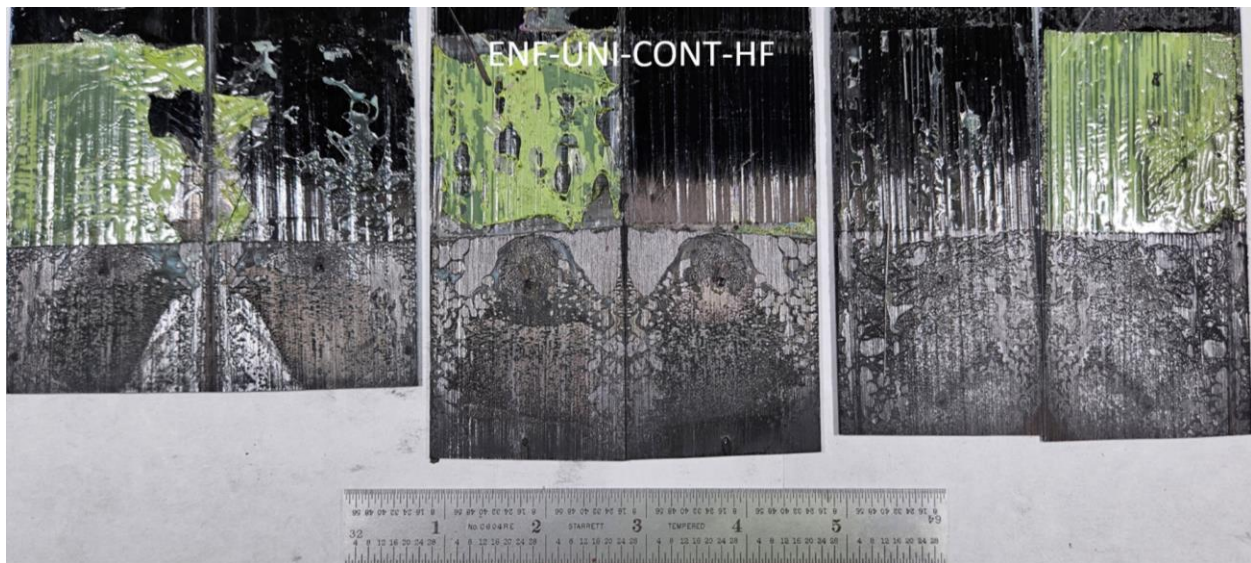
**Figure C.4. ENF-UNI-CONT-HF failure surfaces**

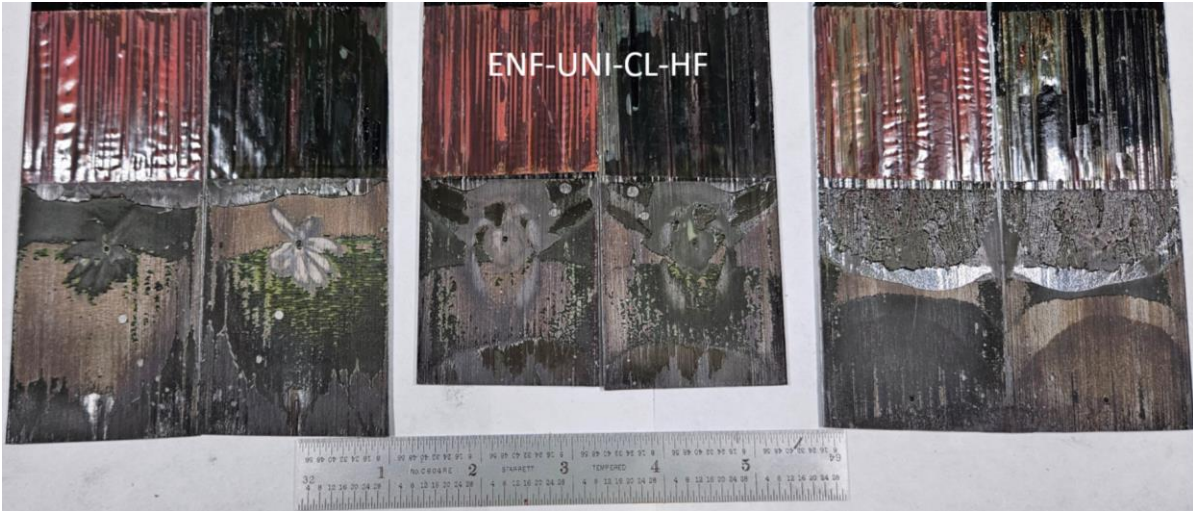
**Figure C.7. ENF-UNI-CL-HF failure surfaces**

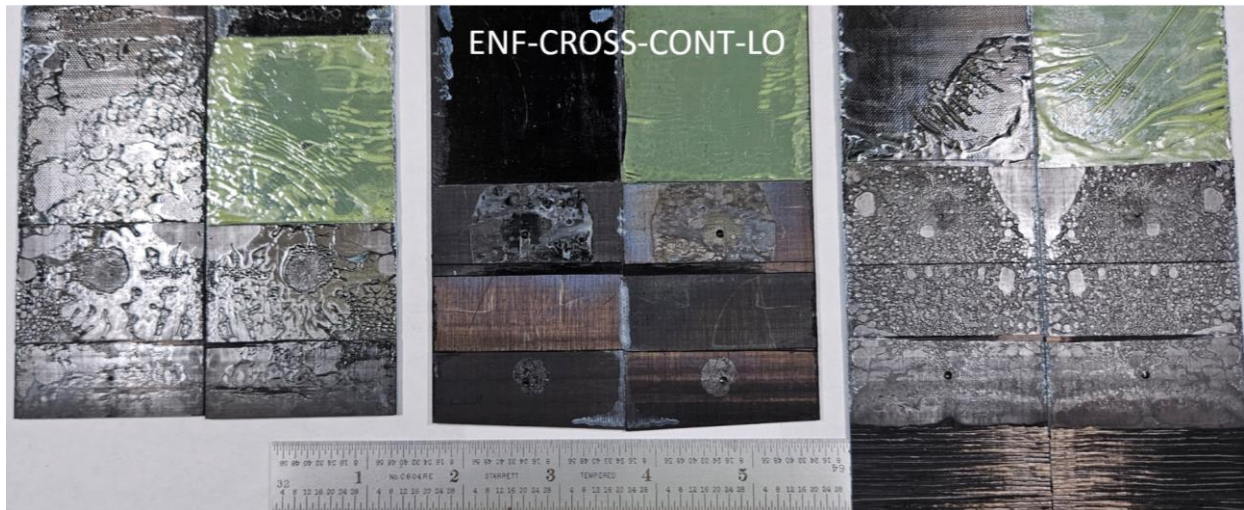
**Figure C.12. ENF-CROSS-CONT-LO failure surfaces**

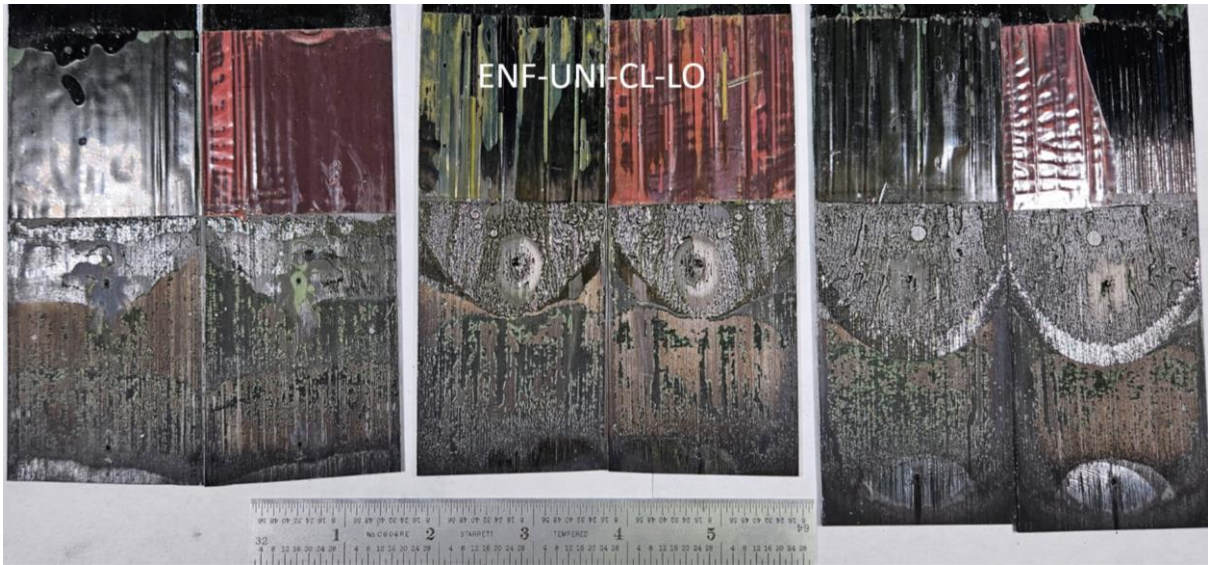
**Figure C.13. ENF-UNI-CL-LO failure surfaces**

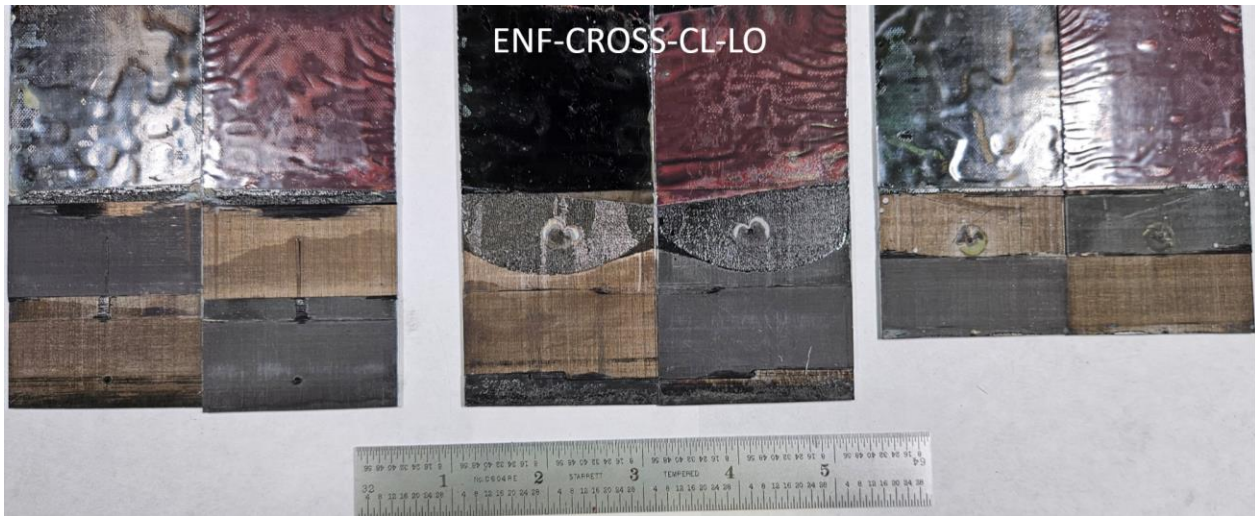
**Figure C.15. ENF-CROSS-CL-LO failure surfaces**
