The New York Times headquarters daylighting mockup: Monitored performance of the daylighting control system

The New York Times Headquarters Daylighting Mockup: Monitored performance of the daylighting control system

E.S. Lee^{*}, S.E. Selkowitz

Building Technologies Program, Environmental Energy Technologies Division, Lawrence Berkeley National
Laboratory, Mailstop 90-3111, 1 Cyclotron Road, Berkeley, CA 94720, USA

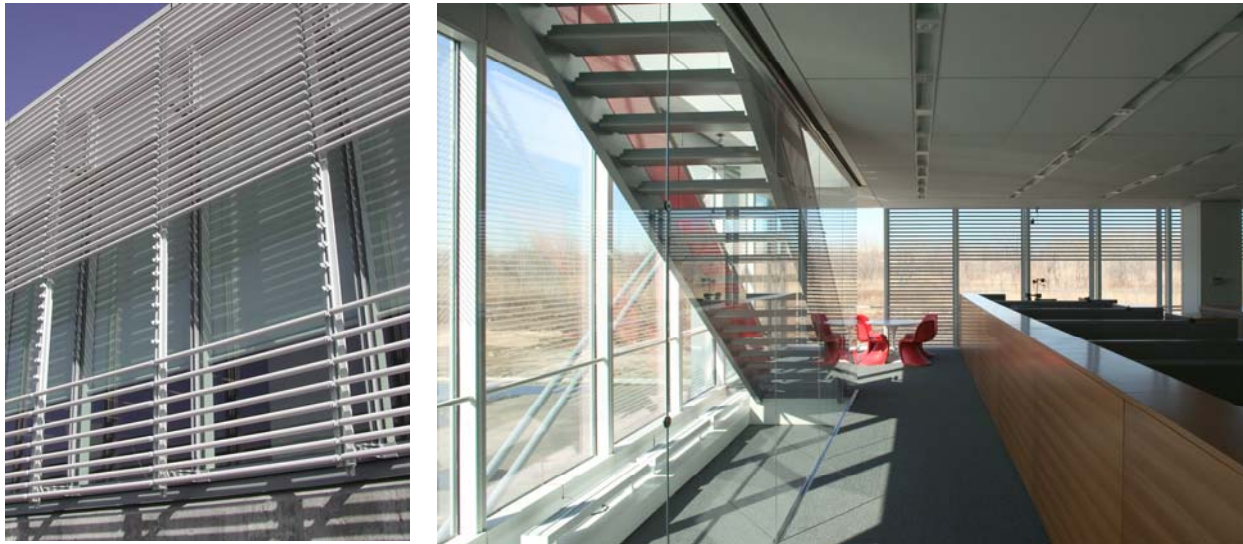
Fig. 1. Exterior view of the west façade of The New York Times daylighting mockup (left) and interior view of Area B (right) on February 23, 2004 with south-facing windows on the left-hand side of the photograph.

parking lot of their nearby printing press site in Flushing, New York. The mockup reproduced the southwest corner of a typical floor in the 51-storey tower (Figure 1). It was located at latitude 40.8° and longitude 73.9° and its orientation matched the orientation of the Manhattan site. The “south” and “west” windows faced 28.7° and 118.7° west of true south, respectively.
