MONITORING AND EVALUATION OF RADON MITIGATION SYSTEMS OVER A TWO-YEAR PERIOD

Presented at the 1988 Symposium on Radon and Radon Reduction Technology, Denver, CO, October 17-21, 1988, and to be published in the Proceedings

R.J. Prill, W.J. Fisk, and B.H. Turk

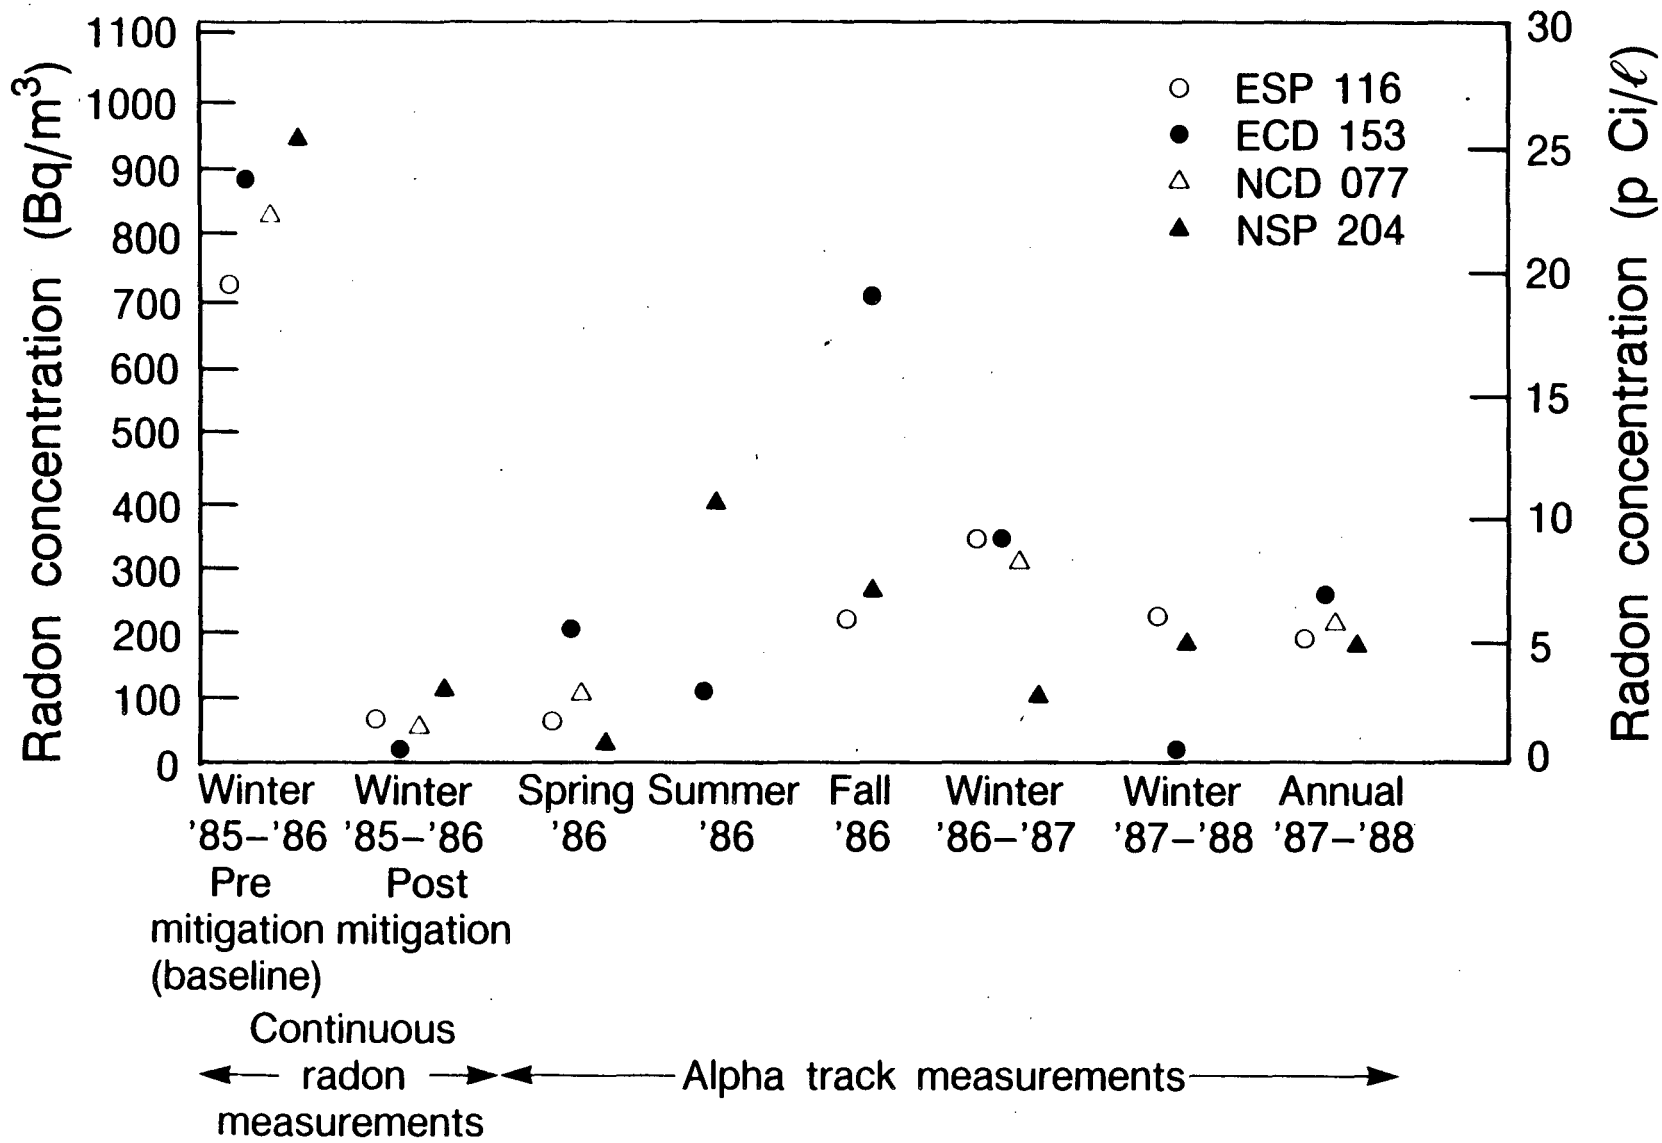
Figure 2. Radon concentrations in the main occupied level of four houses with basement pressurization systems.

These systems have maintained the main level radon concentrations substantially below the baseline values despite periods when some systems were not operated continuously (see Table 1 and Figure 2). However, the radon concentrations in the basements approached pre-mitigation levels in all of the homes during at least one of the alpha track follow-up measurement periods and many of the measured radon concentrations are above both the original post-mitigation concentrations and the EPA guideline. Some of these increases in radon can be explained. For example, during the winter 1986-1987 the system in house ESP153 was turned off at the discretion of the homeowners, while the system in house NCD077 was not operated because the new occupants had not been appraised of the purpose or operation of the system. Also, the crawl-space vents in these homes were closed during these measurement periods. In all of these houses, increased radon concentrations during the summer may be due to the fact that the systems were not operated and adequate natural ventilation may not have been provided. Some of the fall, spring and even the annual measurements may be skewed since the systems were frequently not operated for the entire measurement period. The increased radon concentrations in houses NSP204 and ESP116 during the winter periods 1986-1987 and 1987-1988 are more difficult to explain since the systems were reportedly operated continuously during the entire measurement periods.

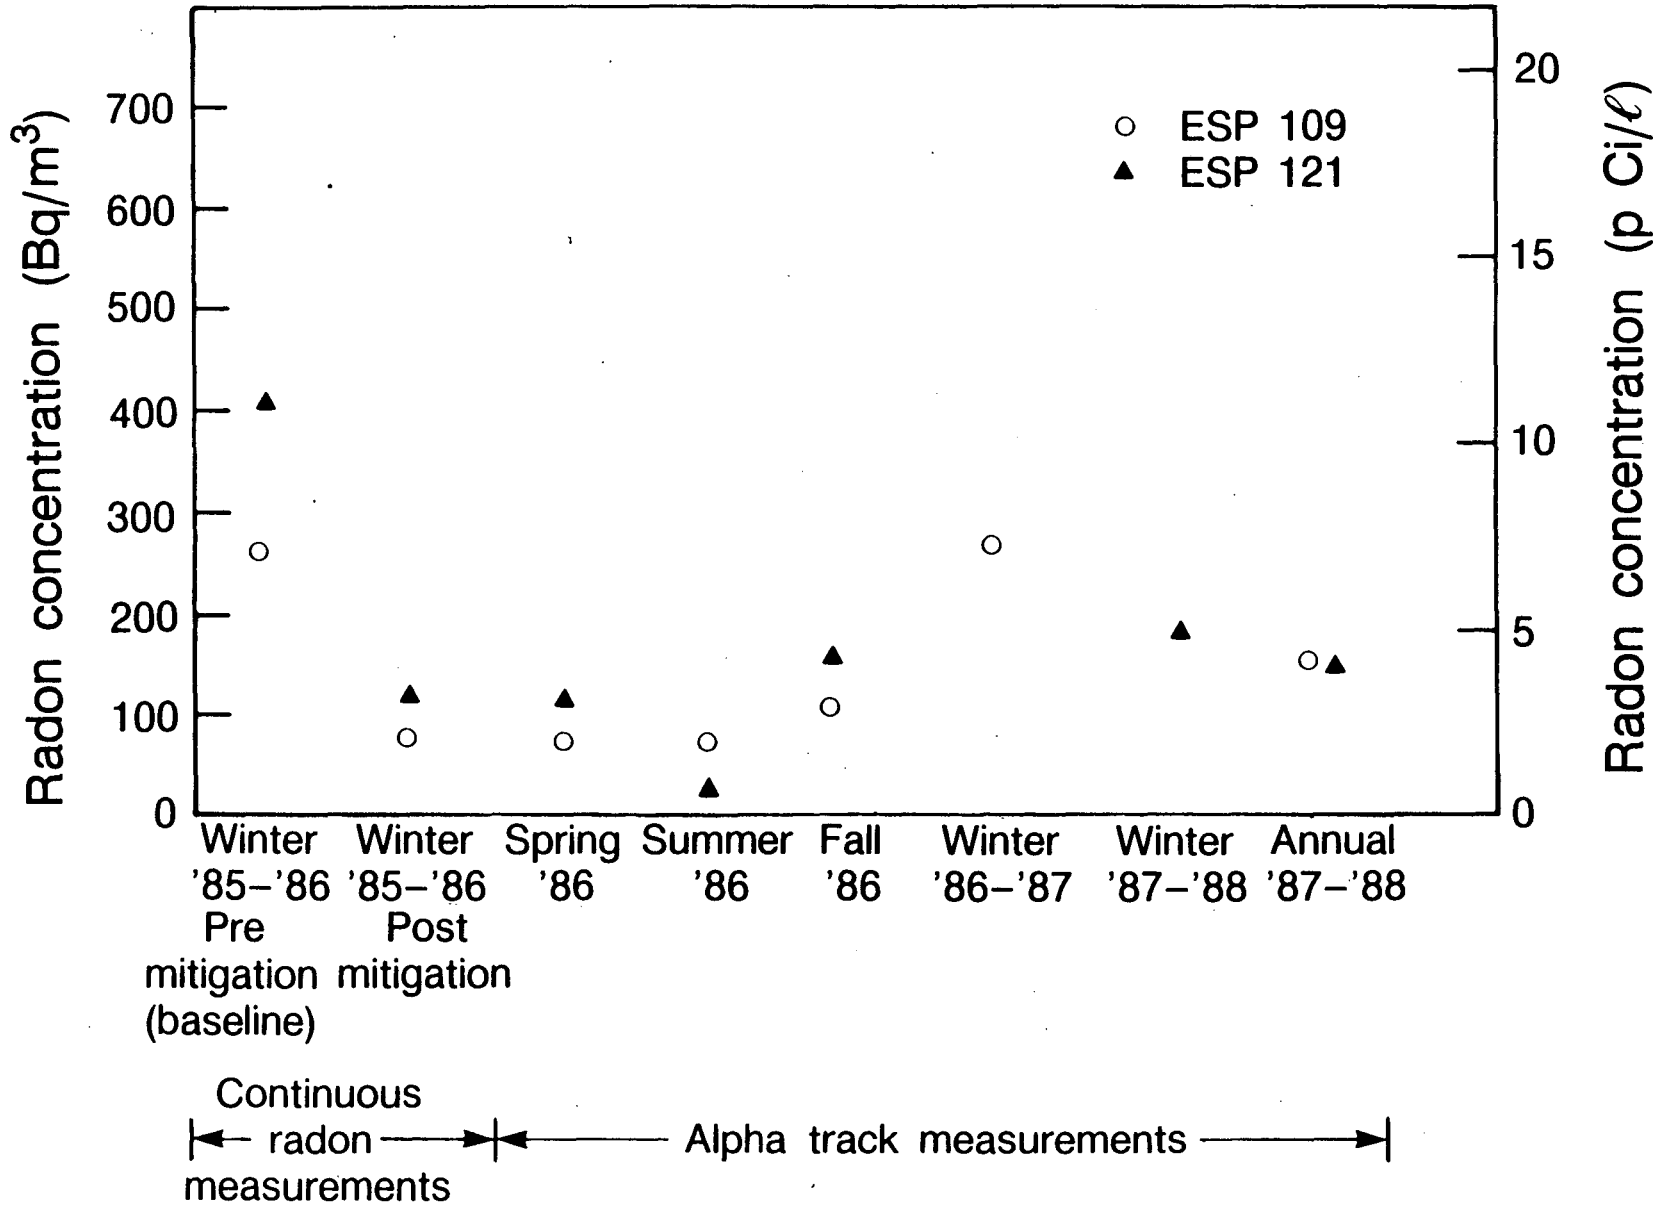
Figure 3. Radon concentrations in the main occupied level of two houses with air-air heat exchangers.
