Development of Hydrologic Characterization Technology of Fault Zones -- Phase I, 2nd Report

**Development of Hydrologic Characterization
Technology of Fault Zones:
Phase I, 2nd Report**

NUMO-LBNL Collaborative Research Project Report

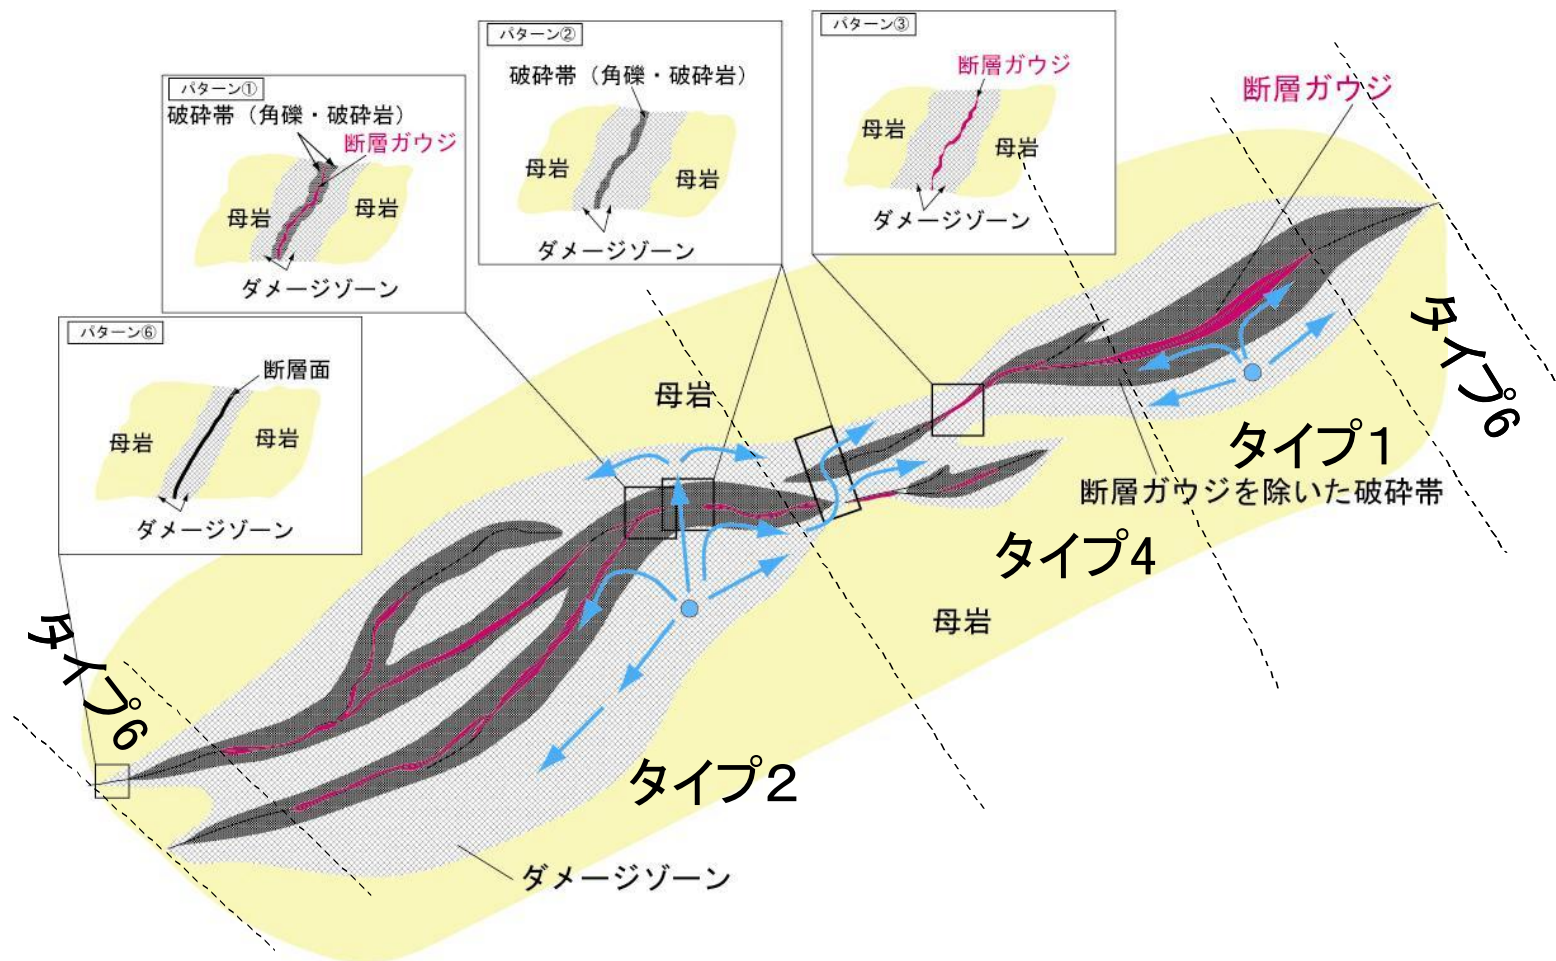
Figure 2-2 Application example of fault type classification. (Kiho et al., 2009)

木方他(2009)はさらに、前節の着眼点における地質特性と断層の水理特性の関連性について整理している (Table 2-3~9)。それらの結果に基づいて木方他(2009)は断層の水理特性を念頭に置いた地質特性に基づく断層のタイプ分類法の提案を行っている (Table 2-10、Figure 2-1 および Figure 2-2)。彼らは以下のようなタイプ分類判定作業の流れを例示している。

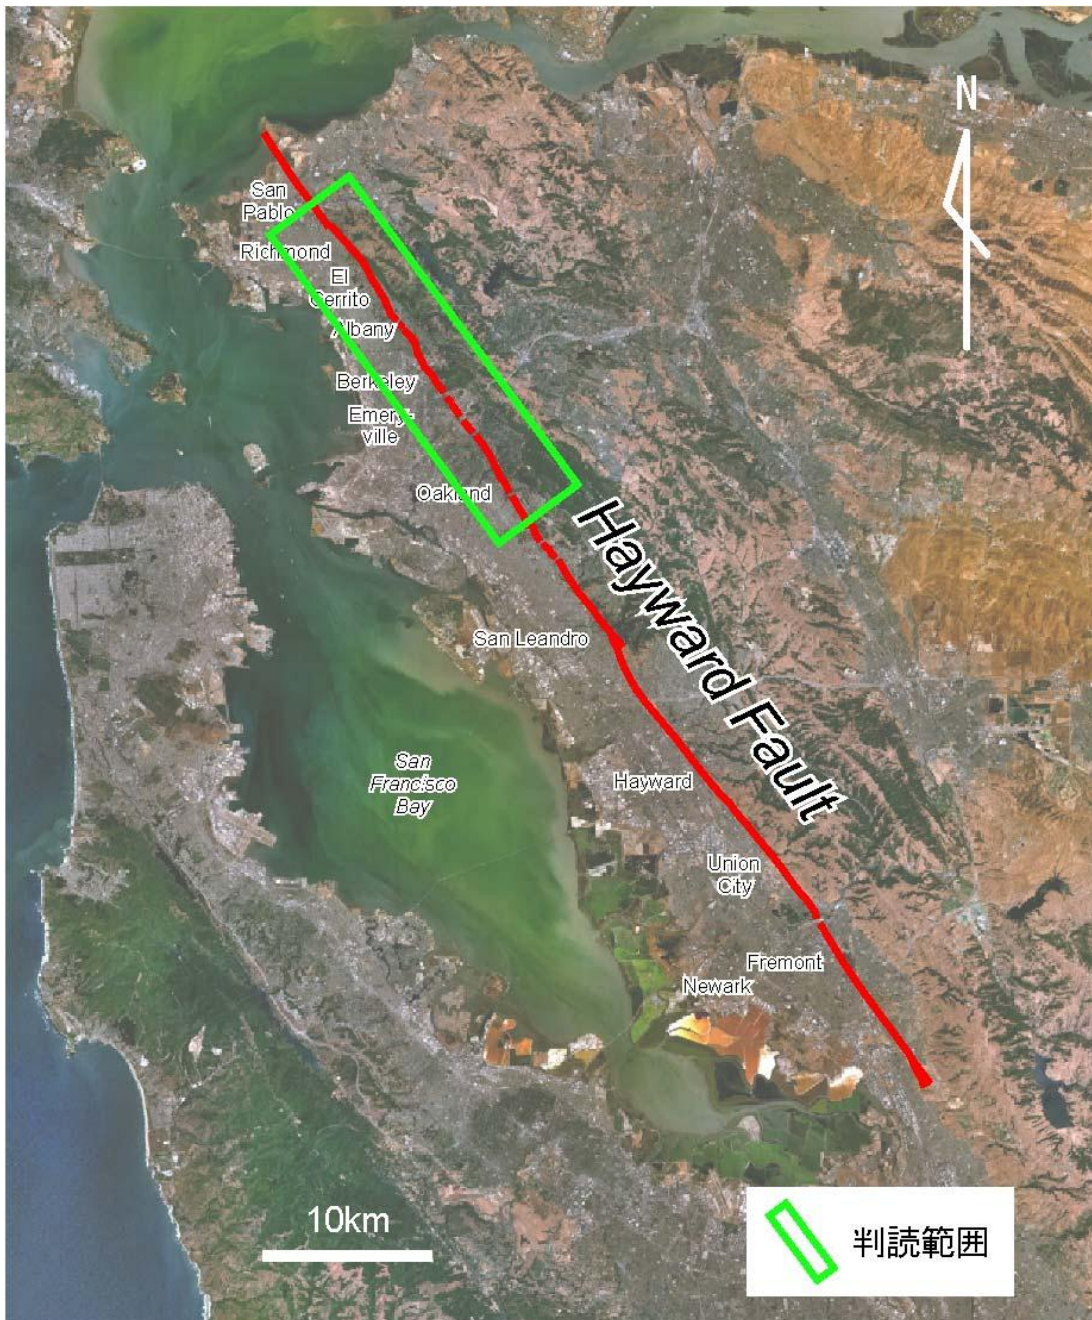
Figure 3-1 Aerial photo analysis area by Kiho et al. (2009).

USGS によって 1968 年に撮影された縮尺約 3 万分の 1 のモノクロ写真を使って木方他(2009) はヘイワード断層系沿いに, LBNL の敷地周辺に分布する Wildcat 断層を中心とした長さ約 25km について空中写真判読をおこなっている (Figure 3-1)。Figure 3-2、Figure 3-3Figure **3-4** に彼らの判読したリニアメントを示す。

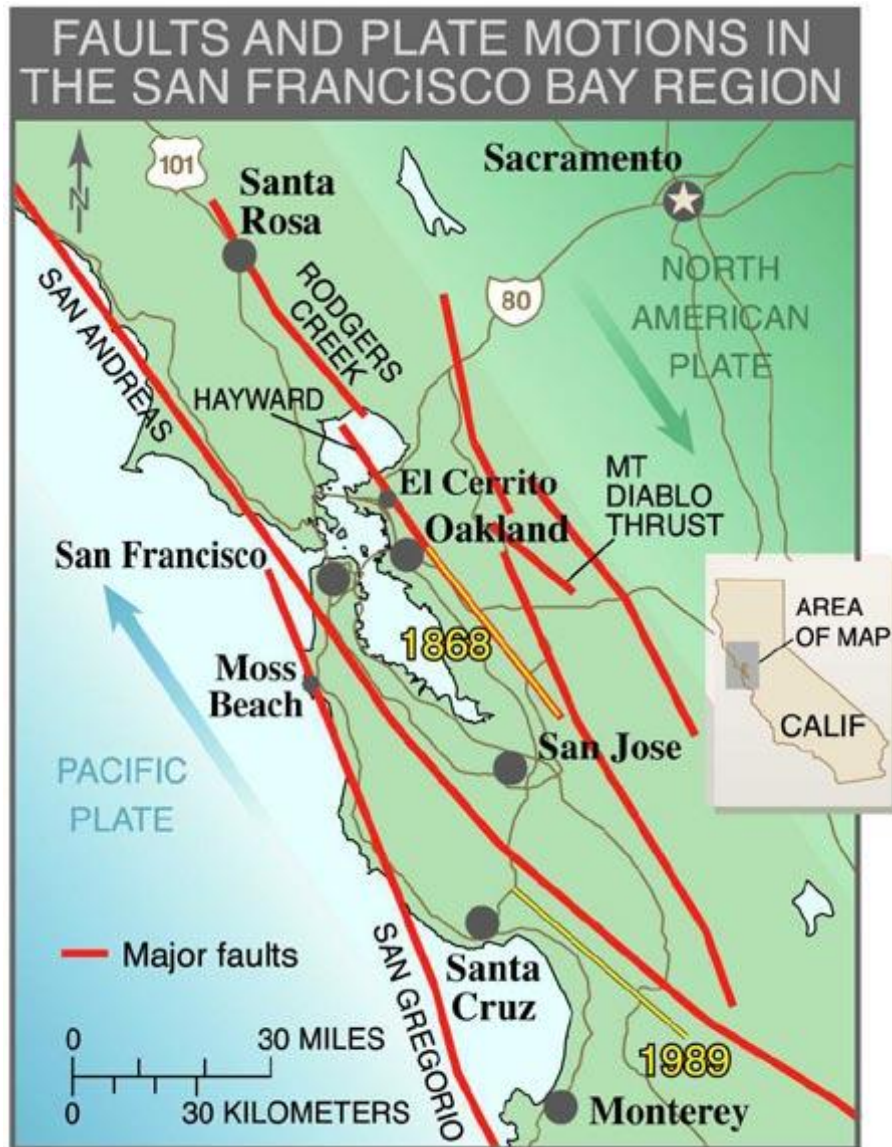
Figure 3-6. Faults and plate motions in the San Francisco Bay Region (USGS). Yellow lines show the location of two major earthquakes.

the 1906 and 1989 events along the San Andreas Fault, and the 1868 along the Hayward Fault (Figure 3-6).

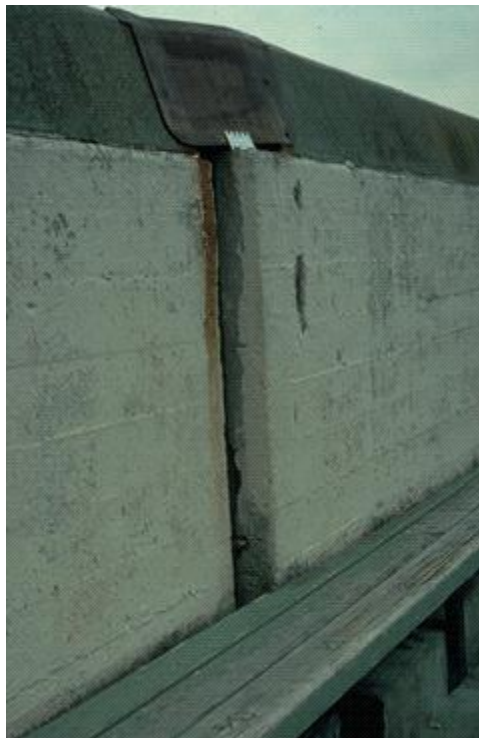
Figure 3-7. Displacement of the U.C. Berkeley Memorial Stadium wall as a result of the movement of the Hayward Fault

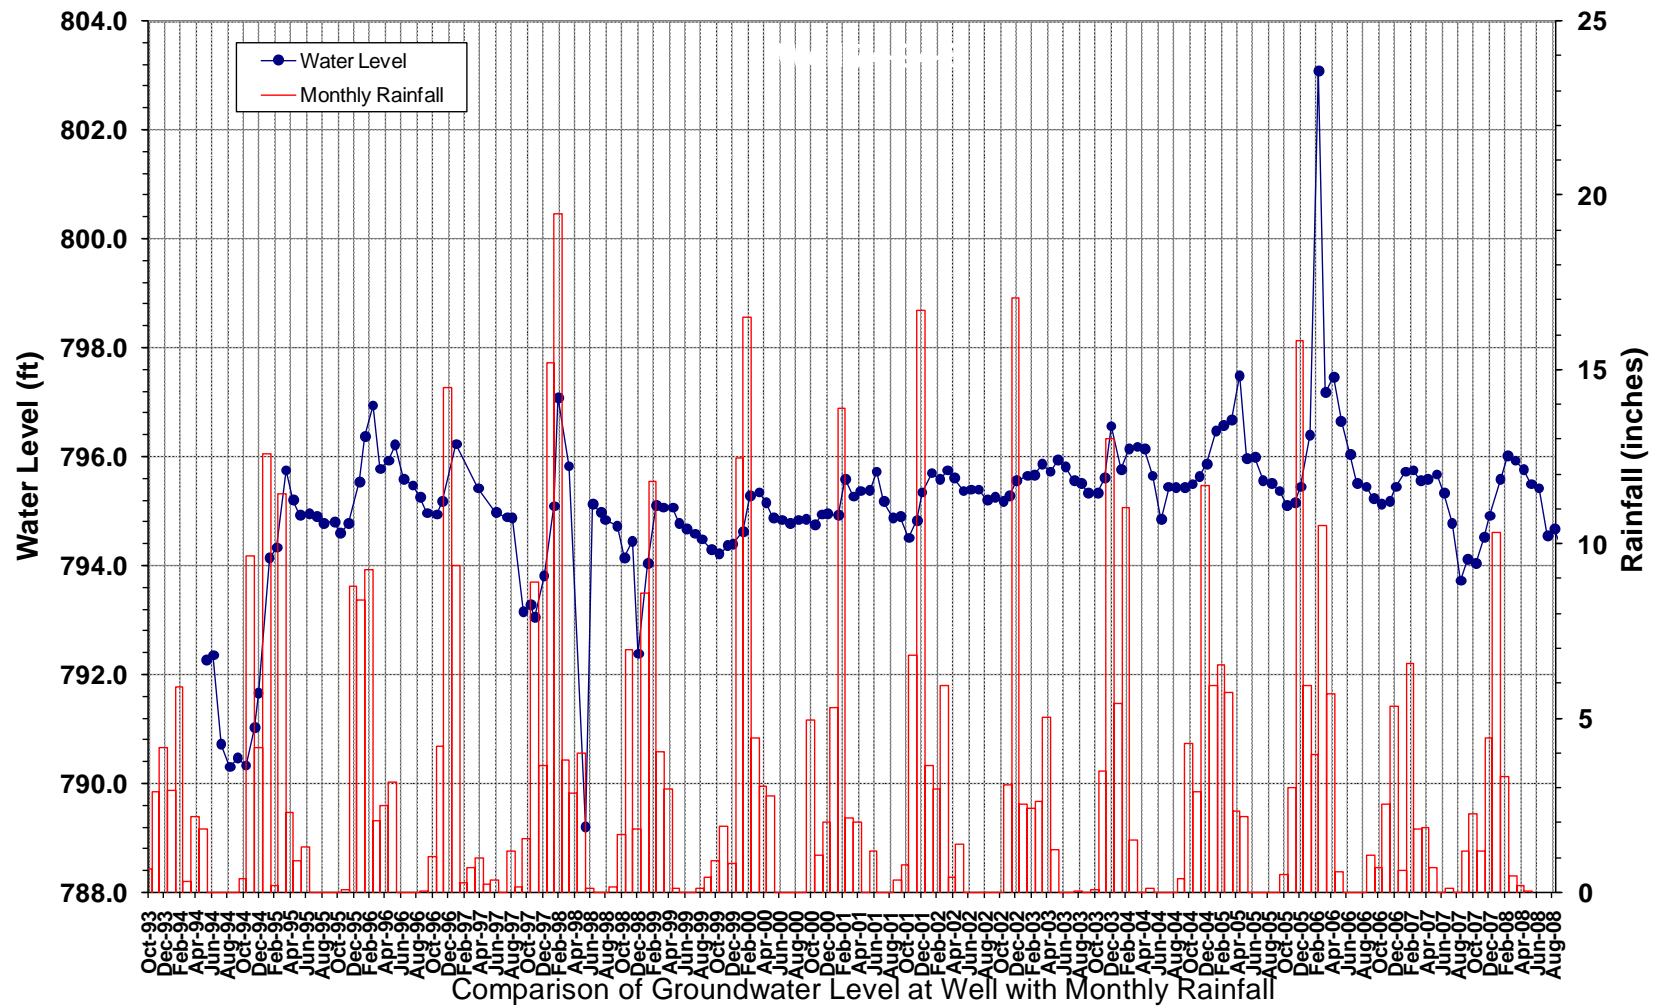
Figure 3-22. Rainfall data and water level in MW74-94-8. (from LBNL 2008)

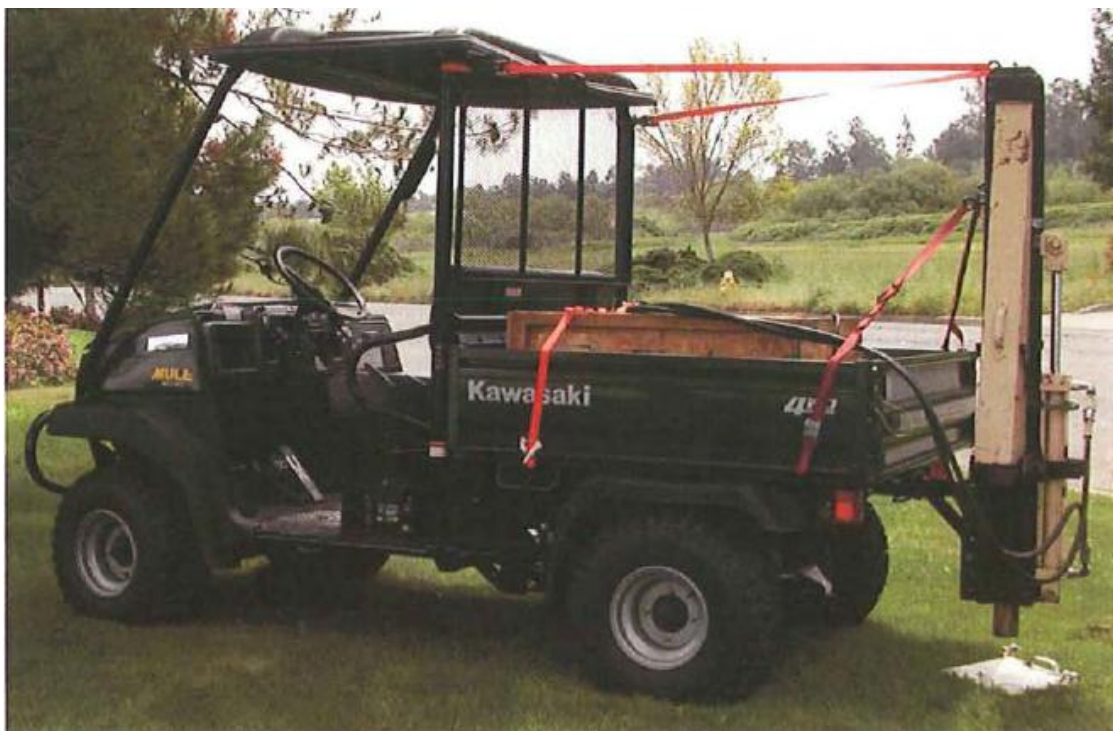
Figure 3-32. Accelerated weight drop system mounted on an ATV (Black, 2009).

反射法地震探査の計測には Geometrics 社の **Geode** と呼ばれる 96 チャンネルの震探システムと 96 機の固有振動数が 40Hz の **Mark Products** の受振機 (**Geophone**) を使用した (Figure 3-31)。測線 1 と 2 では **geophone** の間隔を 3m とし、 $3m \times (96-1)$ で全長 285m の配列とした。測線 3 は 72 個の **geophone** を使用し、全長 213m であった。いずれの測線も予想されている **Wildcat** 断層のトレースを中間点として展開した。震源はそれぞれの測線の端の受振機の 1.5m 外側から開始し、3m おきに発振した。結果、測線 1 は 96 地点で発震、測線 2 は 97 地点、測線 3 は 73 点の発震点となった。殆どの地点において震源は **ATV** (**All Terrain Vehicle**、全地形万能車) に搭載した **accelerated weight drop** と呼ばれる震源を使用した。ATV でもアクセス不能であった測線 1 の東端ではハンマーとプレートを使用した。

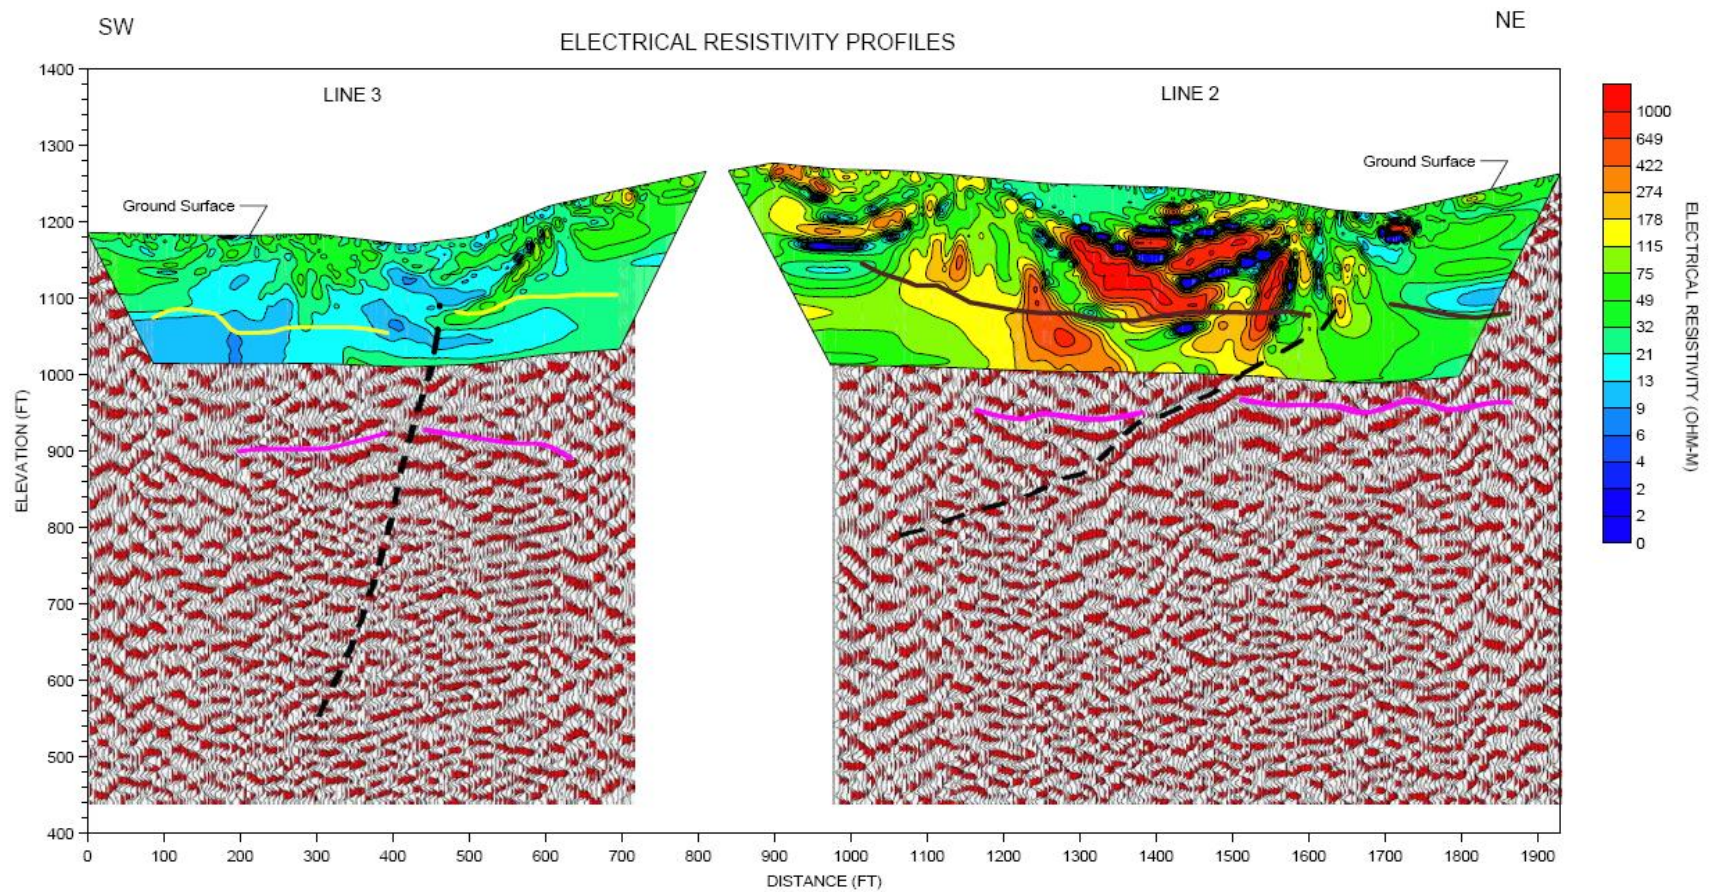
Figure 3-41. Superimposed plot of electrical resistivity and seismic profiles from Line 2(right) and Lin3 3(left).

(CMP Stacking) の地点番号を示す。Figure 3-37、Figure 3-38、及び Figure 3-39 の縦軸は往復走時であり、深度に比例するが、深度の絶対値を決定する為には各地層の P 波速度が必要である。一般に P 波速度はボアホールを掘削して計測するが、現時点ではデータが存在しない。その為、比抵抗解析結果と総合して P 波速度を推定した。具体的には比抵抗が概ね一定になる深度と最も浅い P 波の反射面を同一深度として重ね合わせた (Figure 3-40 及び Figure 3-41)。その結果、風化していない基盤岩表面は標高 256m 付近であると推定される。これは往復走時にして 400 msec となり、P 波速度では 1280 m/s となる。この速度は比抵抗探査の到達深度である 50m~75m の深度では妥当であると考えられる。ただし、より深度が深くなるにつれて速度が早くなると考えられるので 75m 以深の反射面は図に示す深度より、深い深度である可能性があると考えられる。

Figure 3-37、Figure 3-38、Figure 3-39 および Figure 3-40、Figure 3-41 に反射波と比抵抗の総合解析から推定される反射ホライズン A、B、C をそれぞれ緑色、紫色、青色の線で示す。これらの層は地質図からも推定されるそれぞれ異なった堆積地層の反射面であると考えられる。ホライズン A は識別を容易にする為 Figure 3-40 及び Figure 3-41 では黄色、茶色の線で表す。測線 1 の反射断面図の Figure 3-37 に CMP73 地点の直下のホライズン A の上下方向の顕著なオフセットによると考えられるアーチ状の回折パターンを黄線で示す。さらに、A より深い深度の反射ホライズン B、C も鉛直方向にオフセットしていると考えられる。これらのオフセットの位置を総合して判断すると黒の破線で示す断層が存在すると解釈できる。この断層は東側がせり上がり、西に高角度で傾斜していると思われる。これは HLA (1980)が行ったトレンチ A の調査で確認された Wildcat 断層と考えられる断層と性状が一致している。測線 2、3 においても、Figure 3-38、Figure 3-39 に見られるように反射ホライズン A 及び B の存在が推定できる。さらに測線 3 では Figure 3-39 に黄線で示すように測線 1 で見られた反射ホライズン A の不連続性による回折パターンが確認できる。しかしながら、測線 1 で見られた反射ホライズンは測線 2、3 では認める事が出来ない。上下方向のオフセットは測線 1 で見られたほど大きくないが、測線 1 で見られたと同様、東側がせり上がっており、西に傾斜している。測線 2 で解釈される断層は傾斜角度が測線 1 や 3 と比較してかなり浅い。これらを総合し、想定される断層を Figure 3-38、Figure 3-39 に黒い破線で示す。これらを地表に外挿すると地表踏査で確認された断層の位置とほぼ一致する。

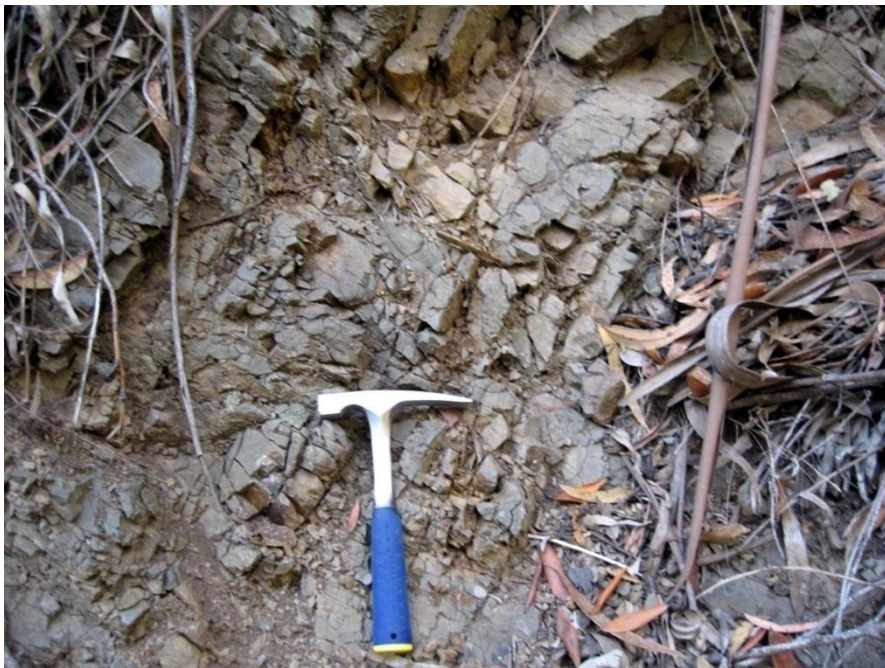
Figure 3-45. Weathered and fractured volcanics of the Moraga Formation

Several outcrops of volcanics of Moraga, cherts and siltstone of Claremont, and sandstone and siltstone of the Orinda Formation are exposed along the Fire Trail. Near the north entrance of Grizzly Peak Road, several blocks of weathered volcanic basalts and volcanoclastics were observed on the ground and exposed at road cut. The exposure near the road cut are highly weathered and fractured near the trace of the Wildcat Fault. It is less weathered farther east along the Fire Trail (see map for details of the outcrop location). Figure 3-45 shows an example of the weathered and fractured volcanic rock near Grizzly Peak.

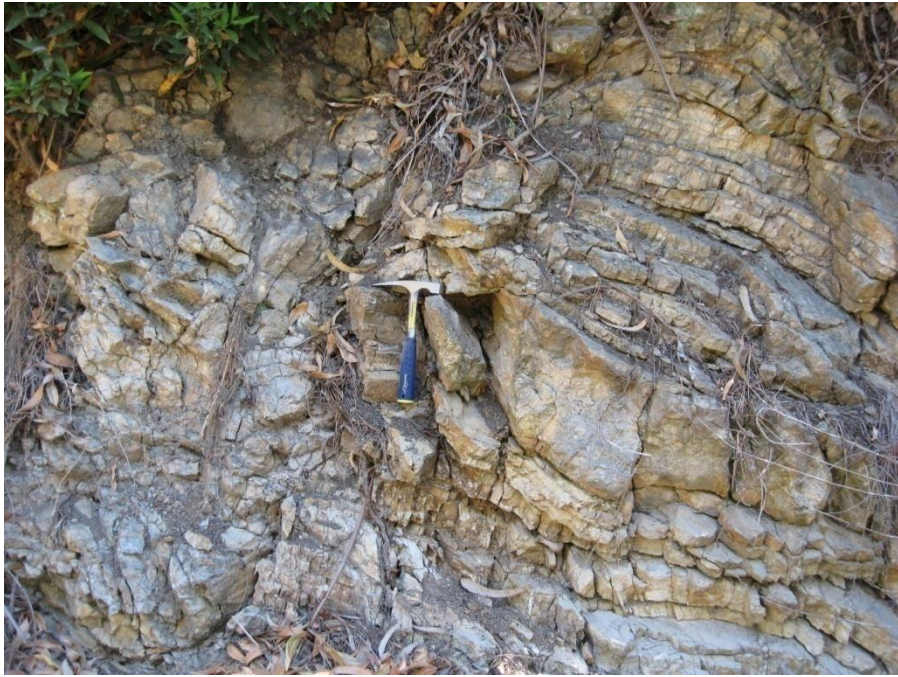
Figure 3-46. Overturned beds of cherts and siltstone of the Claremont Fm, Fire Trail, Berkeley

The outcrops of the Claremont cherts and siltstone are well exposed along the Fire Trail. The bedding varies from subhorizontal to steep dip to the south. Locally, the beds are overturned and tightly folded (Figure 3-46) in the shape of a wave. The cherts are moderately weathered, usually pale yellow with fractures visible normal to the bedding. The average fracture space is 10 cm. Each bed contains millimetric intercalations of a thin (~ 5 mm wide) layer of gray siltstone. Black cherts are also commonly interbedded with light-colored chert. The average thickness of the chert varies from 2 to 10 cm. Occasionally, thick (up to 50 cm), weathered tuffaceous siltstone, oxidized to an orange color, is found intercalated with bedded cherts.

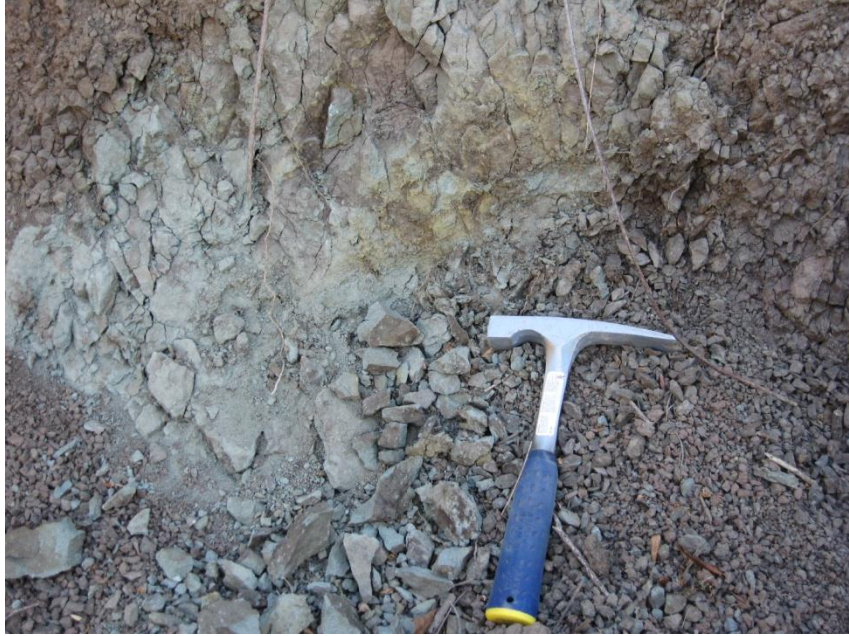
Figure 3-48. Outcrop of typical mottled weathered reddish and greenish siltstone of Orinda formation in the Fire Trail, Berkeley

Outcrops of the Orinda Formation are rare along the Fire Trail. One of the main and typical exposures is near a creek that connects Grizzly Peak and Panoramic Way. There, mottled reddish mudstone, with scaly cleavages and greenish, unconsolidated, and friable fine-grain sandstone to siltstone are exposed at the sidewalk and along the creek (Figure 3-48). According to HLA (1985), several boring tests have been conducted near Bldg 74. The weak consolidated siltstone of the Orinda Formation is found below 45 ft of colluvial soil.

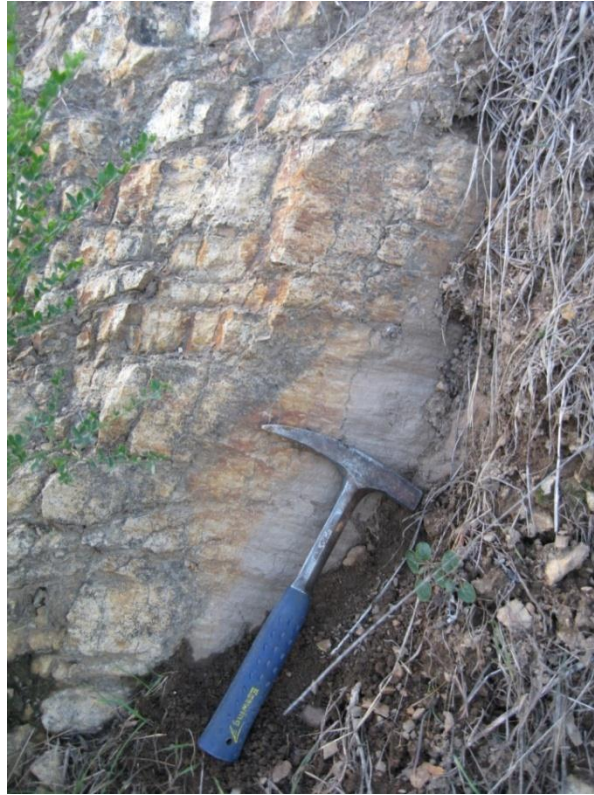
Figure 3-49. Sub-horizontal slickensides in Clermont chert

Along Panoramic Way, which follows a ridge south of LBNL property, cherts of Claremont formation are the bedrock that makes the Sugar Loaf ridge. Several blocks of weathered cherts with slickensides were found near the saddle, suggesting the presence of a fault. About 20 m to the west of the saddle, an outcrop of bedded chert with slickenside indicates right-lateral strike-slip fault movement (Figure 3-49). The fault plane is oriented 37 degrees to the northwest dipping 78 degrees to the northwest, and it shows slickenside with rake of 20°. Near the fault, cherts are fractured in small blocks ranging from 1–2 cm fracture spacing. The bed strikes 27 degrees to the northwest and dips 32 degrees to northeast.

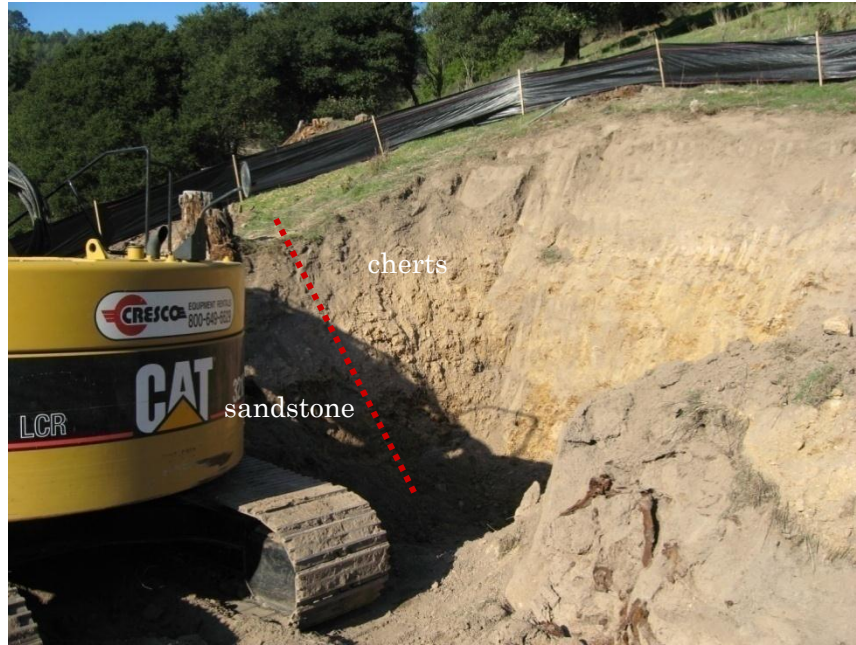
Figure 3-50. Proposed location of Trench TR0. On the north wall, the contact between cherts in the E and sandstone in the W follows the approximate location of the red dotted line.

On December 9, 2008, an excavator started trenching NUMO TR0 near Building 74, about 10 m to the south and parallel to Trench T1 of WLA, 2008. The plan was to have a step trench. Excavation started by opening an area of about 5 m wide into the hill (Figure 3-50). During excavation, a clear contact between the cherts in the east and medium-to-coarse-grained sandstone in the west was observed on the north wall, but before notes and samples could be taken, the site was buried because of safety issues. The lithological contact aligned with the orientation of the trace of the Wildcat Fault from previous work (Figure 3-51).

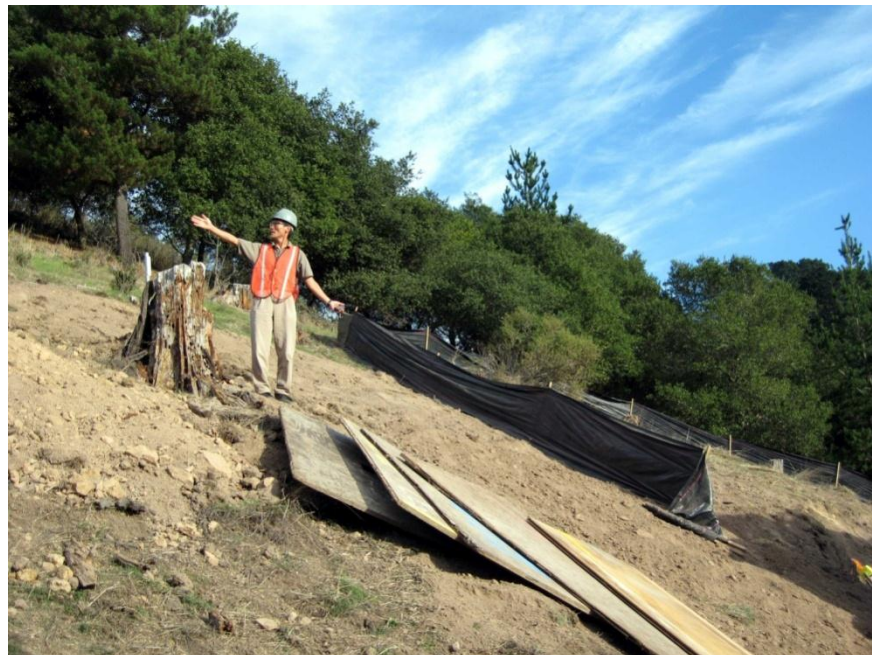
Figure 3-51. Trench TR0 after filled, and location of trench TR1

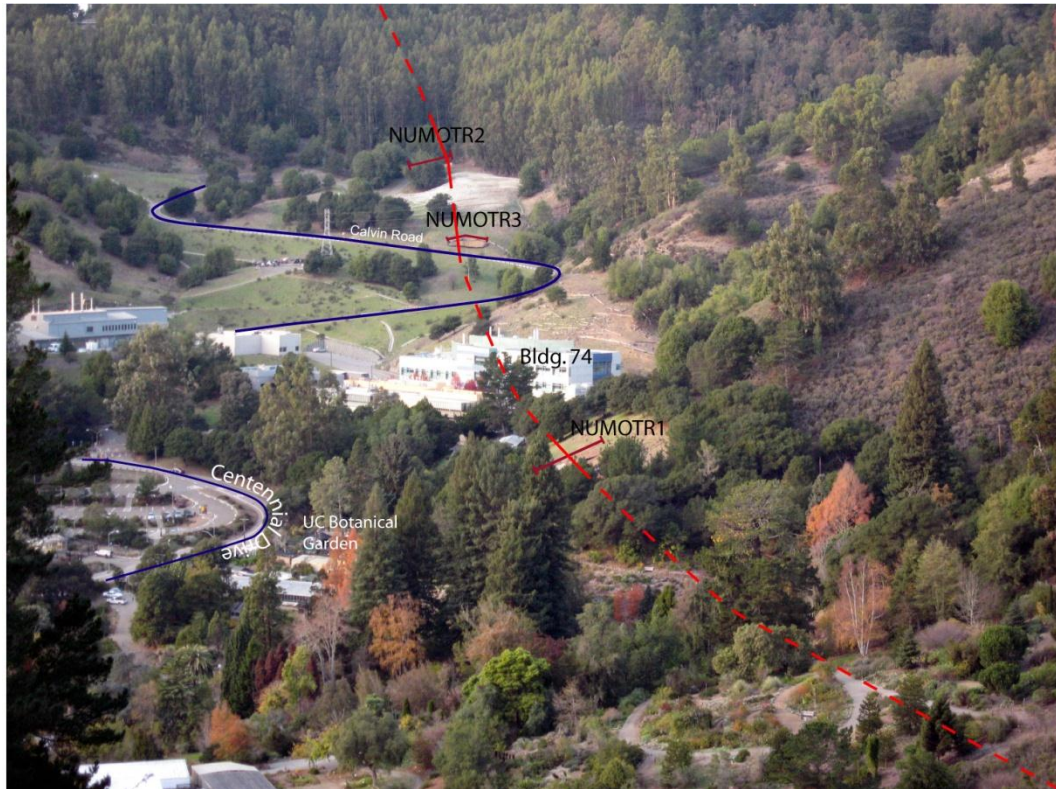
Figure 3-52. View from the Fire Trail of three open NUMO trenches. The lengths of NUMOTR01 and TR02 are approximate. Centennial Road and Building 74 are used as point of reference.

Trench NUMO TR3 was excavated parallel to a ditch a few meters above the hill from Calvin Road (see Figure 3-52). It is oriented N67E and is about 10 m long, 1 m wide, and 1.3 m deep (Figure 3-62). During the visit by NUMO and CRIEPI personnel in September 2008, Preston Jordan led a field trip to the location where NUMO TR3 was trenched. On the ground, several blocks of cherts with slickensides were found. According to Jordan, the fault was observed during the construction of Calvin Road, back in 2001, although it was not recorded in the geotechnical reports. In the geologic map by WLA (2008), the area of NUMO TR3 is covered by a Quaternary landslide. Our field reconnaissance survey and trench work indicated that the area was mostly bedrock.

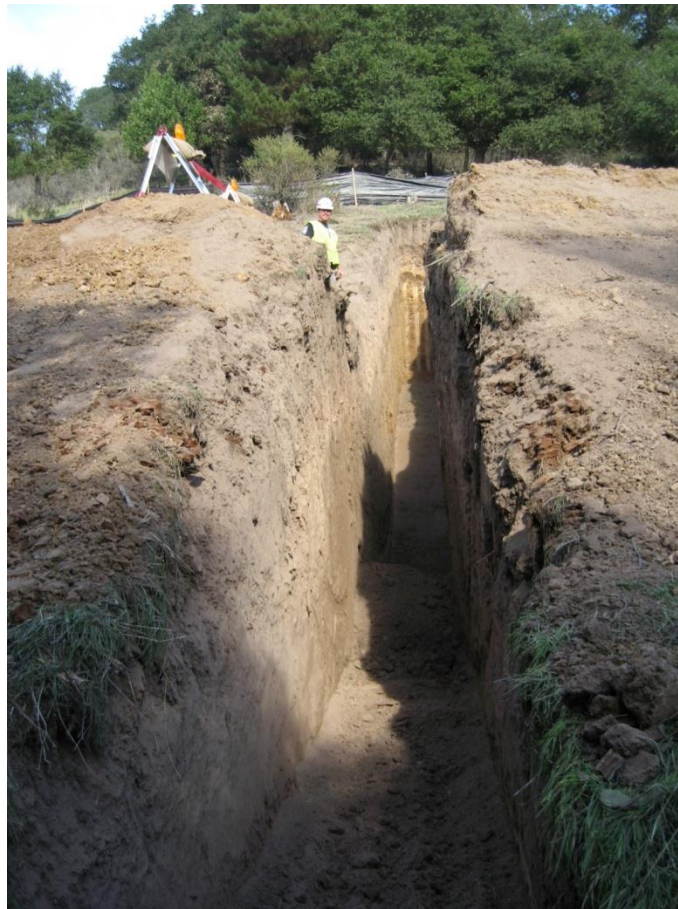
Figure 3-53. View to the east of trench NUMO TR1 before hydraulic shoring was placed.

Trench NUMO TR1 is oriented N15E. It is about 20 m long and 1 meter wide, with depth varying from 2 to 4 m (Figure 3-53).

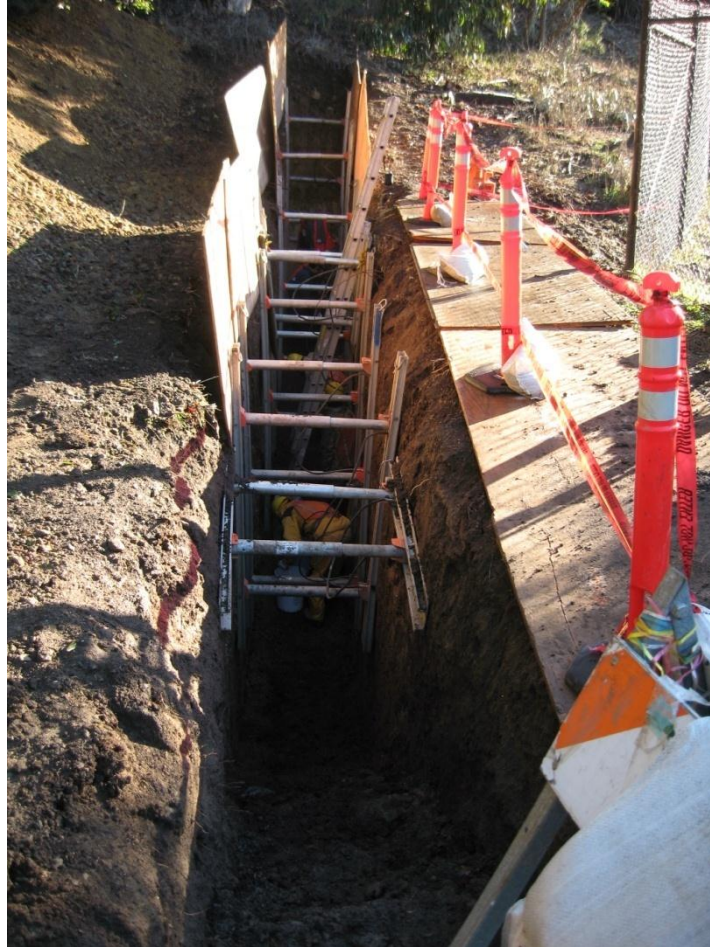
Figure 3-55. View to the east of trench NUMO TR2 near the north gate to the Fire trail.

Trench NUMO TR2 is oriented N79E. It is about 14 m long, 1 m wide and 4 m deep (Figure 3-55).

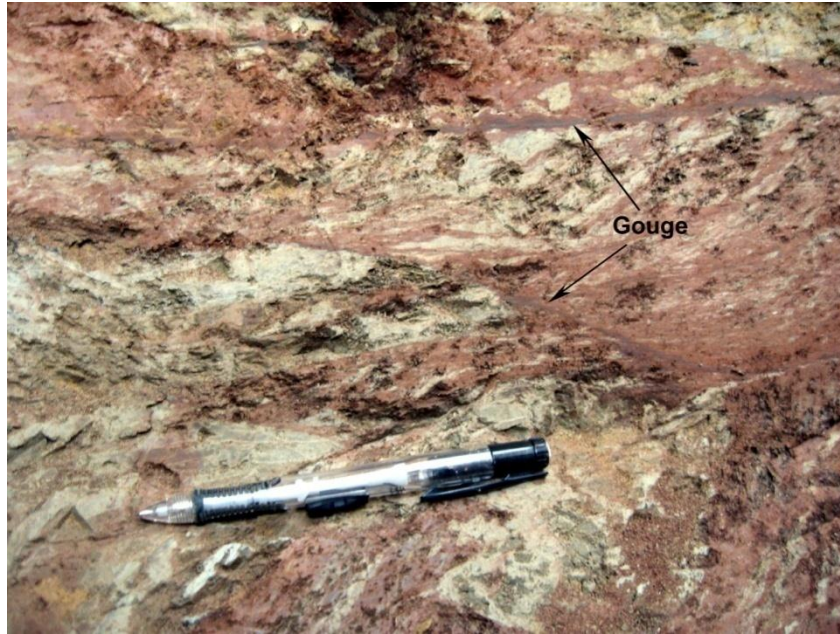
Figure 3-57. Clay gouges in faulted Orinda Formation

In more detail, thin seams of clay gouge (about 1 cm thick) separate portions of the deformed Orinda Formation (Figure 3-57). In the massive sandstone (Figure 3-58), the deformation is concentrated in several vertical to subvertical sets of dark seams less than 0.5 cm wide in average. They are cut by fractures apparently filled with calcium carbonate.

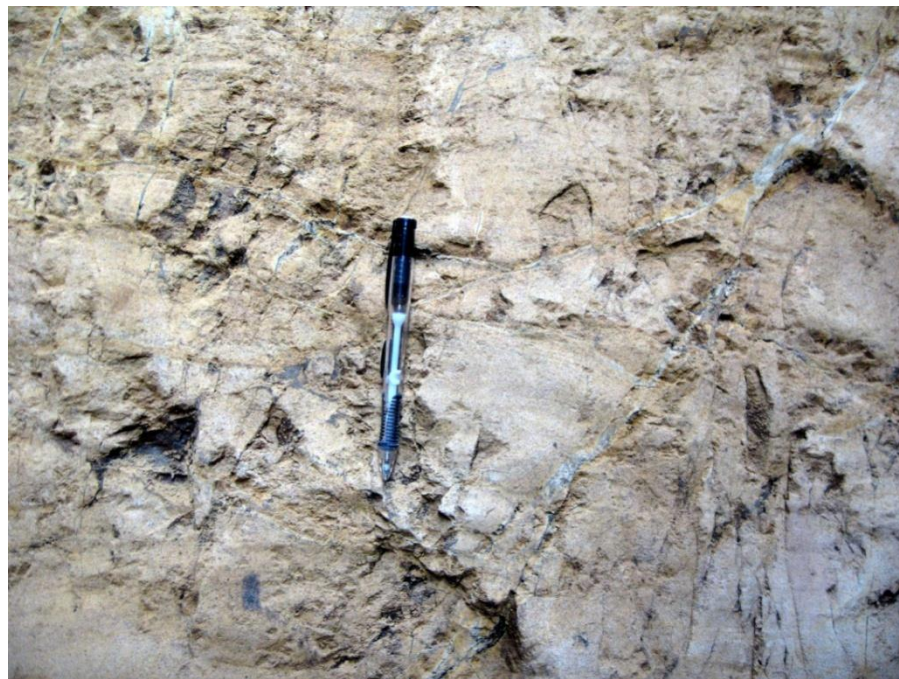
Figure 3-58. Several subvertical and subparallel dark seams observed in the sandstone

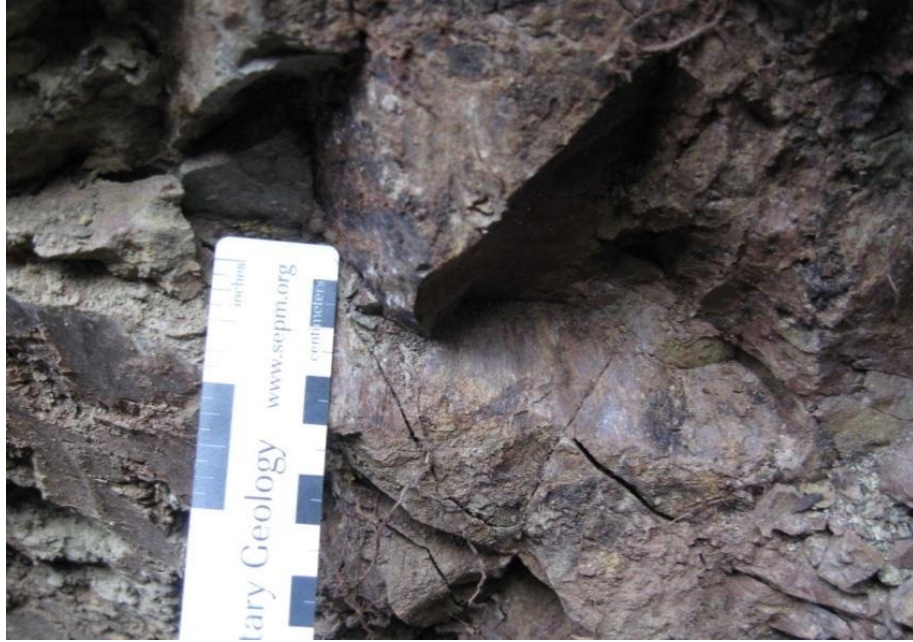
Figure 3-60. Scaly cleavage observed in dark-red mudstone, showing fine slickenside on cleavage plane

The second major fault was observed in the middle of the trench. The fault orientation is northwest with low angle dipping to the northeast (Figure 3-59). The fault contacts the mottled dark red mudstone, bleached to oxidized siltstone and medium-grained green to gray sandstone of the Orinda formation with dark mudstone with scaly cleavage. In the scaly cleavage, fine slickensides are observed on the cleavage plane (Figure 3-60).

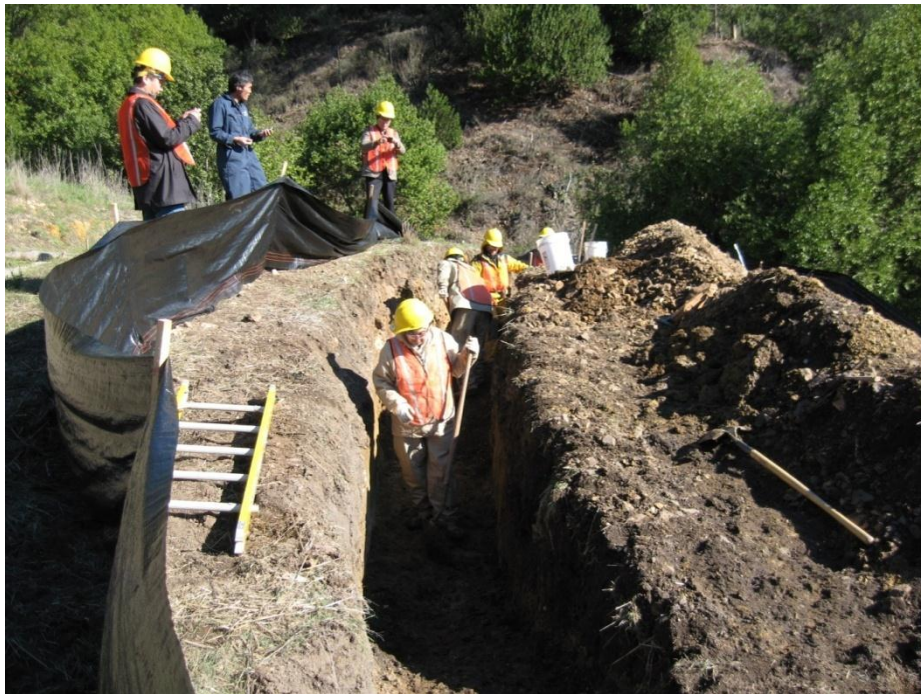
Figure 3-62. View to the east of the trench NUMOTR3

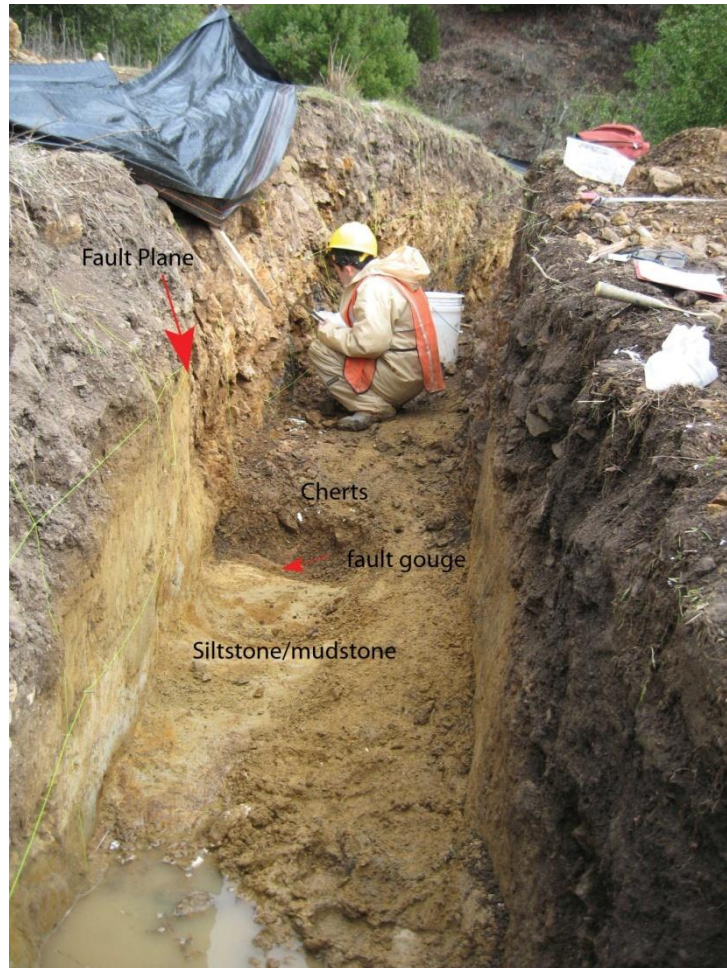
Figure 3-63. West view to NUMO TR3. Note the sharp fault contact between the Orinda and Claremont Formations

The fault zone is a sharp contact between light-green siltstone of the Orinda Formation in the west, and cherts of the Cleramont Formation in the east. In the fault contact, a 2–3 cm up to 25 cm thick zone of gouge was observed. In the gouge, angular fragments of siltstone and cherts were

aligned parallel to the fault plane. The fault orientation is N25W and dip subvertically to the SW. The cherts near the fault were highly fractured (Figure 3-63).

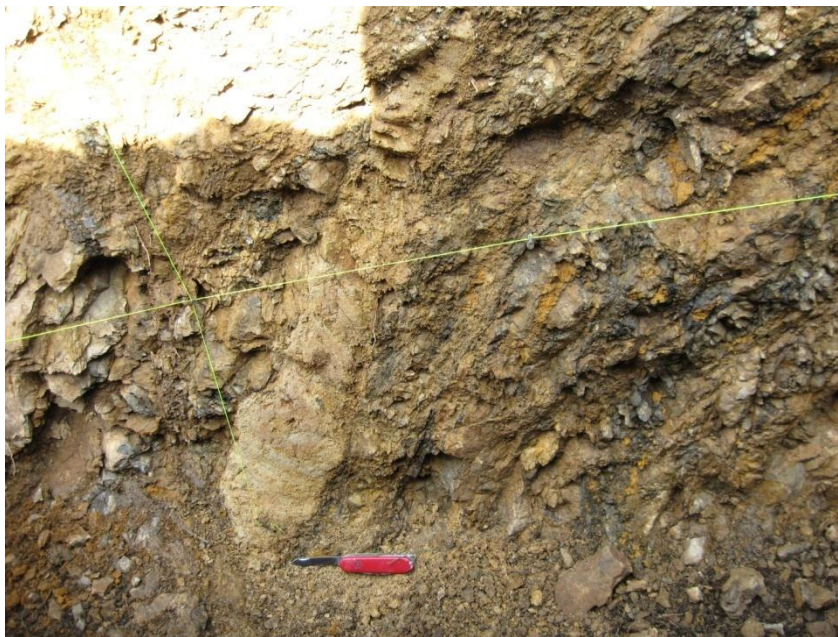
Figure 3-64. Example of intrusive sandstone dike observed in cherts of the Claremont Formation

Approximately four meters east of the fault plane, dikes of weathered, well-sorted, fine-grain sandstone were observed occupying a concordant position with respect to chert bedding. Two sandstone dikes 10–15 cm wide were observed, containing no visible planar structures. The surrounding cherts are moderately fractured (Figure 3-64). The sandstone dikes have been described by Untermann (1935), Graham et al. (1984) and Page (1950) and are common features in the Claremont Formation. Untermann described the presence of sandstone dikes near the zone of disturbance associated with the Wildcat Fault and observed the west side of the fault. Those

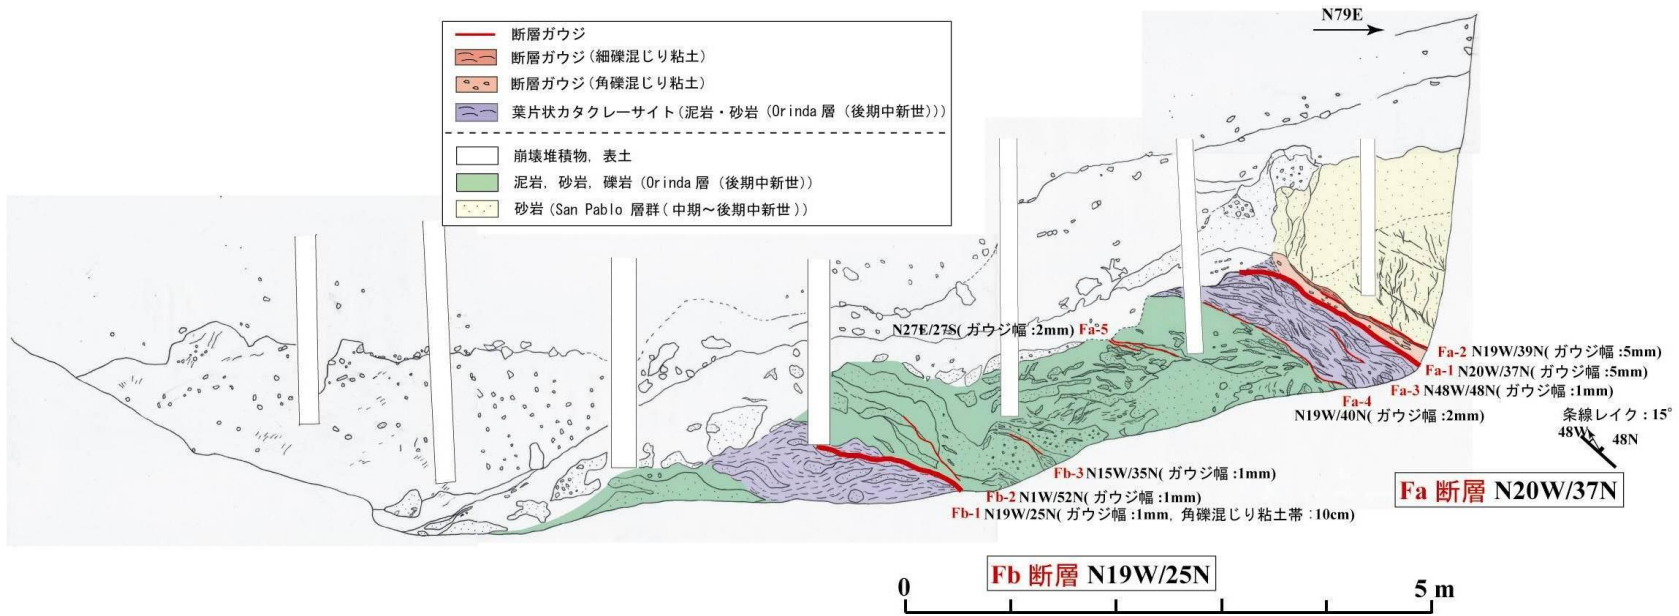
Figure 3-68. Sketch of the north wall of NUMO-TR2. (Kiho et al, 2009)

木方他(2009)は NUMO-TR2 において San Pablo 層に相当する砂岩と Orinda 層に相当する泥岩の境界 (Fa 断層) と, Orinda 層に相当する泥岩内に (Fb 断層) 2つの断層を確認している (Figure 3-68)。以下は木方他(2009)の観察の要約である。

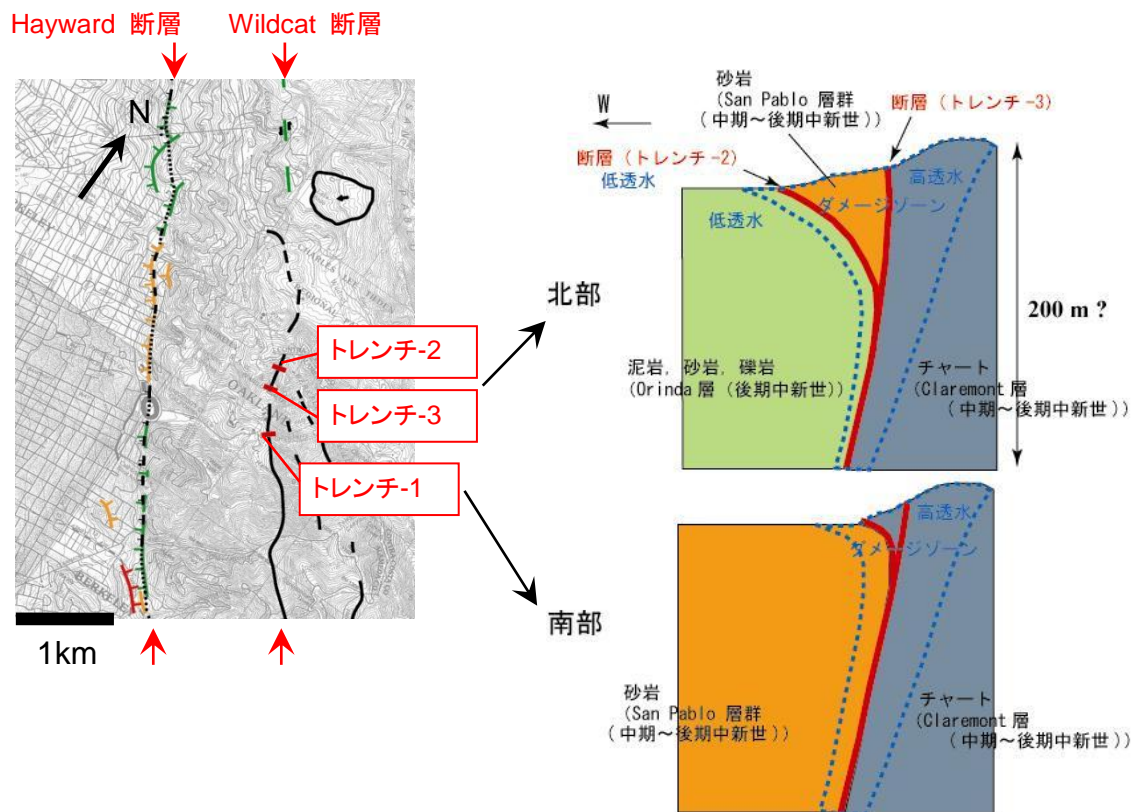
木方他(2009)は 3.1.2.1.3 章で要約した断層構造解析の結果に基づき、LBNL 敷地周辺における Wildcat 断層の北部区間と南部区間を対象に、地質構造モデル(試案)を予察的に作成している (Figure 3-73)。

木方他(2009)は LBNL 敷地の特に北部区間は伸張性のジョグに相当する可能性があるとしている。伸張性のジョグにおいては，正断層変位成分を有する高角度断層の前面側に，逆断層変位成分を有する低角度断層が分岐することが知られており， TR2,TR3 の調査結果に基づく北部区間の断層構造モデルは，これに該当する可能性があるとしている。木方他(2009)はこのような Wildcat 断層系の右横すれ運動が， San Pablo 層群堆積時にも生じていたとした場合，同層群は伸張性ジョグ部の Pull-apart basin に堆積したため，狭長な分布を示していると推定できるとした。さらに San Pablo 層群の砂岩が断層運動により，未固結な状態で Claremont 層と接し，断層変位時の地震動と密接に関連しチャート層に注入して砂岩ダイクが形成され，チャート層も破碎された可能性も挙げている。またトレンチ-2, 3 でみられた断層ガウジの注入やネットワーク状，ジグソーパズル状の割れ目も，断層変位時に伸張性ジョグ部で生じるサクションに関連し，角礫化の進行も hydraulic implosion Breccia の形成過程を示していると推定している。この伸張性ジョグ部は現在の水理特性に大きな影響を与えている可能性を指摘している。

Figure 3-73. Conceptual model of the Wildcat Fault structure by Kiho et al(2009)
