Development of Hydrologic Characterization Technology of Fault Zones -- Phase I, 2nd Report

**Development of Hydrologic Characterization
Technology of Fault Zones:
Phase I, 2nd Report**

NUMO-LBNL Collaborative Research Project Report

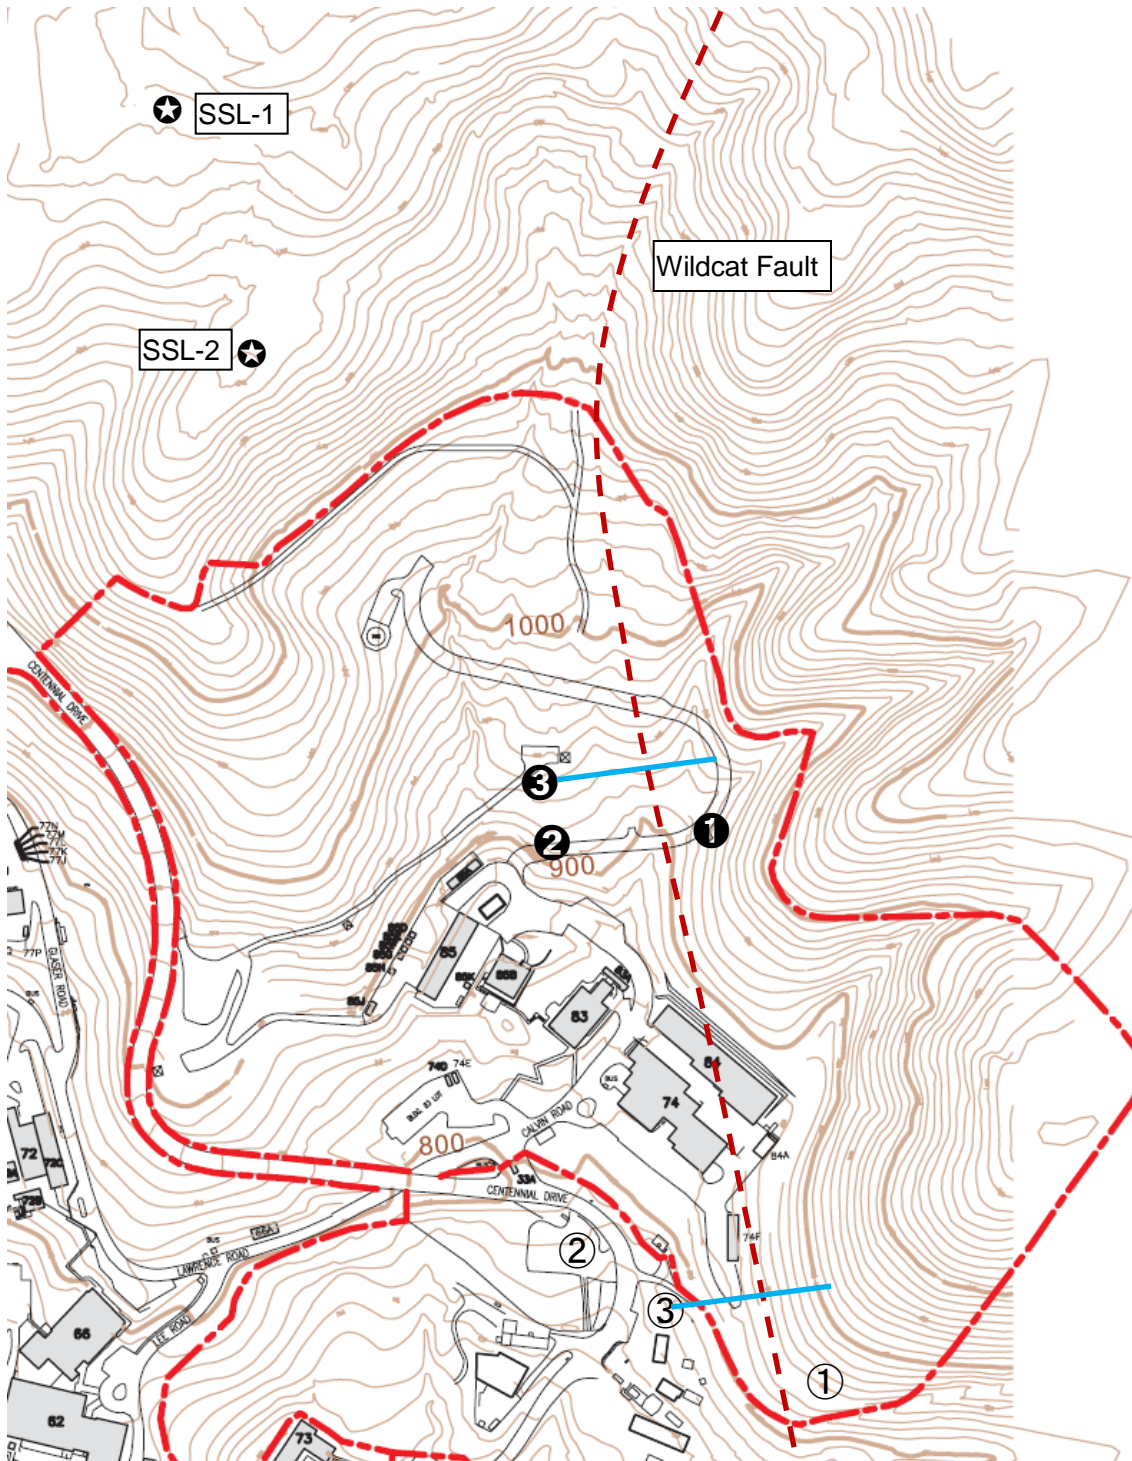
断層からの距離、地下水位、アクセスの問題を総合的に考慮すると、第一候補として Figure 3-83 に黒塗りの数字で示す位置が最も適当であると考えられる。先ず、①で示す断層の東側の箇所に鉛直なボアホールを掘削する。Wildcat 断層が西に傾斜していれば断層を貫かないと予想される。次に②の位置から鉛直方向に掘削する。Wildcat 断層から水平距離でおよそ 70m 離れて西側に掘削すれば、Wildcat 断層が西に 60° より浅く傾斜していない限り、深度 100m で Wildcat 断層に当たることは無いと考えられる。最後に③の位置から傾斜掘りで Wildcat 断層を貫くようにボアホールを掘削する計画である。また、Figure 3-83 の①、②、③の位置に掘削する事も考慮する。

Figure 3-83. Potential borehole locations and existing deep boreholes SSL-1 and SSL-2 in relation to the Wildcat Fault.

ボアホールの位置を考える際、我が国における実際の概要調査ではボアホールの深度が深い為恐らく問題とならないが、本プロジェクトに於いては予算の都合上、100m程度の深度のボアホールを掘削予定の為、地下水位を考慮に入れなければならない。物理探査を行った FSBR や Ridge Rd. でボアホールを掘削するのは、リグのアクセスに関しては十分であり、物理探査の結果とボアホール調査の結果が直接比較出来るという利点もある。しかしながら、FSBR も Ridge Rd. も両側に急傾斜している標高 360m~400m の稜線沿いであり、地下水位がかなり低いと想定される。Figure 3-83 に位置を示す SSL-1 の情報 (Anderson, 2008) から推察すると地下水位は地表から 80-90m 程度と推測され深度 100m のボアホールでは揚水試験などの水理試験が困難である恐れがある。一方、Figure 3-19 に示すように 74, 85 号棟付近の地下水位は地表から 10m 程度である。また、Kleinfelder (2001) によれば、貯水タンク用の道路を建設する際の調査ボーリングにおいて現在の NUMO-TR3 付近で深度 6~7m に地下水面を観測している。しかしながらこの地下水面は宙水である可能性がある。実際、その他の深さ 10m 程度の調査ボーリングでは地下水面を観測していない。

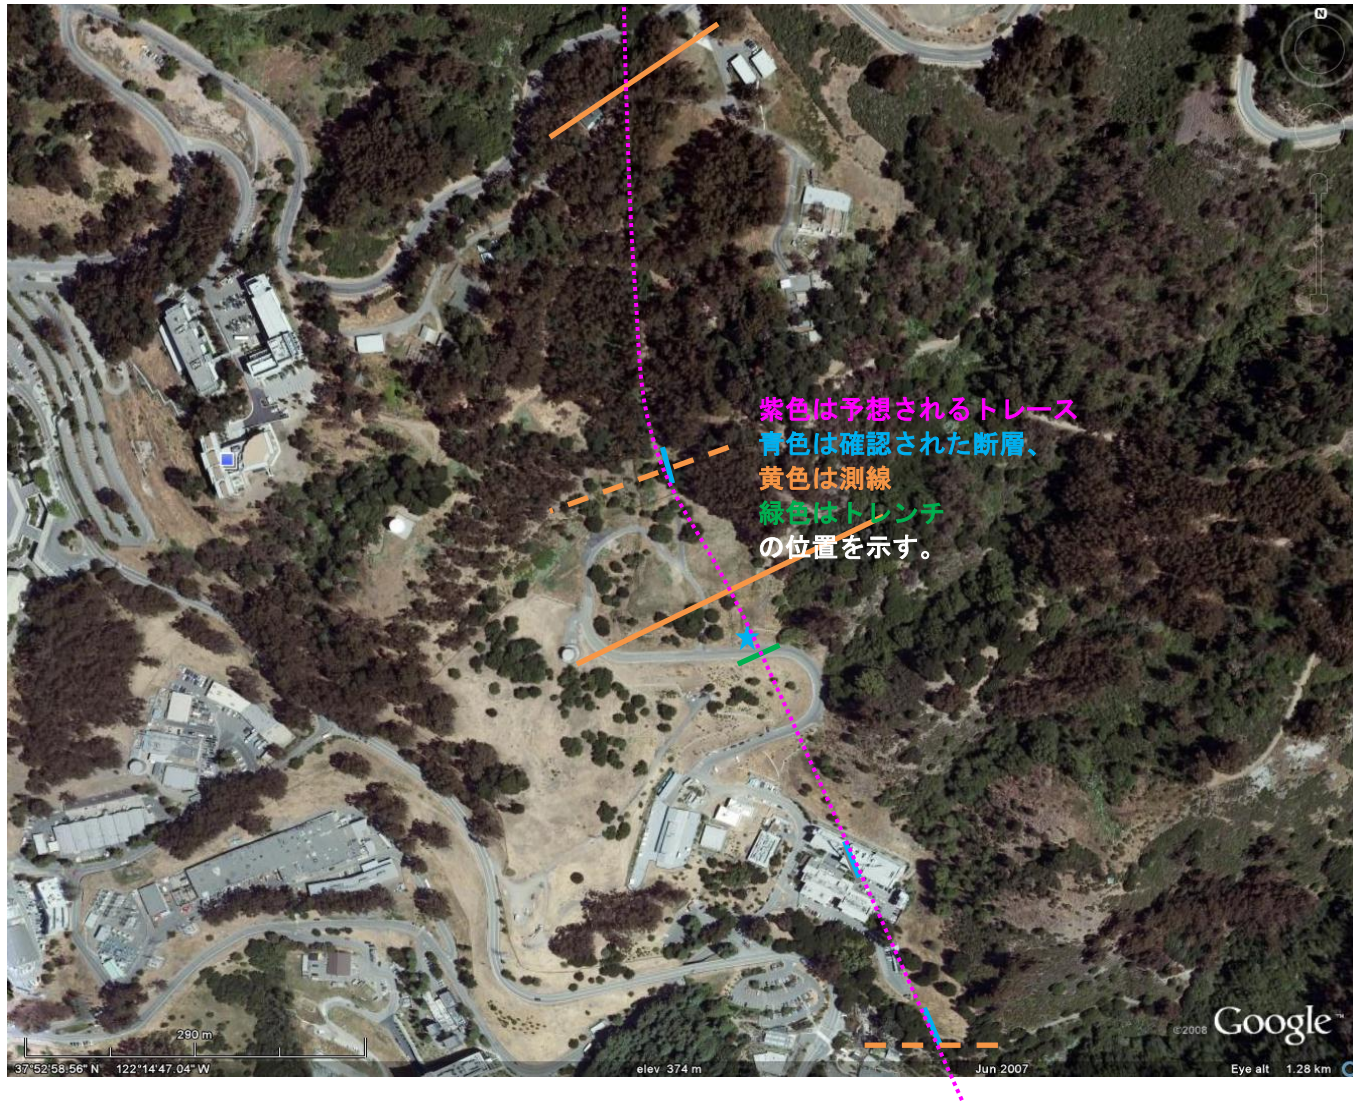
Figure A-1. Initial planned locations of geophysical survey lines and a trench.
