Quieter Pavement Research: Concrete Pavement Tire Noise

# Quieter Pavement Research: Concrete Pavement Tire Noise

Work Conducted as Part of Partnered Pavement Research Center Strategic Plan Element No. 4.22:  
Quiet Concrete Pavement Research

<b>DOCUMENT RETRIEVAL PAGE</b>		<b>UCPRC Research Report No.:</b> UCPRC-RR-2010-03			
<b>Title:</b> Quieter Pavement Research: Concrete Pavement Tire Noise					
<b>Author:</b> E. Kohler and J. Harvey					
<b>Prepared for:</b> California Department of Transportation, Division of Research and Innovation, Office of Roadway Research		<b>FHWA No.:</b> CA121200A	<b>Date Work Submitted:</b> August 20, 2010	<b>Date:</b> May 2010	
<b>Strategic Plan Element No.:</b> 4.22		<b>Status:</b> Stage 6, final version		<b>Version No.:</b> 1	
<p><b>Abstract:</b> This research report presents the results of tire/pavement noise measurements performed on concrete pavements as a part of the California Department of Transportation (Caltrans) Quieter Pavement Research (QPR) study to investigate tire/pavement noise characteristics on concrete pavements and bridge decks.</p> <p>The study included a total of 120 pavement sections at 47 different sites on various state

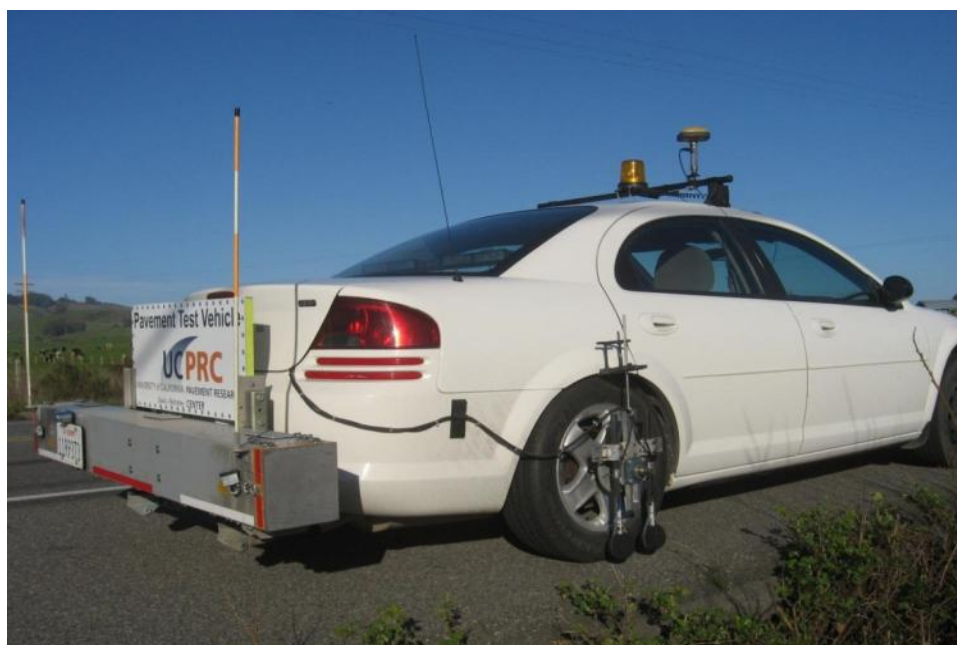
**Figure 2.1: Instrumented vehicle with on-board sound intensity probes and an inertial profilometer.**

In addition to the use of the OBSI method to measure tire/pavement noise, an inertial profilometer was used to measure International Roughness Index (IRI) and Mean Profile Depth (MPD), and visual observations were made of the surface texture type and condition of each test section. The measured IRI values and texture observations were collected at the same fixed short intervals used for OBSI measurement. The instrumented vehicle used in this project is shown in Figure 2.1.

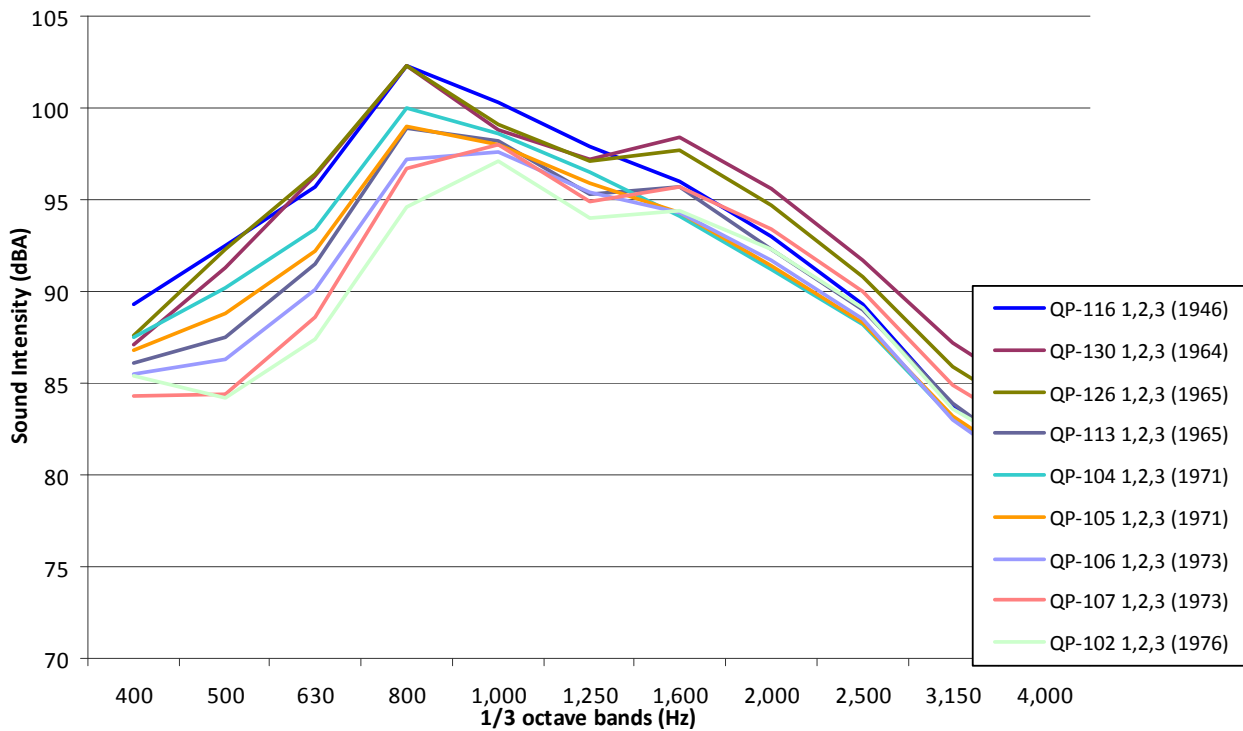
Figure 3.2: OBSI spectral content for burlap drag sections, texture *worn out*.

There were no sections with burlap drag texture in the *new* texture category. The texture *aged* and texture *worn out* sections are shown in Figure 3.1 and Figure 3.2 respectively. A comparison of the average spectral content for the conditions is shown in Figure 3.3. For one-third octave band frequencies below 1,600 Hz, the spectra for the sections with the texture *worn out* have greater sound intensity levels than for *aged* texture sections.

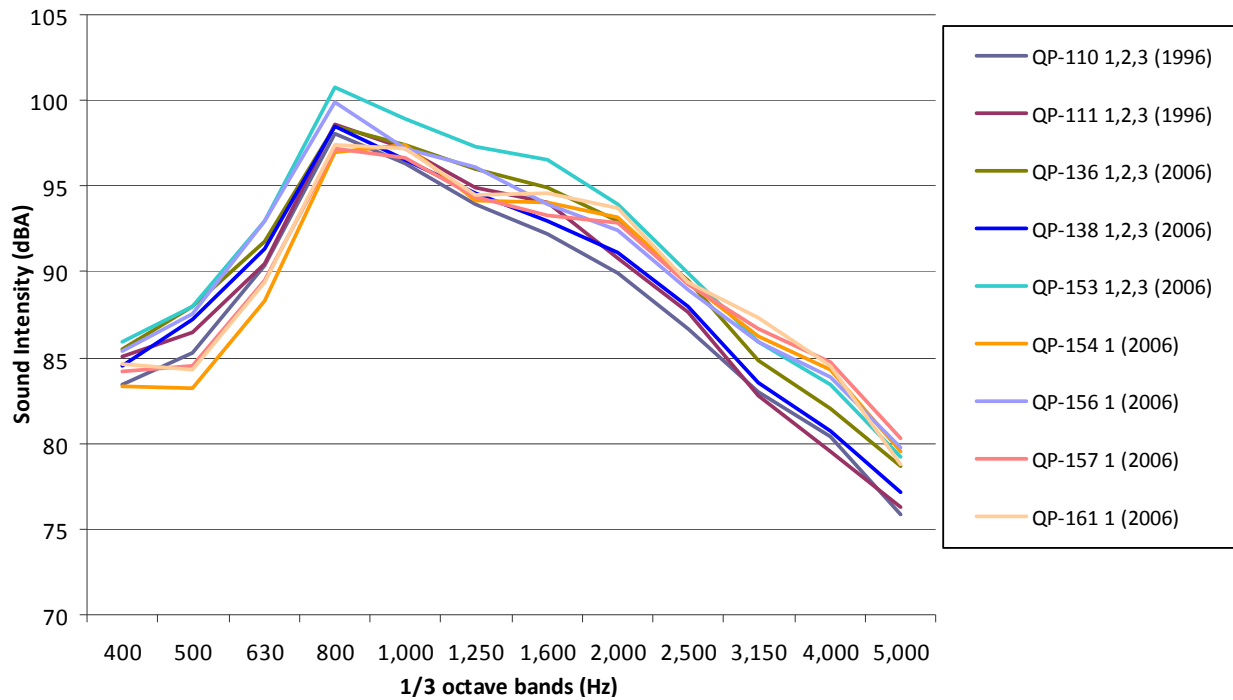
Figure 3.7: OBSI spectral content for diamond grooved sections, texture *aged*.

All diamond grooved sections fall in the *aged* texture category, so comparison against other conditions is not possible. Figure 3.7 shows the results at each site, while Figure 3.8 presents the average of all sites. There is a range of 4 to 5 dB(A) for every frequency within the *aged* texture category. The older sections, built in 1996, appear to have lower OBSI levels for frequencies of 2,000 Hz and higher frequencies, and to have OBSI levels in the middle of the range of the other sections built in 2006 for frequencies below 2,000 Hz.

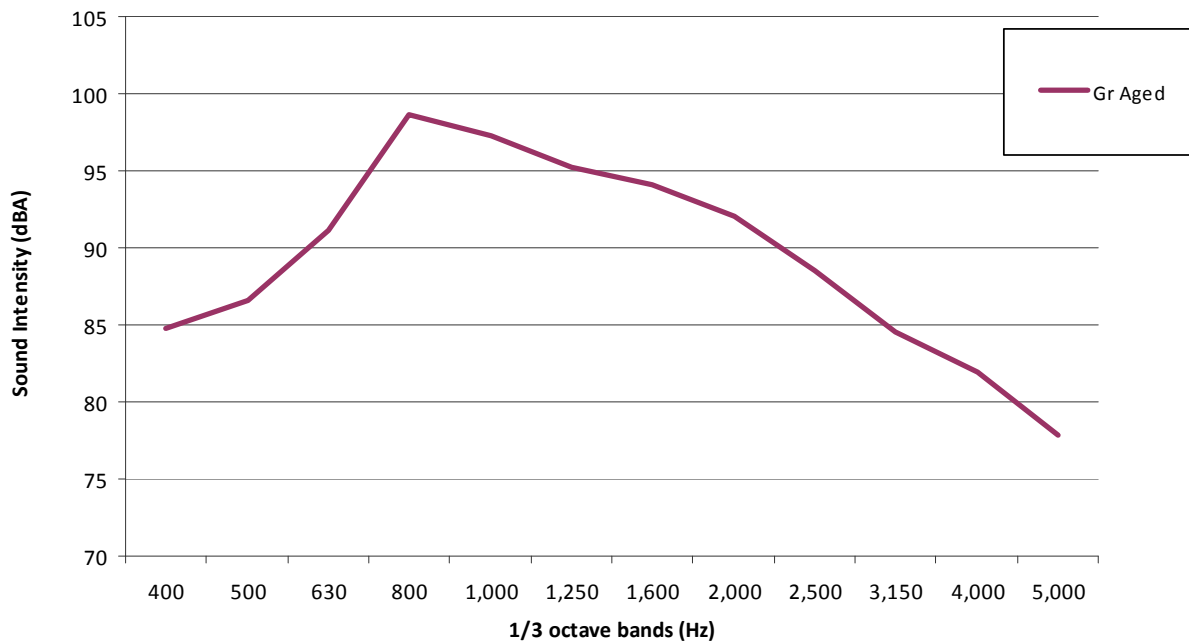
Figure 3.8: Average of OBSI spectral content for diamond grooved sections.

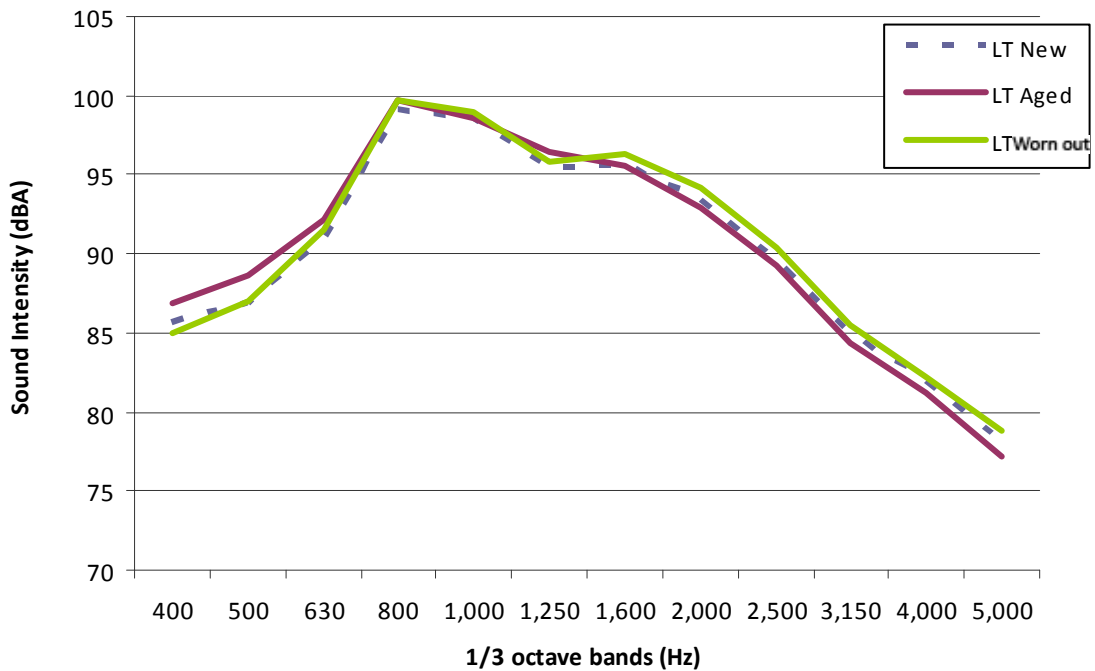
Figure 3.15: Comparison of OBSI spectral content for longitudinally tined sections with texture in different conditions.

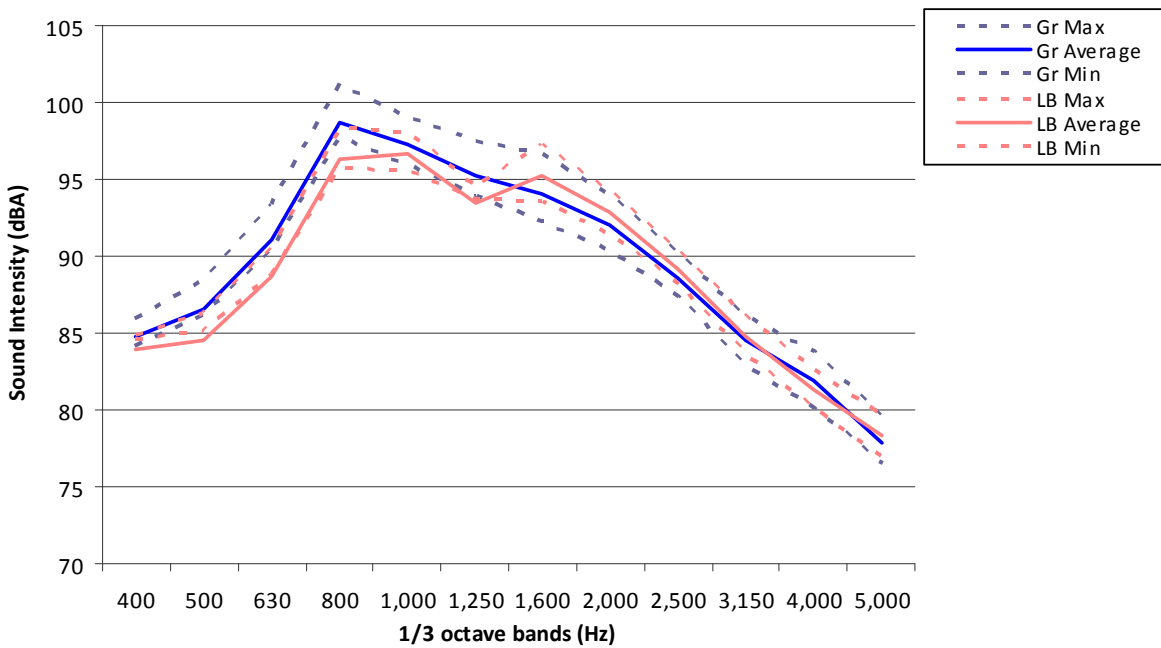
Figure 3.22: Comparison of OBSI spectral content of longitudinally broomed (LB) and diamond grooved (Gr), texture *aged* sections.

Between LB and Gr the analysis is as follows: The Max spectrum is higher for Gr than LB below 1,600 Hz. The Average spectrum is higher for Gr than LB below 1,250 Hz. The LB Average spectrum shows intensities at 800 Hz and 1,000 Hz very similar to those for Gr. The Min LB spectrum is lower than the Average LB spectrum only at the 1,600 and 2,000 Hz bands. The Max and Average LB spectra show markedly lower intensities at 800, 1,000, and 1,250 Hz compared to the Gr spectra, which are the primary contributors to overall sound intensity.

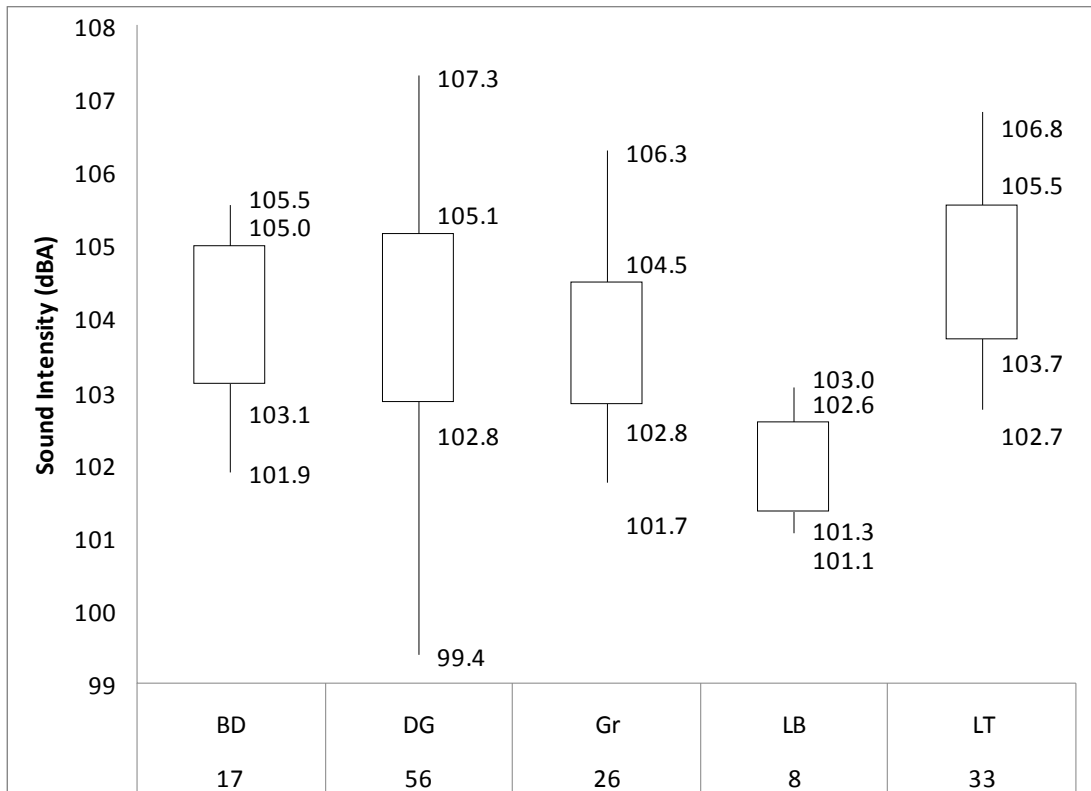
**Figure 3.27: Box plots of overall OBSI results by texture type, Years 1 and 2 combined, only sections with *new* and *aged* textures (sections with texture *worn out* are excluded). (Notes: BD = burlap drag, DG=diamond ground, Gr=diamond grooved, LB=longitudinally broomed, LT=longitudinally tined; number of observations in sample shown below texture type.)**

Figure 3.27 is similar to Figure 3.26 but only showing sections with *new* and *aged* textures.

Figure 3.27 shows a box plot of overall OBSI for each texture type for the *new* and *aged* textures, with those sections with *worn out* textures removed. Figure 3.28 shows the normal distribution curves of OBSI results by texture type, all sections. Figure 3.29 shows the normal distribution curves of OBSI results by texture for the *new* and *aged* textures, with the *worn out* textures removed.

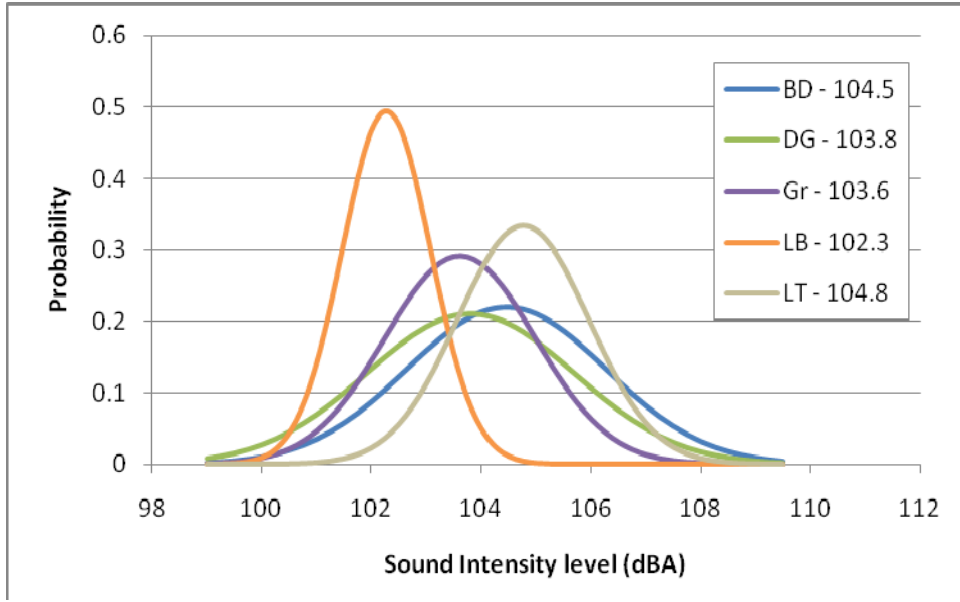
**Figure 3.28: Normal distribution curves of OBSI results by texture type, all sections.**  
 (Notes: BD=burlap drag, DG=diamond ground, Gr=diamond grooved, LB=longitudinally broomed, LT=longitudinally tined; sample sizes for LB and Gr are smaller than for other textures.)

Table 3.3 for the combined data from Year 1 and Year 2, and for each texture type. The resulting charts are presented in Figure 3.28 including all sections and in Figure 3.29 excluding sections with the texture *worn out* condition. The legend includes the mean OBSI level in dB(A) next to the texture-type abbreviation.

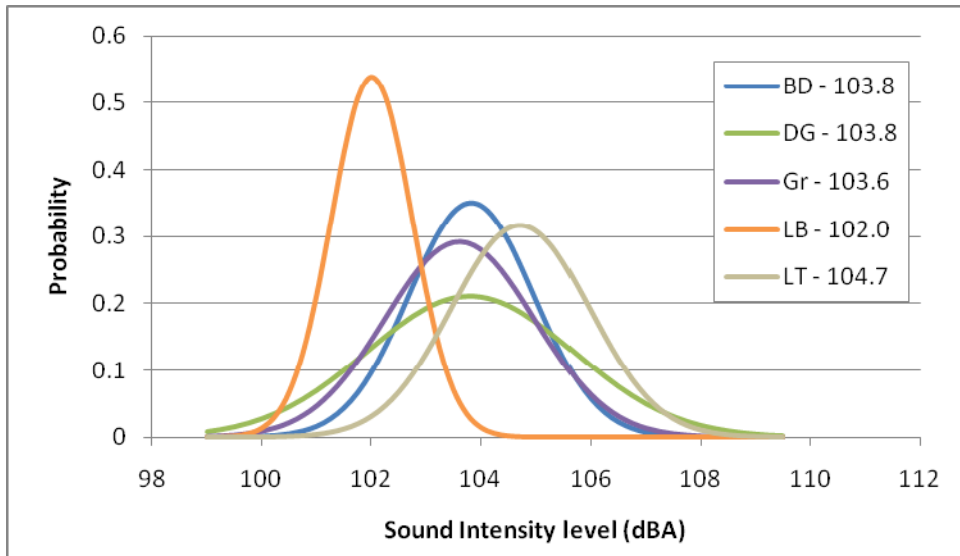
**Figure 3.29: Normal distribution curves of OBSI results by texture type, only *new* and *aged* texture.**  
 (Note: Sample sizes for LB and BD are smaller than for other textures.)

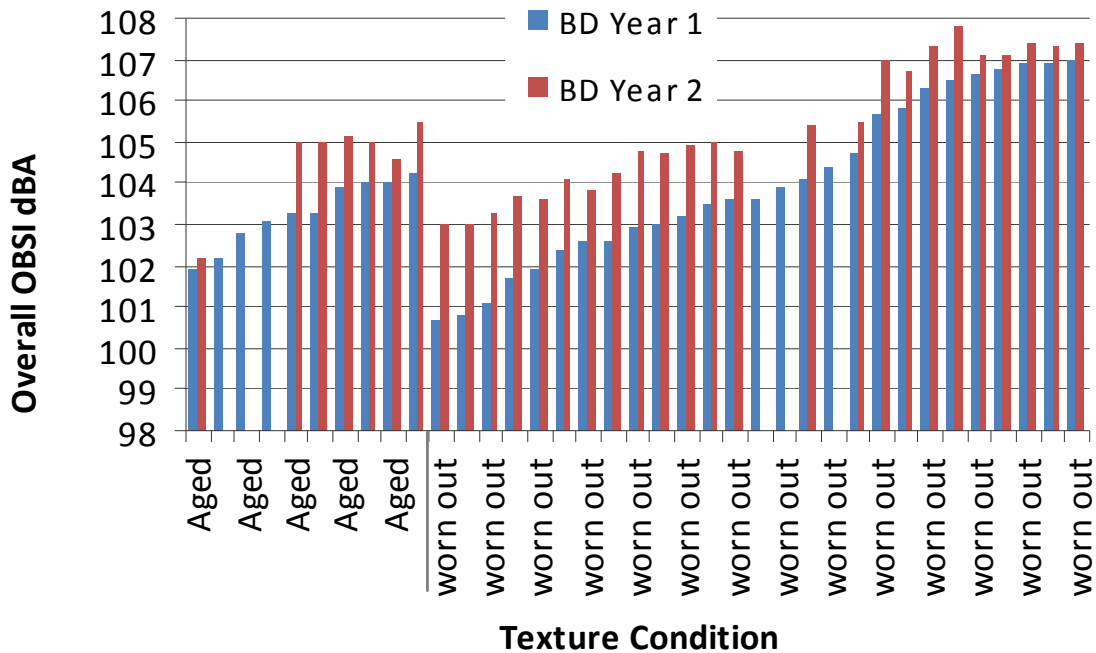
Figure 3.30 shows OBSI results for the burlap drag sections. The vast majority of the burlap drag sections were built in the 1960s and 1970s. The only “young” section, which was about six years old at the time of testing, is QP-159.1 at the Mojave Bypass. The oldest sections, which were 62 years old, are on Interstate 80 in Solano County (QP-116.1, QP-116.2, and QP-116.3). Older sections have higher OBSI levels. Figure 3.31 shows all texture conditions for the burlap drag sections plotted versus the number of years since they were last surfaced, including all Year 1 and Year 2 measurements.

Figure 3.30: Year 1 and Year 2 OBSI values for all burlap drag sections.

Figure E.4: Compare with Figure 3.30: Burlap drag Year 1 and Year 2 results for all texture conditions (*new, aged, worn out*).

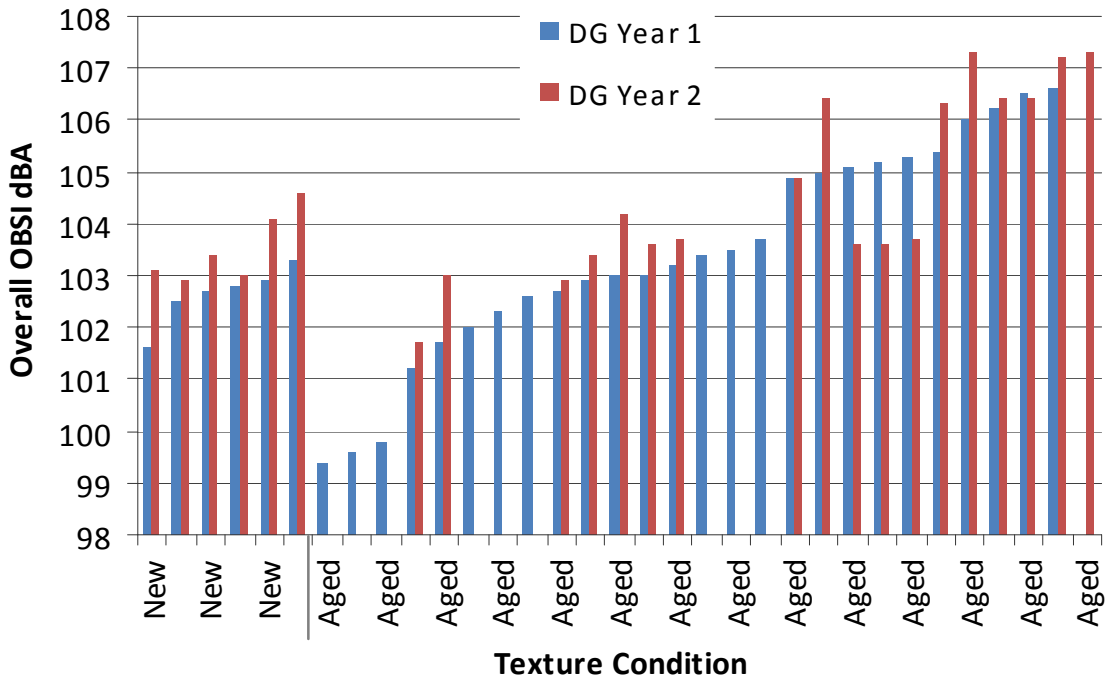
Figure 3.32 shows OBSI results for the diamond ground sections. The oldest sections evaluated were 11 years old at the time of testing. It seems again that older sections have higher OBSI levels. Figure 3.33 shows all texture conditions for the diamond ground sections plotted versus the number of years since they were last surfaced, including all Year 1 and Year 2 measurements.

Figure 3.32: Year 1 and Year 2 OBSI values for all diamond ground sections.

Figure E.5: Compare with Figure 3.32: Diamond ground Year 1 and Year 2 results for all texture conditions (*new, aged, and worn out*).

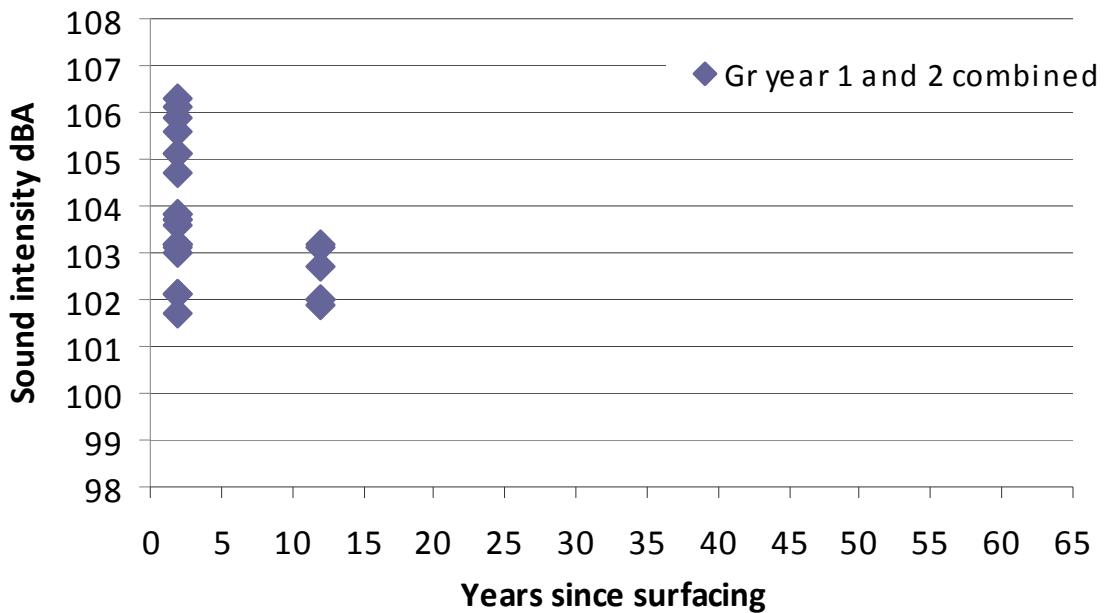
Figure 3.34 shows OBSI results for the diamond grooved sections. Although some of the pavements on US 101 in Sonoma County were built in 1962 (QP-136 and QP-138), records indicate that the sections were diamond grooved in 2006. Older sections were about 12 years old after grooving, and were located on Interstate 80 in Nevada County (QP-110 and QP-111). It is not possible to observe a trend in OBSI level over time with the available data. Figure 3.35 shows all texture conditions for the diamond grooved sections plotted versus the number of years since they were last surfaced, including all Year 1 and Year 2 measurements.

Figure 3.35: Year 1 and Year 2 OBSI values for all diamond grooved sections versus years since last surfacing.

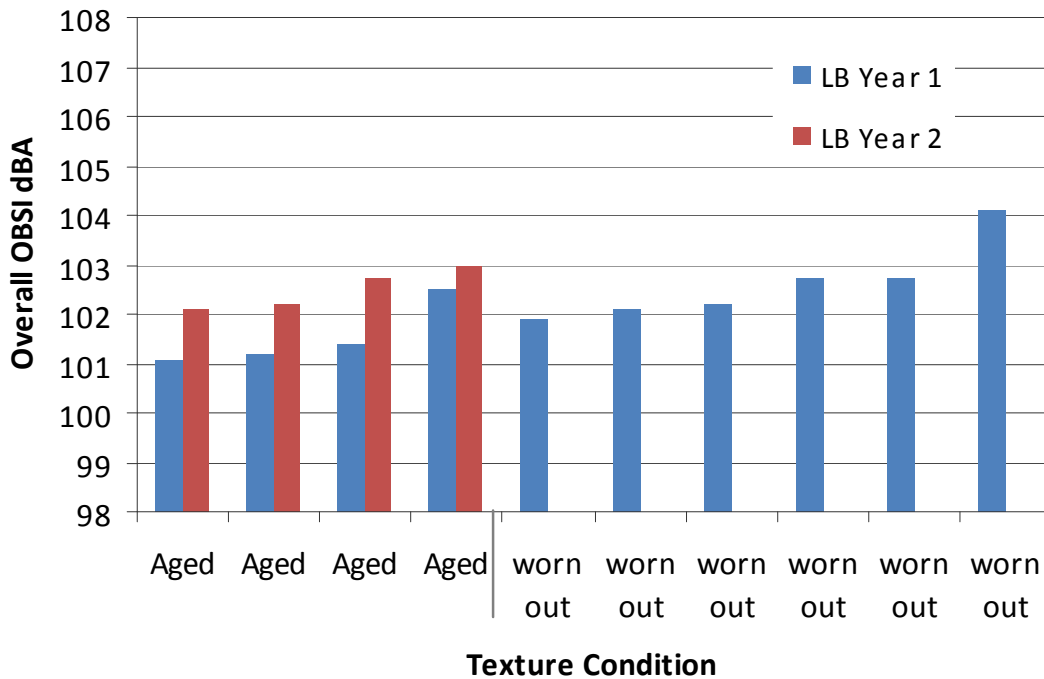
Figure 3.36 shows OBSI results for the longitudinally broomed sections. The six-year old section is at the Mojave Bypass on State Route 58. The 19-year old sections are on Interstate 80 in Nevada County (QP-109 and QP-112), but were overlaid with asphalt between Year 1 and Year 2. The 34-year-old sections are on Interstate 280 in San Mateo County (QP-146). From the limited available data, it seems that OBSI levels on this type of surface texture do not increase much over time. Figure 3.37 shows all texture conditions for the longitudinally broomed sections plotted versus the number of years since they were last surfaced, including all Year 1 and Year 2 measurements.

Figure 3.36: Year 1 and Year 2 OBSI values for all longitudinally broomed sections.

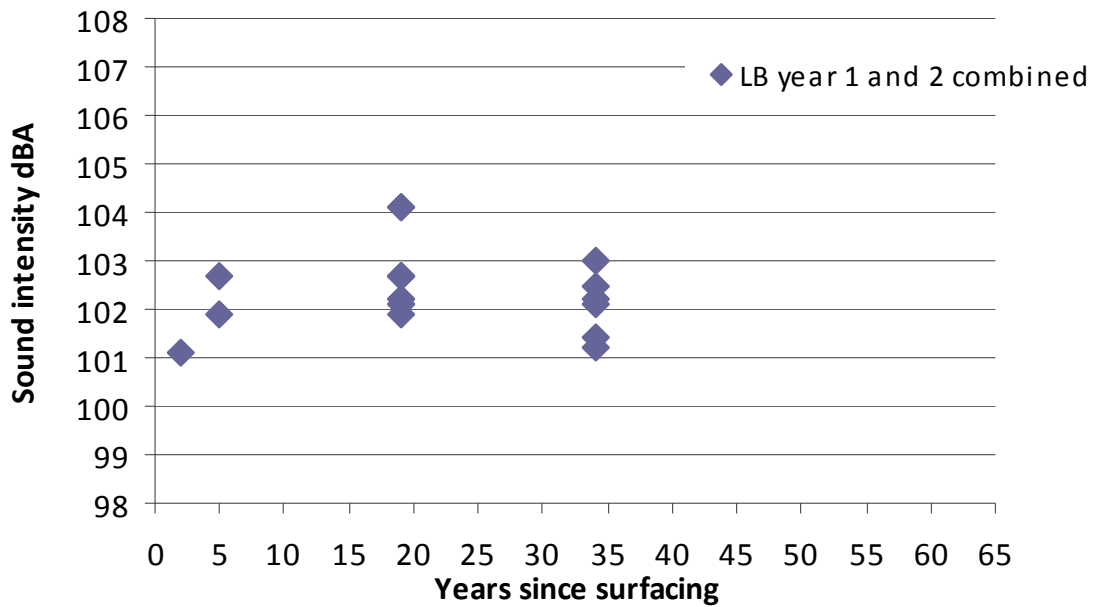
Figure 3.37: Year 1 and Year 2 OBSI values for all longitudinally broomed sections versus years since last surfacing.

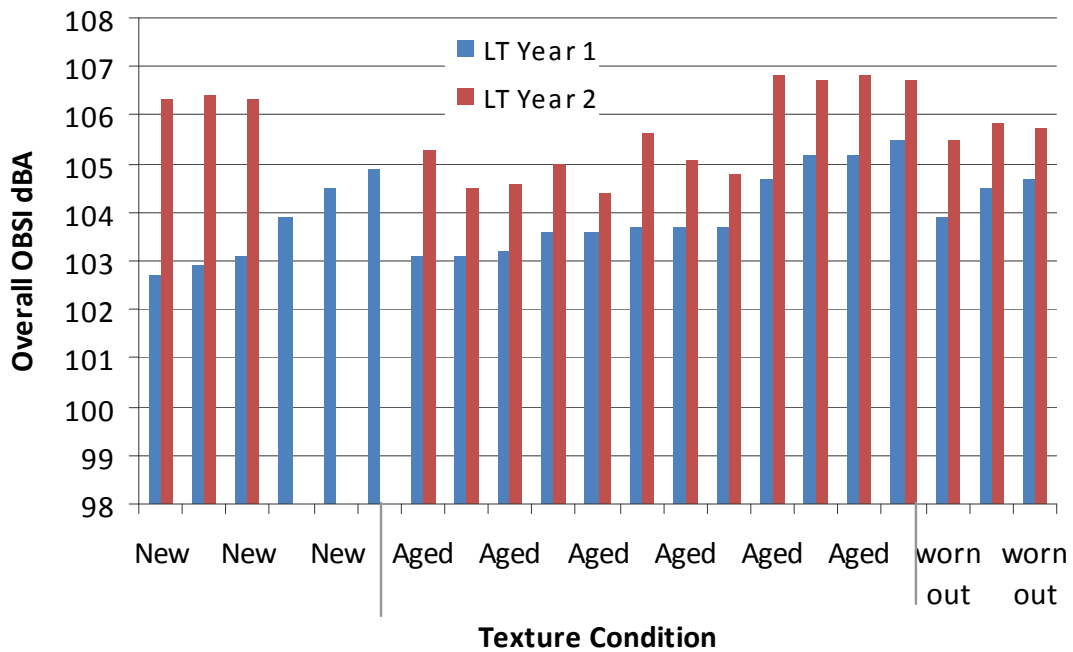
Figure 3.38 shows OBSI results for the longitudinally tined sections. The OBSI levels remain mostly between 103 and 107 dB(A), even for sections that are over 30 and 40 years old. Figure 3.39 shows all texture conditions for the longitudinally tined sections plotted versus the number of years since they were last surfaced, including all Year 1 and Year 2 measurements.

Figure 3.38: Year 1 and Year 2 OBSI values for all longitudinally tined sections.

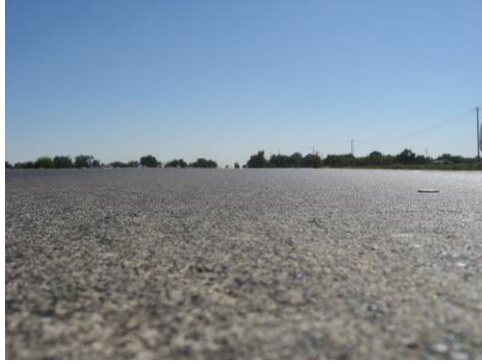
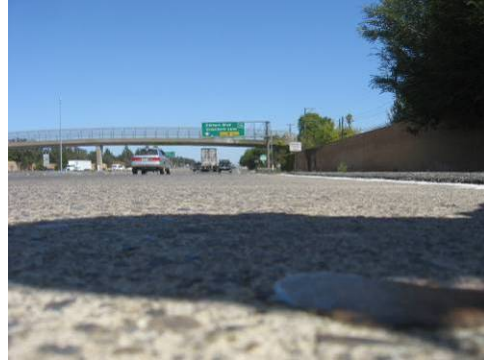
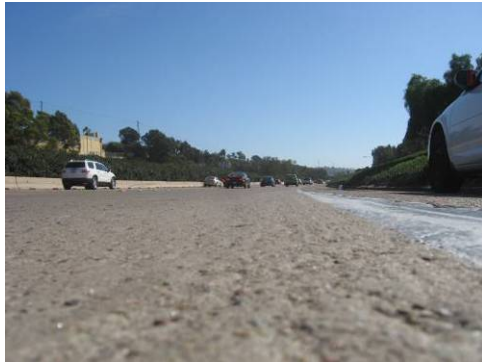
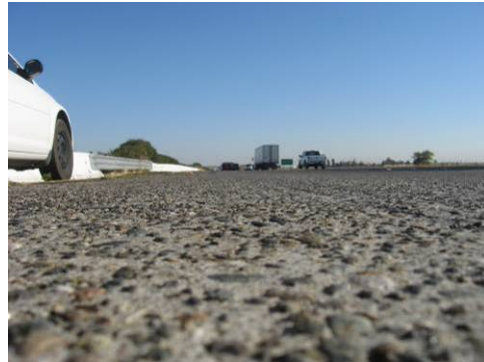
The oldest concrete pavement sections evaluated in this study have burlap drag texture, with sections on Interstate 80 in Solano County having been in service for over 60 years according to the available records (QP-116). Due to their long service life, some of the sections in this category had pavements that showed no signs of applied surface texture, and were then categorized as *worn out* texture. Burlap drag sections are not constructed in California highways any more, which is why no “young” sections, other than one built for a field evaluation experiment, were included in the experiment. This young section, which was about five years old when first tested, yielded an OBSI level of about 102 dB(A). Other than the experimental section, all burlap drag sections were older than 30 years, and had OBSI levels ranging between 101 and 108 dB(A). These values indicate that the actions of traffic, often combined with rainfall, will tend to polish some concrete surfaces and remove positive texture (stones protruding from the surface) without damaging the paste around the stones. The same combination of traffic and environment will tend to ravel asphalt surfaces and cause loss of paste around the aggregates in some concrete surfaces, creating positive texture by leaving the stones protruding from the surface. The quieter sections seem to be, judging from the pictures, those with shallow texture, as shown in Figure 4.1. Therefore, a possible reason for variability of OBSI for the burlap drag sections is variation in the macrotexture caused by the protrusion of aggregates. A summary of the information for burlap drag sections is presented in Table 4.1.

**Figure 4.1: Example photographs of burlap drag surfaces and their OBSI levels.**

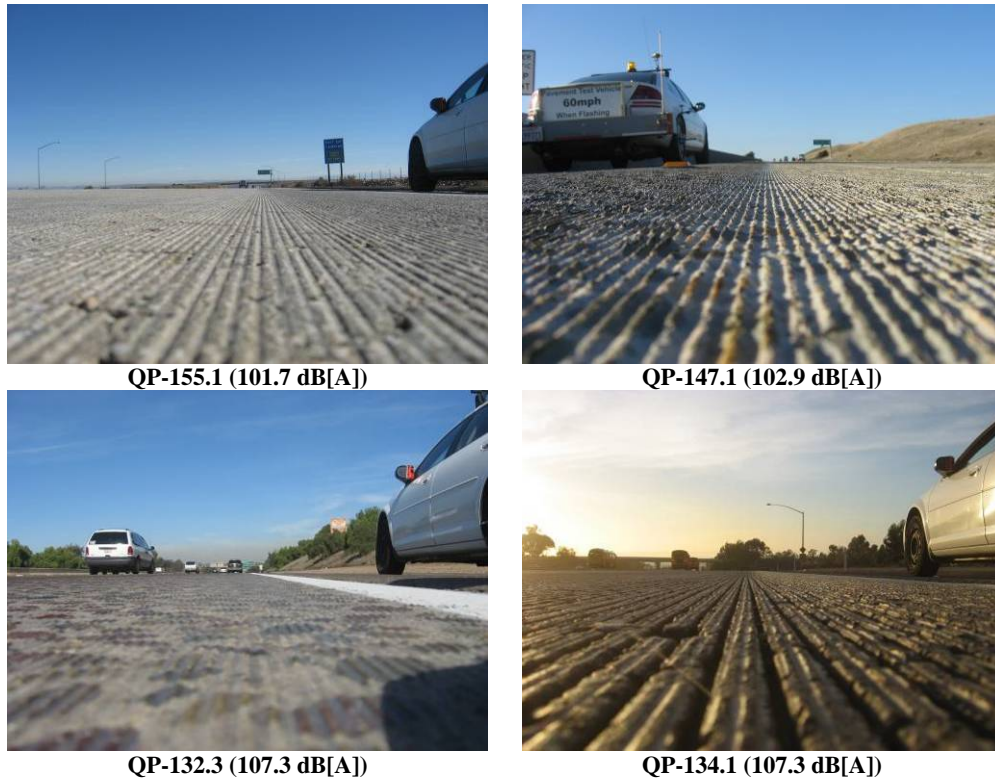
Diamond grinding is a technique commonly used in California to correct texture and profile. Older diamond-ground sections included in this study were about 11 years old. A summary of the information for diamond grinding is presented in Table 4.2. Texture depth (macrotexture) is a possible reason for the variability in OBSI levels, in this case measured as the height of the fins left in the concrete between the diamond grinding blades. Photographs of example diamond ground surfaces are shown in Figure 4.2.

**Figure 4.2: Example photographs of diamond ground surfaces and their OBSI levels.**

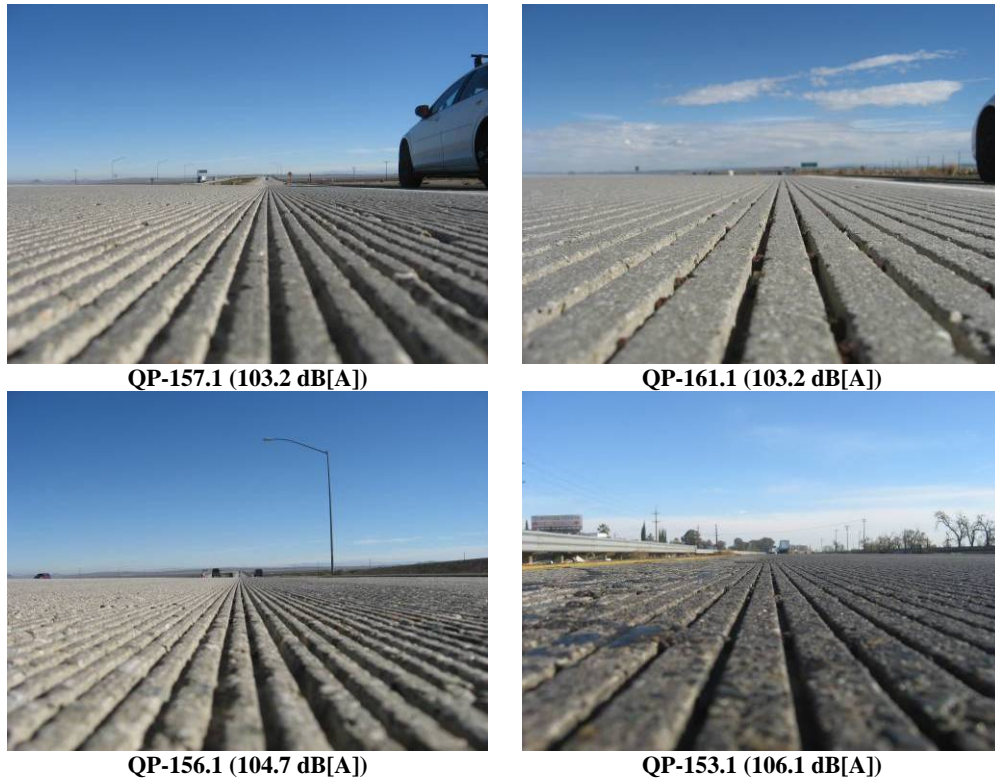
Prior to this testing, it was uncertain whether diamond grooving without diamond grinding had an effect on noise level because the grooves leave most of the contact area between the tire and the pavement unchanged, and therefore diamond grooving might not be as effective as diamond grinding for reducing the noise level on existing concrete pavements. However, based on this study’s results for 19 diamond grooved sections and 32 diamond ground sections (7 and 24 sections in Year 2, respectively), the two techniques appear to yield similar OBSI levels. Comparison of Figure 3.33 (diamond ground) and Figure 3.35 (diamond grooved) shows that experiment samples of both texture types have similar ages, with less than 15 years since their last resurfacing. It can also be seen from Table 2.1 that the DG and Gr sample sections are distributed across both passenger car and truck lanes and in both dry and wet parts of state, except for the very wet North Coast region. A summary of the information for diamond grooved sections is presented in Table 4.3. Photographs of example diamond grooved surfaces are shown in Figure 4.3.

**Figure 4.3: Example photographs of diamond grooved surfaces and their OBSI levels.**

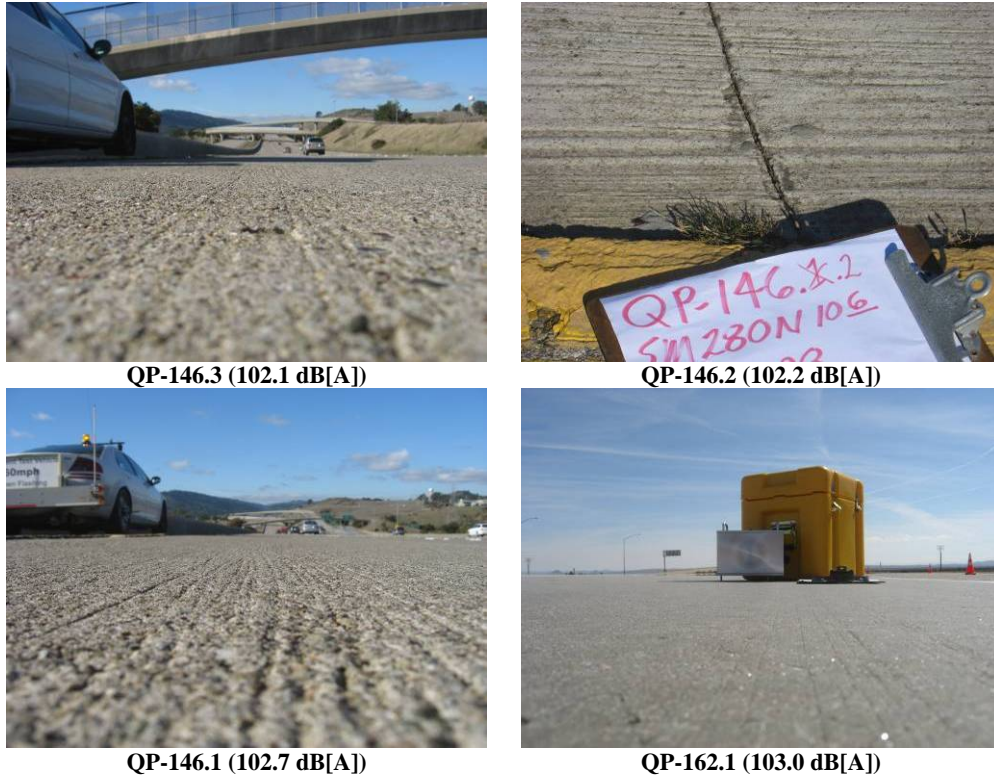
Longitudinally broomed pavement surface texture is uncommon on California highways. The difference between longitudinally broomed and burlap drag surface textures is only clear on surfaces that are not *worn out* (i.e., texture has not been worn off by traffic) and still show the striations caused by the texturing tool. The difference between the two techniques is less apparent in the case of *worn out* surfaces. In this study, the presence of striations of more than 1 or 2 mm depth (as evaluated subjectively from photographs) was considered reason to label a texture as longitudinally broomed. If only shallower striations or none were observed, then the section was labeled as having a burlap drag texture type. This resulted in a low number of longitudinally broomed sections, and affected the balance of the experimental factorial, complicating the interpretation of results. From a practical point of view, longitudinal brooming could be considered equivalent to a “heavy drag” texture. A summary of the information for longitudinally broomed sections is presented in Table 4.4. Photographs of example longitudinally broomed surfaces are shown in Figure 4.4.

**Figure 4.4: Example photographs of longitudinally broomed surfaces and their OBSI levels.**

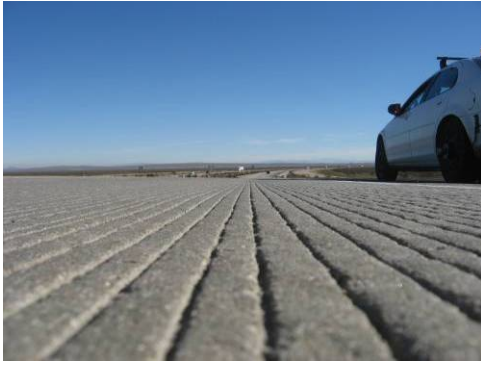
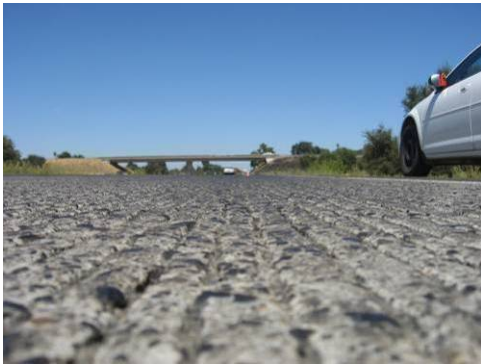
Longitudinal tining is the texture type most commonly found on California highways. Sections tested in the study ranged in surface age from several months to 42 years. The interquartile range reveals that 50 percent of the sections of this texture type are expected to fall between 103.7 and 105.6 dB(A). This is interesting because the longitudinal grooves that result from the tining process vary widely in depth, spacing, the amount of material displaced that protrudes from the surface, and how straight they are (often they appear to be “waves” of different wavelengths, but in other cases they are perfectly straight). Four examples of longitudinally tined sections are shown in Figure 4.5. A summary of the information for longitudinally tined sections is presented in Table 4.5.

**Figure 4.5: Example photographs of longitudinally tined surfaces and their OBSI levels.**

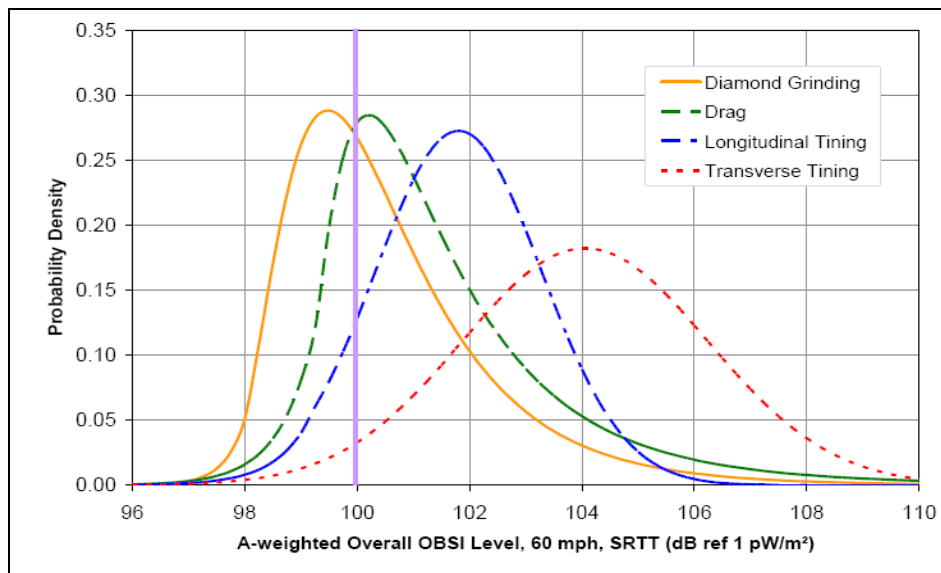
Although the rankings are similar, the OBSI levels included in the 2008 NCPTC report were consistently lower than those measured in this study, as can be seen in Figure 4.8 and Figure 4.9.

**Figure 4.8: Probability distributions of OBSI noise levels for concrete pavement textures as reported by the National Concrete Pavement Technology Center (4).**

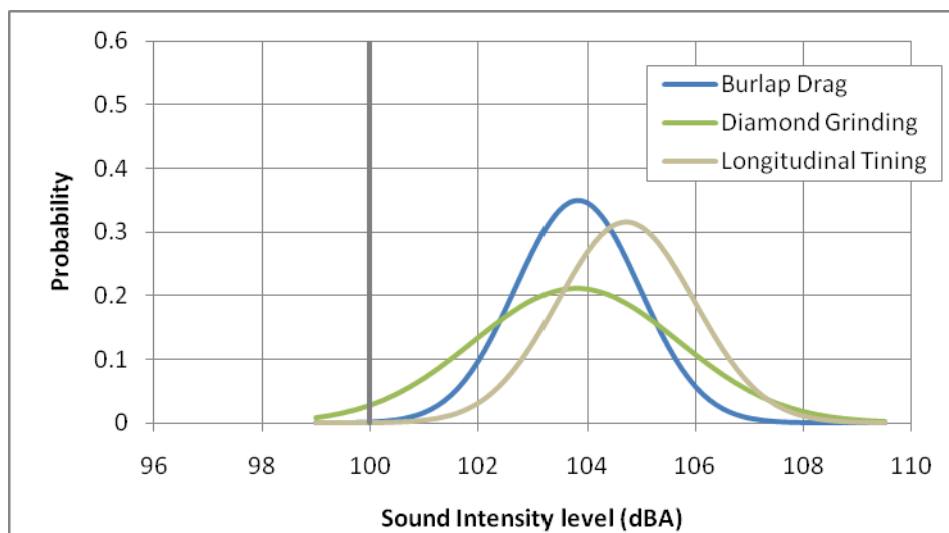
**Figure 4.9: Distributions of OBSI noise levels in this study (excluding LB and Gr because of limited amount of data).**

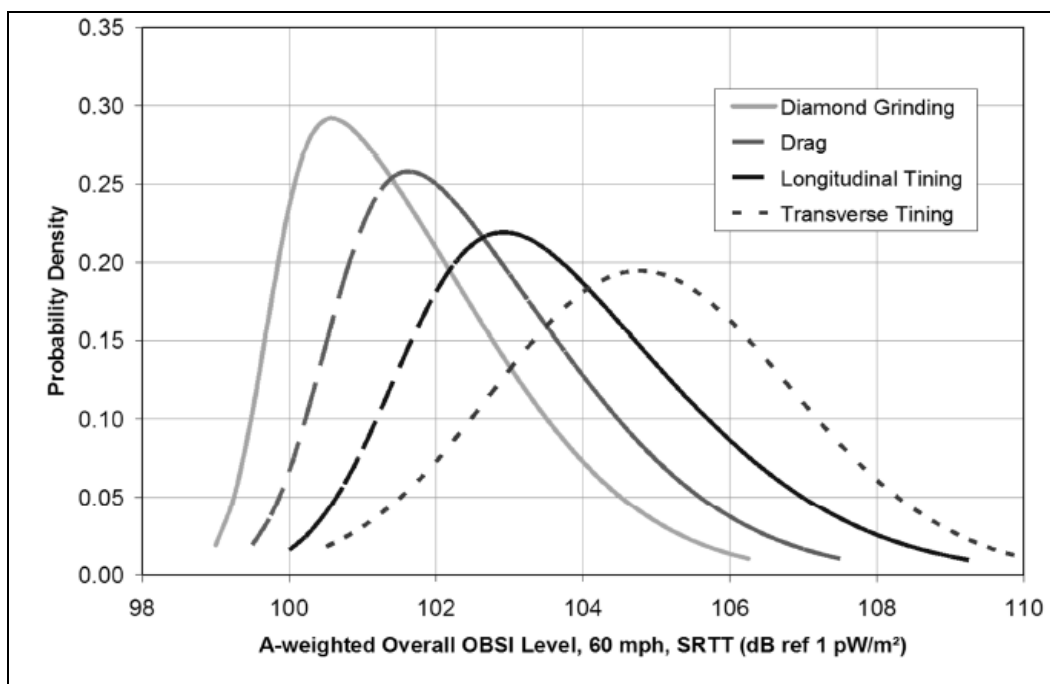
The NCPTC study has been ongoing, with a very large sample. It can be expected that results will change as more measurements are taken. A more recent conference presentation, titled “Quieter Concrete Pavements: An Update of Pooled Fund TPF-5(139)” in October 2010 at the Pavement Evaluation Conference in Roanoke, Virginia, indicates that the NCPTC data is indicating higher OBSI levels than those shown previously. Continued comparisons of California data and NCPTC data will be worthwhile to identify common conclusions and where California and NCPTC data differ, and comparison will provide better understanding of reasons for variability within surface textures.

Figure 4.10: Updated probability distributions of OBSI noise levels for concrete pavement textures from NCPTC study.

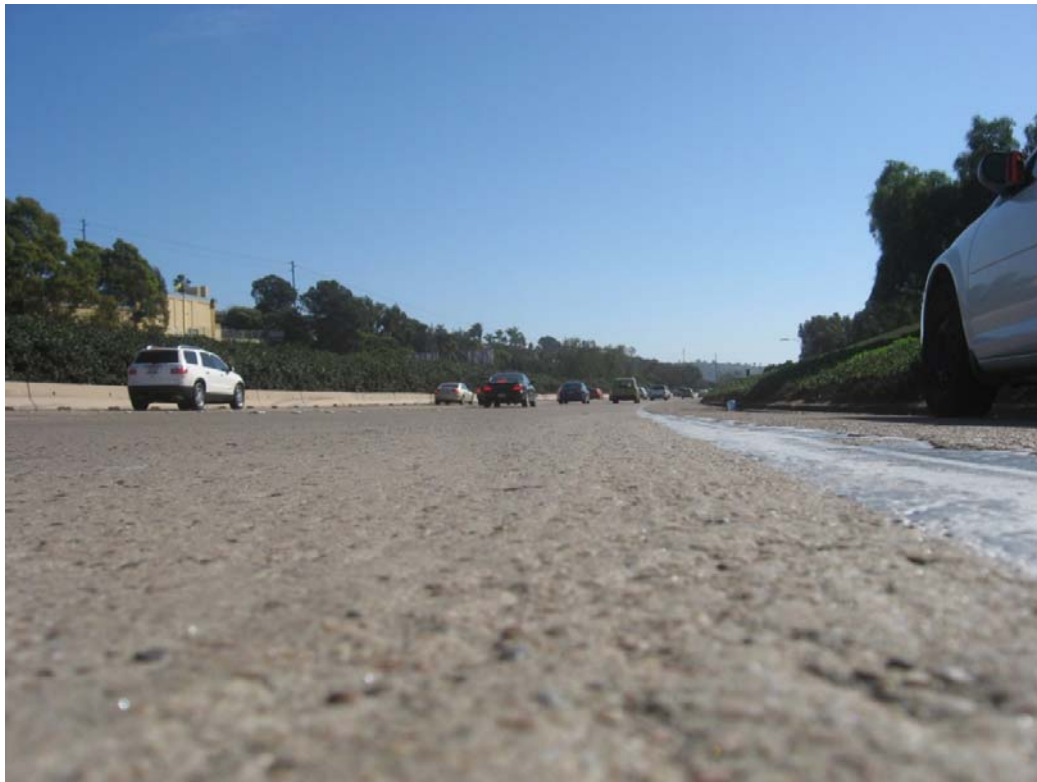
**Figure A.2: Burlap drag, OBSI=107.3 dB(A) (Section QP-130.1).**

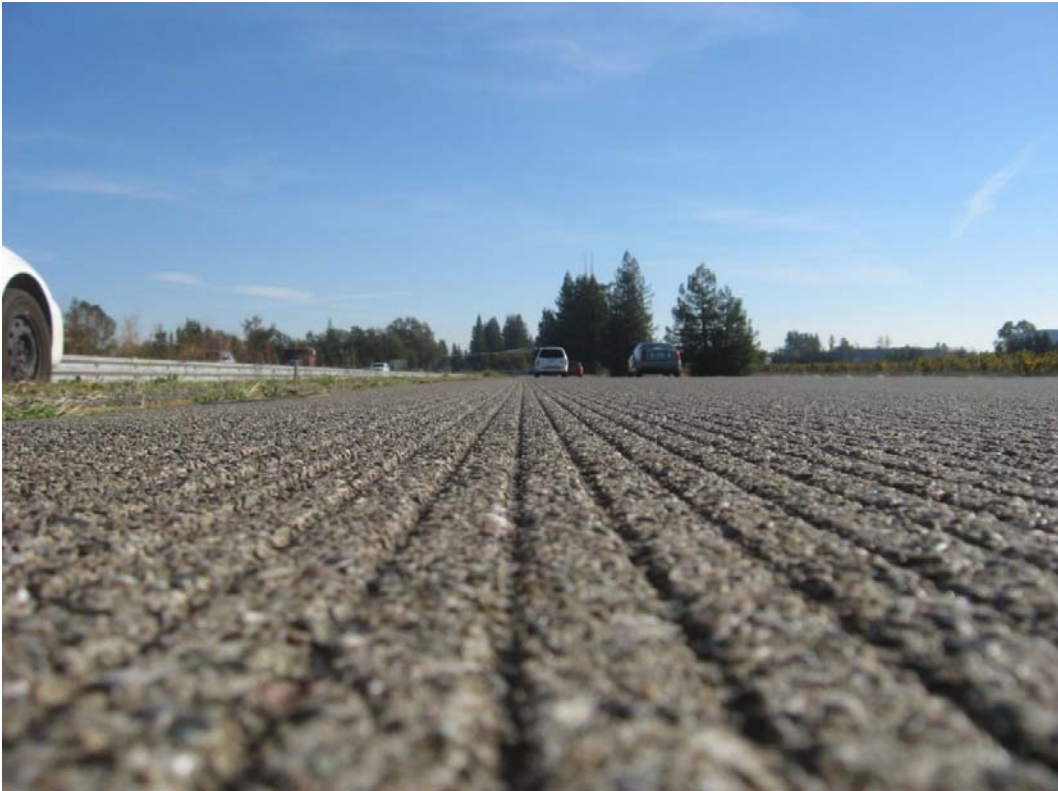
**Figure A.5: Diamond grooved, OBSI=101.7 dB(A) (Section QP-138.3).**

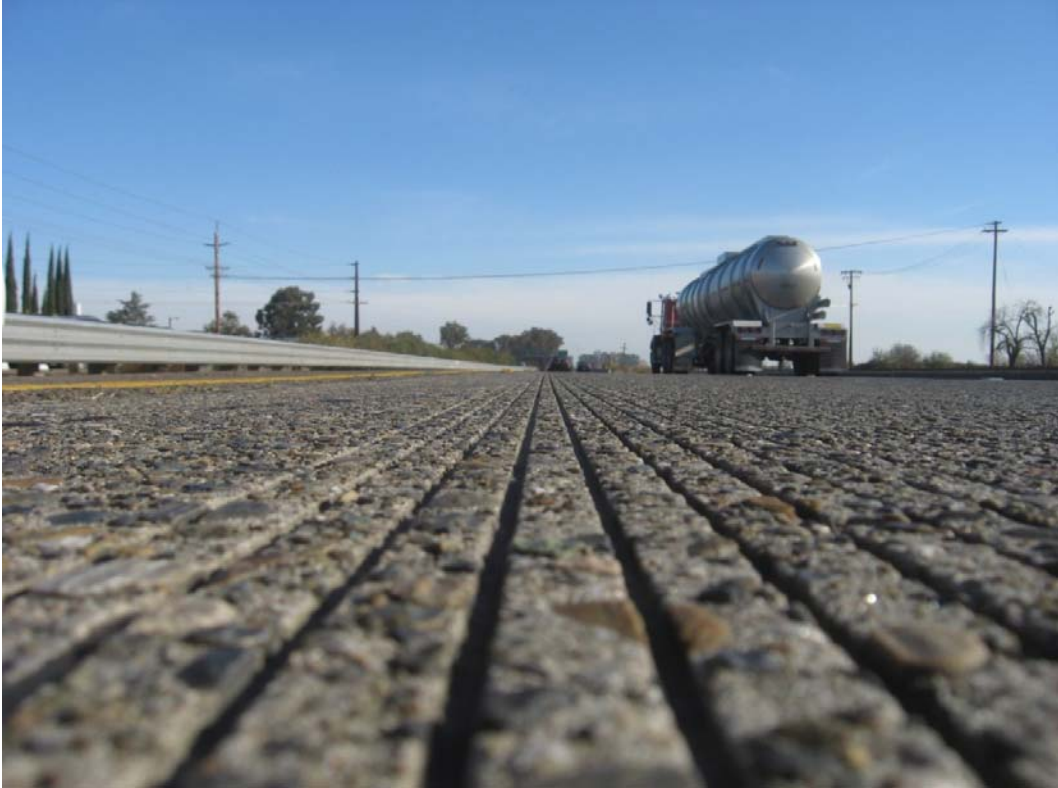
**Figure A.6: Diamond grooved, OBSI=105.6 dB(A) (Section QP-153.2).**
