Quieter Pavement Research: Concrete Pavement Tire Noise

# Quieter Pavement Research: Concrete Pavement Tire Noise

Work Conducted as Part of Partnered Pavement Research Center Strategic Plan Element No. 4.22:  
Quiet Concrete Pavement Research

<b>DOCUMENT RETRIEVAL PAGE</b>		<b>UCPRC Research Report No.:</b> UCPRC-RR-2010-03			
<b>Title:</b> Quieter Pavement Research: Concrete Pavement Tire Noise					
<b>Author:</b> E. Kohler and J. Harvey					
<b>Prepared for:</b> California Department of Transportation, Division of Research and Innovation, Office of Roadway Research		<b>FHWA No.:</b> CA121200A	<b>Date Work Submitted:</b> August 20, 2010	<b>Date:</b> May 2010	
<b>Strategic Plan Element No.:</b> 4.22		<b>Status:</b> Stage 6, final version		<b>Version No.:</b> 1	
<p><b>Abstract:</b> This research report presents the results of tire/pavement noise measurements performed on concrete pavements as a part of the California Department of Transportation (Caltrans) Quieter Pavement Research (QPR) study to investigate tire/pavement noise characteristics on concrete pavements and bridge decks.</p> <p>The study included a total of 120 pavement sections at 47 different sites on various state

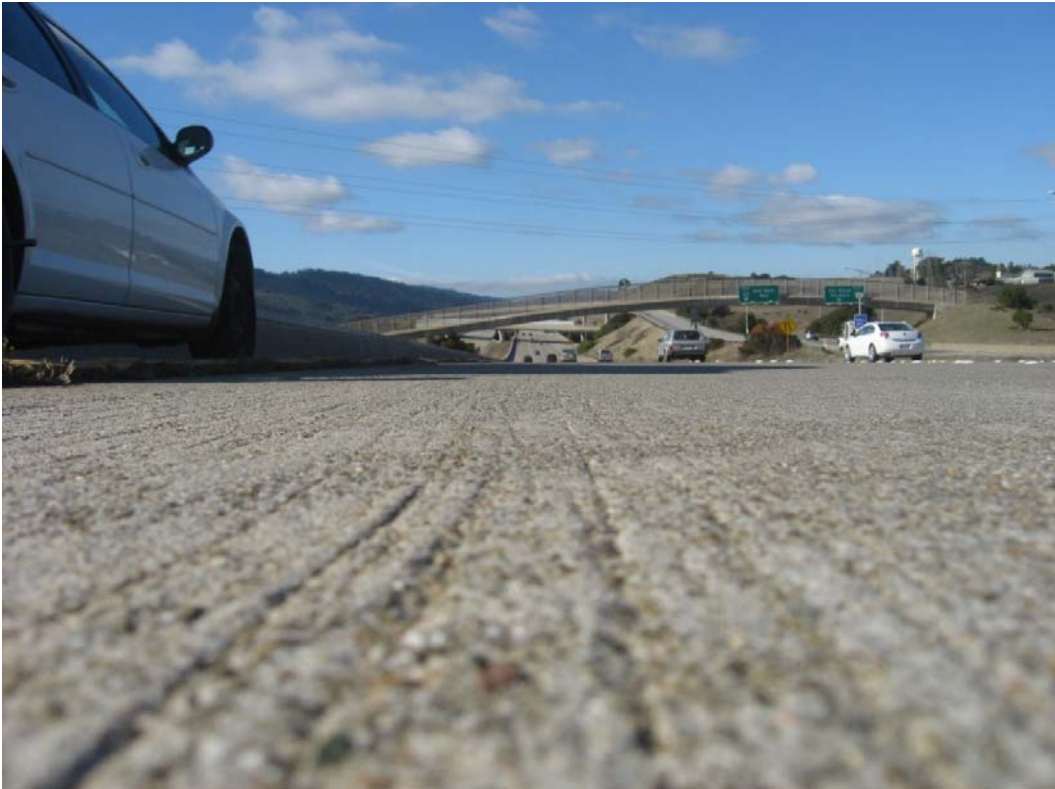
**Figure A.7: Longitudinally broomed, OBSI=101.1 dB(A) (Section QP-146.3).**

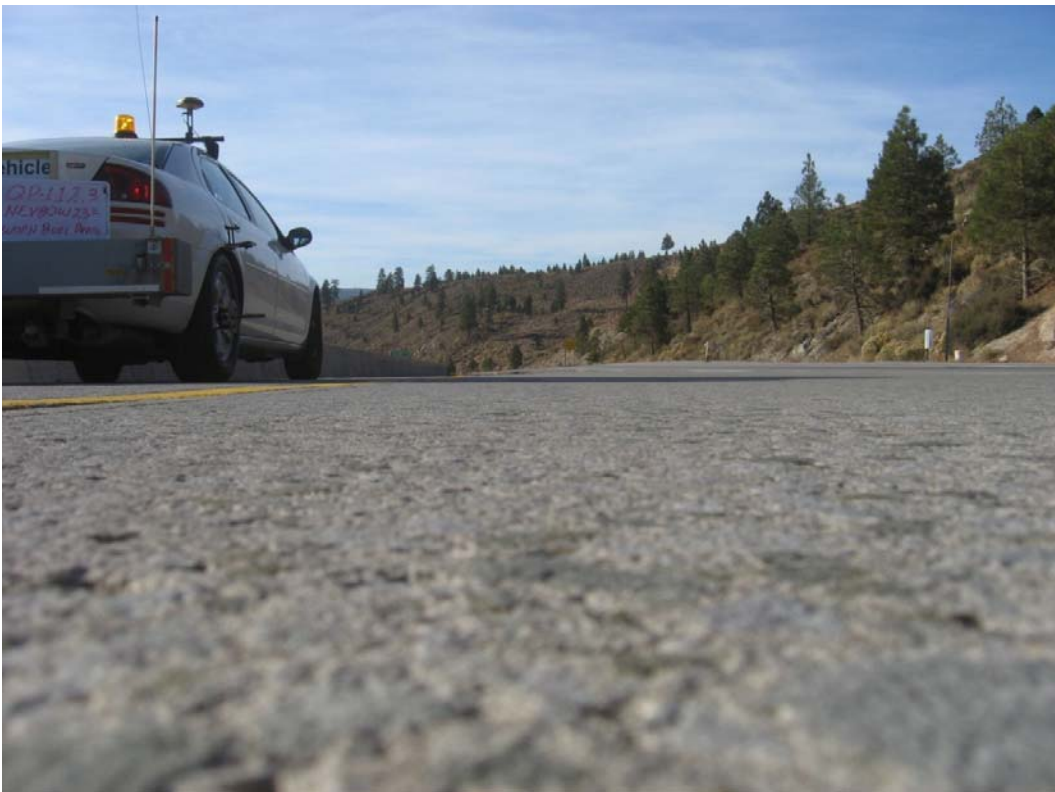
**Figure A.8: Longitudinally broomed, OBSI=104.1 dB(A) (Section QP-112.3).**

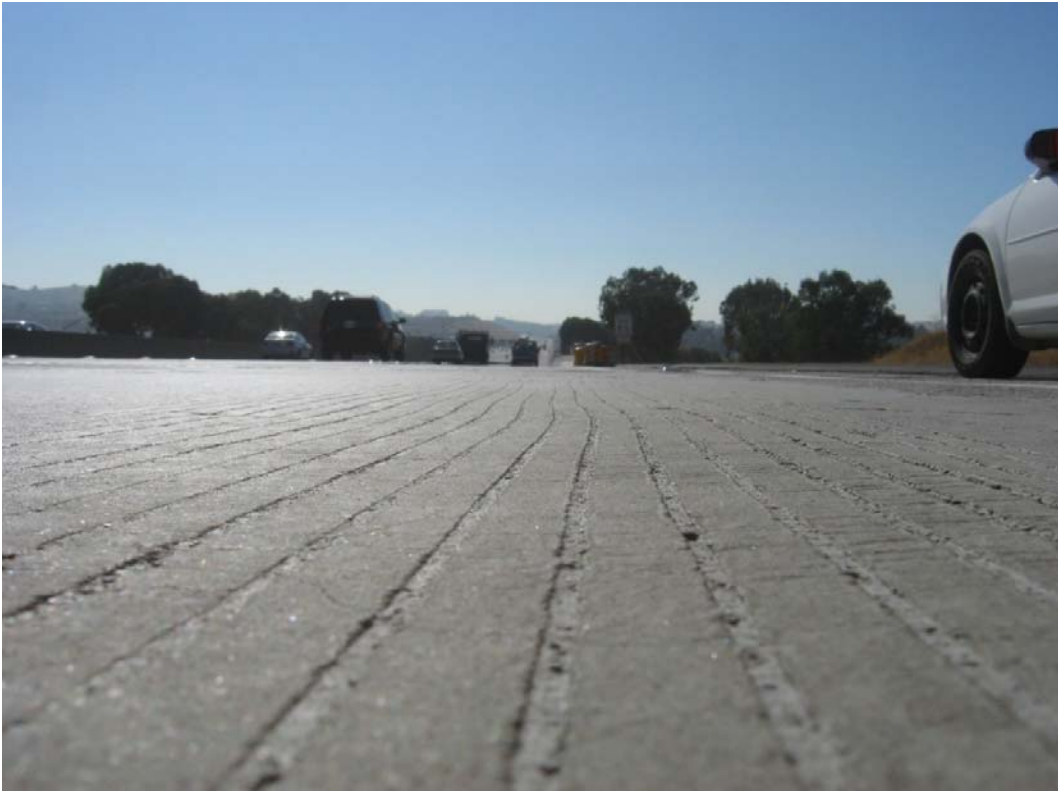
**Figure A.9: Longitudinally tined, OBSI=102.7 dB(A) (Section QP-117.2).**

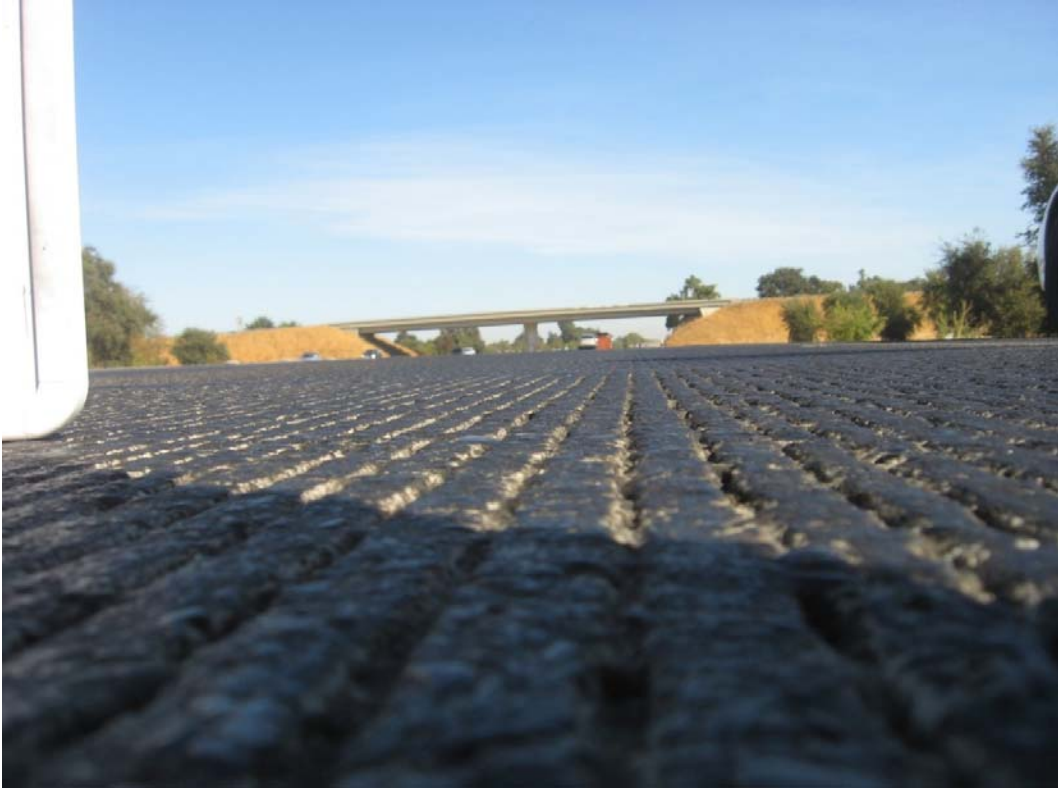
**Figure A.10: Longitudinally tined, SI=105.5 dB(A) (Section QP-101.2).**

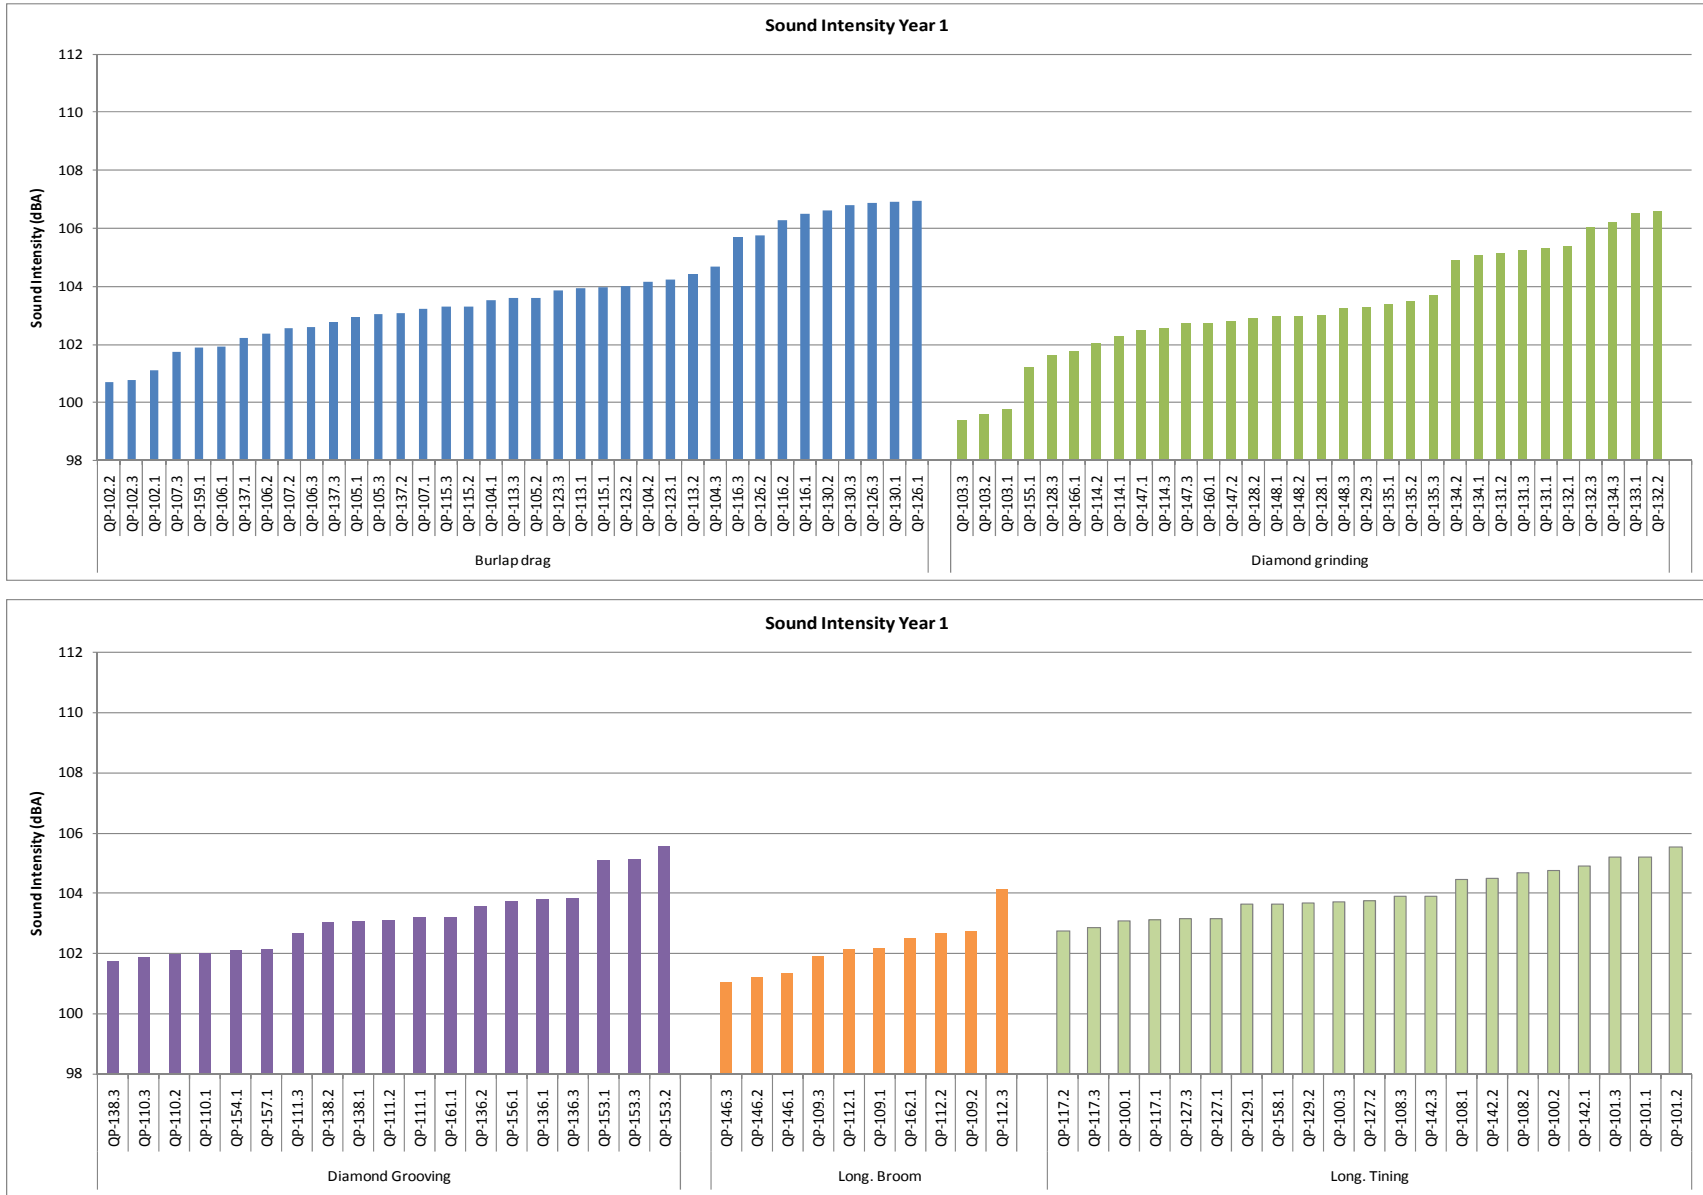
The overall OBSI levels of each section measured in Year 1 and Year 2 are presented here.

**Figure B.1: On-board Sound Intensity levels of all sections as measured in Year 1.**

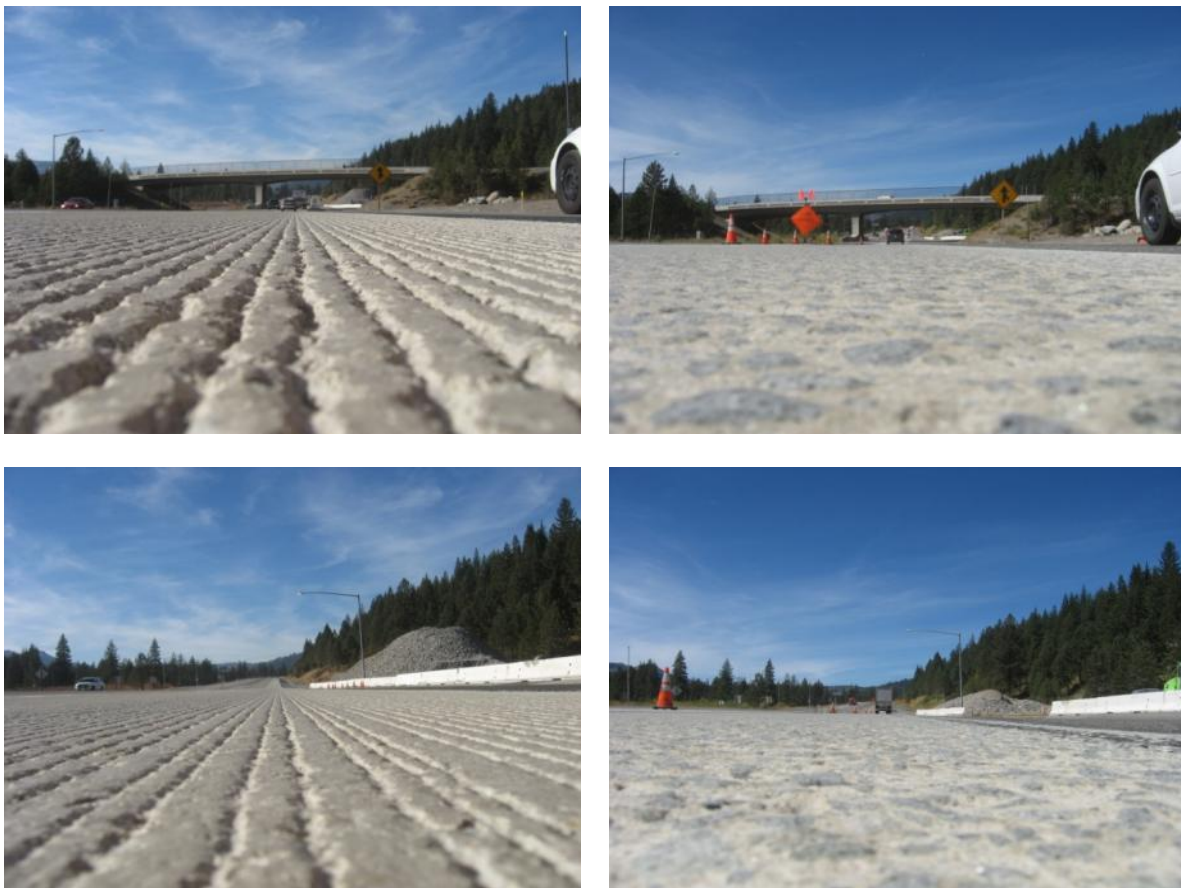
The pavement at Sections QP-142.1, 142.2, and 142.3 all experienced a large increase in noise level from Year 1 to Year 2. The increase was due to an unusual rapid wearing of the longitudinal texture, which disappeared completely, leaving a surface where the concrete paste was recessed and the aggregates were exposed and protruding. The average OBSI values of these sections changed from 104.4 dBA (104.9, 104.5, and 103.9) to 111.8 dBA (111.4, 111.2, and 112.6), an increase of 7.4 dBA.

Images of the surface texture of Sections QP-142.1 and QP-142.3 at approximately the same spots are shown in Appendix D, with the pictures on the left taken in November 2008 and the ones on the right in September 2009. This pavement was new—it had been opened to traffic in the summer of 2008—and is located at 5,900 feet above sea level, where it was subjected to chain wear during snow season. Appendix D shows that the longitudinal tining remains outside the wheelpath, while it has been completely obliterated in the wheelpaths by the chains.

**Figure C.1: Change in texture after one year at Sections QP-142.1 (top) and QP-142.3 (bottom).**

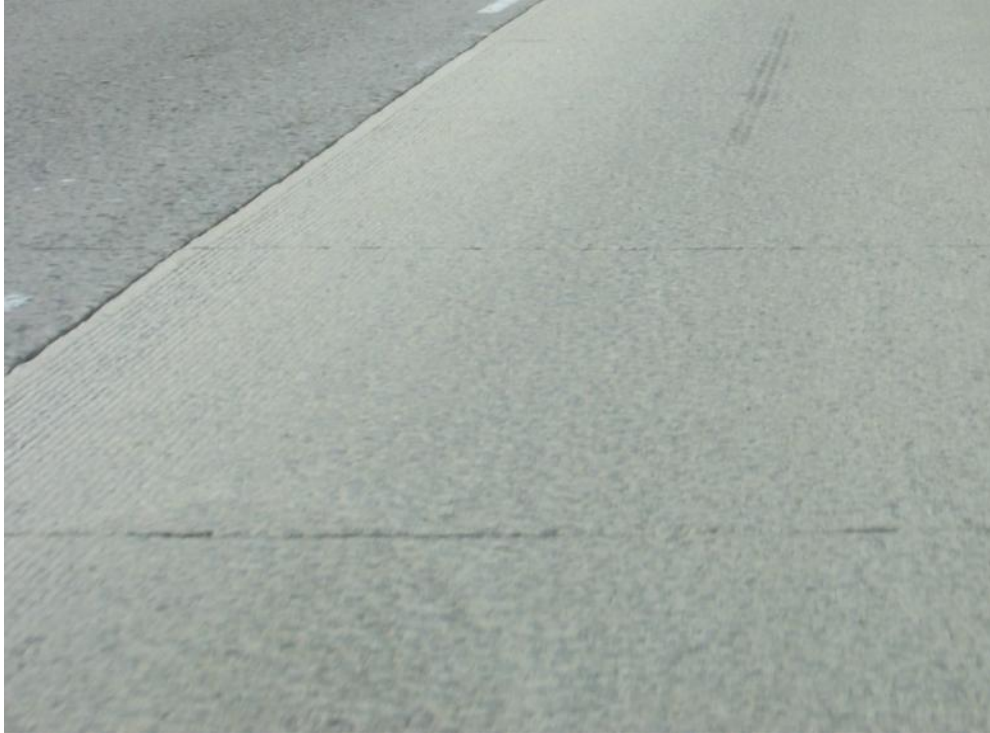
**Figure C.2: Evidence of original longitudinal tines outside of the wheelpaths of Section QP-142.2 after one year of traffic.**

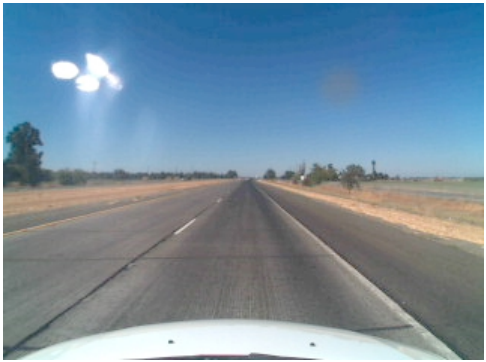
<p>Onboard picture Year 1</p>

Type of section: Pavement      Field testing Year 1: 9/3/2008 15:09  
 Location: 03Yol113N3.0      Field testing Year 2: 9/4/2009 14:07  
 Comments: Longitudinally tined. Aggressive texture, sealed joints.  
 Surface Year: 1976

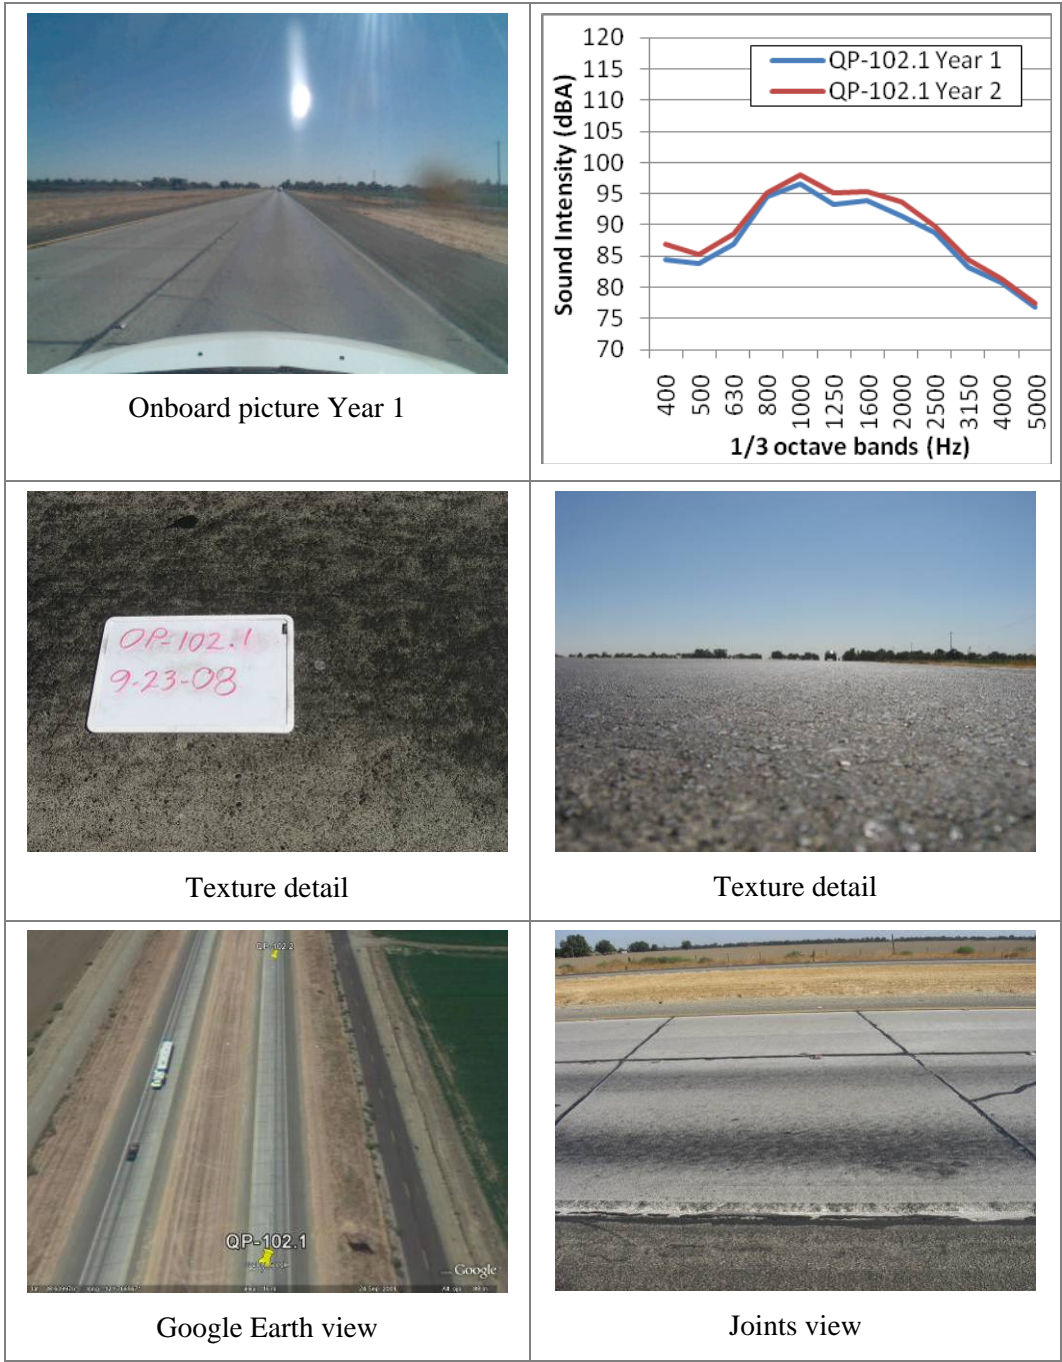
**QP-102.1**

Type of section: Pavement      Field testing Year 1: 9/23/2008 13:12  
 Location: 03Yol113S5.5      Field testing Year 2: 9/4/2009 14:20  
 Comments: Burlap drag. Rubber built-up, some transverse cracks.  
 Surface Year: 1976

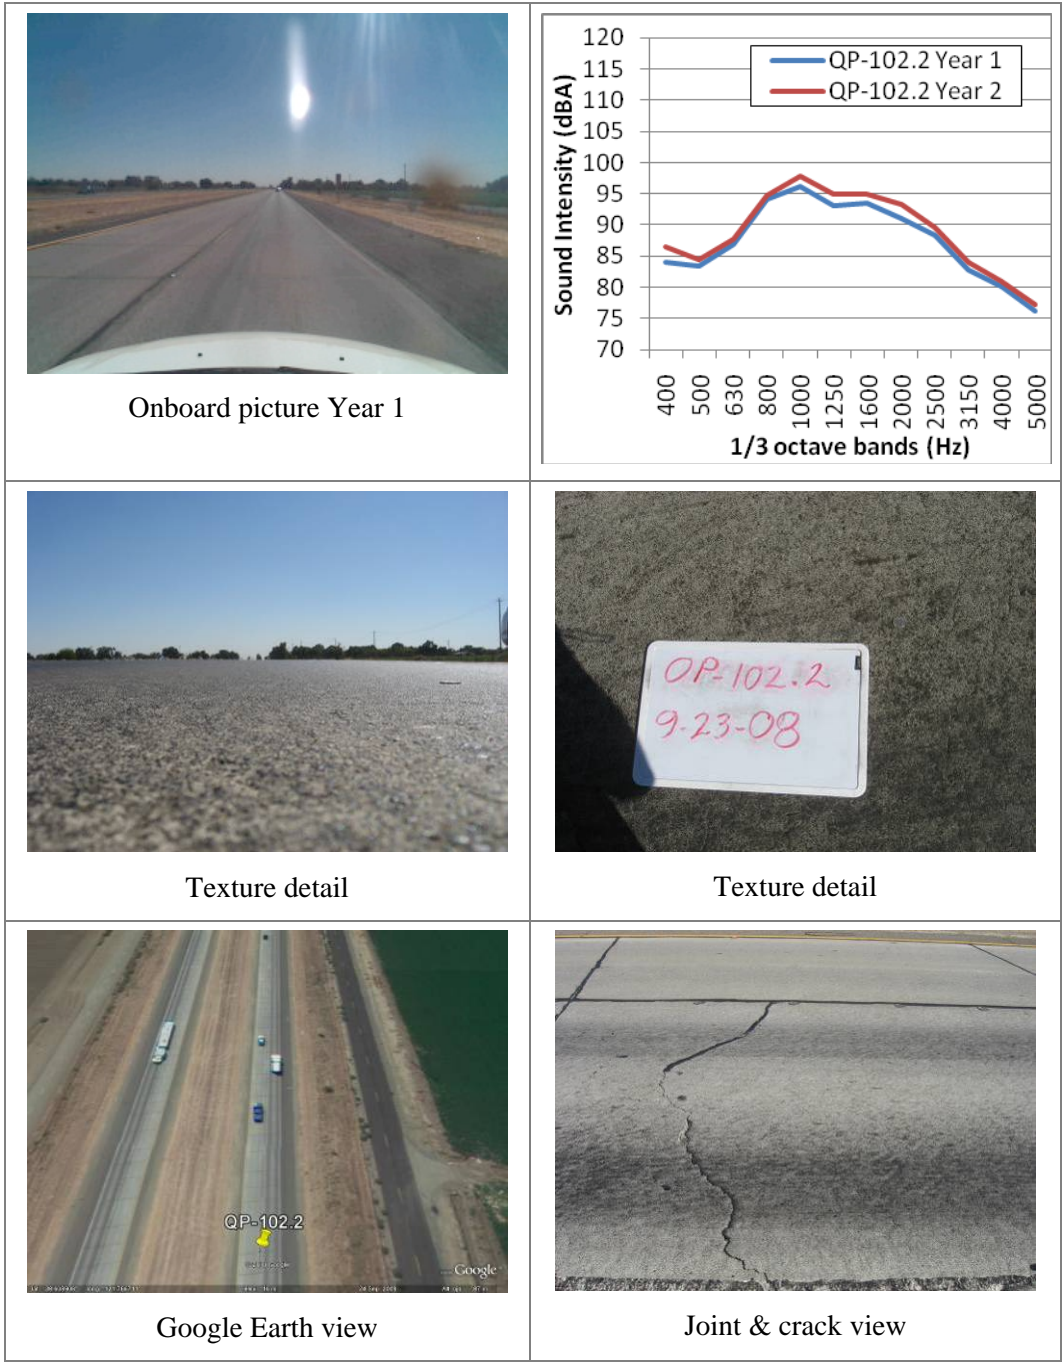
**QP-102.2**

Type of section: Pavement      Field testing Year 1: 9/23/2008 13:46  
 Location: 03Yol113S5.4      Field testing Year 2: 9/4/2009 14:49  
 Comments: Burlap drag. Rubber built-up, some transverse cracks.  
 Surface Year: 1976

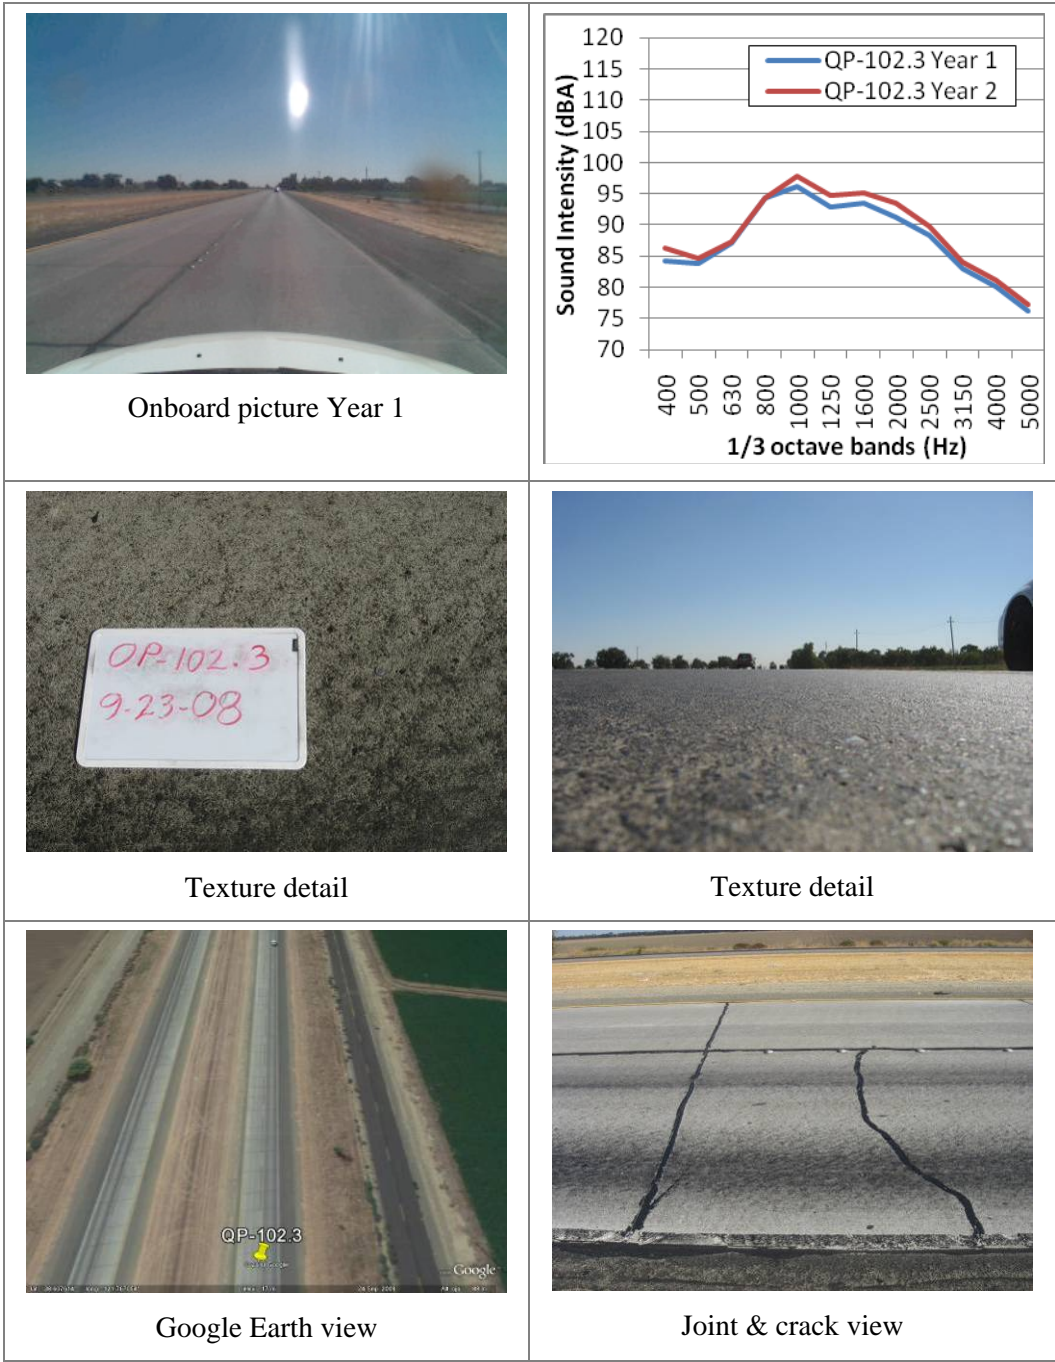
**QP-102.3**

Type of section: Pavement      Field testing Year 1: 9/23/2008 13:58  
 Location: 03Yol113S5.3      Field testing Year 2: 9/4/2009 14:49  
 Comments: Burlap drag. Rubber build-up, some transverse cracks.  
 Surface Year: 1976

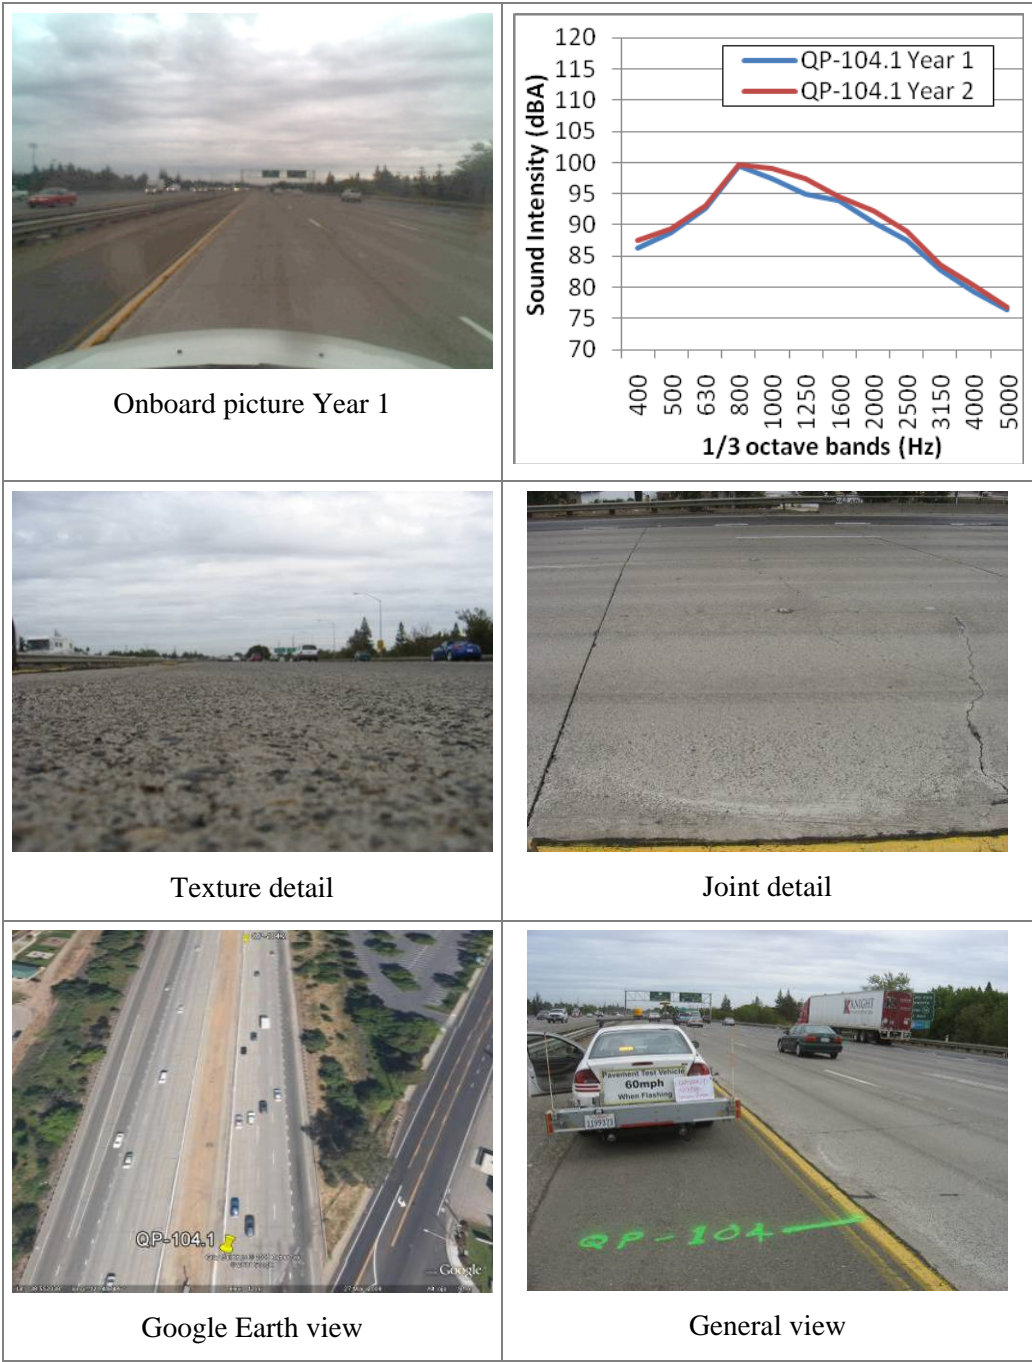
**QP-104.1**

Comments: Burlap drag. Worn BD.

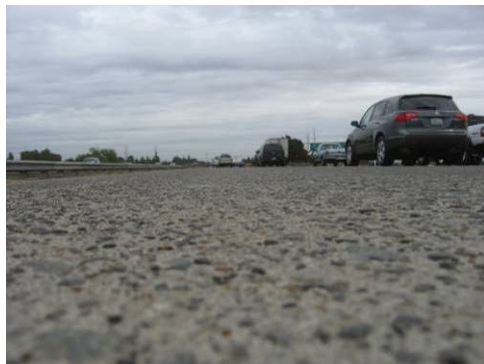
Texture detail

Comments: Burlap drag. moderately worn BD.

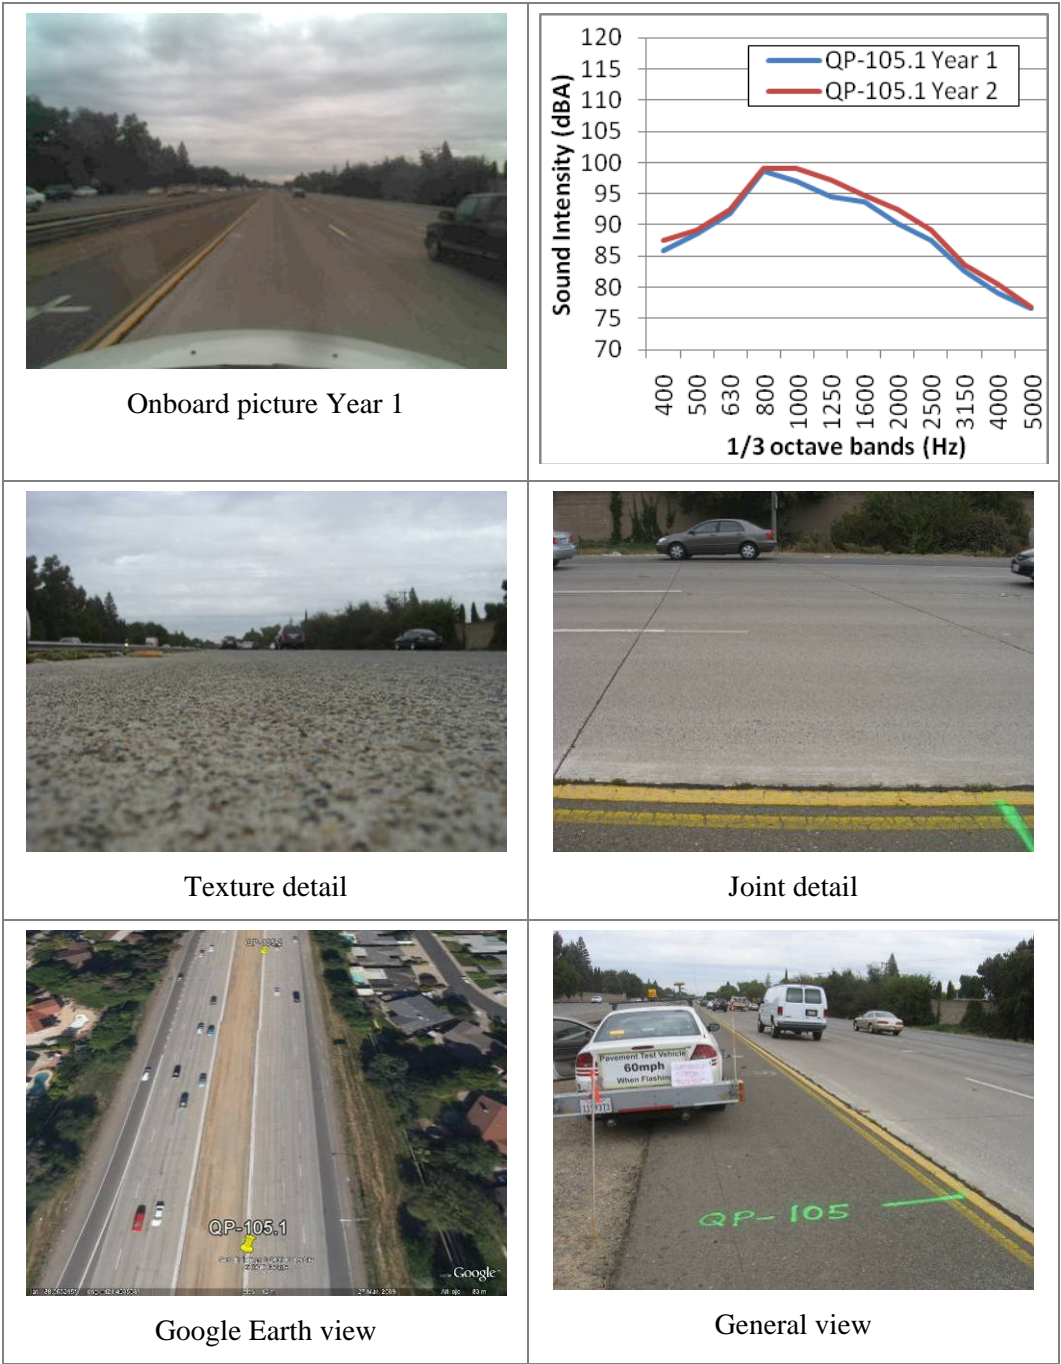
**QP-105.1**

Type of section: Pavement      Field testing Year 1: 10/3/2008 14:00  
 Location: 03Sac50E4.0      Field testing Year 2: 9/11/2009 11:43  
 Comments: Burlap drag. Worn texture, unsealed joints.  
 Surface Year: 1971

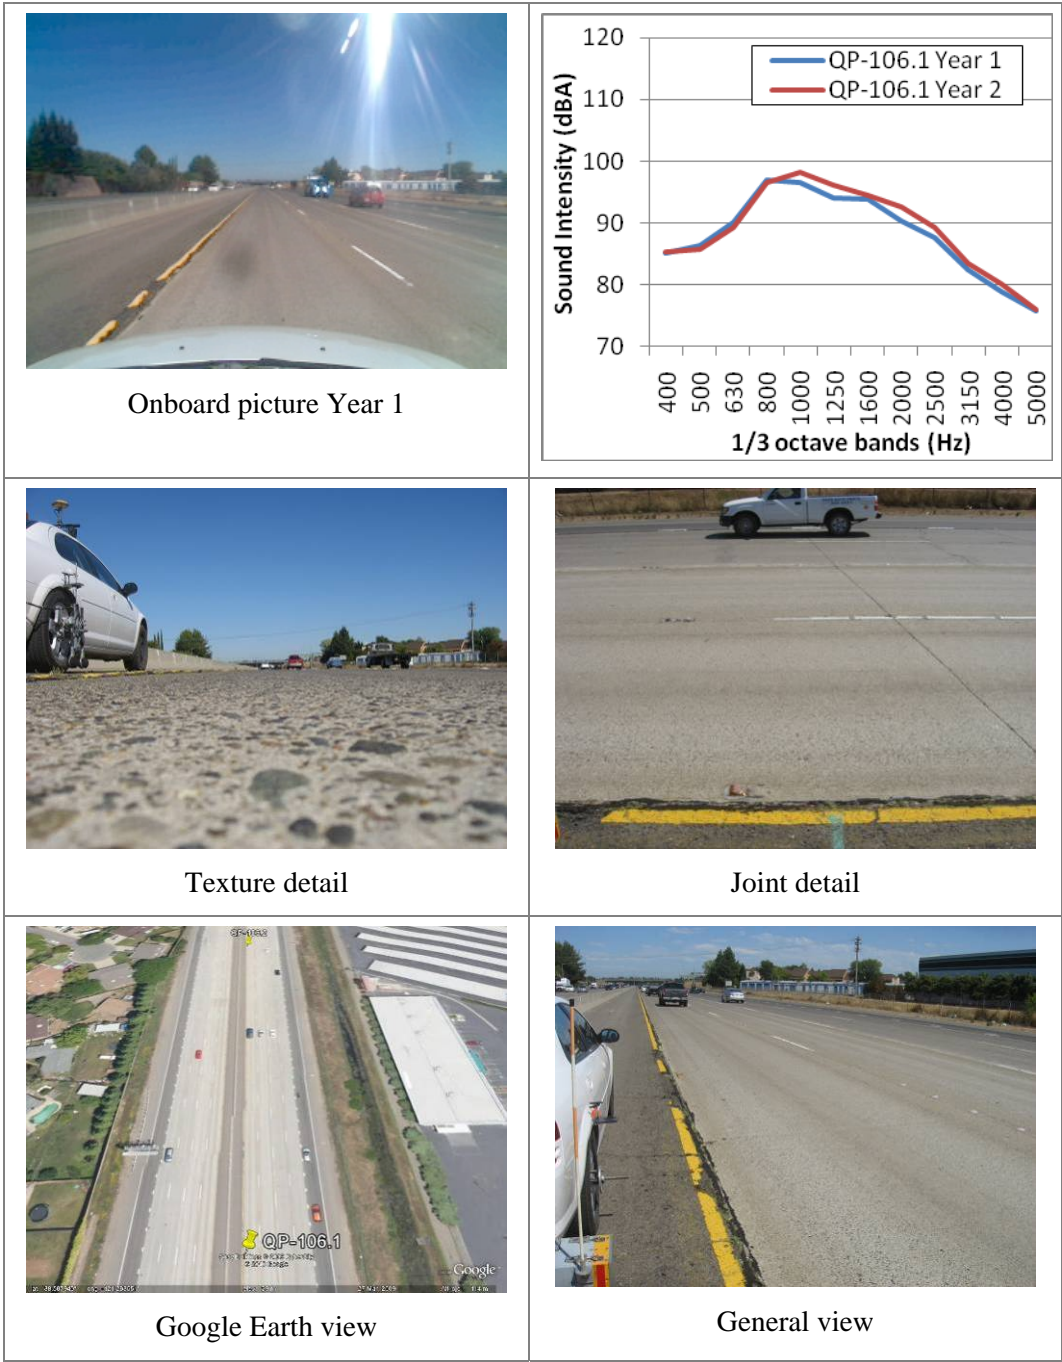
**QP-106.1**

Type of section: Pavement      Field testing Year 1: 10/13/2008 14:48  
 Location: 03Sac50E10.5      Field testing Year 2: 9/11/2009 14:11  
 Comments: Burlap drag. Worn texture, unsealed joints.  
 Surface Year: 1973

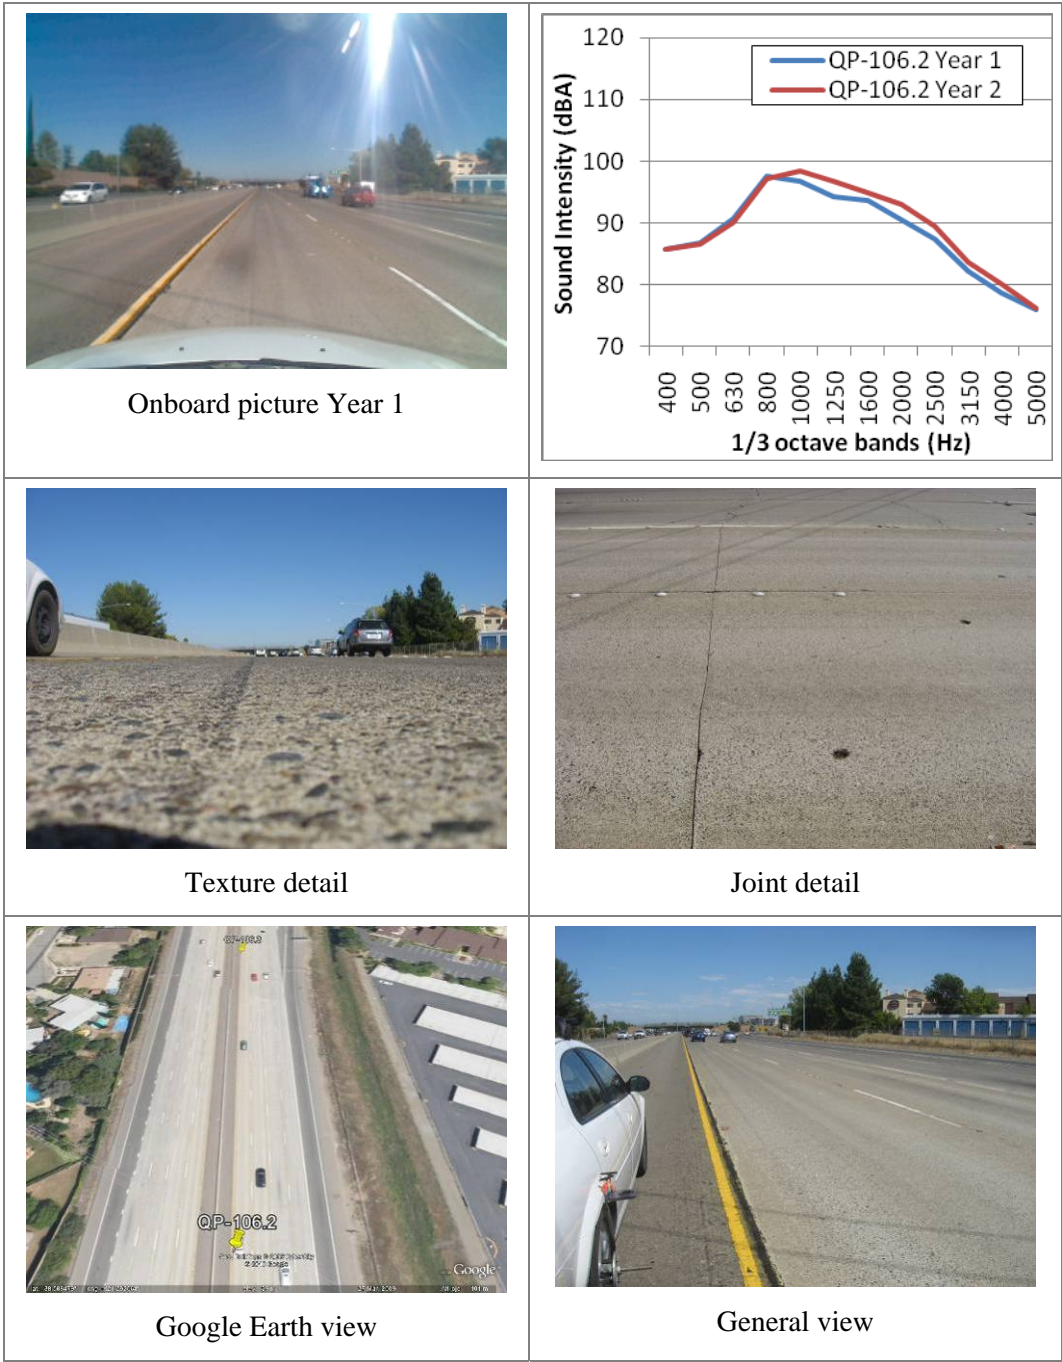
**QP-106.2**

Type of section: Pavement      Field testing Year 1: 10/13/2008 14:55  
 Location: 03Sac50E10.6      Field testing Year 2: 9/11/2009 14:36  
 Comments: Burlap drag. Worn texture, unsealed joints.  
 Surface Year: 1973

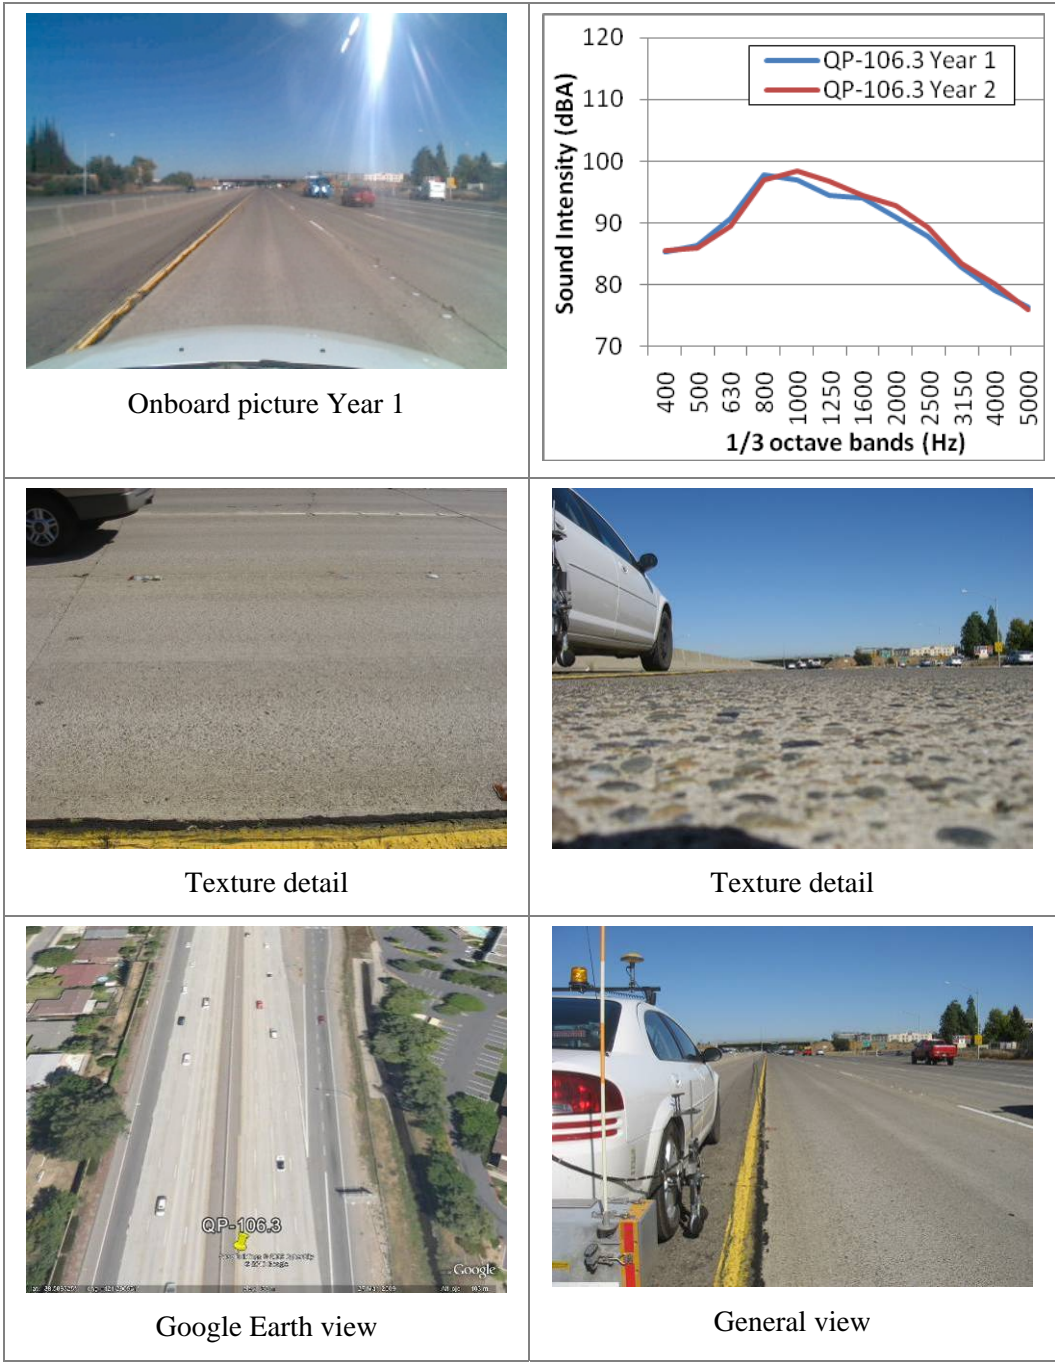
**QP-106.3**

Type of section: Pavement      Field testing Year 1: 10/13/2008 15:14  
 Location: 03Sac50E10.7      Field testing Year 2: 9/11/2009 14:42  
 Comments: Burlap drag. Worn texture, unsealed joints.  
 Surface Year: 1973

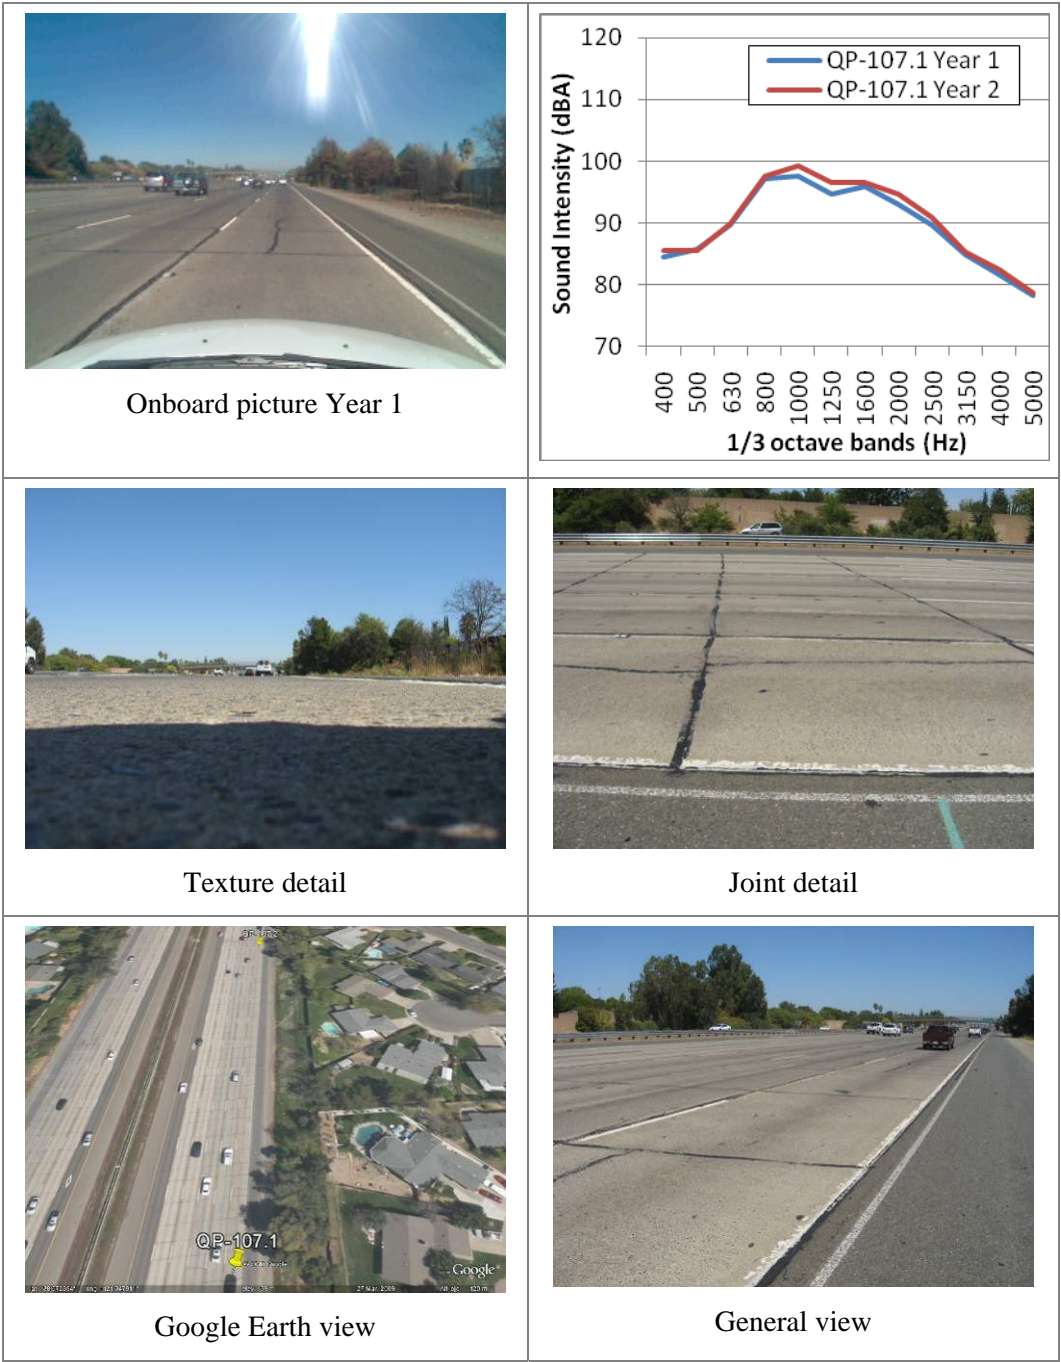
**QP-107.1**

Type of section: Pavement      Field testing Year 1: 10/16/2008 14:23  
 Location: 03Sac80E13.6      Field testing Year 2: 9/9/2009 13:03  
 Comments: Burlap drag. Shallow texture.  
 Surface Year: 1973
