Quieter Pavement Research: Concrete Pavement Tire Noise

# Quieter Pavement Research: Concrete Pavement Tire Noise

Work Conducted as Part of Partnered Pavement Research Center Strategic Plan Element No. 4.22:  
Quiet Concrete Pavement Research

<b>DOCUMENT RETRIEVAL PAGE</b>		<b>UCPRC Research Report No.:</b> UCPRC-RR-2010-03			
<b>Title:</b> Quieter Pavement Research: Concrete Pavement Tire Noise					
<b>Author:</b> E. Kohler and J. Harvey					
<b>Prepared for:</b> California Department of Transportation, Division of Research and Innovation, Office of Roadway Research		<b>FHWA No.:</b> CA121200A	<b>Date Work Submitted:</b> August 20, 2010	<b>Date:</b> May 2010	
<b>Strategic Plan Element No.:</b> 4.22		<b>Status:</b> Stage 6, final version		<b>Version No.:</b> 1	
<p><b>Abstract:</b> This research report presents the results of tire/pavement noise measurements performed on concrete pavements as a part of the California Department of Transportation (Caltrans) Quieter Pavement Research (QPR) study to investigate tire/pavement noise characteristics on concrete pavements and bridge decks.</p> <p>The study included a total of 120 pavement sections at 47 different sites on various state

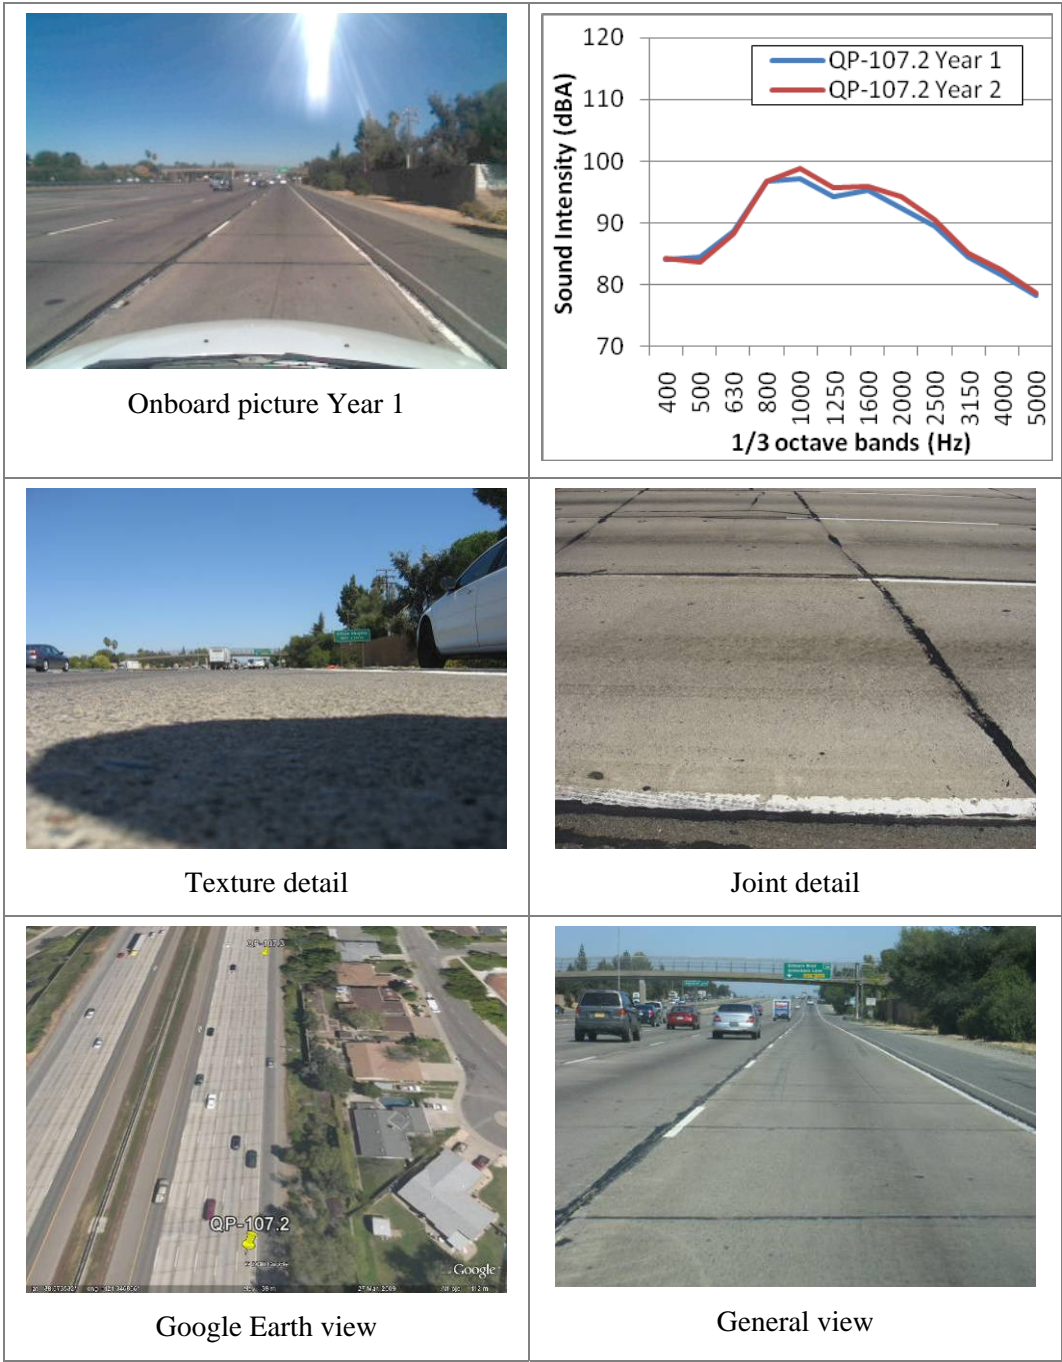
**QP-107.2**

Type of section: Pavement      Field testing Year 1: 10/16/2008 14:29  
 Location: 03Sac80E13.7      Field testing Year 2: 9/9/2009 13:14  
 Comments: Burlap drag. Shallow texture.  
 Surface Year: 1973

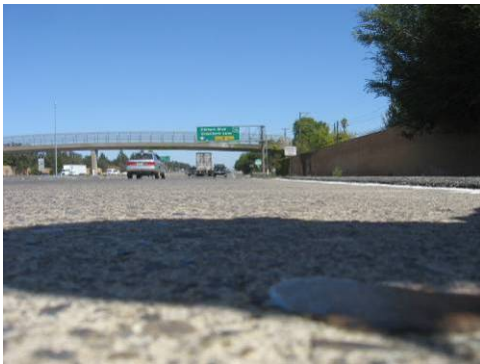
Texture detail

Type of section: Pavement      Field testing Year 1: 10/16/2008 14:36  
 Location: 03Sac80E13.8      Field testing Year 2: 9/9/2009 13:18  
 Comments: Burlap drag. Shallow texture.  
 Surface Year: 1973

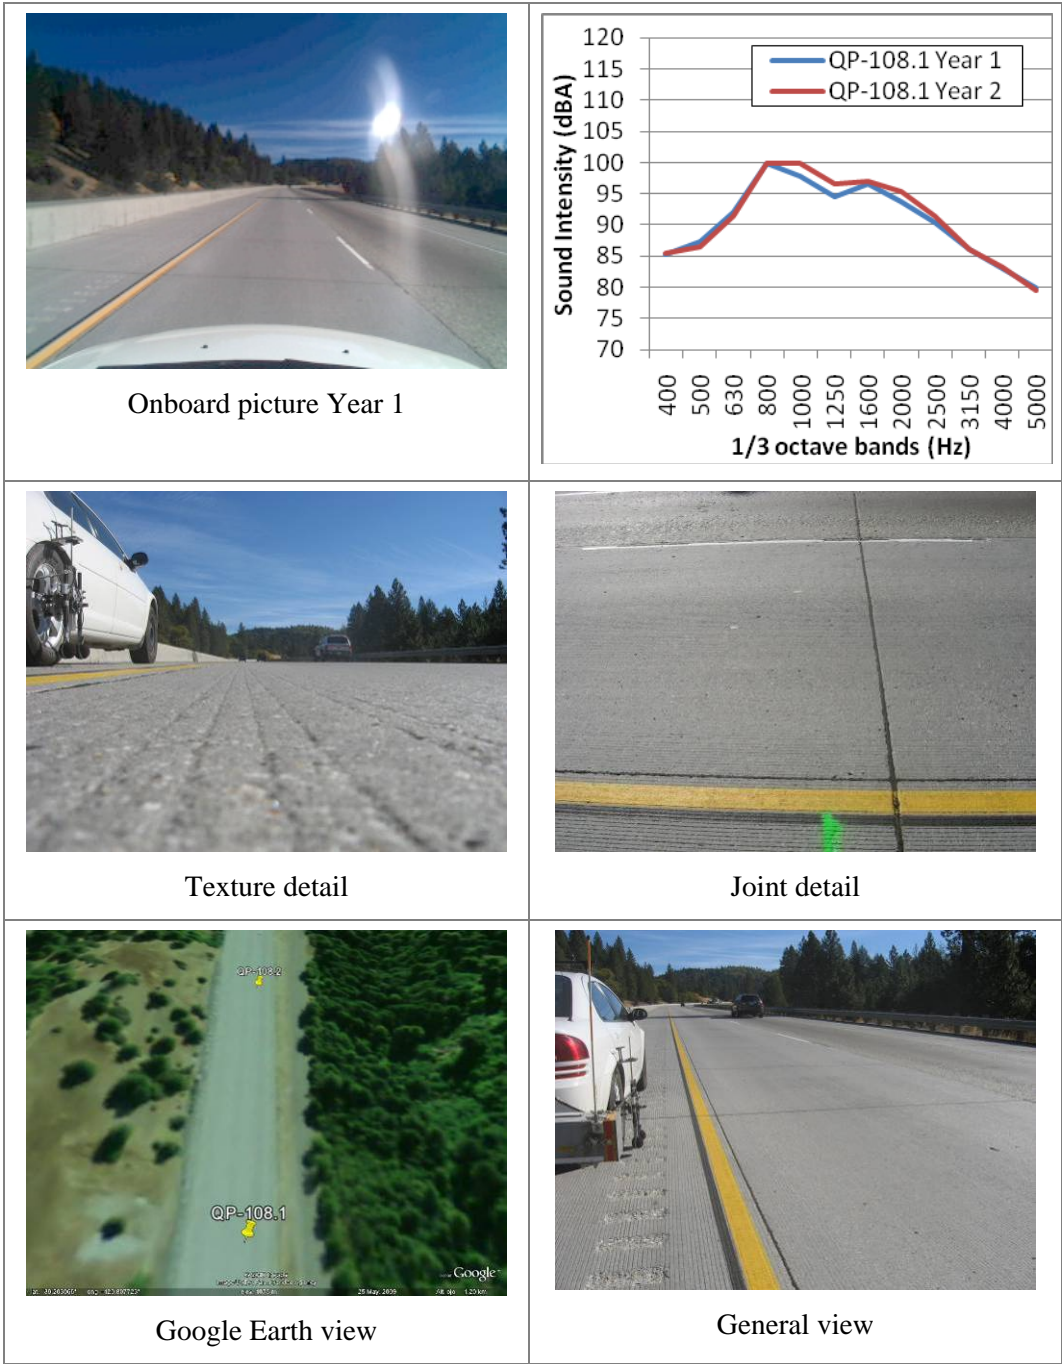
**QP-108.1**

Type of section: Pavement      Field testing Year 1: 10/21/2008 11:24  
 Location: 03Pla80E45.0      Field testing Year 2: 9/16/2009 12:26  
 Comments: Longitudinally tined. Shallow texture, worn out.  
 Surface Year: 2004

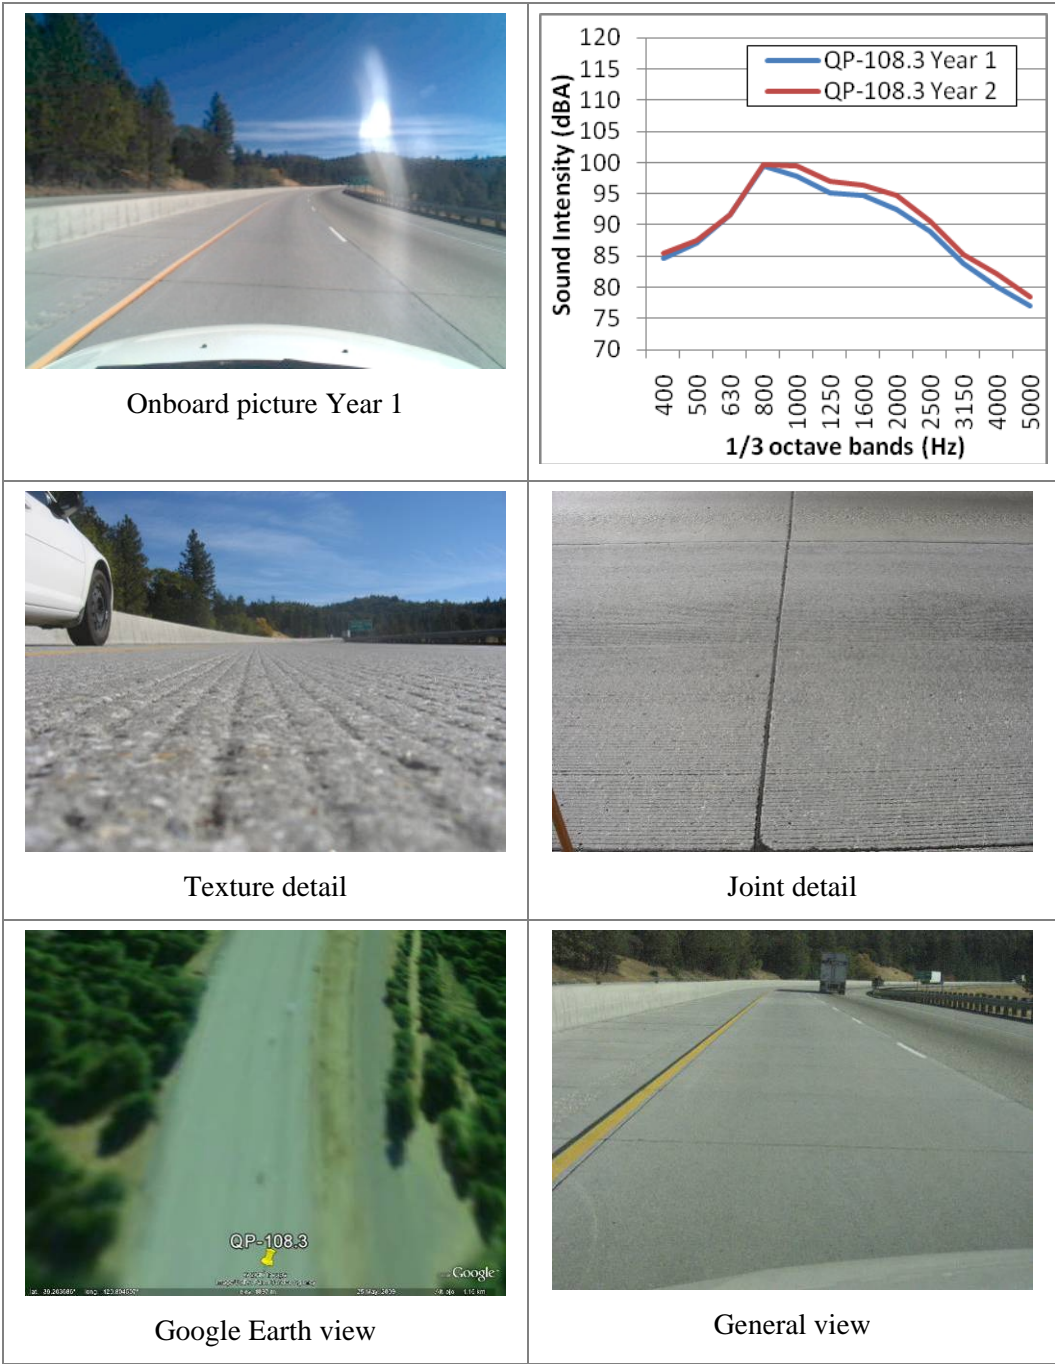
**QP-108.3**

Type of section: Pavement      Field testing Year 1: 10/21/2008 11:48  
 Location: 03Pla80E45.2      Field testing Year 2: 9/16/2009 12:45  
 Comments: Longitudinally tined. Texture deeper than 108.1.  
 Surface Year: 2004

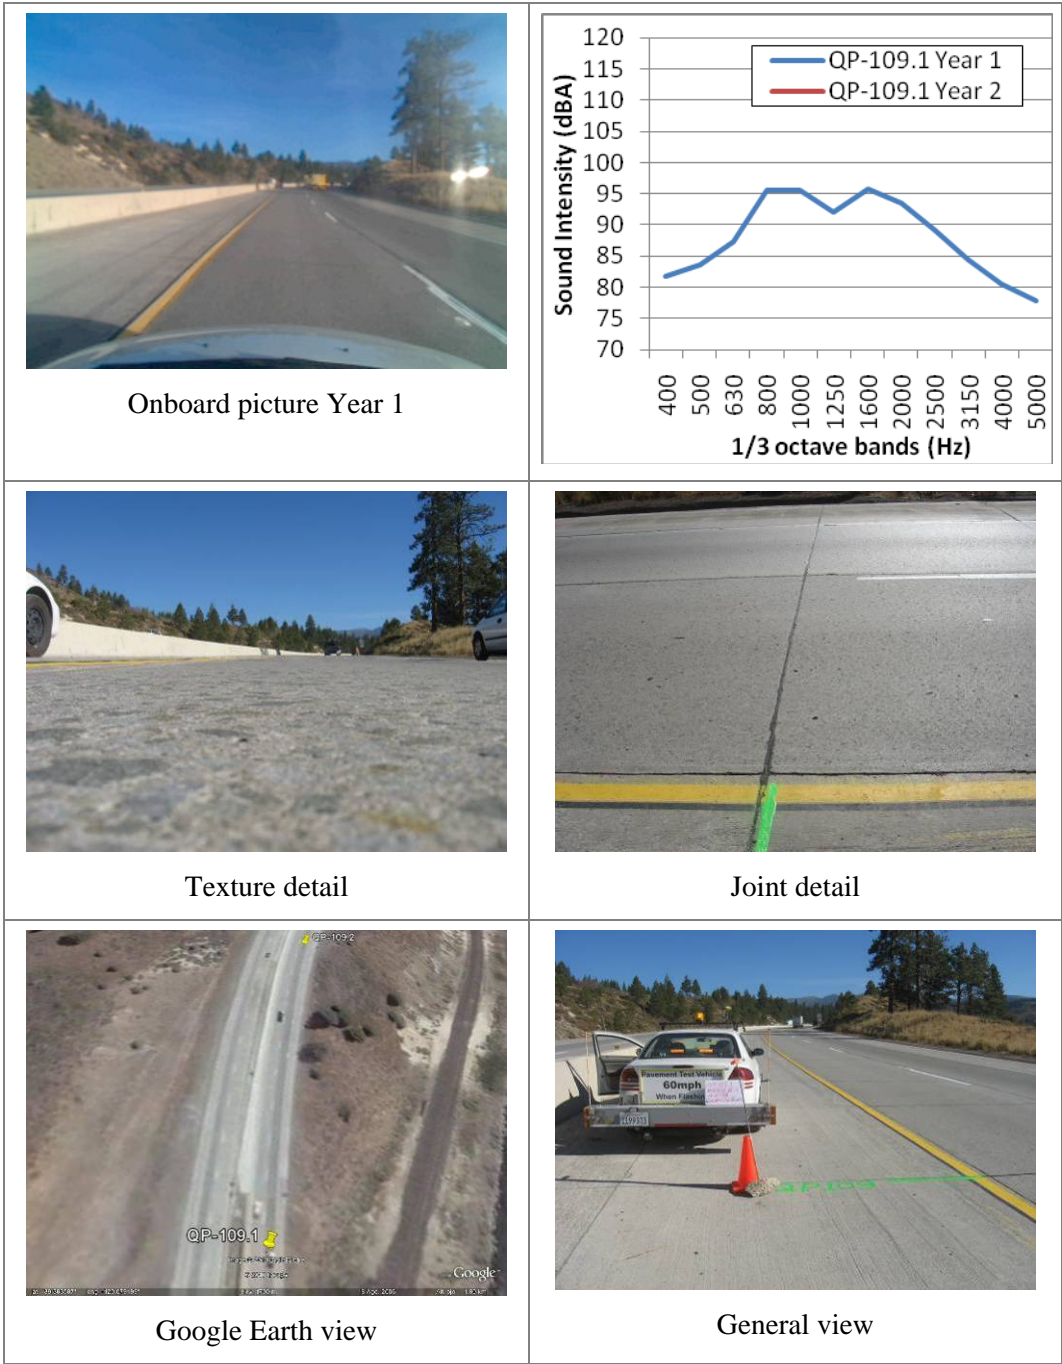
**QP-109.1**

Type of section: Pavement      Field testing Year 1: 10/21/2008 17:02  
 Location: 03Nev80E22.6      Field testing Year 2:  
 Comments: Longitudinally broomed. Worn out texture.  
 Surface Year: 1989

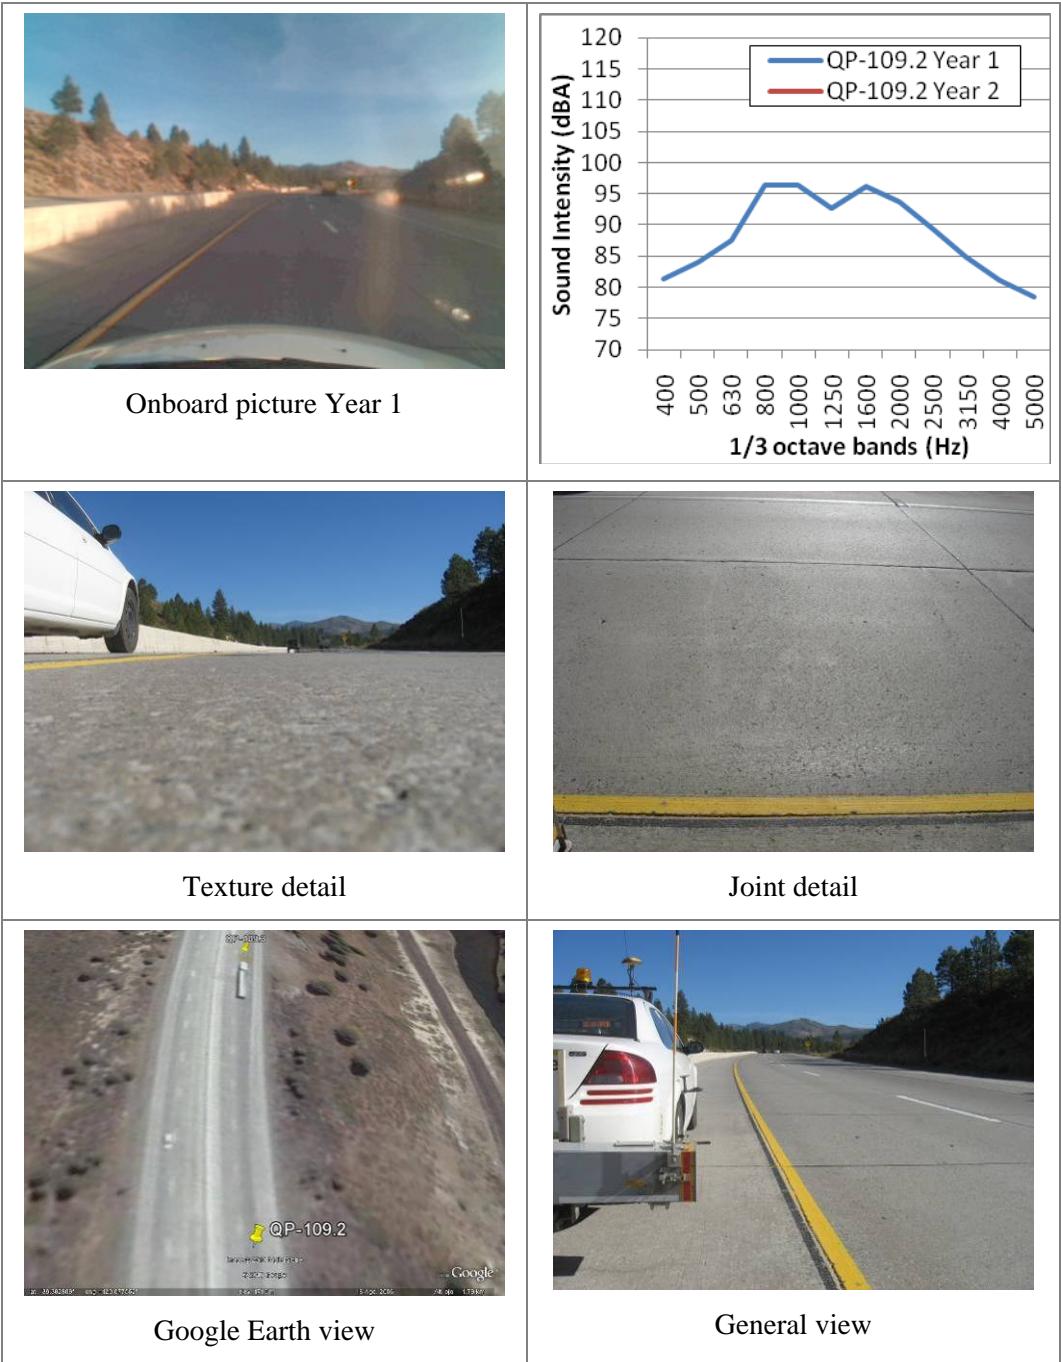
**QP-109.2**

Type of section: Pavement      Field testing Year 1: 10/21/2008 17:24  
 Location: 03Nev80E22.6      Field testing Year 2:  
 Comments: Longitudinally broomed. Worn out texture.  
 Surface Year: 1989

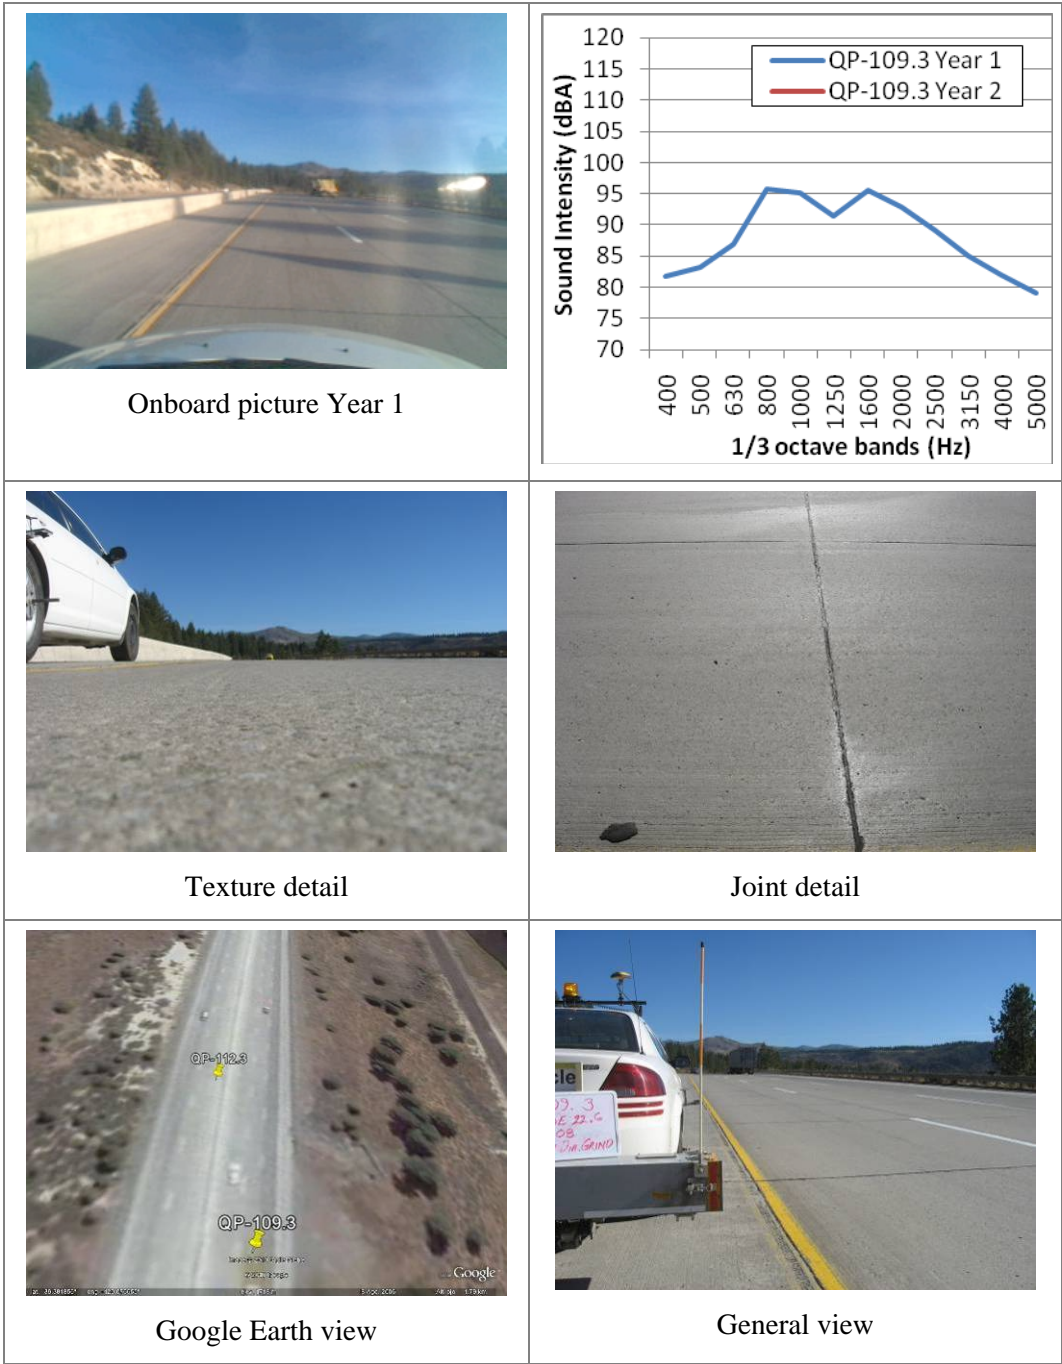
**QP-109.3**

Type of section: Pavement      Field testing Year 1: 10/21/2008 17:35  
 Location: 03Nev80E22.6      Field testing Year 2:  
 Comments: Longitudinally broomed. Worn out texture.  
 Surface Year: 1989

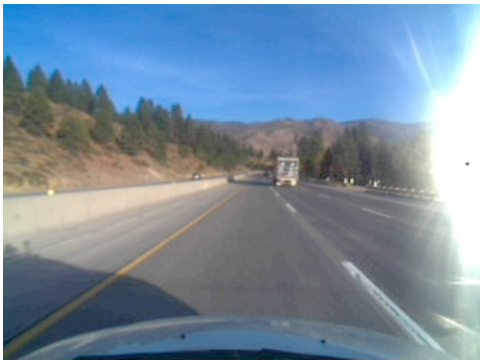
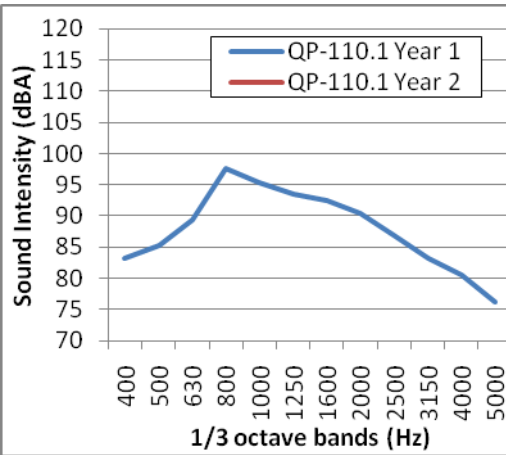
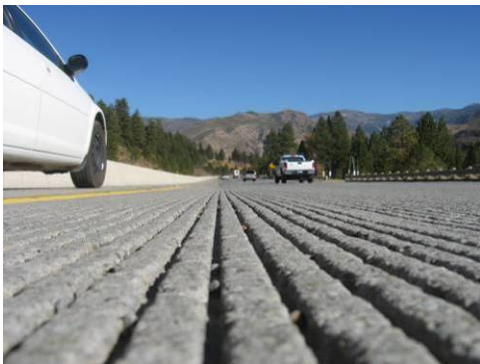
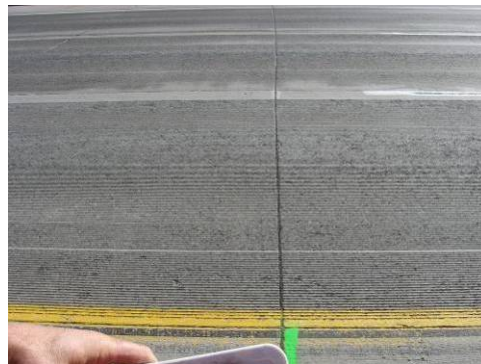
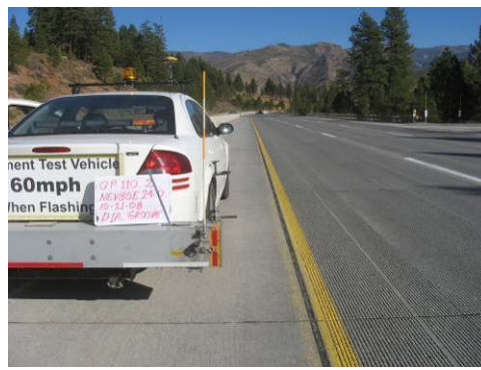
**QP-110.1**

Comments: Diamond grooved.

Texture detail

Joint detail

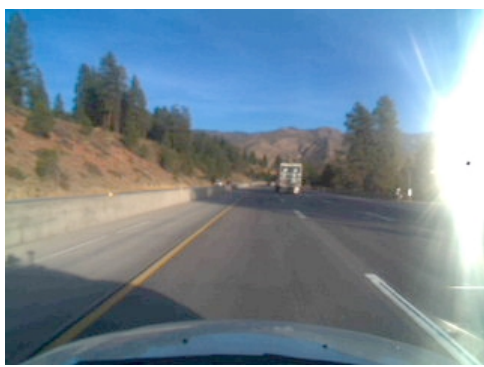
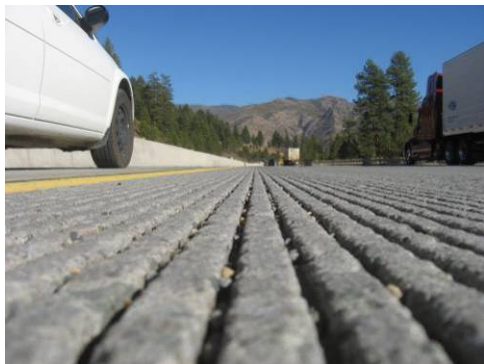
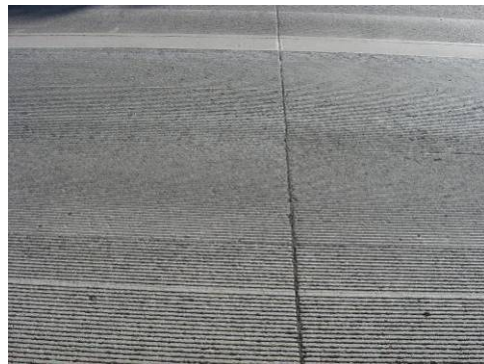
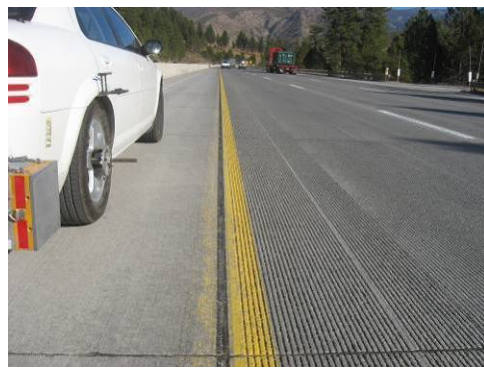
**QP-110.2**

Comments: Diamond grooved.

Texture detail

Joint detail

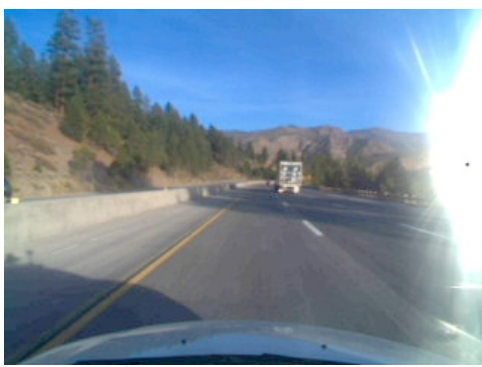
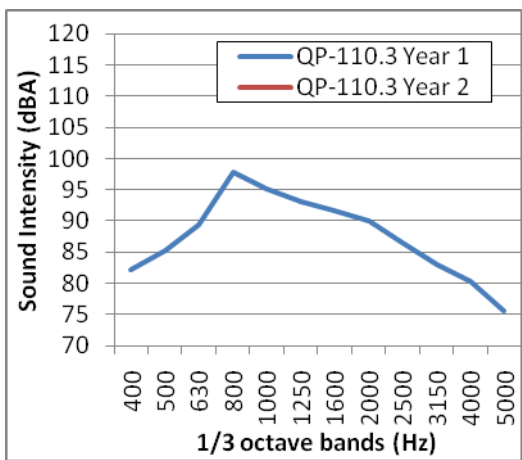
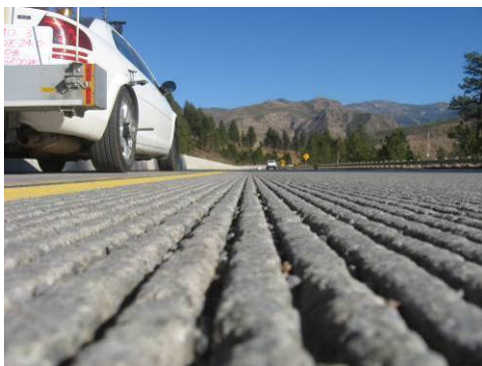
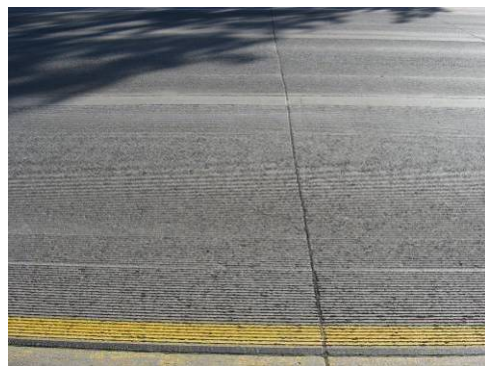
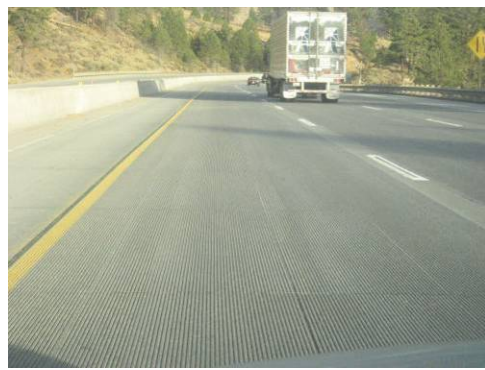
**QP-110.3**

Comments: Diamond grooved.

Texture detail

Joint detail

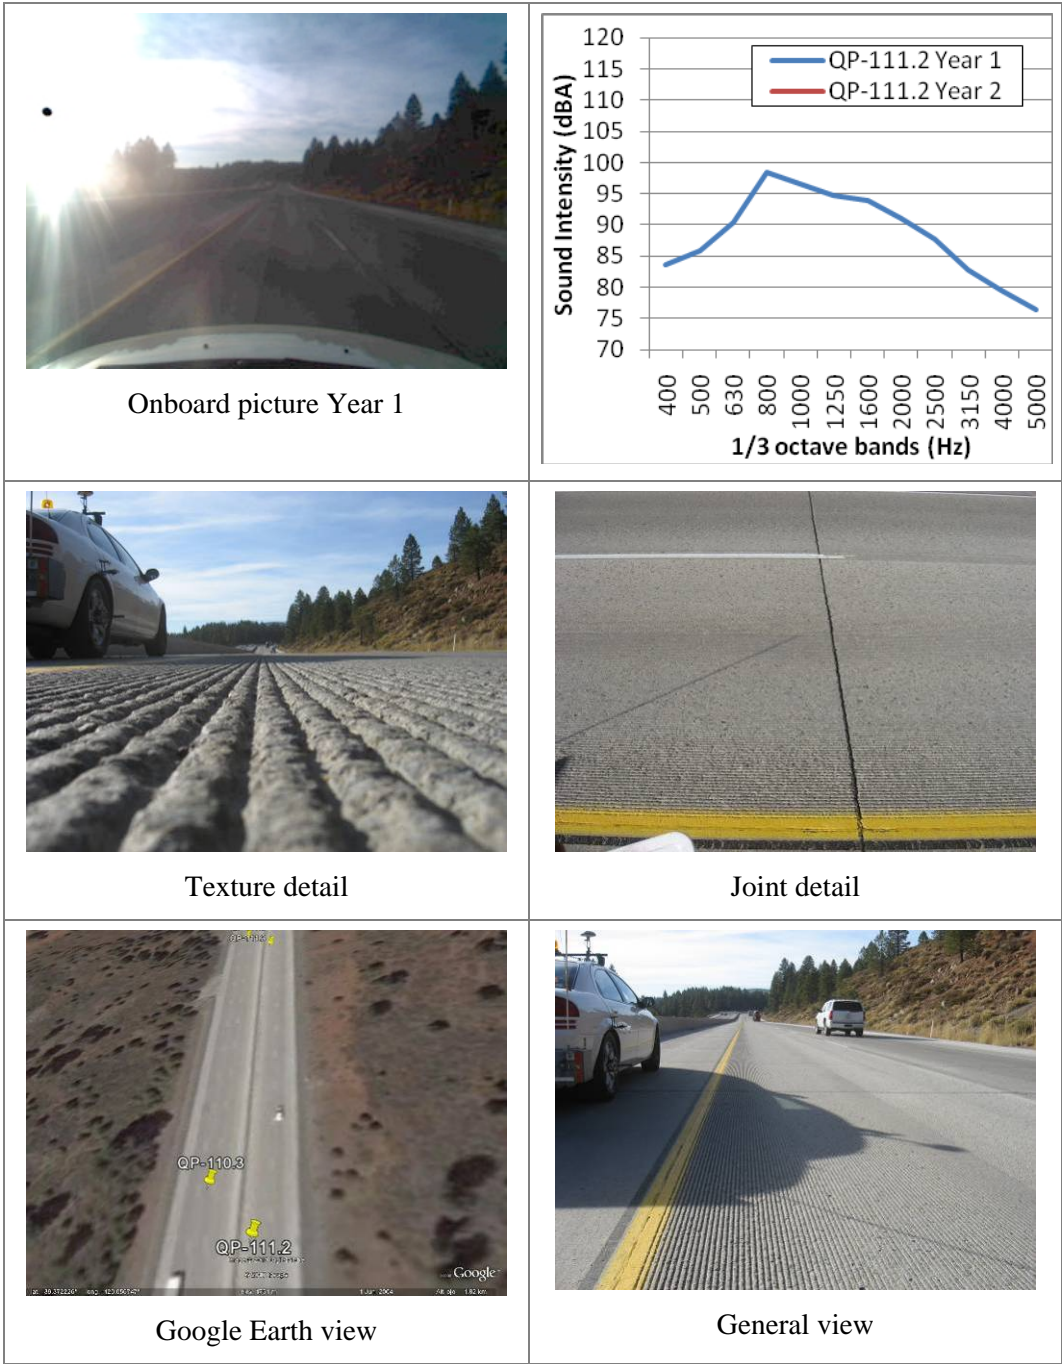
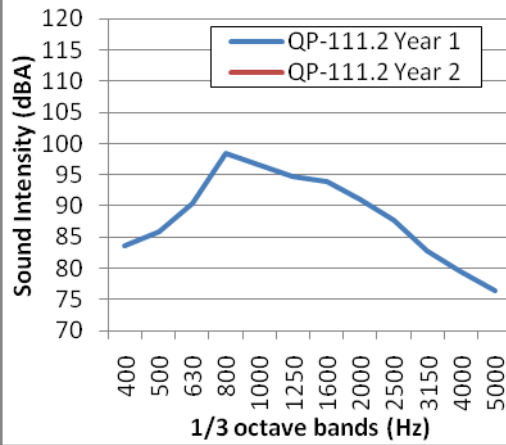
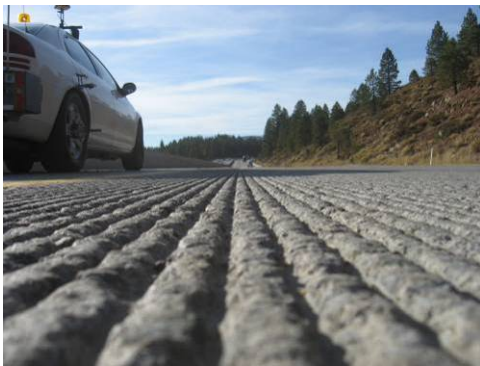
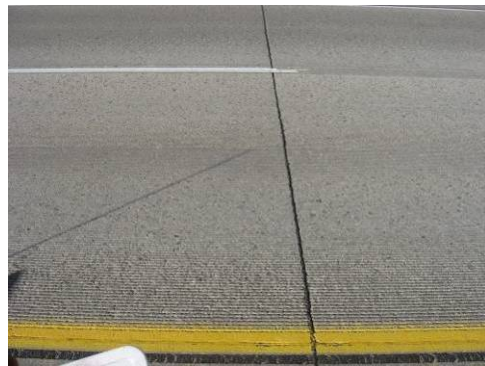
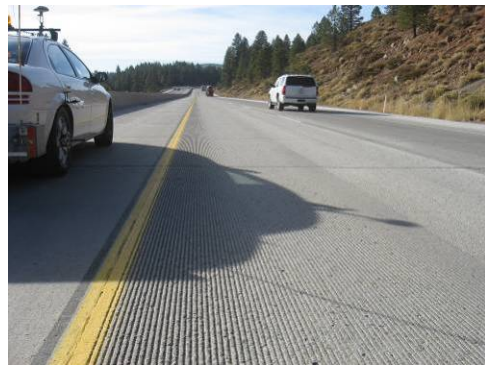
**QP-111.2**

Comments: Diamond grooved.

Texture detail

Joint detail

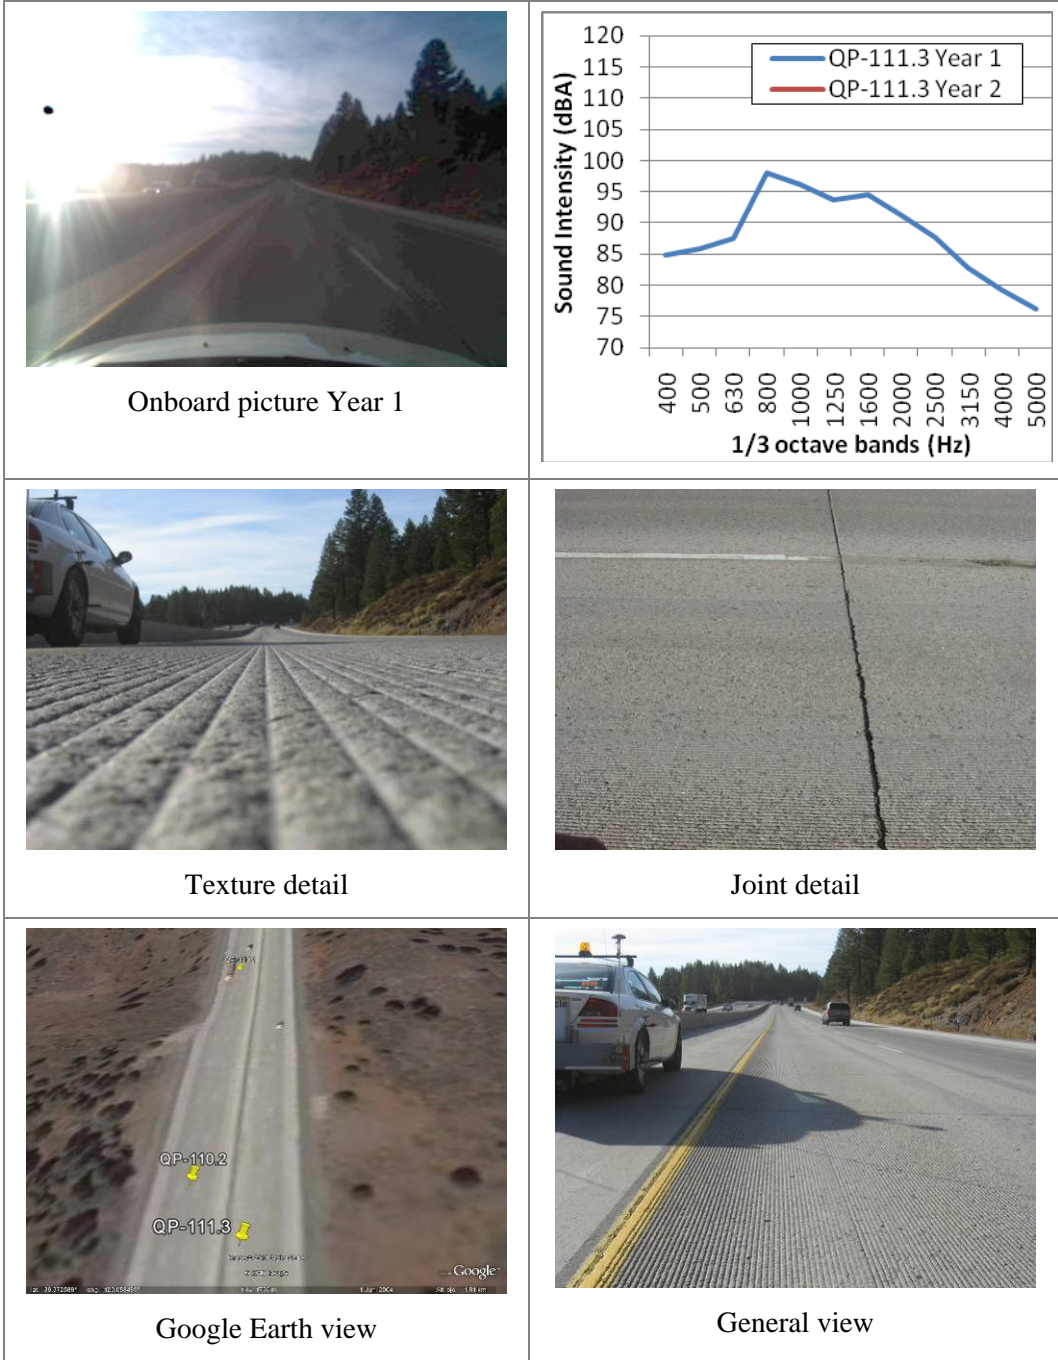
**QP-111.3**

Comments: Diamond grooved.

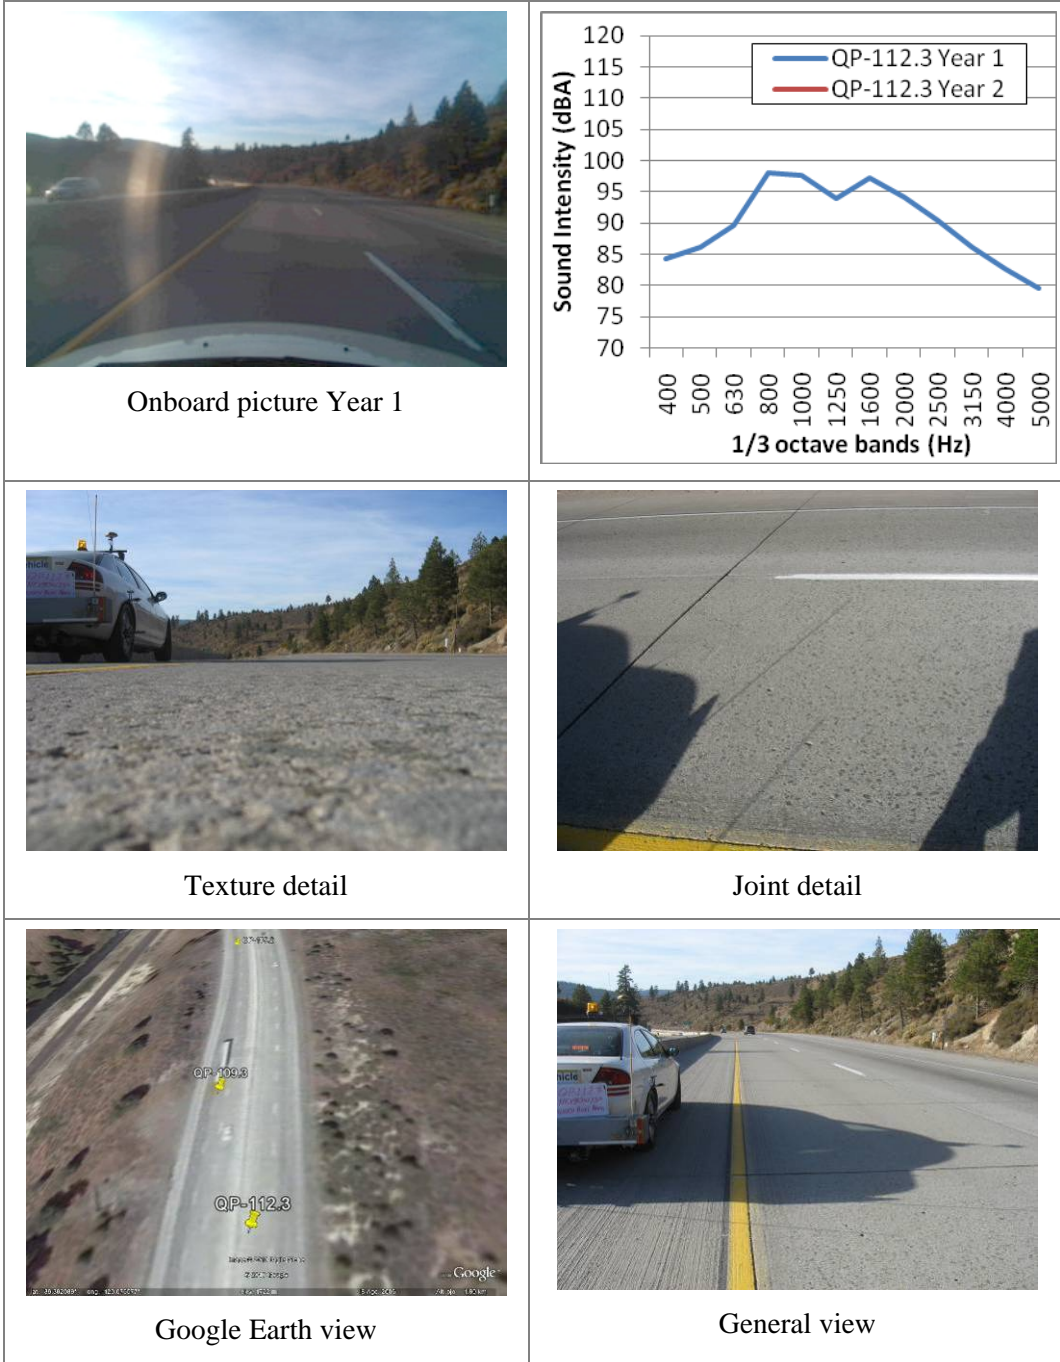
**QP-112.3**

Type of section: Pavement      Field testing Year 1: 10/21/2008 17:45  
 Location: 03Nev80W22.8      Field testing Year 2:  
 Comments: Longitudinally broomed. Uneven wear along section. Wide joints.  
 Surface Year: 1989

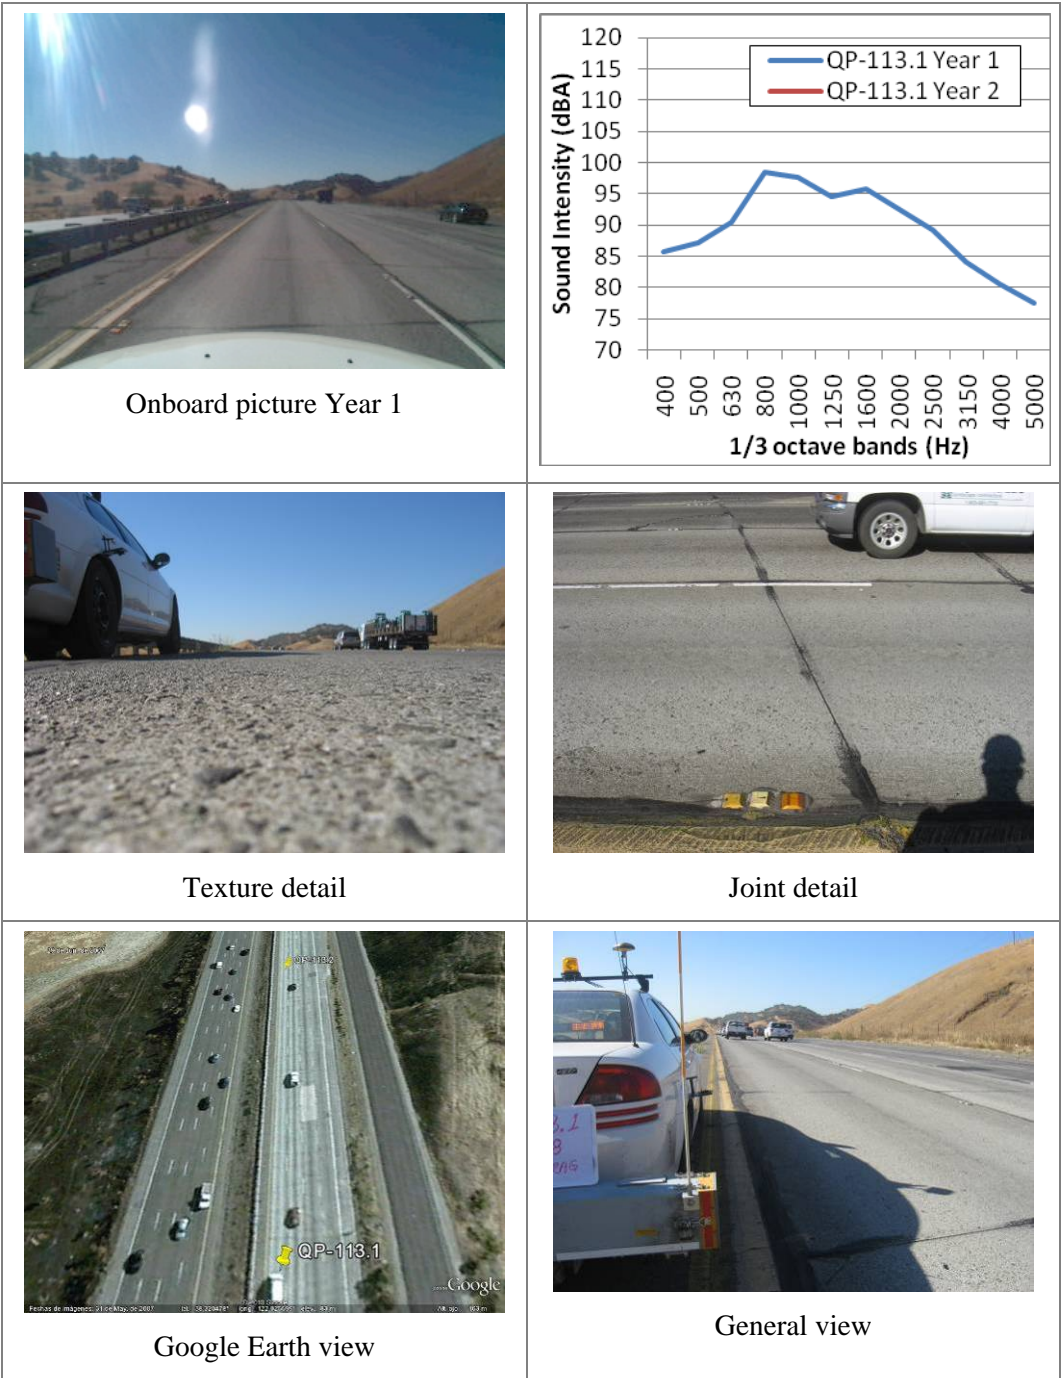
**QP-113.1**

Type of section: Pavement      Field testing Year 1: 10/23/2008 12:37  
 Location: 03Yol80W22.9      Field testing Year 2:  
 Comments: Burlap drag. Worn out texture.  
 Surface Year: 1965

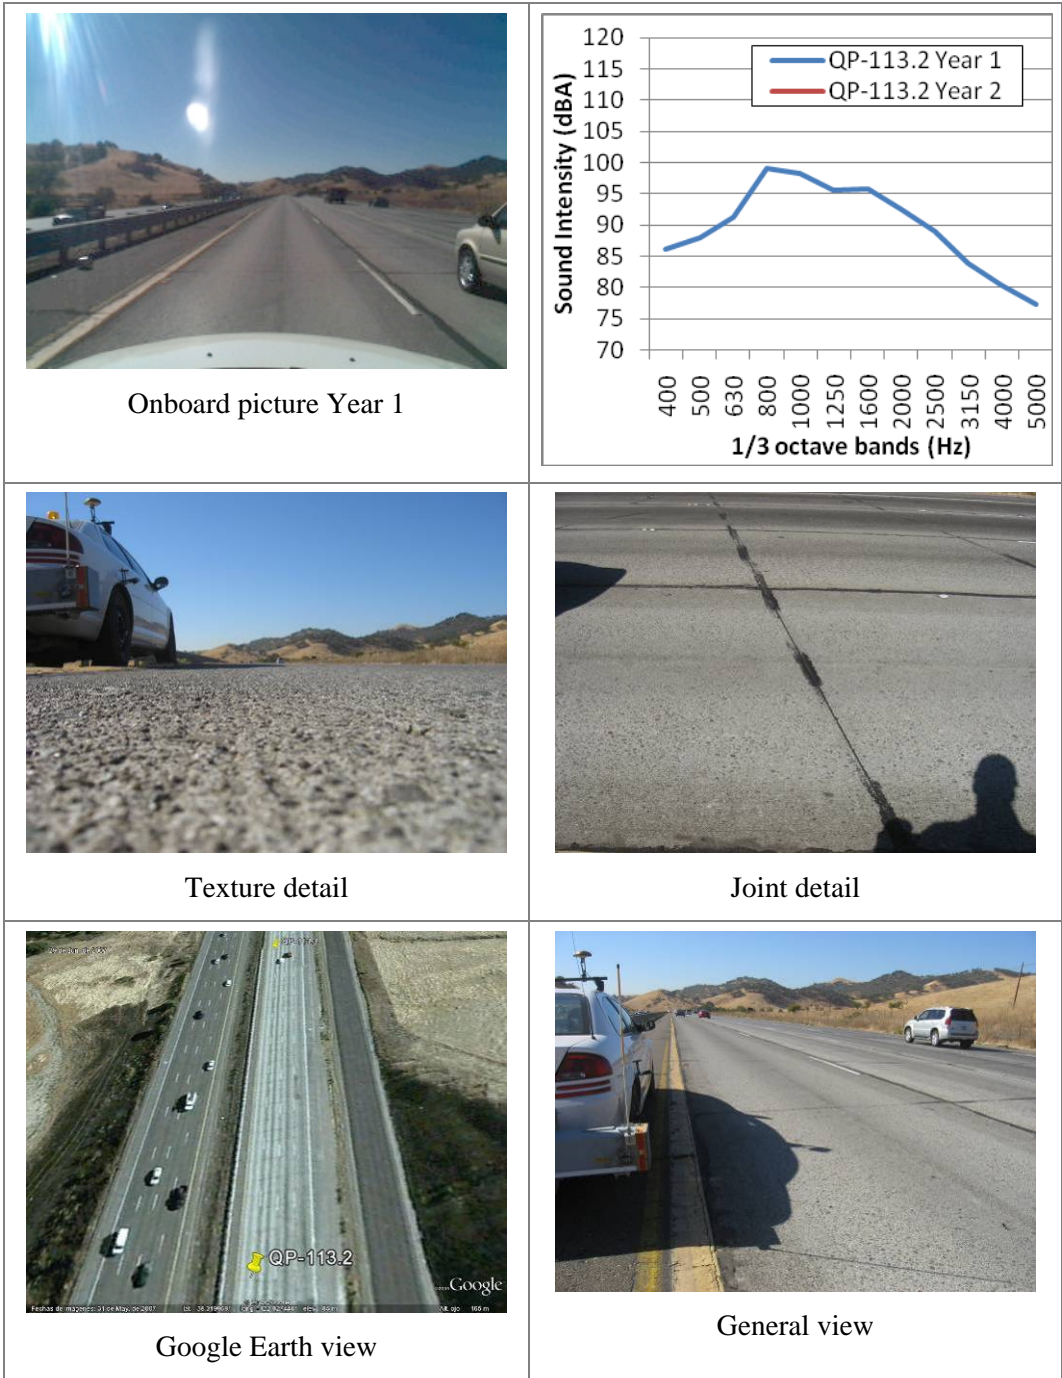
**QP-113.2**

Type of section: Pavement      Field testing Year 1: 10/23/2008 12:45  
 Location: 03Yol80W22.8      Field testing Year 2:  
 Comments: Burlap drag. Worn out texture.  
 Surface Year: 1965

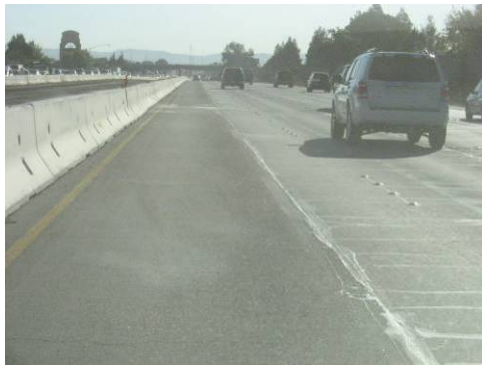
### QP-114.2

Type of section: Pavement      Field testing Year 1: 10/23/2008 15:11  
Location: 04Sol80W18.6      Field testing Year 2:  
Comments: Diamond ground. Right wheelpath on DG CRCP.  
Surface Year: 1999

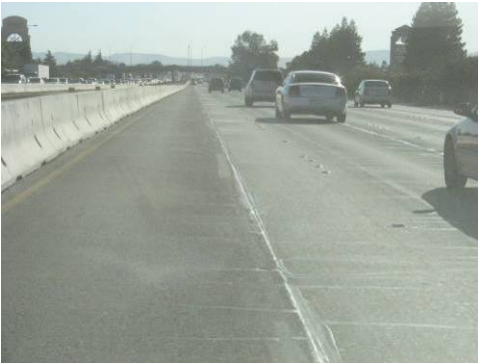
<p>Onboard picture Year 1</p>

**QP-114.3**

Type of section: Pavement      Field testing Year 1: 10/23/2008 15:31  
 Location: 04Sol80W18.5      Field testing Year 2:  
 Comments: Diamond ground. Right wheelpath on DG CRCP.  
 Surface Year: 1999

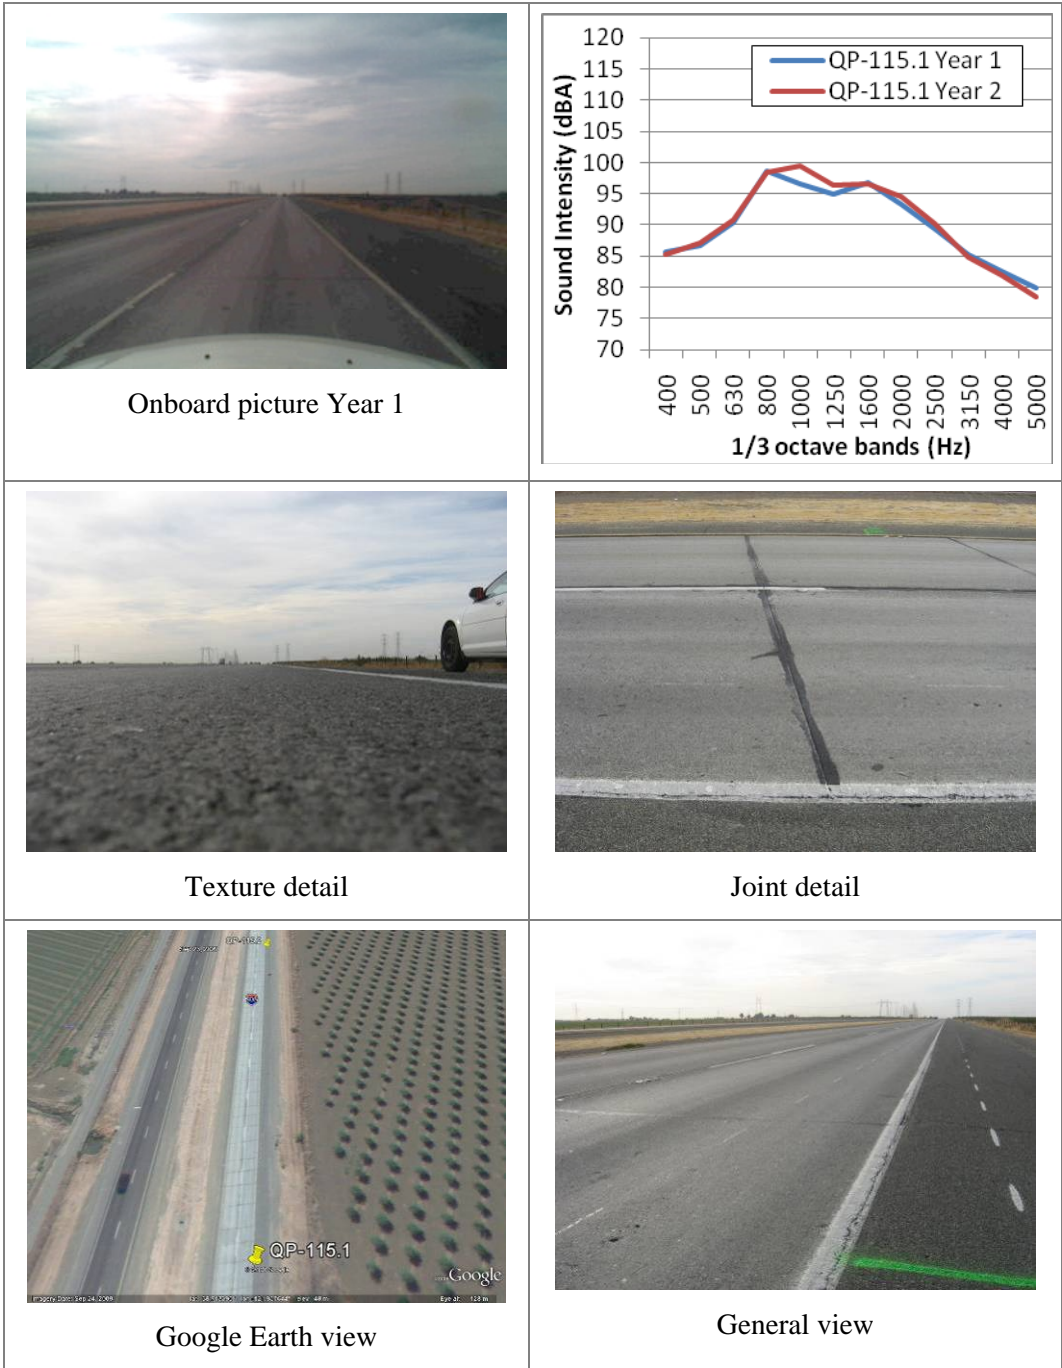
**QP-115.1**

Type of section: Pavement  
 Location: 03Yol505S13.1  
 Comments: Burlap drag.  
 Surface Year: 1977

Field testing Year 1: 10/27/2008 10:33  
 Field testing Year 2: 9/8/2009 11:33
