Quieter Pavement Research: Concrete Pavement Tire Noise

# Quieter Pavement Research: Concrete Pavement Tire Noise

Work Conducted as Part of Partnered Pavement Research Center Strategic Plan Element No. 4.22:  
Quiet Concrete Pavement Research

<b>DOCUMENT RETRIEVAL PAGE</b>		<b>UCPRC Research Report No.:</b> UCPRC-RR-2010-03			
<b>Title:</b> Quieter Pavement Research: Concrete Pavement Tire Noise					
<b>Author:</b> E. Kohler and J. Harvey					
<b>Prepared for:</b> California Department of Transportation, Division of Research and Innovation, Office of Roadway Research		<b>FHWA No.:</b> CA121200A	<b>Date Work Submitted:</b> August 20, 2010	<b>Date:</b> May 2010	
<b>Strategic Plan Element No.:</b> 4.22		<b>Status:</b> Stage 6, final version		<b>Version No.:</b> 1	
<p><b>Abstract:</b> This research report presents the results of tire/pavement noise measurements performed on concrete pavements as a part of the California Department of Transportation (Caltrans) Quieter Pavement Research (QPR) study to investigate tire/pavement noise characteristics on concrete pavements and bridge decks.</p> <p>The study included a total of 120 pavement sections at 47 different sites on various state

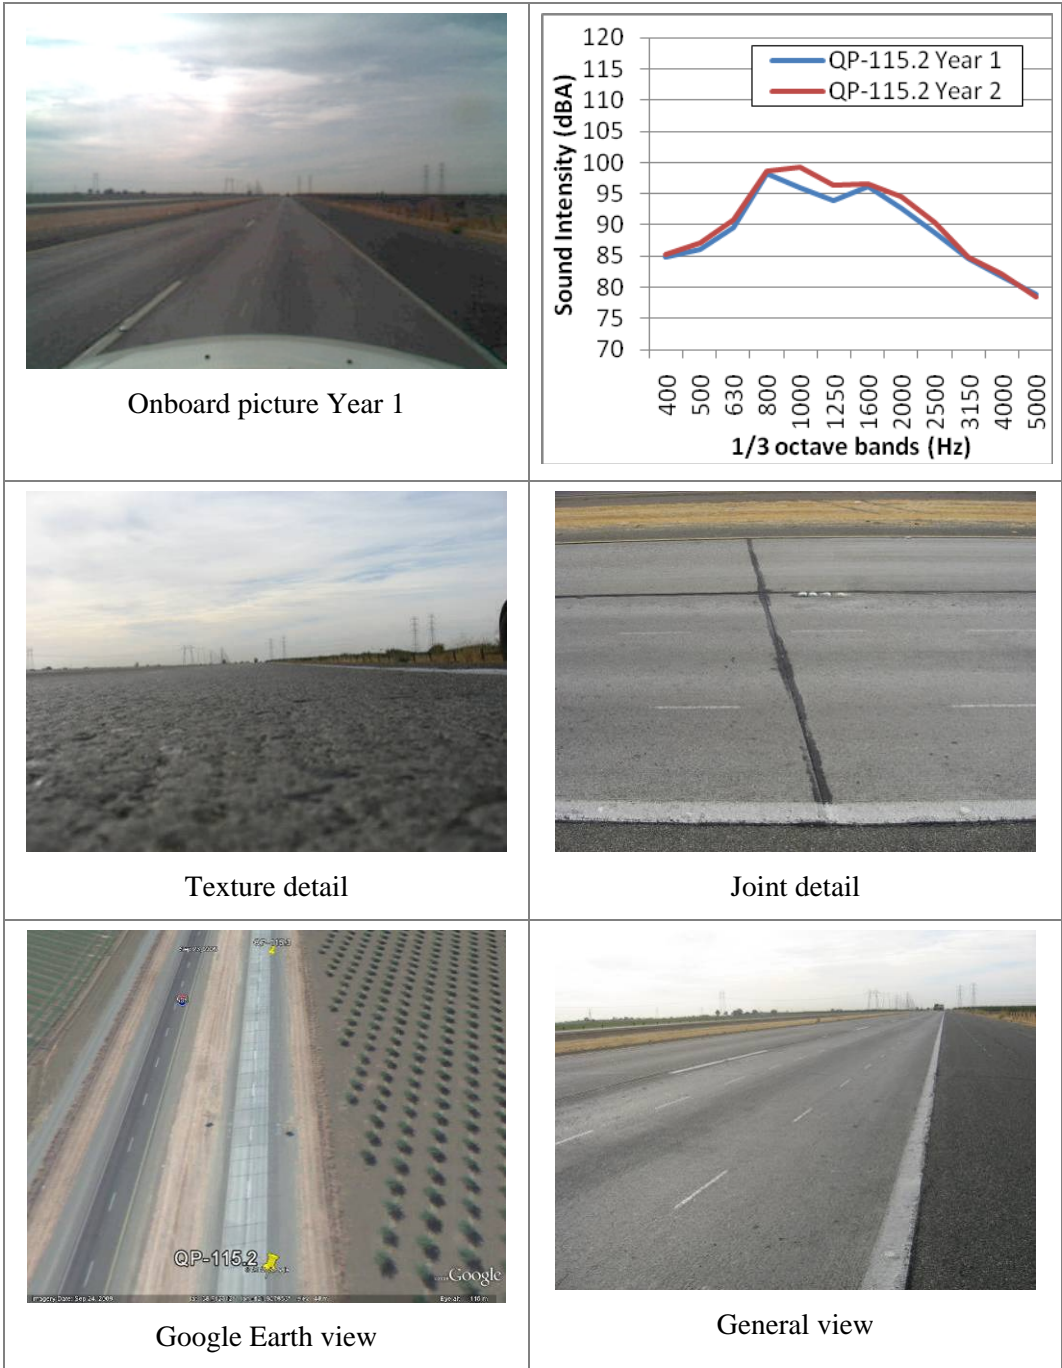
**QP-115.2**

Type of section: Pavement  
 Location: 03Yol505S13.0  
 Comments: Burlap drag.  
 Surface Year: 1977

Field testing Year 1: 10/27/2008 10:56  
 Field testing Year 2: 9/8/2009 11:46

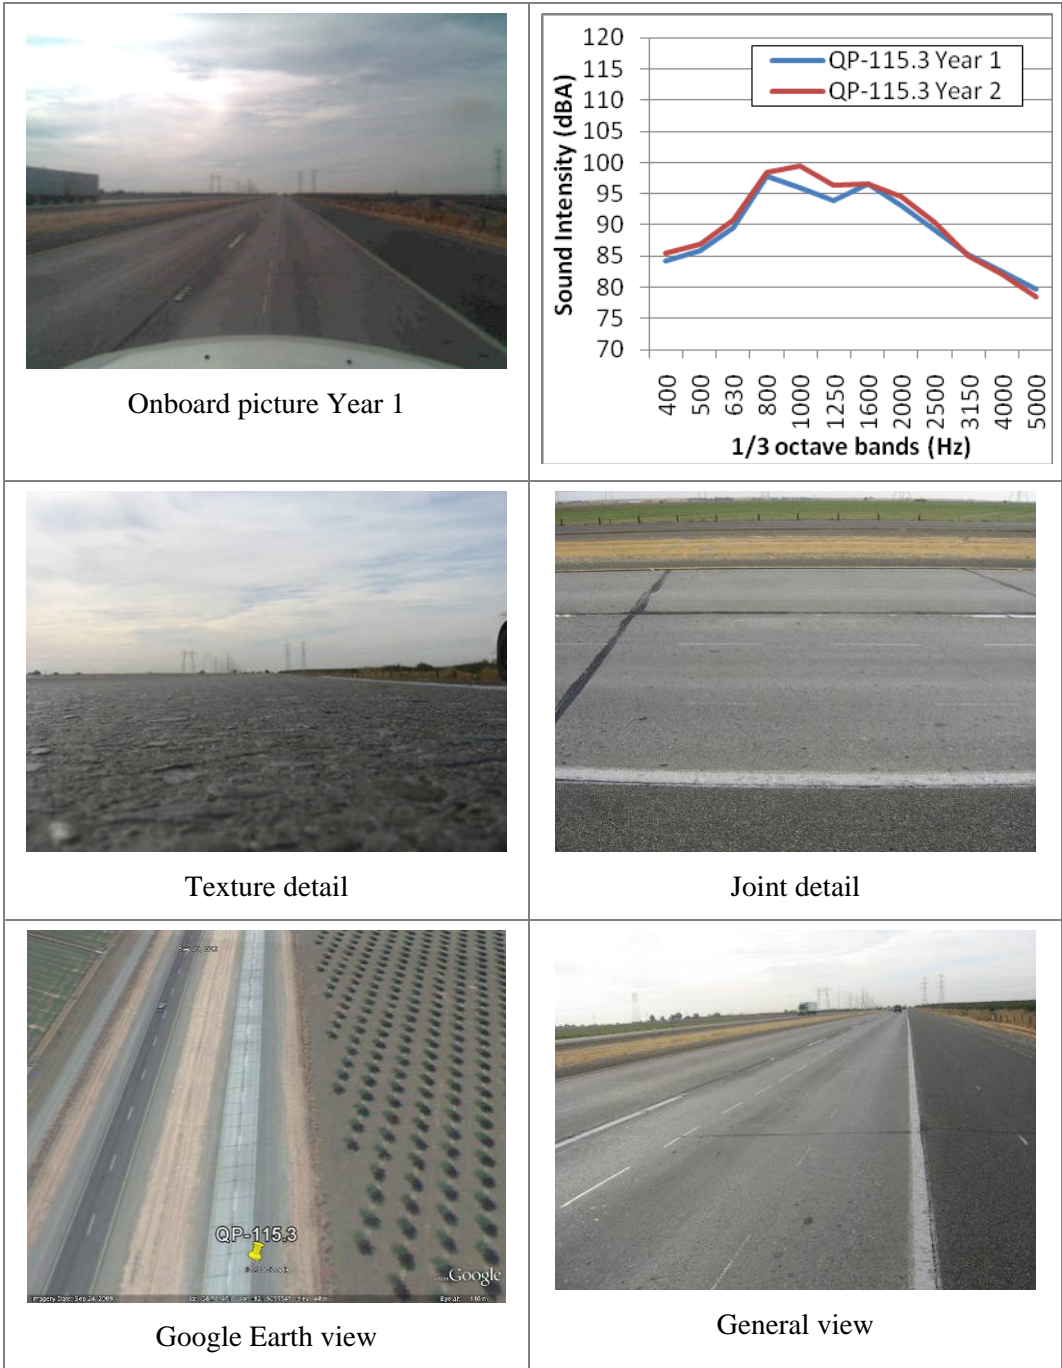
**QP-115.3**

Type of section: Pavement  
 Location: 03Yol505S12.9  
 Comments: Burlap drag.  
 Surface Year: 1977

Field testing Year 1: 10/27/2008 11:21  
 Field testing Year 2: 9/8/2009 12:05

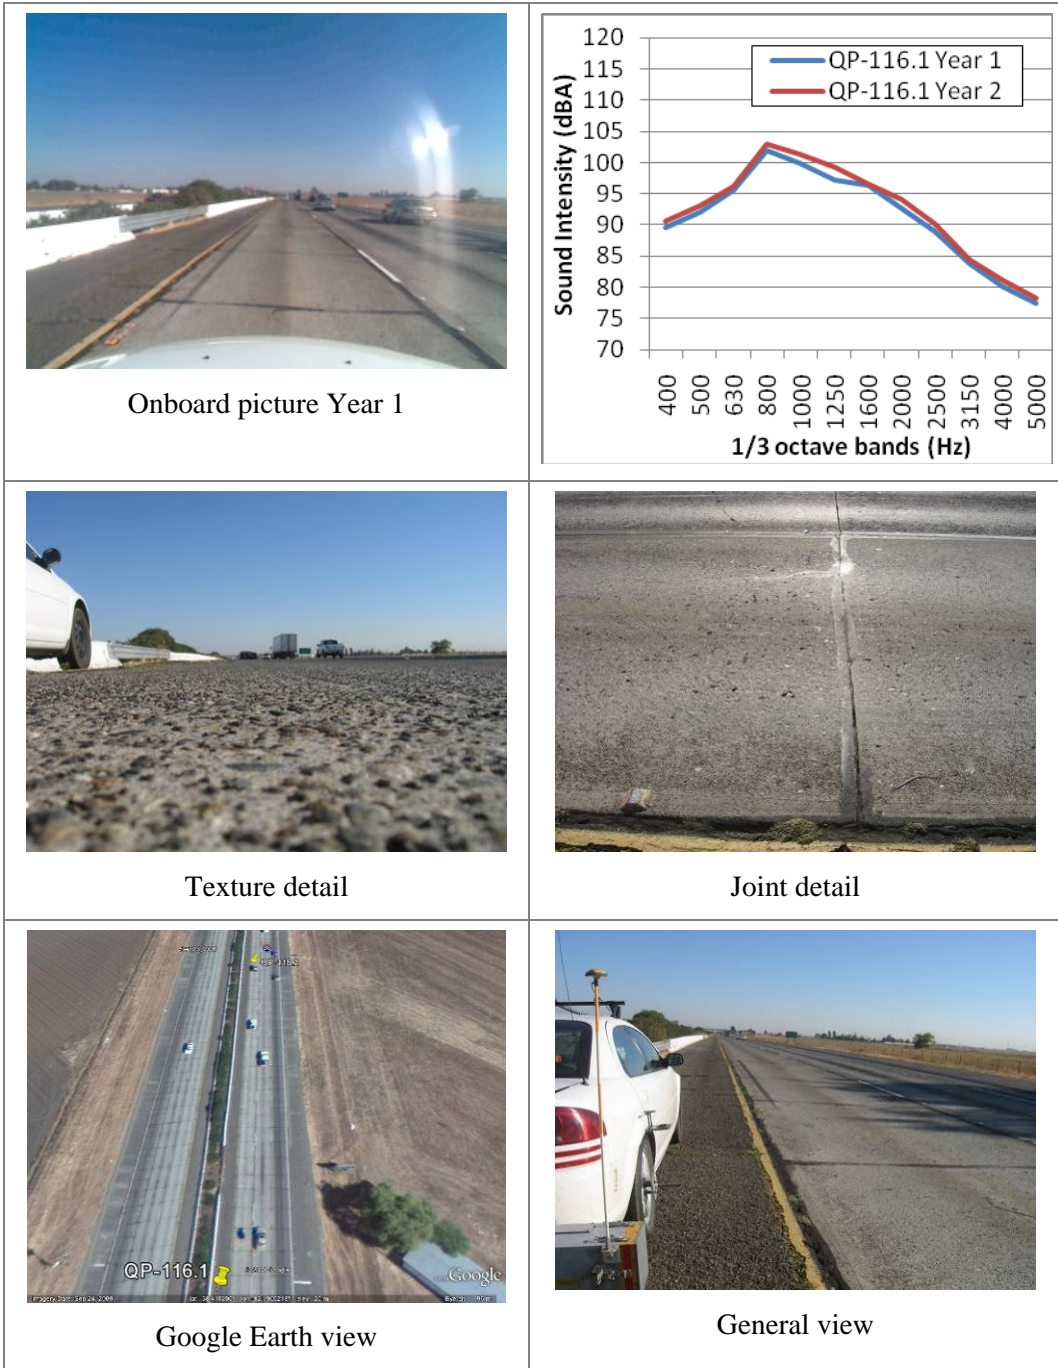
**QP-116.1**

Comments: Burlap drag. Looks like aggressive exposed agg. Maybe no original texture.

Surface Year: 1946

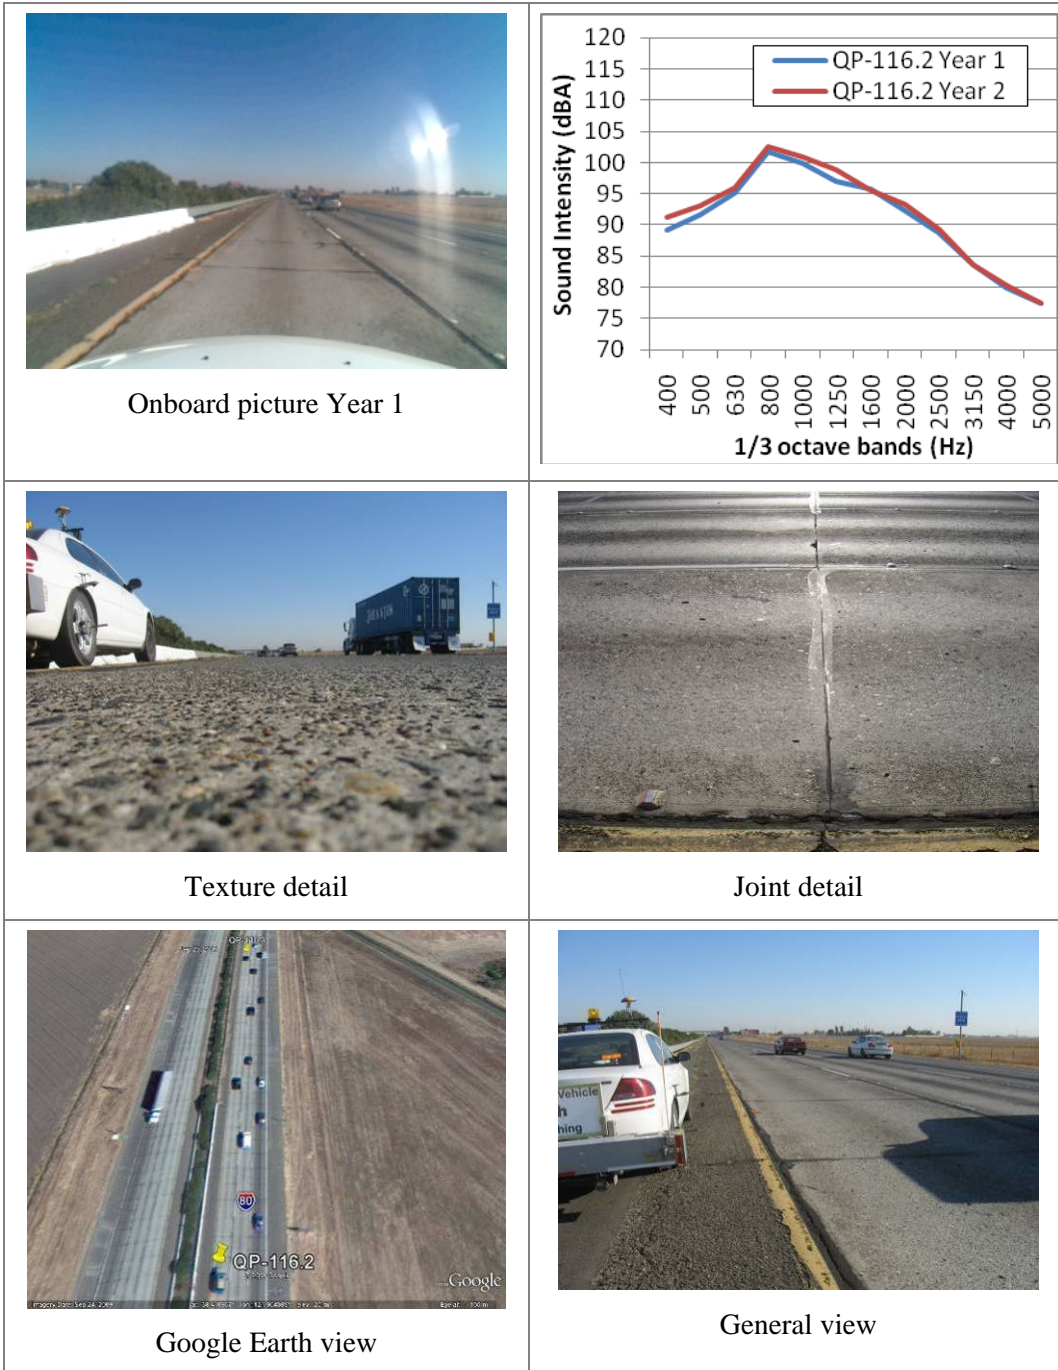
**QP-116.2**

Type of section: Pavement      Field testing Year 1: 10/28/2008 11:06  
 Location: 04Sol80E32.1      Field testing Year 2: 9/10/2009 11:20  
 Comments: Burlap drag. Looks like aggressive exposed agg. Maybe no original texture.  
 Surface Year: 1946

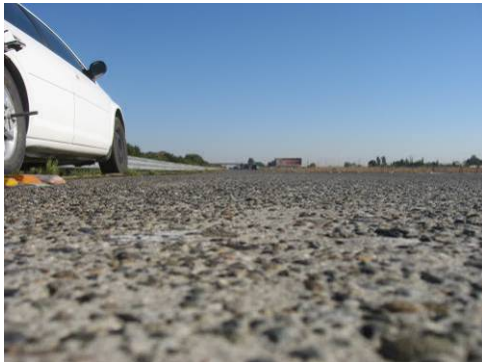
Texture detail

Comments: Burlap drag. Looks like aggressive exposed agg. Maybe no original texture.

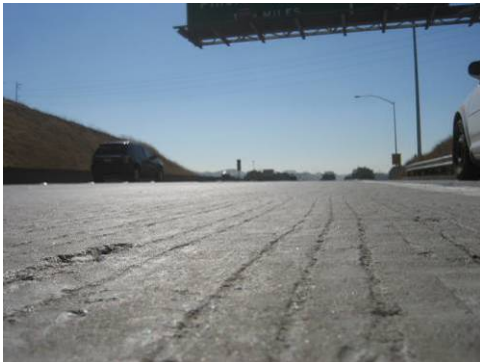
Texture detail

Type of section: Pavement      Field testing Year 1: 10/28/2008 14:14  
 Location: 04CC80W10.3      Field testing Year 2: 10/29/2009 14:57  
 Comments: Longitudinally tined. Shallow and squiggly LT.  
 Surface Year: 2007

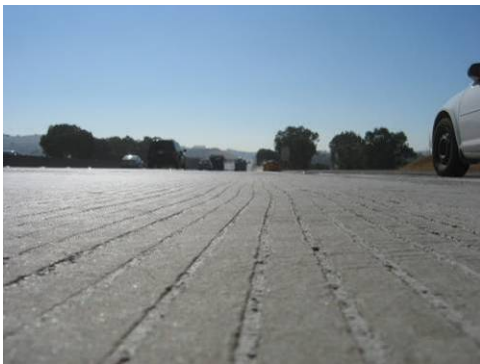
Texture detail

Type of section: Pavement      Field testing Year 1: 10/28/2008 14:45  
 Location: 04CC80W10.2      Field testing Year 2: 10/29/2009 15:03  
 Comments: Longitudinally tined. Shallow and squiggly LT.  
 Surface Year: 2007

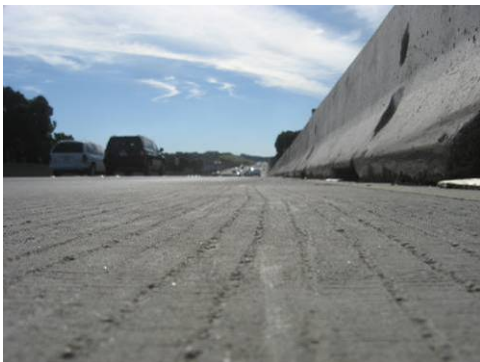
Texture detail

Type of section: Pavement      Field testing Year 1: 10/28/2008 14:54  
 Location: 04CC80W10.1      Field testing Year 2: 10/29/2009 15:12  
 Comments: Longitudinally tined. Shallow and squiggly LT.  
 Surface Year: 2007

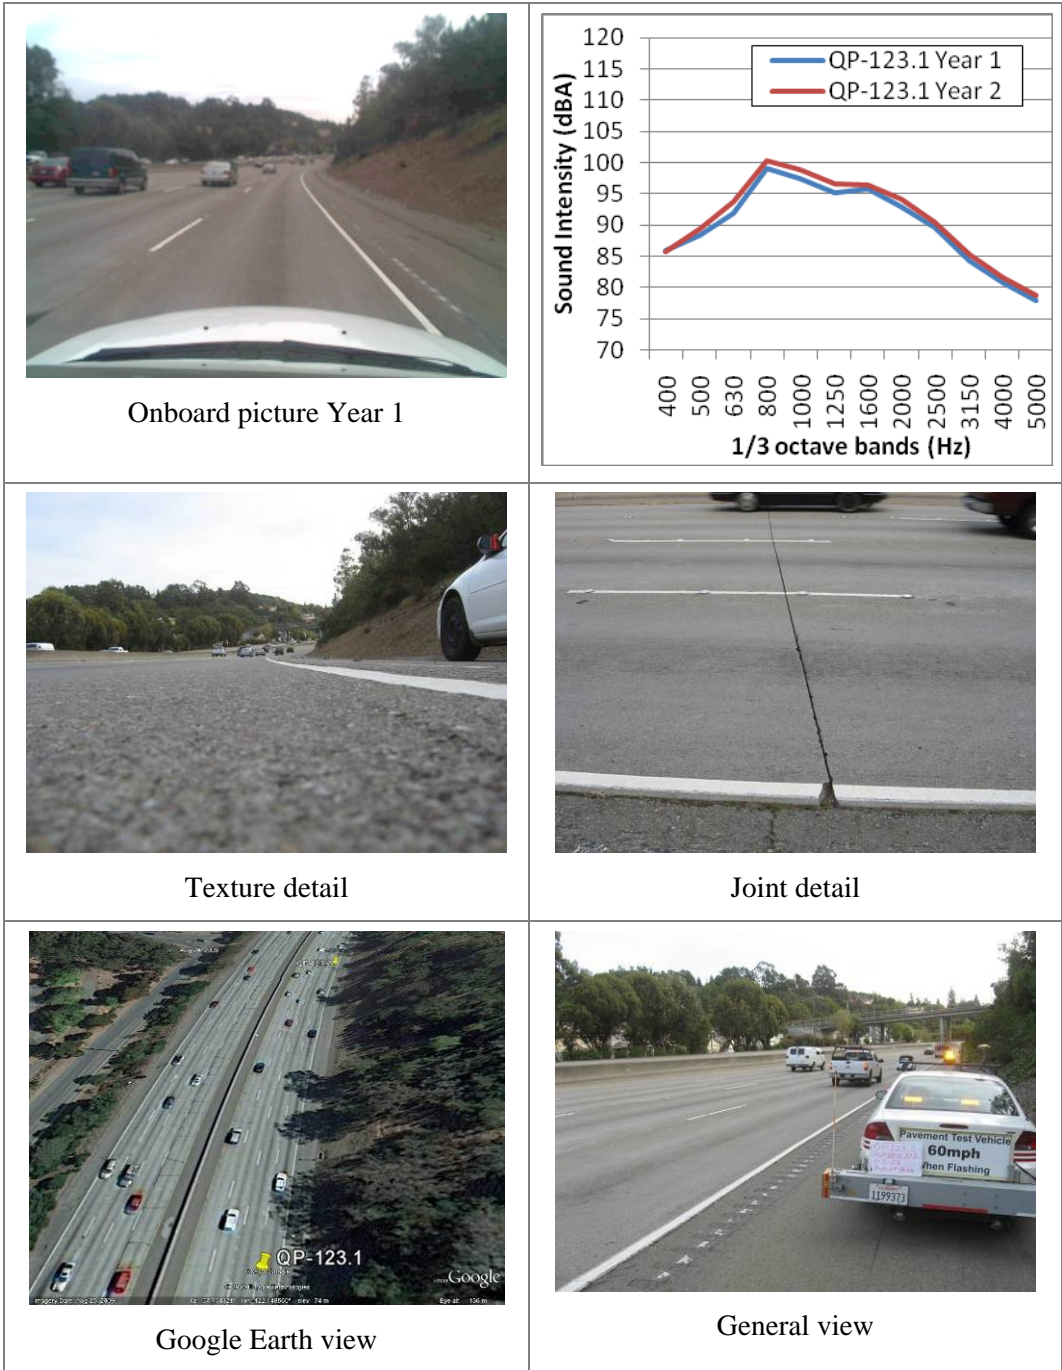
**QP-123.1**

Type of section: Pavement  
 Location: 04ALA580E37.2  
 Comments: Burlap drag.  
 Surface Year: 1965

Field testing Year 1: 11/5/2008 15:30  
 Field testing Year 2: 11/12/2009 14:14

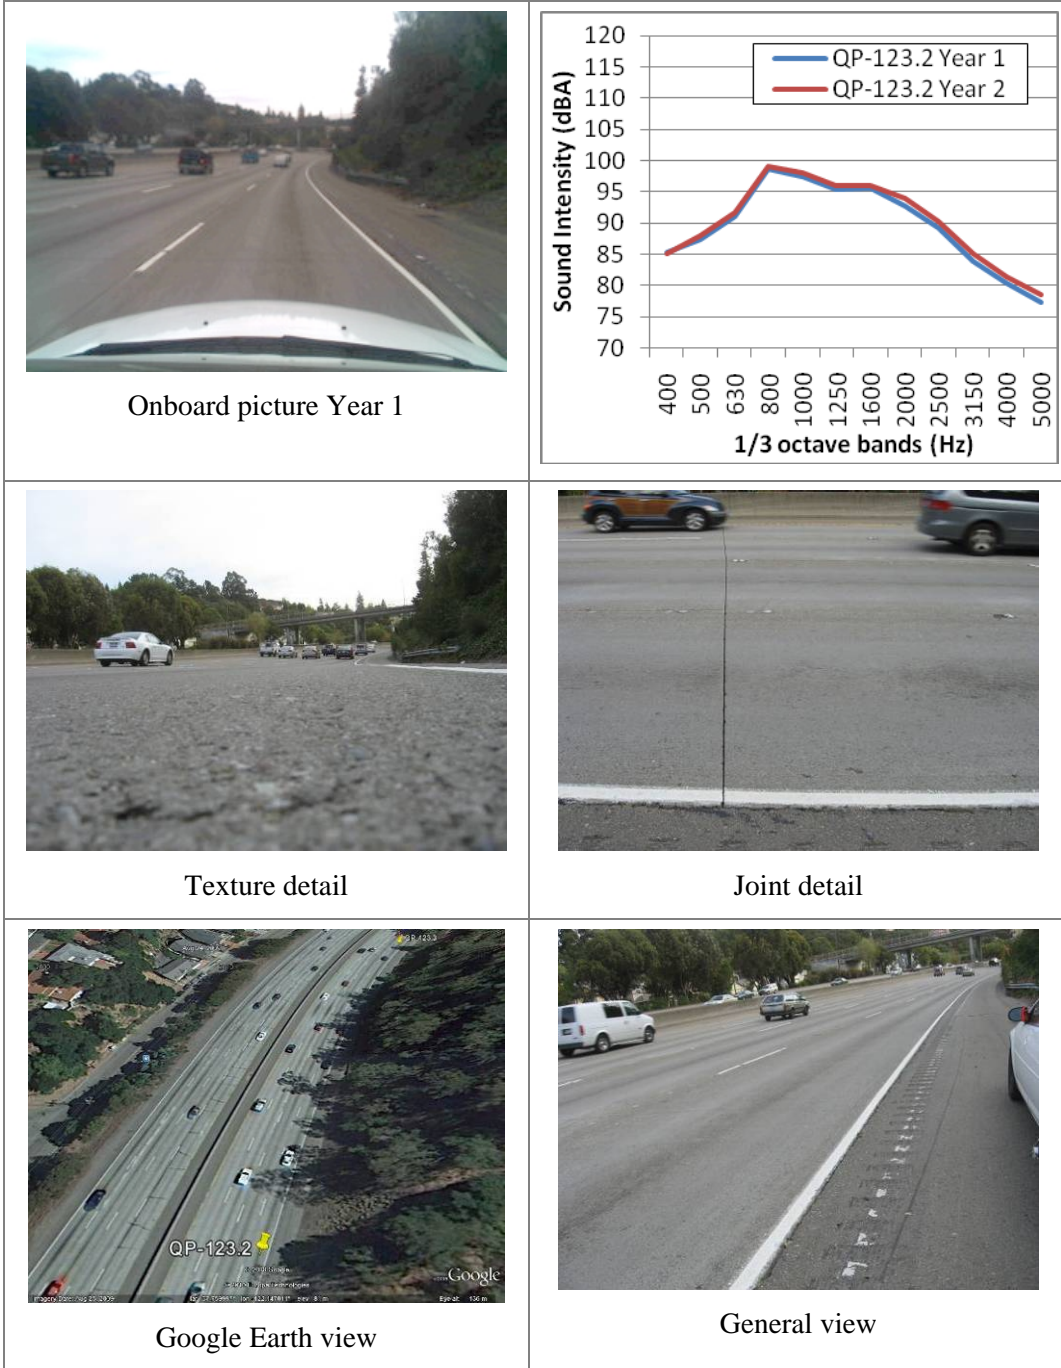
**QP-123.2**

Type of section: Pavement  
 Location: 04ALA580E37.2  
 Comments: Burlap drag.  
 Surface Year: 1965

Field testing Year 1: 11/5/2008 15:51  
 Field testing Year 2: 11/12/2009 14:20

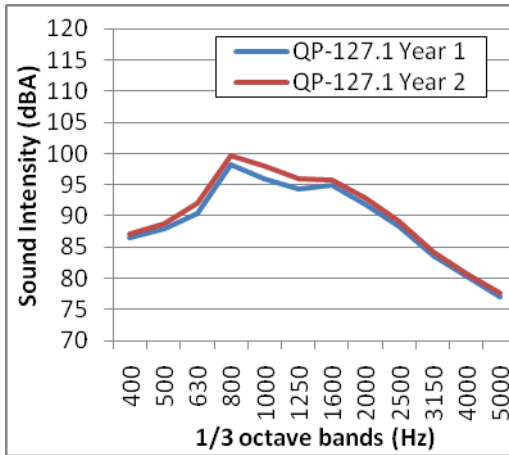
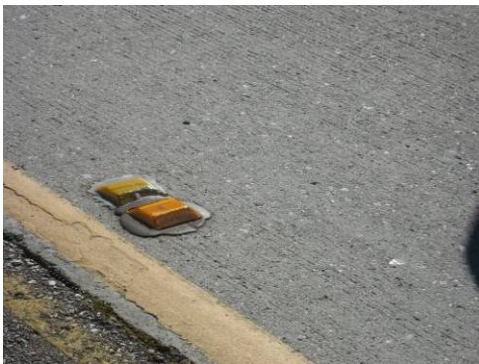
Texture detail

Comments: Longitudinally tined.

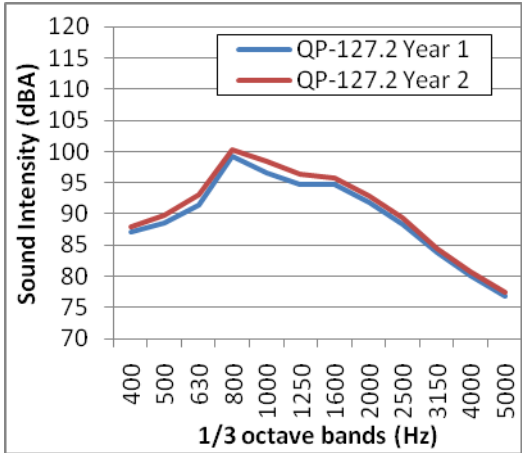
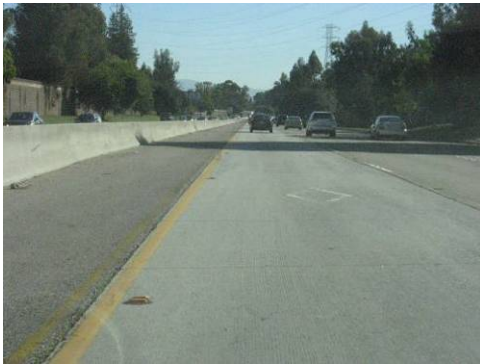
Texture detail

Comments: Longitudinally tined.

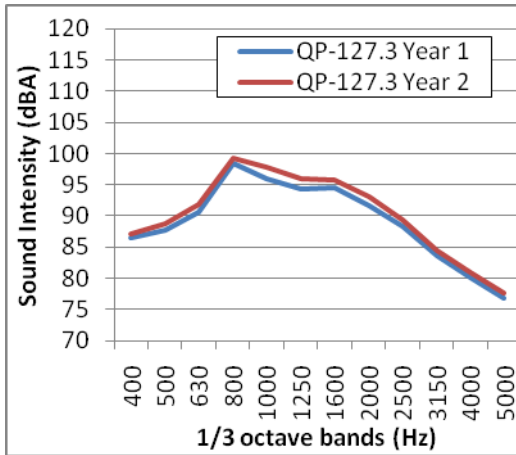
Texture detail

Comments: Longitudinally tined.

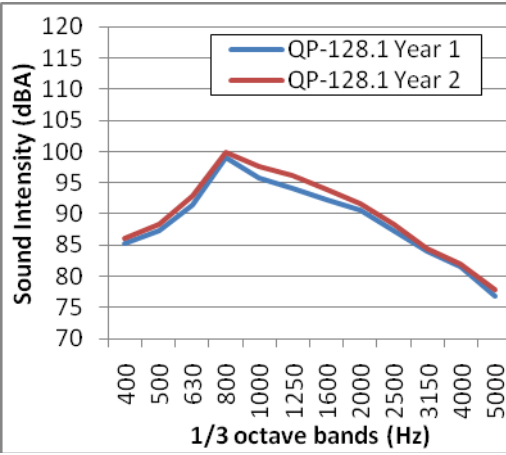
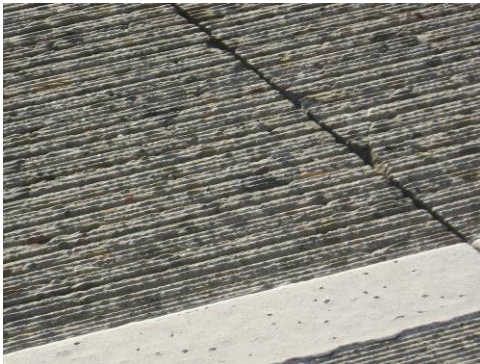
Texture detail

Comments: Diamond ground. Pre-existing longitudinal tining.

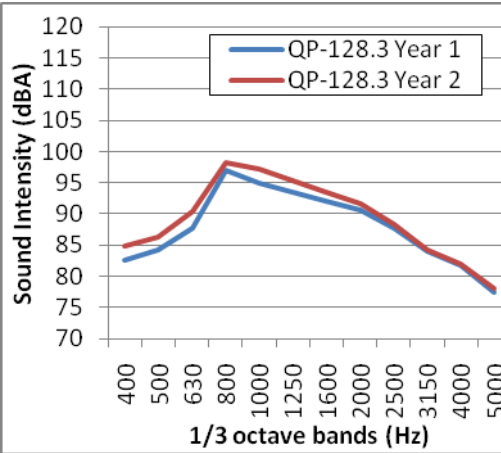
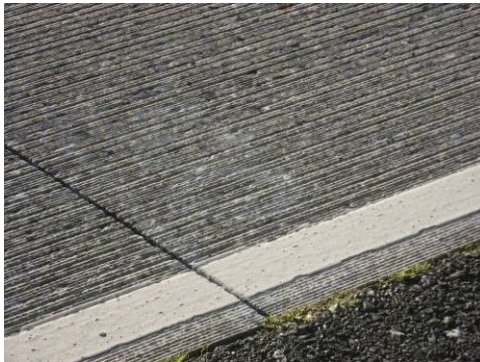
Texture and joint detail

Type of section: Pavement      Field testing Year 1: 11/7/2008 15:46  
 Location: 04SCL85N14.10      Field testing Year 2: 11/18/2009 15:15  
 Comments: Diamond ground. Pre-existing longitudinal tining.  
 Surface Year: 2006

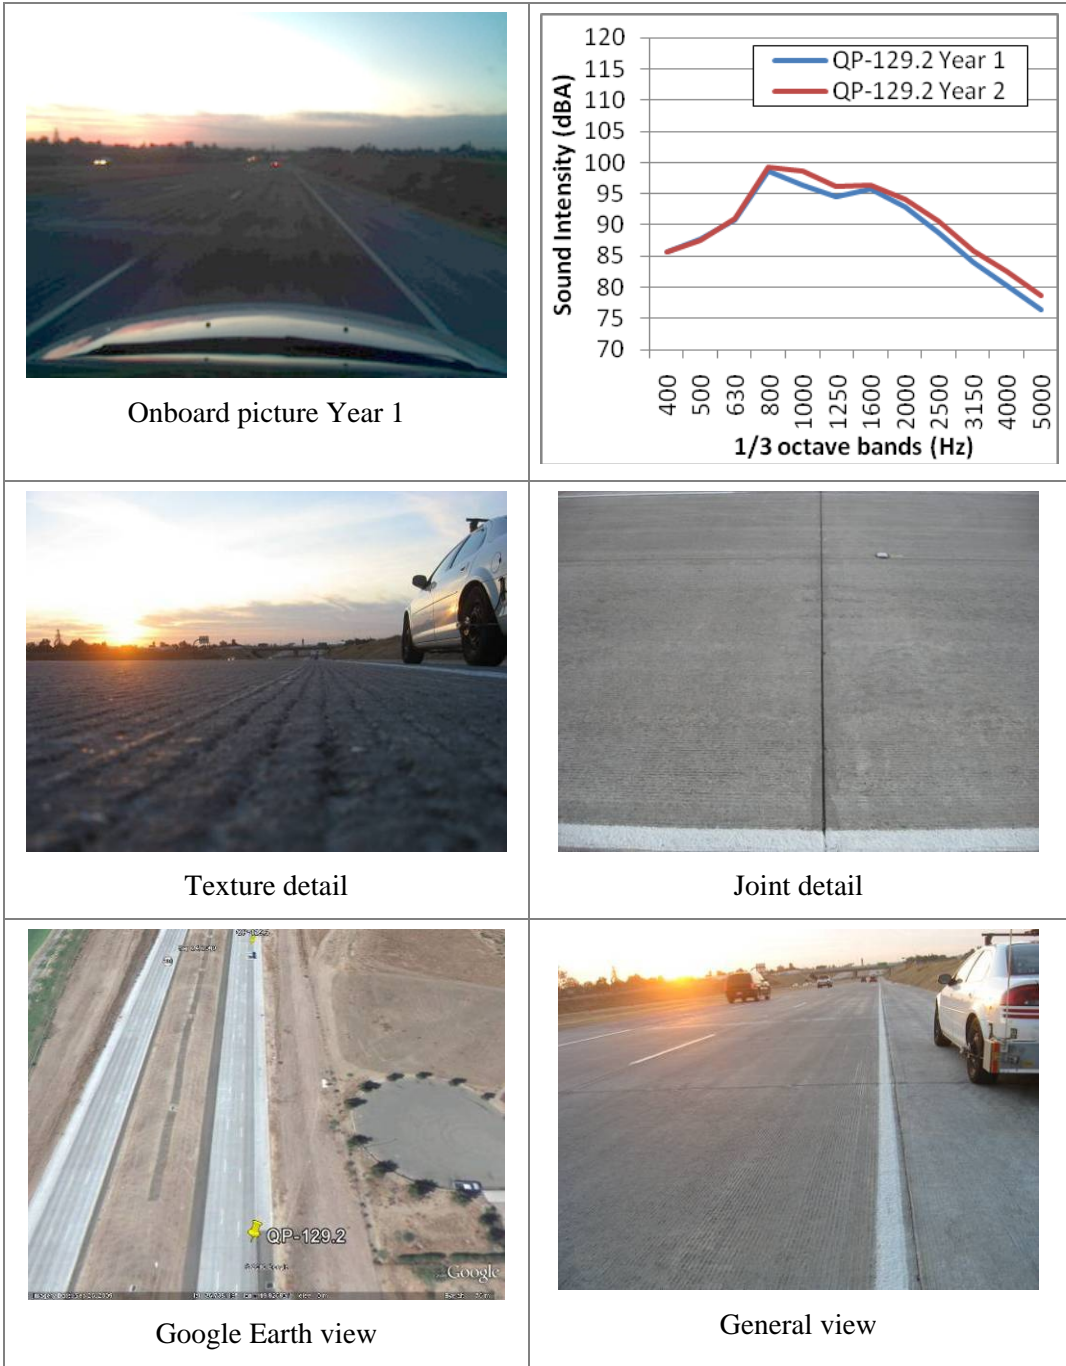
**QP-129.2**

Type of section: Pavement      Field testing Year 1: 11/10/2008 17:09  
 Location: 06FRE180W55.6      Field testing Year 2: 11/13/2009 15:13  
 Comments: Longitudinally tined.  
 Surface Year: 2008

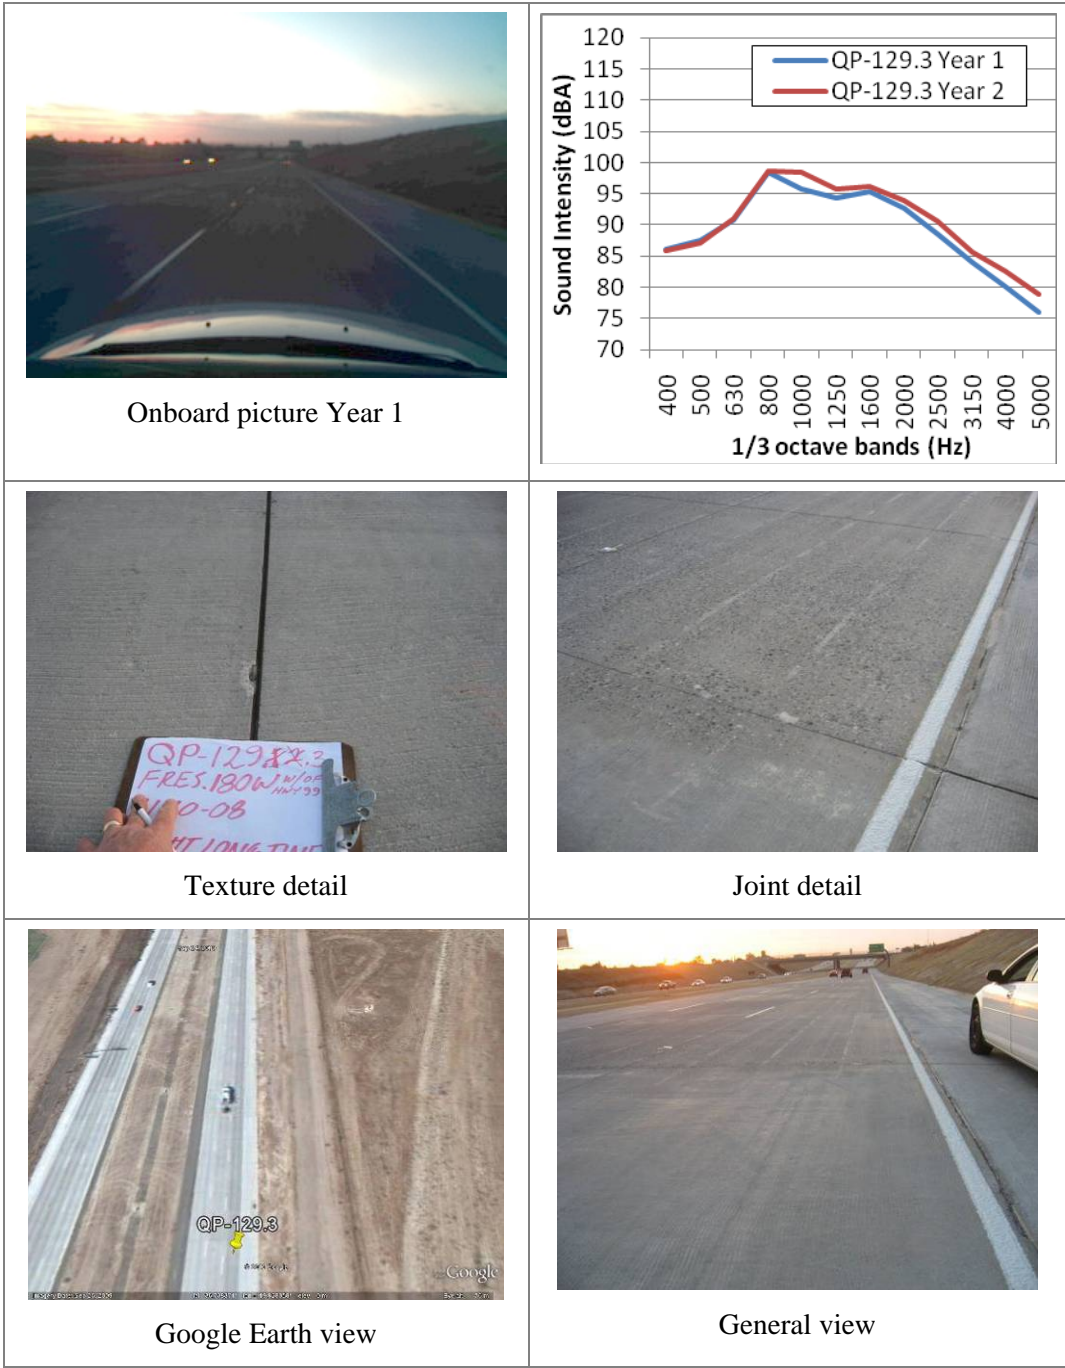
**QP-129.3**

Type of section: Pavement      Field testing Year 1: 11/10/2008 17:17  
 Location: 06FRE180W55.5      Field testing Year 2: 11/13/2009 15:19  
 Comments: Diamond ground. DG on LT.  
 Surface Year: 2008

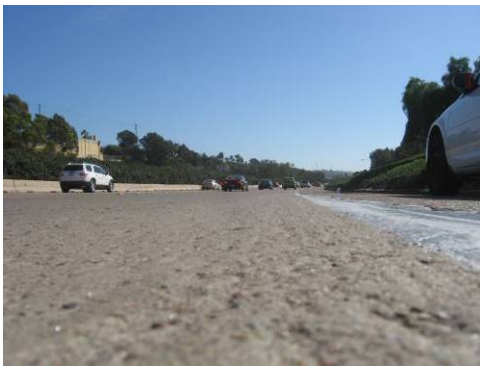
Type of section: Pavement  
 Location: 11SD5S39.7  
 Comments: Burlap drag.  
 Surface Year: 1964

Texture detail

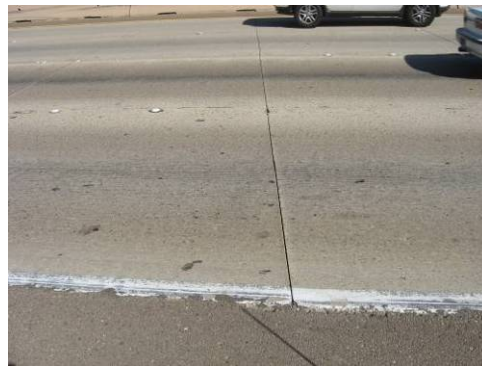
Joint detail

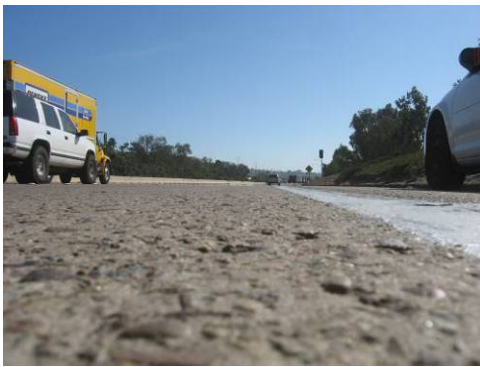
Type of section: Pavement  
 Location: 11SD5S39.6  
 Comments: Burlap drag.  
 Surface Year: 1964

Texture detail

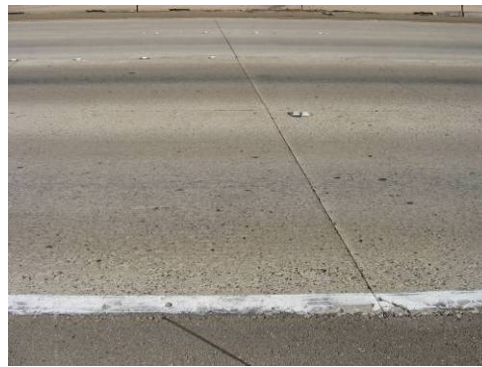
Joint detail

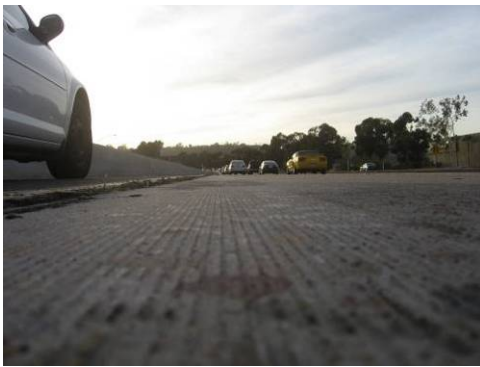
Type of section: Pavement      Field testing Year 1: 11/11/2008 17:01  
 Location: 11SD8W15.5      Field testing Year 2: 11/23/2009 9:33  
 Comments: Diamond ground. DG on LT.  
 Surface Year: 1997

Texture detail

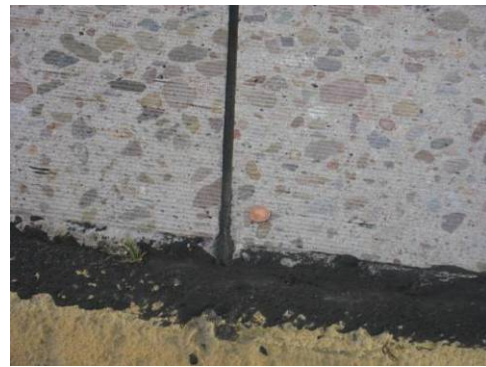
Joint detail

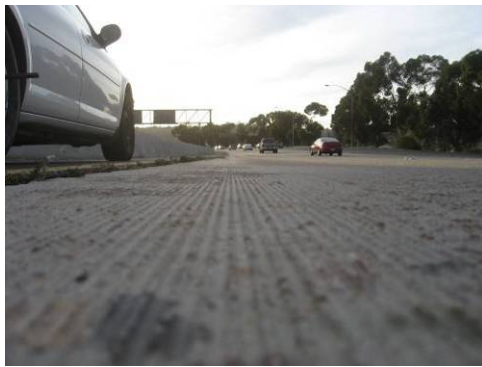
Type of section: Pavement  
Location: 11SD8W15.6  
Comments: Diamond ground.  
Surface Year: 1997

Texture detail

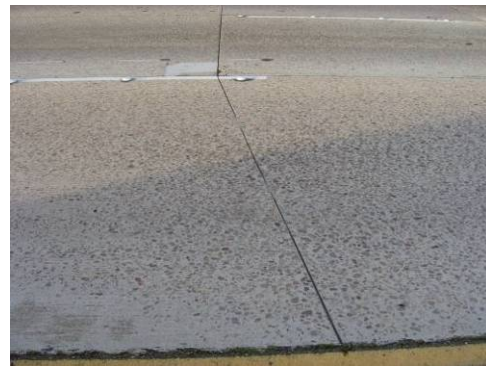
Joint detail

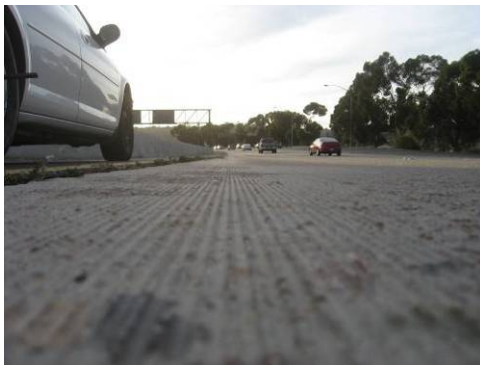
Type of section: Pavement  
 Location: 11SD8W15.7  
 Comments: Diamond ground.  
 Surface Year: 1997

Texture detail

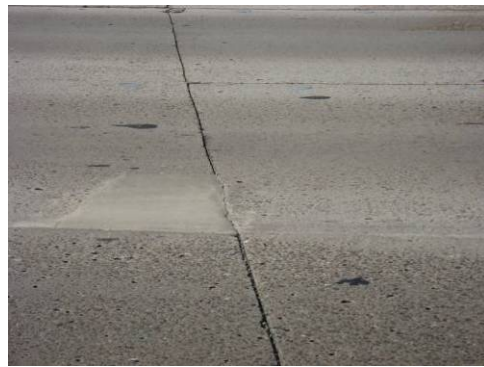
Type of section: Pavement      Field testing Year 1: 11/12/2008 12:39  
 Location: 11SD805N2.1      Field testing Year 2: 11/24/2009 11:06  
 Comments: Diamond ground. DG on LB.  
 Surface Year: 1998

Joint detail

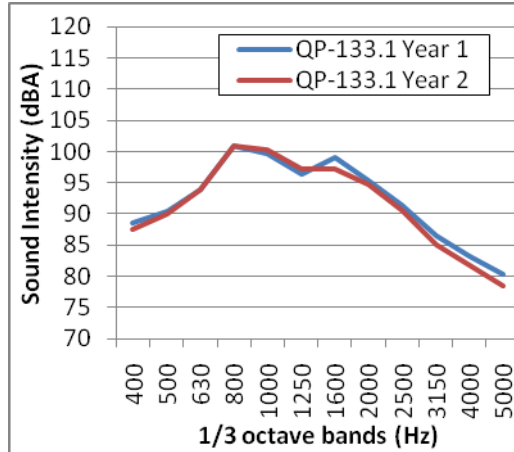
**QP-133.1**

Type of section: Pavement      Field testing Year 1: 11/12/2008 14:36  
 Location: 11SD805N2.3      Field testing Year 2: 11/24/2009 11:50  
 Comments: Diamond ground. DG on transverse tining.  
 Surface Year: 1998

Texture detail

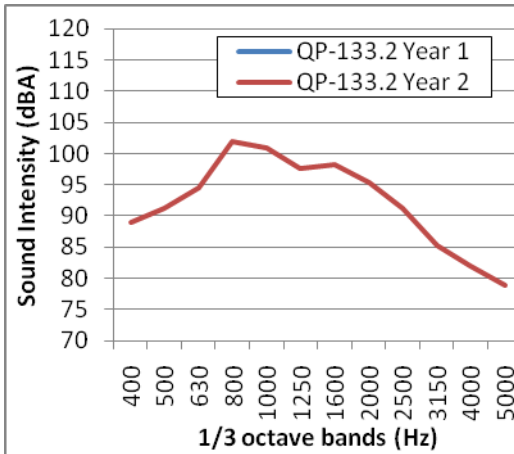
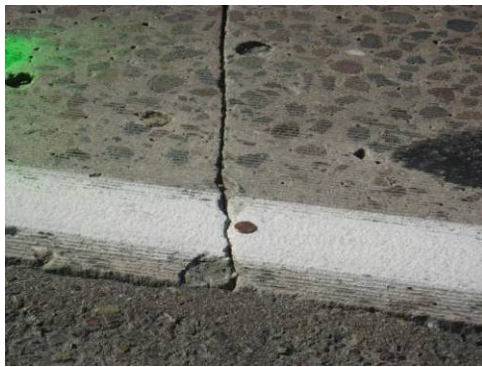
**QP-133.2**

Type of section: Pavement  
 Location: 11SD805N2.4  
 Comments: Diamond ground.  
 Surface Year: 1998

Texture detail

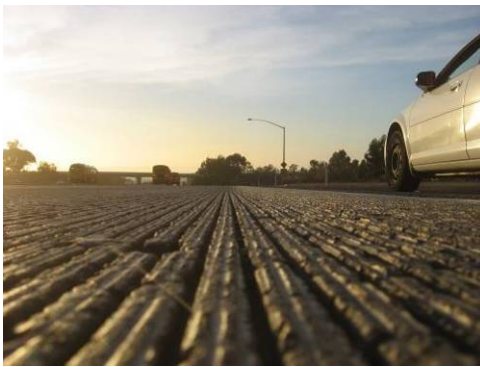
**QP-134.1**

Type of section: Pavement      Field testing Year 1: 11/12/2008 16:03  
 Location: 11SD905W5.2      Field testing Year 2: 11/24/2009 12:21  
 Comments: Diamond ground. DG on deep longitudinal tining. Off-ramp.  
 Surface Year: 2000

Texture detail

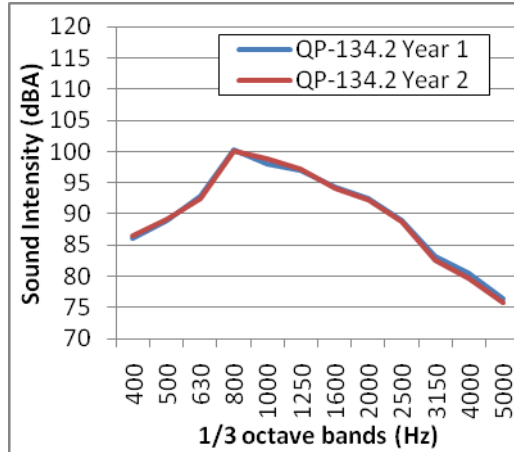
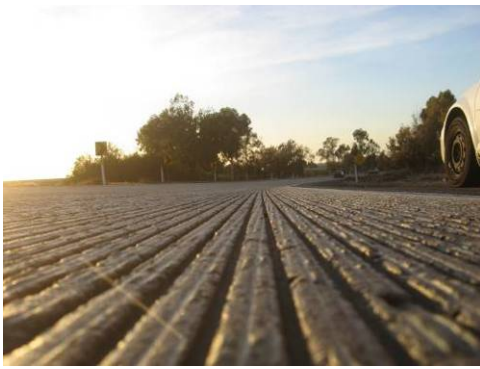
**QP-134.2**

Type of section: Pavement      Field testing Year 1: 11/12/2008 16:35  
 Location: 11SD905W5.1      Field testing Year 2: 11/24/2009 12:31  
 Comments: Diamond ground. DG on deep longitudinal tining. Off-ramp.  
 Surface Year: 2000

Texture detail

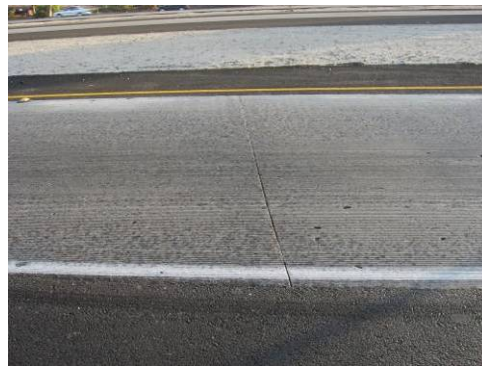
Joint detail

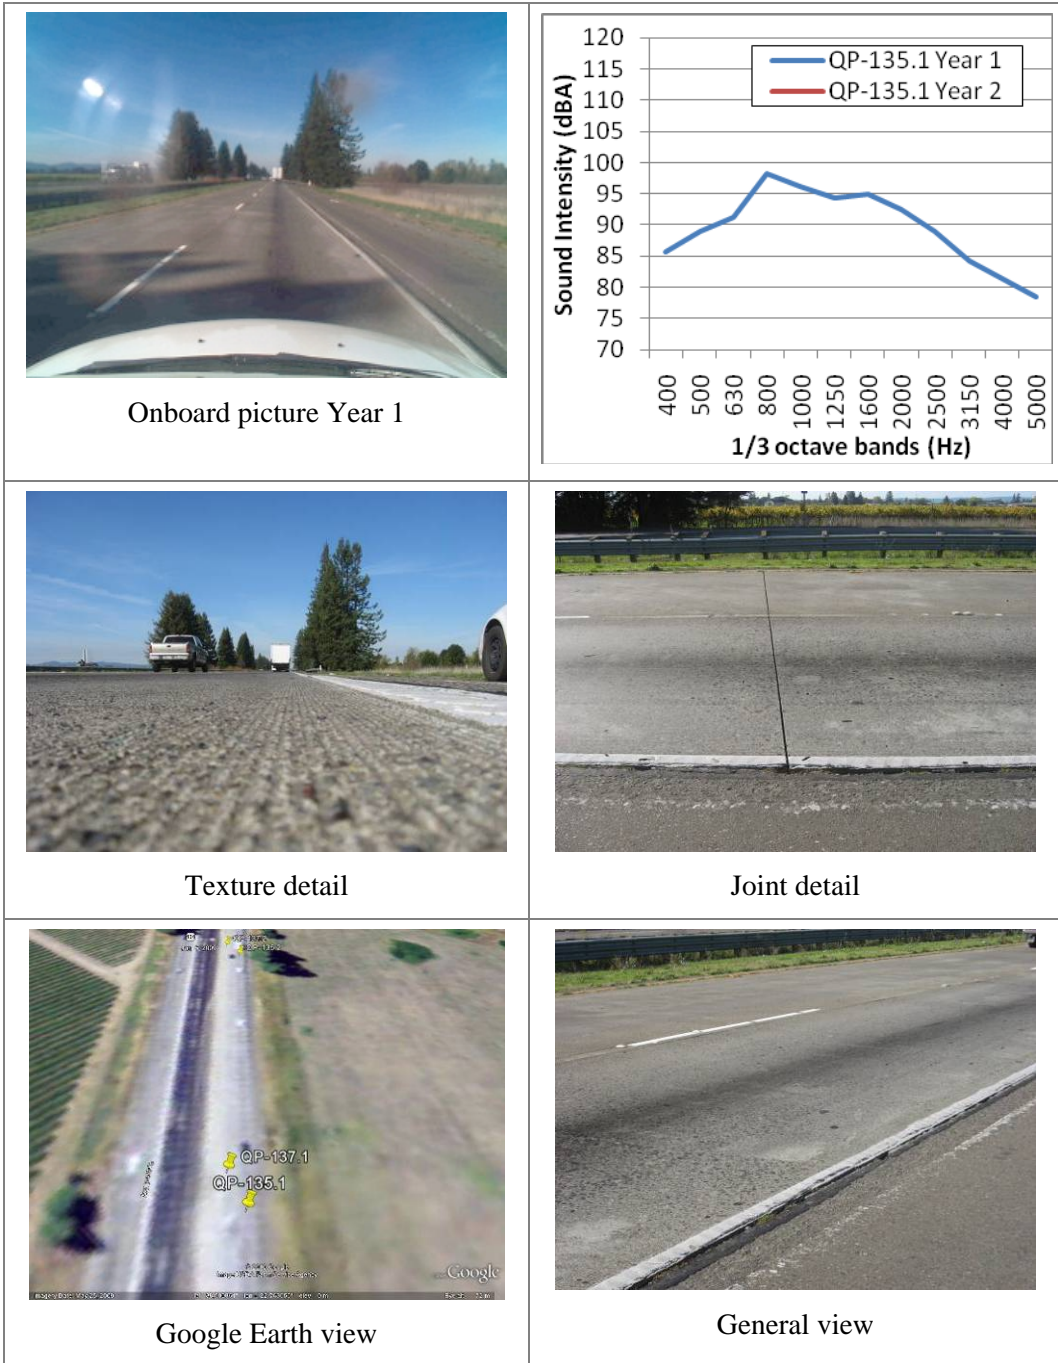
**QP-135.1**

Type of section: Pavement  
 Location: 04SON101N25.4L2  
 Comments: Diamond ground.  
 Surface Year: 2006

Field testing Year 1: 11/17/2008 12:27  
 Field testing Year 2:

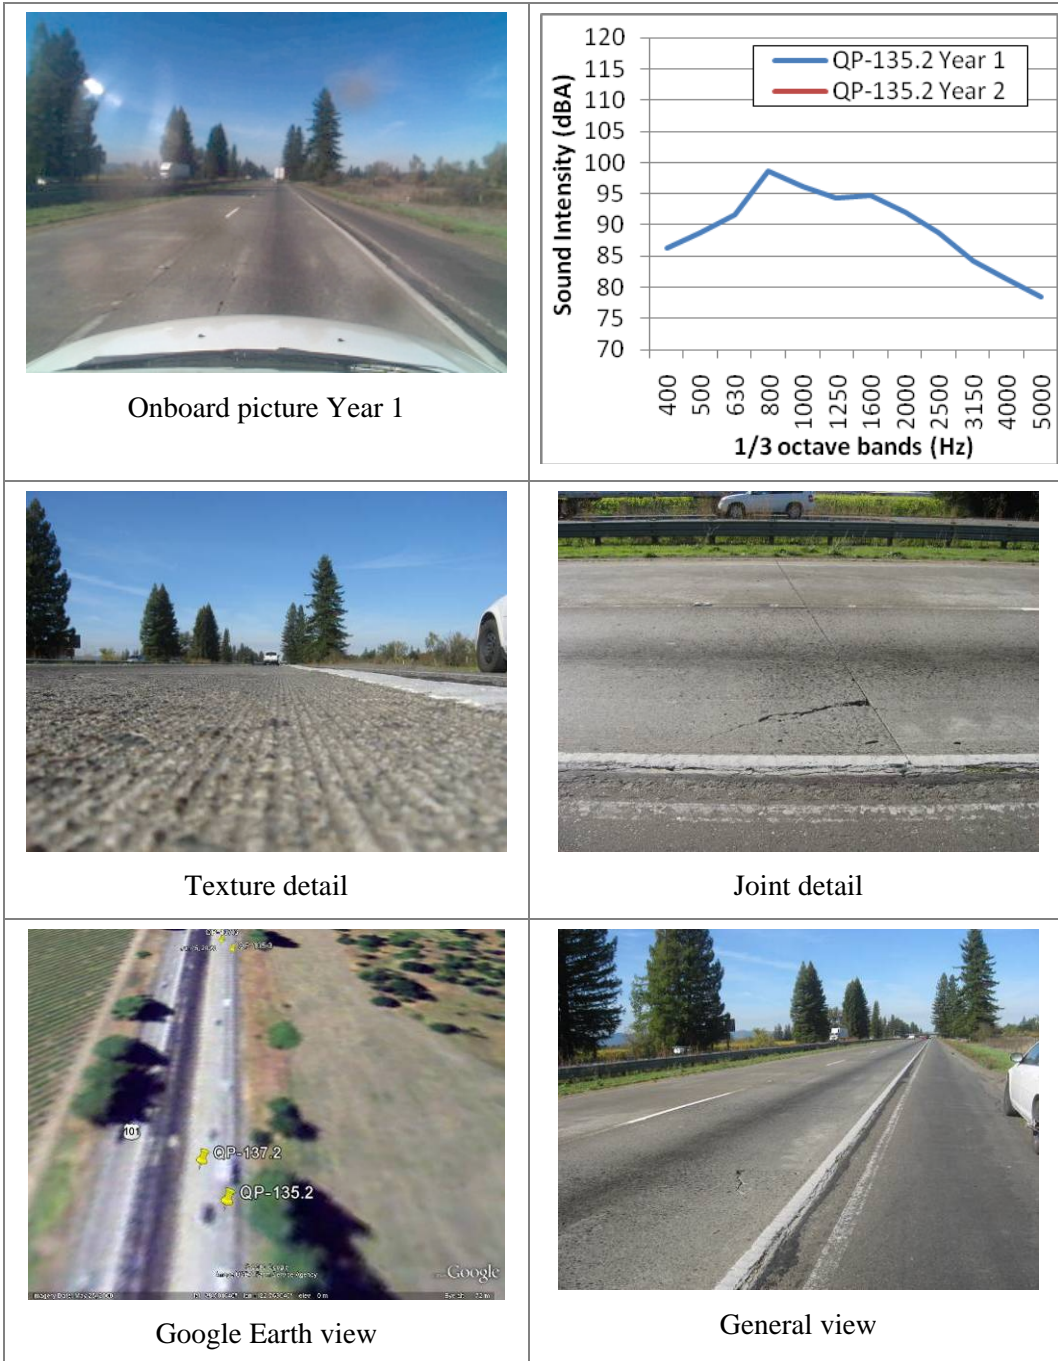
**QP-135.2**

Type of section: Pavement  
 Location: 04SON101N25.5L2  
 Comments: Diamond ground.  
 Surface Year: 2006

Field testing Year 1: 11/17/2008 12:50  
 Field testing Year 2:

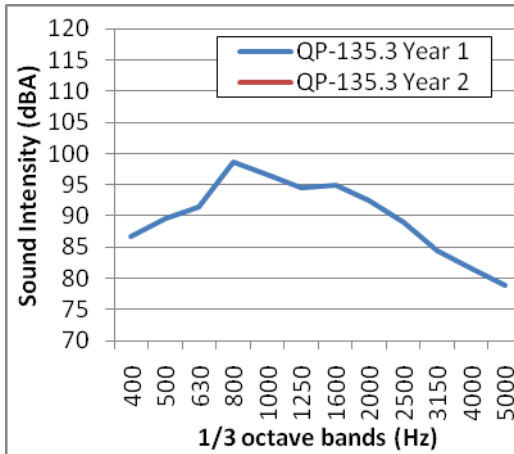
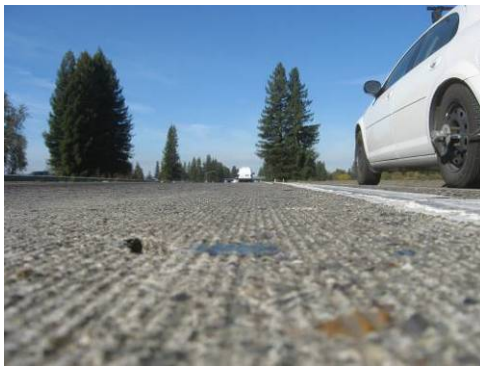
### QP-135.3

Type of section: Pavement  
Location: 04SON101N25.6  
Comments: Diamond ground.  
Surface Year: 2006

Texture detail

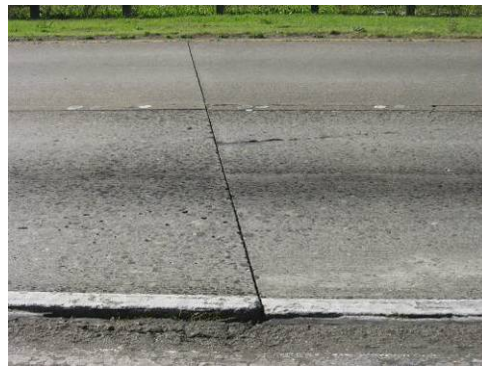
Joint detail
