Quieter Pavement Research: Concrete Pavement Tire Noise

# Quieter Pavement Research: Concrete Pavement Tire Noise

Work Conducted as Part of Partnered Pavement Research Center Strategic Plan Element No. 4.22:  
Quiet Concrete Pavement Research

<b>DOCUMENT RETRIEVAL PAGE</b>		<b>UCPRC Research Report No.:</b> UCPRC-RR-2010-03			
<b>Title:</b> Quieter Pavement Research: Concrete Pavement Tire Noise					
<b>Author:</b> E. Kohler and J. Harvey					
<b>Prepared for:</b> California Department of Transportation, Division of Research and Innovation, Office of Roadway Research		<b>FHWA No.:</b> CA121200A	<b>Date Work Submitted:</b> August 20, 2010	<b>Date:</b> May 2010	
<b>Strategic Plan Element No.:</b> 4.22		<b>Status:</b> Stage 6, final version		<b>Version No.:</b> 1	
<p><b>Abstract:</b> This research report presents the results of tire/pavement noise measurements performed on concrete pavements as a part of the California Department of Transportation (Caltrans) Quieter Pavement Research (QPR) study to investigate tire/pavement noise characteristics on concrete pavements and bridge decks.</p> <p>The study included a total of 120 pavement sections at 47 different sites on various state

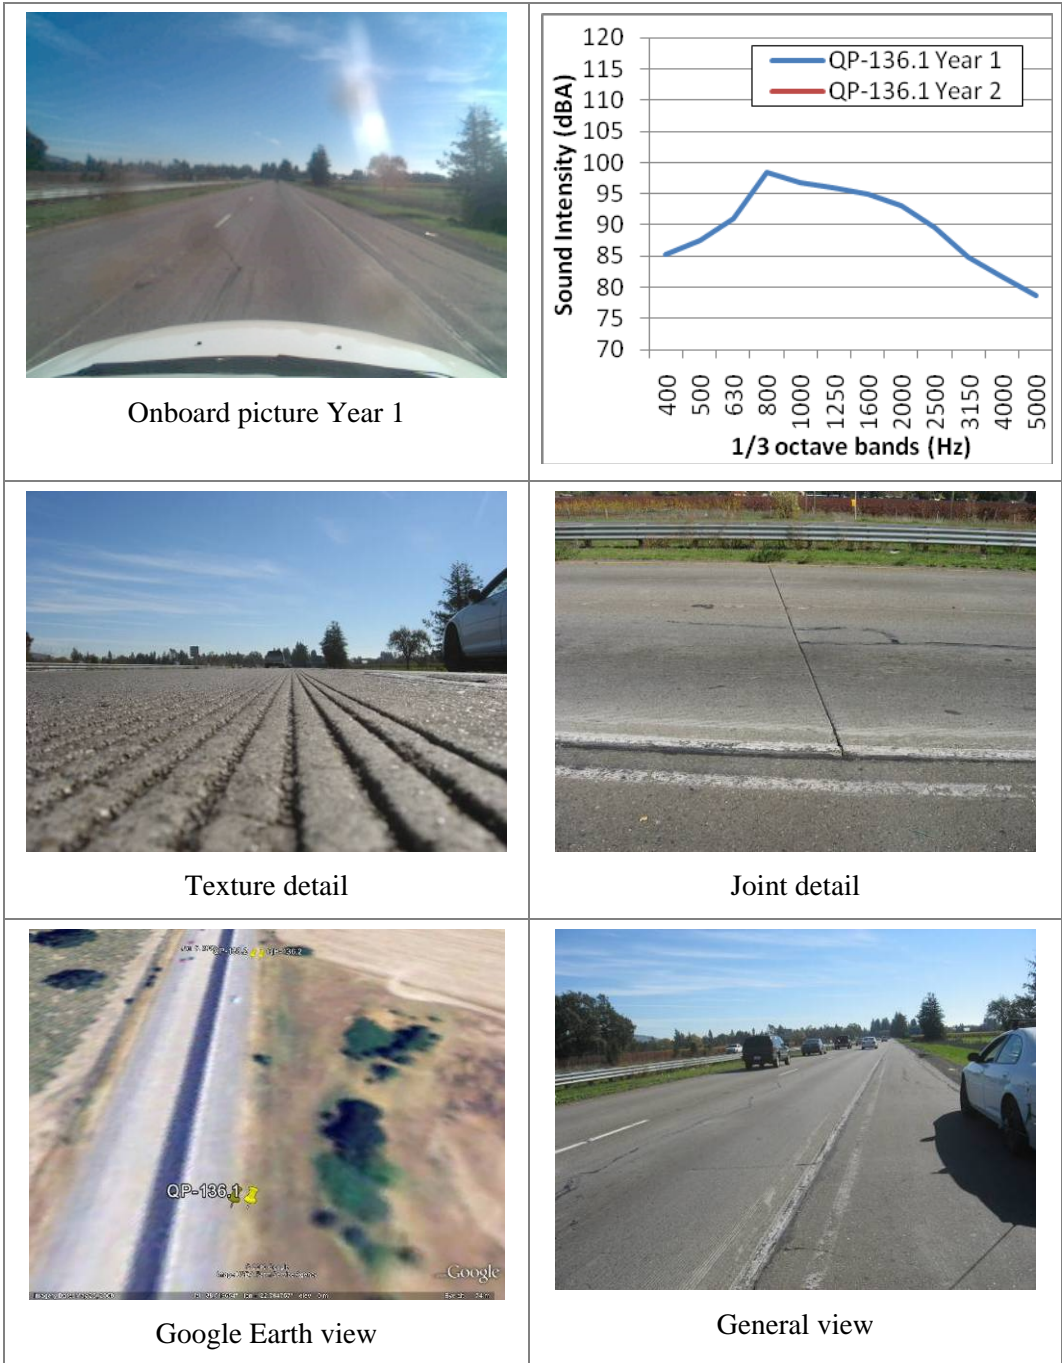
**QP-136.1**

Type of section: Pavement  
 Location: 04SON101S27.3 L2  
 Comments: Diamond grooved.  
 Surface Year: 2006

Field testing Year 1: 11/17/2008 12:40  
 Field testing Year 2:

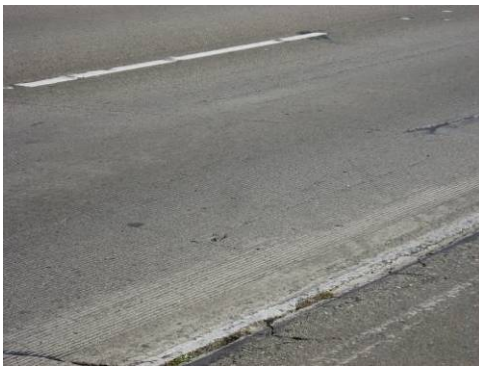
Texture detail

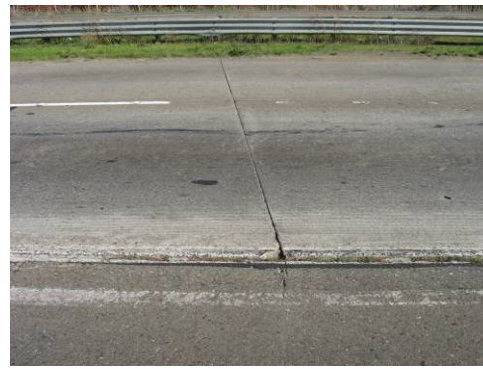
Joint detail

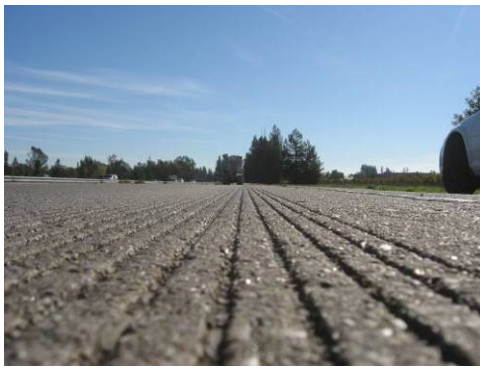
Comments: Diamond grooved.

Texture detail

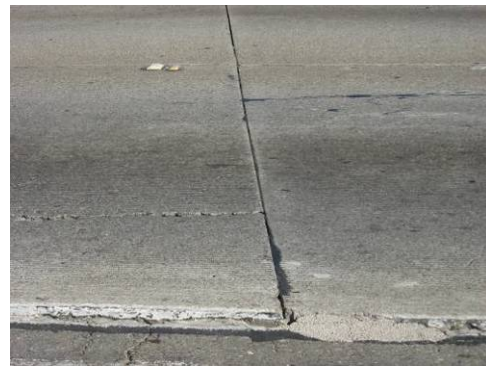
Joint detail

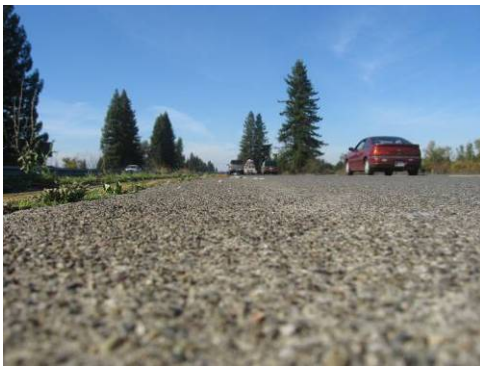
Type of section: Pavement      Field testing Year 1: 11/17/2008 14:36  
 Location: 04SON101N25.4L1      Field testing Year 2:  
 Comments: Burlap drag.  
 Surface Year: 1962

Texture detail

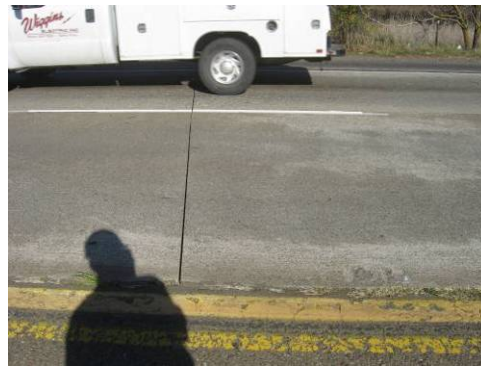
Joint detail

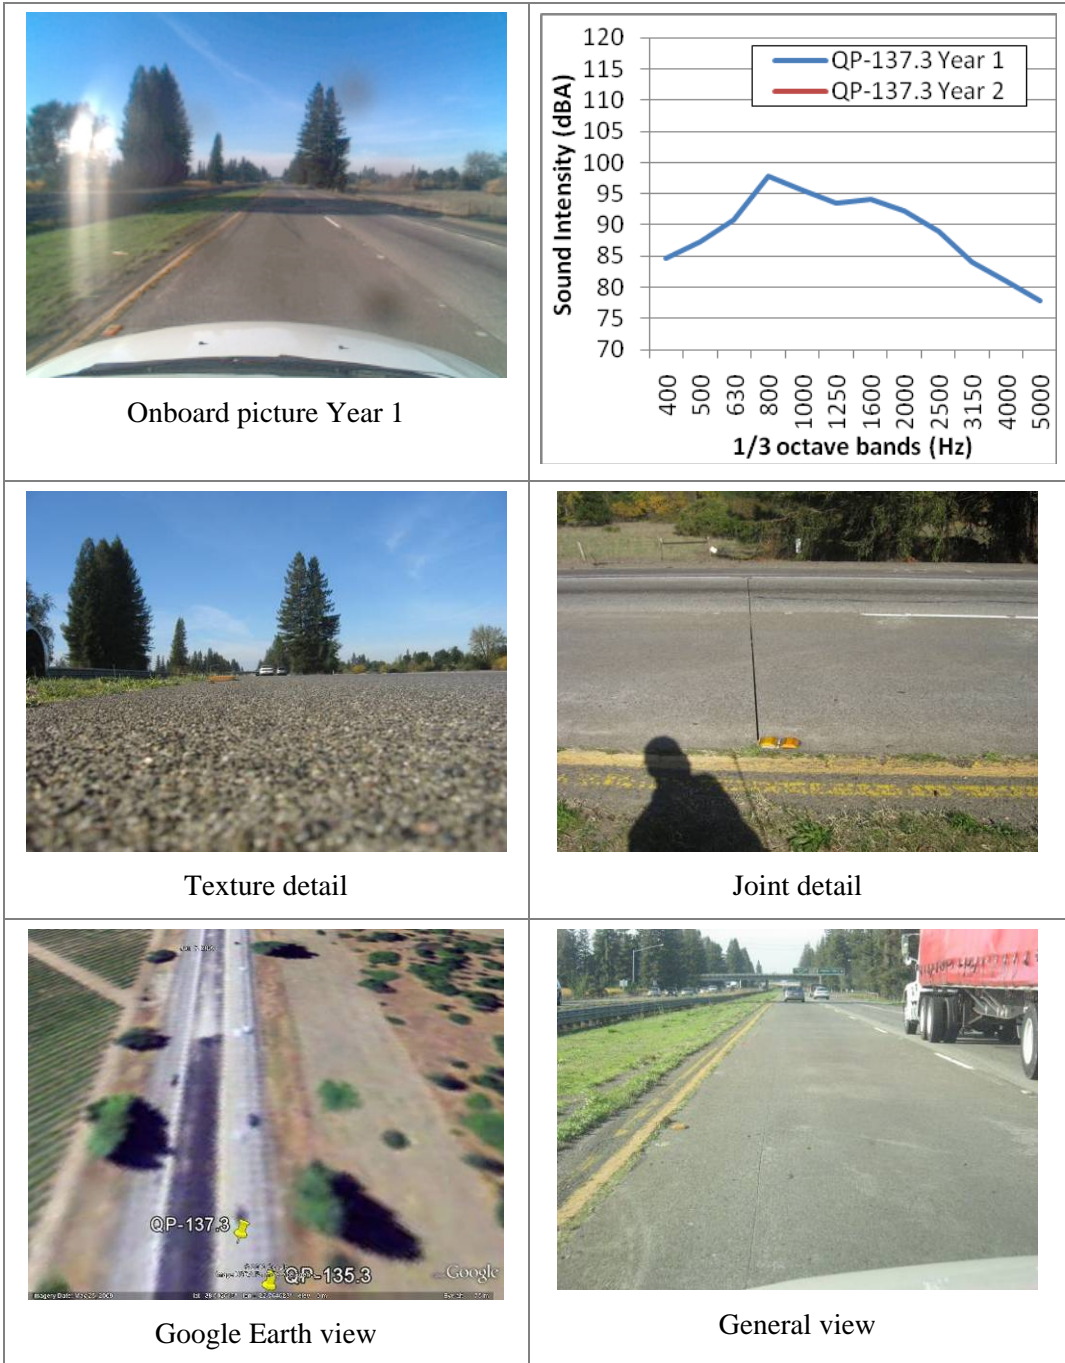
**QP-137.3**

Type of section: Pavement  
 Location: 04SON101N25.4L1  
 Comments: Burlap drag.  
 Surface Year: 1962

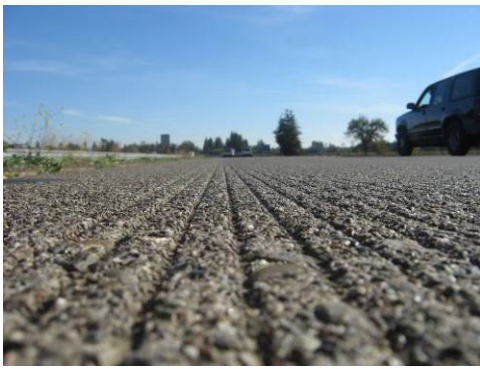
Comments: Diamond grooved.

Texture detail

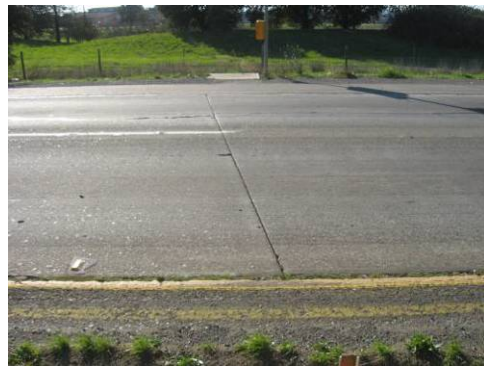
Joint detail

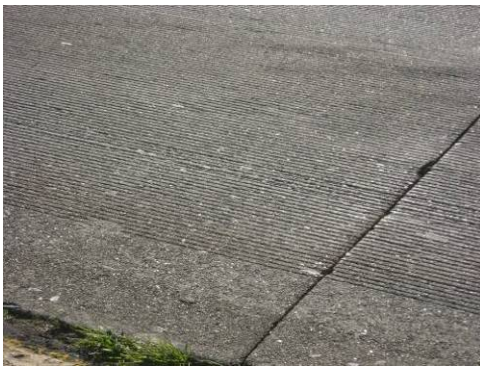
Comments: Diamond grooved.

Texture detail

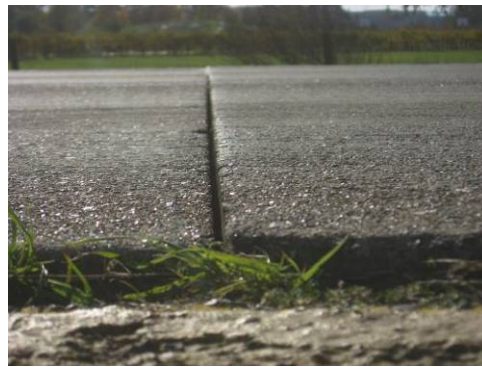
Joint detail

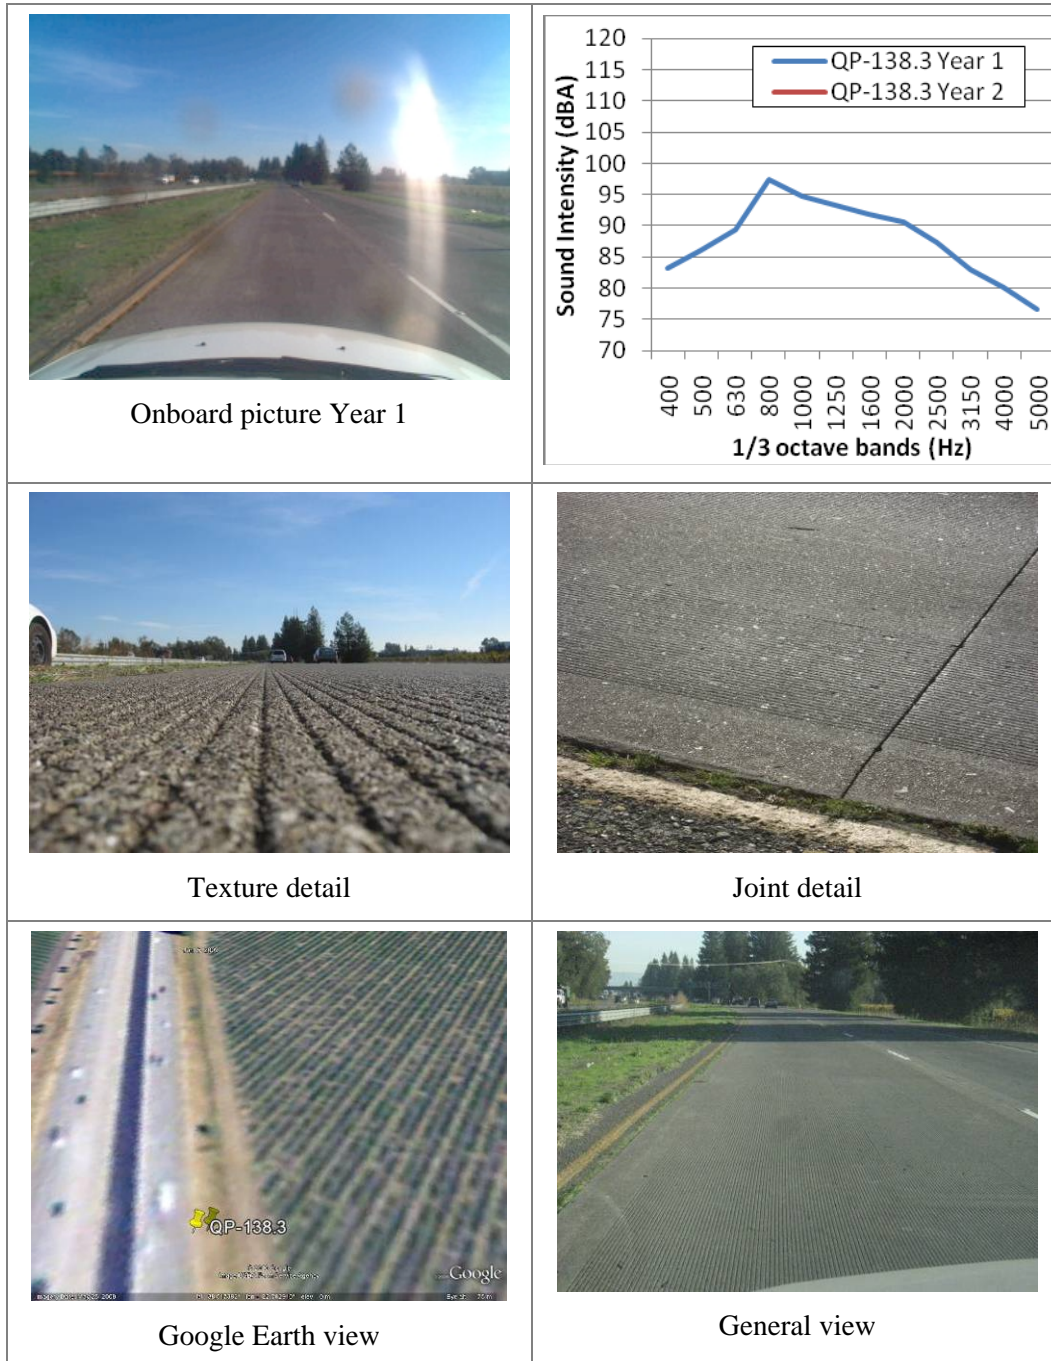
**QP-138.3**

Type of section: Pavement  
Location: 04SON101S27.3L1  
Comments: Diamond grooved.  
Surface Year: 2006

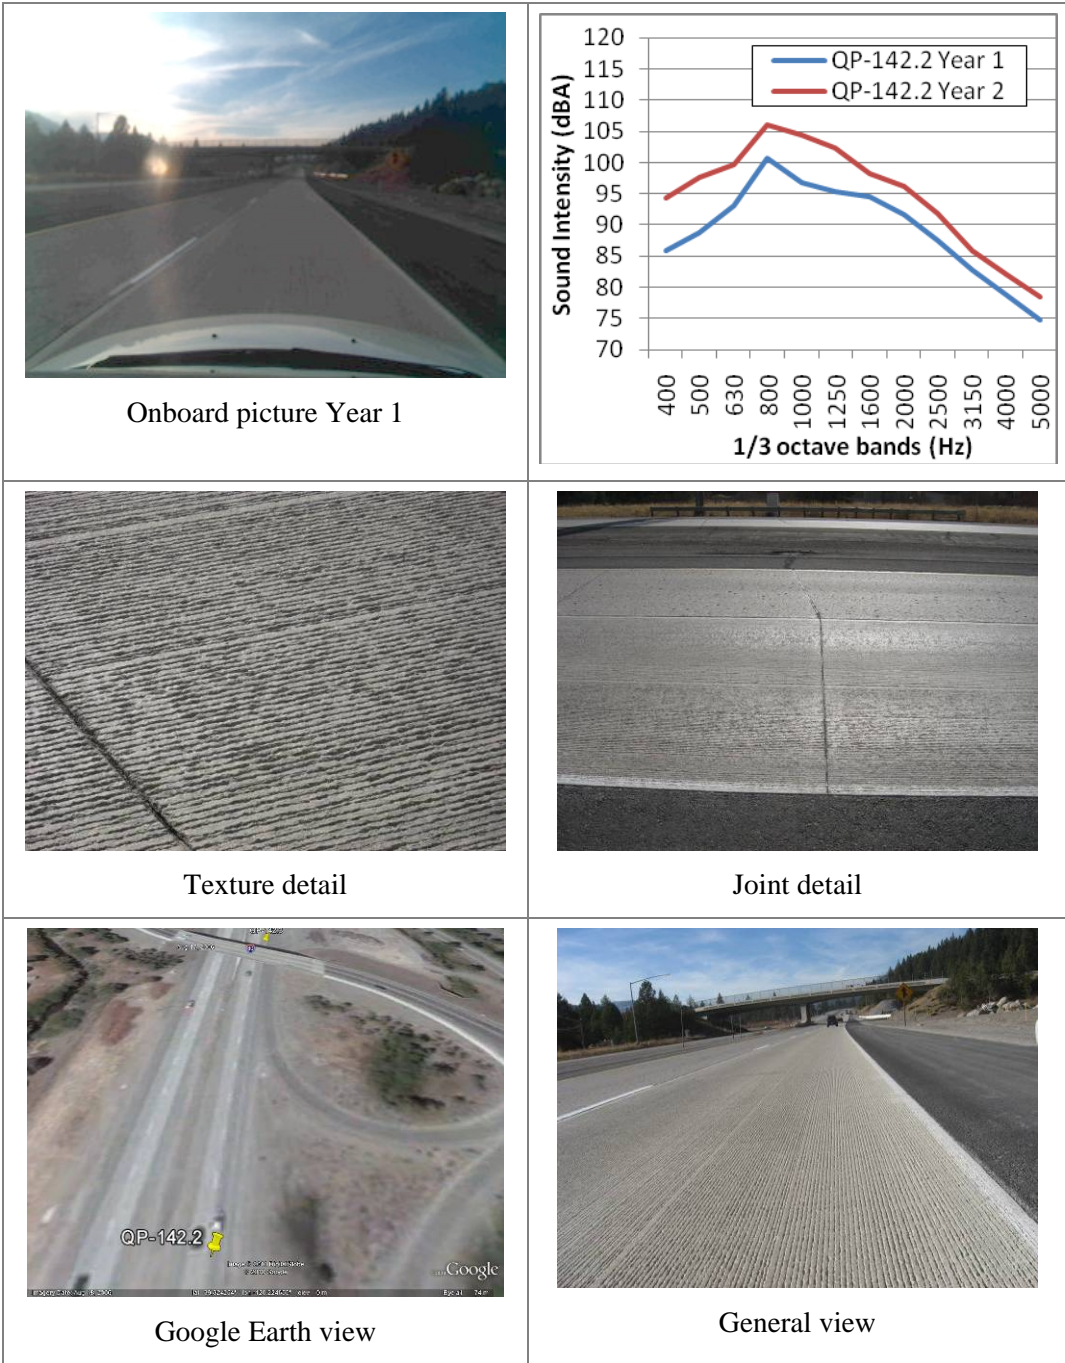
**QP-142.2**

Type of section: Pavement      Field testing Year 1: 11/24/2008 15:16  
 Location: 03NEV80W0.9      Field testing Year 2: 9/17/2009 12:49  
 Comments: Longitudinally tined. New LT.  
 Surface Year: 2008

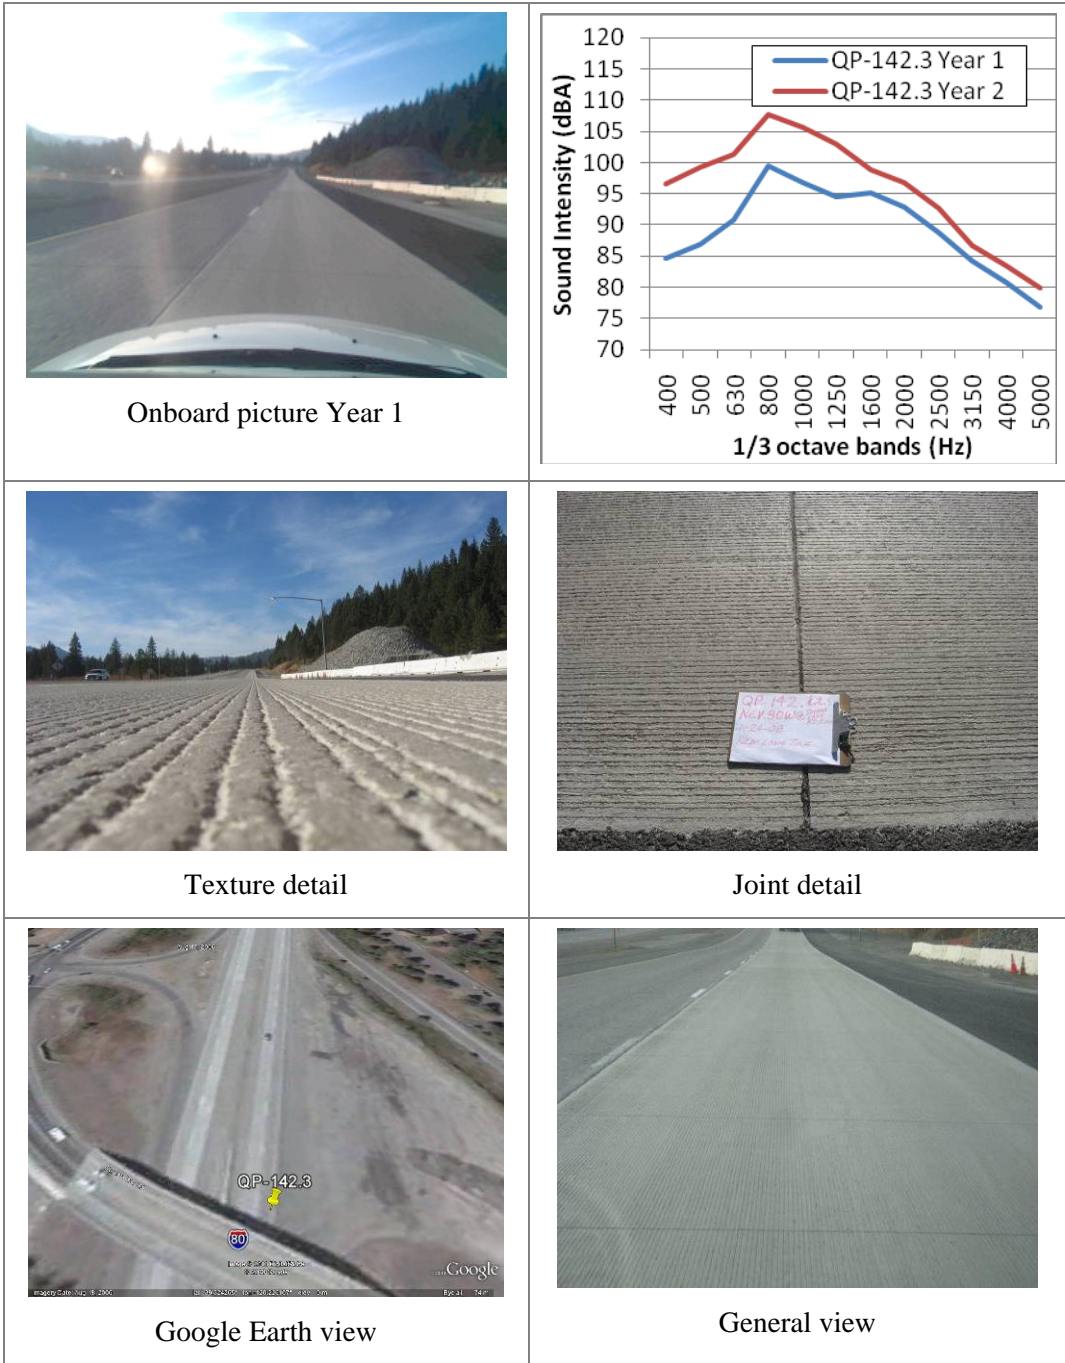
**QP-142.3**

Type of section: Pavement      Field testing Year 1: 11/24/2008 15:19  
 Location: 03NEV80W0.8      Field testing Year 2: 9/17/2009 12:52  
 Comments: Longitudinally tined. New LT.  
 Surface Year: 2008

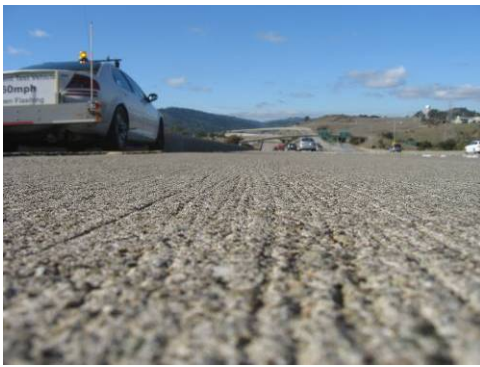
Comments: Longitudinally broomed.

Texture detail

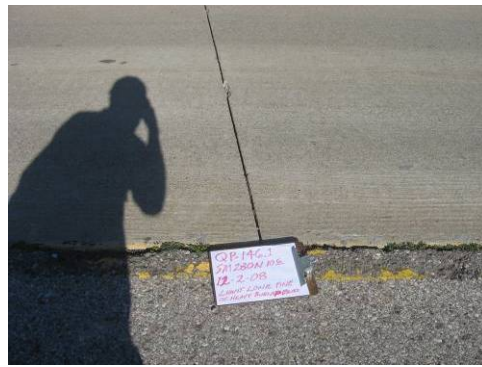
Joint detail

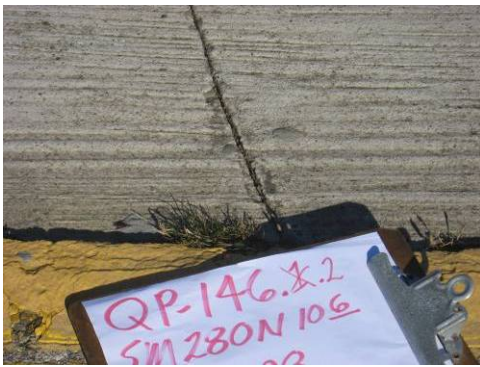
Comments: Longitudinally broomed.

Texture detail

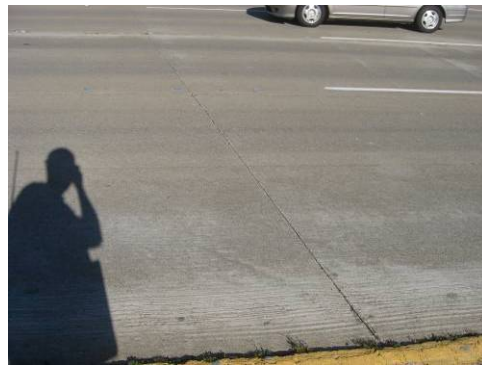
Joint detail

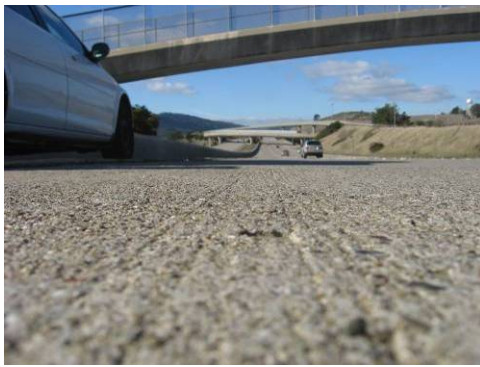
Comments: Longitudinally broomed.

Texture detail

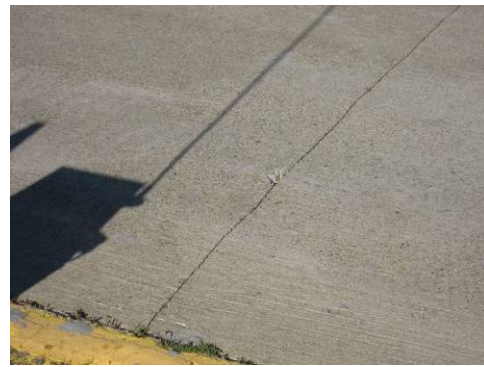
Joint detail

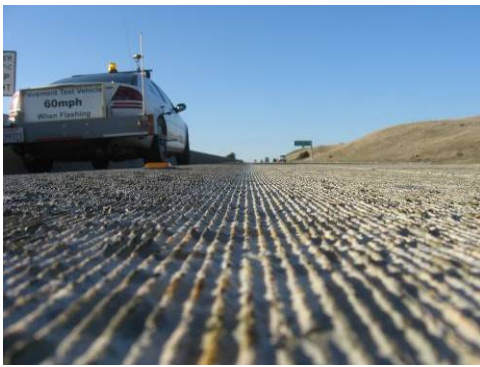
Type of section: Pavement  
 Location: 04SM280N11.6  
 Comments: Diamond ground.  
 Surface Year: 2007

Texture detail

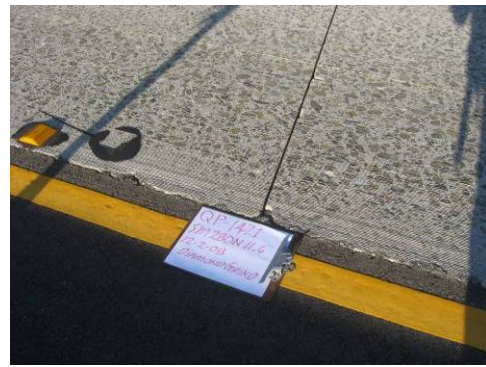
Joint detail

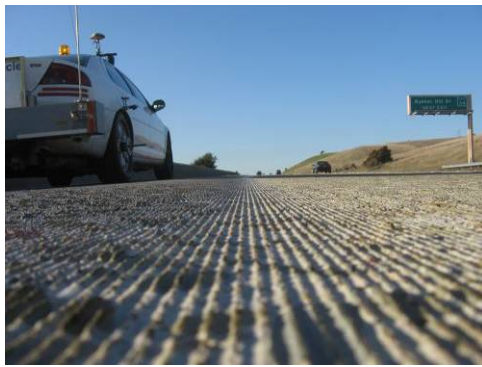
Type of section: Pavement  
 Location: 04SM280N11.7  
 Comments: Diamond ground.  
 Surface Year: 2007

Texture detail

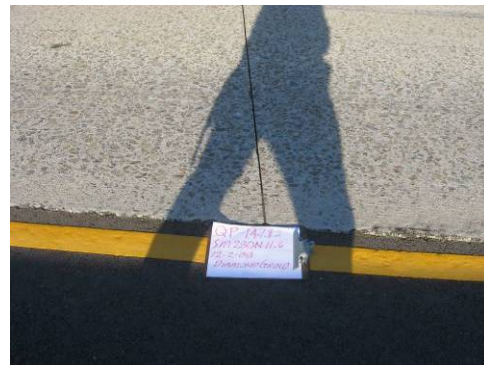
Joint detail

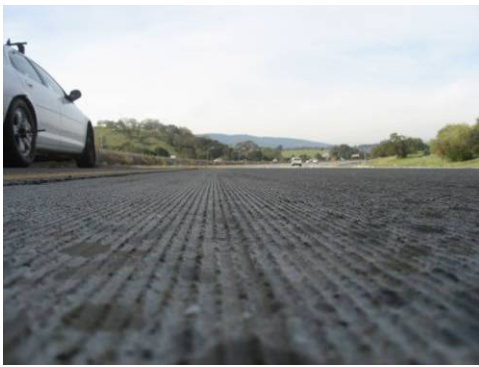
Comments: Diamond ground. Old DG.

Texture detail

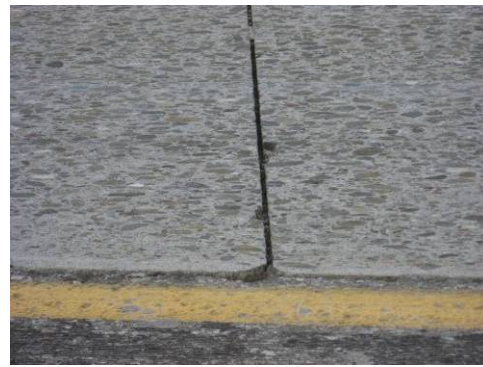
Joint detail

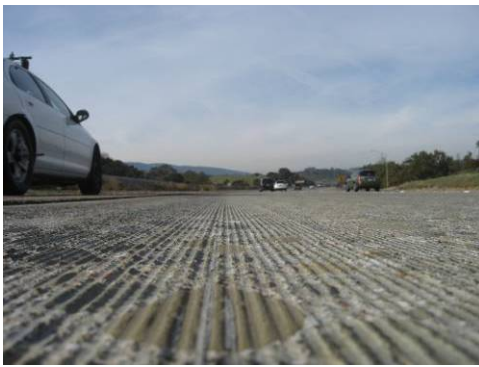
Comments: Diamond ground. Old DG.

Texture detail

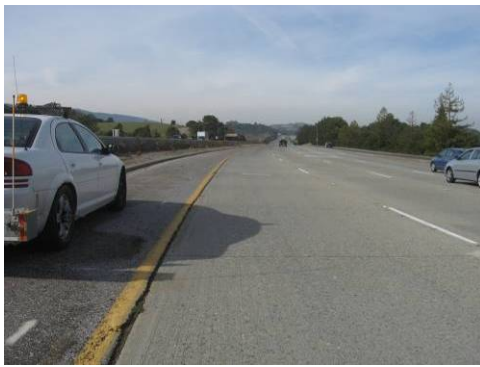
Texture detail

**QP-153.1**

Comments: Diamond grooved.

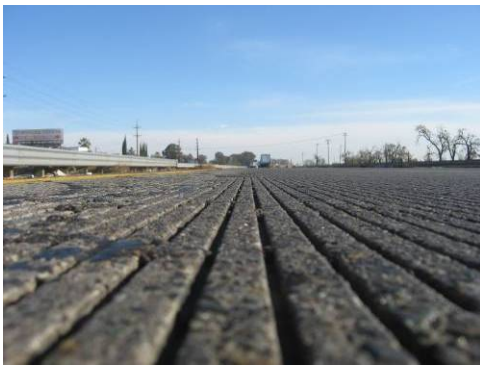
Texture detail

**QP-153.2**

Comments: Diamond grooved.

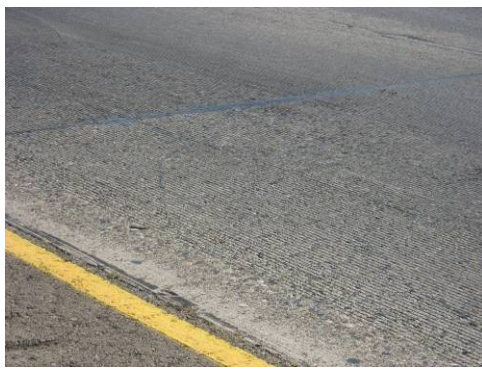
Texture detail

**QP-153.3**

Comments: Diamond grooved.

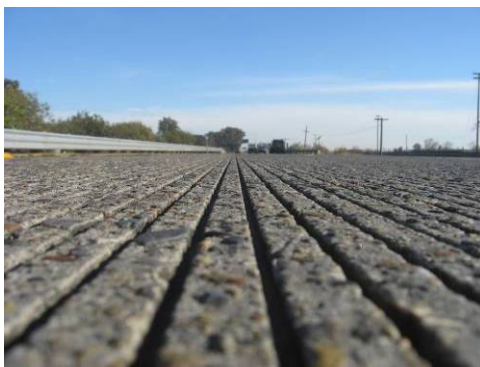
Texture detail

**QP-154.1**

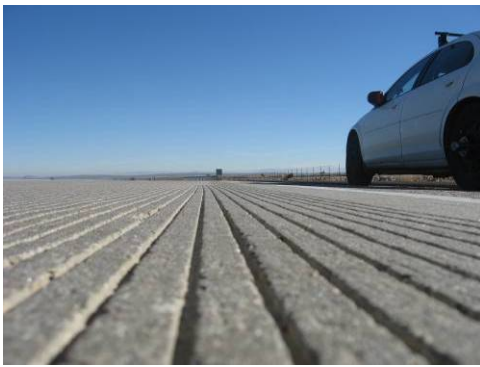
Texture detail

**QP-155.1**

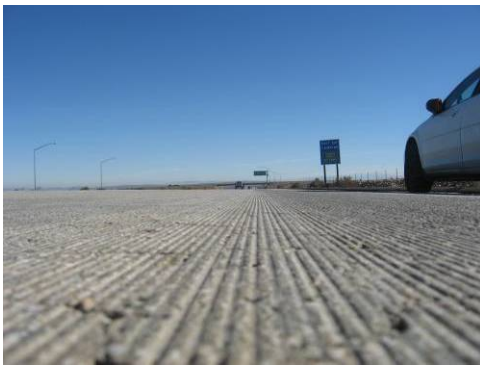
Texture detail

Type of section: Pavement  
 Location: 06Ker58E110.6  
 Comments: Diamond grind.  
 Surface Year: 2006

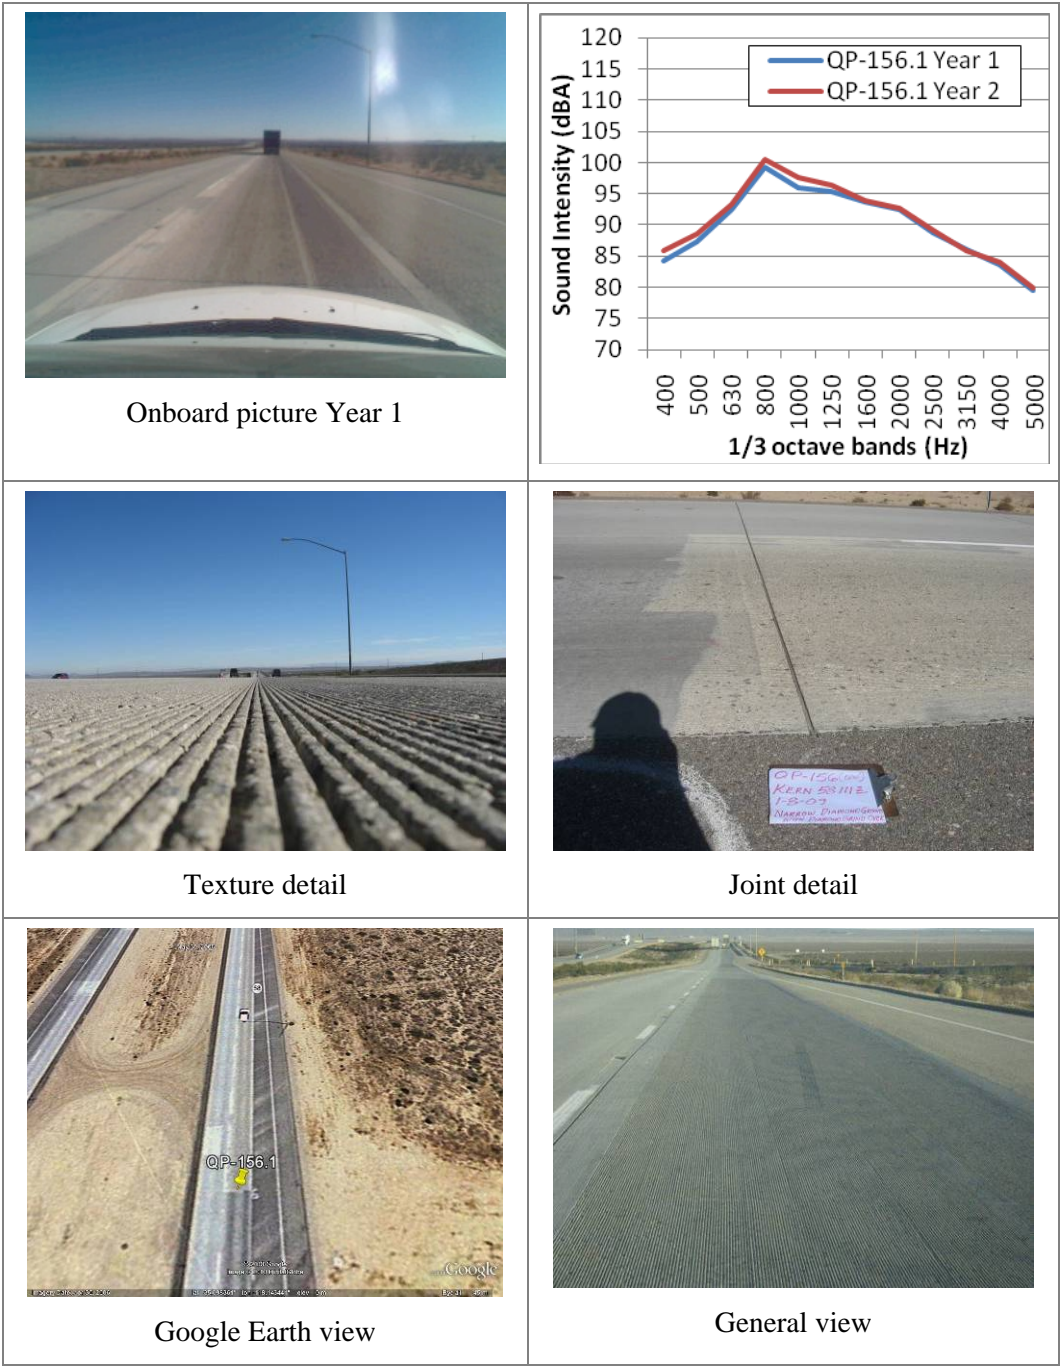
Type of section: Pavement      Field testing Year 1: 1/9/2009 7:57  
 Location: 06Ker58E111.2      Field testing Year 2: 12/2/2009 11:43  
 Comments: Diamond grooved. DG+Gr.  
 Surface Year: 2006

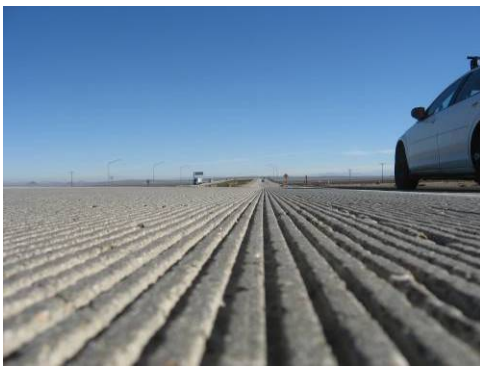
Texture detail

Comments: Diamond grooved.

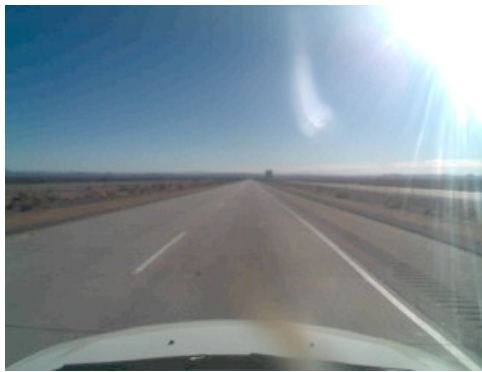
Onboard picture Year 1

**QP-158.1**

Comments: Longitudinally tined.

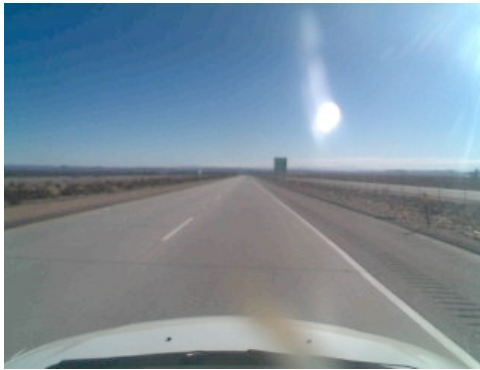
Onboard picture Year 1

**QP-159.1**

Type of section: Pavement  
 Location: 06Ker58E110.3  
 Comments: Burlap drag.  
 Surface Year: 2003

Figure 3.30 shows OBSI results for the burlap drag sections. The vast majority of the burlap drag sections were built in the 1960s and 1970s. The only “young” section, which was about six years old at the time of testing, is QP-159.1 at the Mojave Bypass. The oldest sections, which were 62 years old, are on Interstate 80 in Solano County (QP-116.1, QP-116.2, and QP-116.3). Older sections have higher OBSI levels. Figure 3.31 shows all texture conditions for the burlap drag sections plotted versus the number of years since they were last surfaced, including all Year 1 and Year 2 measurements.

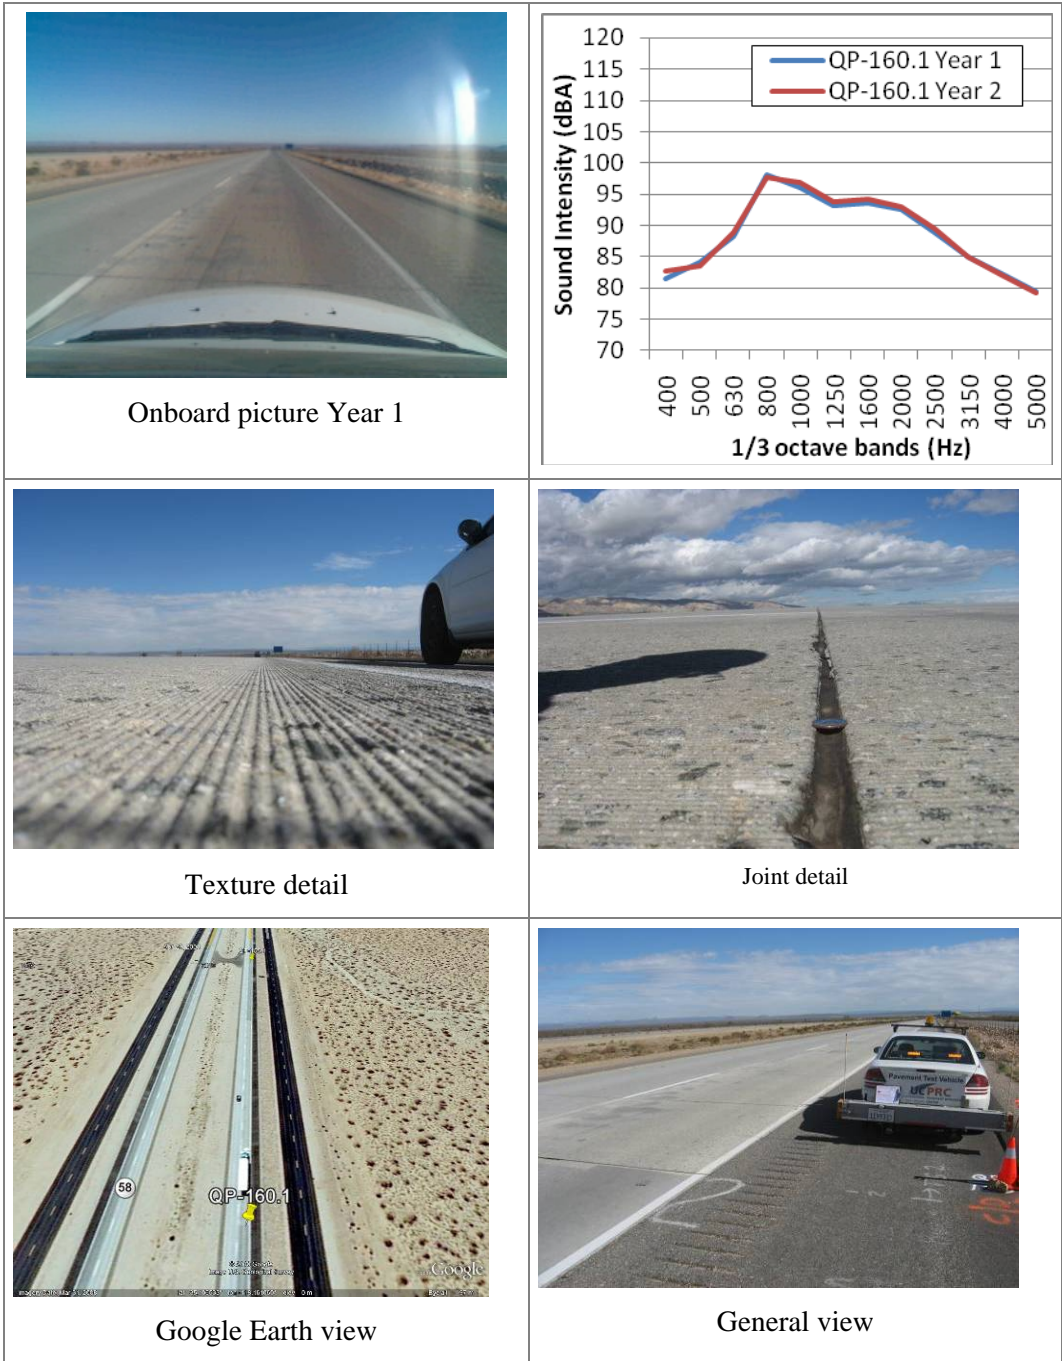
**QP-160.1**

Type of section: Pavement      Field testing Year 1: 2/23/2009 17:08  
 Location: 06Ker58E110.0      Field testing Year 2: 12/2/2009 14:13  
 Comments: Diamond ground. Caltrans section 2, DG 0.12" over burlap drag.  
 Surface Year: 2006

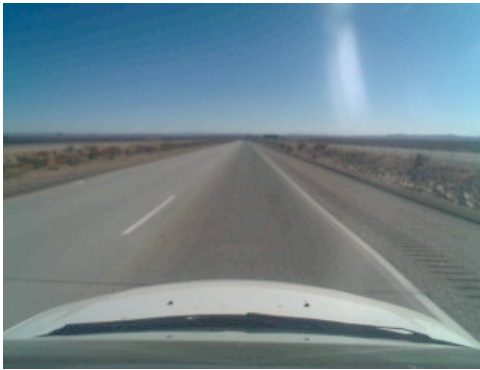
Onboard picture Year 1

**QP-161.1**

Comments: Diamond grooved. CT section 4, 3/4" spacing, 1/4" deep, over burlap drag.

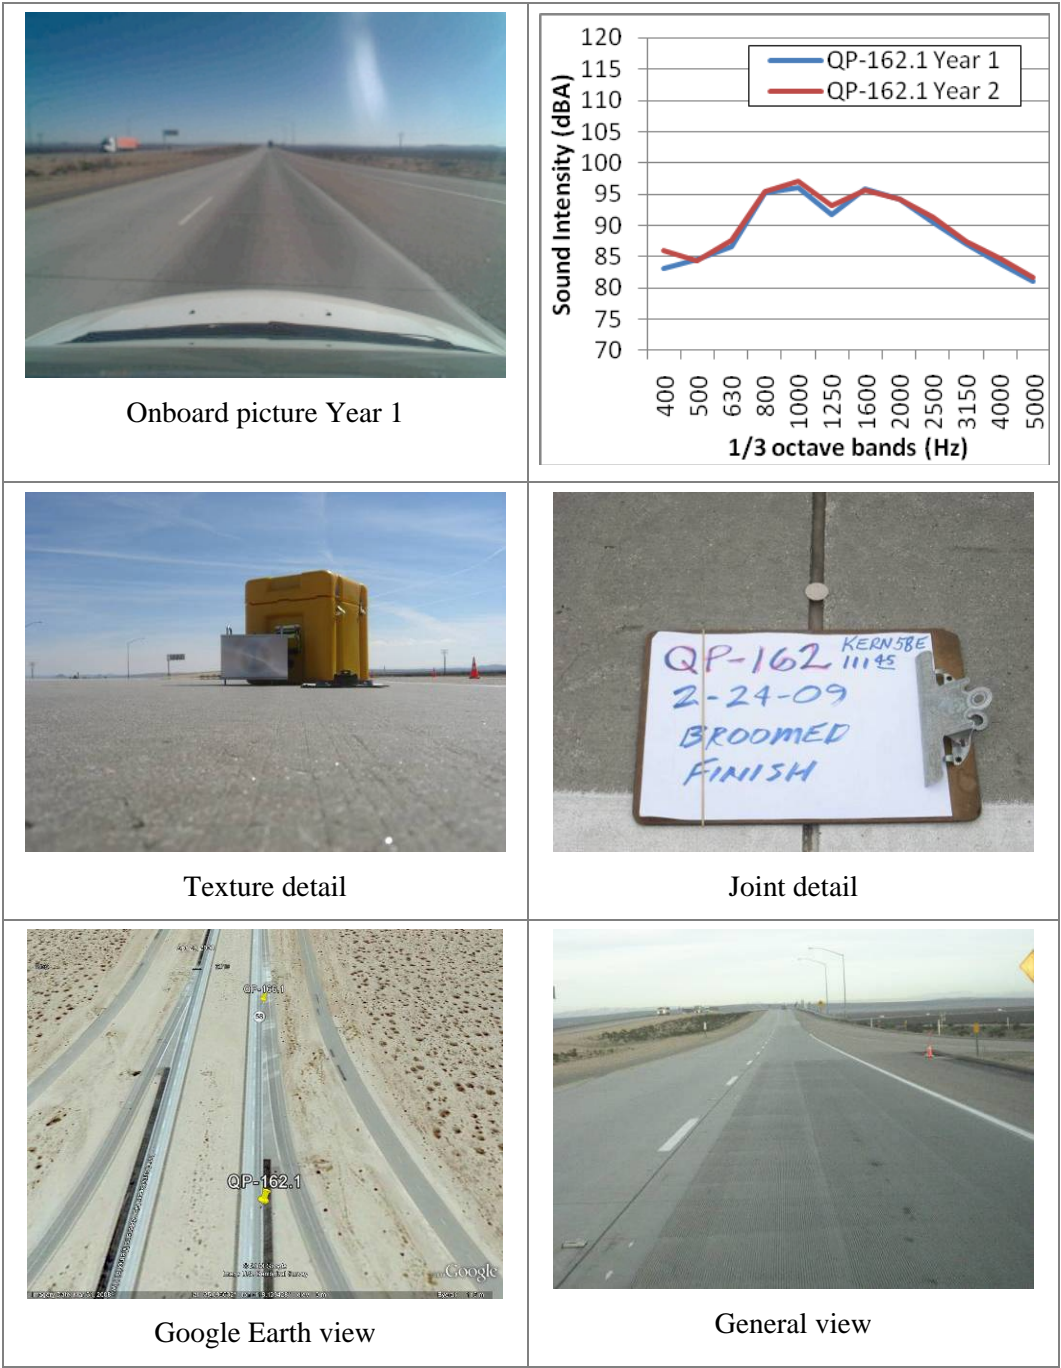
**QP-162.1**

Type of section: Pavement      Field testing Year 1: 2/24/2009 16:53  
 Location: 06Ker58E111.5      Field testing Year 2: 12/3/2009 10:41  
 Comments: Longitudinally broomed. Base texture for other sections in this area.  
 Surface Year: 2003

Figure 3.36 shows OBSI results for the longitudinally broomed sections. The six-year old section is at the Mojave Bypass on State Route 58. The 19-year old sections are on Interstate 80 in Nevada County (QP-109 and QP-112), but were overlaid with asphalt between Year 1 and Year 2. The 34-year-old sections are on Interstate 280 in San Mateo County (QP-146). From the limited available data, it seems that OBSI levels on this type of surface texture do not increase much over time. Figure 3.37 shows all texture conditions for the longitudinally broomed sections plotted versus the number of years since they were last surfaced, including all Year 1 and Year 2 measurements.

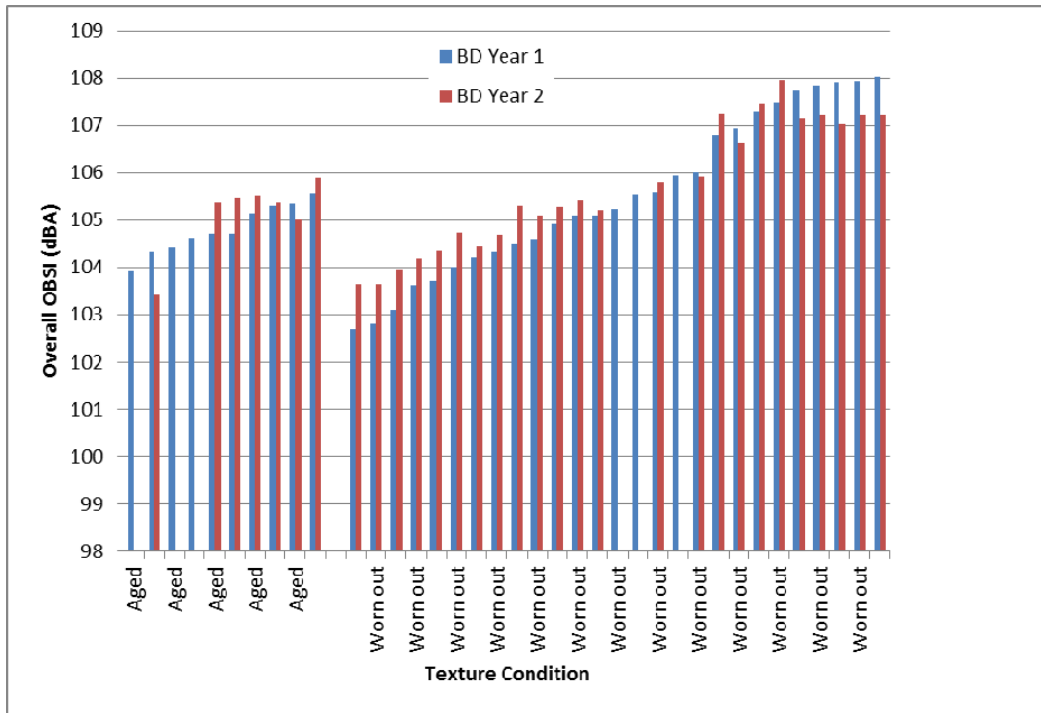
Figure E.4: Compare with Figure 3.30: Burlap drag Year 1 and Year 2 results for all texture conditions (*new, aged, worn out*).

Figure 3.30: Year 1 and Year 2 OBSI values for all burlap drag sections.

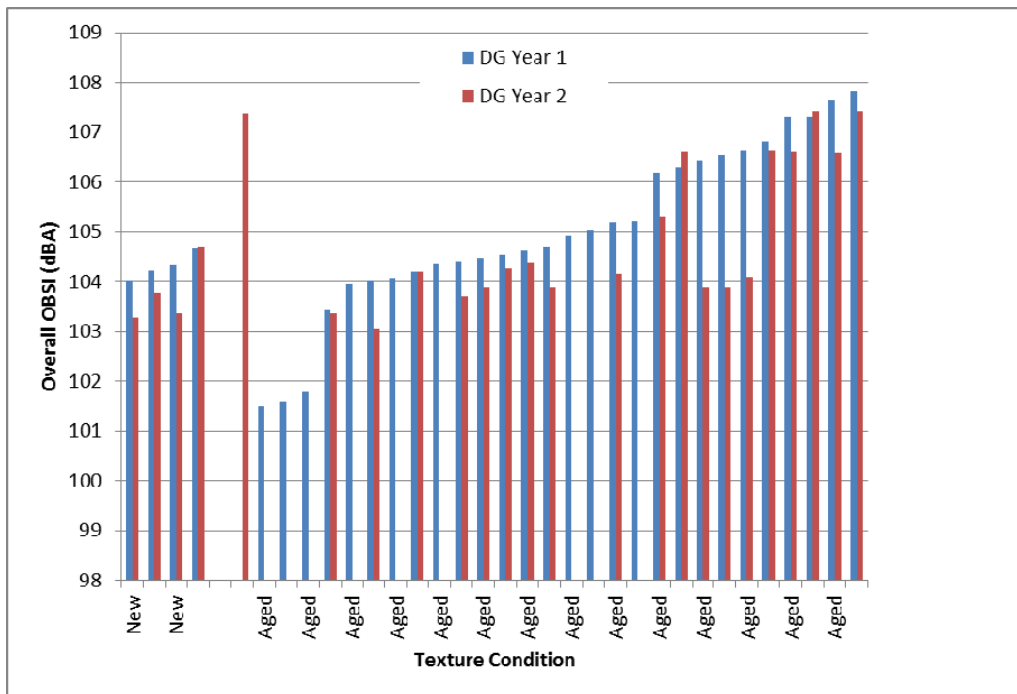
Figure E.5: Compare with Figure 3.32: Diamond ground Year 1 and Year 2 results for all texture conditions (*new, aged, and worn out*).

Figure 3.32 shows OBSI results for the diamond ground sections. The oldest sections evaluated were 11 years old at the time of testing. It seems again that older sections have higher OBSI levels. Figure 3.33 shows all texture conditions for the diamond ground sections plotted versus the number of years since they were last surfaced, including all Year 1 and Year 2 measurements.

Figure 3.32: Year 1 and Year 2 OBSI values for all diamond ground sections.
