Static and Seismic Performance of California Levees

Michelle Jennifer Shriro

Doctor of Philosophy

Engineering - Civil and Environmental Engineering

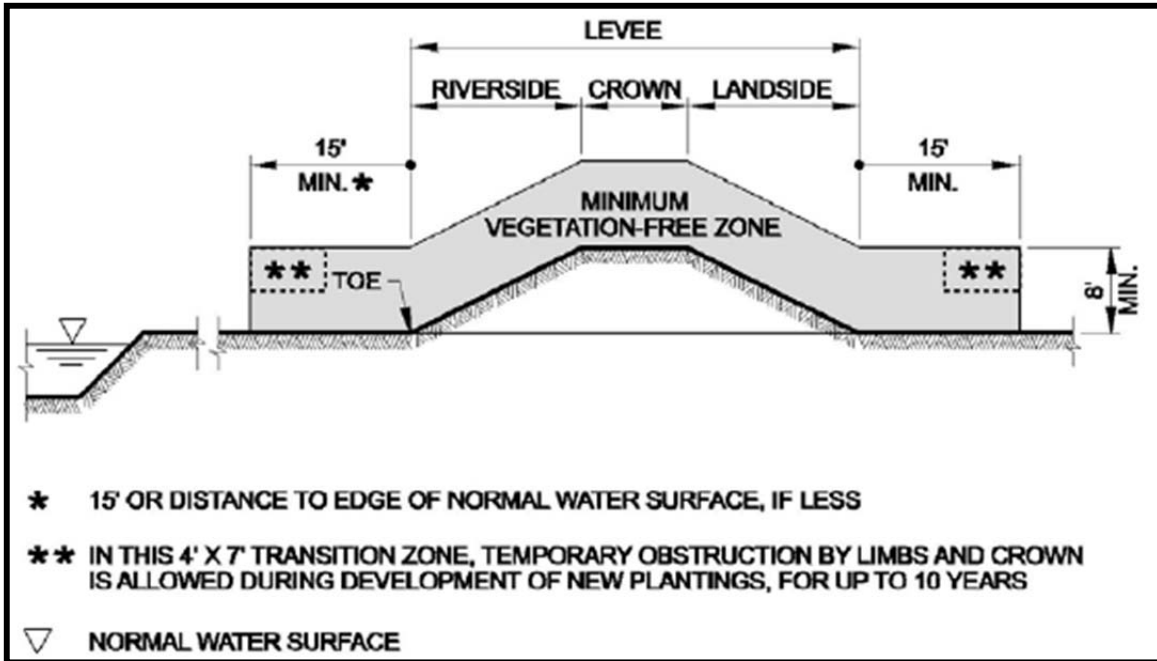
Figure 1-1. USACE Vegetation-Free Zone (Source: USACE ETL 1110-2-571).

In 2009, the United States Army Corps of Engineers (USACE) released the document "Guidelines for Landscape Planting and Vegetation Management at Levees, Floodwalls, Embankment Dams, and Appurtenant Structures", ETL 1110-2-571, recently released an update with minor changes (USACE, 2014). The guidelines show a vegetation-free zone across the levee surface and extending 15 feet from the toe of both the land and water sides (Figure 1-1). The vegetation-free zone is expanded where stability berms or other structures are present near the toe. This policy has been the subject of debate in states where levees were built close to adjacent to the rivers and as a result critical riverine habitat shares space with structures providing flood protection (Harder et al., 2011).

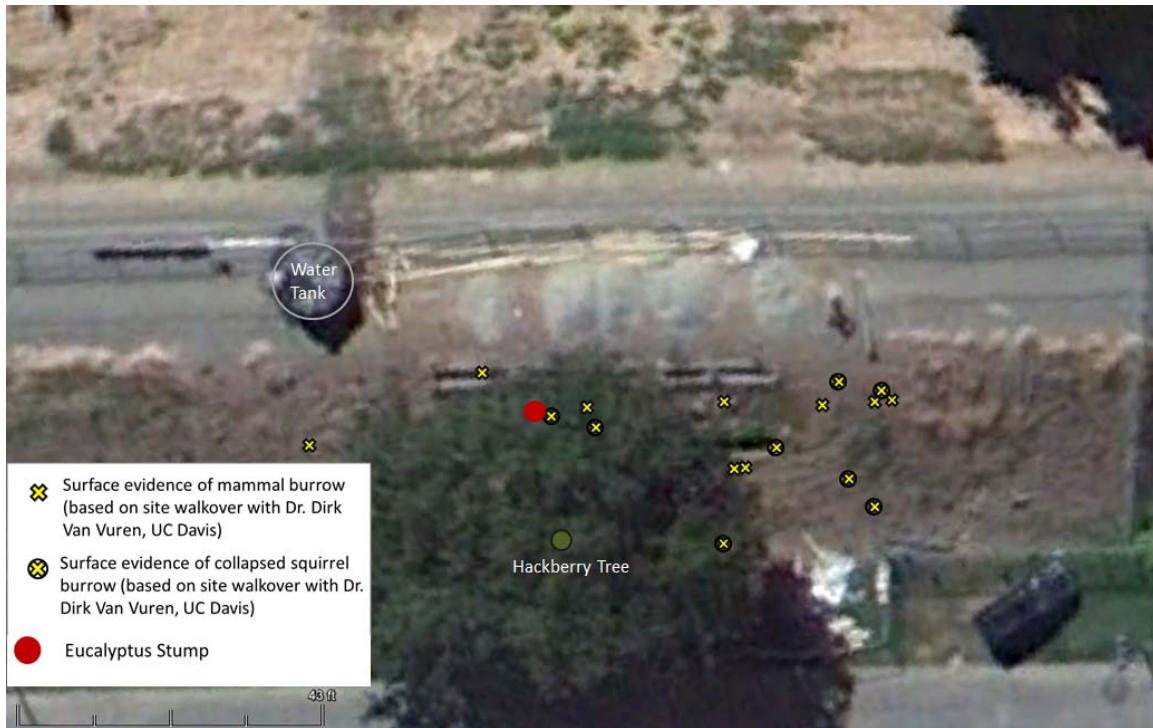
Figure 2-3. Aerial view of the site showing the scatter of burrows relative to the study area. Base photo source: Google Earth, September 19, 2010.

As previously discussed, the selected site is located along the landside of the northern levee bordering the American River. A site walkover was performed to evaluate site conditions from the surface. Professor Dirk Van Vuren of UC Davis served as the CLVRP team expert on burrowing mammals. Professor Van Vuren viewed the site with our team and burrow locations were flagged and categorized based on his experience. A total of 17 surface expressions of burrows were found within 20 feet of the test (to the east and west) on the landside slope face. Based on Professor Van Vuren's visual observations, the burrows consisted of abandoned and some collapsed burrows of the California ground squirrel and the pocket gopher (Figure 2-3).

During trench construction, consideration was given to grouting burrows onsite prior to the flow test. Field logs of the lower trench wall revealed 15 burrows in the uphill wall, while the downhill wall of the uphill trench did not reveal any burrows. As previously discussed and shown on Figure 2-3 and Figure 2-19, surface expressions of mammal burrows were observed across the site. The holes were viewed by a member of the CLVRP team, Dr. Dirk Van Vuren, a burrowing mammal expert from UC Davis. All of the locations were considered either abandoned ground squirrel burrows, which were partially collapsed and had not been in use for some time, or burrows of the pocket gopher.

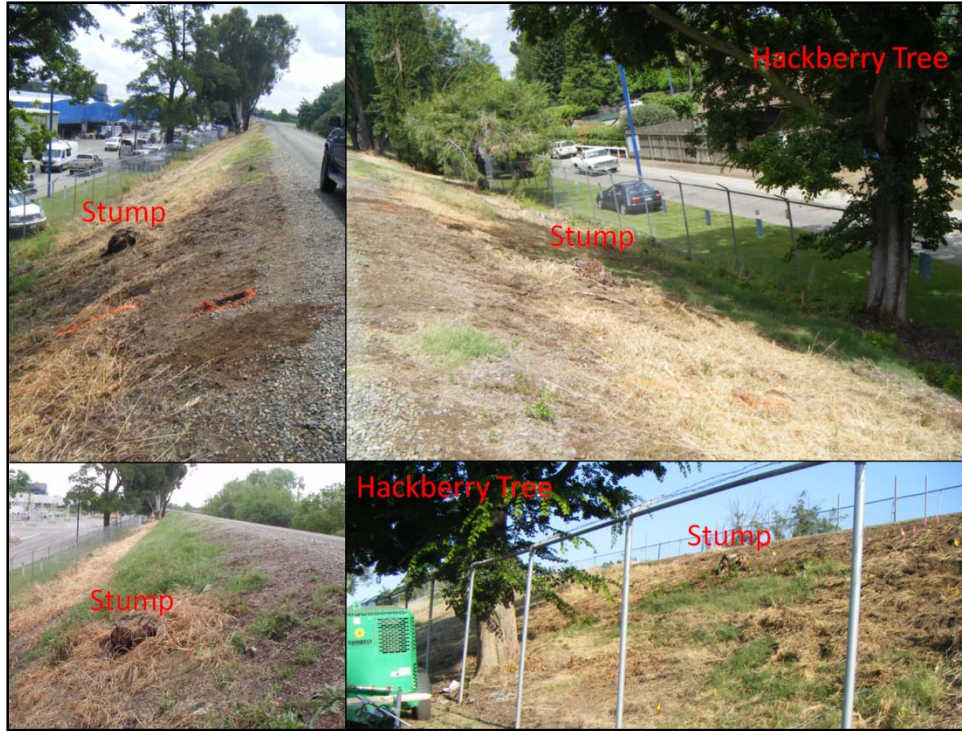
Figure 2-4. Photos of the study site at the Eucalyptus stump.

The landside of the levee is inclined at approximately 2H:1V (horizontal:vertical). The eucalyptus stump selected for study was positioned approximately 6 feet from the crown and 10 feet from the toe of the levee, measured vertically (Figure 2-4).

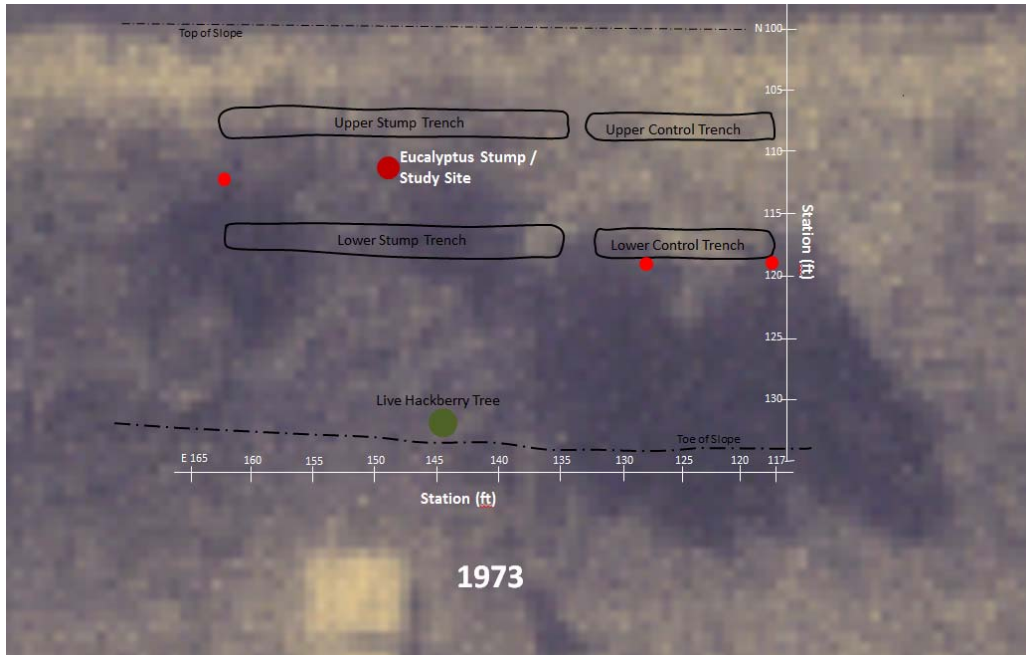
Figure 2-5. Plan view showing trench configuration and stump locations identified during construction. Base photo provided by Cal Expo, 1973.

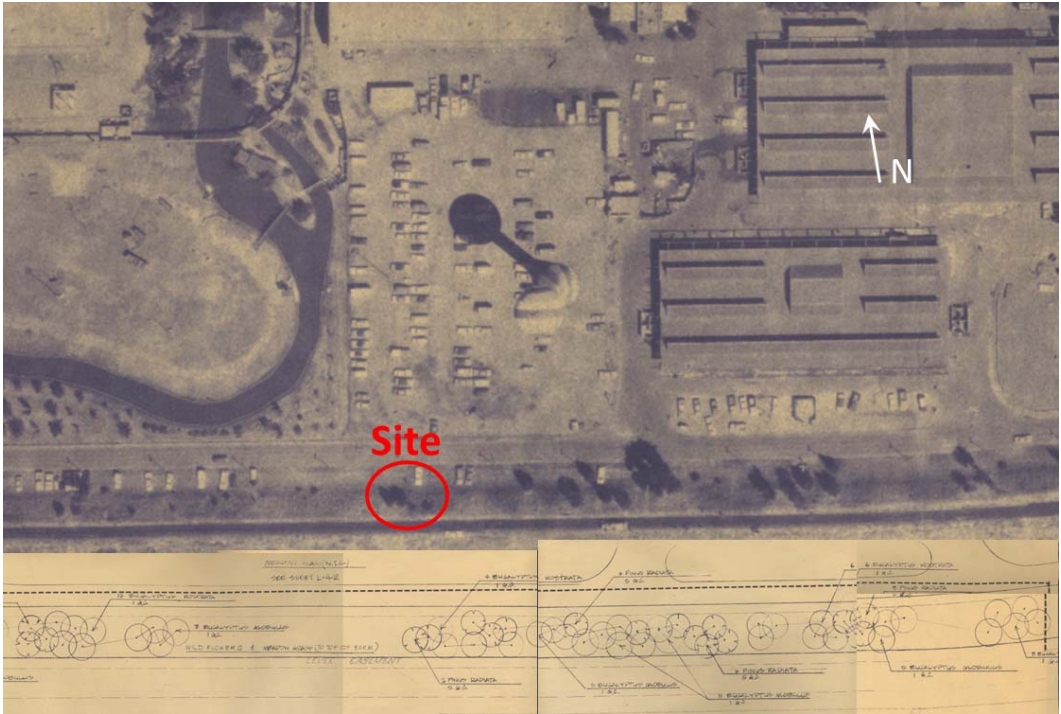
Figure 2-7. 1973: Approximate alignment of planting plan with aerial photo of site. Aerial image provided by Cal Expo.

Figure 2-6 shows Cal Expo under construction in 1968 at which time trees has not yet been planted along the levee. A planting plan prepared by Lawrence Halprin and Associates and dated November 27, 1967 was provided by Cal Expo for our review. Figure 2-7 shows an approximately 1500 foot stretch of the planting plan aligned with an aerial photo taken in 1973. The plan shows many trees that do not exist in the 1973 photograph, while trees actually seen in the 1973 aerial photograph do not appear to have been planted in the precise locations proposed. Nevertheless, a mass planting took place and many more trees are present in 1973 than in 1968. According to Ron King, the head of grounds maintenance for Cal Expo, many of the initial trees planted at that time did not survive. This observation is consistent with our review of planting plans as compared with aerial photography in the years following construction.

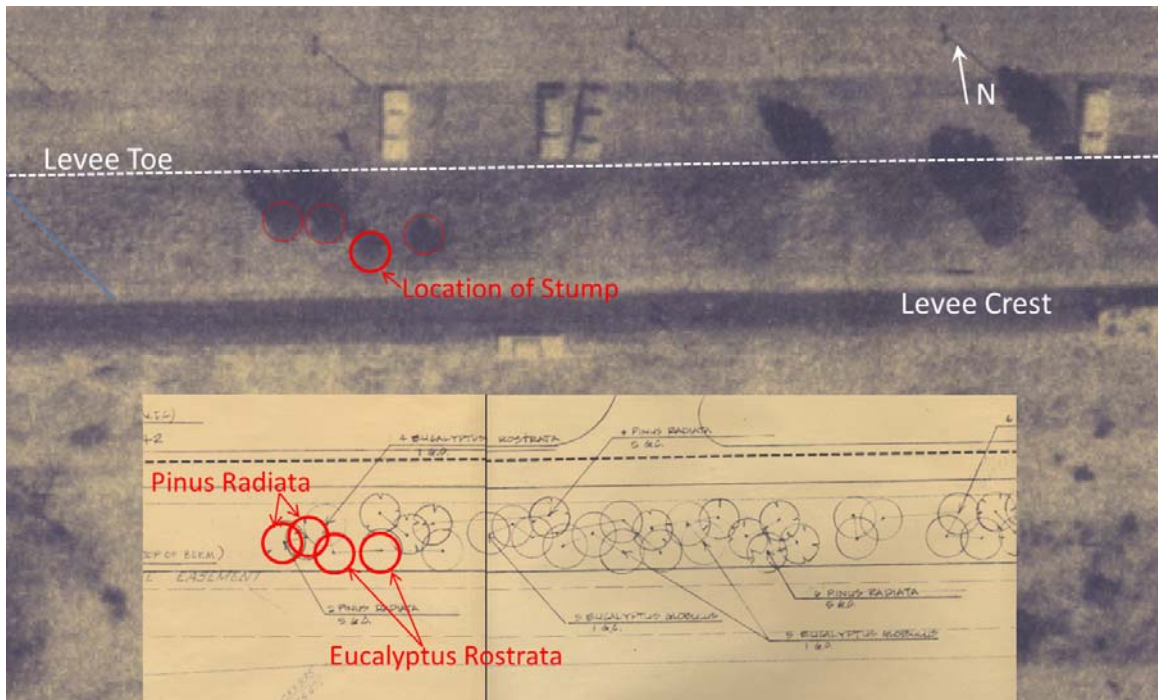
Figure 2-8. A view of the four trees on site as of 1973 with corresponding planting plan showing proposed planting for those trees. Aerial images provided by Cal Expo.

Figure 2-8 shows a close-up of the aerial photo from 1973 with the tree identified as the stump under study indicated. Four trees are shown within the study area and street lights are used to pinpoint the location of our Eucalyptus stump. The planting plan shows the two trees to the east are *Eucalyptus rostrata*, while the two trees to the west are *Pinus radiata*. The position of trees does not seem to correlate exactly with the plan. In general, the species of the trees onsite currently seem to match those planted and consist primarily of eucalyptus and pine. Based on a visual evaluation, CLVRP root architecture research expert, Dr. Alison Berry of UC Davis identified the two stumps to the east as Eucalyptus. Stumps to the west were not evaluated for species as they were not visible from the surface, were highly

decomposed and generally downslope of the study area. Additional stumps were found during trench construction and may have been remnants of the trees shown on Figure 2-8.

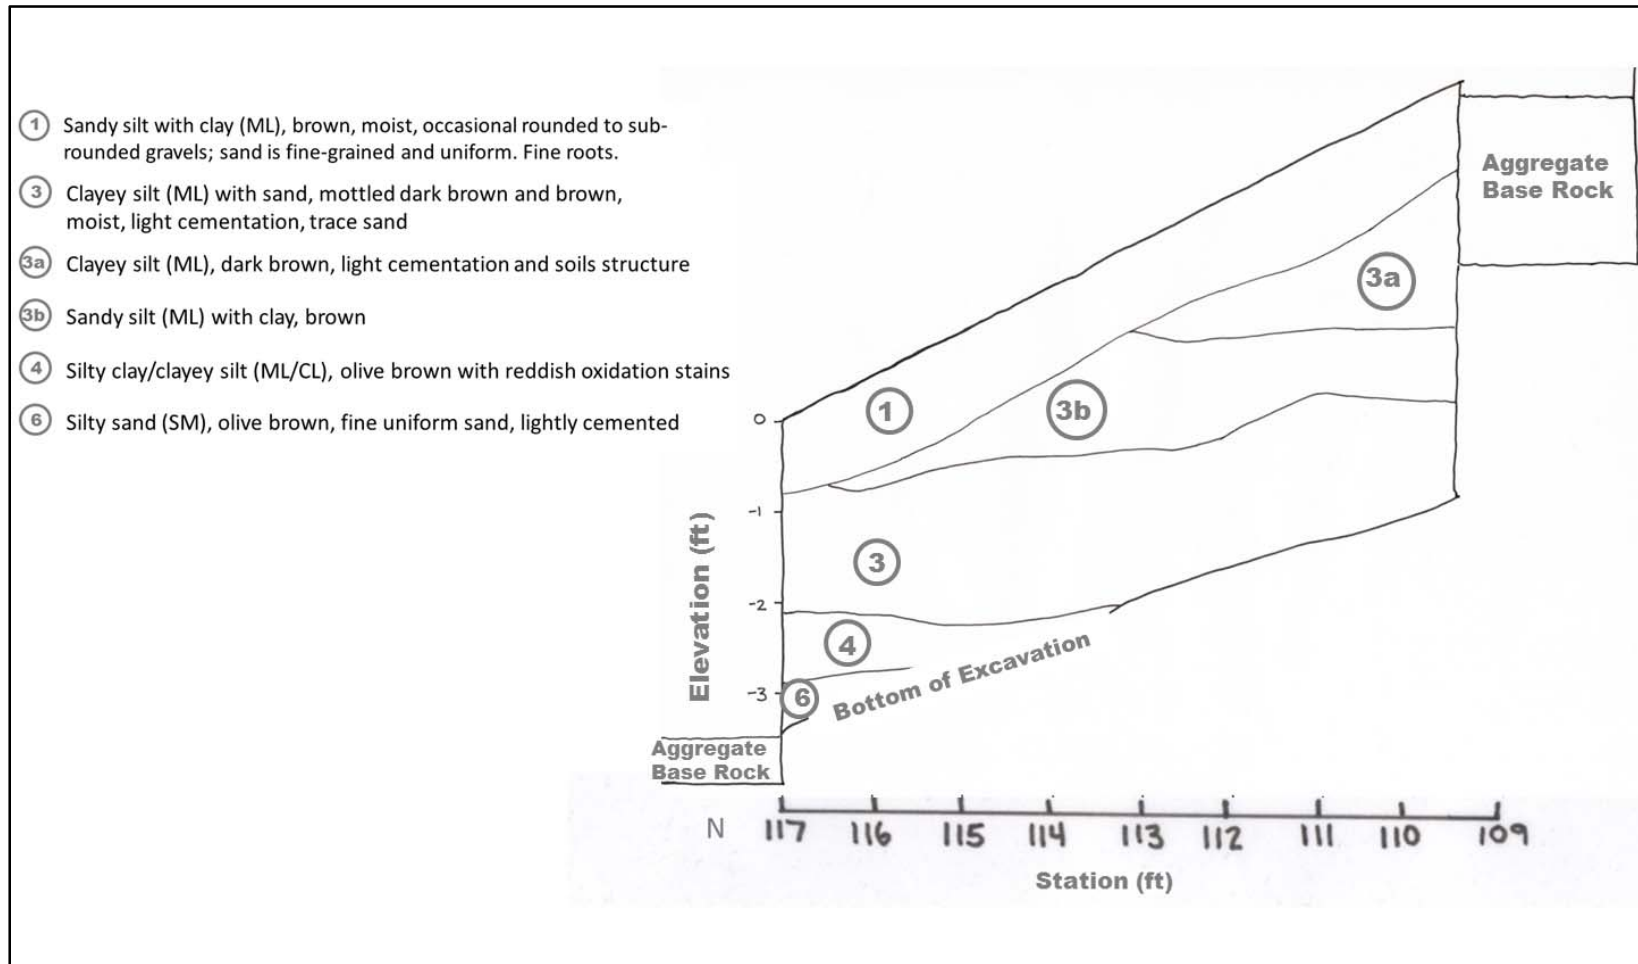
Figure 2-14. Stratigraphic section at control trenches, located just west of instrument Line C (see Figure 2-21).

During construction and after the flow test, trench walls and excavations were observed and observations were recorded onto field logs. These field logs are provided in Appendix 2C. Our post-flow characterization effort included excavation of the zone surrounding the stump with observations recorded through both traditional field logging and tripod-based light detection and ranging (T-LiDAR) imaging (Cobos-Roa et al., 2012). A cross section showing the stratigraphy in the area of the eucalytus stump under study is provided as Figure 2-13. T-LiDAR was used only in the area around the stump and root system. At the control section, a backhoe test pit was excavated at instrument Line C in order to view the and log the stratigraphy (Figure 2-14). Site soils consisted of interbedded silts, silty sands, sandy silts, and lean clay.

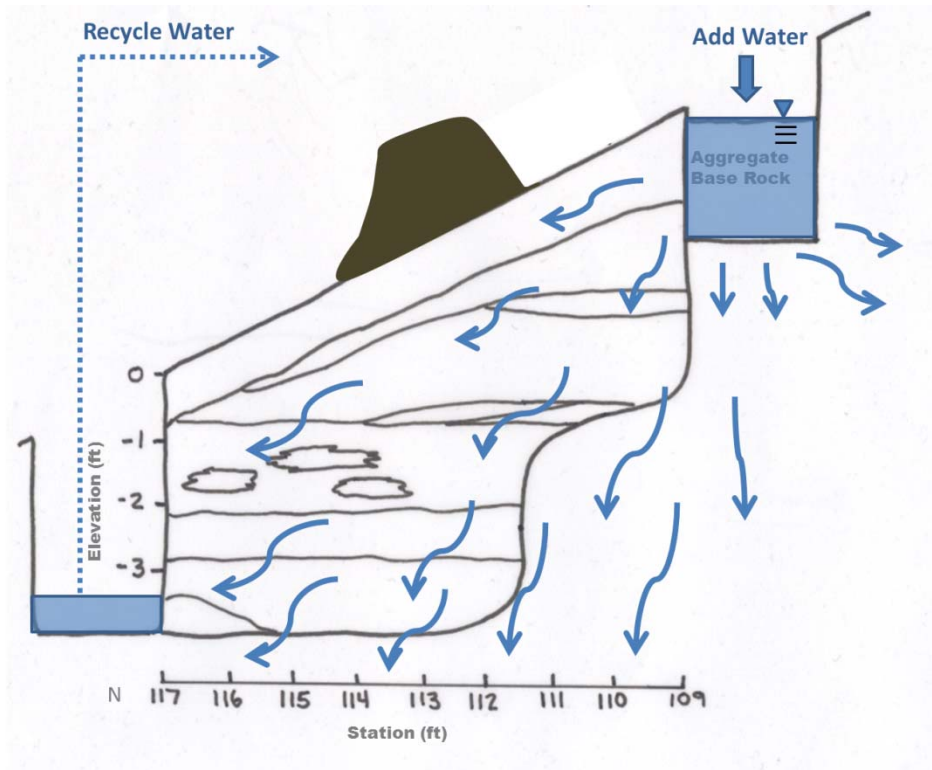
Figure 2-15. Cross section between upper and lower trenches at eucalyptus stump showing concept of proposed wetting front flow test.

As previously discussed, the flow test was designed to deliver water above the decomposing root system of the eucalyptus stump, inducing a wetting front and a flow net that could be monitored through observation and instrumentation. Water was delivered to an upper trench, constructed above the stump, and held at a constant head during the test (Figure 2-15 and Figure 2-16). A lower trench was constructed below the stump for viewing the exposed trench wall face and to capture seepage flowing downslope during the flow experiment. The walls of the trench were braced with shoring to prevent collapse. The uphill side and base of the upper trench as well as the base of the lower trench were lined with plastic sheeting to minimize water losses outside the study area. Stockpiled gravel was available to rapidly infill the lower trench in the event of instability prior to the equilibration of flow patterns.

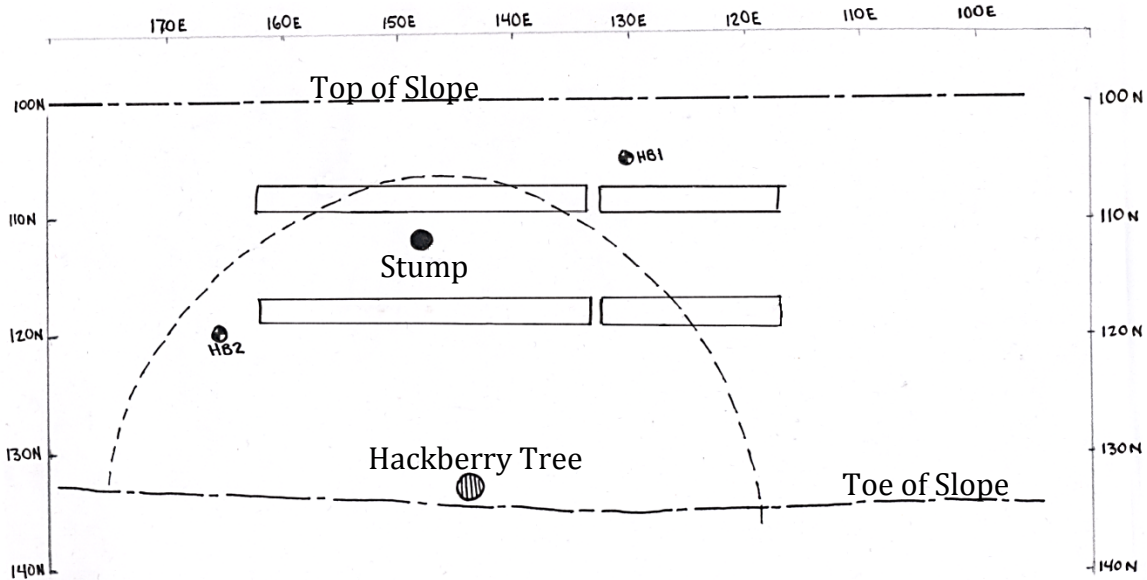
Figure 2-16. Site plan with coordinate grid showing the stump and trenches under study, and the location of hand auger borings HB1 and HB2.

Figure 2-16 shows the configuration of trenches constructed above and below the stump. An approximate 30-foot long zone around the stump was deemed the 'stump zone' and a 'stump trench' was constructed above and below this segment. The water delivery trench above the stump will be referred to as the 'Upper Stump Trench' while the viewing trench below the stump will be known as the 'Lower

Stump Trench'. As seen on the figure, the stump and control trenches were separated by a small gap in excavation in order to control water flow and volumes to the two trenches separately.

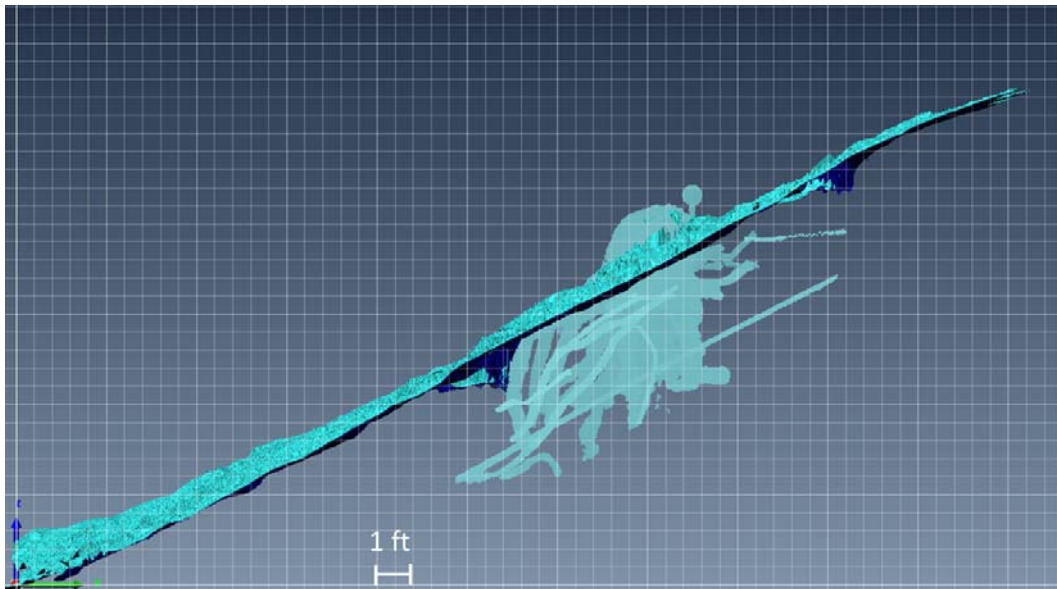
Figure 2-17. T-LiDAR image looking east at the eucalyptus stump and root system. Base T-LiDAR Image provided by Gerald Bawden of the USGS.

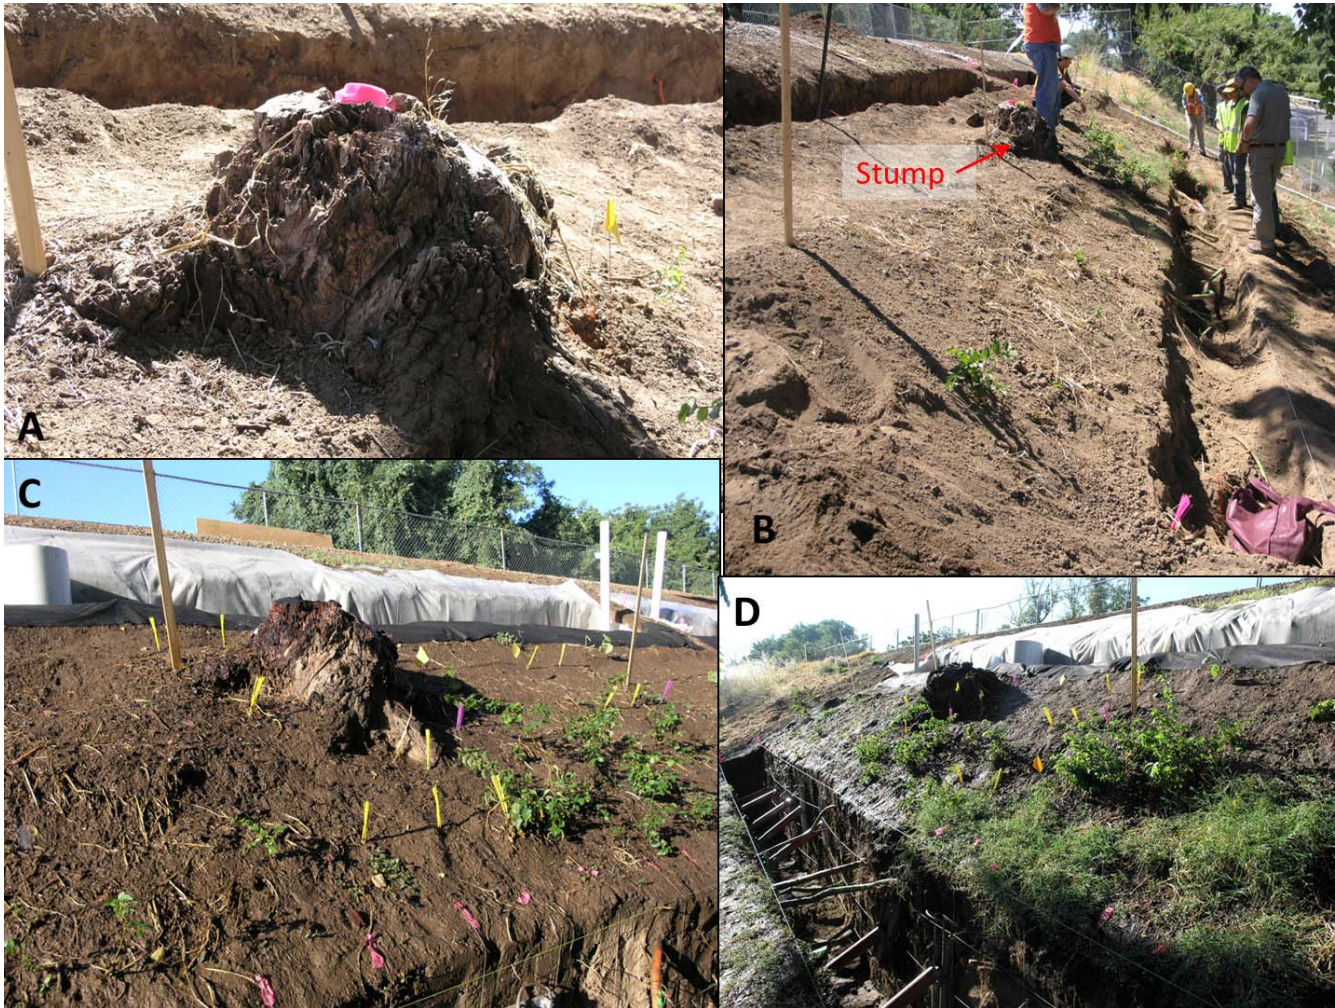
Figure 2-18. Eucalyptus stump is shown A) close in, B) from the east end of the trenches looking west, C) from below the stump trench looking southeast, and D) from the west end of the stump trench looking east.

wall of the lower trench. To the west of the stump trenches, a 15-foot long levee segment was identified as a 'control' area. Both an upper and lower trench were constructed spanning this zone. Measured trench dimensions and coordinates are shown on Table 2-1. In Figure 2-18, the stump is shown in relation to the upper and lower trenches. An as-built plan showing trenches, soil borings, stumps (those visible from the surface and those found during trench construction), the hackberry tree at the toe, surface expressions of burrows, as well as the top and toe of slope is provided in Figure 2-19.

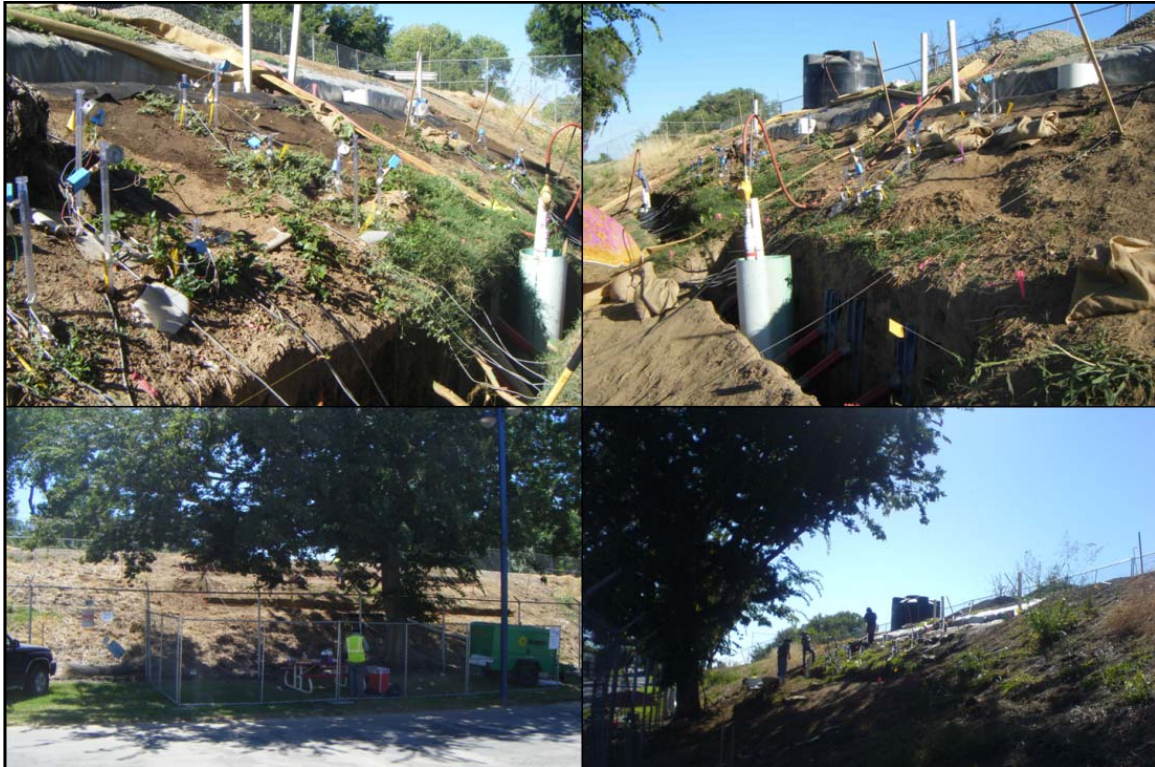
Figure 2-20. Field test layout looking west (upper left), east (upper right), and south (bottom left). Lower right is a site overview looking east and showing the hackberry tree in relation to trench excavations.

Photos showing an overview of the overall site are shown on Figure 2-20. As can be seen in the photographs, the site design concept includes three instrument lines to monitor the progression of the wetting front and pore pressures at increasing distance from the stump center. Instrument Lines A, B, and C were placed a distance of 0, 7, and 23 feet west of the stump center, respectively (Figure 2-21).

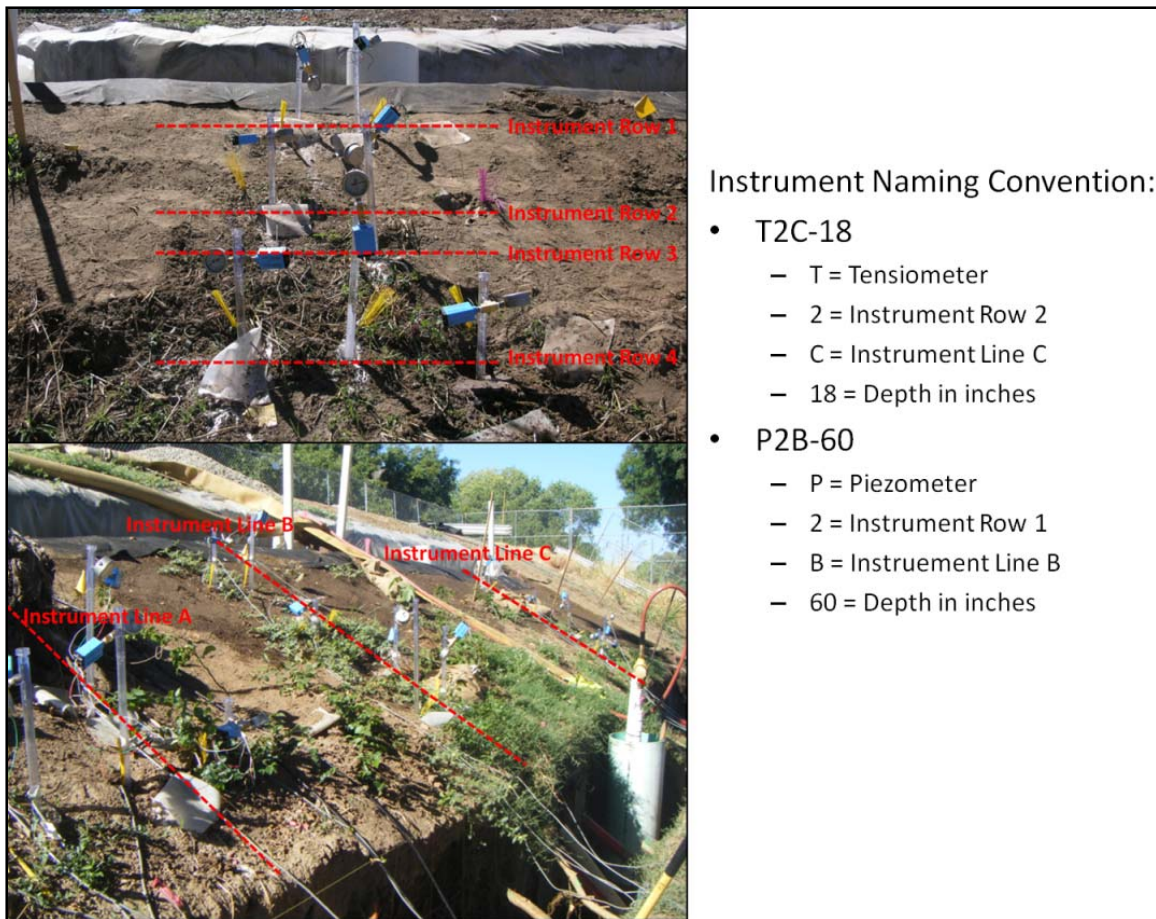
Figure 2-22. Photographic instrument plan showing the locations of piezometers and tensiometers as well as the naming conventions.

Transducers continuously recorded suction values during the flow test. Piezometers were read manually at varied intervals determined in the field based on the rate of change of the data. Figure 2-22 shows a typical instrument line as well as a photographic view of the three installed instrument lines. Tensiometer locations are named to reflect the type of instrument, the row number, the section number, and the depth in inches (i.e., T4A-18 is a tensiometer located in row 4 within Section A, and was installed to a depth of 18 inches below grade). The naming convention is illustrated in Figure 2-22. Figure 2-23 shows the layout of instrument Line A in cross section relative to the upper and lower trenches. Instrument Line C, within the control area, has an identical instrument layout.

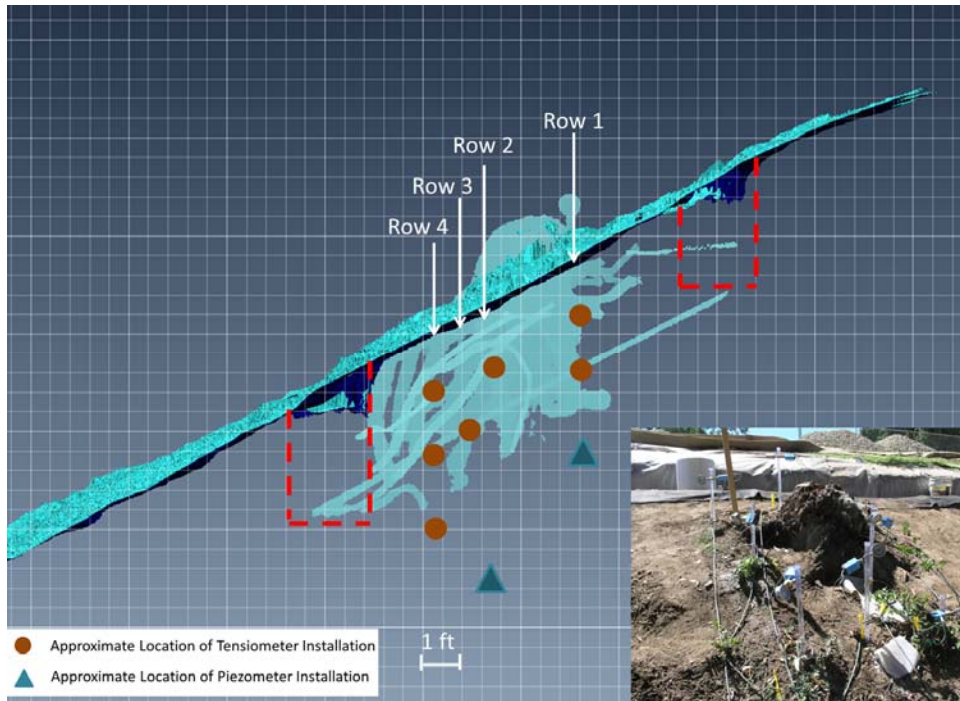
Figure 2-23. Instrument layout at Line A at the eucalyptus stump in photograph and cross section. Base T-LiDAR image provided by Gerald Bawden, USGS.

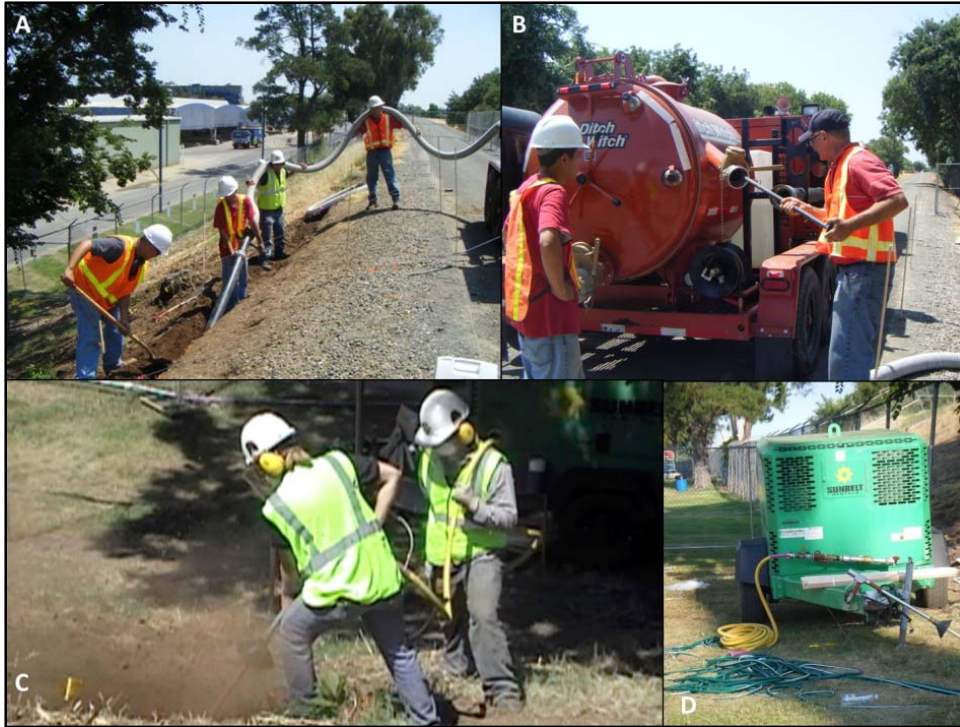
Figure 2-24. Construction equipment used during excavation. A) hand excavation with vacuum to remove spoils; B) a vacuum trailer; C) air knife used to excavate around live roots; D) 375 CFM compressor to run the air knife.

Upper and lower trenches were constructed to depths of 3 and 4 feet, respectively, using primarily manual efforts to loosen soils (shovels, digging bars, and trowels) and a vacuum trailer to remove spoils (Figure 2-24). Where decomposing roots were found, manual excavation allowed them to be viewed photographed and appropriately characterized. Where live roots were encountered, an air knife operating with a compressor capable of compressing 375 cubic feet of air per minute (CFM) was used to excavate around roots. Most areas were excavated with a lower compressor setting in order to minimize disturbance to sidewalls and fragile areas where decomposing roots were suspected.

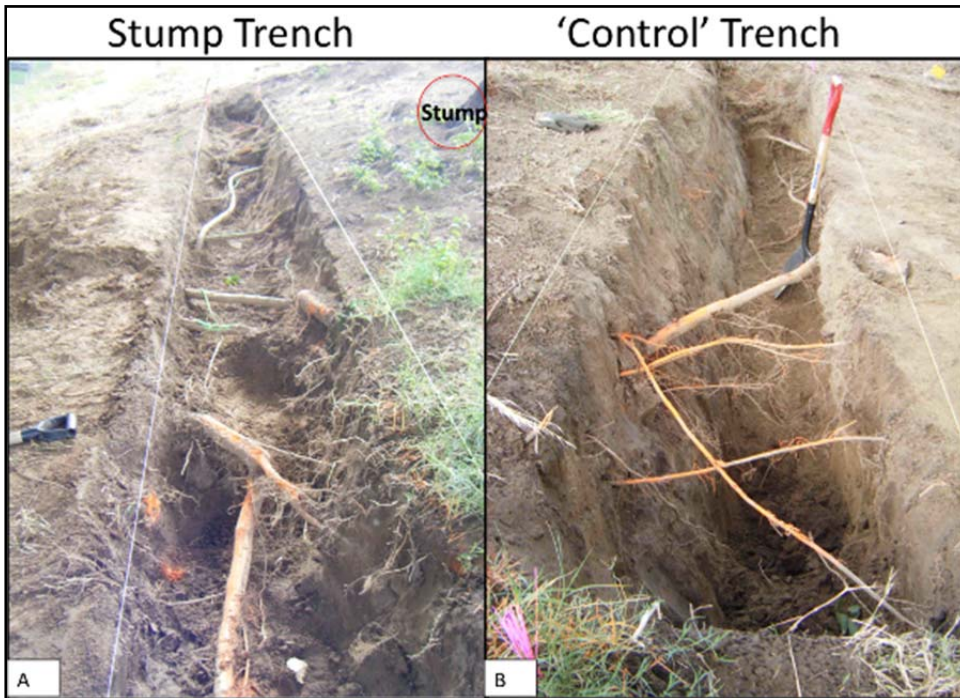
Figure 2-25. View of trenches, A) looking east at stump trench and; B) looking west at control trench.

Live roots were sketched onto logs and photographed prior to being gently cut with hand tools to avoid disturbance in the vicinity of roots. Roots were more abundant in the stump trenches relative to the control trenches (Figure 2-25 and Figure 2-26).

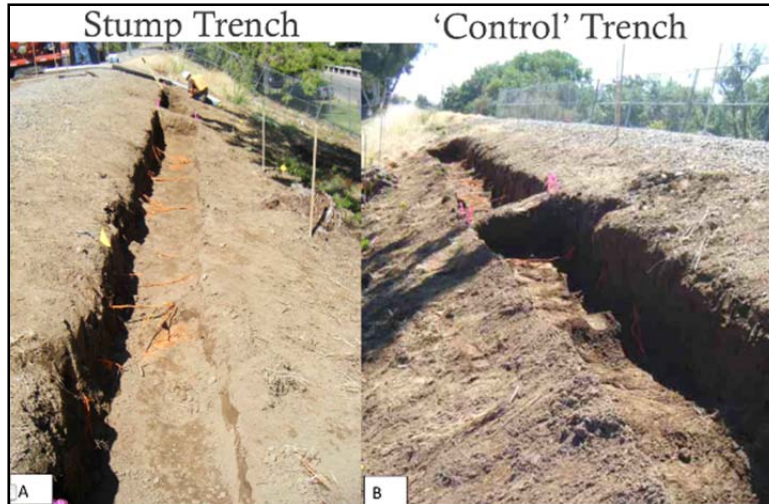
Figure 2-26. View of upper trenches, A) looking west at stump trench and; B) looking east at control trench.

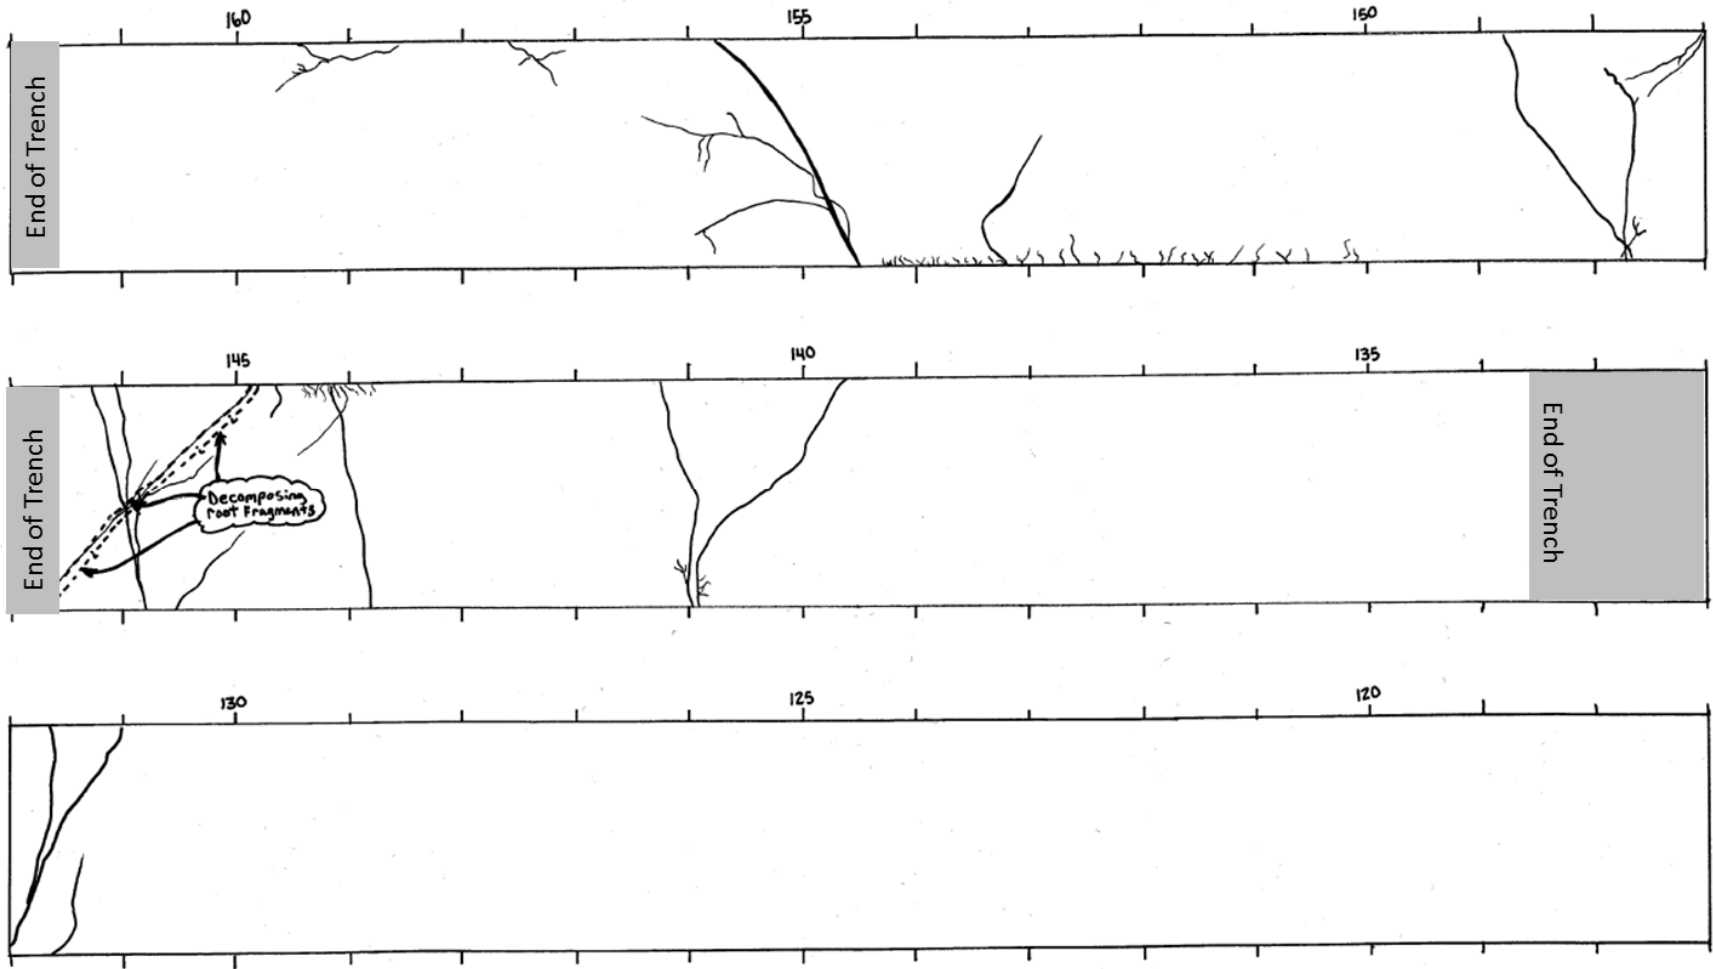
Figure 2-27. Upper stump and control trench plan view logs (Stations 117-162).

String was stretched across the trenches in 1 foot increments to facilitate plan-view sketches and photographic documentation of the root system (Figure 2-27 and Figure 2-28). Not all roots in the logs are visible in the photograph as shallow roots were removed as needed to achieve depth. Appendix 2C provides a complete set of similar plan view site logs and spliced photography. Roots are shown to be more abundant in the lower trenches than the upper. The lower trenches are closer to the live hackberry at the toe, which is the source of the live roots. Decomposing roots also appear to be more abundant in the downhill direction than the uphill direction.

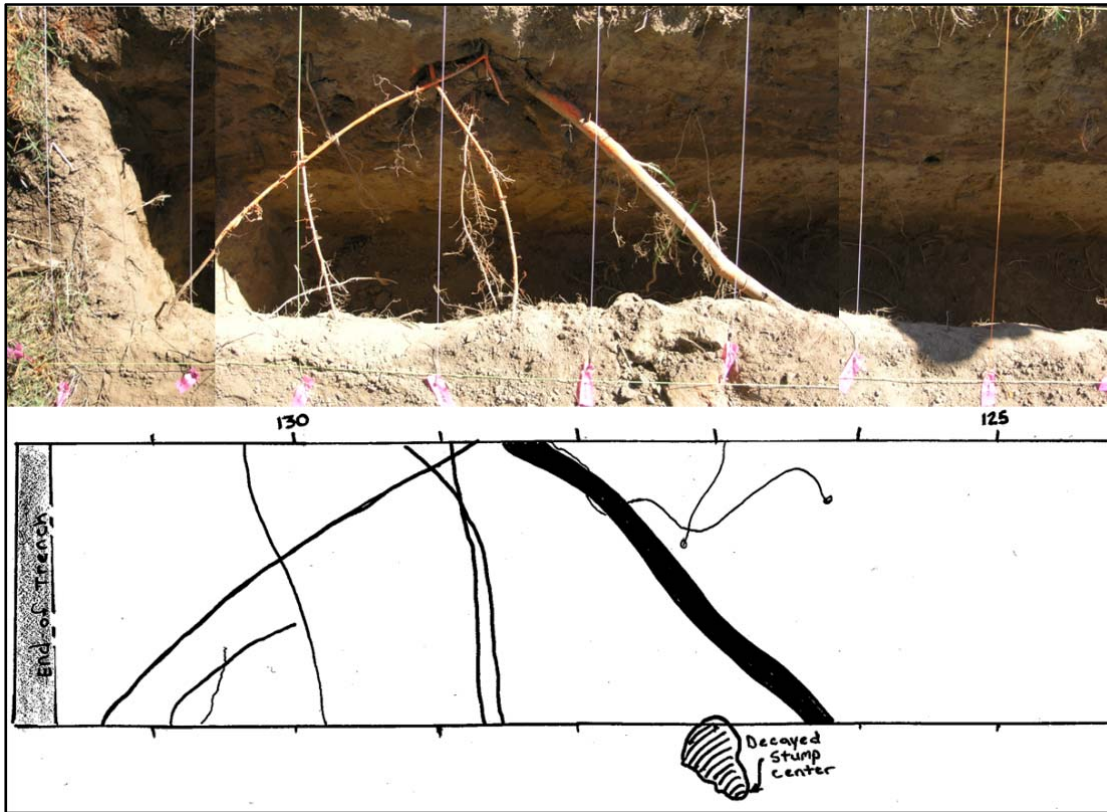
Figure 2-29. Lower control trench Stations 124-132. Spliced plan view photos (top) during excavation of lower control trench and log of analogous segment below.

Decomposing roots were found in the upper and lower trenches in the vicinity of the eucalyptus stump. Additional decomposing roots were found outside of the study area at the periphery of the excavations. Figure 2-29 and Figure 2-30 show an example of a segment of the control trench where a stump was uncovered on the downhill side during excavation. As discussed in Section 2.1.2, this may have been an original tree planted during Cal Expo construction in 1968 that was seen in aerial photographs to have disappeared between 1983 and 1990. The stump would have been decaying for 20 to 27 years at the time of our study there was no significant trace of a root system found to be associated with this stump within the trench.

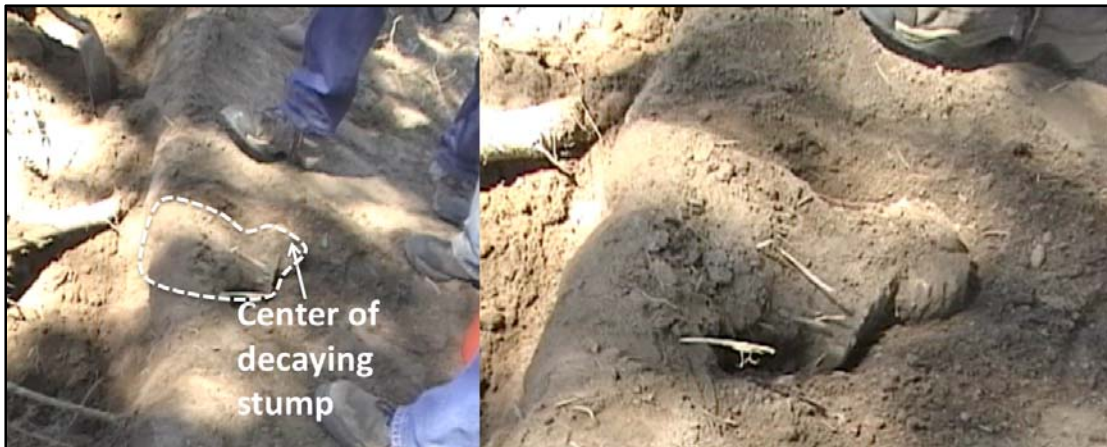
Figure 2-30. Stump found on downhill side of control trench at Station 127 as shown on Figure 2-29.

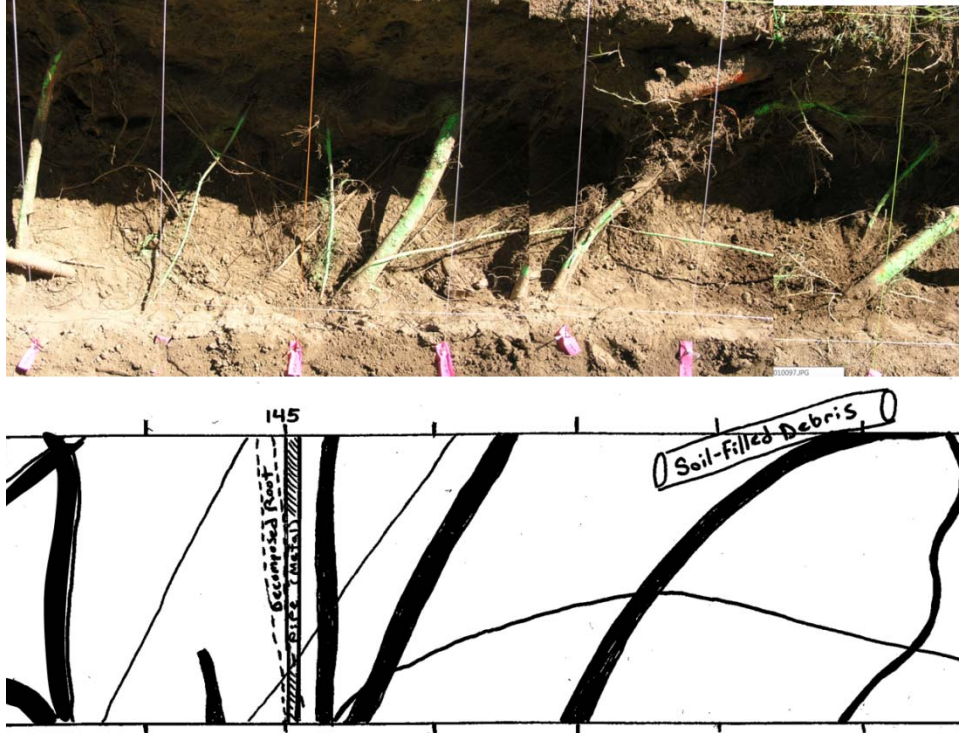
Figure 2-31. Lower stump trench Stations 140.5-146 (increasing to left). Spliced plan view photos (top) during excavation of lower stump trench and log of analogous segment below. Excavation not shown to full depth.

Figure 2-31 provides another example of field logs correlated to photographic documentation of the roots encountered. When roots prevented excavation, they were carefully logged and cut prior to proceeding with additional excavation and documentation efforts. Figure 2-32 shows the same section of trench excavated to full depth. The photo shows roots and a metal pipe that are not visible in the photographs of Figure 2-31.

Figure 2-34 shows a typical wall face field log including decomposing and live roots, animal burrows, and the metal pipe shown on Figure 2-31 and Figure 2-32 above. Complete trench wall logs are provided in Appendix 2C along with the plan view logs previously discussed.

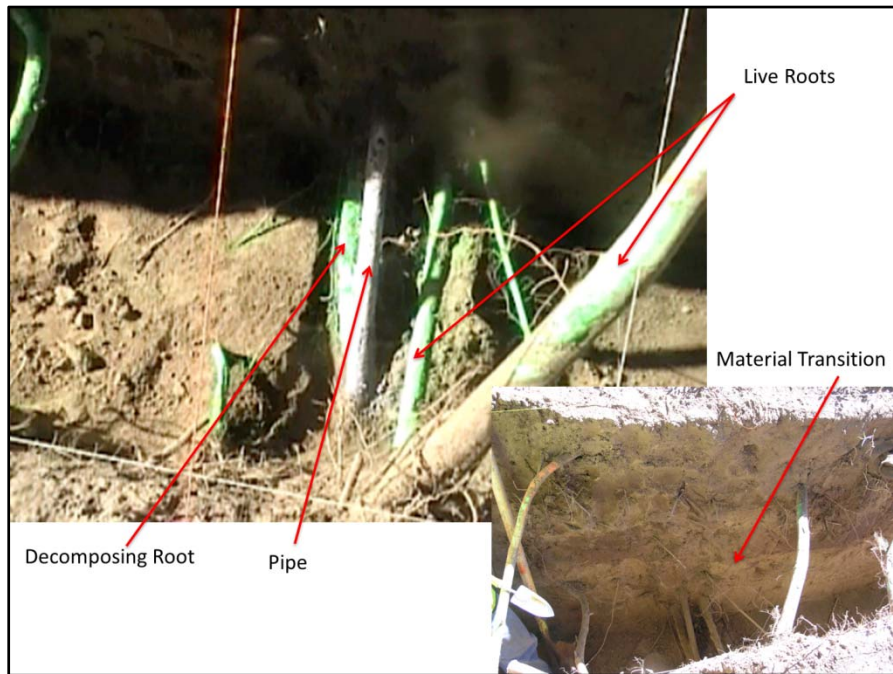
Figure 2-32. View looking south of 4' deep trench at Station 145. Upper left photos are a cluster of live and decomposing roots and a 1" diameter pipe. Bottom right is a larger view of the same trench segment.
