Static and Seismic Performance of California Levees

Michelle Jennifer Shriro

Doctor of Philosophy

Engineering - Civil and Environmental Engineering

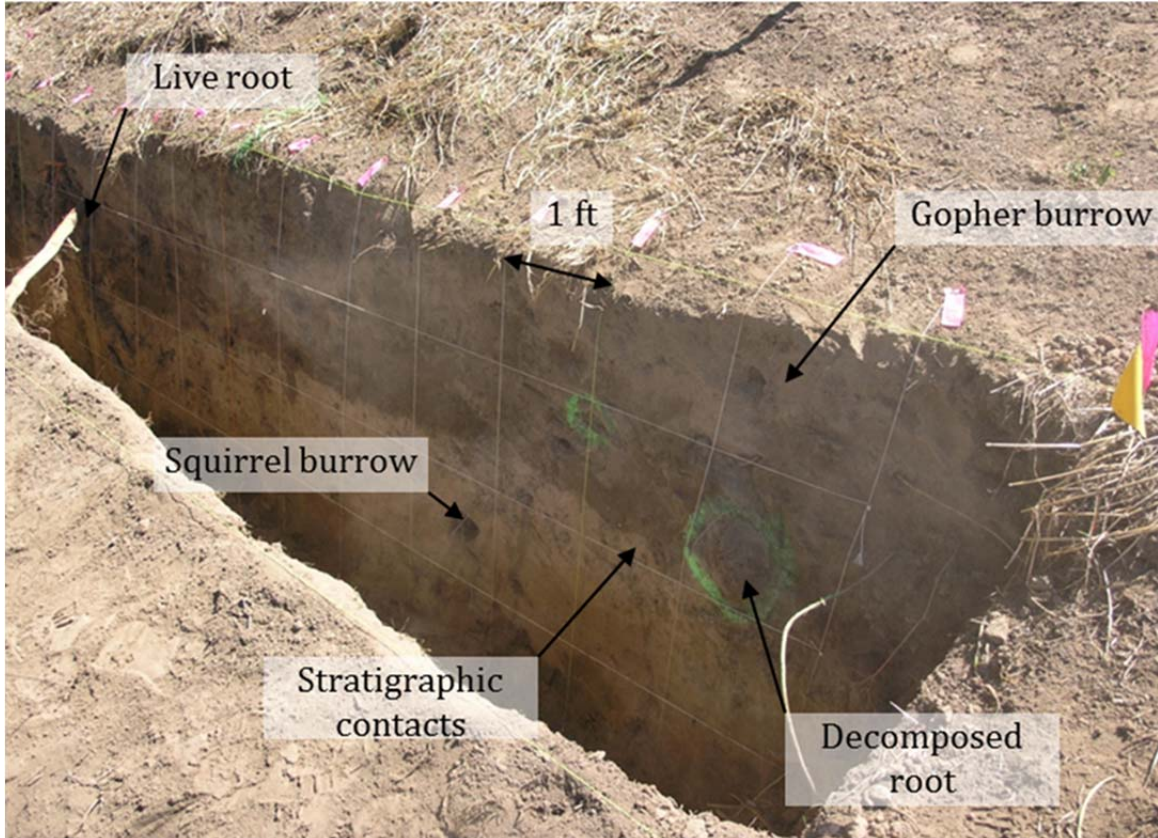
Figure 2-33. A 1-foot by 1-foot square grid was constructed to aid in logging and documentation of observations during the flow test. Source: Cobos-Roa et al. 2012.

Upon completion of trench excavation and plan view documentation, roots were cut flush with the wall face, a grid with 1-foot contours was placed over the uphill wall face in order to facilitate documentation (Figure 2-33).

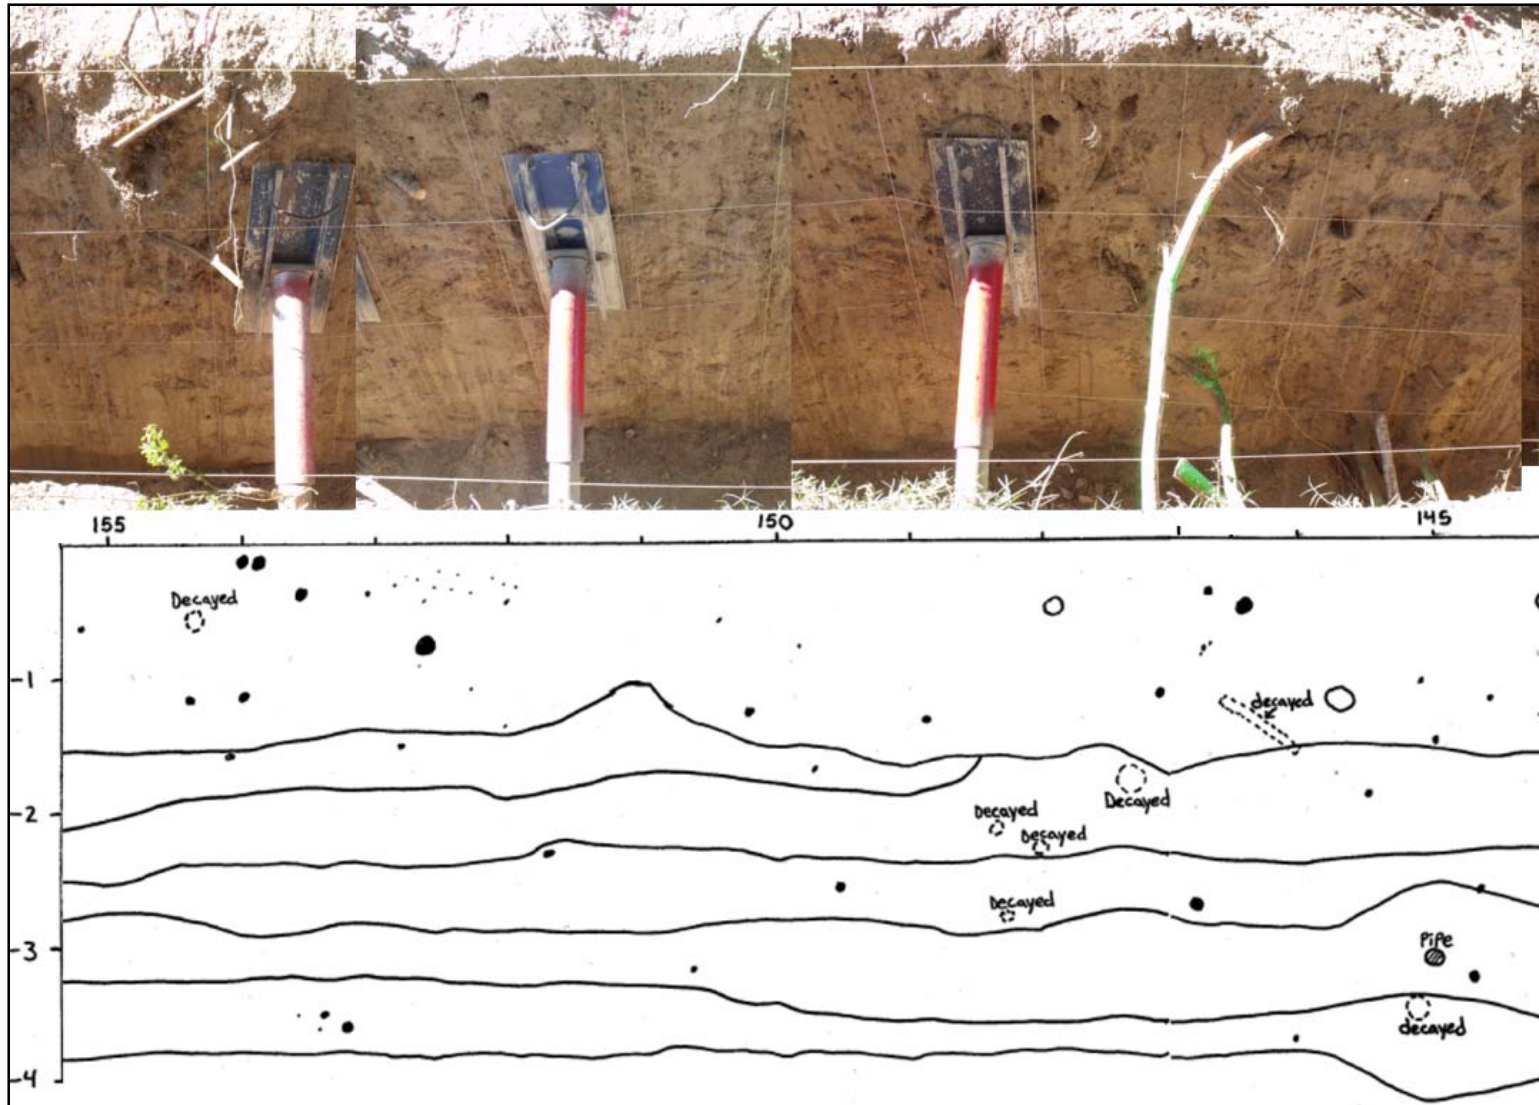
Figure 2-34. Field log of uphill trench wall of lower stump trench, Stations 144-155 with corresponding photos above.

Figure 2-34 shows a typical wall face field log including decomposing and live roots, animal burrows, and the metal pipe shown on Figure 2-31 and Figure 2-32 above. Complete trench wall logs are provided in Appendix 2C along with the plan view logs previously discussed.

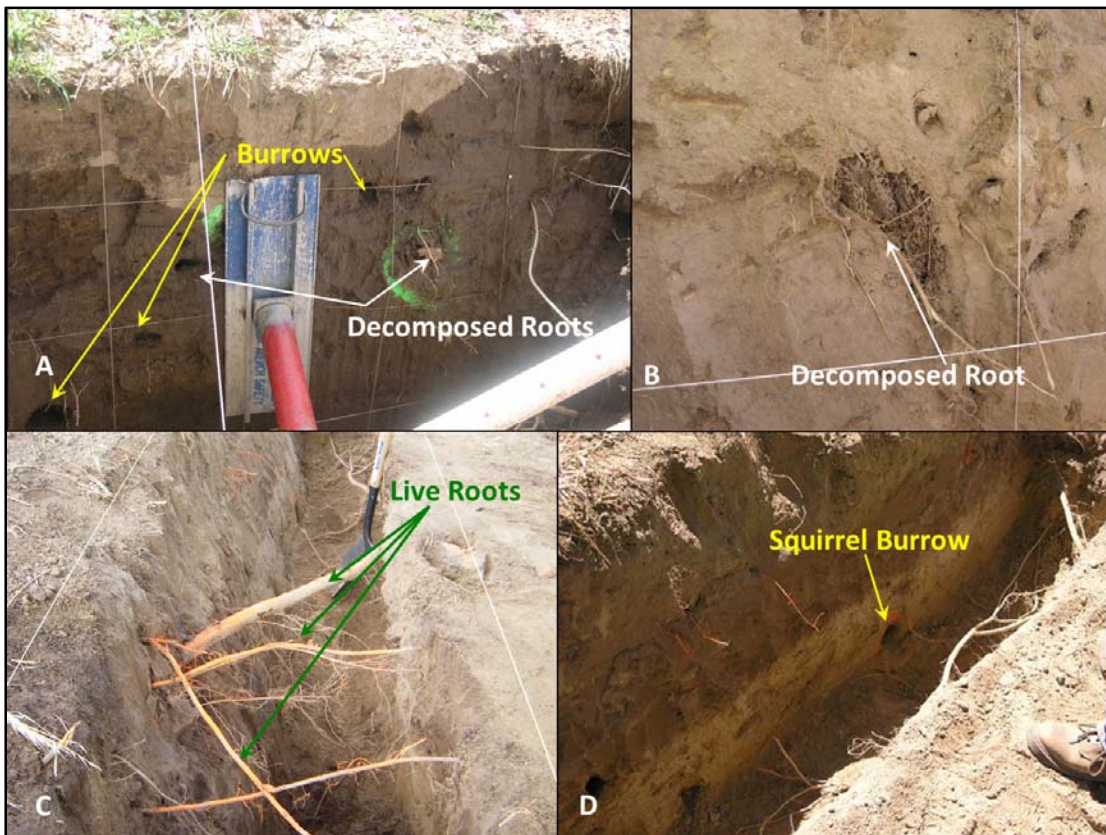
Figure 2-35. Lower trench photos with A) burrows and decomposing roots, B) a decomposing root, C) live roots, and D) a squirrel burrow and a material change.

- 1.5 to 2-inch holes (likely pocket gopher) in the shallow zones extending back a distance of a few inches to a little over a foot (Figure 2-35 A).
- Two holes of approximately 4 inches in diameter (believed to be ground squirrel burrows) extending back a distance of 10 and 18 inches from the upper wall of the lower trench.
- Live roots as shown on Figure 2-35C and in Sections 3.5.1 and 3.7.

- Decayed roots (of various levels of decomposition and some with small holes bored in them) as shown on Figure 2-35A and B and in Sections 3.5.1 and 3.7.
- A 1.5 inch diameter metal pipe at a depth of nearly 4 feet in the lower trench (pipe points downhill at approximately 11 degrees from horizontal) as shown previously in Figure 2-32.
- Small holes of ½ to ¼ inch in diameter. Based on observations with Dr. VanVuren, we believe the holes may be related to ant activity at the site (Figure 2-36). During excavation, worms were also seen creating and traveling through small holes in the trench walls as shown on Figure 2-37.
- Differing material types ranging from loose sandy silts and discontinuous pockets of clean sand to clayey silts and occasional lean clays.

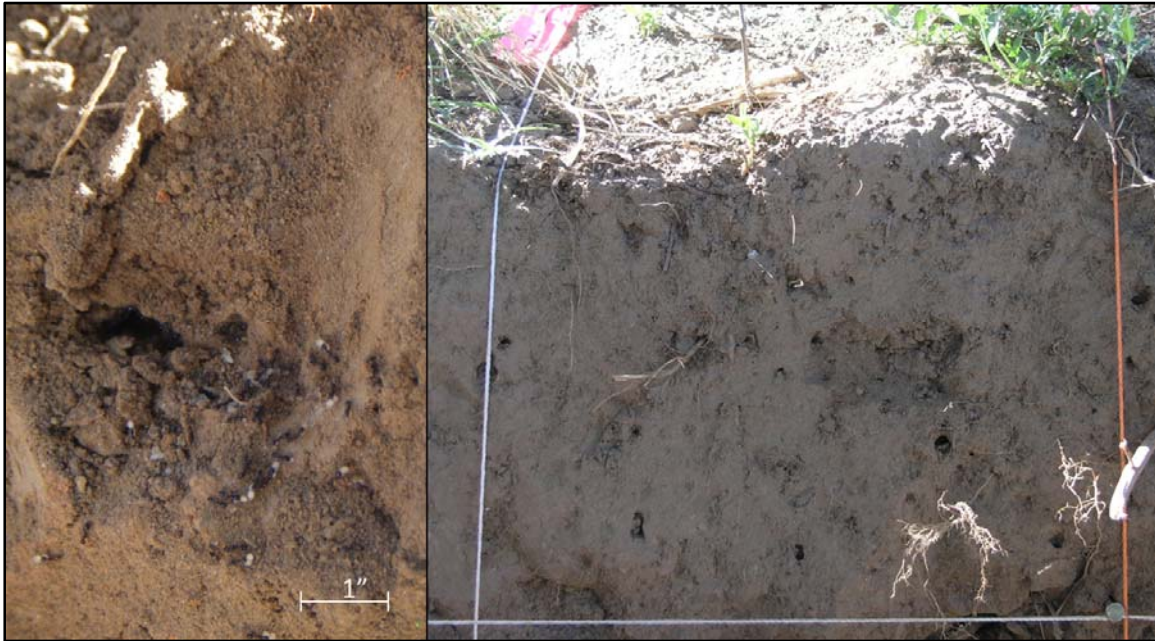
Figure 2-36. Ants encountered during trenching activities (left). Small holes (1/2 to 1/4 inch) found in trench wall could be related to ant activity (right).

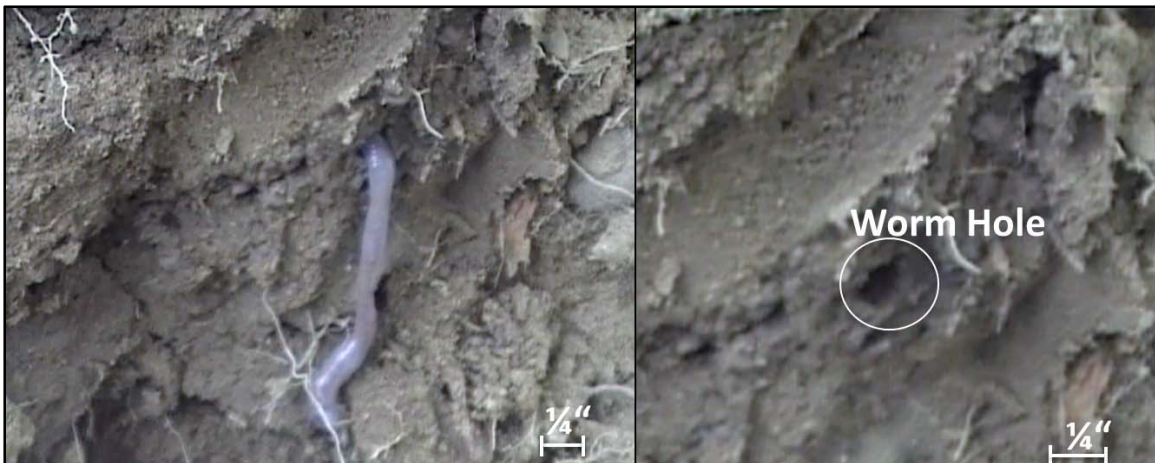
Figure 2-37. Worm activity was observed to be responsible for some of the small holes (<1/4 inch diameter) encountered during trenching.

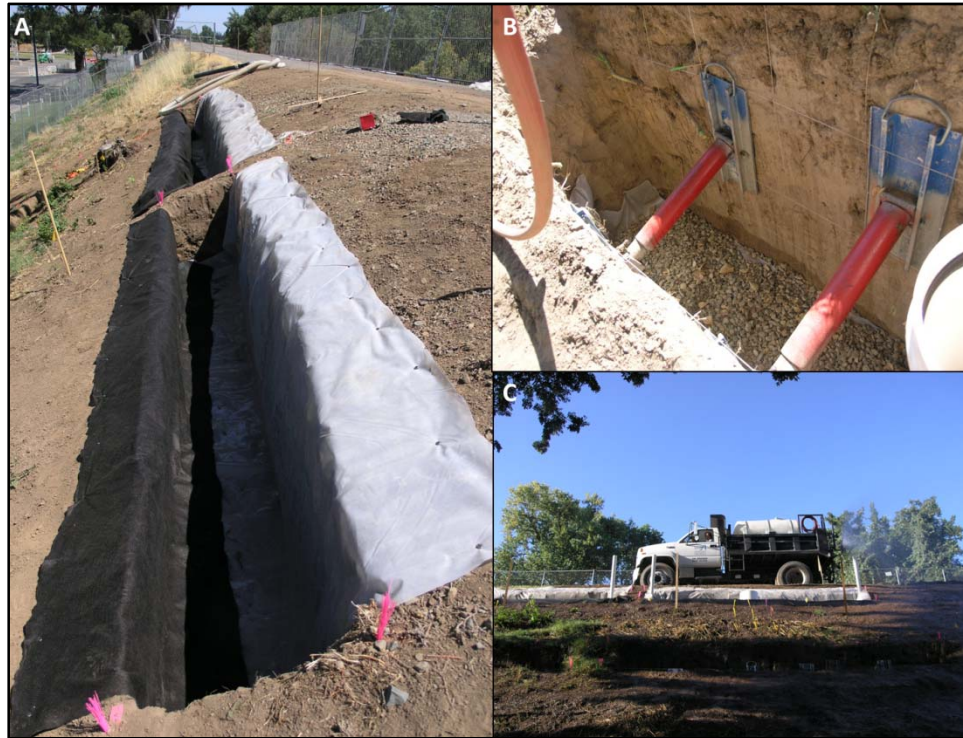
Figure 2-38. Trench preparation prior to commencement of flow. A) Upper trenches lined with plastic sheeting (uphill and base walls) and permeable fabric (downhill wall); B) shored lower trench lined with plastic sheeting and gravel (base); C) water truck moistens site to prevent cracking prior to flow test.

the sheeting in place. The upslope wall was left open for viewing during the test (Figure 2-38). An effort was made to place hydraulic shoring such that key features observed in the wall during the logging phase were not obscured from view.

Figure 2-38A shows the 1 foot wide band of soil that separated the 'control' and 'stump' trenches. The band of soil was not expected to fully prevent flow between the zones. The upper trench was separated to allow the flexibility of inflow into the two trenches separately in the event that one or the other needed to be shut off due to unforeseen conditions. The lower trench was separated so that outflow volumes from water entering the two trenches could be separately tracked. In photo B, the lower trenches are shown shored for stability with hydraulic vertical shores placed at intervals of 2 to 5 feet across the lower trench, taking care not to obscure visible irregularities such as decaying or live roots or mammal burrows. Slopes and trench walls were periodically moistened to aid in air knife excavation and prevent cracking prior to the flow test as shown on photo C.

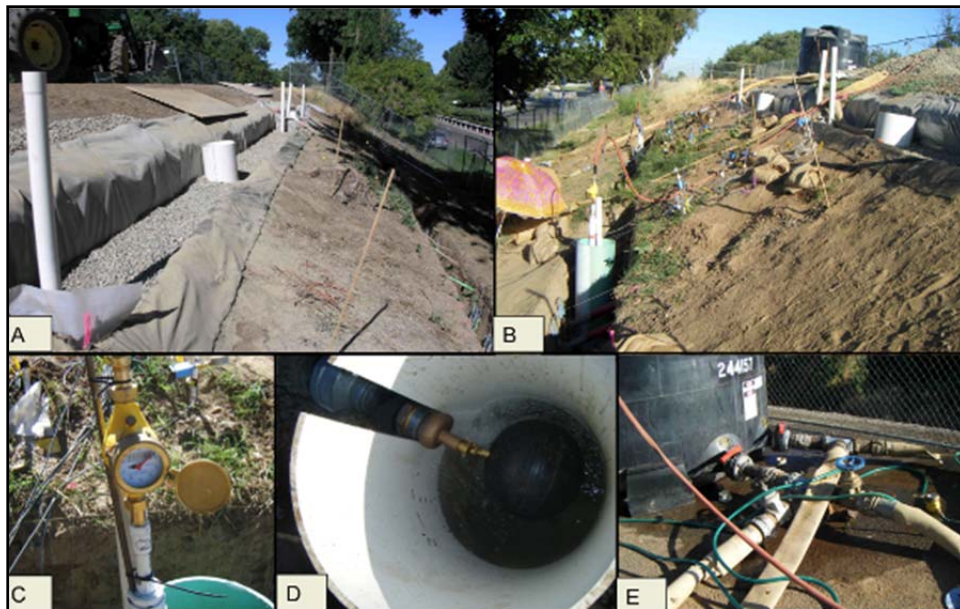
Figure 2-39. A) Upper gravel-filled trenches; B) Water delivery system; C)  $\frac{3}{4}$ " flow meter for monitoring flows into water storage tank; D) Mechanical float to maintain constant head in upper trenches; E) Control valves at tank

Once trench excavations were complete, the water delivery and pumping systems were installed to deliver water into the upper trench. A 2500-gallon polyethylene tank was placed on the levee crown and filled prior to commencement of the test. Figure 2-39 shows the water delivery and recycling system installed at the site. Water was delivered into the upper trenches via a 15-inch well casing connected to

a perforated pipe embedded in the gravel-filled upper trench. The pipes acted as a water delivery manifold rapidly distributing the water throughout the upper trenches (Figure 2-39A). Perforated riser pipes at the trench ends provided points along the trench to confirm water levels. Fire hoses were used to deliver water (Figure 2-39B and D) into a 15-inch diameter perforated pipe through a mechanical float valve (Figure 2-39D). The float valve is shown mounted into the well casing and used to maintain a constant head in the upper trenches during the flow test. The water tank was refilled throughout the test and the level of water in the tank as well as flow volumes of water into the tank were measured and used to approximate the amount of water delivered into the upper trenches with time. Water collected from the lower trenches was recycled into the delivery tank. All flows into the tank were tracked using  $\frac{3}{4}$  inch flow meters (Figure 2-39C).

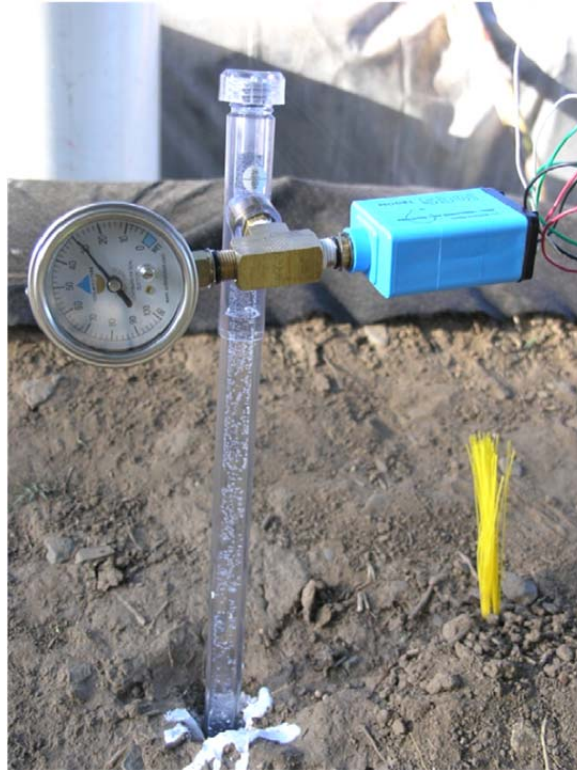
Figure 2-40. A typical tensiometer is shown including a mechanical gauge and pressure transducer. White silica sealing material is seen at the hole entrance.

Tensiometers were obtained from Soil Moisture, Inc. and equipped with a mechanical pressure gauge and a pressure transducer with maximum suction capacity of 100 kpa (Figure 2-40). Tensiometers of 24, 48 and 60 inches were installed to depths of 18, 36, and 60 inches, respectively. All instruments were installed in accordance with the manufacturer's specifications. Holes were advanced with a gauge auger (provided by the manufacturer) with a diameter slightly larger than the instrument diameter of  $\frac{3}{4}$  inch. The instrument holes were logged for soil conditions prior to installation.

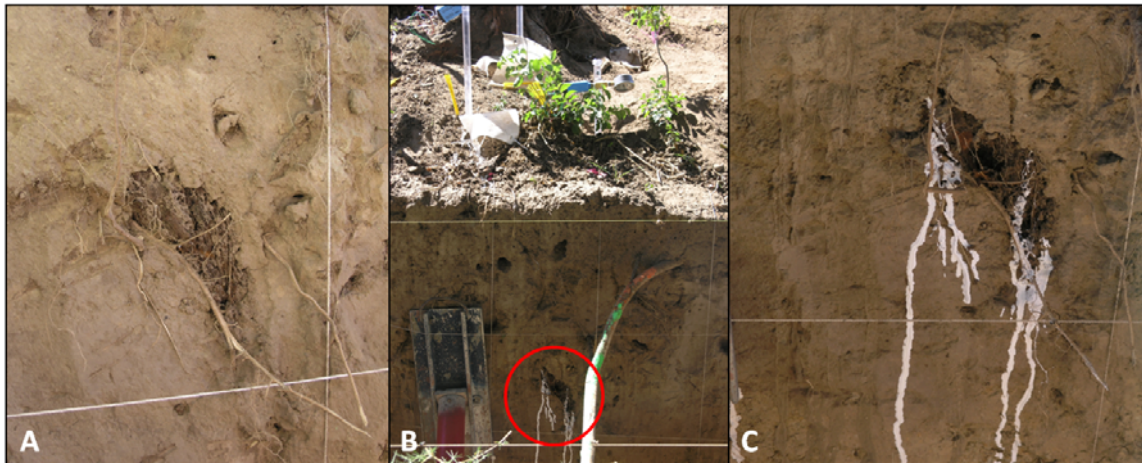
Figure 2-41. Silica flour migration pattern below the stump (red circle) following installation of tensiometers.

Instruments installed within row 4 of instrument Line A (below the Eucalyptus stump) were among those encountering decomposing roots during installation (T4A-18, 36, and 60). The tensiometers were located approximately 16 inches from the uphill wall face of the lower trench (measured horizontally). Within 1 hour of installation, silica slurry was observed trickling out of two exposures of one of the decomposing roots. Photos were taken and observations were recorded (Figure 2-41). Excavation of the root system at the end of the flow test revealed a number of locations where silica slurry flowed for distances of a few inches to approximately 5 feet along a decomposing root within a cavity observed between the decaying bark and the inner woody core (*xylem*) of the root.

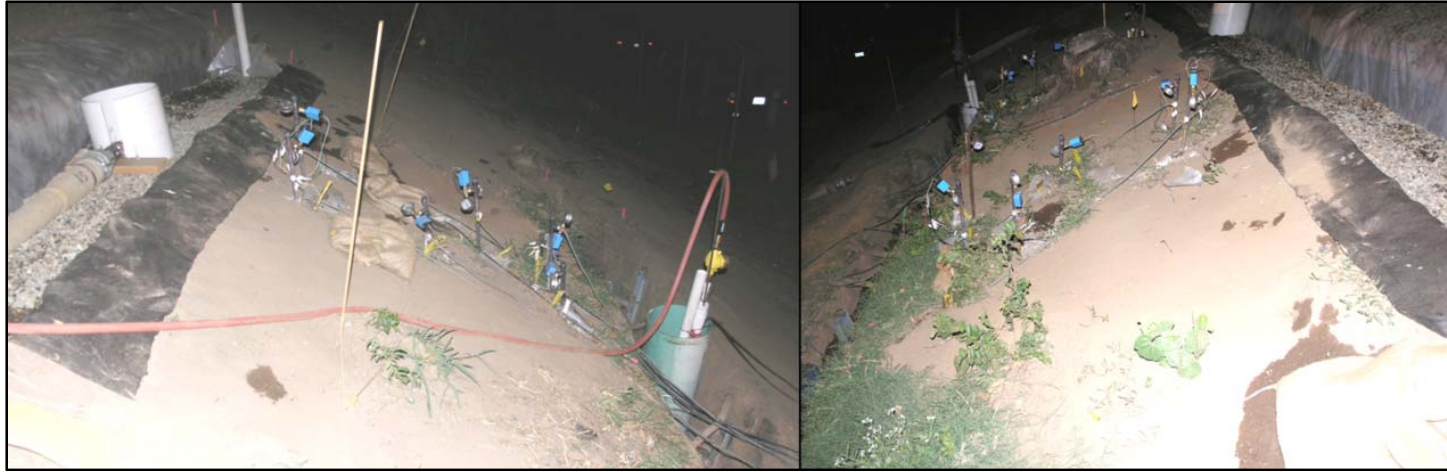
Figure 2-43. View of instrument line C (left) looking west and instrument Lines A and B looking east (right) 9.25 hours into the flow test. Note isolated seeps (darker spots) and gravel bags (covering seeps) at the top of Line C and extending down Line B.

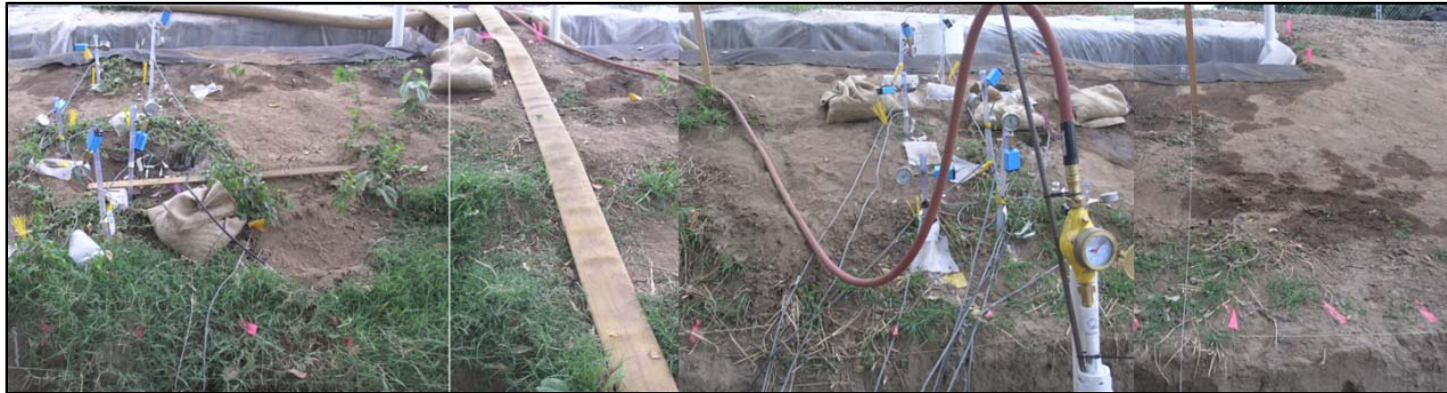
Figure 2-44. View of instrument Lines B and C looking south 19.5 hours into the flow test. Note wet zones in slope face (darker spots) and gravel bags (covering seeps).

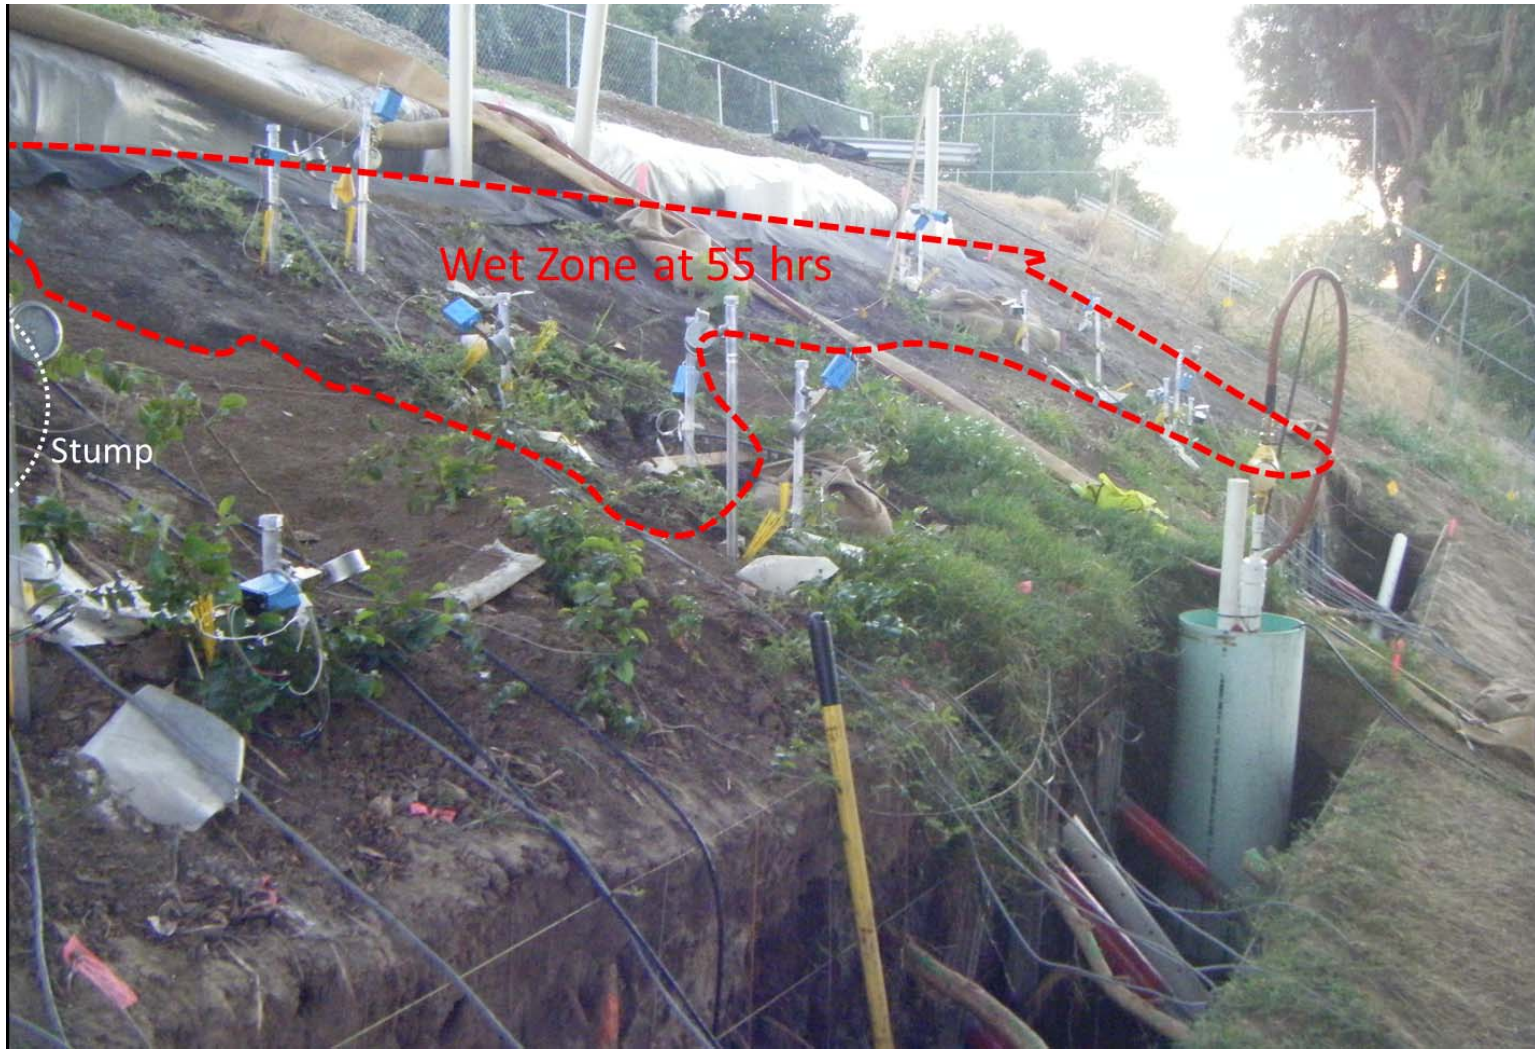
Figure 2-45. View looking west from instrument Line A at stump at 55 hours into the flow test. Note the outline (red) of the growing wet zone observed at the levee slope face.

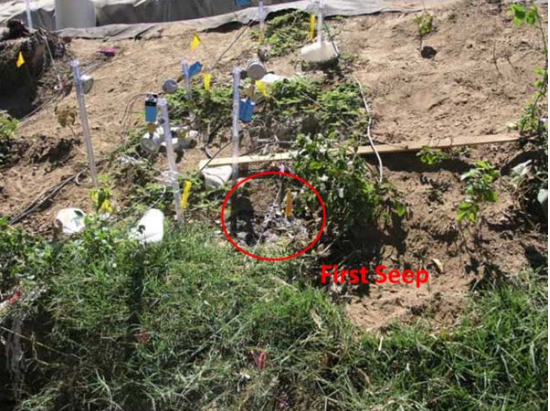
Time (hrs)	Observation	Photo or Illustration
0	Water flow begins	
0.45	Sta. 140 (Instrument Line B) at 2.3 feet upslope of lower wall face, water seeping out of slope near T4B-36, P2B-24, and T3B-36; water began pouring down the face of the lower wall threatening to erode; gravel bag was placed over each seep

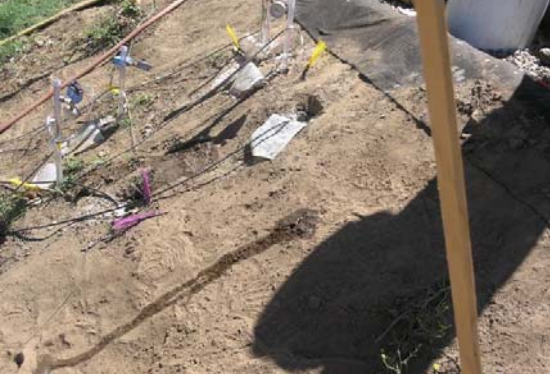
0.60	Seep at Sta. 123, 125, 127 (Instrument Line C – Control). Gravel bags were placed

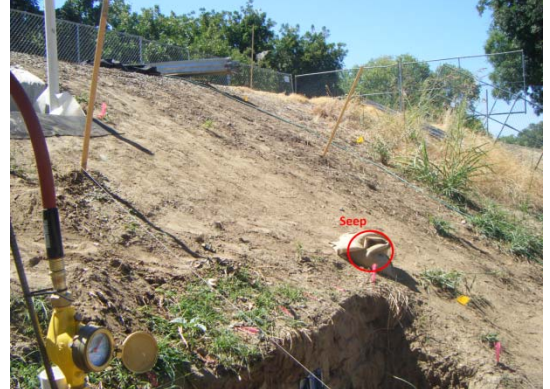
0.73	Seep Sta. 116 (west of control and 7” uphill of lower trench)

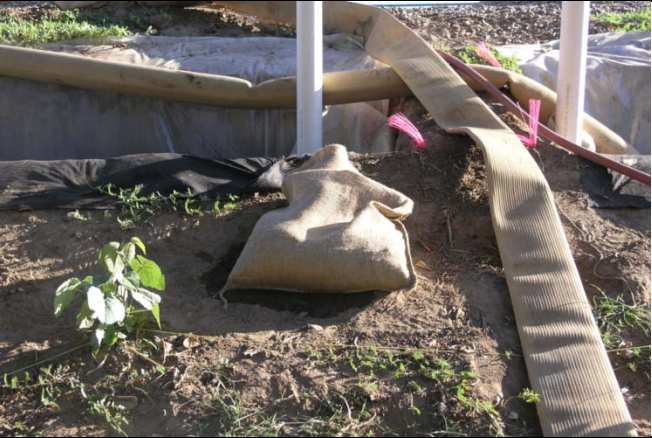
0.9	Seep at Sta. 135, 1.8 ft down from upper trench

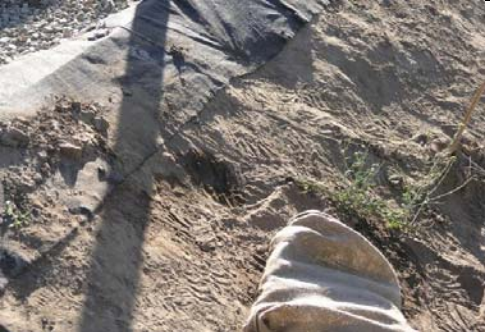
1.4	New seeps between old seeps at instrument rows 1 and 2 at Stations 121, 122, 125 (Instrument Line C). Instrument rows increase from top trench to bottom trench.	No photo available.
2.3	Sta. 120-122 seeps observed between upper trench and instrument row 2 (just west of seeps at Instrument Line C)

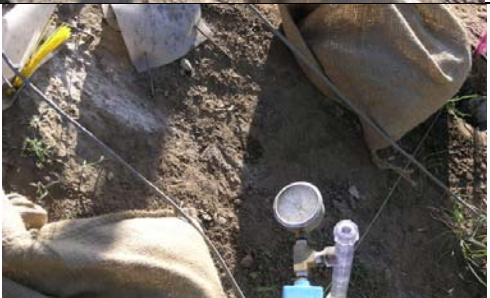
3.7	Sta. 120-128 existing seeps expanding in size while adjacent new small seeps form between gravel bags

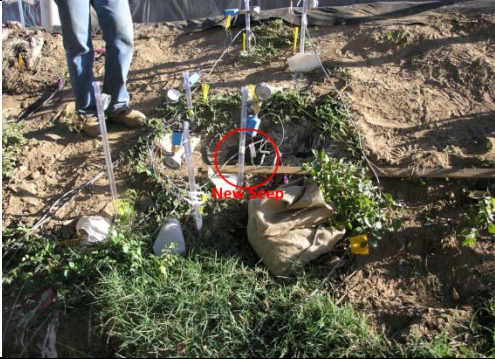
5.2	Sta. 141 a 7" diameter seep southeast of tensiometer T3B-36

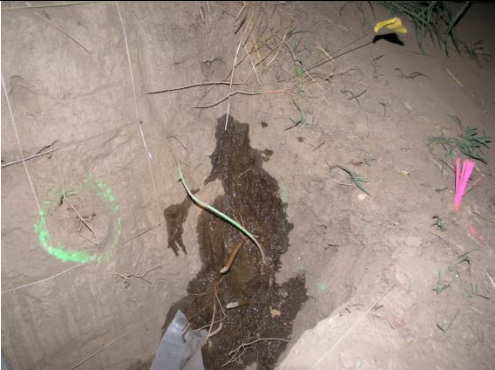
10.3	Seep at Sta. 117 at western limit of lower trench and extending down the western end wall of the trench as it grows

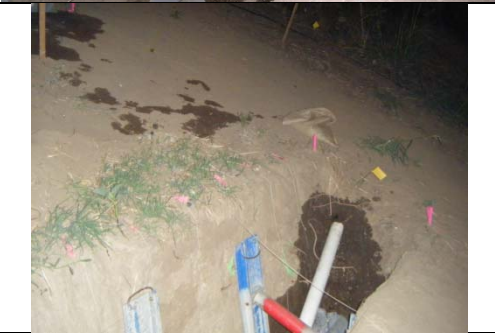
15.7	Sta. 117 to 125; Seeps growing larger and pipe placed at area of rapid flow to prevent erosion

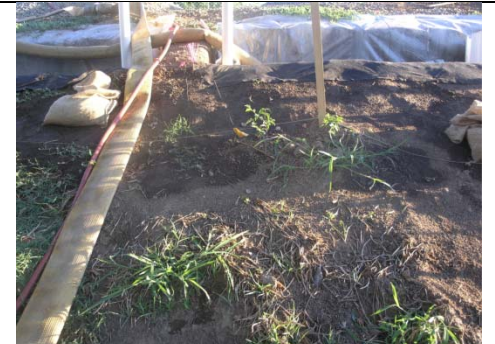
19.8	Moisture seeping from eastern-most leg of equipment table below lower trench (outside of study area)	No photo
23.6	New seep at Sta. 127 at 1 ft above tensiometer T4C-18	No photo
54.4	New seep near Sta. 131

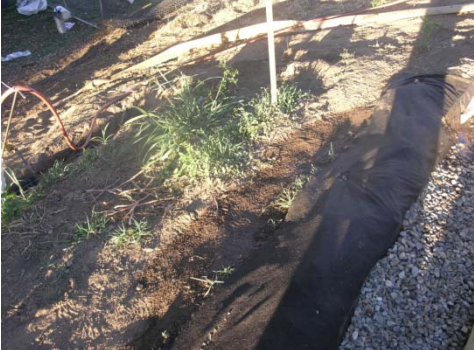
54.4	Seep near upper trench at Sta. 155 and greater

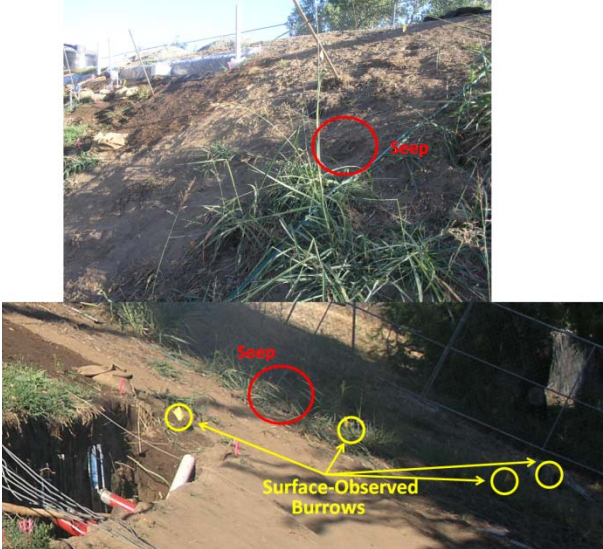
67.6	Pattern of small seeps observed about 10 feet west of western limit of control trench, following a line of gopher burrows visible from surface

As shown in Table 2-2, burrow patterns were found to have a major influence on slope face seepage patterns and flows throughout the test. For this reason, burrows influencing flow patterns are discussed in detail in Section 3.6.2.

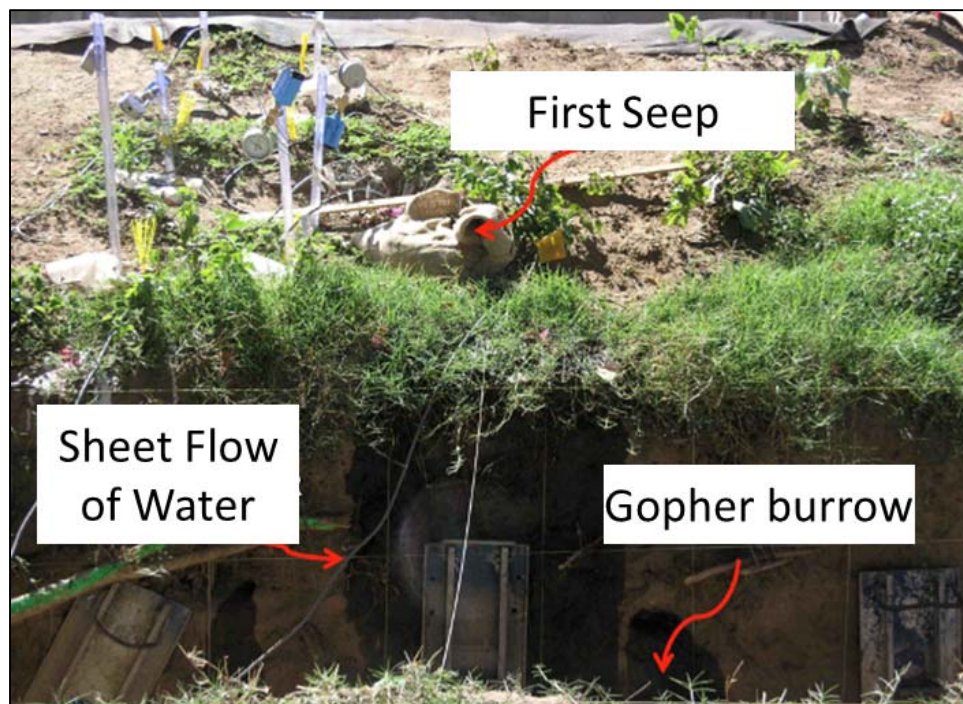
The gopher burrow at Line B produced water at the lower trench approximately 30 minutes following the beginning of water flow to the upper trench, about the time needed to fill the trench. Flow began as a small seep at the levee surface and proceeded to flow through a gopher burrow at the face of the lower wall upon placement of a gravel bag at the location of the initial seep (Figure 2-47). Table 2-3 provides a detailed account of observations associated with the flow of water through the gopher burrow at instrument Line B, Station 138-140. Table 2-4 provides a similar account for a gopher burrow encountered near instrument Line C that extended down toward the western corner of the control trench. Based on post-test grouting of the burrow adjacent to instrument Line C, the hole did not connect directly to the lower trench. A preferred flow pathway appears to have been established via another gopher burrow at the western extent of the lower control trench. It is possible that the gopher burrow networks once connected and a collapsed or plugged segment did not allow the grout to fill the full extent of the burrow. Instrument test results presented later in this report will detail the arrival of the wetting front in the vicinity of these burrows compared to the vicinity of the eucalyptus stump.

Figure 2-47. Water seepage at lower trench wall near gopher burrow at instrument Line B minutes after first water appeared on the levee slope face.

0.52	Gravel bag placed on slope seep.	Figure 2-47
0.53	Water burst from gopher burrow at Sta 138-139 and Sta 141 (both about 1.2 feet down from top of wall). Station 138-139 produced the majority of free water.

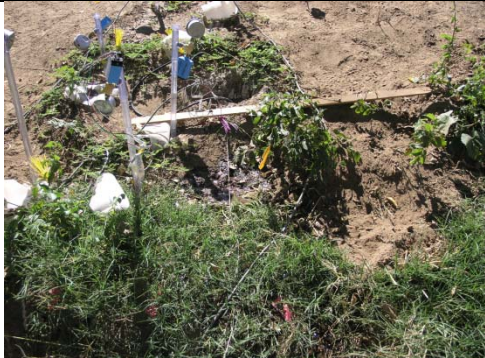
Time (hrs)	Observation	Photo or Illustration (if available)
0	Begin water flow.	No photo
0.45	Water seeping out of slope face at tensiometers T4B-36, P2B-24, T3B-36.

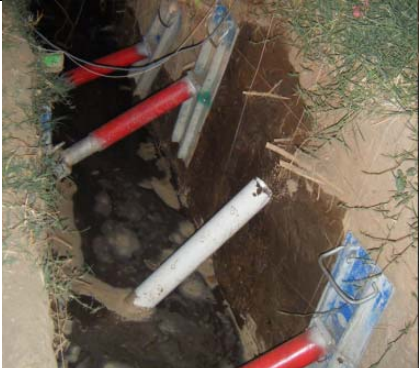
1.2	Measured 4.3 inches standing water in lower stump trench due entirely to water flow through gopher burrow at Sta 138-139.	No photo
4.7	Water level in lower stump trench at Sta 138 is 0.65 ft above bottom.

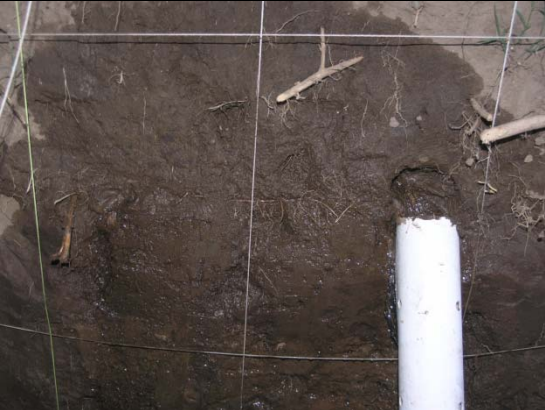
5.85	Water seeping out of saturated zone east of gopher hole at Sta 138-139.

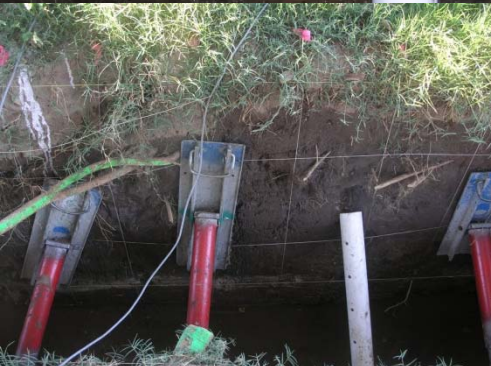
55.1	Flow through gopher hole at Sta 138-139 slowing rapidly between 53.1 (rate = 2 gal/min) and 55.1 hrs (rate = 1.7 gal/min).

During field observations, at approximately 55 hours, we observed a rapid decline in the rate of flow from the gopher burrow in the lower stump trench at Station 138.25. It appears that flow began slowing at 30 hours, though the decline in flow rate became apparent after a time of 55 hours. The recycle rate refers to the number of gallons of water pumped from the lower stump trench into the 2500 gallon reservoir over a period of 1 hour. Virtually all of this water was delivered to the lower trench via the gopher burrow at Station 138.25. This rate underestimates the actual rate of flow through the burrow. Water lost through the lower trench due to standing water percolating into surrounding soils arrived through the burrow and was lost outside of the study area prior to being recycled into the reservoir. In the first 30 hours of the flow test, a minimum of 367 gph flowed through the burrow, while 321 gph was saturating soils between the trenches, or was lost outside of the study zone.

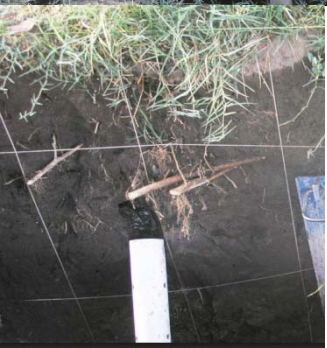
67.1	Flow has stopped and all that remains is moisture seeping through as seen in the photo to the right. This observation was made early in the morning and no observations were made between the last recorded observation at time = 55.1 hours.

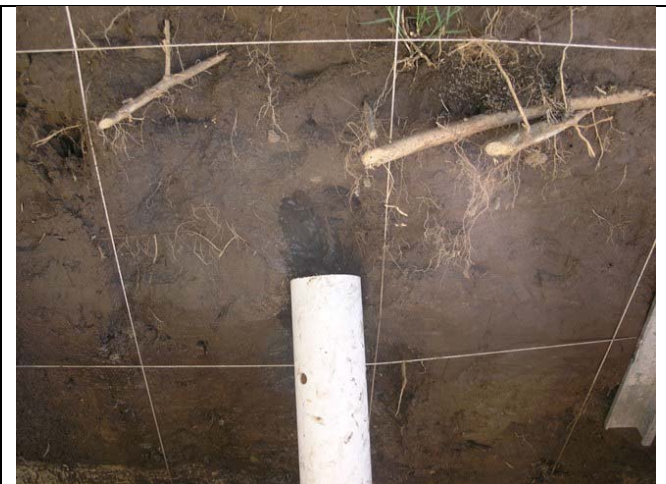
125.9	Water seeping out of wall face near burrows at Station 138.25. Much of the walls appear to be saturated.

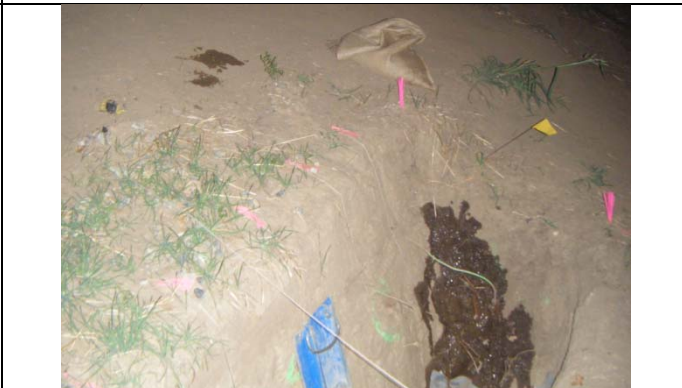
Time (hrs)	Observation	Photo or Illustration (if available)
0	Begin water flow	
0.73	Seep Sta. 116 (west of control and 7" uphill of lower trench). Original seep location is under the gravel bag in the photo below (time =10.27 hrs).	See photo at time = 10.27 hours.
10.27	Seep observed at the western end of the control trench at Sta. 117

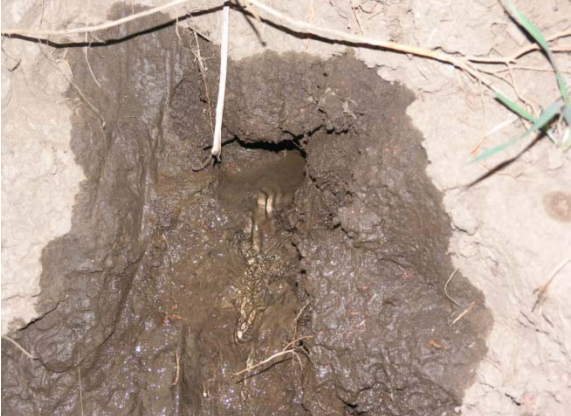
10.52	Water burst through trench wall at Sta. 117 and began to flow through gopher burrow (< 2" in dia). Some decomposed root fragments came out of the hole, likely from old stump and root system. Water begins ponding in control trench.

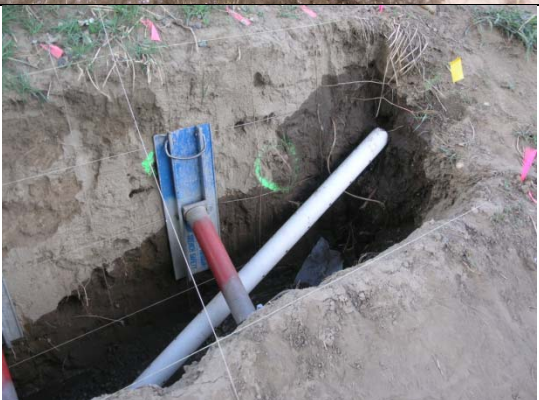
22.6	Water stops flowing through gopher burrow. Seep continues to produce moisture and water wicks up the lower trench walls adjacent from the standing water in the base.

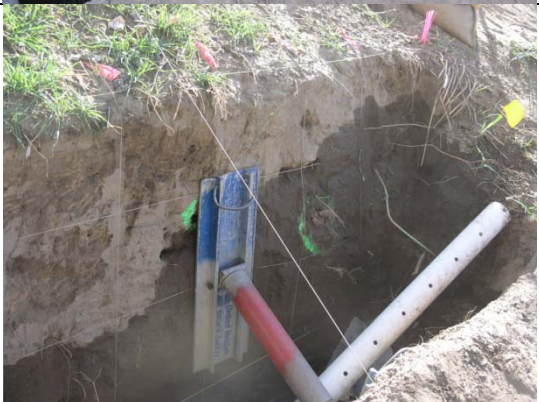
28.4	No water observed free flowing through gopher burrow but saturation zone continues to expand around zone of seep.

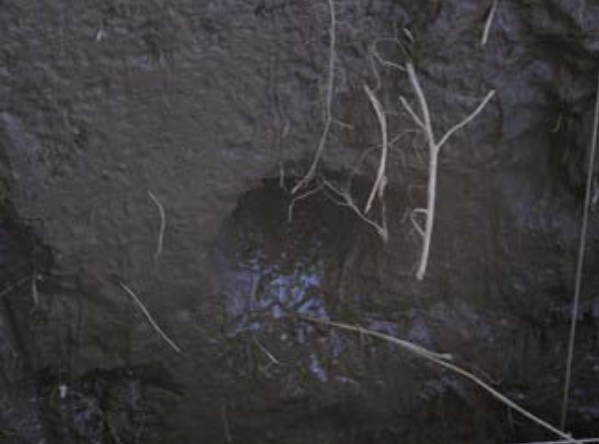
125	Small seep seen producing a trickle of water at squirrel burrow in control trench (Sta. 121.5). Photo to the right is of the squirrel burrow

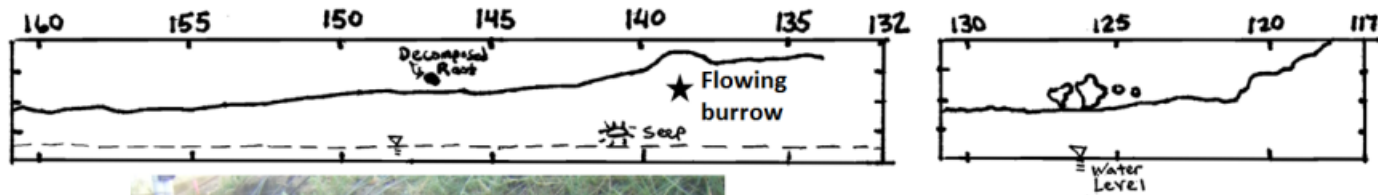
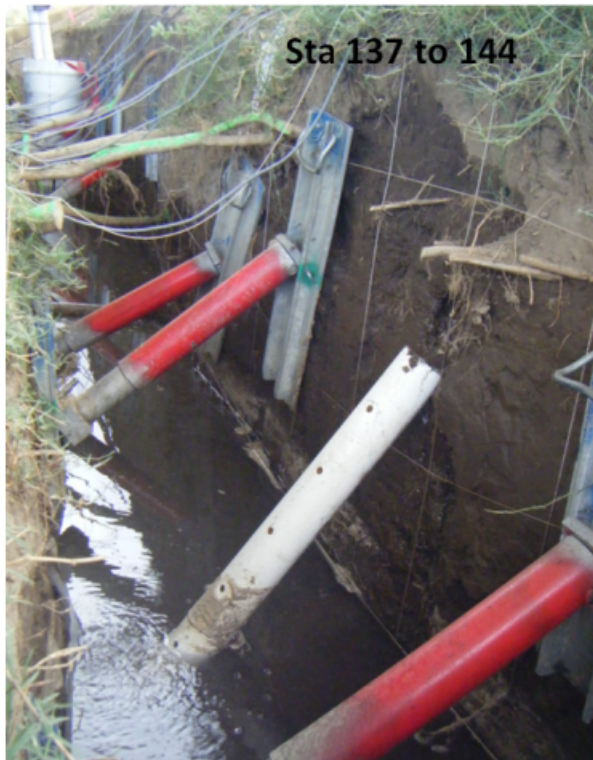
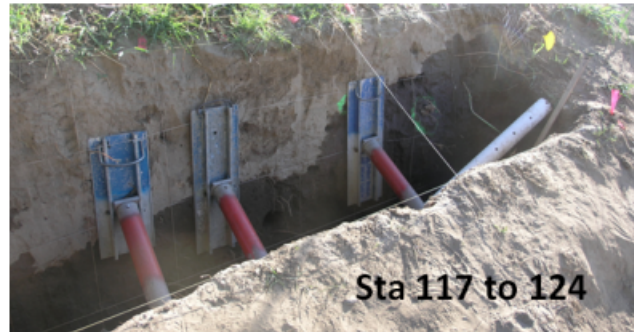
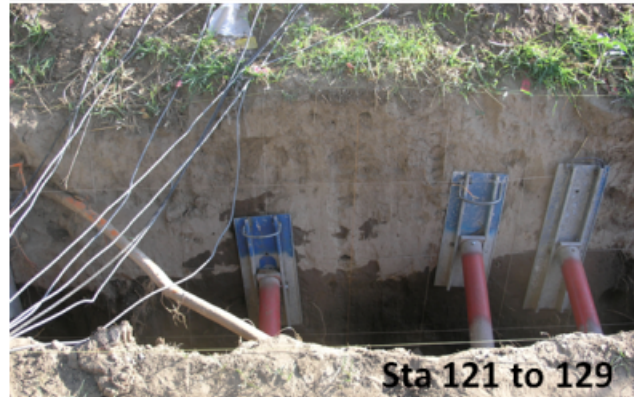
Time = 29.1 hrs

Figure 2-48. Saturation patterns in lower wall face at 29.1 hours after inundation of the upper trench with water. The lower stump (top left) and control (top right) trench wall seepage patterns are documented by station with corresponding photos below.

Figure 2-48 through Figure 2-52 show sketches of wetting front patterns in the uphill wall of the lower trench beginning at 29.1 hours from the time of initial inundation of the upper trench to 51.7 hours from inundation. Sketches were made to support observations during this time window as changes in site conditions were occurring rapidly. Figure 2-53 and Figure 2-54 show photographs of the site (both stump and control trenches) at 67.9 hours and 140 hours, respectively. Some visual changes can be detected between photos at 67.9 hours and 140 hours (the end of the test), but the site had essentially achieved a steady state by 67.9 hours into the flow test. These figures show only minor changes in the arrival of the wetting front at the uphill wall of the lower trench.

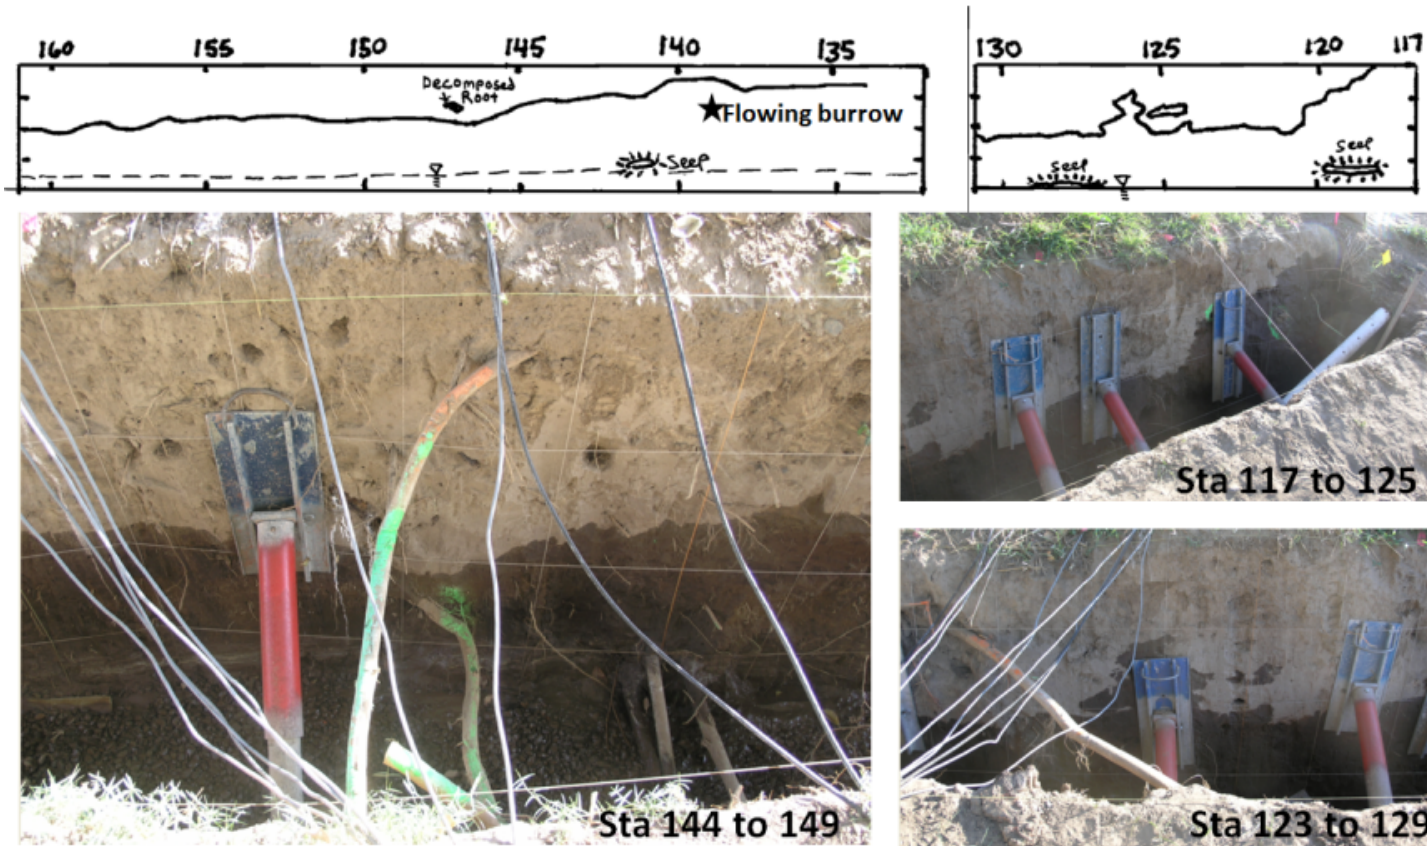
Time = 29.4 hrs

Figure 2-49. Saturation patterns in lower wall face at 29.4 hours after inundation. Note the appearance of seeps in permeable zones near the trench bottom. The lower stump (top left) and control (top right) trench wall seepage patterns are documented by station with corresponding photos below.

Figure 2-56 combines approximate gopher burrow alignments, outlet locations and wetting front patterns at 50 hours into the flow test to better understand the effect of these burrows on the wetting front at the lower trench. During a post-flow test site characterization effort, the gopher burrow at Line C was found to not connect directly to the lower trench, while the gopher burrow at Line B connected directly to both the upper and lower trenches. The influence of these gopher burrow patterns on the wetting front at the lower wall is shown in Figure 2-57 and Figure 2-58. Gopher burrows that did not connect directly with the upper trench, also did not conduct water preferentially (Figure 2-59) – at least not until saturation was achieved in surrounding soils. As shown in Table 2-3 at a time of 125 hours, the squirrel burrow shown in Figure 2-59 did eventually produce water once the surrounding walls had saturated. The small metal water pipe encountered during trench excavation at Station 145 was found to extend beyond our study area on each end and did not conduct visible free water along the zone of backfill (consisting of gravel within a fine-grained soil matrix). The pipe can be seen on Figure 2-49, Figure 2-50, and Figure 2-51 at times 29.4, 29.9, and 46.6 hours into the flow test, respectively.
