Static and Seismic Performance of California Levees

Michelle Jennifer Shriro

Doctor of Philosophy

Engineering - Civil and Environmental Engineering

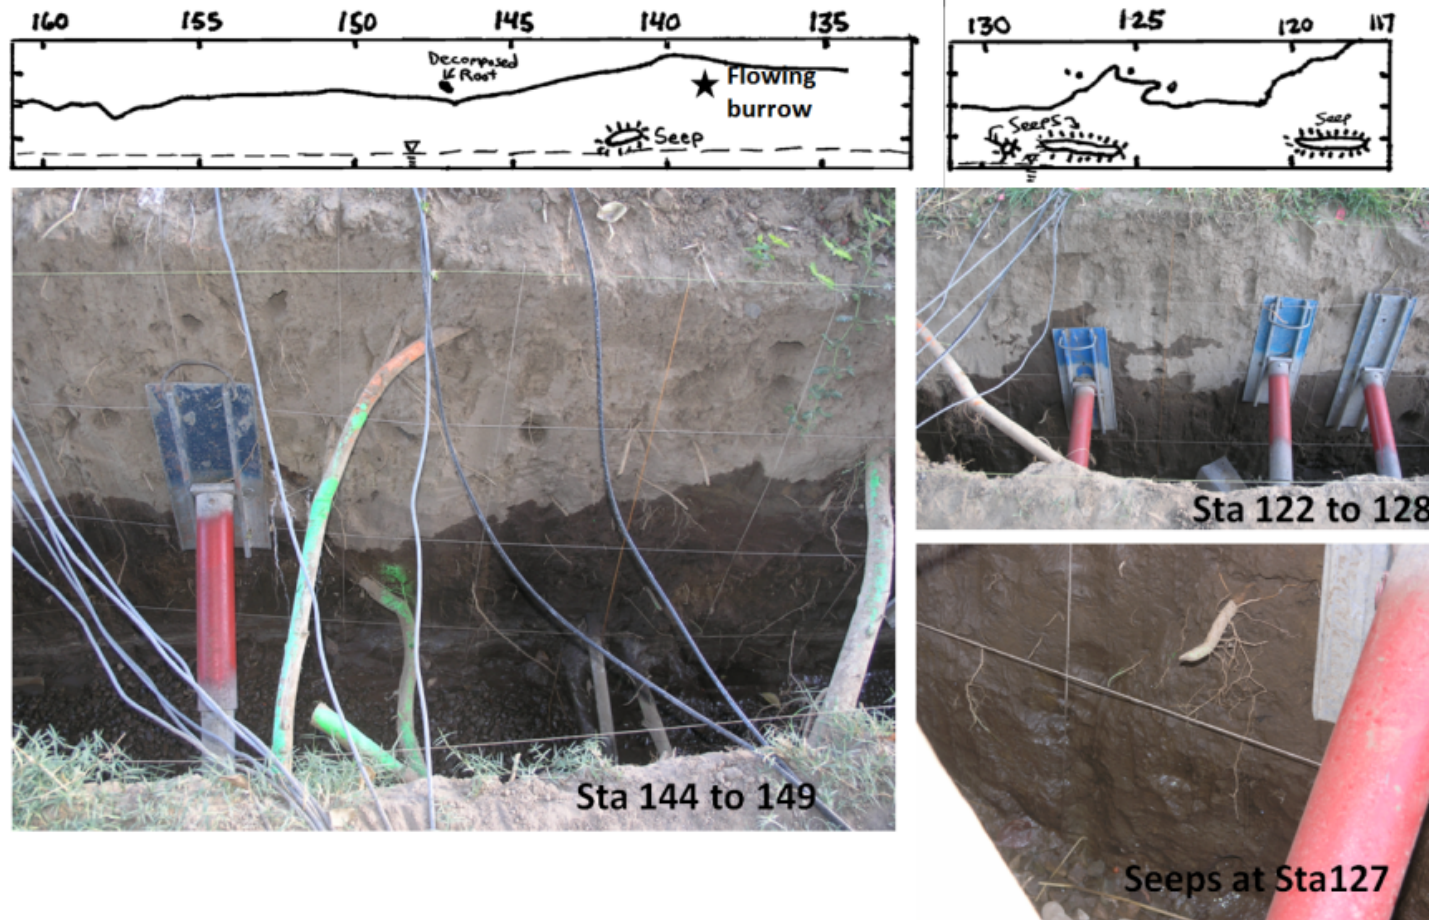
Time = 29.9 hrs

Figure 2-50. Saturation patterns in lower wall face at 29.9 hours after inundation. Note that seeps seem to be related to permeable material types. The lower stump (top left) and control (top right) trench wall seepage patterns are documented by station with corresponding photos below.

Figure 2-48 through Figure 2-52 show sketches of wetting front patterns in the uphill wall of the lower trench beginning at 29.1 hours from the time of initial inundation of the upper trench to 51.7 hours from inundation. Sketches were made to support observations during this time window as changes in site conditions were occurring rapidly. Figure 2-53 and Figure 2-54 show photographs of the site (both stump and control trenches) at 67.9 hours and 140 hours, respectively. Some visual changes can be detected between photos at 67.9 hours and 140 hours (the end of the test), but the site had essentially achieved a steady state by 67.9 hours into the flow test. These figures show only minor changes in the arrival of the wetting front at the uphill wall of the lower trench.

Figure 2-56 combines approximate gopher burrow alignments, outlet locations and wetting front patterns at 50 hours into the flow test to better understand the effect of these burrows on the wetting front at the lower trench. During a post-flow test site characterization effort, the gopher burrow at Line C was found to not connect directly to the lower trench, while the gopher burrow at Line B connected directly to both the upper and lower trenches. The influence of these gopher burrow patterns on the wetting front at the lower wall is shown in Figure 2-57 and Figure 2-58. Gopher burrows that did not connect directly with the upper trench, also did not conduct water preferentially (Figure 2-59) – at least not until saturation was achieved in surrounding soils. As shown in Table 2-3 at a time of 125 hours, the squirrel burrow shown in Figure 2-59 did eventually produce water once the surrounding walls had saturated. The small metal water pipe encountered during trench excavation at Station 145 was found to extend beyond our study area on each end and did not conduct visible free water along the zone of backfill (consisting of gravel within a fine-grained soil matrix). The pipe can be seen on Figure 2-49, Figure 2-50, and Figure 2-51 at times 29.4, 29.9, and 46.6 hours into the flow test, respectively.

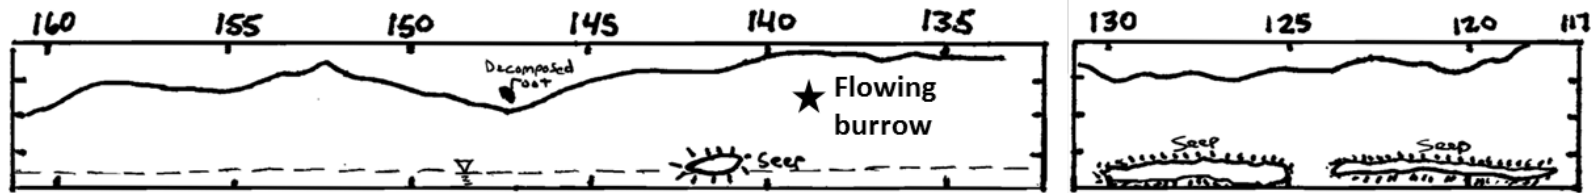
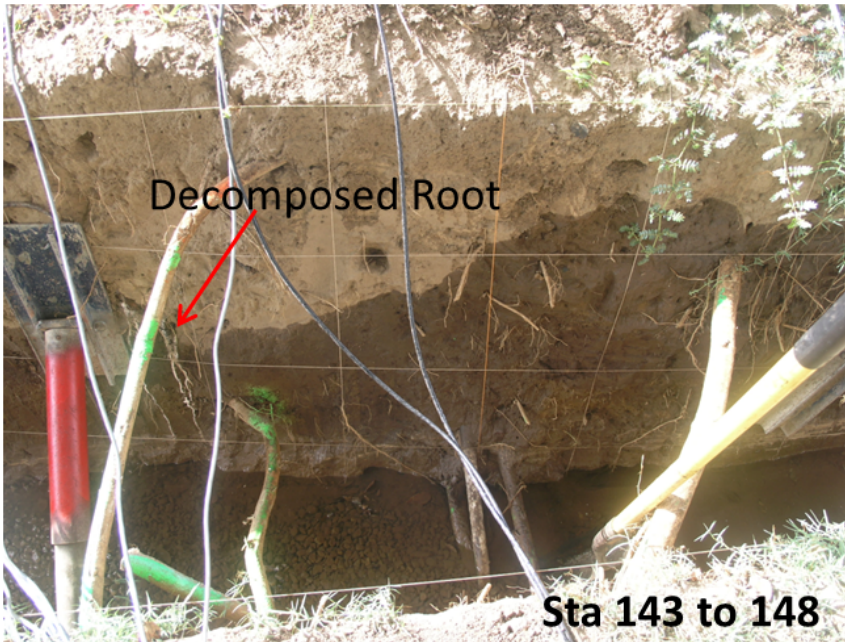
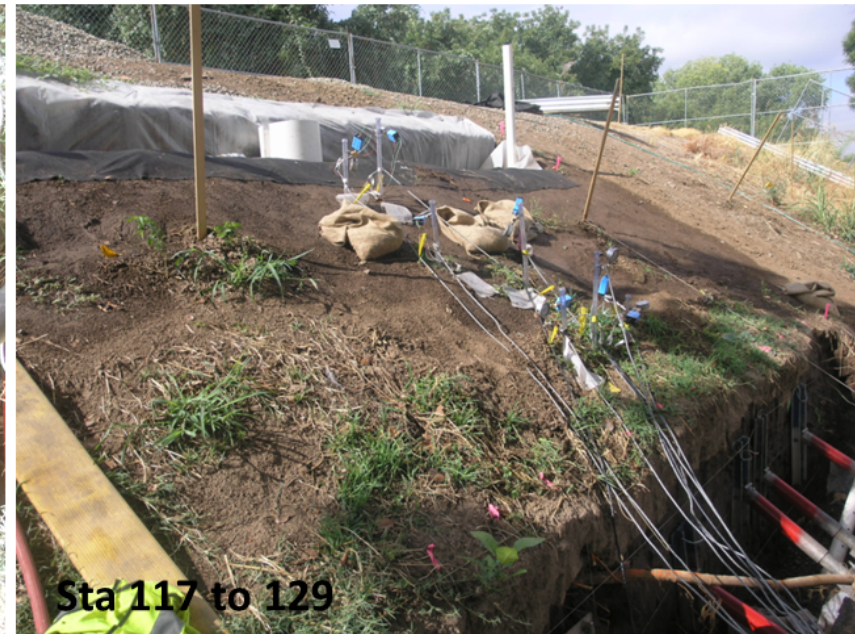
Time = 46.6 hrs

Figure 2-51. Saturation patterns in lower wall face at 46.6 hours after inundation. Note the depression in the saturation pattern in the area of the decomposed root at Station 147. The lower stump (top left) and control (top right) trench wall seepage patterns are documented by station with corresponding photos below.

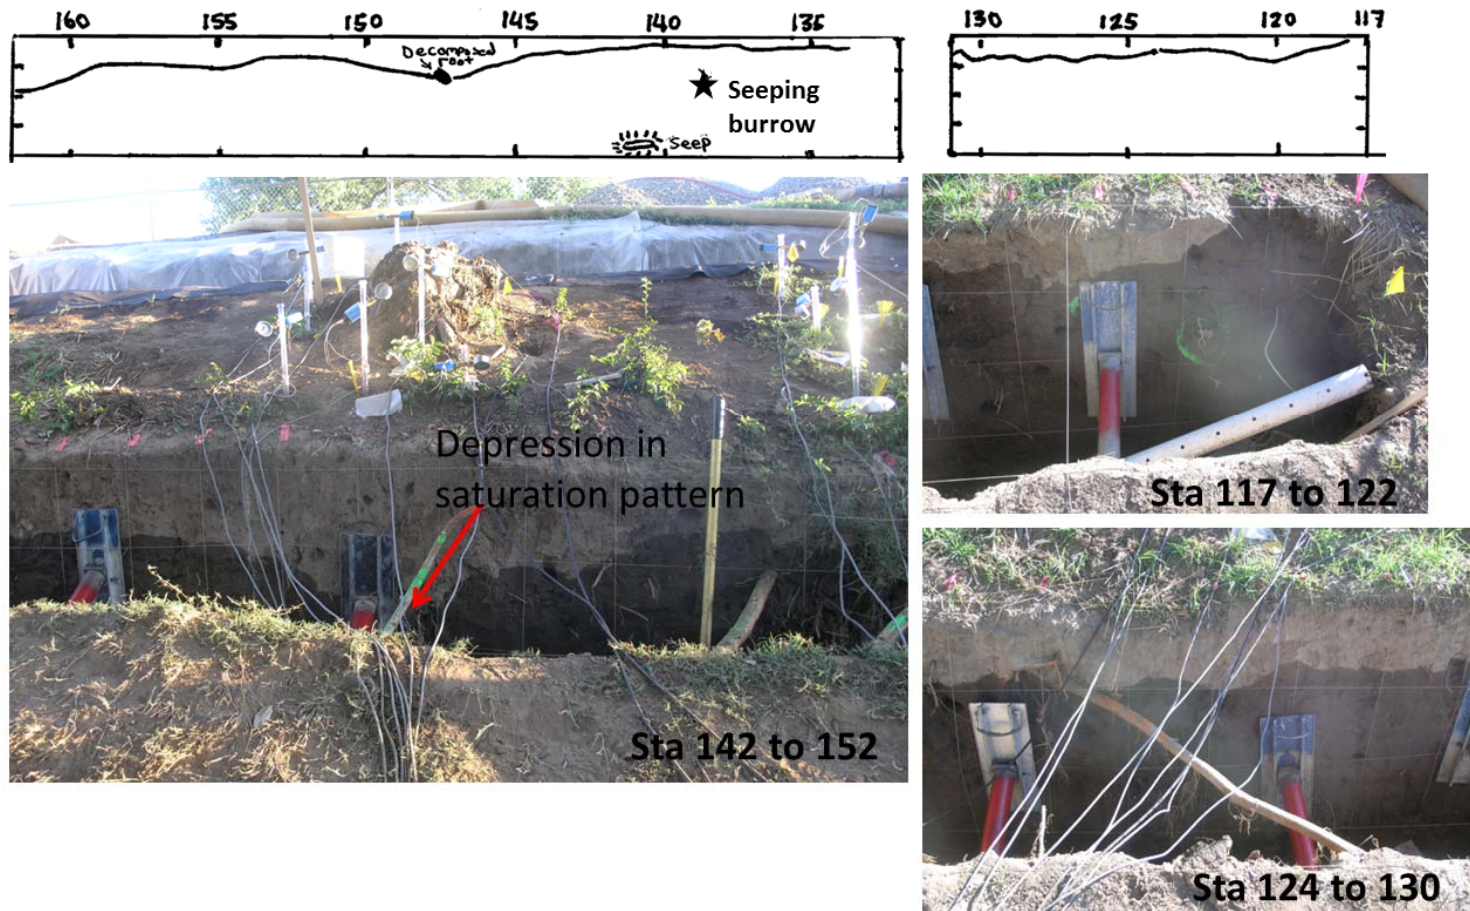
Time = 51.7 hrs

Figure 2-52. Saturation patterns in lower wall face at 51.7 hours after inundation. Note the wetting front continues to rise near the stump at Stations 145-150, though a depression is still visible indicating the stump is the last zone to saturate. The lower stump (top left) and control (top right) trench wall seepage patterns are documented by station with corresponding photos below.

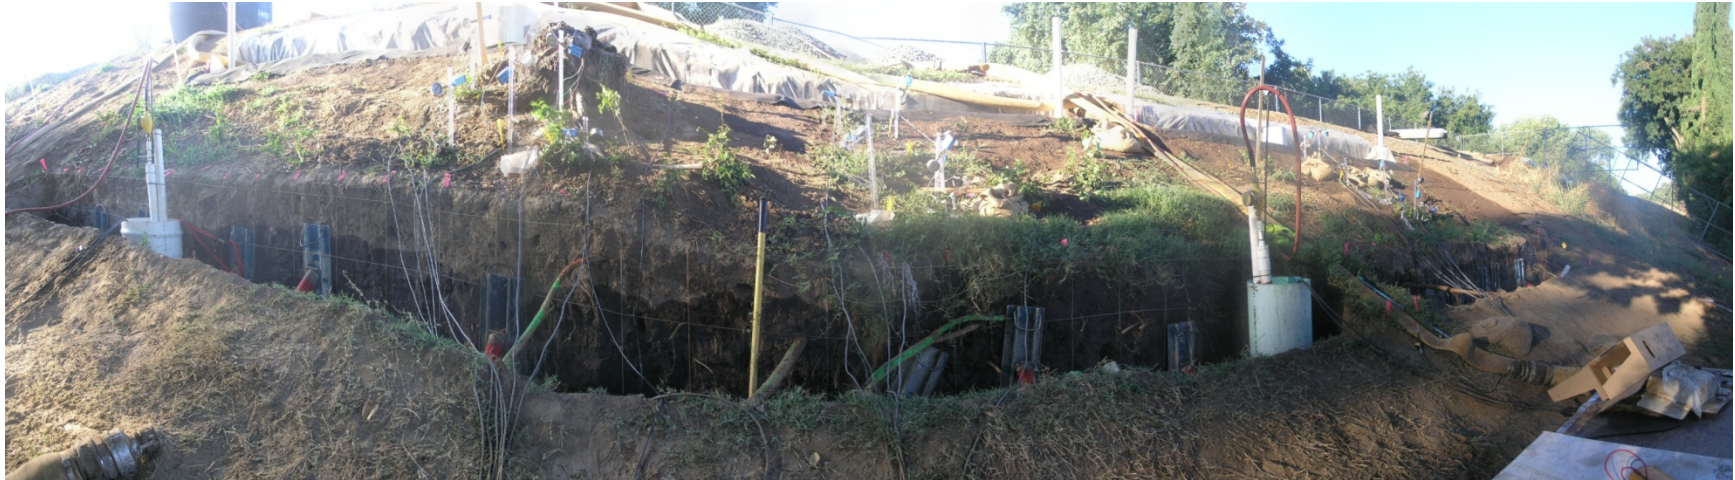
Figure 2-53. Wide angle view of saturation patterns at 67.9 hours into the flow test. The area below the stump has begun to saturate.

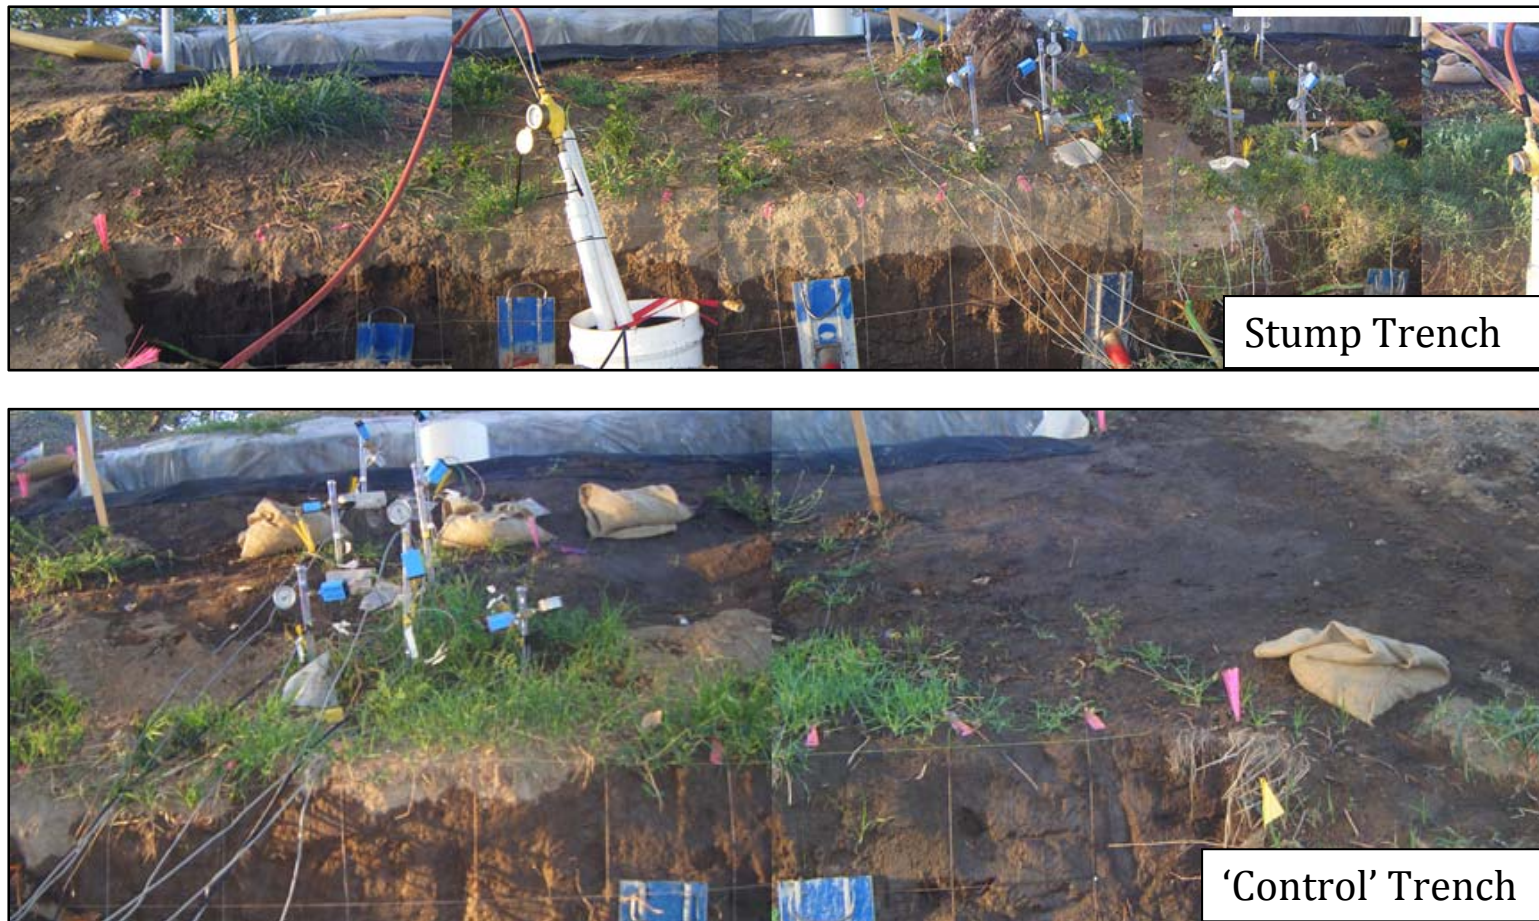
Figure 2-54. Saturation patterns in the stump and control trenches at 140 hours into the flow test, just before the end of the test. Only small changes were observed in saturation patterns between 67.9 hours and 140 hours.

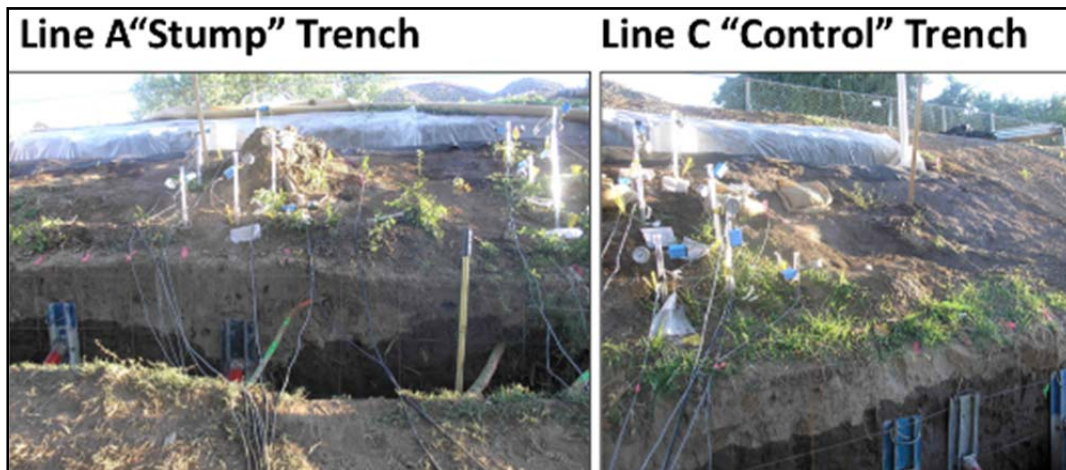
Figure 2-55 shows a direct comparison between the stump and control trenches showing a delayed wetting front in the vicinity of the decaying stump. Possible reasons include a reduced permeability in soils surrounding the stump, a physical obstacle to saturation and flow is created by the stump and root system, or the water is being redirected beneath the test through permeable layers or anomalies. Adding further complexity, the saturation of instrument Lines B and C are influenced by the presence of animal burrows, making a direct comparison between the instrument results and observations increasingly complex. Observations were made with regard to factors which may be influencing the pattern of the wetting front.

Figure 2-55. Comparison after 51.7 hours of flow. The zone in front of the stump was the last to saturate.

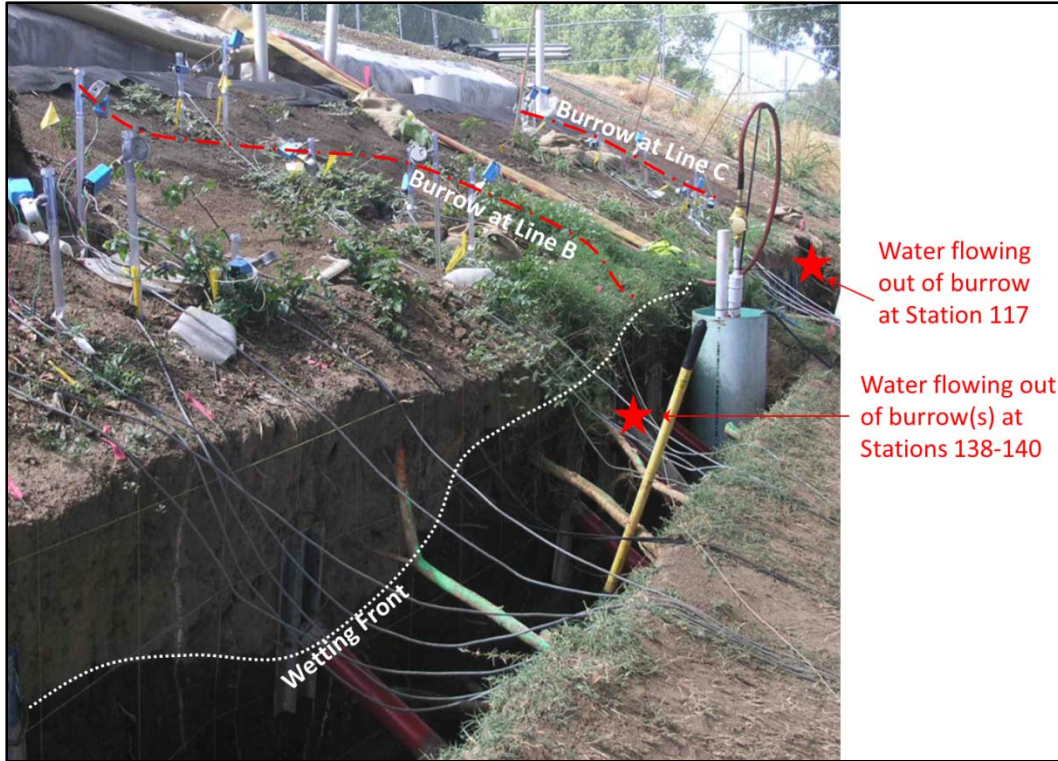
Figure 2-56. View looking west at the uphill wall of the lower stump trench 50 hours into the flow test. Gopher burrow outlet locations at Stations 138.25 and 117 are identified on the diagram as well as approximate alignments of burrows.

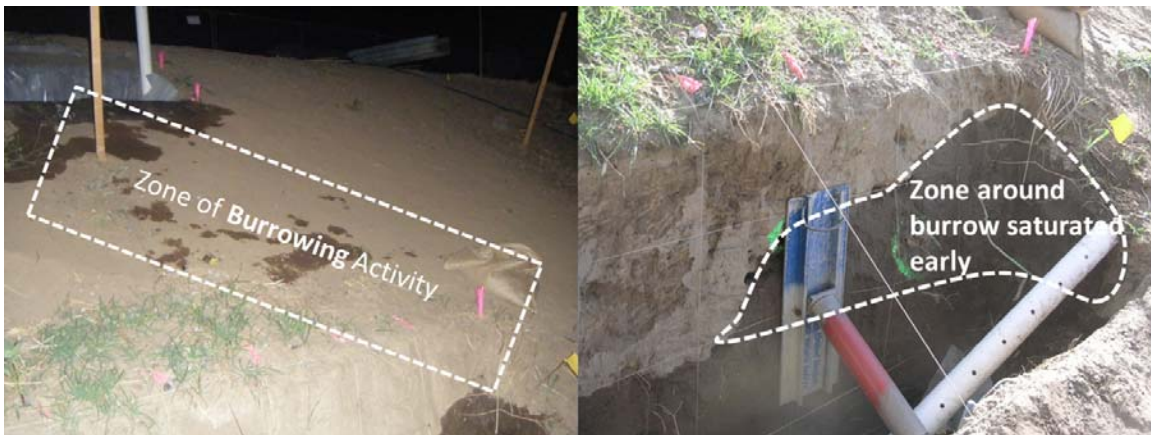
Figure 2-57. Control trench gopher burrow advances the wetting front (left) tracing a pathway to the outlet location at Station 117 (right). The outlet flowed briefly.

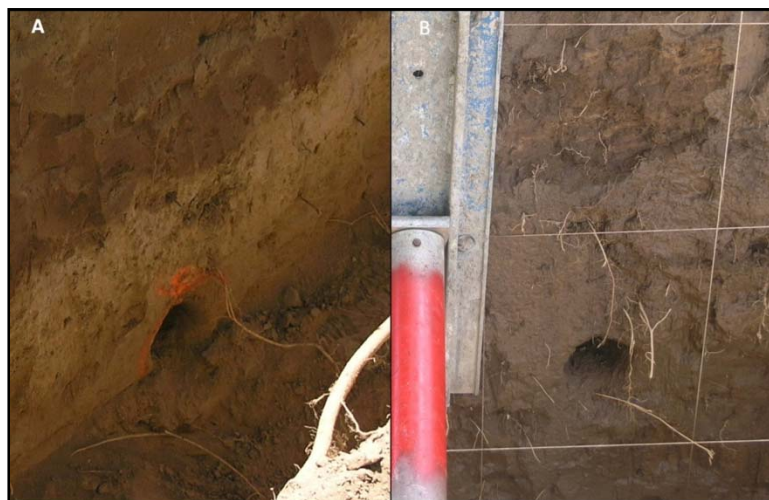
Figure 2-59. Squirrel burrow extending at least 18 inches into the uphill wall of the lower trench at A) the time of trench construction and B) 50 hours into the flow test. No free water flows until a seep upon saturation at 125 hours (See Table 2-2)

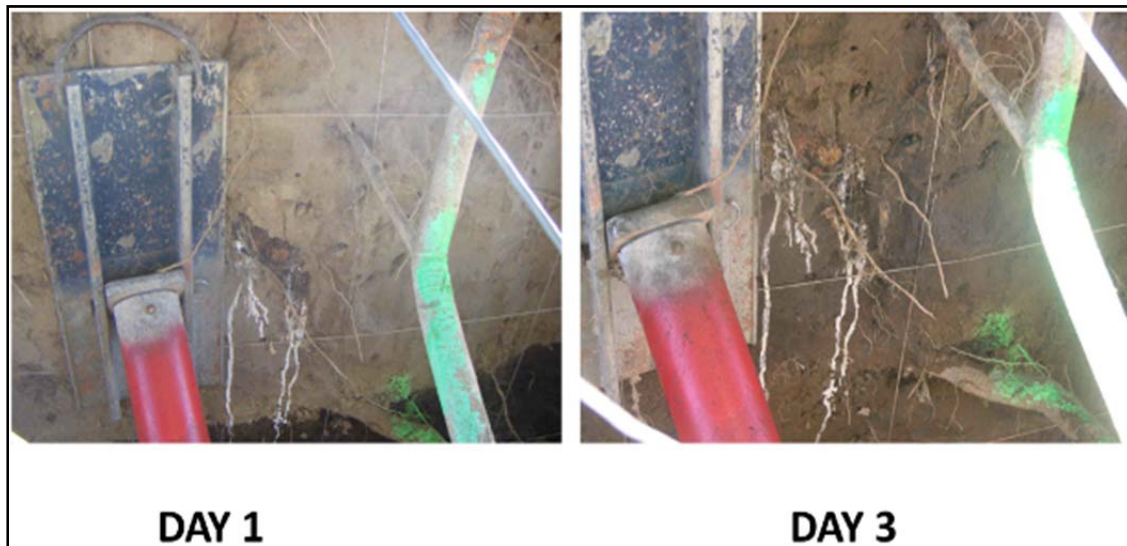
Figure 2-60. Progression of wetting at the decomposed root at Station 147.5.

Neither live roots nor decomposing roots were observed to conduct water preferentially during the flow test. Figure 2-60 and Figure 2-61 show how the wetting front progressed in the vicinity of the decomposing roots. In particular, the root shown on Figure 2-60 was initially observed to conduct silica slurry during the installation of tensiometers. Preferential flow of water was not observed through the annular space between the bark and the woody core of the root during the flow test, despite an intermittent annular space which was found and explored in the post flow test site characterization effort. As previously discussed, the area of the stump was the last zone to saturate.

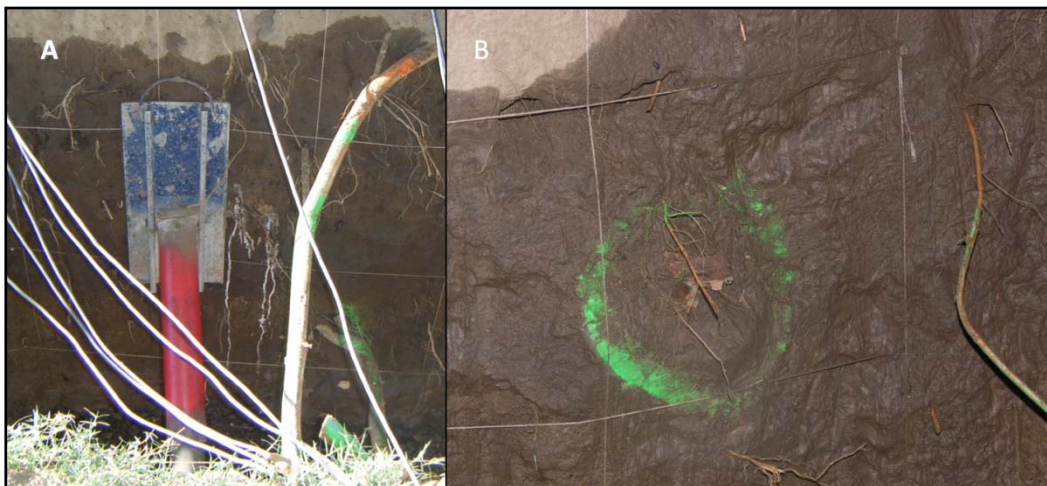
Figure 2-61. Progression of wetting at decomposed roots showing no preference to flow through the root zone or surrounding loose soil zones surrounding the roots.

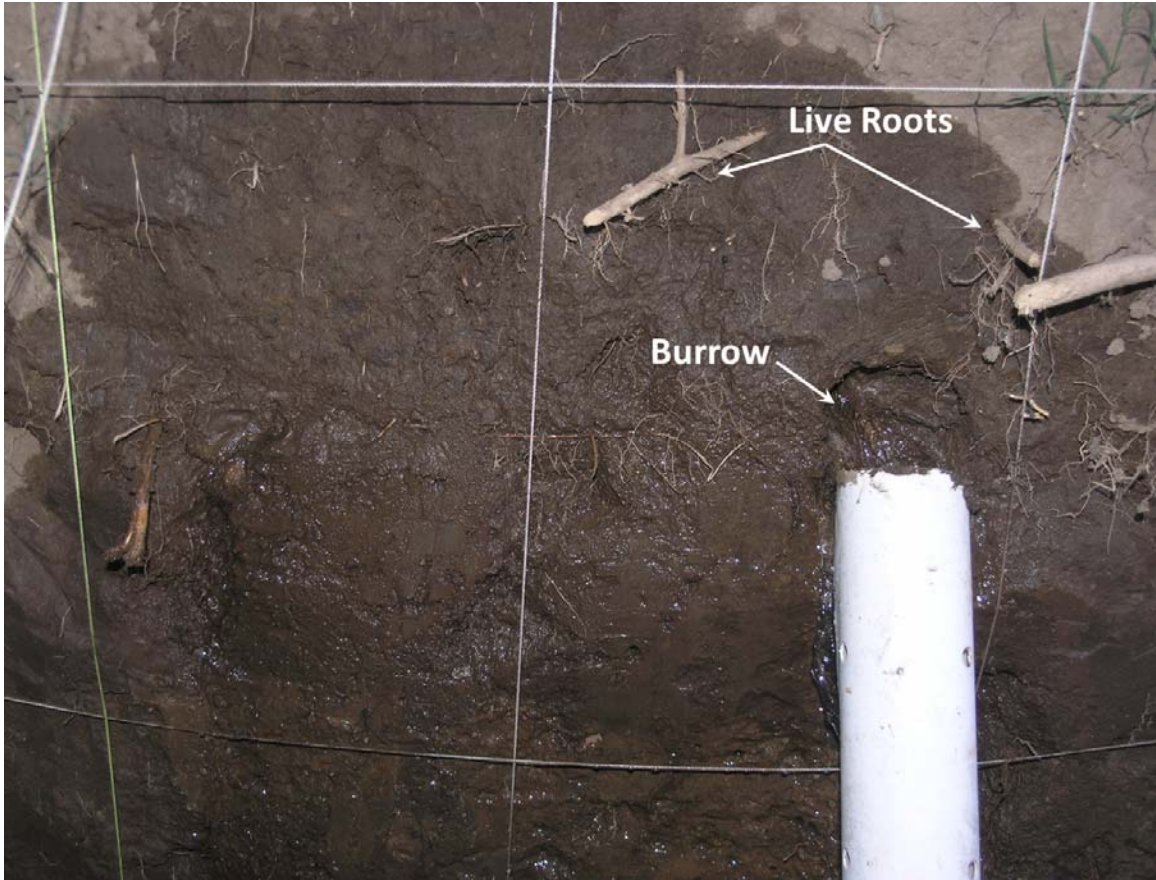
Figure 2-62. During the flow test water is shown flowing through the gopher burrow and seeping out of permeable soils within the wall face, though no flow was observed through the adjacent live roots.

No impact on flow or wetting front patterns was observed to be connected with live roots. No voids or annular spaces were observed in connection with the live roots extending radially from the hackberry tree located at the toe of the levee. Figure 2-62 shows water preferentially flowing through the gopher burrow at Station 138.25 while no flow is observed through nearby live roots. Even as the wetting front arrived, observations of numerous live roots during the duration of the flow test show no preference for water to flow through or around these live root systems (Figure 2-63).

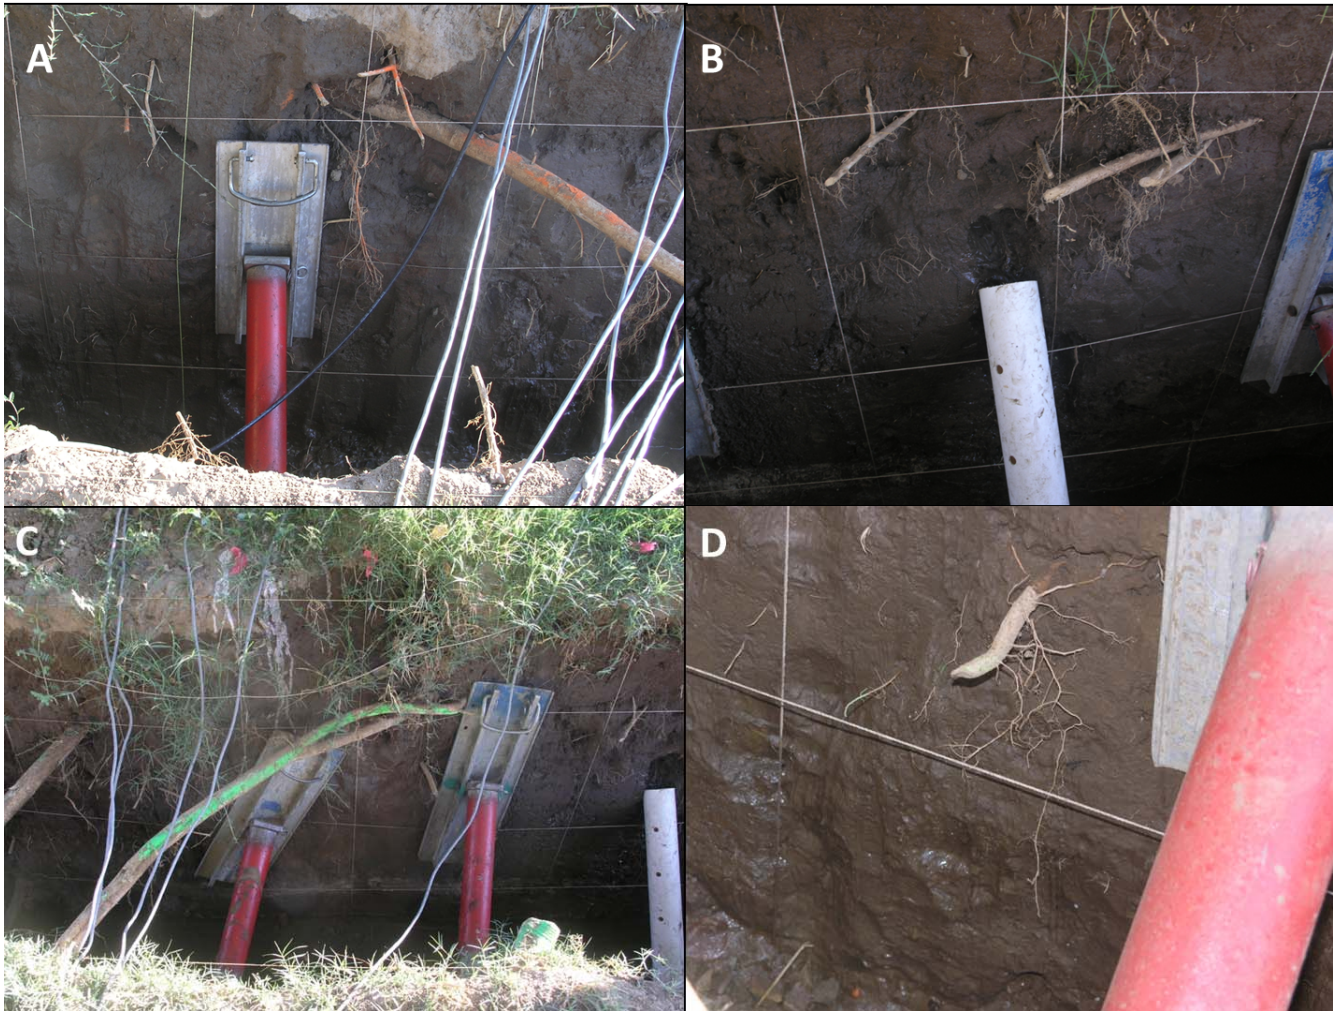
Figure 2-63. Live roots are shown during the flow test throughout the lower stump trench. At no time during the flow test were live roots observed to conduct water.

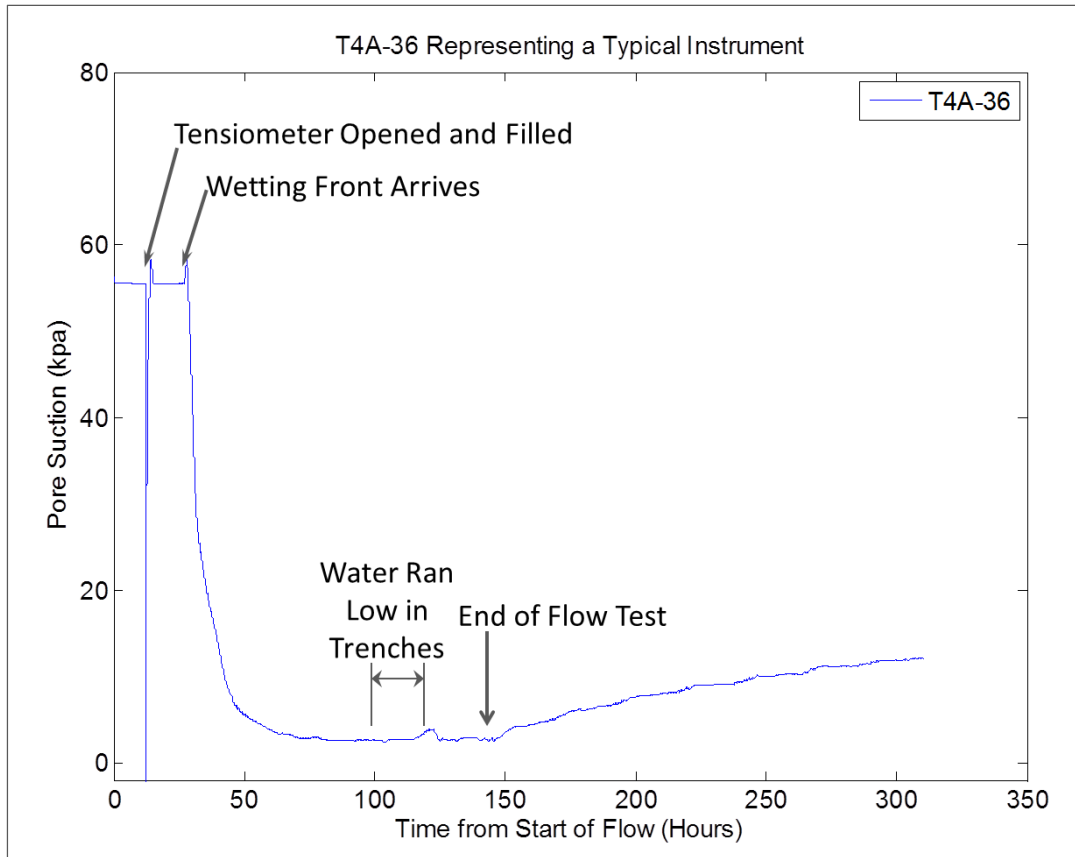
Figure 2-64. Typical tensiometer result plot.

Typical tensiometer results showing values of soil suction measured with time are shown on Figure 2-64. An initial drop in suction and recovery is seen during refilling of the instruments with water. Stable values drop suddenly indicating the time corresponding to the arrival of the wetting front at the instrument tip. The drop in suction values beginning at 30 hours indicates the arrival of the wetting front.

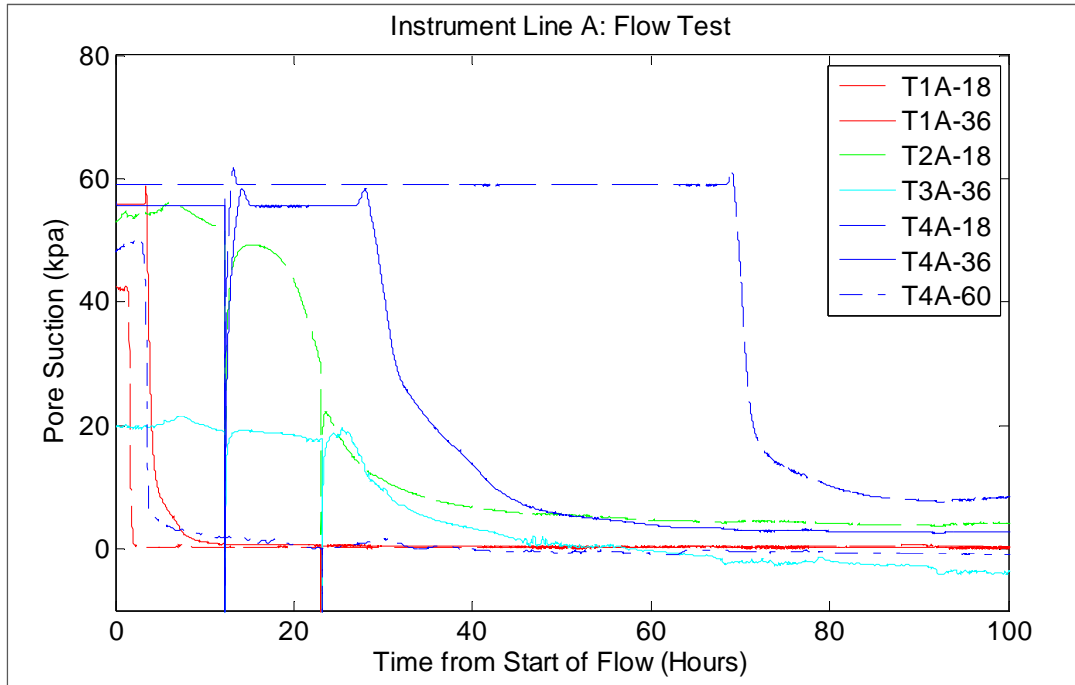
Figure 2-65. Tensiometer data for instrument Line A (at stump).

The saturation front in the vicinity of instrument Line A was observed to progress more slowly than in instrument Lines B and C. In particular, Line A instruments in the area below the stump showed the arrival of the wetting front at approximately 70 hours after the start of the test. In contrast, analogous instruments of Lines B and C recorded no suction approximately 10 and 20 hours, respectively, from the start of the test, indicating rapid saturation in comparison to Line A. Physical observation of the saturation front, as seen from the lower wall, confirmed the area below the stump was the last location to saturate during the wetting test.

Figure 2-65 through Figure 2-67 show tensiometer data by instrument line. Figures showing comparisons of similarly positioned instruments across the various instrument lines are provided in Appendix 2D. As discussed previously, gopher burrows at Lines B and C appear to have accelerated the progression of the wetting front and the stump at Line A appears to have retarded the progression of the wetting front. Tensiometer T4A-60 (Line A) was observed to saturate more quickly than surrounding shallower instruments. This is likely due to free water present in the base of the lower stump trench flowing through the gopher burrow at Station 138.25. Tensiometers T2B-18 (Line B) and T2C-18 (Line C) were very proximal to the path of the gopher burrow which likely acted as a water conduit with patterns

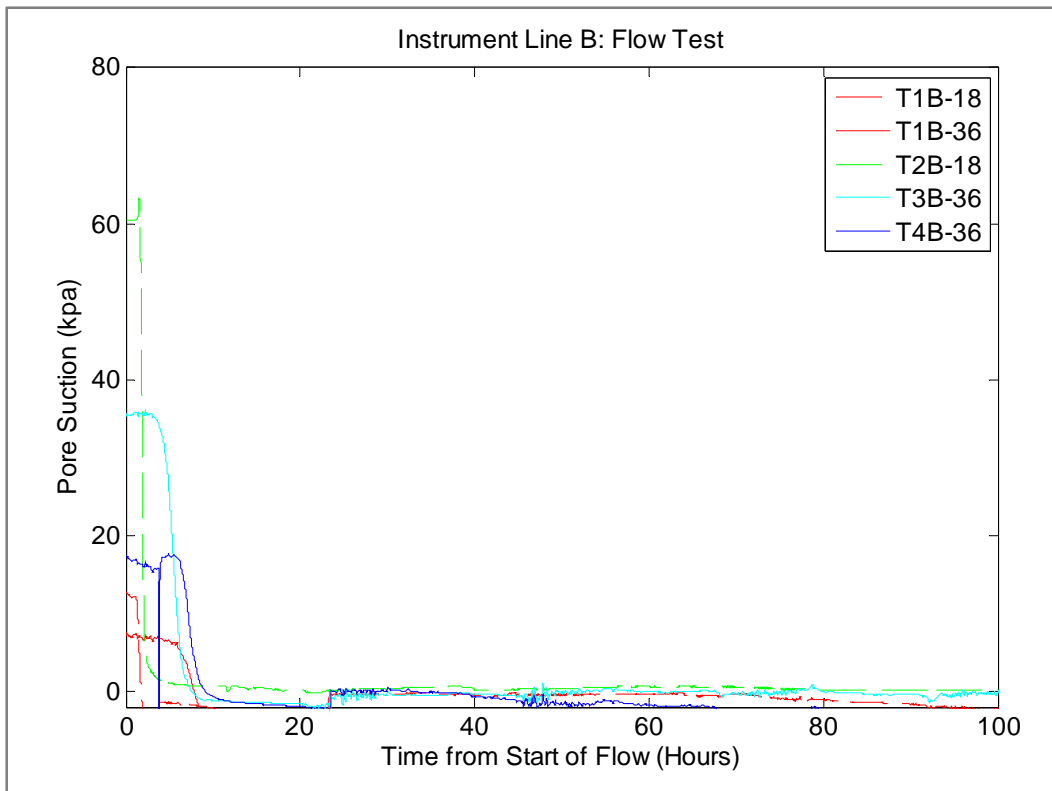
Figure 2-66. Tensiometer data for instrument Line B (7 ft from stump).

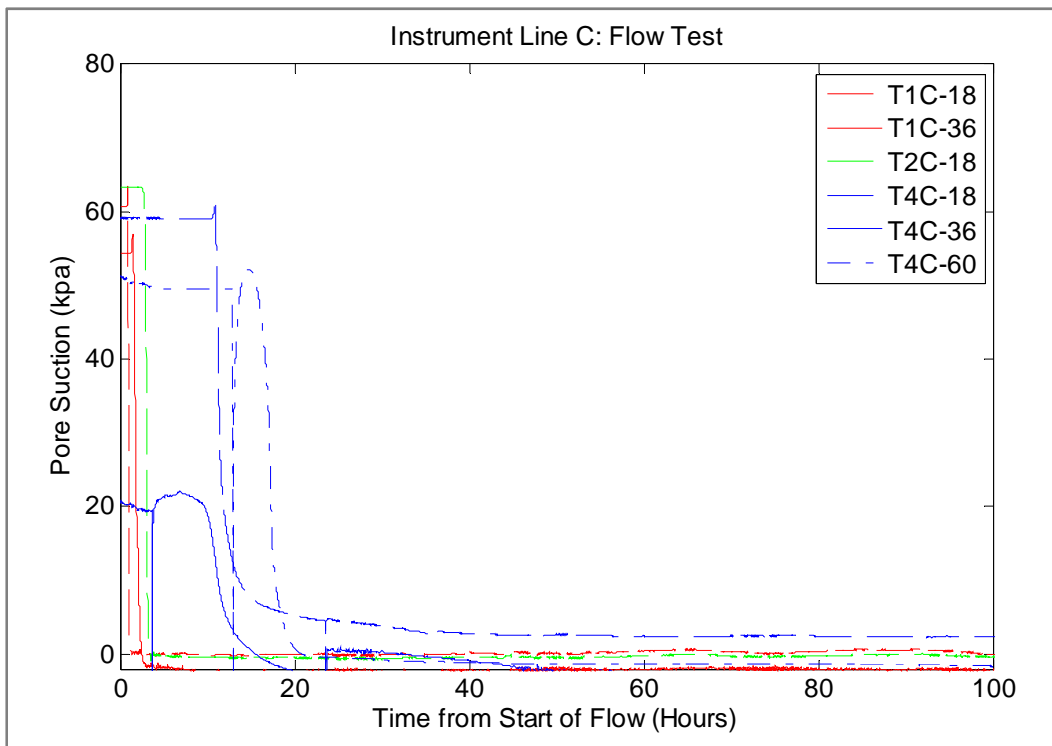
Figure 2-67. Tensiometer data for instrument Line C (23 ft from stump).

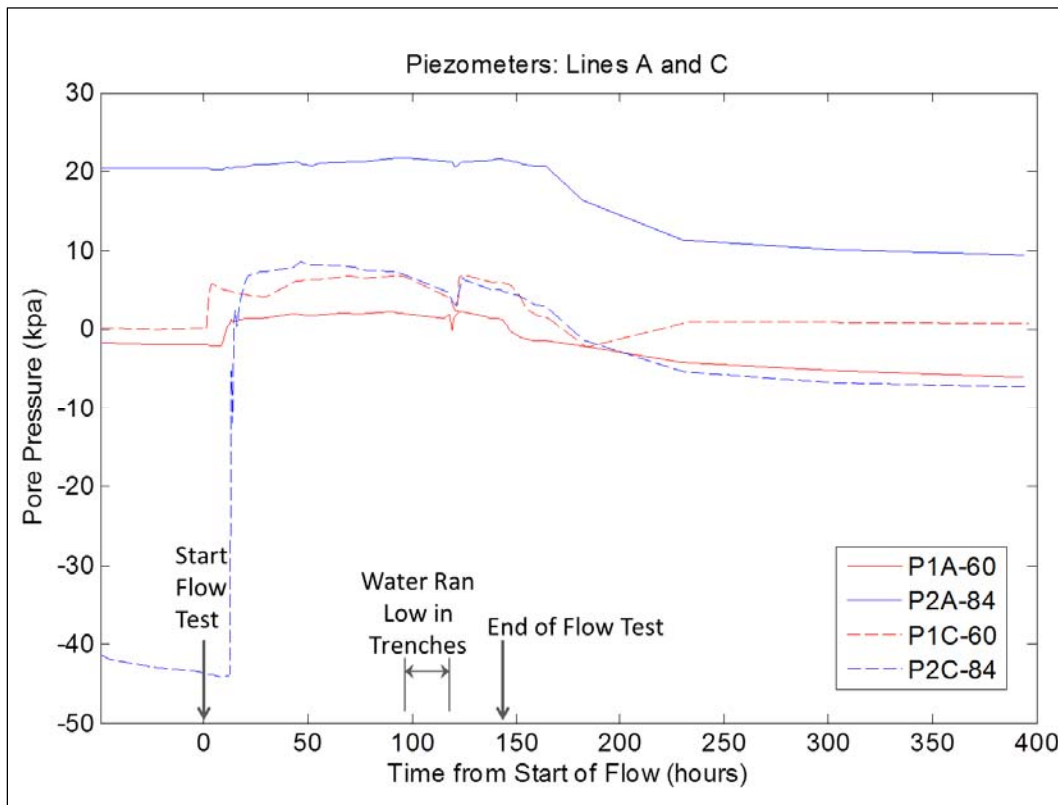
Figure 2-68. Pore pressures measured during flow test at instrument Lines A and C.

Based on piezometer data, saturation of the instruments was achieved within 1 to 2 days of flow. Pore pressures of less than 10 kPa (1.45 psi) developed following saturation (Figure 2-68) for 3 of the 4 instruments. High initial and final pressures in Piezometer P2A-84 did not fit with physical observations and available data. The piezometer was not able to be recovered for laboratory calibration testing and therefore data from this instrument was excluded from our analysis.

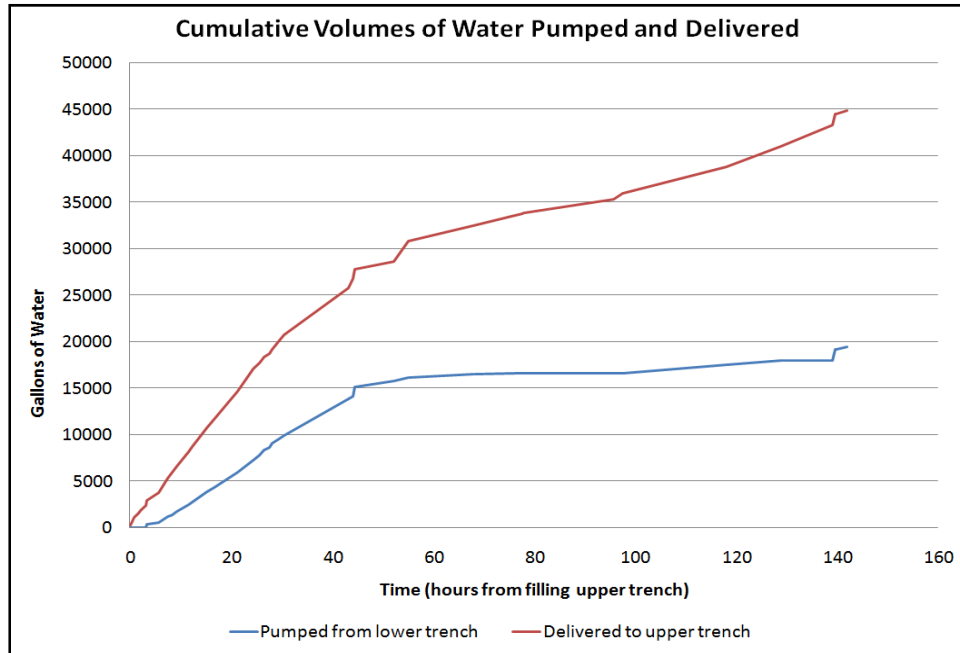
Figure 2-70. Plot of cumulative water delivered to the upper trenches from the 2,500 gallon reservoir and water recycled from the lower stump trench to reservoir.

Figure 2-70 shows the cumulative volume of water delivered to the upper trenches and cumulative water recycled/pumped from the lower stump trench as a function of time during the flow test. Note the slope of the water delivery curve changes over the course of the test.

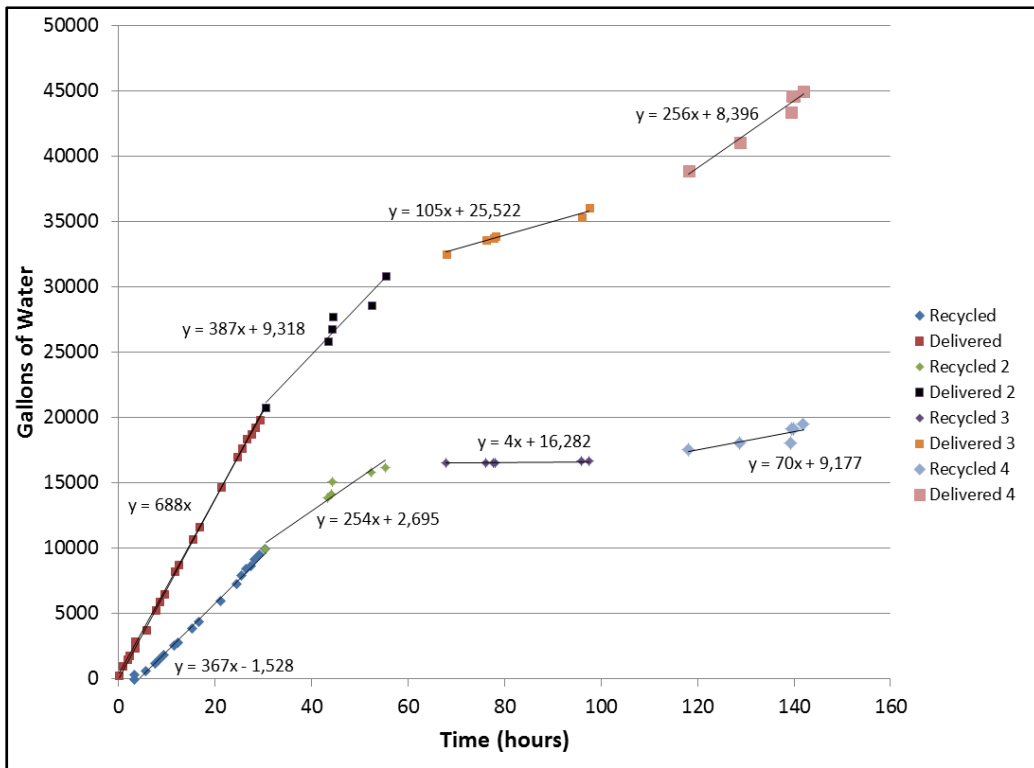
Figure 2-71. Cumulative gallons of water either delivered to the upper trench from the reservoir or recycled from the lower trench back to the reservoir. Curves are broken into segments with slopes representing the rate of flow.

Figure 2-71 breaks the curve into segments and the slope of each segment is calculated with a linear regression. The slope of each segment is the rate of water flow over that time period. Table 2-5 provides a summary of flow rates along with a reminder of key observations relevant within each interval.

During field observations, at approximately 55 hours, we observed a rapid decline in the rate of flow from the gopher burrow in the lower stump trench at Station 138.25. It appears that flow began slowing at 30 hours, though the decline in flow rate became apparent after a time of 55 hours. The recycle rate refers to the number of gallons of water pumped from the lower stump trench into the 2500 gallon reservoir over a period of 1 hour. Virtually all of this water was delivered to the lower trench via the gopher burrow at Station 138.25. This rate underestimates the actual rate of flow through the burrow. Water lost through the lower trench due to standing water percolating into surrounding soils arrived through the burrow and was lost outside of the study area prior to being recycled into the reservoir. In the first 30 hours of the flow test, a minimum of 367 gph flowed through the burrow, while 321 gph was saturating soils between the trenches, or was lost outside of the study zone.

Between hours 30 and 55, the rate of recycled water pump, which flowed through the gopher burrow at Station 138.25 decreased from 367 to 254 gph. The loss rate for water declined from 321 to 140 gph. Between 55 and 97 hours into the flow test, burrow flow slowed and then stopped and the loss rate for water dropped to 101 gph. When the reservoir ran out of water at 97 hours and was refilled at 118 hours, the burrow at Station 138.25 began to flow again, but resulting in only 70 gph, available for recycle while the loss rate of water to surrounding soil was 186 gph.

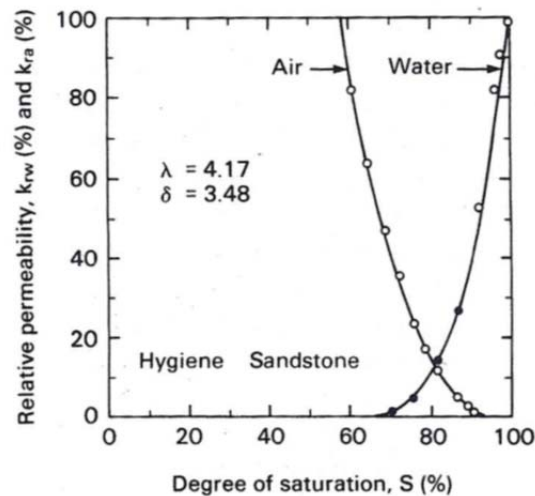
Figure 2-72. Relative permeability of water and air as a function of degree of saturation during drainage (Freundlund and Rahardjo, 1993; originally from Brooks and Corey, 1964). Note: Diagram intended for the illustration of concepts only. Actual relative permeability is expected to vary by soil or rock type.

Two burrows were observed to stop flowing over the course of the test. A reduction in macropore flow is expected as losses to surrounding soils rise with increased saturation of surrounding soils (Figure 3-71). This is consistent with observations by Beven and Germann (1982), who note that the rate of input into the hole must exceed losses to the surrounding soils and continuity must be maintained for the macropores to preferentially flow water. Collapse, siltation, or plugging may also have occurred over the course of the flow test. The gopher burrows may have been partially backfilled with loose soils, aiding in siltation or plugging of the burrows during the flow test. The overall reduction in water losses from the beginning of the flow test to the end is indicative of the reduction in flow through macropores as hydraulic conductivity of soil is expected to rise with increased degree of saturation (Figure 2-72), increasing rather than decreasing the flow rates.

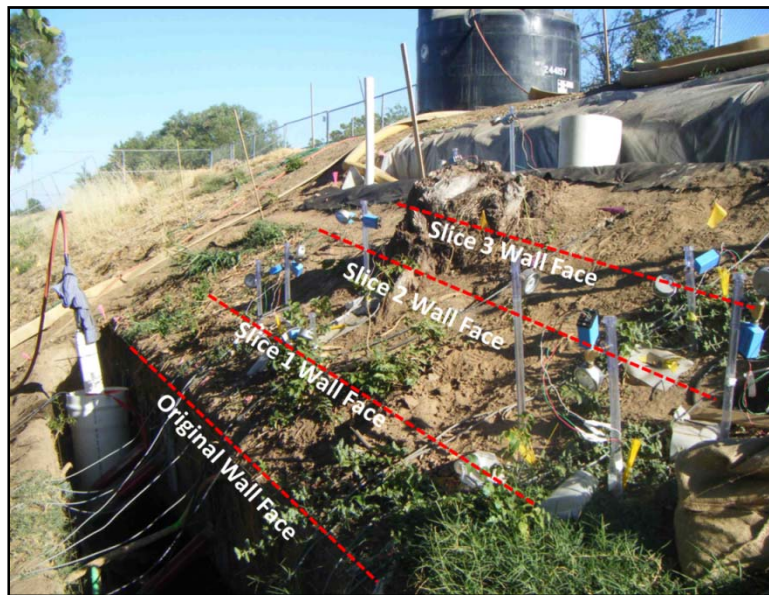
Figure 2-73. Excavation was completed around the stump in a series of vertical slices from Stations 138 to 153 as shown.

Soil surrounding the eucalyptus stump was excavated in vertical slices extending back from the upslope side of the lower stump trench wall face as shown on Figure 2-73. When the last segment of soil was removed and the stump was removed to view the roots beneath. Segments of approximately 1.5 to 2 feet in thickness (measured into the trench wall) were removed with an air knife (connected to a compressor as described earlier). In the vicinity of delicate, decomposing roots, hand excavation was necessary to observe and document the *in-situ* condition. Areas of decomposing roots were carefully hand excavated, logged, photographed, and shot with T-LiDAR. Original logs prepared by Richard Evans and John Lichter are provided in Appendix 2E. The mammal burrow at Instrument Lines B and C were grouted, uncovered, photographed, and shot with T-LiDAR.

As previously discussed, the site characterization effort consisted of excavation around the decaying stump in a series of slices/soil segments. Root conditions were photographed and logged at 4 wall faces as shown on Figure 2-73. Detailed logs were created through a collaborative effort of our team with Professor Richard Evans of UC Davis and John Lichter, consulting arborist with Tree Associates. The logs are provided in Appendix 2E and are examined herein.
