Static and Seismic Performance of California Levees

Michelle Jennifer Shriro

Doctor of Philosophy

Engineering - Civil and Environmental Engineering

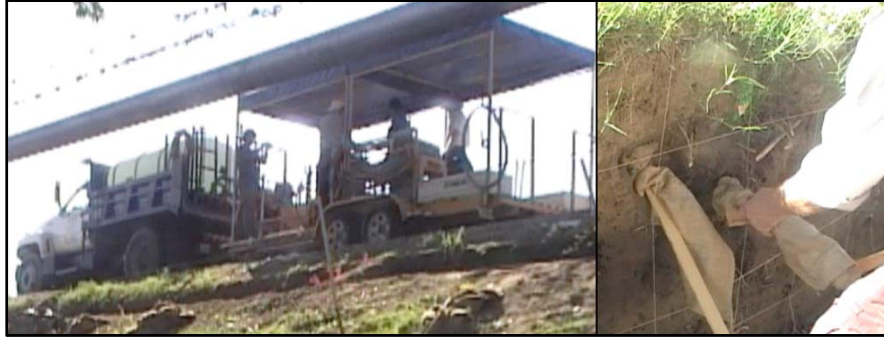
Figure 2-74. ARFCD grout plant and trailer combination is shown (left). To the right, burrows are plugged with burlap sacks using a rod leveraged against the ground in order to prevent loss of grout.

Grouting of burrows was performed by the American River Flood Control District (ARFCD) using a Chemgrout plant and trailer equipped with a moyno pump for grout delivery. Jim Warner, PE was retained as a grout expert to consult with our team on the grouting approach. At his recommendation, a grout mix was prepared with 10 percent bentonite and blended to a consistency that maximized thickness while remaining flowable. The mix was placed under low pressure (less than 10 psi) and injected slowly with enough pressure to move the grout to maximize filling of the hole while minimizing upheaval of the shallow surface soils covering the burrow. Burlap gravel sacks were positioned near the burrow outlet and were used to plug the burrows when grout began to flow from the lower trench wall (Figure 2-74).

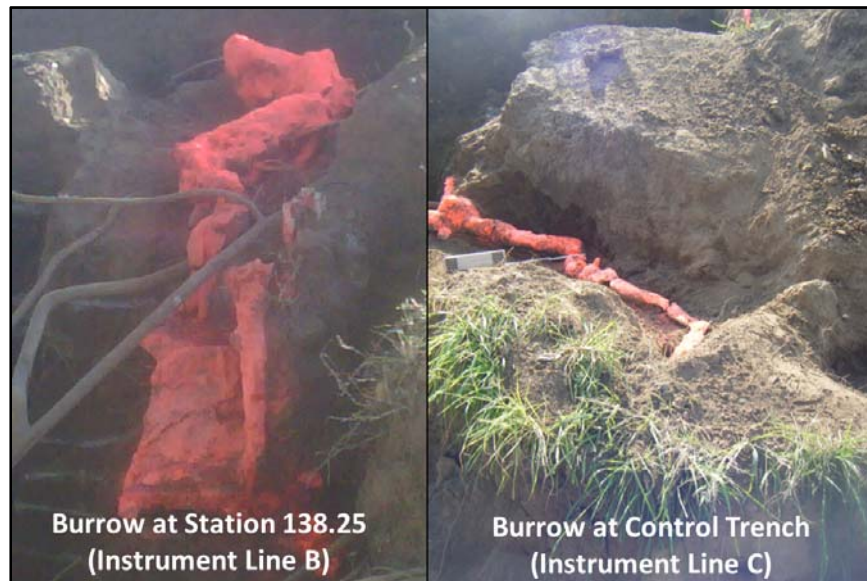
Figure 2-75. Mammal burrows at instrument Lines B and C following post-flow grouting and characterization efforts.

The mammal burrow in Lines B and C were grouted and the soil covering them was excavated to expose the alignment extending from the upper trench. Figure 2-75 shows the exposed mammal burrows at Lines B and C.

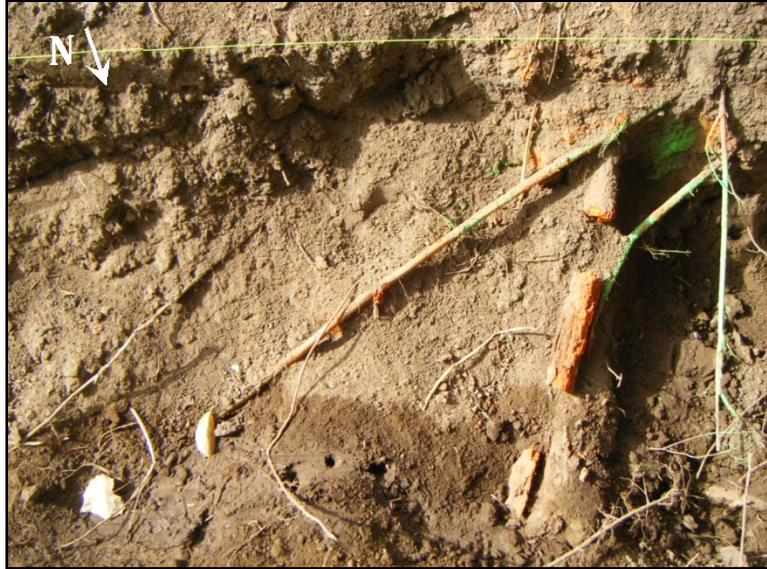
Figure 2-76. View of decomposing root encountered in the lower stump trench, Station 155.

Excavation began by removing the downslope wall of the lower stump trench for access and in doing so gently following the remains of a decomposing root extending downslope of the lower trench from Station 155 (Figure 2-76). Careful excavation around the root revealed no gap between it and the soil. The root was sufficiently decomposed such that a distinction could not be made between bark and woody center. Figure 2-77 shows a sandy silt soil matrix directly against the root.

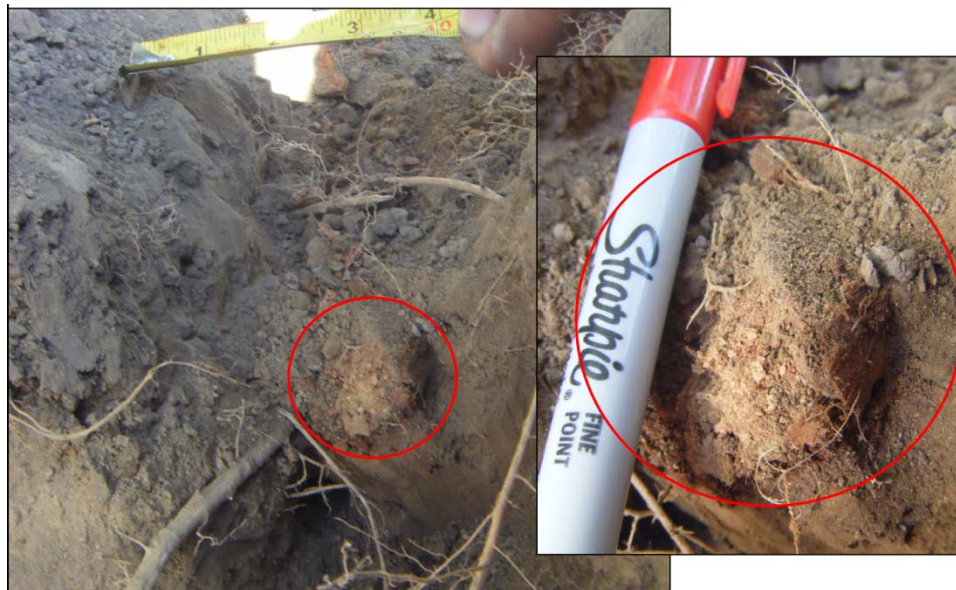
Figure 2-77. Close in view of decomposing root at Station 155. No gap was observable around this friable and highly decomposed root.

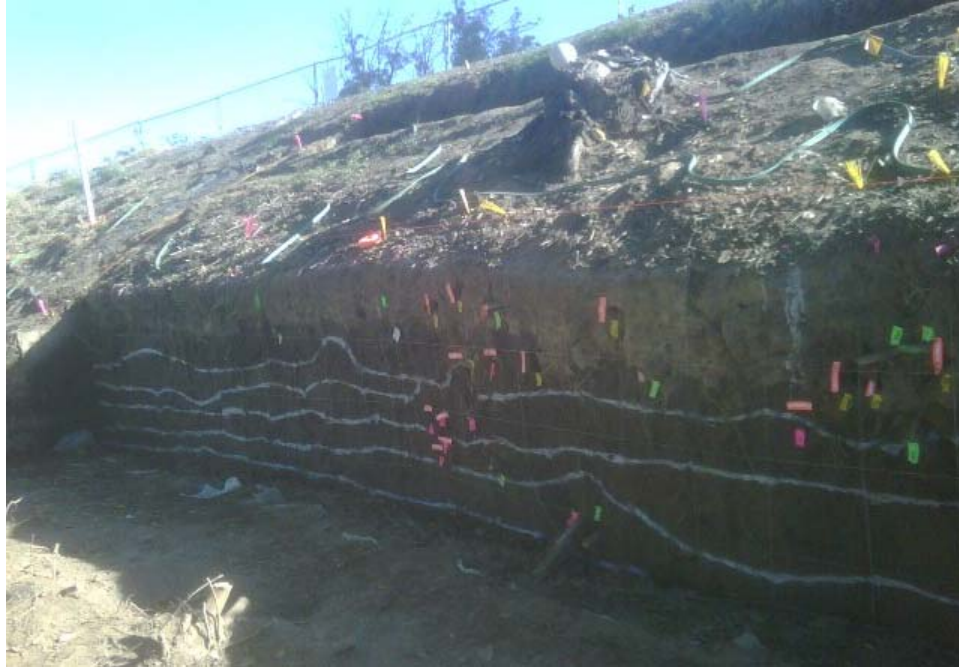
Figure 2-78. View looking southeast at the trenches following excavation of the downhill wall of the lower stump trench.

Figure 2-78 shows the final excavation of the upper wall of the lower trench, revealing the uphill wall to be scanned with T-LiDAR. Though field logs of this wall had already been generated, the wall was labeled with a consistent system for consistency and for the purposes of collecting T-LiDAR data (Figure 2-79). Visible live and decomposing roots as well as burrows were given labels and a reflective strip affixed proximally to aid in location of features that were difficult to isolate with T-LiDAR data.

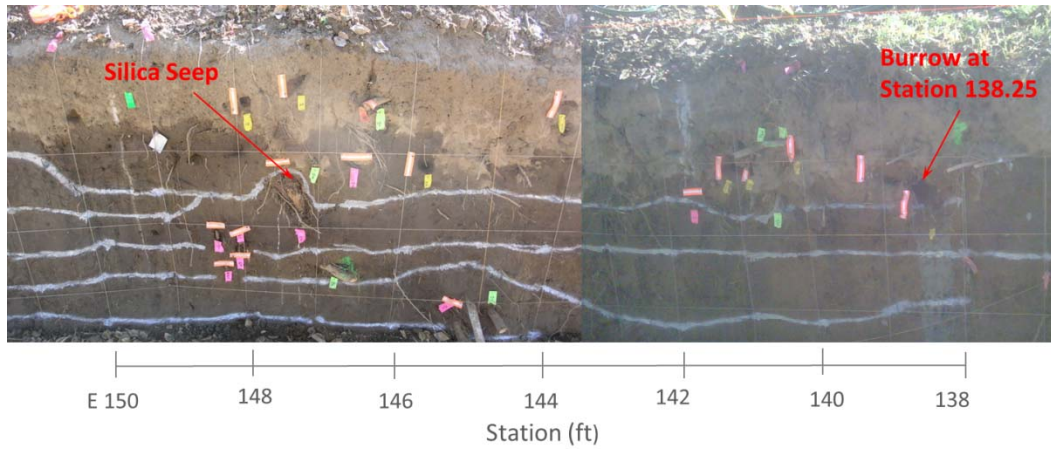
Figure 2-79. View of the uphill wall of the lower stump trench between Stations 138 and 151 just prior to scanning with T-LiDAR.

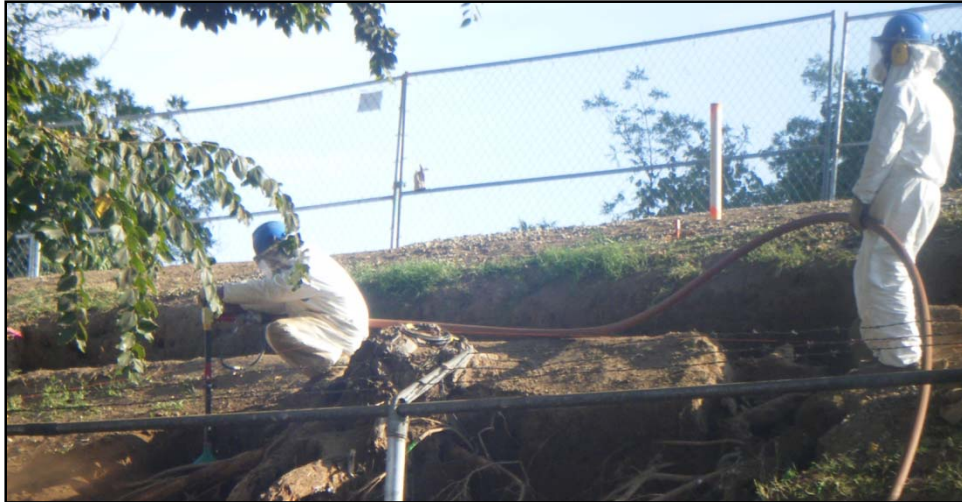
Figure 2-80. View of air knife operation during post-flow test site characterization effort.

Excavation of the first slice began with removal of overburden and soils surrounding the stump using the air knife (Figure 2-80). As excavation proceeded, a prominent root emerged between tensiometers T4A-36 and T4A-60 (Figure 2-81). The excavation revealed this root to be the conduit for the silica seen flowing through a decomposing root at Station 147 during installation of tensiometers in the 4<sup>th</sup> row of Line A. Figure 2-82 shows the location of that root relative to the approximate installation position of tensiometers T4A-36 and T4A-60 and the seep location. The figure also shows the completed the first slice – ‘Slice 1’ - excavation wall with roots exposed in the vicinity of the observed seep as compared with the

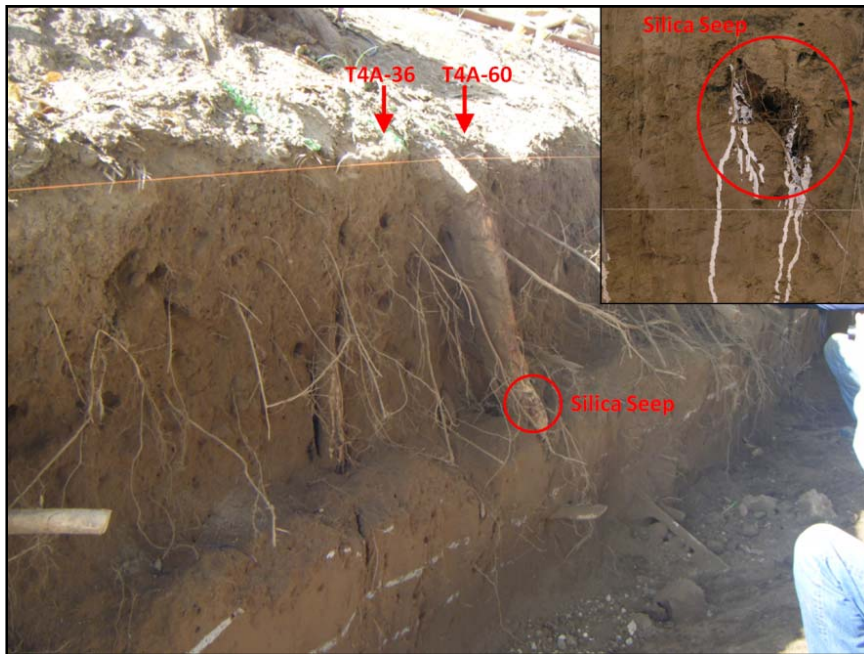
Figure 2-81. View of uphill wall of the lower stump trench as excavation of Slice 1 began. The root that was a conduit for silica slurry to the face of the lower wall during tensiometer installation is pictured.

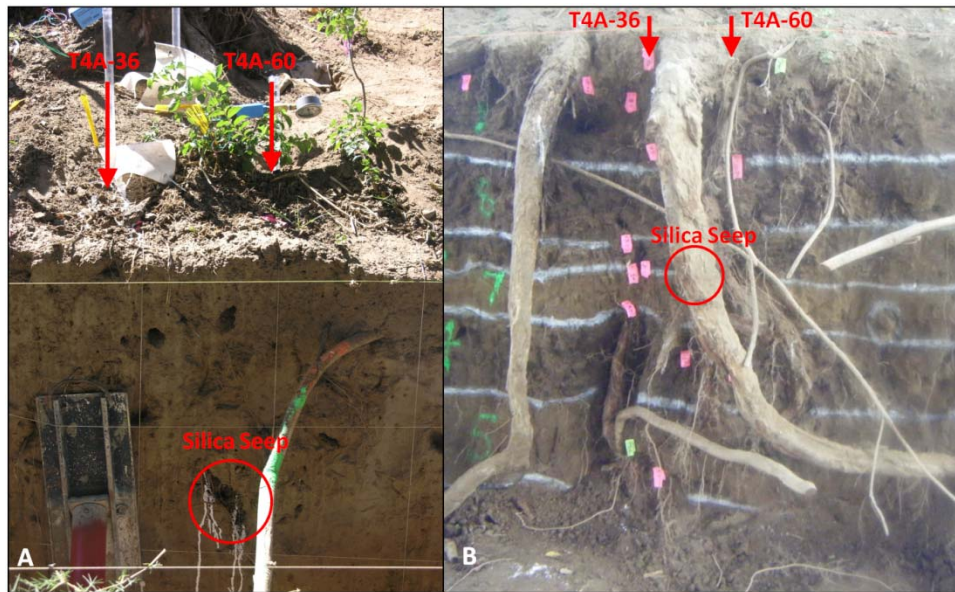
Figure 2-82. View of upper wall in lower trench below the stump A) during the flow test, and B) following the completion of 'Slice 1' excavation.

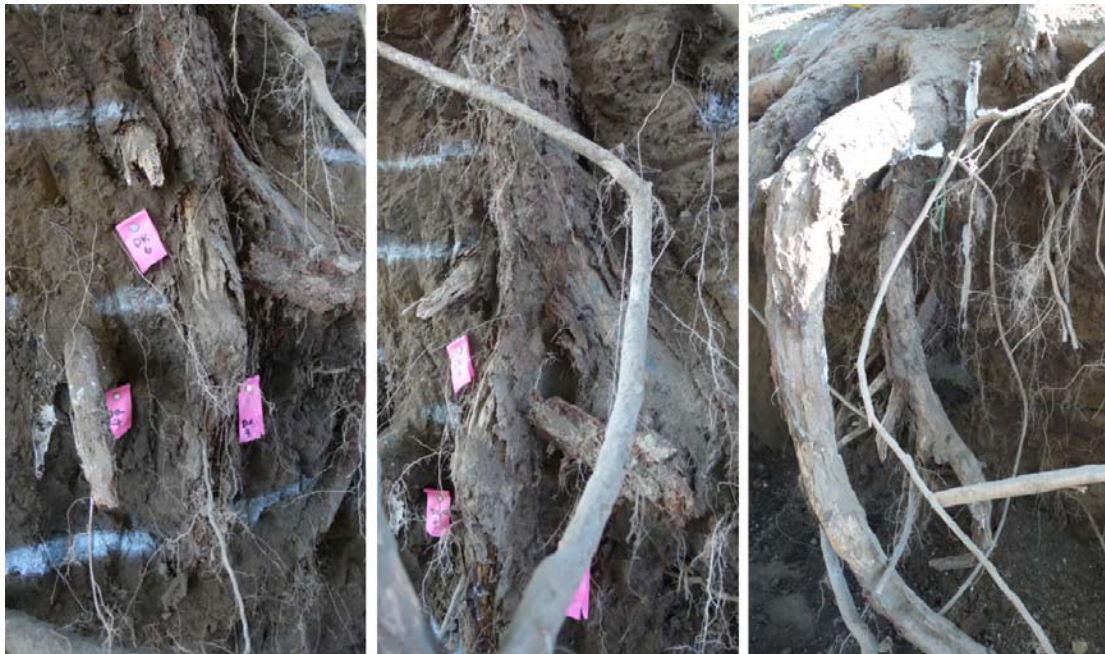
Figure 2-83. Typical appearance of decomposing roots encountered. Bark was fragile and discontinuous in many places. Annular spaces are seen on larger roots. Photos by Richard Evans.

initial lower trench wall. The silica slurry had traveled down the back of the root and a small volume turned to the west following the bend in the root. The silica traveled a tortuous path of approximately 5 feet in total length. Another prominent root was revealed to the east and silica staining was also found on this root likely originating from its connection with Tensiometer T4A-18. Typical decomposing roots encountered are shown on Figure 2-83. Examples of annular spaces were most common in larger roots, likely because these spaces were larger and more noticeable. Figure 2-84 shows some examples of annular spaces and hollowed roots.

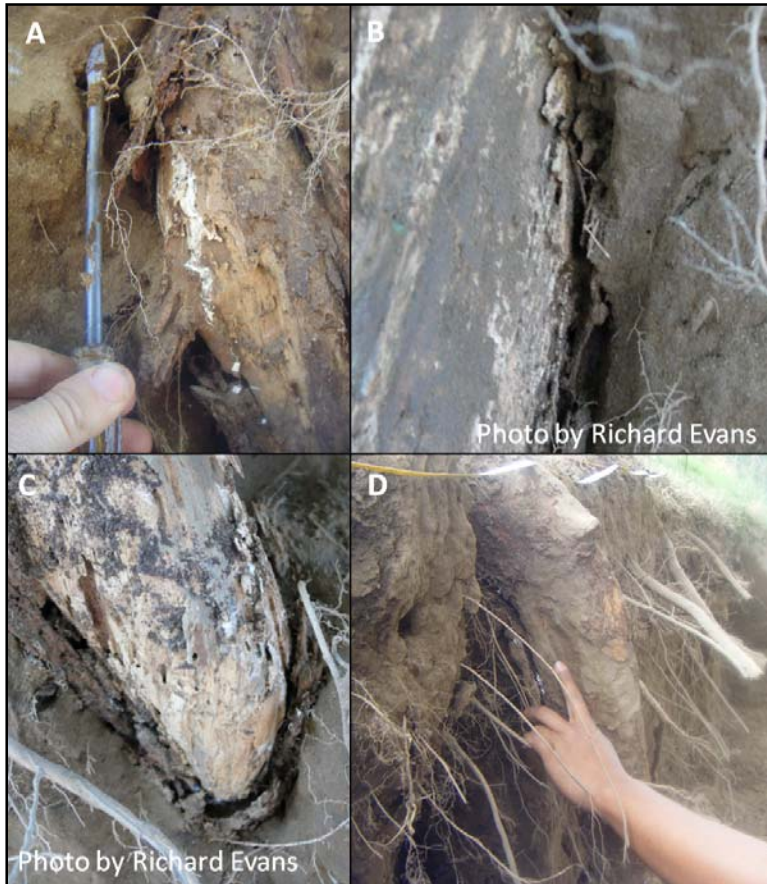
Figure 2-84. Examples of discontinuous annular space found in some decomposing roots. Many decomposing roots did not display this gap

Annular spaces or voids, as shown on Figure 2-84, were observed in some form in approximately 39% of the roots intersected. This included roots hollowed or cored in sections by biological activity as well as spaces between the woody root center (xylem) and the bark, or the bark and the soil. In general, annular spaces were not noted in roots smaller than 1 inch in diameter. These spaces can be difficult to positively identify for smaller roots. Annular spaces were noted to be absent in 24% of the roots intersected. while for 37% the presence or absence of these spaces was not clear and therefore not noted.

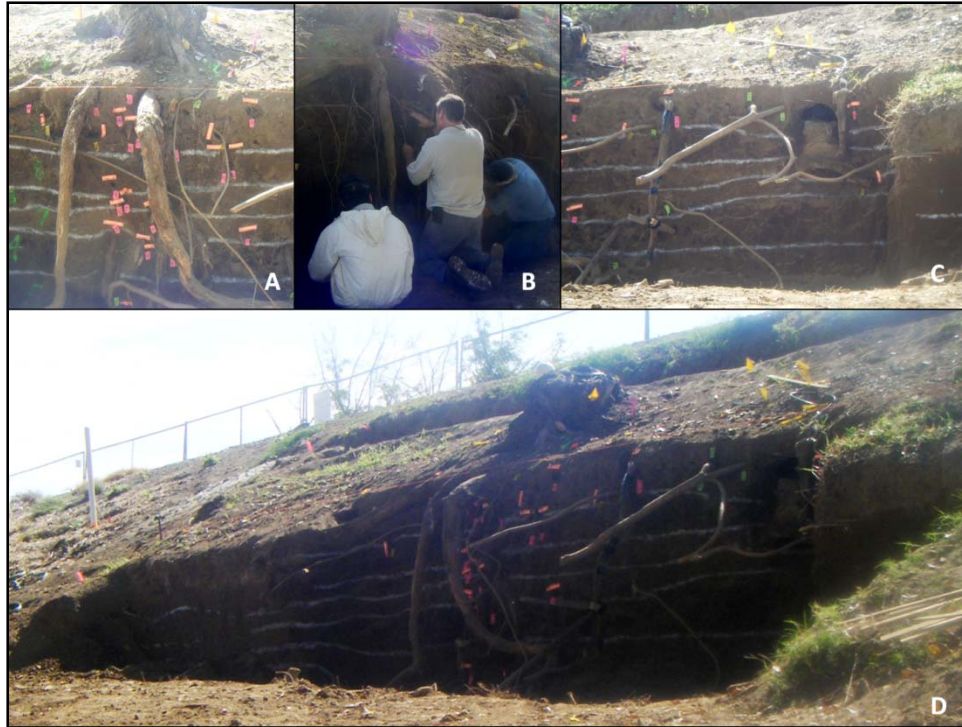
Figure 2-85. Slice 1 wall surface

Figure 2-85 provides an overview of findings from the excavation of 'Slice 1'. Live roots smaller than about  $\frac{1}{2}$  inch in diameter were cut as they interfere with T-LiDAR data collection. Figure 2-85B shows the excavation team exposing the decomposing root system through manual excavation. In Figure 2-85C, the burrow can be seen prior to removal of overburden soils. Portions of the burrow could not be grouted as seen in the photograph.

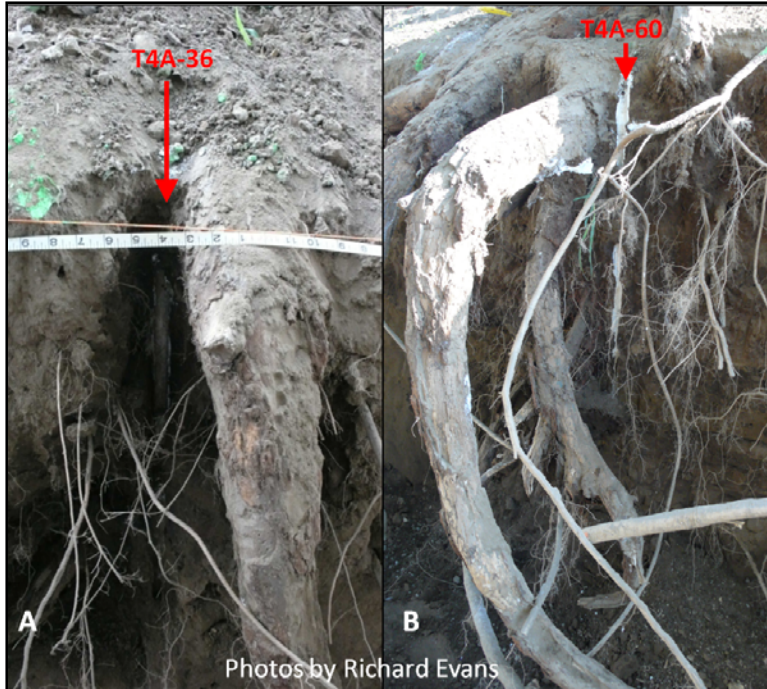
Figure 2-86. Hardened silica slurry associated with tensiometers T4A-36 (left) and T4A-60 (right) is discovered. Flow paths were observed showing that silica flowed through a burrow or void when a direct hydraulic connection was present.

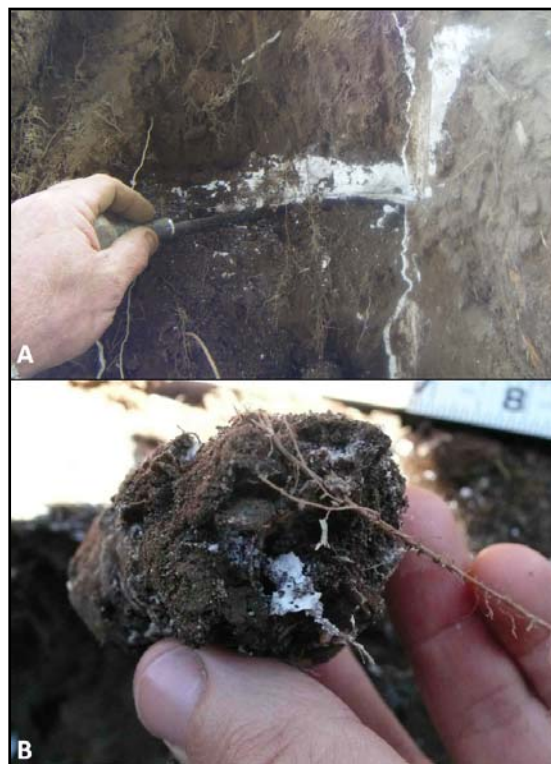
Figure 2-87. Silica slurry freely flowed in burrows (as shown in A) and void spaces within roots (as shown in B) when a direct hydraulic connection was available (or present).

Throughout excavation, examples were uncovered of silica slurry flowing in animal burrows, in burrows within the woody core of the root (Figure 2-87), and even for short distances into loose soils (Figure 2-87A and C). With the exception of mammal burrows, the annular spaces were generally not sufficiently continuous to permit liquid silica slurry to flow far or to conduct large volumes. In general, the decomposition process of a root was found to be heterogeneous and segments where a clear gap was visible were followed by segments where the bark (Figure 2-88) or even the entire root (Figure 2-89) were so decomposed that all that remained was a hole with a loose fill of organic matter and soil. Depending on the stage of decomposition, voids may fill with surrounding soils and decomposed organic matter. Figure 2-90 illustrates examples of decaying roots exhibiting a space between the woody center and the bark and where sand has infilled the annular space of these root sections.

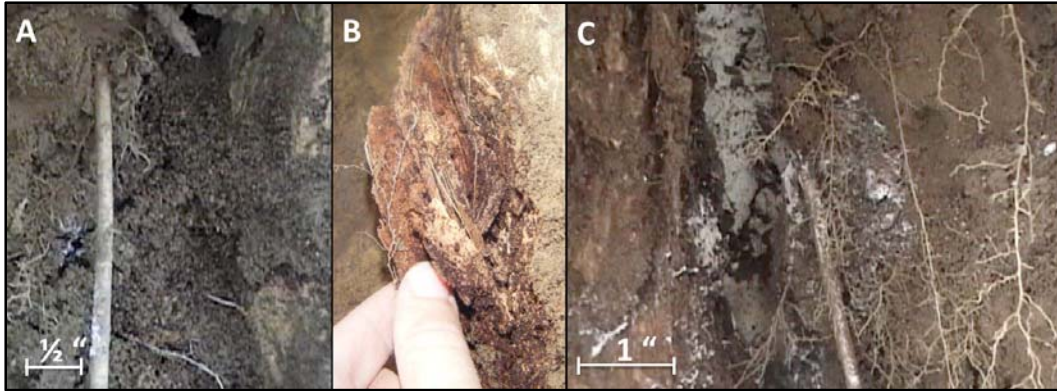
Figure 2-88. Bark fully decomposed with annular space between the woody core and bark, loosely filled with decomposed organic matter and soil (A and B). White silica slurry in Photos A and C are from a tensiometer intersecting loose organic soils and the silica slurry permeating the void space for a short distance.

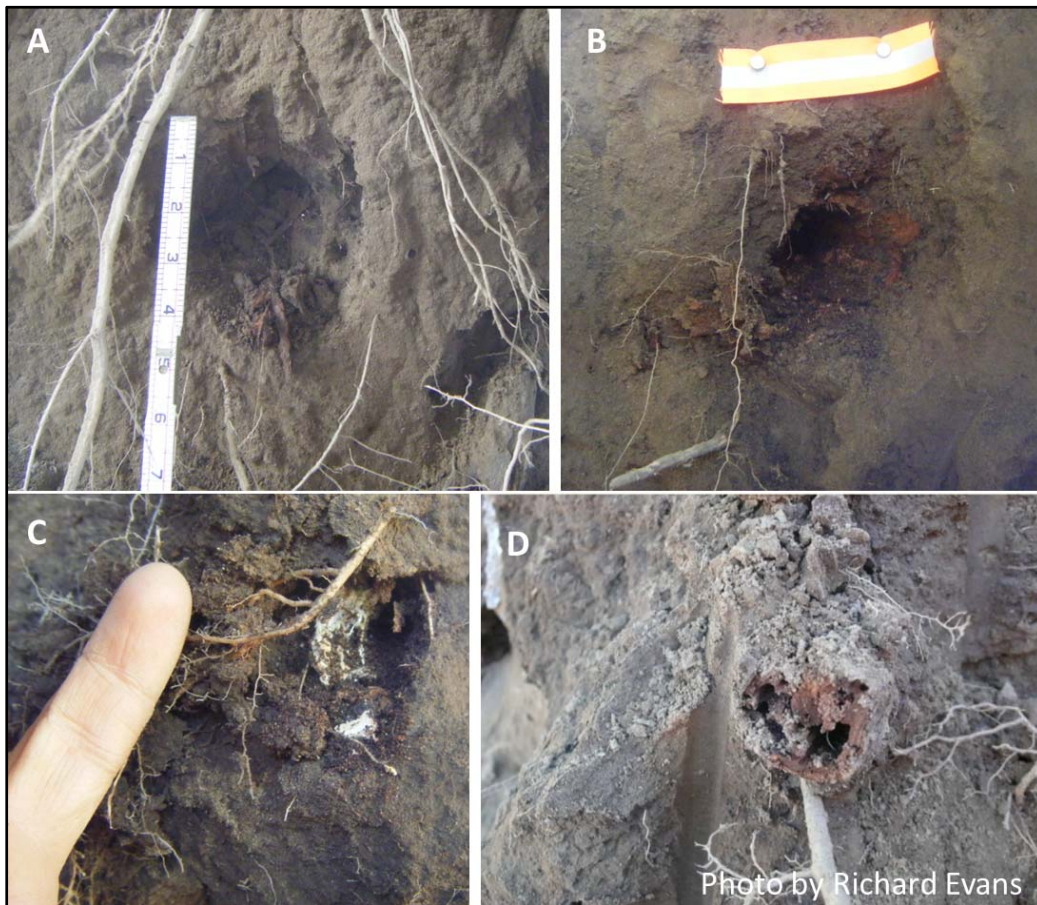
Figure 2-89. Roots can leave a void where they become completely decomposed and surrounding soils and live roots have not yet in filled the void. The root in Photo D has likely been subjected to decomposition from biological activity.

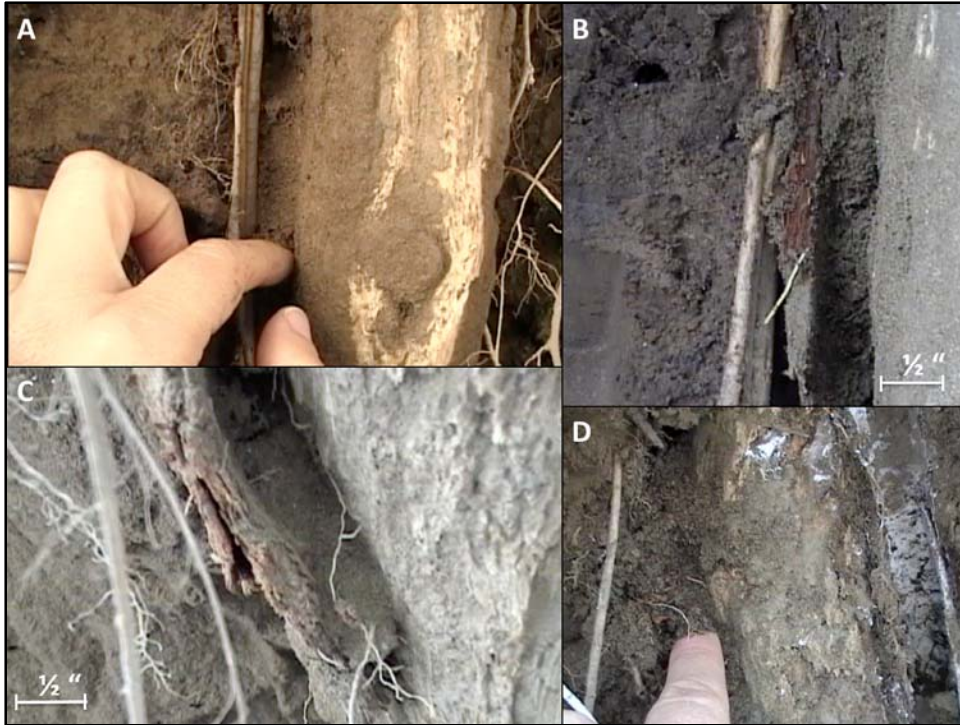
Figure 2-90. Photos A through D are examples of sands in-filling void spaces present between the decaying roots woody center and the bark. In Photo B, from right to left we see the woody core, an infill sand layer, a layer of decomposing bark, a live root, and then the surrounding soil matrix.

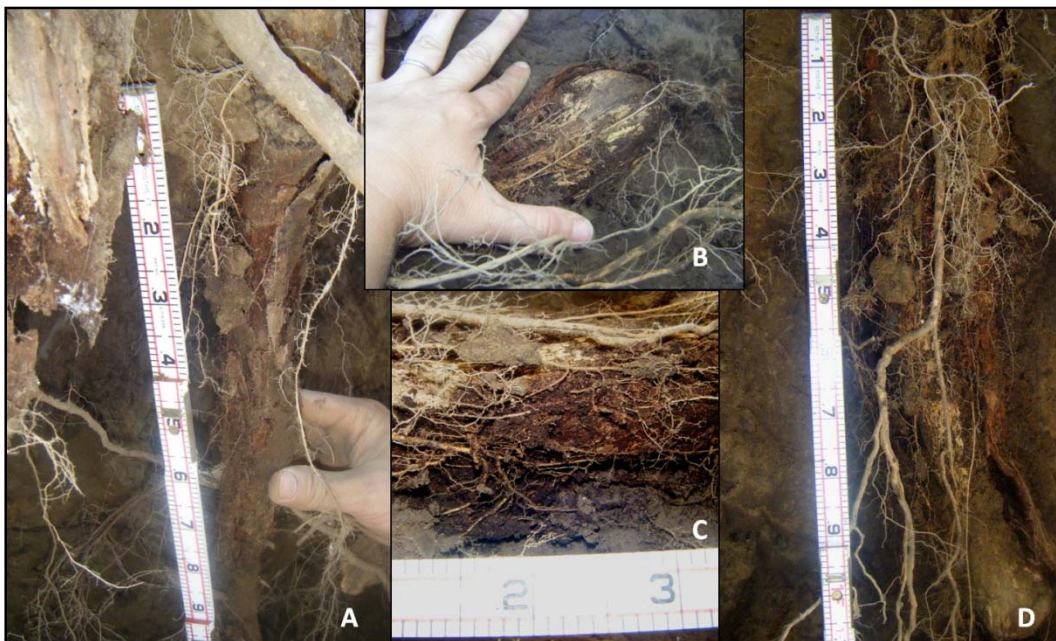
Figure 2-91. Live roots frequently observed growing within the decomposing organic matter of old root systems.

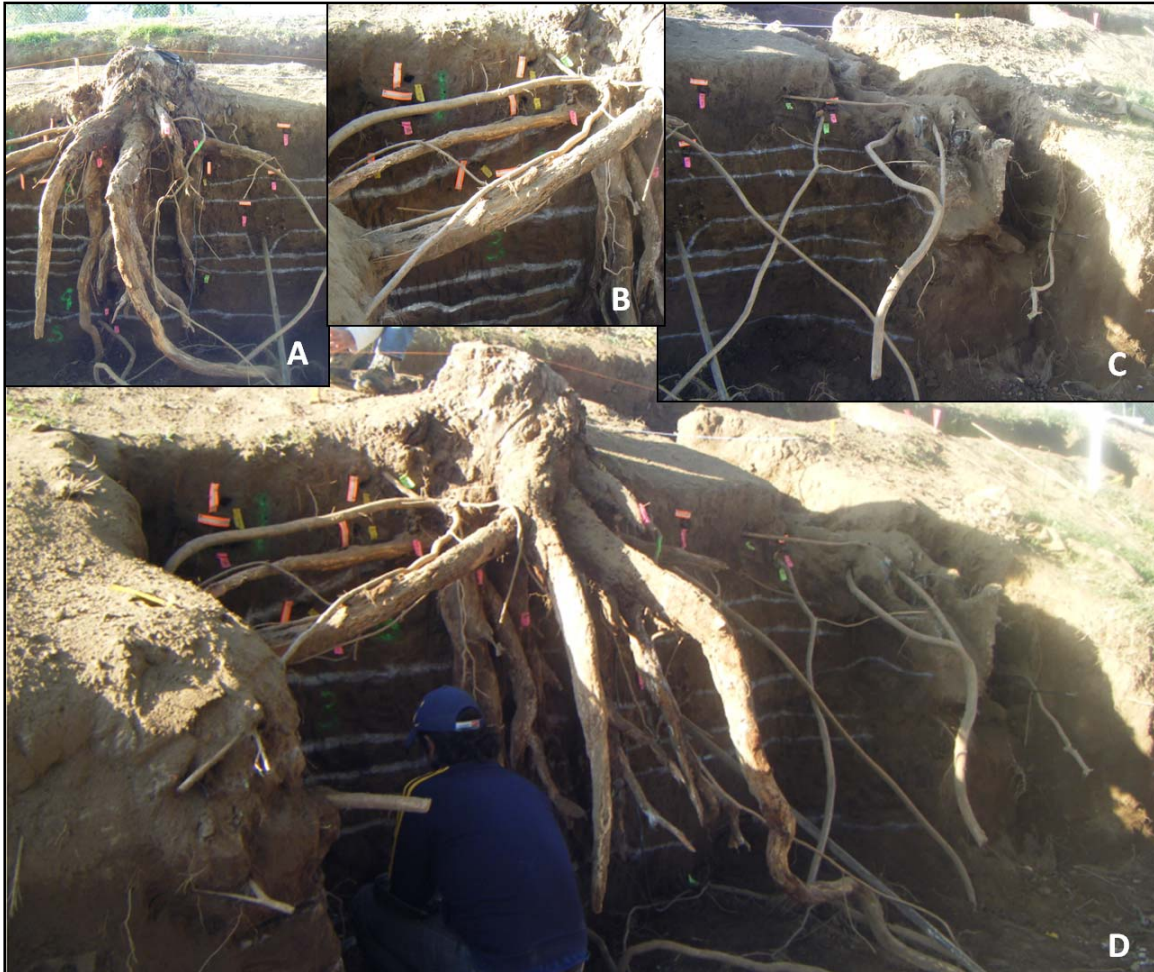
Figure 2-92. Final position of 'Slice 2' at the time of logging and before T-LiDAR scanning. Note presence of burrow networks between the root system in Photo B (indicated by vertically-oriented orange nylon strips). Photo C shows the newly revealed burrow casting at Station 138.25.

Figure 2-92 illustrates the final wall face following excavation of Slice 2. At this time, the gopher burrow (grouted) at Station 138.25 has been revealed and the root architecture of the stump has begun to take shape. Burrows were present in the vicinity of the stump, though animal burrows were present in large numbers throughout the site and did not seem to be more common at the stump than in other areas of the site, as discussed in a subsequent section. Once uncovered, the gopher burrow casting at Station 138.25 was cleaned and undermined slightly in several places to capture its dimension with a T-LiDAR scan. The casting was painted orange for photographs.

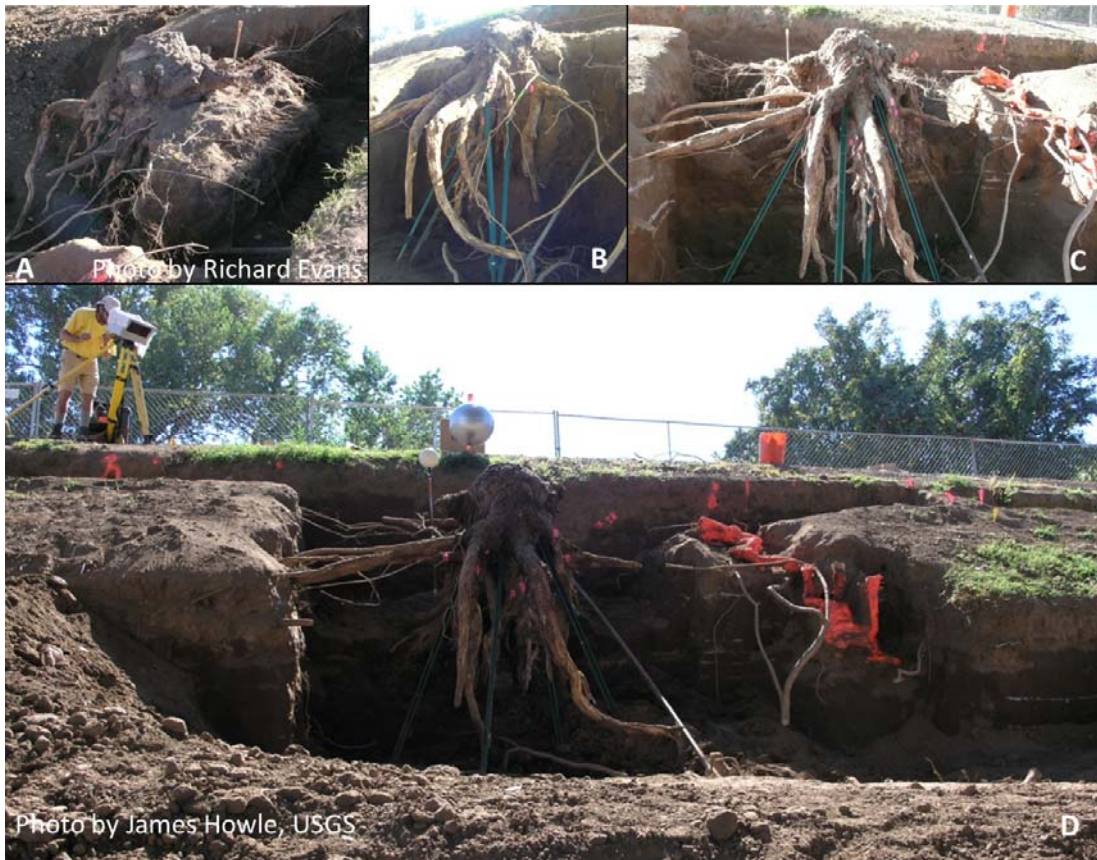
Figure 2-93. View of stump excavation following removal of ‘Slice 3’ soils. Photo A is a view of the stump from the crest of the levee looking down into the upper trench. Photos B through D show the stump from varying angles. Photo D also shows T-LiDAR scanning in progress.

removed. A segment of soil was left behind (Figure 2-93A) and below the stump, supports rods added, and additional soils were removed just prior to the final T-LiDAR scan. Figure 2-93 shows the final slice from multiple angles. Figure 2-93D shows the final wall face of Slice 3 and provides a perspective of the proximity of the stump and root system to the burrow (cast painted orange) that allowed over 19,000 gallons to pass from the upper to lower stump trench during the 6 day flow test.

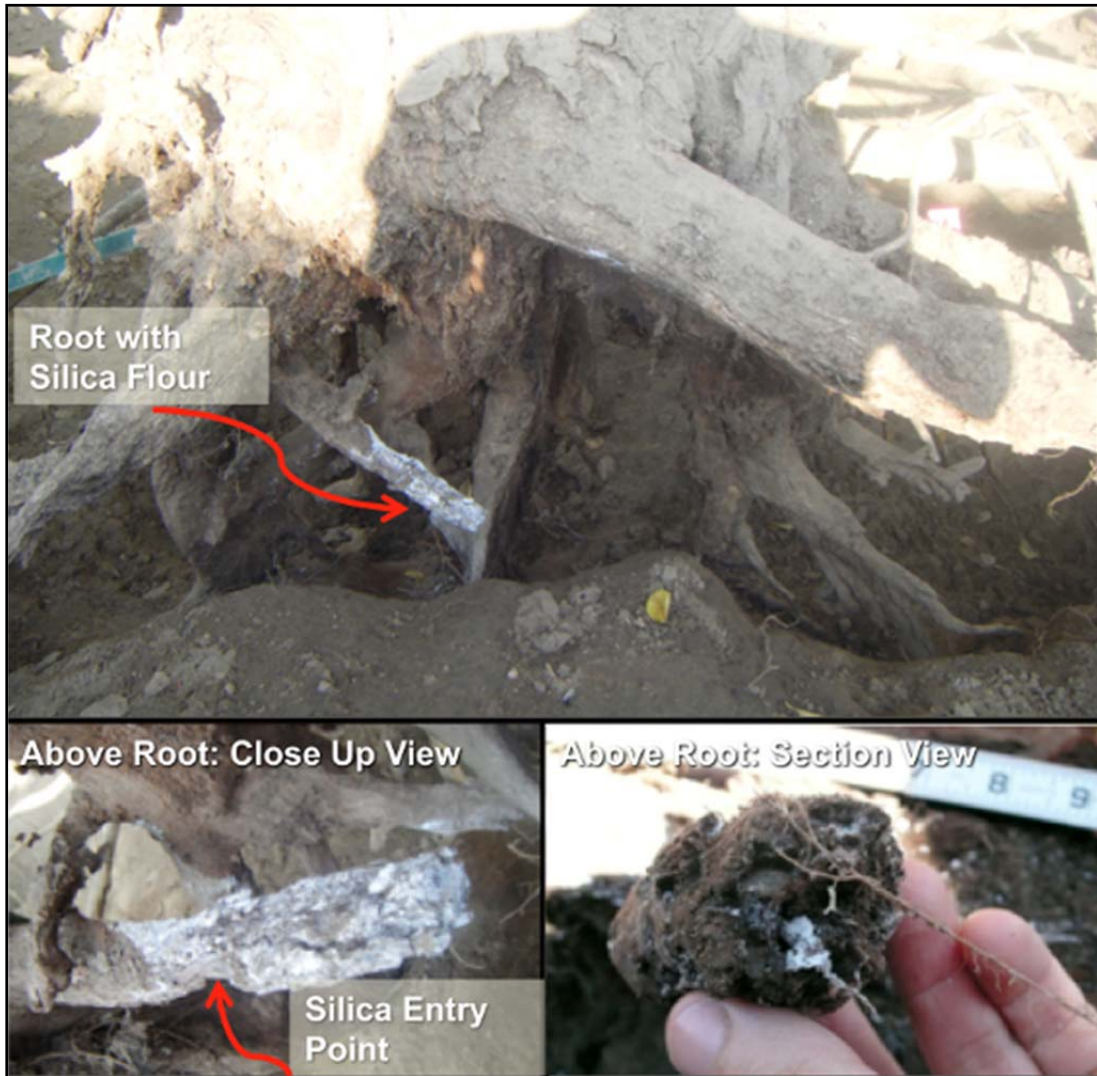
Figure 2-94. View root system of the decomposing stump looking north from the upper trench (top). Note migration of silica flour through a path directly traceable to a location where the installation of a tensiometer penetrated the root.

Once the final logs and T-LiDAR scanning were complete, additional excavation was performed behind the stump and then beneath the stump to reveal and photograph more of the root system. The excavation effort behind the stump revealed few roots extending into the levee uphill of the stump (Figure 2-94 and Figure 2-95). Figure 2-94 shows another example of a root that had been pierced by a tensiometer on the uphill side of the stump. This root had begun to decompose inside the woody core of the root. When a tensiometer installation pierced this friable root, the silica slurry used to seal the instrument into the hole filled voids traceable to the tensiometer (Figure 2-94).

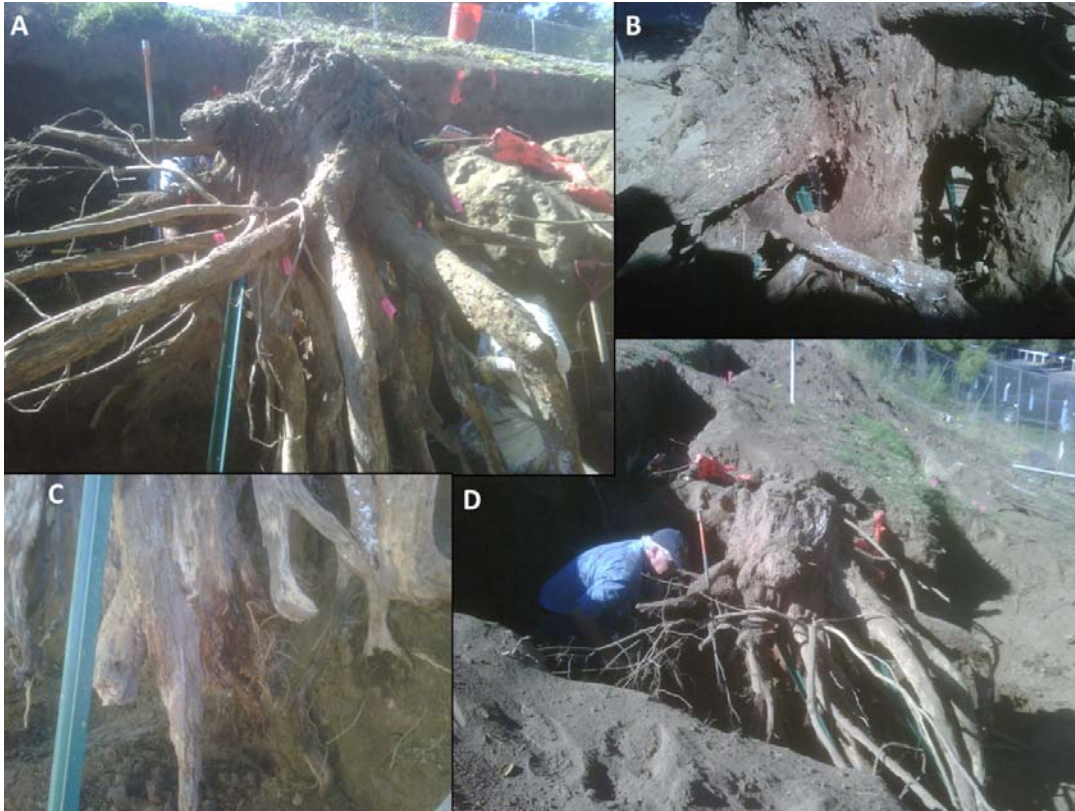
Figure 2-95. View of the excavated eucalyptus stump looking A) southwest from the former location of the lower trench, B) north from the upper trench, C) south at the roots at base of stump, and D) west from between the upper and lower trenches as Richard Evans, UC Davis, inspects the roots system from the uphill side.

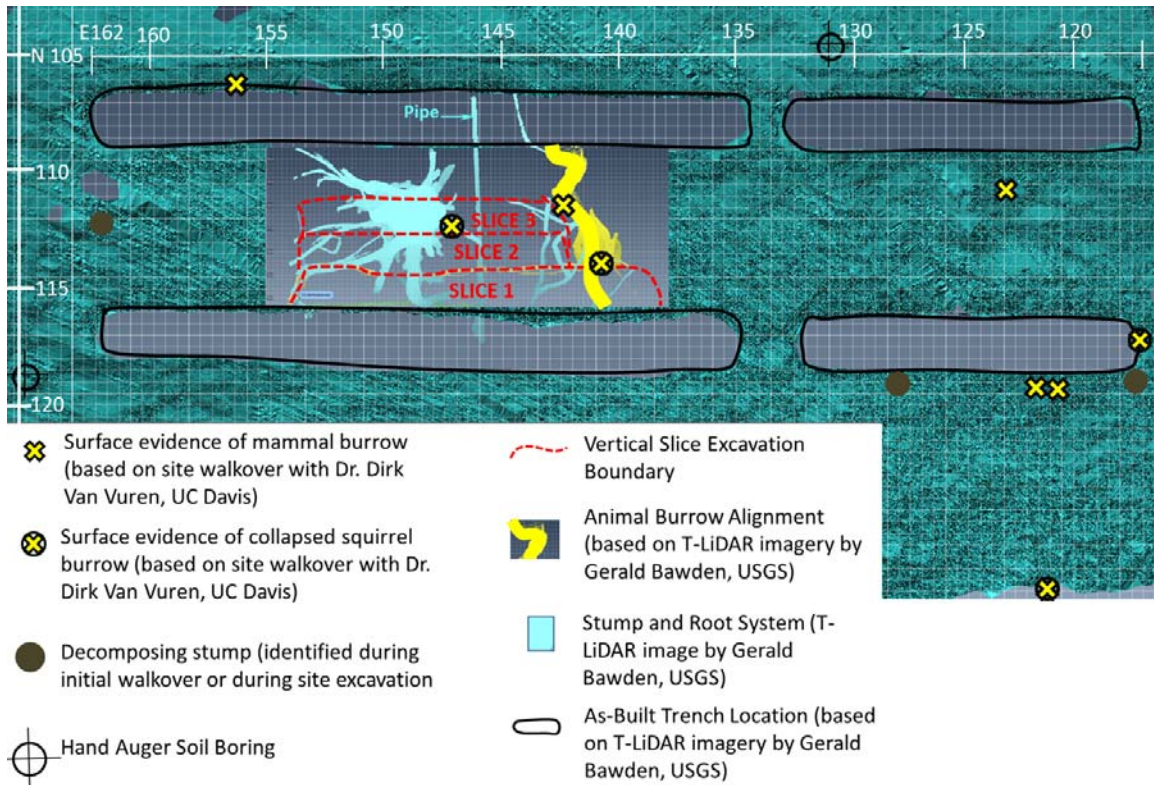
Figure 2-96. As-built site plan showing T-LiDAR scans of root system and burrow (provided by Gerald Bawden, USGS) at Station 138.25.

The soil ‘slices’ were placed in the coordinate system developed for the site (Figure 2-96) and radial distances from the stump center were calculated for each of the decomposing roots logged in each slice. The data was merged into a single database and categorized by root size, radial distance from stump, degree of weathering and presence or absence of void spaces creating a potential hydraulic conduit through the root.

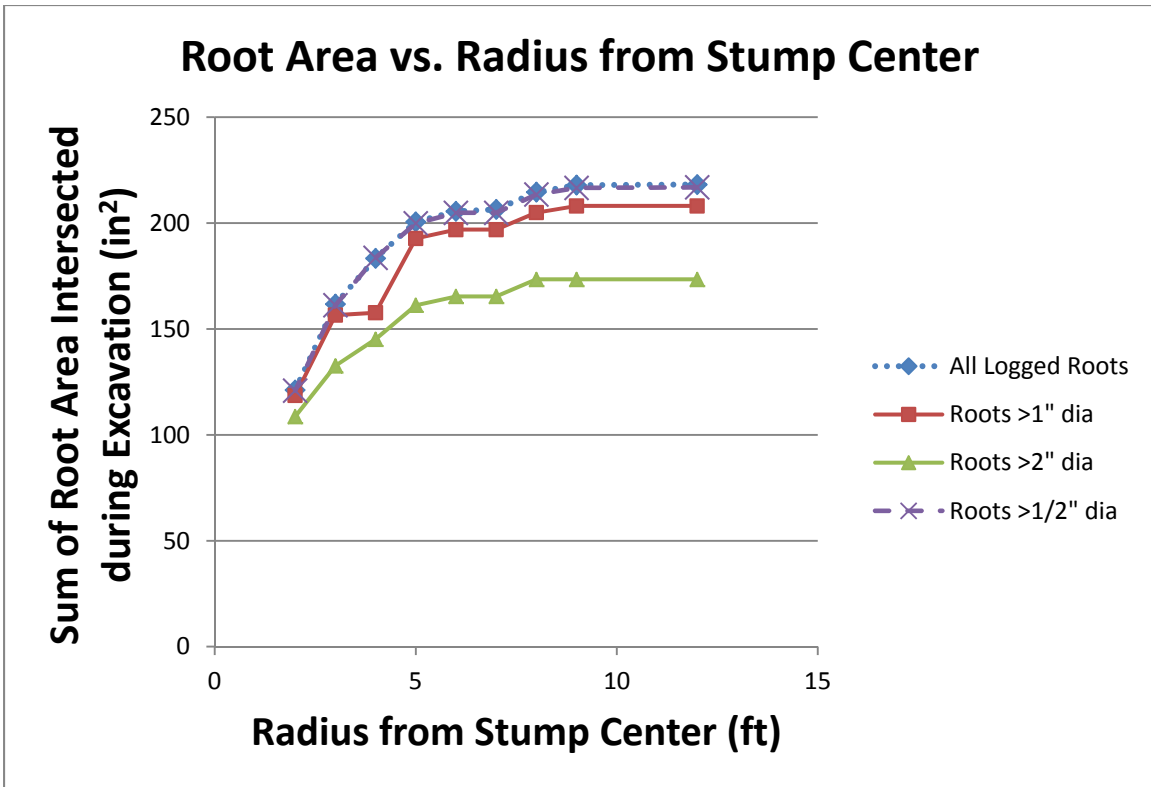
Figure 2-97. The area of each root intersected was calculated and sorted by distance from the stump center. The chart shows the cumulative sum of root area from the center of the stump extending radially outward

Figure 2-97 provides a plot of the total root area with distance for each size category. It should be noted that roots smaller than about ¼ inch were not logged. Removal of all roots down to ½ inch in diameter would require excavation of up to twelve (12) feet in diameter around this Eucalyptus stump. Removal to a radius of eight (8) feet is estimated to remove 98% of root matter, while a removal radius of five (5) feet would result in a 92% removal of root matter. These estimates assume an excavation depth of six (6) feet.

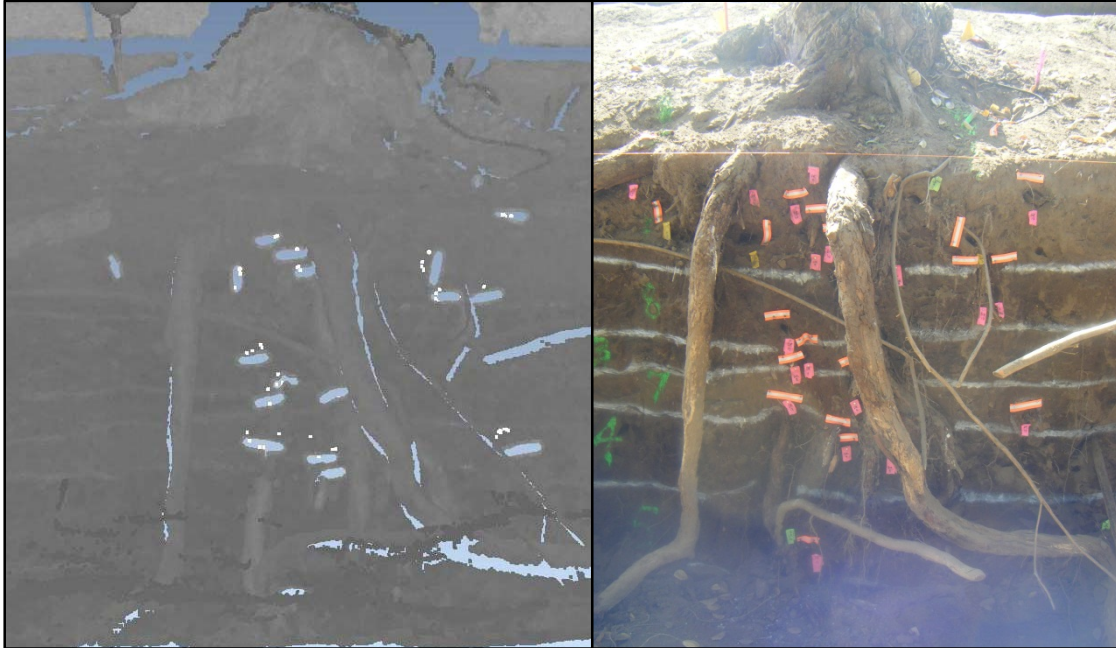
Figure 2-98. Slice 1 comparison between T-LiDAR image (left) and photograph (right). Note reflectors in T-LiDAR image indicating burrows (vertically oriented) and decomposing roots (horizontally oriented). Source: Cobos-Roa et al. 2012.

T-LiDAR scans were taken to generate a three-dimensional model of the pre-test site condition, excavation walls and flow test site, and throughout excavation efforts to expose the root system. Reflective targets were placed next to roots and burrows (Figure 2-98) and metallic paint was used to highlight the different stratigraphic contacts, thus allowing the T-LiDAR to capture these features given the reflectance contrast between the reflective strips, metallic paint and moist soil (Cobos-Roa et al., 2012).

Figure 2-98 shows a comparison between a T-LiDAR image and a photograph of the site at the same time, following removal of the first segment of soil - 'Slice 1'. Stratigraphic contacts, live and decomposing roots, and reflective targets are visible in the T-LiDAR image. The points gathered can be digitally processed into 3D images of the entire root system. In addition the technology facilitates taking measurements or making calculations that would be difficult to capture using other methods. Data can be managed in a 3D environment in the KeckCAVES at University of California Davis shown on Figure 2-99. Personnel from the USGS-Sacramento Western Remote Sensing and Visualization Center and the UC Davis KeckCAVES were able to use the center's facilities to isolate decomposing roots, burrows, and geologic layers so that they may be viewed separately.

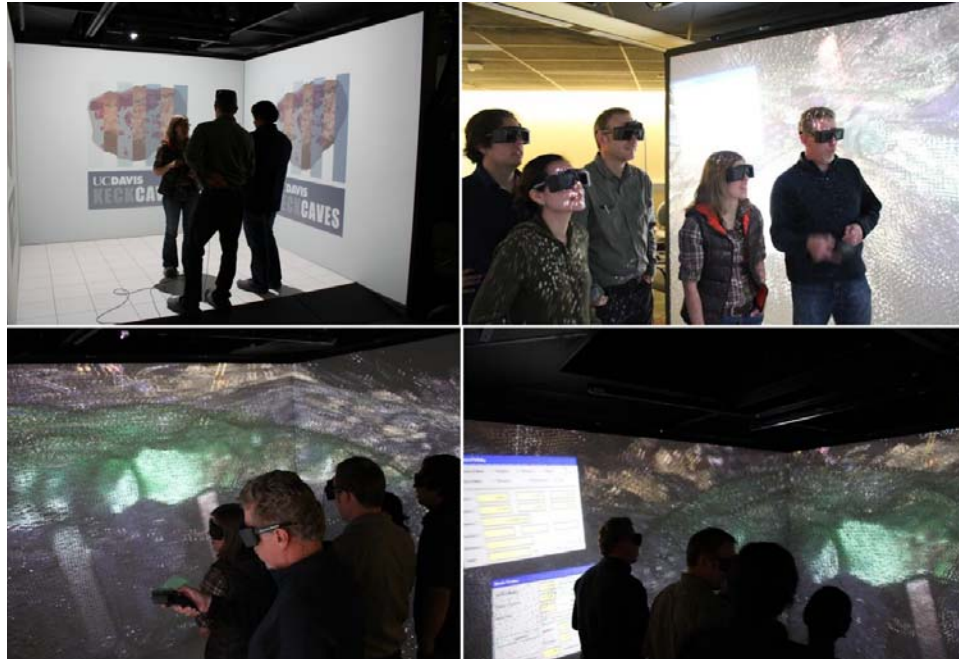
Figure 2-99. T-LiDAR data is viewed in 3D at the UC Davis KeckCAVES. Point clouds are selected and isolated, separated, relocated, and rotated through this user-friendly 3D interface. Gerald Bawden of the USGS gives the UC Berkeley team a tour. Photos courtesy of Mick Klasson.
