Static and Seismic Performance of California Levees

Michelle Jennifer Shriro

Doctor of Philosophy

Engineering - Civil and Environmental Engineering

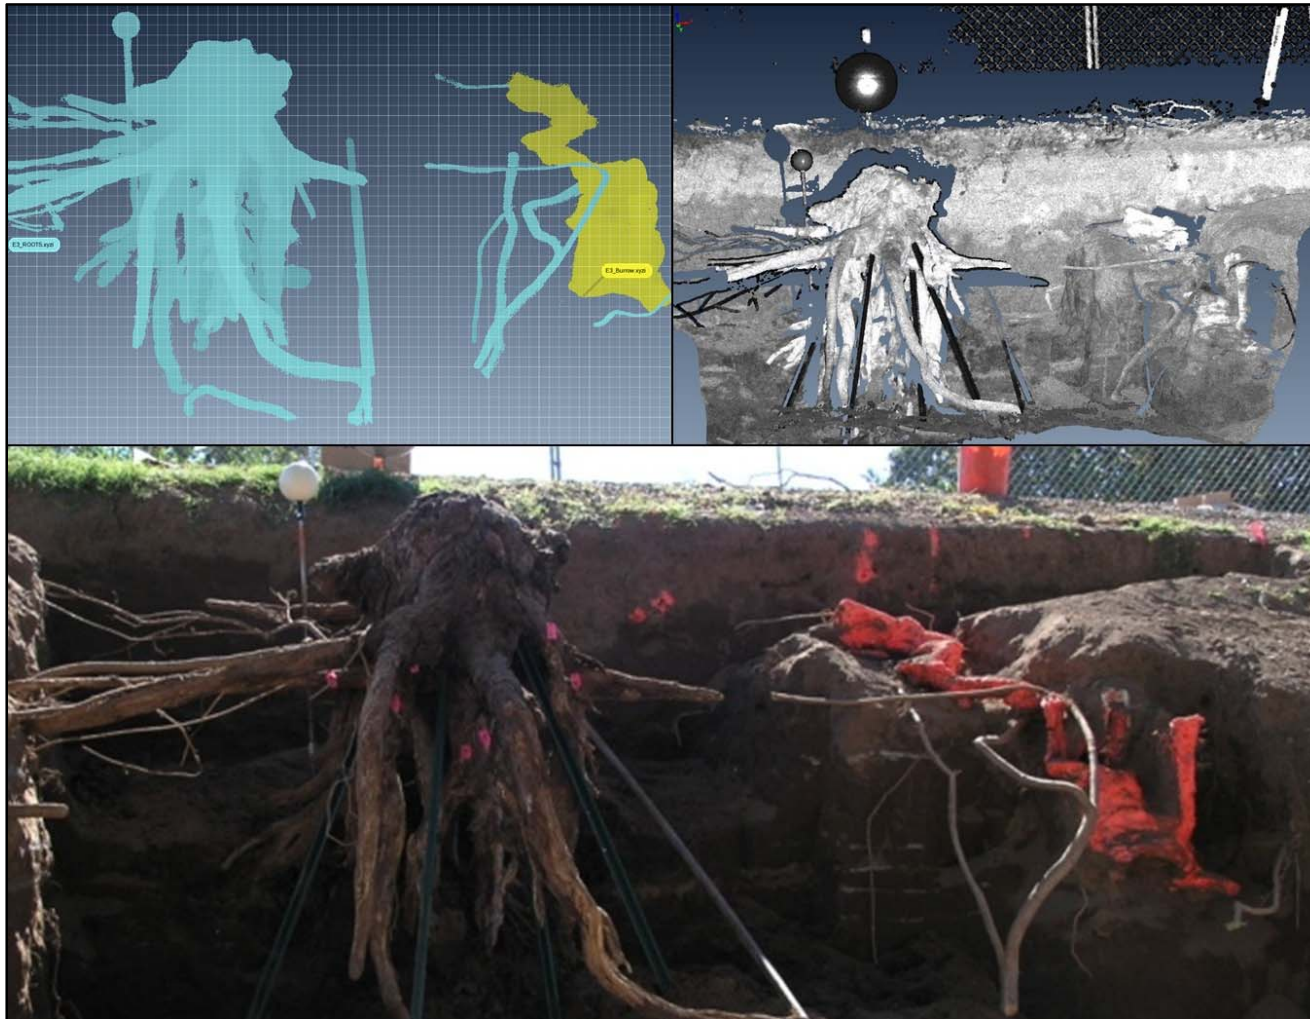
Figure 2-100. T-LiDAR images provided by Gerald Bawden of the USGS (top) looking south compared with photograph of root system (bottom) and burrow at Station 138.25.

Figure 2-100 provides a view of the completed excavation looking south with a corresponding T-LiDAR scan and a view where the live and decomposing root systems, pipe, and burrow are isolated for easier interpretation. Figure 2-101 is useful to visually understand the extent (in plan-view) of the decomposed root system. Fully decomposed roots are not included in this image. Scans were viewed in the KeckCAVE as a means of enhancing field documentation, sketches, and measurements. In Figure 2-102, the root system of the stump is isolated and this plan view image is useful in illustrating the path of silica flow during installation of tensiometers. Figure 2-103 and Figure 2-104 are additional T-LiDAR images generated from different vantage points to illustrate the different geometric characteristics of the root system. The T-LiDAR image in Figure 2-105 shows a view of the stump looking west as compared with a vectorized version of the root system generated from the data.

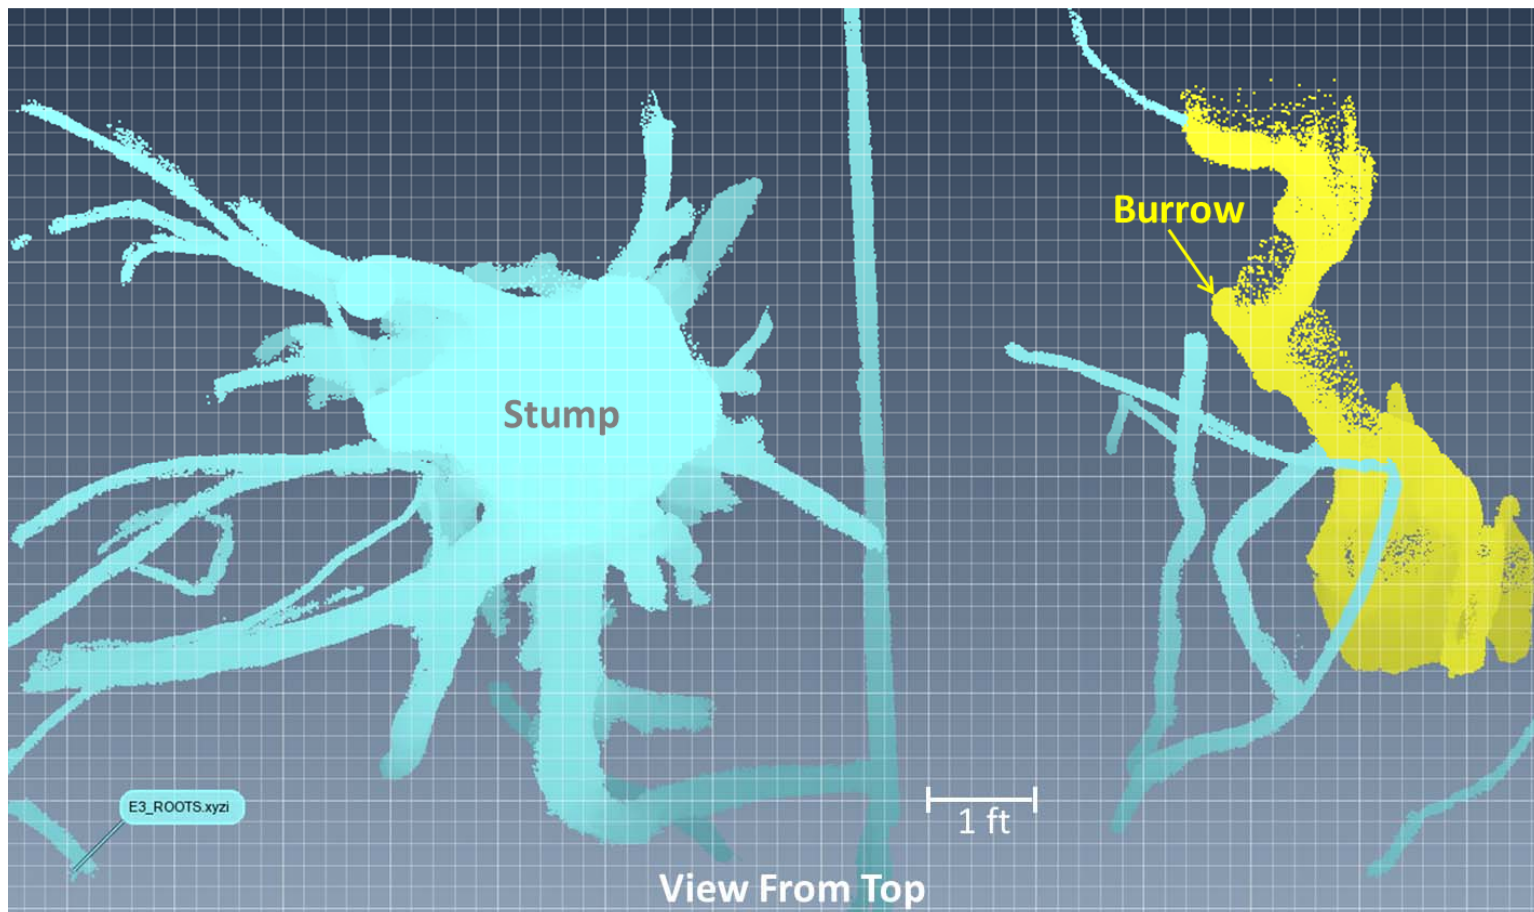
Figure 2-101. T-LiDAR scan of root system and burrow at Station 138.25 (provided by Gerald Bawden of the USGS). View is from the top. Most roots are decomposing roots related to the eucalyptus stump, but live roots are present, particularly in the vicinity of the burrow.

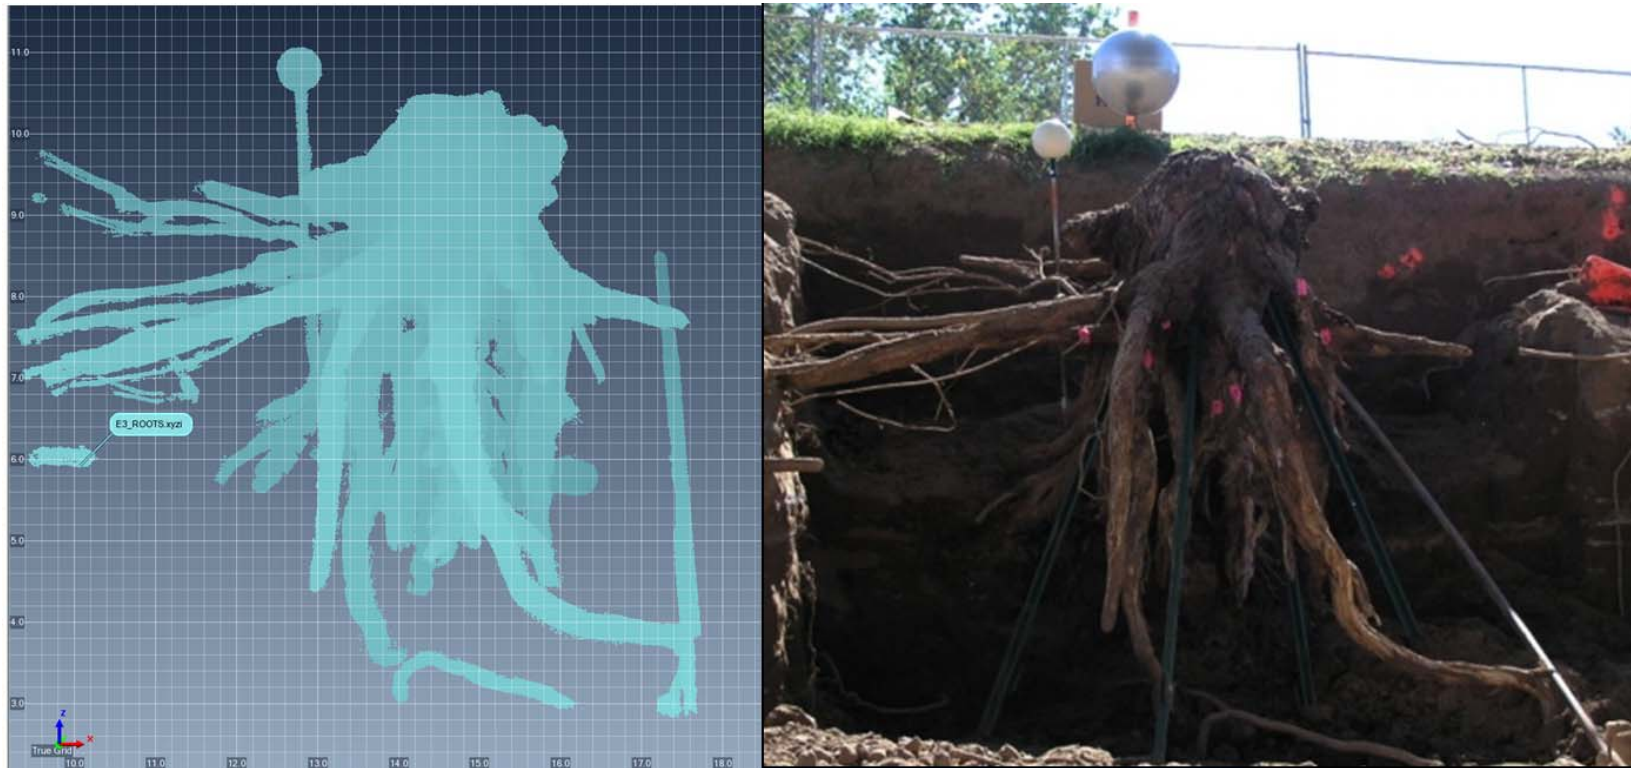
Figure 2-103. A south-facing view of eucalyptus stump and root system (right) and the corresponding point cloud image (left) derived from combining data from a series of T-LiDAR scans. T-LiDAR image courtesy of Gerald Bawden of the USGS.

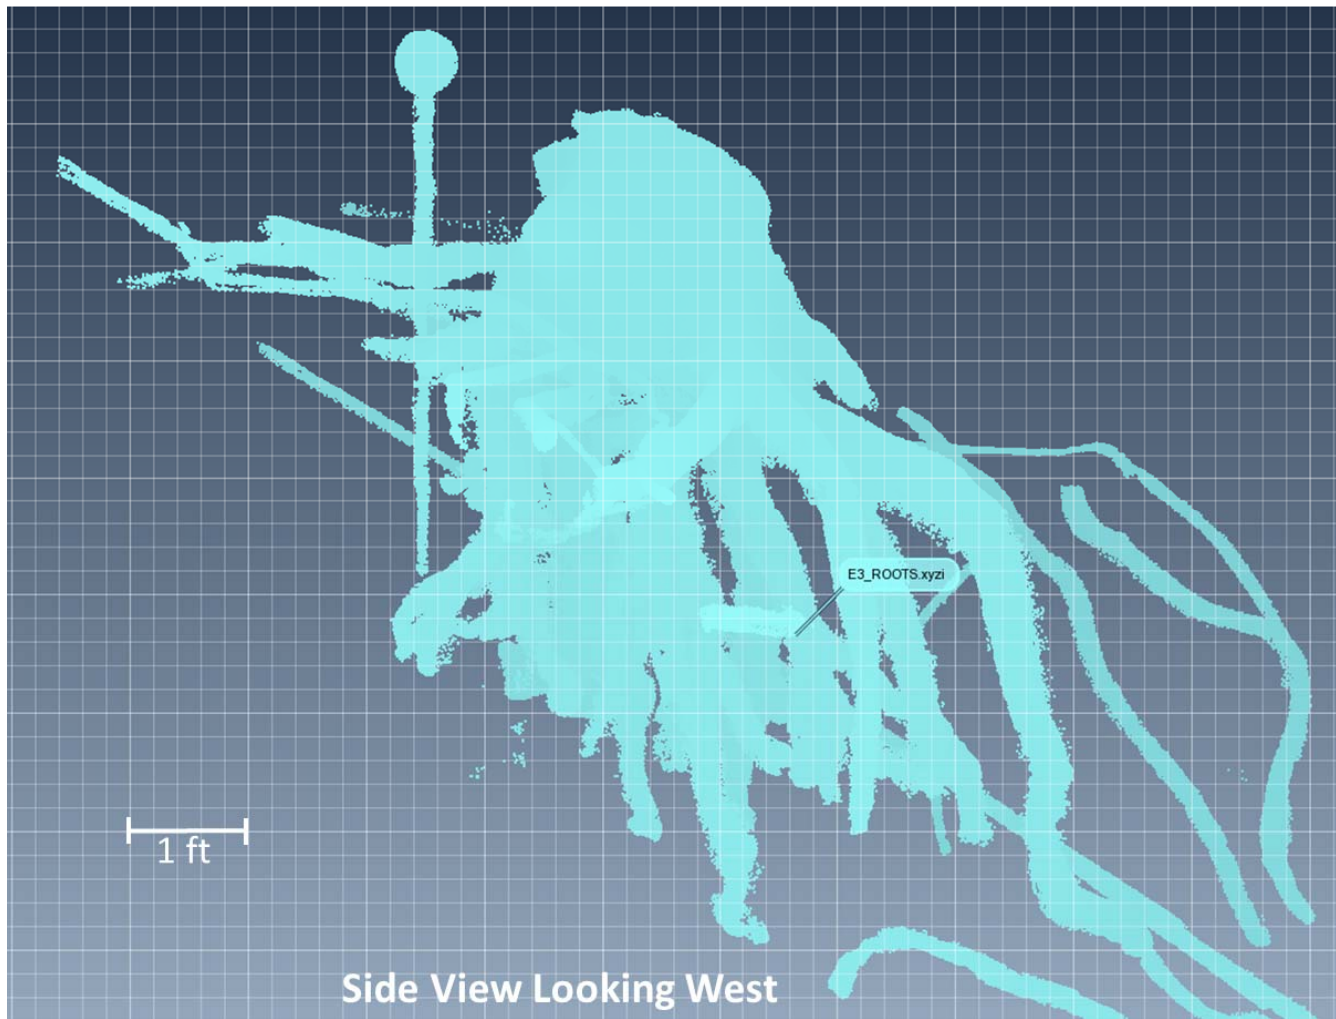
Figure 2-104. A west-facing view of the Eucalyptus stump and root system stitched together from a series of T-LiDAR scans (provided by Gerald Bawden, USGS).

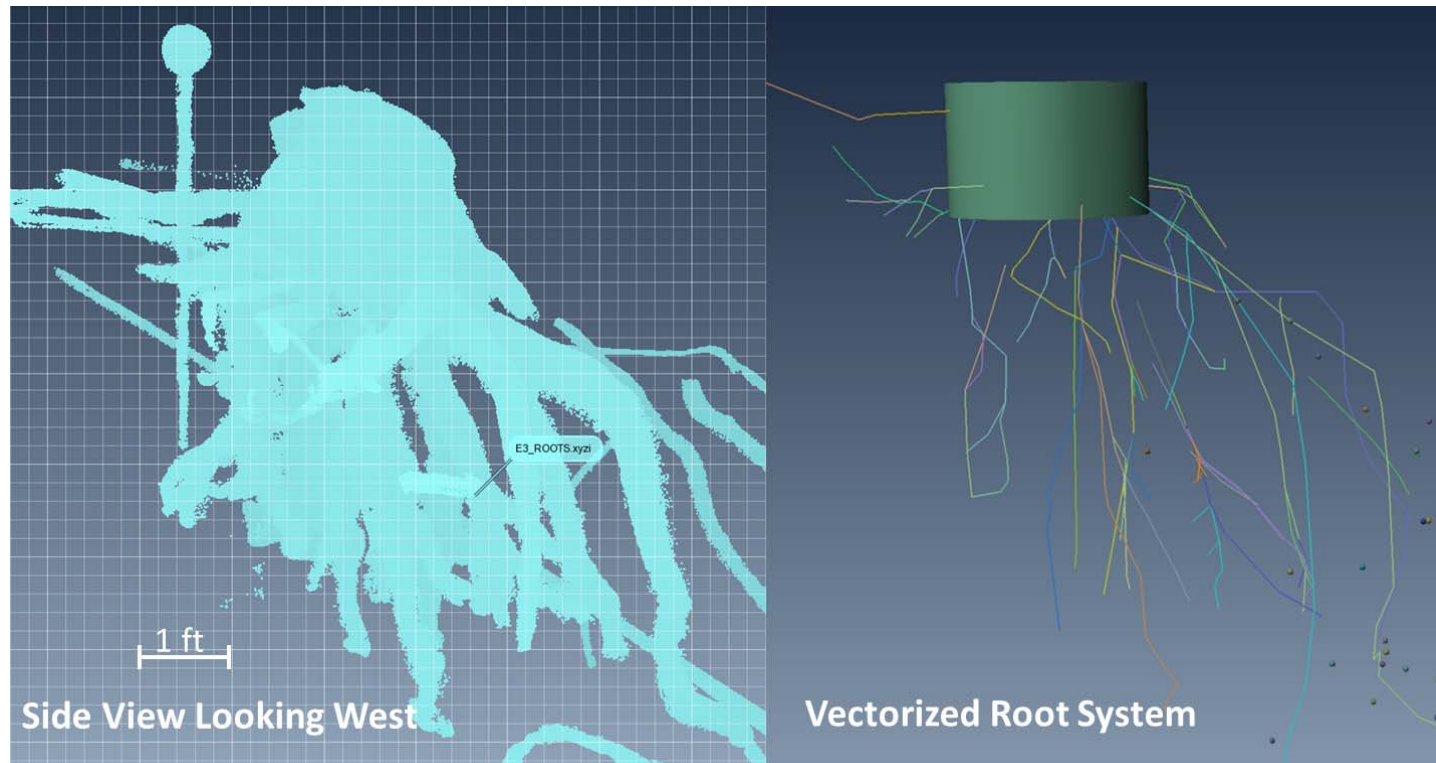
Figure 2-105. A view of the Eucalyptus root system as a point cloud generated from T-LiDAR scans (left) and a vectorized plot of the root system to aid in modeling efforts. Base source: Gerald Bawden, USGS.

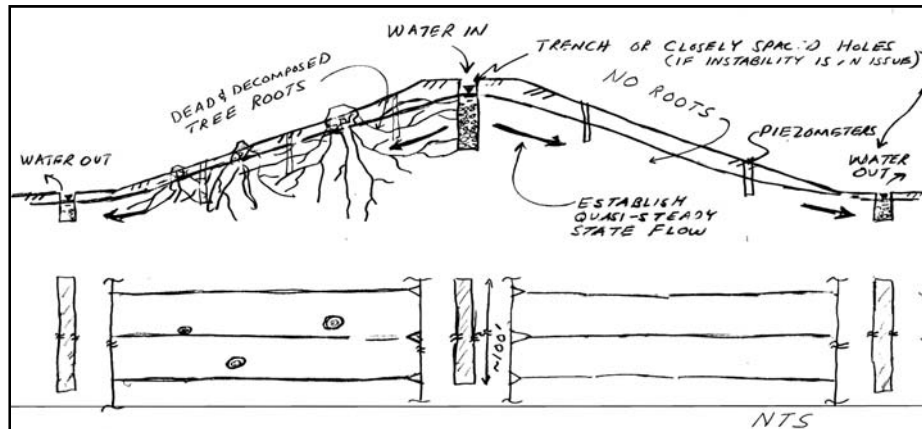
Figure 3-1. Conceptual sketch by Professor Jonathan Bray illustrating concept of crown trench seepage test.

A second field test focusing on achieving saturation of levee embankment soils through the root systems of live trees was conceived to further explore the effects of these root systems on the integrity of a levee. The concept of the Crown Trench Seepage Test involved excavation of an 8 foot deep trench through the levee crown and supplying the trench with water held at a constant head, simulating a flood condition where water is delivered from the center rather than the side. Instrumentation installed within the zone of flow captures positive and negative pore water pressures before, during, and after flow. A conceptual sketch of the second field test is provided as Figure 3-1. While the focus of the first field test was on the study of decomposing tree roots, the second field test was modified slightly to focus on the effects of live, native root systems to levee seepage and stability under conditions approximating steady state flow.

As discussed, the conceptual test design intended to simulate a flood condition where water is delivered into a trench through the levee crown rather than from the side. Upon site selection, the team modified the test concept slightly from that shown on Figure 3-1 to account for differences between waterside and landside site conditions. A control section and a study tree, the landside oak that was the focus of the study, exhibited the uniformity appropriate for a reasonable comparison to be made. As previously mentioned, given the layout of the site, with a waterside tree existing between the landside oak tree and a control section, the experiment was extended to include study of a waterside tree to be evaluated against a waterside control section. With the landside as the primary study site, the trench was shifted from the levee centerline toward the landside. A location was selected where the wall of the trench would be positioned approximately 3 feet from the hinge point of the landside slope. The new configuration allowed the 'tree trench' to intersect the root systems of both land and water side levee trees. In addition, a separate 'control' trench was constructed north of the tree trench, as shown on Figure 3-20.

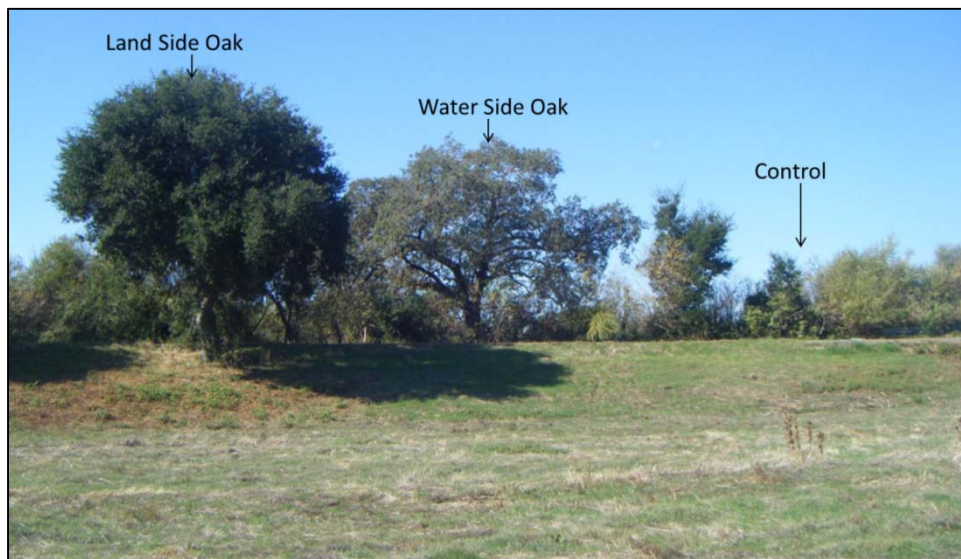
Figure 3-4. View looking west at landside oak, waterside oak, and study control section.

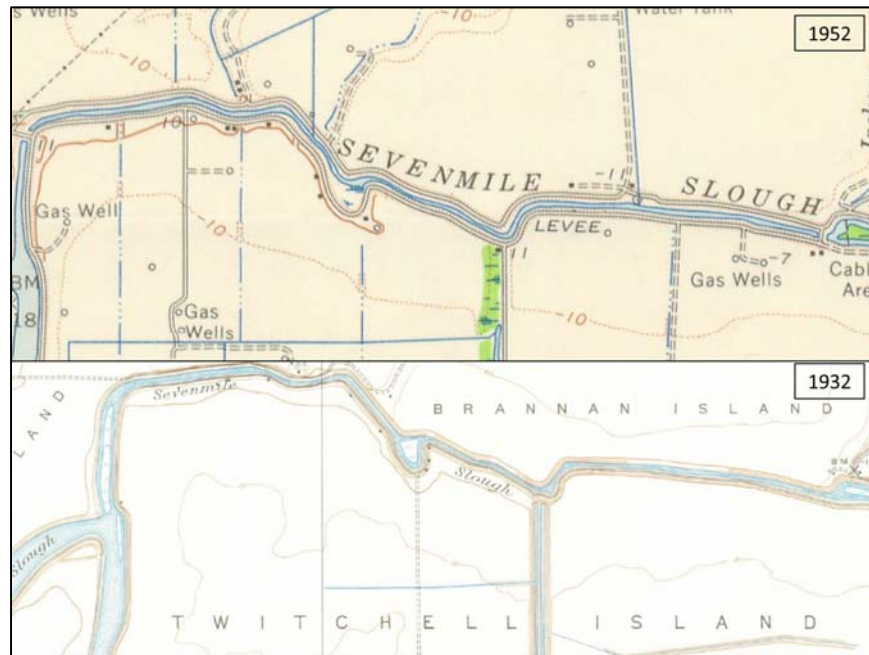
Figure 3-9. Historic topographic maps: USGS (1932) and USGS (1952). Note the position of structures have changed along the Sevenmile Slough between 1932 and 1952. A flow control gate has been installed by 1952 and the oxbow section appears to be wetland.

Historic topography and available historical documents were reviewed to provide an understanding of the age, construction methods, and materials used to construct the site levees. A historical account of reclamation of Twitchell Island and surrounding islands is provided by Thompson (2006). Twitchell Island, originally marshland, was reclaimed in 1869. Due to the presence of peat soils and high flows in the San Joaquin River at the southern border, the island suffered frequent floods between 1869 and 1875 and was temporarily abandoned. Levees were originally constructed to a height of 3 ½ to 5 feet with a 2 to 4 foot crown width. When this was found to be inadequate, levees increased in height by about 3 feet with a crown width of at least 6 feet and a base of 12 to 20 feet. Levees to the south were more problematic due to construction on peat foundation soils. Reclamation began again in 1894 and portions of the island were being leveed through 1904. Flooding problems continued in 1906, 1907, and 1909. In a 1910 topographic map, the levees appear to be in their current configuration. Flood impacts to northern levees, on firmer soils than southern levees, are not detailed. Figure 3-9 shows topographic maps of the site in 1932 and 1952. The Sevenmile Slough has been gated within this time window. High waters occurred in 1937 and 1950 (Paulson, 1988-89). Based on discussions with Mr. Rick Carter of RD1601, the gate was installed in part due to problems with scour. According to URS (2011), their engineer noted during a field reconnaissance interview that gate structures were constructed around 1950. The URS summary document also states that data related to levee segment improvements occurring between 1920 and 1960 were not available for review.

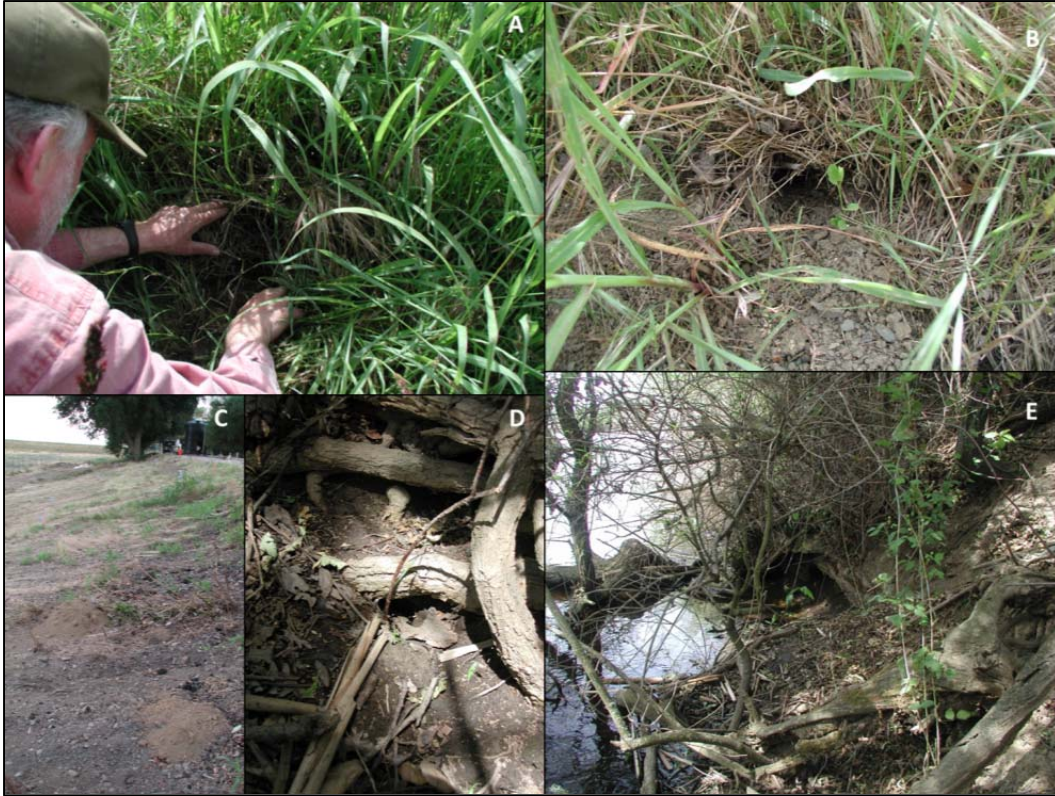
Figure 3-13. Evidence of burrowing animals on the landside consisting of voles (A and B) and gophers (C) and evidence of muskrats found on the waterside (D and E).

Dr. Dirk Van Vuren of UC Davis visited the site as the CLVRP team expert to evaluate the potential for burrowing mammals at the Twitchell Island study site. During a site walkover on May 2, 2012, Dr. Van Vuren identified evidence of vole activity on the landside (Figure 3-13A and B) and noted that pocket gophers are likely present at this site as well. He suggested both are likely to dig shallow burrows with exits on the landside of the levee. Blackberry makes for a protected burrow entrance as well as a food source (Ordeñana et al., 2012). Evidence of gophers appeared during trench construction (Figure 3-13C).

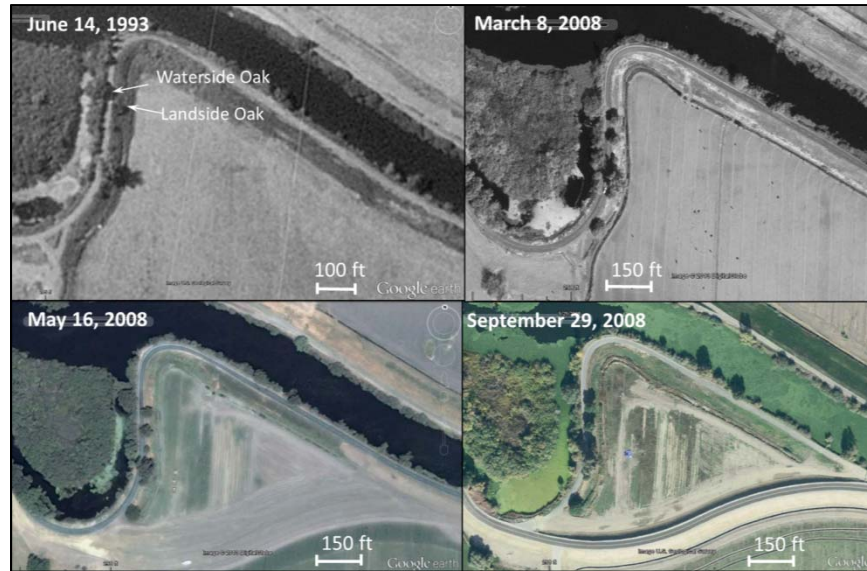
Figure 3-18. Image of the study site in 1993 showing a small, but present, landside oak. Images between March and September of 2008 show the construction of the levee bypass.

The waterside Valley oak can be seen in the 1993 aerial image as shown in Figure 3-18. The tree appears to extend farther into the levee road in 1993 than in subsequent years which may indicate an increasing lean angle or pruning. Figure 3-18 shows the construction of the bypass levee in 2008, serving as both flood protection and a paved primary access road along the north side of Twitchell Island and diverting traffic flows from the site under study.

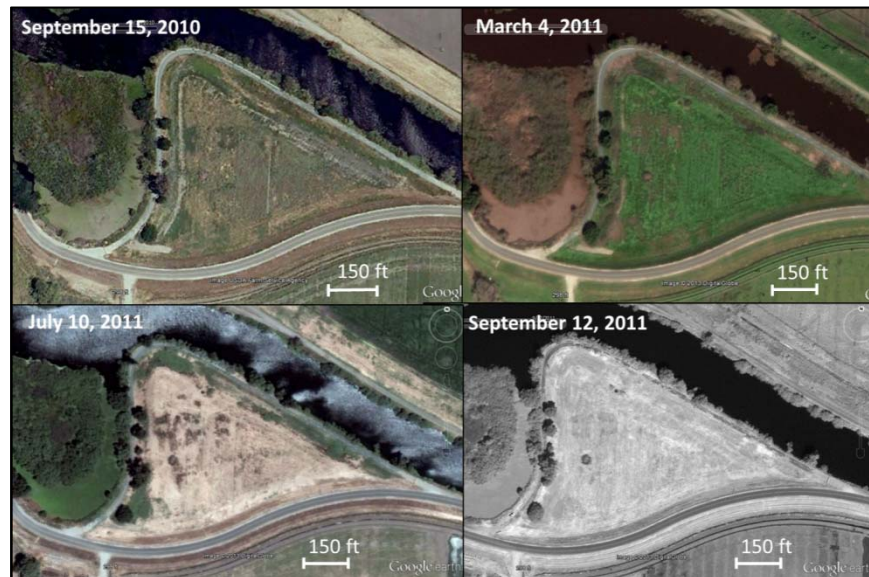
Figure 3-19. Aerial imagery in the years before the flow test show minor re-grading in 2011 to remove a toe ditch abandoned during the bypass installation.

In September of 2008, an irrigation ditch interrupted by the bypass levee can be seen abandoned. Figure 3-19 shows the ditch intact in 2010 and overgrown or possibly removed by July of 2011. The site appears to have undergone minor re-grading by September of 2011 with the toe ditch completely removed in this photograph. The ditch was located at the toe of the landside levee within our study site.

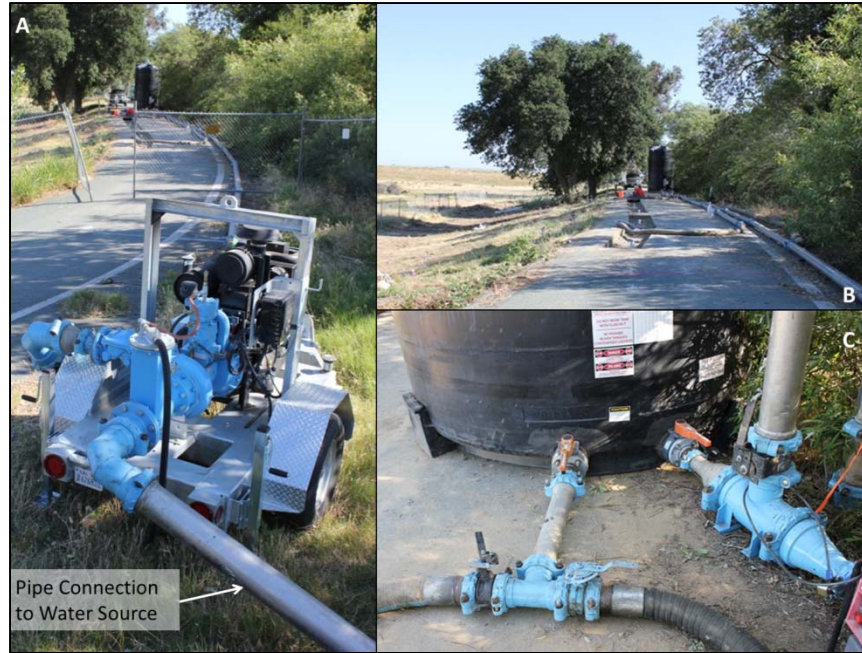
Figure 3-21. Pump and tank system (A and B). Image C shows valves used to control rate of flow into the trenches.

The trenches were excavated to a width of 2 feet and a depth of 8 feet. The as-built length of the control trench was approximately 31.5 feet while the as-built length of the tree trench was 95 feet with an approximate 5 foot separation between them. Water was pumped from the main channel of the slough and delivered to the trenches via gravity from a 4900 gallon polyethylene water reservoir placed at the highest location at the southern end of the trenches (Figure 3-21).

The water supply pump was a model DV-100c diesel unit with a minimum pump rate at idle of approximately 500 gallons per minute. The pump was activated by an automatic switch installed in the water tank that indicated when the water reached a maximum level. The reservoir was equipped with an overflow pipe with an outlet to the slough in the event of switch malfunction. Flow meters were installed on the water tank inflow pipe as well as the delivery lines into the trenches (Figure 3-22).

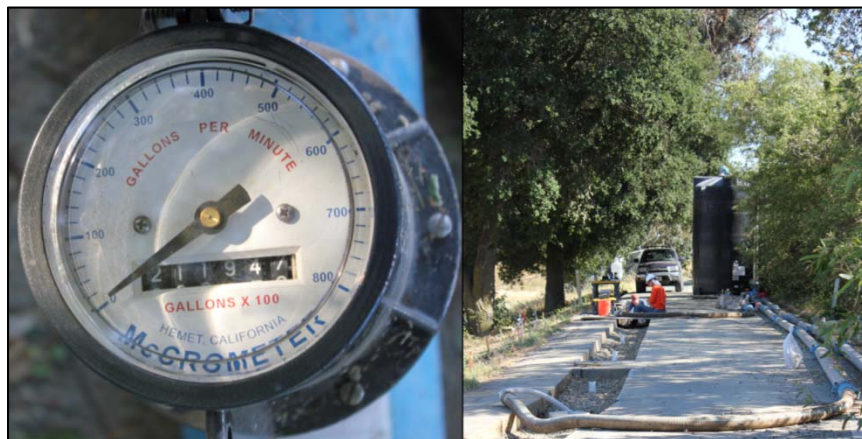
Figure 3-22. Typical flow meter (left) as installed on pipes flowing into and out of the 4900 gallon reservoir. Water delivery pipes and hoses are pictured to the right.

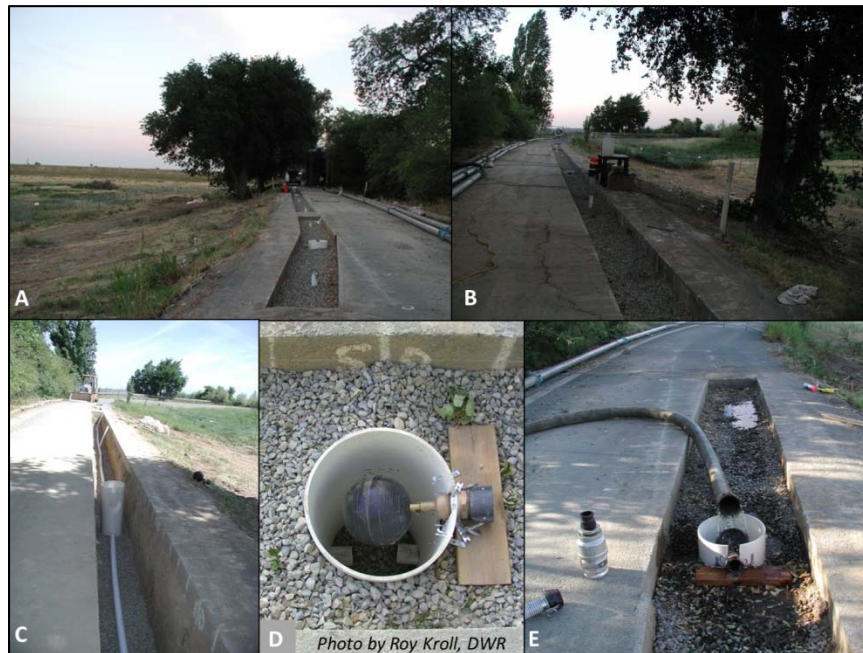
Figure 3-23. Gravel filled A) Control trench and B) Tree trench. The water delivery manifold (photo C), the constant head mechanical float (photo D), and the delivery hoses (photo E) are shown.

The trenches were filled with clean crushed gravel for stability during the experiment. A manifold of perforated pipes was installed to encourage rapid delivery of water throughout the trench and vertical risers were used to monitor water levels (Figure 3-23). Delivery of

water into the trenches was via a 4-inch diameter fire hose. The hose was equipped with 2-inch diameter removable adapter hoses connecting to mechanical float valves to maintain a constant head in each trench once flow volumes were sufficiently reduced (Figure 3-23D and E).

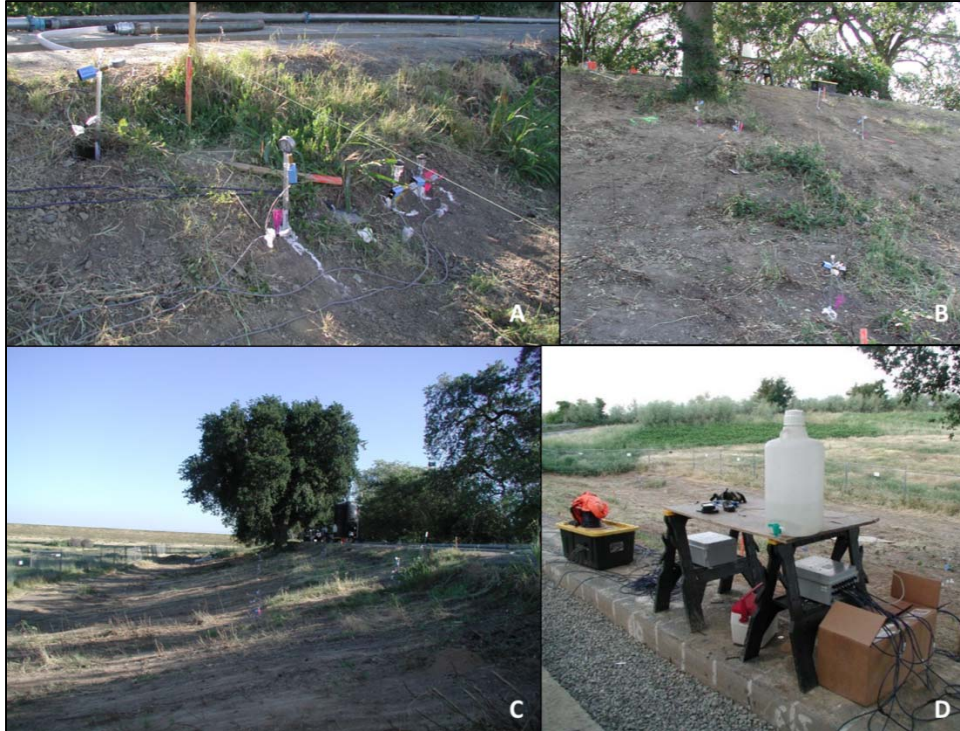
Figure 3-27. Instruments (photos A through C), once installed, are wired into readout boxes (D) for continuous readings during the flow test.

reading recorders, as shown on Figure 3-27 and discussed further in a subsequent section of this report.

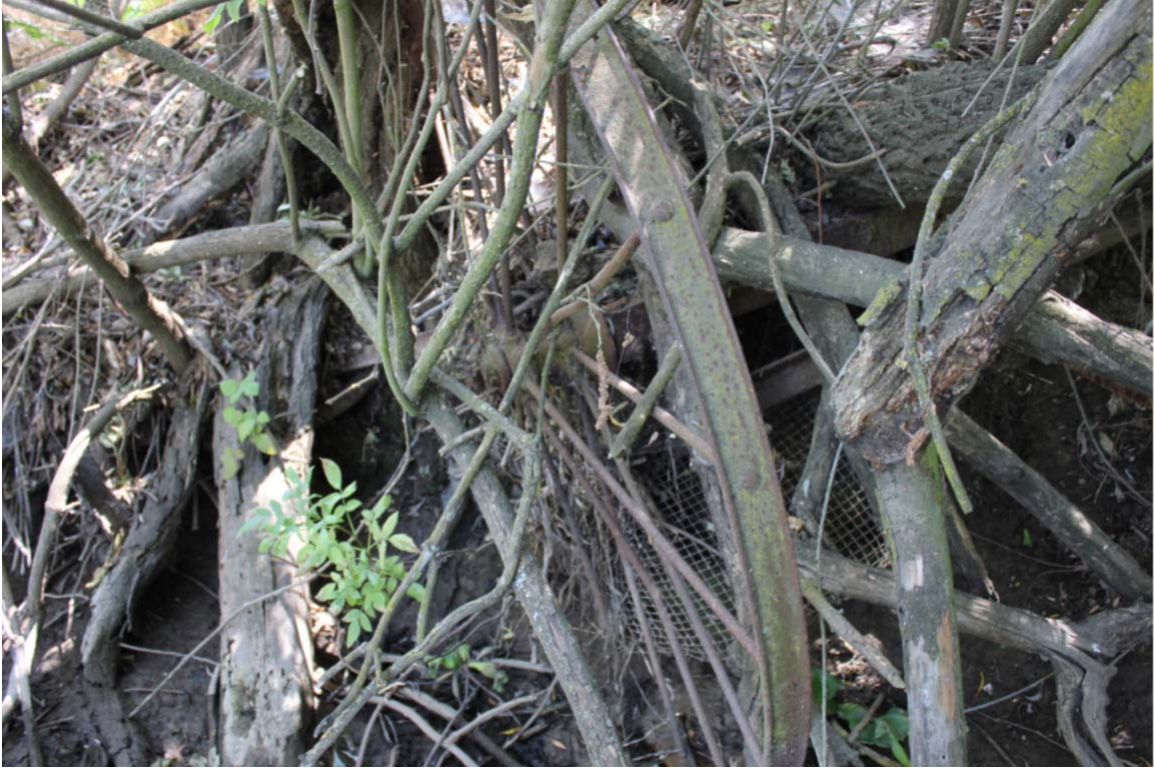
Figure 3-28. The wheel of what appears to be horse-drawn farming equipment protruding from the waterside of the levee (Sta TT 70). The axle and possibly the other wheel extend into the levee slope.

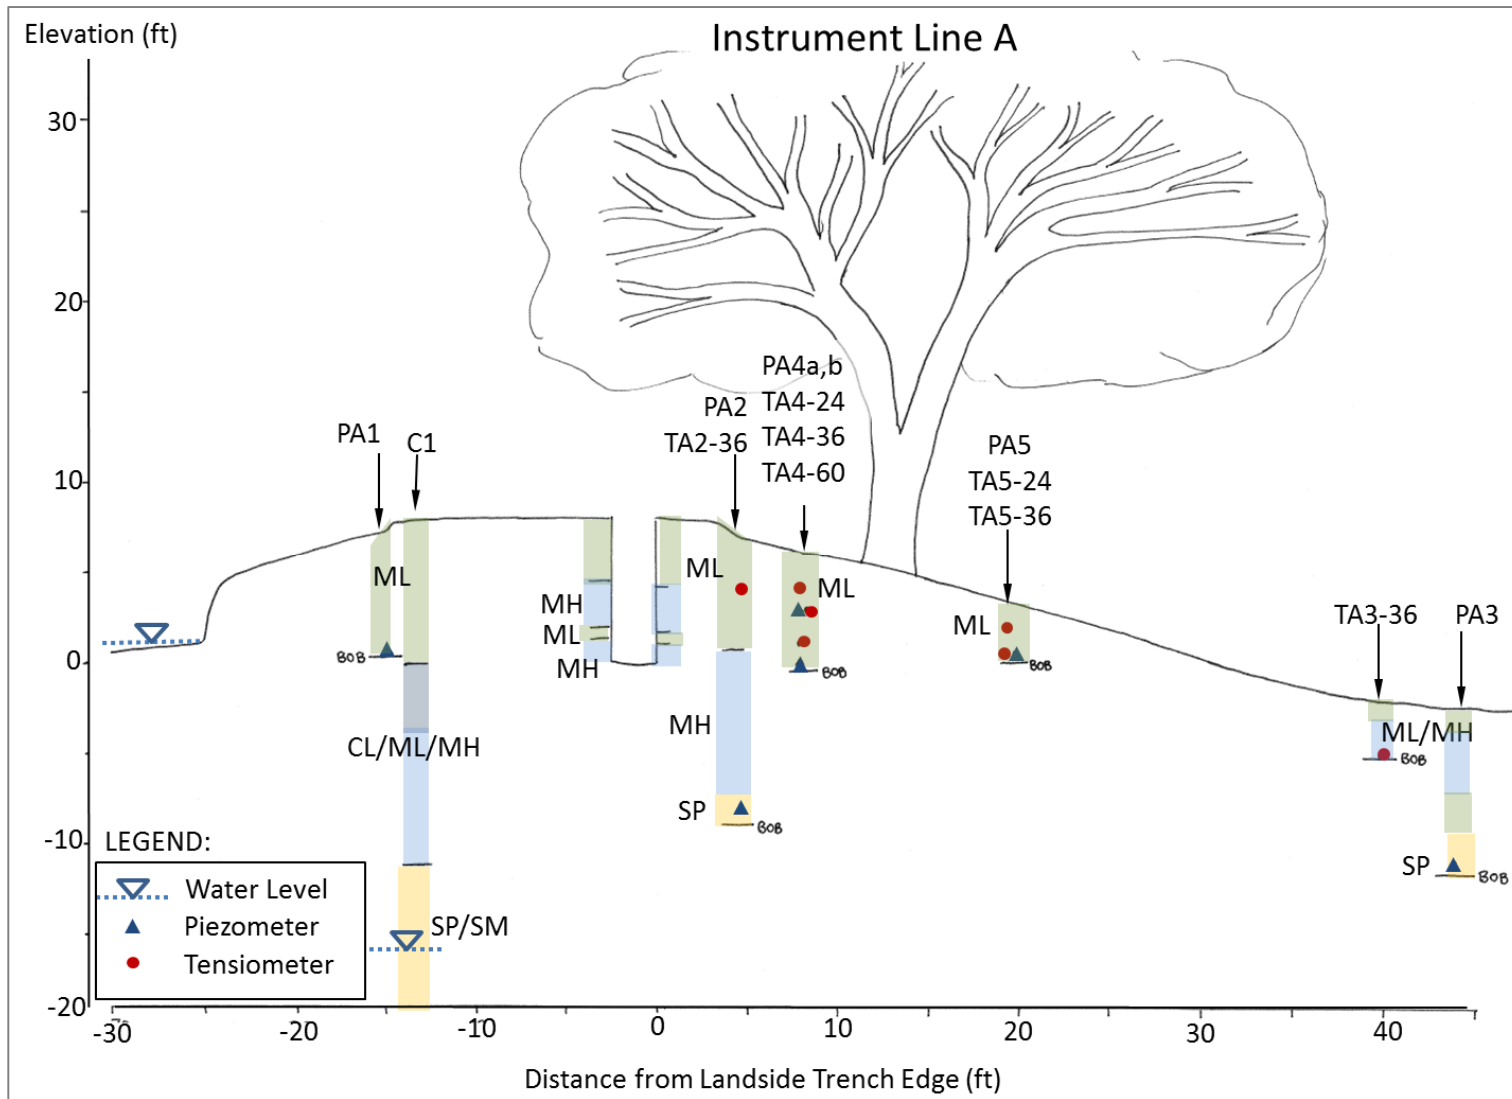
Figure 3-29. Levee section view of Instrument Line A (landside oak) showing instrument locations and generalized soil stratigraphy.

At deeper elevations, about 4 to 6 feet within the levee, a layer of stiff to very stiff clayey plastic silt was encountered, which was relatively homogeneous and consistently present throughout most of the site. This deposit was named Material 4 during trench logging and it may be the Columbia clay silty clay deposit mapped by the USDA (1935) and shown on Figure 3-10. This soil is encountered in foundation soils and forms the shape of a small levee within the existing levee, as shown on the detailed stratigraphic sections at A, B, and C, provided as Figure 3-29, Figure 3-30, and Figure 3-31, respectively. According to the Twitchell Island 5-year plan:

The water delivery trench was located within the crown of an early, and possibly natural, levee of lower permeability than soils used in raising the levee (Figure 3-29 through Figure 3-31 and Figure 3-188 through Figure 3-190). A discontinuity in the natural overbank

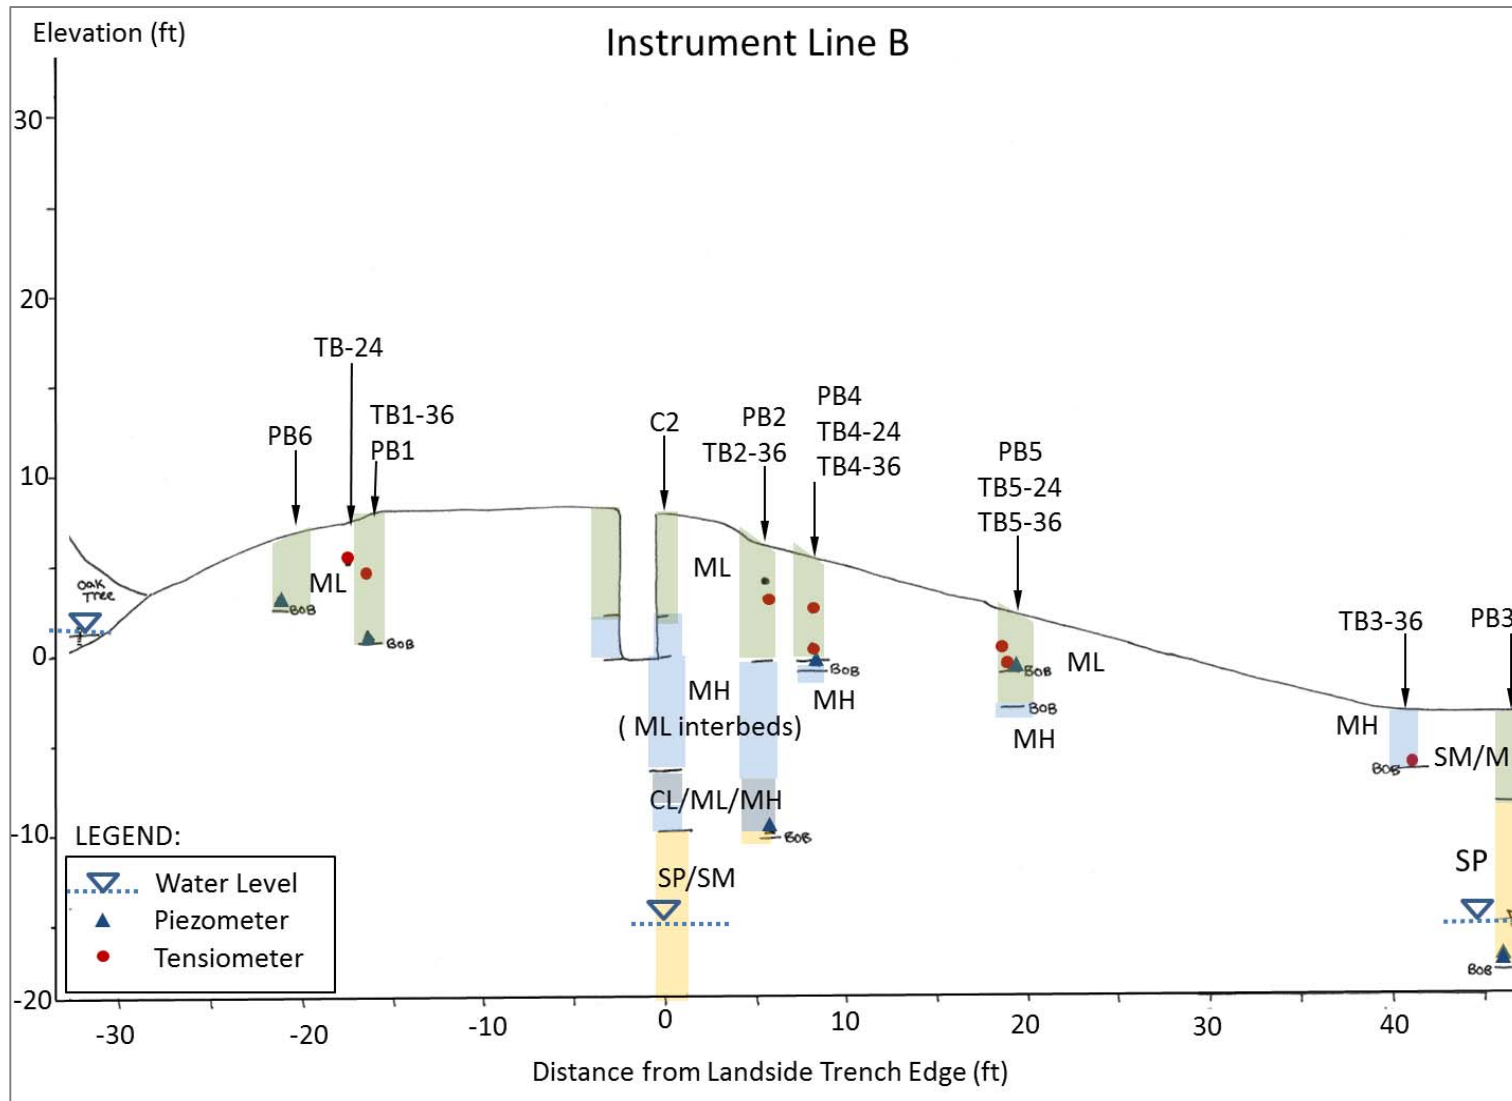
Figure 3-30. Levee section view of Instrument Line B (waterside oak) showing instrument locations and generalized soil stratigraphy.

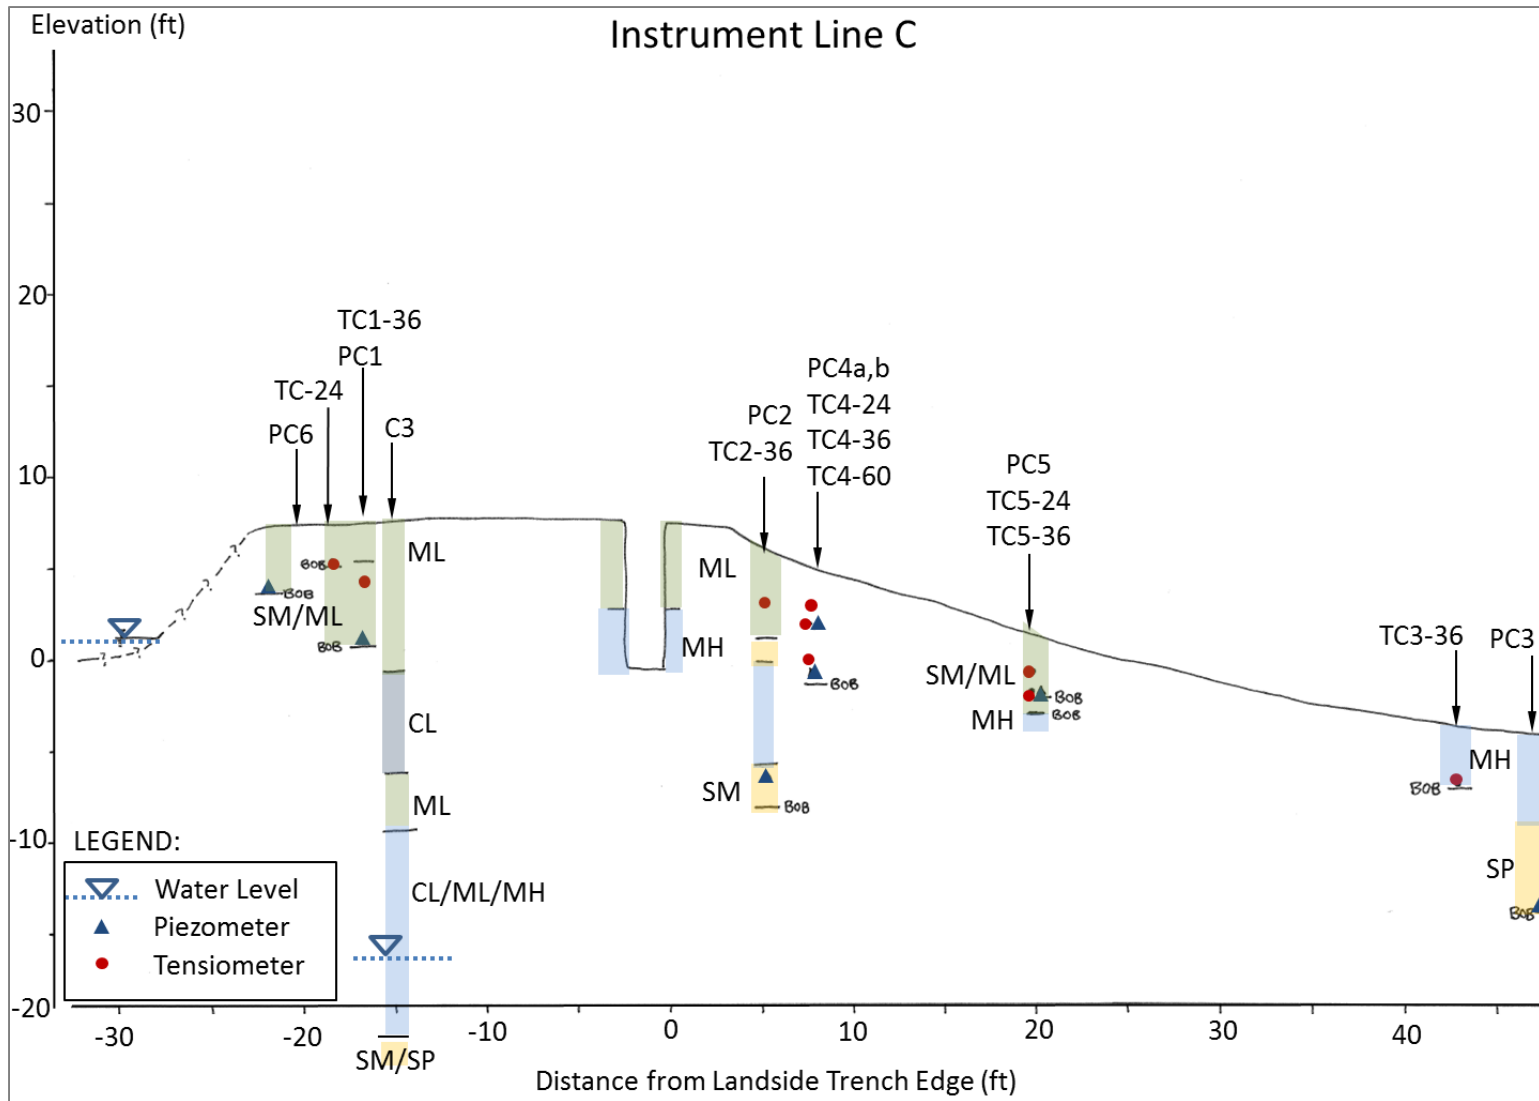
Figure 3-31. Levee section view of Instrument Line C (control) showing instrument locations and generalized soil stratigraphy.

Instrument line C, at the control trench, began with saturation of the 36 inch deep instrument at row 2 and the 60 inch instrument at row 4. Looking at Figure 3-31, these instruments are in close proximity to one another. They may be connected by a sand lens, a burrow, or fracture as they saturated at close to the same time. TC4-24 is the only shallow instrument on site that saturated before the adjacent instrument at a depth of 36 inch. This 24 inch deep tensiometer was positioned closest to the burrow encountered during trenching as well as those discovered in post-flow exploration, as will be discussed in a subsequent section. In row 4, the 60 inch deep tensiometer saturates at 3.9 hours, the 24 inch instrument saturates in 9.8 hours, and the 36 inch instrument between them saturates in 11 hours. This is an indication of non-uniform flow, likely related to the burrowing activity that we have seen evidence of. Burrows seen at this location have been shallow, in the upper 3 feet of the control trench.

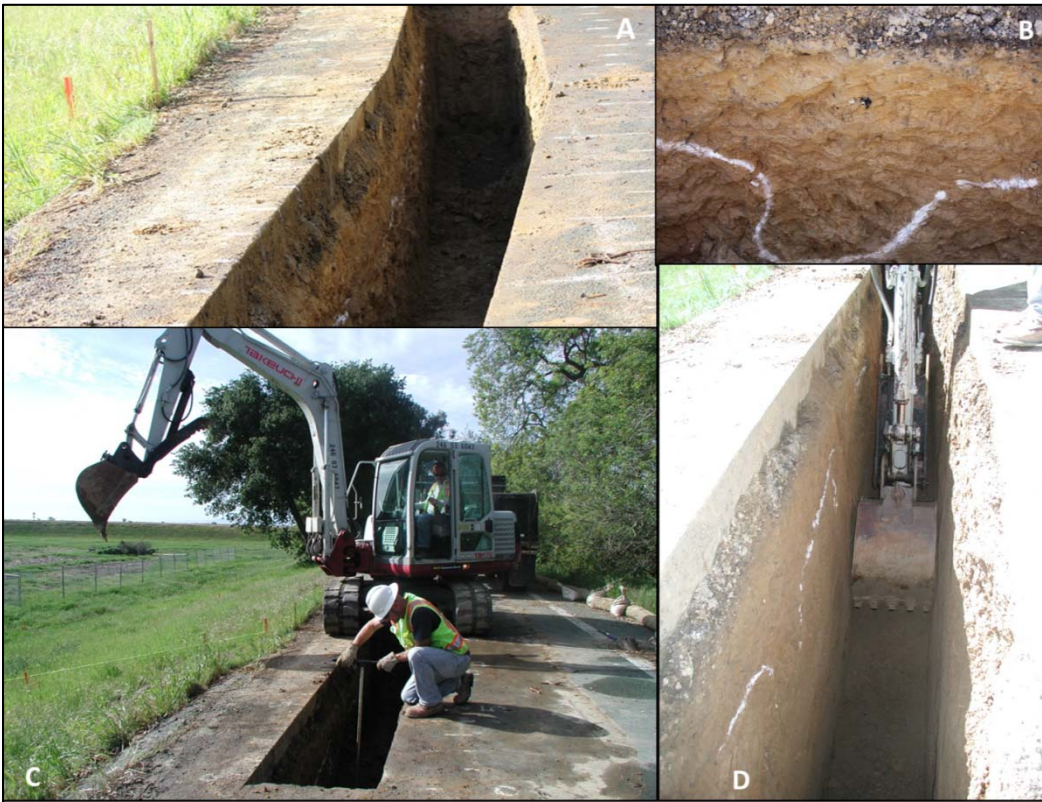
Figure 3-33. A) The control trench excavated to 4 foot depth; B) Walls are logged; C) Walls are sampled ahead between 4 and 8 feet; D) Excavation of small segments proceeds to 8 feet.
