Static and Seismic Performance of California Levees

Michelle Jennifer Shriro

Doctor of Philosophy

Engineering - Civil and Environmental Engineering

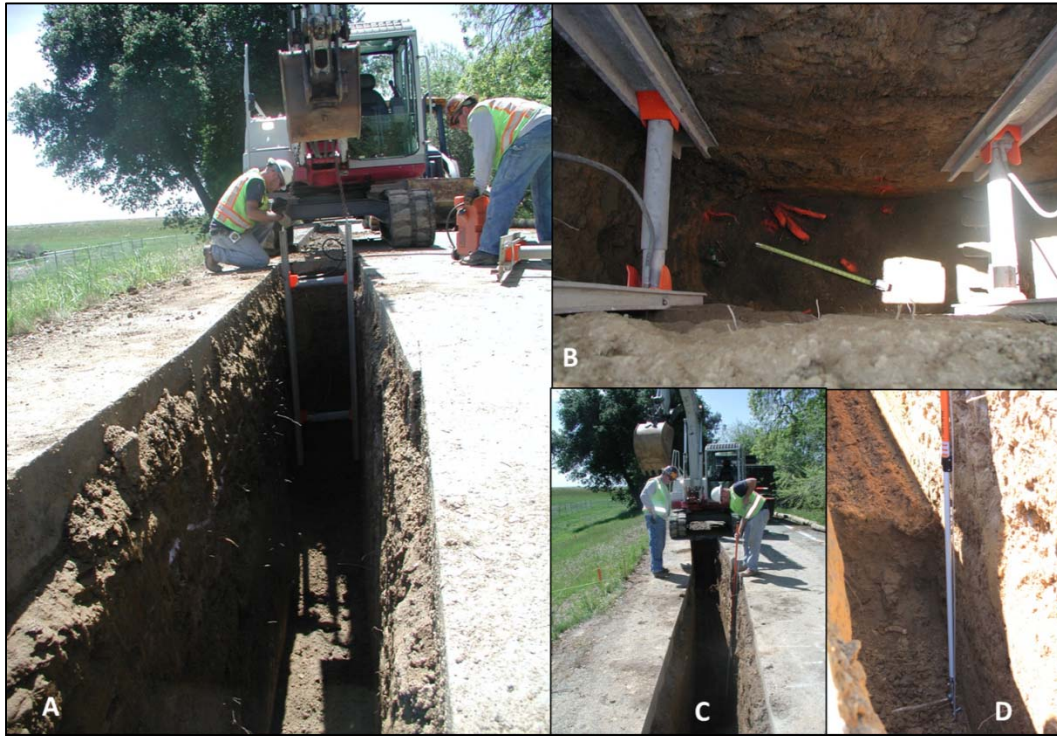
Figure 3-34. A) The control trench is shored for logging; B) Station 26 to 31.5 is shored for manual excavation and logging of first large roots; C) and D) Smaller roots are logged and trimmed from above prior to proceeding with excavation.

The walls were then shored, cleaned, and logged to a depth of 8 feet in the first segment. Additional control trench segments of 5 feet long were excavated to 8 feet in depth using the excavator and encountering only small isolated roots near the base of the excavation (Figure 3-34A,C, and D). Each 5 foot segment was mapped first in plan view for roots (when applicable), and then the walls were mapped for soil conditions.

The last 5-foot increment of the control trench (station CT 25 to 31) encountered a cluster of large roots requiring manual excavation (Figure 3-34B). Upon close inspection, some of the roots had been broken in excavation and the area was carefully evaluated for damage to the walls from the root breakage. The location where the root entered the trench was revealed and found to be undamaged. The remainder of the segment was shored and hand excavated to reveal the root cluster (Figure 3-34B).

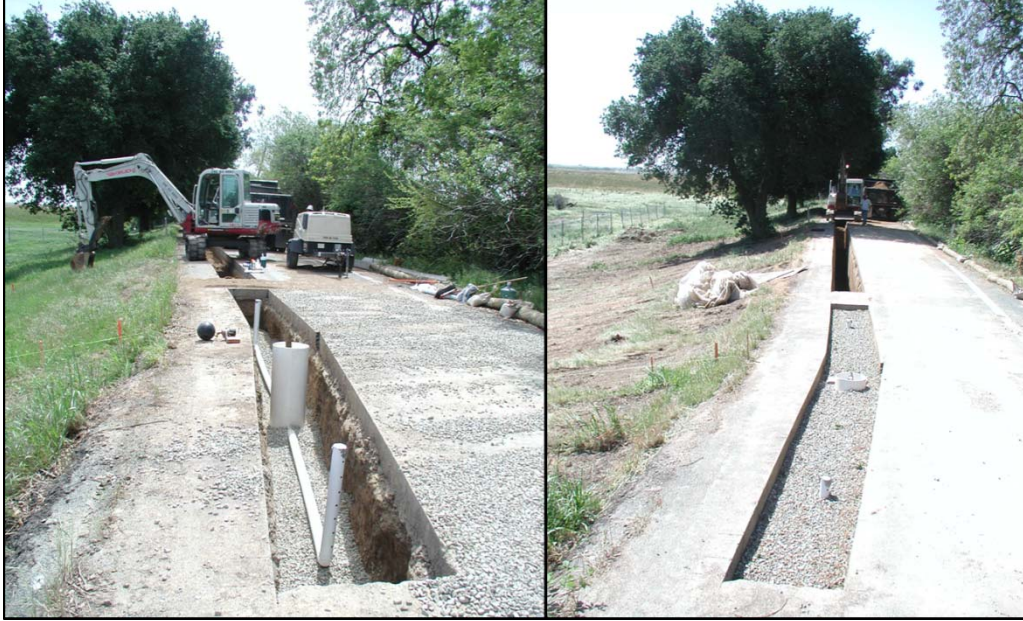
Figure 3-35. The control trench is partially filled with gravel, a manifold installed, and backfill with gravel is completed.

Once completed, the entire trench was backfilled to a depth of 4 feet with  $\frac{3}{4}$  inch clean crushed rock. The manifold of perforated pipes was installed at a depth of 4 feet to facilitate even water delivery throughout the trench (Figure 3-35). No compaction efforts were made other than light tamping and smoothing with the excavator bucket. From start to finish, the control trench was excavated and backfilled between April 12 and April 17 of 2012.

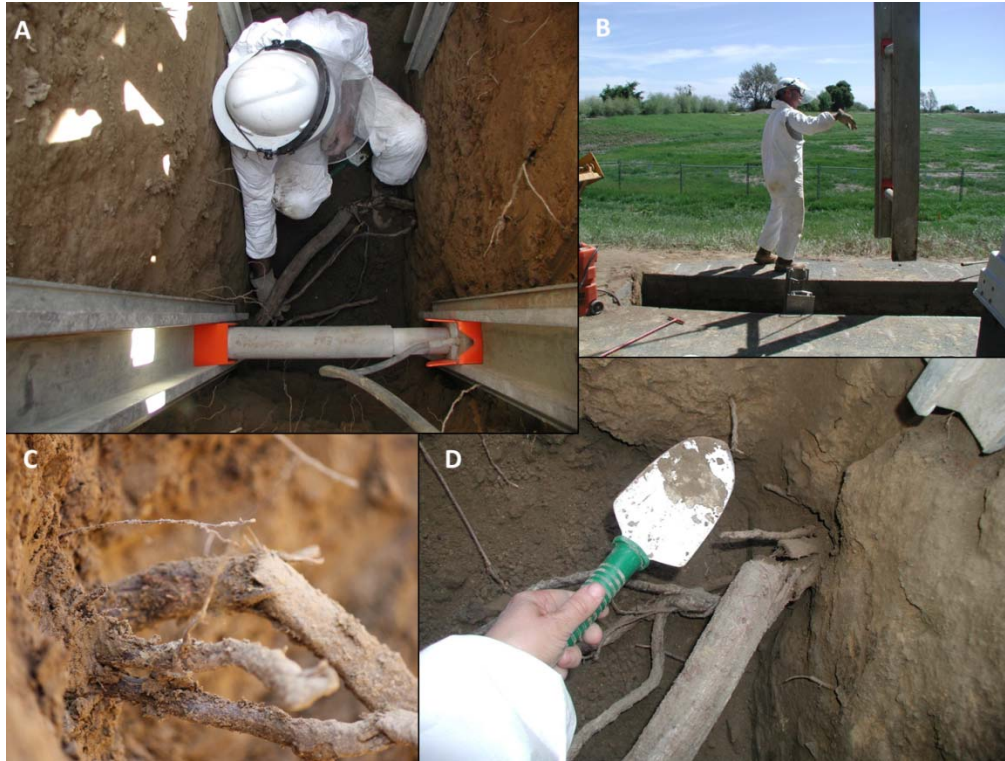
Figure 3-36. A) Root encountered during excavation of initial spoils pit at Station TT 0 to TT5; B) Trench is shored; C) and D) Roots damaged by excavation are carefully inspected at walls and found to be intact at connection to the wall.

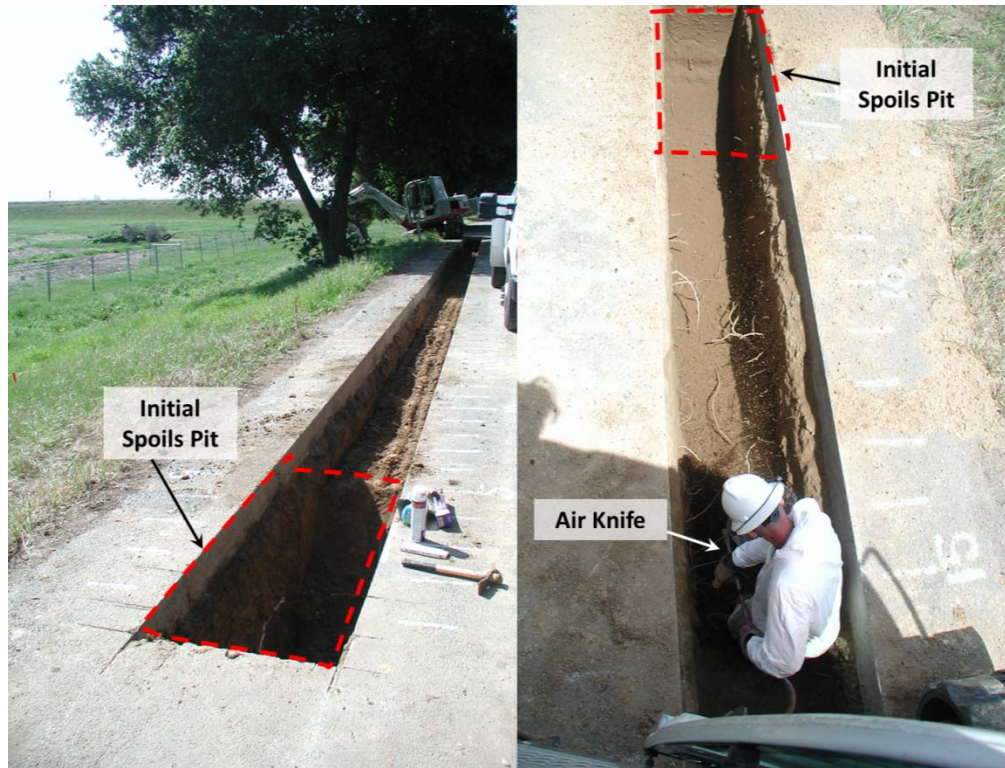
Figure 3-37. Initial spoils pit (left) and air knife operation revealing the upper 4 feet within Stations TT 5 to TT 15.

Roots from the ‘initial pit’ were trimmed flush with the walls and spoils generated by air knife from the upper 4 feet of the adjacent 20 foot segment were directed into the pit (Figure 3-37). Spoils were periodically removed by excavator to make room for new spoils (Figure 3-38). The 4 foot deep segment was logged in plan view for roots. The roots were then cut flush and the walls cleaned to log soils on the landside and waterside walls.

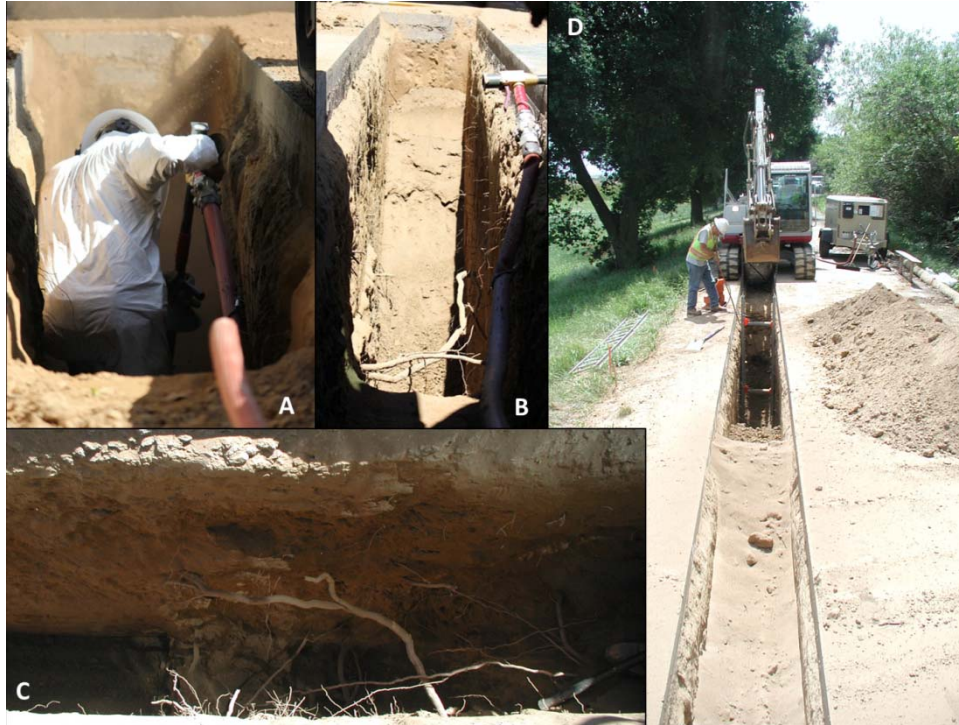
Figure 3-38. A) Air knife operator stands in 4 foot deep trench excavating to 8 feet; B) and C) New roots revealed as air knife spoils are blown in the previously logged segment; C) Spoils are used to stabilize previously excavated sections as new excavation proceeds.

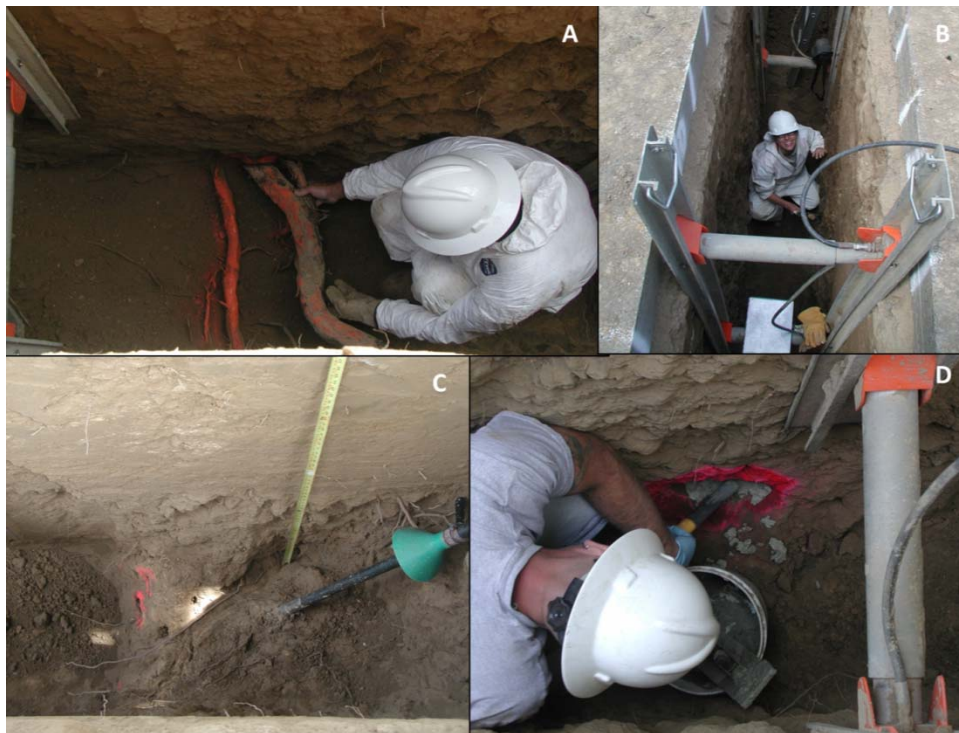
Figure 3-39. A) Large root at Station TT 17; B) Logging; C) Burrow found during air knife excavation; D) Burrow patched prior to flow test.

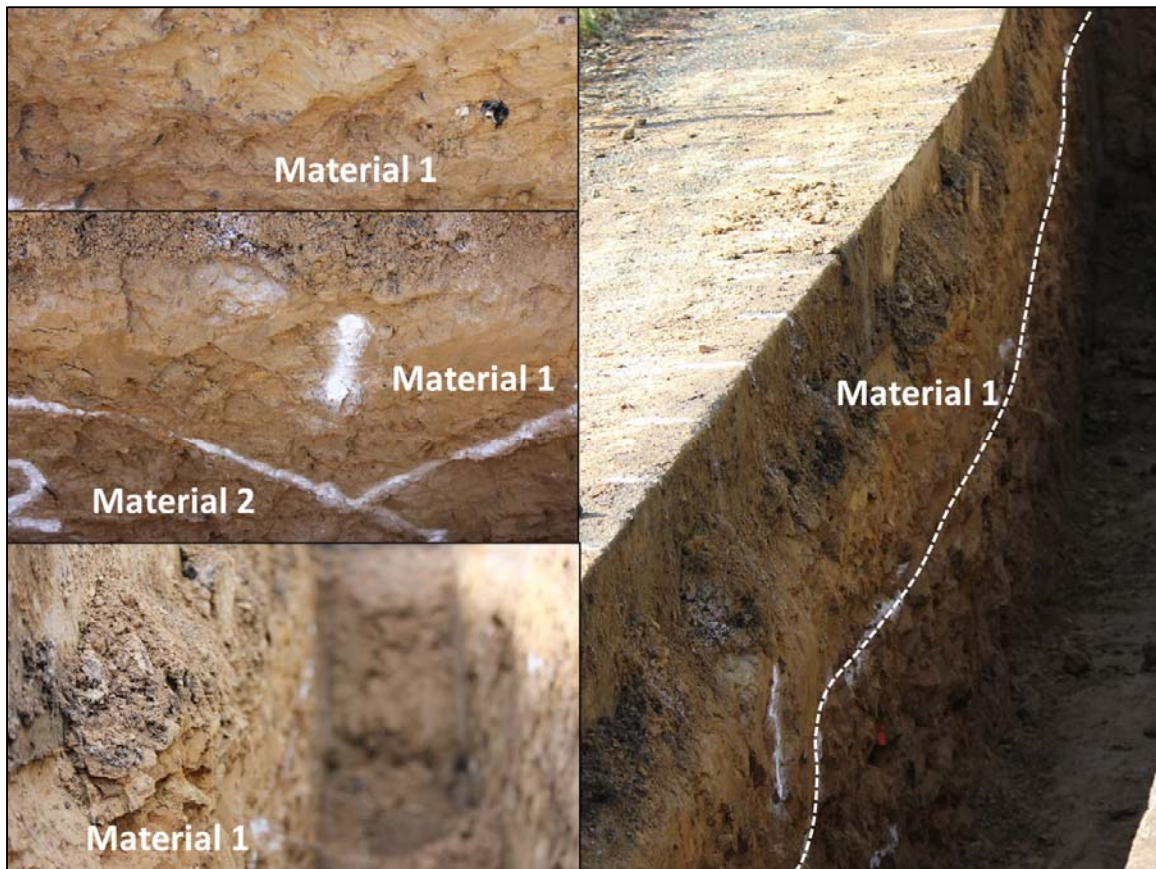
Figure 3-41. Photographs of Material 1, clayey silt found near the surface of the levee.

Soils encountered during excavation were categorized into 7 material types to aid in logging (Figure 3-40). In general, all of the material types found within the levee were sandy and clayey silts. Materials 1 through 3 generally represented the shallower soils within the levee (Figure 3-41, Figure 3-42, Figure 3-43, and Figure 3-44), typically within the upper 4 feet but extending deeper in some areas.

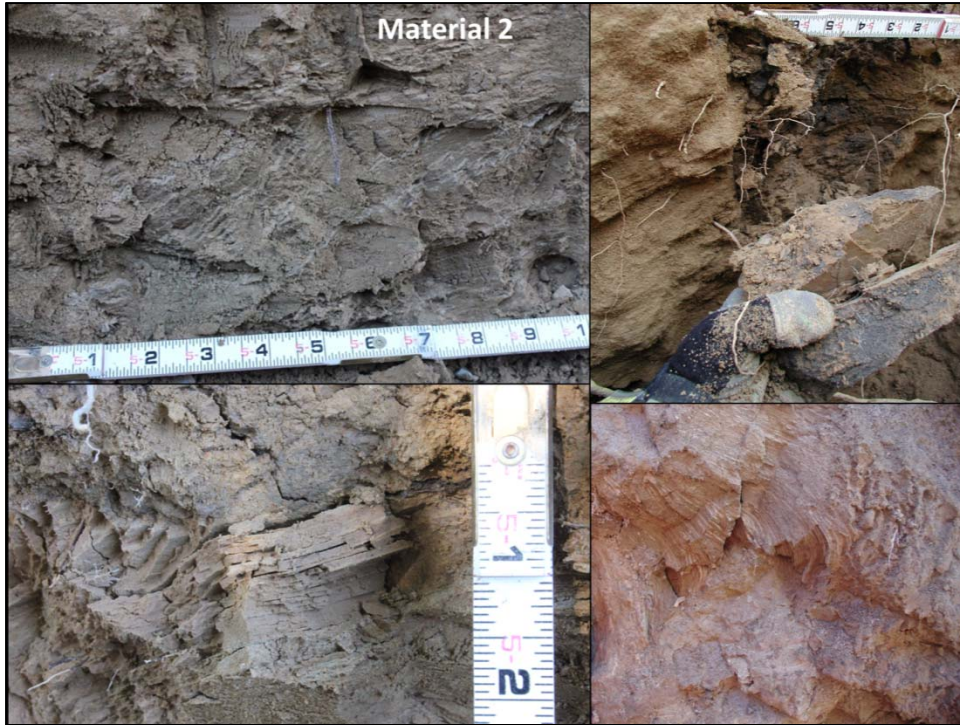
Figure 3-42. Photographs of Material 2, the thinly bedded silt. Notice variable bedding angles (upper left) and occasional voids within the material (lower photos).

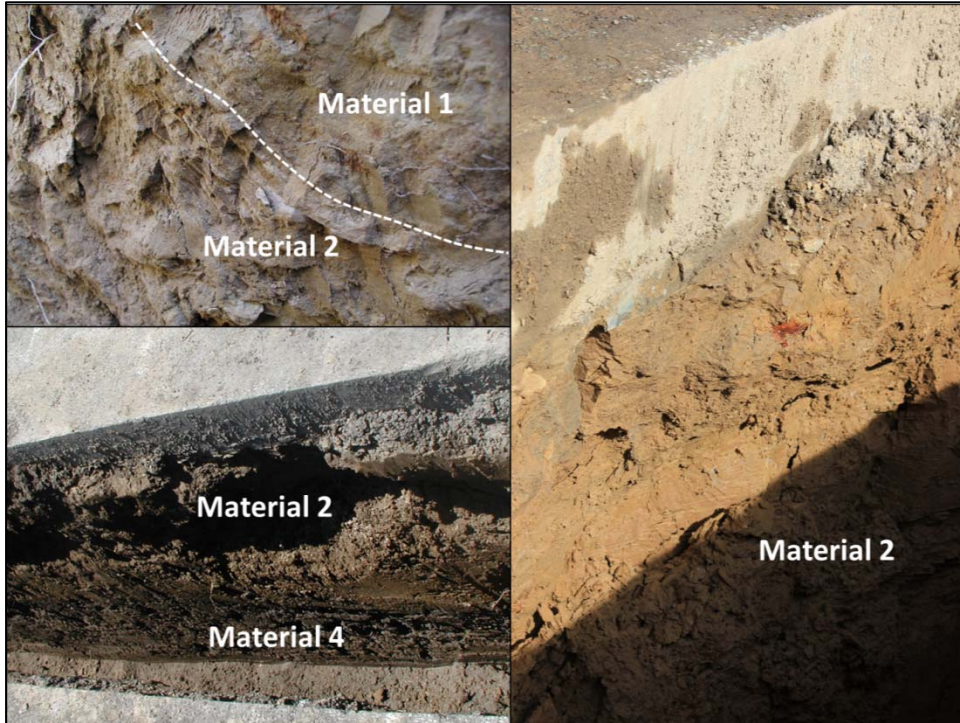
Figure 3-43. Materials 1 and 2. Material 2 was prone to sloughing (right and lower left).

Figure 3-51, Figure 3-52, and Figure 3-53 illustrate that Stations CT 0 to 27 of the control trench had very few roots or other anomalous features with the exception of one burrow. As discussed previously, the thinly bedded silt (Material 2) was found to be sloughing on the waterside Stations CT 0 to 5 (Figure 3-43).

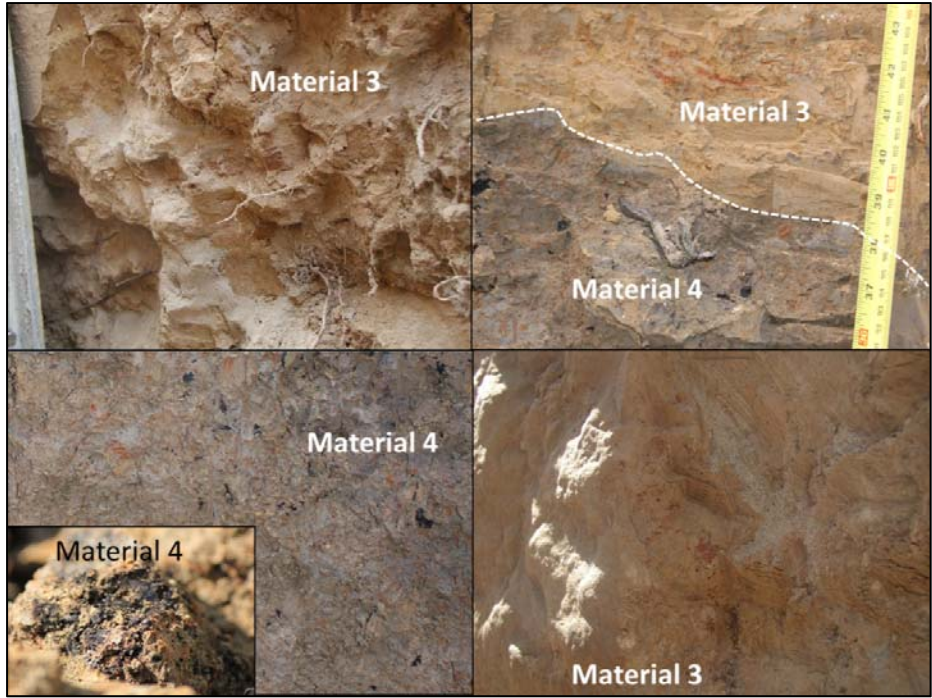
Figure 3-44. Material 3, a light brown sandy silt (USCS ML) with pockets of silty sand, is seen overlying Material 4, a plastic silt (USCS MH). Material 4 contains pockets of decomposed organic matter (lower left).

Material 4, a plastic silt, is an important soil as it is believed to have acted as a low permeability barrier to flow during the flow test (Figure 3-44 and Figure 3-45). Further, the consistency, density and apparent age of the material imply that the soil may have been a natural overbank deposit, as already indicated.

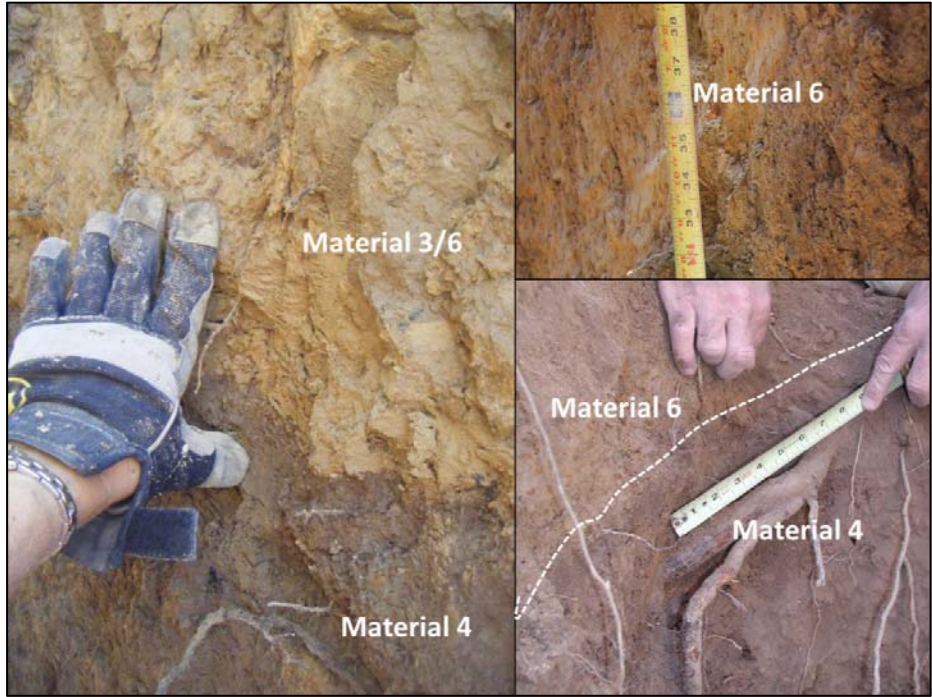
Figure 3-45. Pockets of Materials 3 and 6 (light brown and olive sandy silts, respectively) frequently occur together (left) and underlain by the plastic silt layer, Material 4.

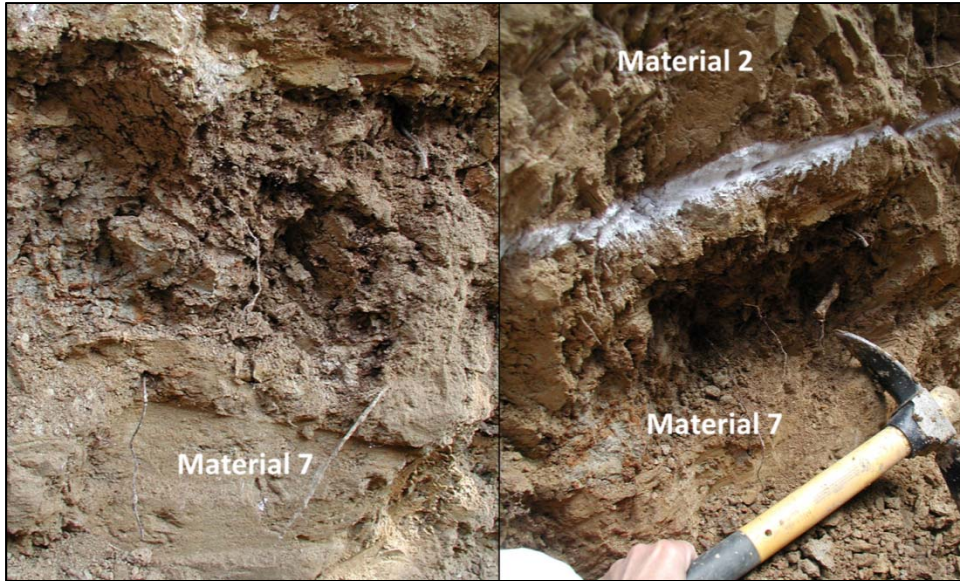
Figure 3-46. Material 7, encountered between Station TT 37 and TT 85, was highly unstable when encountered at depth and was comprised primarily of Materials 2, 3 and 4.

Finally, Material 7 represented a variable but at times loose, unstable or unpredictable blend of Materials 2, 3 and 4 (Figure 3-46). This material was encountered between at depth between Stations TT 37 to 42, but pockets were encountered between Stations TT 37 and TT 85 (for reference the landside oak was at Station TT 70 and the waterside oak was at Station 20).

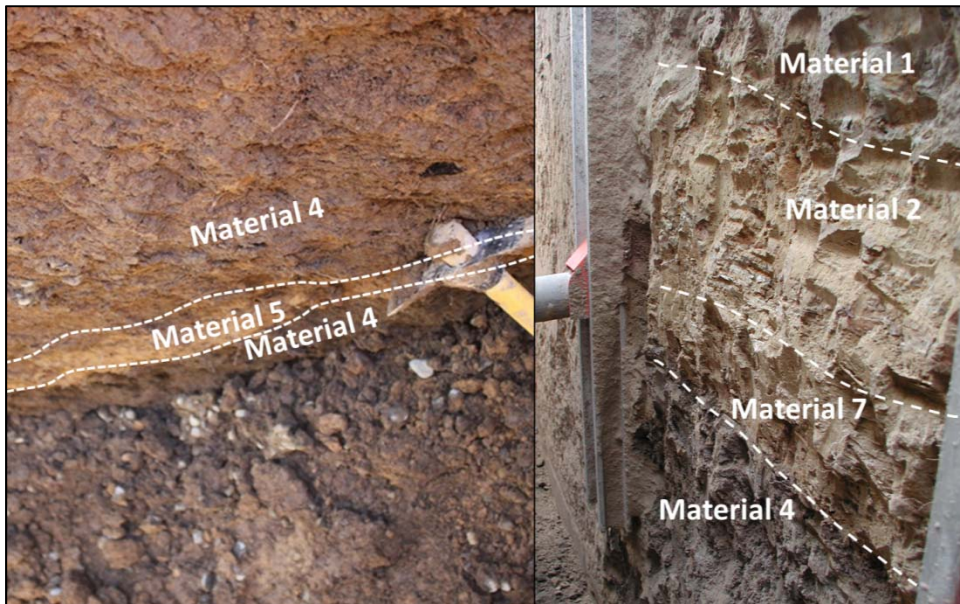
Figure 3-47. Near Station TT 70 to 75, Material 4 became slightly lighter in color (left). A thin lift of Material 5 (USCS ML) commonly occurs between zones of Material 4. Photo to the right shows typical layering with variable low plasticity silts (Materials 1, 2 and 7) overlying the plastic silt (Material 4) near the base of the 8 foot trench.

Material 5 was a lighter colored and lower plasticity silt layer that was found typically as a thin sublayer (less than about 6 inches to 1 foot thick) within the Material 4 soils near the base of the tree trench (Figure 3-47 and Figure 3-48).

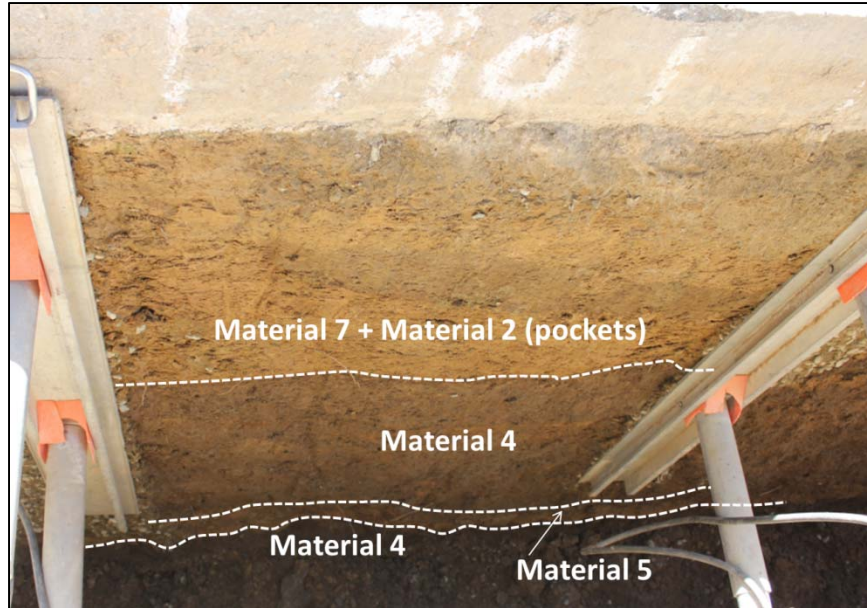
Figure 3-48. Typical layering with low plastic silts overlying plastic silt (Material 4) with a thin lense of Material 5 shown within the Material 4 layers.

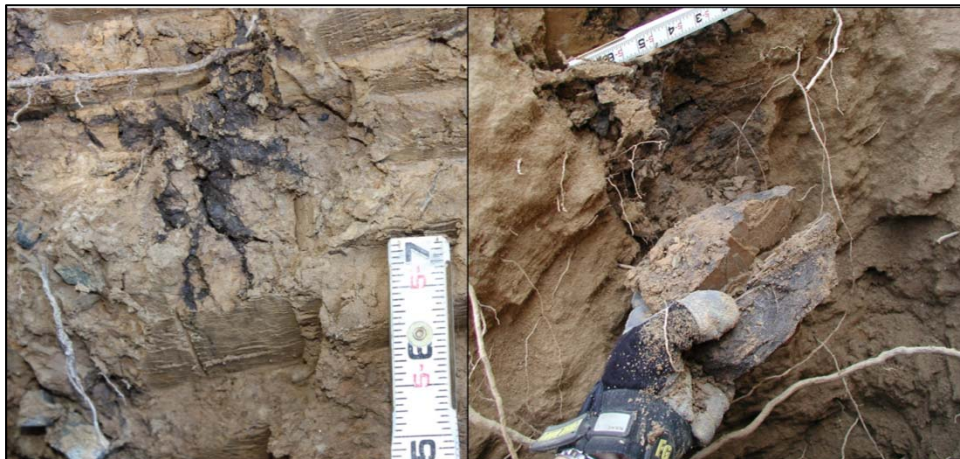
Figure 3-49. Materials 1 and 3 (left) and Material 2 (right) exhibit manganese oxide staining on what appear to be fractures within the levee soils.

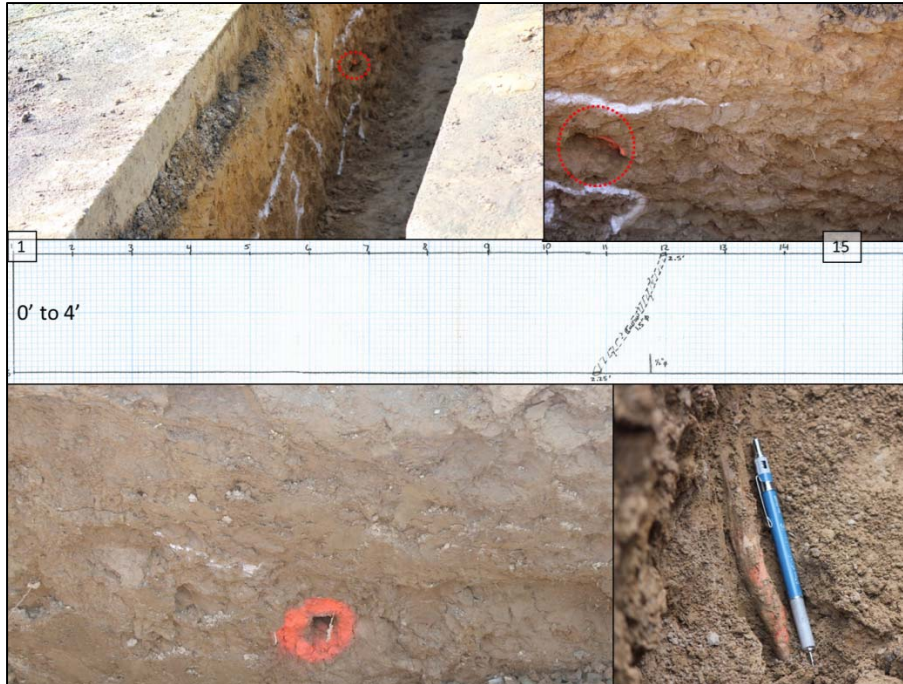
Figure 3-50. Notable features of control trench 0 to 4 foot depth: A burrow at Station CT 11 to CT 12 (diameter 1 ½ inch) and a single ½ inch diameter root at CT 12 (lower right).

The control trench excavation began with excavation of the shallow zone between 0 and 4 feet below grade. Complete trench logs are provided in Appendix 3E. A 1 ½ inch diameter burrow was discovered between Stations 11 and 12 at a depth of about 2 ¼ to 2 ½ foot below grade (Figure 3-50). A single ½ inch diameter root was encountered. The size and depth were consistent with either gopher or vole activity based on discussions with burrowing animal advisor to the CLVRP Dr. Dirk Van Vuren of UC Davis. Surficial evidence of both animals was found in the vicinity as previously discussed.

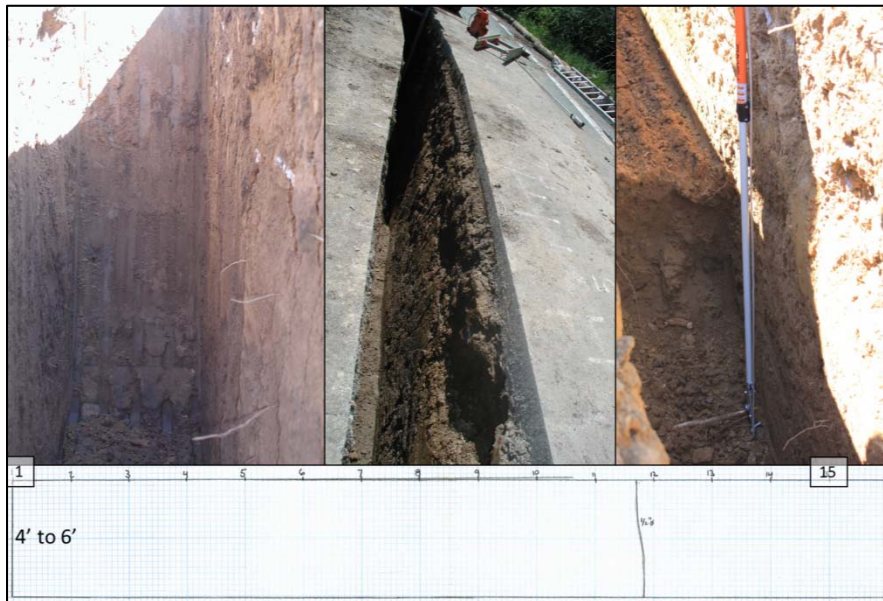
Figure 3-51. A single ½ inch diameter oak root is found and cut when excavating to full depth of 8 feet within the control trench Stations CT 1 to 15.

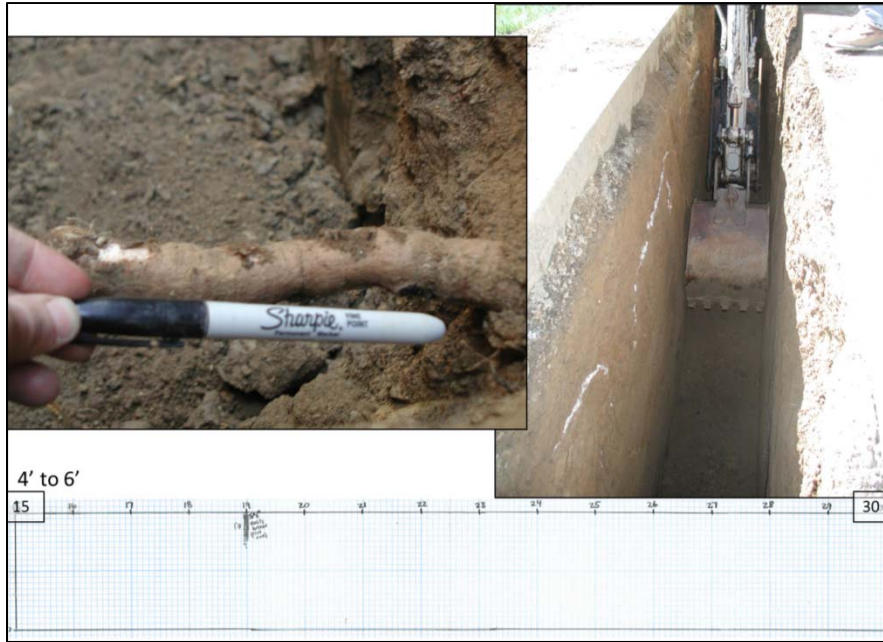
Figure 3-52. A 1" diameter root is encountered at Station CT Station 19. The inner core of the root is not woody and is assumed not to have originated from either oak tree.

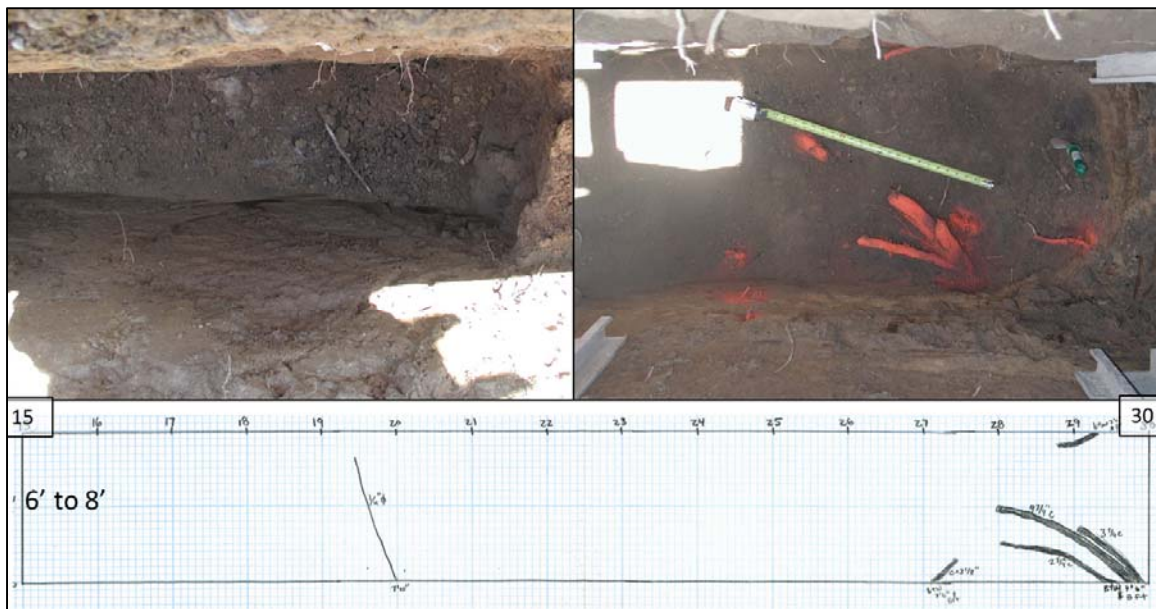
Figure 3-53. A cluster of roots ranging from about  $\frac{3}{4}$  inch to  $1\frac{1}{2}$  inch diameter are encountered at Stations CT 27 to CT 30.

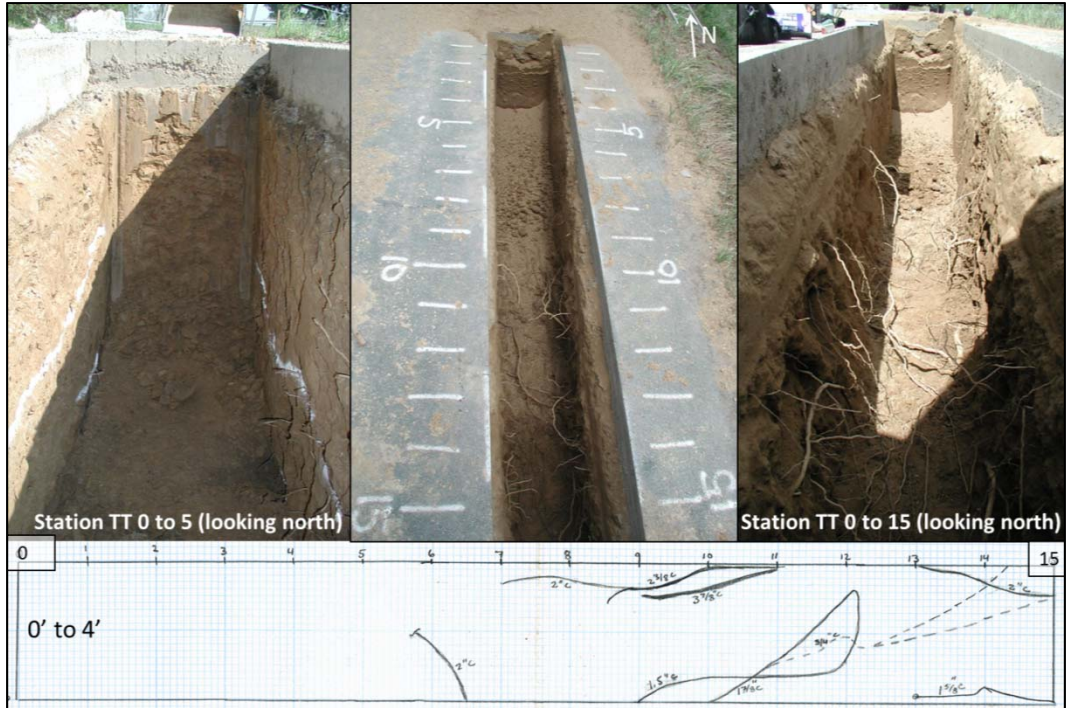
Figure 3-55. Root log at 0 to 4 foot depth Station TT 0 to 15.

The maximum root diameter found within the upper 4 feet of the tree trench was 1 ¼ inch. In general, roots smaller than about ½ inch in diameter were not logged. Root and burrow locations are shown on plan view logs discussed below and provided as complete field logs in Appendix 3E. Plan view field sketches were logged in depth categories of 0 to 4 feet, 4 to 6 feet, and 6 to 8 feet. Stations TT 6 through TT 17 encountered abundant roots ranging from about ¼ inch to about 1 ¼ inch in diameter (Figure 3-55 and Figure 3-56). The directionality of the roots was not readily apparent, but roots in the 4 to 6 foot depth range in the same segment had branching indicative of a waterside origin and no other trees were nearby other than the waterside oak tree. Between Stations 33 and 49 (Figure 3-57 and Figure 3-58), two roots on the order of ½ inch diameter were logged. Again, the origin of the roots was unclear but deeper roots in the vicinity originated from the waterside. Stations TT 62 to TT 86 (the vicinity of the landside tree) encountered abundant roots smaller than 1 inch in diameter (Figure 3-60 and Figure 3-61). Branching of these roots indicated a landside origin. Roots were not found at stations TT 0 to 6 (Figure 3-55), TT 19 to 33 (Figure 3-56 and Figure 3-57), TT 49 to 62 (Figure 3-58 and Figure 3-59), and TT 86 to 95 (Figure 3-61). No burrows were found in the upper 4 feet of the tree trench during logging.

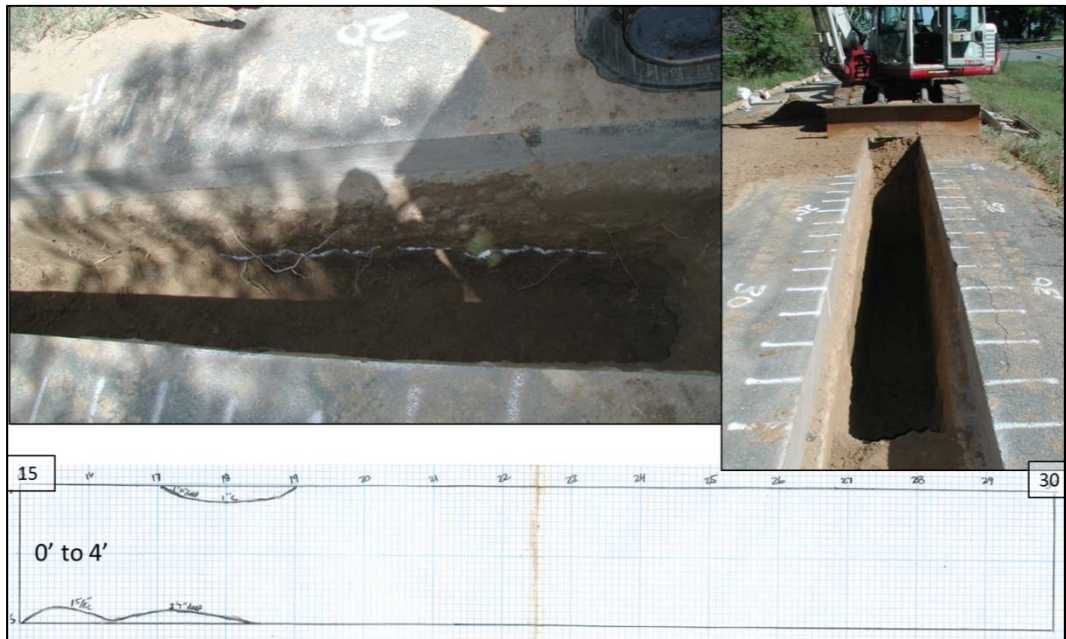
Figure 3-56. Root log at 0 to 4 foot depth Station TT 15 to 30.

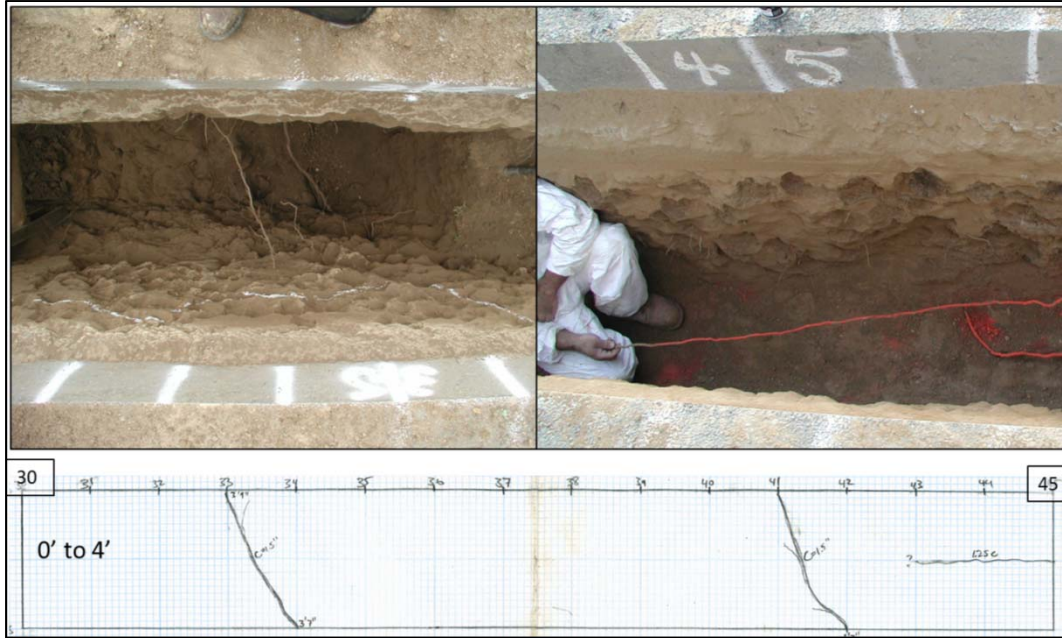
Figure 3-57. Root log at 0 to 4 foot depth Station TT 30 to 45.

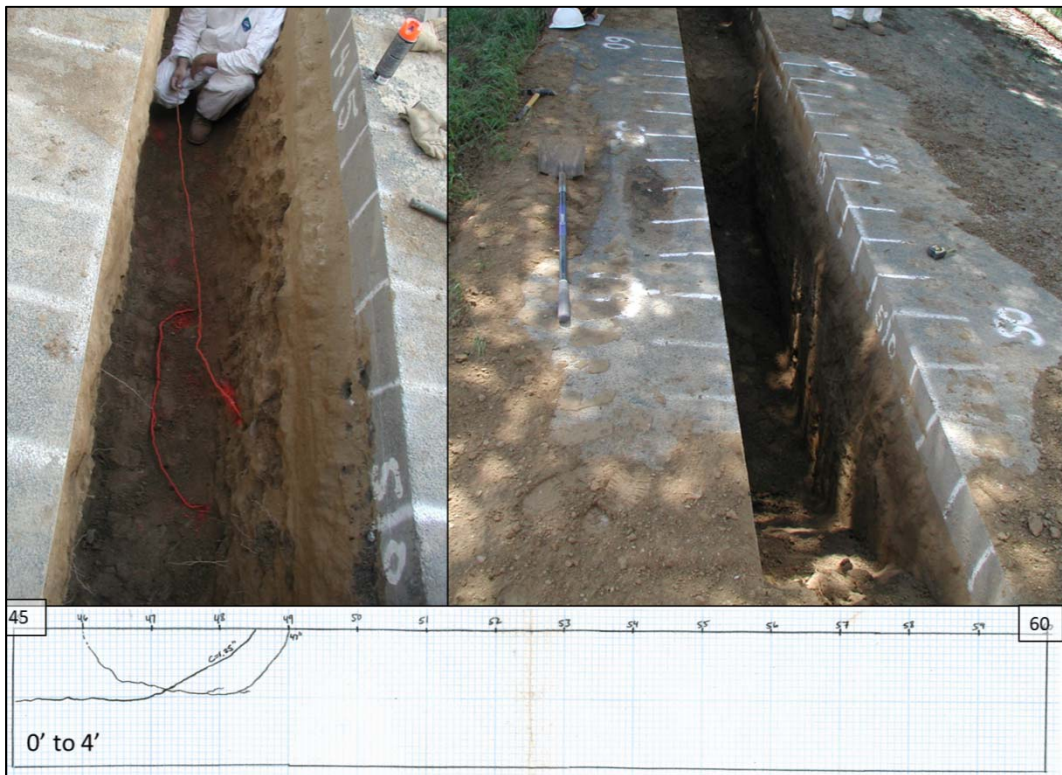
Figure 3-58. Root log at 0 to 4 foot depth Station TT 45 to 60.

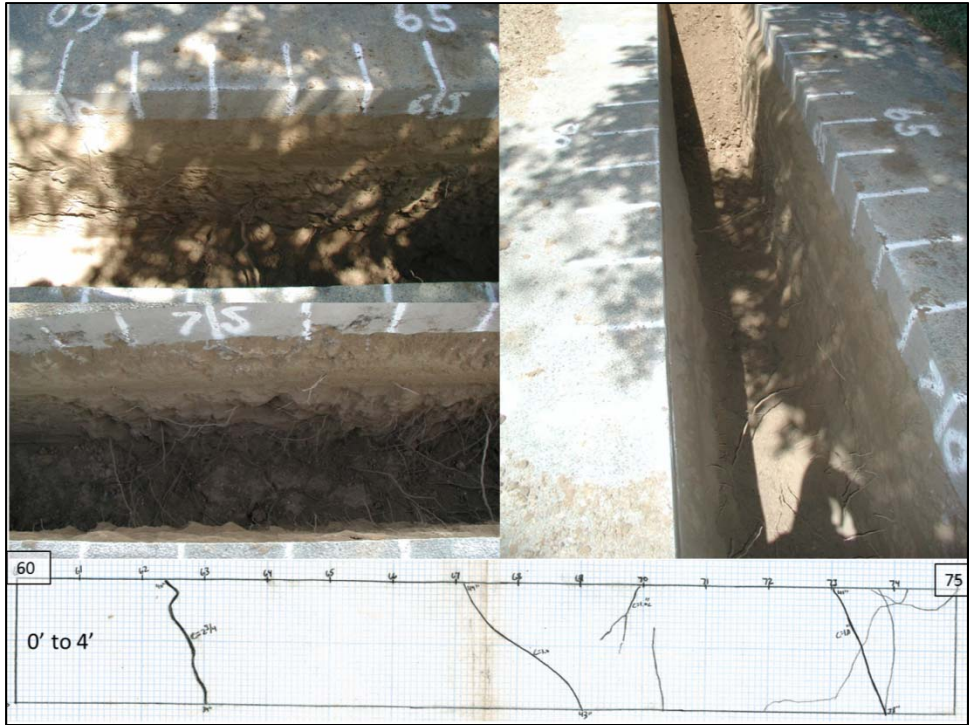
Figure 3-59. Root log at 0 to 4 foot depth Station TT 60 to 75.

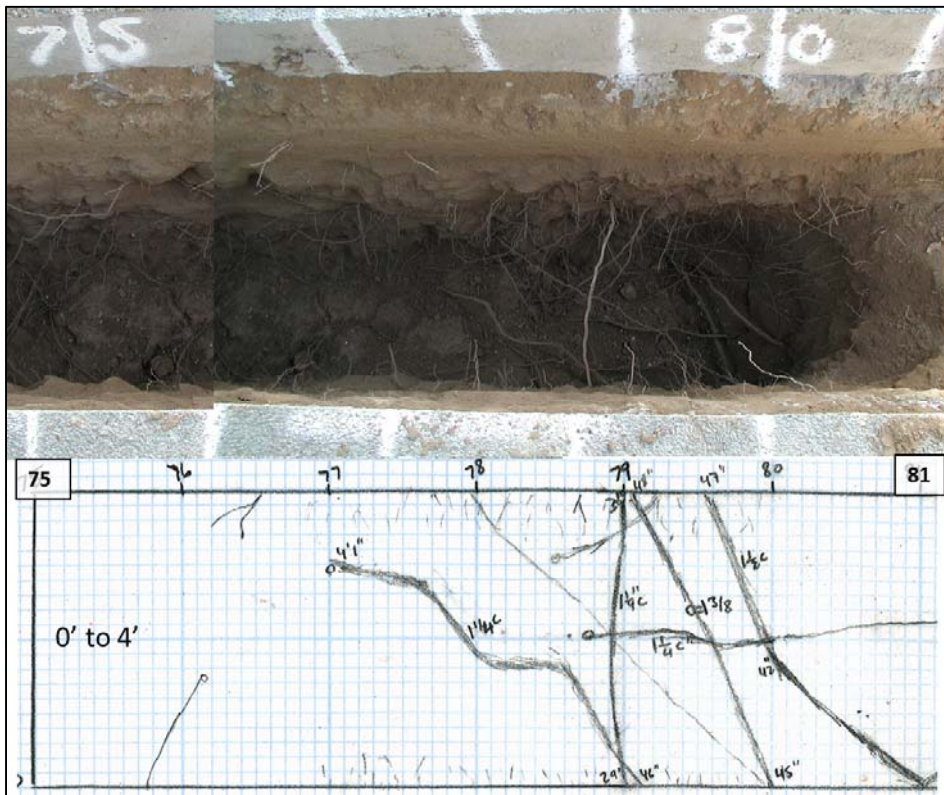
Figure 3-60. Root log at 0 to 4 foot depth Station TT 75 to 81.

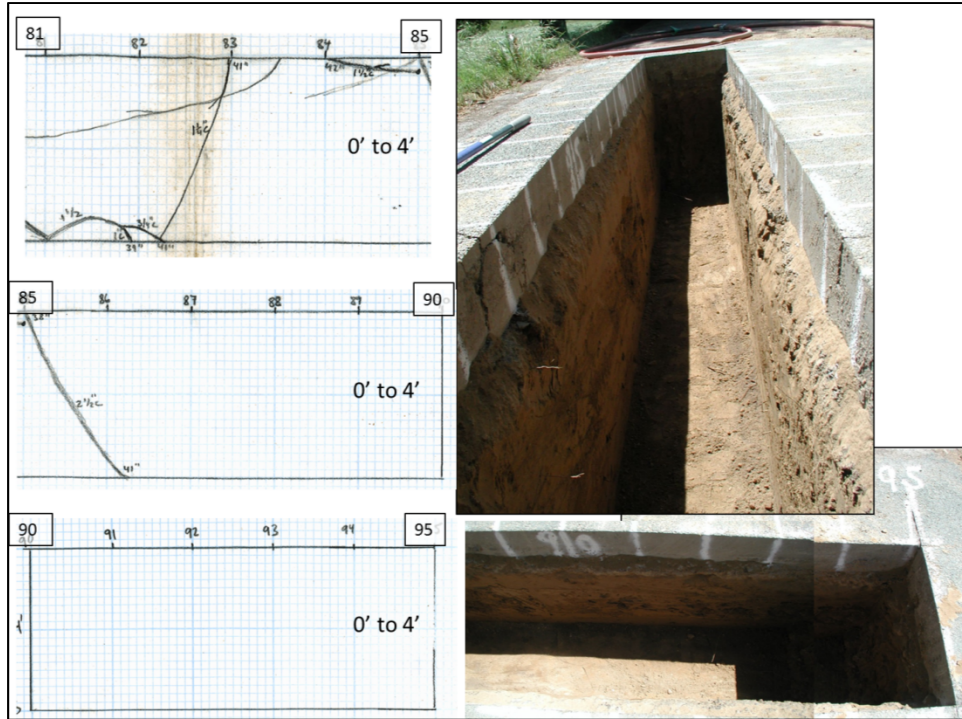
Figure 3-61. Root log at 0 to 4 foot depth Station TT 81 to 95.

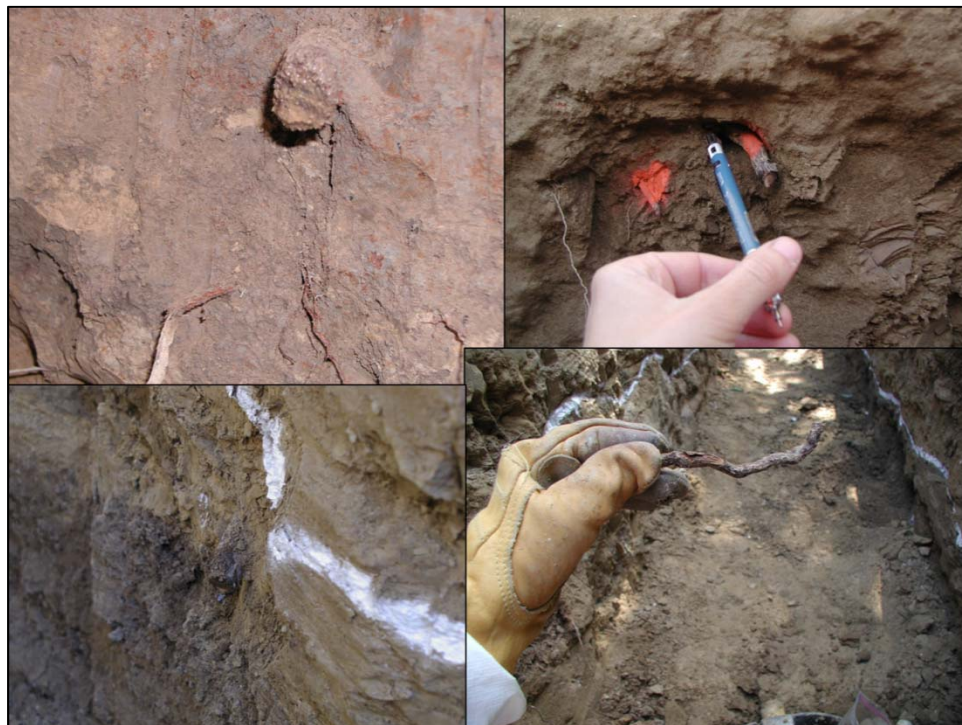
Figure 3-62. Some live roots wept from the inside of the root upon cutting. No void space around the root was observed.

Roots encountered were cut after logging. Some live roots wept upon cutting. No void space for flow around the root was observed, but the weeping occurred from the inside of the root (Figure 3-62). When reviewing logs below landside is always facing up and station numbers increase to the right (or to the south).

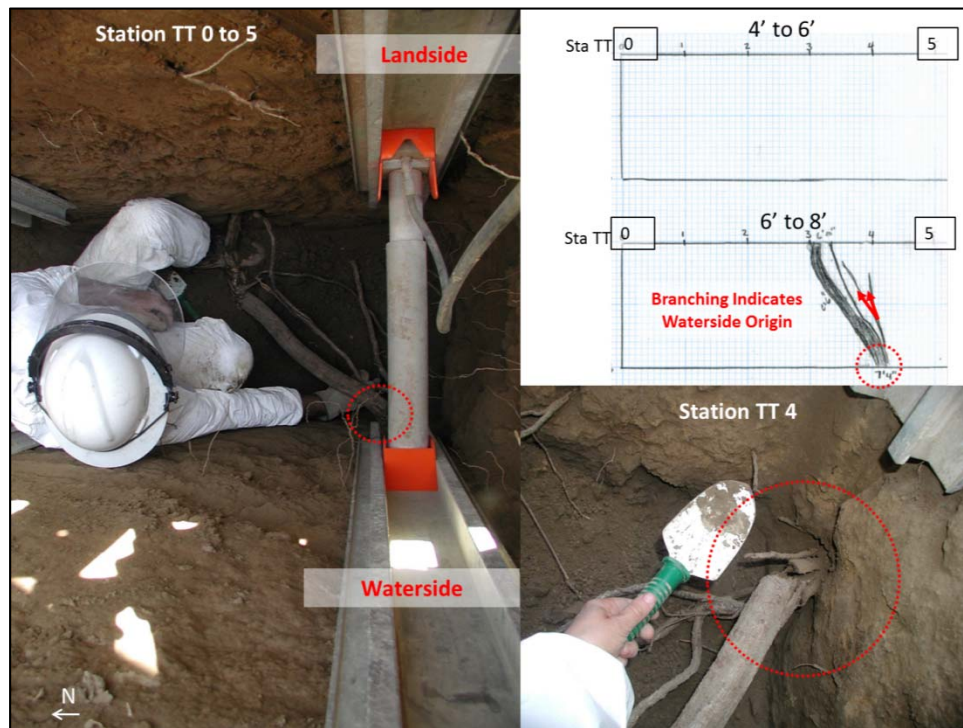
Figure 3-63. Root logs at 4 to 8 foot depth Stations TT 0 to 5.

In general, the root zone for the waterside oak tree (Station TT 20) extends from Station CT 27 to Station TT 50 (30 feet on either side of the trunk) with a few small (< ½ inch diameter) roots extending 7 feet beyond this zone to the south to Station TT 57. Root size in the upper 4 feet was never larger than 1 ½ inch in diameter. Roots became larger with depth. It should be noted that the tree is located at an elevation approximately 7 feet lower than the levee crown and so roots encountered at a depth of 7 to 8 feet in the tree trench are growing approximately horizontally from the tree. At depths of 4 to 6 feet below grade, the root system of the waterside oak extended from Station TT 9 to 42 with root sizes typically on the order of ½ to 1 ¼ inch in diameter but growing as large as 2 ½ inches between Stations TT 15 and 26. Detailed logs and photographs of roots associated with the waterside oak tree at depths greater than 4 feet are shown on Figure 3-63 through Figure 3-73.

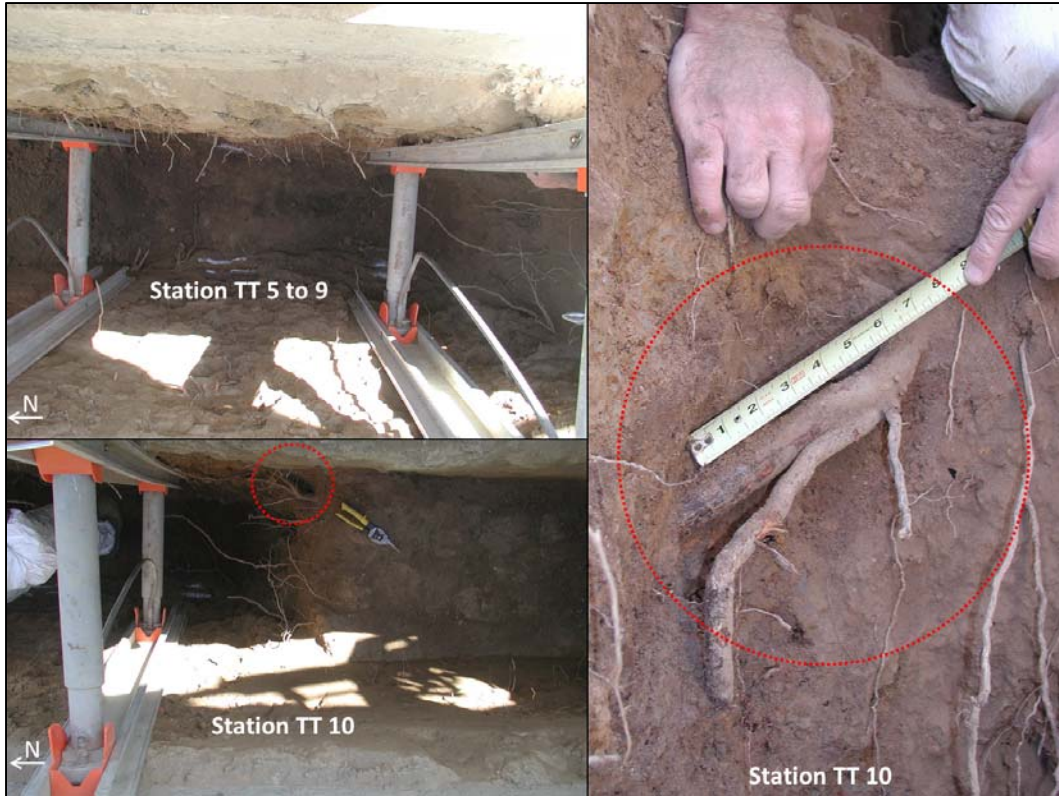
Figure 3-64. Roots at Station TT 5 to TT 10.
