Static and Seismic Performance of California Levees

Michelle Jennifer Shriro

Doctor of Philosophy

Engineering - Civil and Environmental Engineering

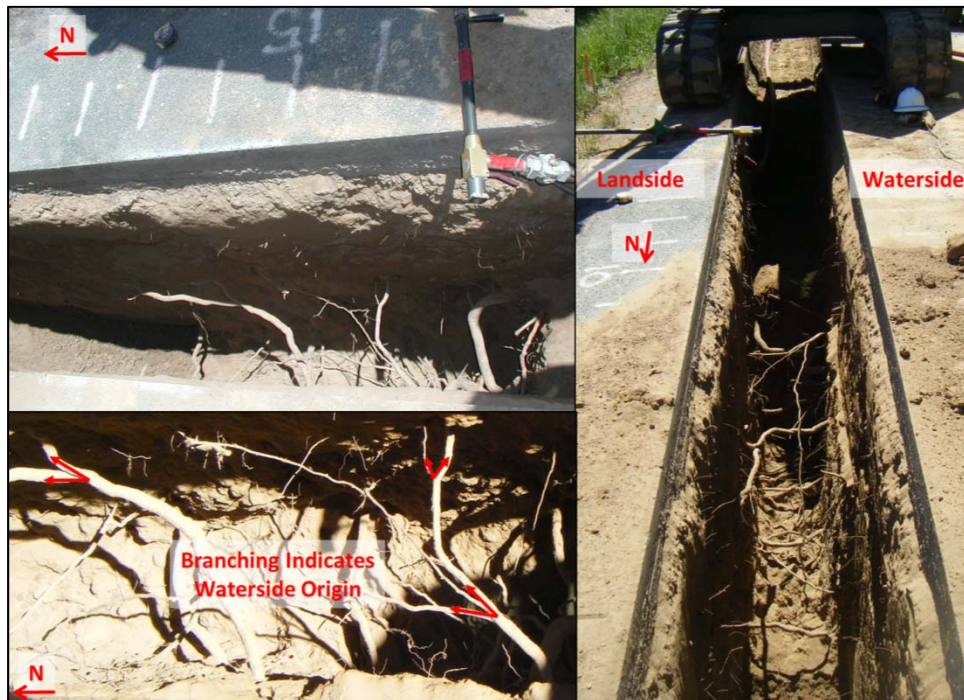
Figure 3-65. Roots at depths of 4 to 8 feet at Station TT 10 to 15.

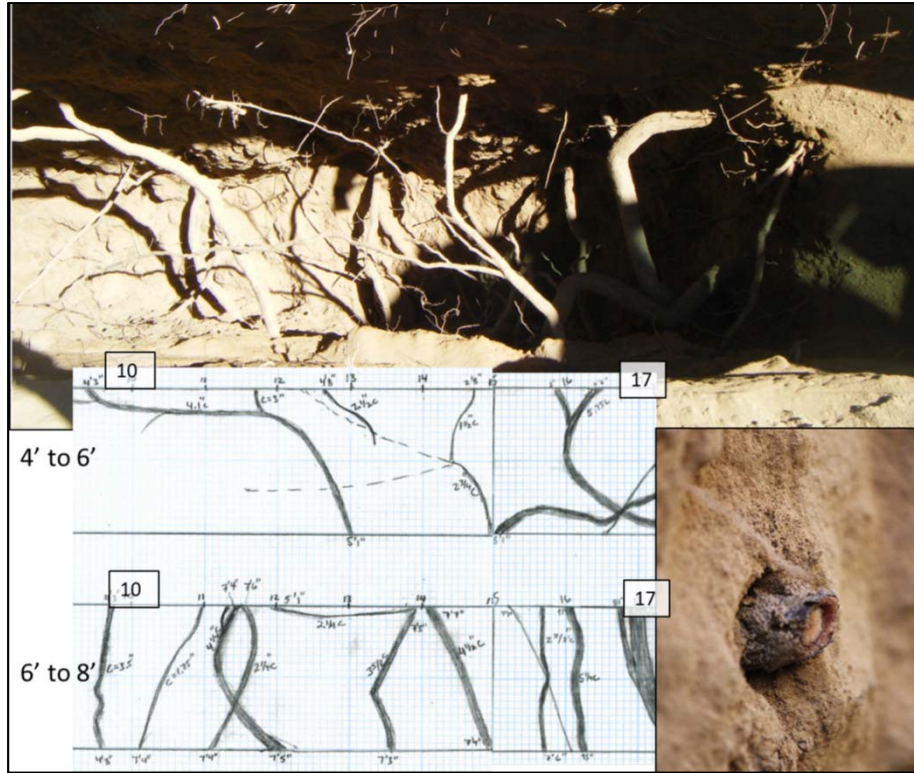
Figure 3-66. Root logs at 4 to 8 foot depth Stations TT 10 to 17.

The deeper roots from 6 to 8 feet in depth were the most extensive, beginning at Station CT 27 and extending to Station TT 57. Roots were generally larger to the north (typically up to 2 inches in diameter) with the largest root being 3 ½ inches at Station TT 17 to 18 (Figure 3-66 and Figure 3-67). This larger root was slightly below the 8 foot base of the trench but a decision was made to excavate it out to prevent the excavator from pulling on it when preparing the final trench. The bottom was locally excavated to a depth of 8 foot 9 inches at this location, which is below the surface water level in the adjacent slough. The root appeared to originate from the waterside tree whose root system extended from the waterline of the slough to the trench. It was noted that the conditions around the root did not differ from surrounding conditions and water was not observed traveling around the roots.

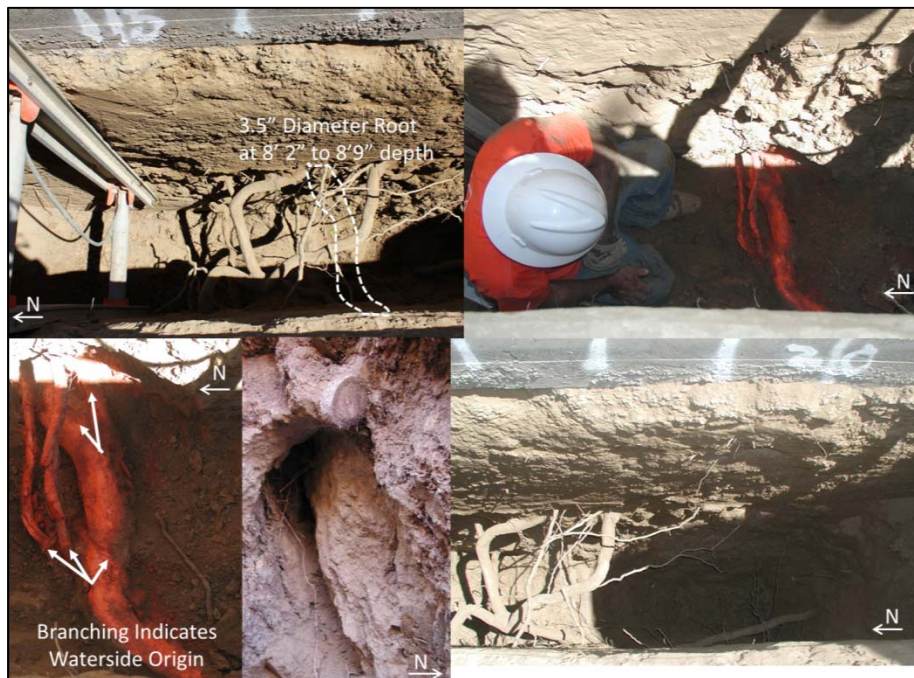
Figure 3-67. Station TT 15 to 20. Excavation extended below 8 feet to remove a 3.5 inch diameter root for constructability concerns (upper right, lower left). Void space was found in the soils at Station TT17 waterside (bottom center).

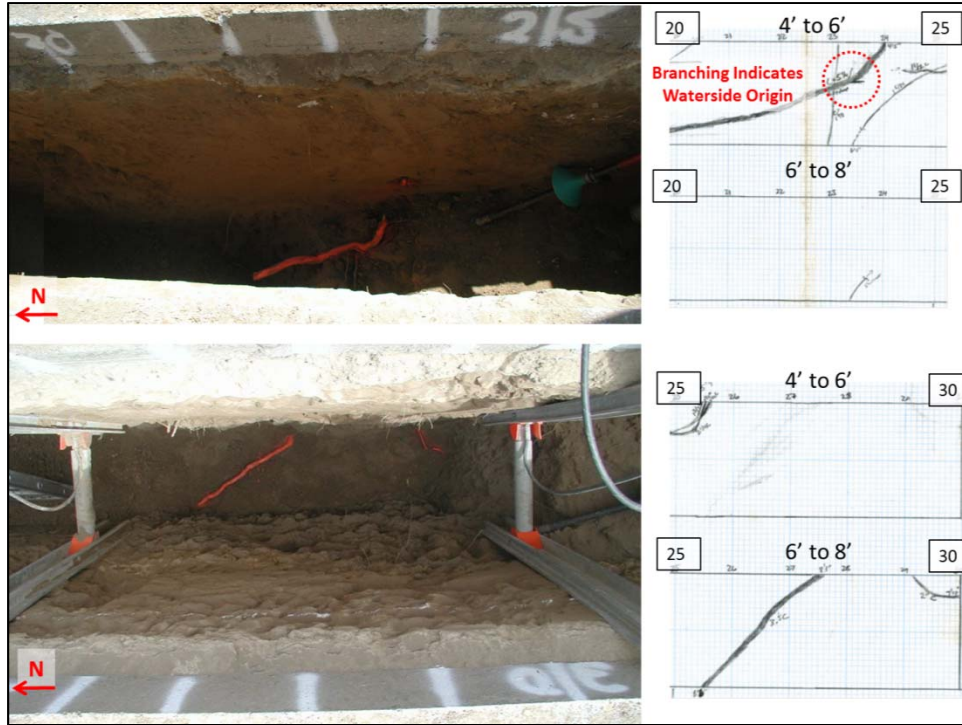
Figure 3-68. Root logs at 4 to 8 foot depth Stations TT 20 to 30.

The largest roots were found in the vicinity of Stations TT 17 and 18 (up to 3 ½ inches in diameter). Root sizes between Stations TT 18 and 45 were on the order of 1 to 2 inches with many smaller than 1 inch (Figure 3-68 through Figure 3-71). Between Stations TT 45 and 57, roots were on the order of ½ inch or smaller (Figure 3-72 and Figure 3-73).

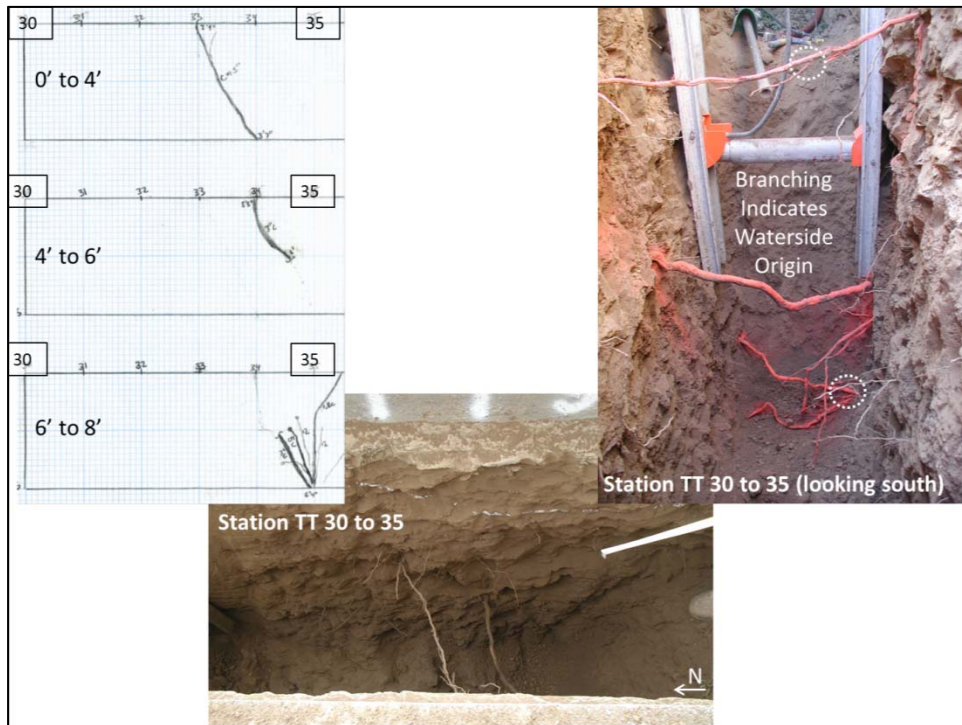
Figure 3-69. Root logs at 0 to 8 foot depth Stations TT 30 to 35. Plan view log compared with view from above and inside trench. The difficulty of capturing three dimensional aspects of a root system in plan view logs is illustrated.

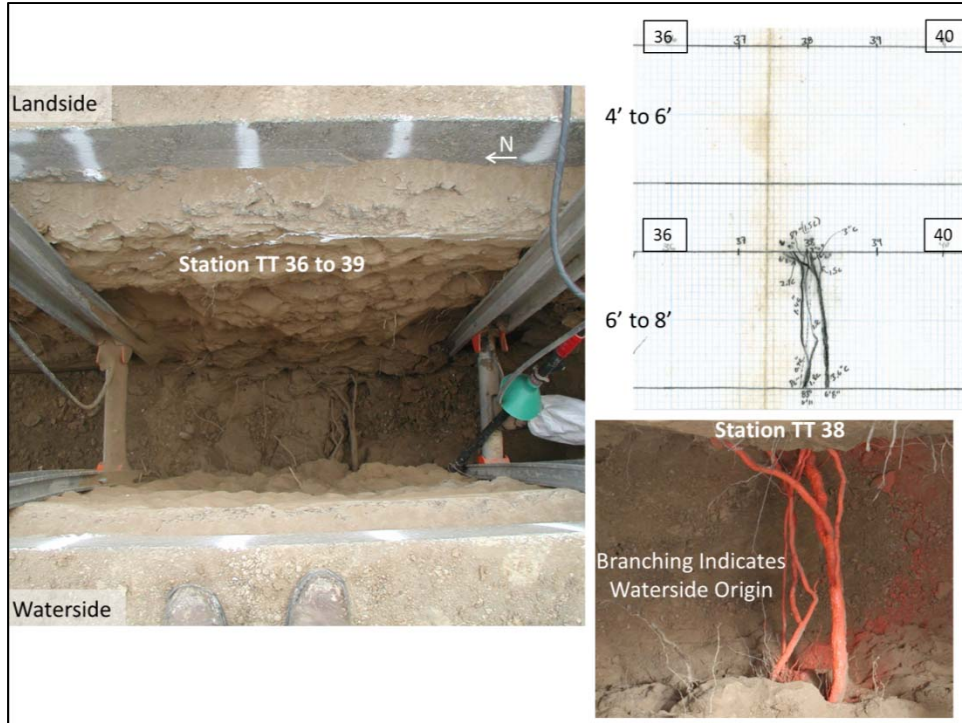
Figure 3-70. Root logs at 4 to 8 foot depth Stations TT 35 to 40.

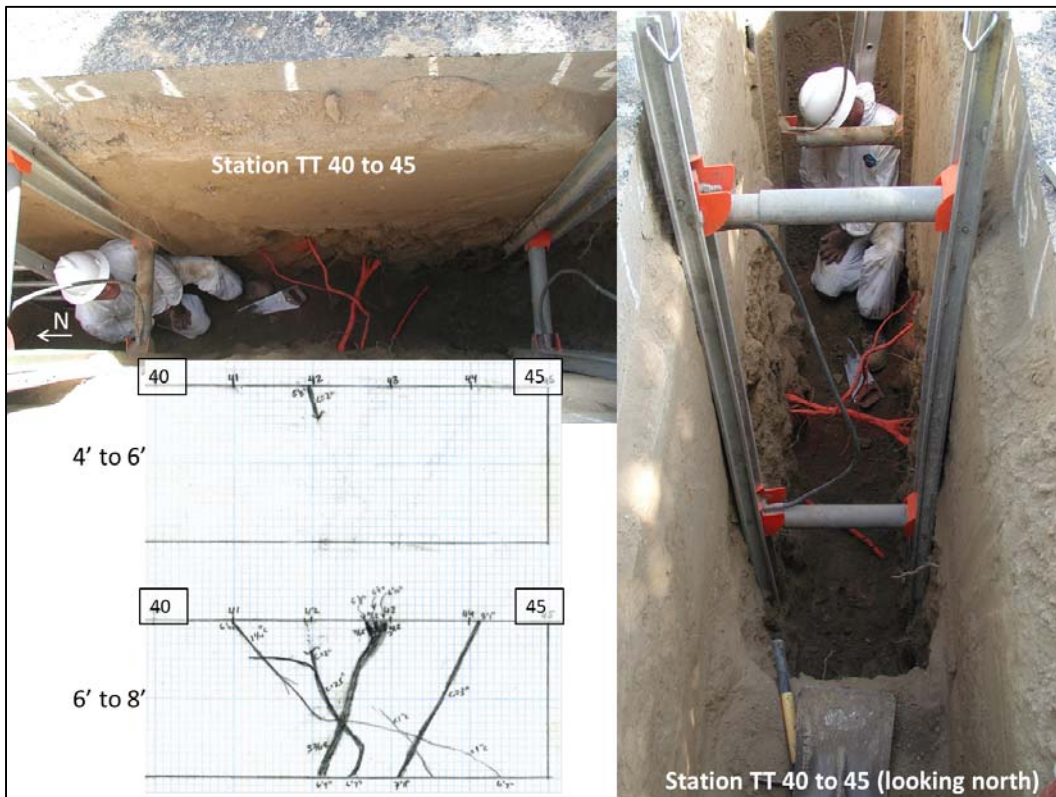
Figure 3-71. Root logs at 4 to 8 foot depth Stations TT 40 to 45.

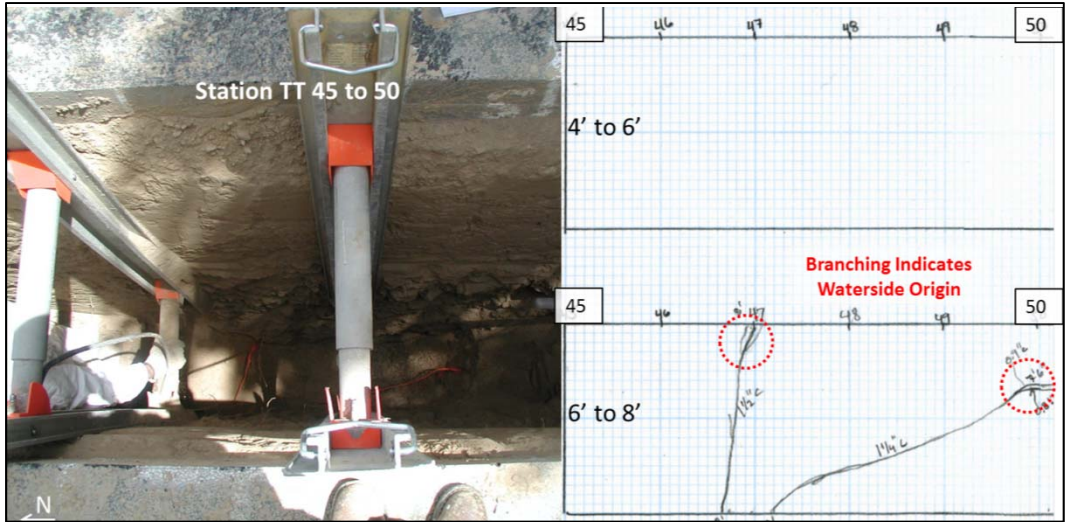
Figure 3-72. Root logs at 4 to 8 foot depth Stations TT 45 to 50.

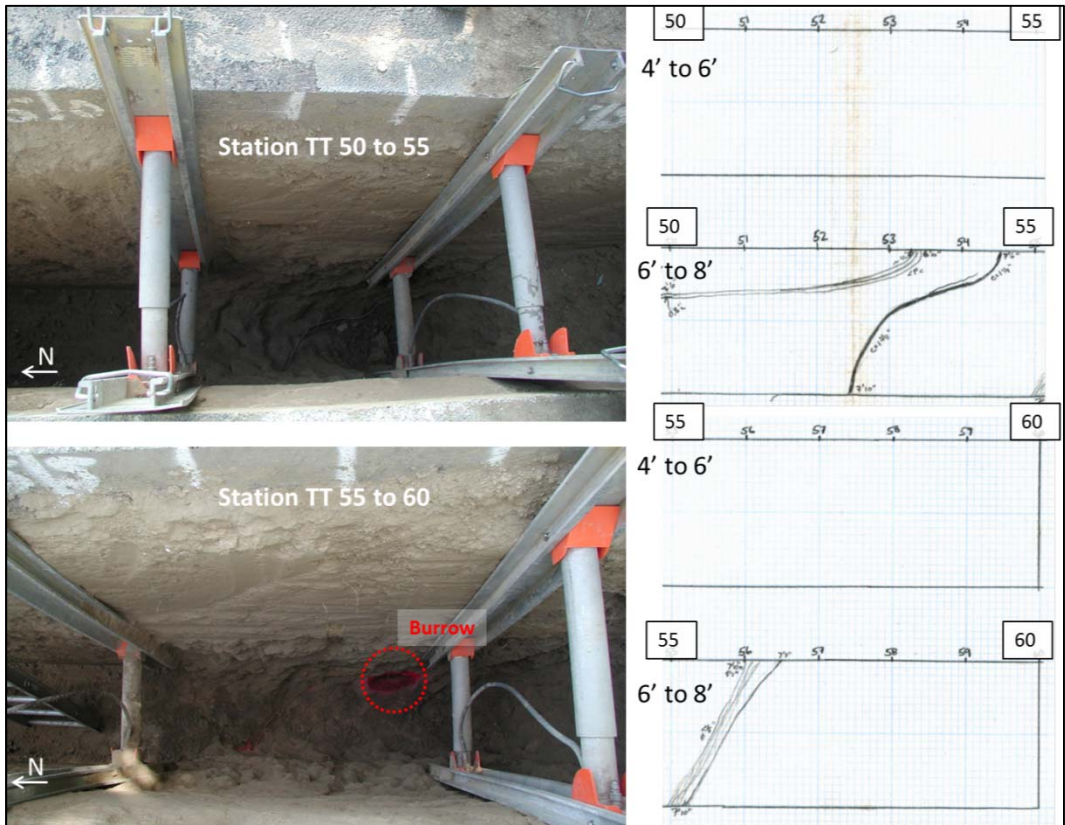
Figure 3-73. Root logs at 4 to 8 foot depth Stations TT 50 to 60. Note the first burrow of the tree trench was encountered at landside Station TT 57 at a depth of 7 feet.

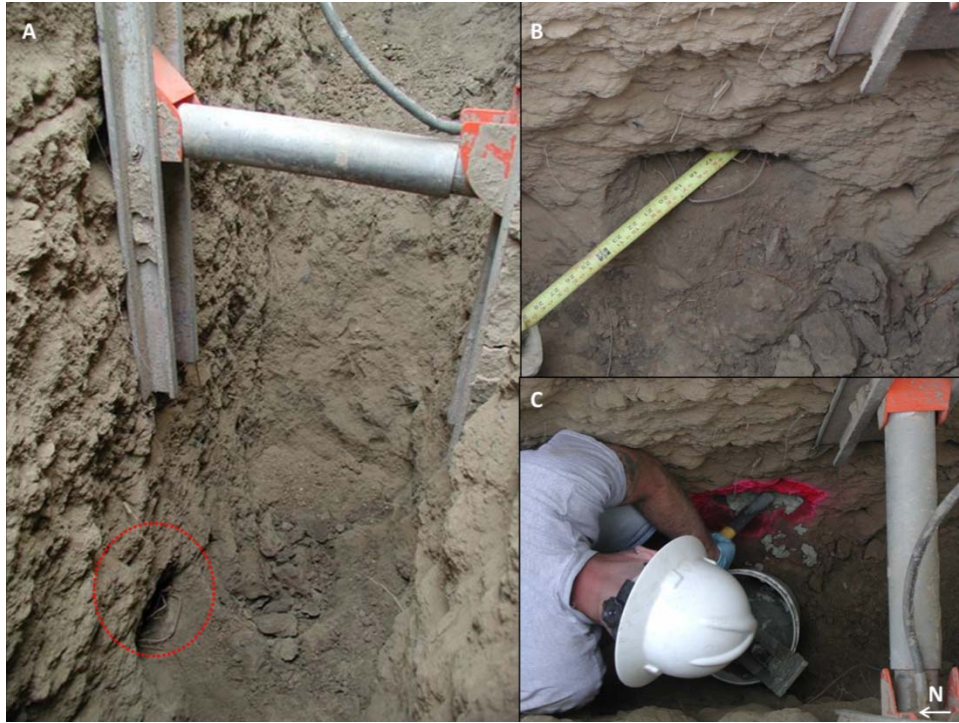
Figure 3-74. Burrow on landside of Station TT 57 at 7 foot depth. Vegetative debris and live root growth found inside 2 ½ diameter hole (left, top right). A plug of grout is placed (bottom right).

Burrowing activity began at Station 57 (Figure 3-74) and was extensive in the zone between Stations TT 64 and 81 (Figure 3-75 through Figure 3-82). Burrow diameters ranged from tiny holes on the order of ¼ to ½ inch, to moderately sized holes of 1 to 1 ½ inch, up to holes 2 to 3 ½ inch. Based on discussions with Dr. Van Vuren of UC Davis, the 1 to 1 ½ inch diameter holes were likely due to gopher or vole activity originating on the land side, but the depth of 6 to 8 feet was unusual. The larger holes were suggested to be related to muskrat activity originating on the water side. Dr. Van Vuren suggested that perhaps the smaller rodents were taking advantage of pre-existing abandoned burrows created by the muskrat, explaining the range in size of the burrows as well as the unusual depth of the smaller rodent burrows.

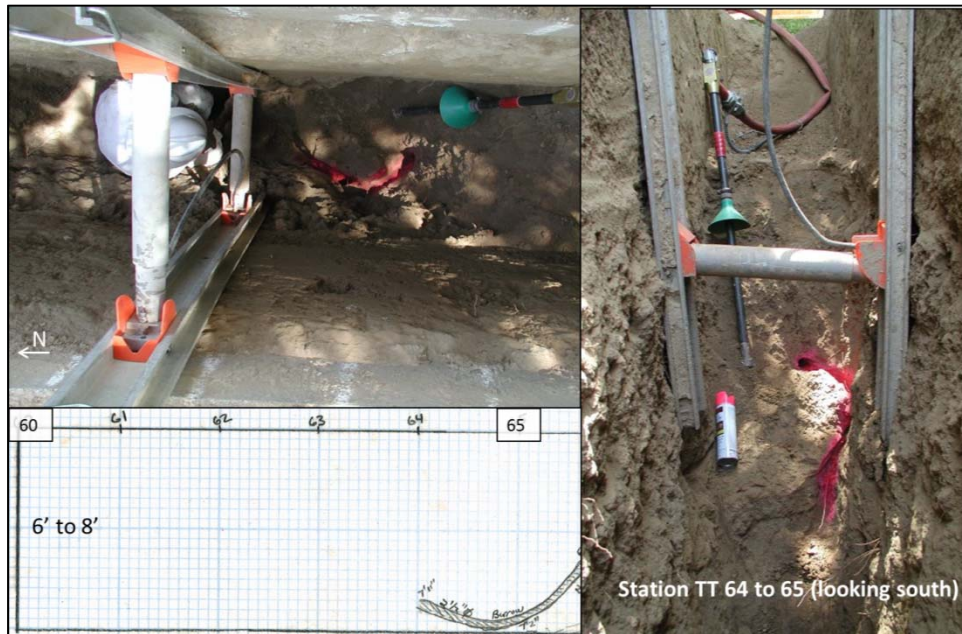
Figure 3-75. A burrow is encountered during air knife work. The burrow is painted pink in photographs. Burrow diameter varies from 2 to 2 ½ inches.

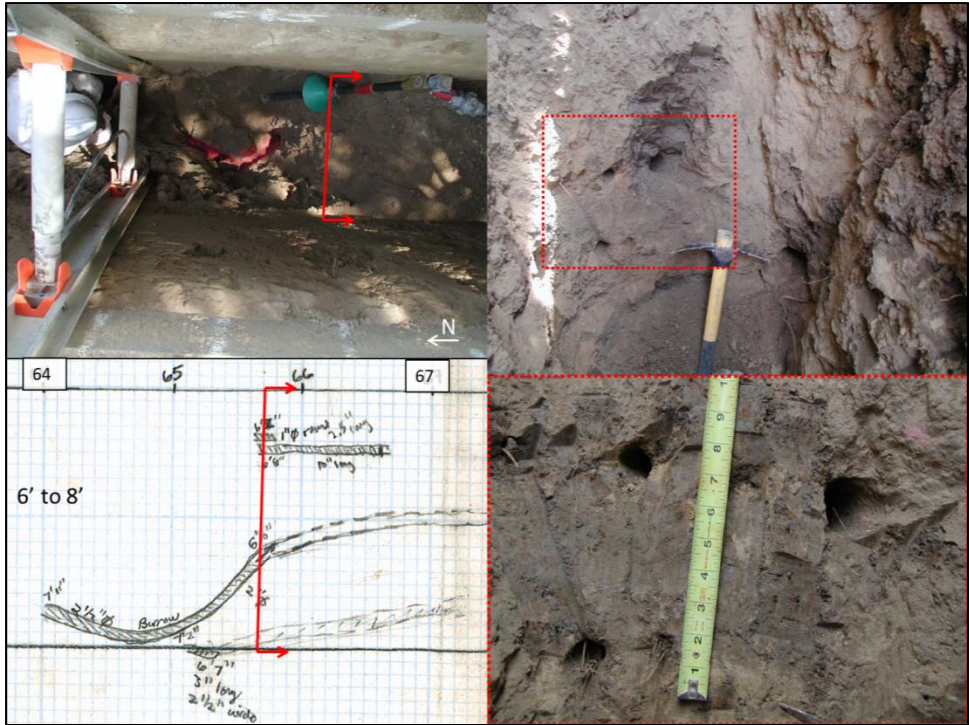
Figure 3-76. Views of burrow network extending south from Station TT 66 (right). Burrows ranging from 1 inch to 2 inches in diameter.

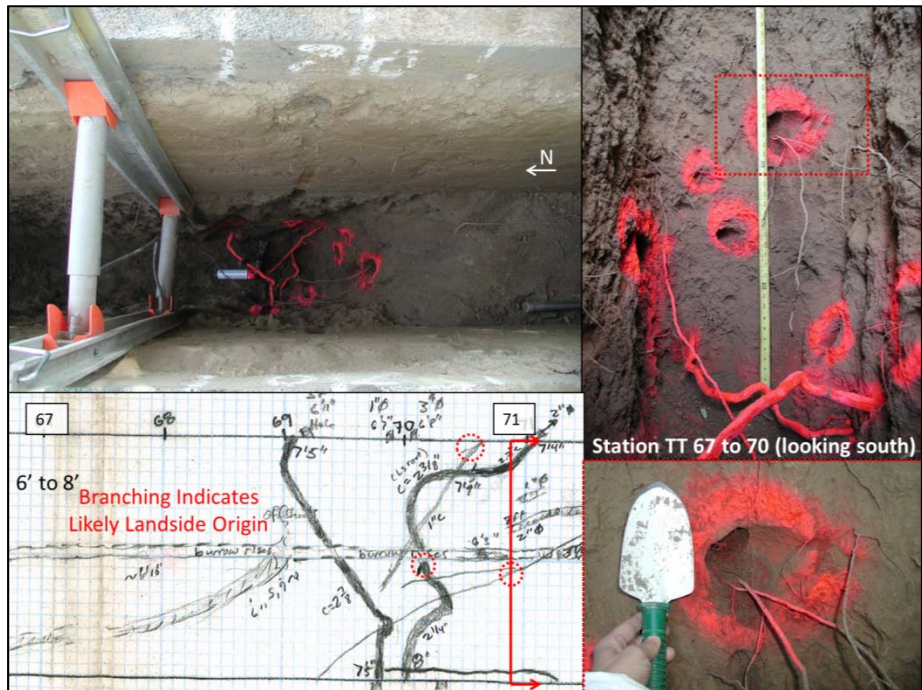
Figure 3-77. Root and burrow log at depth of 6 to 8 feet at Stations 70-71. Live root growth in burrows of 2 to 3 1/4 inch diameter.

The root system of the landside tree (centered at Station TT 70) was found to extend from Station TT 62 to TT 89 (Figure 3-77, Figure 3-79 through Figure 3-84). All roots extending from the landside oak tree that were encountered in the tree trench were 1 inch in diameter or smaller. Unlike the waterside oak tree roots, the larger roots were found between 3 and 8 feet deep and did not show a notable increase in size at any particular depth but rather were distributed throughout the depth profile. Roots were generally not found at depths above 3 feet.

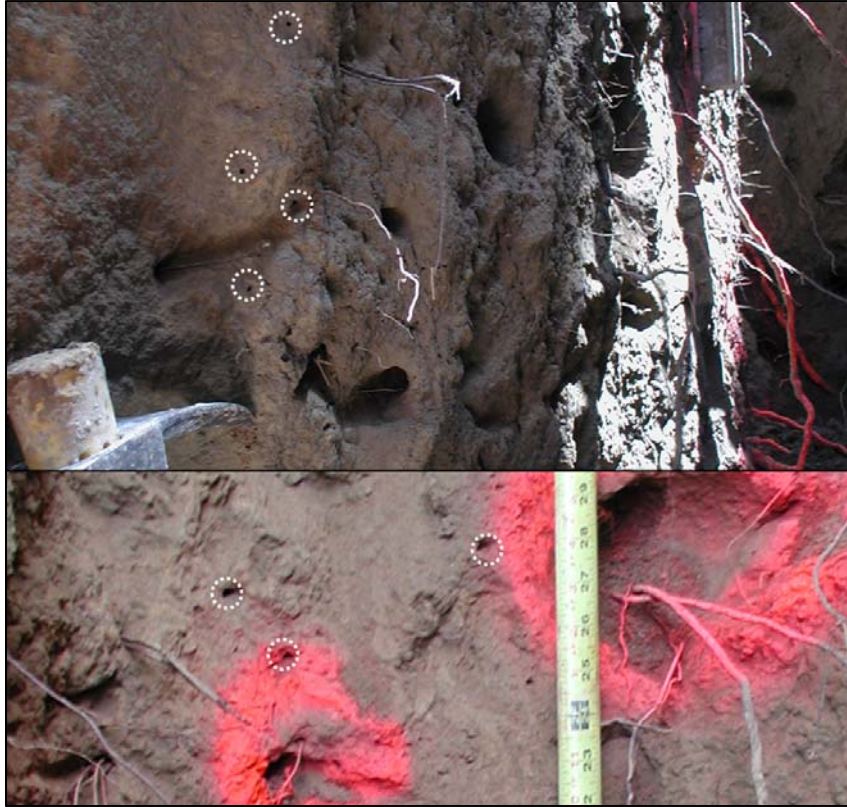
Figure 3-78. Small holes, less than 1/2 inch in diameter observed near mammal burrows.

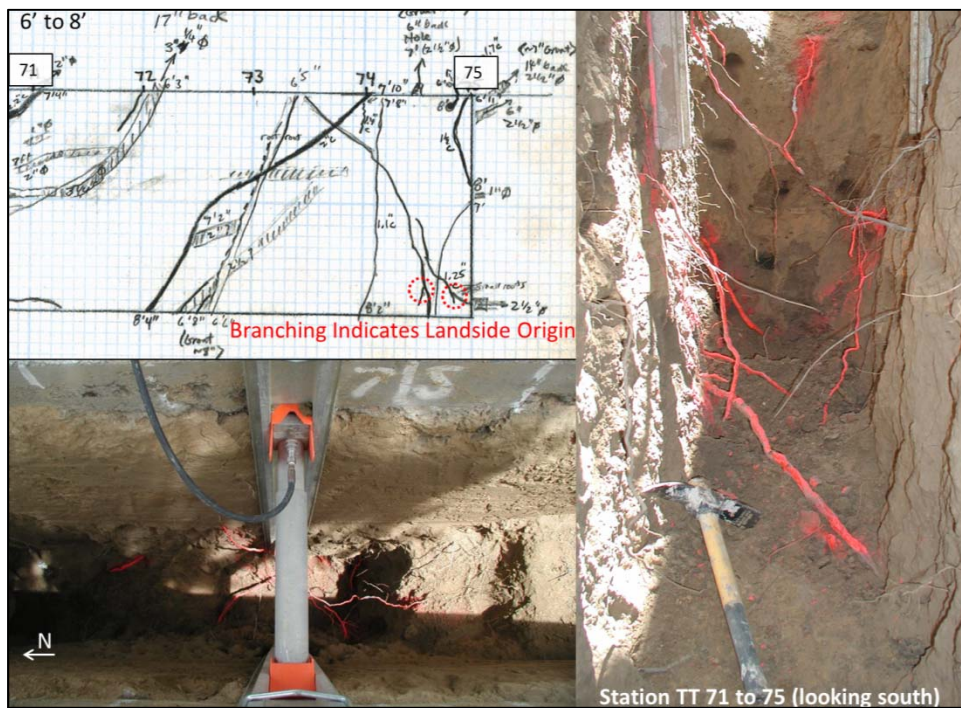
Figure 3-79. Root log for Stations TT 71 to 75 including plan view photo (bottom left) and trench view (right).

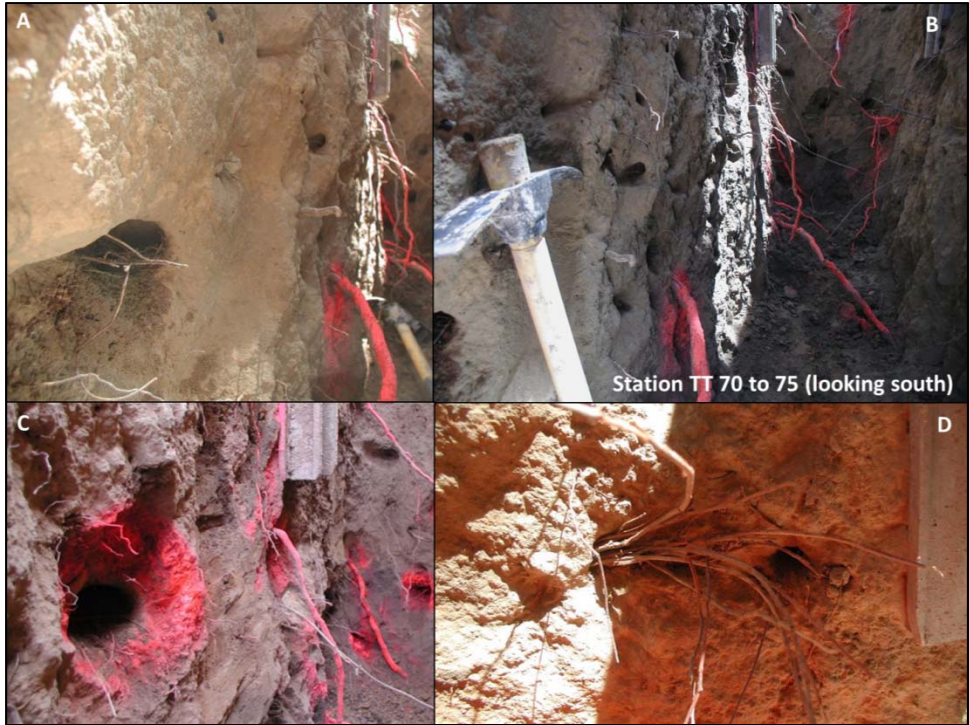
Figure 3-80. Close in view of mammal burrows with root growth and vegetative litter left by mammals (A, C, D) and an overview of extensive burrowing activity between Stations TT 70 and TT 75 (B). Burrows range in diameter from 1 to 2 ½ inches.

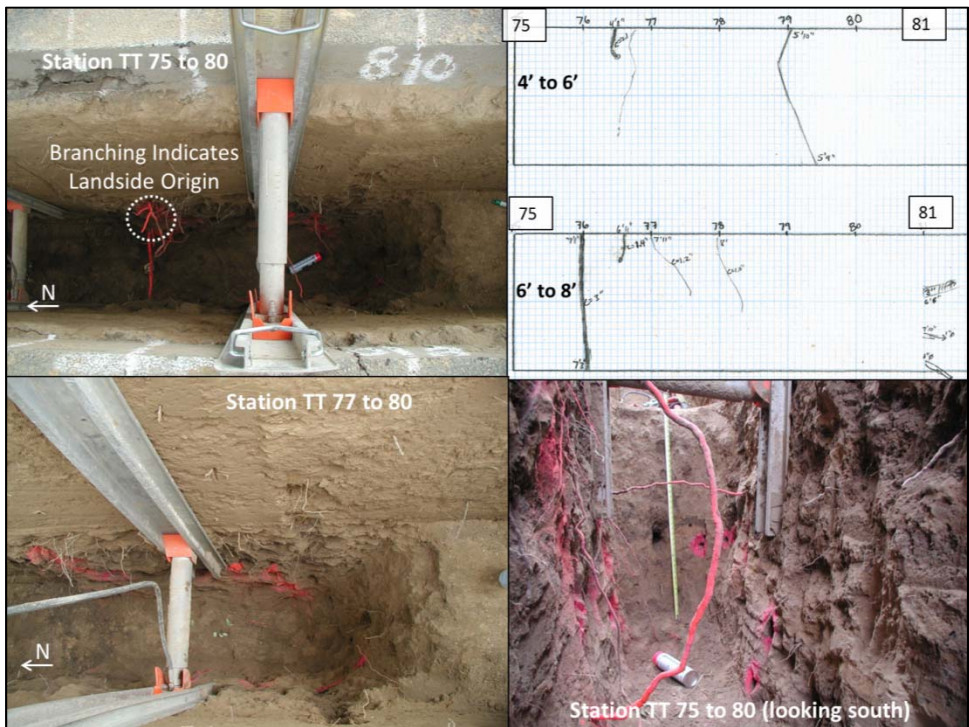
Figure 3-81. Burrowing activity and live root logs between Stations TT 75 and 80.

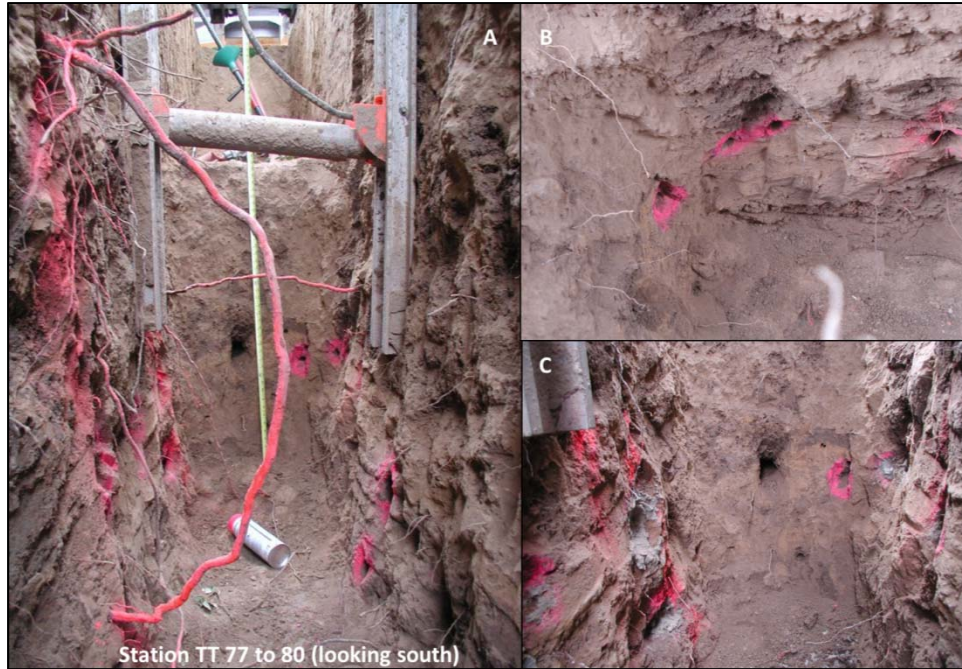
Figure 3-82. A) Overview of roots and burrowing activity (diameters from 1 to 3 inches) from Stations TT 77 to 80. B) View of 1 to 1 ½ in diameter holes at Station TT 81 waterside wall; C) View of 3 inch diameter burrow at Station TT 81.

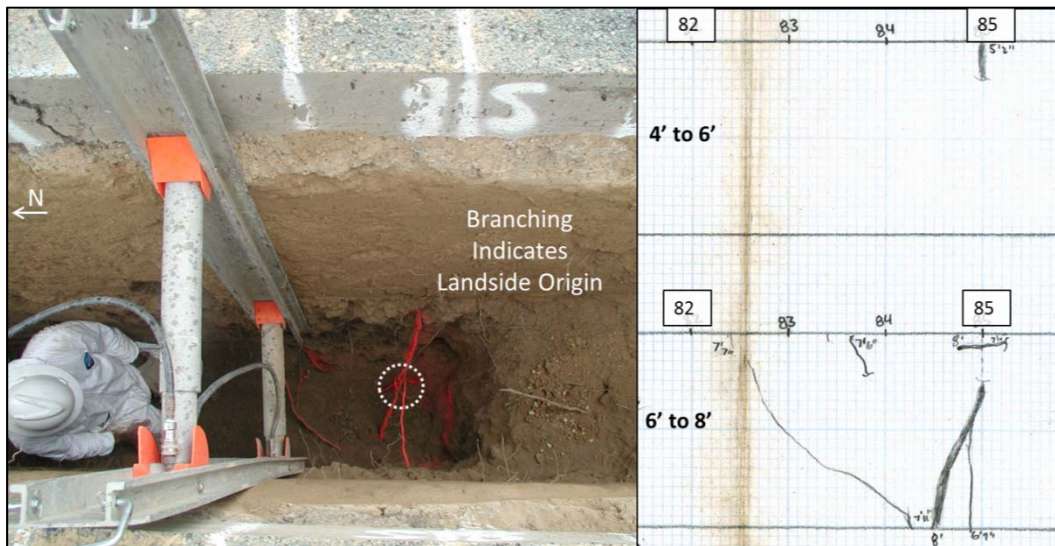
Figure 3-83. Root logs at depths 4 to 8 feet at Stations TT 82 to 85 showing a 1 inch diameter root originating from the land side of the trench.

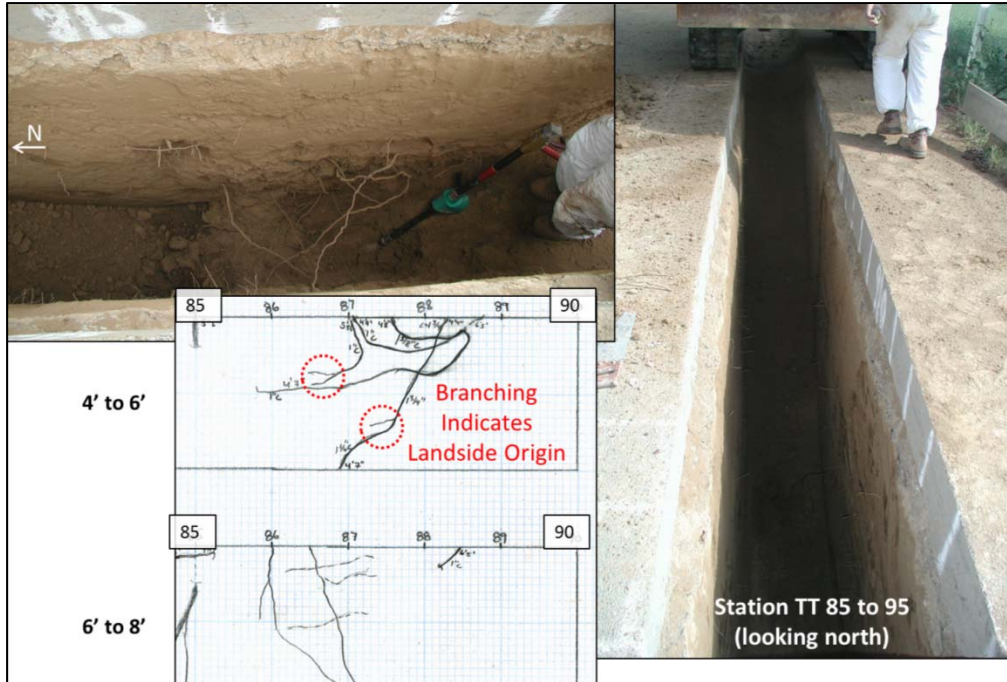
Figure 3-84. Root logs at depths of 4 to 8 feet at Stations 85 to 90 showing the last cluster of roots (approx. ½ inch and smaller) that appear to originate from landside oak tree.

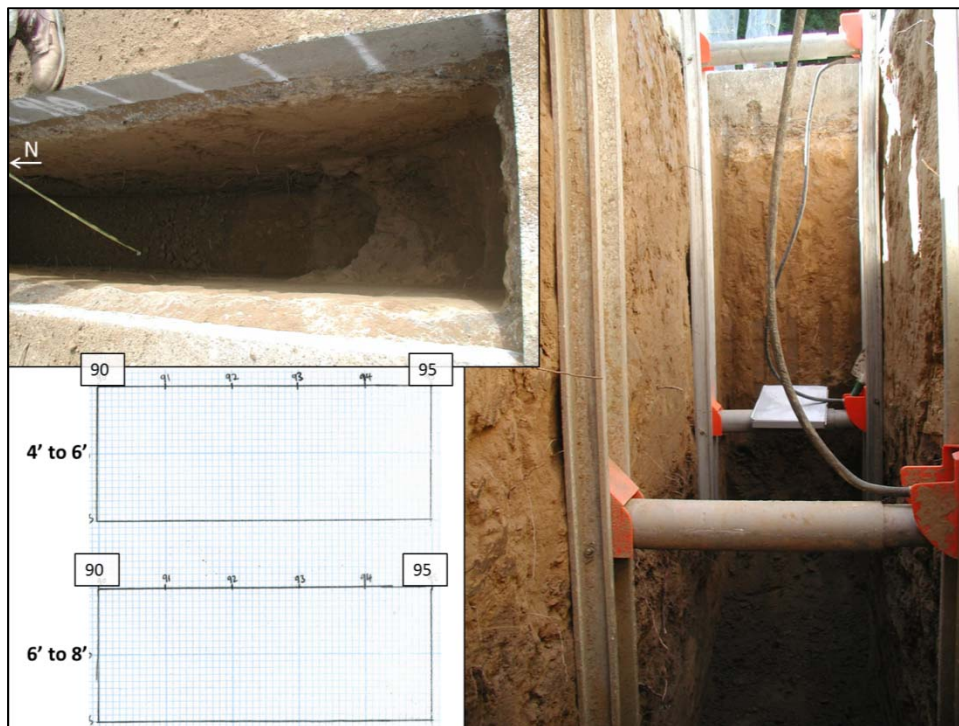
Figure 3-85. Root logs and photographs of the 4 to 8 foot depth range at Station 90 to 95 show an absence of roots and burrows. A clean transition from low plasticity silts (Materials 2, 3, 5, and 7) to plastic silts (Material 4) is seen visible as a shift to darker material midway down the trench (right).

The last 5 feet of trench from Station TT 90 to 95 were devoid of roots (Figure 3-85). Trench wall logs for the tree trench show the material types (from Section 3.1.3.2.1, Materials) encountered on the waterside and landside walls of the tree trench. These logs are provided as Figure 3-86 through Figure 3-89. Of note is the sharp dip of the Material 4 layer at Stations 37 to 42 on the land and water side of the trench. This material is believed to be an older, possibly natural levee as discussed previously. The surface of Material 4 dips along with Material 5, implying that perhaps this was a low point, or a point that settled to become a low point, in the overbank deposits. This depression is filled with the loose, highly variable Material 7, suggesting later infilling. The observations in this area are consistent with an old excavation or possibly a deep scour or breach location, backfilled with loose fills. Poor performance records were kept prior to the 1950s. A deep scour or breach may have occurred during one of the flood events in the late 1800s or early 1900s, possibly breaching from the landside from the flooding on the San Joaquin River.

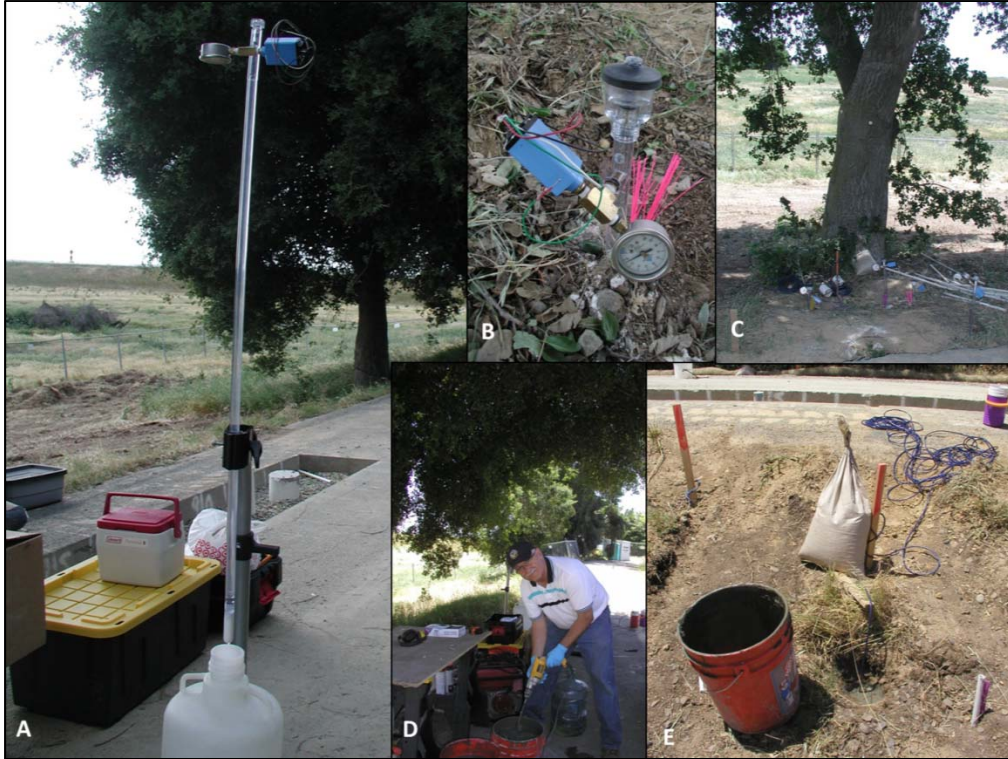
Figure 3-90. Tensiometer is leak-checked, saturated (A) and sealed into the ground (B and C). Grout is mixed (D) and piezometers are grouted into the ground (E).

Initial instrument equilibration and additional installation details are provided in Appendix F. Tensiometers were obtained from Soil Moisture, Inc. and equipped with a mechanical pressure gauge and a pressure transducer with maximum suction capacity of 100 kPa. They were pre-assembled and saturated prior to installation (Figure 3-90). All connections were cleaned, the gauge and transducer ensemble connected to the tensiometer, taking care to properly achieve a seal on each connection. The porous tips were pre-saturated in vacuum with de-aired water and brought to the site in de-aired water. They were connected to the tensiometers onsite just prior to installation. De-aired water was brought into each instrument through a suction pump attached at the top. Once the tensiometer was filled, the suction pump was used, along with tapping action, to remove trapped pockets of air from the gauge and transducer connections.

Tensiometers of 24, 48 and 60 inches were installed to depths of 18, 36, and 60 inches, respectively. All instruments were installed in accordance with the manufacturer's specifications. Holes were advanced with a gauge auger (provided by the manufacturer) with a diameter slightly larger than the instrument diameter of  $\frac{3}{4}$  inch. The instrument holes were logged for soil conditions prior to installation.

With all seals checked and no observed leaks, silica slurry (a mixture of water and silica flour with silt-sized particles) was used to create a seal between the soil and the tensiometer. This step is optional according to the manufacturer if the hole is snug to the tensiometer, but proved helpful in our soil conditions. De-aired water was periodically refilled by opening the instrument, losing tension, refilling, closing the instrument, and allowing time for re-establishment of tension. For convenience, many of the instruments were equipped with a reservoir cap to facilitate refilling (Figure 3-90B), however the effect on soil tension was the same. The functionality of the instruments was checked after each refilling.

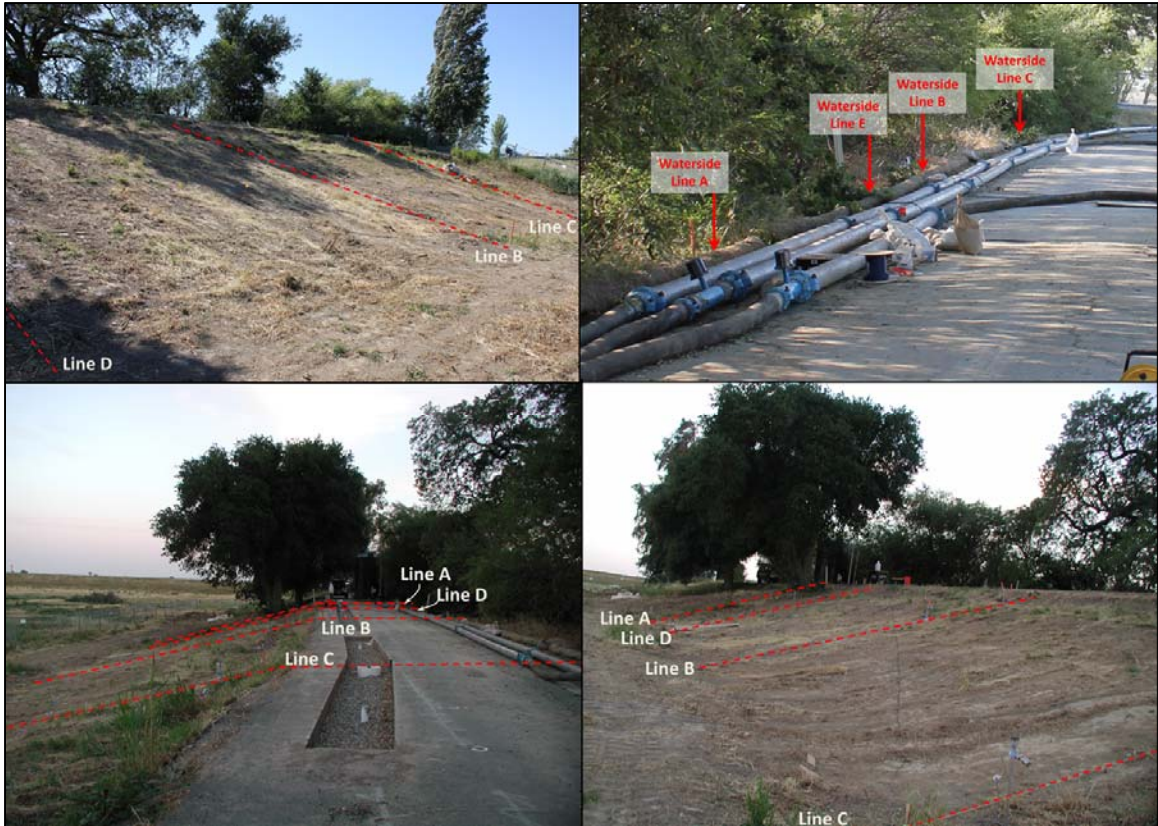
Figure 3-91. Photographic view of landside and waterside instrument line locations.

Approximate alignments of instrument lines are shown overlain onto site photography in Figure 3-91. Figure 3-92 through Figure 3-95 show photos of installed instrument lines on the landside and waterside. Piezometers are difficult to see in photographs as the only visible element is a wire protruding from the ground unlike tensiometers which have an above grade mechanical gauge and transducer.

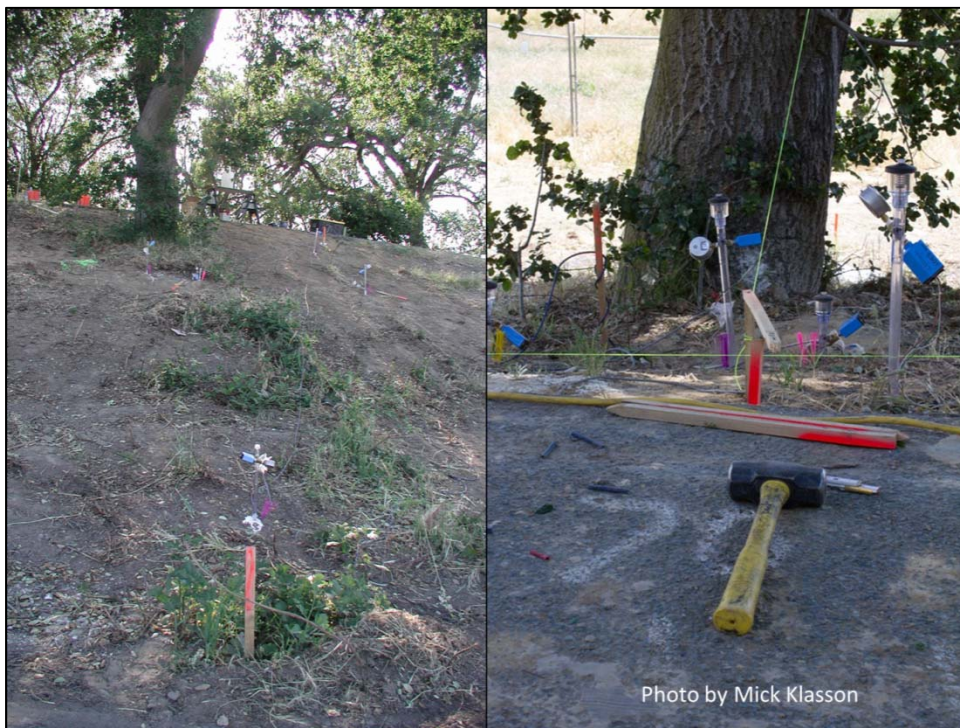
Figure 3-92. Instrument line A looking west from toe (left) and east from top of slope. (right)

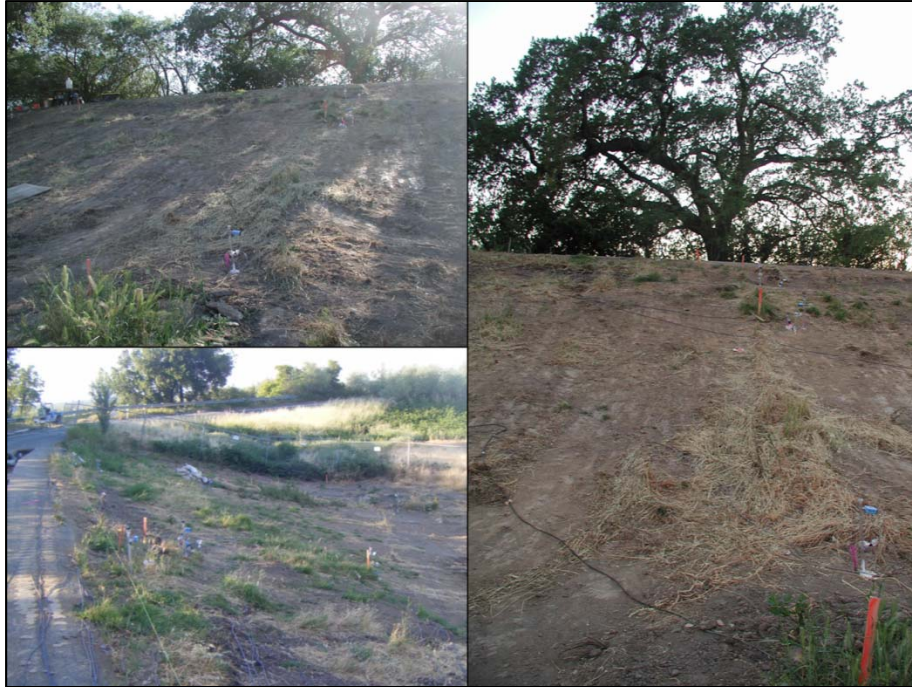
Figure 3-93. Instrument Line B at waterside oak tree looking west (upper left, right) and north (lower left).

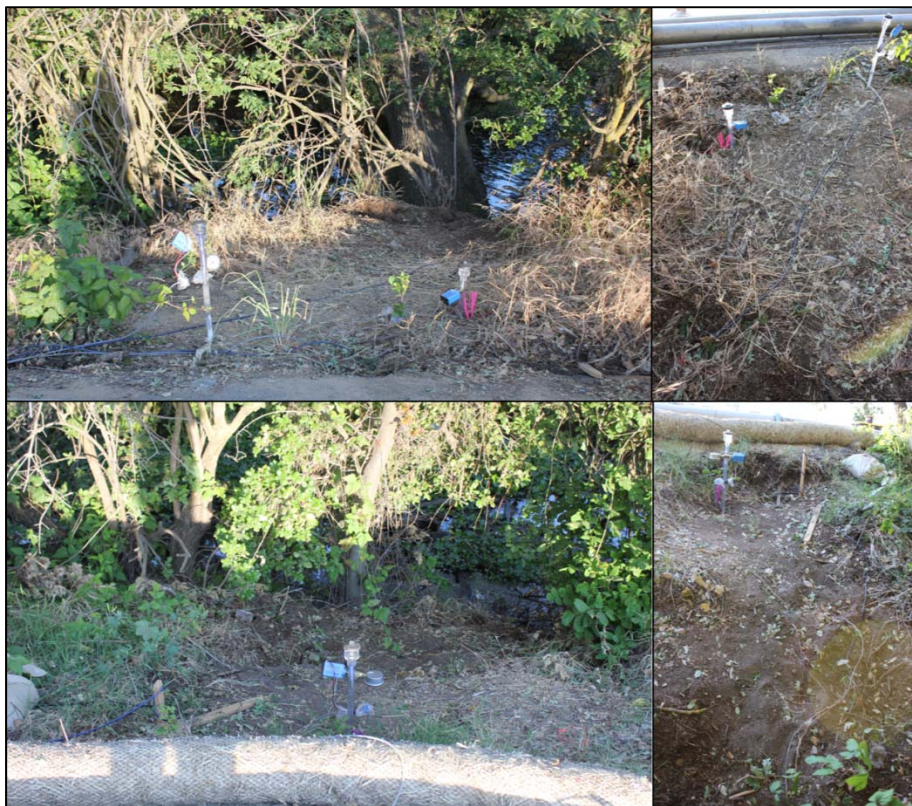
Figure 3-94. Waterside instrument line B (top images) and line E (bottom images).

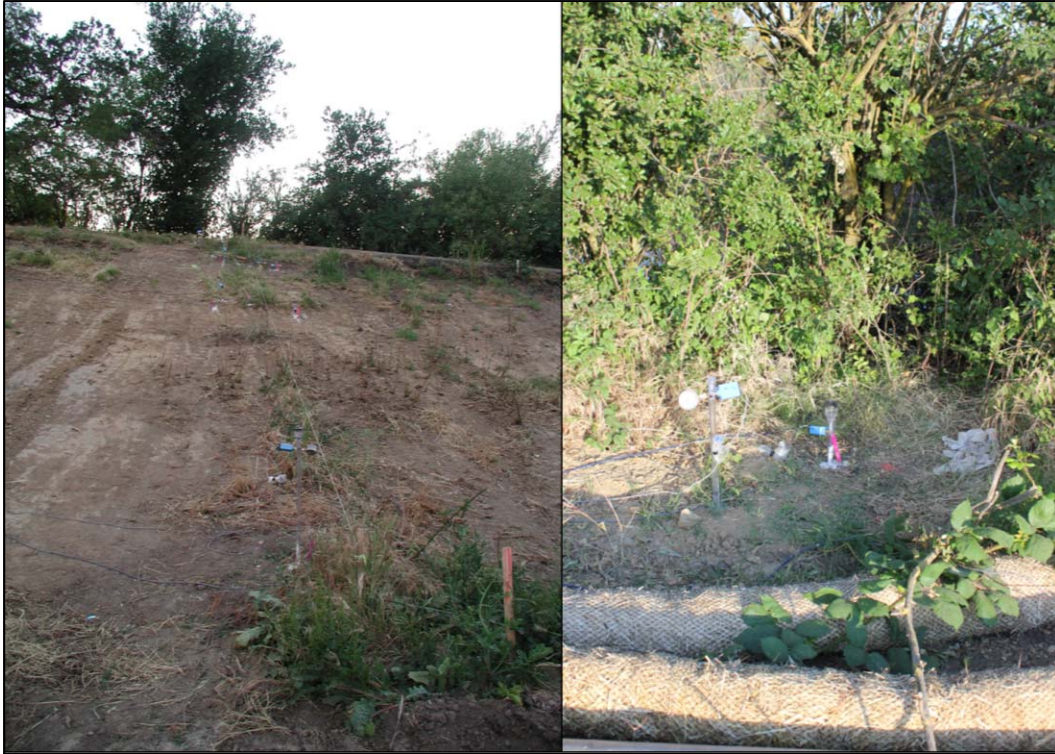
Figure 3-95. Instrument line C from the toe of slope looking west (left) and from the crest looking west at waterside instruments.

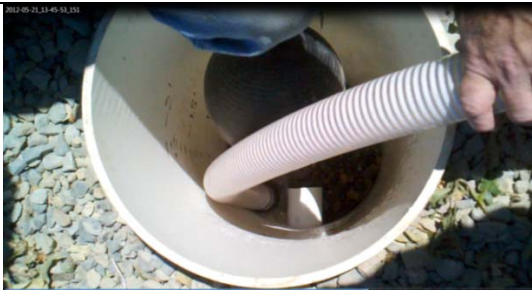
Time (hrs)	Date	Time	Observation	Photo or Illustration
0	5/21	13:43	Water flow begins at 1:43pm on 5/21/12.  Mechanical float introduces bottleneck and is removed.

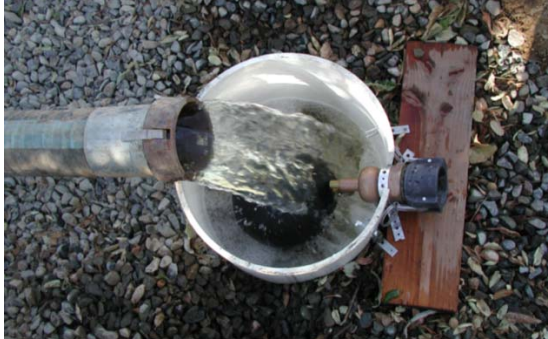
1.32	5/21	15:02	2" diameter hose (connection to float) removed to allow flow through 4" diameter delivery hose. Flows were not sufficient to fill the trenches with 2" diameter hose.

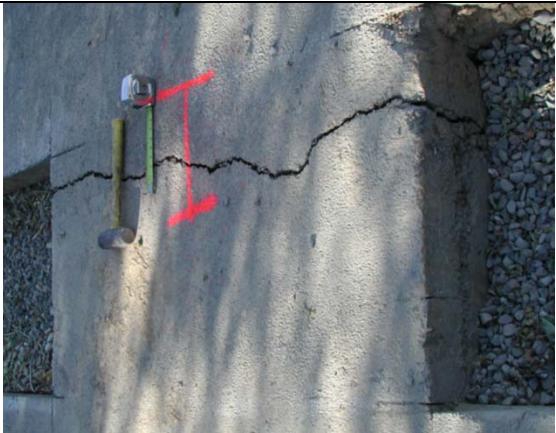
2.6	5/21	16:16	Noticed crack between Control and Tree Trenches. Nails installed to monitor separation.  (also see Figure 3-112 through Figure 3-117).

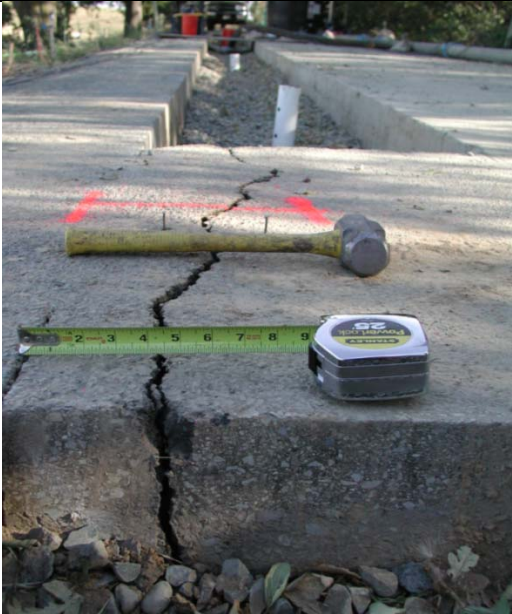
4.3	5/21	18:01	Crack between trenches grows and begins to develop vertical offset .

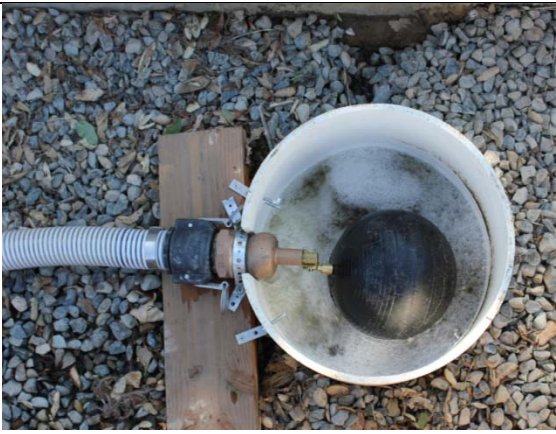
4.8	5/21	18:30	Flows in Control Trench have stabilized and reduced to where the head can be maintained with the float.
