Static and Seismic Performance of California Levees

Michelle Jennifer Shriro

Doctor of Philosophy

Engineering - Civil and Environmental Engineering

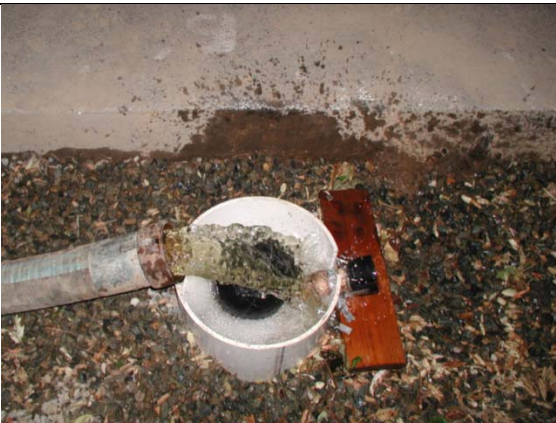
4.8	5/21	18:30	Tree Trench nearly to target water surface elevation, but capacity of mechanical float insufficient to maintain constant head. Must use valve on tank to maintain target water surface elevation.

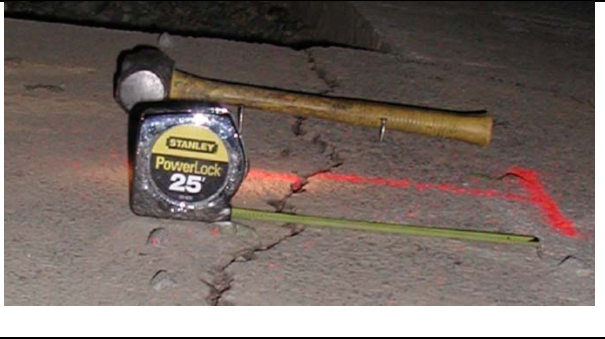
7.3	5/21	21:00	<p>¼ inch vertical offset measured at crack between the trenches.</p>

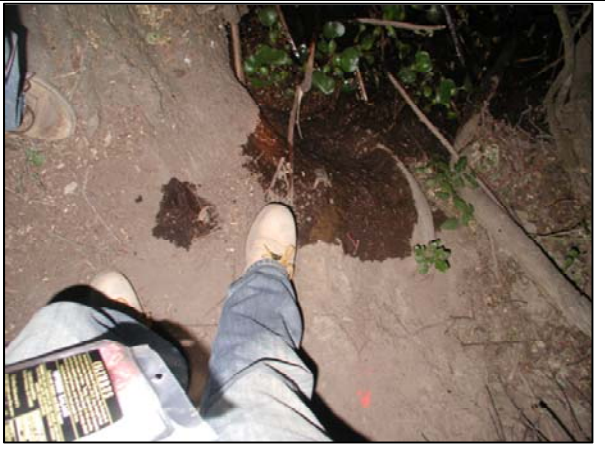
9.0	5/21	22:40	<p>A seep was noticed at the waterside oak tree.</p>

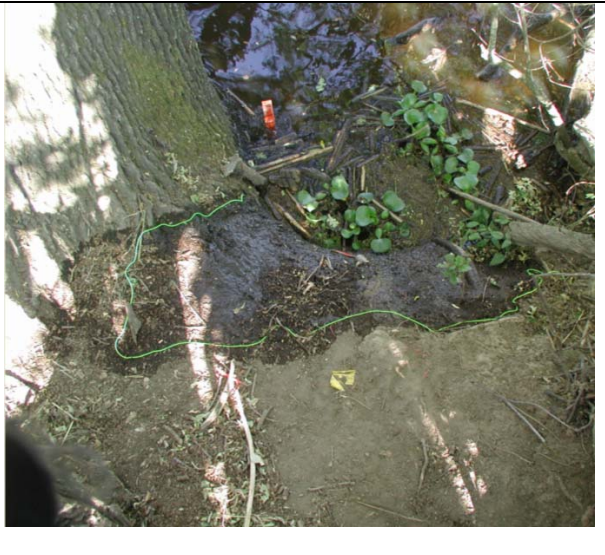
13.3	5/22	03:00; photo at 05:30	<p>Seep at oak had grown; Traced with string for photograph at 5:30am (shown)</p> <p>Seep recorded on the landside at Control Trench (CT) Stations 7 to 10 (no photo). Gravel bags not needed to contain.</p>

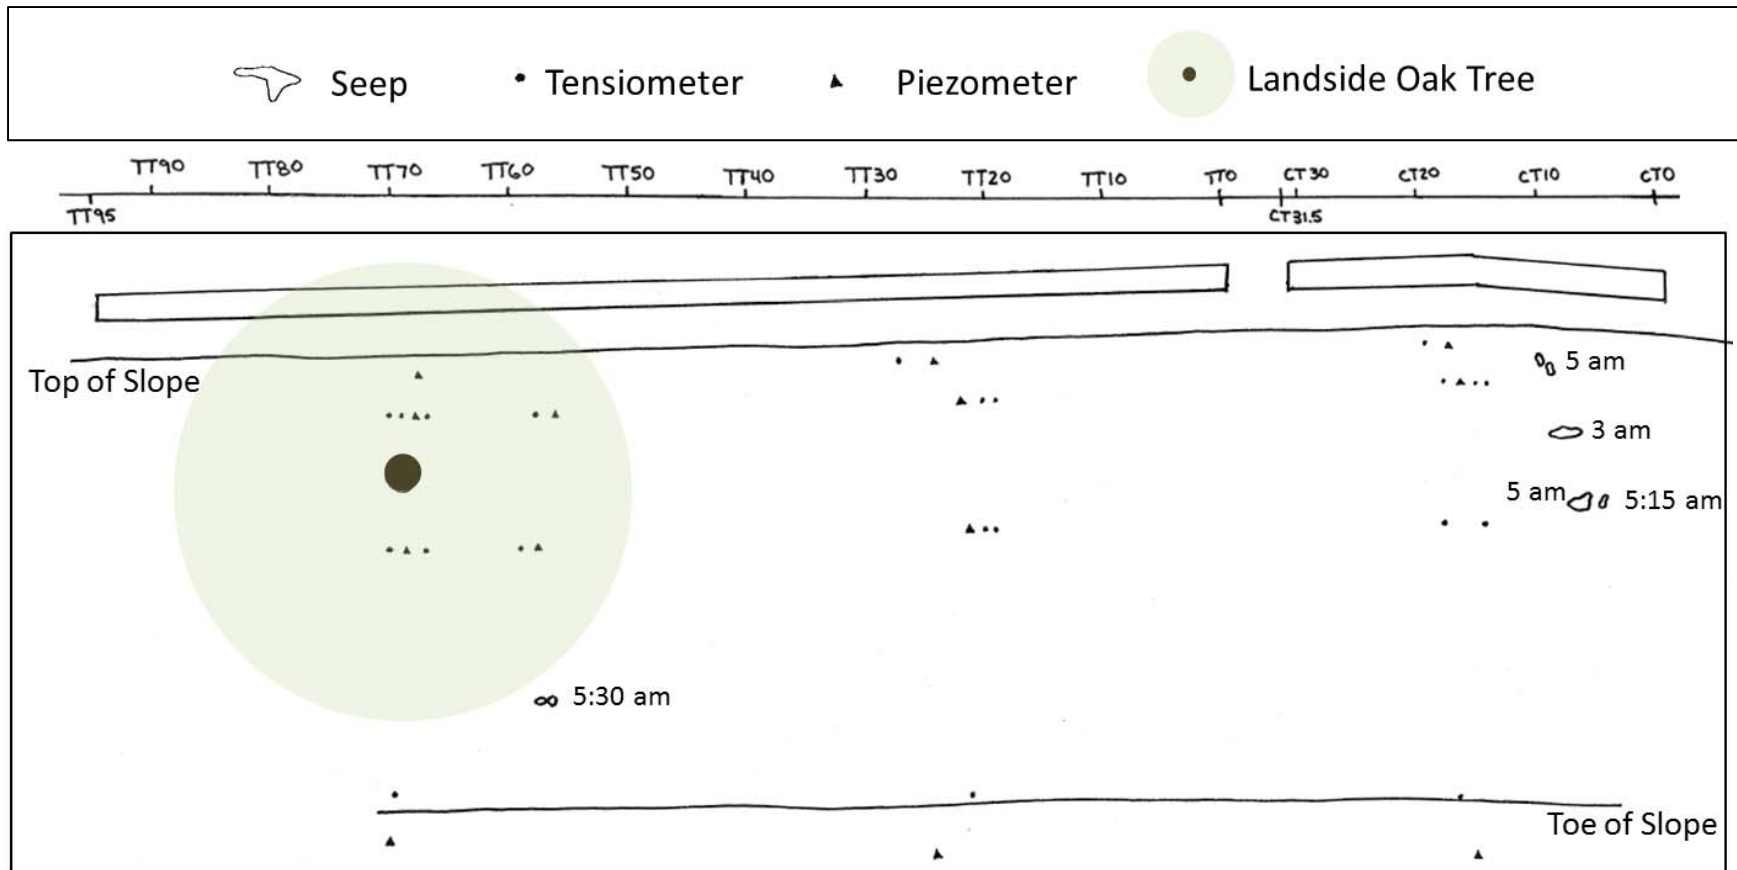
Figure 3-97. Sketch of landside seepage patterns: Time=15.8 hrs (5:30 am on 5/22/12). Time of seep appearance listed next to seep.

As shown on Table 3-2, observations on the landside of the levee consisted of mapping the locations of seeps on the face of the slope and noting those that appeared to exhibit flows through macropores. Figure 3-97 through Figure 3-109 show sketches and associated photographs of wetting front patterns on the face of the landside slope between 15.8 and 92.8 hours from the time of initial inundation of the trenches. Sketches were made to support observations and photographs during this time window as visual changes were occurring rapidly, particularly over the first 48 hours.

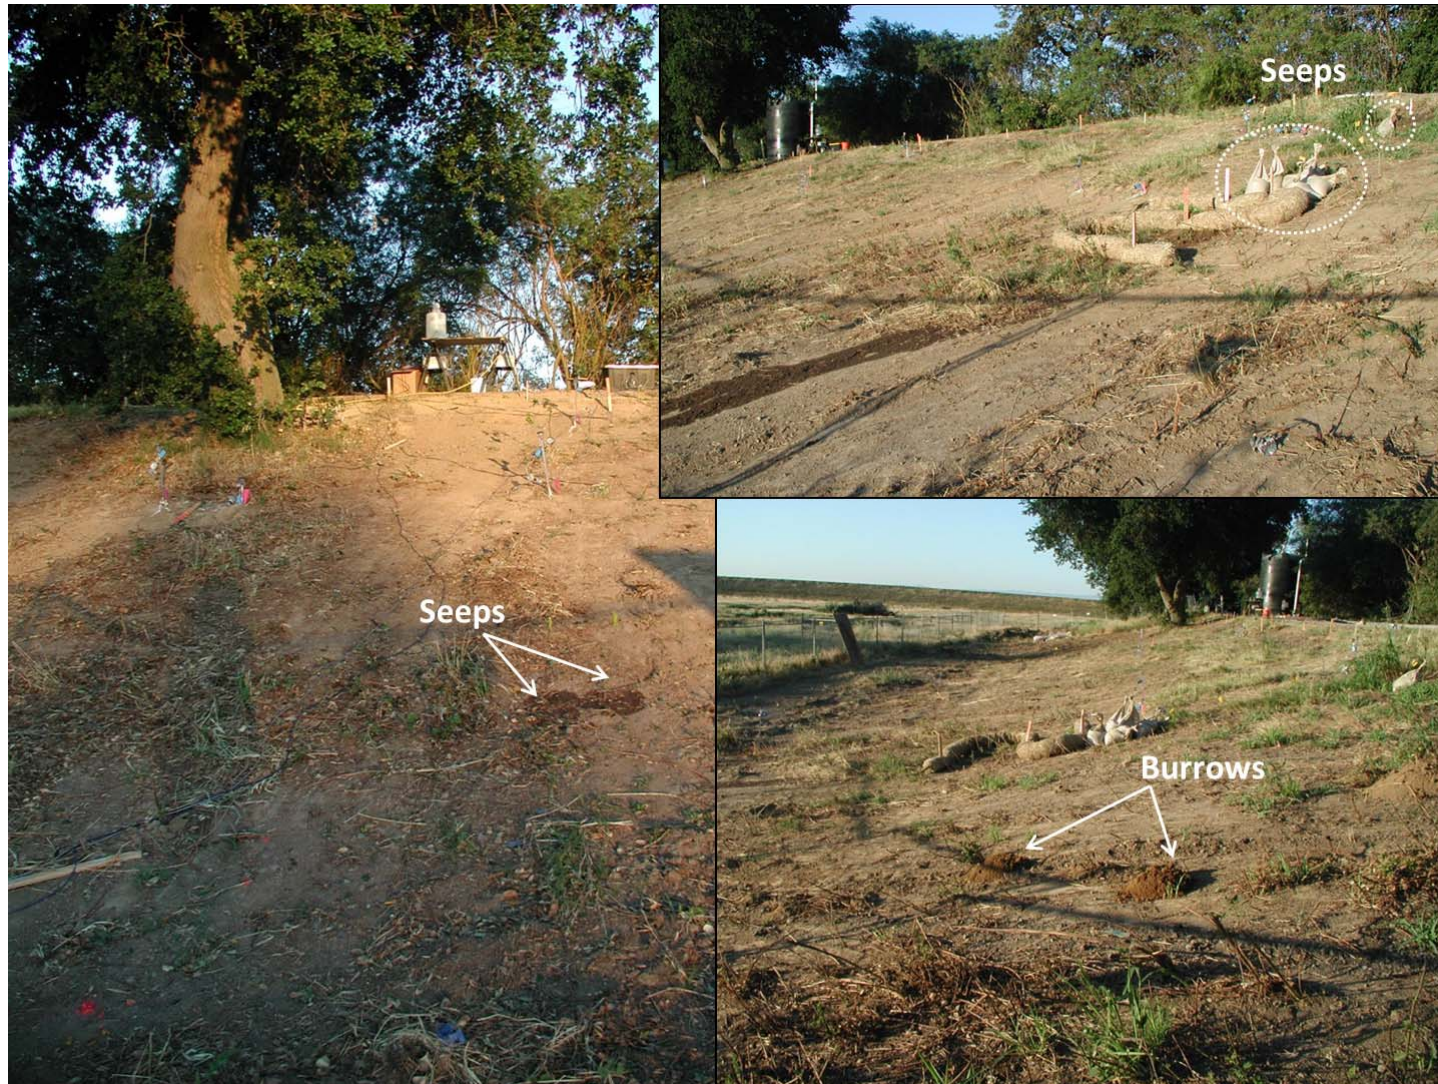
Figure 3-98. Time = 15.8 hours (5:30 am 5/22/13): Seeps at Line D (left), macropore flow near Line C (top right), and active gopher activity to north of control line (lower right).

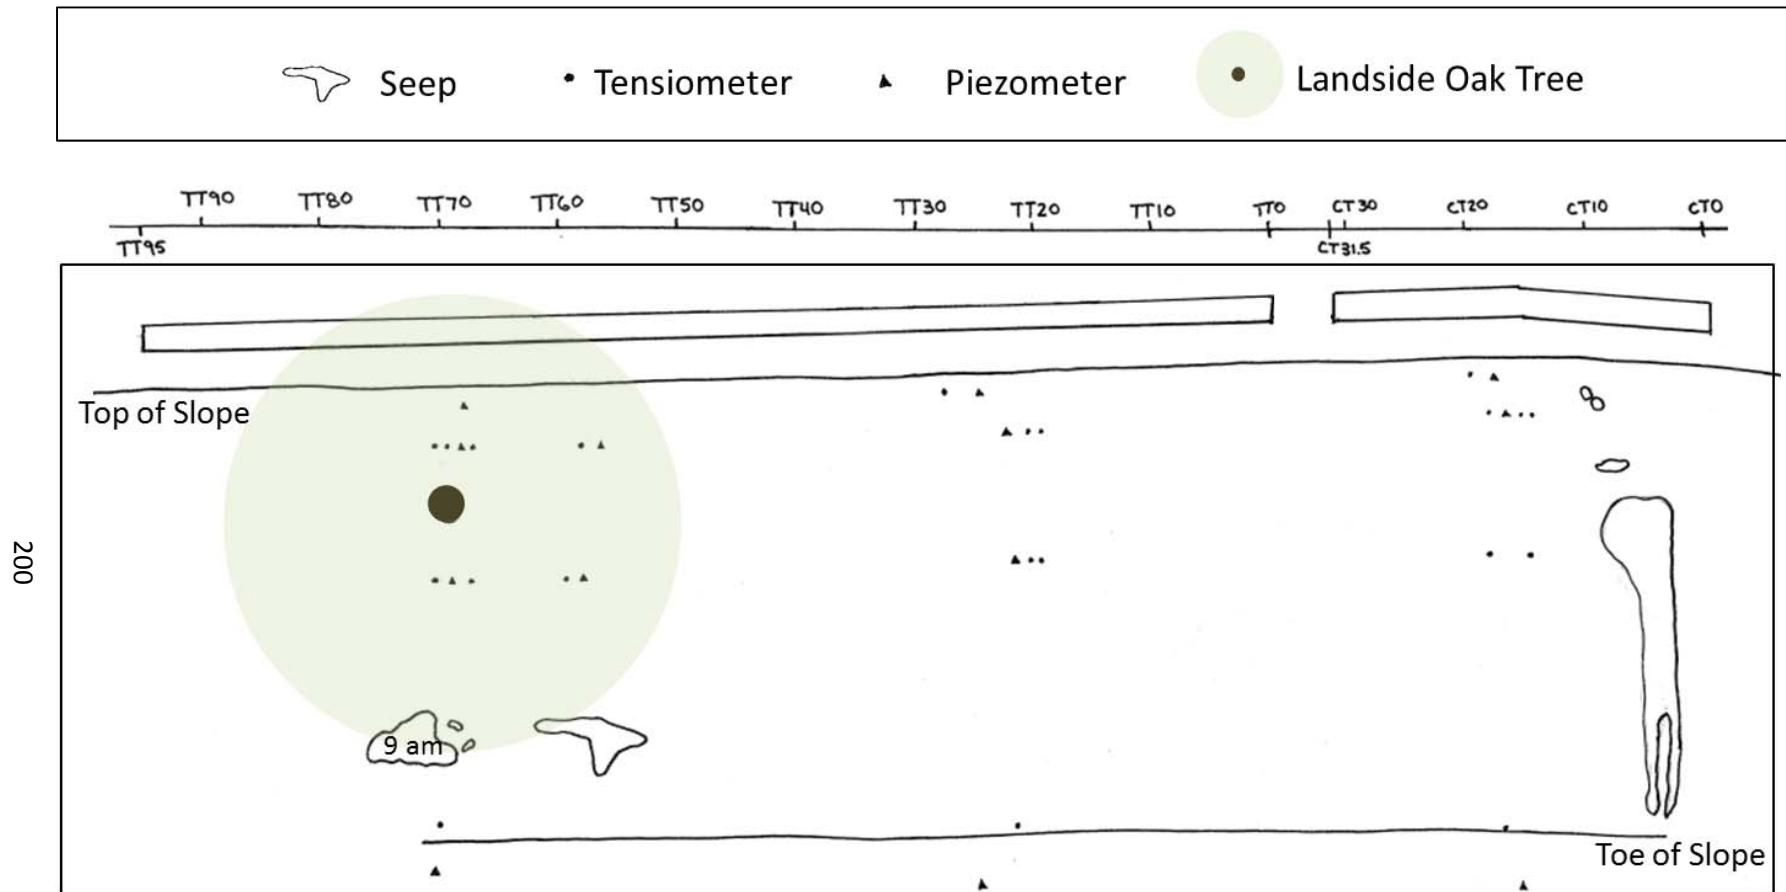
Figure 3-99. Sketch of landside seepage patterns: Time=20 hrs (9:45 am on 5/22/12).

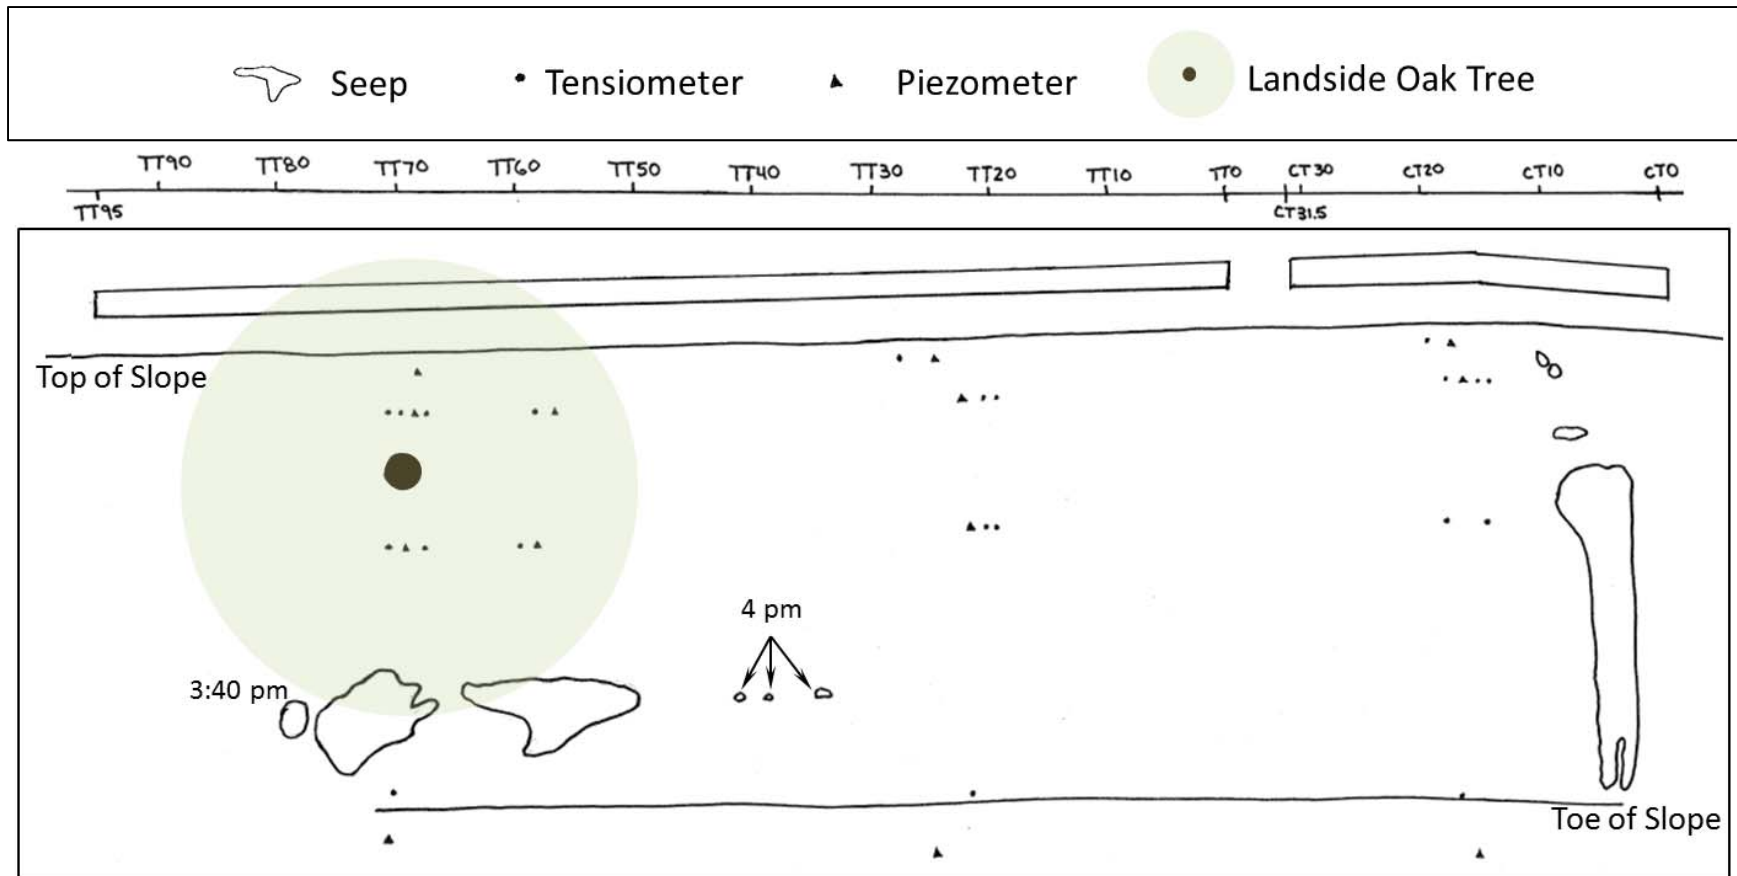
Figure 3-100. Sketch of landside seepage patterns: Time=26.3 hrs (4:00 pm on 5/22/12); Seep to the north of control line C has begun to produce less flow.

Another early seep was encountered just after those found north of instrument line C in the vicinity of instrument line D just north of the landside oak tree. The seeps started small and grew throughout the day on 5/22/12, the second day of the flow test. Later that morning flow from the seeps began and gravel bags were placed. By 9 am that same morning, another seep had appeared under the landside oak tree along instrument line A. By 3:40 pm (26 hours into the flow test), gravel bags were added to these seeps to control water flows. Shortly after, at 4 pm (time = 26.3 hours), three new seeps were discovered at Stations TT 34, 39, and 44. By 5:35 pm, another seep appeared at Station TT 25. All seeps appeared in a linear alignment about 2 feet (measured vertically) from the base of the slope (Figure 3-100 and Figure 3-101).

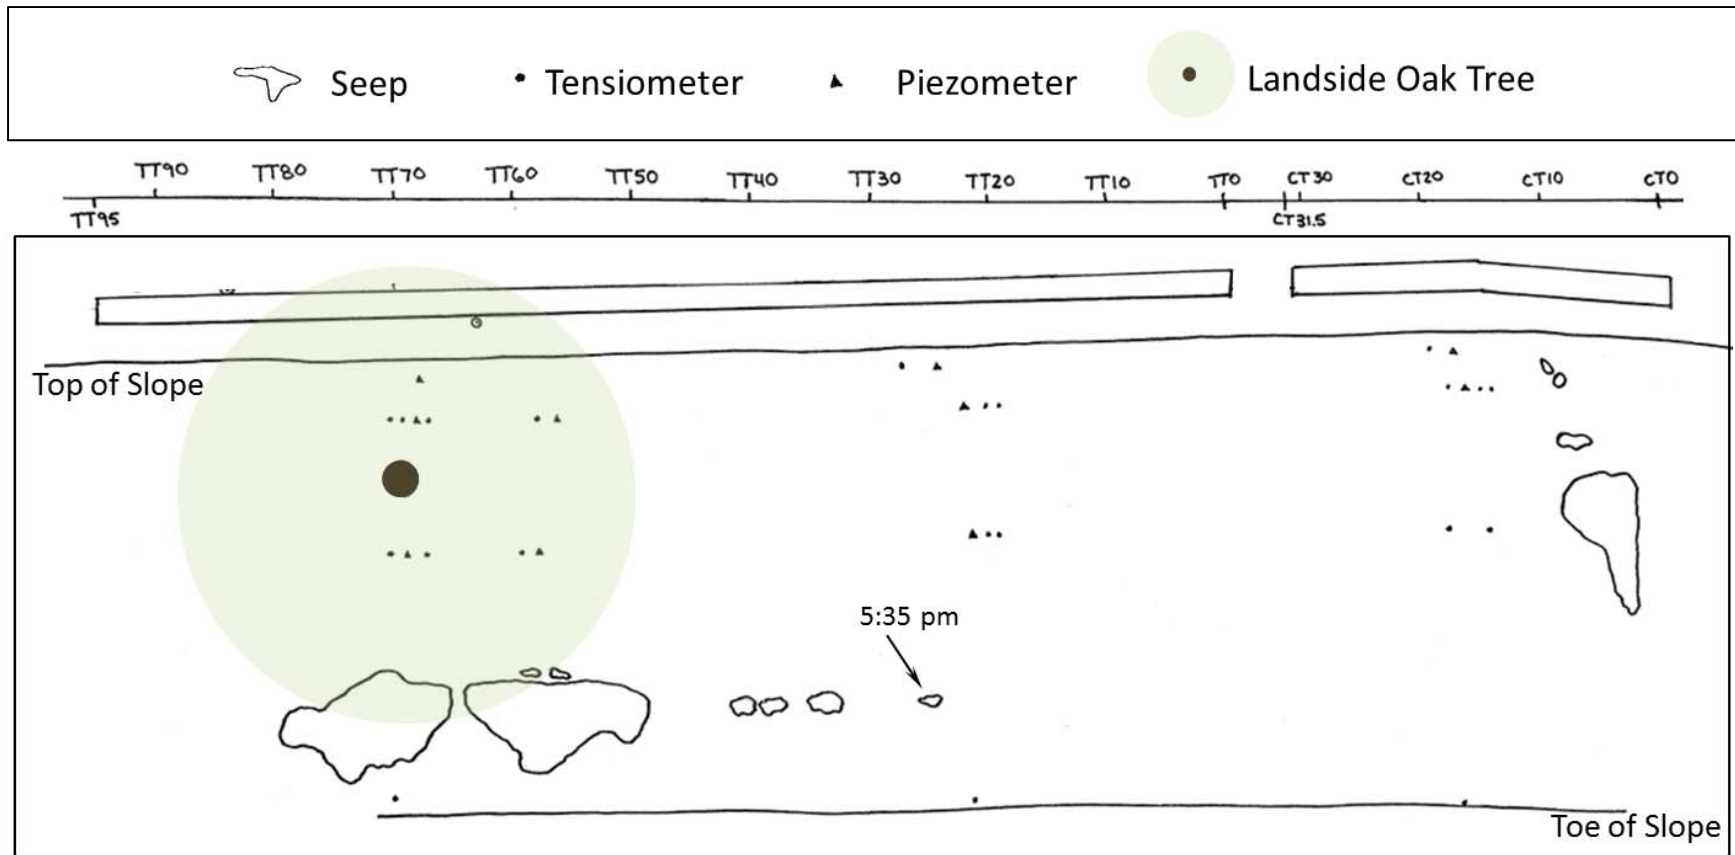
Figure 3-101. Sketch of landside seepage patterns: Time=28.3 hrs (6:00 pm on 5/22/12); Rills from seep to the north of control line C have begun to dry up.

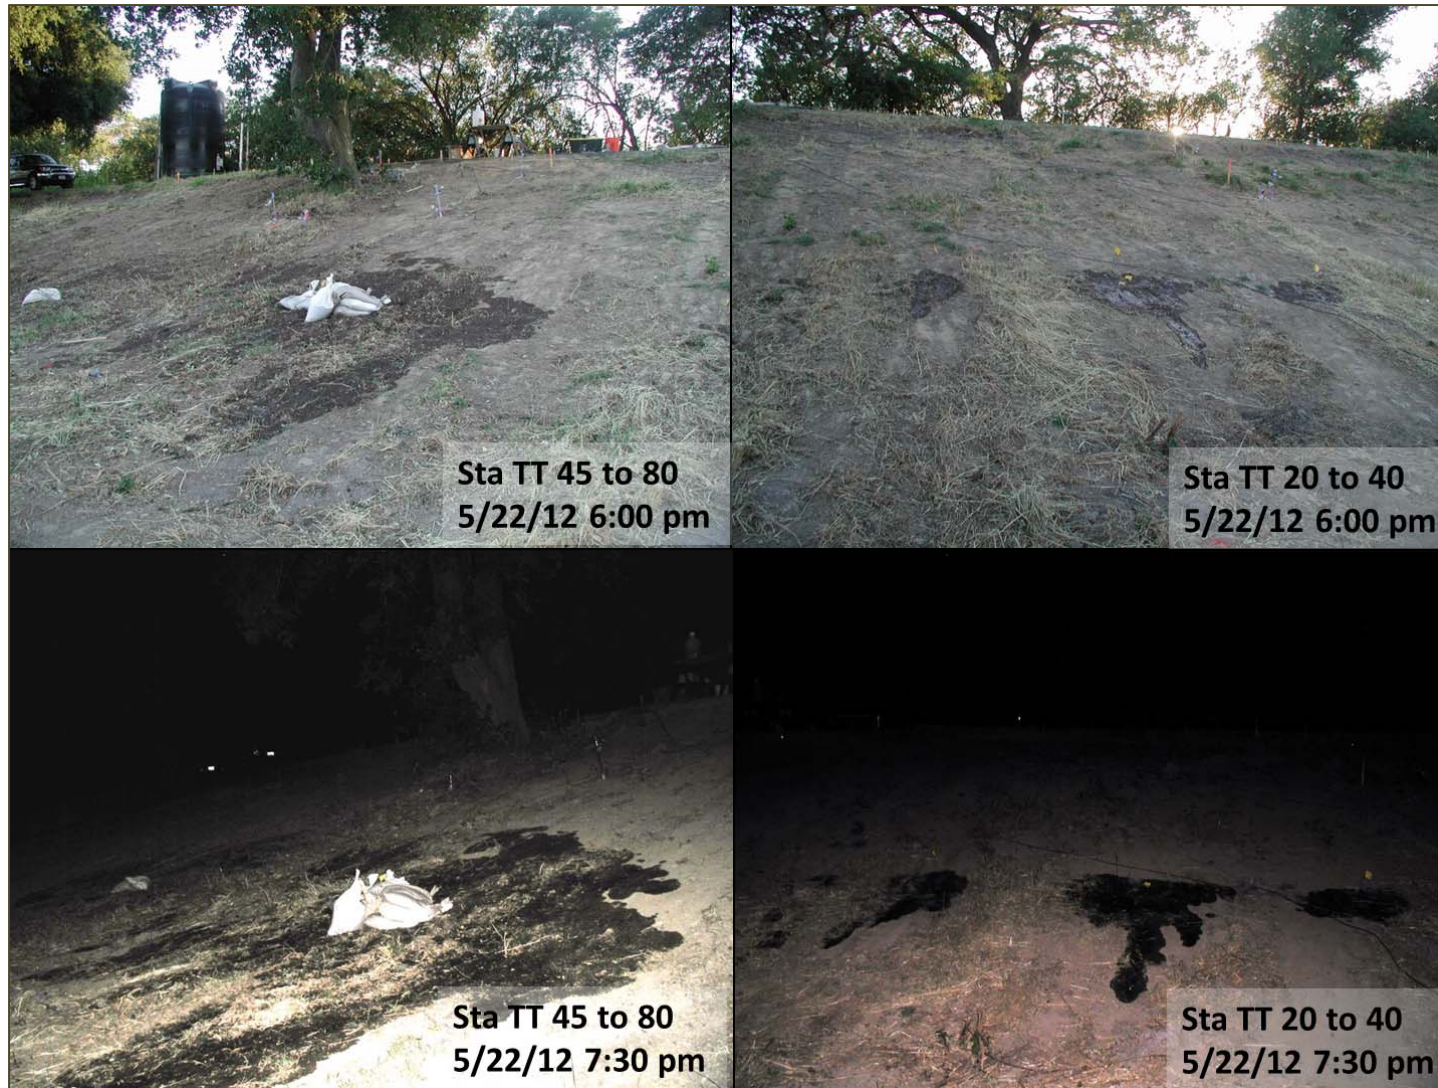
Figure 3-102. Time = 28.3 to 29.8 hours. Seeps continue to expand slowly, growing closer together with a small amount of free water flow from the newer seeps at Sta. TT 20 to 40 (right) as well as continued steady seepage from larger seeps at Sta. TT 45 to 80 (left).

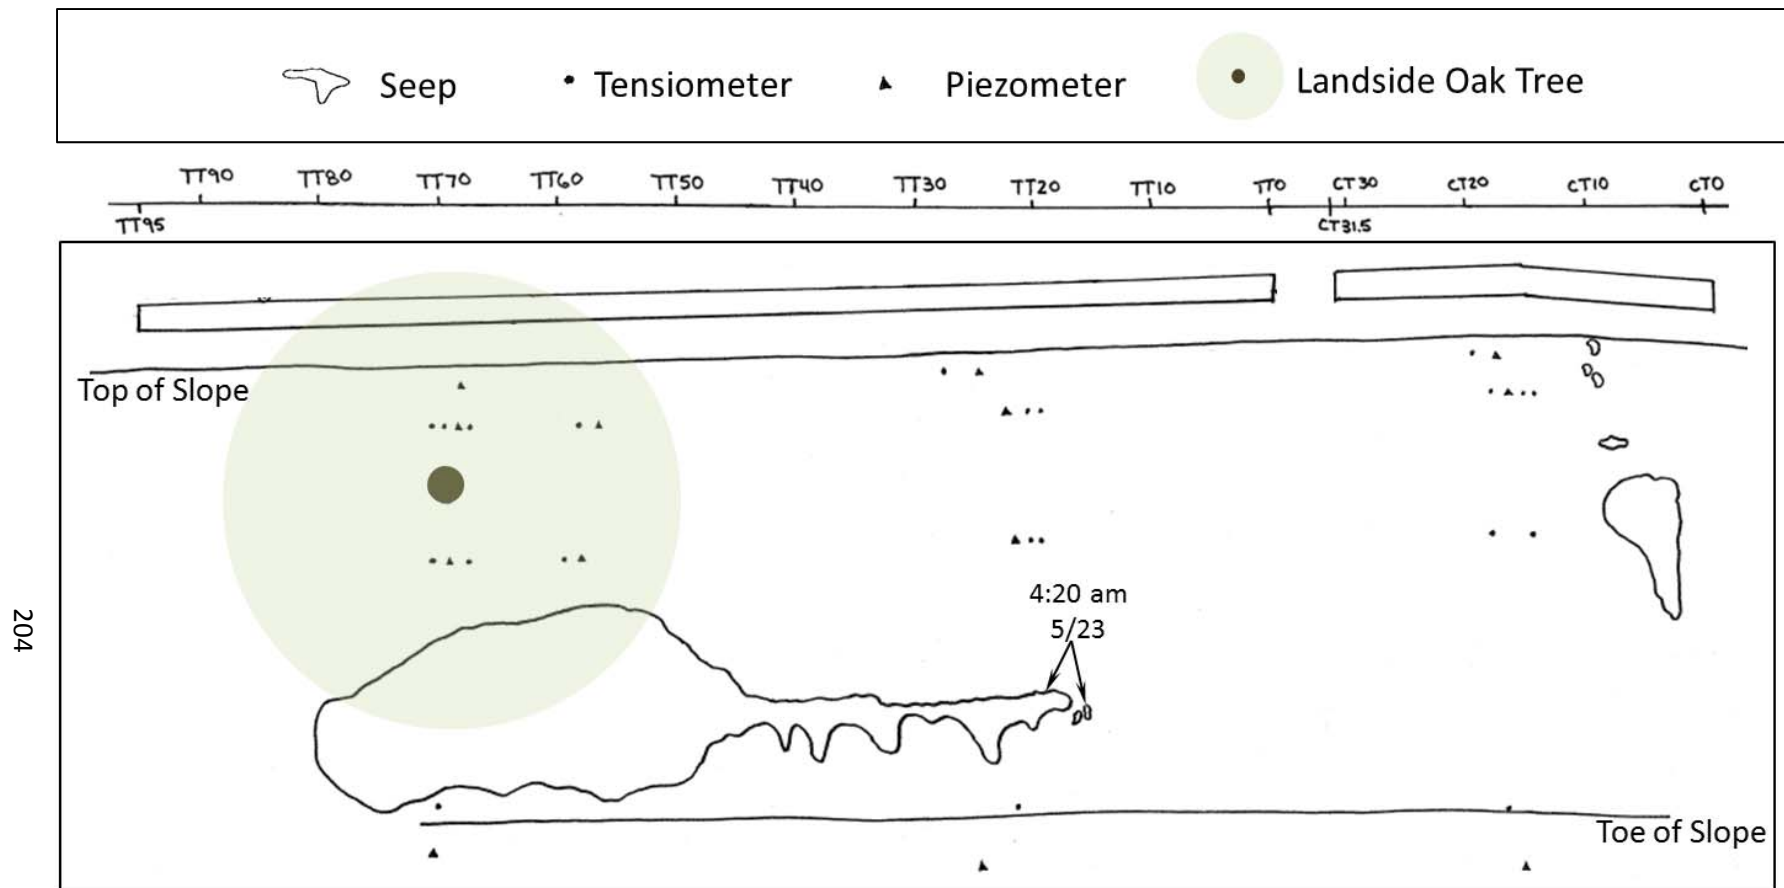
Figure 3-103. Sketch of landside seepage patterns: Time=43.8 hrs (9:30 am on 5/23/12).

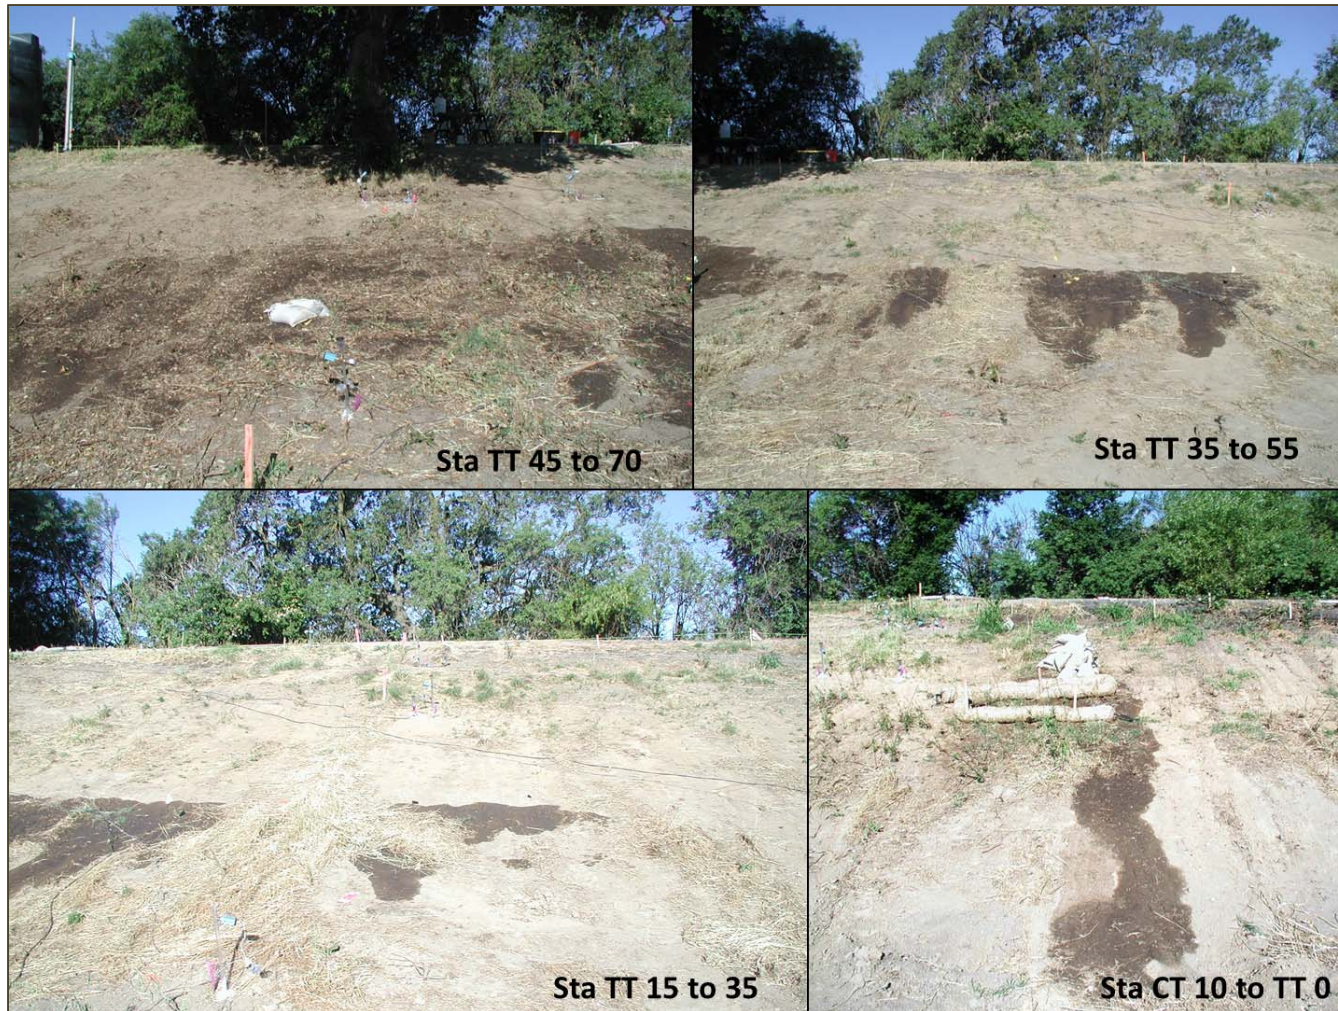
Figure 3-104. Time = 43 hours (8:45 am on 5/23/12) Seepage on the landside Line C has significantly slowed in concentrated flow at macropores. Notice the waterside oak looks different in this series (top right, lower left) – it had rotated 20 degrees into the slough and was discovered just after this series of photographs was taken.

After a little over 39 hours of testing, and the monitoring of a growing seep at the base of the waterside oak tree, the tree rotated approximately 20 degrees and came to rest with the long branch of the tree providing support within the shallow oxbow section of the slough. Cracking and deformation was monitored around the tree, the waterside slope, and the pavement at the crown throughout the duration of the test. T-LiDAR scans were performed by Gerald Bawden and his team at the USGS to document deformations at the site. A pre-flow scan was taken as well as a scan following the primary flow test, and a scan following the final dye test. His results and deformation analysis are summarized in Bawden et al. (2013).

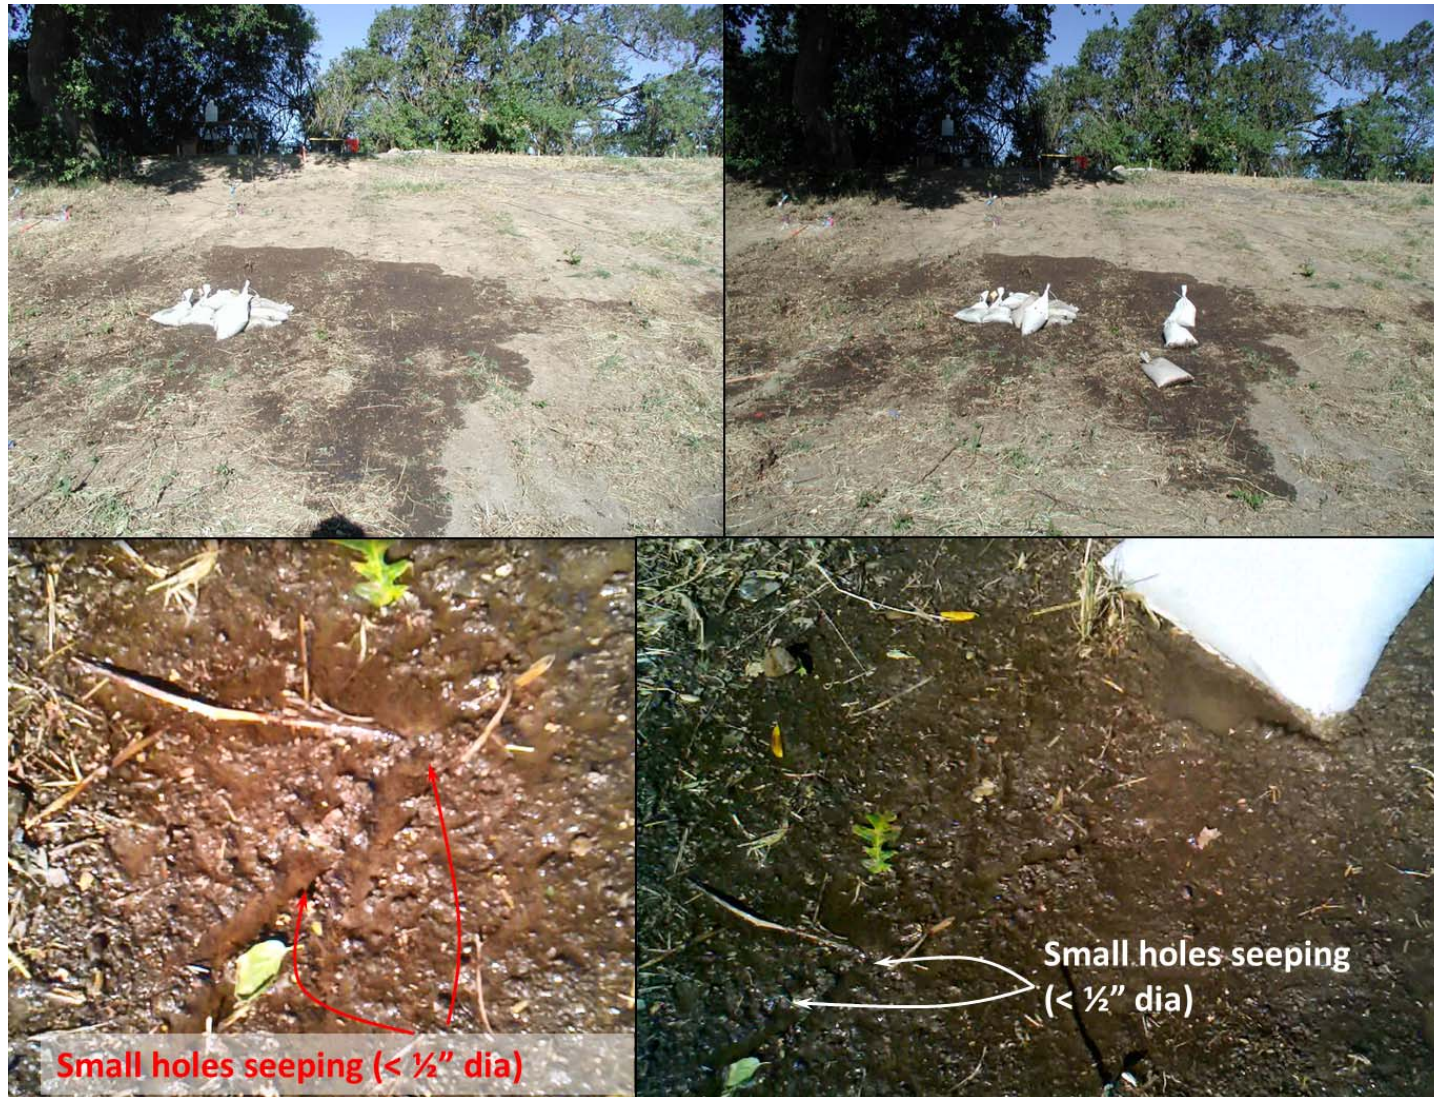
Figure 3-105. Time = 43 hours (8:45 am on 5/23/12). In the vicinity of Stations TT 45 to 60, seeps are observed to be flowing from tiny holes on the order of  $\frac{1}{4}$  to  $\frac{1}{2}$  inch in diameter (lower photos). Later exploration revealed worm burrows in these locations as discussed in subsequent sections.

Upon the commencement of water flow into the upper trench, a crack occurred between the control trench and the tree trench within about 2 ½ hours of the test start. The crack was monitored for changes throughout the duration of the flow test as discussed in a subsequent section. The first seep occurred at the waterside oak tree about 9 hours into the flow test. Seeps began to appear on the landside near the control line C in the middle of the night, about 13.3 hours into the flow test. By morning, more seeps were appearing in this area and also near instrument Line D, downslope from the extensive burrowing activity that was encountered during trenching. Within a few hours, large seeps were appearing under instrument line D and also instrument line A below the landside oak tree. The area of seepage correlated well with the area of extensive burrowing encountered in the tree trench between Stations TT 56 and 82. Upon post-flow test inspection of the seepage areas on the slope, the surface expressions of the burrows were not apparent. The water at the slope face was observed to be exiting the slope through ¼ inch to ½ inch diameter macropores. These holes

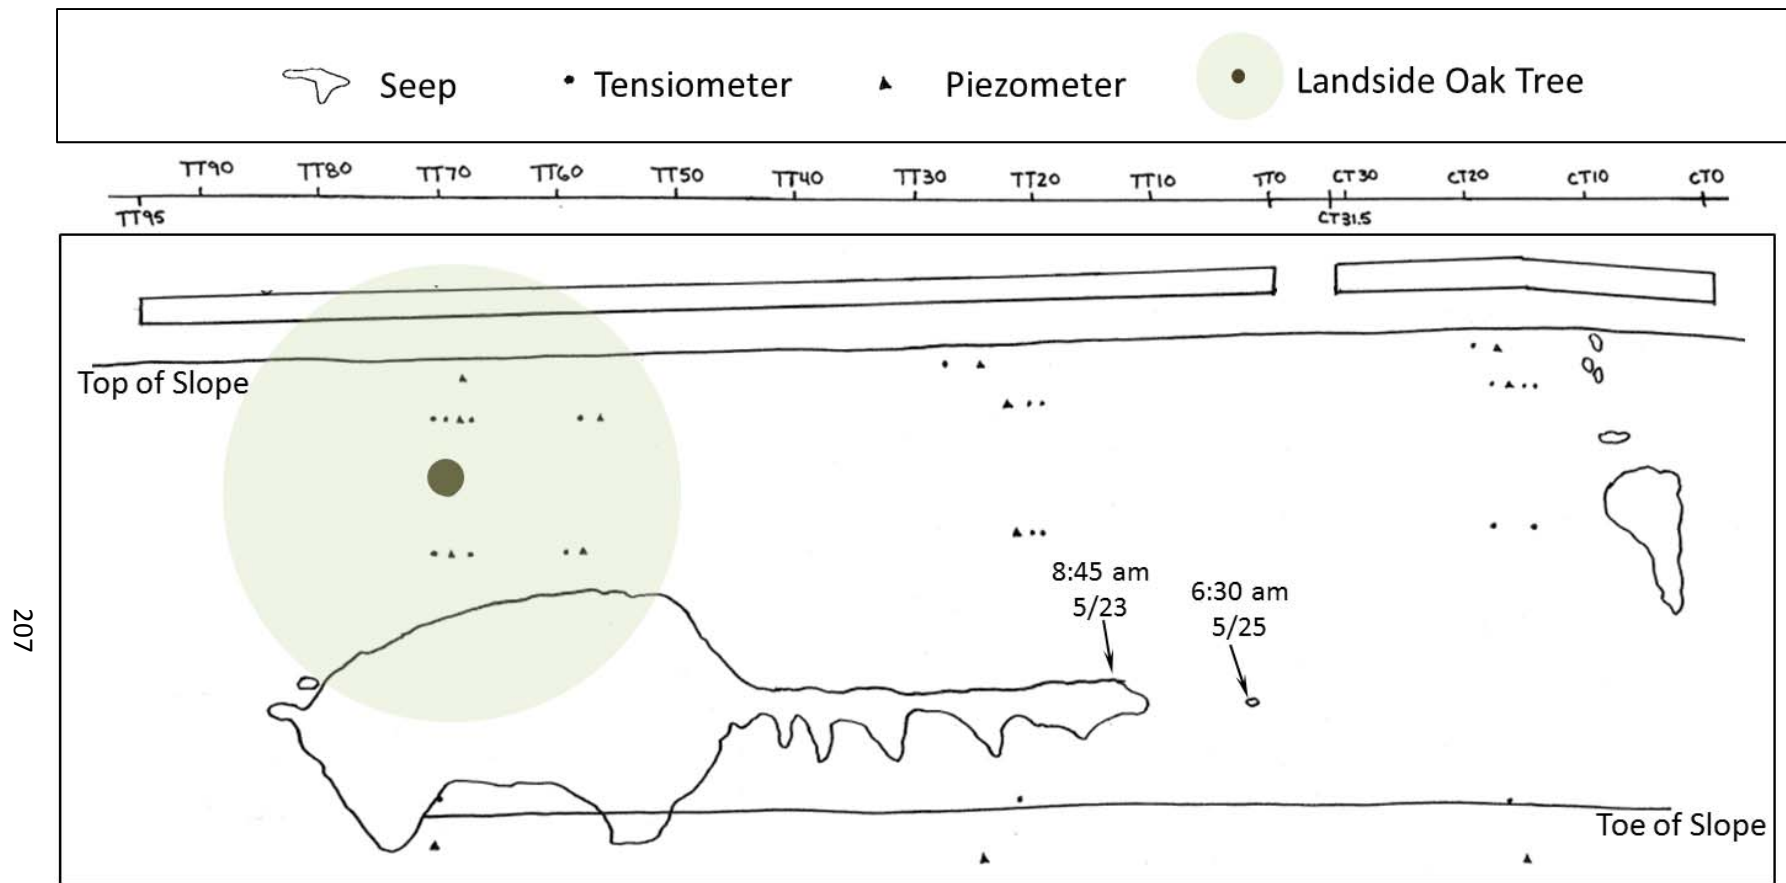
Figure 3-106. Sketch of landside seepage patterns: Time=92.8 hrs (6:30 am on 5/25/12).

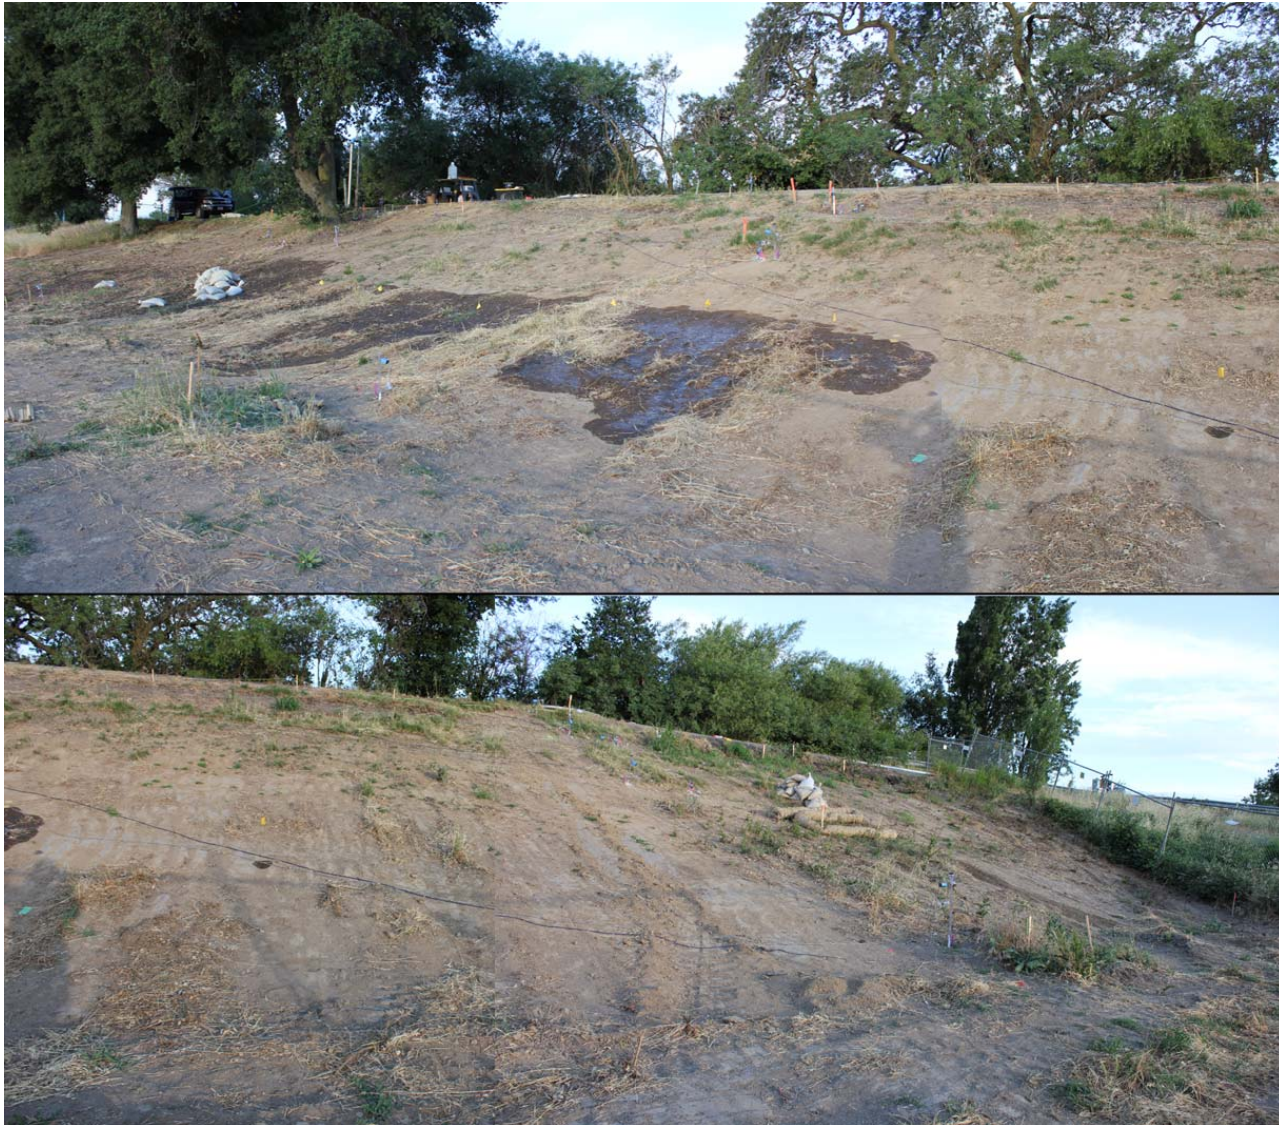
Figure 3-107. Time = 93 hours (6:45 am on 5/25/12); Small new seep near Station TT 3 while seeps to the south expand.

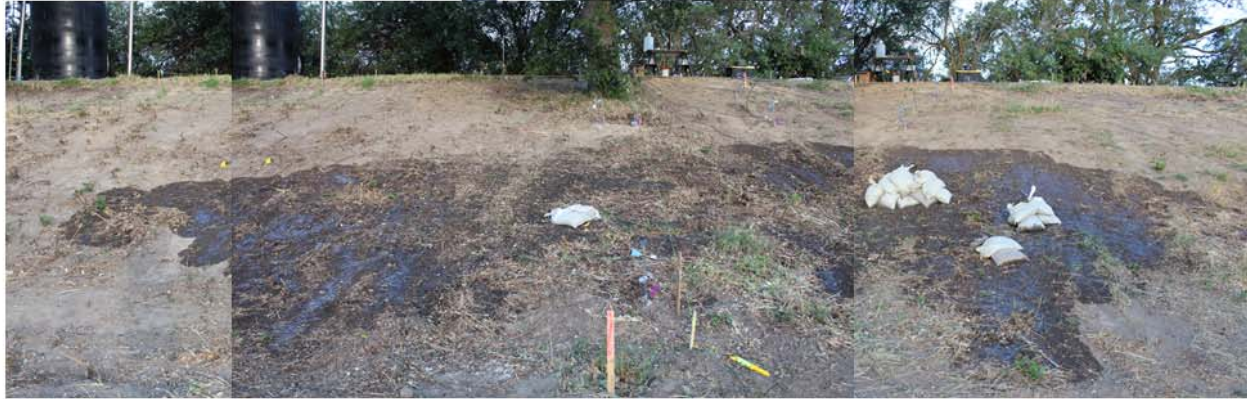
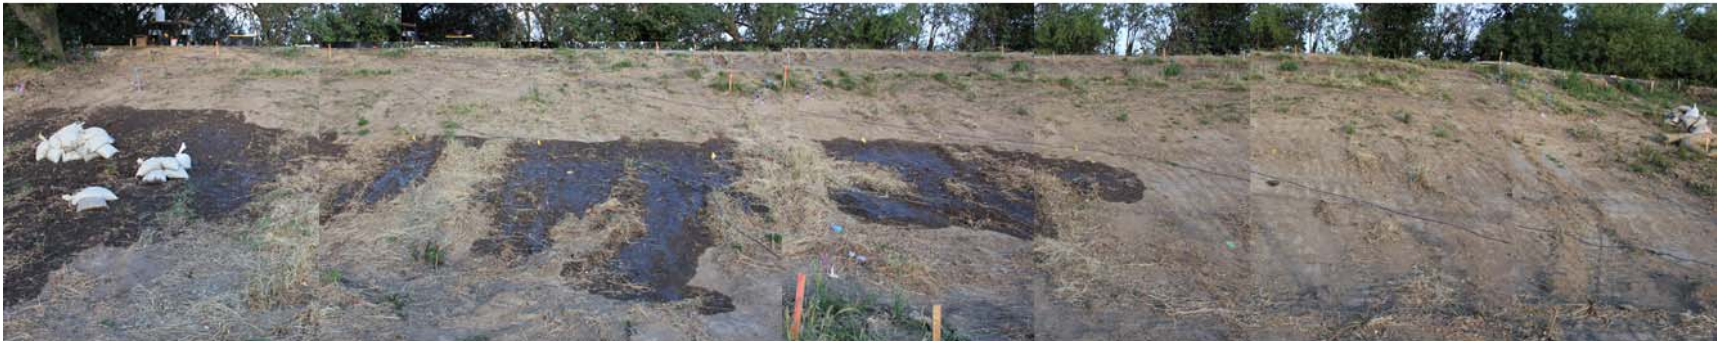
Figure 3-108. Time = 93 hours (6:45 am on 5/25/12). View west of Stations TT 45 to 90 (top) and Stations TT 60 to CT 10.

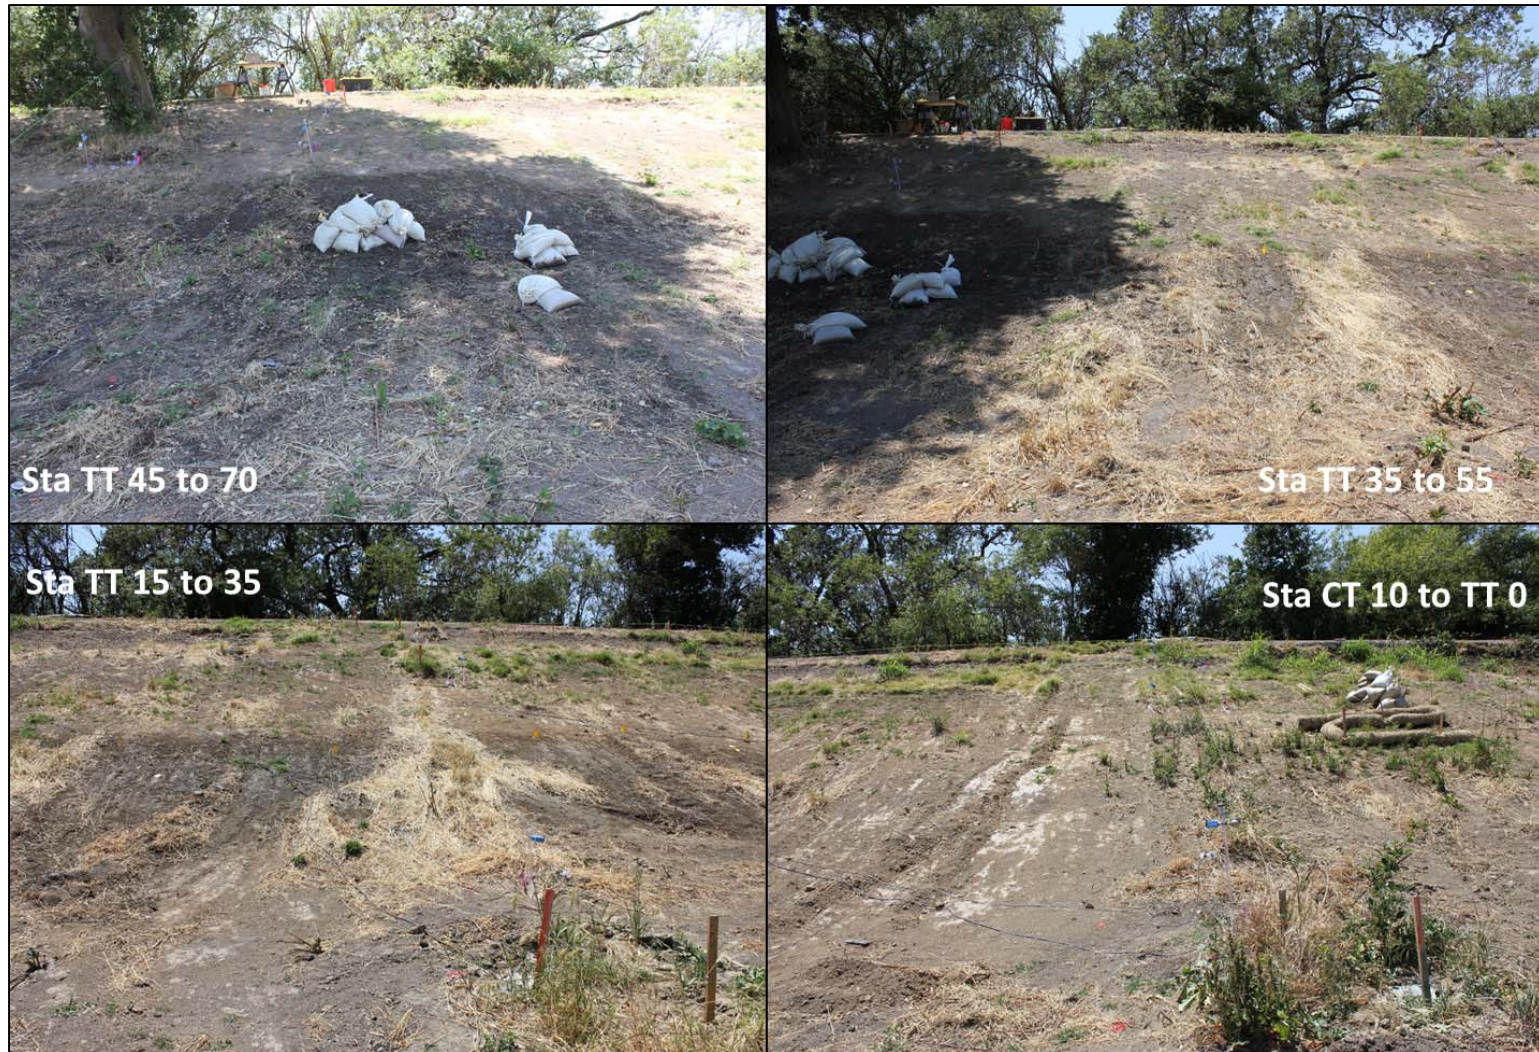
Figure 3-109. Time = 168.9 hours (5/28/12 at 2:35 pm). Tree trench was turned off on 5/25 at 1:45 pm and site has begun to dry up despite the fact that water has not fully drained from the tree trench. Note the blackberry vegetation beginning to grow back around the seepage areas north of instrument line C (lower right).
