Static and Seismic Performance of California Levees

Michelle Jennifer Shriro

Doctor of Philosophy

Engineering - Civil and Environmental Engineering

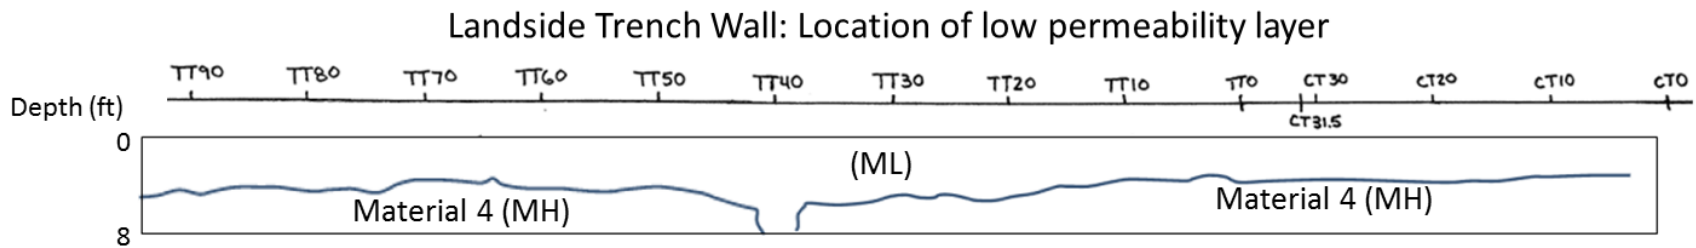
Landside Seepage Patterns : Time = 92.8 hrs (6:30 am on 5/25/12)

Figure 3-110. Simplified trench wall log showing the pattern of Material 4, the plastic silt that may be acting as a low permeability layer. The contact begins to dip to the south at Station TT0, disappears below the trench bottom between TT 37 and 42, and dips from Station TT 50 toward Station TT 40.

Figure 3-110 shows a sketch of seepage patterns observed plotted with a simplified log of the contact between the older levee (lower permeability clayey silt named Material 4 in Section 3.1.3.2.1) and the higher permeability, heterogeneous and sometimes loose and more recent silt fills above. Instrument data show that saturation occurred in deeper instruments before shallower ones. Further, the linear pattern of seepage that occurred implied that water may be traveling along this low permeability layer and flowing out the face along that contact. The Material 4 contact dips to the east as we saw in Figure 3-29 through Figure 3-31, but also dips from the control trench toward Station TT 37 where the layer disappears and reappears at Station TT 42. In general, there is also a dip from Station TT 50 to Station TT 42. Localized but distinct dips in the Material 4 contact were observed where water accumulated and was channeled out to the surface, especially where burrow networks accelerated flows. Such response was observed between Stations TT 70 and 85 and TT 50 and 65, which corresponds to early seeps as shown on Figure 3-99. The spatial gap between these seeps and those appearing to the north in Figure 3-100 may be related to the sudden drop in elevation or lack of a Material 4 contact. Figure 3-111 shows the 5/25/12 seepage patterns overlain with the original location of blackberry at the site. Locations where macroporosity was observed correlate well to these areas. Though an extensive burrowing area was near the landside oak tree, the tree did not appear to play a significant role in the flow test.

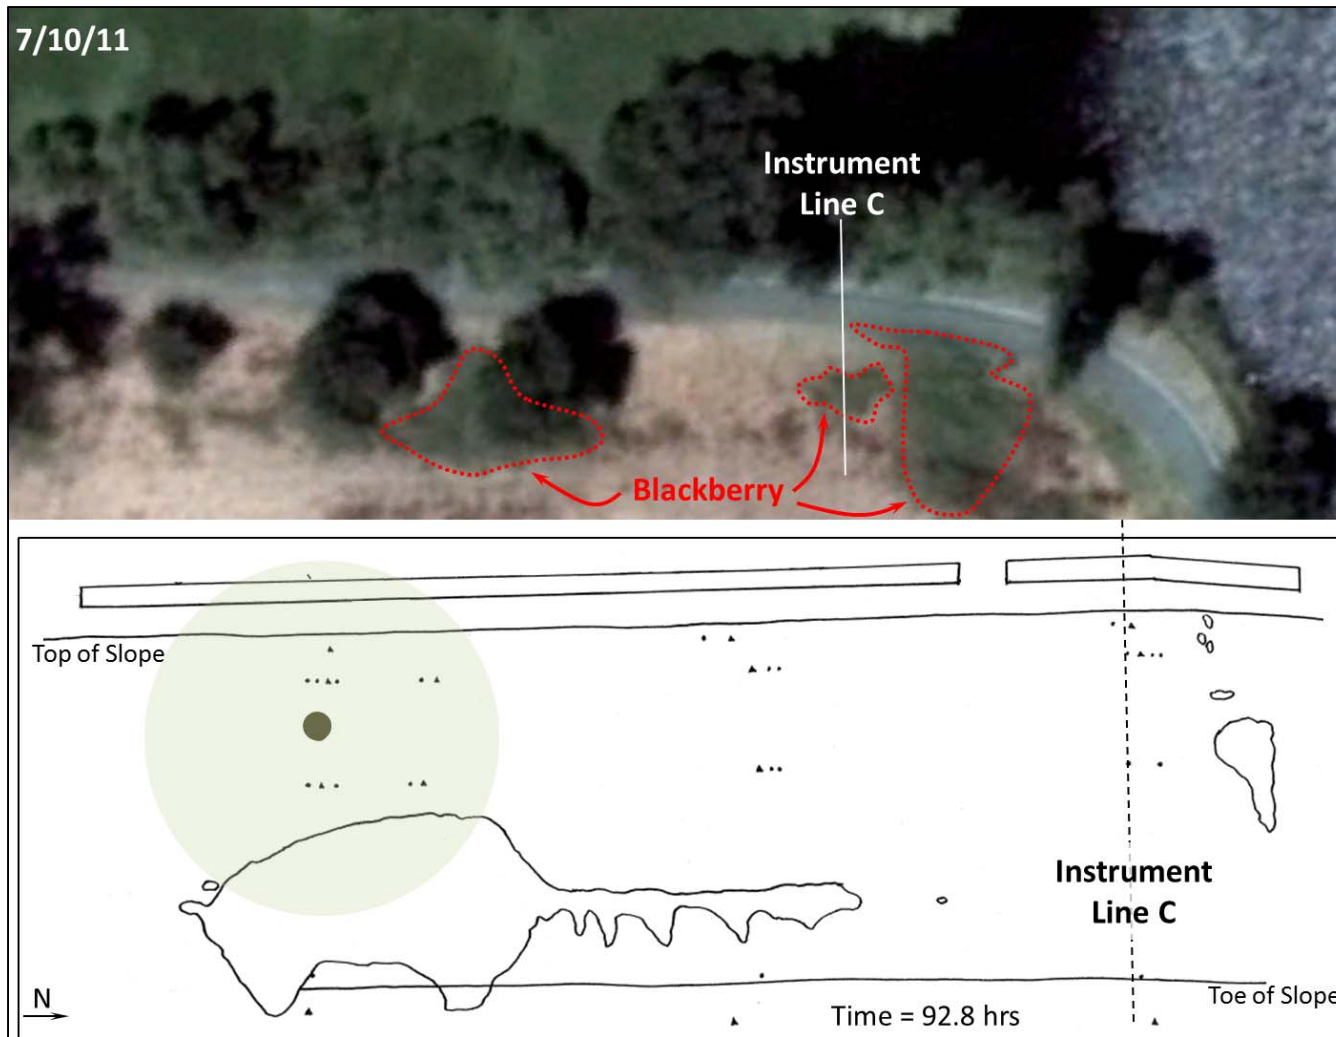
Figure 3-111. Seepage patterns at time = 92.8 hrs as compared with patterns of blackberry growth in the pre-test condition in July of 2011. Blackberry was dense in the locations indicated prior to our testing. Burrowing activity in areas north of the control instrument line C could be heard during the construction phase. Burrow activity was observed in both locations during trench construction.

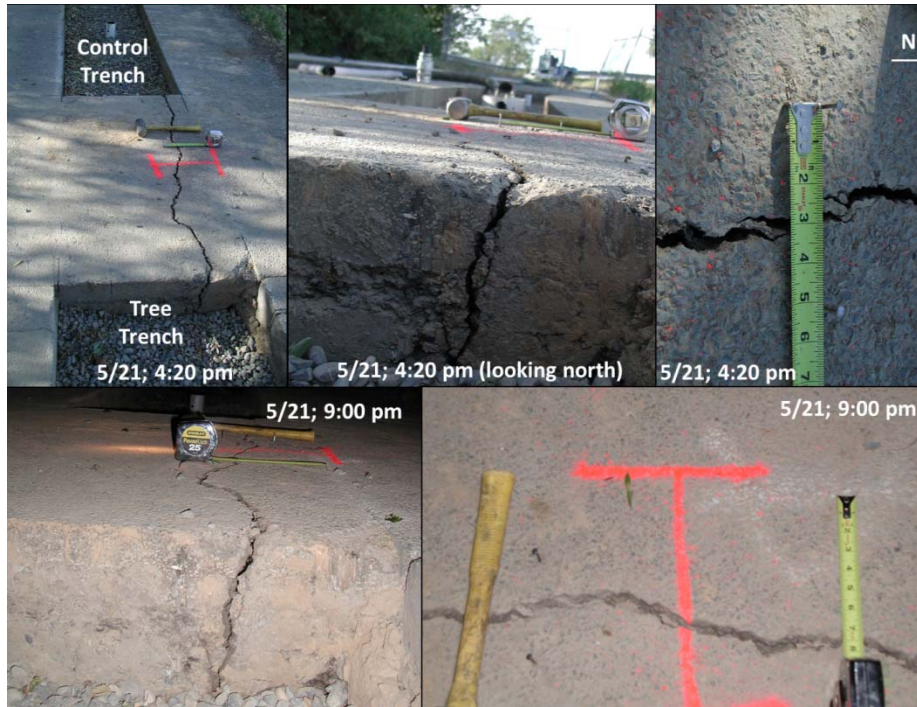
Figure 3-113. Cracking between tree trench on the first day of the field test (Time = 2.6 hours to 7.3). The crack grew and the waterside began to drop relative to the landside

Figure 3-112 shows the location of a crack that appeared between the tree trench and the control trench less than 3 hours into the flow testing program. The crack continued to grow throughout the first day and began to develop a visible vertical offset by the end of the first day, about 9 hours into the flow test (Figure 3-113). Overnight, crack growth continued, reaching a maximum width of just under 0.6 inch and a vertical offset of  $\frac{3}{8}$  inch at 13.3 hours into the flow test (Figure 3-114 and Figure 3-115).

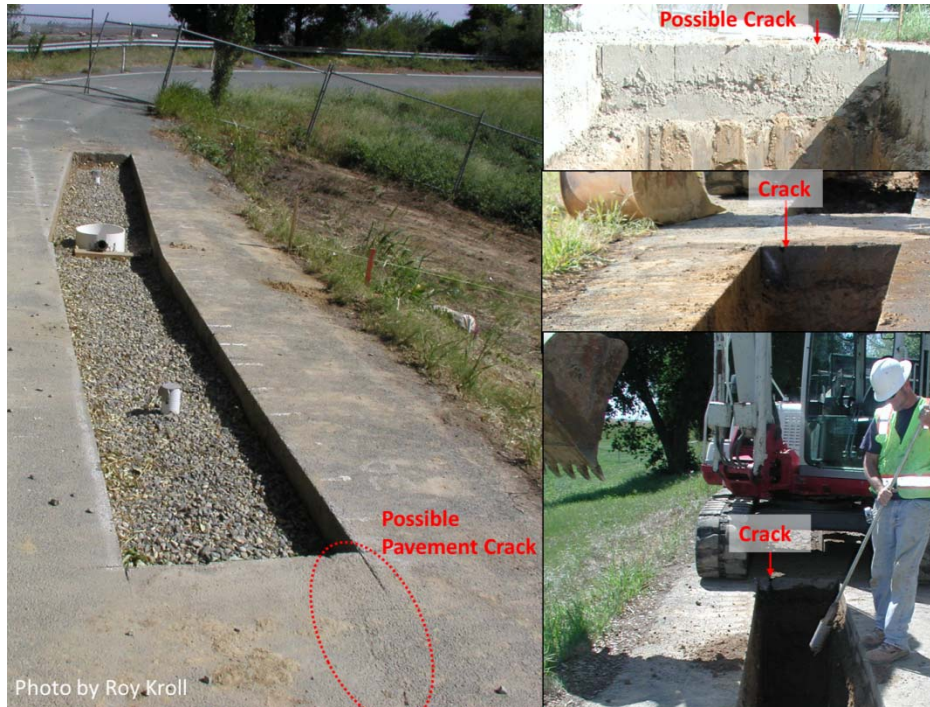
Figure 3-115. The size of the crack between the tree trench and the control trench was monitored as it grew to a maximum size and then began to get smaller. The crack peaked in size at about 13 hours into the flow test.

The crack between the trenches was explored. White paint was funneled into the crack prior to excavation of the gravel in an effort to reveal the pattern and depth of cracking. The crack had partially closed by the time of repair as discussed previously and shown on Figure 3-115. The crack did not follow a clean path as the soils are heterogeneous and may pull apart along several planes rather than forming a single clean crack. Figure 3-175 and Figure 3-176 show the trench wall at Station CT 31.5 looking south, while Figure 3-177 shows the trench wall at Station TT 0 looking north. A burrow was encountered connecting the trench walls positioned a distance of 43 inches from the top of the asphalt at Station CT 31.5 and a distance of 24 inches from the top of pavement at Station TT 0 (size = 2.5 inches high, 3.5 inches wide). A crack was seen on the control trench end wall extending down to a depth of 82 inches from the surface, beginning at the crack between the trenches (Figure 3-175 and Figure 3-176). In some places the crack becomes very visible and in

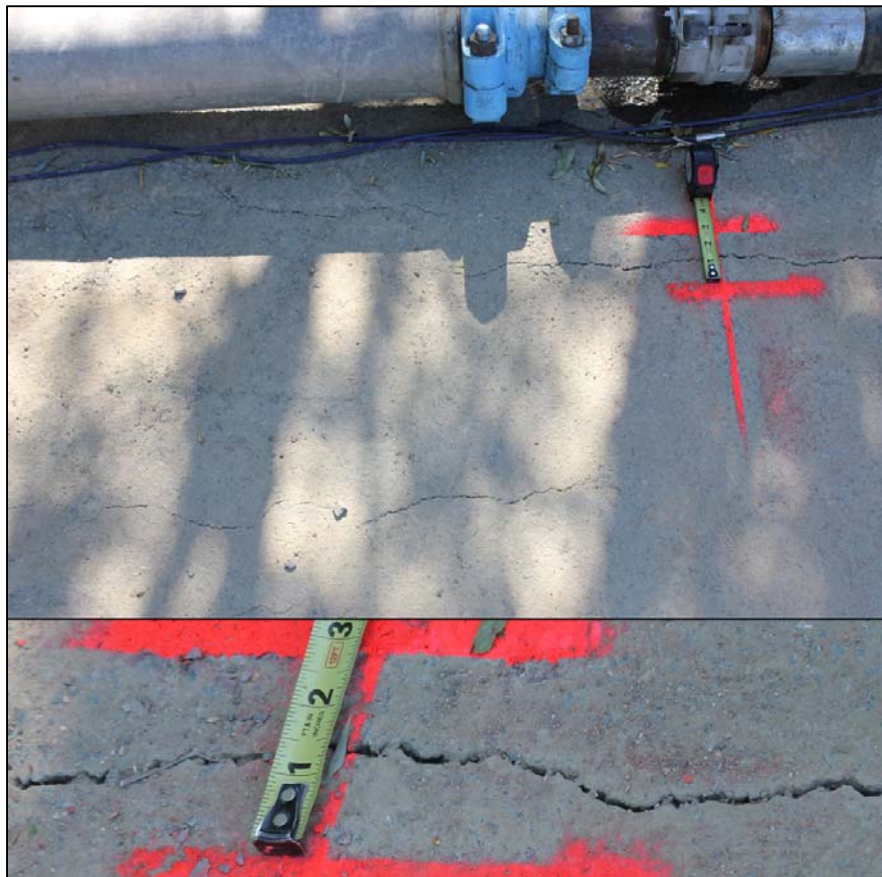
Figure 3-118. Cracking was observed in the pavements at approximate Stations TT 53 to 73 at 3:10 pm on the second day of the flow test (Time = 25.5 hours).

In the afternoon of 5/22/12, a little over 25 hours into the flow test, a series of fine cracks opened up in the vicinity of Station TT53 to 73 ranging in size from hairline to 1/8 inch (Figure 3-118). Monitors were installed (Figure 3-119) but did not yield measureable movements after the cracks were observed. The cause of the cracking was not entirely clear, as discussed later.

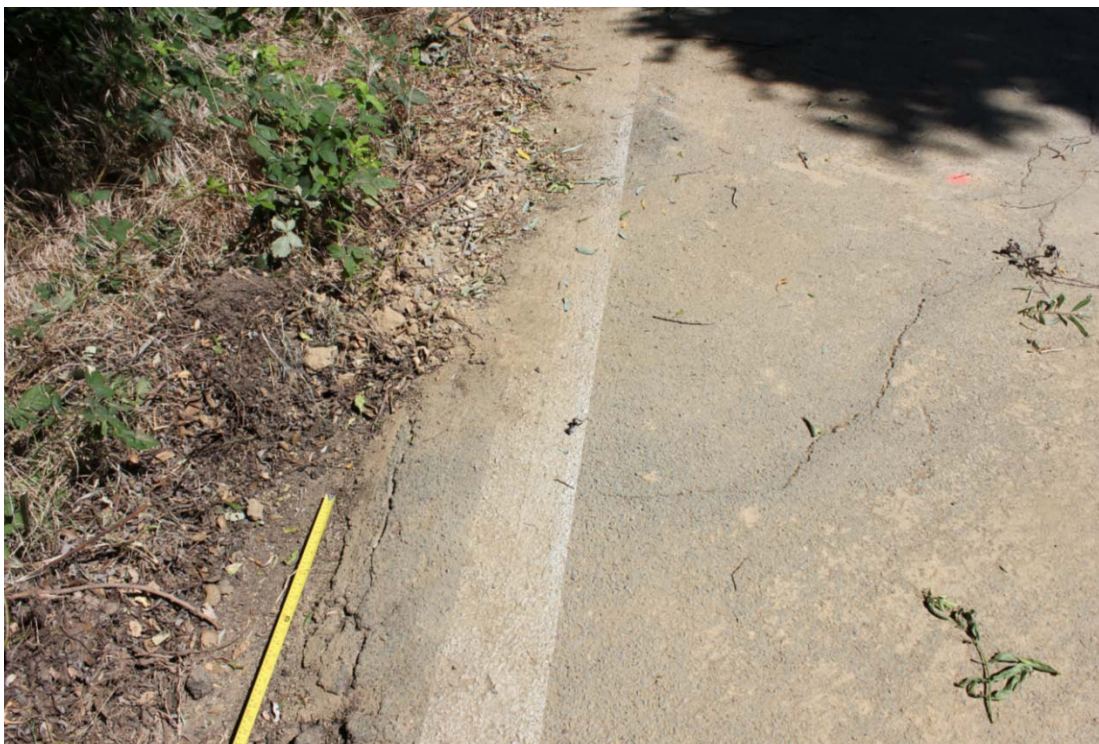
Figure 3-120. Cracking was observed in the pavements at approximate Stations TT 70 to 95 at 6 pm on the second day of the flow test (Time = 28.3 hours).

Figure 3-120 highlights cracking in the vicinity of Stations TT 70 to 95 first observed at 6 pm on 5/22/12, a little over 28 hours into the flow test. Cracking along the west side of the crown road appeared that it may continue into the waterside slope. Once the flow test was over, pipelines moved, and vegetation trimmed to allow for access, the area was inspected and a trace of the crack could not be found located (Figure 3-121).

The crack adjacent to the trench within this zone was first noticed during construction (Figure 3-120 and Figure 3-122). The crack may have been pre-existing, but grew during trench construction to have an offset of about  $\frac{3}{8}$  inch before the flow test began (Figure 3-123). At the time of construction, there was a question as to whether the pavement had slid on the soils under equipment loading or if a segment of soil had moved with the pavement. Walls were cleaned and inspected along this segment of trench with special focus placed on the zones extending down the wall from where the cracks intersected the trench. Cracking extended a few inches into the soil and soils beneath appeared to be intact (Figure 3-123D and E). At a time of 28.3 hours into the flow test, signs of fresh movement were observable, though it was unclear whether movements were occurring towards the trench or whether the waterside block of soil was moving to the west.

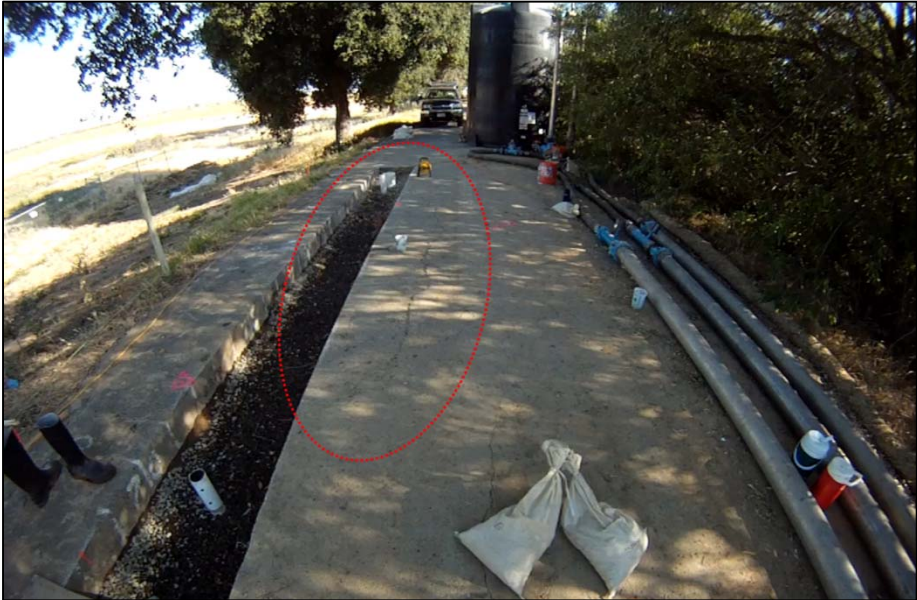
Figure 3-121. Waterside Station TT 85 to 90 on 6/8/12 after the tank, pipes, and wattles had been removed. Vegetation was locally cleared and the crack was not found extending outside of pavements.

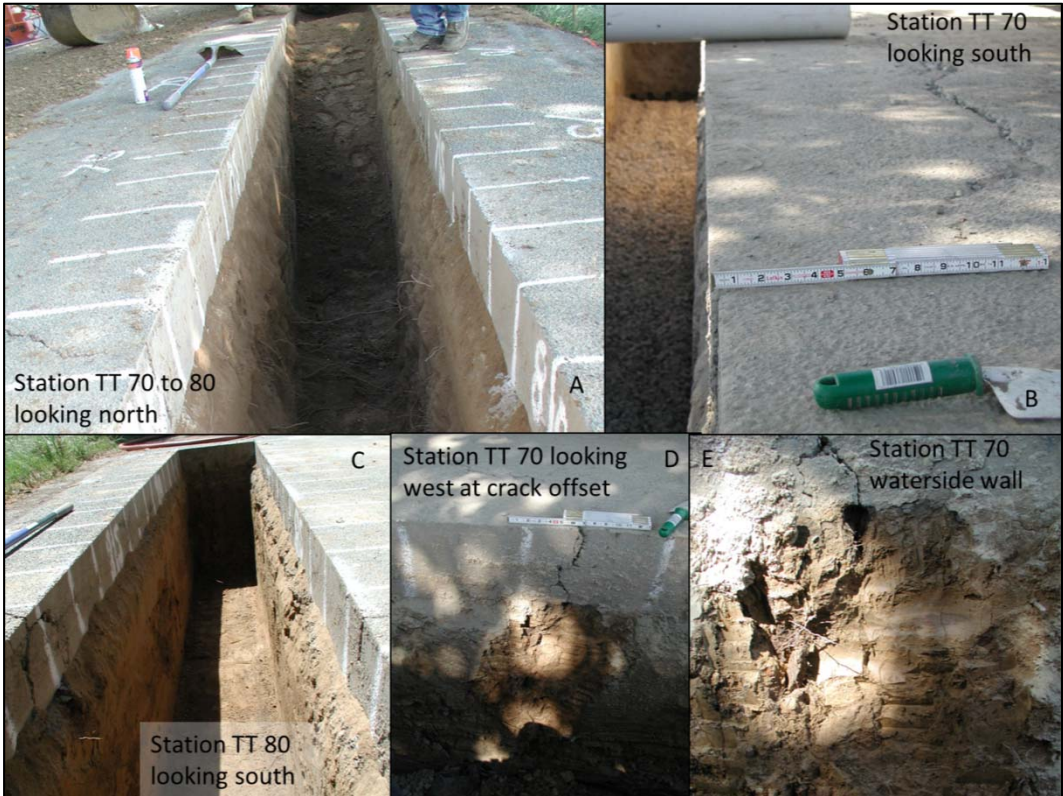
Figure 3-122. Crack at Stations TT 70 to 95 seen through wide angle lens on 5/31/12 facing south. Cracking observed during original excavation but grew slightly (<math><1/8''</math>) during flow testing.

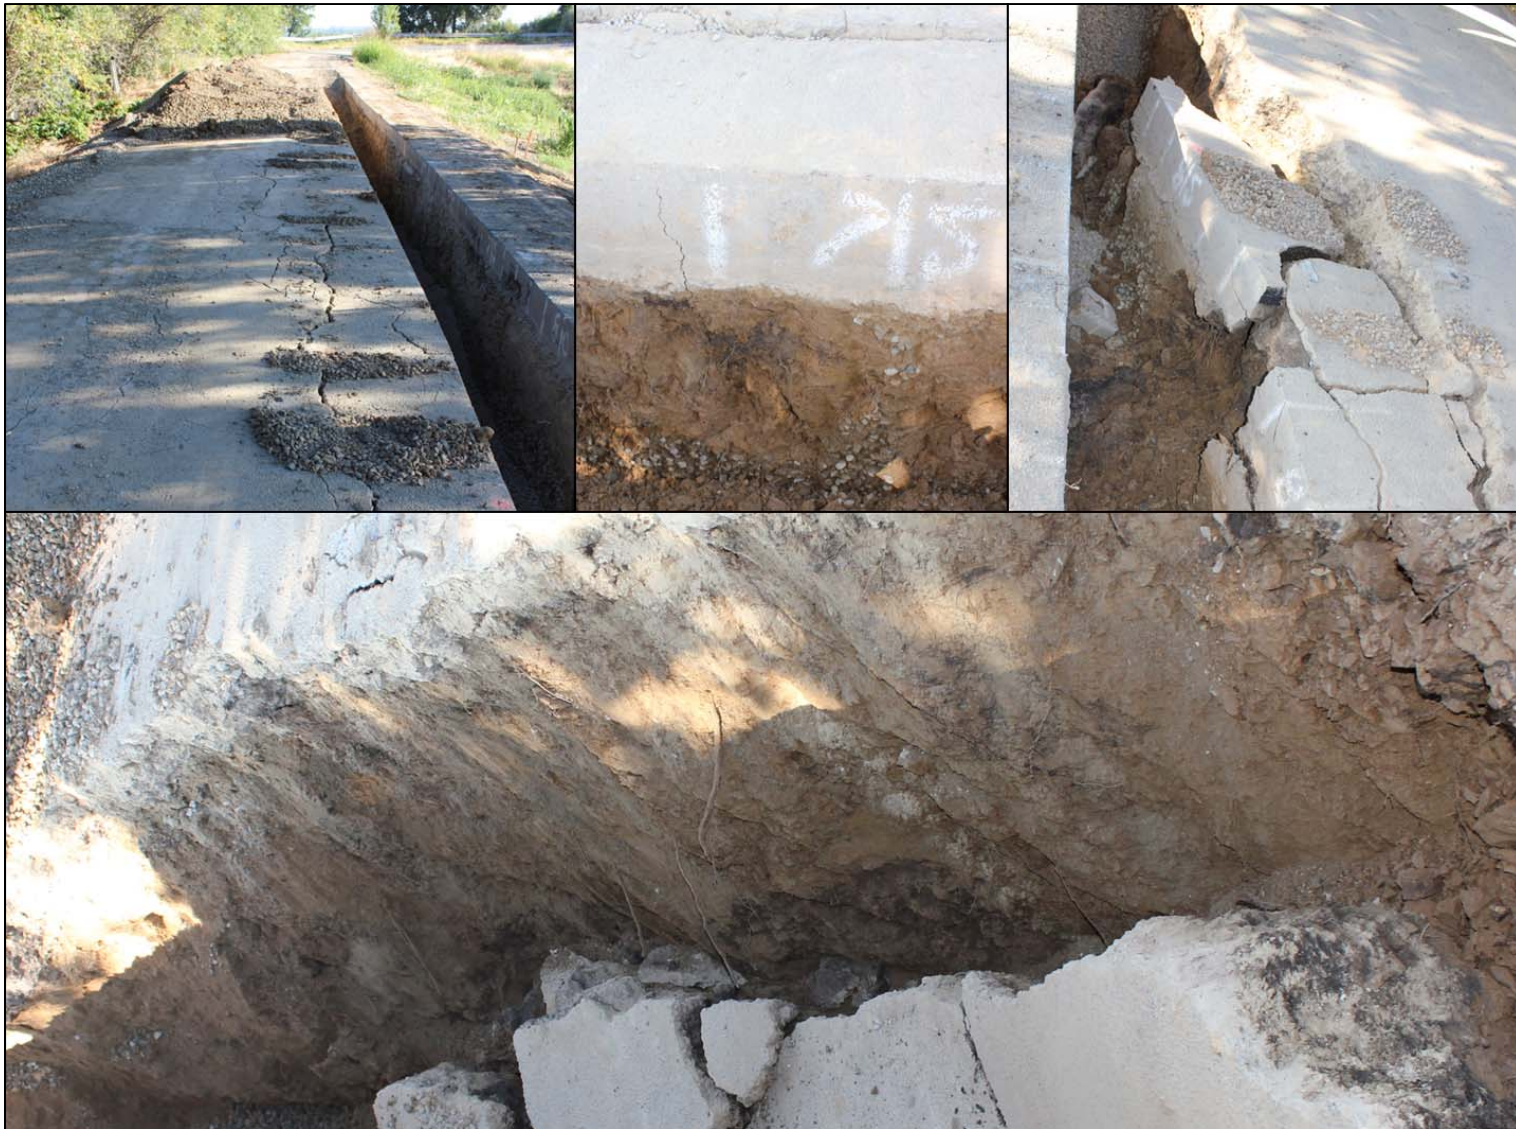
Figure 3-123. During trench construction Stations TT 70 to 95. A) Original crack appeared during 0 to 4 foot excavation but showed no offsets; B) During backfill with rock, 3/8" offset visible; C) Cracking may have been present before construction as it is seen on landside and waterside at Station TT 80-81; D) and E) Wall inspection at Station 70; crack not continuous down wall face.

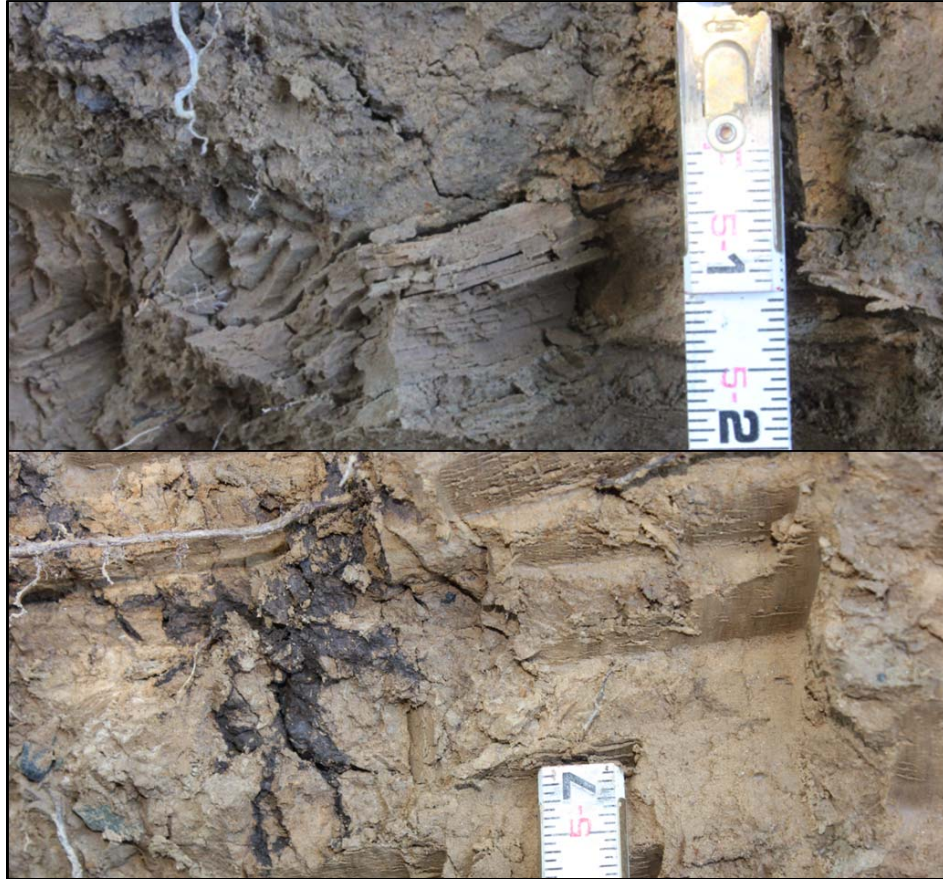
Figure 3-124. Station TT 65 to TT 88 failed under equipment loading during repair. Dark staining appearing to be manganese oxides appear along the failure plane in numerous locations indicating possible pre-existing fracturing within the leve

Though the cause of movements between Stations TT 70 to 95 during the flow test is difficult to determine, Figure 3-124 shows this section during site repair after equipment loads collapsed the segment between Station TT 65 and 88. A clear failure plane is visible and in many locations the failure followed weak zones within the thinly bedded silt material (Material 2 as described previously) and along zones with dark staining appearing to be manganese oxides, commonly indicating previously existing fractures. Manganese oxide staining along fractures was discussed in an earlier description of materials encountered during trench construction. These stains were encountered throughout trenching activities, particularly in the most unstable wall sections. Dark staining can be seen in the overall wall failure photographs on Figure 3-124 with a close-in view on Figure 3-125.

- Subsidence of up to 6 cm between Stations TT 20 and 50: An area subsided up to 6 cm (observable in the T-LiDAR scans but not noted during testing), coincident with loose soils associated with the dip in the natural levee (Material 4) and the gap at Stations TT 37 to 42 (Figure 3-186). Timing of deformation is unknown, but a crack at Stations TT 40 to 50 opened late in the test (day 10 of flow). The crack lies near the zone of subsidence captured by analysis (Figure 3-186). The subsidence could be caused by settlement of the loose materials at this location toward the trench, as implied by the semicircular patterns on both land and water sides. Lateral offsets of pavement at the trench was not observed at this location, and trench walls did not collapse during the repair phase as they did at Stations 65 to 88 (Figure 3-124).

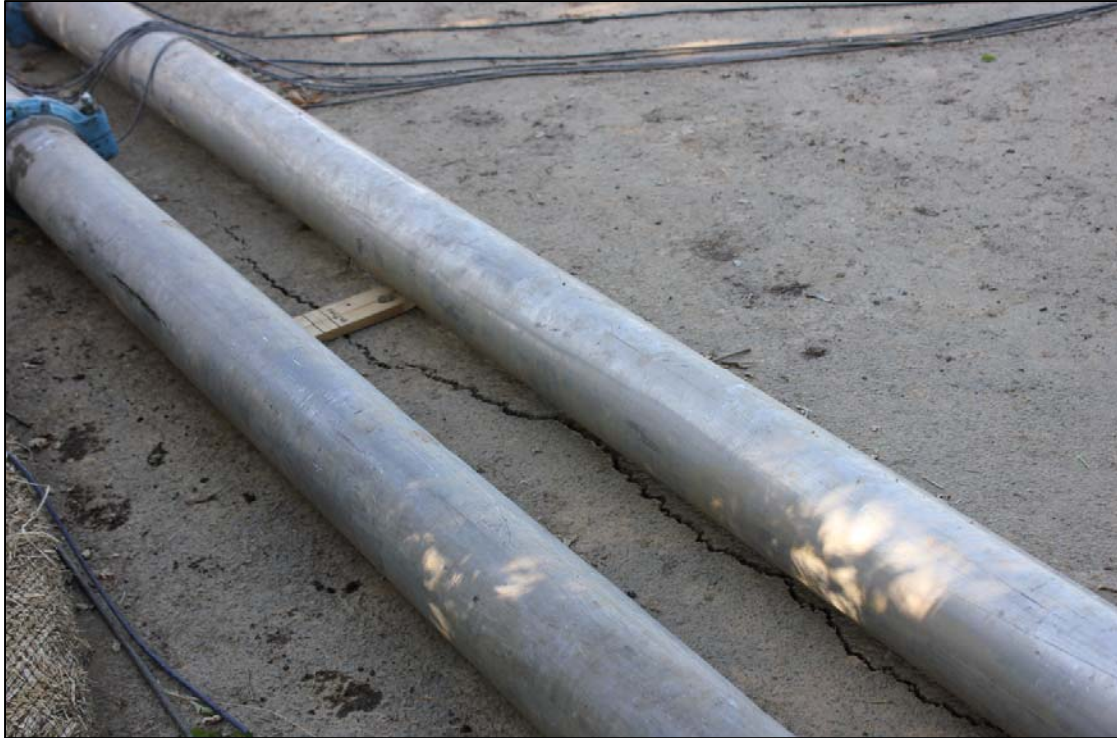
Figure 3-126. Cracking was observed in the pavements at approximate Stations TT 40 to 52 at 4:30 pm on 5/31, the last day of flow (Time = 242.8 hours)

A crack of about  $\frac{1}{8}$  to  $\frac{1}{4}$  inch in size opened between the water delivery pipelines between Stations TT 40 and 52 on 5/31 in the afternoon of the dye test just a couple of hours before the end of the test (Figure 3-126 and Figure 3-127). A crack monitor was installed and the crack was inspected several times post-flow, displaying no additional movements.

Cracking was noted on the west side of the crown road during the dye test on 5/31/12, the last day of flow (Figure 3-126 and Figure 3-127). It can be seen on Figure 3-184 and Figure 3-185 that this cracking is just on the outer edge of the movement area and may be associated. During trench

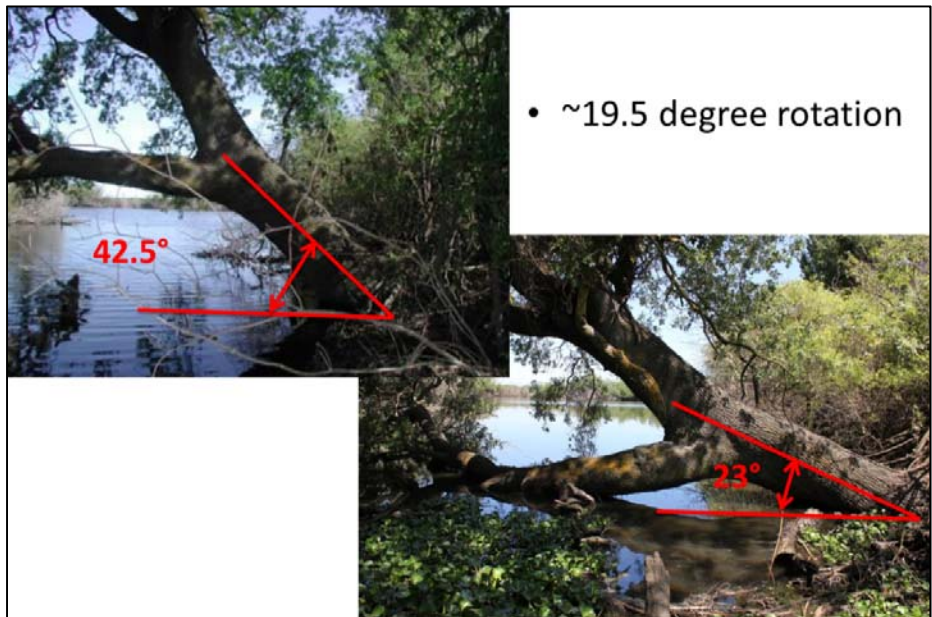
Figure 3-128. On 5/23, the third day of flow, the waterside oak tree was found to have fallen between 4:45 and 8 am (Time = 39 to 42.3 hours). Based on instrument readings, this may have been at about 5:00 to 5:30 am.

On 5/23/12, the third day of the flow test, between about 4:45 am and 8:00 am (39 to 42.3 hours into the flow test), the waterside oak tree rotated approximately 20 degrees toward the oxbow section of the Sevenmile Slough, leaving a set of slope cracks that were apparent upon morning inspection of the site (Figure 3-128 through Figure 3-130). The likely time of the fall is somewhere between 5 and 5:30 am based on instrument data (discussed in subsequent sections). Figure 3-131 shows the study site from a distance before and after the tree fell.

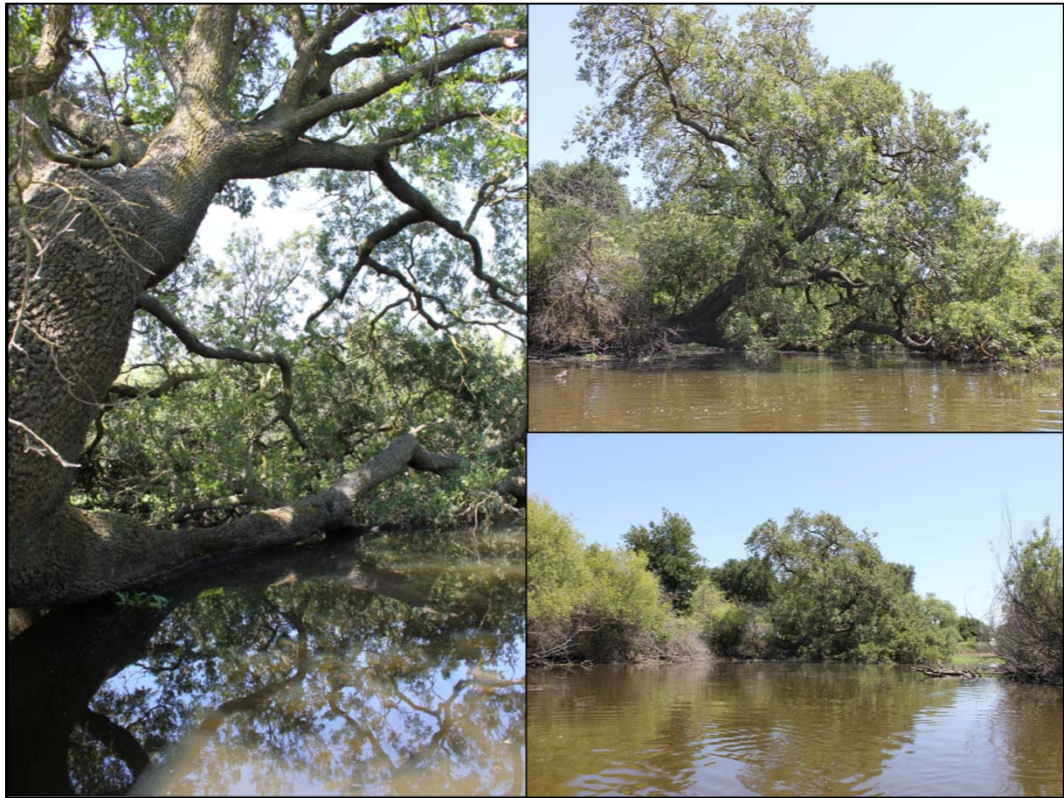
Figure 3-129. The waterside oak rotated just under about 20 degrees to rest the long waterside branch in the shallow oxbow section of the Sevenmile Slough.

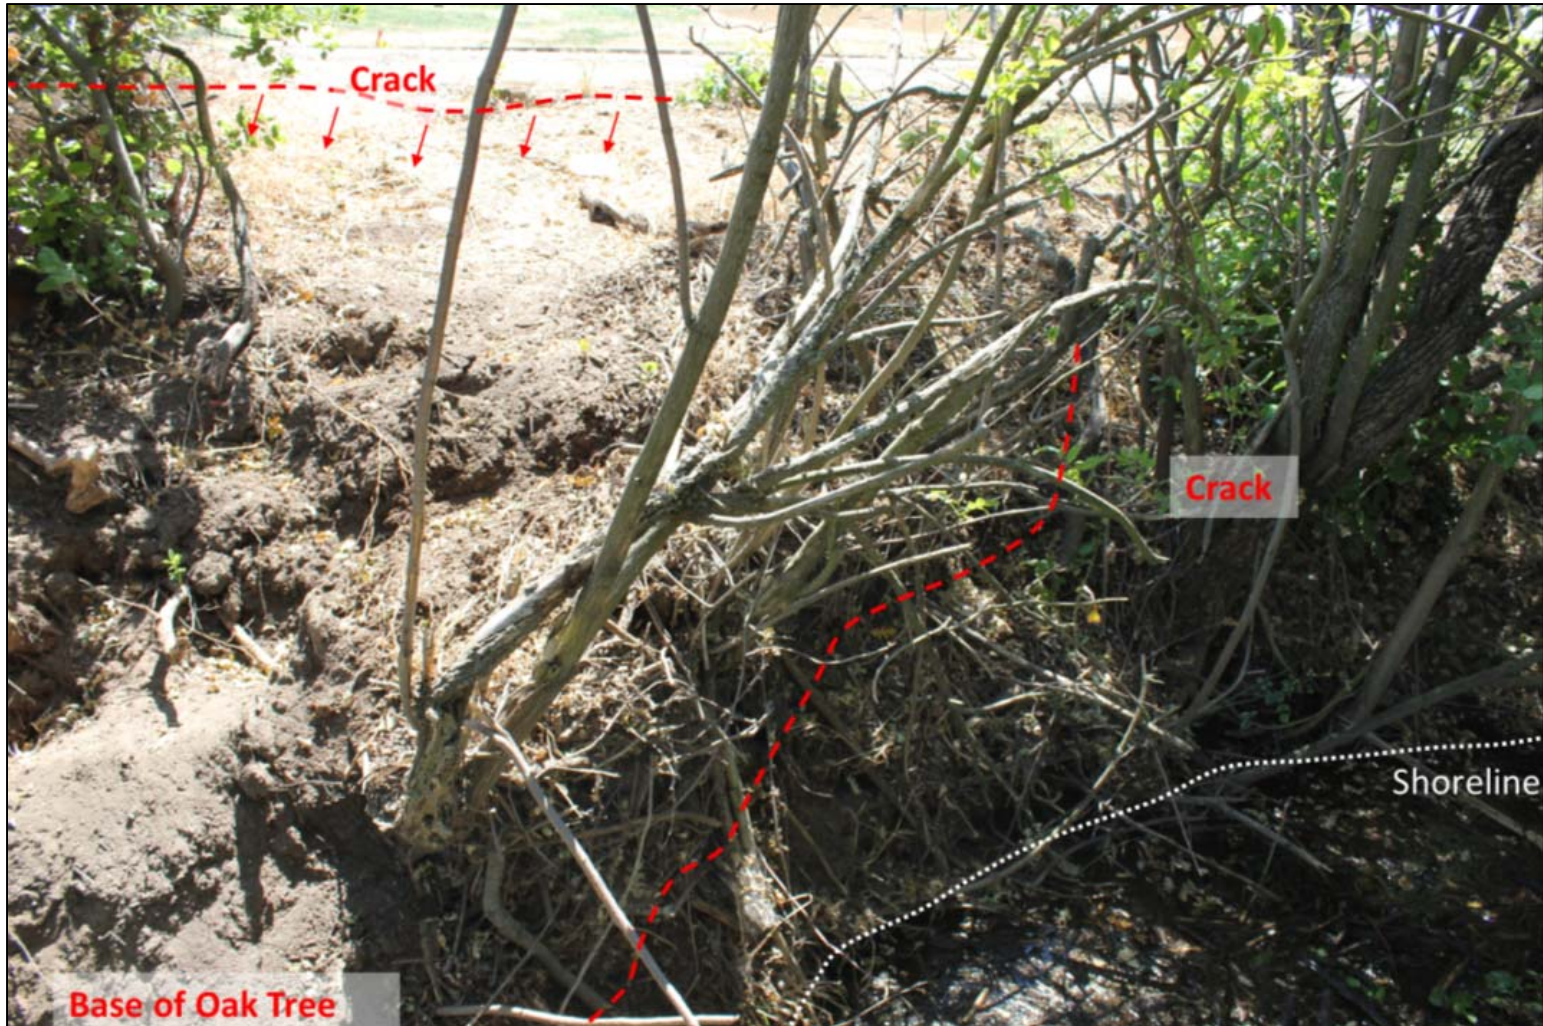
Figure 3-133. The fallen waterside oak as seen from the crown road (left and upper right) and the access path to the water at instrument line E.

Figure 3-133 through Figure 3-135 detail the deformation of the waterside slope that are believed to be directly associated with the movement of the waterside tree. Large cracks, one displaying about 12 inches of vertical offset, were present in the loose soils on the pathway leading down to the waterside tree, directly around the root ball (Figure 3-133). Figure 3-134 shows a view of these cracks taken from the fallen tree looking east at the levee access road, including a sketch of cracking found to the south of the tree. Figure 3-135 provides a detailed view of this cracking as well as a sketch of the approximate location. As shown on Figure 3-128 as well as Figure 3-134 through Figure 3-138, a crack was uncovered at the top of slope, running parallel to the levee just off the paved crown road. A small blackberry bush marked the end of the fresh crack and where an old crack extended along the same alignment, not displaying movement in this event (Figure 3-137). The fresh crack intersected the grout of a piezometer that was installed prior to testing (Figure 3-138).

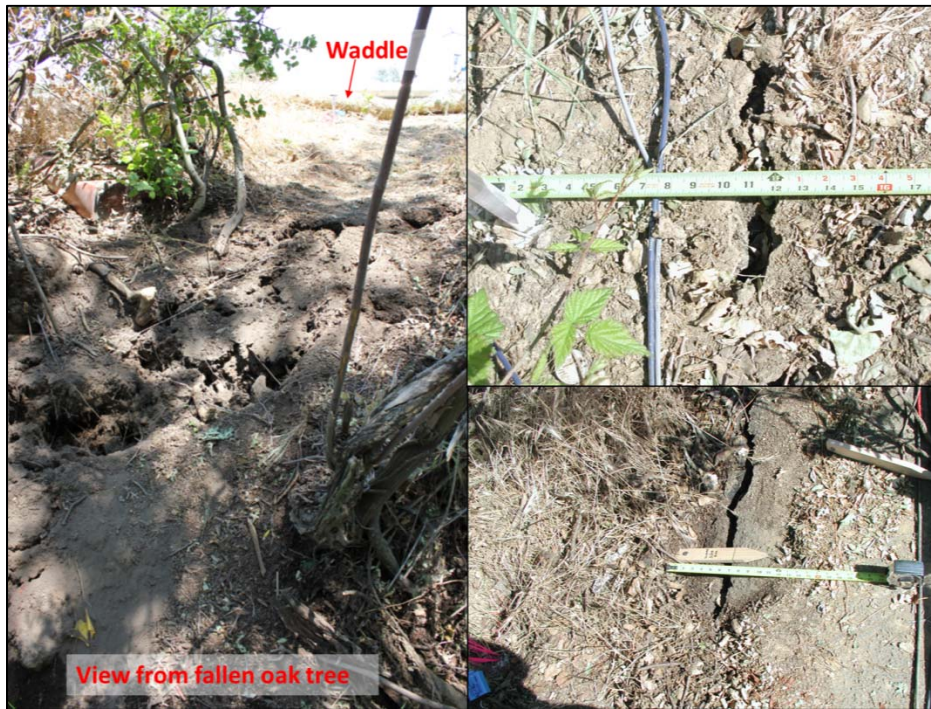
Figure 3-135. A view of the cracking within the loose waterside soils surrounding the fallen tree (right). Surficial excavation did not reveal a connection between this crack and cracking at the top of slope (upper and lower left).

bush shown on Figure 3-135 and Figure 3-137. Dead vegetation was found growing out of portions of it (Stations TT 49 to 55) as shown on Figure 3-141. Crack widths ranged from  $\frac{1}{2}$  to  $\frac{3}{4}$  inch on this segment. Other segments appear to be little more than distressed pavement at the edge of the road (Figure 3-141), but showing small amounts of lateral offset toward the waterside (on the order of  $\frac{1}{2}$  inch or less). Fresh movement was not observed in these cracks during or in the weeks following our flow test.

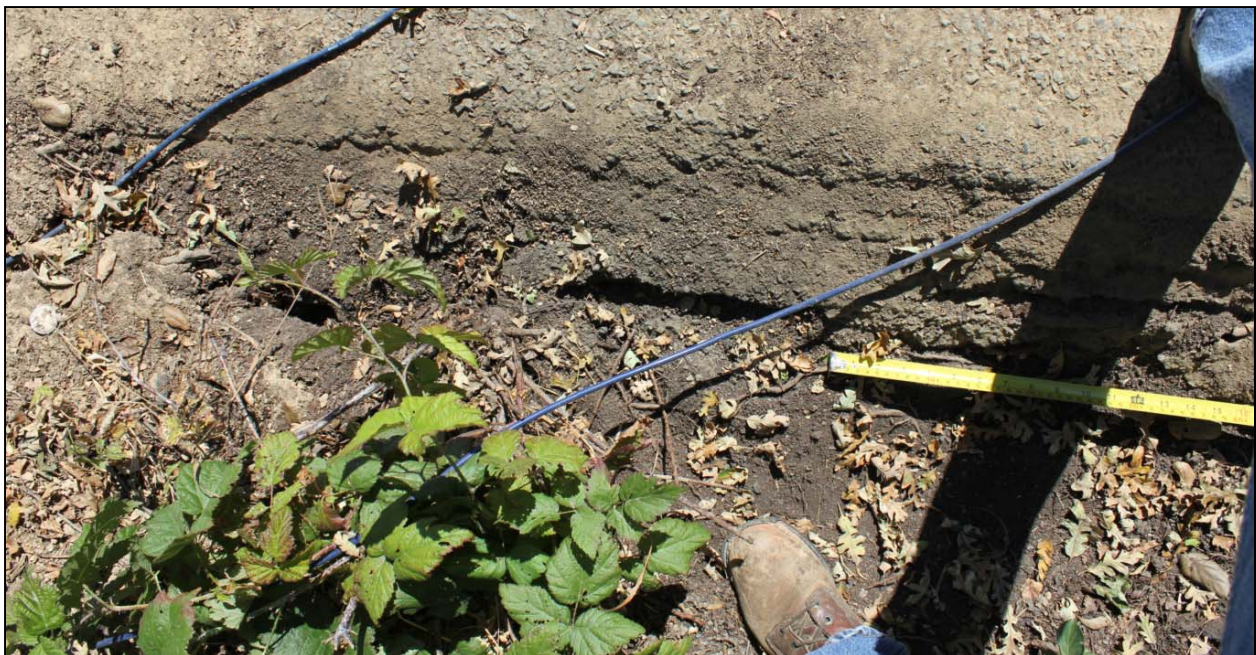
Figure 3-136. In the afternoon of 5/23, during a visit from Dr. Les Harder of HDR, a fresh crack was revealed along the top of slope, previously concealed by leaves and an erosion control wattle.

51.8	5/23	17:30	<p>Visit from team advisor Dr. Les Harder. Additional cracking observed beneath an erosion protection wattle and leaf litter. Cracking was mapped, photographed and further explored. Monitors were installed to track movements.</p>

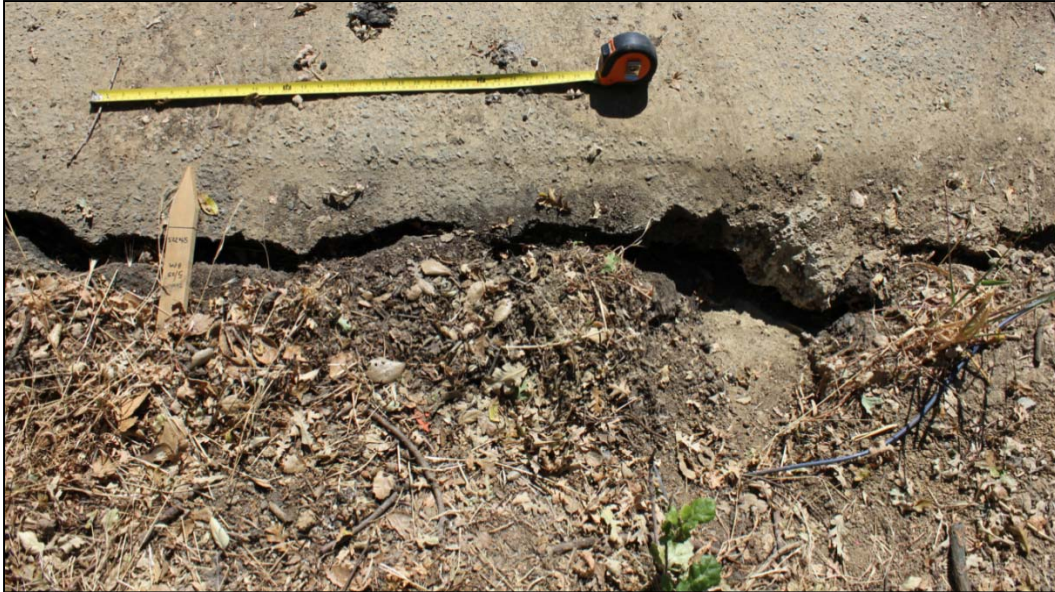
Figure 3-137. A blackberry bush is the transition point between the fresh crack (left) and an older crack (right).

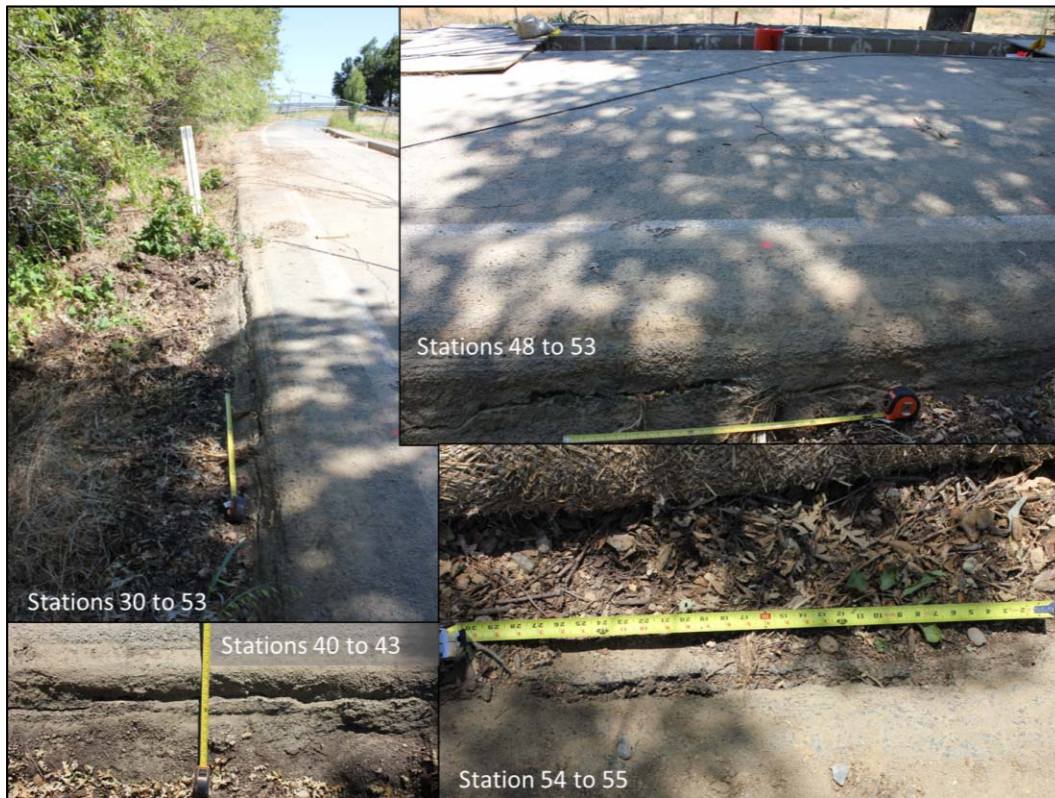
Figure 3-140. A crack at the top of slope (Stations TT 30 to TT 55) was found on 5/25. The crack did not exhibit signs of recent movement but rather is evidence of past deformation.

An old crack was discovered extending along the top of slope just south of the actively moving top of slope crack as shown on Figure 3-140. The crack began at the southern end side of the blackberry

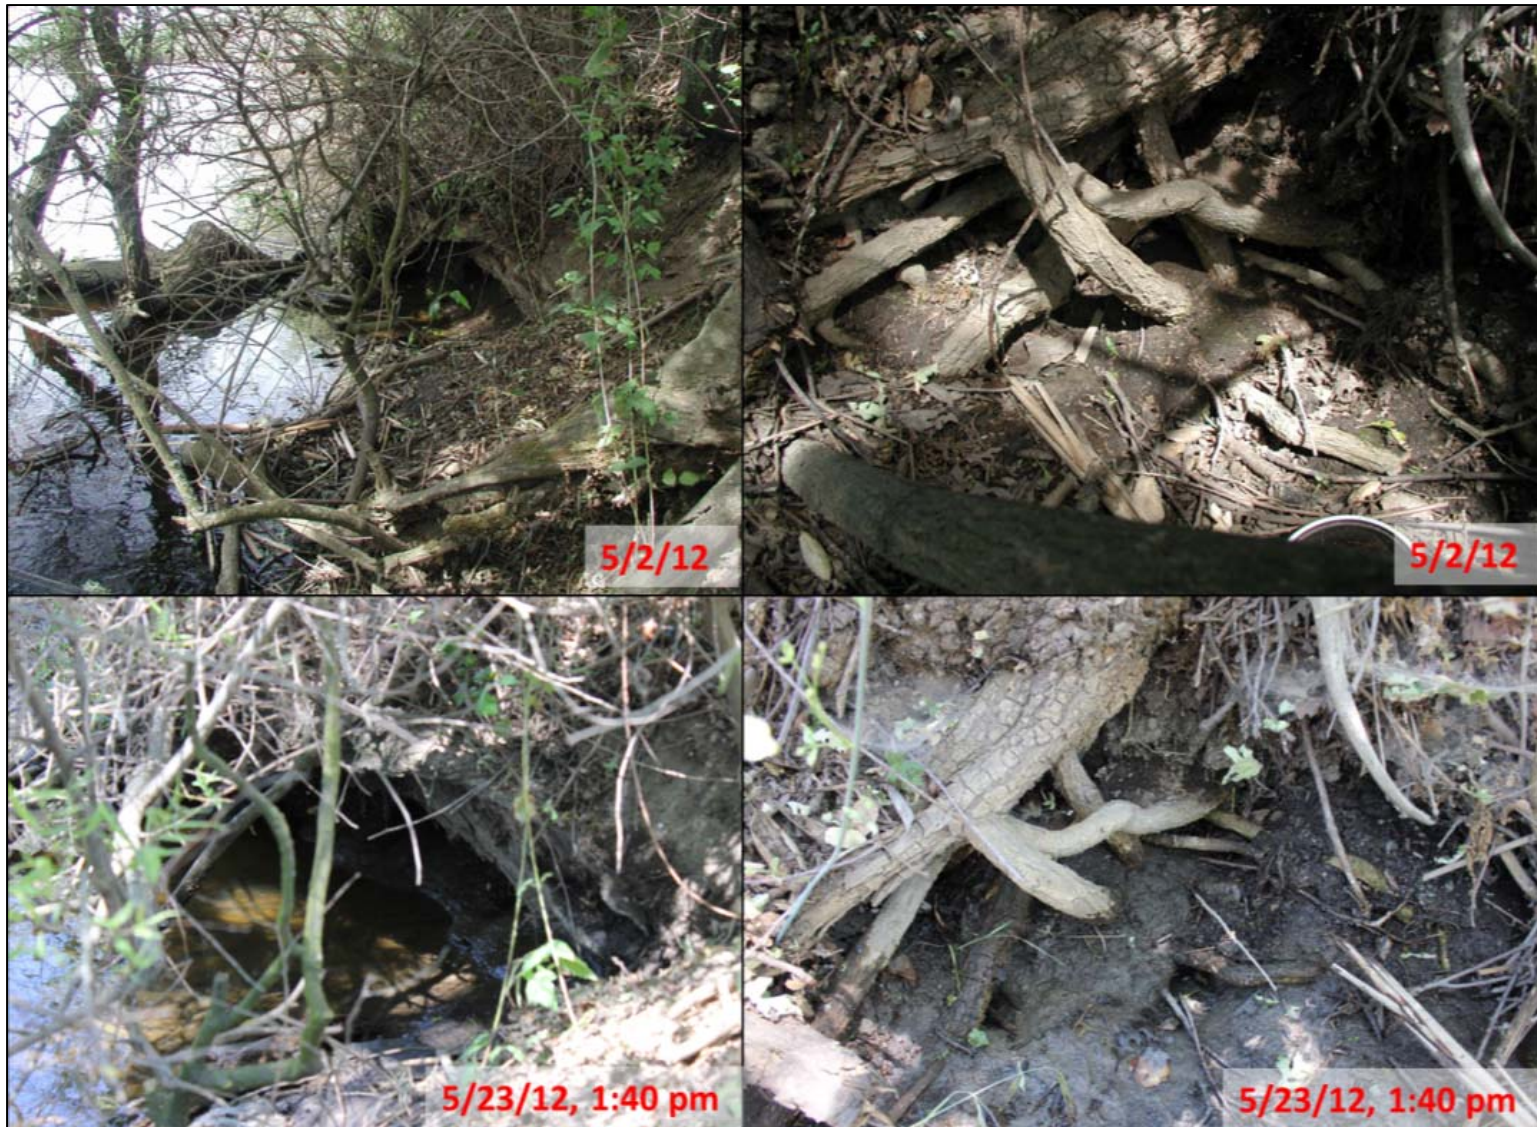
Figure 3-142. Cracking and seepage locations at the end of the flow test (Time = 245.1 hrs). Details for landslide seeps were presented previously.

Figure 3-141. An older crack at Stations TT 30 to 55. Note dead plants rooted into the crack. Seepage at the waterside oak tree was the first location that moisture was observed coming out of the slope at approximately Station TT 20. The seep was first spotted at 10:40 pm on 5/21/12, 9 hours into the flow test, at the location shown on Figure 3-142. By 6 pm the following day, nearly 29

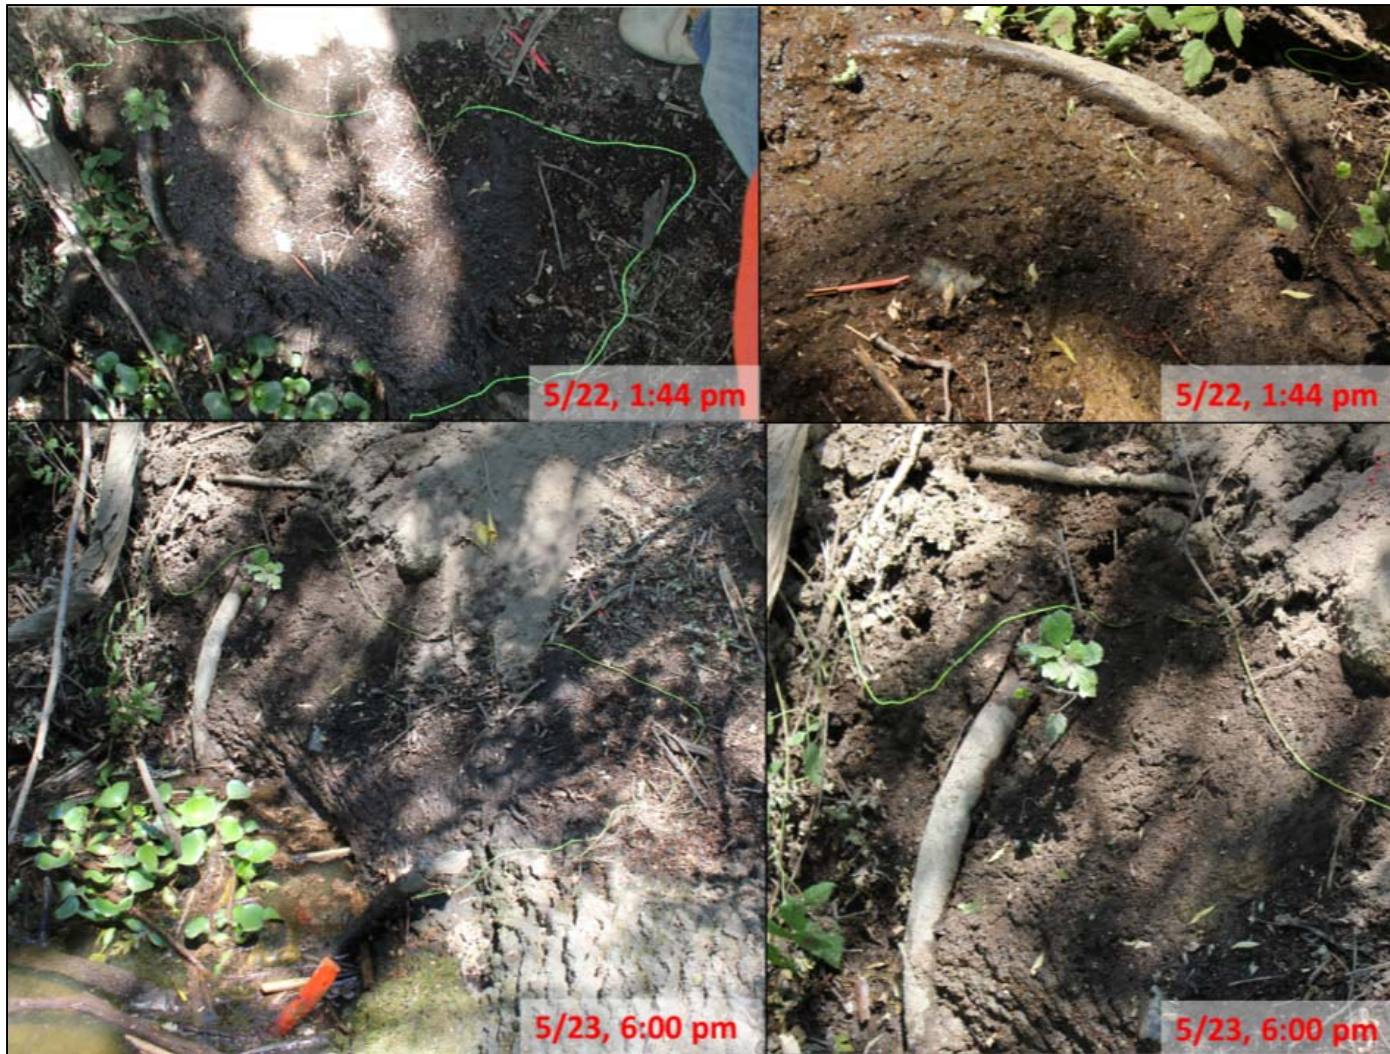
Figure 3-143. Top photos show locations of suspected muskrat burrows identified by Dr. Dirk Van Vuren on 5/2/12. Photos below show corresponding locations (Station TT 13, left and Station TT 24, right) seeping during the flow test.

hours into the flow test, seeps were encountered at Station TT 13 (just north of waterside oak) and TT 24 (just south of waterside oak). These seeps were coming from burrows that had been identified as likely muskrat burrow entrances during a visit by Dr. Van Vuren. Photographs of these burrow entrances are shown on 5/2/12 (the day of the walkover with Dr. Van Vuren) and on 5/23/12 at 1:40 pm, 48 hours into the flow test (Figure 3-143). The rate of flow within the burrows had slowed from the day prior, particularly the burrows to the south of the tree at Station TT 24.
