Static and Seismic Performance of California Levees

Michelle Jennifer Shriro

Doctor of Philosophy

Engineering - Civil and Environmental Engineering

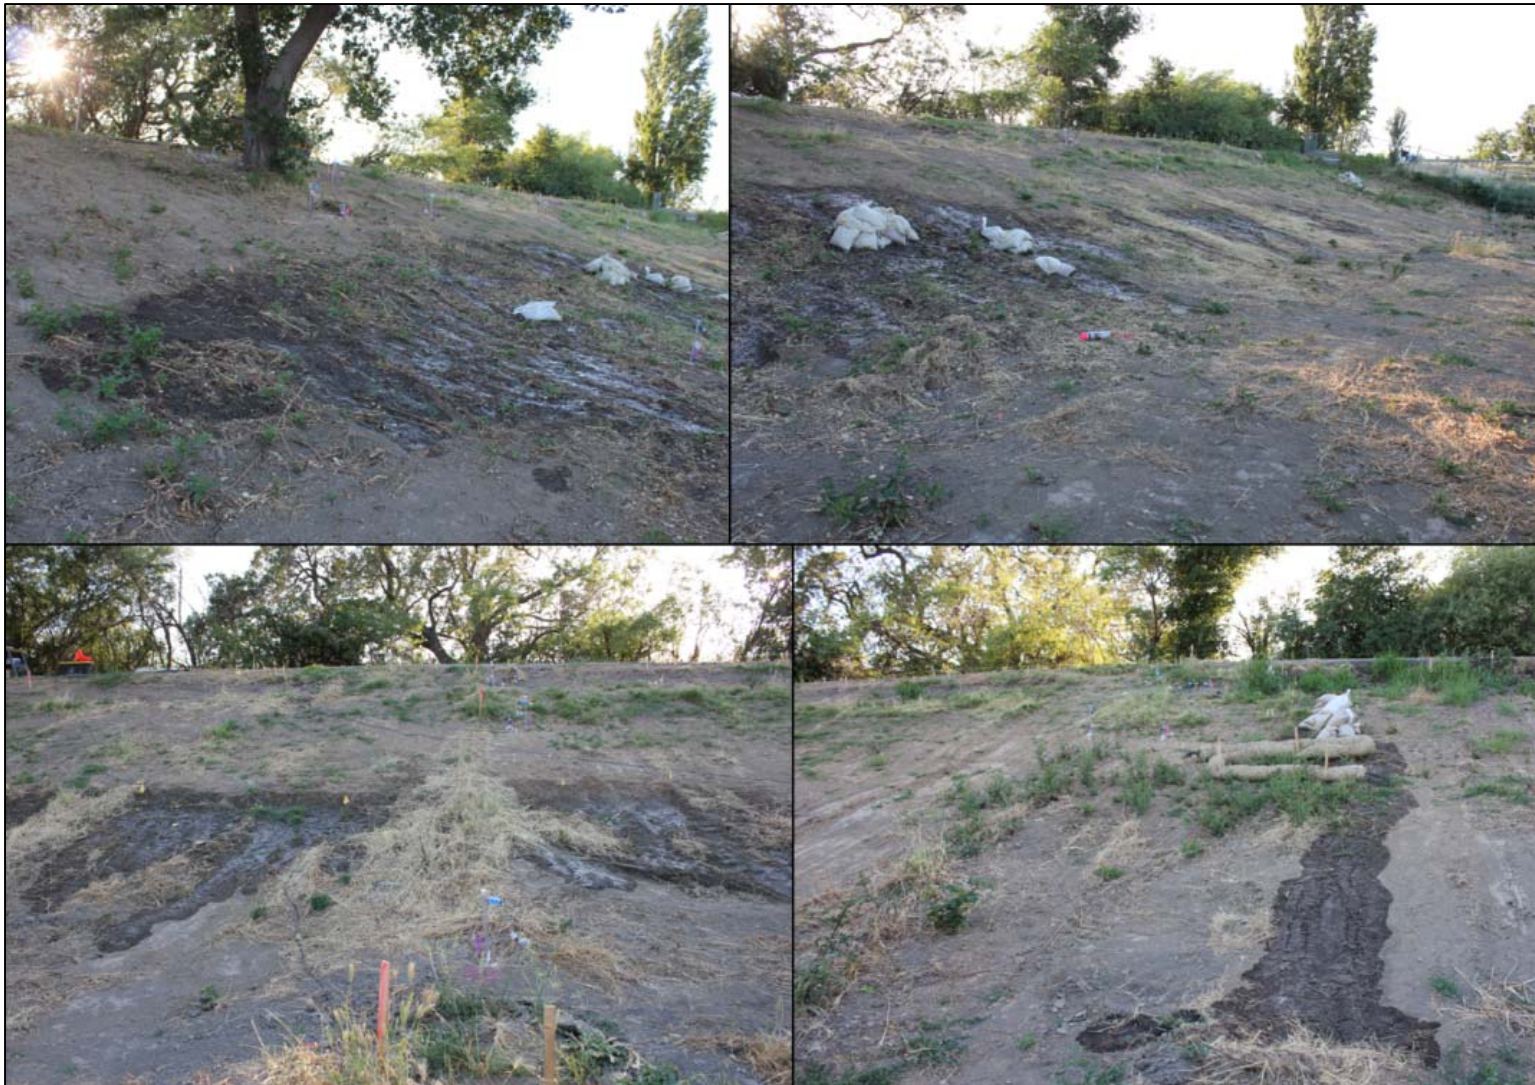
Figure 3-146. Flow on the landside at the end of the dye test (Time = 245.1 hours).

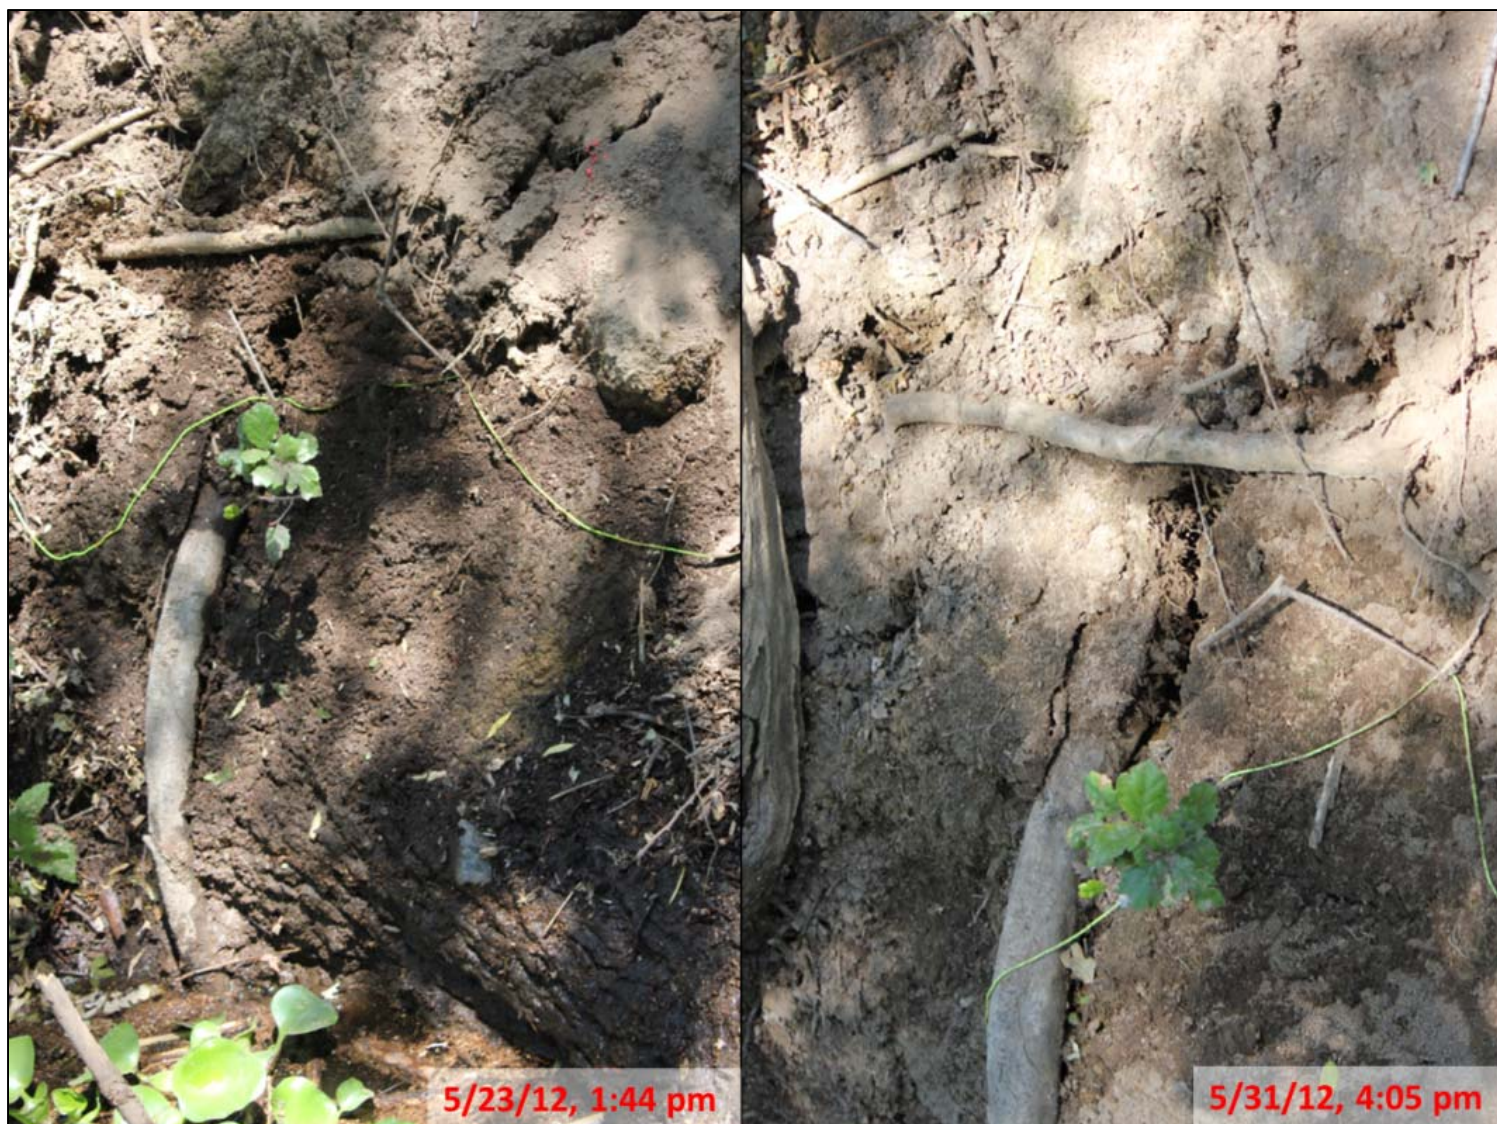
Figure 3-147. Several hours into the dye test, early seep discovered at waterside oak ceased flowing once the tree fell (left) and did not begin flowing again during the dye test on 5/31 (right).

Waterside seeps observed between Stations TT 13 and 24 during the primary flow test began to dry up following the fall of the waterside oak tree, as previously discussed. Figure 3-147 shows an early seep location, drying after the waterside oak has fallen and almost completely dry 4 hours into the dye test. The seeps surrounding the waterside oak tree did not flow during the dye test, while seepage was observed away from the tree. The water level in the Sevenmile Slough was held low during the dye test, by request of our team to the gate operator at Brannan Island. Access was possible with waterproof boots and careful footing. A boat was also made available by Mr. Rick Carter of RD 1601. Given these factors, we were able to make observations of seepage during the dye test in areas that were inaccessible during the primary flow phase. Seeps were photographed between Stations CT 15 and TT 0 as well as from Stations TT 45 to TT 70. Seeping burrows could be seen north of Station CT 15 and south of Station TT 70, but the locations could not be accessed.

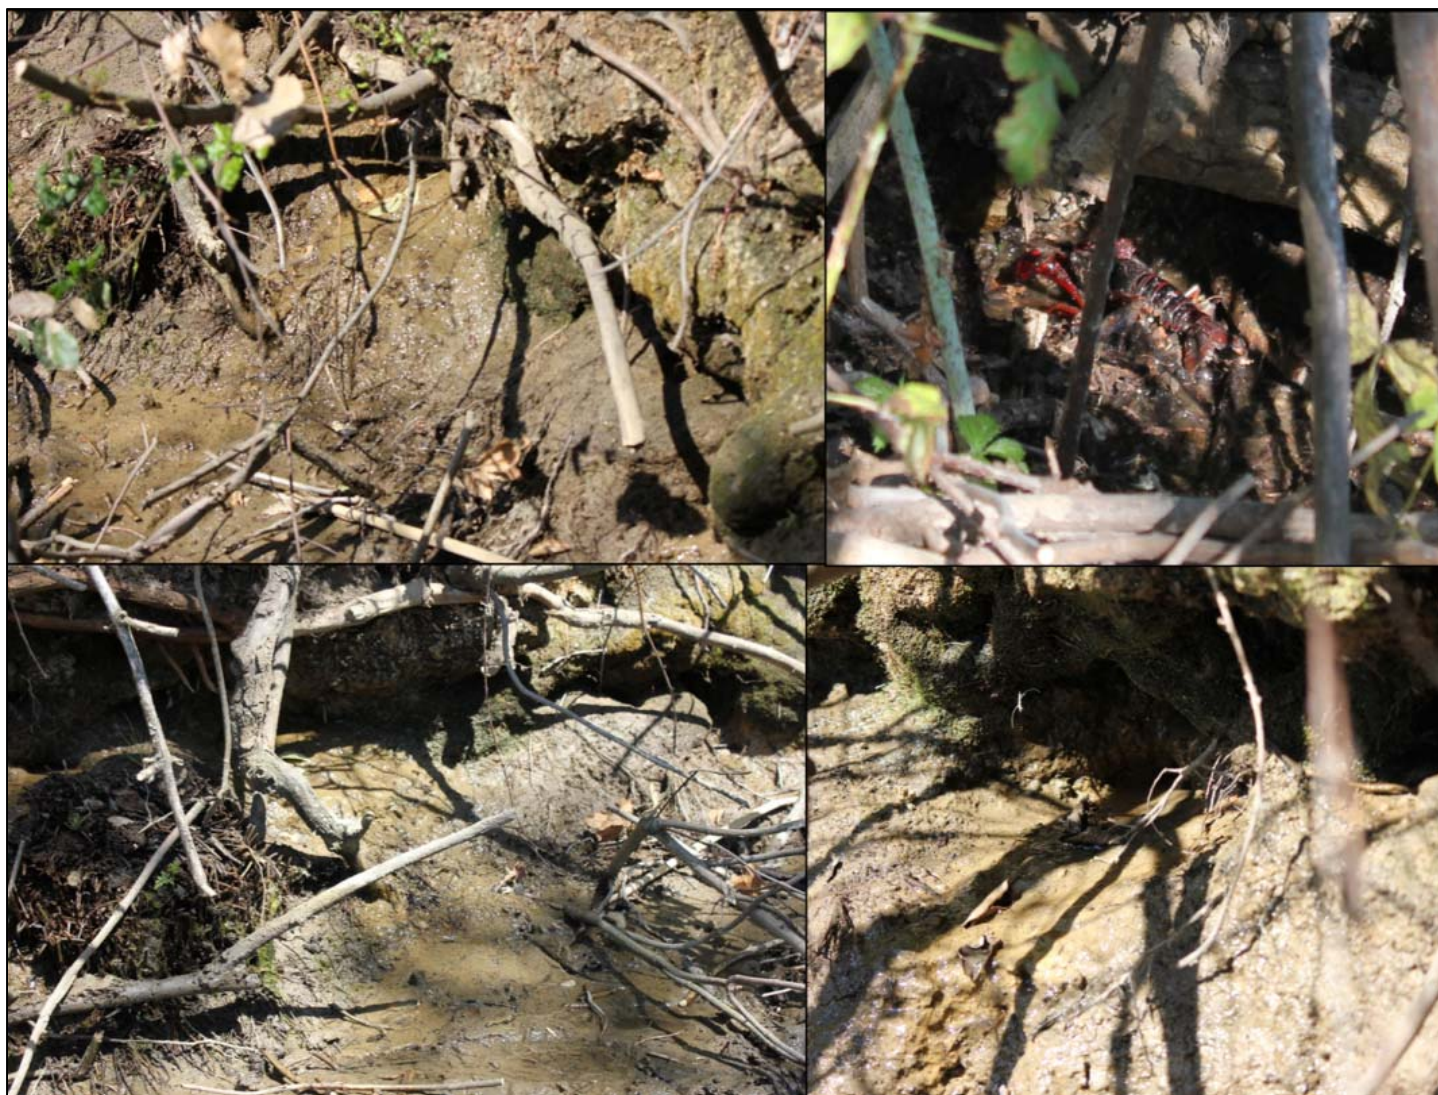
Figure 3-148. Burrows were observed flowing during the dye test both to the north and south of the waterside oak tree. Note a crawdad at the entrance to a burrow (top right).

Figure 3-148 provides photographic examples of seeping waterside burrows observed during the dye test. Blue dye was not observed flowing from the majority of the burrows during the limited timeframe of our dye test. Figure 3-149 shows a burrow at Station TT 70 that flowed blue-tinted water at a rate of approximately  $\frac{1}{2}$  gallon per minute. The burrow flow rate was measured with a graduated cup and timer at 6:30 pm (5/31/12). This burrow displayed the fastest flow rate observed in any burrow that was seen during our inspections, while the majority of burrows were found to slowly weep. Figure 3-150 shows burrows along the waterside slope toe on 6/1/12, the day after the dye test. Weeping of water had stopped. The photographs indicate the density of burrows along the toe of slope, typically out of view due to higher water levels. According to Dr. Van Vuren, muskrats prefer entry under the water. A detailed photographic timeline is provided for the events and key observations associated with the dye test on 5/31/12 (Table 3-3) while dates are provided for previously observed features.

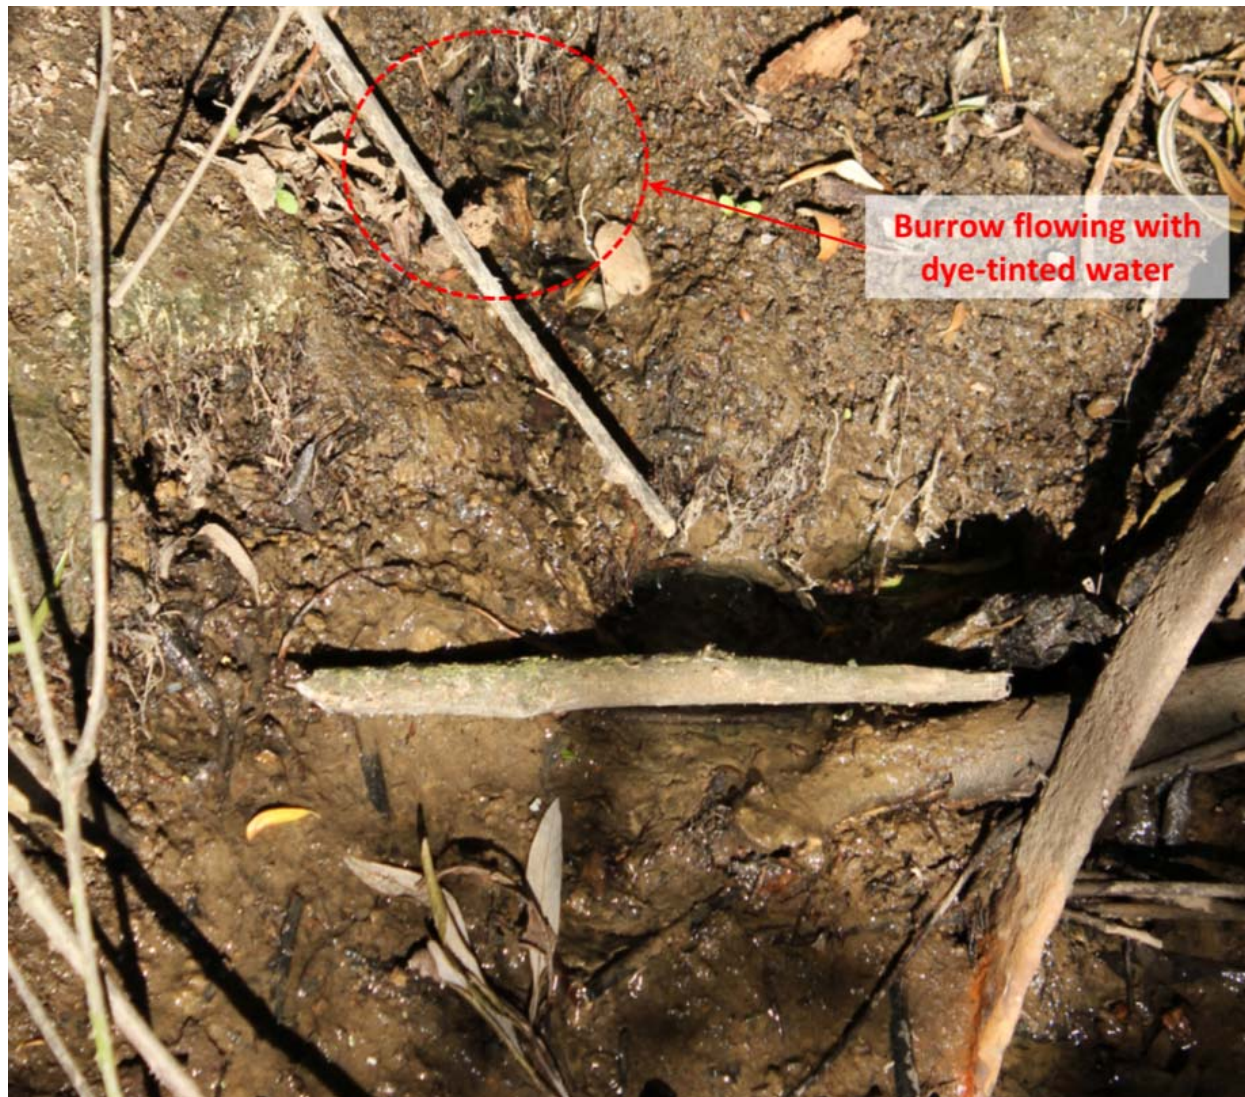
Figure 3-149. Burrow at Station TT 70 flows blue-tinted water at a measured rate of about ½ gallon per minute from a 2 ½ inch diameter burrow, likely muskrat.

245	5/31	18:43	Flow rate is measured at ½ gallon per minute in burrow at Sta. TT 70.	See Figure 3-149
245.1	5/31	18:51	Water off; begin falling head test

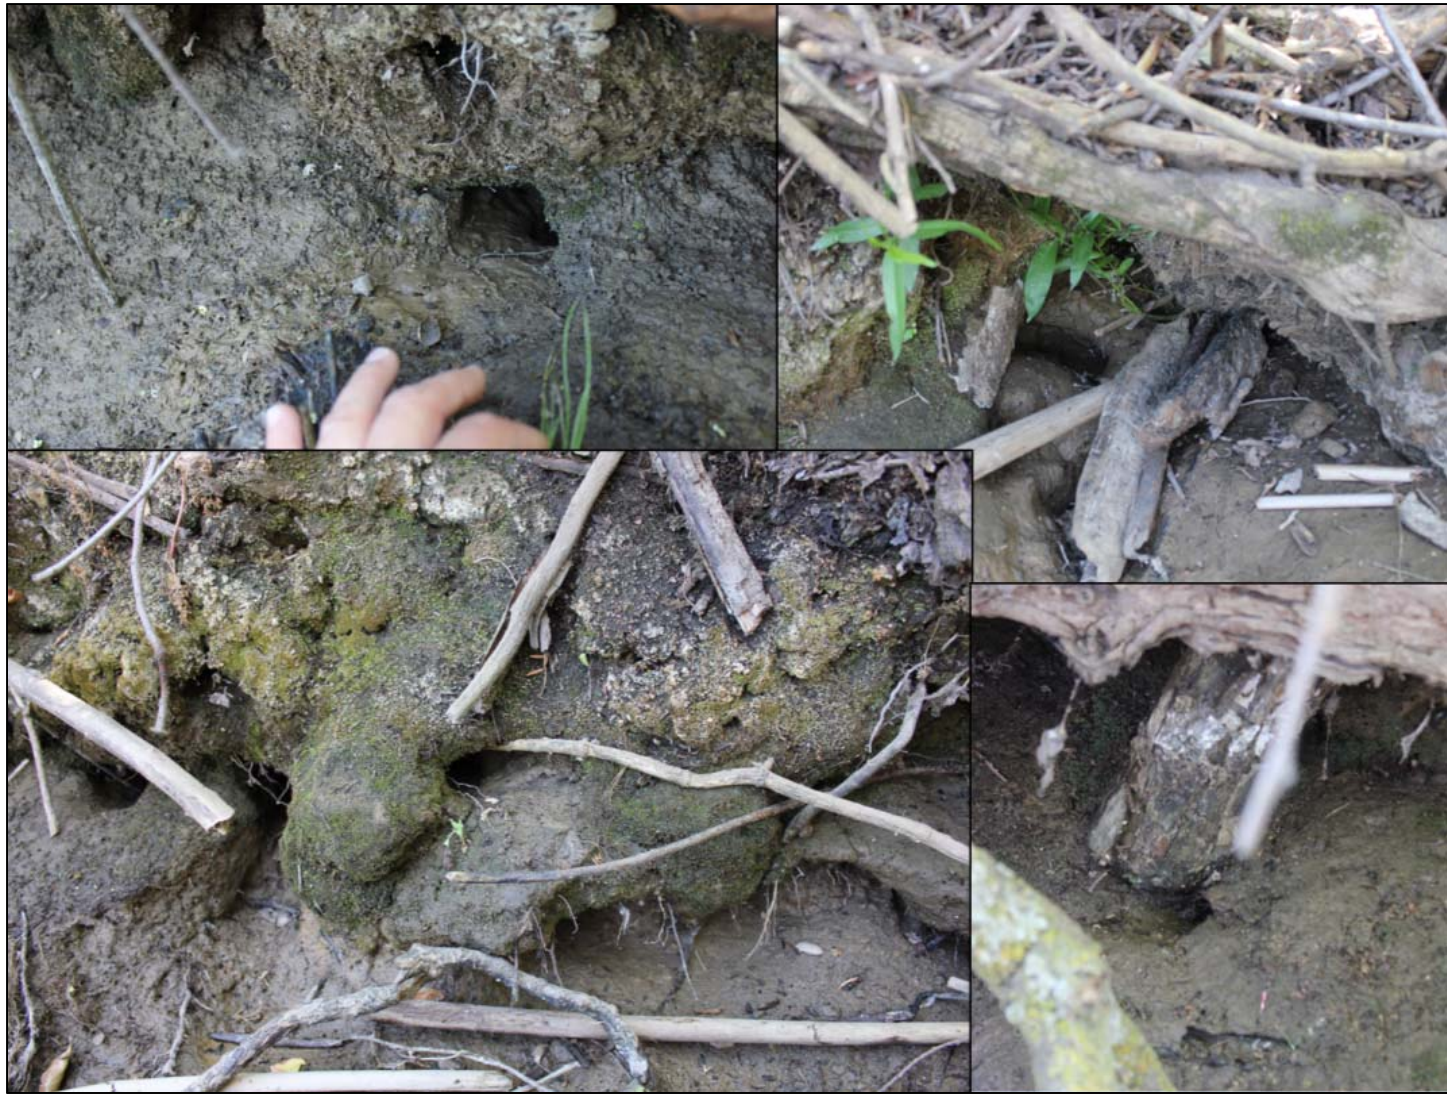
Figure 3-150. Photos taken on 6/1/12, the day after completion of the flow test. The waterside burrows are photographed and observed to have stopped flowing.

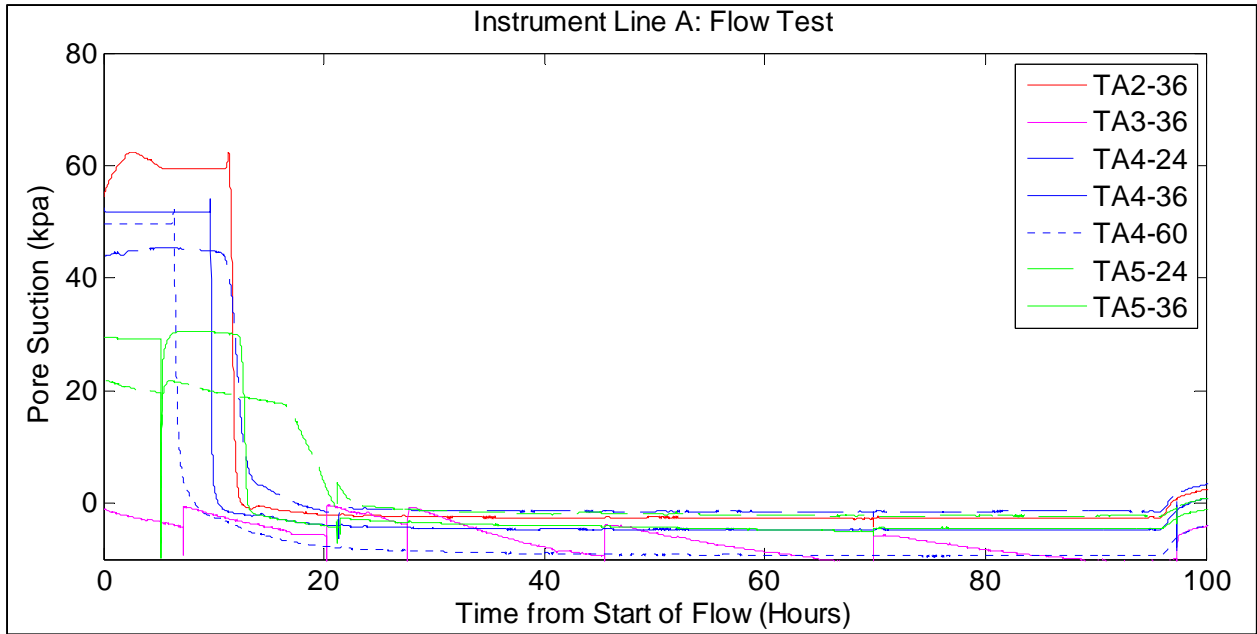
Figure 3-151. Tensiometer data for the primary flow test at instrument line A.

Landside tensiometer results during the 4-day primary flow test and the complete 15-day flow test with post flow period are summarized by instrument line and presented below. The primary flow test represents the time when both trenches were filled to a constant head. Figure 3-151, Figure 3-152, Figure 3-153 and Figure 3-154 show results of instrument lines A, B, C, and D, respectively, during primary flow. Some instruments experienced problems retaining water and sustaining suction, possibly due to an imperfect seal. Tensiometers TC3-36, TB5-36, TA3-36, TC4-24, and TA5-24 began to drop water levels and suction potentially while the instrument is still re-gaining suction after the instrument was opened for filling. In many cases, the data are sufficient to determine the arrival of the wetting front, but the peak values of suction may not have been reached and, therefore, reported values may not be reliable other than to provide a lower bound on the suction value.

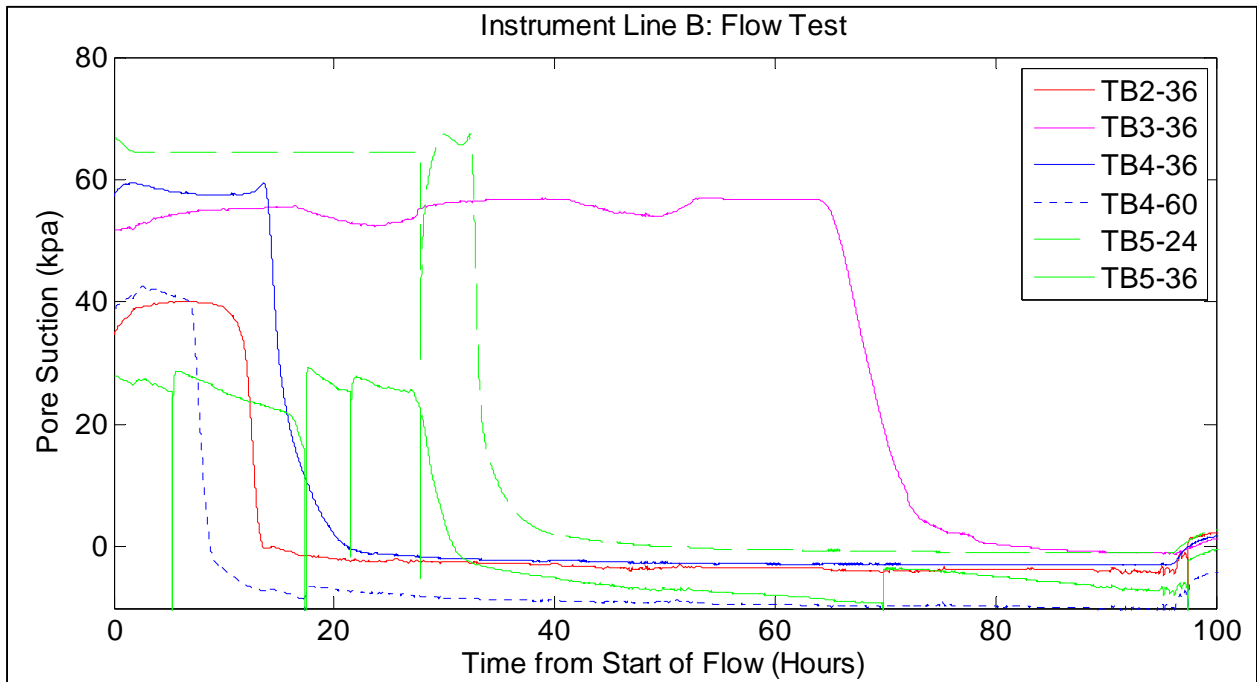
Figure 3-152. Tensiometer data for the primary flow test at instrument line B.

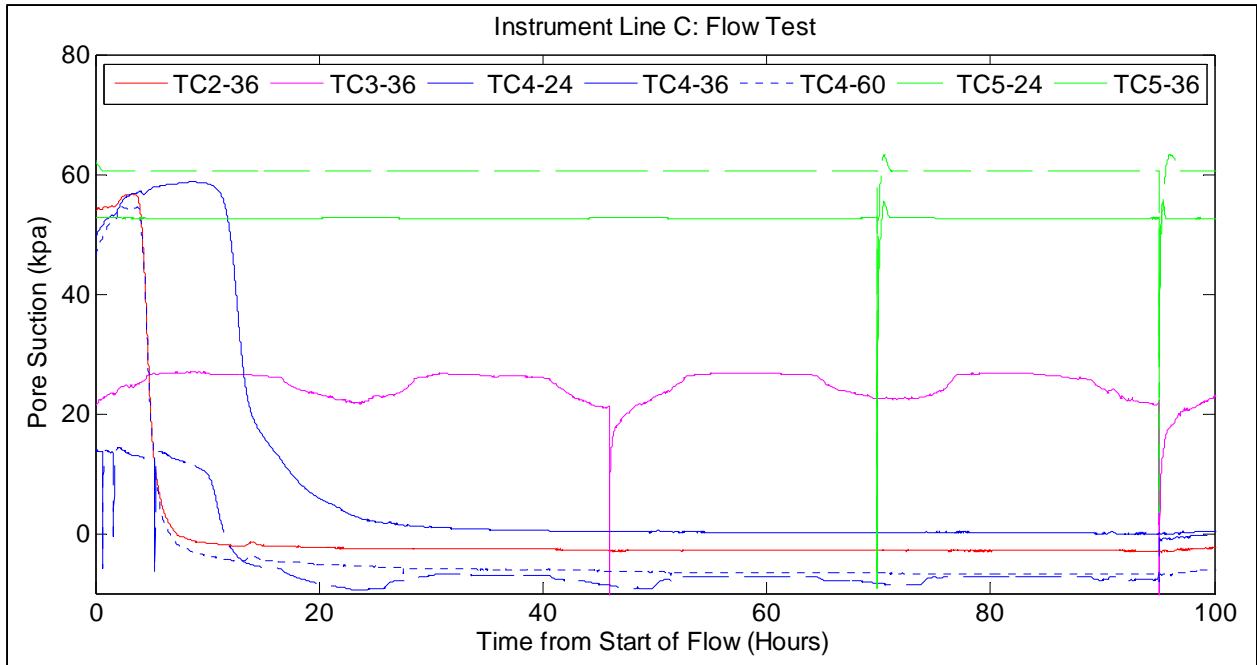
Figure 3-153. Tensiometer data for the primary flow test at instrument line C.

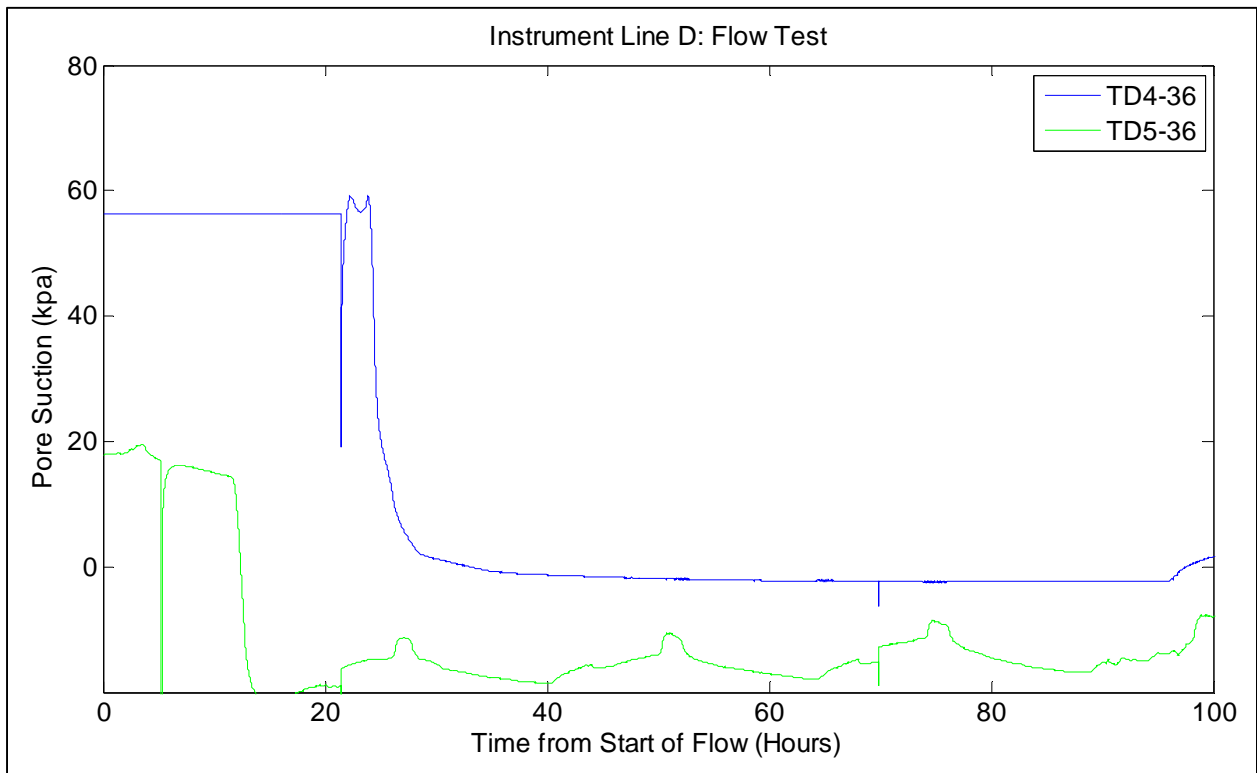
Figure 3-154. Tensiometer data for the primary flow test at instrument line D.

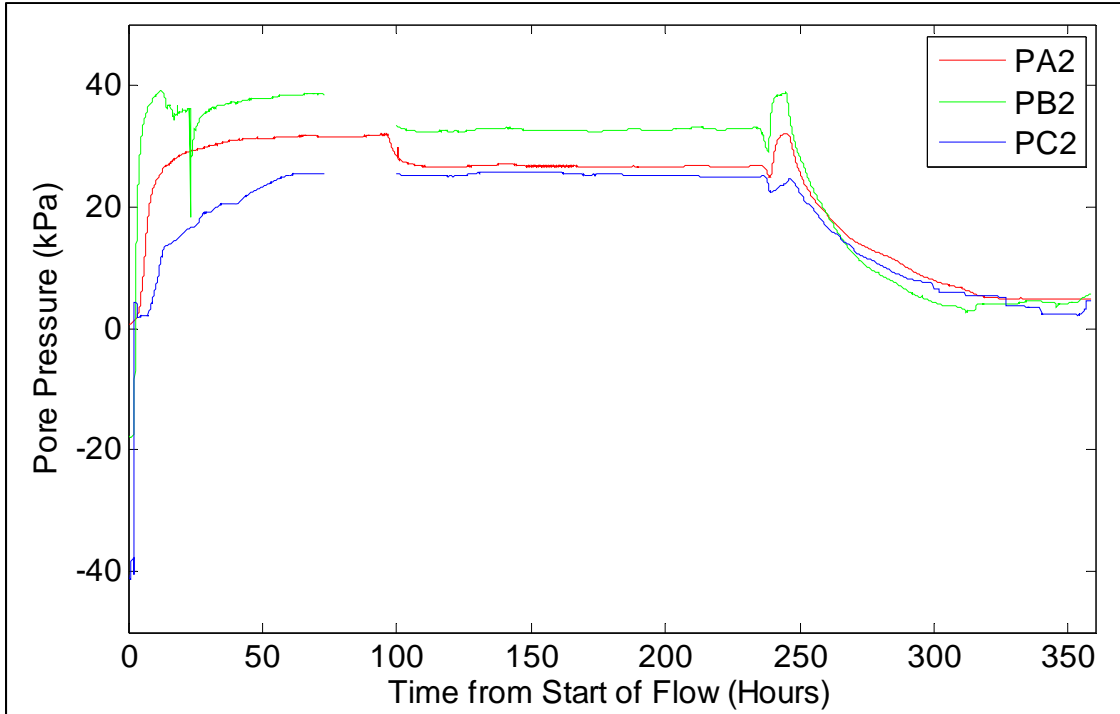
Figure 3-155. Piezometer data for the 10-day flow test and post flow at instrument row 2 (at the top of the slope) at depths of 15, 15.9, and 12.4 feet for lines A, B, and C, respectively.

Landside piezometer results are presented as analogous rows plotted together beginning with row 2 at the top of the levee (Figure 3-155) followed by row 4, just above the landside oak (Figure 3-156 and Figure 3-157), row 5, just below the landside oak (Figure 3-158), and row 3 at the toe of slope (Figure 3-159). For ease of comparison, summaries of time of arrival of the wetting front and saturation are provided for each landside tensiometer on Table 3-4. Similarly, time to wetting front arrival, the value of and time of steady state pore pressure for each piezometer are provided on

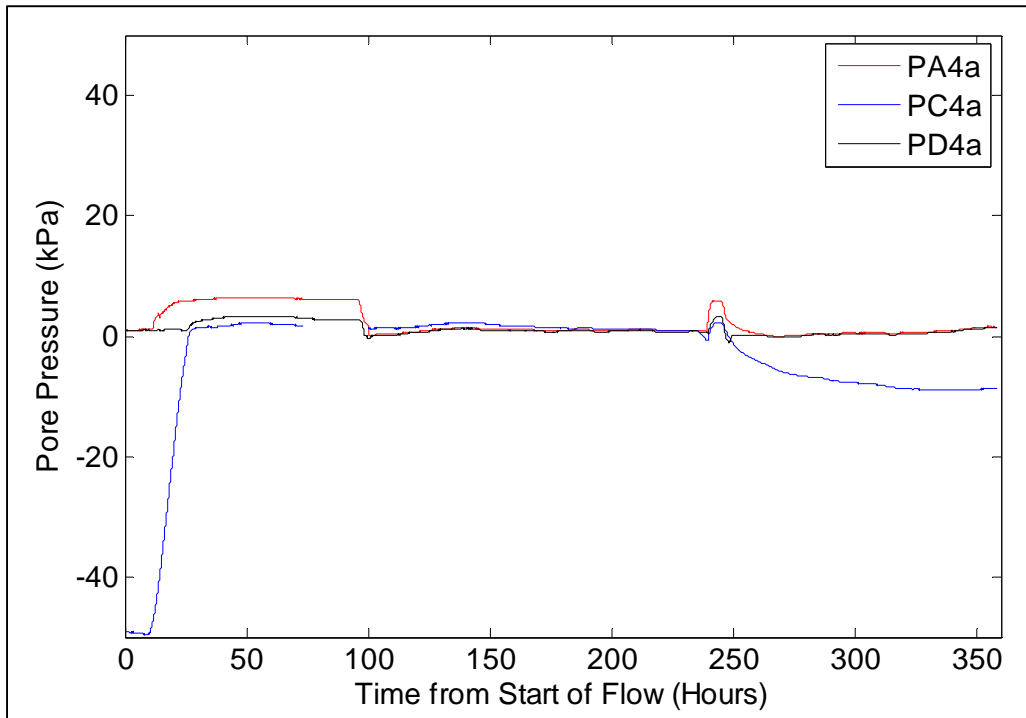
Figure 3-156. Piezometer data for the 10-day flow test and post flow at instrument row 4 (elevation just above the landside oak) at depths of 2.4 feet below grade.

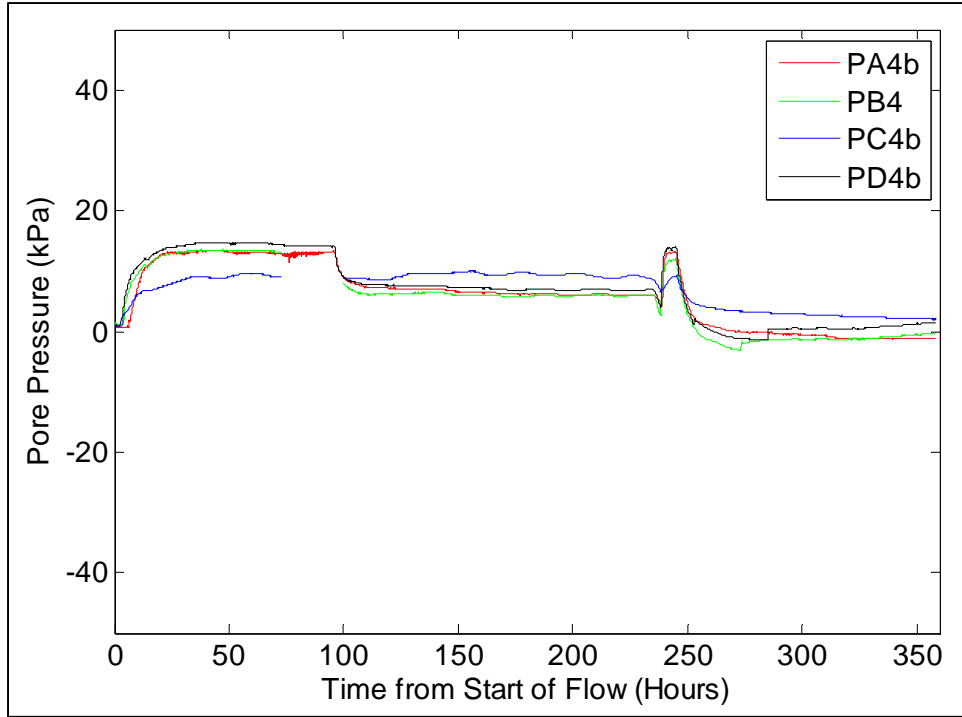
Figure 3-157. Piezometer data for the 10-day flow test and post flow at instrument row 4 (elevation just above the landside oak) at depths of 5.7 feet below grade.

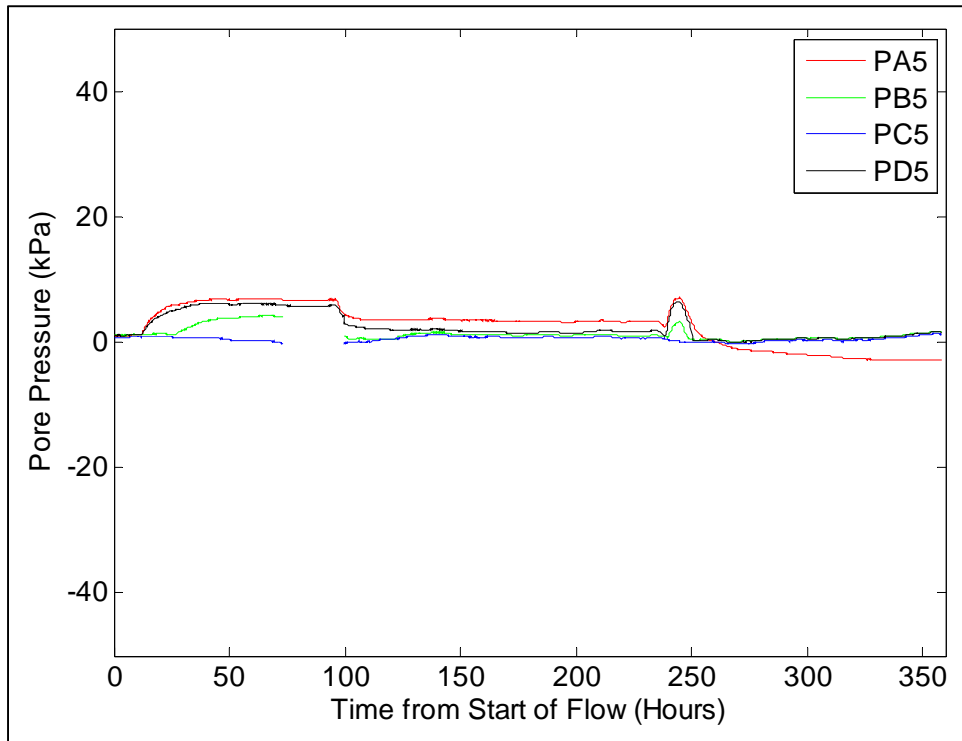
Figure 3-158. Piezometer data for the 10-day flow test and post flow at instrument row 5 (elevation just below the landside oak) at depths of 3 feet below grade.

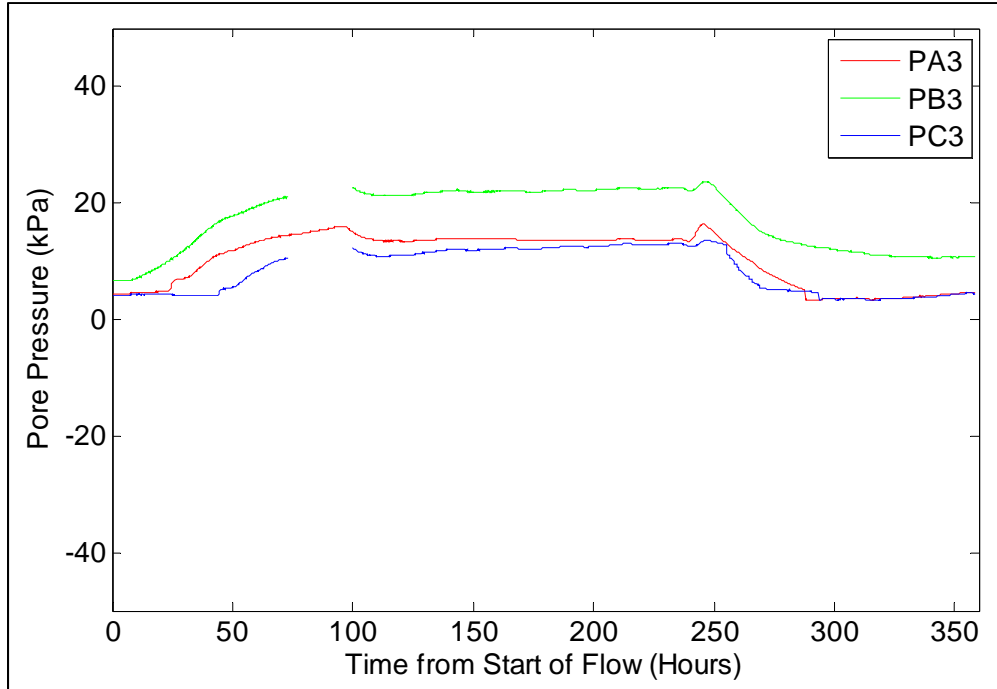
Figure 3-159. Piezometer data for the 10-day flow test and post flow at instrument row 3 (at the toe of slope) at depths of 7.9, 13.5, and 8.5 feet below grade for lines A, B, and C, respectively.

Piezometers located in row 3 at the toe of slope are not all the same depth. PB3 was installed deeper and under the groundwater so that effects on the groundwater table could be monitored. The instruments were building pore water pressure steadily and had not achieved steady state. PB3 predictably begins to build water pressure before PA3 and PC3. PA3, however, begins to build pore pressure prior to the arrival of hydrostatic water pressures as measured by PB3.

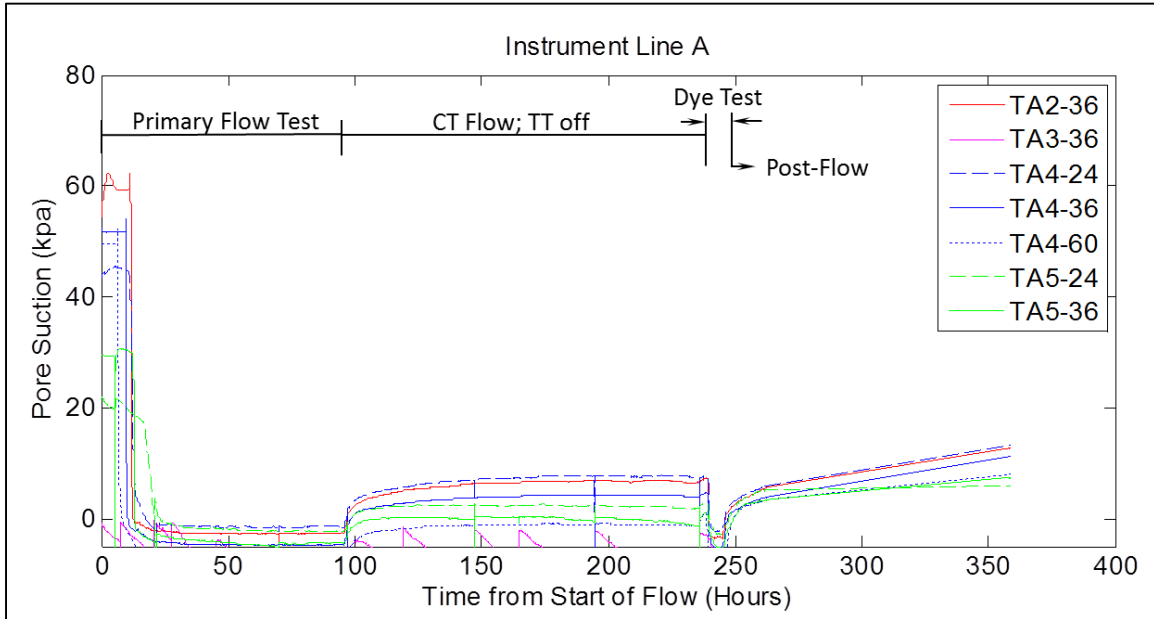
Figure 3-160. Tensiometer data for 10-day flow test and post flow at instrument line A.

Figure 3-160, Figure 3-161 and Figure 3-162 show the entire 10-day flow test (including 4 days of primary flow, 5 ½ days of control trench flow only and ½ day of dye testing) and 5 days of post-flow readings as site soils begin to dry and rebuild suction.

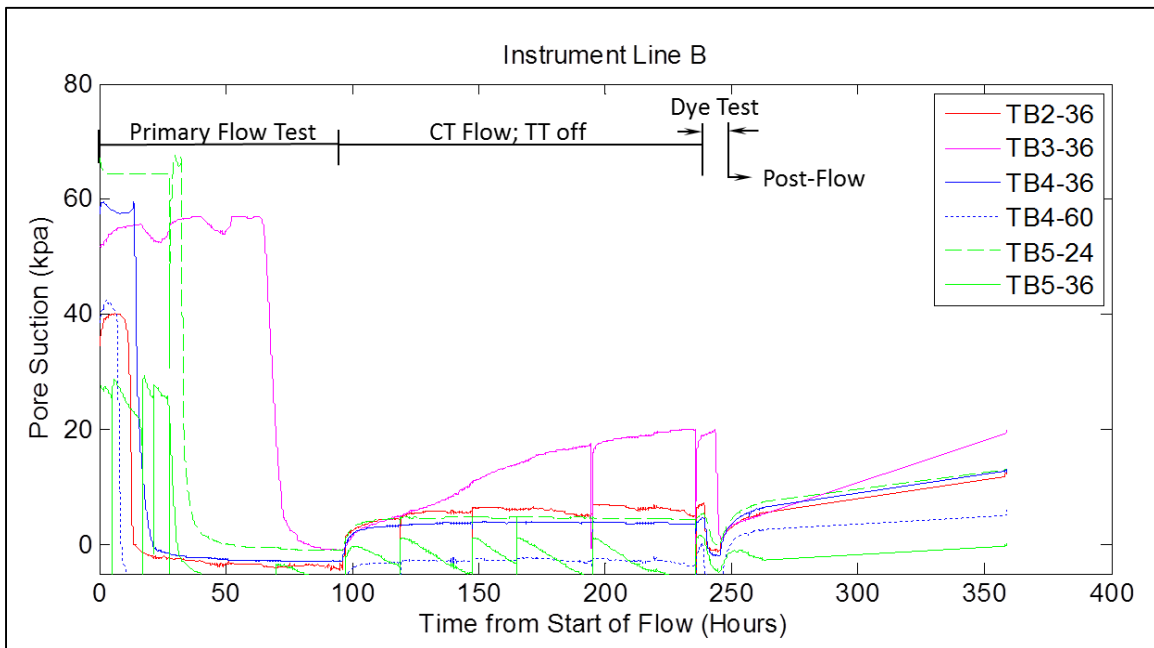
Figure 3-161. Tensiometer data for 10-day flow test and post flow at instrument line B.

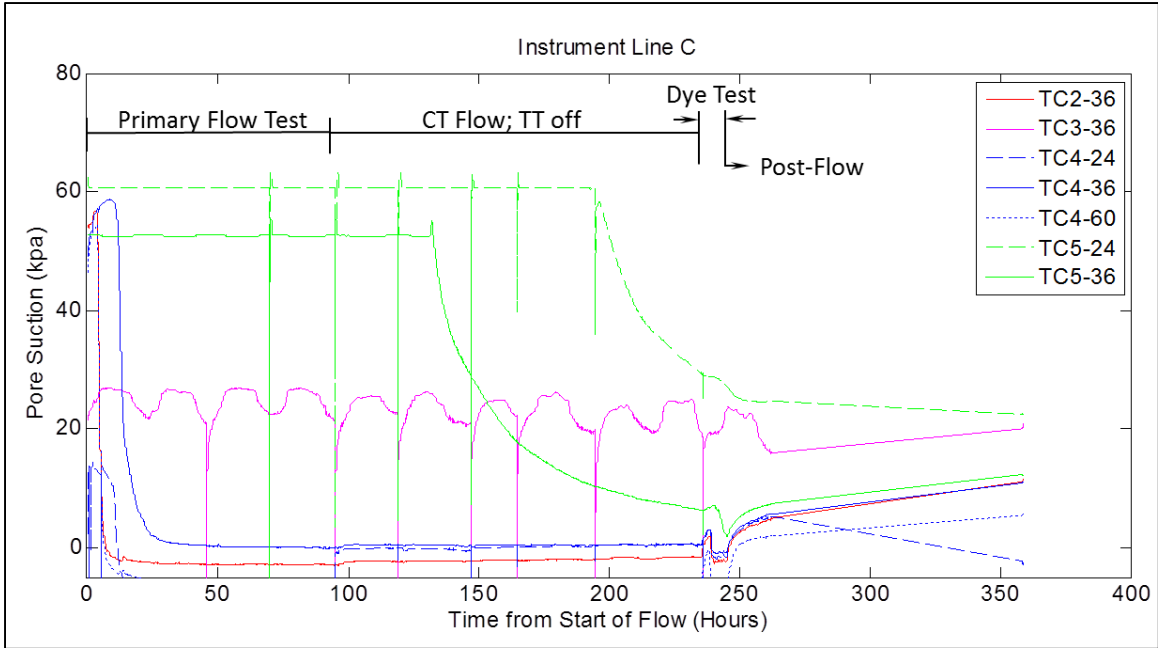
Figure 3-162. Tensiometer data for the 10-day flow test and post flow at instrument line C.

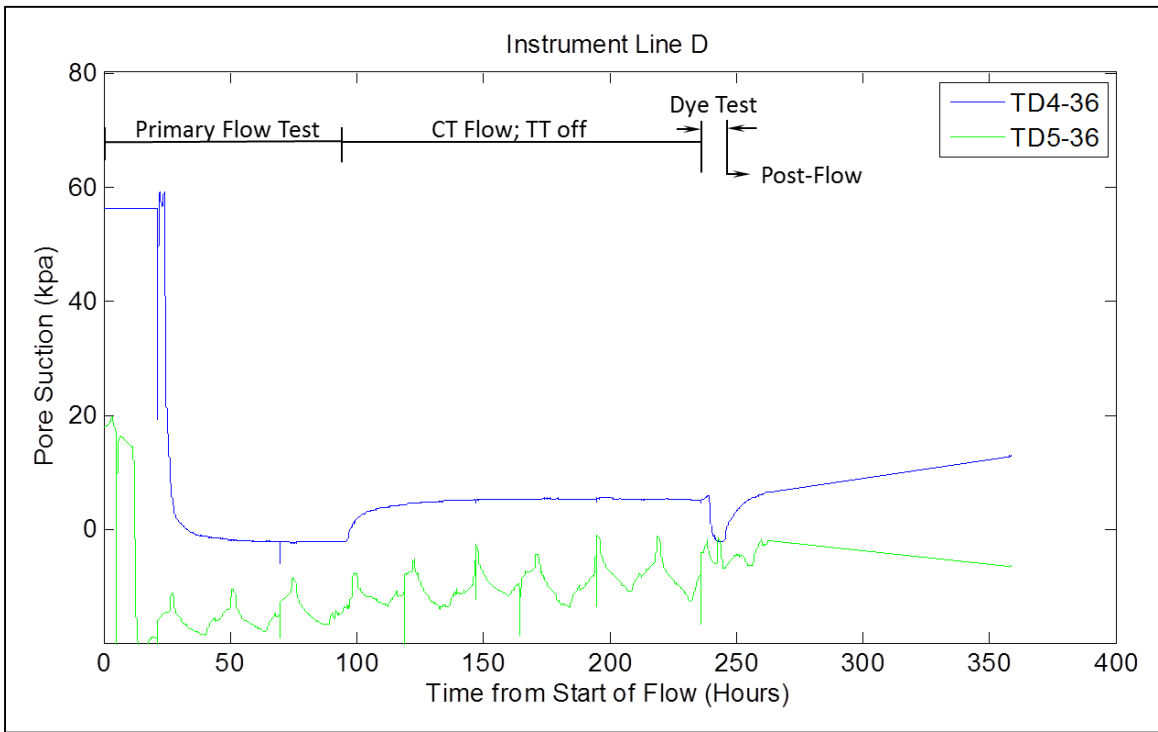
Figure 3-163. Tensiometer data for the 10-day flow test and post flow at instrument line D.

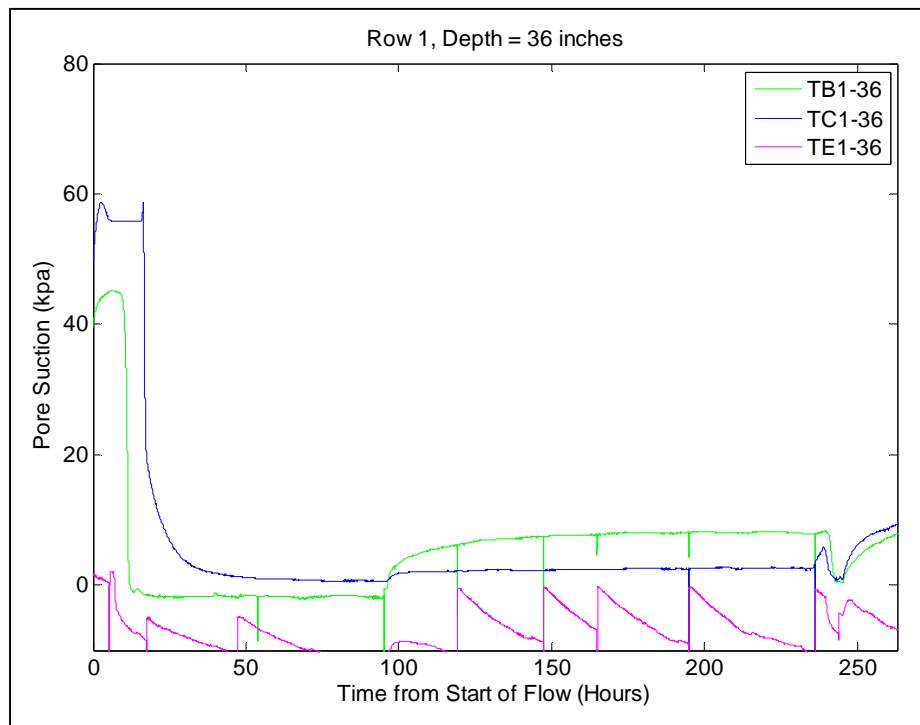
Figure 3-164. Tensiometer results for Row 1, 36 inch depth, for the 10-day flow test and early post-flow.

Waterside tensiometer results during the 10-day flow test with post flow period are summarized by row and instrument depth and presented below on Figure 3-164 and Figure 3-165. Waterside

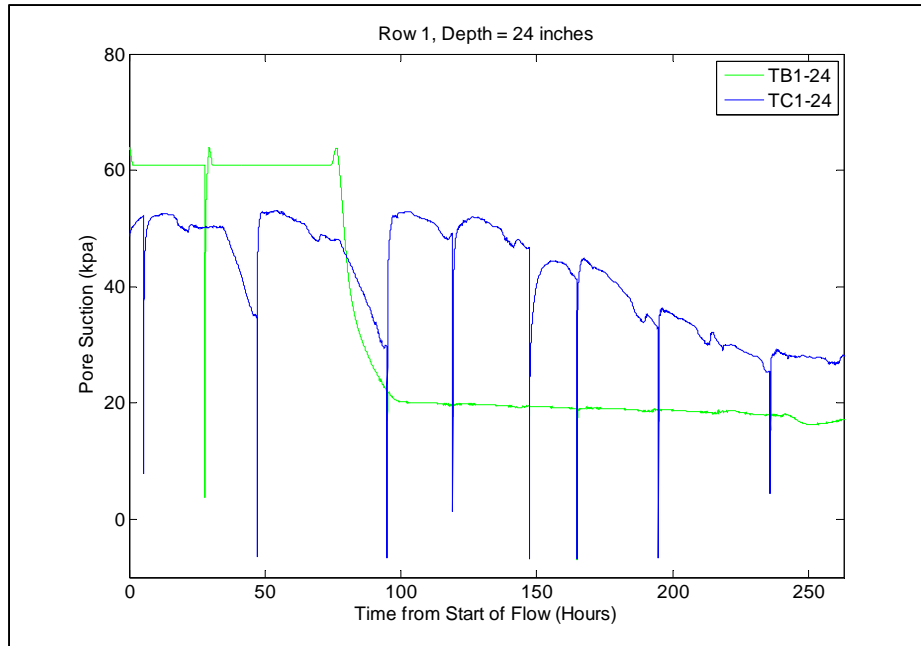
Figure 3-165. Tensiometer results for Row 1, 24 inch depth, for the 10-day flow test and early post-flow.

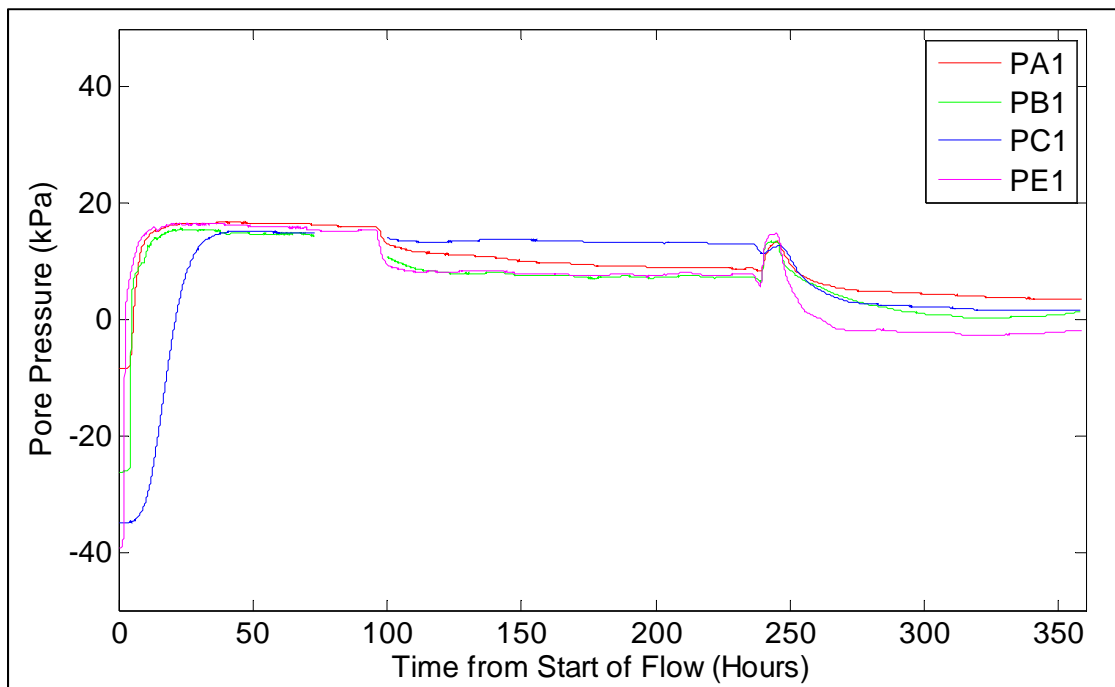
Figure 3-166. Piezometer data for the 10-day flow test and post flow at instrument row 1 (top of waterside slope) at a depths of 5.9, 6.5, 6.2, and 6.5 feet below grade for lines A, B, C, and E, respectively.

piezometer data are plotted by row (1 and 6) and provided as Figure 3-166 and Figure 3-167. For ease of comparison, summaries of time of arrival of the wetting front and saturation are provided for each waterside tensiometer on Table 3-6. Similarly, time to wetting front arrival, the value of and time of steady state pore water pressure for each piezometer are provided on Table 3-7.

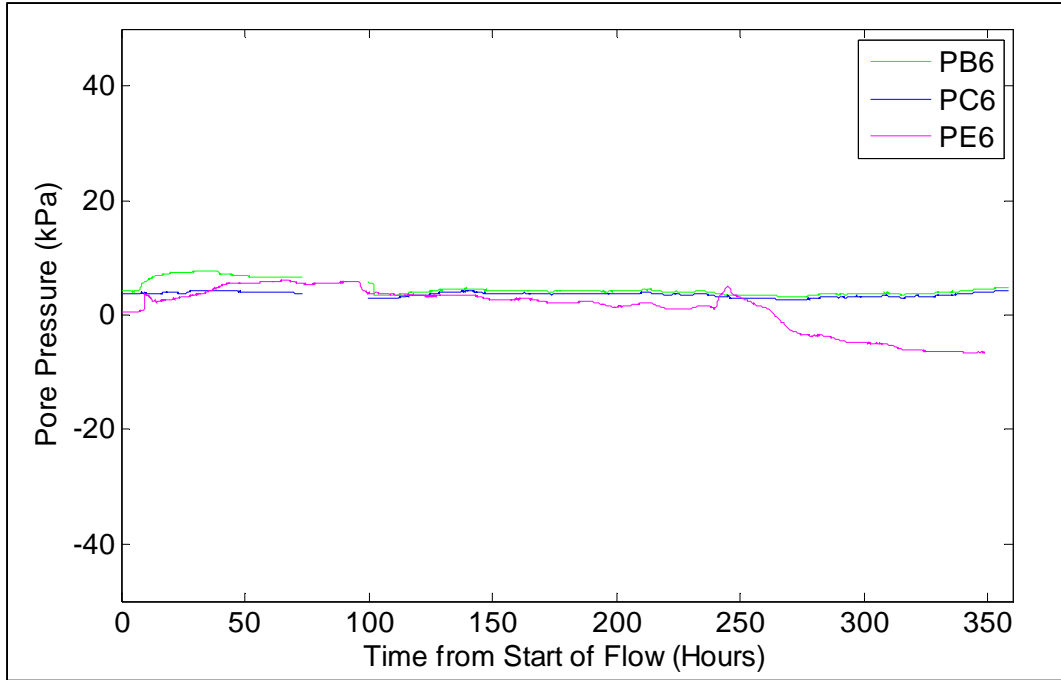
Figure 3-167. Piezometer data for the 10-day flow test and post flow at instrument row 3 (middle of waterside slope) at depths of 3.4 feet below grade.
