Static and Seismic Performance of California Levees

Michelle Jennifer Shriro

Doctor of Philosophy

Engineering - Civil and Environmental Engineering

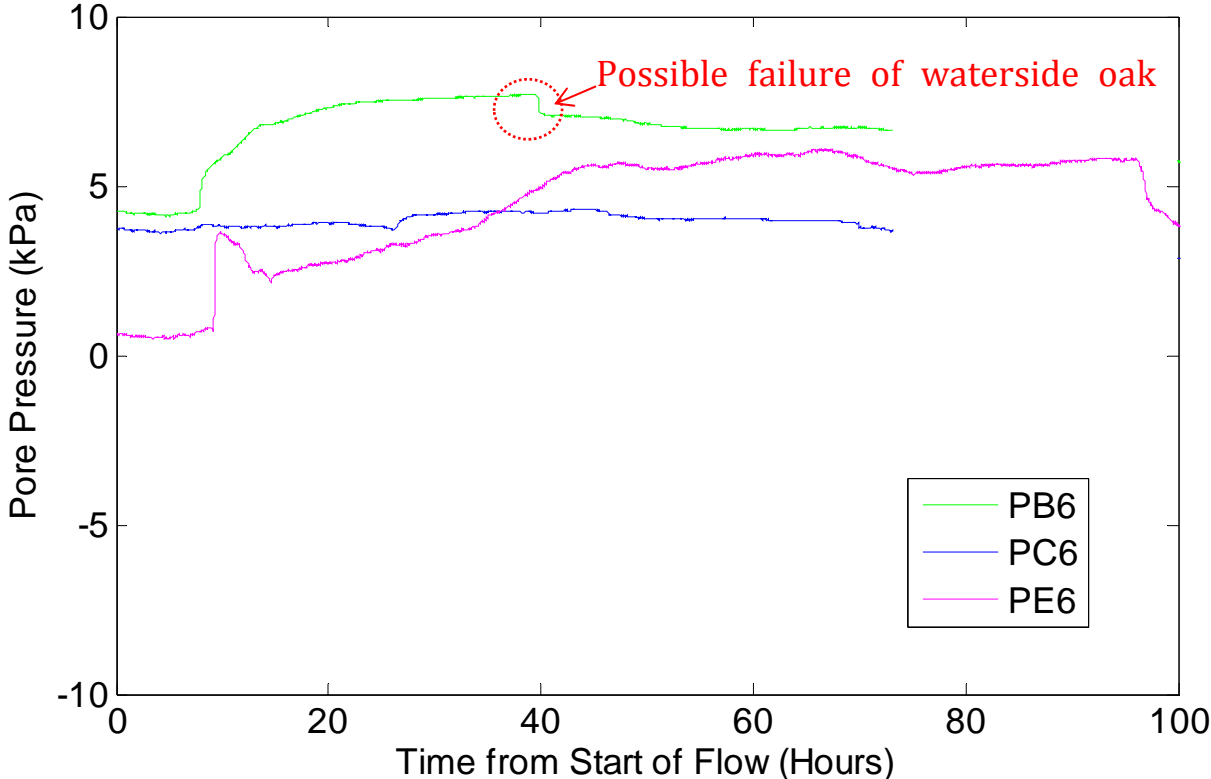
Figure 3-168. Piezometer PB6, at the waterside oak, shows a notable dip in pore pressure. The time of the dip is 39.7 hours, or 5/23/12 at 5:25 am and could be the time of tree failure.

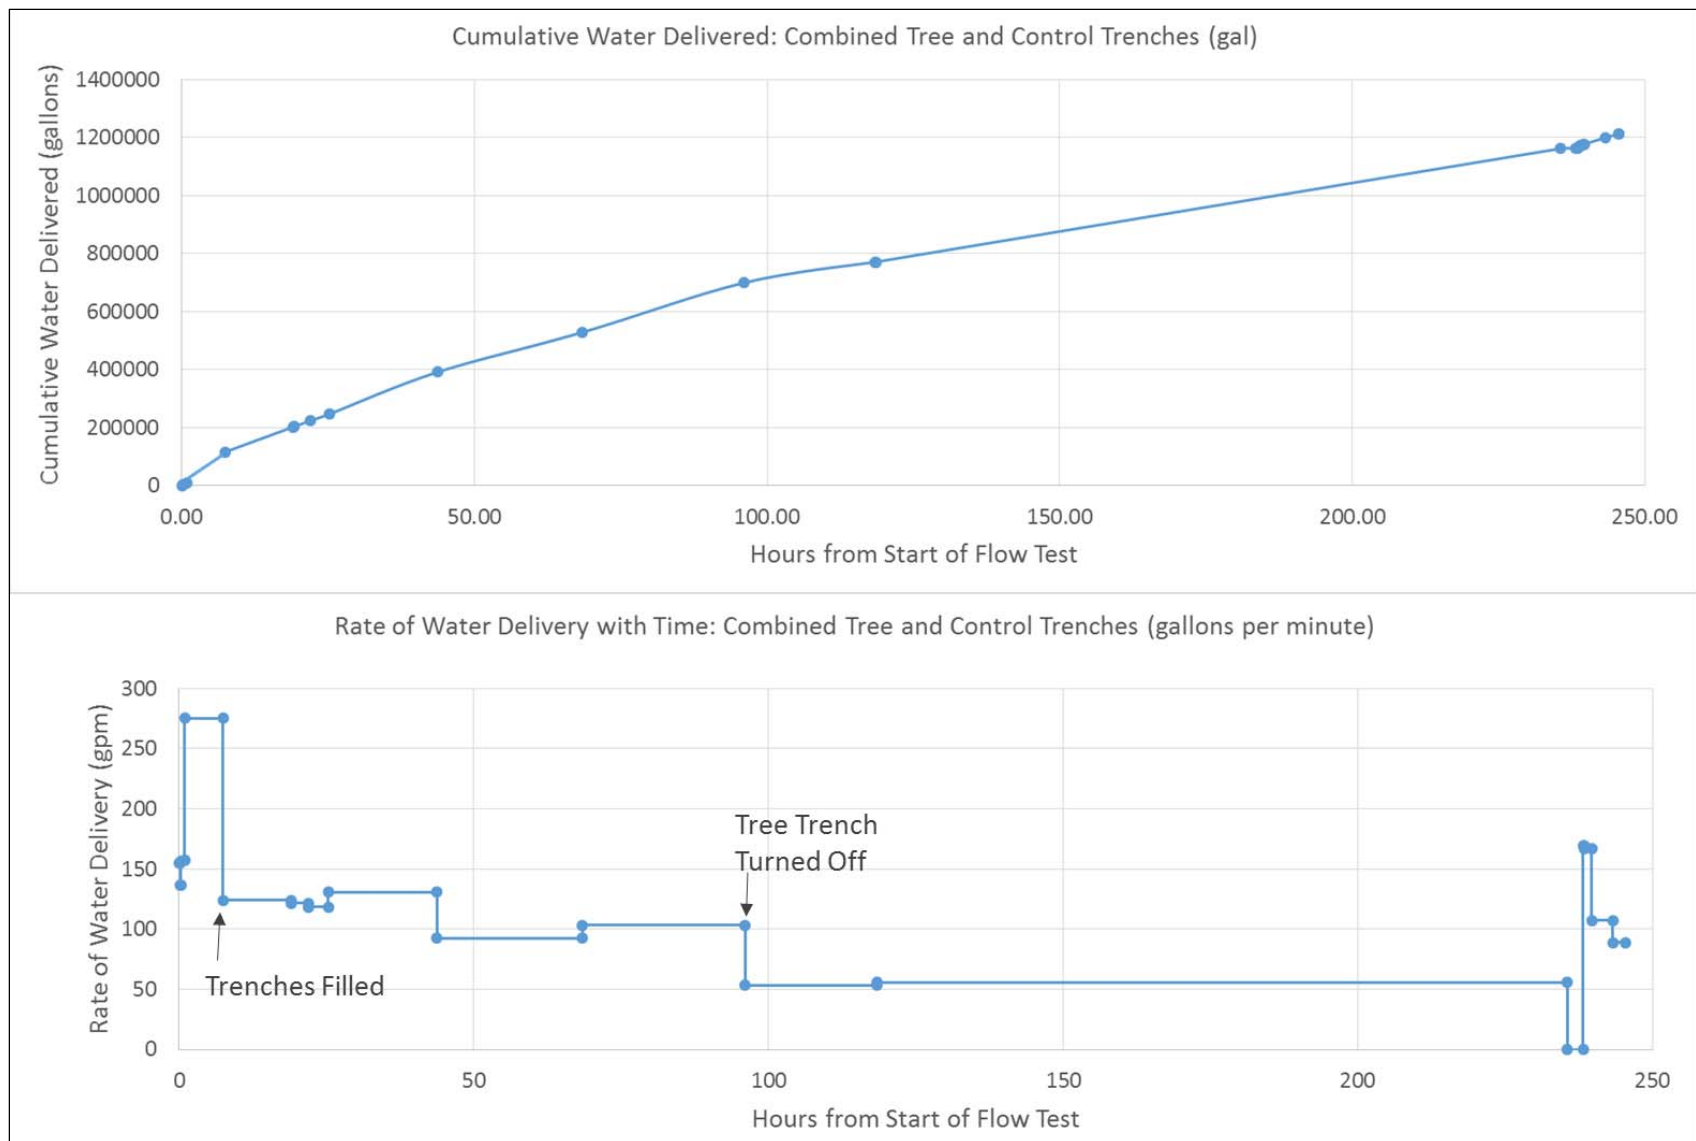
Figure 3-169. Water flow cumulative volumes over time (top) and corresponding flow rates (below).

During the 10-day flow test, a total of 1,212,500 gallons of water was pumped into the reservoir and released by gravity into the control and tree trenches (Figure 3-169). As previously described, flow monitoring devices were installed on the inlet pipeline into the reservoir as well as both outlet lines into the control and tree trenches.

Reviewing Figure 3-169 and Table 3-9, flow rates are seen to decrease at about 40 hours into the flow test. This corresponds to the failure of the waterside oak tree. Observations of reduced seepage to this area following the tree failure could mean that the tree falling introduced discontinuities in the previously active flow pathways leading to a reduction in overall flow through the network of macropores at the site. The flow rate into the trenches was higher at the beginning of the dye test after water to the tree trench had been cut off for several days and then restarted. Once the test had run for several hours, the flow rate decreased to a similar rate observed at steady state during the primary flow phase, a little over 100 gallons per minute.

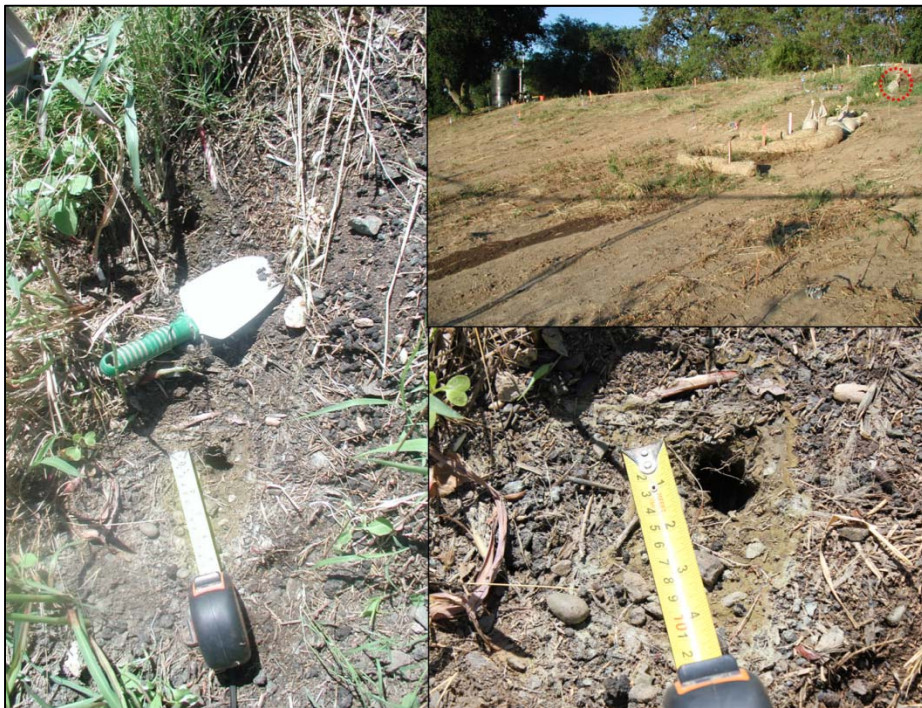
Figure 3-170. Two burrows (left) encountered at Station CT 9 near the top of slope (upper right). The burrows were about 1.5 inches in diameter.

On the landside slope of the control trench, between Stations CT 6 and 10, mid-slope and top of slope gravel bags were placed to prevent erosion of the slope under concentrated flows. Near the top of slope, at Stations CT 7 to 10, two seeps were encountered at 3 am on 5/22, a little over 13 hours into the flow test. A photograph of the findings at that location is provided as Figure 3-170. Two burrows were encountered (1 ½ inch diameter each) consistent in size with gopher or vole. Similarly, Figure 3-171 shows the mid-slope burrow beneath the pile of gravel bags at Station CT 7. Upon lifting the gravel bags, worms and traces of worms were found through the soils under the bag. *Armadillidiidae*, also known as pill bugs, were abundant and disappeared into the burrows and worm traces when the gravel bags were lifted.

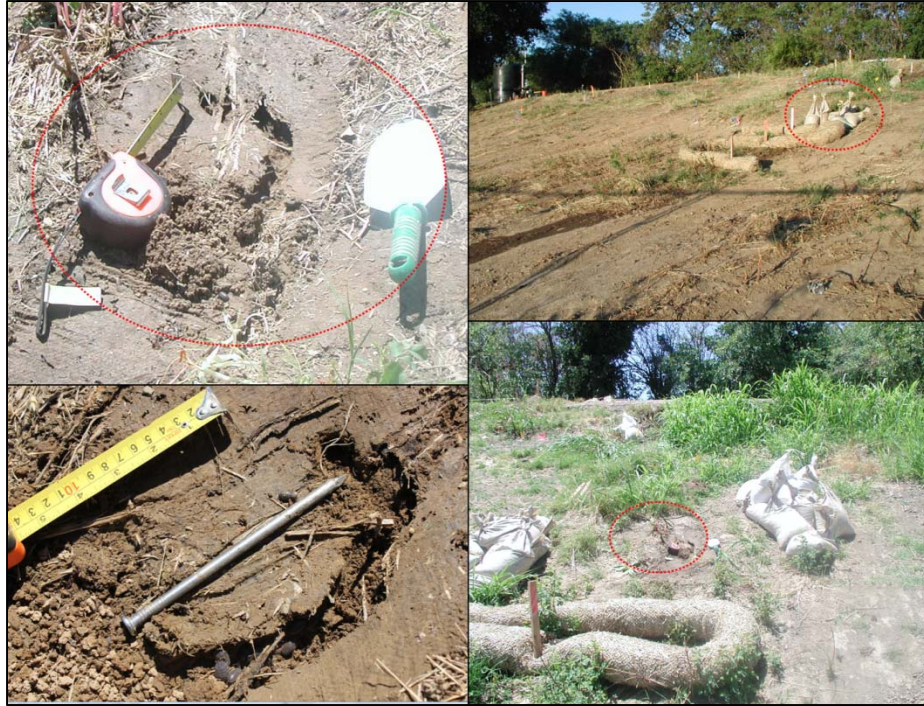
Figure 3-171. The gravel bags were parted (lower right) and a single burrow was revealed at Station CT 7. The burrow was about 1 ½ inch in diameter and the top of the burrow extended into the slope.

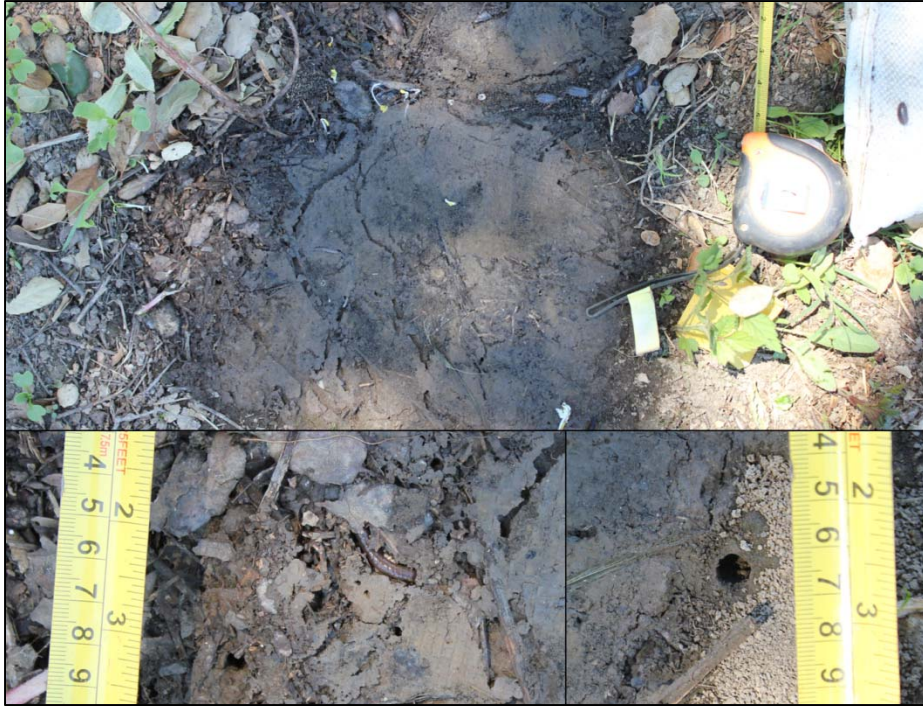
Figure 3-172. Station TT 57 to 59 seepage location upon lifting gravel bags. Worm traces were abundant and  $\frac{1}{4}$  inch diameter holes entering into the slope were occasional.

The seep areas at instrument lines A and D were inspected and no traces of mammal burrows could be found in this area. Similar to the burrow at instrument line C, however, earthworms and pill bugs were observed to be in abundance as shown on Figure 3-172 through Figure 3-174. Occasional holes on the order of ¼ inch diameter and traces of earthworms, some still occupied by a worm, were seen under each gravel bag. These were noted, as no other mammal burrow could be located. Further, water had been recorded about 19 hours into the flow test flowing from small holes (¼ to ½ inch diameter) at the location of these seeps near Station 56 at instrument line D. The small holes were found beneath gravel bags at all locations where gravel bags had been placed, but it is unclear whether the holes had been present during the flow test or were created post-flow.

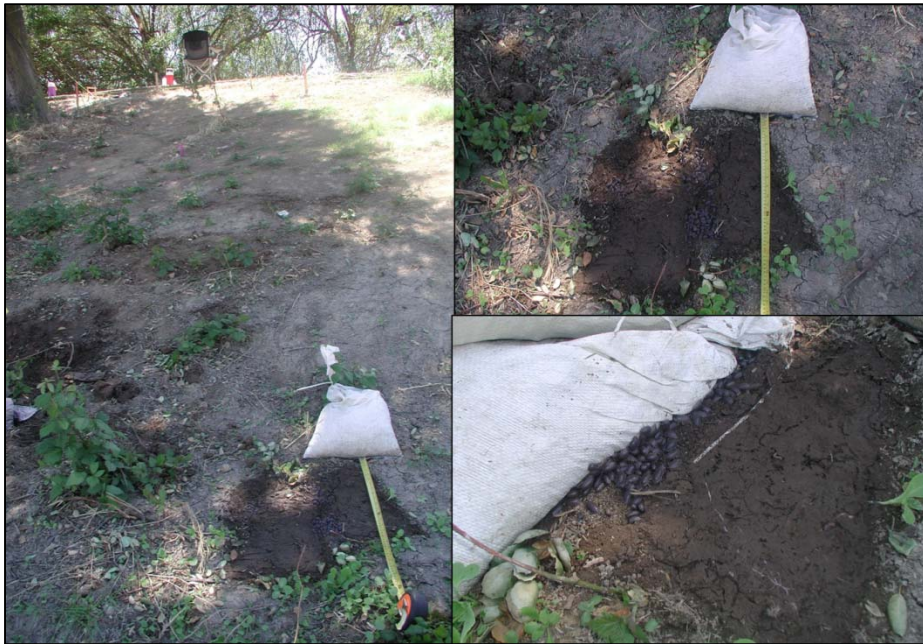
Figure 3-173. View beneath gravel bags at Station TT 50, 8 days post-flow. Note earthworm traces and pill bugs in abundance.

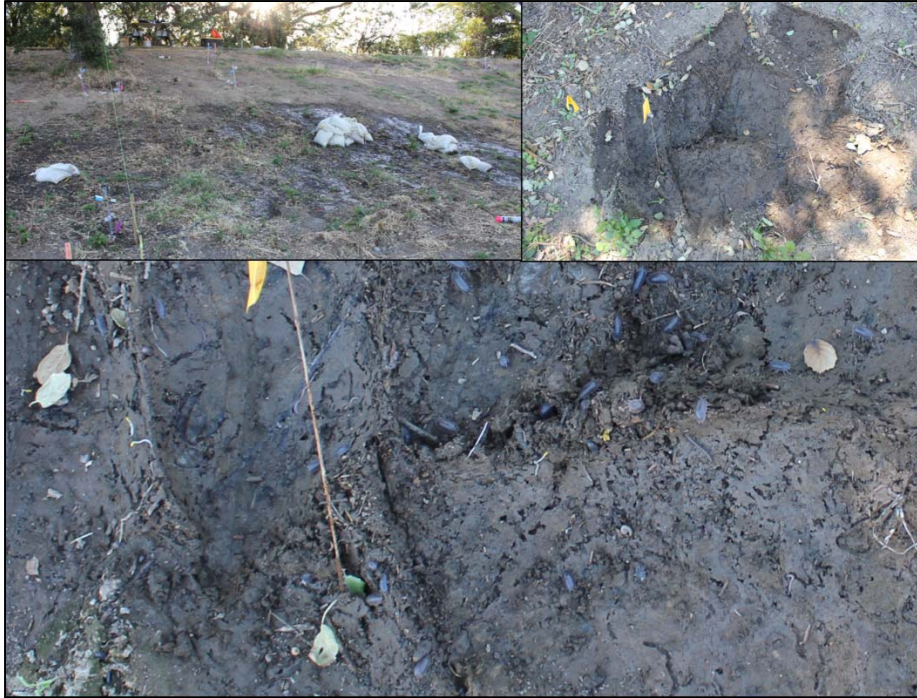
Figure 3-174. Gravel bag Station 73 below landside oak tree. Pill bugs seemed to disappear into a cavity that, upon excavation, did not seem to extend anywhere or resemble a burrow. Worm traces were found to be abundant as in other locations.

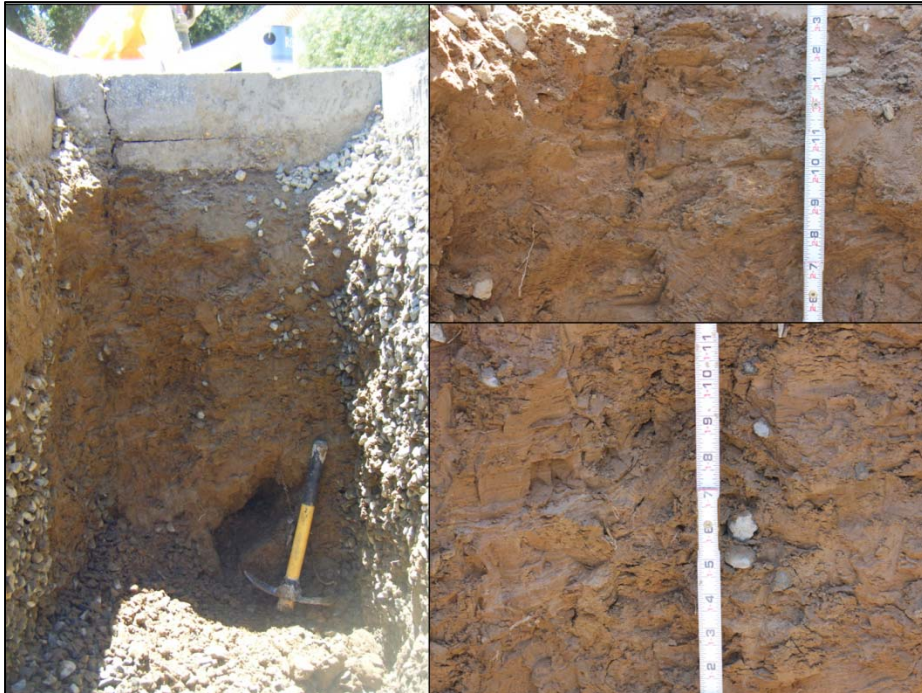
Figure 3-175. View looking south at the upper 4 feet of control trench end wall at Station CT 31.5 (left) with close-in views of cracking near the top of the trench (upper right) and just above and to the left of the burrow.

The crack between the trenches was explored. White paint was funneled into the crack prior to excavation of the gravel in an effort to reveal the pattern and depth of cracking. The crack had partially closed by the time of repair as discussed previously and shown on Figure 3-115. The crack did not follow a clean path as the soils are heterogeneous and may pull apart along several planes rather than forming a single clean crack. Figure 3-175 and Figure 3-176 show the trench wall at Station CT 31.5 looking south, while Figure 3-177 shows the trench wall at Station TT 0 looking north. A burrow was encountered connecting the trench walls positioned a distance of 43 inches from the top of the asphalt at Station CT 31.5 and a distance of 24 inches from the top of pavement at Station TT 0 (size = 2.5 inches high, 3.5 inches wide). A crack was seen on the control trench end wall extending down to a depth of 82 inches from the surface, beginning at the crack between the trenches (Figure 3-175 and Figure 3-176). In some places the crack becomes very visible and in

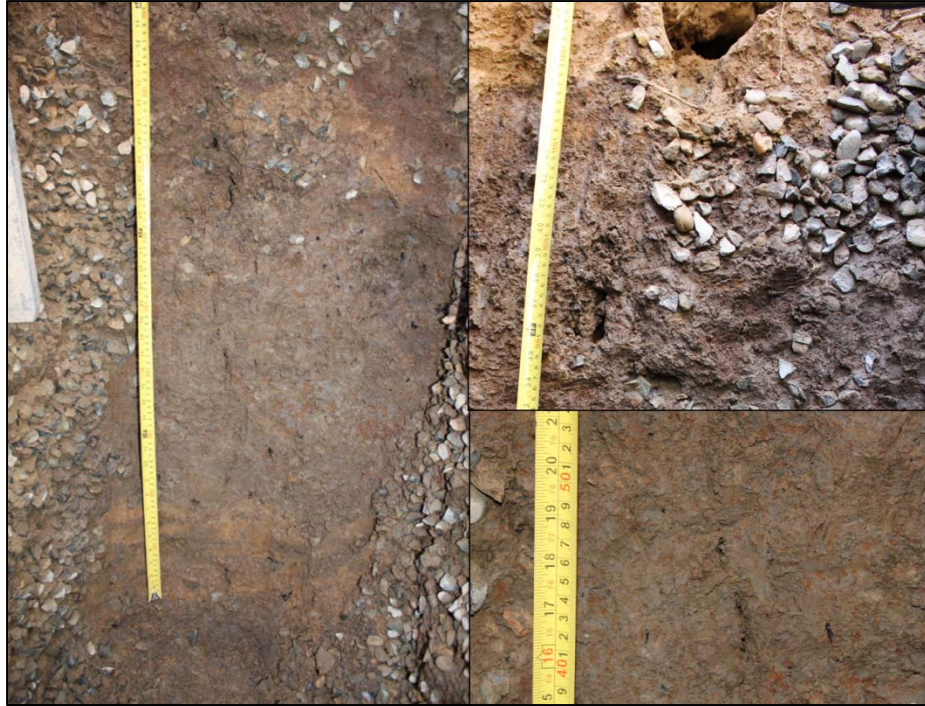
Figure 3-176. View looking south of 8 foot deep trench at end wall of control trench at Station CT 31.5 showing cracking to a depth of 82 inches.

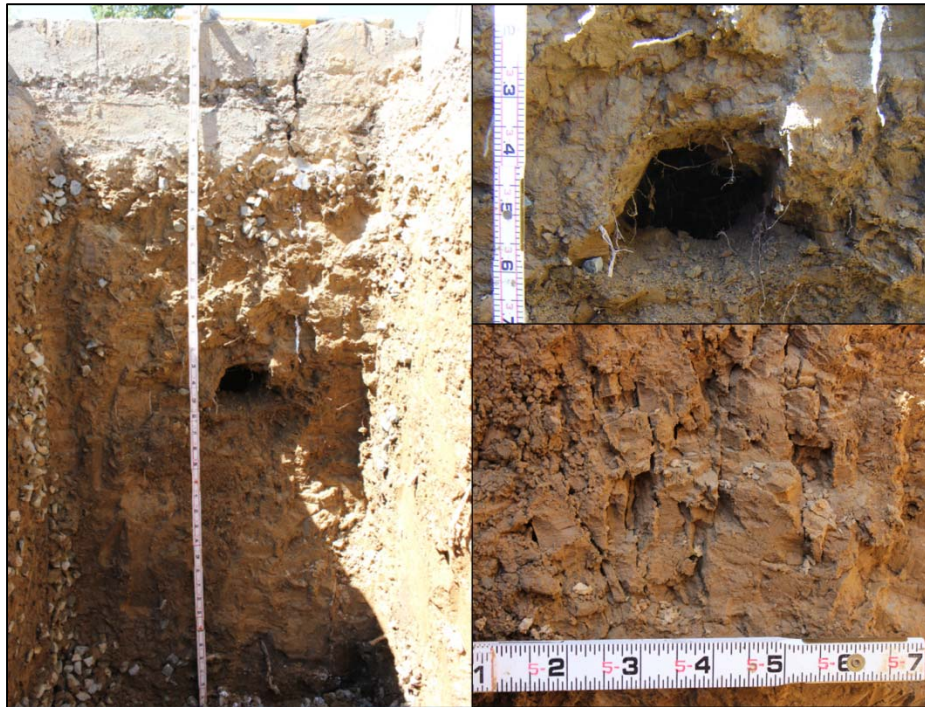
Figure 3-177. View north of tree trench end wall at Station TT 0 showing a burrow (2 feet deep) and a series of vertical tension cracks along bedding planes of Material 2 (thinly bedded silt).

other places concealed within looser deposits. On the tree trench endwall at Station TT 0, the visible crack extends down to the burrow location and then transitions into as deposit of Material 2, the thinly bedded silt material, which cleaves readily along predefined planes. Figure 3-177 shows cracking at the end wall of Station TT 0 with the lower right photo showing Material 2 with vertical bedding, exhibiting small separations along beds of fine sand between silt layers. Evidence of soil deformation could not be found at depths below 43 inches as the stratigraphy transitioned into Material 4, a plastic silt material discussed previously.

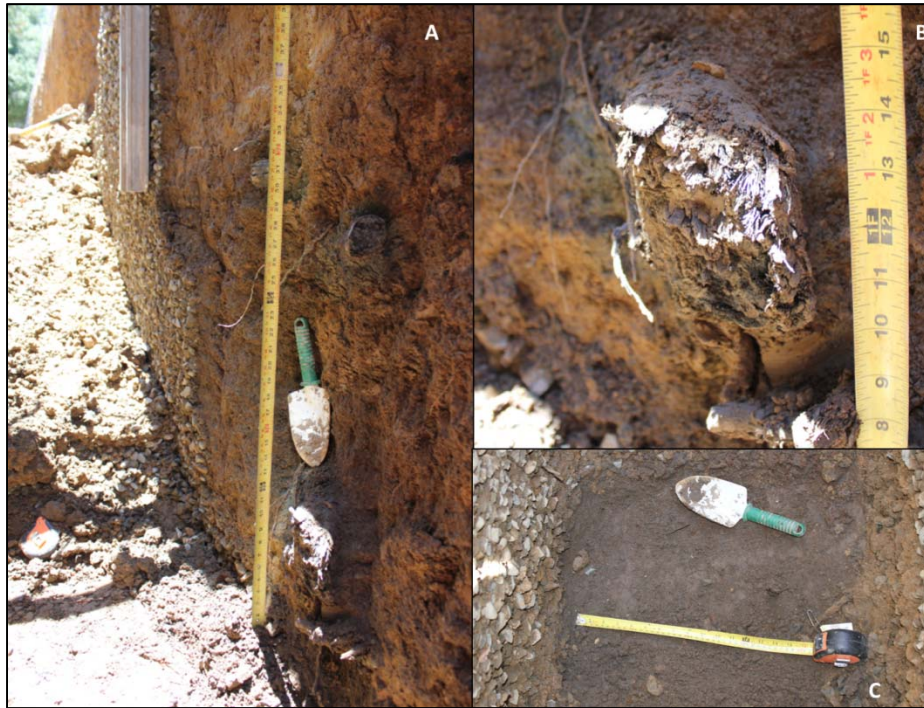
Figure 3-178. Roots at Sta 17; and bottom inspection for cracks at base of trench.

The area at Station TT 17 to 18, particularly the waterside wall, was inspected for the condition of roots and the condition of the trench bottom. The trench bottom was inspected looking for cracks extending below the trench (Figure 3-178). No cracking was found along the walls or base in this area. Large roots had been encountered and cut prior to the flow test. These roots were viewed and nothing abnormal was discovered. The roots did appear to have begun to decay between the time of excavation and the post-flow repair (about 2 months), but did not show clear signs of pullout or deformation due to falling of the waterside tree (Figure 3-178).

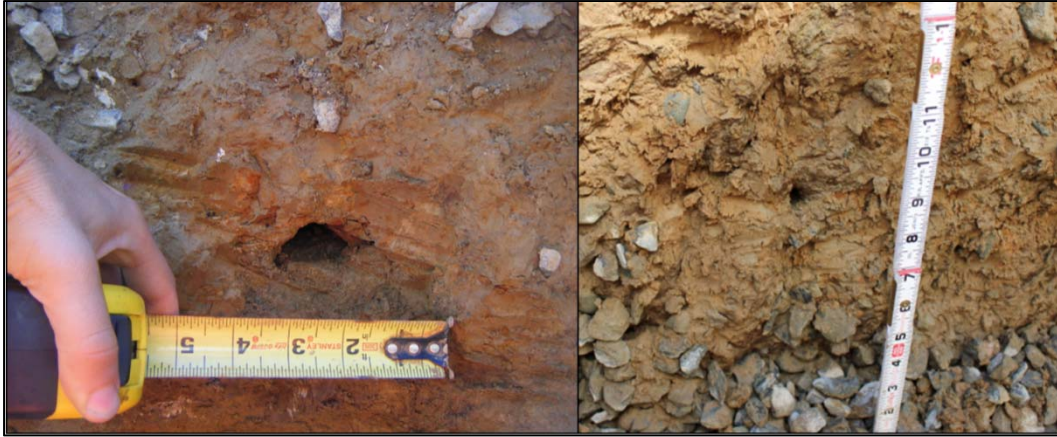
Figure 3-179. New burrow landside Station CT 10 at 18 inches deep (left) and new small burrow at landside CT 3 (right).

Burrowing activity is believed to have played a key role in influencing the flow patterns during the flow test. Inspections determined whether additional burrows had opened or whether plugs that had been placed during construction had held up over the 10 day flow test. Figure 3-179 shows the locations of two new burrows within the control trench that were not found or plugged during trenching operations. Both burrows were on the land side at Station CT 10 (depth 18 inches, diameter 1 ½ inch) and at Station CT 3 (depth 3 feet, diameter ¾ inch). Figure 3-180 shows a zone of burrow patches located within Stations 70 to 73. For reference, the landside tree is centered at Station 70 with the canopy spanning from approximate Stations TT 50 to TT 90. Three burrows can be seen in the photo and all are intact following the flow test. All burrow patches are found intact except one waterside burrow at Station 11 within the control trench. At this burrow, the burrow patch was missing and the hole had grown in size since initial discovery during the trenching phase (Figure 3-181).

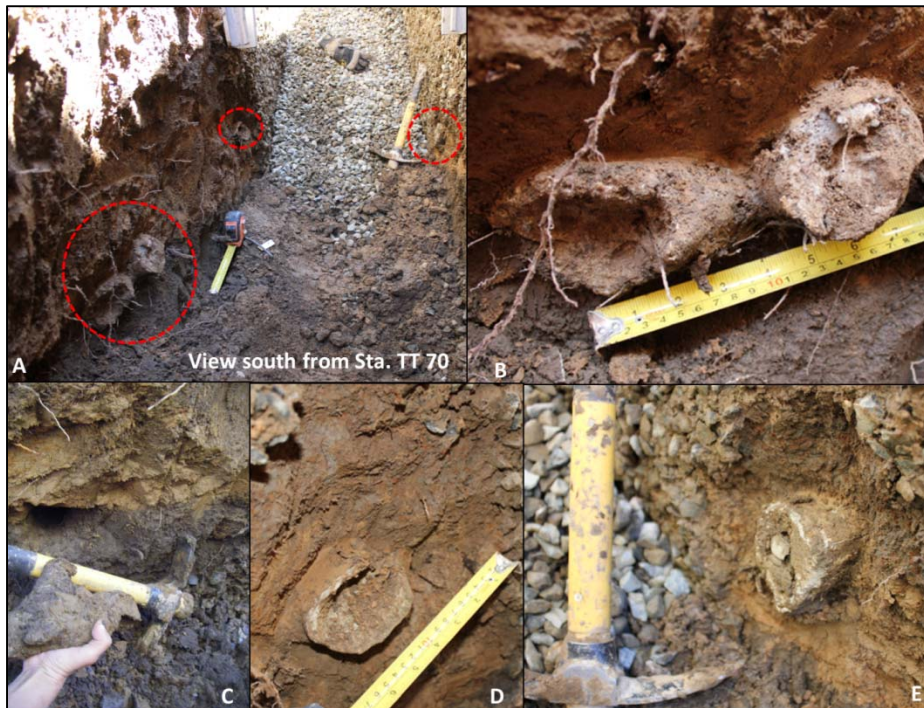
Figure 3-180. Patched burrows Station TT 70 to 73. A) overview of patched burrows, B) and C) Initially intact burrow patch is removed and viewed; D) intact landside burrow patch; E) intact waterside burrow patch.

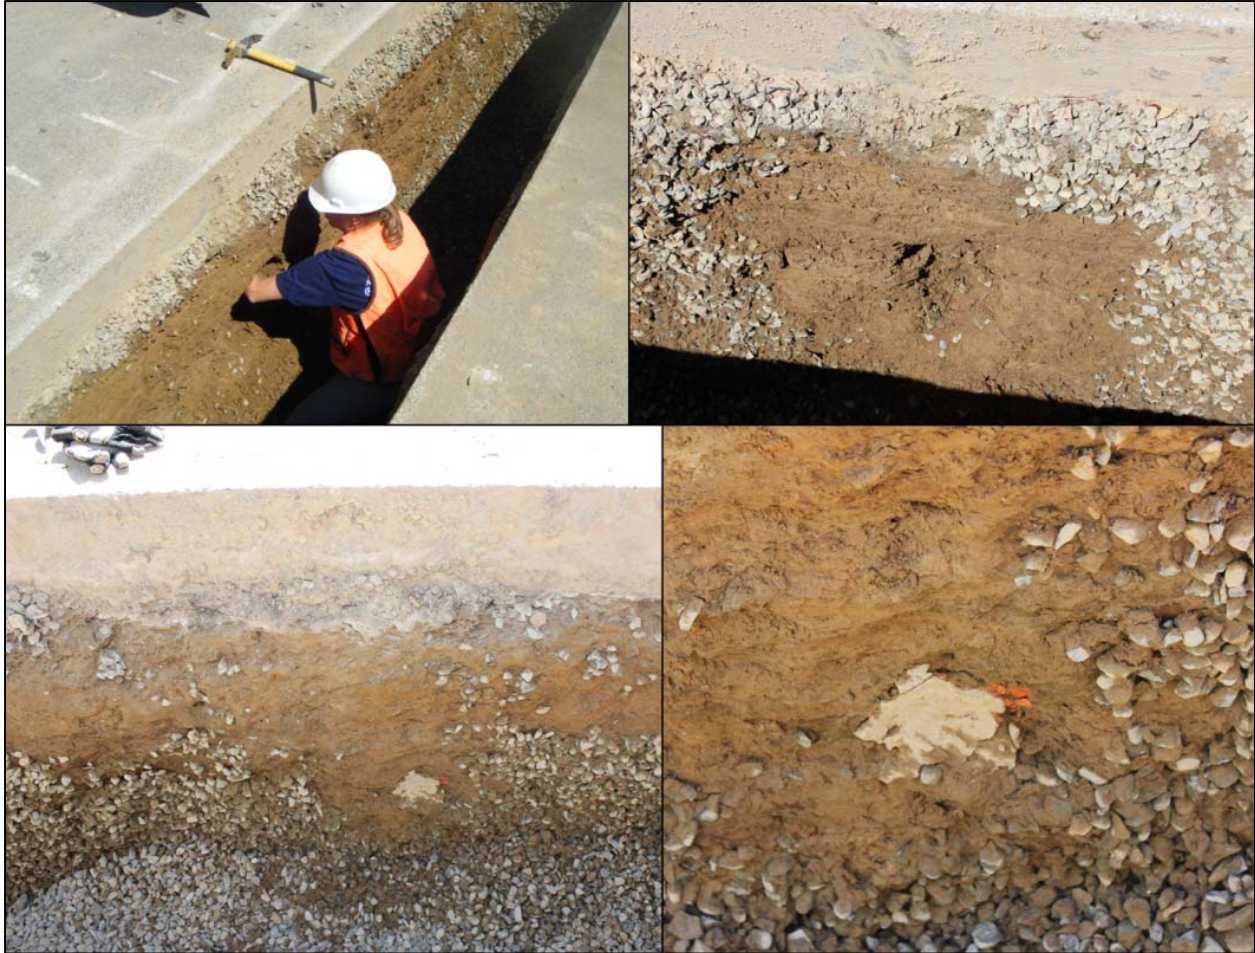
Figure 3-181. Open burrow at waterside Station CT 11 (top images) and intact patch on burrow at landside Station CT 12 (bottom images).

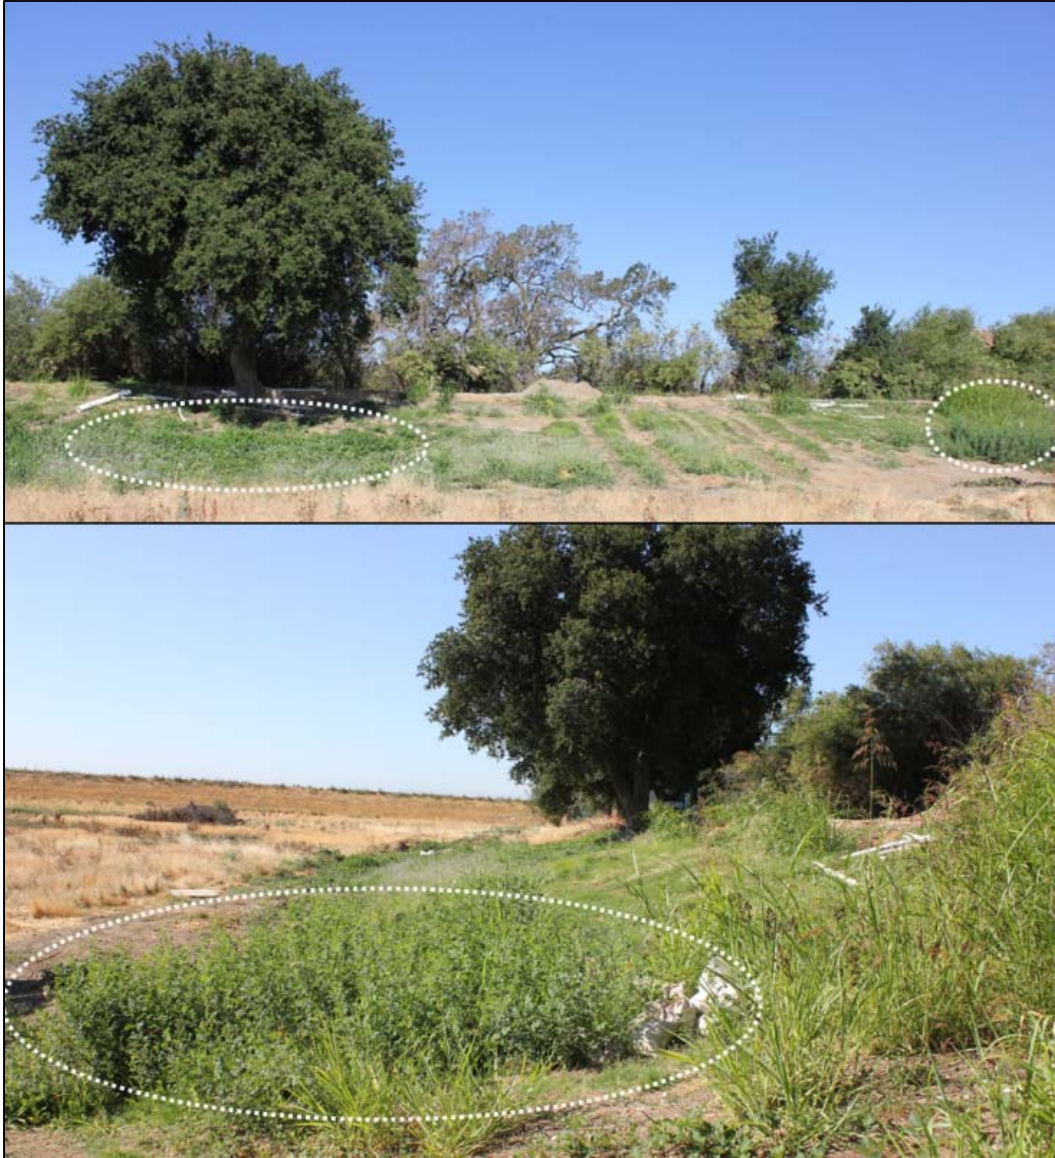
Figure 3-182. Vegetation patterns post-flow show blackberry growing back aggressively and coinciding with areas of observed burrowing activity.

Once the site repair had been completed, temporary fencing was removed and photographs were taken showing the site after vegetation returned several weeks following the flow test (Figure 3-182). Patterns of aggressive blackberry growth within the zones of highest burrowing activity are apparent in the photographs.

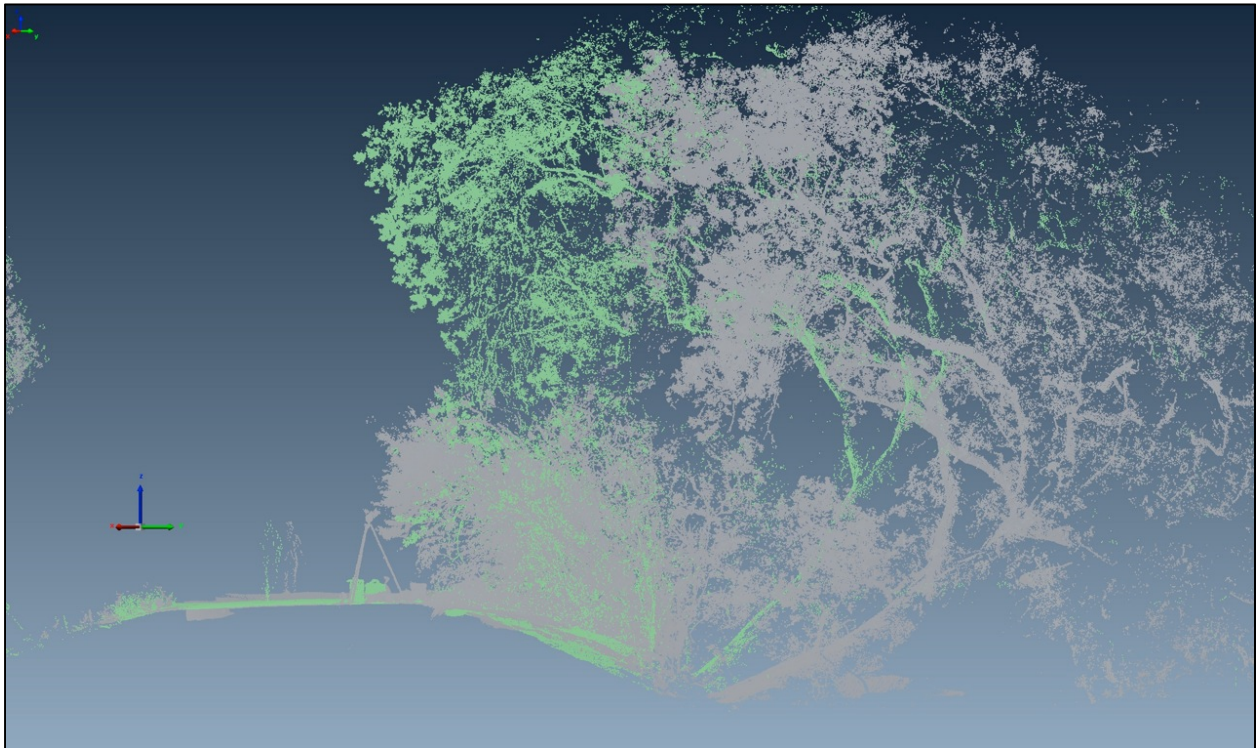
Figure 3-183. T-LiDAR images shot and analyzed by Gerald Bawden and his team from the USGS. The image shows the rotation of the waterside oak tree between April 2012, prior to construction of the trenches, and May 29, 2012, after the failure of the tree on May 23.

Baseline scans with tripod-based light detection and ranging (T-LiDAR) equipment were performed prior to trench construction. This work was performed by Dr. Gerald Bawden and his team with the USGS. The USGS team subsequently scanned the site following the primary flow phase of the test and the dye test for the purpose of improving upon standard field data gathering methods to monitor deformations associated with the flow testing at the site. The USGS team has compiled their findings and published a report summarizing their work under separate cover (Bawden et al., 2013-DRAFT). Figure 3-183 shows a T-LiDAR image from the pre-scan condition shot on April 9, 2012 before trenching began overlain with an image shot on May 29<sup>th</sup>, 2012 following the primary flow test and failure of the waterside oak tree. The image shows the rotation of the waterside oak tree.

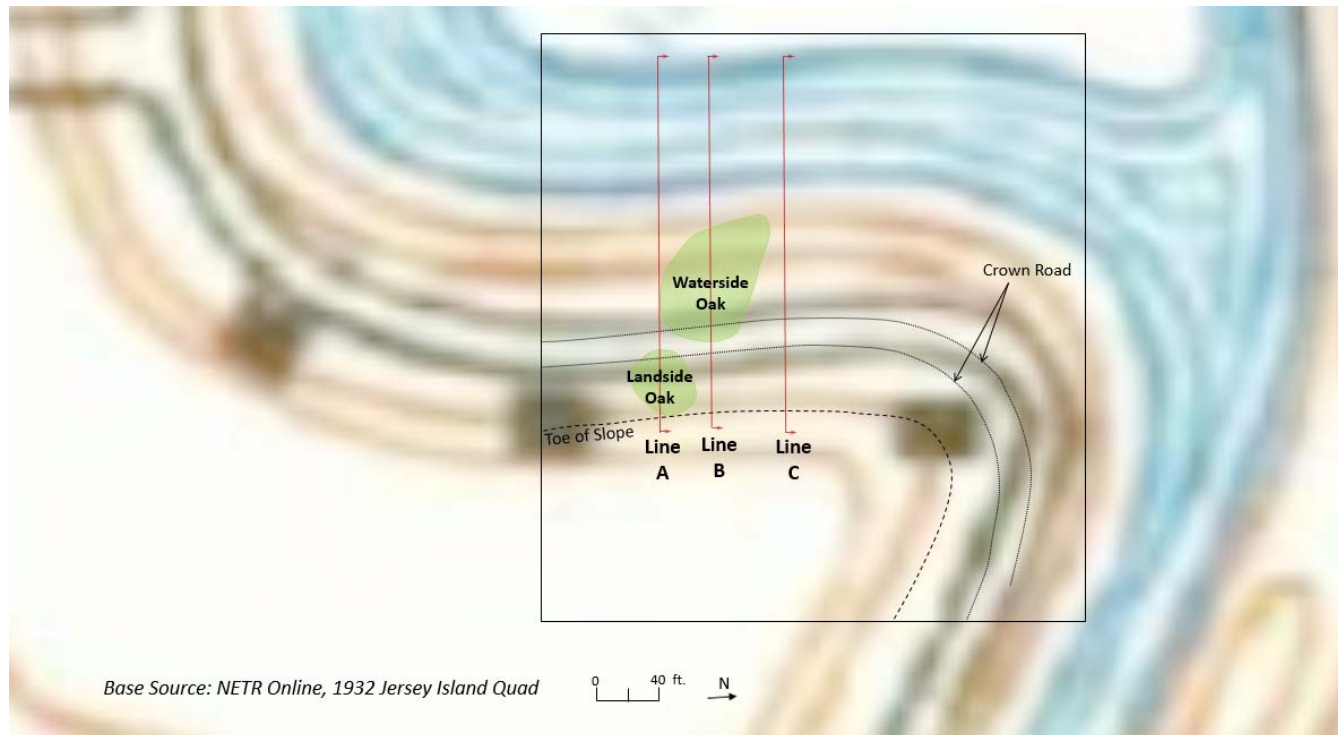
Figure 3-187. Section locations and oak trees under study overlain onto 1932 Jersey Island Quadrangle to estimate waterside channel geometry for interpreted sections.

Figure 3-187 shows the study area overlain on 1932 topography in order to create interpreted stratigraphic sections of the levee for the purposes of seepage and slope stability modeling. Sections are shown extending across the former flow channel. Depth to sediment within the main channel of the slough was measured at 25 feet below the water line at the time of study, while shallow, loose sediments were found at depths of 2 to 3 feet from the water line within the oxbow section of the slough. Exploration to define site stratigraphy and geotechnical conditions did not extend into the slough. Interpreted stratigraphic sections are shown on Figure 3-188 through Figure 3-190. Where geologic contacts are bounded by exploratory points, solid contacts are shown, while queried contacts are shown in areas where contacts were approximated. It is unknown whether the current depth of the slough represents the original depth of the oxbow section, but it was considered to be an upper bound on the depth for the purpose of our analysis. The natural levee and sand deposits were extended in the stratigraphic sections based on available data. The natural levee clays and clayey silts may disappear beneath the channel, but a low permeability layer exists, separating the flow of water in the slough from the groundwater at depth, and so the layer is shown beneath the sediment.

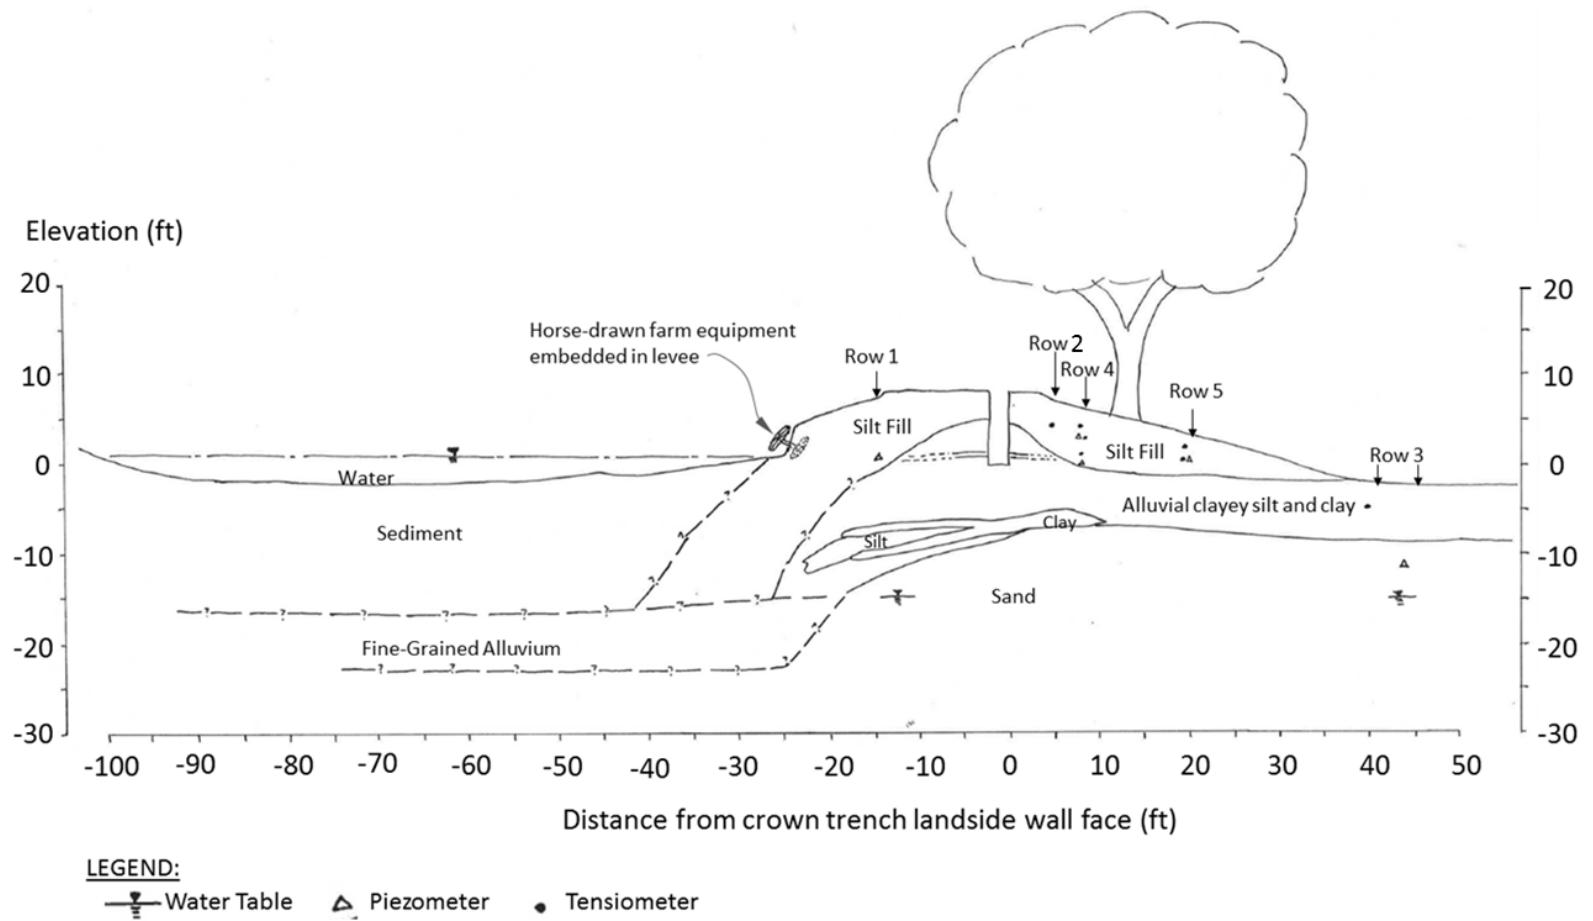
Figure 3-188. Interpreted stratigraphic section at instrument line A, through the landside oak tree. Instrument rows 1 through 5 are shown.

The water delivery trench was located within the crown of an early, and possibly natural, levee of lower permeability than soils used in raising the levee (Figure 3-29 through Figure 3-31 and Figure 3-188 through Figure 3-190). A discontinuity in the natural overbank

Pore water pressures in row 6 instruments (at the toe of the waterside oak tree as shown on Figure 3-188 through Figure 3-190) were evaluated to determine whether elevated values could be found upslope of the waterside oak tree, and no discernible pattern was found. Seepage was observed at the waterside oak tree at about 9 hours into the flow test. Water appeared to be seeping out of burrow entrances all along the waterside toe, and the area adjacent to and upslope of the tree trunk. When the tree fell, the pore water pressure dropped by about 0.25 feet of head at PB6 (Row 6 of Figure 3-189). Seepage stopped from the areas around the oak tree and pore pressures never returned to the level previously achieved prior to the fall of the tree. The fall of the tree seemed to render previously preferred macropore pathways inactive, possibly by introducing discontinuities. During they dye test on the tenth day of flow, seepage was seen flowing only from burrow sites outside of the area of the waterside oak tree (Figure 3-145; discussed in detail in Section 3.1.4.3). The complexity of preferred pathways created by muskrat burrow networks along the waterside slope seem to have a larger effect on pore water pressure accumulation than the presence of the root ball of the waterside oak tree.

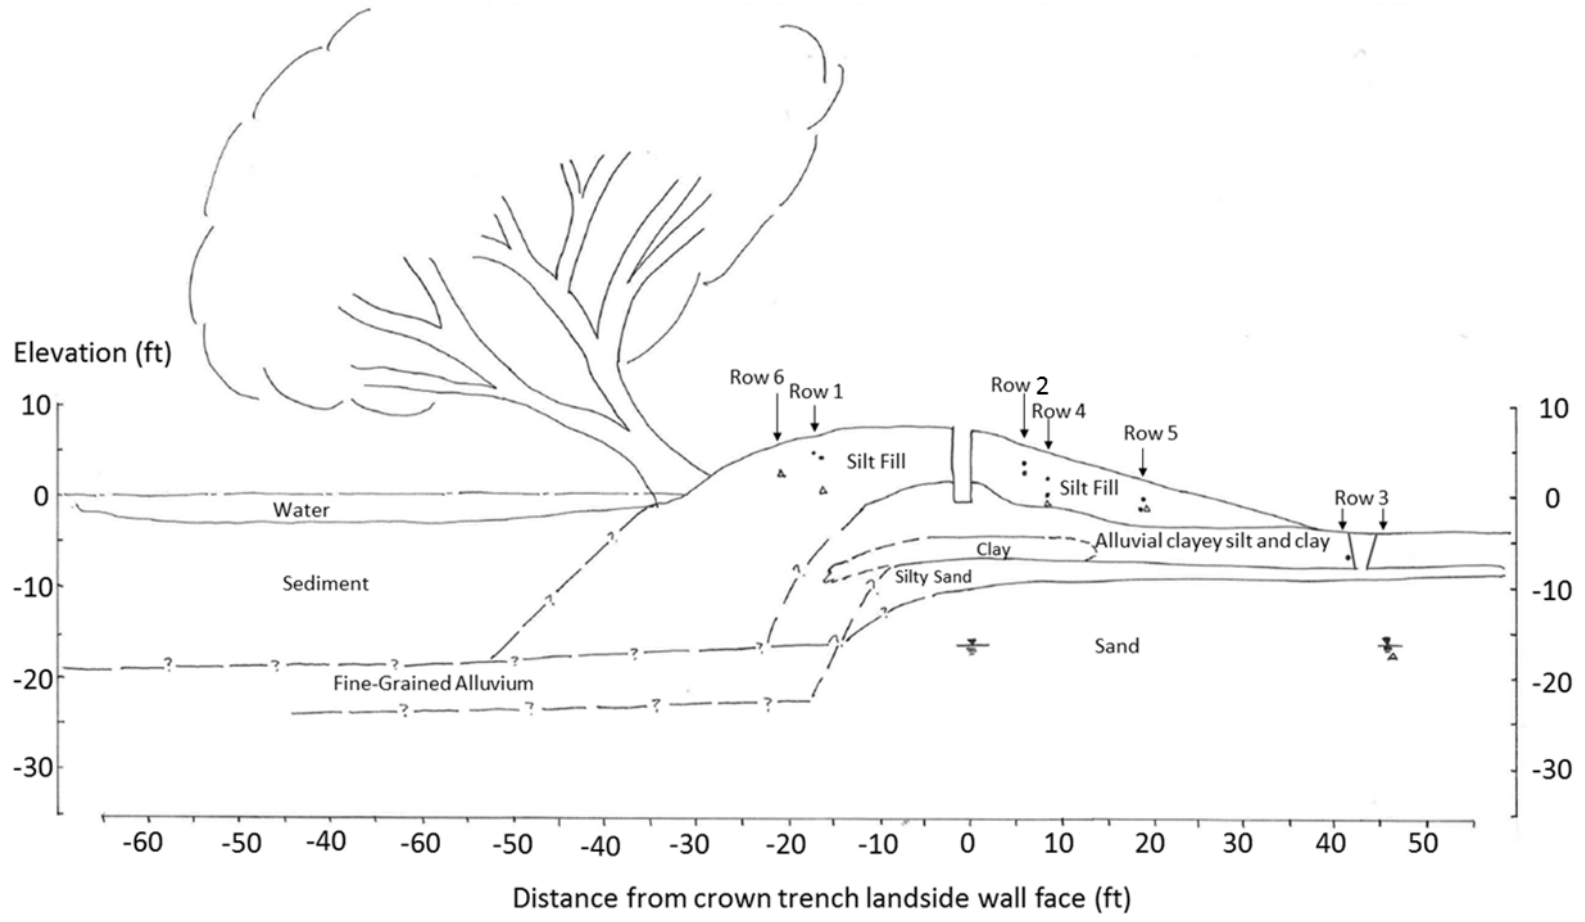
Figure 3-189. Interpreted stratigraphic section at instrument line B, through the waterside oak tree. Instrument rows 1 through 6 are shown.

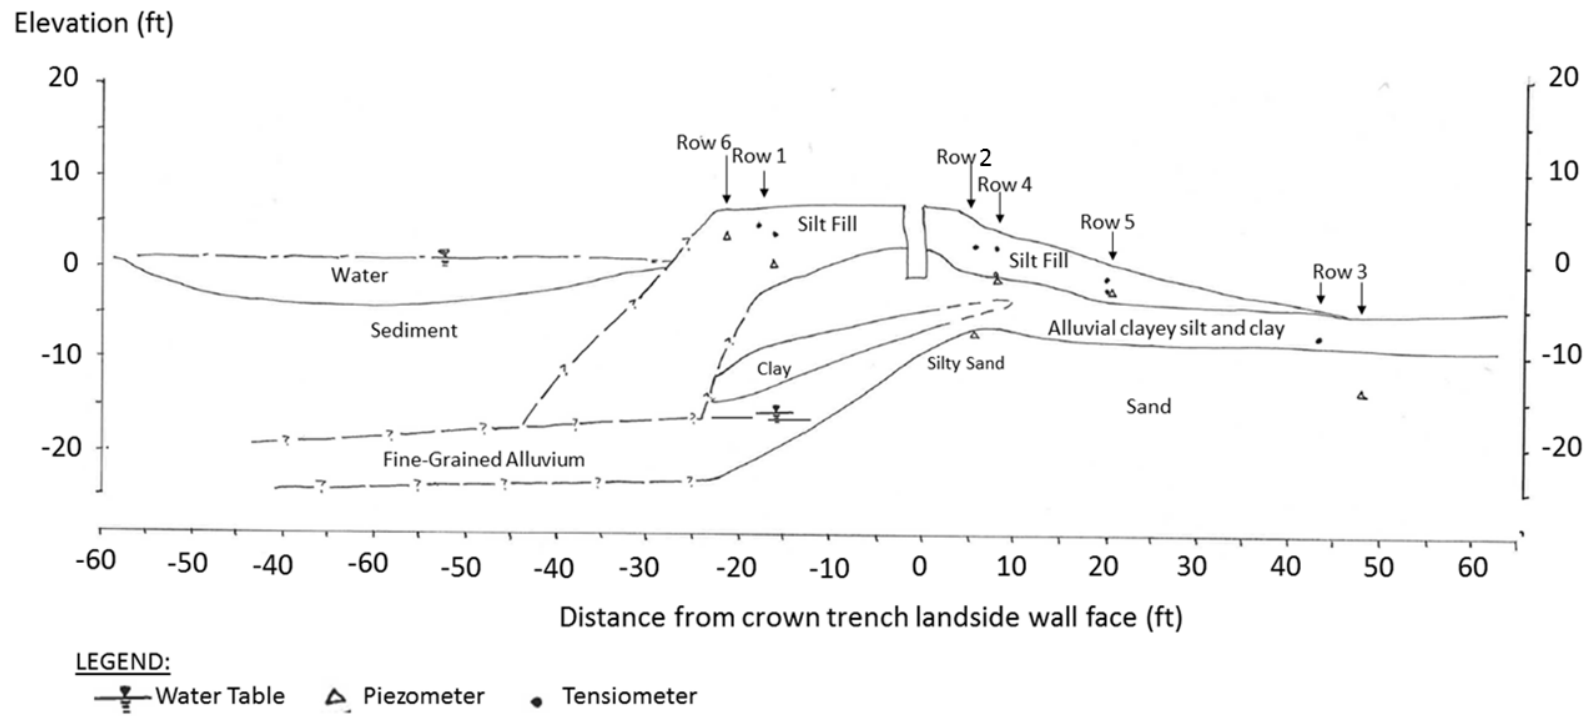
Figure 3-190. Interpreted stratigraphic section at instrument line C, within the control trench. Instrument rows 1 through 6 are shown.
