Static and Seismic Performance of California Levees

Michelle Jennifer Shriro

Doctor of Philosophy

Engineering - Civil and Environmental Engineering

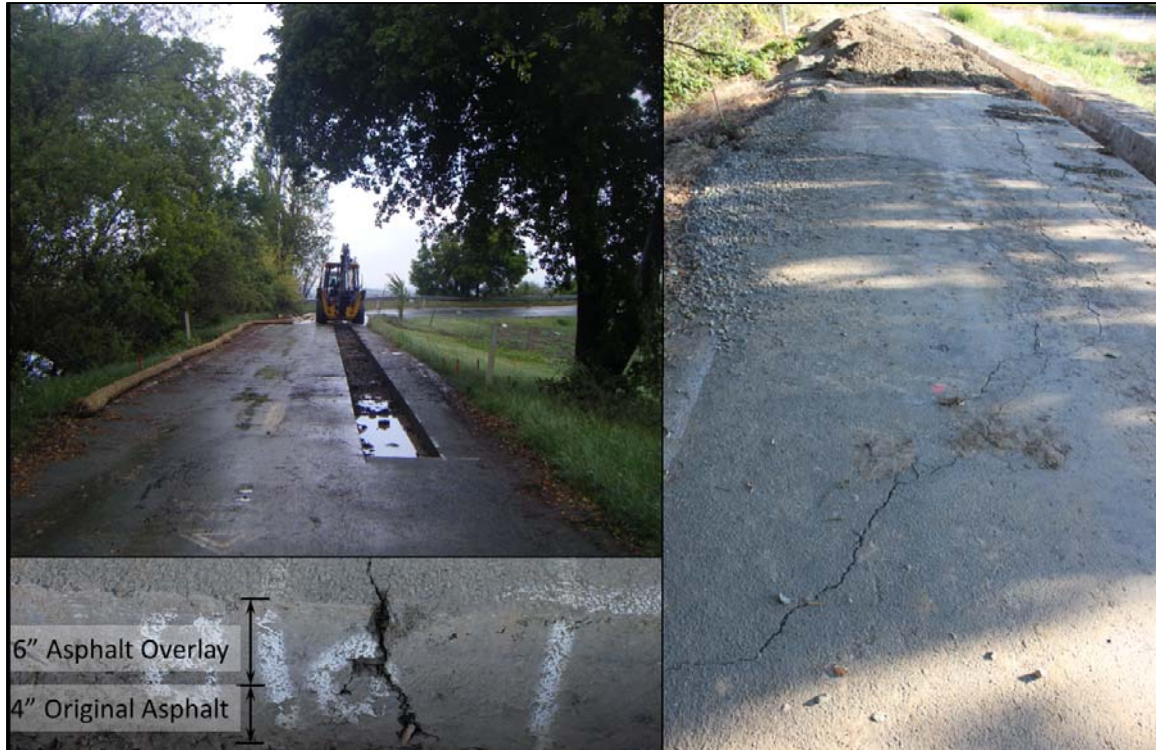
Figure 3-191. Pattern of pavement cracking (right) is similar to pattern of ponding in the pavement just following a rain event and prior to trench construction. Asphalt sections show evidence of a thick overlay, an indication of previous pavement distress.

The instability of loose soils along the waterside slope as well as potential sliding along the weak clay seam will be considered to explain the cracking observed at the southern end of the tree trench. A photograph taken just following a rain at the beginning of trench construction is shown on Figure 3-191. The photograph shows zones of water ponding in linear patterns west of the centerline of the levee crown road and tapering toward the waterside pavement edge near the southern end of the tree trench. Cracking patterns observed in the field follow a similar pattern. Subsidence may have occurred at pre-existing crack locations from past movements along the waterside slope. An old crack was found at the top of the waterside slope at Stations TT 28 to 55.

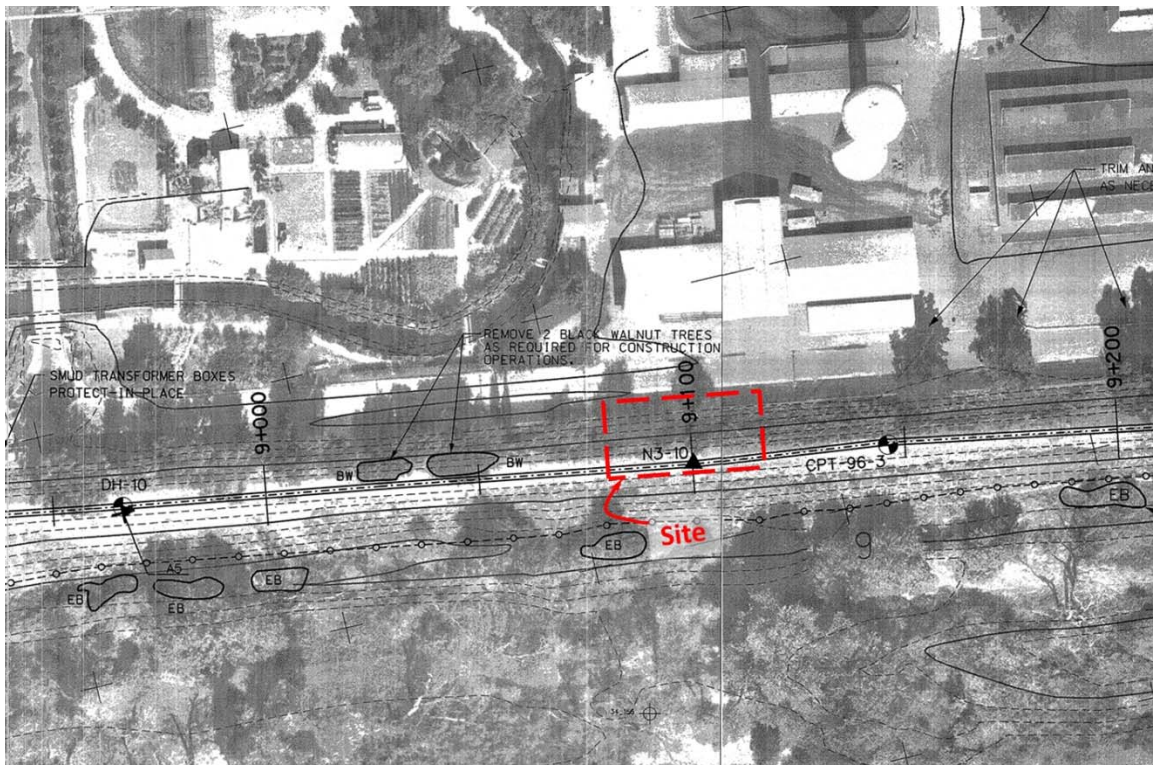
Figure 4-1. Excerpt from the American River Watershed Project. Our study site is at Station 9+100 on the plan. Source: USACE, 1999.

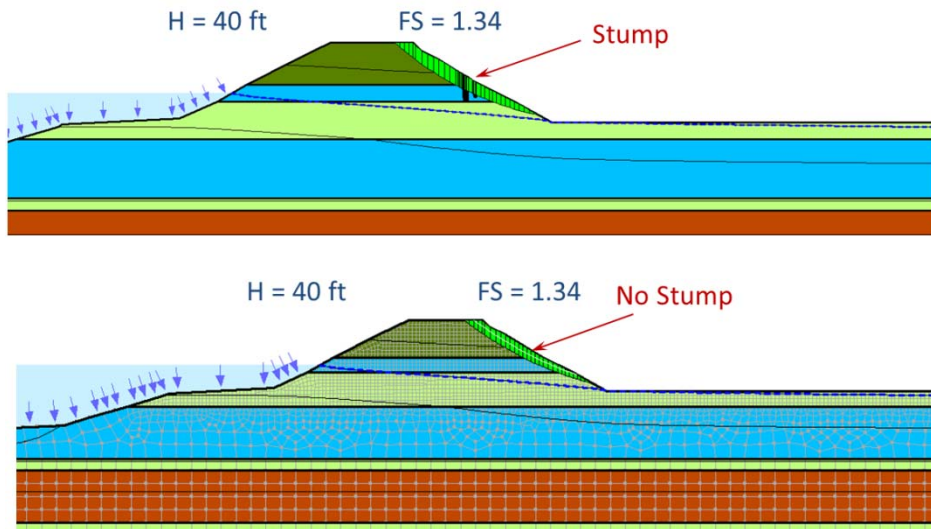
Figure 4-3. A comparison of simulations with and without a stump yields factors of similar factors of safety for similar slide circles.

The effect of a decomposing root system was explored based on the conditions noted above. Figure 4-3 presents factors of safety at a cross section extending through the root system of the decomposing stump as well as a similar section without a stump. Steady state seepage conditions were generated based on a waterside flood condition at a constant head of 40 feet and these conditions were input into the slope stability model. The water surface within the levee embankment has not risen to the level of the root system and therefore pore water pressure differences between the two models are minimal within the slide circle. Both show factors of safety of 1.34 for similar slide circles.

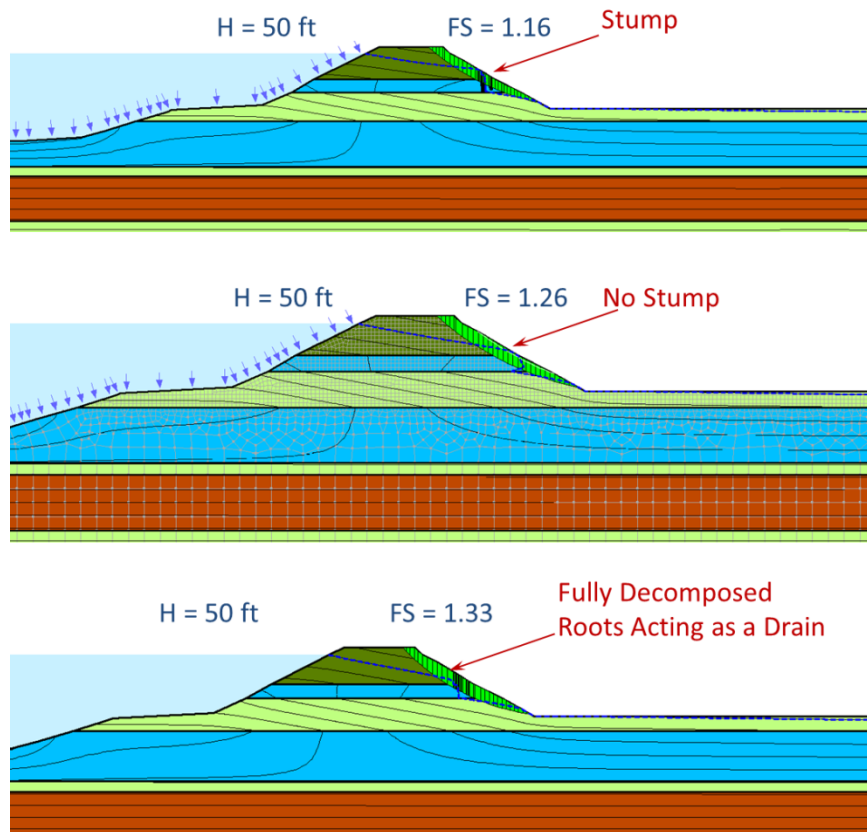
Figure 4-4. Total hydraulic head is held at 50 feet on the waterside. Three models are compared showing factor of safety with a low permeability stump and root system, no root system, or a fully decomposed root system acting as a series of voids.

In Figure 4-4, the levee section is modeled with a root system acting as a barrier, acting as a drain or absent. Results show factors of safety are lowest (FS = 1.16) when the root system acts to block flow. Pressures build behind the blockage, reducing frictional strength due to decreased effective stress. In the case where the stump acts as a drain, the water surface is drawn down, reducing pore water pressures, increasing frictional shear strength, and increasing the factor of safety (FS = 1.33) against slope instability. When no stump is present, the factor of safety against instability was calculated to be 1.26. Other mechanisms of failure, such as the change in exit gradients due to the stump, were not evaluated as part of this effort. When the root system acts as a series of voids, high seepage exit gradients may present a more important failure mechanism than slope stability.

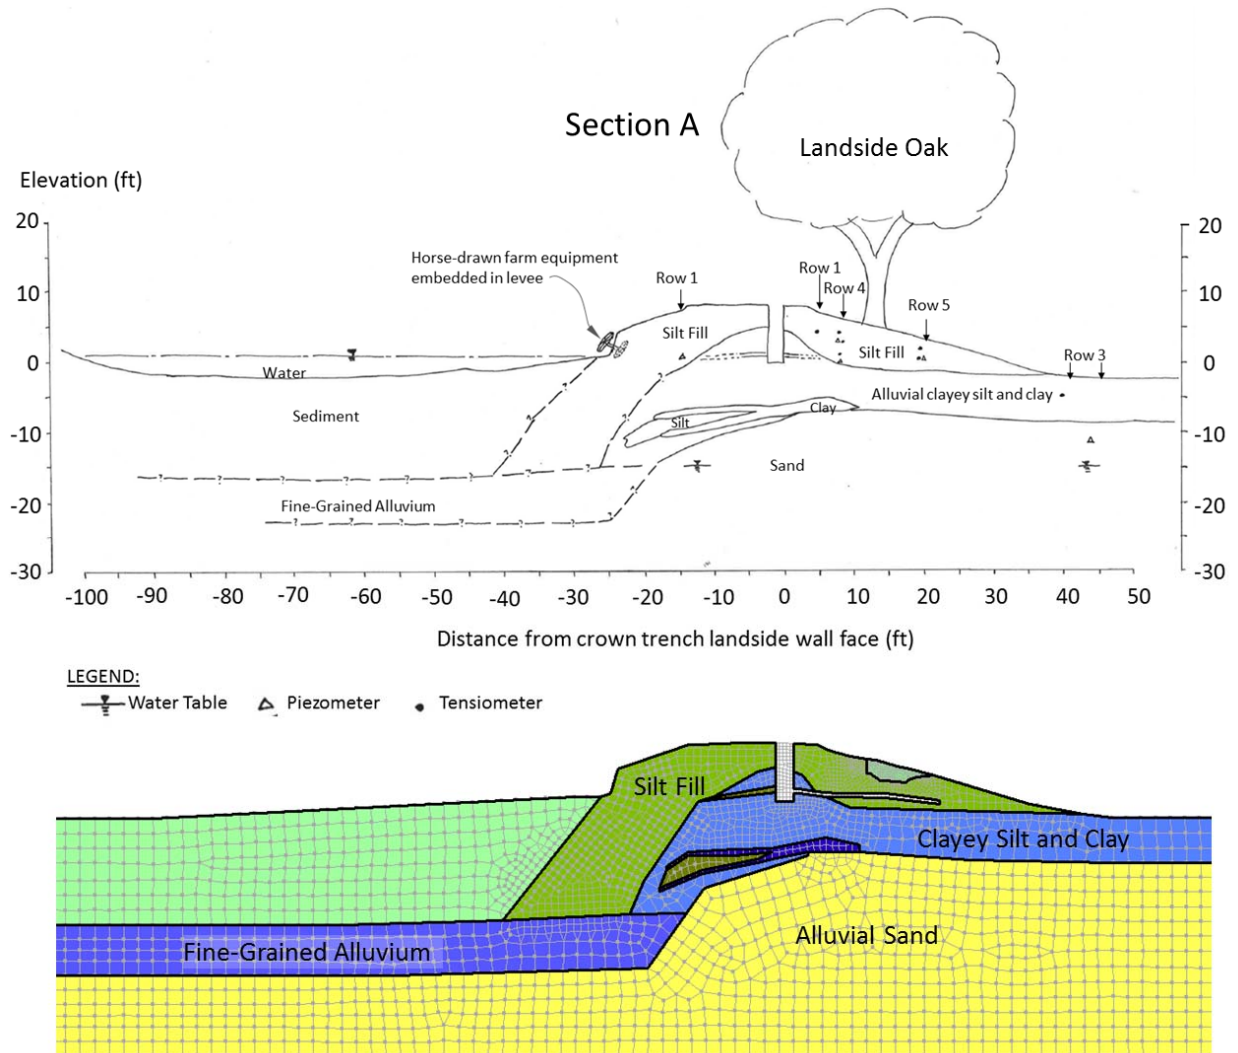
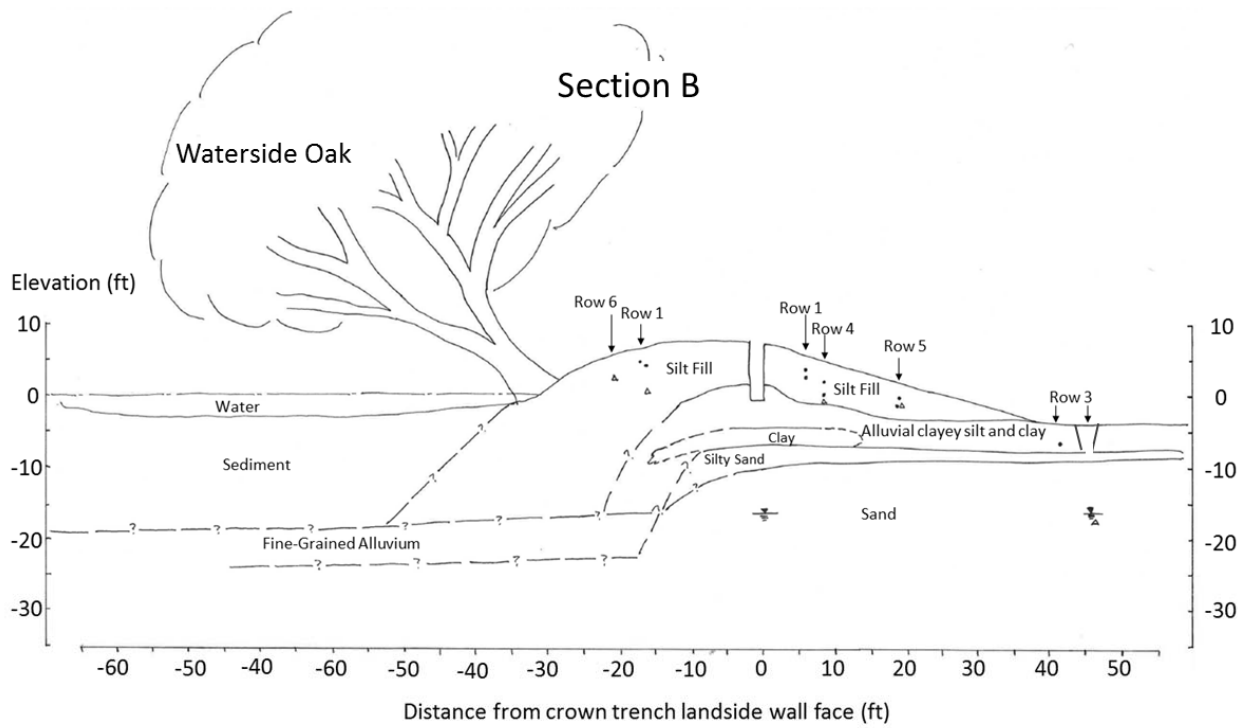
Figure 4-6. Section A interpreted section with model mesh.

Three basic cross sections based on the interpreted geometry of the Twitchell Island test site, as discussed in Chapter 3, are presented as Figure 4-6, Figure 4-7, and Figure 4-8. These three basic sections are used in all models, varying the loading and reinforcement conditions the scenarios, as appropriate.

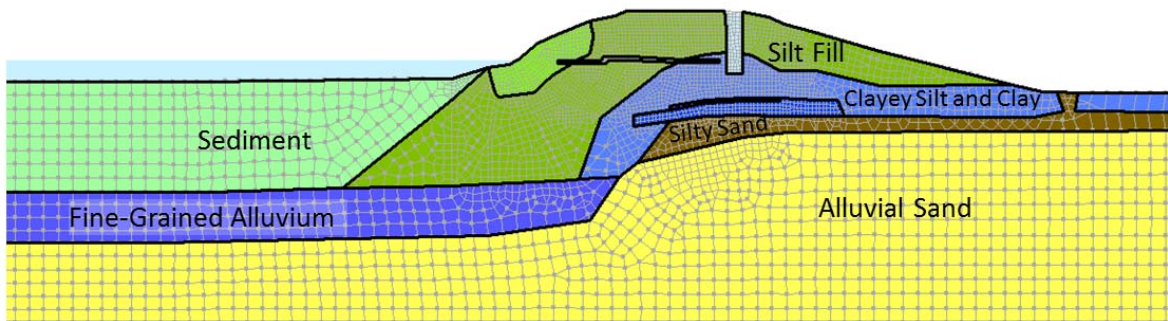
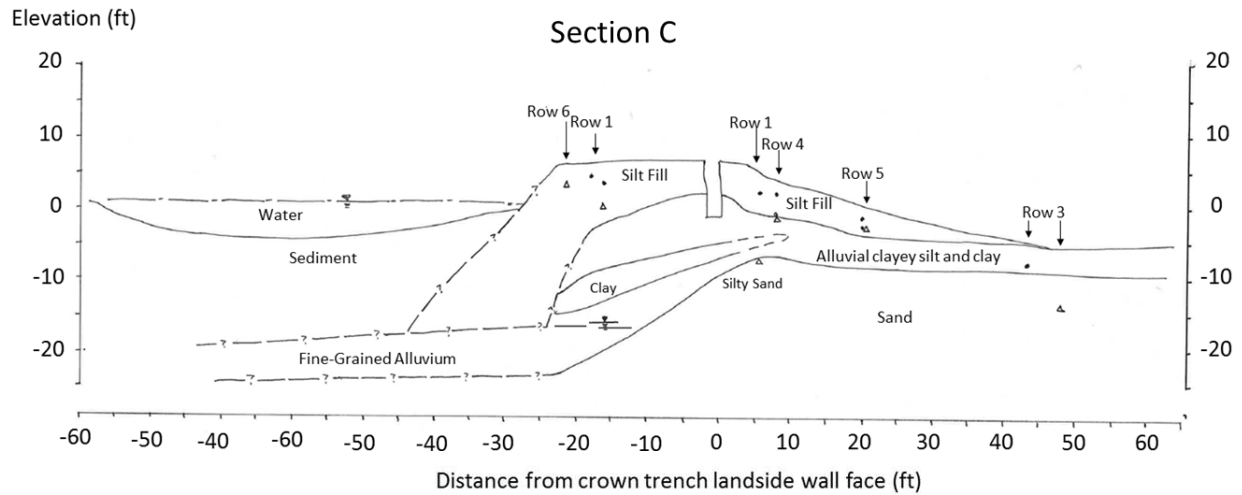
Figure 4-7. Section B interpreted section with model mesh.

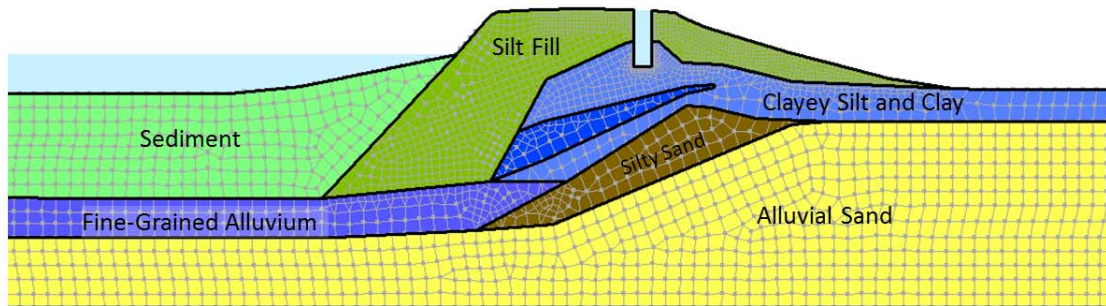
Figure 4-8. Section C interpreted section with model mesh.

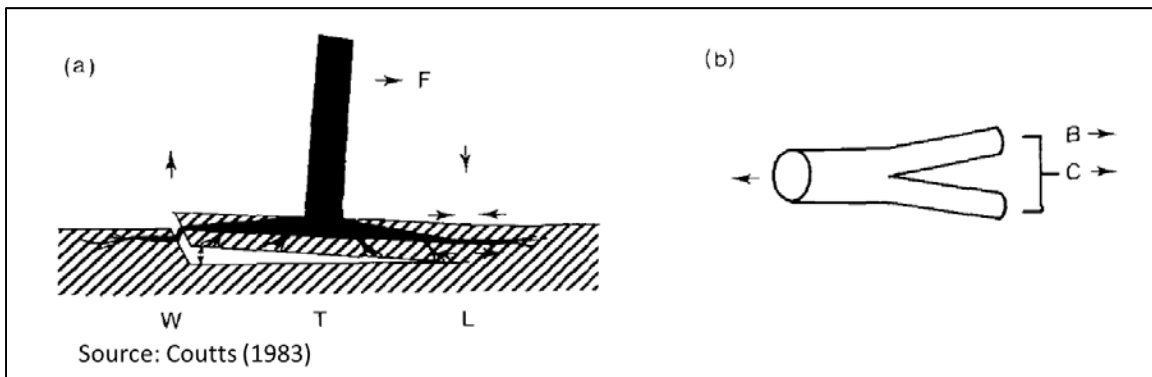
Figure 4-9. Diagram showing (a) the mechanism of overturning and (b) branching. According to Coutts (1983), branching on the leeward side can determine the position of the fulcrum on which the root plate is hinged in overturning.

Tree lean and wind loading are key factors in the analysis of a root system. Figure 4-9 shows a diagram by Coutts (1983) explaining the mechanism of tree uprooting under a horizontal force. The leeward side, or 'L' in Figure 4-9, the root-soil system is subject to bending with the position of the fulcrum determined by the branching of roots (Coutts, 1983) and their reduced ability to resist bending. The windward side, or 'W' in Figure 4-9 is able to stiffen soil more efficiently as roots are able to deform and develop tension without significant overburden to restrict uplift.

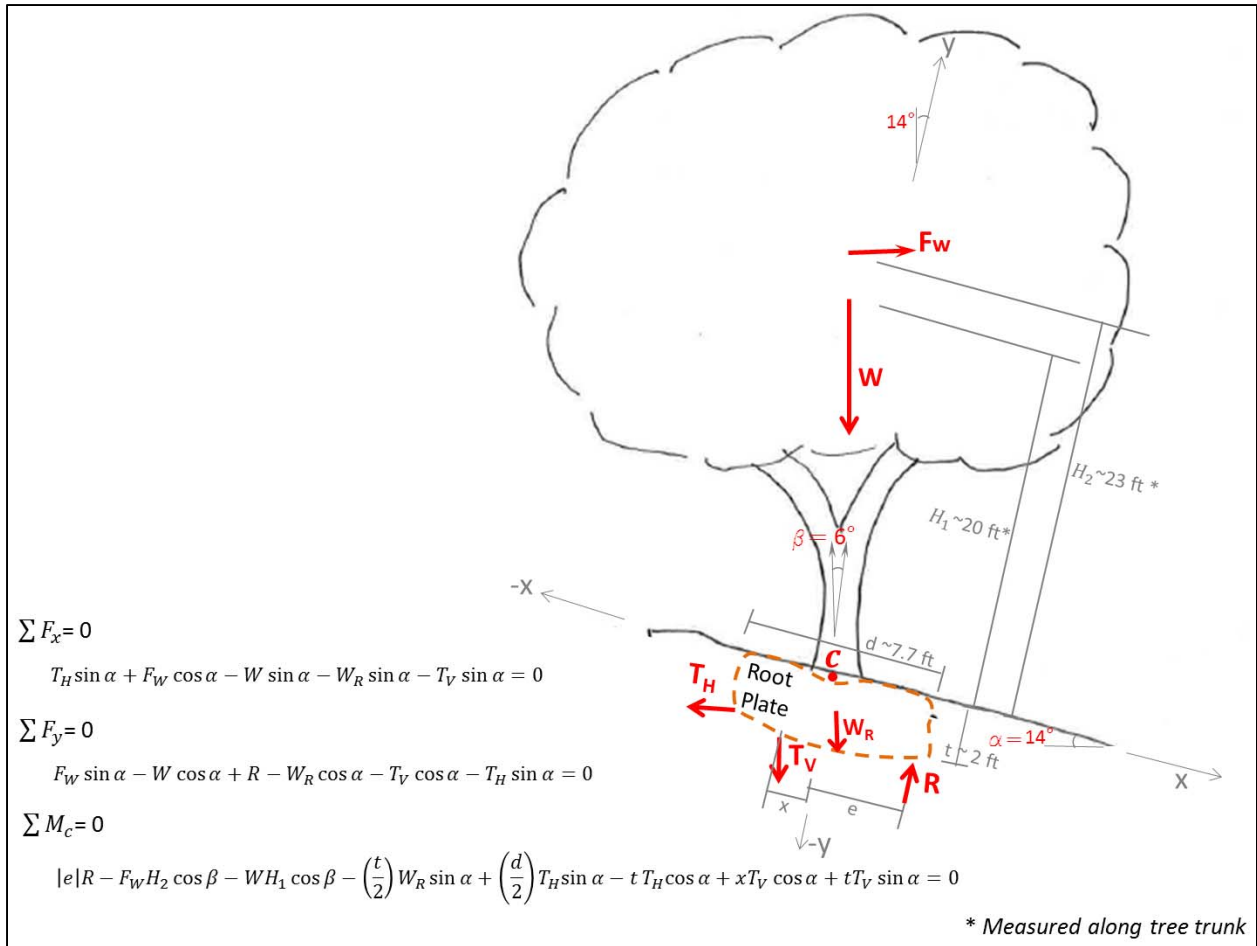
Figure 4-11. Free body diagram representing the force balance on the landside oak tree at Twitchell Island.

A free body diagram detailing the loading on the landside oak tree is presented as Figure 4-11. **Error! Reference source not found.** Based on T-LiDAR scans of the tree shape performed by Gerald Bawden of the USGS, the tree exhibited a slight lean (about 6 degrees). The diagram details wind forces, gravitational forces, a reaction force, and root tensile forces extending from a root plate. The size of the root plate was estimated from the empirically derived data associated with windthrow studies (e.g., Peterson, 2012). Table 4-1 solves equations presented on Figure 4-11 based on assumed values of key input parameters (highlighted in green) to arrive at horizontal and vertical loading of the tree based on an assumption that the tree and root plate act as a rigid body.

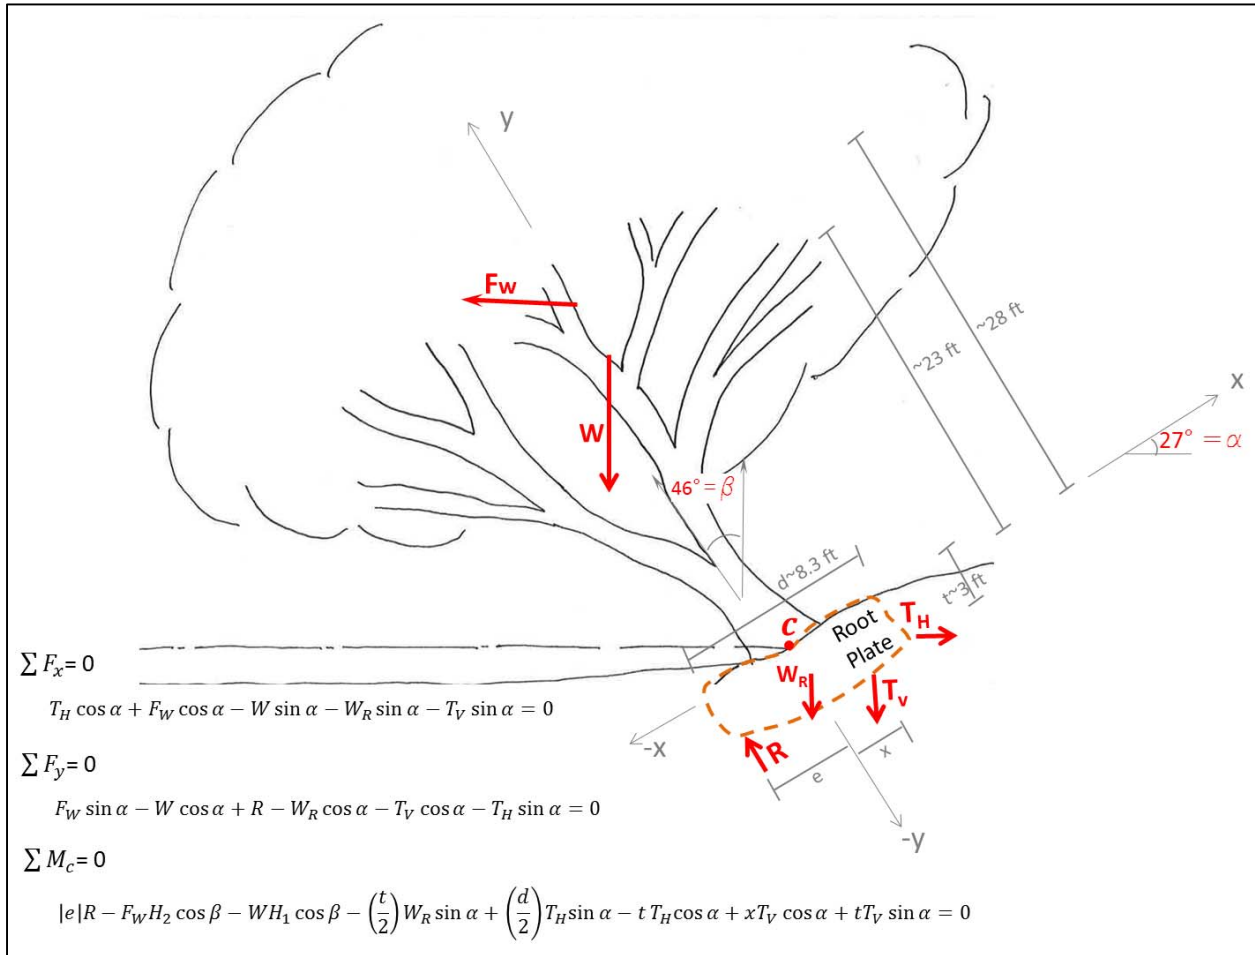
Figure 4-12. Free body diagram representing the force balance on the waterside oak tree at Twitchell Island.

A free body diagram detailing the loading associated with the waterside oak tree is presented as Figure 4-12. Based on estimates from pre-test photographs, the waterside oak tree leaned at an angle of approximately 46 degrees from vertical prior to testing. The diagram details wind forces, gravitational forces, a reaction force, and root tensile forces extending from a root plate. As discussed for the landside oak tree, the size of the root plate was estimated from the empirically derived data associated with windthrow studies (e.g., Peterson, 2012). Table 4-3 provides input parameter (highlighted in green) and solutions to equations presented on Figure 4-12 to arrive at horizontal and vertical loading of the tree based on an assumption that the tree and root plate act as a rigid body.

center and the edge of the root plate (i.e., a value of  $x = \frac{d}{4}$  as shown on Figure 4-12). The vertical loading delivered to the root system is expected to be 25 percent smaller if the vertical root tension force,  $T_V$ , acts at the windward edge of the root plate, and 50 percent larger if the vertical root tension force acts at the center of the tree trunk (assumes a 27 degree slope angle). Similarly, the horizontal force,  $T_H$ , is also impacted by the assumed position of the vertical force. The horizontal force is reduced by 16 percent when the vertical root tension force acts at the windward edge of the root plate ( $x = \frac{d}{4}$ ) and increased by 32 percent when the vertical root resists tree topple from the trunk center.

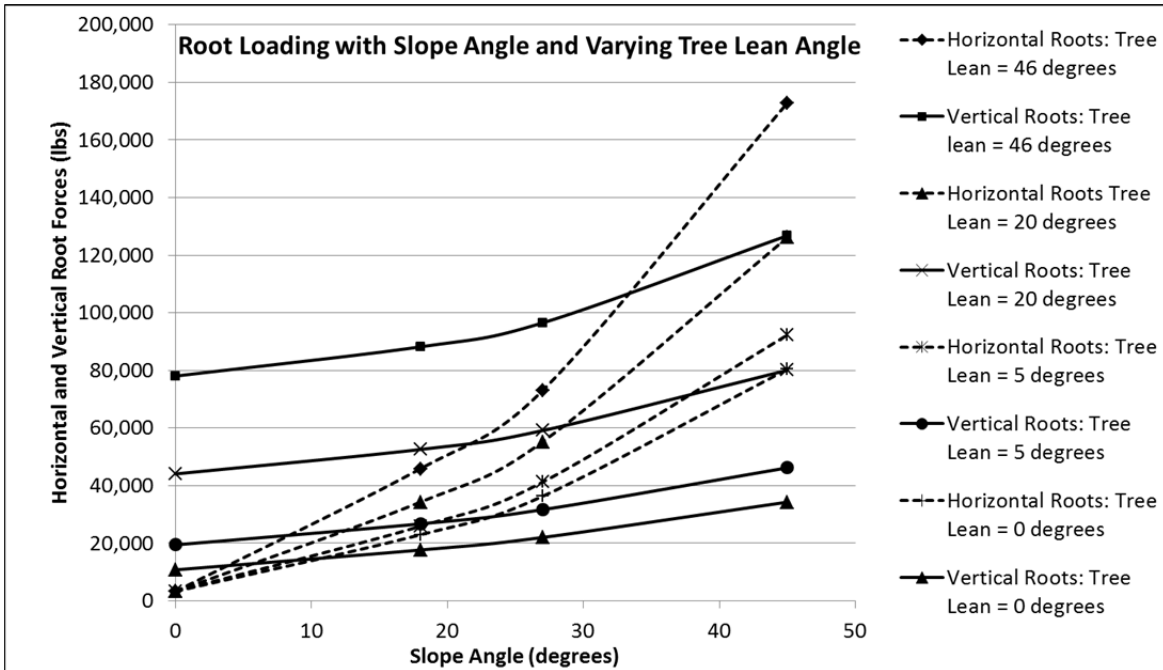
Figure 4-13. Horizontal and vertical root loading plotted against slope angle for tree lean angles ranging from 0 to 46 degrees (measured from vertical). Plots assume a 26,000 pound tree similar to the waterside oak tree with a tap root and windward roots with a vertical component (resultant acting downward from 2 feet windward of the trunk center).

Horizontal and vertical root loading associated with the waterside oak tree (estimated to weigh about 26,000 pounds) was calculated with slope angles varying from 0 to 45 degrees (measured from horizontal) and with tree lean angles of 0 to 46 degrees (measured from vertical). Root loading increases with increasing slope angle and tree lean angle. Figure 4-13 shows a steep rise in horizontal root loading for slopes steeper than 27 degrees (about 2 horizontal to 1 vertical) regardless of tree lean, while vertical root loading appears to respond more strongly to tree lean. Figure 4-14 shows the relationship between horizontal and vertical root loading with increasing tree lean. Loading calculations neglect deformations associated with the system and are estimated for a tree and root system considered as a rigid body.

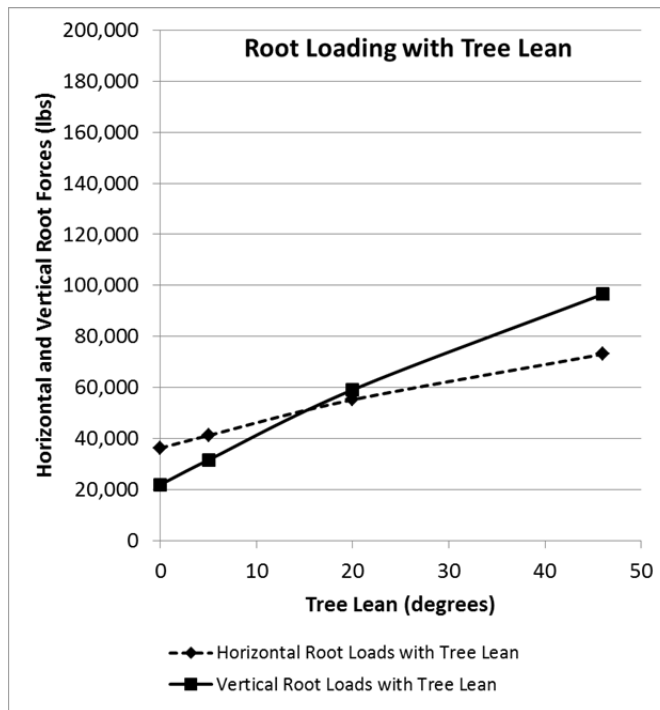
Figure 4-14. Horizontal and vertical tree root loading plotted with increasing slope angle (top) and increasing tree lean angle (bottom). Assumes a tree similar to the waterside oak tree, weighing approximately 26,000 pounds with a tap root and windward roots with a vertical component (resultant acting downward from 2 feet windward of the trunk center).

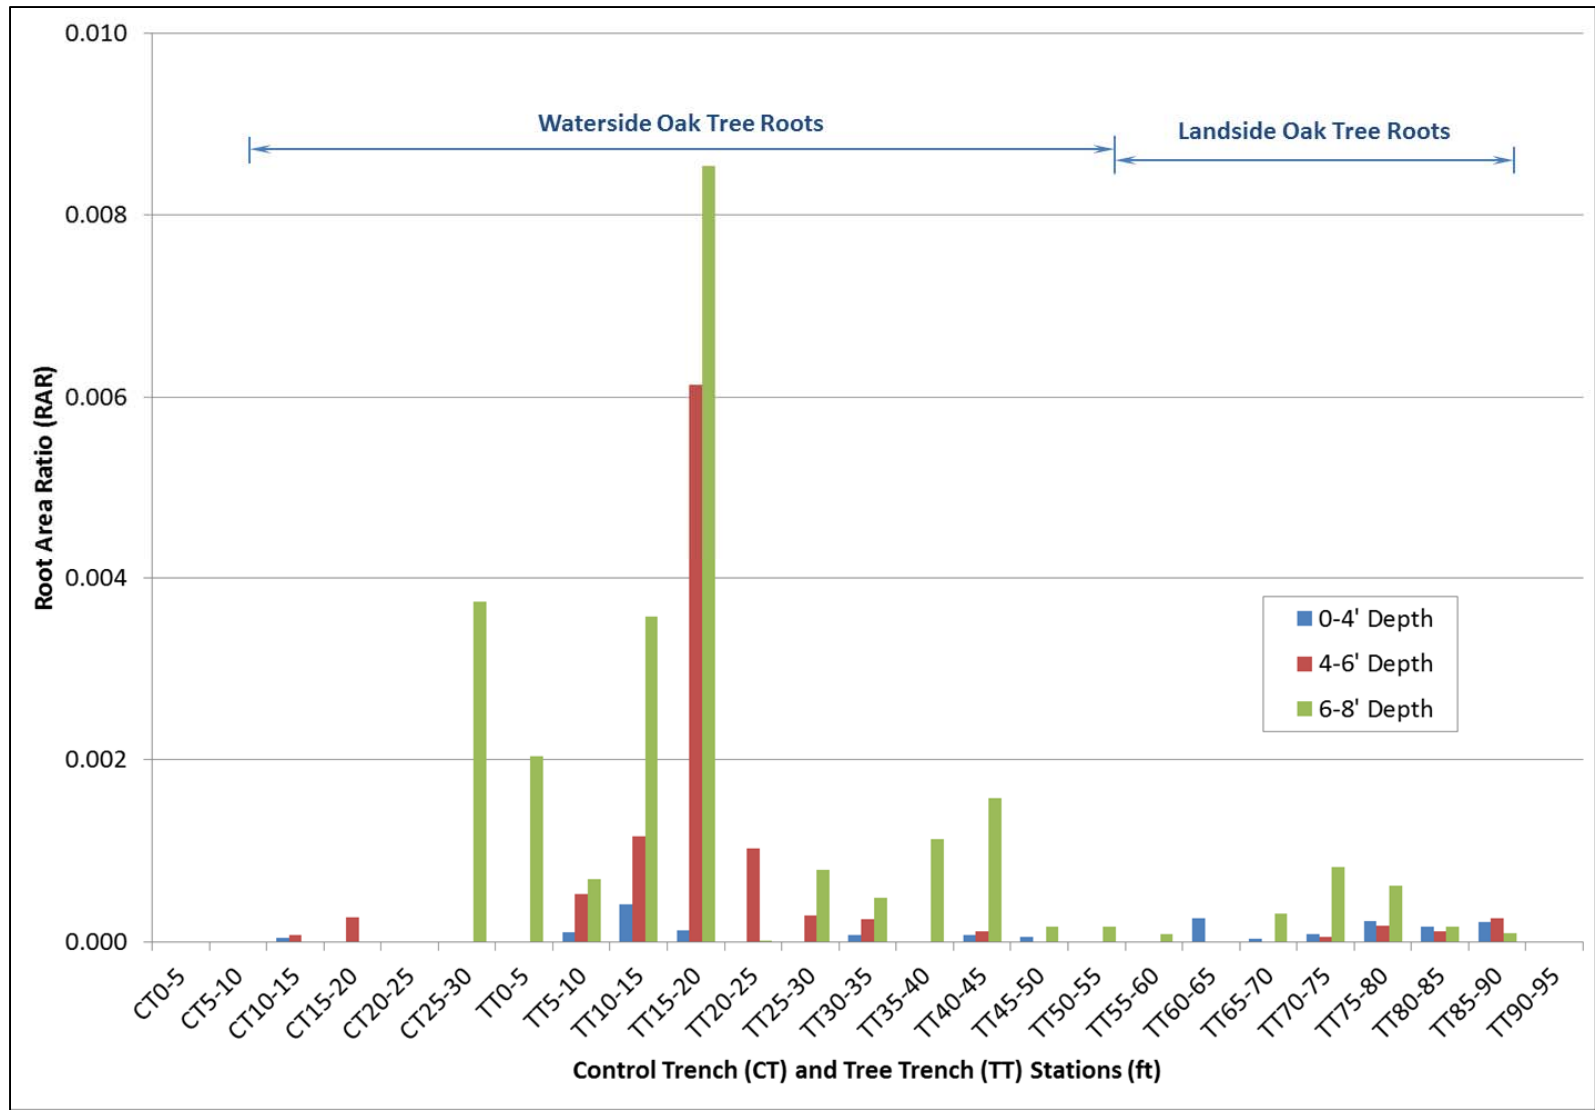
Figure 4-15. Root area ratio along the length of the control and tree trenches. Ratios are broken out for three depth categories within each 5 foot segment of trench. The waterside oak root system spans from Station CT25 to TT55, while landside oak roots were encountered between Station TT60 and TT90.

Trench logs show that the root system of the waterside oak was significantly more extensive within the trench than the landside oak (Figure 4-15). The majority of roots of the waterside oak were found at depths of 4 to 8 feet within the trench. The waterside tree was positioned at an elevation approximately 6 feet below the levee crown and the largest roots were found to extend approximately horizontal into the levee. The landside tree shows significantly lower root area ratios and a more even distribution with depth. Our observations seem to be consistent with those reported by Cooper (1926). Figure 4-16 provides a graphical breakdown of the root size and number of occurrences within the trench wall.

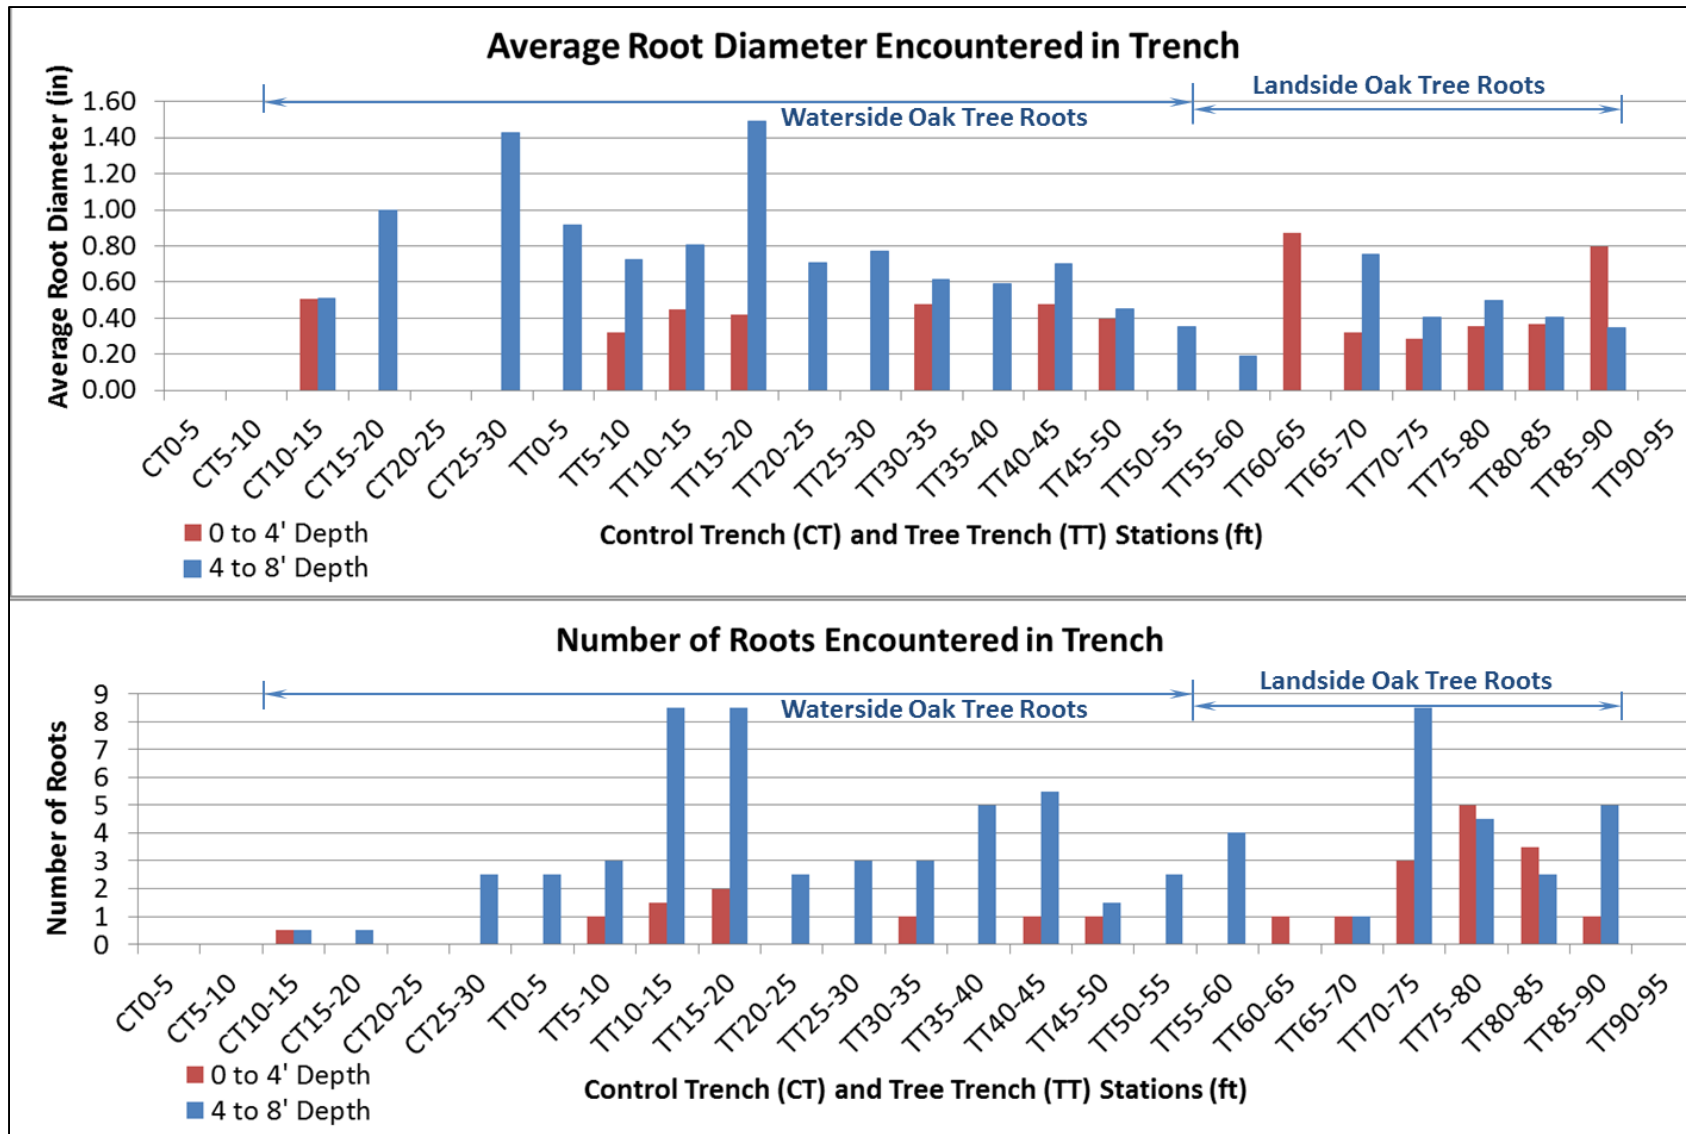
Figure 4-16. Average root diameter and number of roots encountered along the walls of the control and tree trenches. Ratios are broken out for two depth categories within each 5 foot segment of trench. Results are averaged from waterside and landside walls.

The critical overturning moment estimated by empirical data provided by Peterson (2012) for the waterside valley oak tree is about 1,100 kip-ft. Looking at Figure 4-16, typical root sizes are on the order of 0.8 to 1.5 inches at depths of 4 to 8 feet. Smaller and shallower roots do not provide much reinforcing. Looking at an 8 foot failure zone and the primary roots extending back from this zone, assume one root of 1.5 inch diameter and one root of 0.75 inch diameter per foot across an 8 foot section. The critical overturning moment for a one foot thick slice would be 138 kip-ft. Using Gray and Sotir (1996), each root is evaluated to determine if it fails in tension or pullout. In general, roots of 0.75 to 2 inches and an assumed 25 feet in length will not break in tension. Bond strengths are estimated using equation 3-13 of Gray and Sotir (1996):

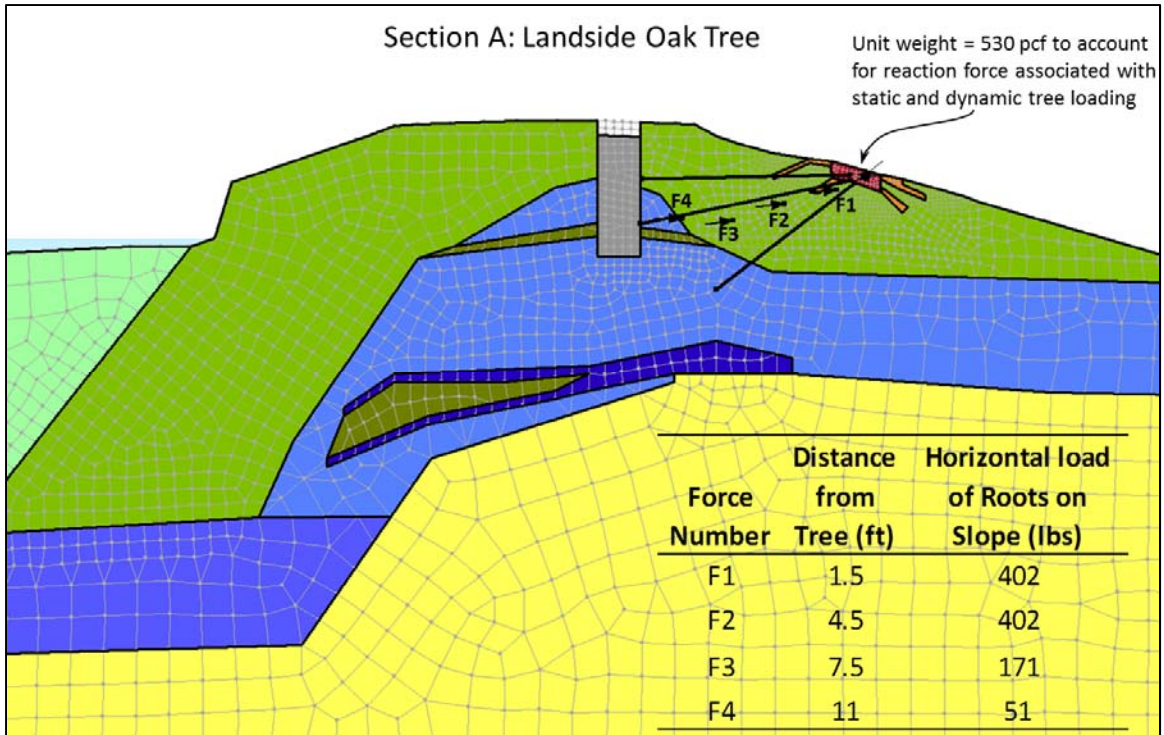
Figure 4-17. Example of root reinforcing and distributed horizontal forces at the landside oak.

Estimates for number and size of roots at closer distances to the tree were estimated based on available root architecture data. Roots located between the tree and the trench were not captured in trench logs. Based on a review of raw data charts for several valley oak trees excavated, which were provided by Dr. Alison Berry and Shih-Ming Chung of UC Davis, roots were estimated to be about 5 times more abundant at distances of 25 to 50 percent of the canopy radius. Roots were about 2.5 times larger at 25 percent of the canopy radius than the size at 50 to 100 percent of the canopy radius. For roots that are too short to have been intersected by trench logs, the total load capacity of these roots could be estimated from the size and number of roots encountered at the trench. The roots extending from both the waterside and landside oak trees intersected during trenching extend to approximately 65 to 100 percent of the canopy diameter. Using these relationships, root load distributions were estimated for the landside and waterside trees as shown on Table 4-4 and Table 4-5, respectively. These assumptions were used in estimating values of horizontal forces shown in Figure 4-17 and Figure 4-18 for the landside and waterside trees, respectively.

The horizontal component of force is divided over the 'slice width' to arrive at a unit horizontal force and is then further divided to create 5 forces, evenly distributed over the root zone within Slope/W model sections (Figure 4-17 and Figure 4-18). These forces represent the horizontal load on the embankment associated with the lean of the tree and a downhill wind force. Root reinforcement is modeled as a horizontal force acting into the slope, resisting movement. The bonded length of the reinforcement is equal to the length of the reinforcing element outside of the slide zone. Horizontal point loads are only active in the calculation of the factor of safety when included inside the slide circle. Combining the use of reinforcing elements with the use of horizontal forces allows for the inclusion of loading associated with wind and tree lean within the slide mass. In general, loads are higher near the tree (F1 and F2) and lower with distance.

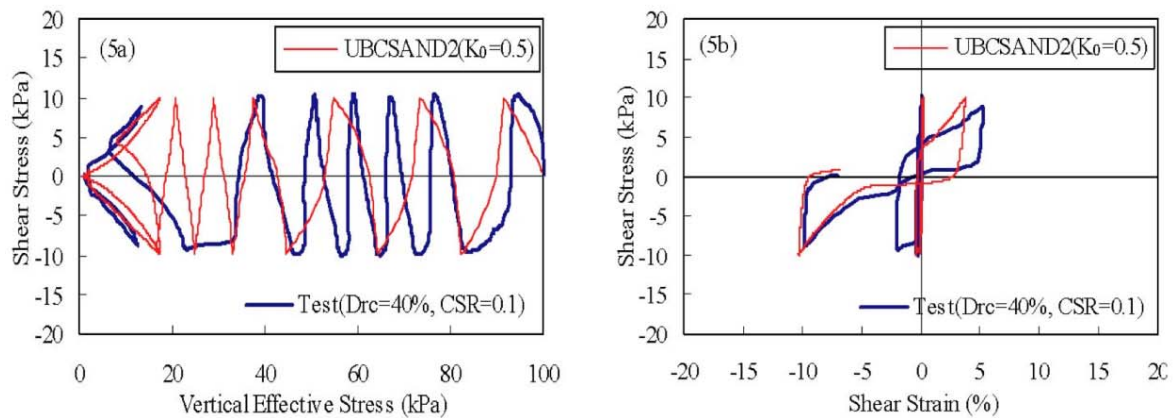
Figure 5-1. Predicted and measured stress paths and stress-strain responses for a sand with relative density of 40% at low CSR = 0.1 using UBCSAND (from Park and Byrne 2004).

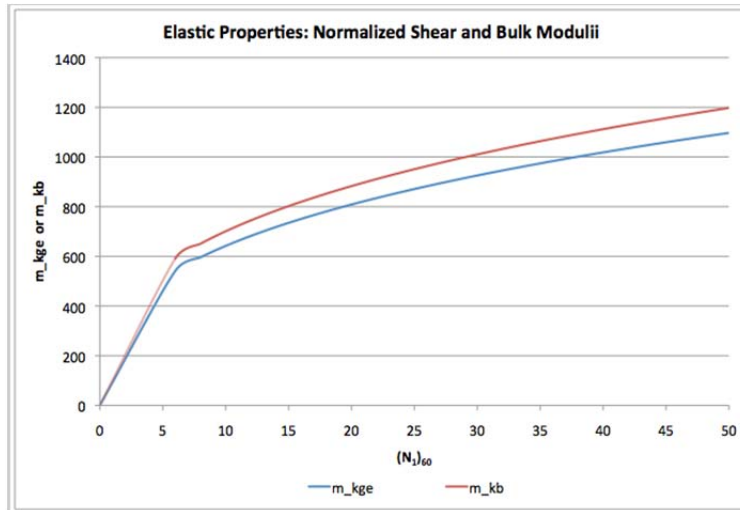
Figure 5-2. Elastic Shear and Bulk Stiffness Numbers with  $(N_1)_{60}$  blow count.

A plot showing the variation of normalized bulk and shear moduli with  $(N_1)_{60}$  blow count is shown in Figure 5-2.

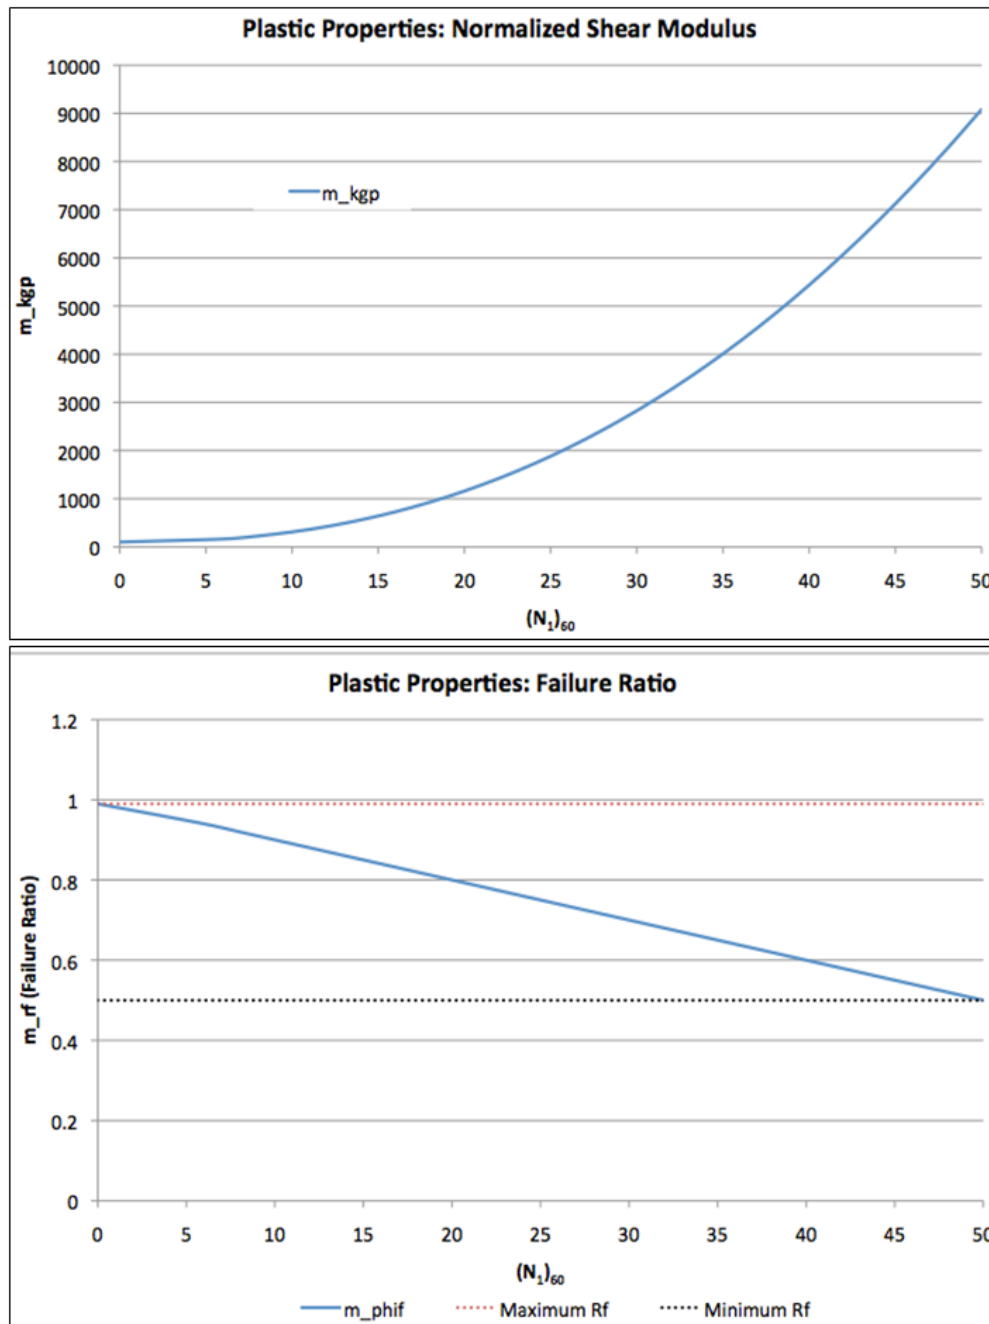
Figure 5-3. Plastic Shear Modulus Number and Failure Ratio vs.  $(N_1)_{60}$  blow count.

Figure 5-3. The anisotropy parameter varies linearly between 0.333 for loose pluviated soils and 1.0 for isotropic stress conditions.

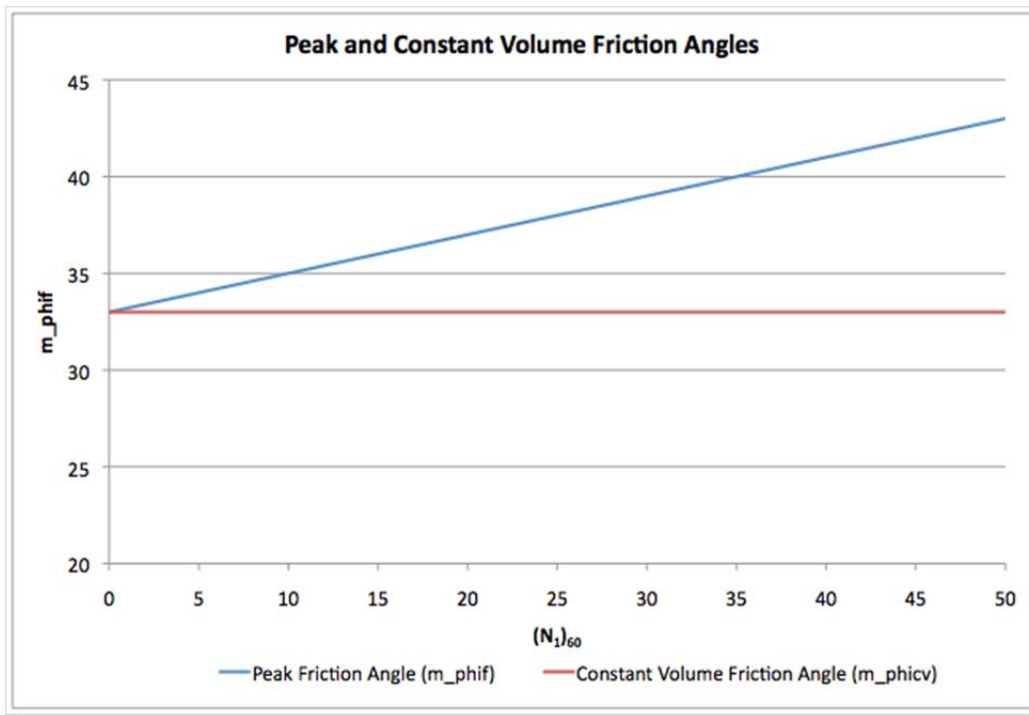
Figure 5-4. Peak and Constant Volume Friction Angles with  $(N_1)_{60}$  blow count.

The constant volume friction angle is the parameter controlling the flow rule. Volumetric strain is calculated as a function of dilation angle. The dilation angle is calculated from the difference between peak friction angle and constant volume friction angle. The generic value of the constant volume friction angle is 33 degrees where the peak friction angle is calculated as a function of constant volume friction angle and blow count. Generic equations used in this study are provided below, and Figure 5-4 shows peak and constant volume friction angles plotted against blow count.
