Static and Seismic Performance of California Levees

Michelle Jennifer Shriro

Doctor of Philosophy

Engineering - Civil and Environmental Engineering

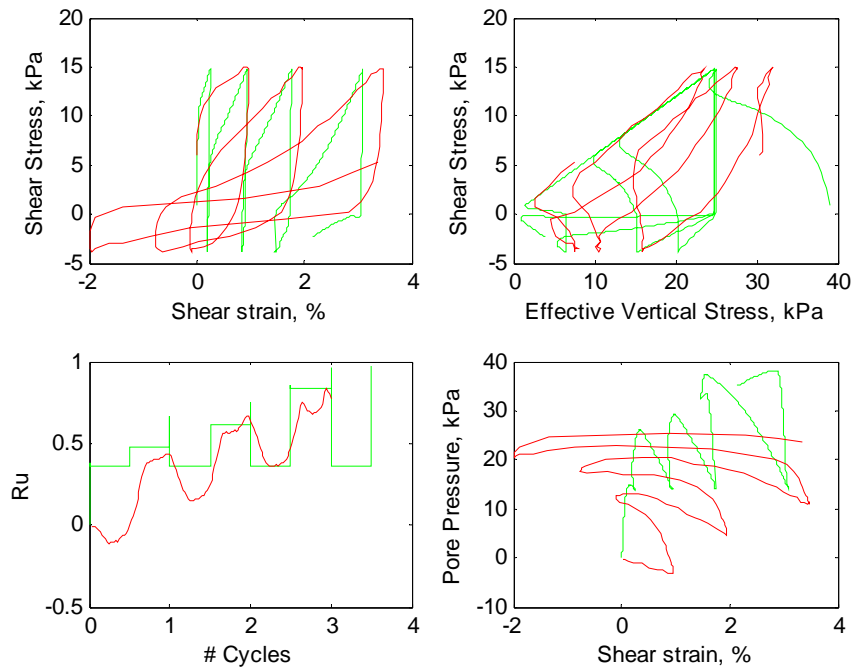
Figure 5-8. Test NS3:  $\alpha=0.14$ ;  $D_r=62\%$ ;  $CSR=0.24$  (Kammerer, 2002). Test data in red and UBCSAND output in green.

Figure 5-8 through Figure 5-11 show examples of calculated vs. measured response of clean sand Specimens of Monterey and Nevada Sands under initial static loading conditions and subjected to cyclic loading in simple shear. The UBCSAND model can capture many key aspects of soil response. However, it has a few limitations, which will be the focus of this discussion.

Shear strain is typically not matched in both the forward and reverse directions. Instead, it is matched in only the forward direction as can be seen for tests NS3 (Figure 5-8), MS118J (Figure 5-10), and MS11J (Figure 5-11). Further, the model is unable to calculate accurately the significant shear strains that sometimes occur due to the static shear loading prior to the triggering of flow liquefaction but during the incremental building of pore water pressures. Laboratory test specimens NS9 and MS11J are excellent examples of this (Figure 5-9 and Figure 5-11, respectively). Specimen NS9 does not liquefy during the test and strains are not well captured. Similarly, Specimen MS11J exhibits cyclic mobility with limited strain potential as well as incremental movements in the downslope direction (the direction of the initial static shear stress). Looking at the plot of pore water pressure with shear strain (lower right corner) of Figure 5-11, the UBCSAND model can capture the deformation well once pore water pressures have incrementally increased to a pore water pressure ratio ( $R_u$ ) of greater than about 50%. The UBCSAND model has not captured the effects of cyclic mobility with limited strain potential or the ‘creeping’ movements in the downslope direction driven by the initial static shear.

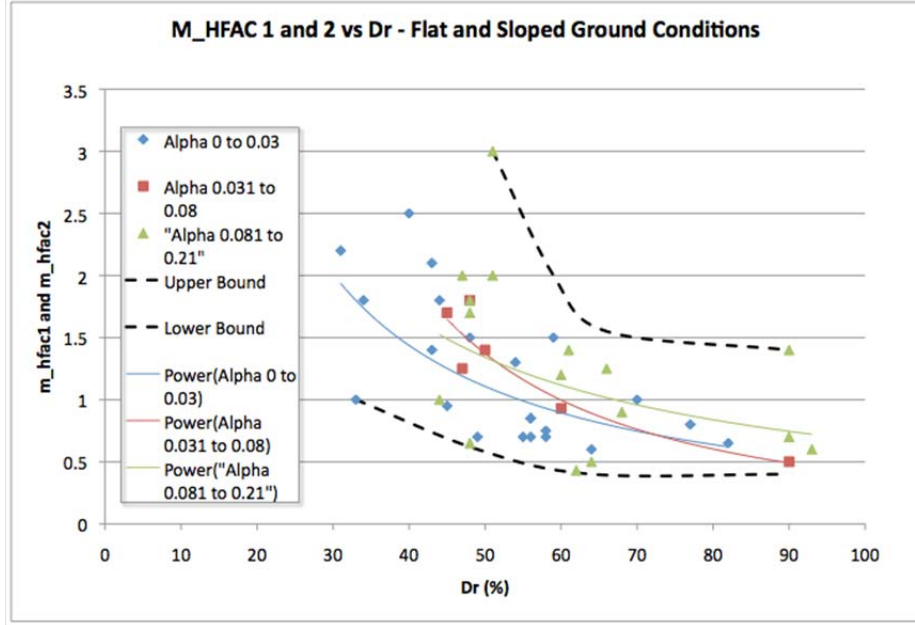
Figure 5-12. Triggering Parameters  $m_{hfac1}$  and  $m_{hfac2}$  vs. Relative Density ( $Dr$ ).

Figure 5-12 shows how the  $m\_hfac1$  and  $m\_hfac2$  parameters vary with relative density ( $D_r$ ). In general, we found that tests with lower initial static shear stress required slightly lower values of the  $m\_hfac1$  and 2 while specimens with higher initial static shear stress required higher values of these fitting parameters to achieve the best match with laboratory testing values. Specimens with higher initial static shear stress exhibited greater variation in the  $m\_hfac1$  and 2 parameters to capture the response. Larger values of the  $m\_hfac1$  and 2 fitting parameters reduce the rate of pore water pressure rise with cycles and increase the number of cycles to liquefaction.

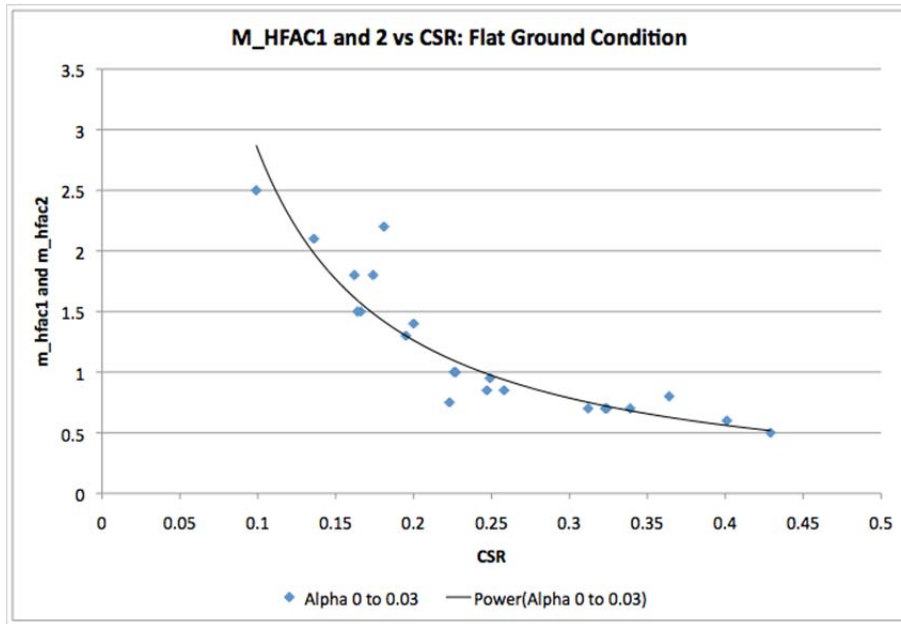
Figure 5-13. Triggering Parameters m\_hfac1 and 2 vs. CSR – Flat Ground Condition.

Trends of  $m_{hfac1}$  and 2 with CSR are plotted on Figure 5-13 for the flat ground condition and Figure 5-14 for sloping and flat ground conditions. A clear trend is seen with CSR for the flat ground condition. It should be noted that effects of relative density were not separated out in Figure 5-13 and Figure 5-14 and laboratory specimens prepared with a low relative density tend to be tested at low CSR, while those prepared at higher relative density tend to be tested at higher CSR in order to trigger liquefaction.

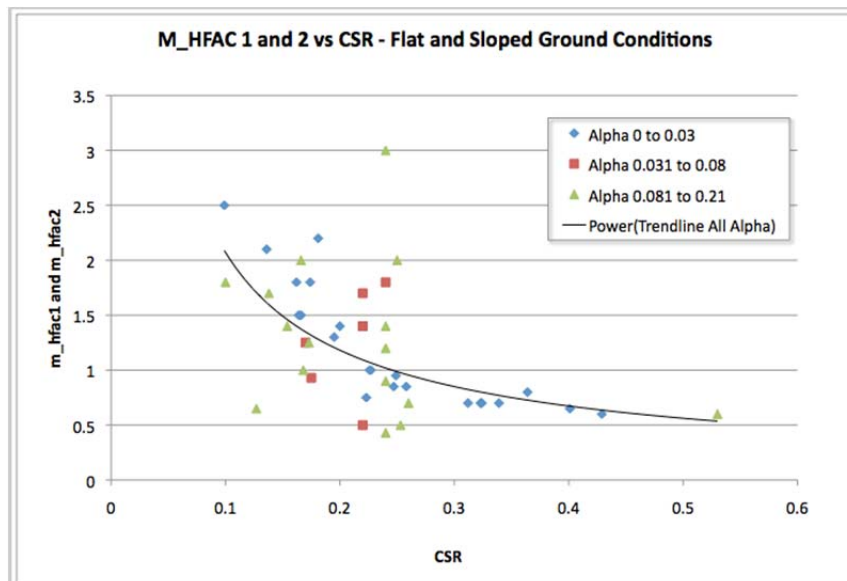
Figure 5-14. Triggering Parameters m\_hfac1 and 2 vs. CSR – Flat and Sloping Ground Conditions.

It is clear from Figure 5-14 that sloping ground conditions do not exhibit the same trend with CSR seen with flat ground specimens. The triggering parameters used to capture the liquefaction response for specimens with larger initial static shear stress exhibit trends with density as opposed to CSR. Both Figure 5-13 and Figure 5-14 were used in determining the values of fitting parameters  $m_{hfac1}$  and  $m_{hfac2}$  for use in back analysis of case histories as well as forward modeling of the simplified cases of our sensitivity study. Parameter selection for these models will be discussed in subsequent sections of this report.

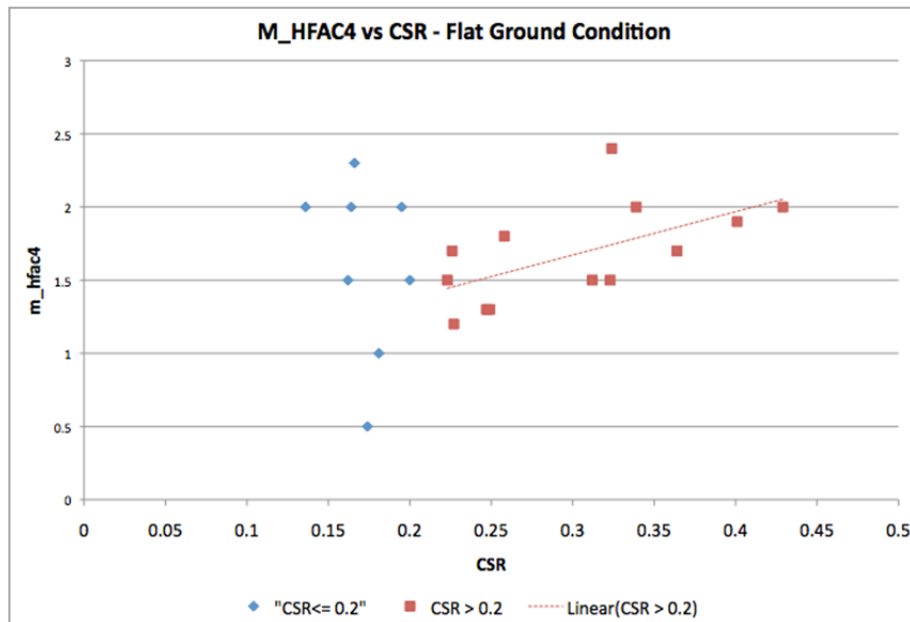
Figure 5-15. Dilation reduction parameter,  $m\_hfac4$  vs. CSR – Flat Ground Case. A weak trend with CSR is visible for values of CSR greater than 0.2. No trend is observed at CSR values of 0.2 or less.

Figure 5-15 and Figure 5-16 show the value of  $m\_hfac4$  that was used to capture the level of shear strain in clean sand specimens with varying CSR and  $D_r$  respectively for a flat ground case. The data were divided into groups of low CSR (equal to 0.2 or less) and higher CSR (greater than 0.2). Specimens subjected to higher CSR values showed a weak trend with CSR and no noticeable trend with  $D_r$ . The value of  $m\_hfac4$  increases with increasing CSR. Increasing  $m\_hfac4$  reduces dilation after triggering and increases incremental strains. Specimens subjected to lower CSR did not show a trend with increasing CSR, but rather exhibited a weak trend with  $D_r$ . As soils became looser, the value of  $m\_hfac4$  was decreased to match strains. Decreasing  $m\_hfac4$  increases dilation after triggering and limits the overestimation of shear strains.

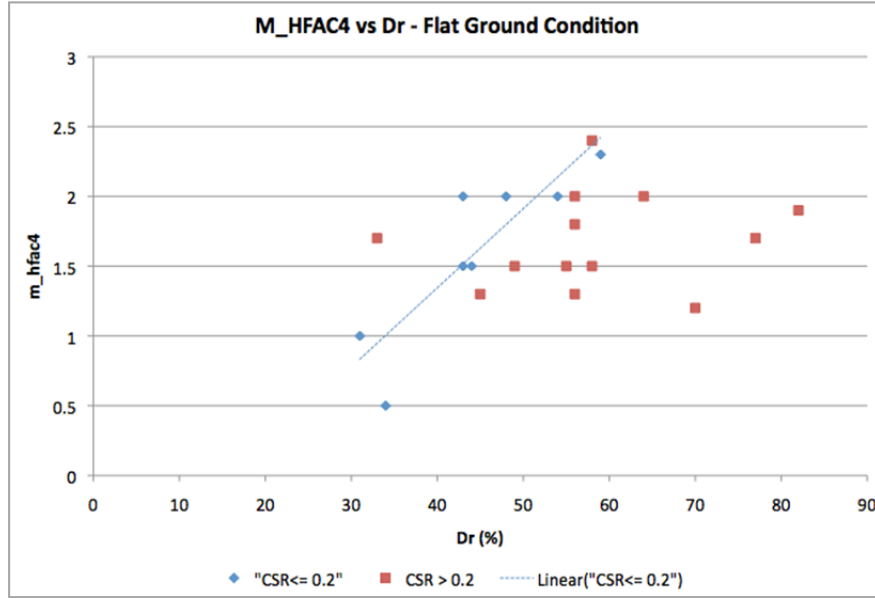
Figure 5-16. Dilation reduction parameter,  $m_{hfac4}$  vs.  $D_r$  – Flat Ground Case. A weak trend is visible with  $D_r$  at values of CSR of 0.2 or less.

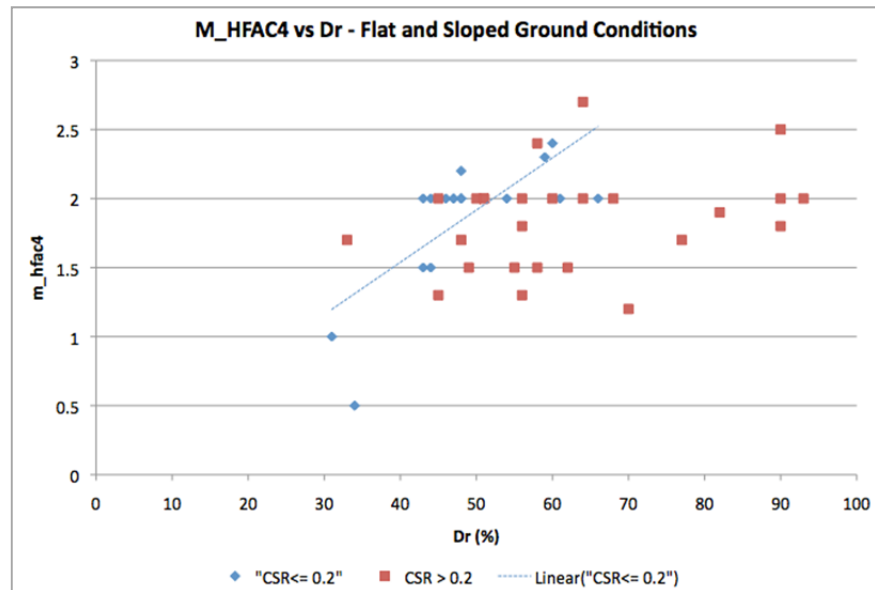
Figure 5-17. Dilation reduction parameter,  $m_{hfac4}$  vs.  $D_r$  – Sloping and Flat Ground Cases. A weak trend is visible with  $D_r$  at values of CSR of 0.2 or less.

Figure 5-17 and Figure 5-18 show plots of both sloping and flat ground condition cases against relative density and CSR. A weak trend with  $D_r$  can still be seen in the specimens subjected to CSR values of 0.2 or less (Figure 5-17). No trend is visible with CSR (Figure 5-18), though values typically range between 1.5 and 2.0.

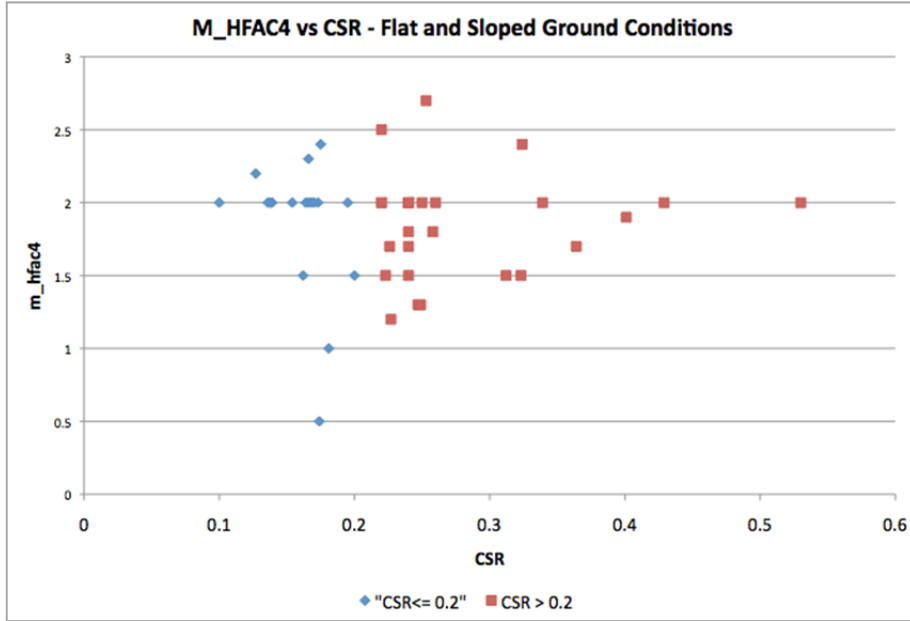
Figure 5-18. Dilation reduction parameter,  $m_{hfac4}$  vs. CSR – sloping and flat ground cases.

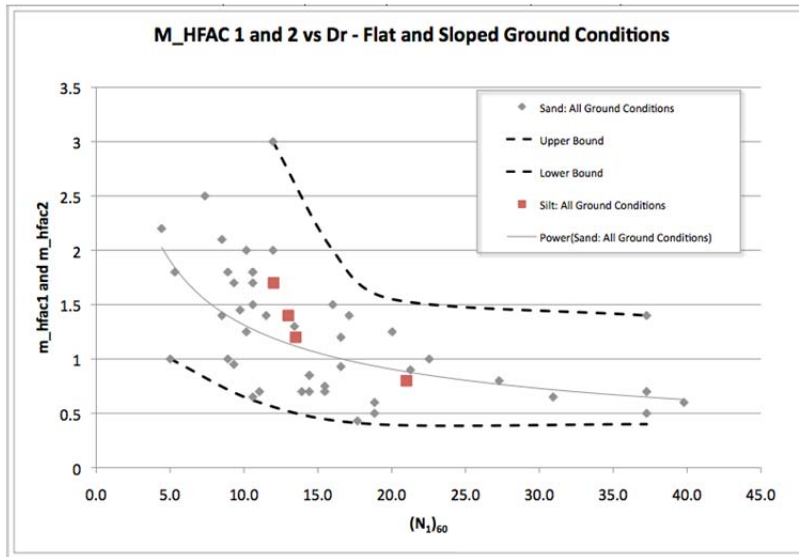
Figure 5-19. Selected values of m\_hfac1 and m\_hfac2 found to yield a fit to the laboratory data.

Parameters used for modeling silts were developed by modeling laboratory tests using a series of blow count values within UBCSAND to determine a value that yielded a realistic fit to laboratory data. In general, values of  $m_{hfac1}$  and  $m_{hfac2}$  selected were found to be slightly higher for silts than sands of zero initial static shear stress but were found to follow a similar trend when considering the void ratio of the sample as a relative measure of blow count. Figure 5-19 shows a plot of  $m_{hfac1}$  and 2 for the 4 laboratory tests considered against the selected value of blow count. The data are plotted with previously reported sand data for comparison. The values selected for  $m_{hfac4}$  were lower than those selected for sands of similar fines corrected  $(N_1)_{60}$  blow count. For higher void ratio silts, a value of  $m_{hfac4}$  of 0.5 was found to be appropriate. For silts of lower void ratio as well as silty sands, we selected a value of  $m_{hfac4}$  of 1.5.

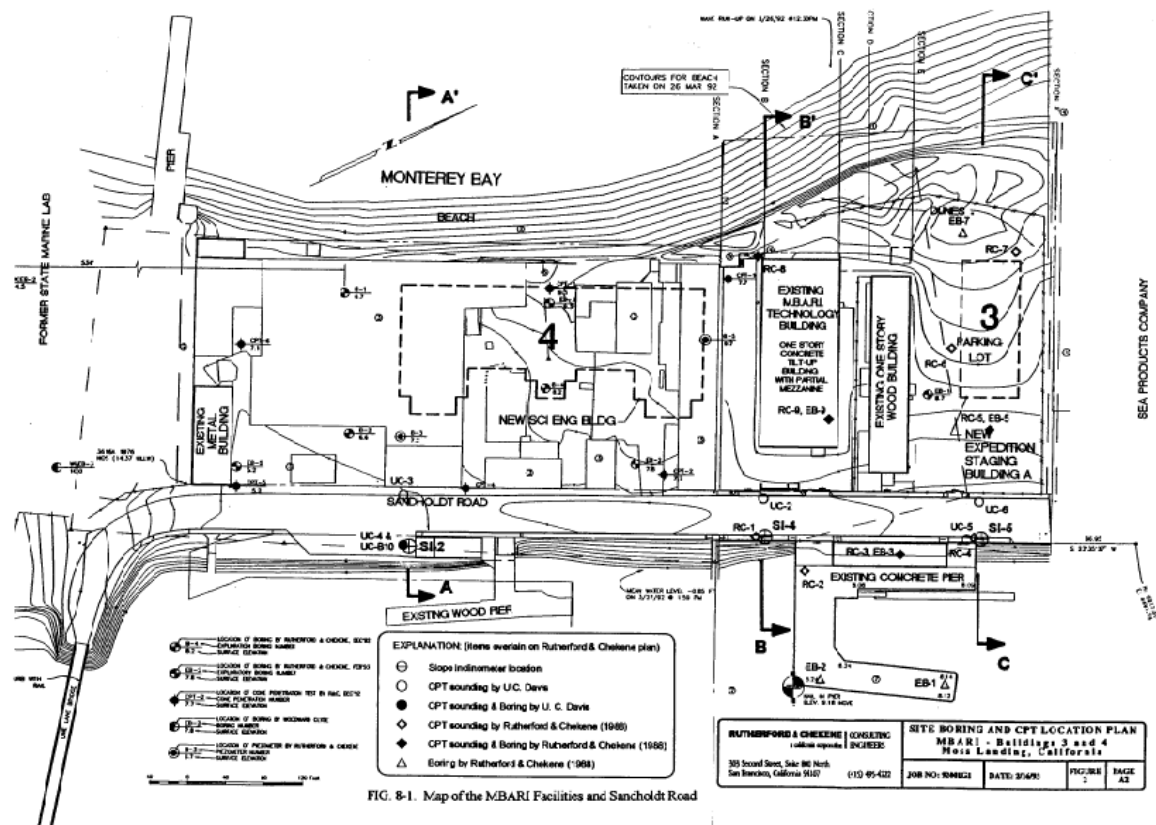
FIG. 8-1. Map of the MBARI Facilities and Sandholdt Road

Figure 5-20. Site plan showing Sandholdt Road, the MBARI complex, waterfront piers, and the former State Marine Lab site discussed in Section 3.2.

Institute (MBARI). Sandholdt Road runs in a north/south direction and functions as the primary access road for MBARI complex (Figure 5-20. ).

Cone penetration data (UC-4 and UC-3) are available on either side of Sandholdt road as indicated on Figure 5-20. and Figure 5-21. The 'clayey silt' layer appears in both CPTs, while the 'clayey silt seam' appears only in UC-4, adjacent to inclinometer S-2. A comparison of CPT data yielded an inconclusive result as to whether the 'clayey silt' layer at the toe of slope should be modeled as a potentially liquefiable layer with the UBCSAND model or with the Mohr-Coulomb model. Thus, both cases were considered, and the results compared. In Model A, the 'clayey silt' layer at the toe of slope is modeled as a cohesive soil with the Mohr-Coulomb model. Figure 3.1.6 shows the mesh and layers used to model the site. As summarized in Boulanger et al. (1995), the ground motion driving the observed lateral spread deformation was estimated to have a peak ground acceleration (PGA) of approximately 0.2 to 0.3 g using a bedrock motion of 0.15 g. The report concluded that 0.25 g would likely represent a median or slightly lower estimate of Loma Prieta earthquake. The Salinas ground motion record (PGA = 0.15 g) was identified as having similar soil conditions at depth and was scaled to 0.25 g. This ground motion was used as input in our analysis.

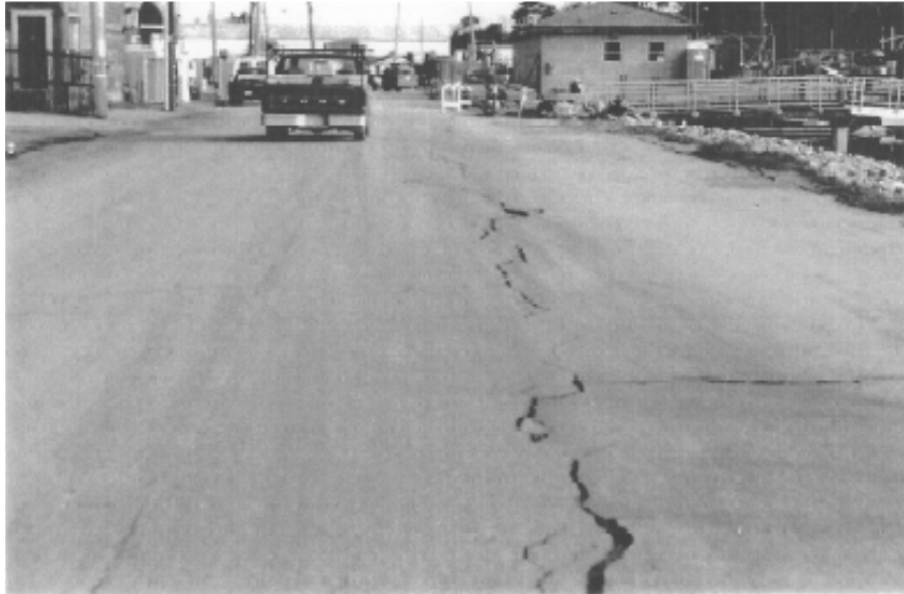
Figure 5-22. Cracking along Sandholdt Road (looking north just south of MBARI pier; from Boulanger et al. 1995).

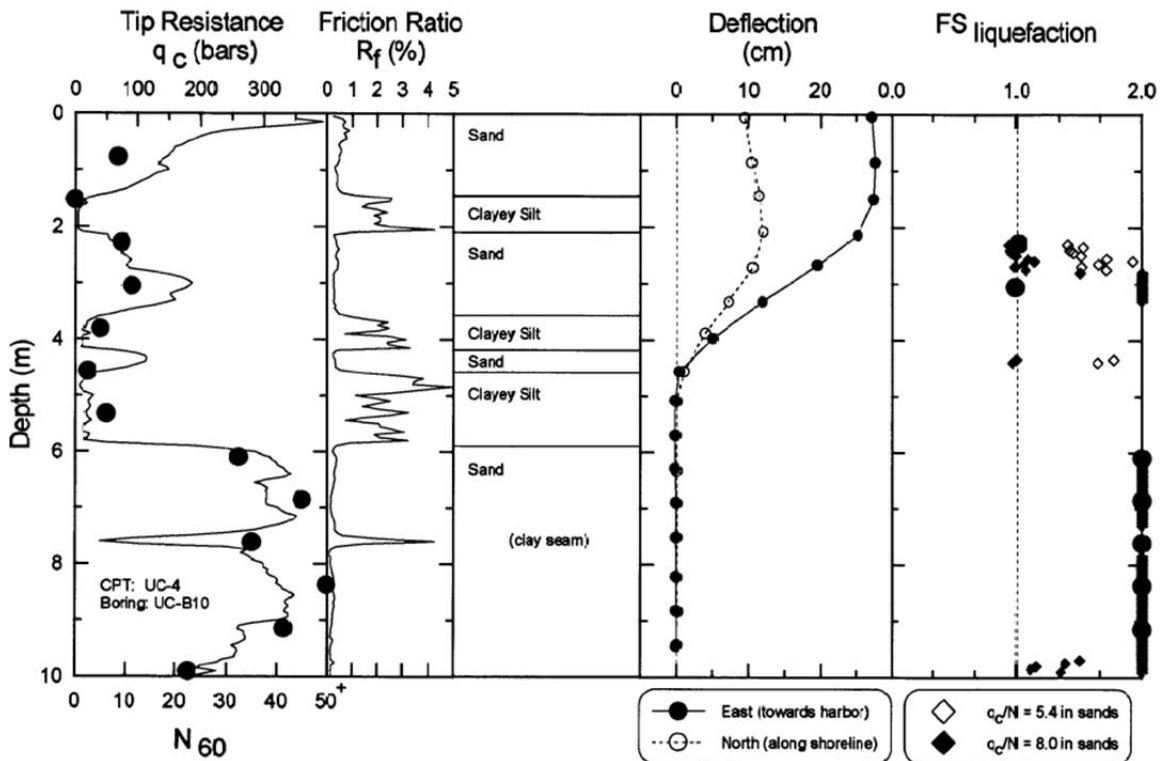
Figure 5-23. Inclinerometer S-2 measured deformation data. Data is plotted with subsurface stratigraphy from boring UC-B10 and CPT UC-4 (from Boulanger et al. 1995).

displacements of up to approximately 27 cm at the surface. Deformations extended to a depth of approximately 4.6 meters from the surface and stopped at the transition between the thin sand layer and the clayey silt layer below. The movement occurred gradually over a zone extending from a depth of approximately 1.5 m to a depth of 4.6 m rather than sliding as a block on a single slide plane as would be assumed by post-liquefaction stability analysis methods using residual strength assumptions.

Two silt layers are labeled on Figure 5-21 as 'clayey silt' and 'clayey silt seam' for the purpose of this discussion. Based on Figure 5-23, inclinometer data shows that movement occurred within the 'silt seam' but not within the 'clayey silt' layer below it. The 'clayey silt seam' may be so thin that it deformed with sand layers above and below or that the inclinometer pipe stiffness 'averaged' the deformations across thin seams of sand and silt. In deciding whether to model each silt layer with the UBCSAND or Mohr-Coulomb models, available CPT, boring, and laboratory data were evaluated in detail for each layer.

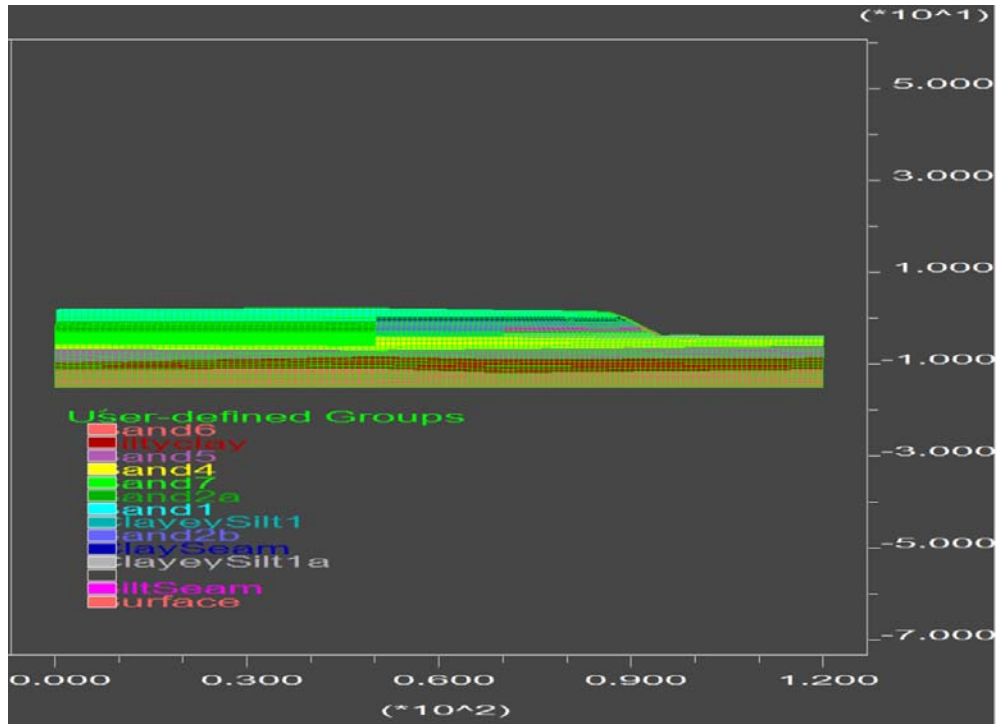
Figure 5-24. Mesh and soil groups at the site of the MBARI/Sandholdt Road lateral spread.

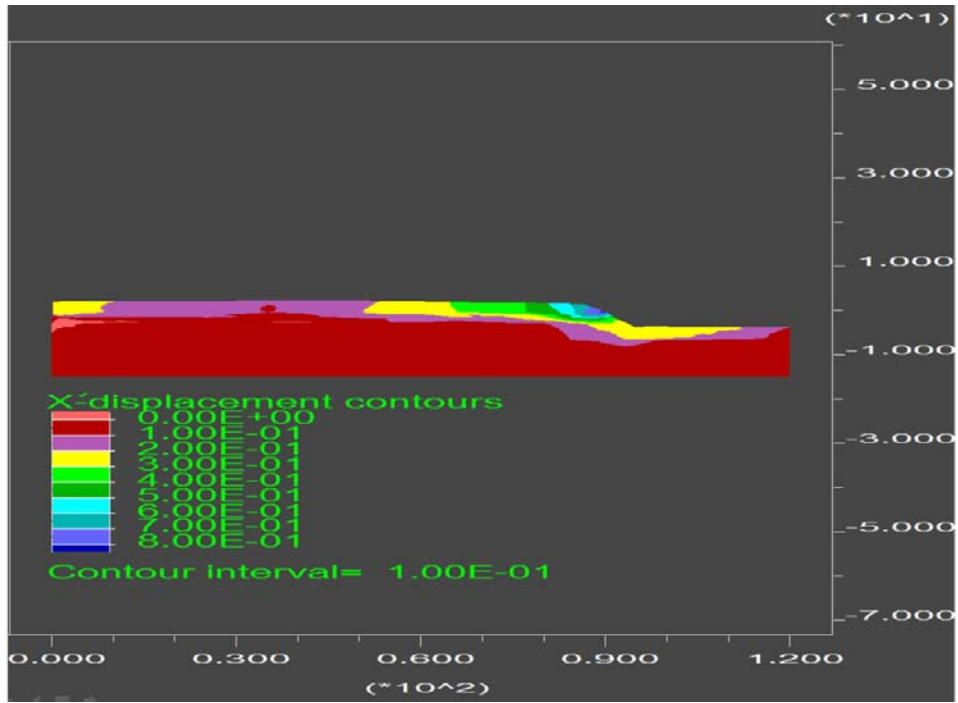
Figure 5-25. Predicted lateral displacements at MBARI/Sandholdt Road Section A-A' as predicted by Model A.

Figure 5-25 and Figure 5-27 show the resulting lateral deformations from each model. Figure 5-26 and Figure 5-28 show vectors of deformation showing both horizontal and vertical movements for Models A and B, respectively. Figure 5-29 shows the resulting deformations for each model plotted with measured inclinometer data. It can be seen that when the 'Clayey Silt' layer is modeled with the Mohr-Coulomb model, estimated deformations closely match observations. When the UBCSAND model is used to model the 'Clayey Silt' layer, the simulation calculates deformations in this layer that were not observed and as a consequence, the deformations are overestimated by a factor of about 2. As discussed previously, numerical models are not a substitute for detailed subsurface characterization as the model may be improved significantly with increased understanding of the subsurface conditions.

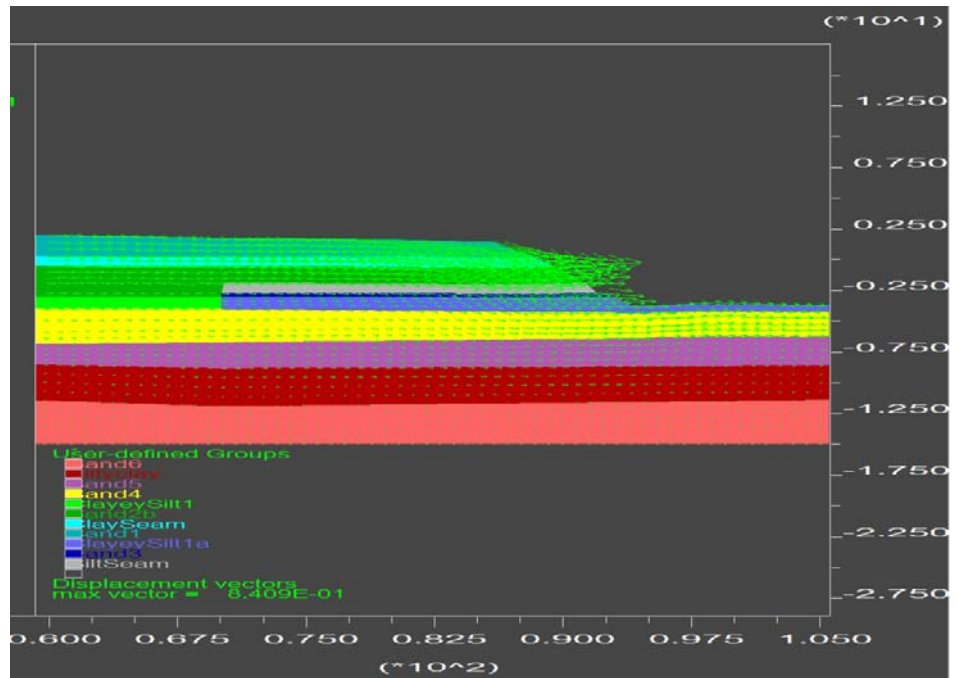
Figure 5-26.. Predicted displacement vectors plotted with soil type at MBARI/Sandholdt Road Section A-A' as predicted by Model A.

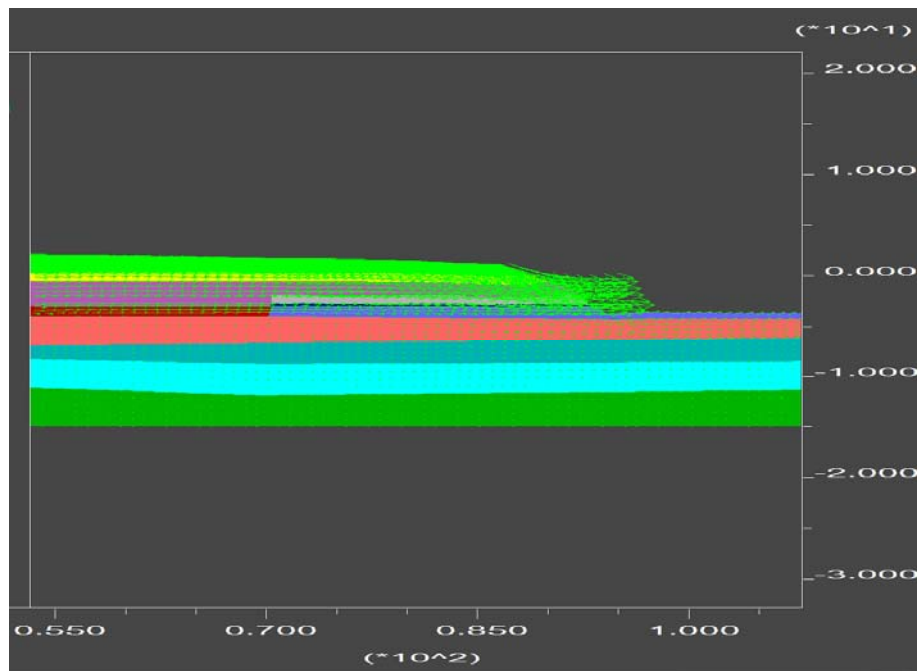
Figure 5-28. Predicted displacement vectors plotted with soil type at MBARI/Sandholdt Road Section A-A' as predicted by Model B.

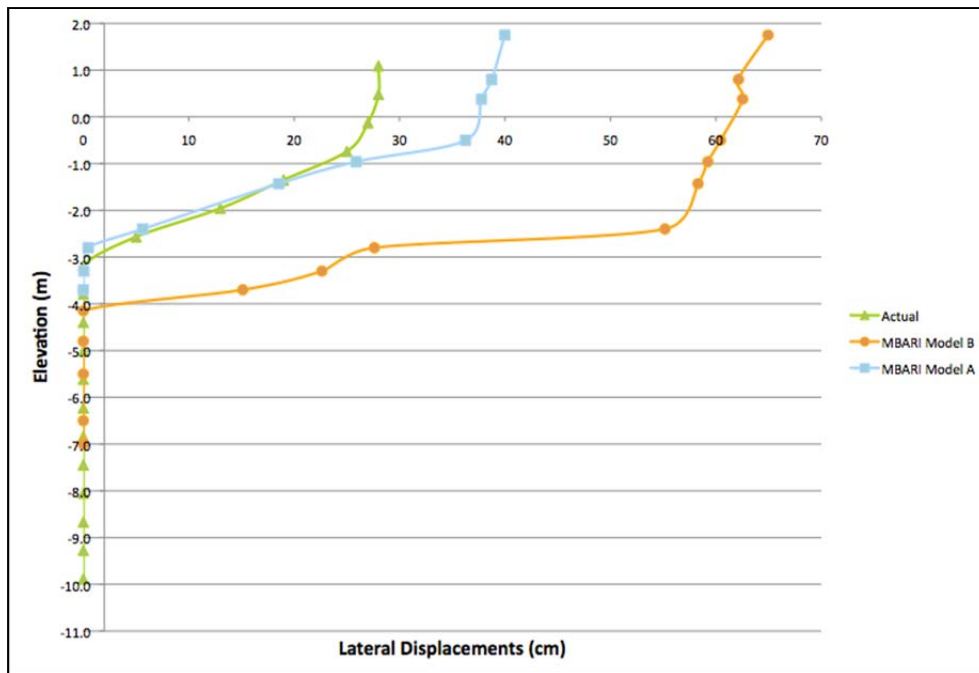
Figure 5-29. Measured and predicted lateral displacements at MBARI/Sandholdt Road. Deformations predicted by Models A and B as well as measured values are compared with depth.

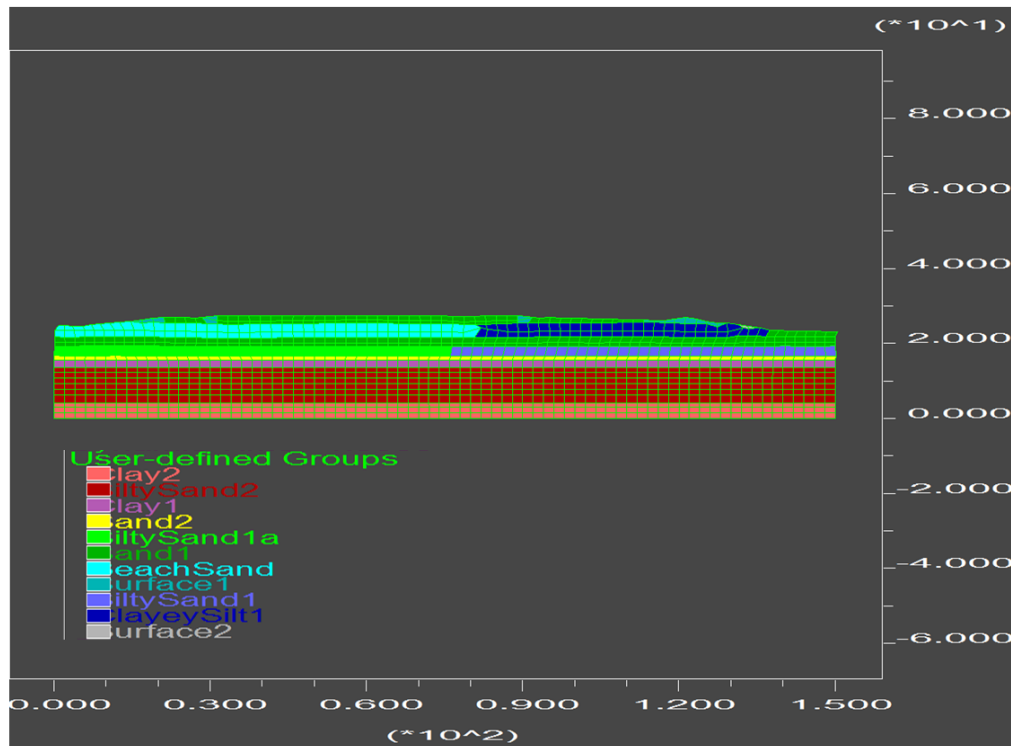
Figure 5-33. Mesh and soil types south of MLML facility (Section A-A' of Figure 5-30).

As with the MBARI facility previously discussed in Section 3.1, the Salinas ground motion record (scaled to a PGA of 0.25 g) was used to simulate ground motions at Moss Landing during the Loma Prieta earthquake. Figure 5-33 and Figure 5-36 show the mesh and layers used to model sections A-A and B-B to the south and north of the facility, respectively. Figure 5-34 and Figure 5-35 show the horizontal and vertical displacement respectively as predicted at Section A-A'. Figure 5-37 and Figure 5-38 show contours of lateral and vertical displacement predicted for Section B-B', north of the MLML structure. A plan view summary showing contours of predicted lateral displacement extrapolated from Sections A-A' and B-B' is provided as Figure 5-39. Overall, lateral displacements were captured well as the calculated lateral spread displacements of the Moss Landing spit is approximately 2.25 m on the south side of the structure and 0.85 m on the north side of the structure. Calculated vertical displacements ranged from approximately 10 to 60 cm. Measured values of vertical displacements generally fall into this range.

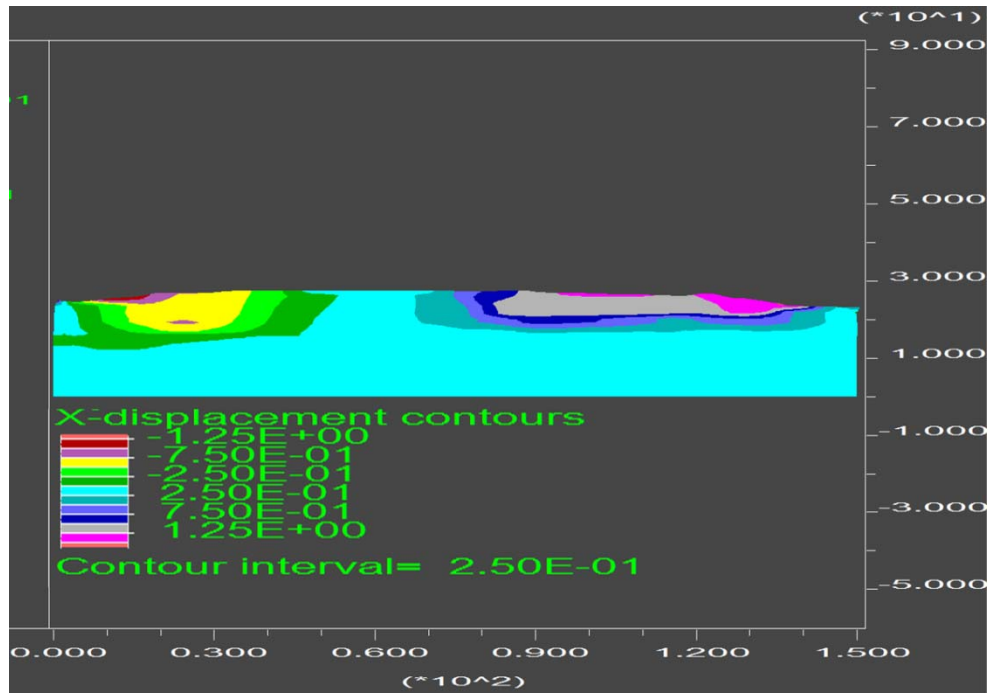
Figure 5-34. Predicted lateral displacements south of MLML facility (Section A-A' of Figure 5-30).

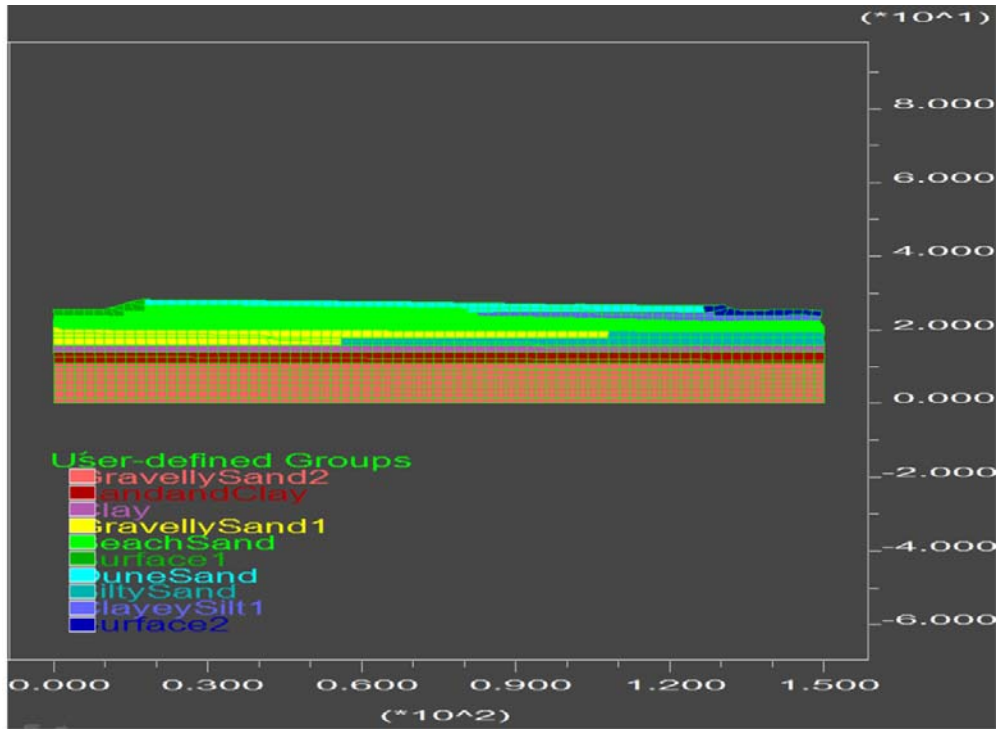
Figure 5-36. Mesh and soil types north of MLML facility (Section B-B' of Figure 5-30).

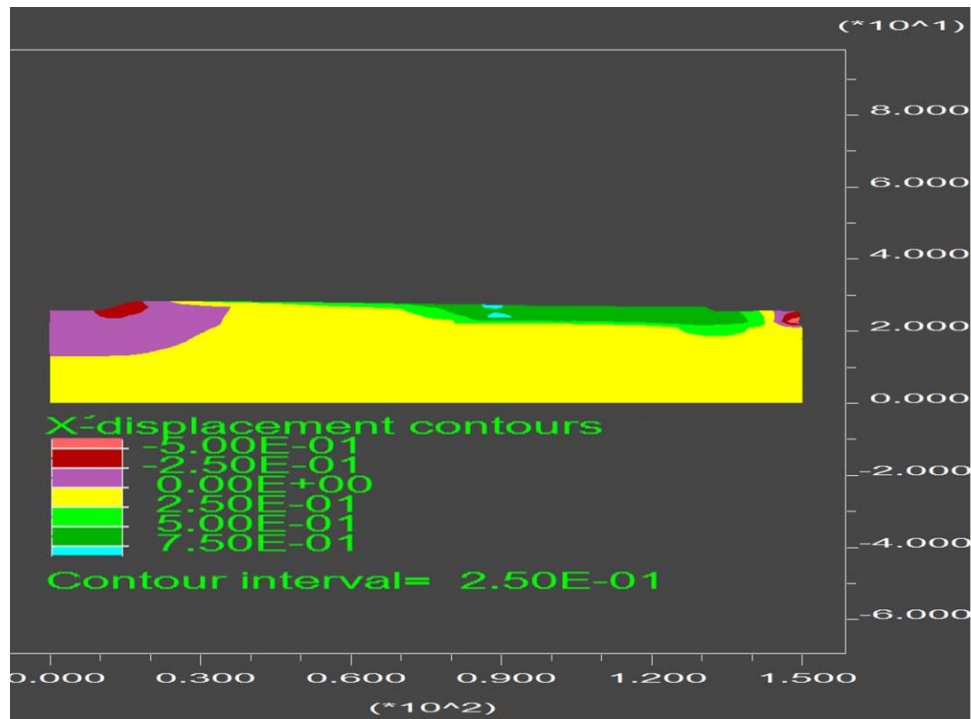
Figure 5-37. Predicted lateral displacements north of MLML facility (Section B-B' of Figure 5-30).

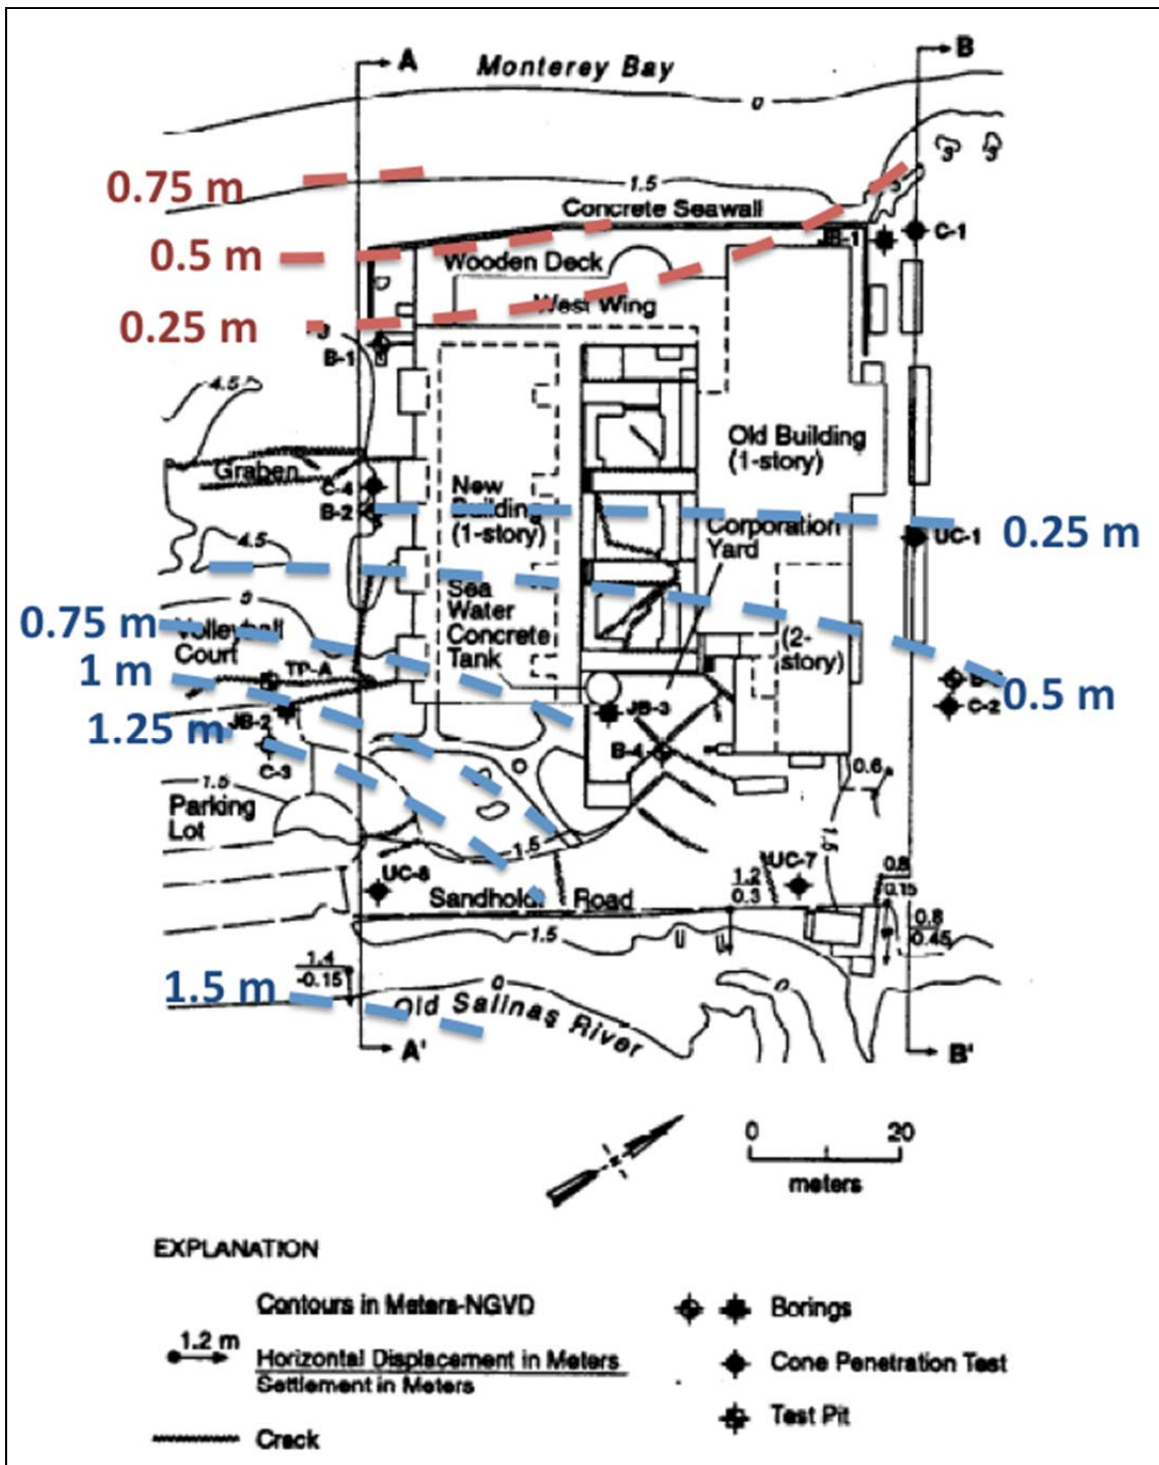
Figure 5-39.. Measured and predicted lateral deformations at the MLML Facility during the Loma Prieta Earthquake in 1989. Blue contours represent movement to the east toward the Old Salinas River. Red contours represent movement to the west toward the Monterey Bay. Prediction contours based on extrapolations from models performed at Sections A and B.

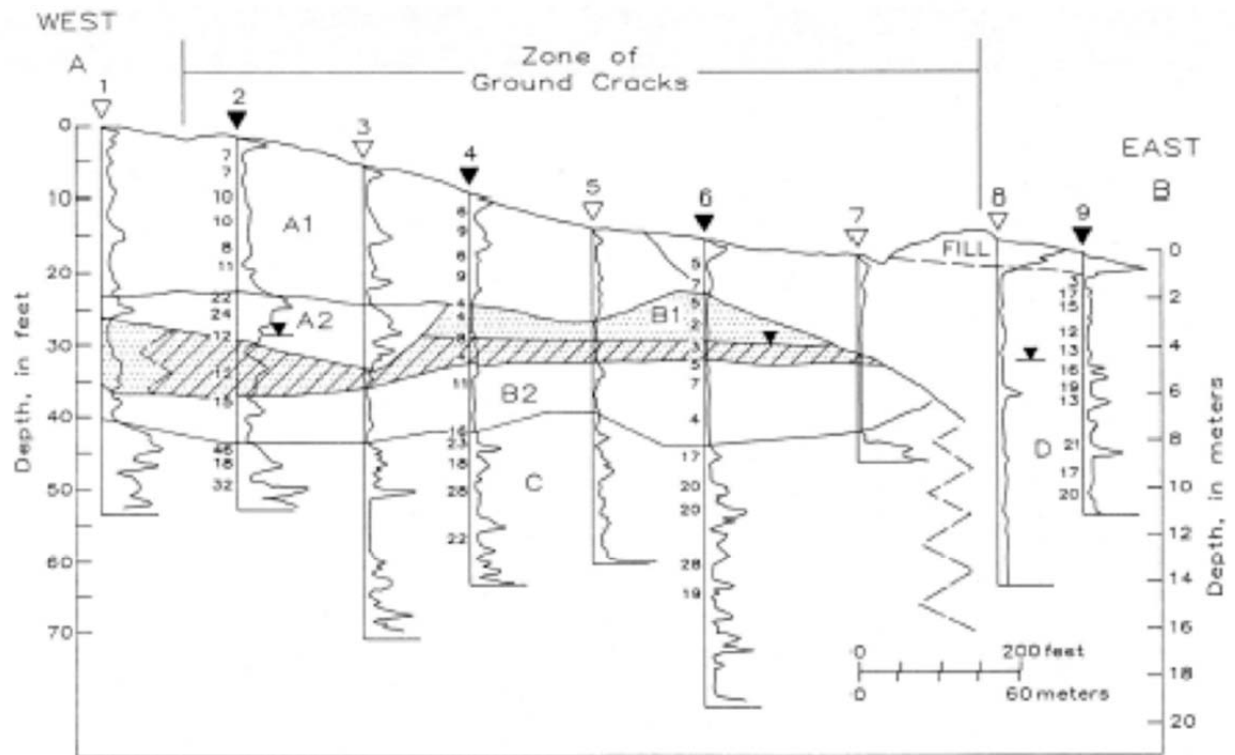
- Subunit B1
- Zone of sediment having low resistance to liquefaction
- Contact between informal sediment units
- Water table
- 3 Site and number of sounding for cone penetration test
- 6 Site and number of sounding for cone and standard penetration tests

Figure 5-44. Subsurface profile at Juvenile Hall (Bennett, 1989).

Four alluvium units, labeled A through D are shown in subsurface profiles on Figure 5-44 and Figure 5-45. Unit A consists of a 2-7 m layer of poorly sorted, loose to medium-dense silty sand located above the groundwater table. Underlying Unit A is Unit B, 2-5 m layer of very loose to loose, poorly sorted silty sand to silt. Unit C consists of medium-dense to dense, poorly sorted silty sand, while Unit D consists of stiff clayey silt. Liquefaction initiation analyses performed by Faris (2004) confirmed that the loose, saturated silty sand and sandy silt within Unit B was likely to have liquefied during the event. The precise locations of the geologic sections shown on Figure 5-44 and Figure 5-45 were not included in Faris (2004). The approximate location of the section was interpreted from the topographic map included as Figure 5-41 and the exploratory point locations shown on Figure 5-43.

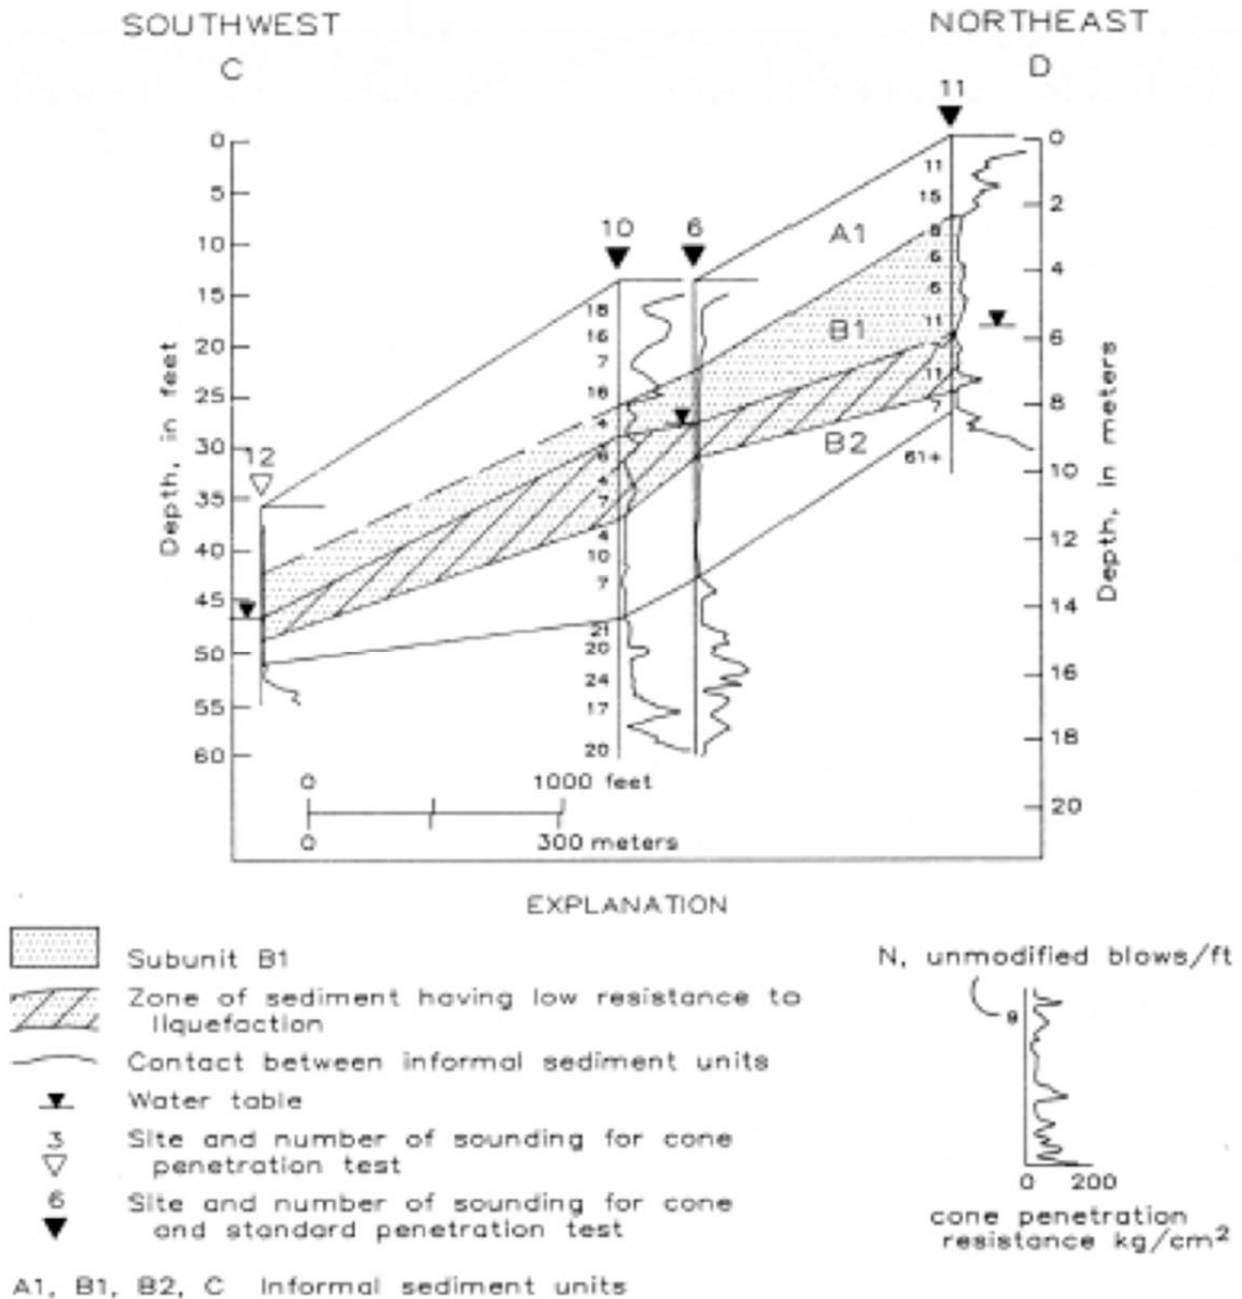
Figure 5-45.. Subsurface profile at Juvenile Hall (Bennett, 1989).

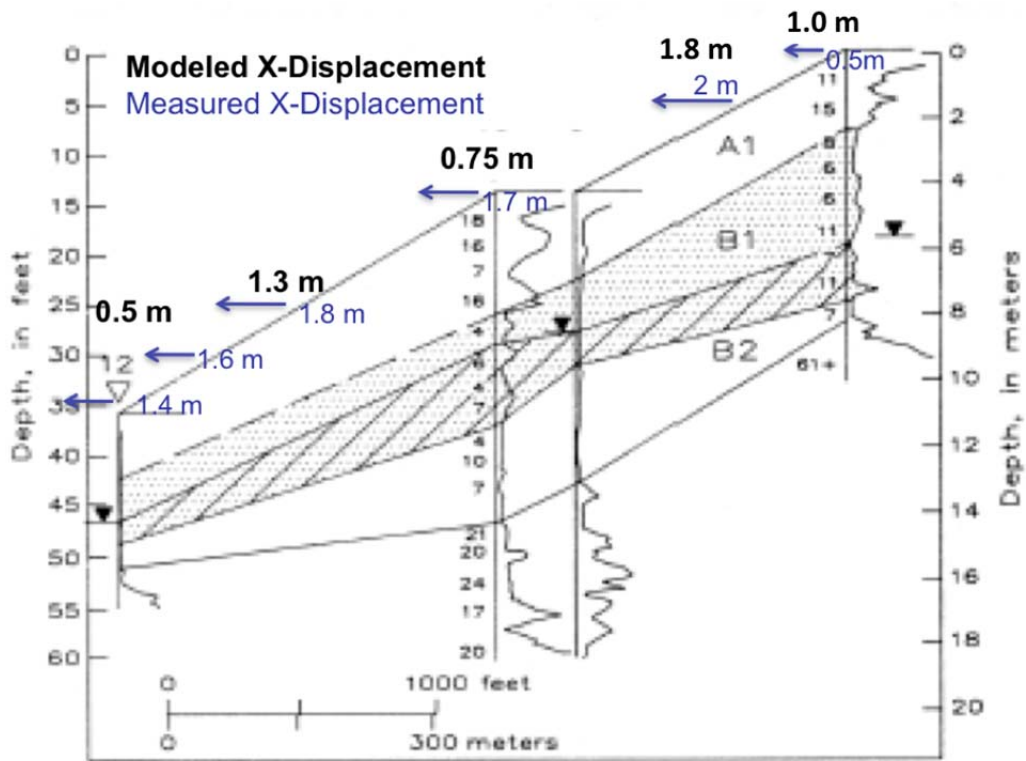
Figure 5-49. Measured and predicted lateral deformations at Juvenile Hall following the San Fernando earthquake of 1971 (modified from Bennett, 1989).

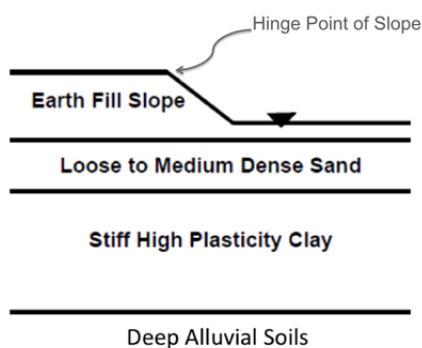
After the back-analyses of the aforementioned case histories were performed, forward modeling of a simplified embankment section allowed for the use of the calibrated FLAC/UBCSAND model in calculating liquefaction-induced deformations under seismic loading in a limited lateral spread condition. The simplified baseline model is shown in Figure 6-1.

Figure 6-1. Simplified Embankment Model.

slope, or the location of a dramatic change in slope near the top of the embankment (Figure 6-1). The backward-directivity motion shows significantly less lateral displacement for this case, especially at a blow count of 8. Figure 6-3 shows the variation in calculated lateral displacement at this point for two values of  $(N_1)_{60}$  for the cases wherein the liquefiable soil is a clean sand or a low plasticity silt. For this model, the variation in lateral displacement is modest.
