Static and Seismic Performance of California Levees

Michelle Jennifer Shriro

Doctor of Philosophy

Engineering - Civil and Environmental Engineering

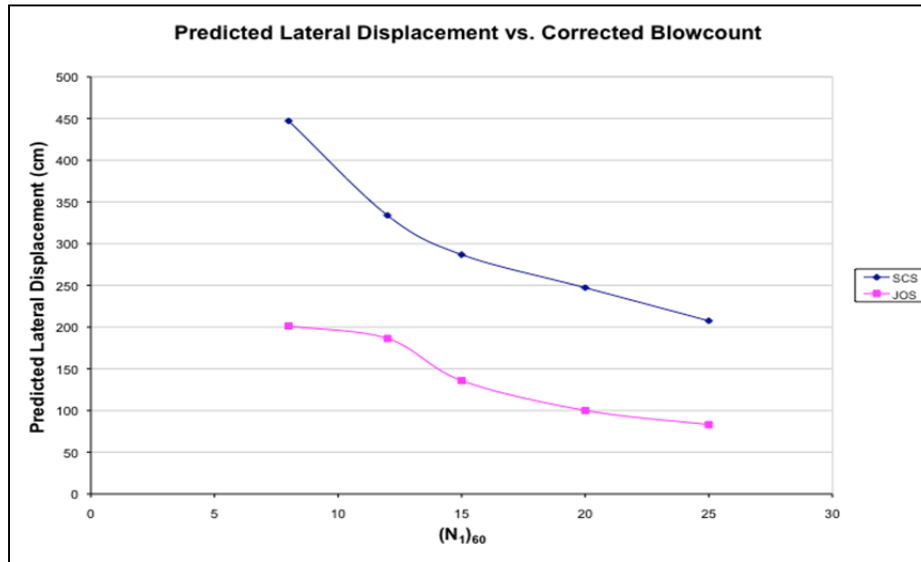
Figure 6-2. Comparisons of predicted response of ‘clean sand’ over similar blow count range but loaded with different ground motions. Data points marked ‘SCS’ were calculated using the 1994 Northridge Sylmar Converter Station motion (blue) and those labeled ‘JOS’ were calculated using the 1992 Landers Joshua Tree motion (pink).

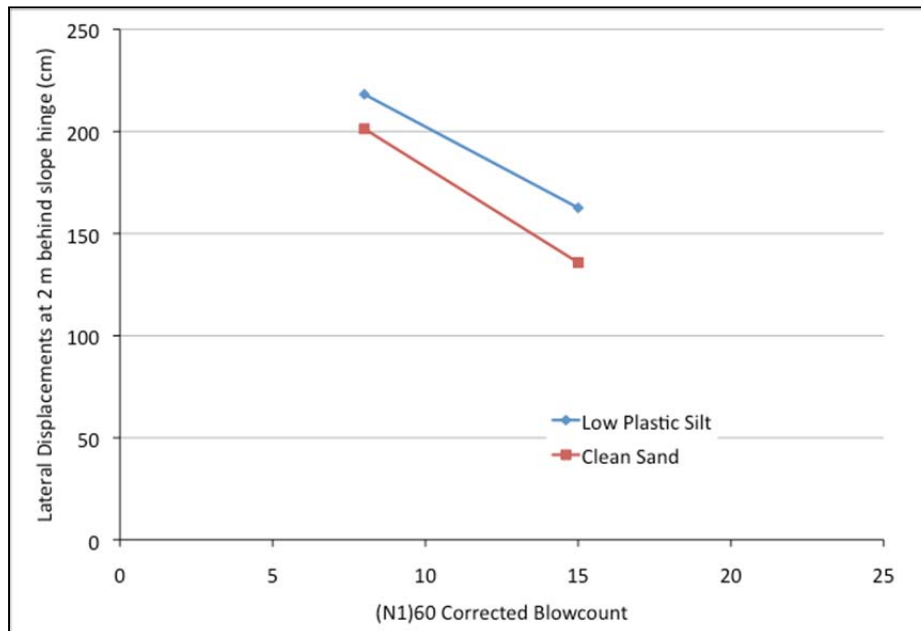
Figure 6-3. Predicted Lateral Displacement of ‘low plasticity silt’ and ‘clean sand’ as a function of blow count. Data was calculated using the 1992 Landers Joshua Tree motion.

slope, or the location of a dramatic change in slope near the top of the embankment (Figure 6-1). The backward-directivity motion shows significantly less lateral displacement for this case, especially at a blow count of 8. Figure 6-3 shows the variation in calculated lateral displacement at this point for two values of  $(N_1)_{60}$  for the cases wherein the liquefiable soil is a clean sand or a low plasticity silt. For this model, the variation in lateral displacement is modest.

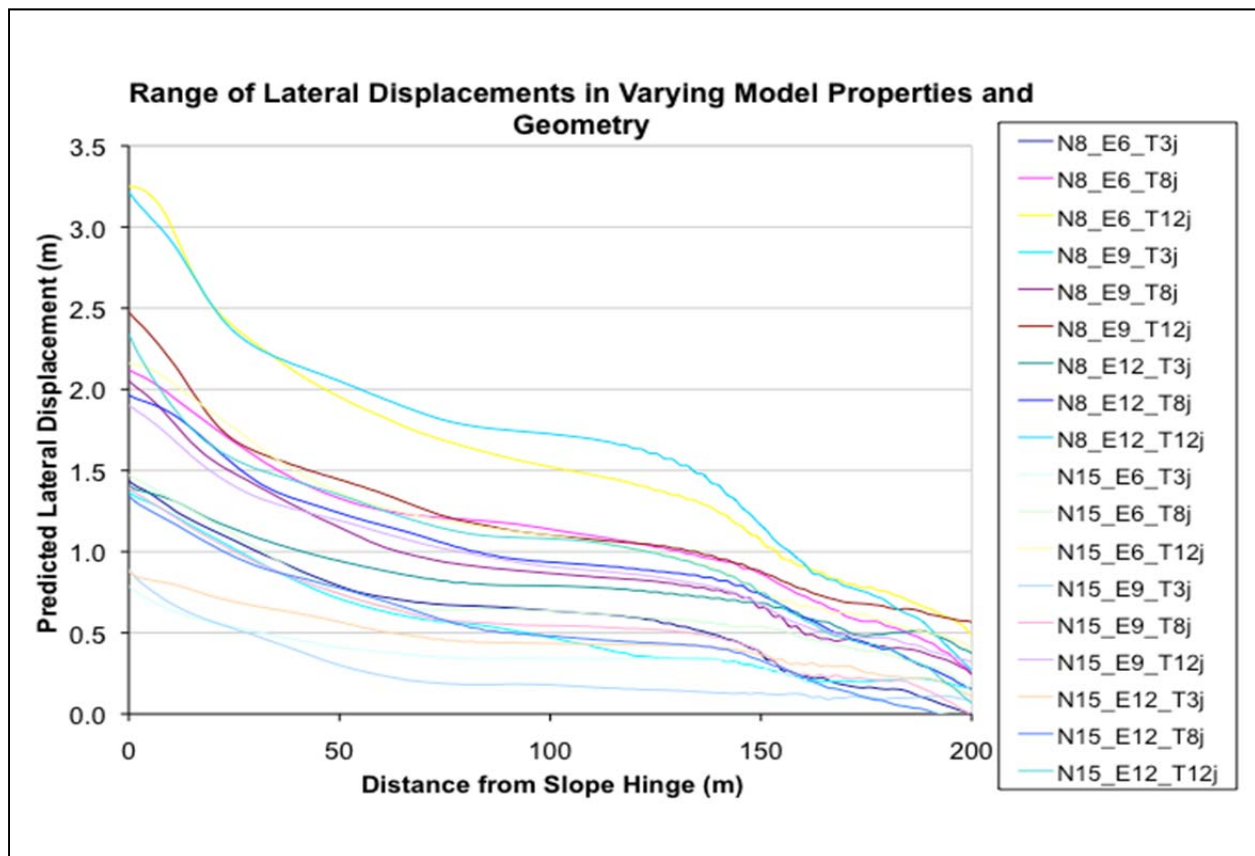
Figure 6-4. Range in liquefaction-induced lateral displacement with distance from the slope hinge point for the 1992 Landers Joshua Tree ground motion.

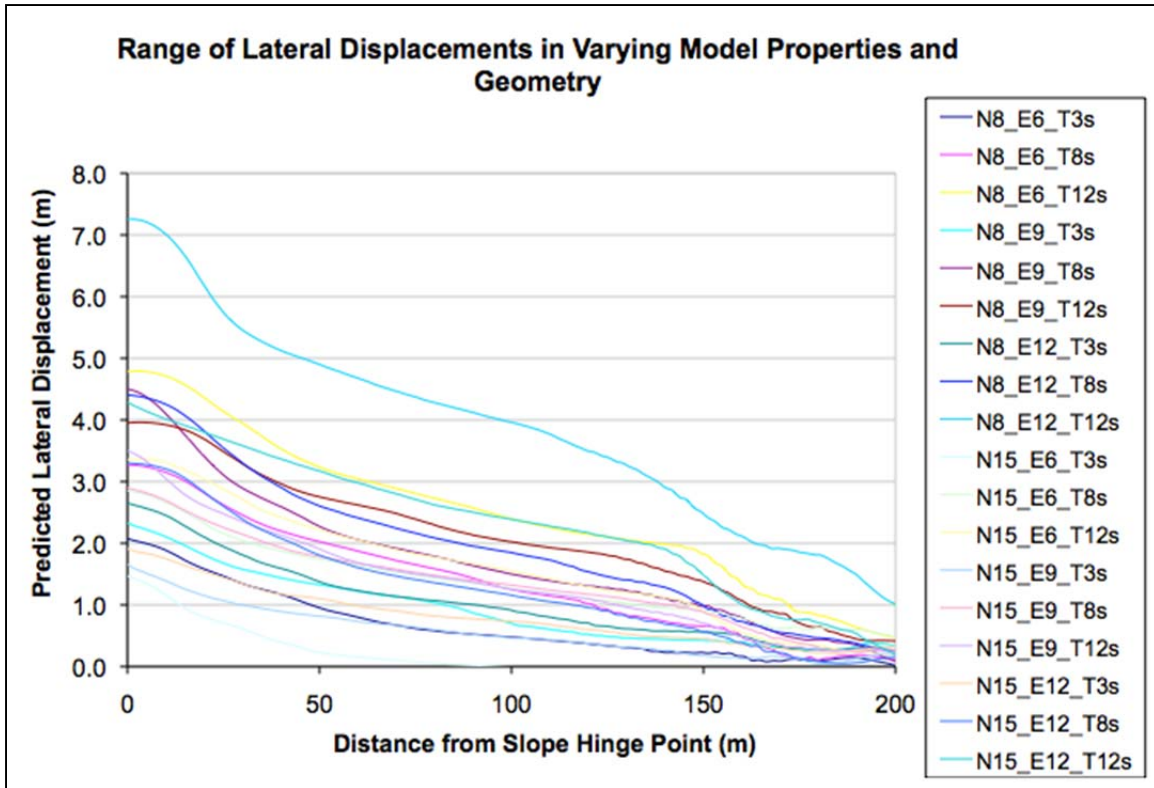
Figure 6-5. Range in liquefaction-induced lateral displacement with distance from the slope hinge point for the 1994 Northridge Sylmar Converter Station ground motion.

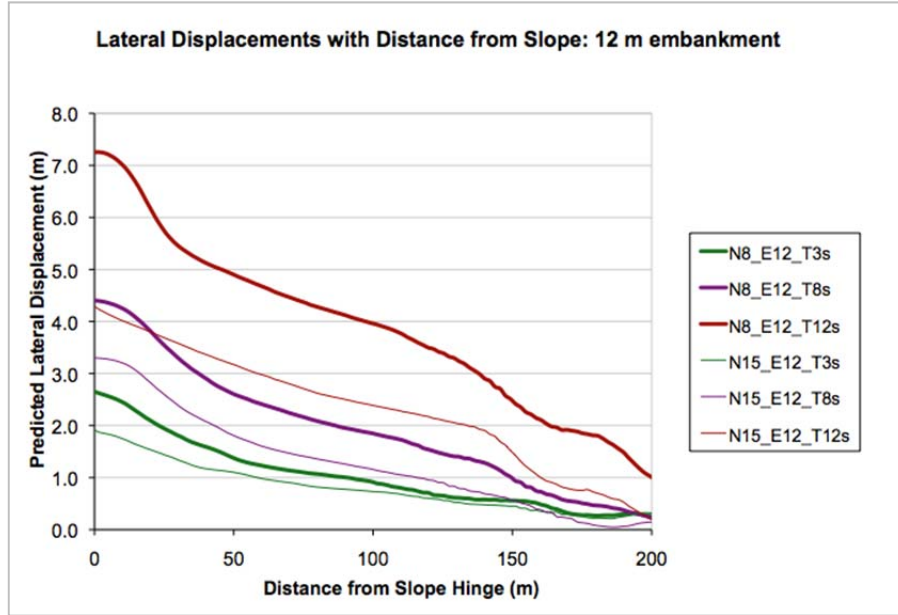
Figure 6-7. Calculated lateral displacements with distance from a slope hinge point for an embankment 12 m high founded on a sand layer of variable thickness and with  $(N_1)_{60}$  blow count value of 8 and 15. (Ground Motion: 1994 Northridge Sylmar Converter Station).

Layer thickness was found to have a significant impact on deformations. Figure 6-7 through Figure 6-12 show comparisons of models with the same embankment height and density of loose to medium dense sand, but with different thicknesses of liquefiable sand. The effects of increasing the layer thickness of the liquefiable soils can be significant. For example, increasing layer thickness while decreasing blow count can increase deformations to over 7 m as shown on Figure 6-7.

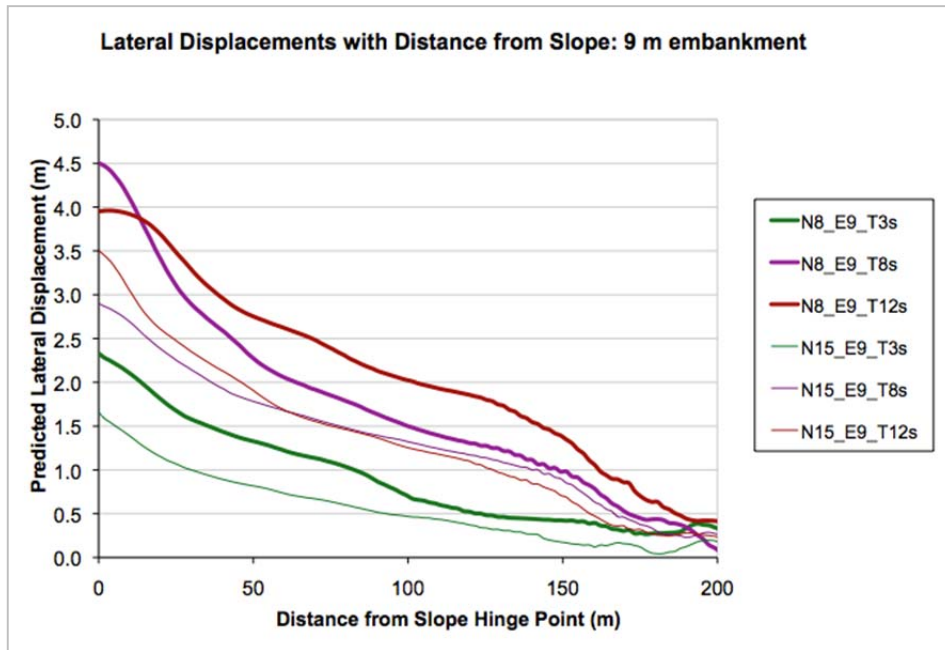
Figure 6-8. Calculated lateral displacements with distance from a slope hinge point for an embankment 9 m high founded on a sand layer of variable thickness and with  $(N_1)_{60}$  blow count value of 8 and 15. (Ground Motion: 1994 Northridge Sylmar Converter Station).

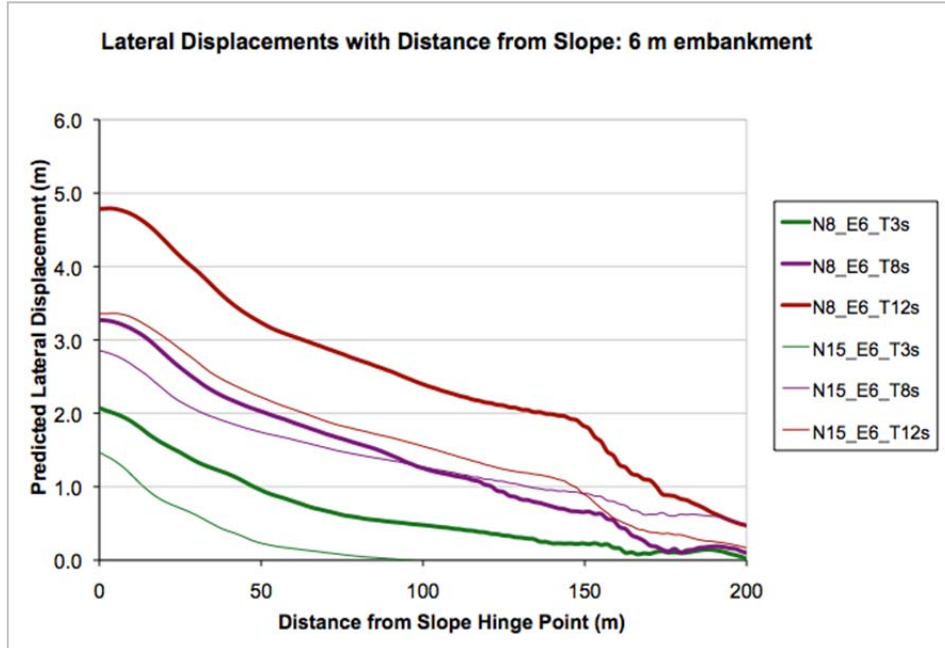
Figure 6-9. Calculated lateral displacements with distance from a slope hinge point for an embankment 6 m high founded on a sand layer of variable thickness and with  $(N_1)_{60}$  blow count value of 8 and 15. (Ground Motion: 1994 Northridge Sylmar Converter Station).

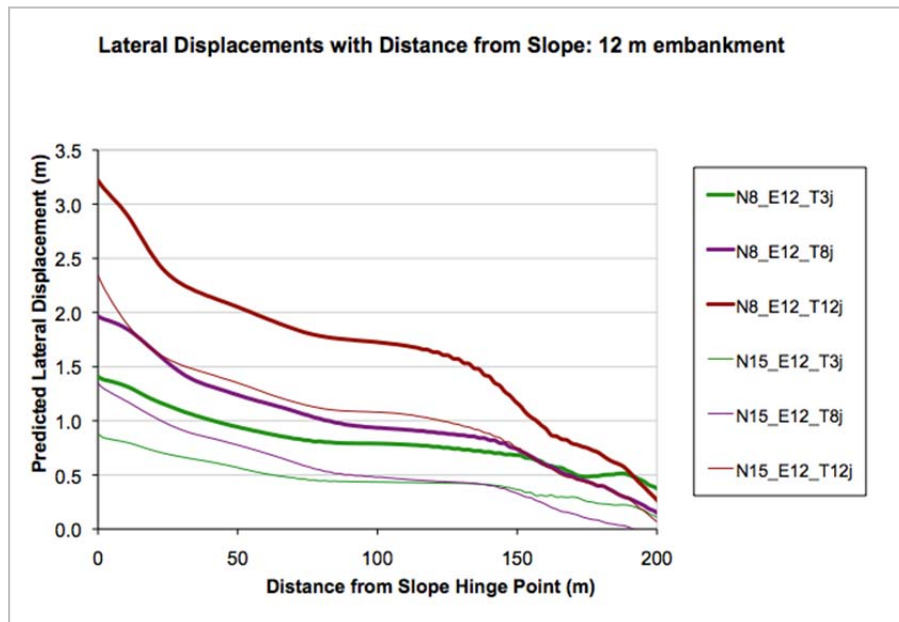
Figure 6-10. Calculated lateral displacements with distance from a slope hinge point for an embankment 12 m high founded on a sand layer of variable thickness and with  $(N_1)_{60}$  blow count value of 8 and 15. (Ground Motion: 1992 Landers Joshua Tree).

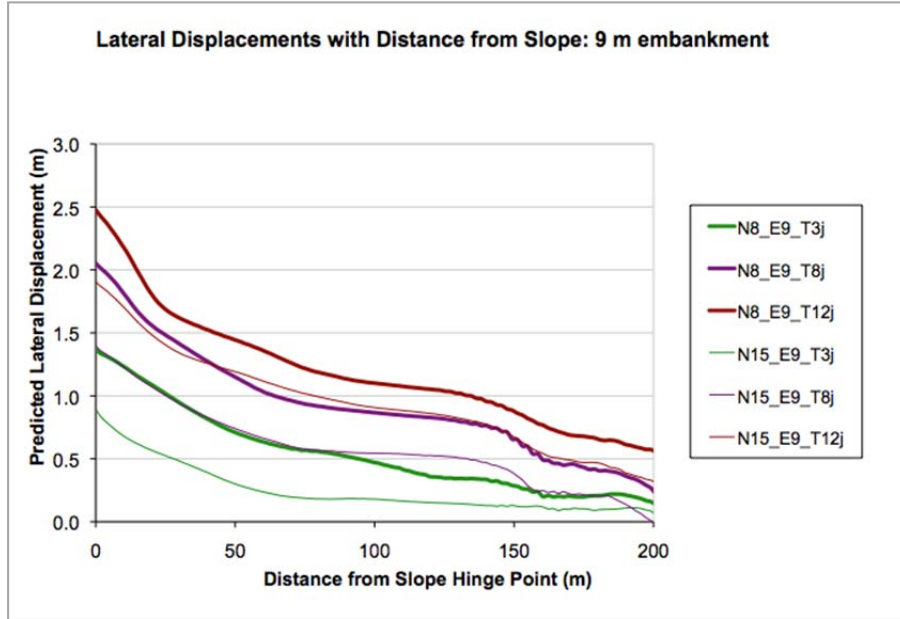
Figure 6-11. Calculated lateral displacements with distance from a slope hinge point for an embankment 9 m high founded on a sand layer of variable thickness and with  $(N_1)_{60}$  blow count value of 8 and 15. (Ground Motion: 1992 Landers Joshua Tree).

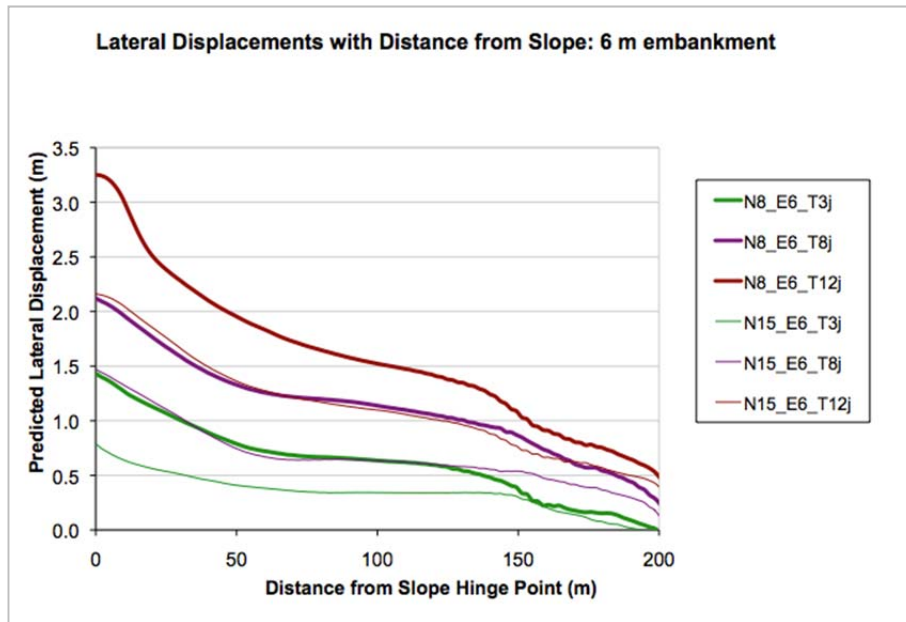
Figure 6-12. Calculated lateral displacements with distance from a slope hinge point for an embankment 6 m high founded on a sand layer of variable thickness and with  $(N_1)_{60}$  blow count value of 8 and 15. (Ground Motion: 1992 Landers Joshua Tree).

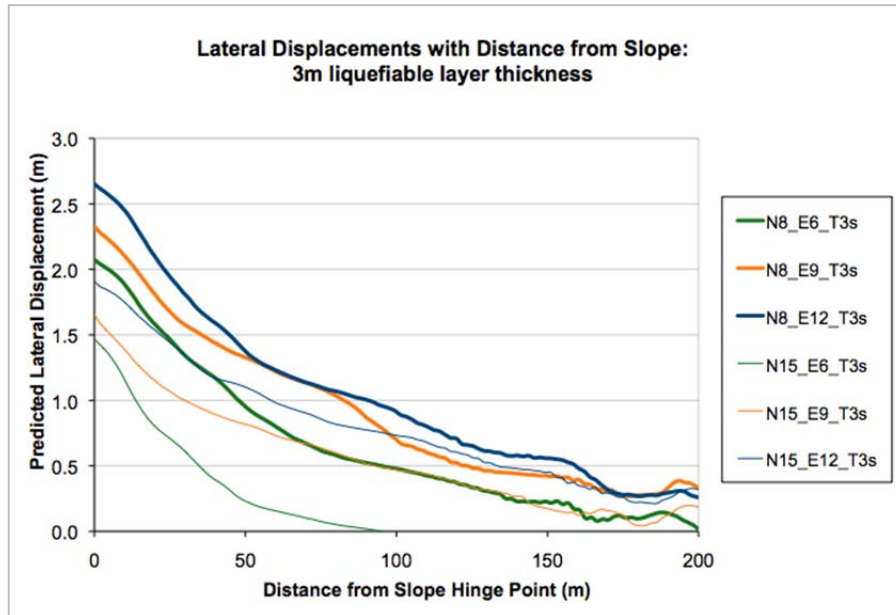
Figure 6-13. Calculated lateral displacements with distance from a slope hinge point for a variable height embankment over 3 m of liquefiable foundation soils with  $(N_1)_{60}$  blow count value of 8 and 15. (Ground Motion: 1994 Northridge Sylmar Converter Station).

The embankment height of the model had a relatively minor effect on the calculated seismic displacement, though the effect became more pronounced when combined with a thicker zone of liquefiable foundation soils. Results are shown in Figure 6-13 to Figure 6-18.

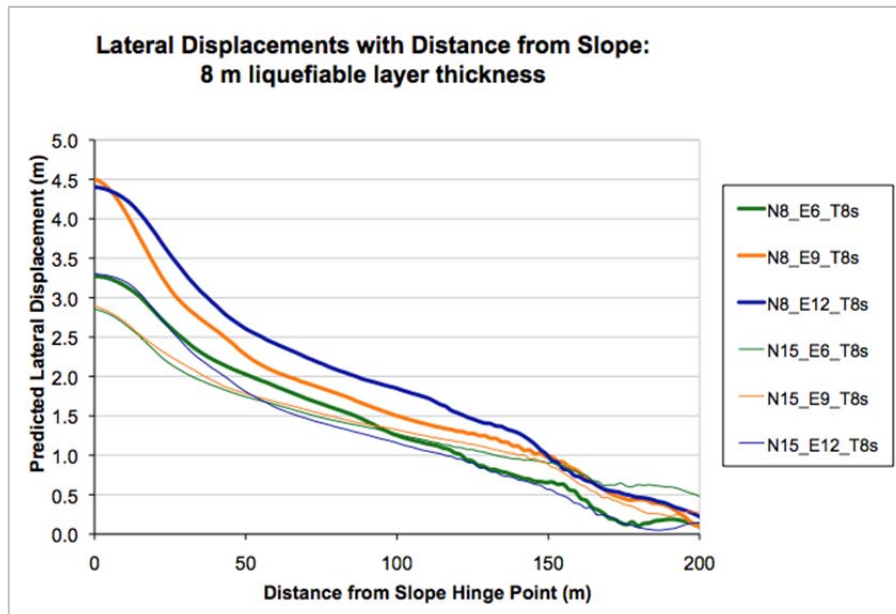
Figure 6-14. Calculated lateral displacements with distance from a slope hinge point for a variable height embankment over 8 m of liquefiable foundation soils with  $(N_1)_{60}$  blow count value of 8 and 15. (Ground Motion: 1994 Northridge Sylmar Converter Station).

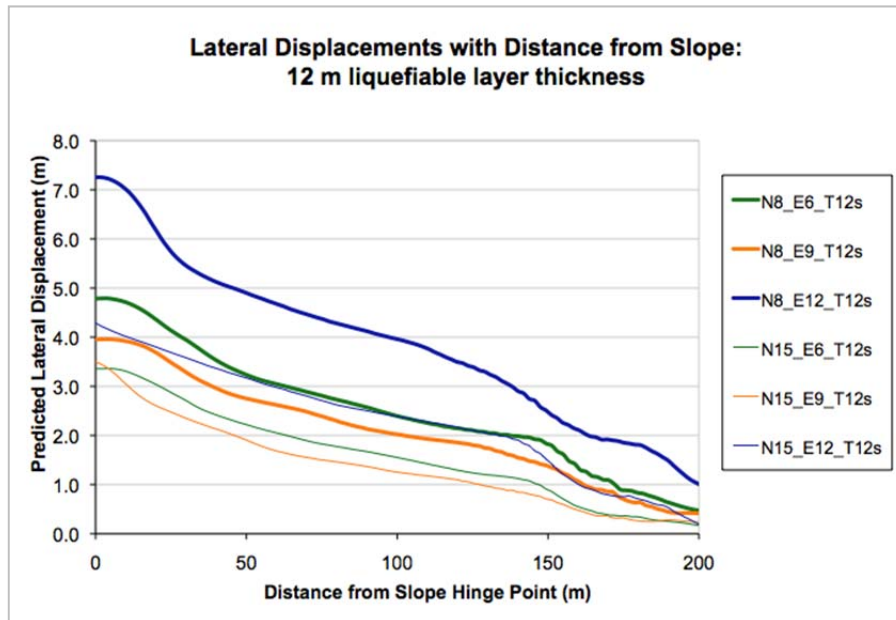
Figure 6-15. Calculated lateral displacements with distance from a slope hinge point for a variable height embankment over 12 m of liquefiable foundation soils with  $(N_1)_{60}$  blow count value of 8 and 15. (Ground Motion: 1994 Northridge Sylmar Converter Station).

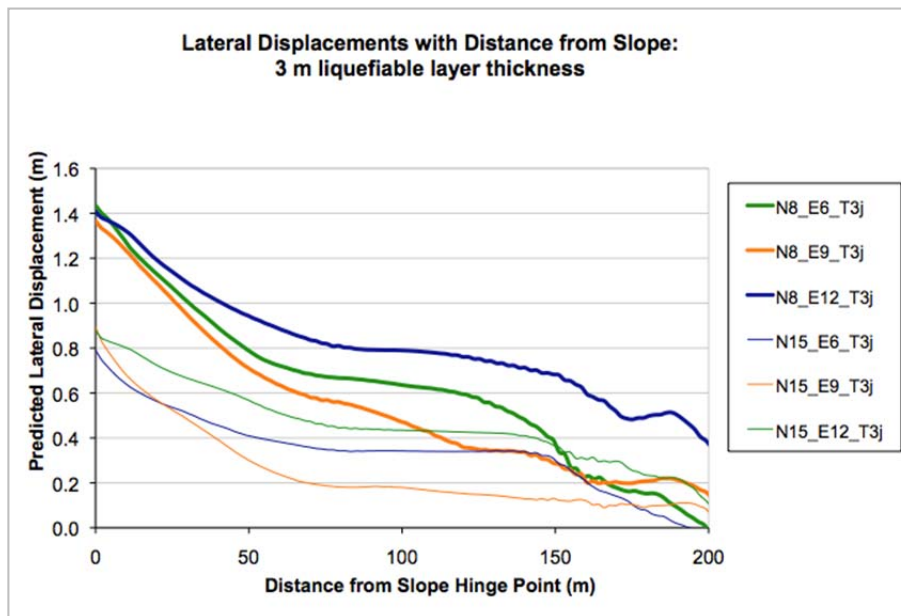
Figure 6-16. Calculated lateral displacements with distance from a slope hinge point for a variable height embankment over 3 m of liquefiable foundation soils with  $(N_1)_{60}$  blow count value of 8 and 15. (Ground Motion: 1992 Landers Joshua Tree).

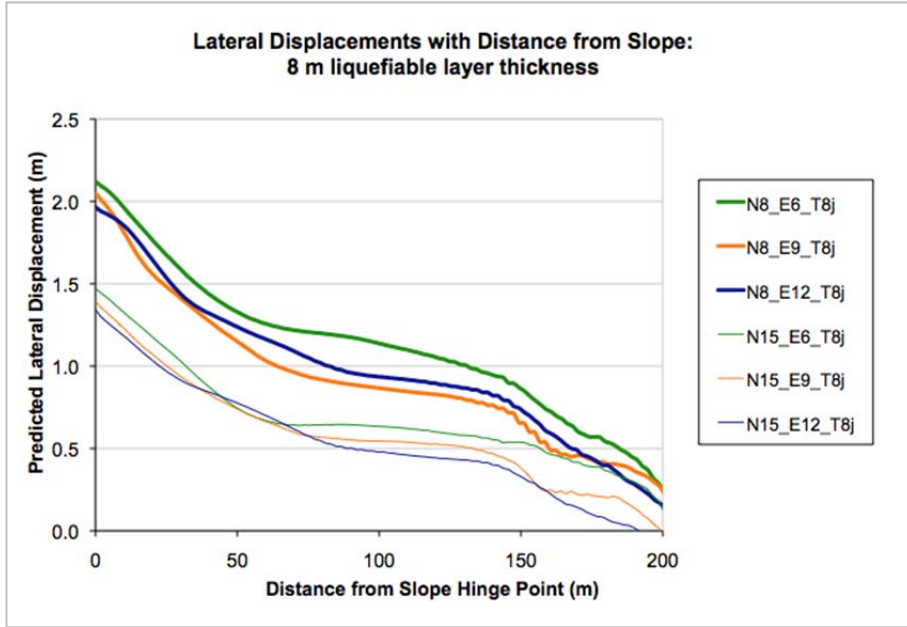
Figure 6-17. Calculated lateral displacements with distance from a slope hinge point for a variable height embankment over 8 m of liquefiable foundation soils with  $(N_1)_{60}$  blow count value of 8 and 15. (Ground Motion: 1992 Landers Joshua Tree).

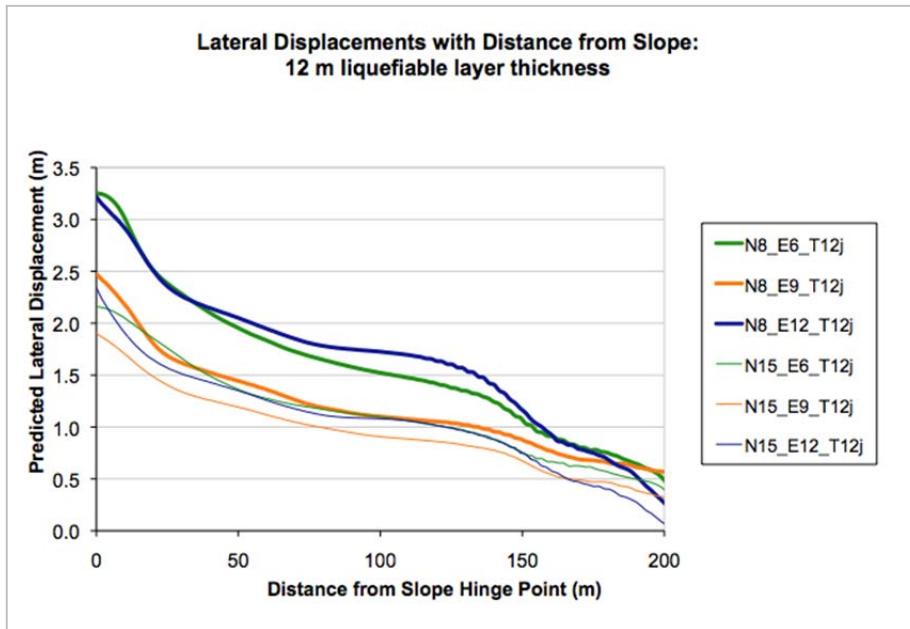
Figure 6-18. Calculated lateral displacements with distance from a slope hinge point for a variable height embankment over 12 m of liquefiable foundation soils with  $(N_1)_{60}$  blow count value of 8 and 15. (Ground Motion: 1992 Landers Joshua Tree).

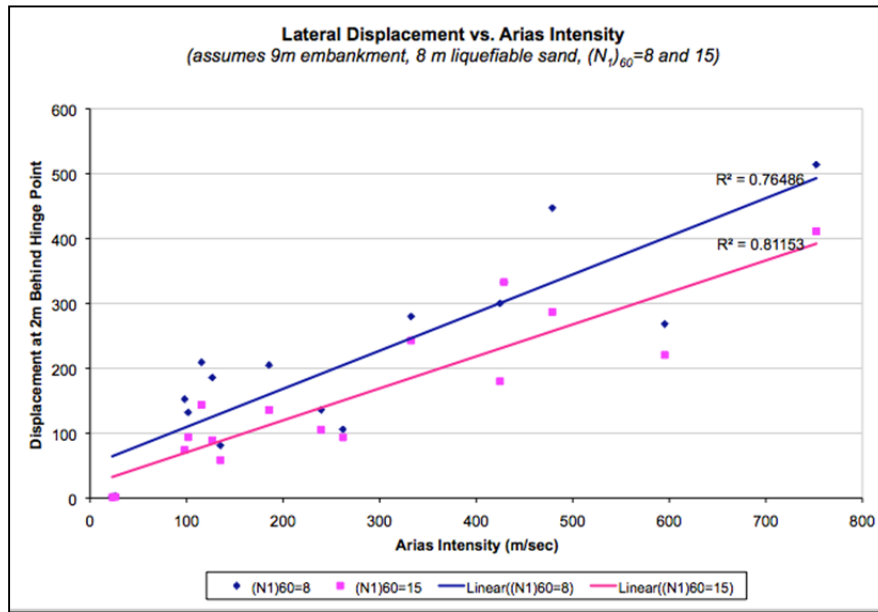
Figure 6-19. Calculated liquefaction-induced lateral displacement (cm) as a function of the Arias Intensity of the input earthquake ground motion.

Table 6-1 and Table 6-2 provide additional information for each ground motion. Table 6-3 presents the calculated lateral and vertical displacements at a distance of approximately 2 m behind the slope hinge point for each ground motion. Arias intensity proved to correlate well with predicted displacement, as shown in Figure 6-19. Peak ground acceleration (PGA) was found to have a weaker correlation with the predicted displacements, as shown in Figure 6-20. Figure 6-21 and Figure 6-22 show calculated displacements plotted with the peak ground velocity (PGV) and the square of the PGV. Arias intensity provides the best fit with displacement as can be seen below.

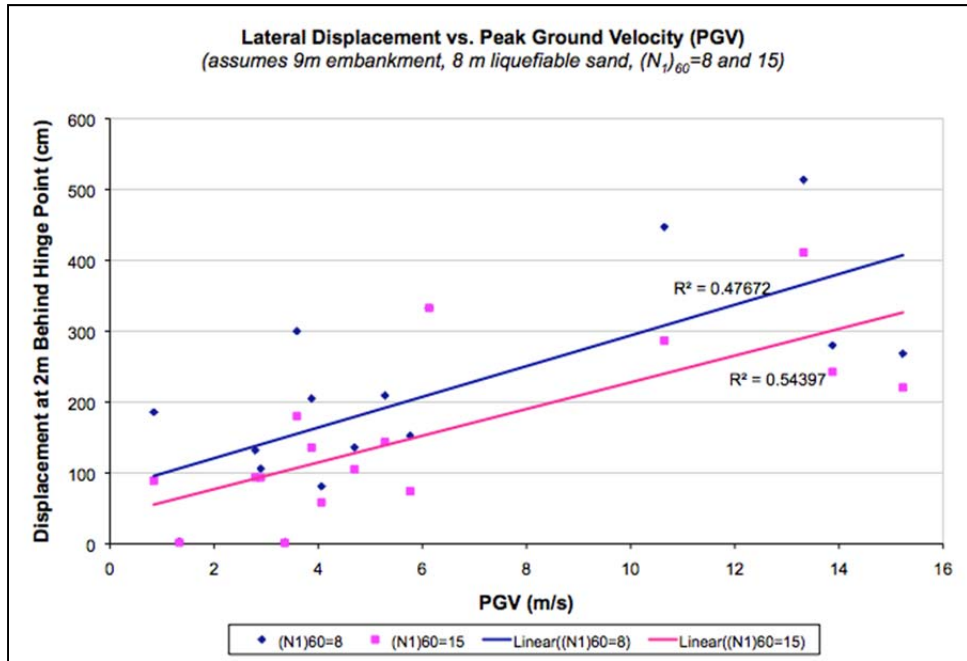
Figure 6-20. Calculated liquefaction-induced lateral displacement as a function of the peak ground acceleration of the input earthquake ground motion.

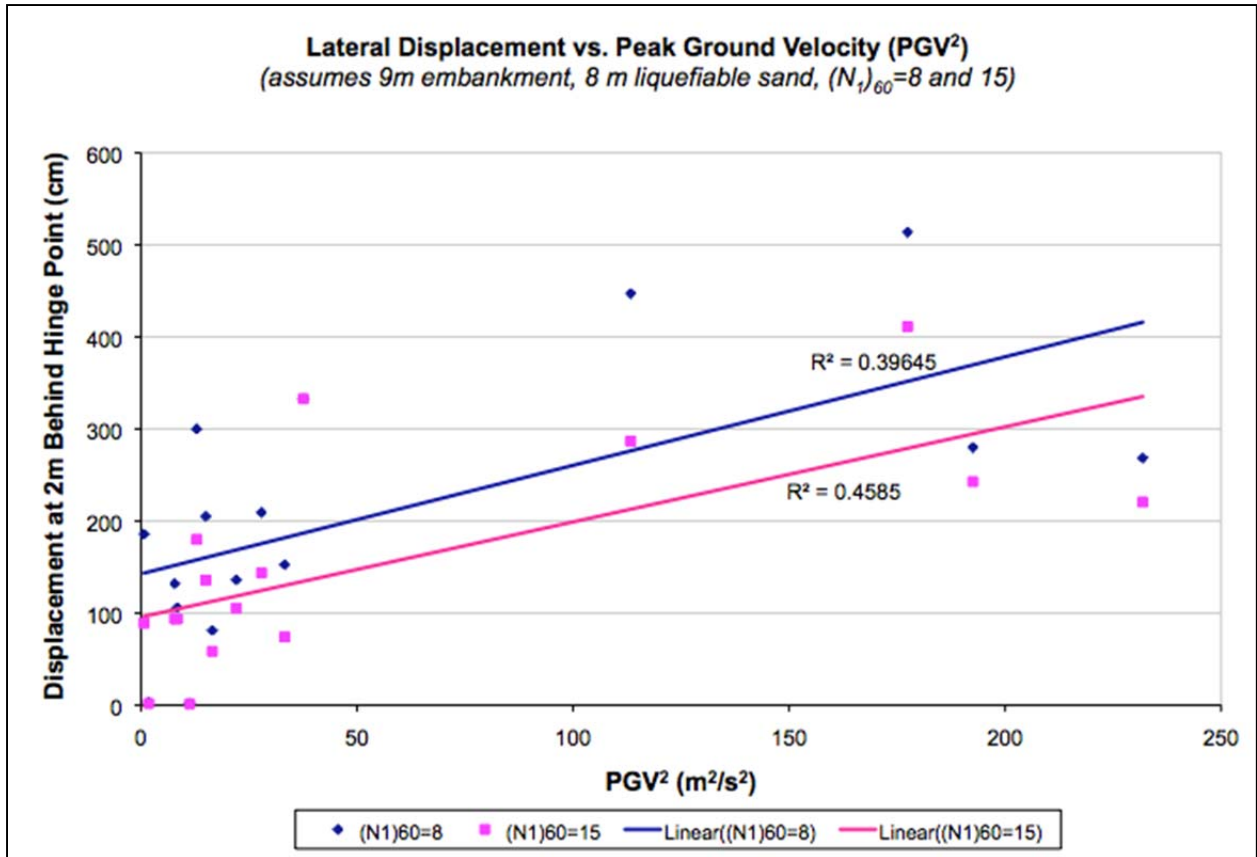
Figure 6-21. Calculated liquefaction-induced lateral displacement as a function of the peak ground velocity of the input earthquake ground motion.

Figure 6-22. Calculated liquefaction-induced lateral displacement as a function of the square of the peak ground velocity of the input earthquake ground motion.

FIGURE 6-22. CALCULATED LIQUEFACTION-INDUCED LATERAL DISPLACEMENT AS A FUNCTION OF THE SQUARE OF THE PEAK GROUND VELOCITY OF THE INPUT EARTHQUAKE GROUND MOTION. ....	382

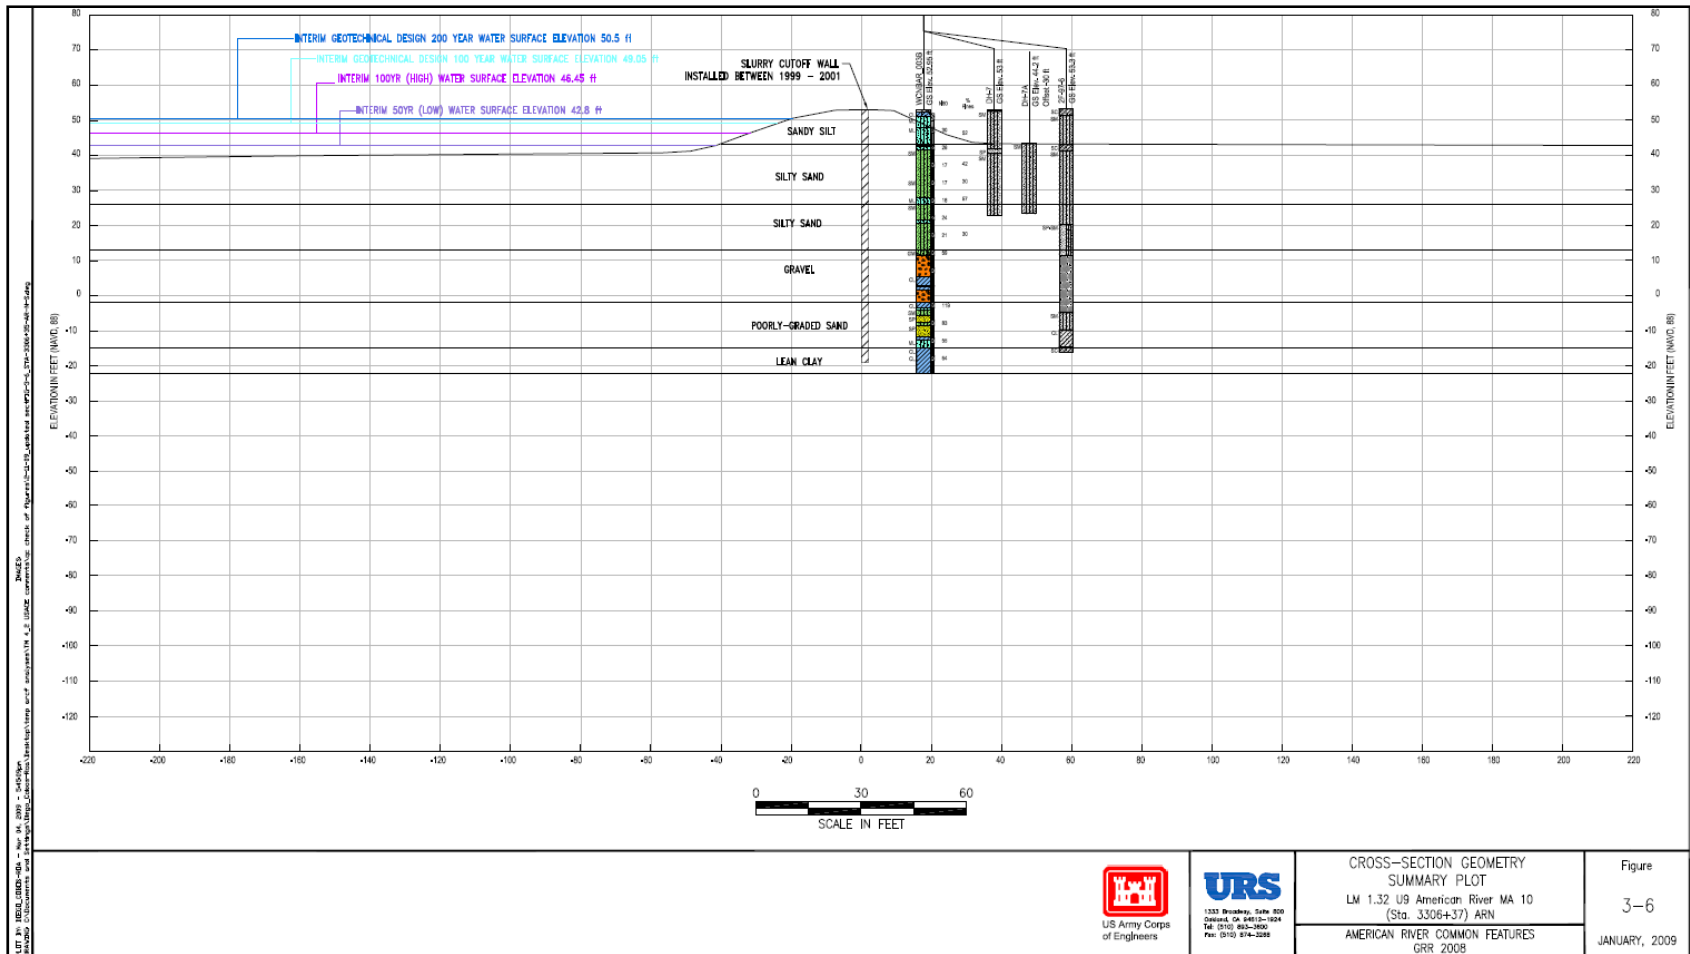
Figure 2B- 4. Close-in view of soil borings at LM 1.32, Unit 9 (RM 3306+37 of American River North levee) within American River MA 10. Source: URS, 2009.

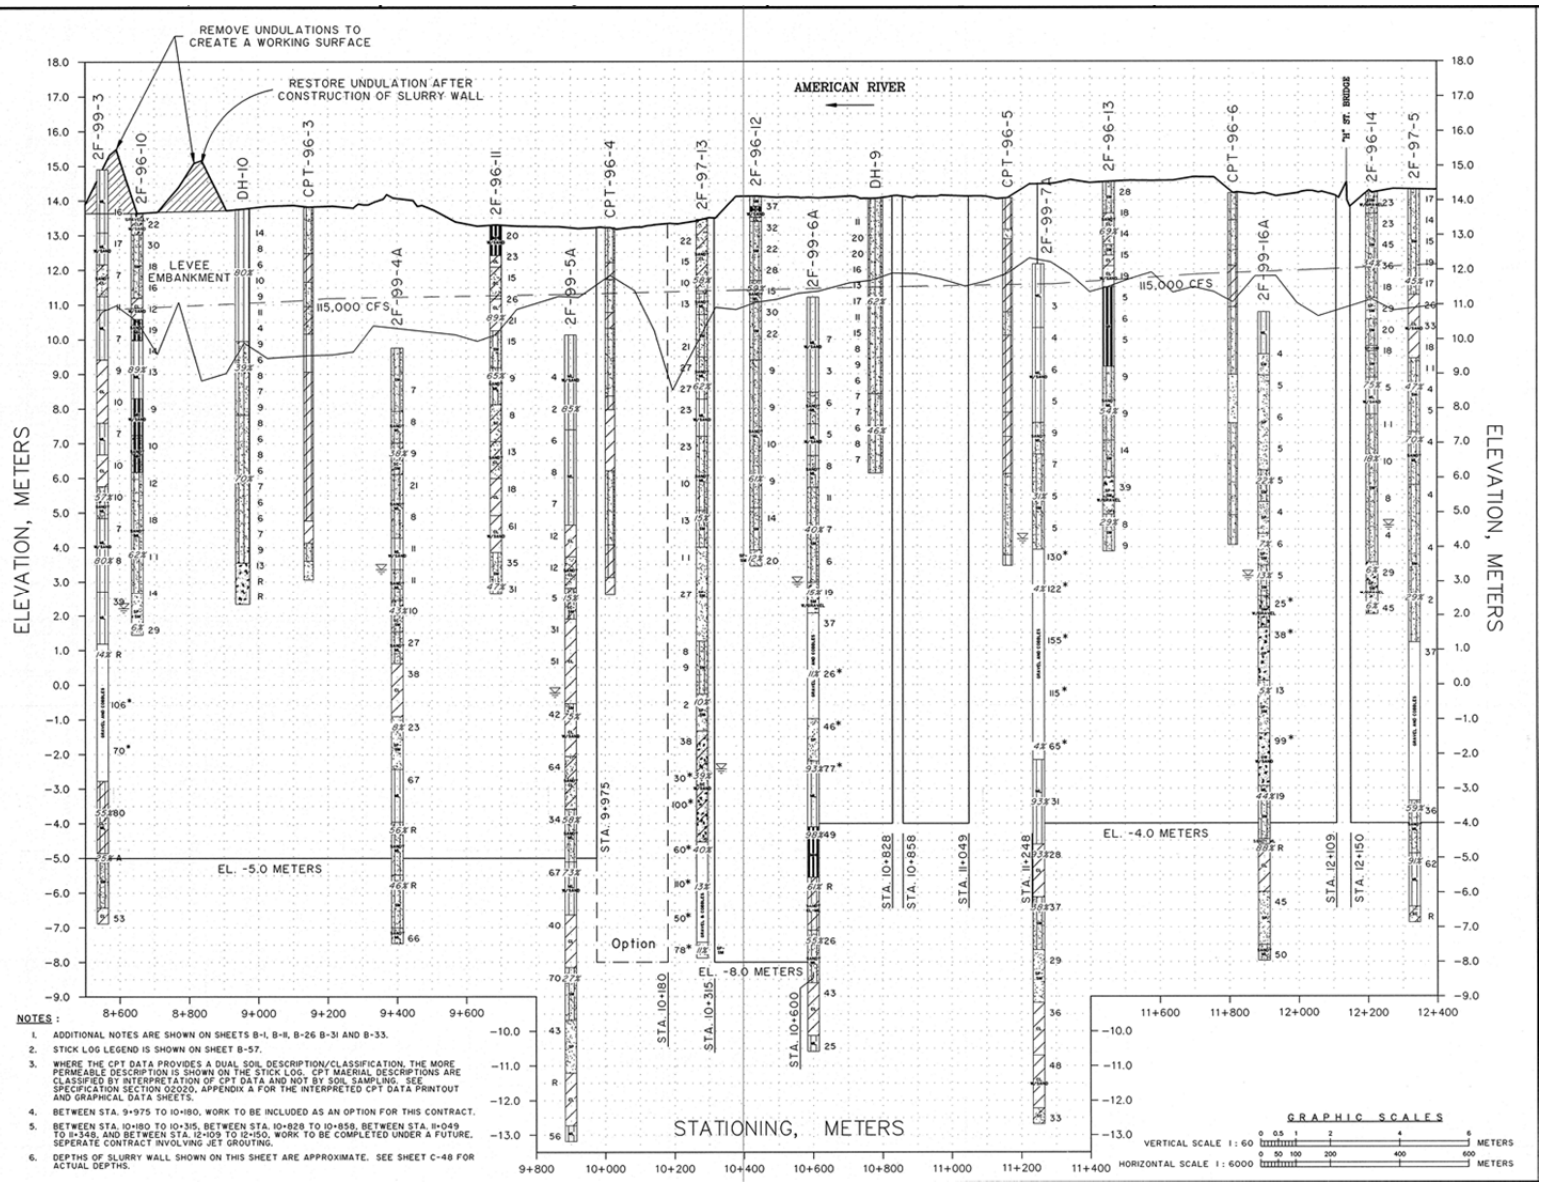
Figure 2B- 9. Profile view along levee showing available soil data. Source: USACE, 1999.

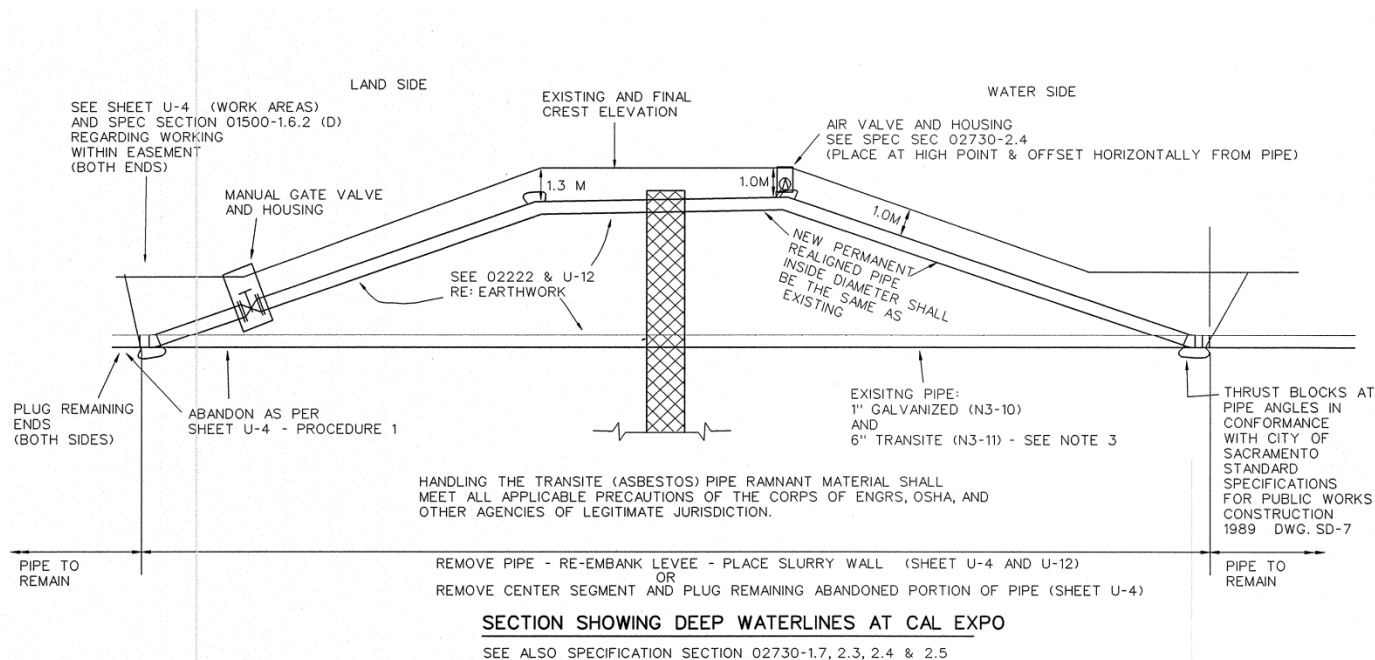
Figure 2B- 12. Notes regarding the pipeline N3-10 intersecting the study site. The pipeline is shown to be a 1 inch galvanized water line that was re-routed as shown as part of the American River Watershed Project in 1999. Source: USACE, 1999.

Utility Crossing Survey Point	Station (m)	Have As-Built	LS Levee Height (m)	Depth Below Crown (m)	diameter (in)	number of pipes/distance apart (m)	Pipe Material	Utility Type
N3-10	09+100.889		4.3	5.5	1	1	Galvanized	Water
Agency of ownership and jurisdiction					Reference to other sheets		bypass diameter if service pipe is tapped (Inches)	flow rate minimum if separate hose and pump used (GPM)
Cal Expo	SEE NOTES 4 SHT	U-6	U-6	U-4	U-11	spec 01500-1.6.2	1"	N/A
Accommodation					Confirmation Method			
COMPLETE REMOVAL OR REMOVE SEGMENTS & PLUG PIPE - RELOCATE PIPE CLOSER TO CREST					STANDARD POT HOLE PROCEDURE FROM WATER SIDE TOE

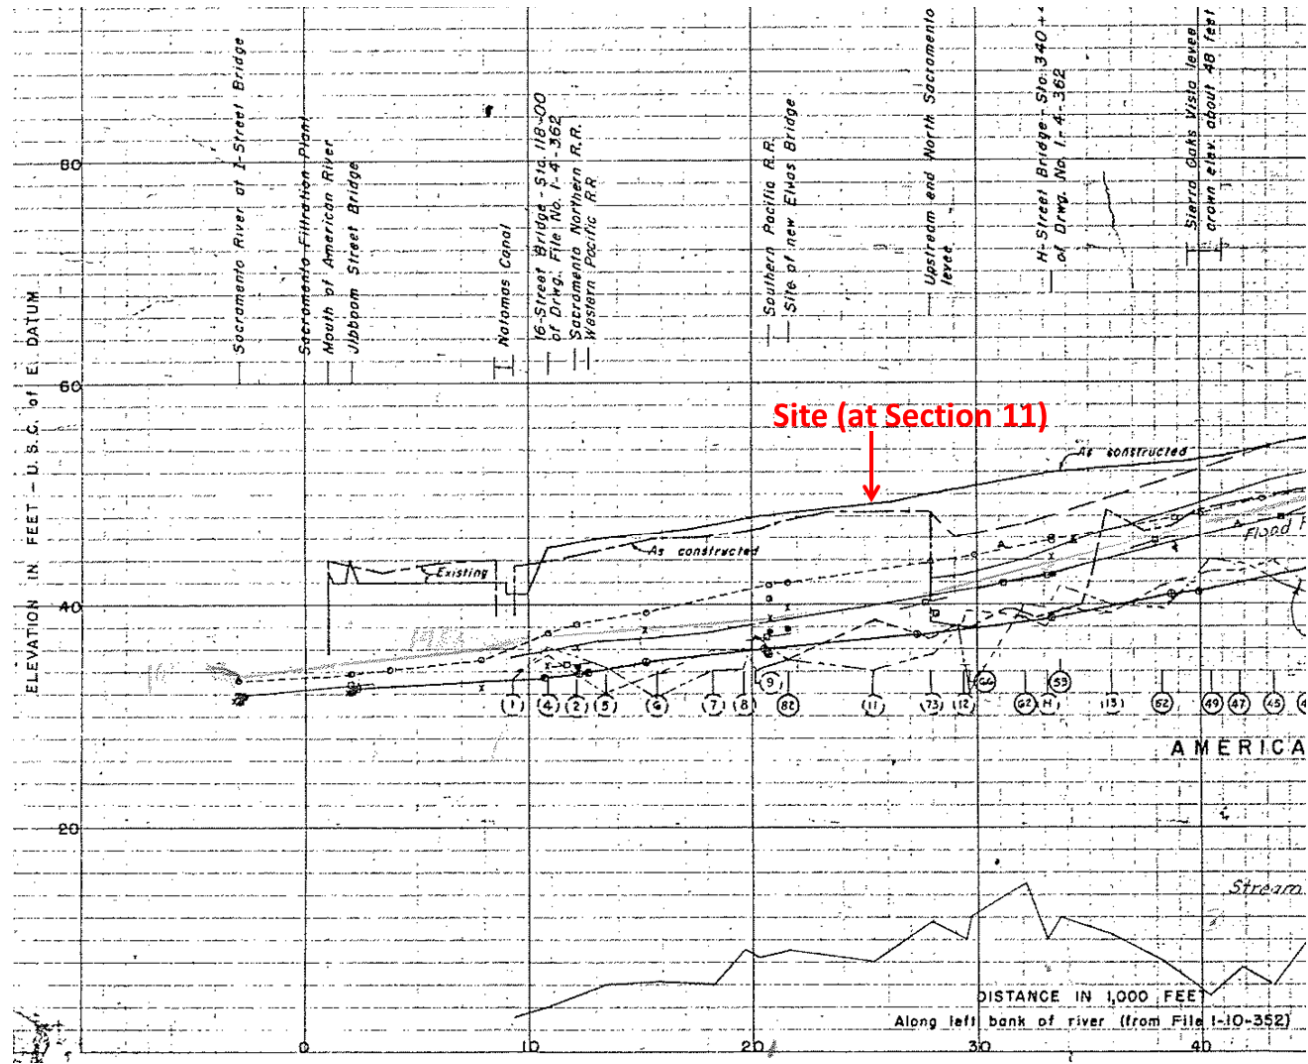
Figure 2B- 14. Cross section view along the levee showing the height existing and proposed levees at the time of the American River Levee General Design report dated June of 1956. It appears that the site, shown at section 11, was not proposed to be raised from the elevation of approximately 48.5 feet (NGVD29, or 51 feet NAVD88) as it stood at the time of the report in 1956. Source USACE, 1956.

Figure 2B- 13 and Figure 2B- 14 show a site plan and section view, respectively, of the existing and proposed site elevations at the time of the American River Levee General Design report in June of 1956.

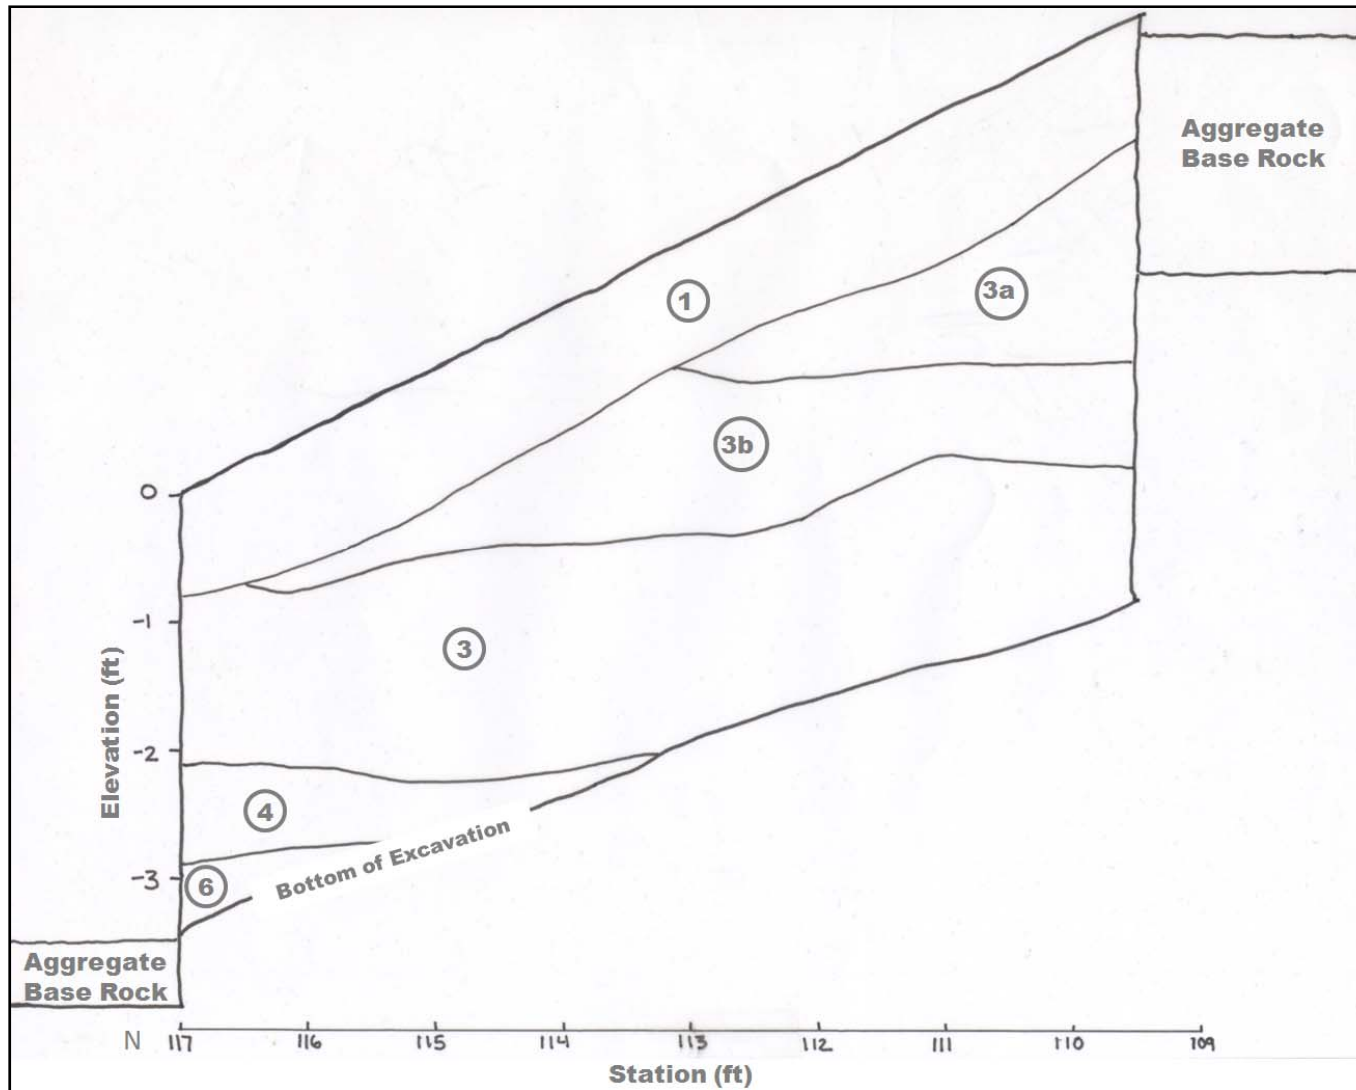
Figure 2C- 2. Trench log at Station 125 east along control trench spanning from the upper to lower trenches (Station 109.5 to 117 north). Geologic key provided on Figure D-1.
