Static and Seismic Performance of California Levees

Michelle Jennifer Shriro

Doctor of Philosophy

Engineering - Civil and Environmental Engineering

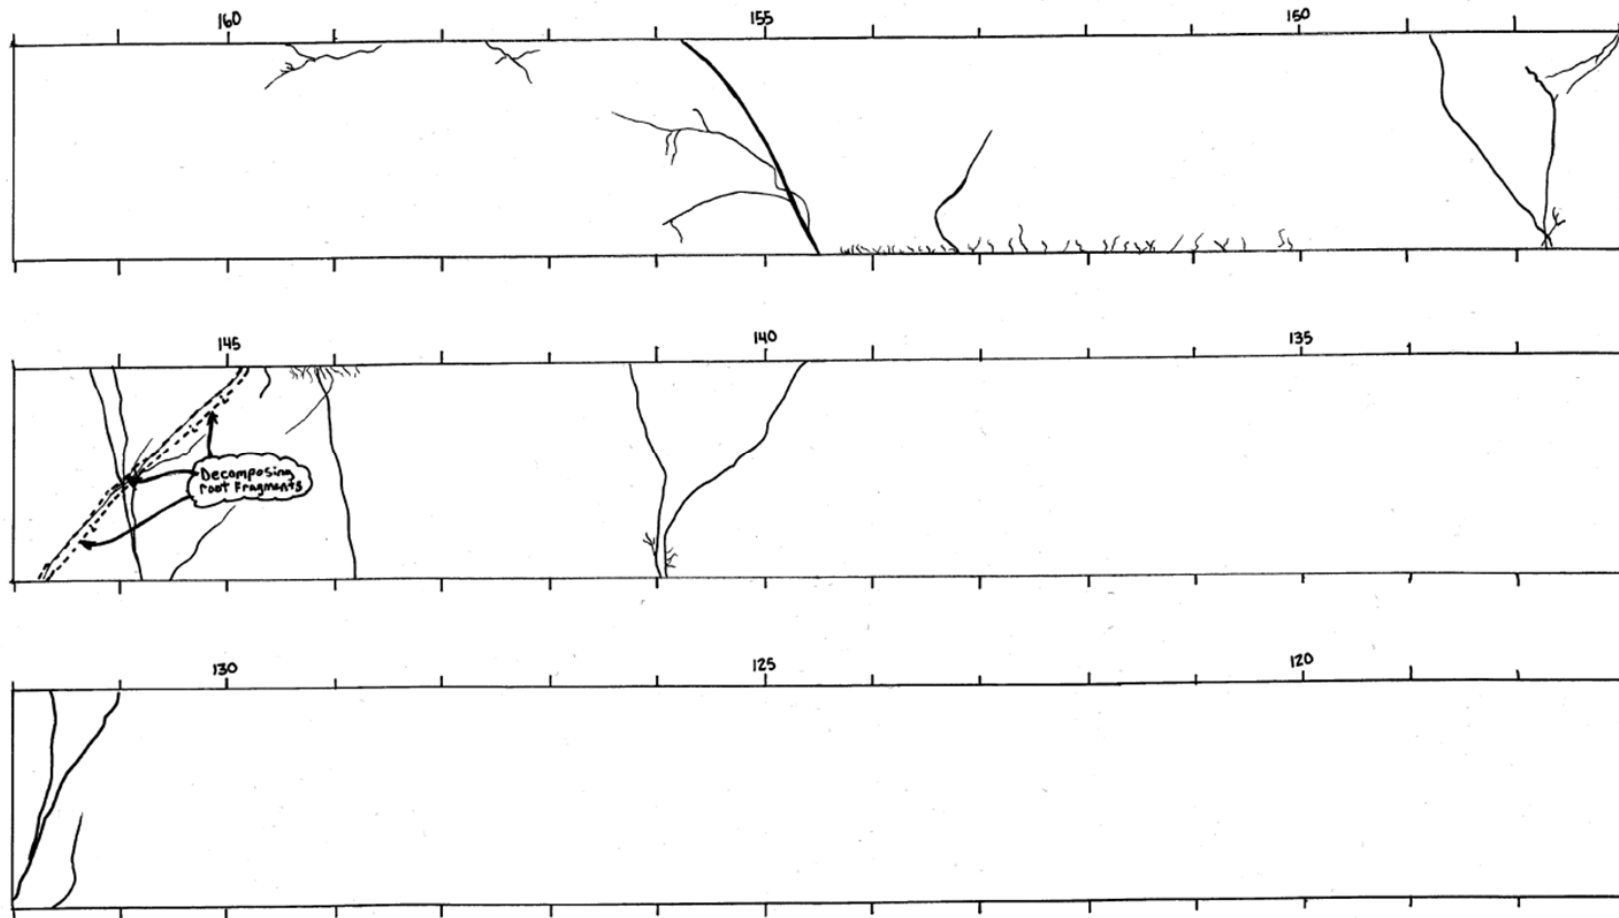
Figure 2C- 5. Upper stump and control trench plan view logs (Stations 117-162).

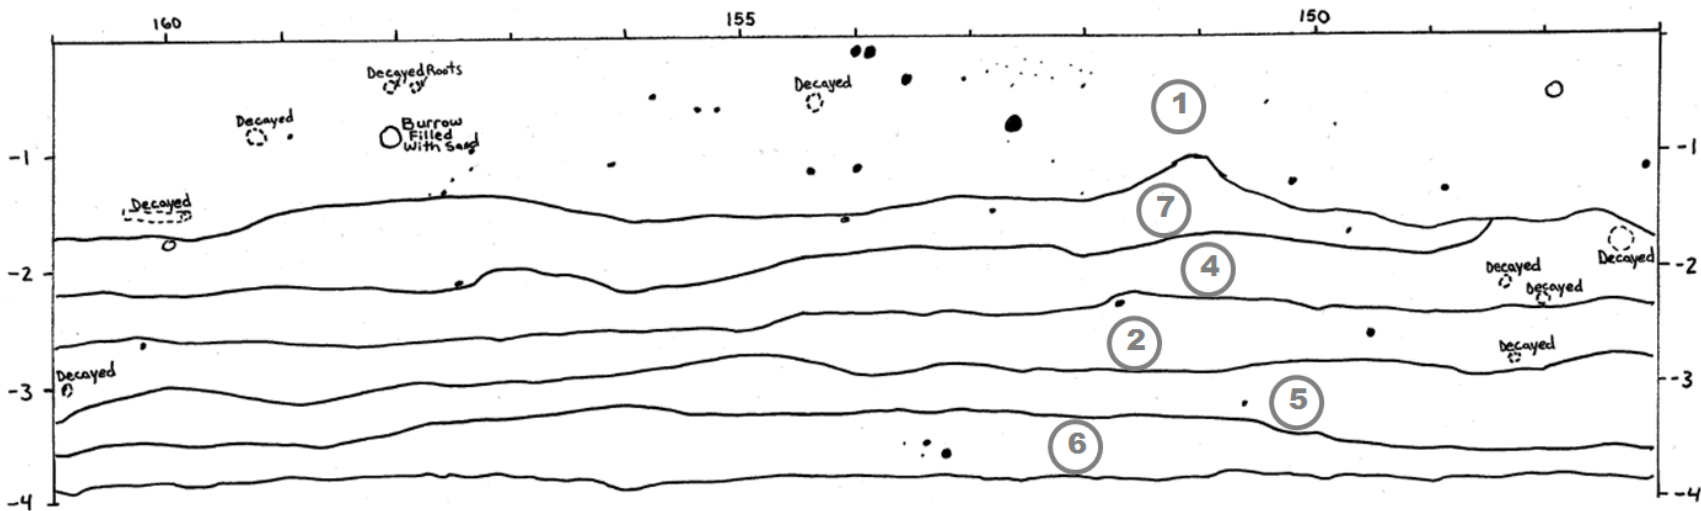
Figure 2C- 7. Log of uphill wall of the lower stump trench, Stations 147 to 161.

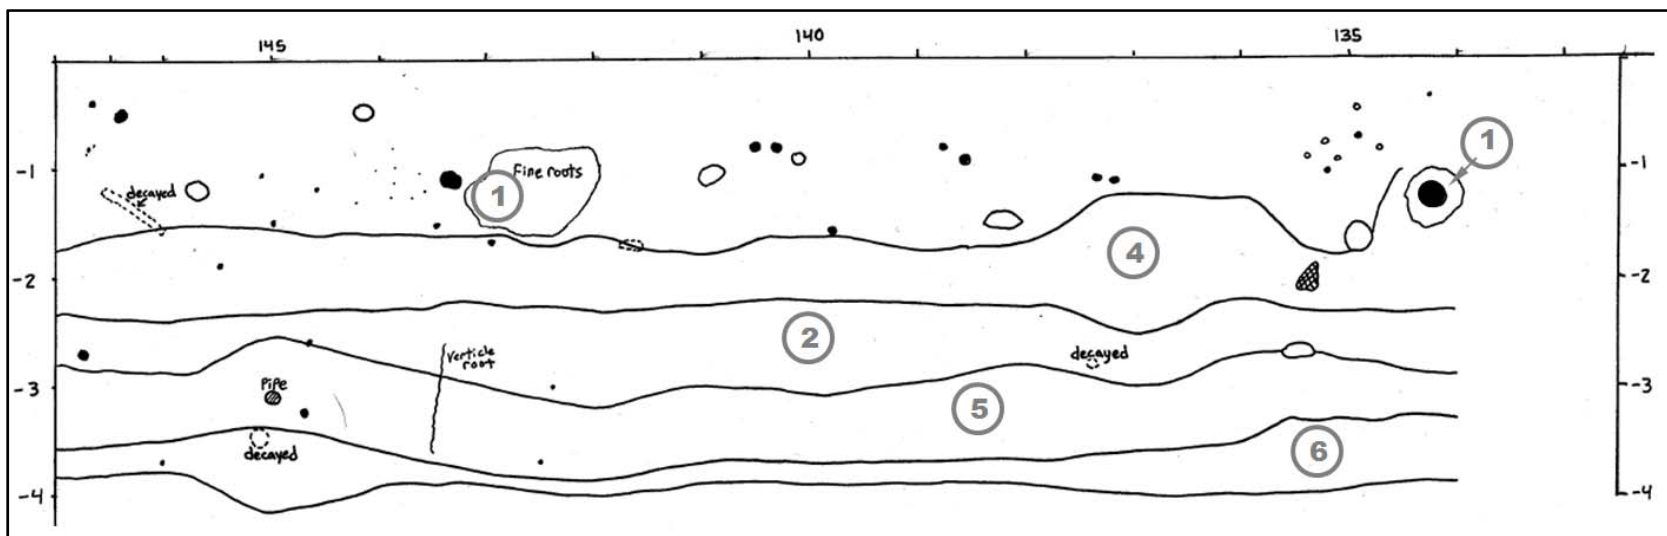
Figure 2C- 8. Log of uphill wall of the lower stump trench, Stations 133 to 147.

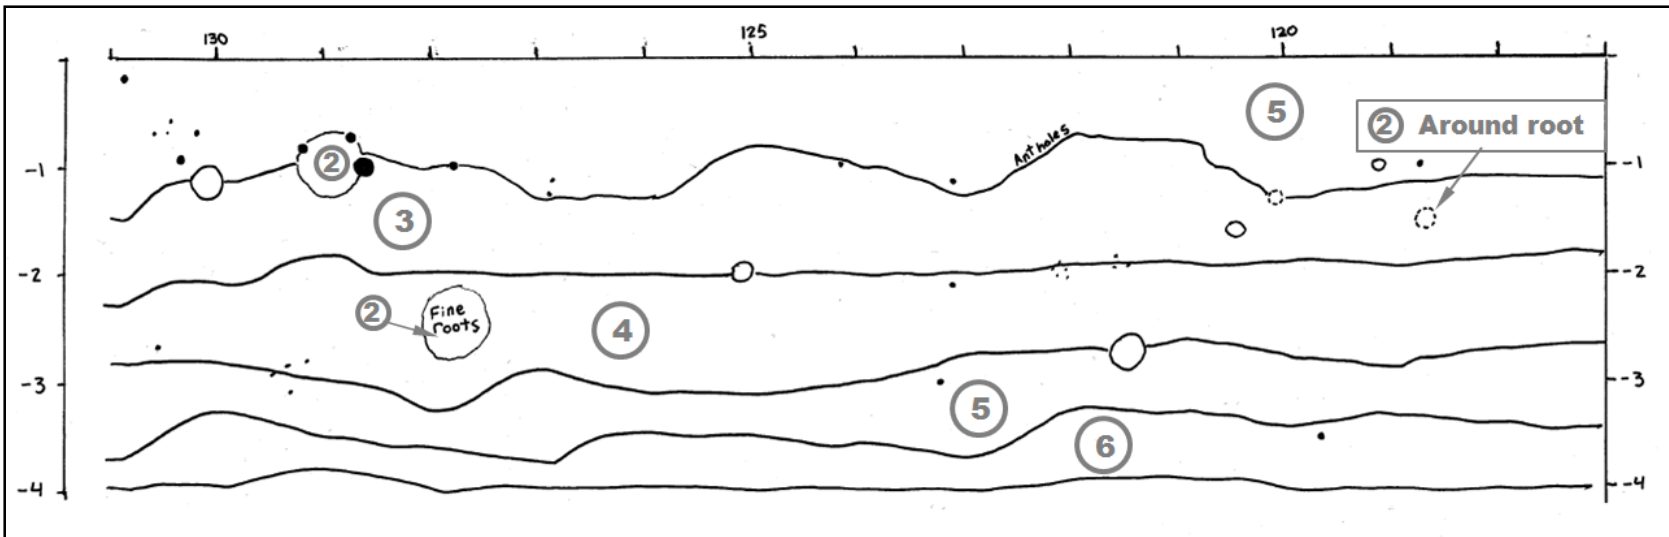
Figure 2C- 9. Log of uphill wall of the lower control trench, Stations 117 to 131.

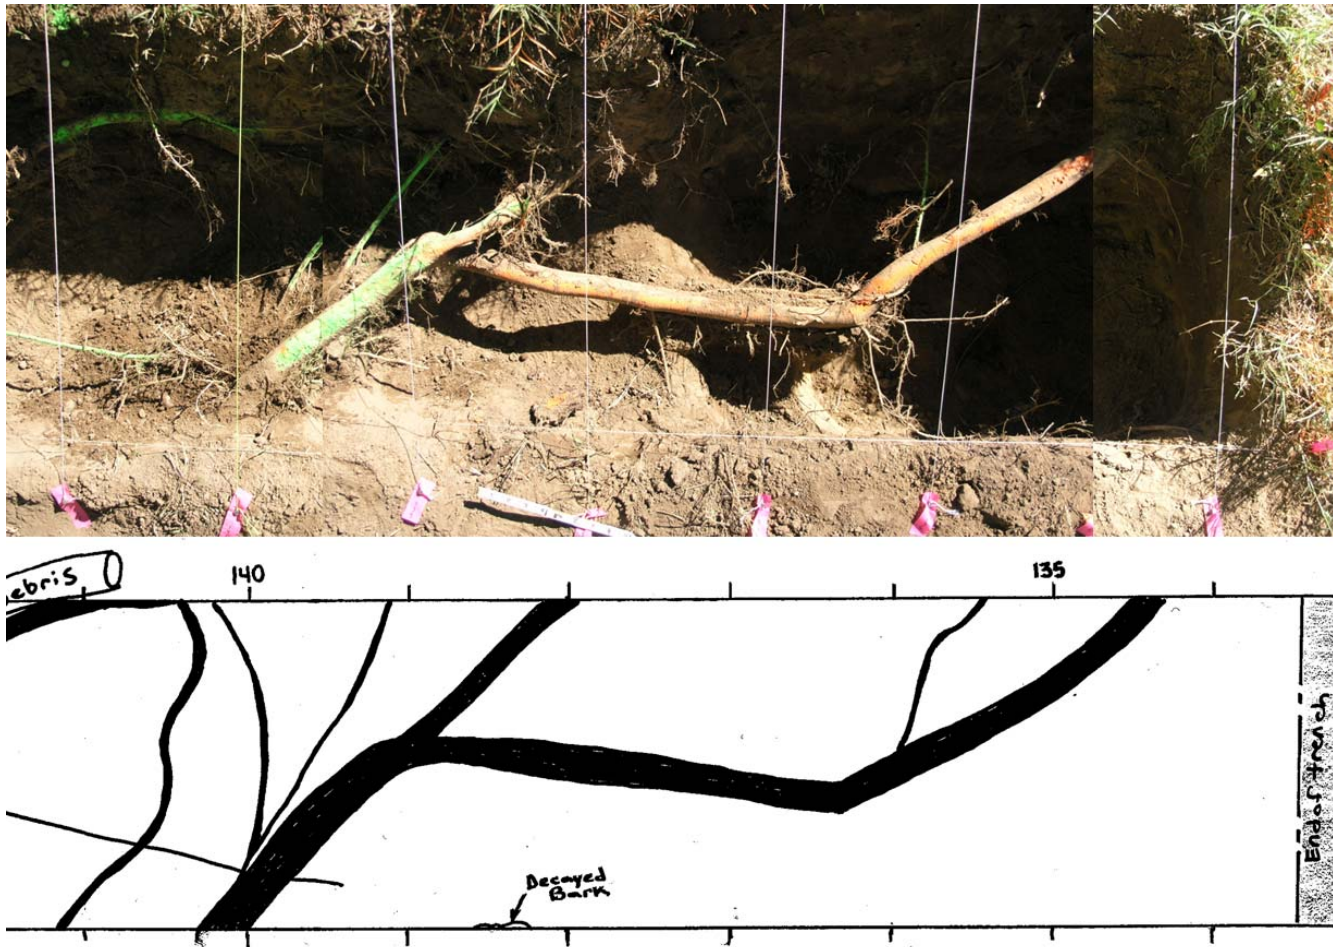
Figure 2C- 11. Lower stump trench Stations 133-141.5. Spliced plan view photos (top) during excavation of lower stump trench. Plan view log of analogous segment is below. Not all roots in the log are visible in the photograph. Additional roots may have been revealed at deeper levels.

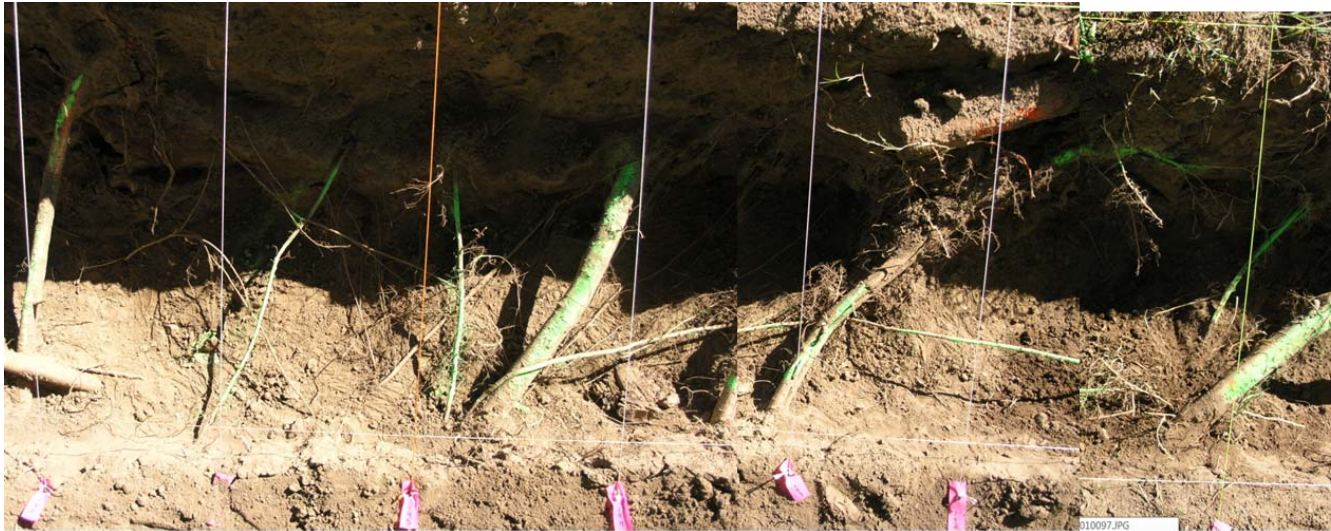
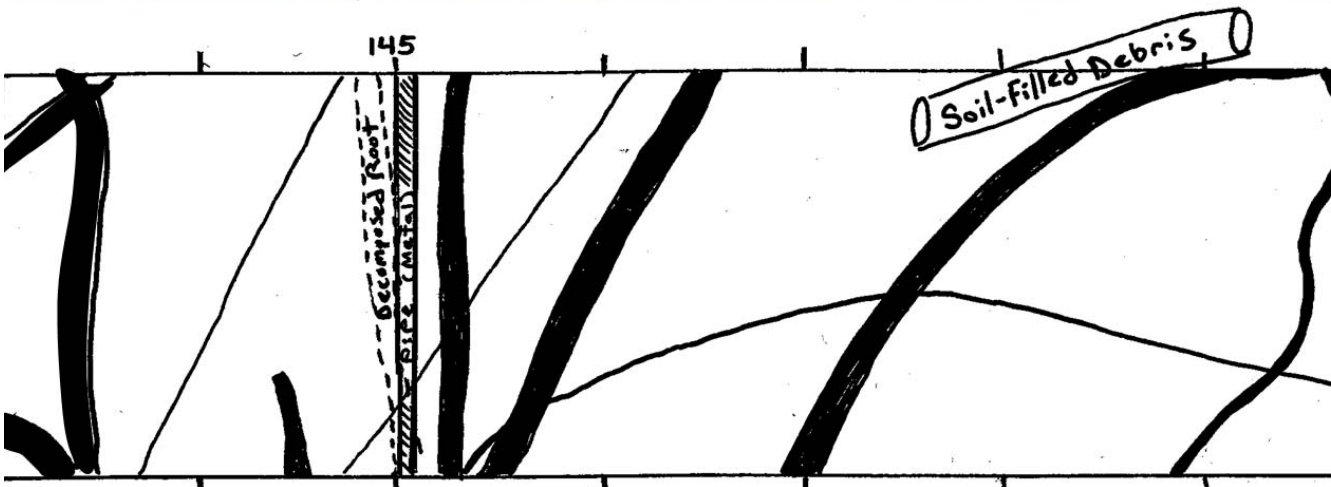
Figure 2C- 12. Lower stump trench Stations 140.5-146 (increasing to left). Spliced plan view photos (top) during excavation of lower stump trench. Plan view log of analogous segment is below. Not all roots in the log are visible in the photograph. Additional roots may have been revealed at deeper levels.

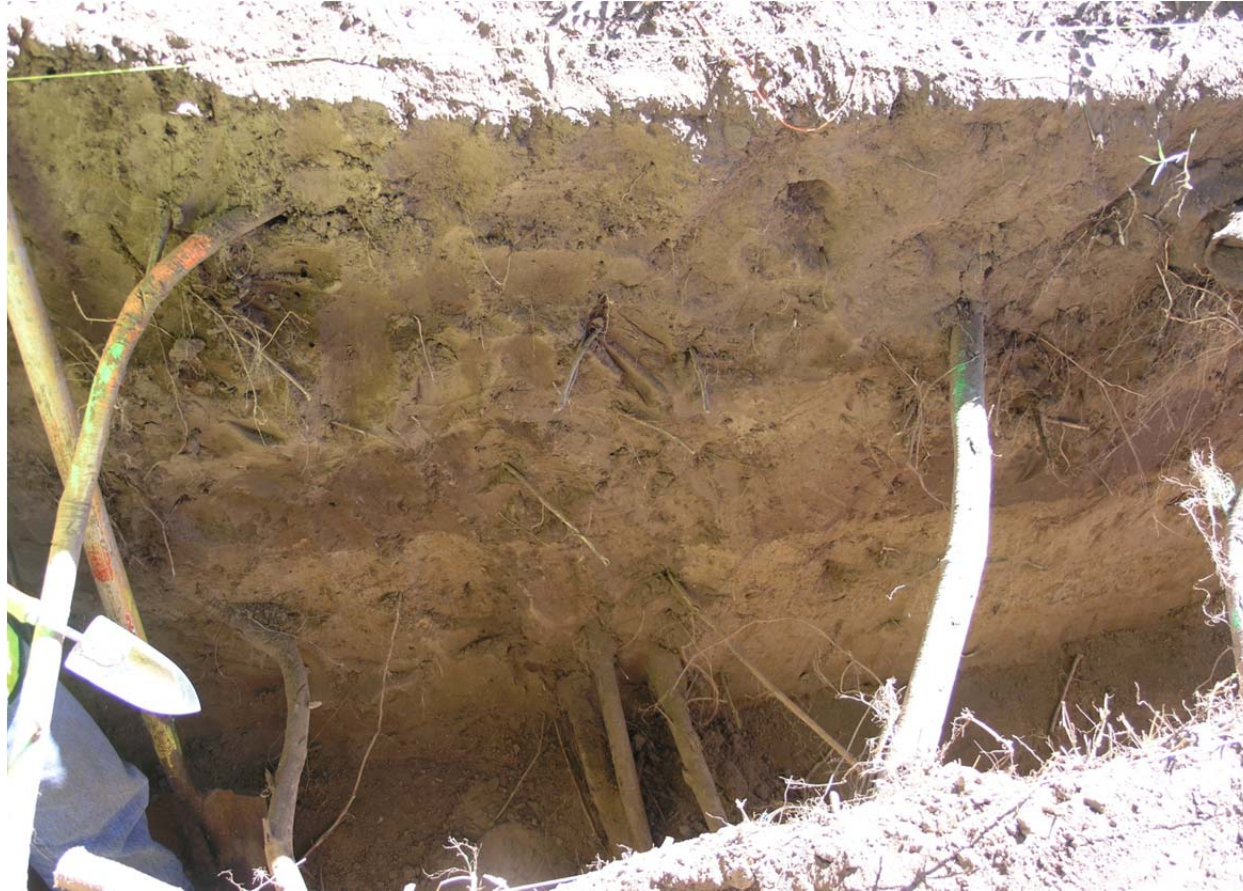
Figure 2C- 13. Stations 143 to 147 excavated to full depth and showing a cluster of decomposing and live roots as well as a 1.5 inch diameter pipe identified as a water line based on USACE documentation (USACE, 1999) as summarized in Appendix C.

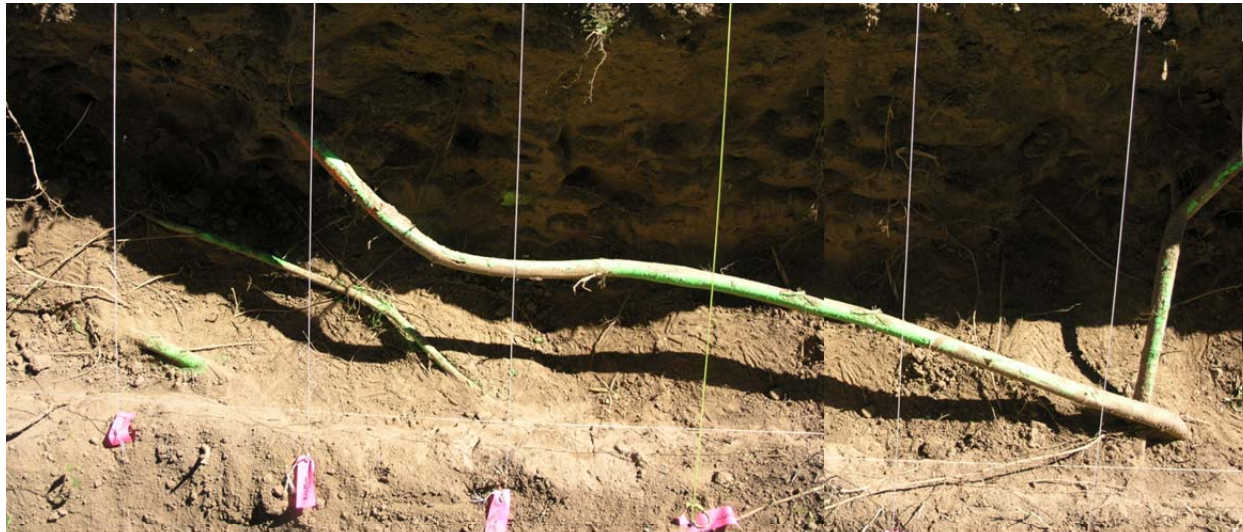
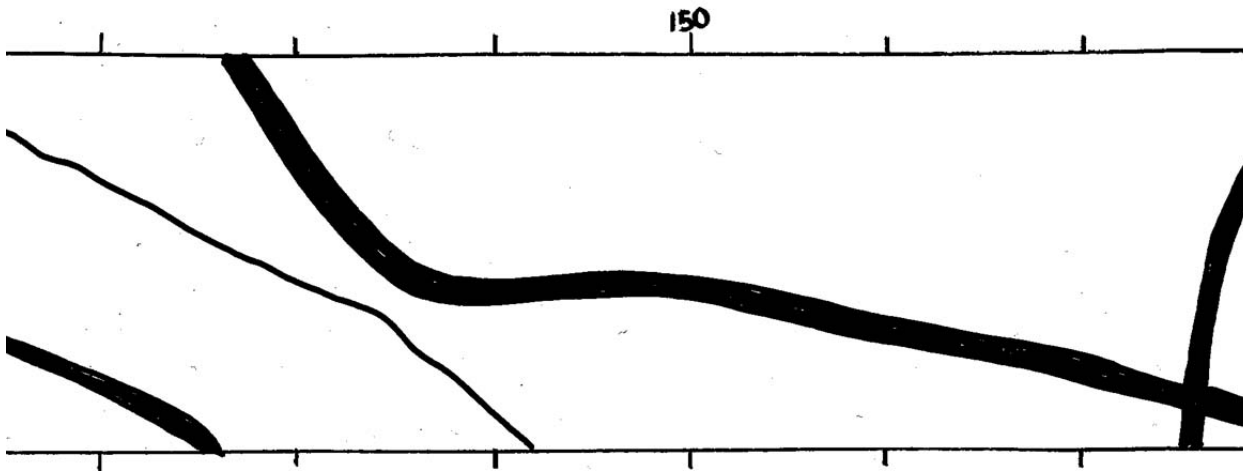
Figure 2C- 14. Lower stump trench Stations 147.5-153.5 (increasing to left). Spliced plan view photos (top) during excavation of lower stump trench. Plan view log of analogous segment is below. Not all roots in the log are visible in the photograph. Additional roots may have been revealed at deeper levels.

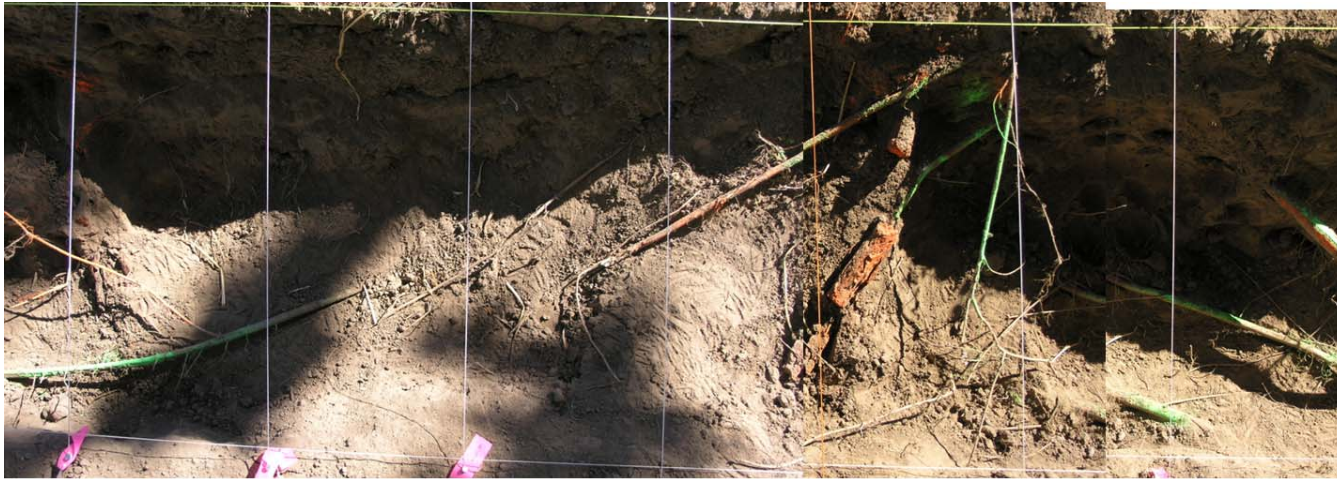
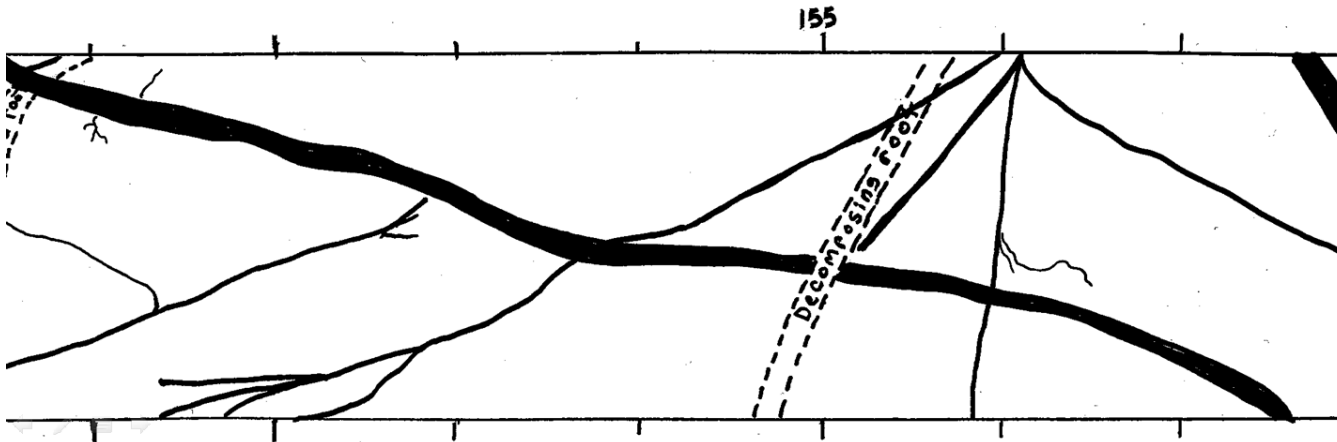
Figure 2C- 15. Lower stump trench Stations 153-159. Spliced plan view photos (top) during excavation of lower stump trench. Plan view log of analogous segment is below. Not all roots in the log are visible in the photograph. Additional roots may have been revealed at deeper levels.

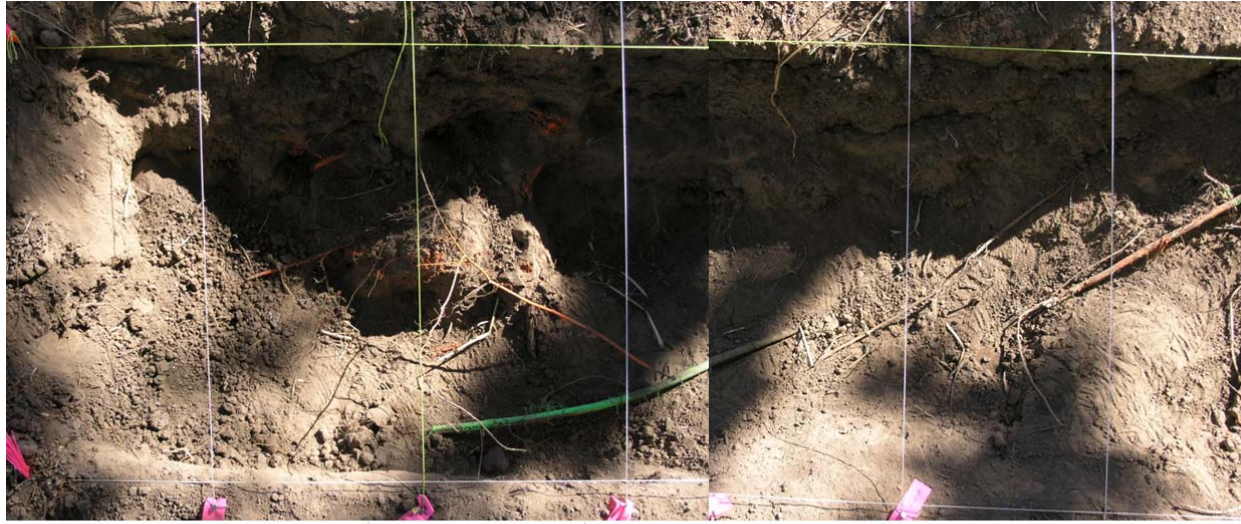
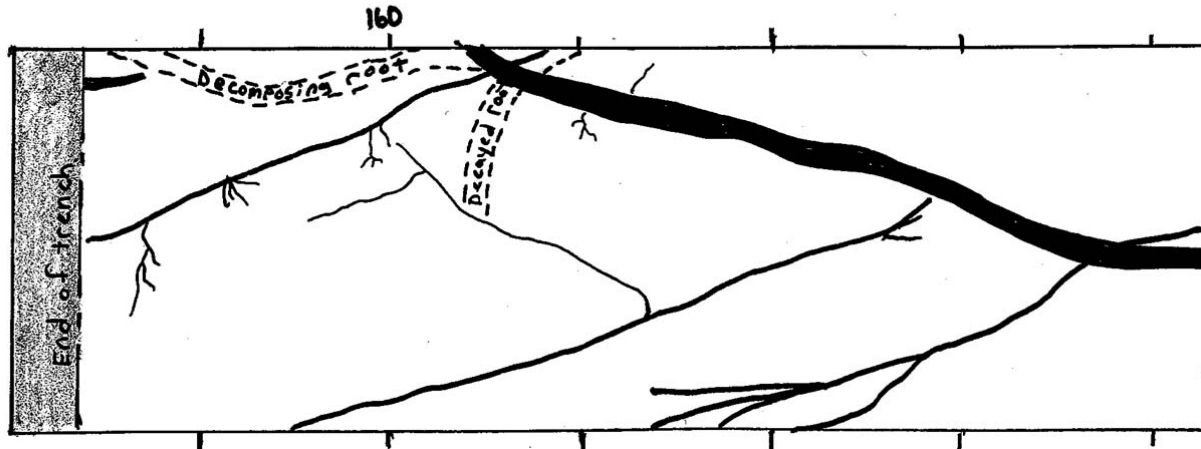
Figure 2C- 16. Lower stump trench Stations 156-161.5 (increasing right to left). Spliced plan view photos (top) during excavation of lower stump trench. Plan view log of analogous segment is below. Not all roots in the log are visible in the photograph. Additional roots may have been revealed at deeper levels.

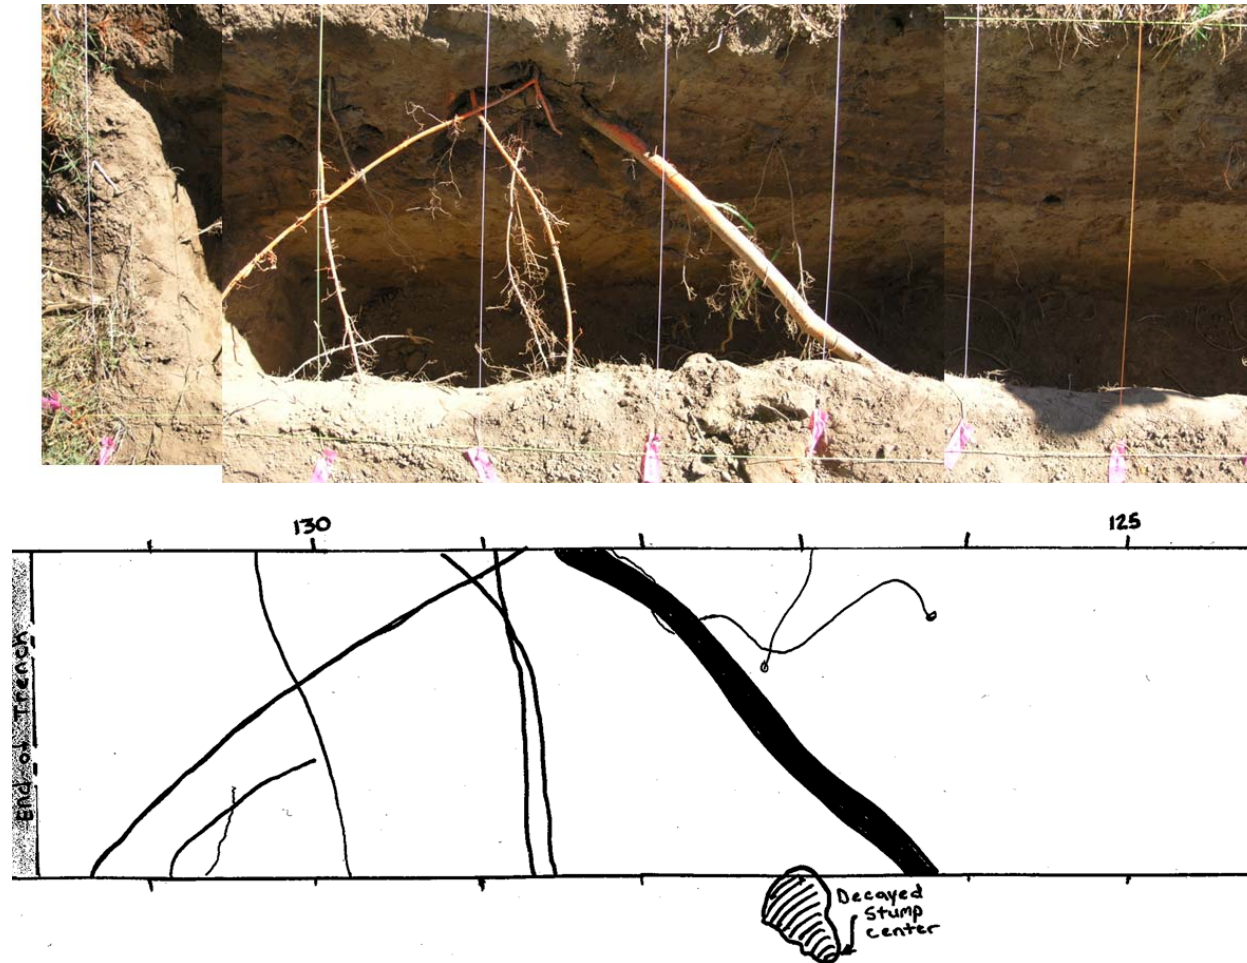
Figure 2C- 17. Lower control trench Stations 124-132. Spliced plan view photos (top) during excavation of lower control trench. Plan view log of analogous segment is below. Not all roots in the log are visible in the photograph. Shallow roots were removed as needed to achieve depth.

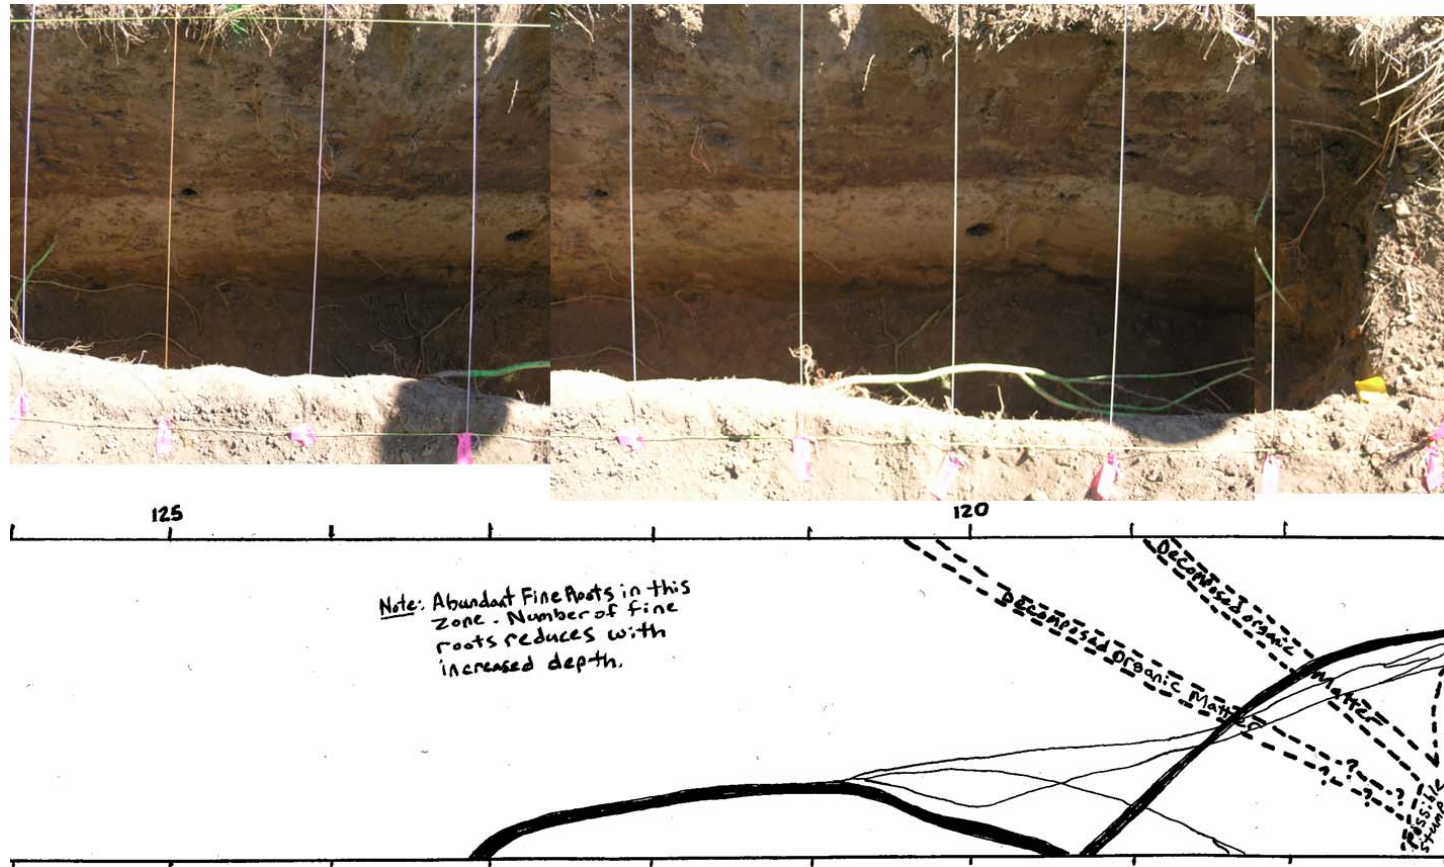
Figure 2C- 18. Lower control trench Stations 117-126. Spliced plan view photos (top) during excavation of lower control trench. Plan view log of analogous segment is below. Not all roots in the log are visible in the photograph. Shallow roots were removed as needed to achieve depth.

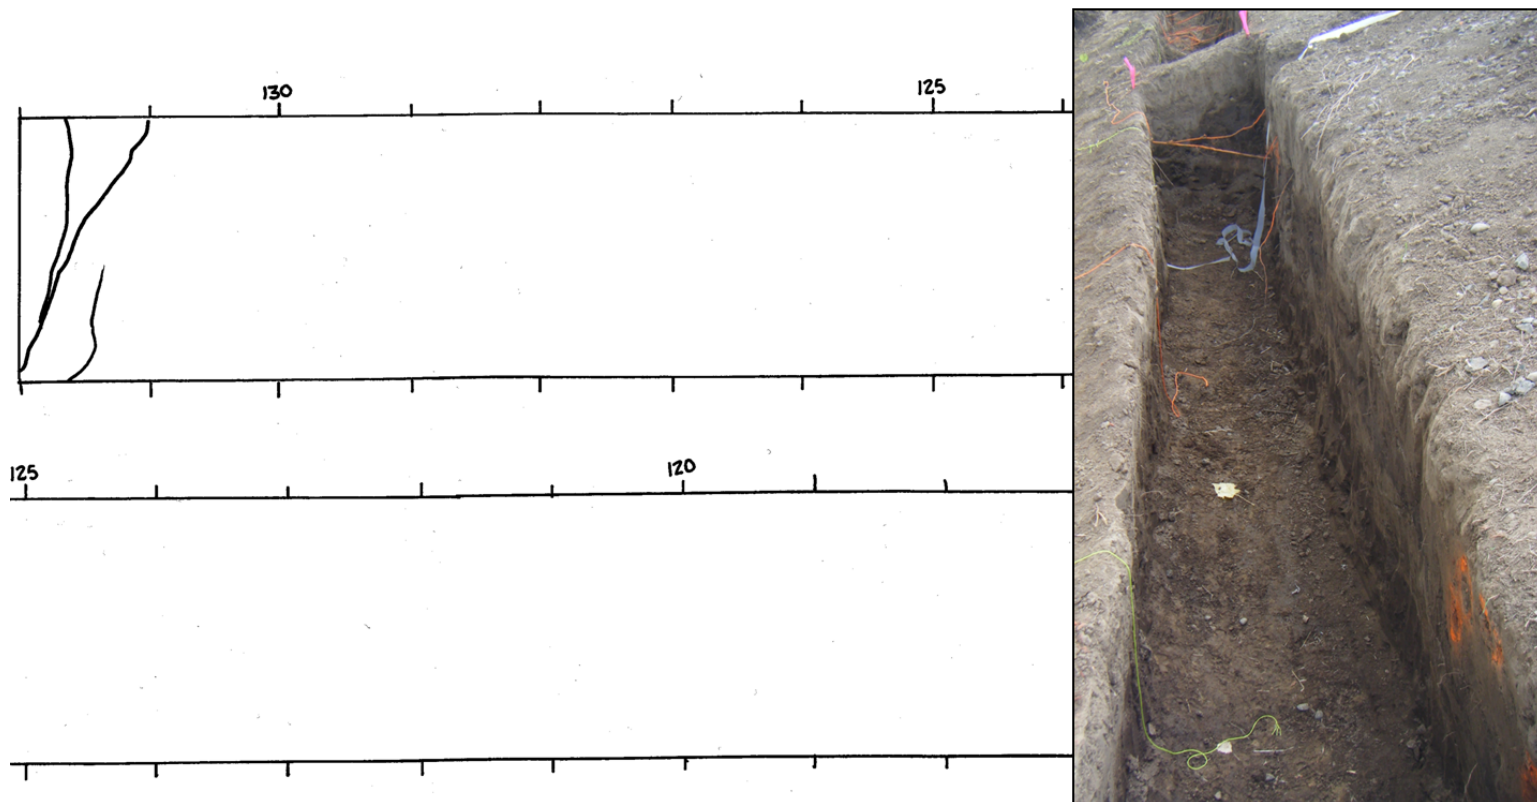
Figure 2C- 19. Photo looking east toward Station 132 from Station 118 (right) and plan view root logs (left) of upper control trench.

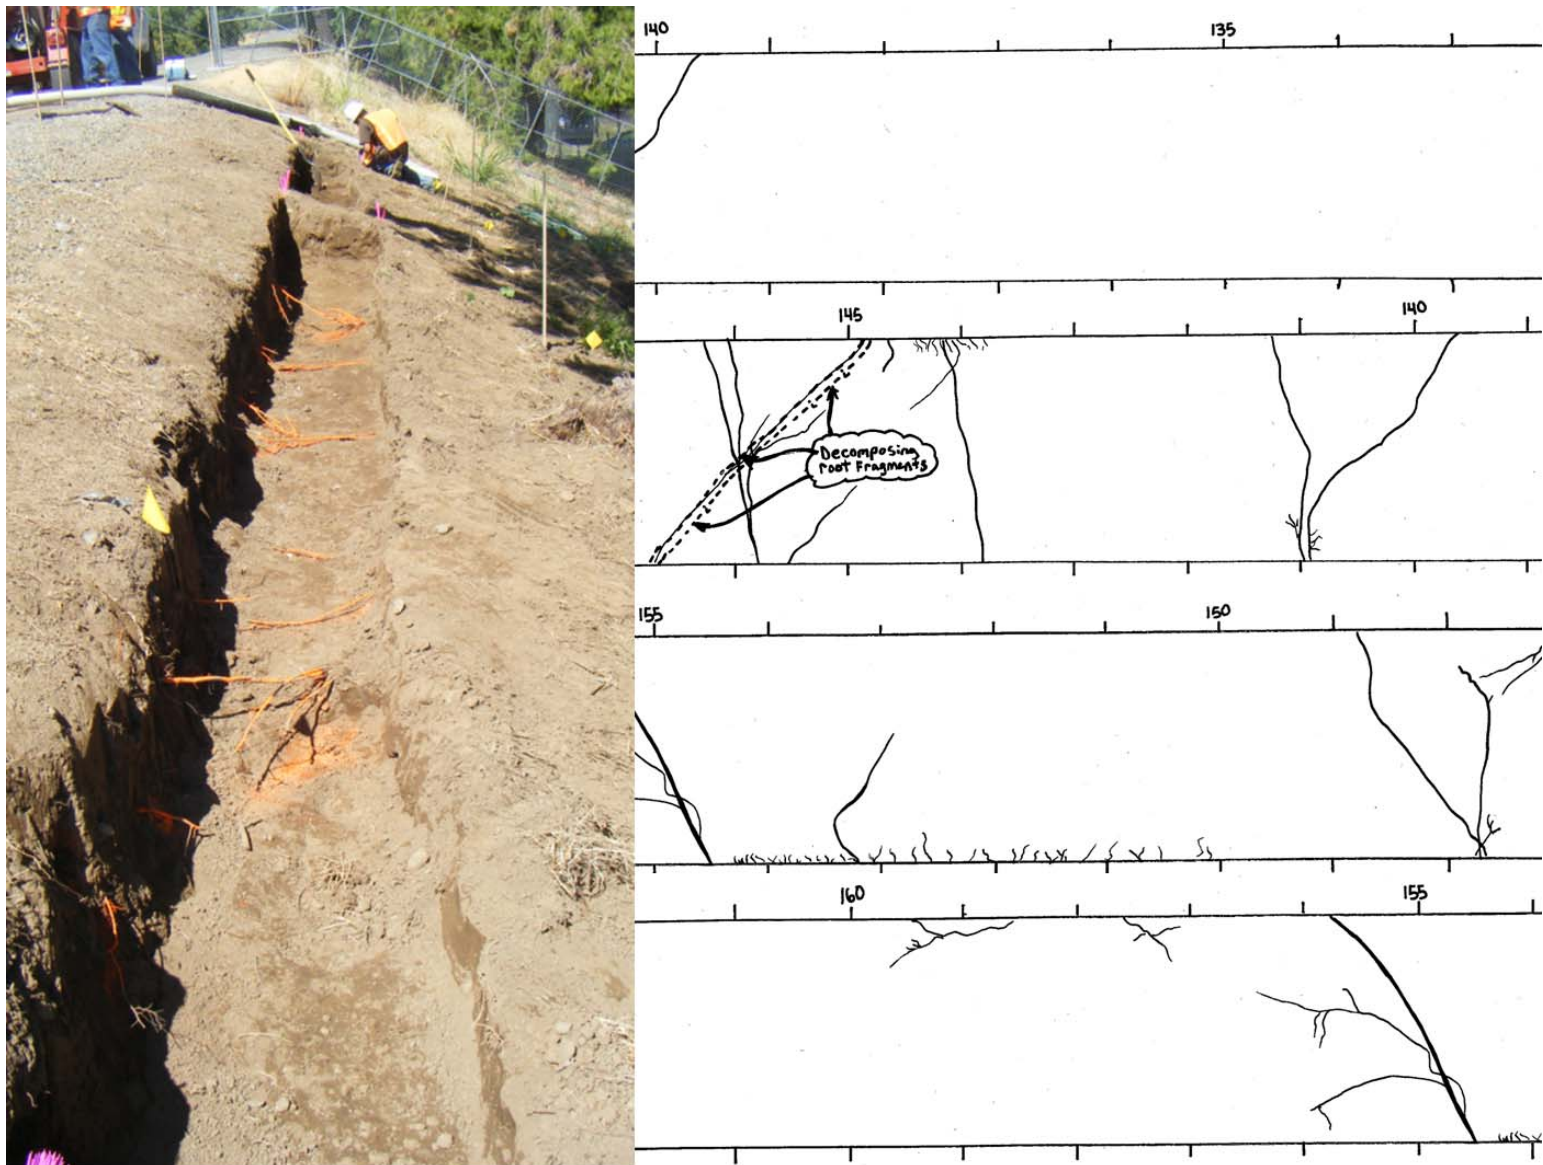
Figure 2C- 20. Photo looking west (left) and plan view logs of roots (right) of upper stump trench.

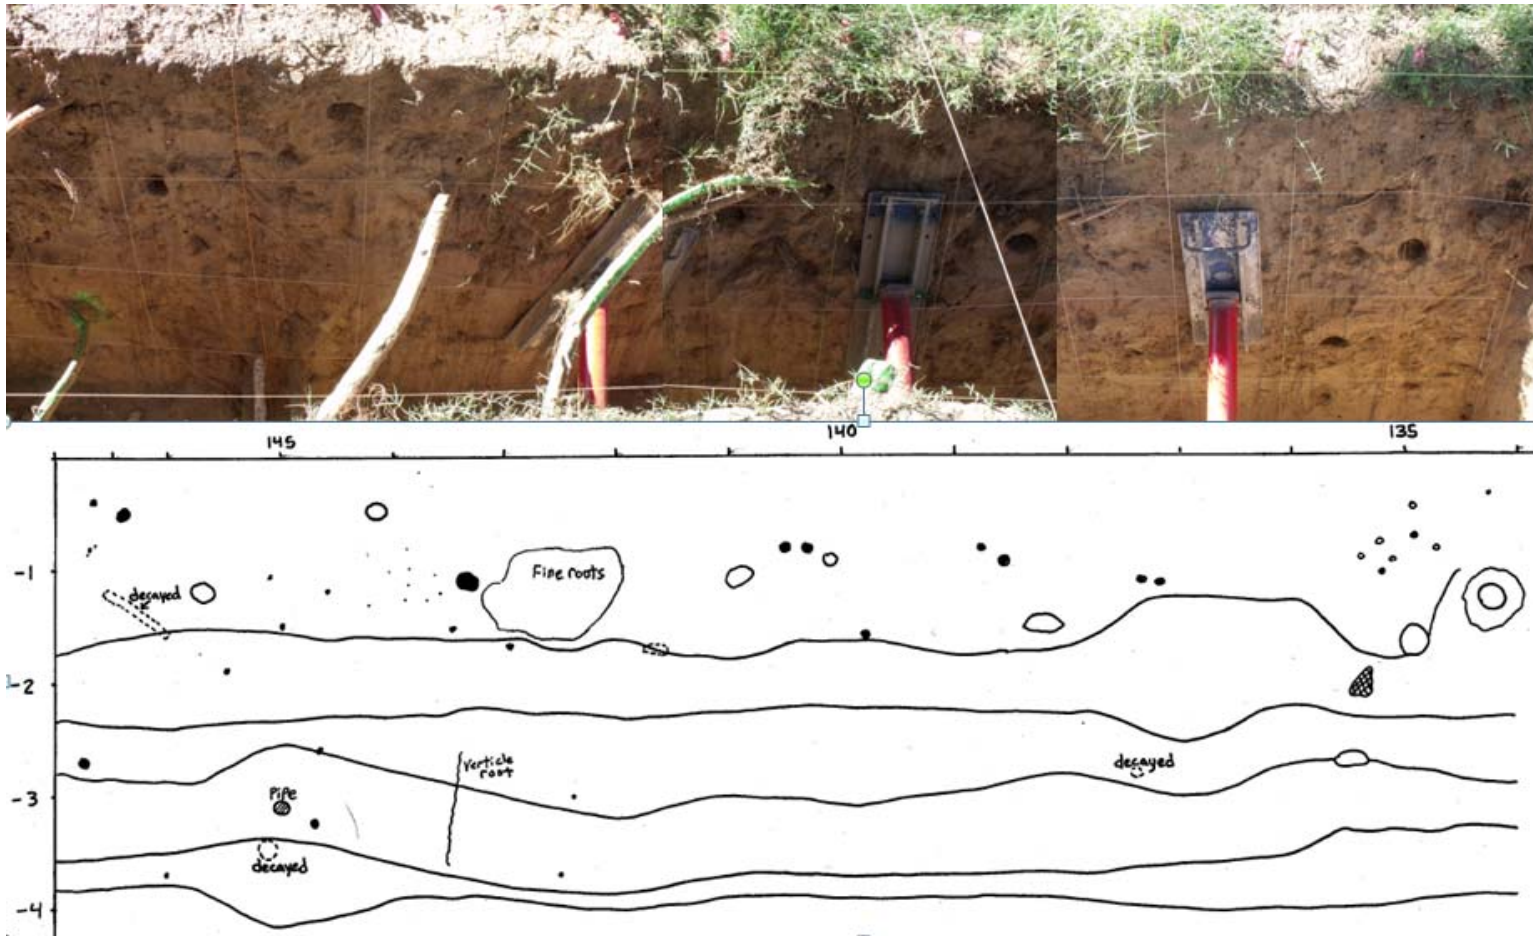
Figure 2C- 21. Spliced photos looking south (top) and analogous uphill wall log (bottom) of lower stump trench Stations 134-147.

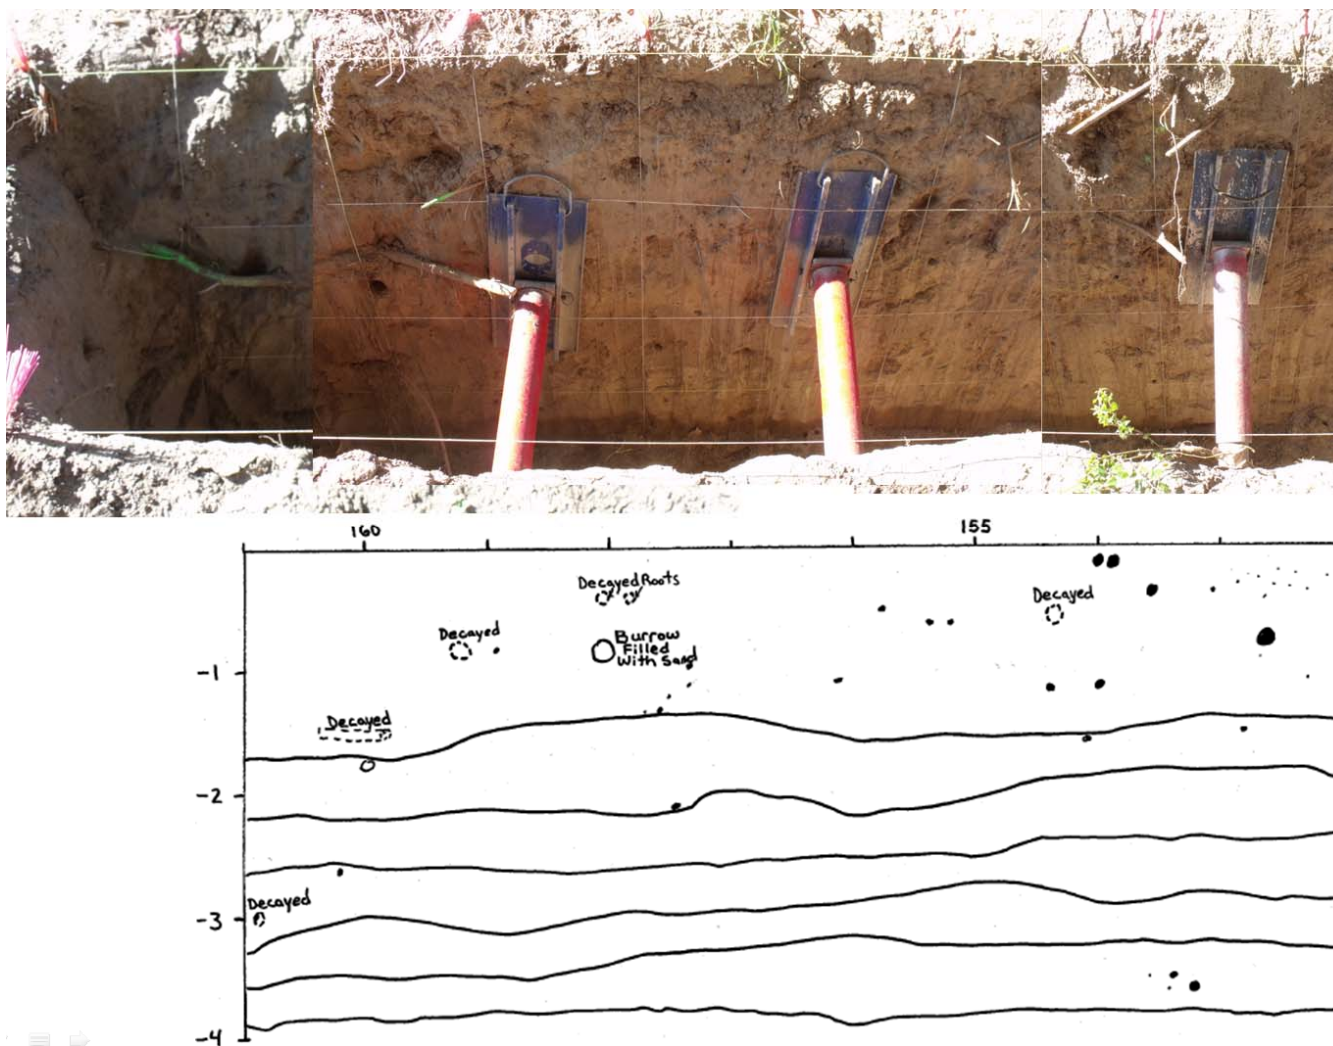
2C-23

Figure 2C- 23. Spliced photos looking south (top) and analogous uphill wall log (bottom) of lower stump trench Stations 152-161.

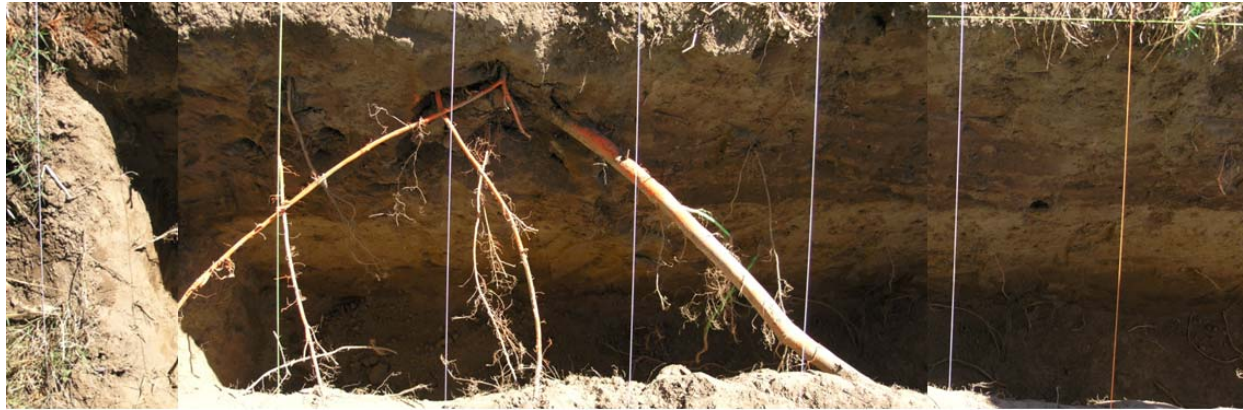
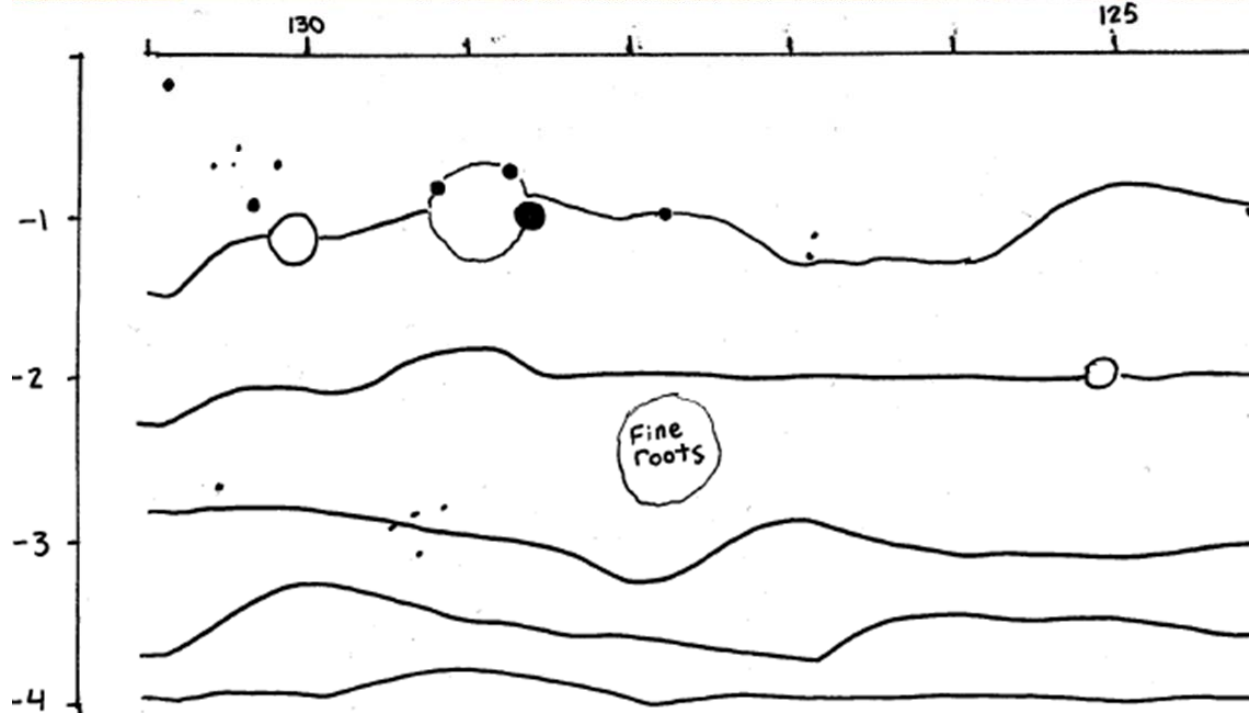
2C-24

Figure 2C- 24. Spliced photos looking south (above) and uphill wall log (below) of lower control trench Stations 124-131.
